Select Inspect

PROPERTY INSPECTION REPORT

10777 Freedom

Tuesday, December 18, 2007

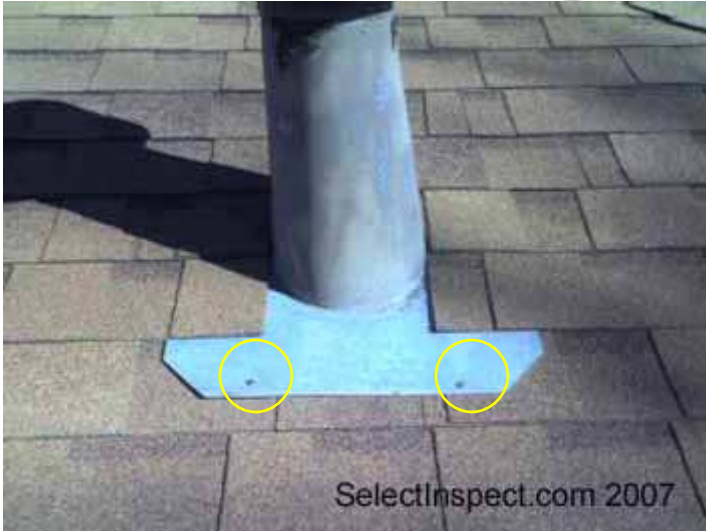
- Leakage condition exists at the furnace flue.
- Open-faced (uncaulked) fasteners were seen at roof vents. Though technically incorrect this is commonly found, even on new homes. This is a relatively inexpensive item to correct, and the need for immediate corrective action is subjective and a matter of personal preference.
- Furnace flue cap was rusted and had some small corrosion holes.
- NOTE: repair evidence was implied by tar-like sealant at chimney flashing, plumbing vents, flues, and turbines. The Texas Real Estate Commission requires notation of repair evidence found regarding roof components. This is not necessarily a repair statement. Refer to the seller's disclosure for possible information regarding this item.

↑ uncaulked fasteners at roof- example

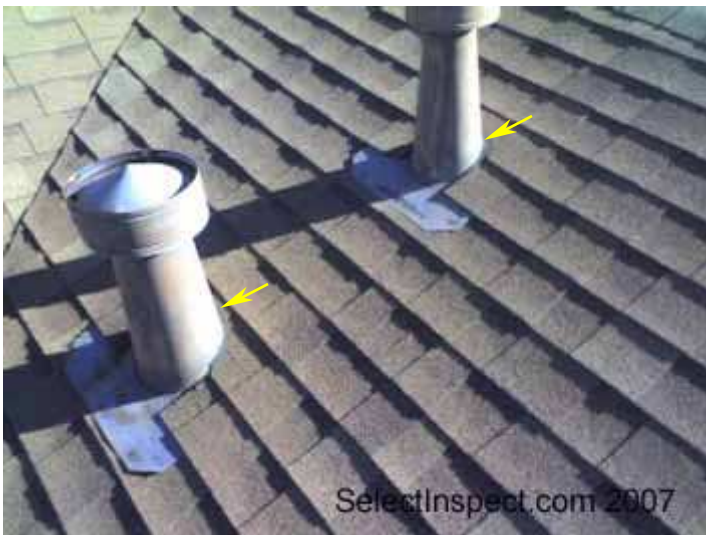
↑ tar repair at flues- example

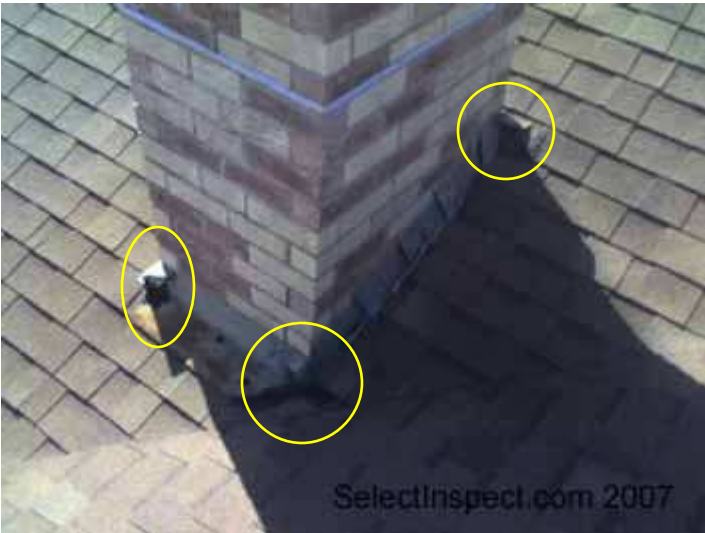
↑ tar repair at chimney flashing

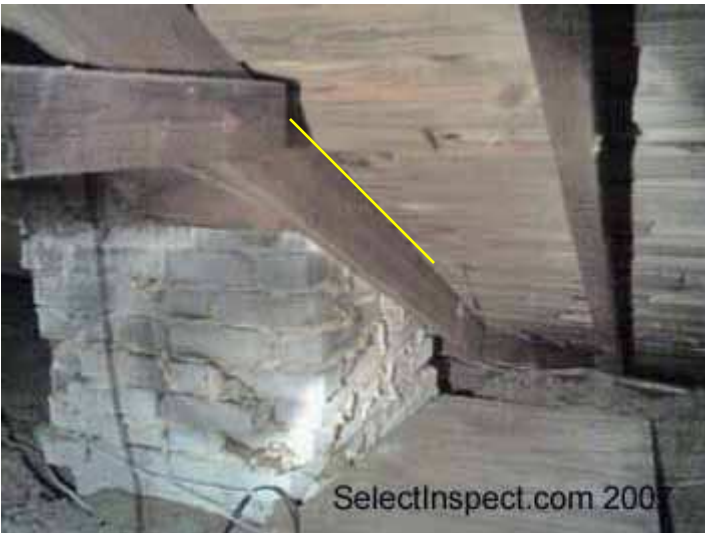
- Moisture staining/evidence was discovered at the furnace flue and chimney.

↑ moisture staining/evidence at chimney – attic

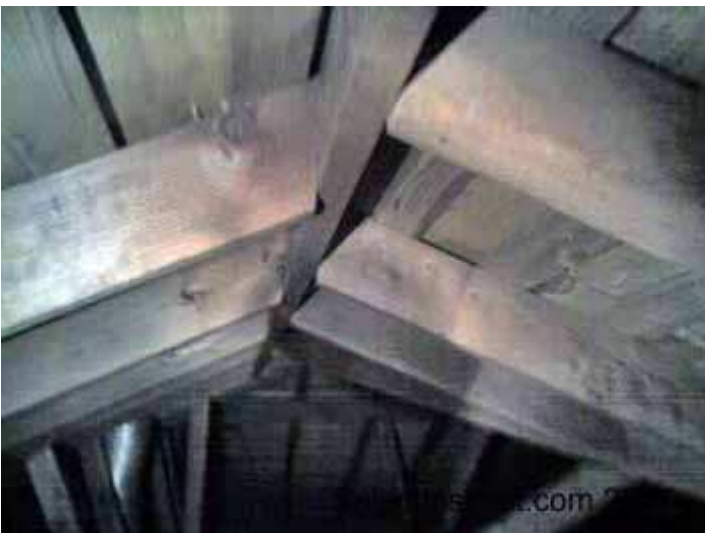
- Some rafters are offset at the ridge. This is not as stable as rafters set directly adjacent each other.
- Ridge rafters are smaller than the cut end of diagonal rafters. This is sometimes referred to as "undersized ridge" The condition is common on older homes and the concern is that this method is not as strong as a deeper ridge that can support the entire depth of the rafter(s). Immediate repair needs were not discovered at the time of inspection; Monitor this item periodically and maintain as needed.

↑ offset rafters and undersized ridge example in attic

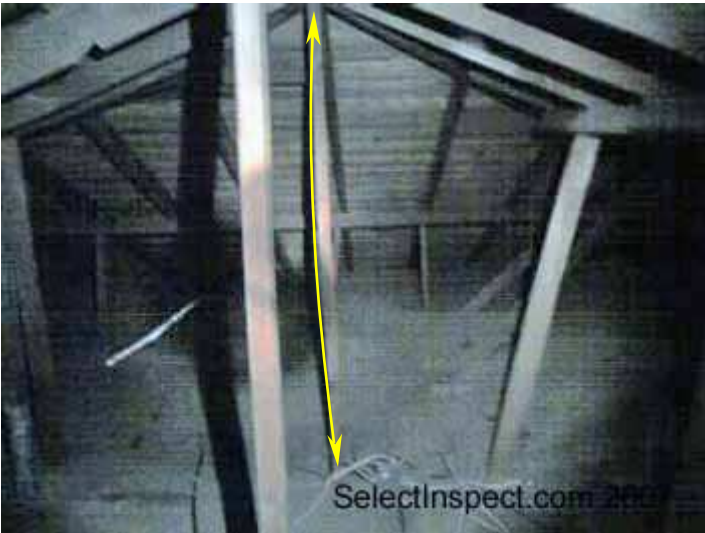
- "T-bracing" was amiss / deficient at vertical framing. Deflected struts were noted in related area(s). Recommend considering correction/improvement of the conditions. Technically, 6 foot or longer struts that are 45 degrees or more should be "T" braced for added strength.

↑ "T backs" not present and deflected struts in central east attic

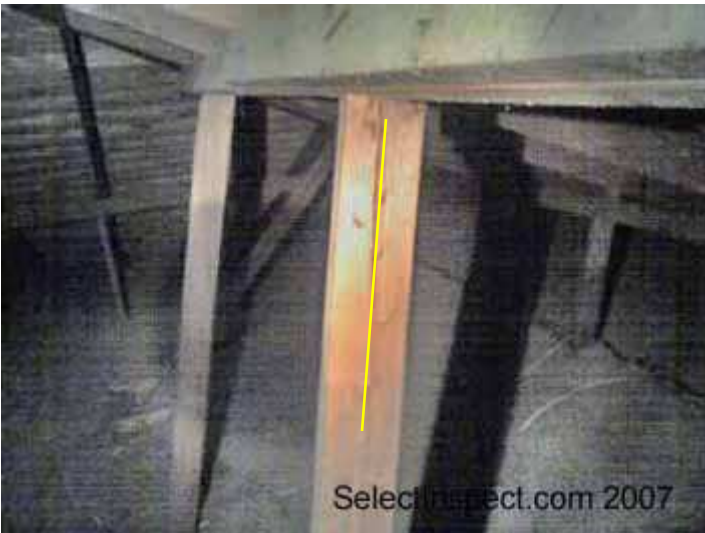
↑ cracked strut at south-southeast attic

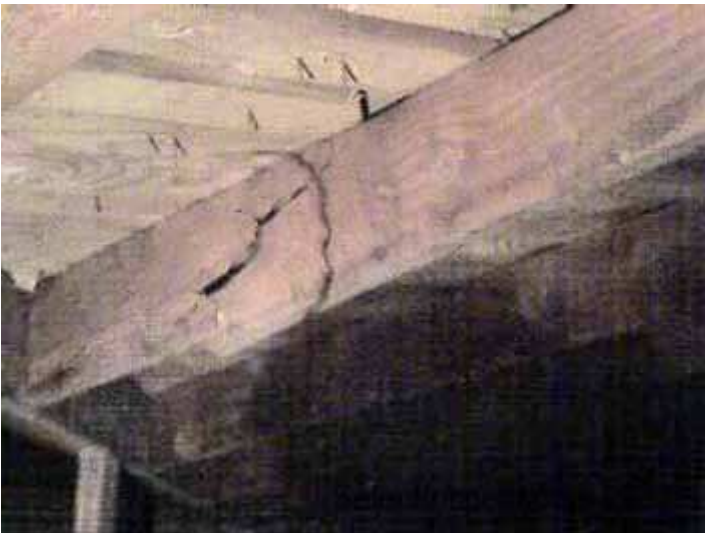
↑ failed rafter at northeast attic –left

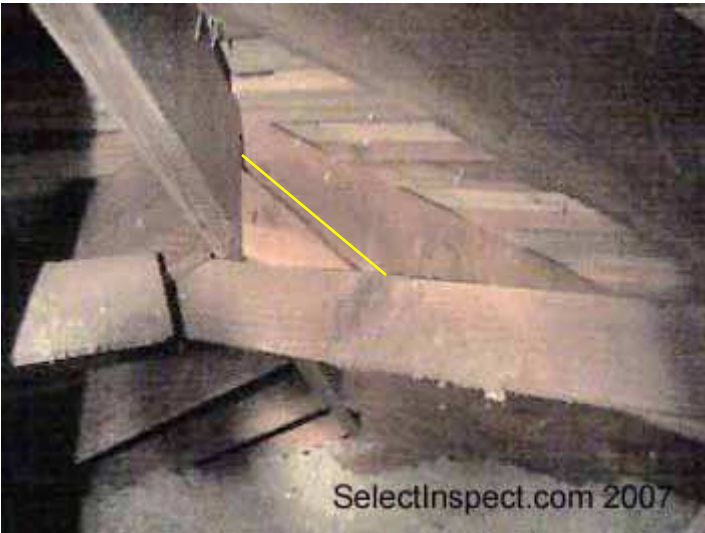
- Failed rafter exists at the northeast; Correction / improvement would be prudent.
- Cracked rafter exists at the northeast; cracked strut exists at the central southeast; cracked collar exists at the southwest (south of the attic access). Additional bracing should be considered to prevent future issues.

↑ cracked rafter at northeast attic – right

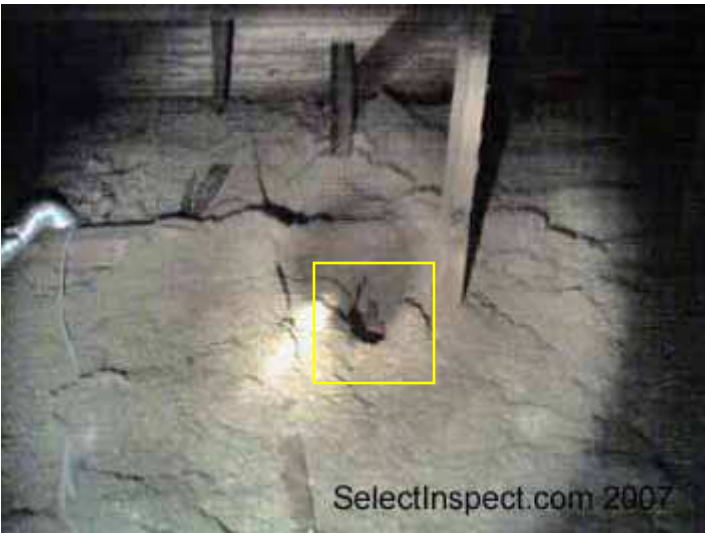
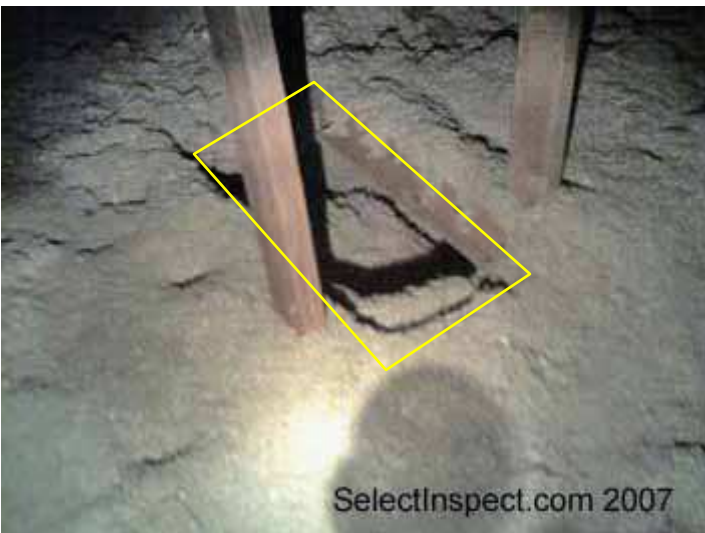
- Insulation was missing at various furdow perimeters. This can cause some degree of energy loss.

↑ amiss insulation at furdown- example

↑ amiss insulation at furdown- example 2

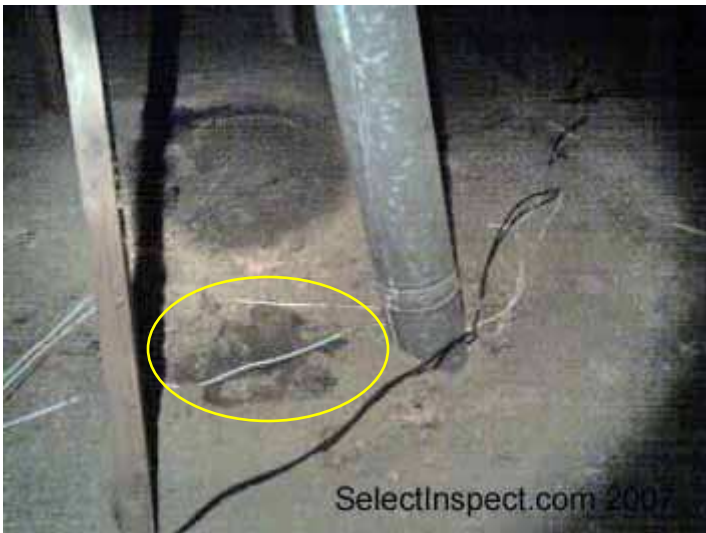
↑ wet, moisture damaged insulation adjacent furnace flue

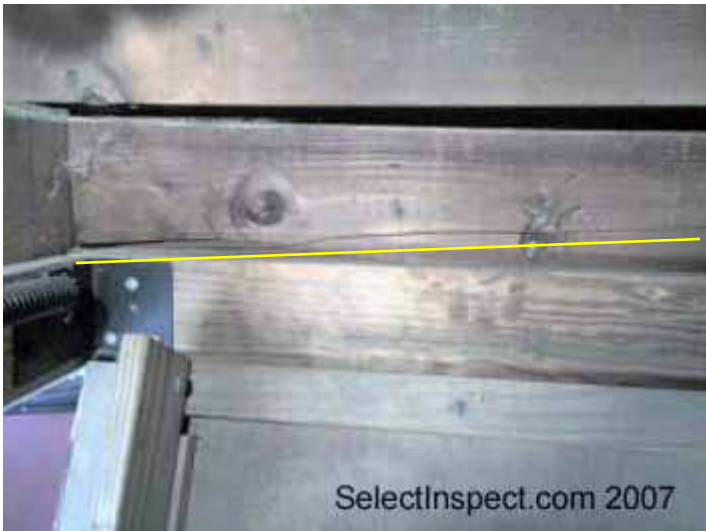
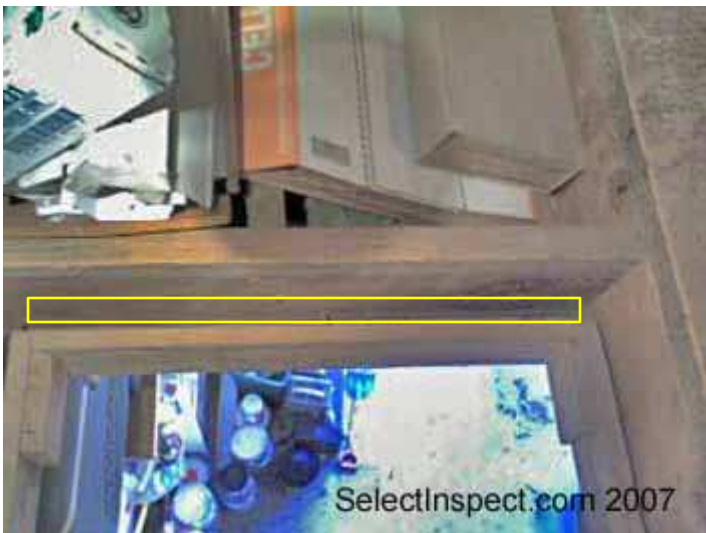
- The frame header was cracked, failed, and poorly secured to related joists. The footer end had a large gap that was not appropriately shimmed. The stair should be considered unsafe until appropriate, professional repair is made.
- The attic ladder(s) does not extend properly and is unsteady / potentially unsafe. Correction / improvement would be prudent.
- Advisory Use caution when entering/exiting or moving about in attic areas.

↑ failed and poorly secured header at attic ladder

↑ unworkmanlike connection of attic ladder to footer

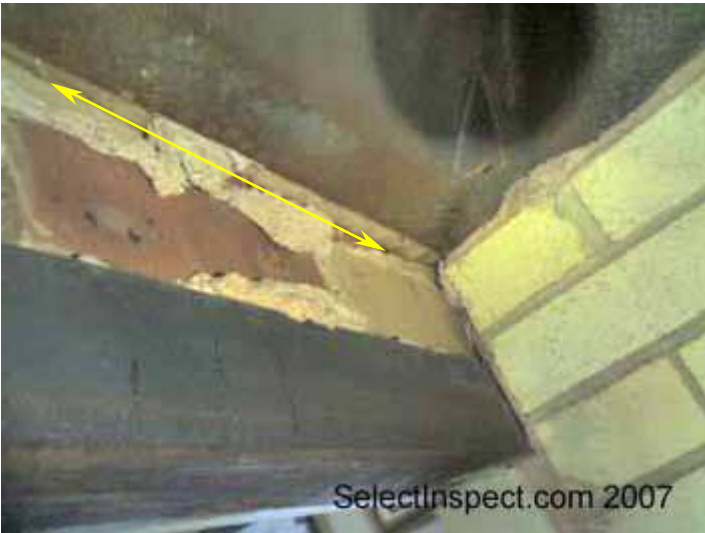
- The smoke shelf is not sealed appropriately at the front of the fireplace and may present a fire hazard. Mortar touch-up is recommended.

↑ poor mortar seal at smoke shelf- fireplace

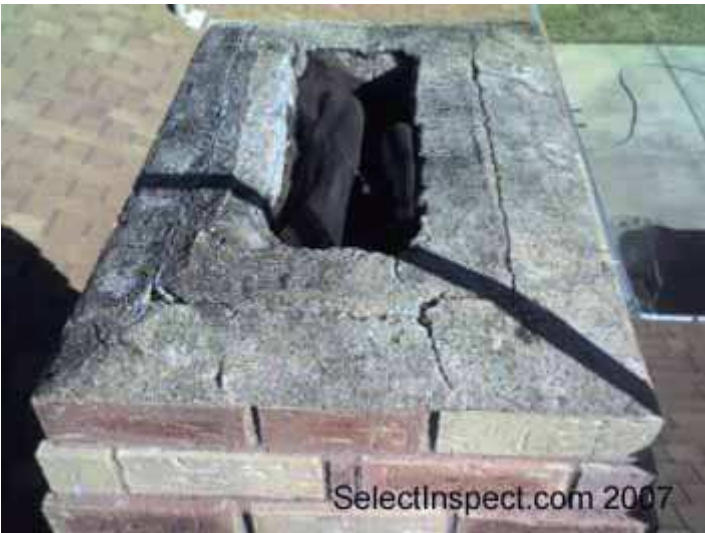
- The screen at the cap is inappropriate. Replace with appropriate material.
- Mortar at the chimney crown needs minor touch-up repair.

↑ chimney cap needs mortar repair and appropriate ember screen

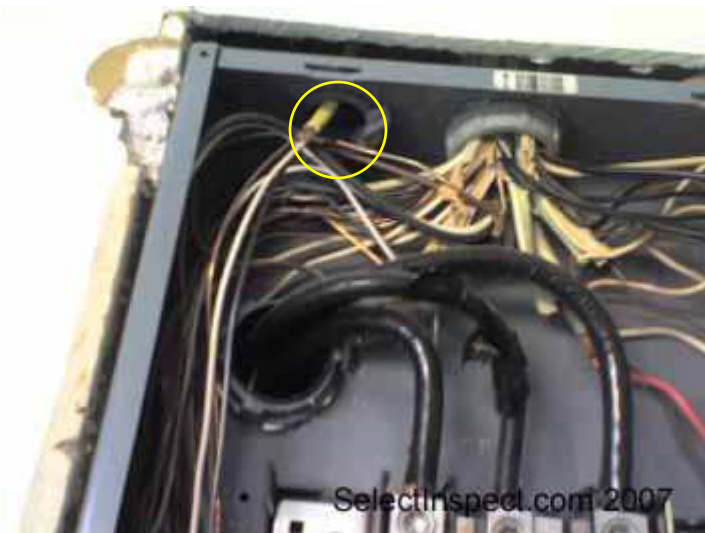
↑ unsealed opening at electrical panel

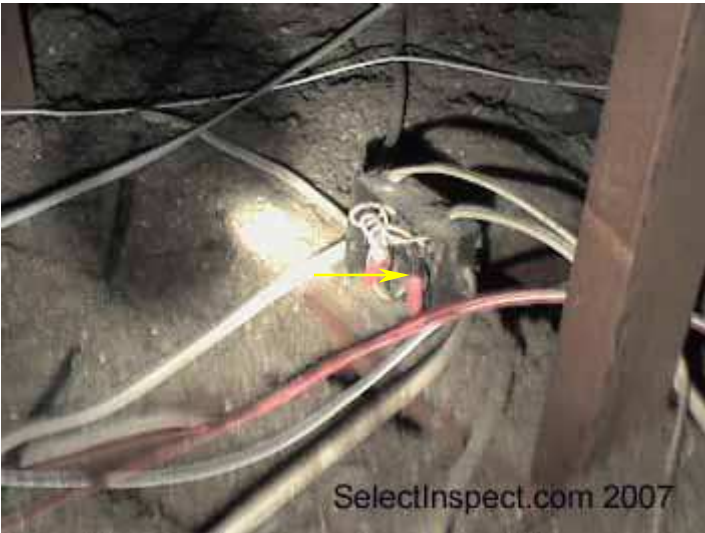
↑ amiss / deficient electrical box in attic- example at central east

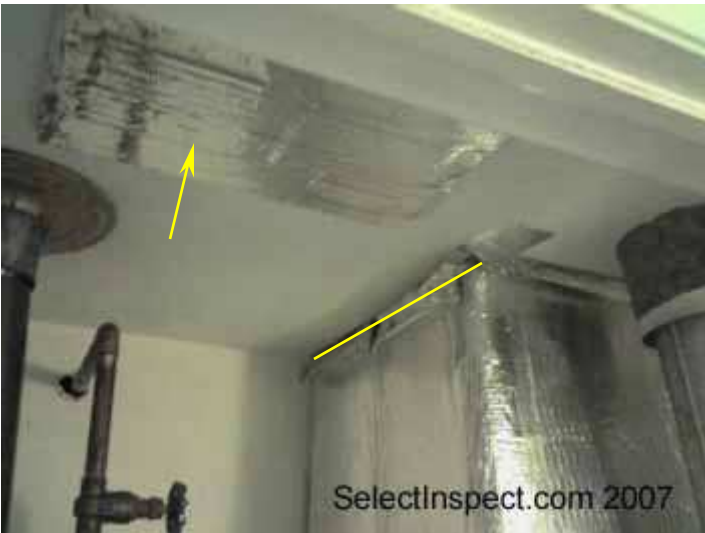
↑ sealed mechanical closet fresh air port and amiss / deficient tape joints at HVAC

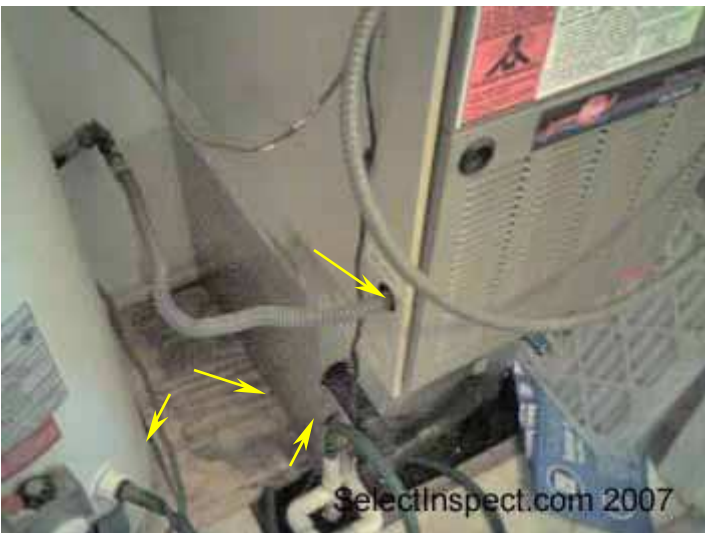
↑ flexible gas pipe unprotected at furnace cabinet penetration; no pan under water heater; HVAC resting on deflected plywood; leakage (corrosion) evidence at air-conditioner evaporator

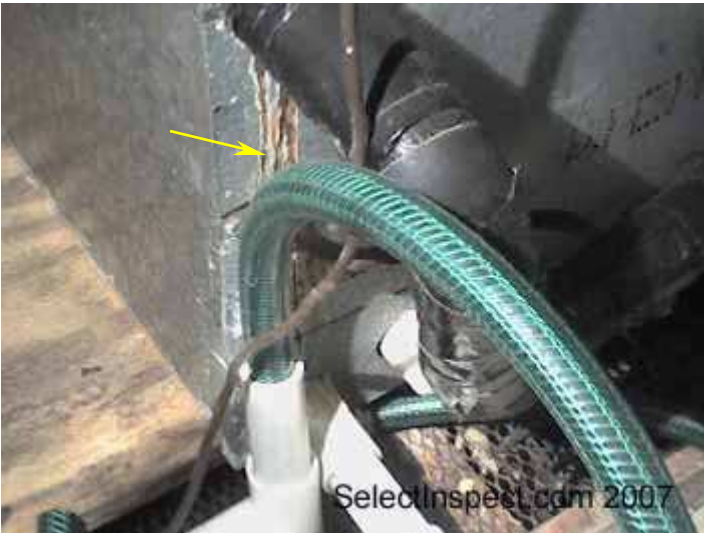
↑ close view of corrosion and leakage history at air-conditioner evaporator

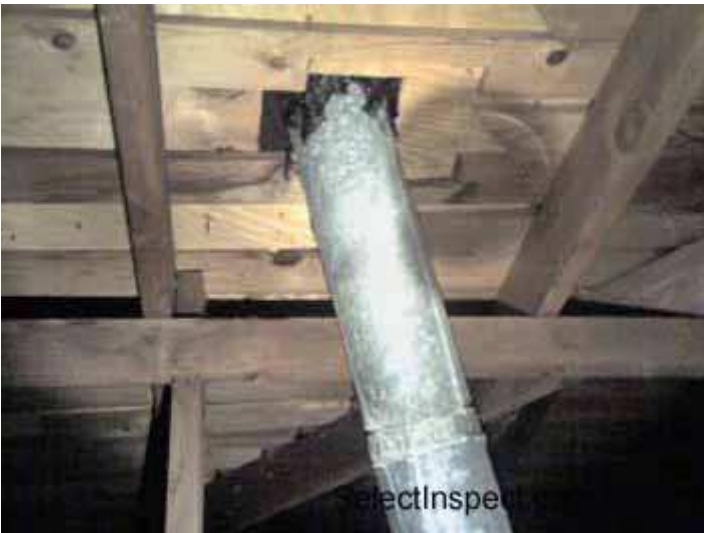
↑ furnace- flue does not meet listed clearance ratings from combustible materials; tar repair history and current leakage

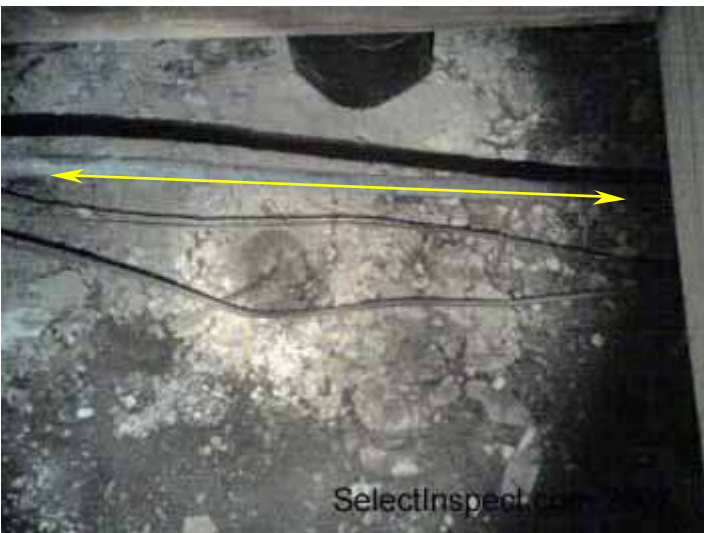
↑ air-conditioner refrigerant line not insulated at crawl space

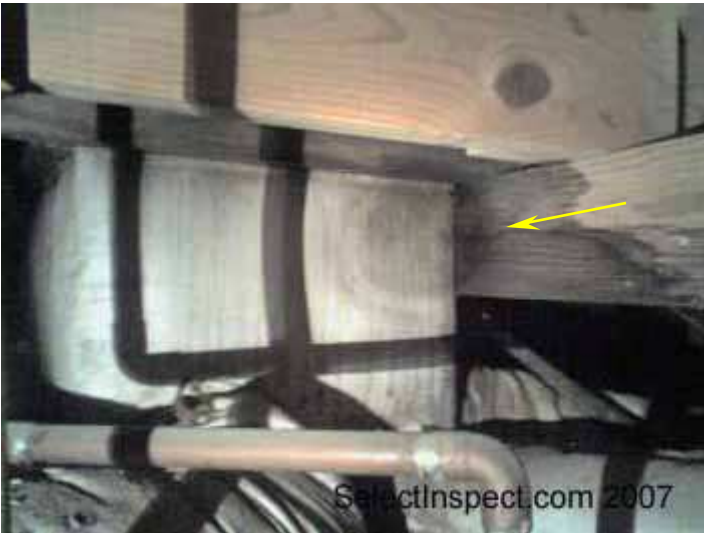
↑ moisture staining/evidence below HVAC (crawl space) and fungus on air plenum components

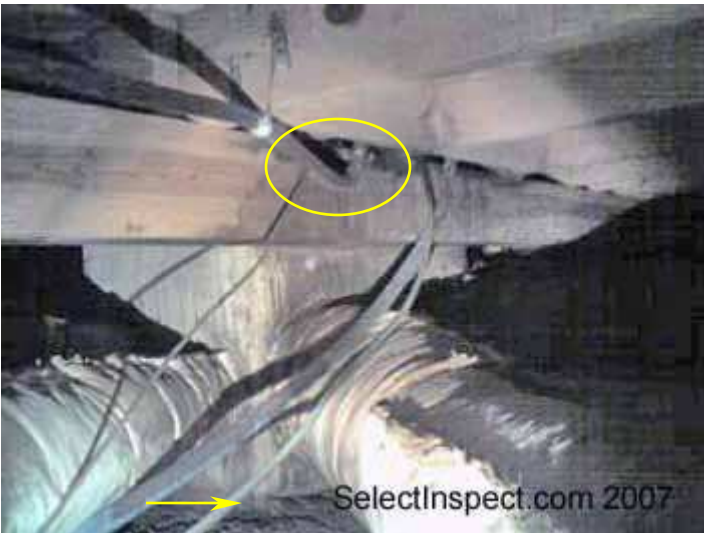
↑ crimped primary condensate line and plenum/duct components not raised 4 inches above soil- below HVAC (crawl space)

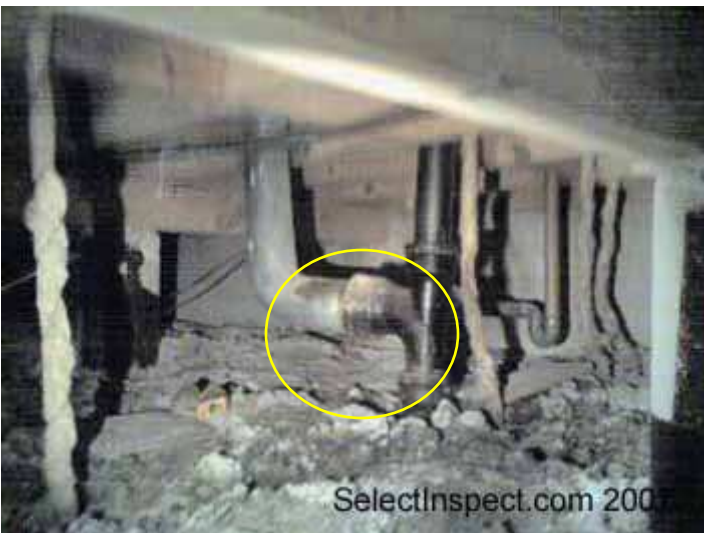
↑ leakage and moisture discovered below hall bathroom toilet

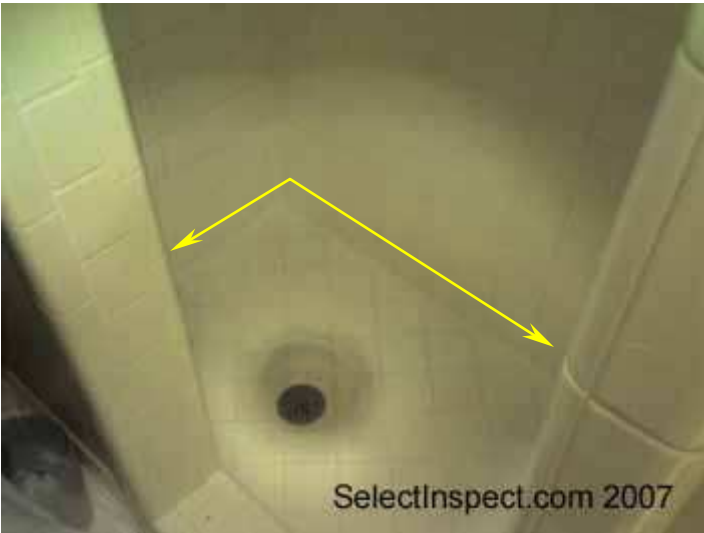
↑ cracked perimeter at master shower tiles

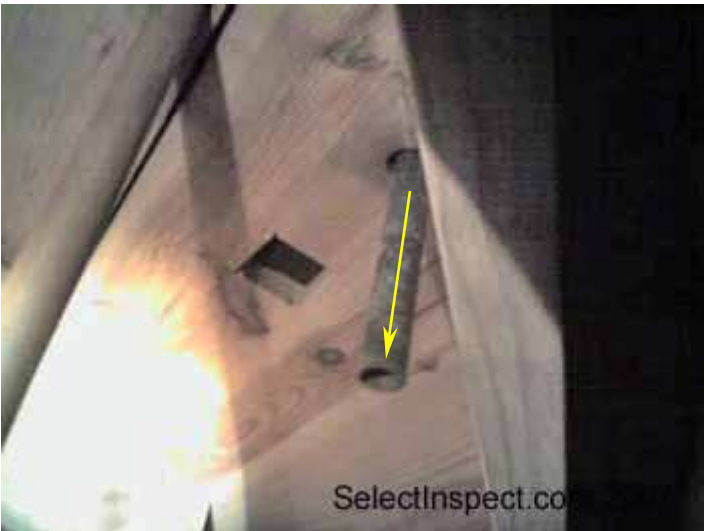
↑ water heater temperature-pressure-relief improperly terminates in the crawl space

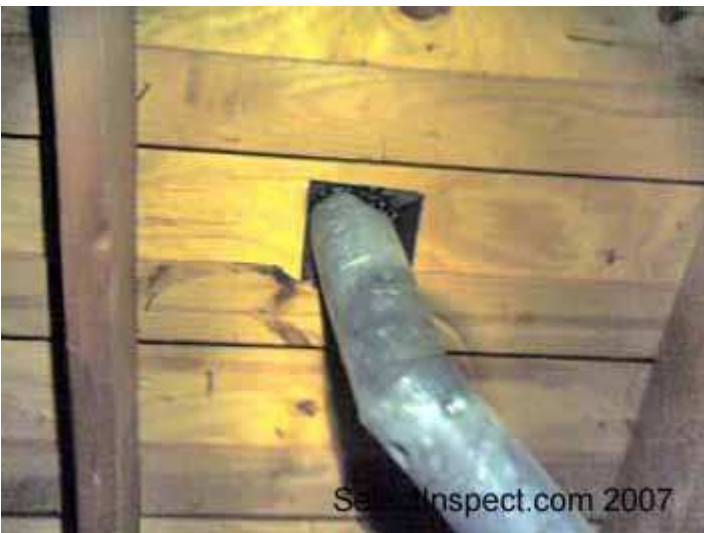
↑ water heater- flue not meeting wood clearance requirements

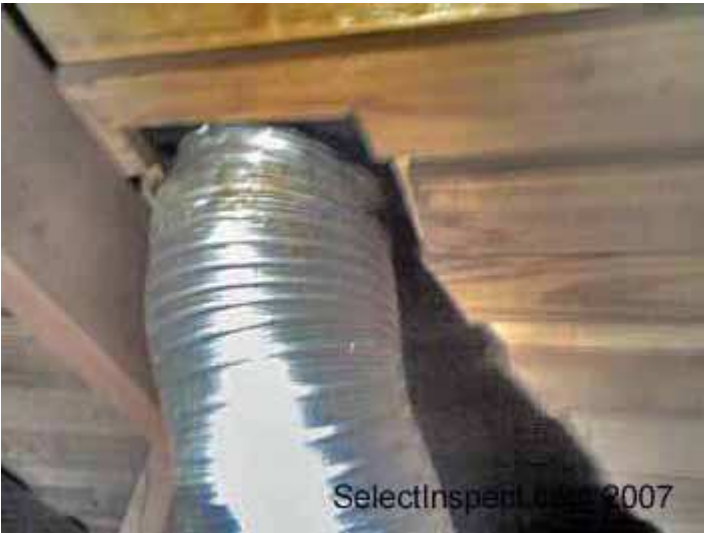
↑ recommend more thorough sealing of kitchen vent at roof penetration- metal tape and or mastic

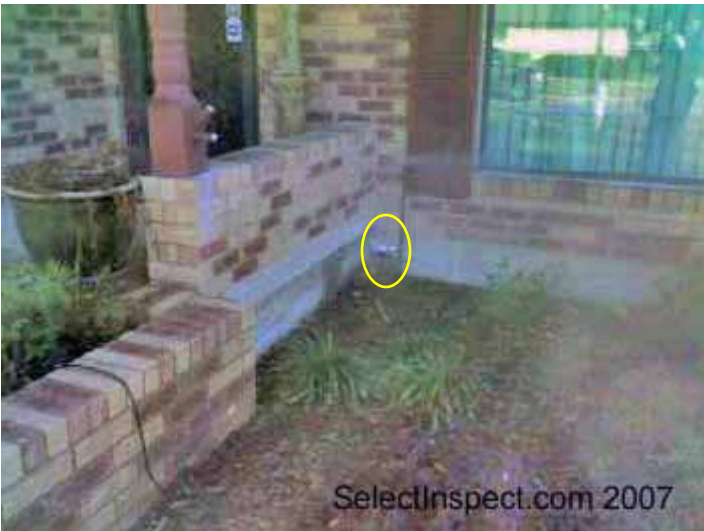
↑ small leak discovered at irrigation connector, adjacent front porch- zone 4
