Property Inspection Report

Concerning: 123 street Lucas, Texas
(Address or Other Identification of Inspected Property)

By: Bruce W. Carr; TREC #5281 ASHI Member # 211804 Friday, May 13, 2011
(Name and License Number of Inspector) (Date)

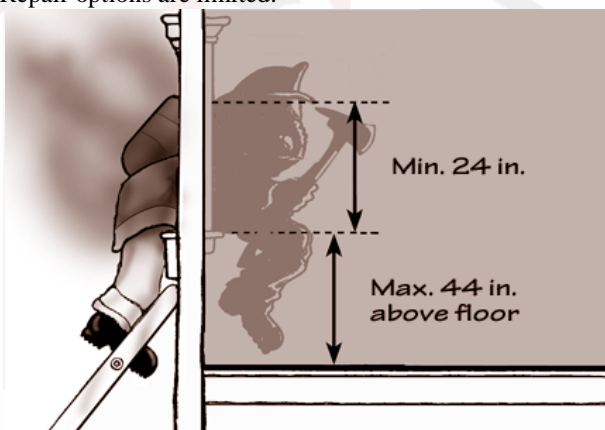
- Broken glass noted at 2 family room & one southeast bedroom location.
- Locks were deficient at the dining room, east bedroom, gameroom, north bedroom.
- Northwest bedroom window(s) is higher than recommended by current standards. It is now desirable to have the lower edge of the window < 44’ for ease of entry by firemen, during cases of emergency. Repair options are limited.

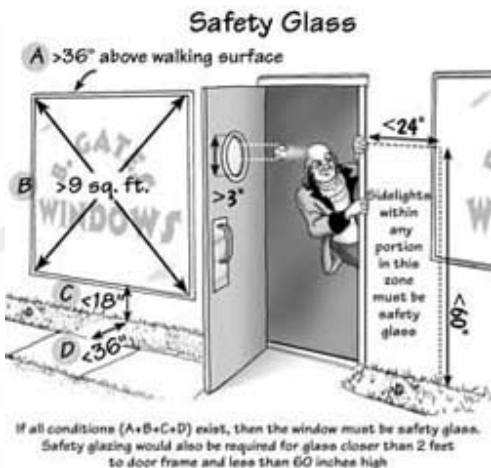
- Windows at front hall & breakfast nook were not clearly labeled as safety glass, and were within 24 inches of a door’s arc and less than 60 inches from the floor. (IRC 308) Texas inspectors are required to comment on the absence of safety glass, even in older homes. The label may have worn off, or the

glass may not be compliant.

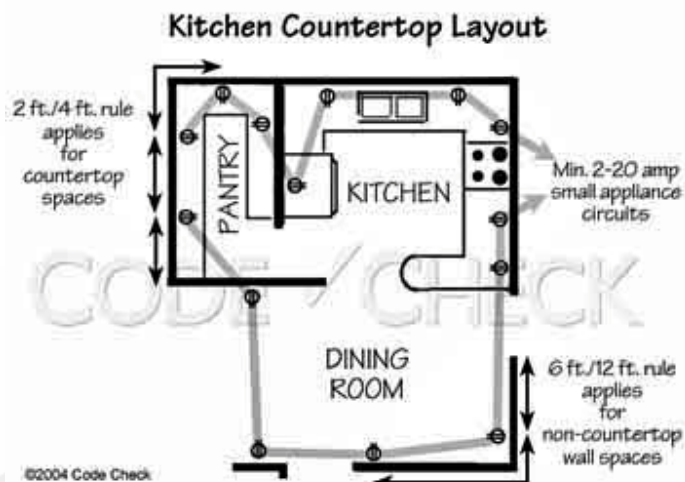
- ✚ Front hall & south hall did not have enough (none discovered) properly located electrical receptacle(s). "Receptacles shall be installed so that no point along the floor line in any wall space is more than 6 feet horizontally from an outlet in that space." Each wall/counter space 12 inches or wider shall have a receptacle; and no point along those walls shall exceed 24 inches horizontally without a receptacle. Island and peninsular countertops $\geq 24"$ x $\geq 12"$ require at least one receptacle(s). Receptacle(s) shall be no more than 20" above the countertop and shall not be installed face-up. (IRC E3801.1 - 3801.11)

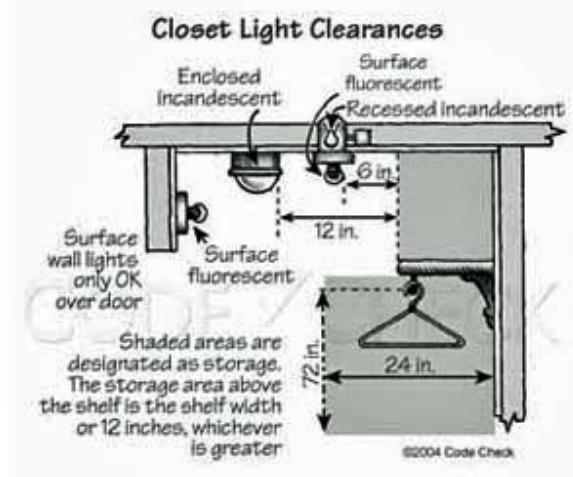
- ✦ Some lights in closets would not meet modern standards. Incandescent lights should be enclosed and at least 12” from combustibles; non-enclosed incandescent lights are no longer permitted, and we recommend that these be replaced with fluorescent bulbs or fluorescent fixtures.

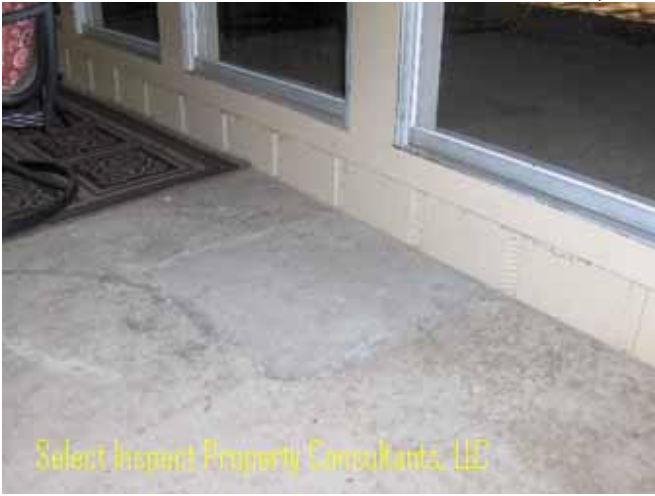
↑ low siding obstruction & pier location; example at rear porch

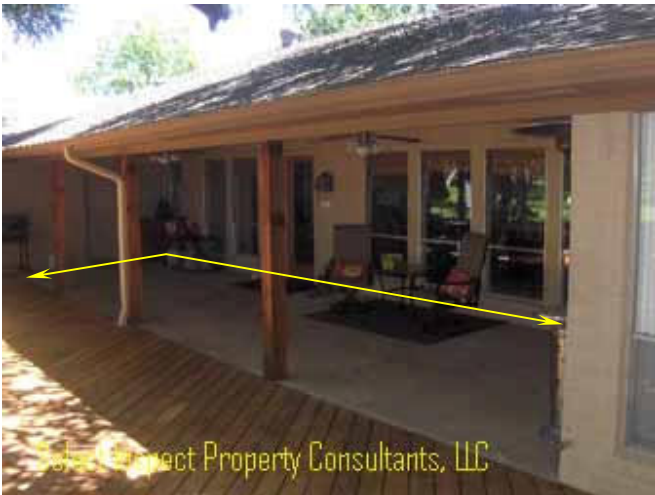
↑ rear porch roof is on separate foundation from the home

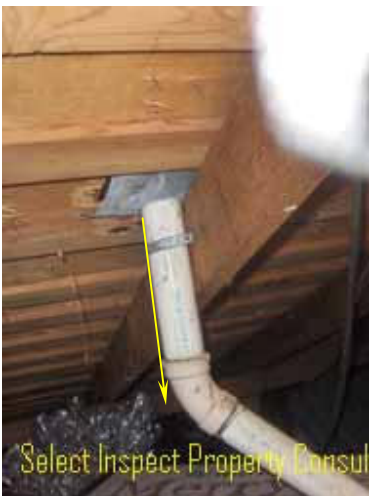
↑ leakage history at laundry room plumbing vent

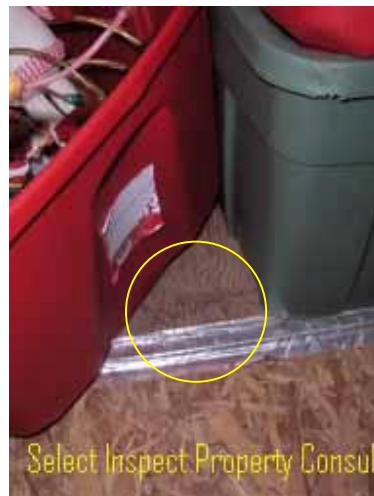
↑ moisture staining below vent penetration

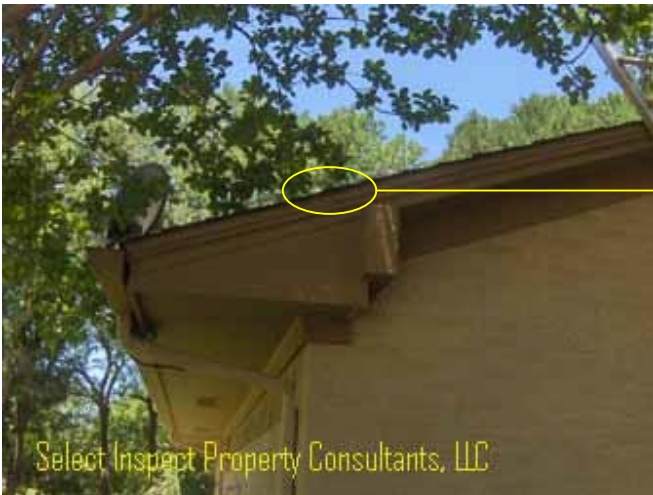
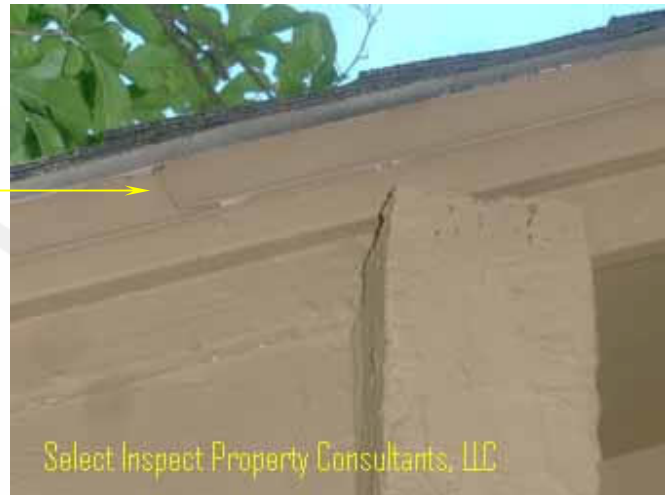
↑ inadequate lap at drip edge flashing; southeast

↑ close view of image at left

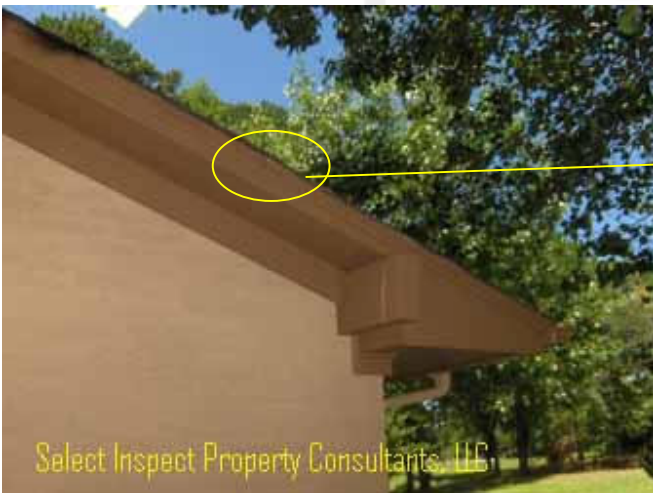
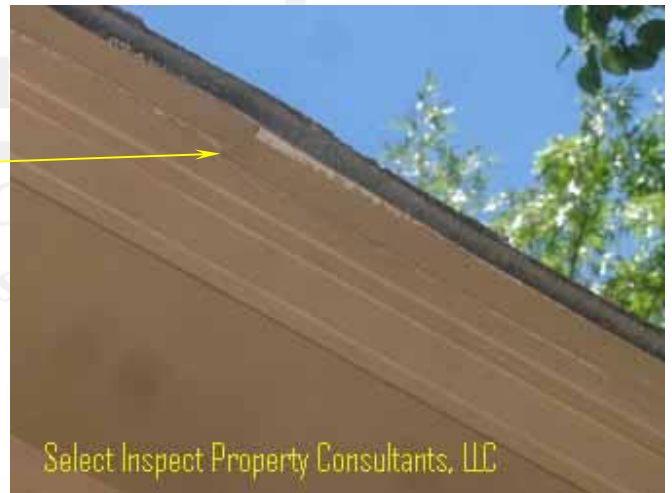
↑ inadequate lap at drip edge flashing; northeast

↑ close view of image at left

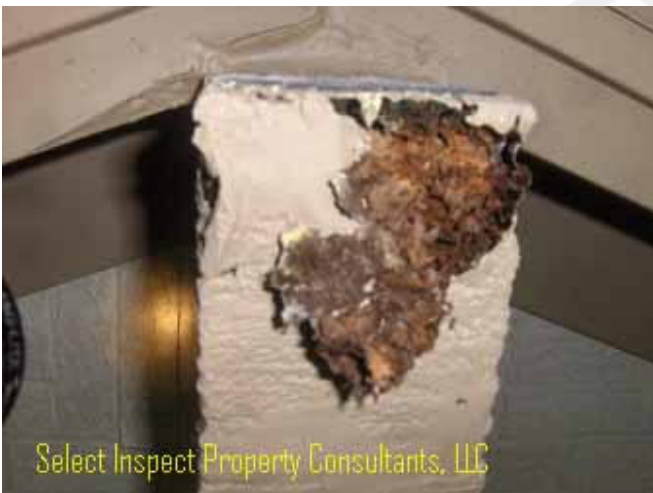
↑ moisture damage & fire ants at southeast beams

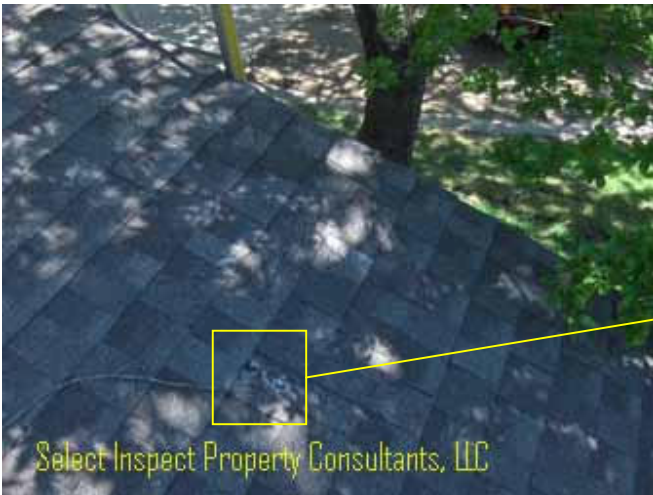
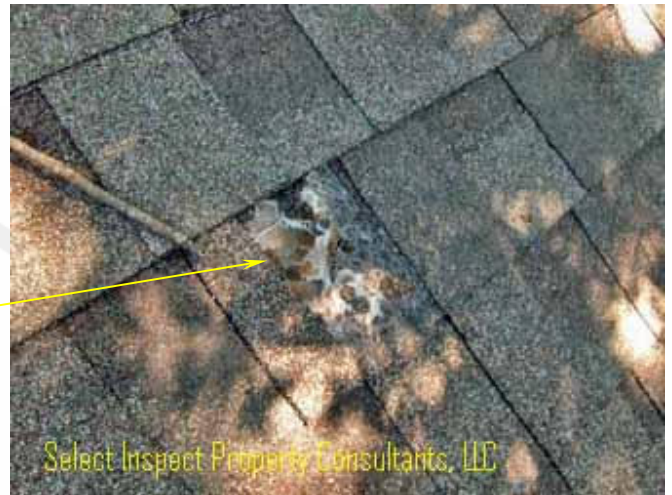
↑ delaminated shingle; southeast

↑ close view of image at left

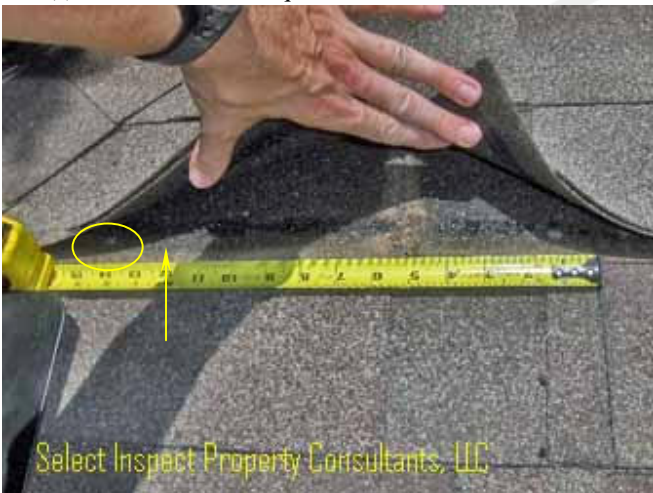
↑ improper nailing discovered at random shingles; example- should be 1" & 12" from each end, this one is 1" & 14"- Immediate corrective needs were not discovered

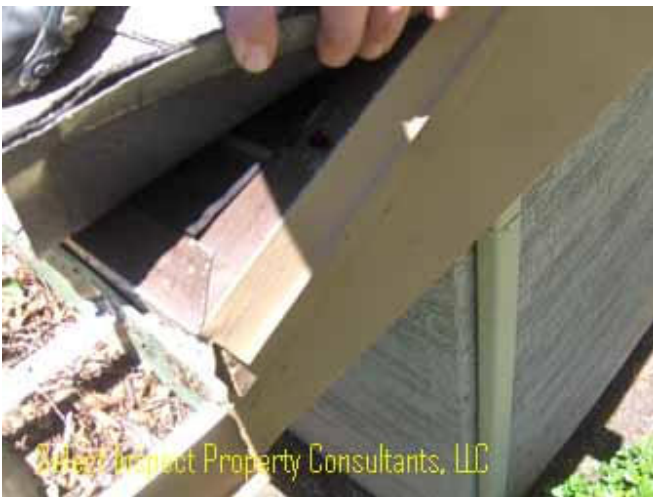
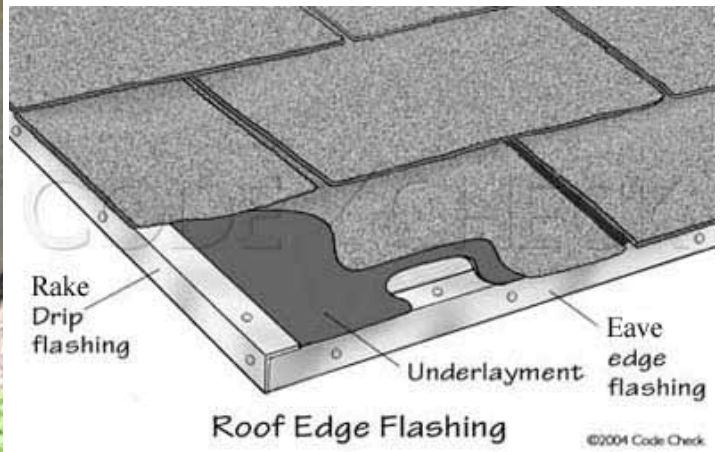
↑ example-unworkmanlike drip edge/felt; corners should have no gaps; rake (diagonal) edge & roof felt should be atop the eave (lower) edge flashing; roof underlayment should be under rake flashing

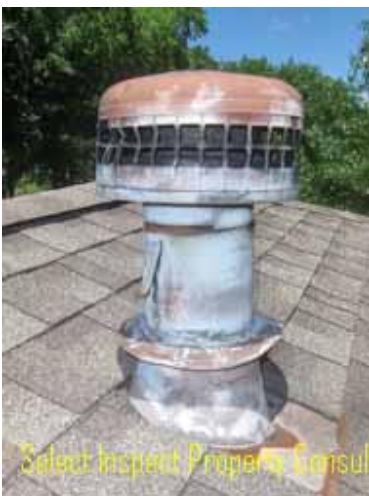
↑ damaged HVAC flue

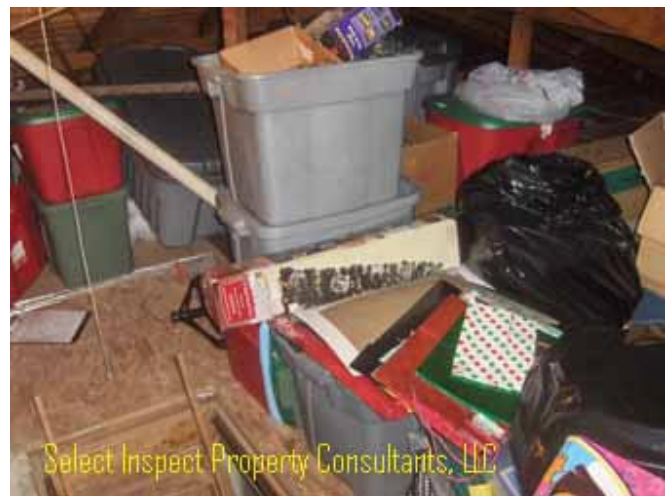
↑ obstructed attic; example

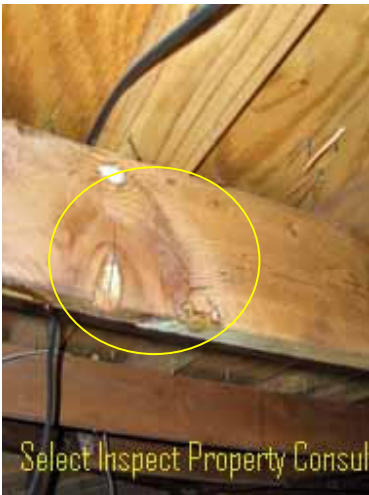
↑ cracked rafter at knot; example

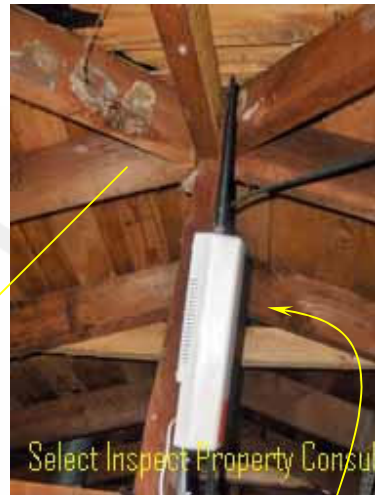
↑ cracked rafters example

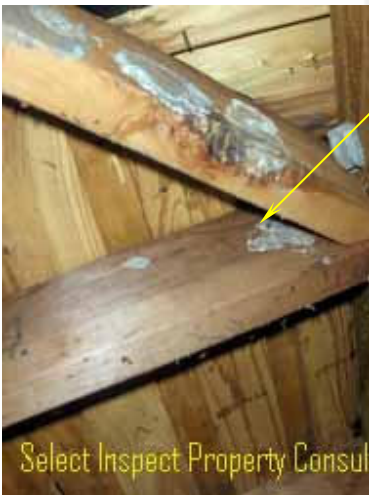
↑ close view

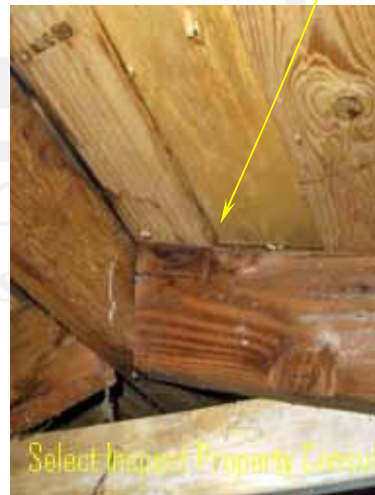
↑ close view & undersized ridge example & moisture staining

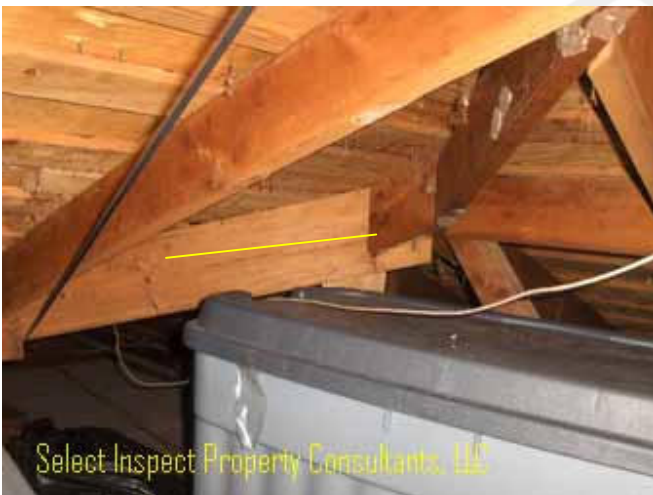
↑ cracked rafter example

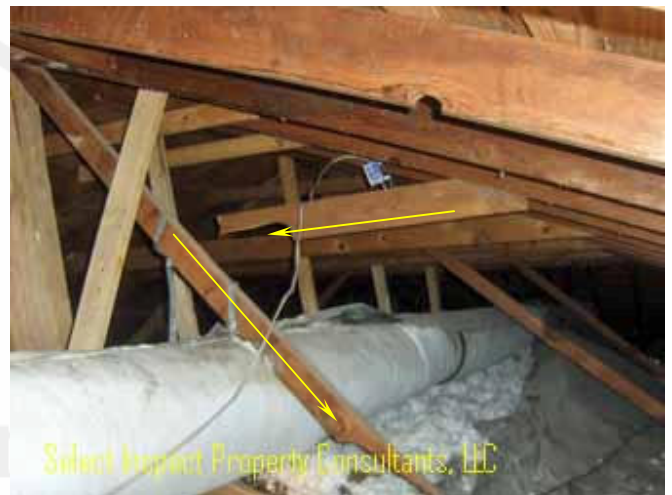
↑ cut/broken strut & collar tie over family room

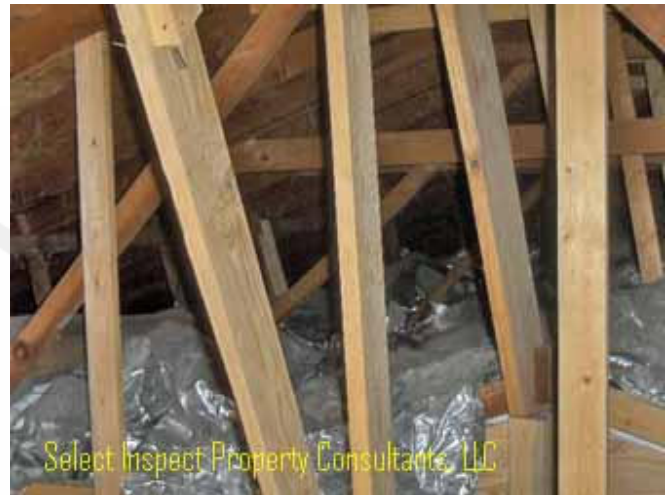
↑ east & southeast attic not readily accessible; "newer" framing seen above the family room

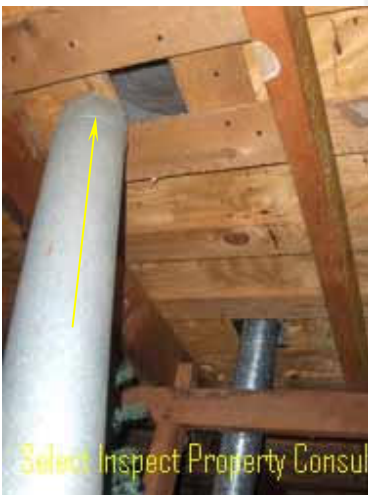
↑ deficient exhaust fan termination (& unclean screen) & garage water heater flue did not meet clearance requirements to combustibles

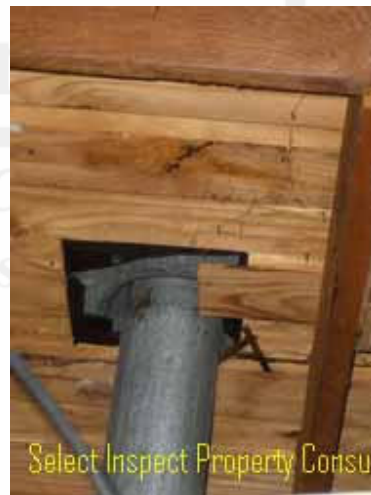
↑ HVAC flue did not meet clearance requirements to combustibles

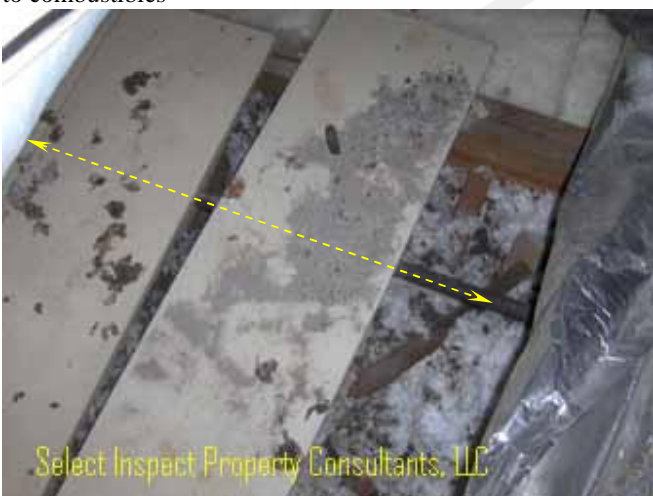
↑ attic floor partially supported on gas piping- northwest of family room

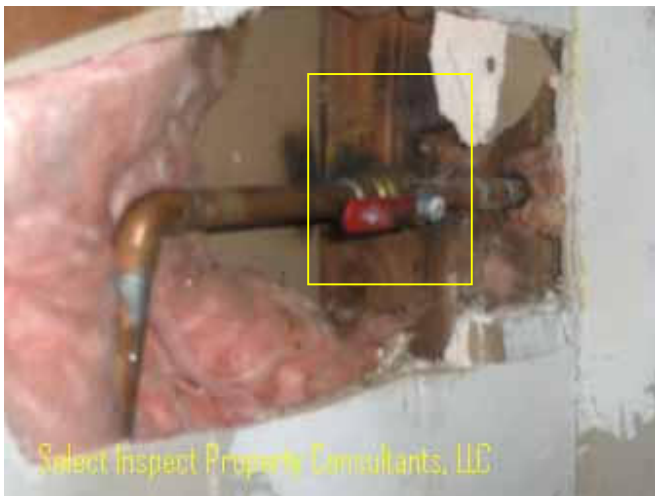
↑ stud under south bathroom sink notched at 28.57%; did not appear to be load bearing at this location; monitor.

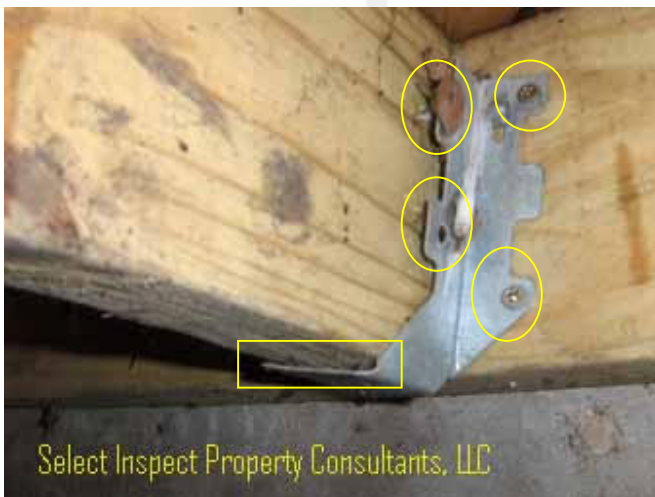
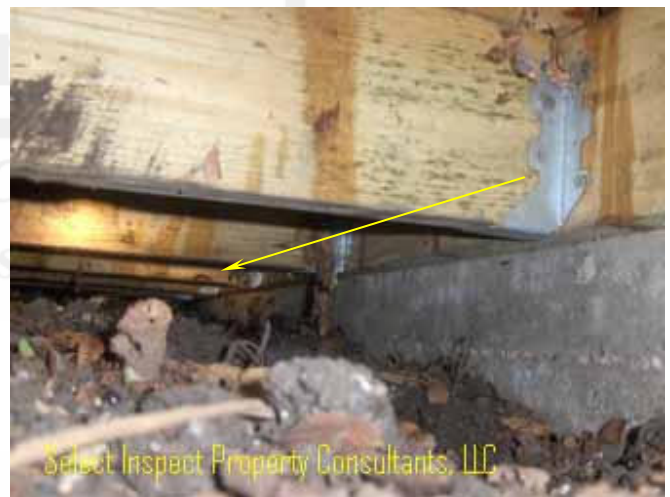
↑ below decking- incorrect fasteners & unworkmanlike joist hanger installation example

↑ all *visible* joist hangers under the deck were incorrect. & low deck/high soil can limit ventilation & may eventually be prone to fungus

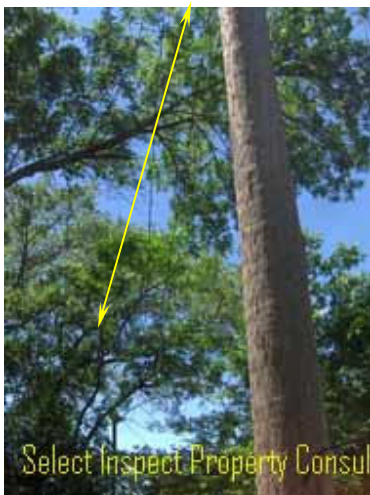
↑ electrical cables through trees

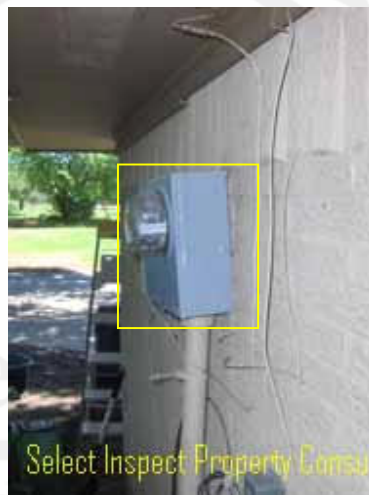
↑ inadequately secured electrical meter

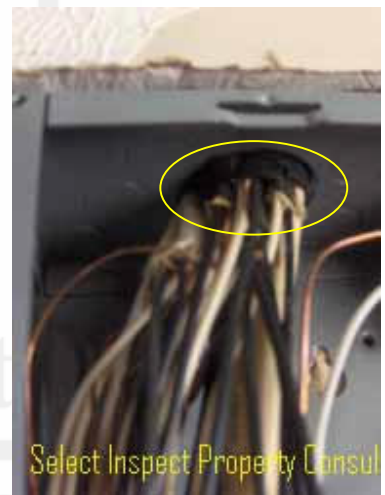
↑ deficient bushing at electrical cabinet

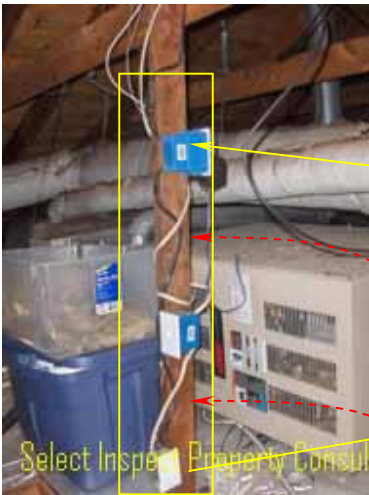
↑ multiple deficiencies at attic electrical

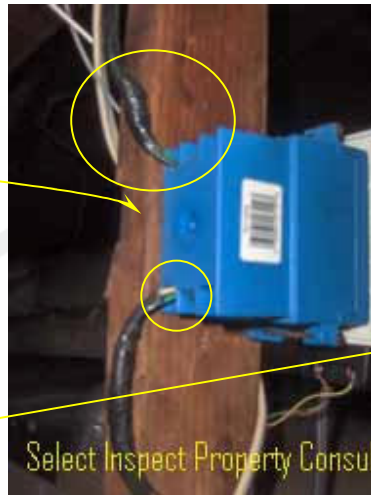
↑ unworkmanlike & missing sheathing

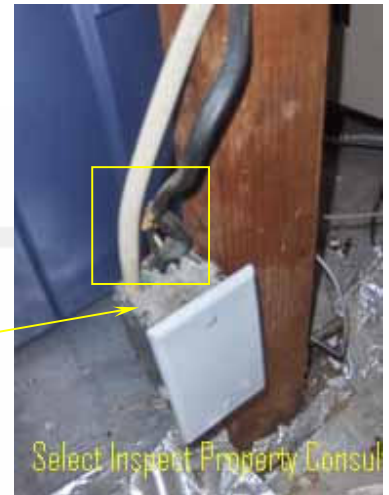
↑ unworkmanlike, missing sheathing

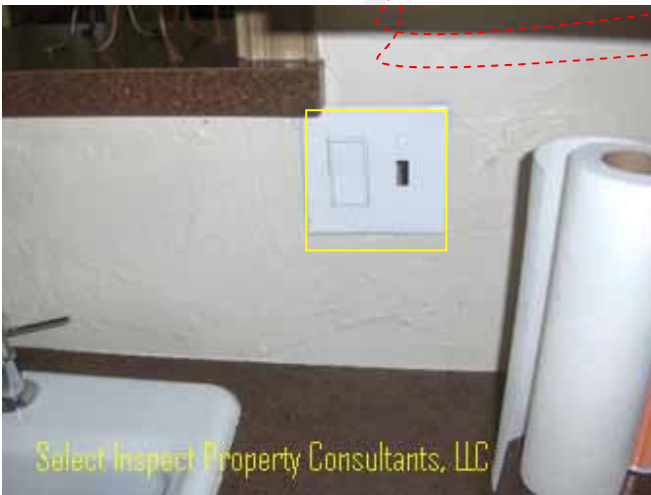
↑ Deficient excess electrical reveal at kitchen; incorrect cover plate

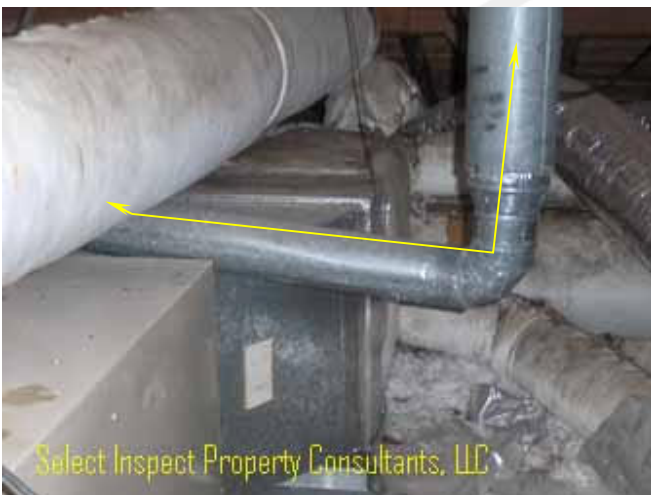
↑ unworkmanlike negative slope; inadequately secured furnace flue

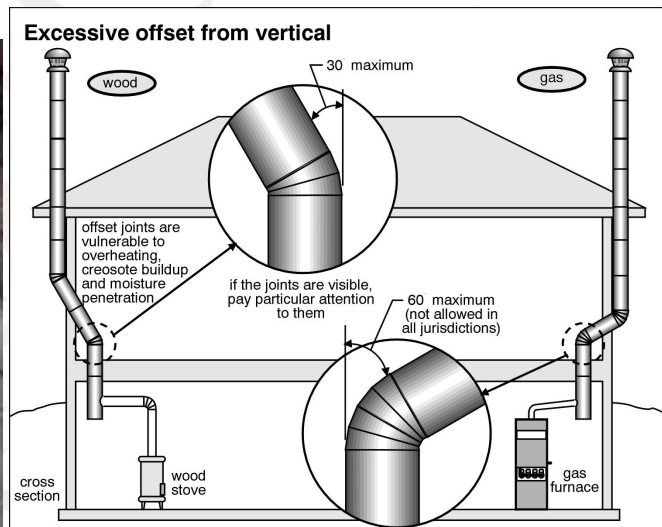
↑ unworkmanlike negative slope; inadequately secured furnace flue

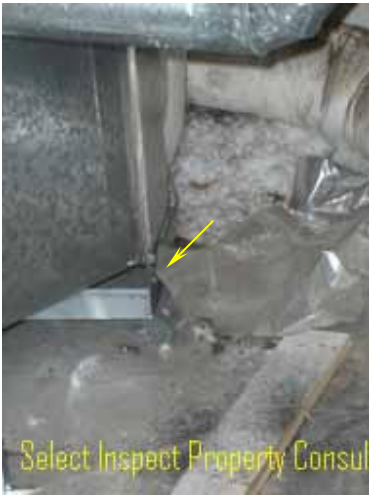
↑ improper alignment of evaporator(s) auxiliary pan

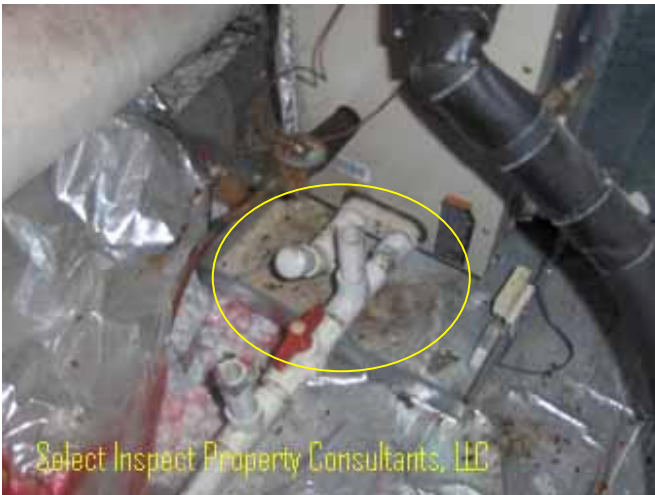
↑ leakage history at evaporator(s) auxiliary pan; monitor

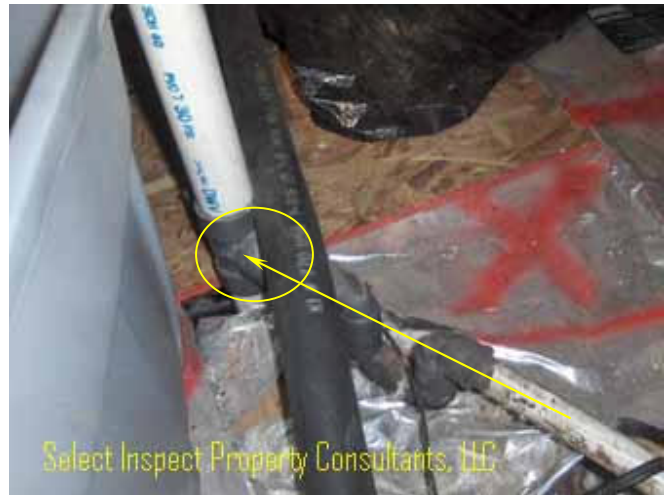
↑ primary condensate drain terminates at plumbing vent

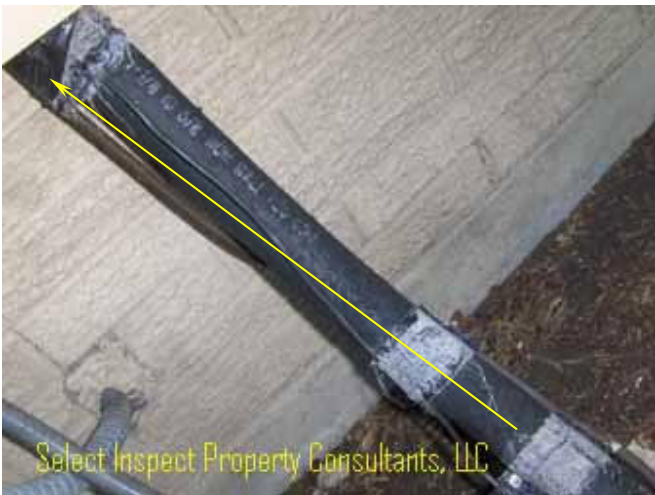
↑ damaged refrigerant insulation; rodent entry point to attic-exterior north

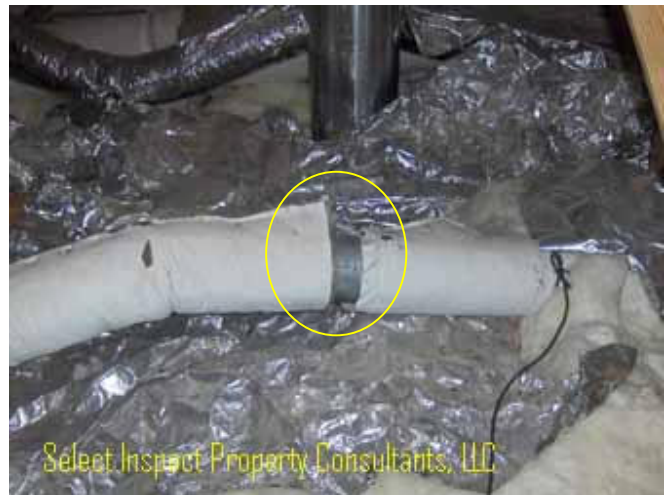
↑ energy loss at air ducting; inadequate insulation & seals

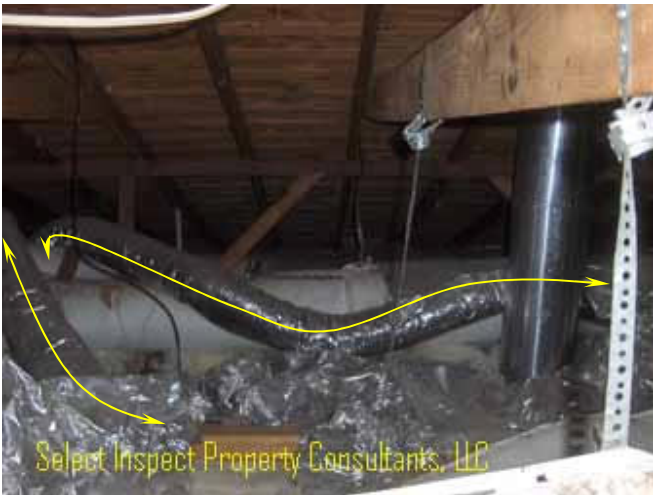
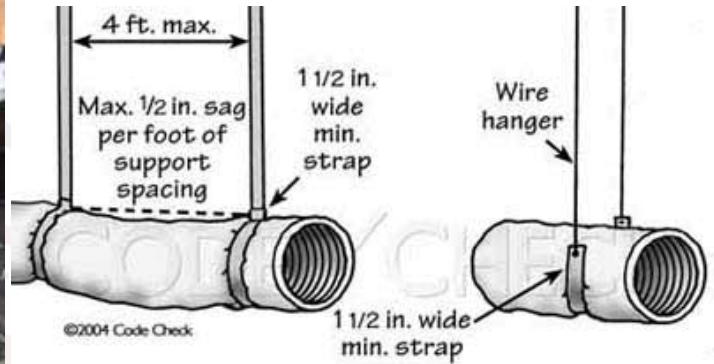
↑ inadequate support of air ducting; example

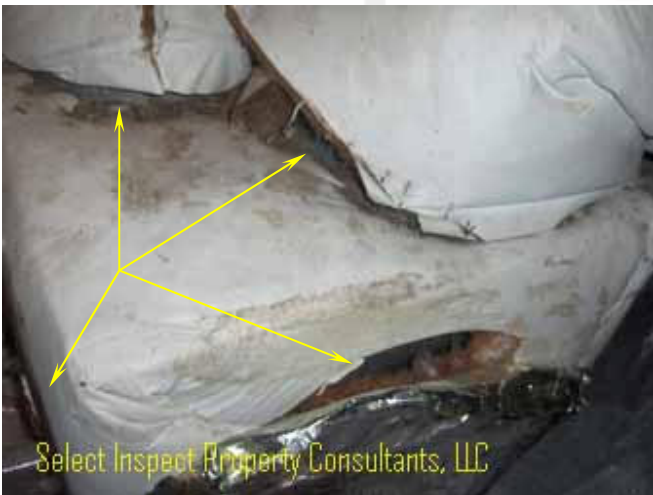
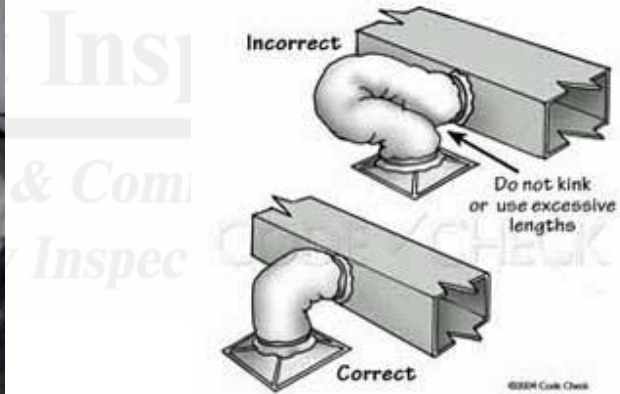
↑ energy loss at air ducting; inadequate insulation & seals; example at plenum/manifold

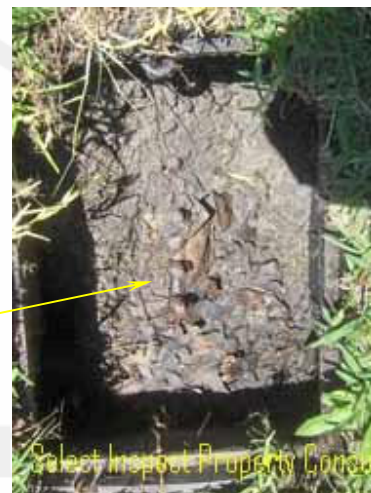
↑ Shut-off-valves require 3" clearance from soil; irrigation anti-siphon; corrosion; damaged lid

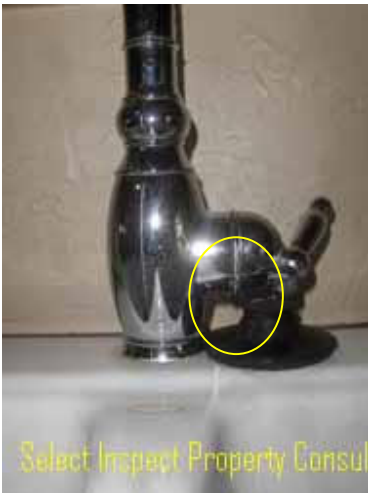
↑ kitchen sink leaks when operated

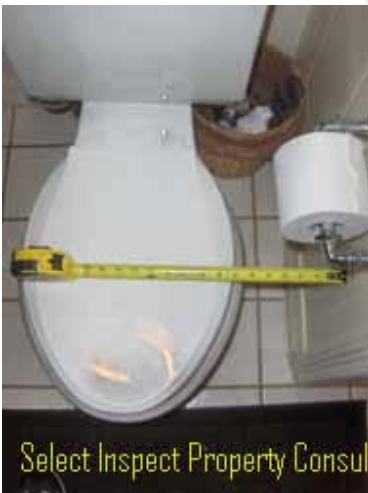
↑ toilet at east bathroom & master did not have required clearance

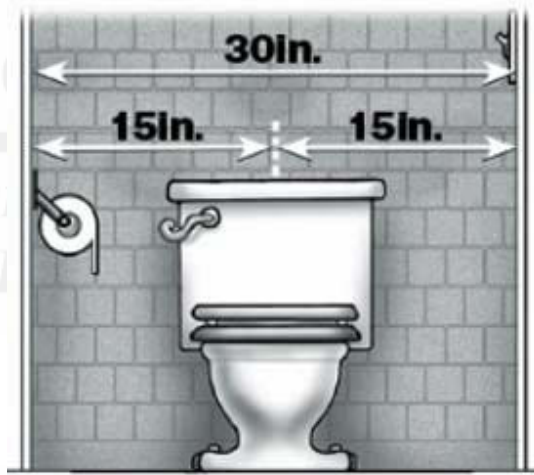
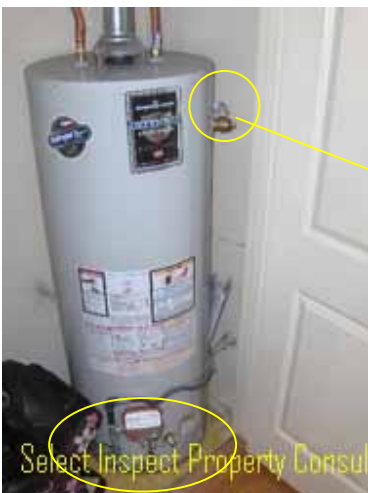
↑ multiple deficiencies at both water heaters; example at hall unit

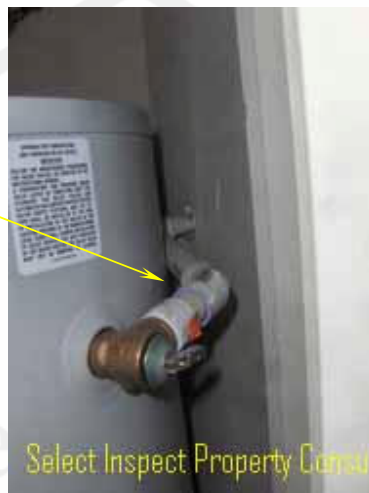
↑ improper piping, routed uphill, & improper termination

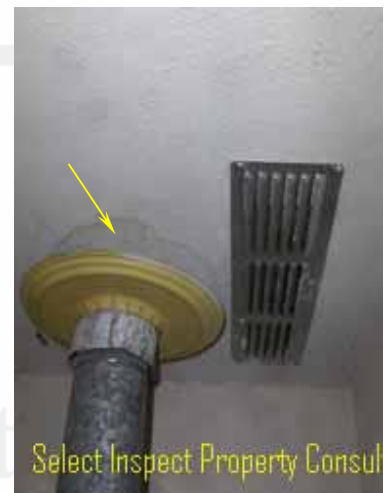
↑ moisture staining, incorrect flue material, & screened vent

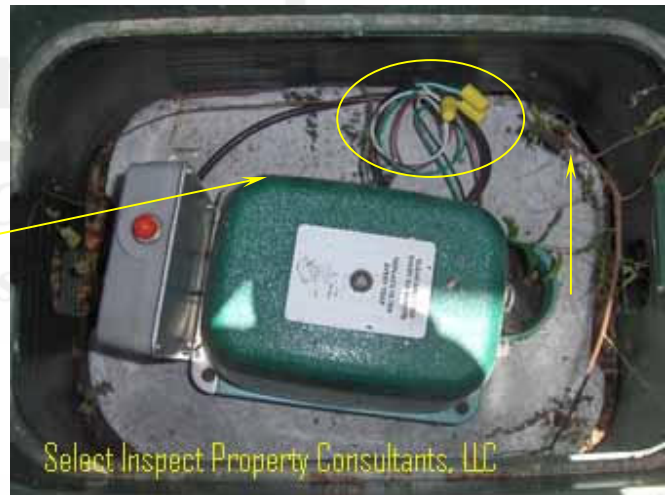
↑ foliage & missing electrical junction box

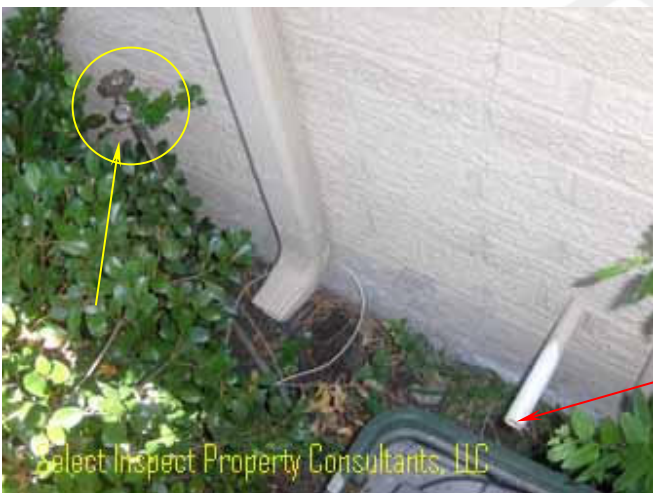
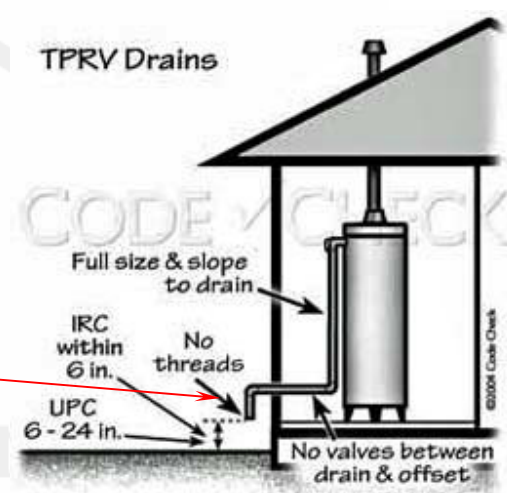
↑ inoperable exterior faucet(s) & improper termination (& wrong pipe material) of south water heater temperature/pressure relief & missing block/extension at gutter down-spout

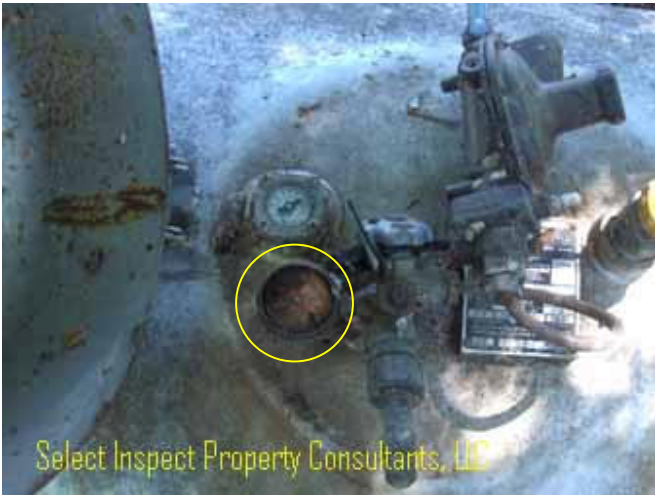
↑ damaged gauge at propane tank

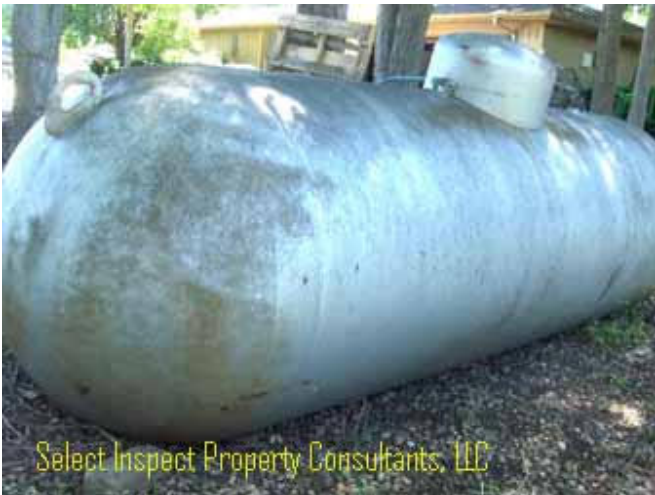
↑ some surface rust seen at visible areas; recommend rust inhibitive paint & consider raising off soil to extend service life of the tank.
