Property Inspection Report

PROPERTY INSPECTION REPORT

2020 Wing Point

Tuesday, November 09, 2010

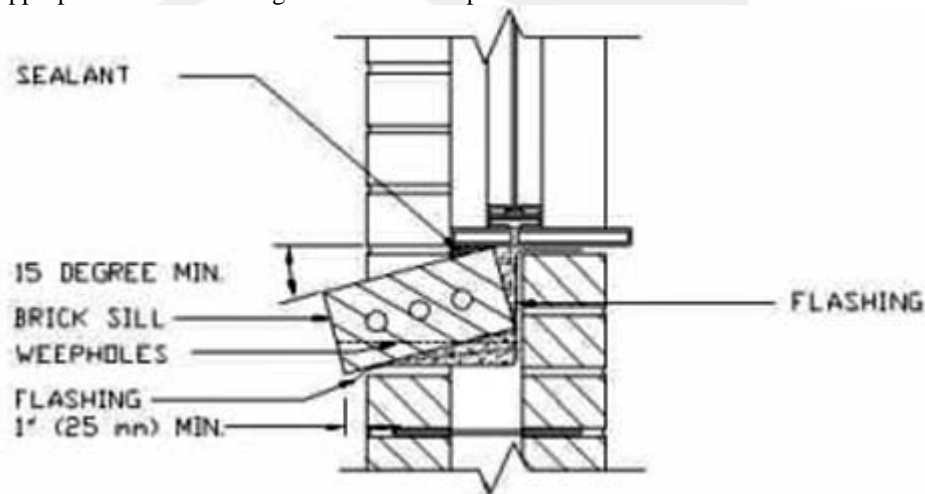
Exterior window sills did not have a recommended 15° slope for drainage at multiple locations; slope at random locations was approximately 4-7° Repair options may be limited. Condition & appropriateness of flashing & substrate components is undetermined.

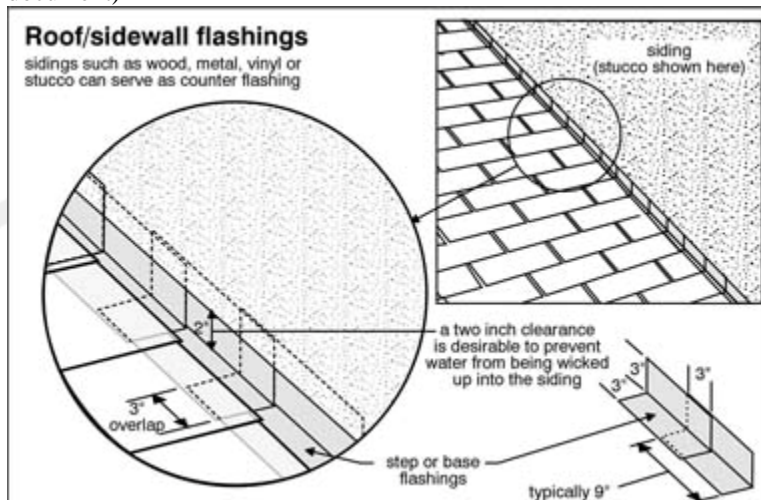
- Veneer (siding, stone, brick, etc) & or trim/fascia at vertical wall & or eave locations is lower than recommended, and touches the roof surface. The veneer should be a few inches above the roof, to prevent moisture from soaking into the bottom through the mortar or siding. (related image(s) in this document)

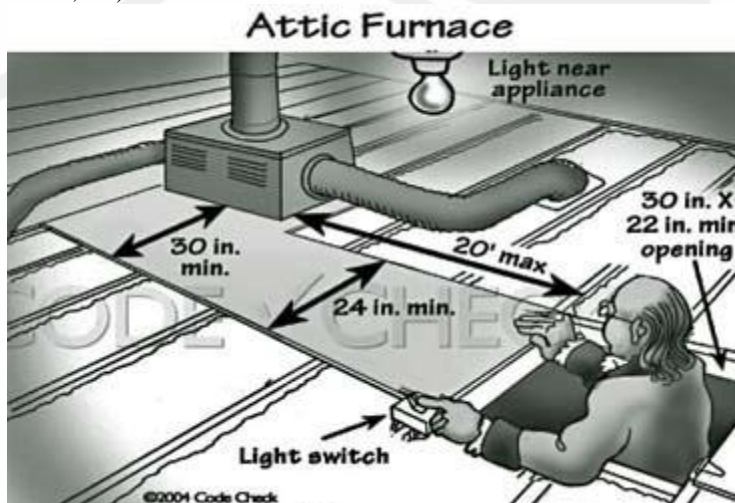
- "T-bracing" was not present; multiple cracked/failed struts were noted. Deflected roof was noted at the exterior in some related area(s). Recommend considering correction/improvement of the conditions. Technically, 6 foot or longer struts that are 45 degrees or more should be "T" braced for added strength.
- There was not a clear, solid (having no gaps), unobstructed 24" floored pathway to the mechanical system(s) from the access. This is considered a safety risk for persons examining or servicing the mechanical systems (HVAC, water heater, etc).
- There was not a clear, solid (having no gaps), unobstructed, 30" floored service area at the main service side of one or more mechanical systems in the attic(s). This is considered a safety / accessibility concern for persons examining or servicing the mechanical systems (HVAC, water heater, etc).

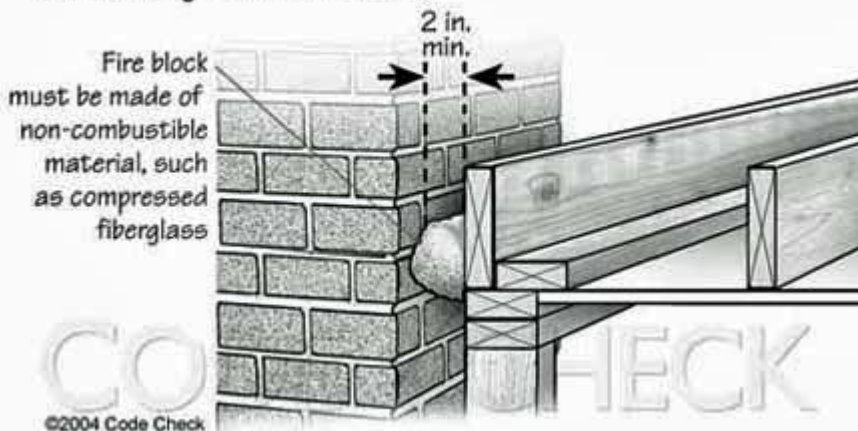
Chimney Fire Block

- Proper firestopping provisions were not present or are amiss around the fireplace chimney. Fireblocking is required in concealed spaces vertically at ceiling & floor levels and horizontal intervals not exceeding 10 feet (R602.8)

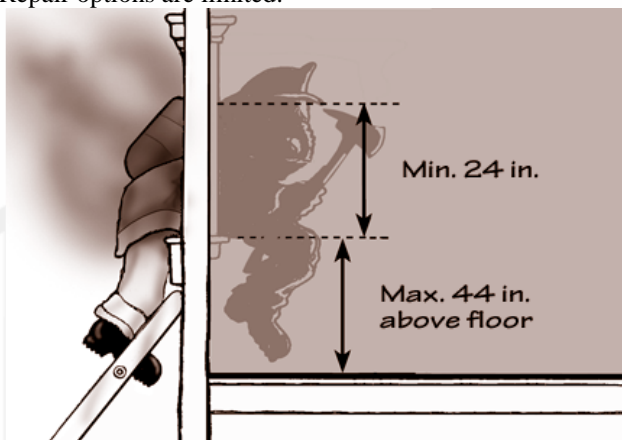
- Some bedroom window(s) were higher than recommended by current standards. It is now desirable to have the lower edge of the window < 44’ for ease of entry by firemen, during cases of emergency. Repair options are limited.

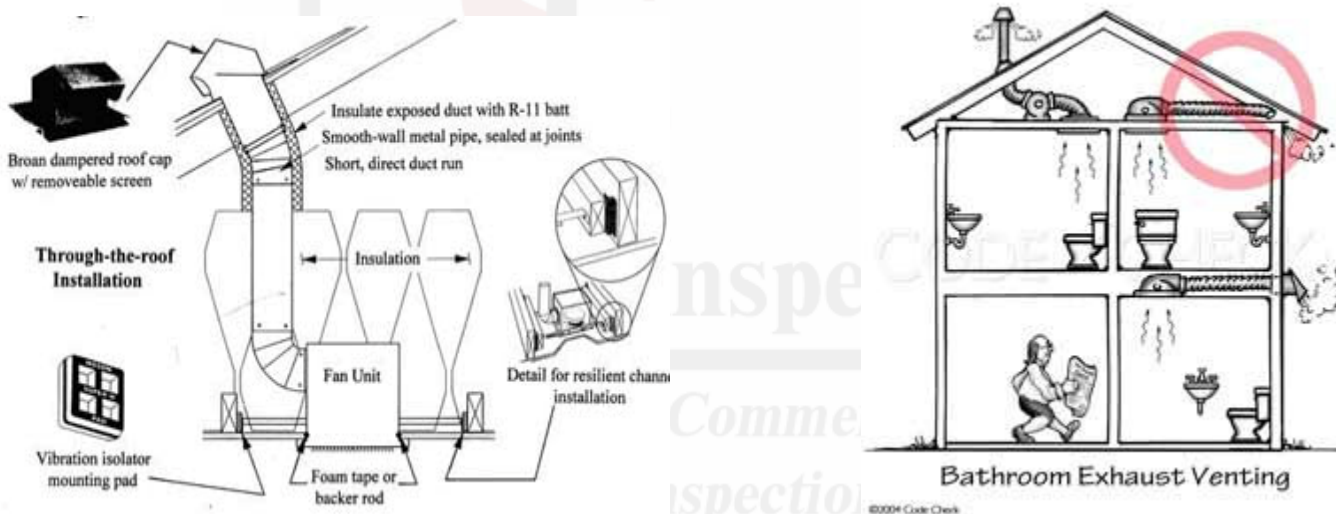
- Some / all bathroom /laundry exhaust fans appear to vent to the eaves/attic. Vent termination within the attic, at passive roof vents, or at eave vents does not meet most manufacturer guidelines. Current standards require venting of bathroom and utility room exhaust fully to the exterior. (IRC M1507). Texas Real Estate Commission considers this deficient, even on older homes. Related technical information can be found at: <http://www.toolbase.org/PDF/DesignGuides/spotventilation1.pdf>

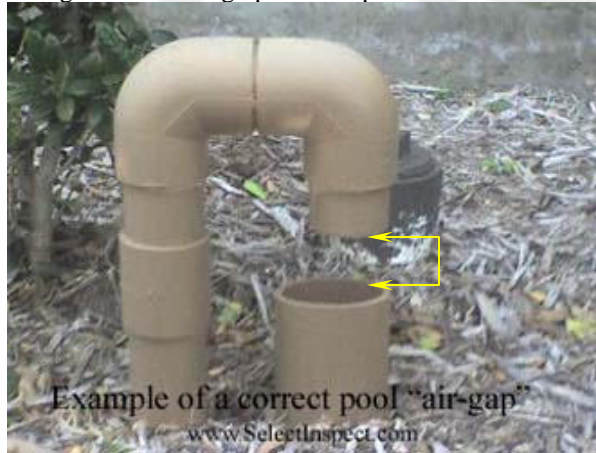
- The anti-siphon device at the front right garden does not have an adequate air gap present to prevent sewage from backing up into the pool.

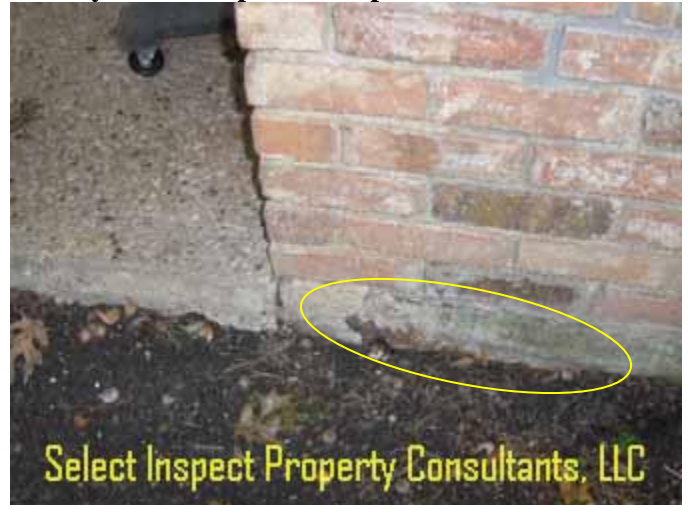
- Exposed or damaged reinforcement steel or similar was exposed at northeast & northwest corners of the master bedroom / bathroom. The exposed components should be sealed to prevent corrosion. These areas should be cleaned thoroughly & sealed with water resistant mortar or an appropriate high performance epoxy. In some cases it may be necessary to cut & remove the steel, then replace it with new reinforcing steel. Extended / long-term exposure & subsequent corrosion may result in failure of the clamp/cable connection & expensive related repairs.
- Deteriorated concrete noted at the northeast & northwest corners of the master bedroom / bathroom

↑ deficient concrete & exposed reinforcement steel; northeast

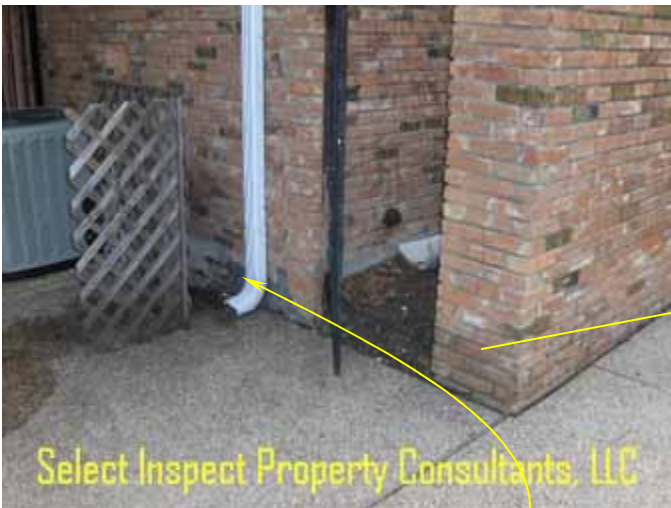
↑ deficient concrete, reinforcement steel, stress

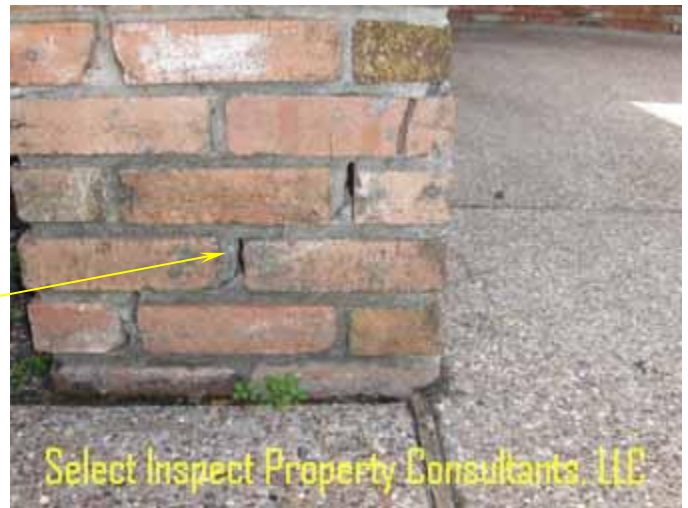
- Open masonry/veneer cracks (*greater than 1/8" wide*) discovered at the north wingwall & south home wall.
- Some cracks at the east, south, & west had separated since the time of mortar patching, implying continued movement.

↑ differential movement at north wingwall

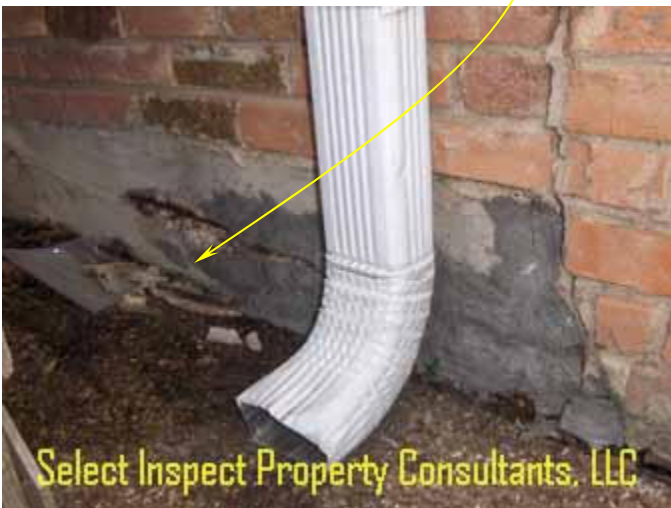
↑ deficient concrete & exposed reinforcement steel; northwest master

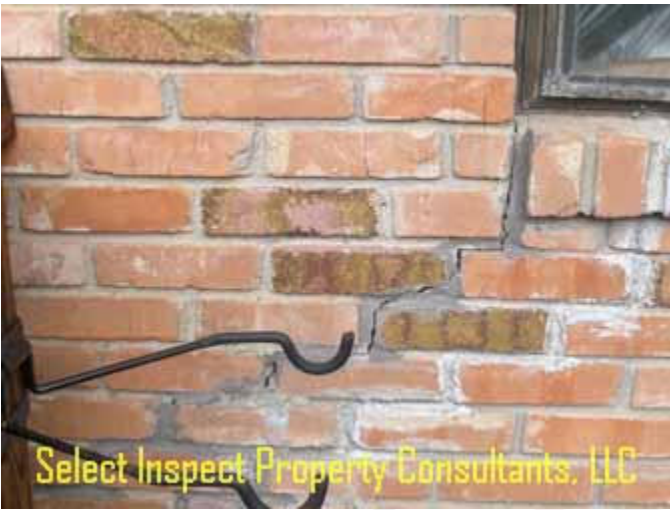
↑ stress crack; south example

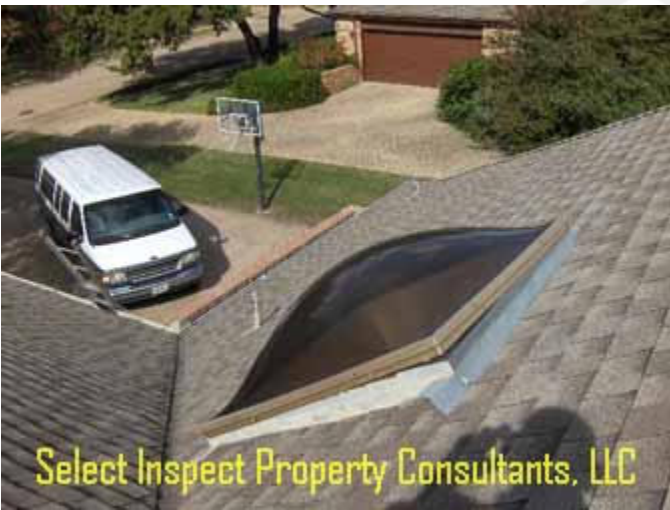
- Both skylights need repair; entry skylight had visible air leakage; master skylight had shifted, visible rot, & an opening to the interior from the roof assembly.

↑ deficient skylight; rot & moisture intrusion

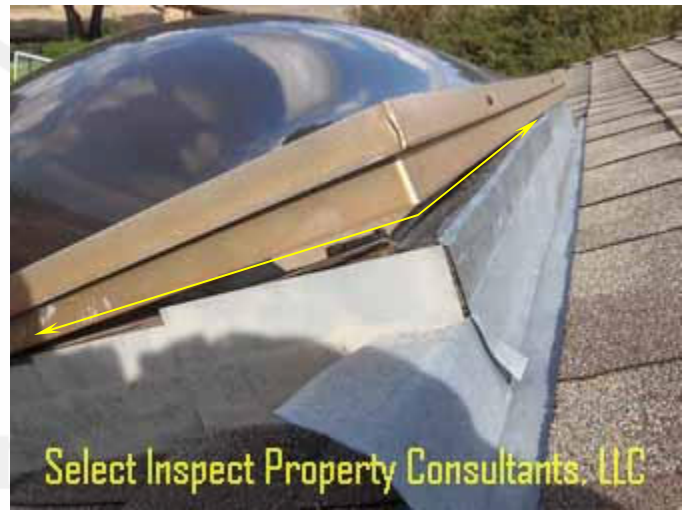
↑ close view of image at left; open to interior of home

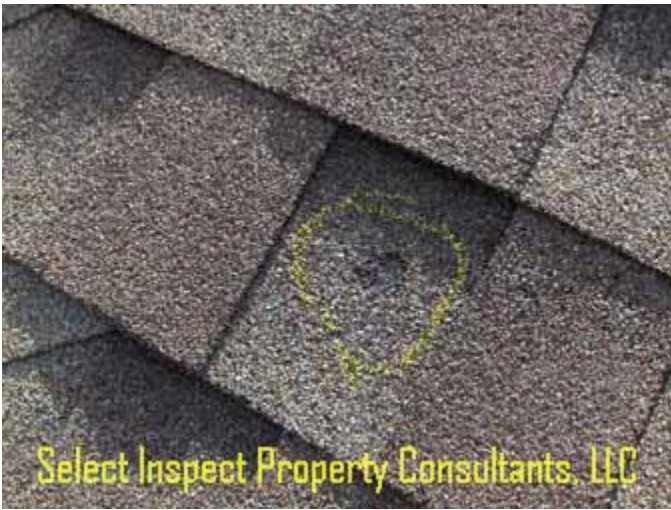
↑ impact damage example

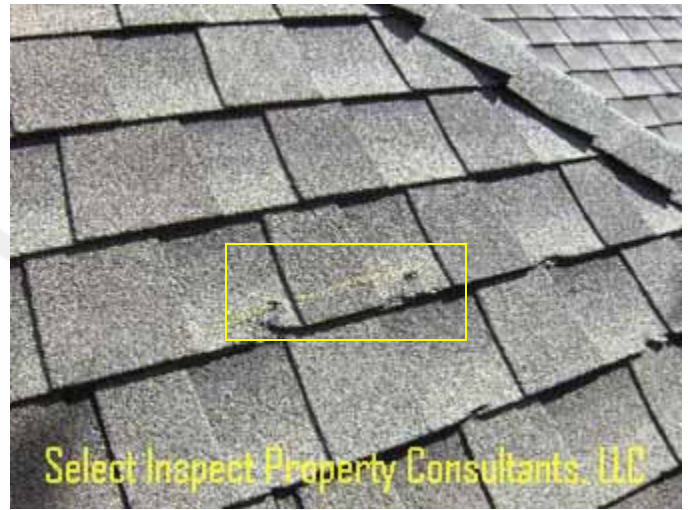
↑ undetermined damage; example

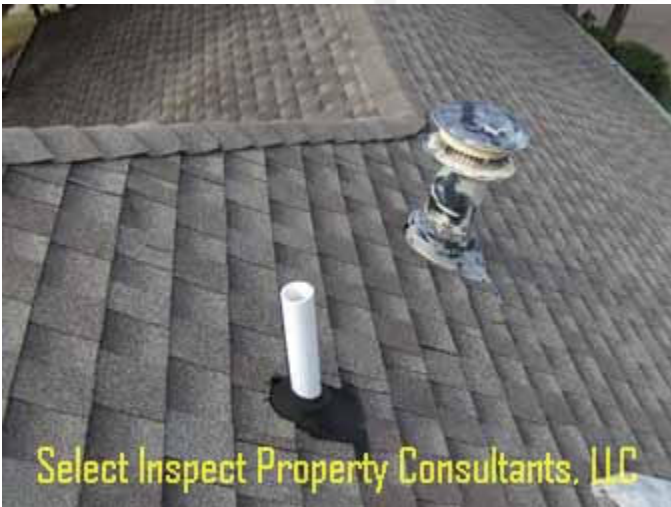
↑ unpainted plumbing vent; uncaulked, exposed fasteners

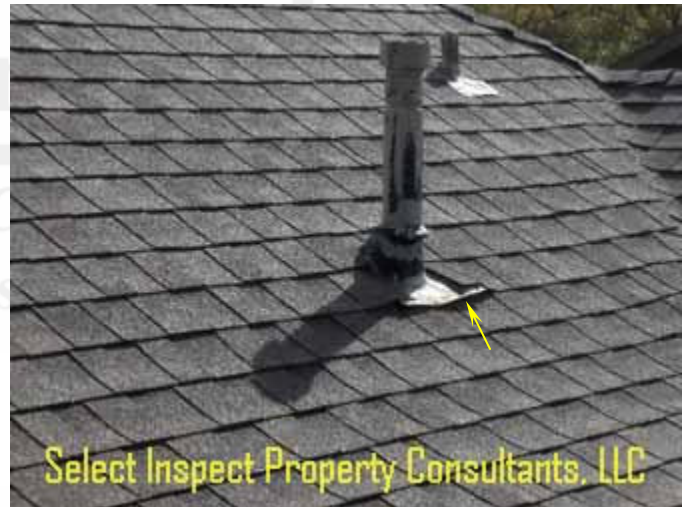
↑ lifted flashing; inadequately secured flue

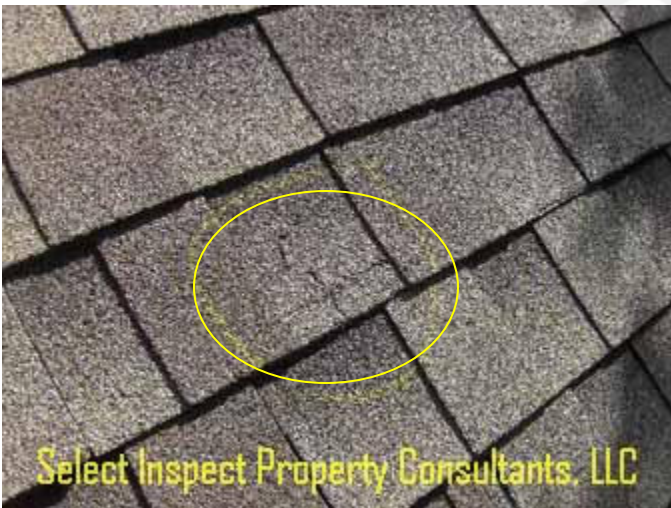
↑ undetermined damage/cracking; example

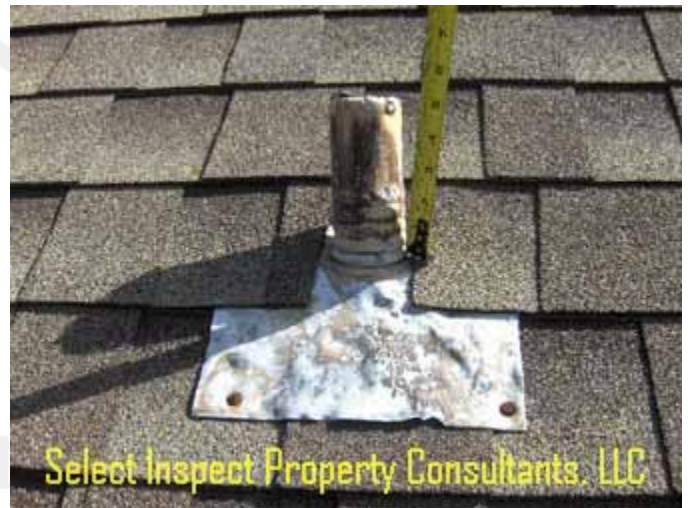
↑ plumbing vent(s) was shorter than required & uncaulked, exposed fasteners

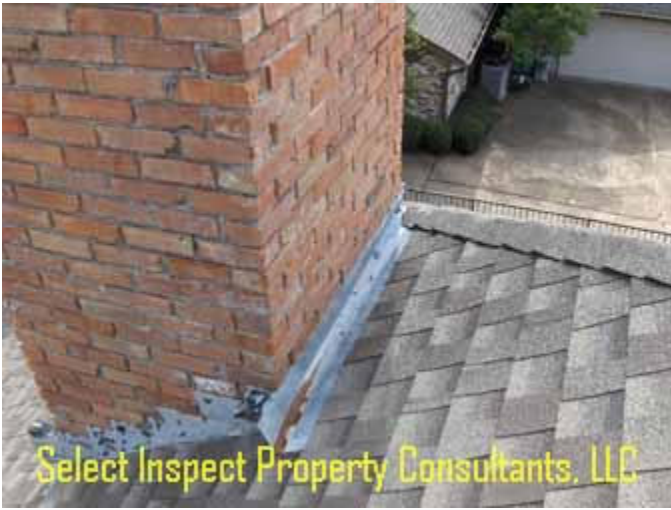
↑ Saddle/cricket should be present for water shedding at the chimney; low side flashing was lifted; moisture intrusion evidence discovered in attic

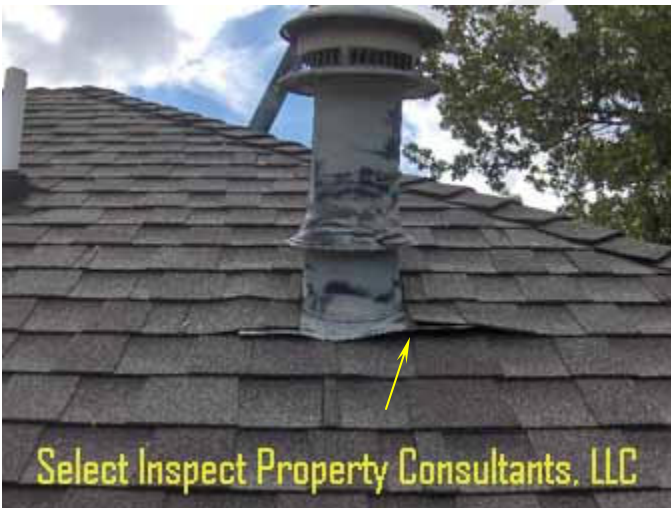
↑ lifted flue flashing example

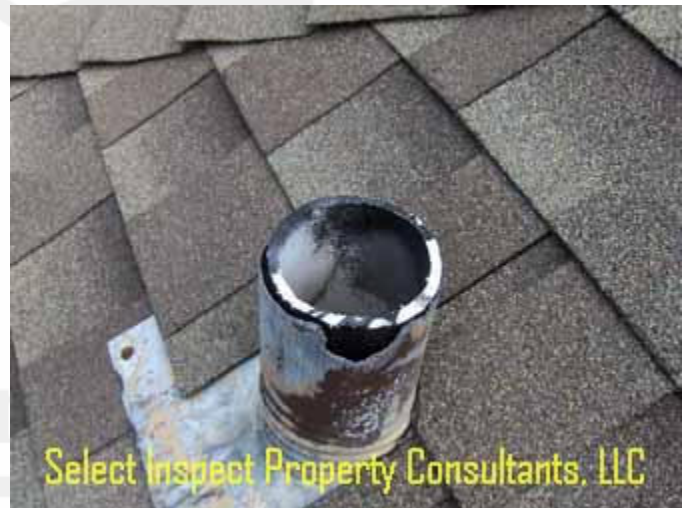
↑ rodent damage example at plumbing vent; moisture intrusion concern & uncaulked, exposed fasteners

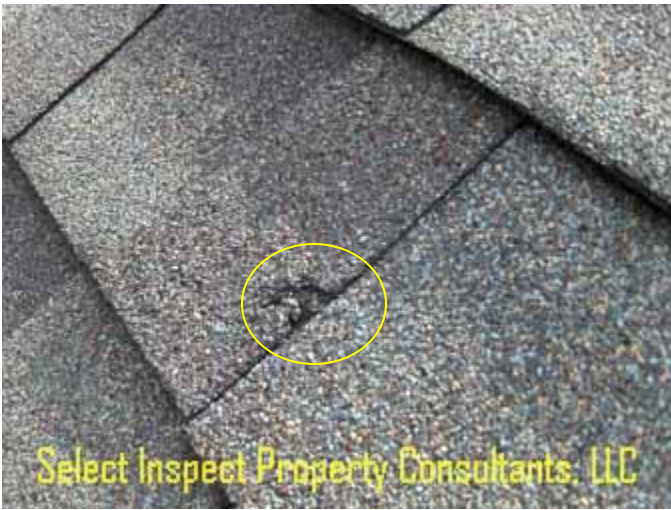
↑ impact or popped nail damage; example

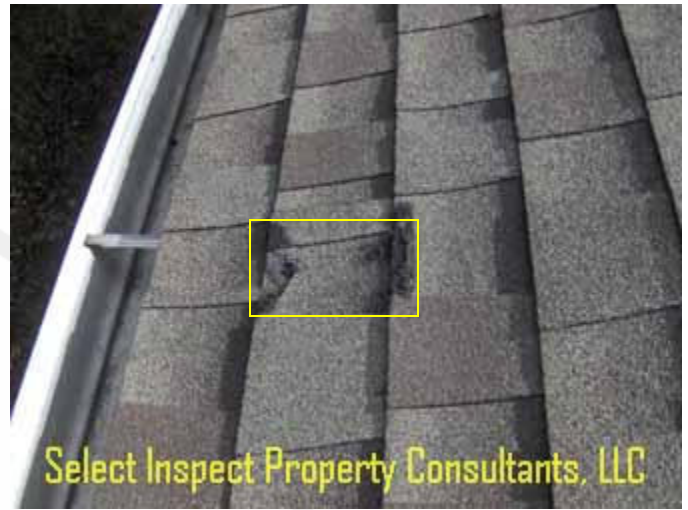
↑ missing shingle tab example

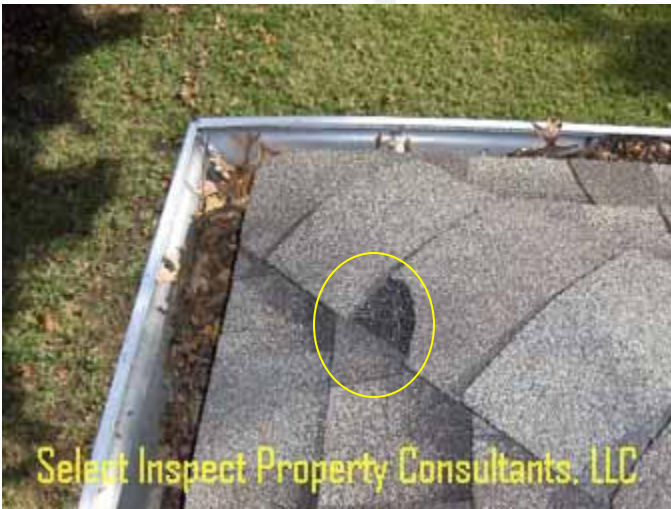
↑ damaged ridge shingle

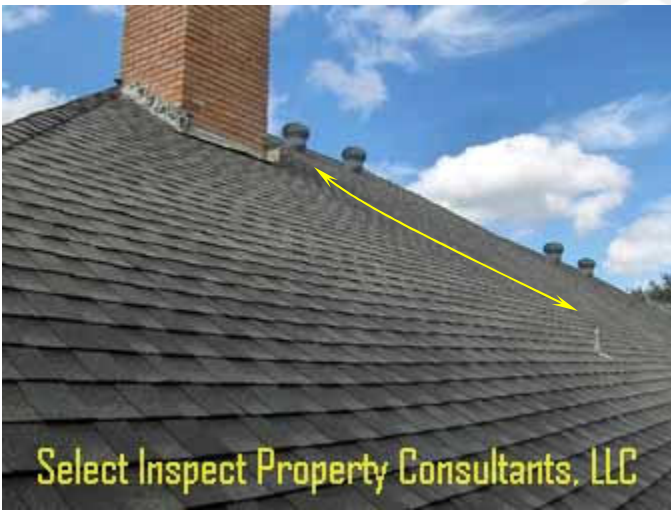
↑ deflection seen at rear roof structure

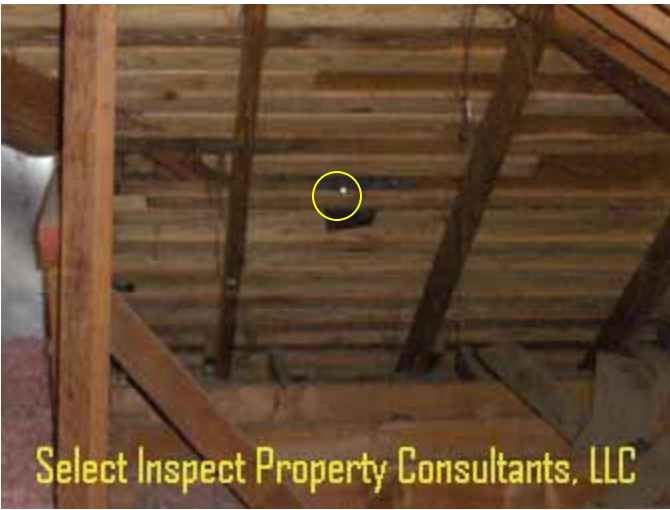
↑ daylight seen from north attic; deficient flashing suspected

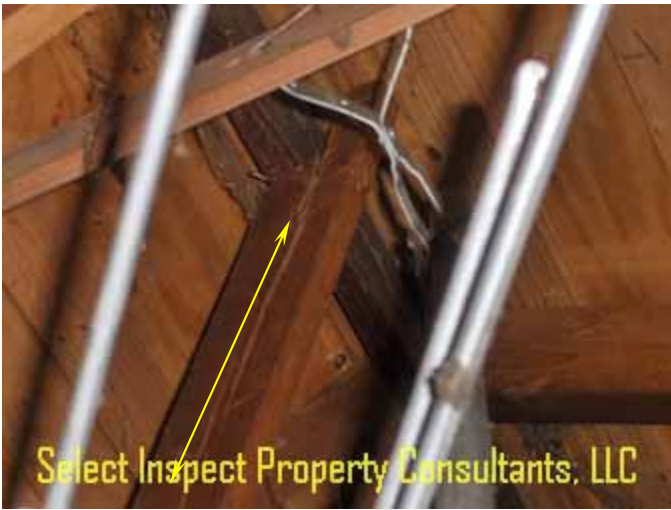
↑ cracked framing

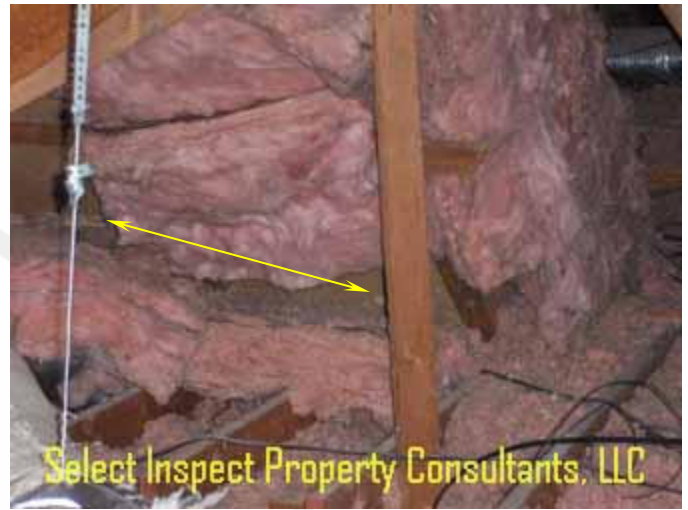
↑ deficient insulation; skylight

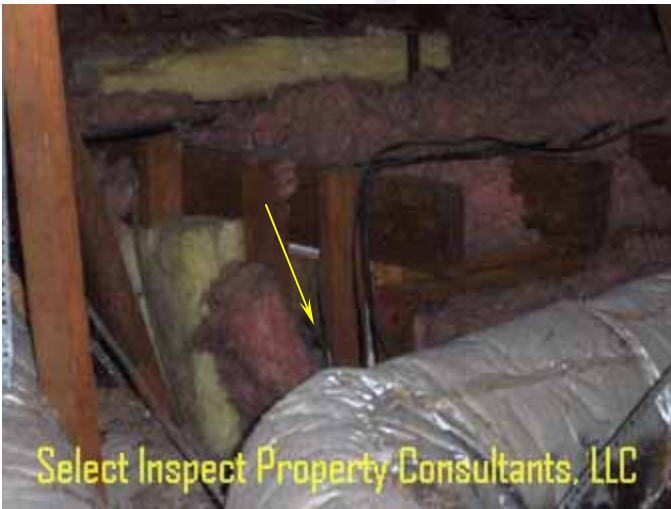
↑ deficient insulation; raised wall

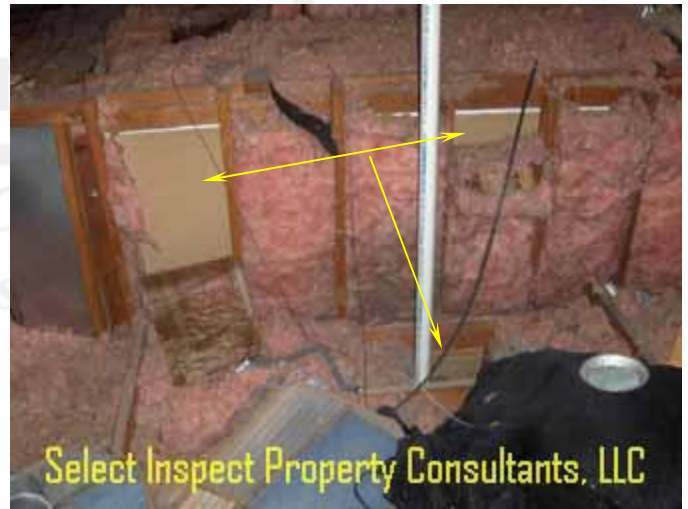
↑ deficient insulation; raised wall

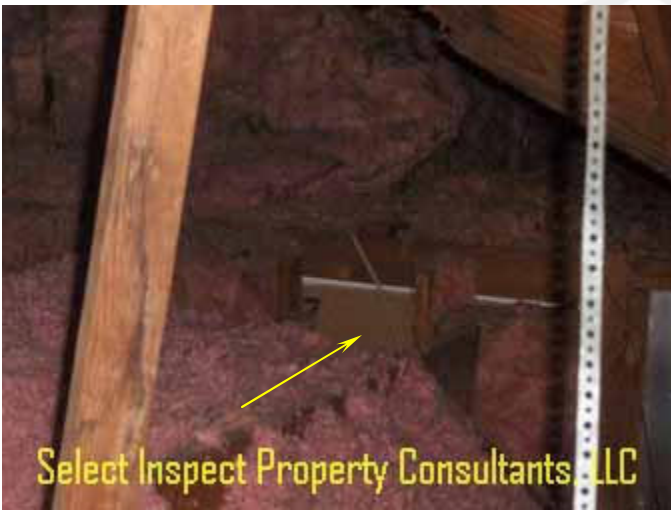
↑ deficient insulation; raised wall

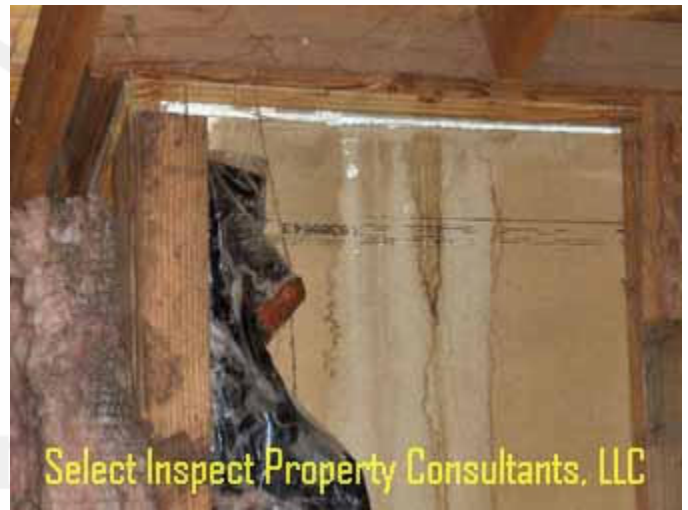
↑ deficient insulation & moisture intrusion/damage at front skylight

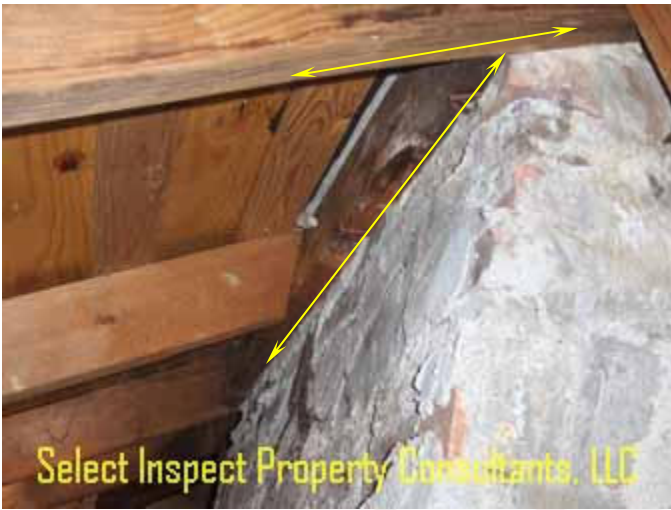
↑ moisture damage & fungus at fireplace framing

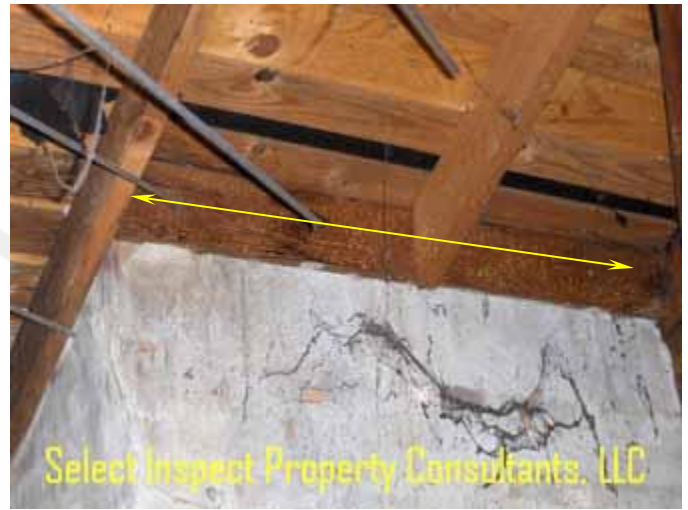
↑ moisture staining at fireplace framing

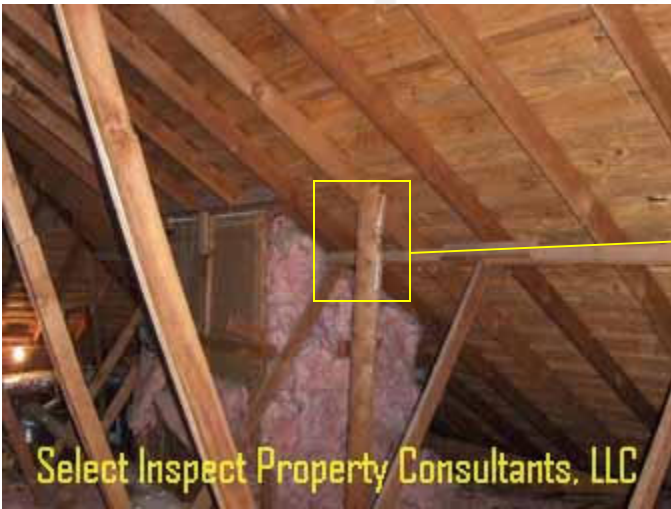
↑ failed framing adjacent front skylight

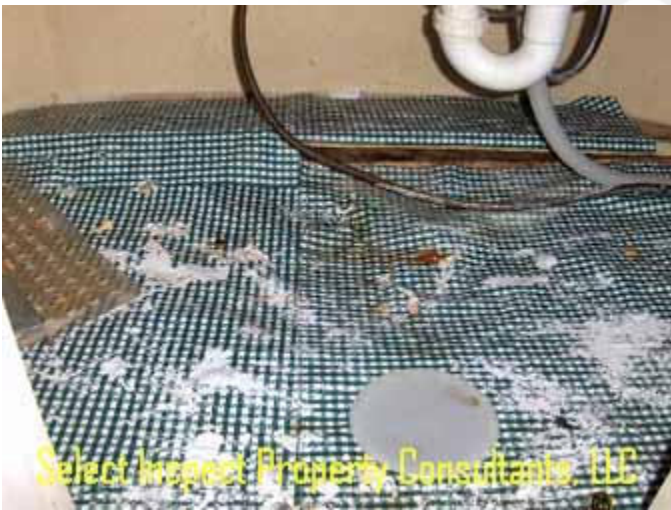
↑ moisture damage & fungus below sinks; example at kitchen

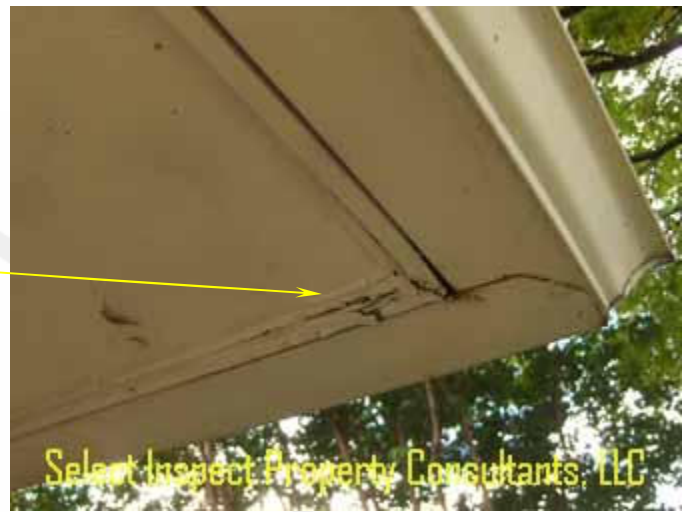
↑ close view of image at left

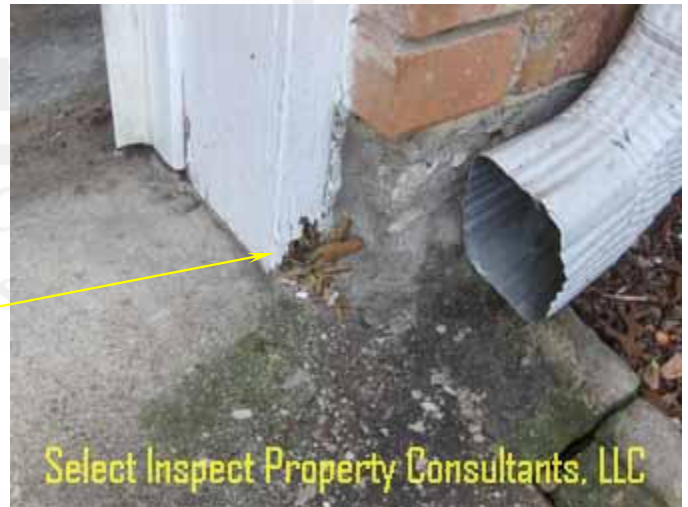
↑ close view of image at left

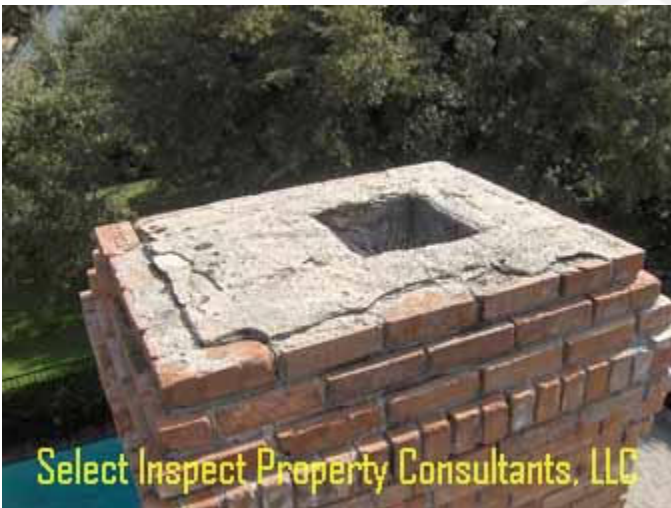
↑ chimney cap needs mortar repair & screen was inadequate

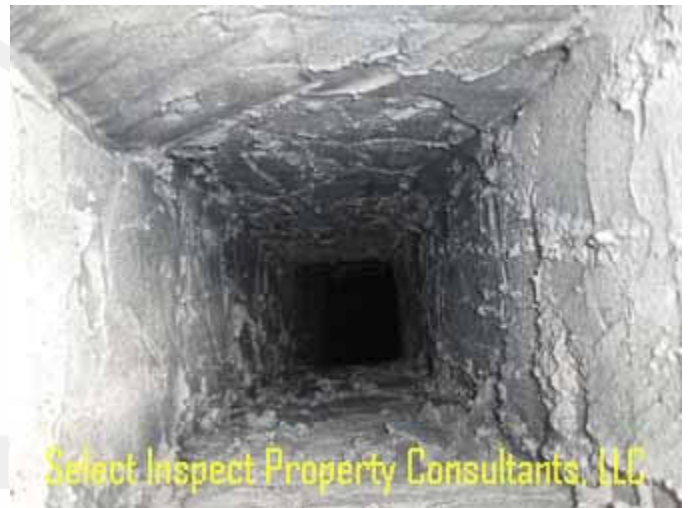
↑ chimney interior; Immediate corrective needs were not discovered at this section

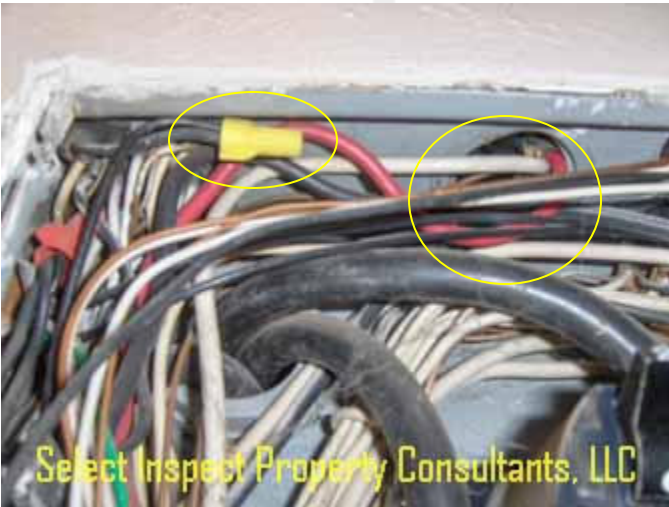
↑ splices & missing grommet; main panel

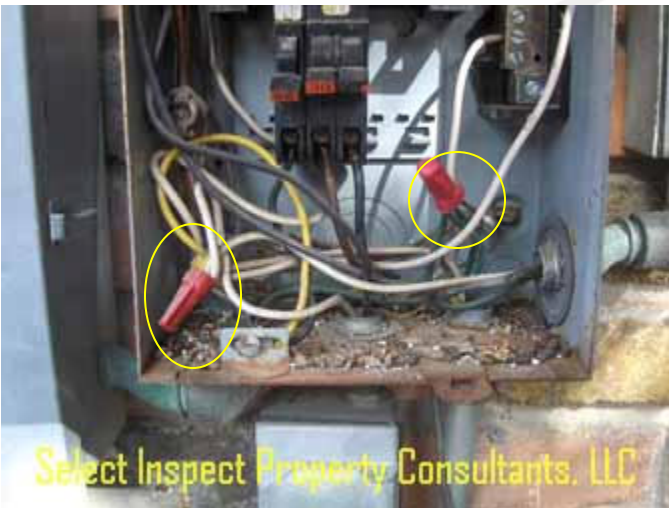
↑ splices & feces; sub panel

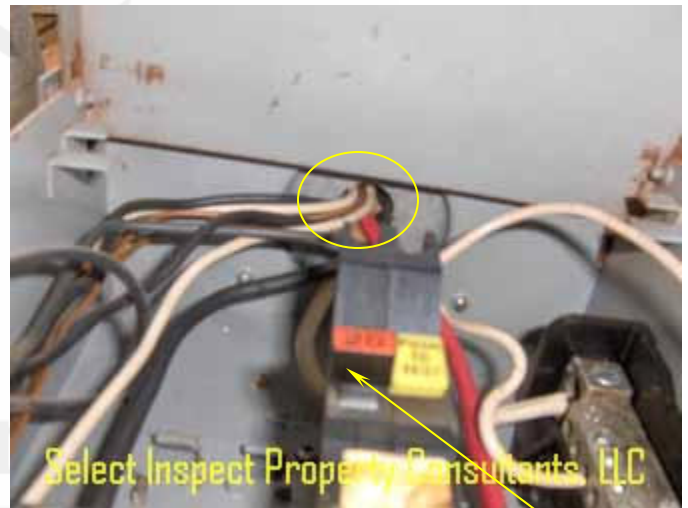
↑ missing grommet & not functioning as intended ground-fault circuit interrupt (GFCI) overcurrent-protection-device; sub panel

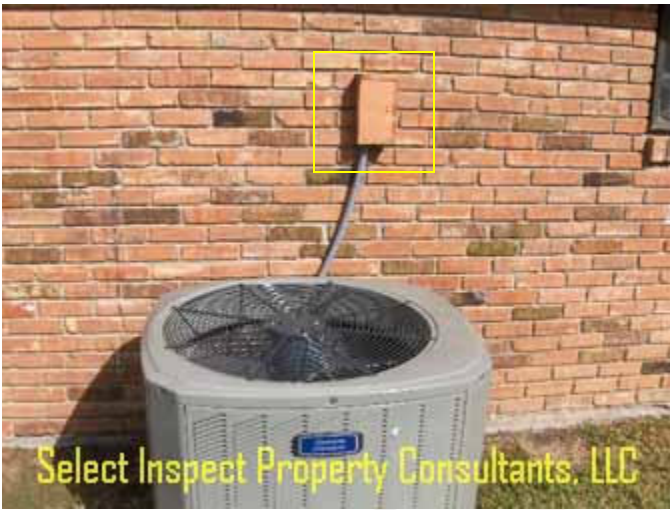
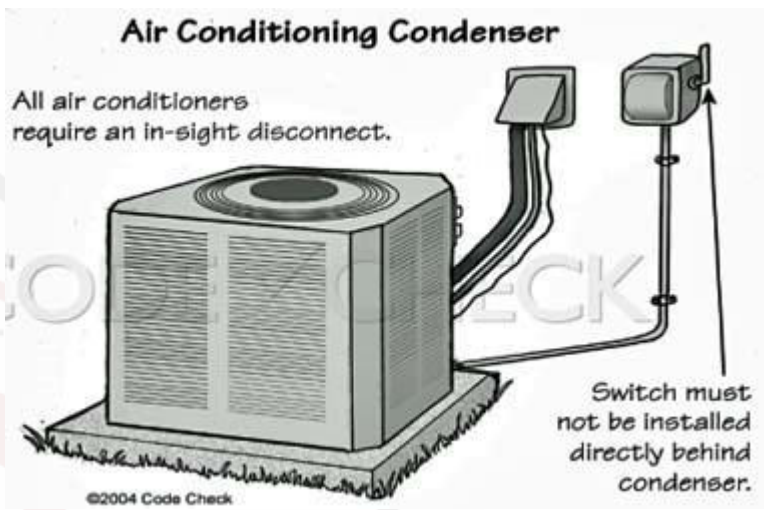
↑ incorrect location of air conditioning condenser(s) service disconnect; inadequate clearance of electrical panel for service personnel & service boxes are not to be painted

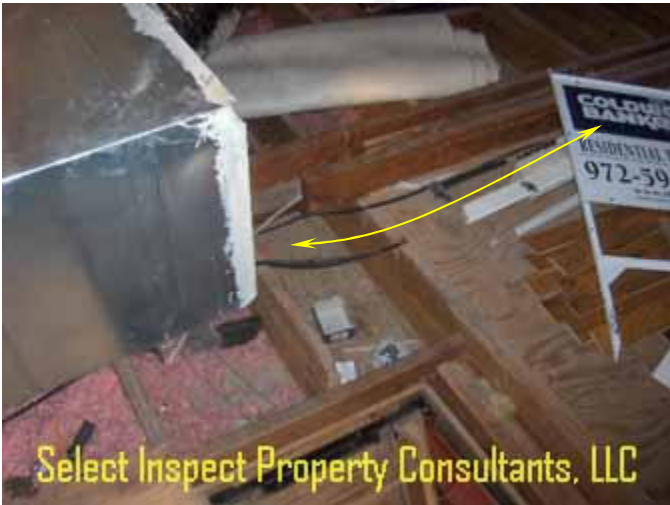
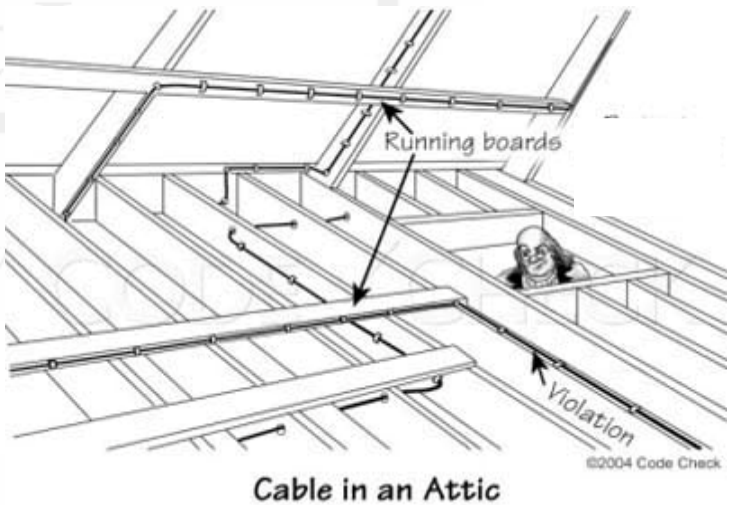
↑ electrical wires in the attic shall be adequately protected within 7' of attic stairs & electrical wires/cables shall not be routed along walking surfaces or in any location prone to traffic damage

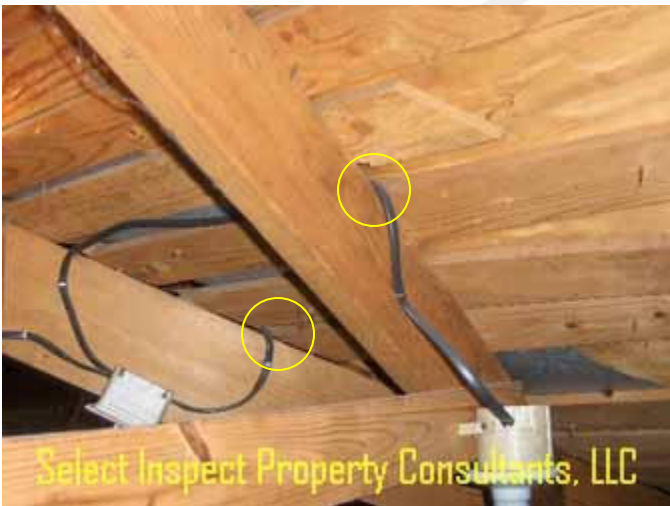
↑ wires shall not be routed between rafters & decking; example at north attic

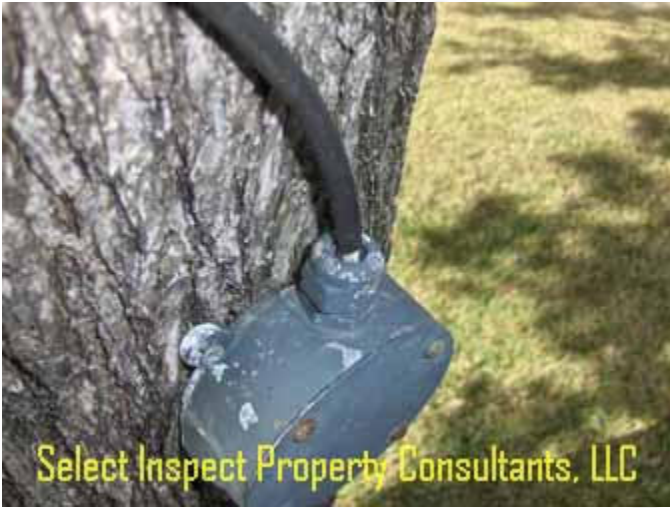
↑ deficient electrical; inadequate weather seal; example

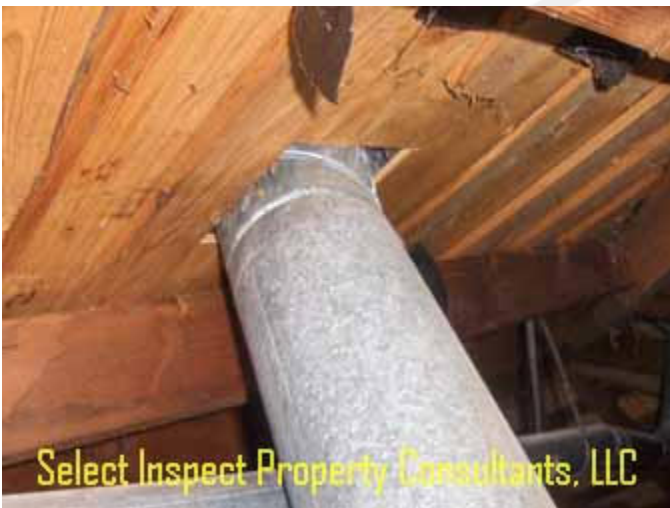
↑ furnace flue did not meet clearance requirements to combustibles

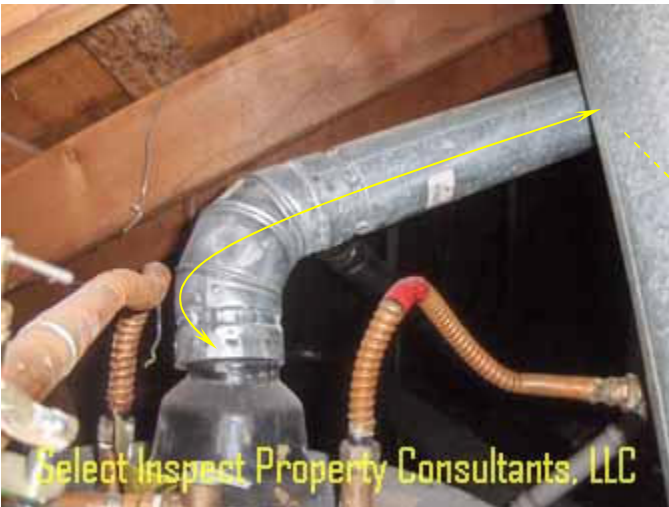
↑ inadequately supported & partially disconnected water heater flue; north

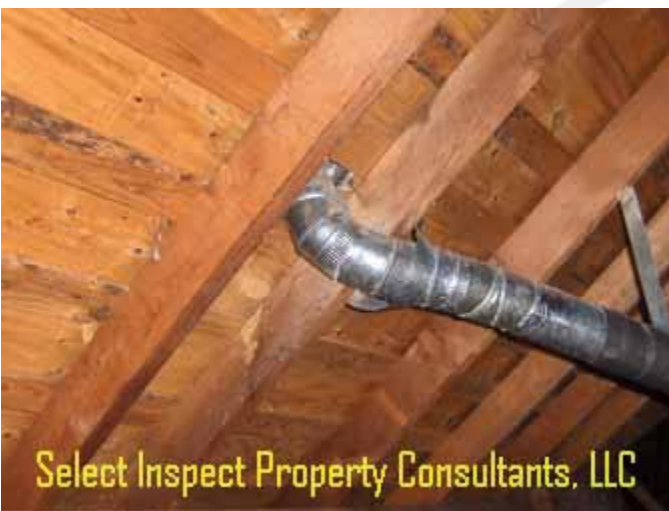
↑ dryer vent amiss/deficient & lint spillage into attic; fire hazard

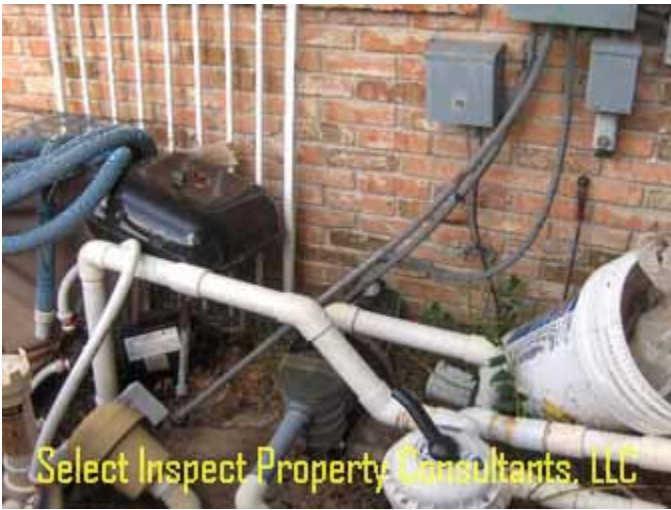
↑ multiple deficiencies, unworkmanlike, & unsafe conditions at pool equipment.

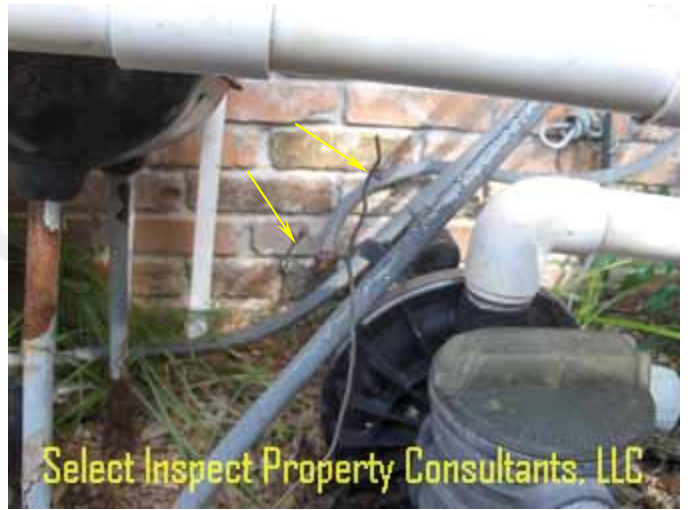
↑ unbonded pool equipment & damaged/stressed conduit

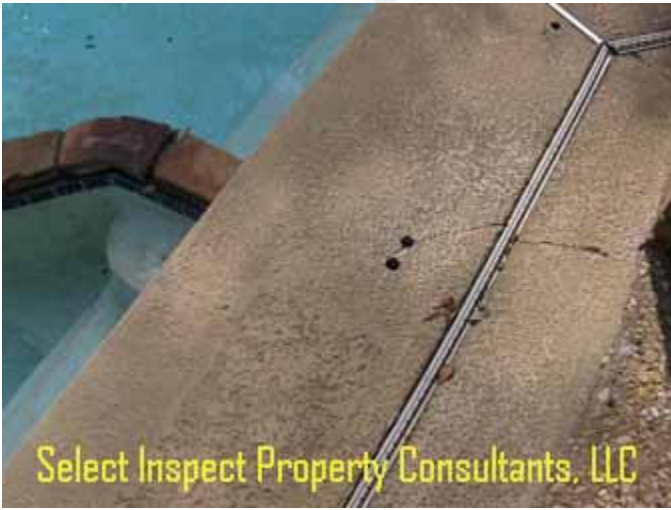
↑ stress & cracks at pool deck

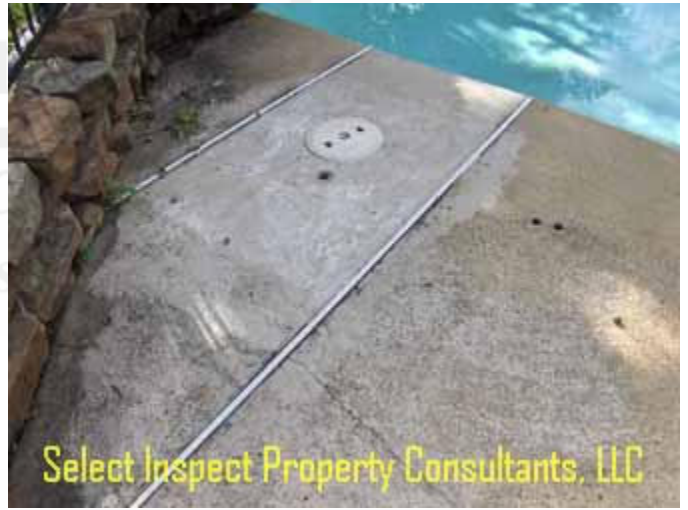
↑ repair evidence at north skimmer

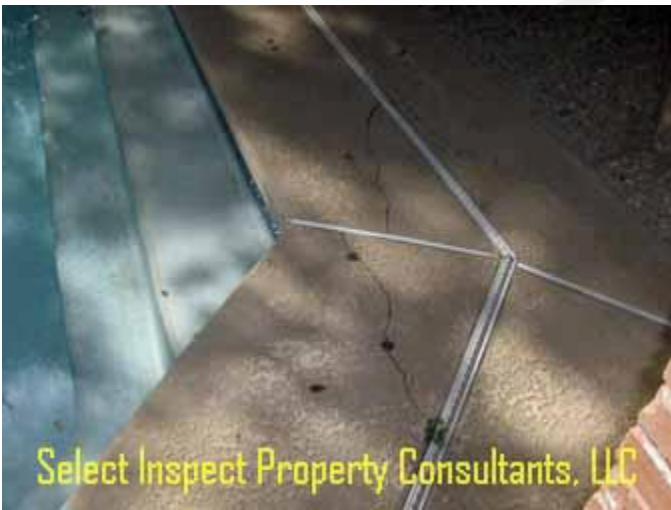
↑ stress & cracks at pool deck & channel drains

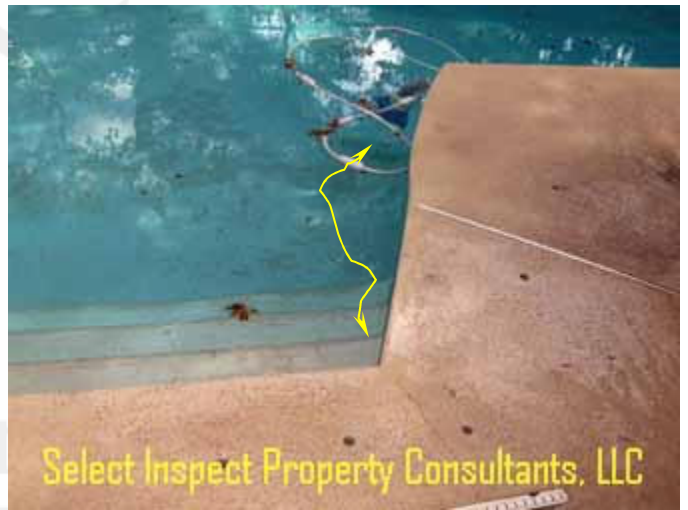
↑ suspected crack at pool
