Property Inspection Report

PROPERTY INSPECTION REPORT

2020 Wing Point

Tuesday, November 09, 2010

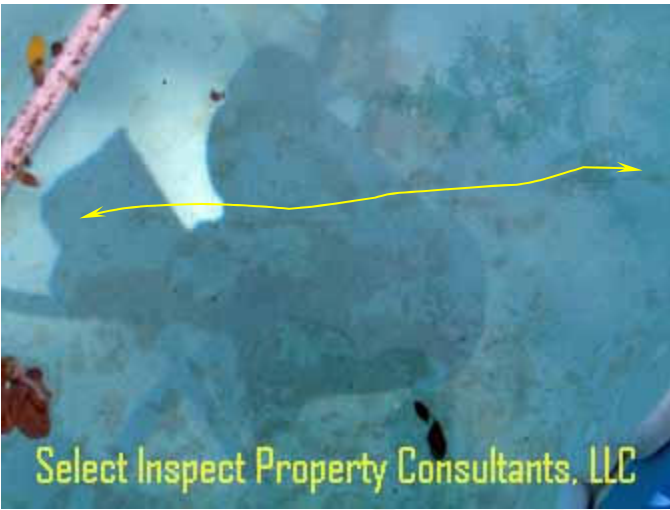
↑ close view of suspected crack

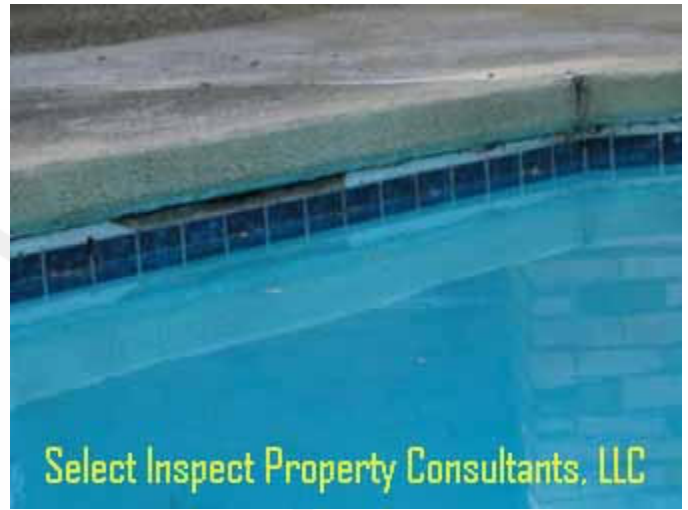
↑ deficient mortar at deck overhang; example

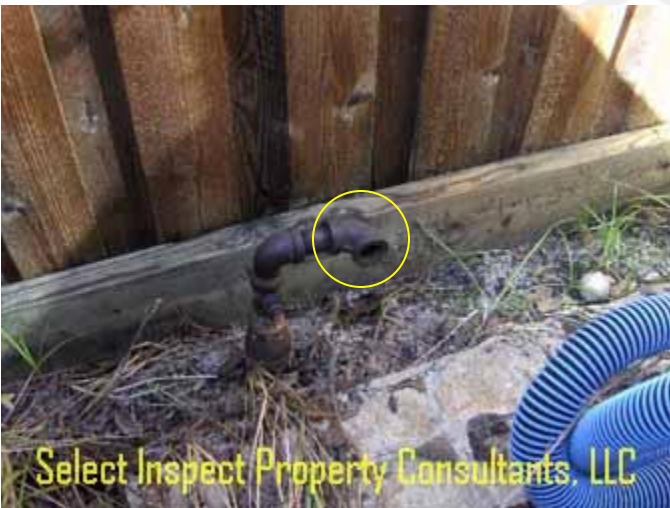
↑ abandoned gas pipe should be plugged
