Property Inspection Report

Select Inspect Property Consultants LLC
2001 Reston McKinney, TX 75070
PROPERTY INSPECTION REPORT

Concerning: 123 street Garland, Texas
(Address or Other Identification of Inspected Property)

By: Bruce W. Carr; TREC #5281 ASHI Member # 211804 Wednesday, April 27, 2011
(Name and License Number of Inspector) (Date)

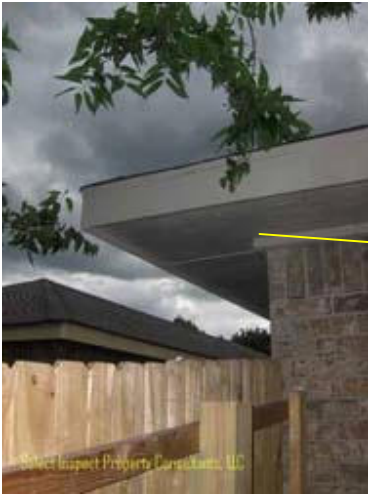
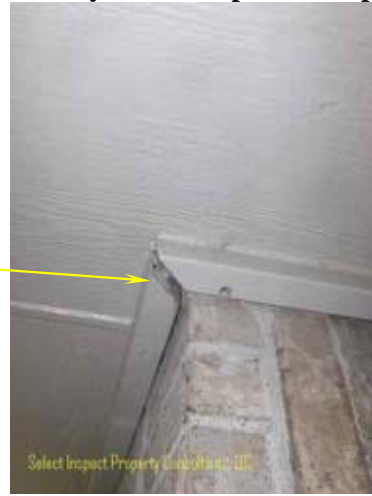
↑ frieze-board separation at the northeast

↑ close view of image at left

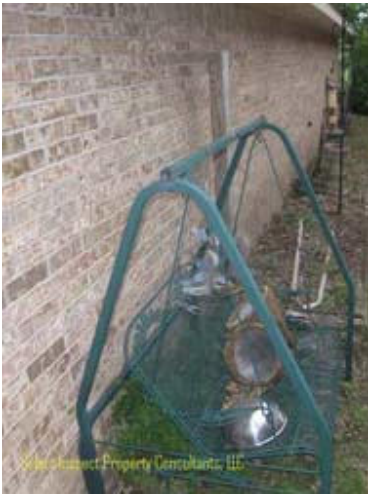
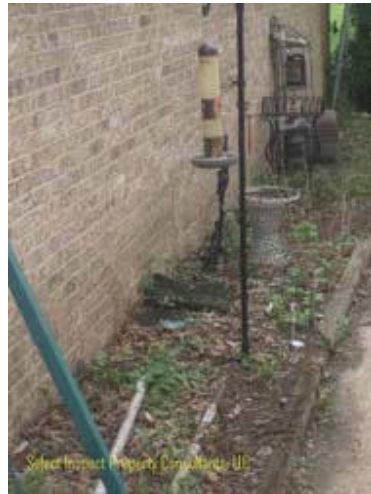
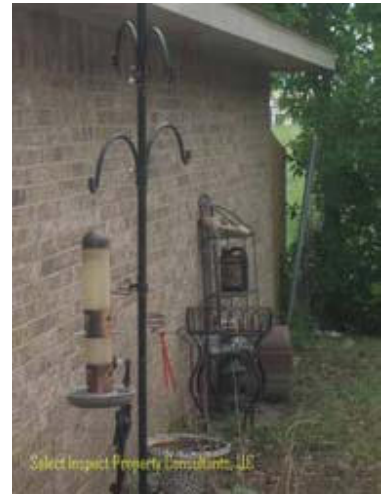
- ✦ The grade/soil level at the east & west was at or above the bottom of the veneer (stucco, brick, stone, siding, etc). Repair is recommended. This may obstruct weep openings and is conducive to moisture intrusion, rot, and termites. Ideally, the brick / stone joint at the foundation would be four to six inches above soil and at least one inch minimum from adjacent concrete slabs. This would allow the edge of the foundation to be visible for inspection of termites and moisture intrusion conditions. It is common for this standard to be frequently ignored. If repairs are made, the substrate should be examined for wood rot and termites. If undesirable conditions are found, further repairs should be arranged. If soil/bark/mulch is lowered or removed, ensure the areas will have proper drainage away from the structure; ideally 6" drop in slope within the first 10 feet from the structure; or to an appropriate drain to not allow excess moisture within 6 feet of the home.

↑ high soil & obstructions-east

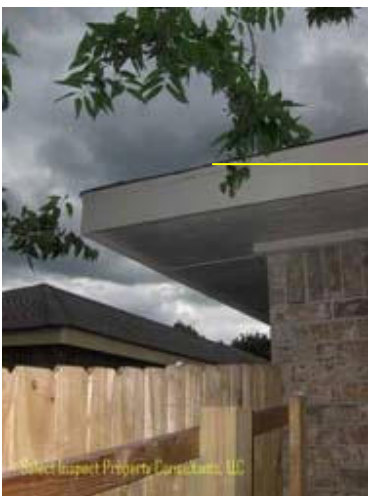
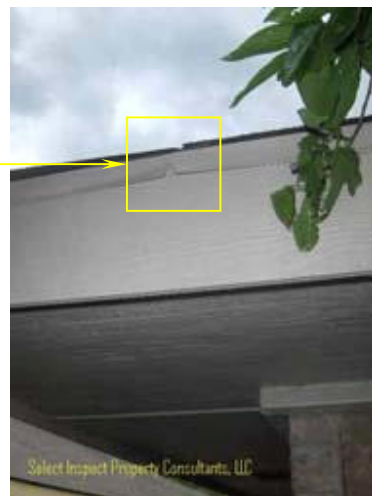
↑ inadequate drip edge flashing overlap at all sides; example at north-northeast

↑ close view of image at left

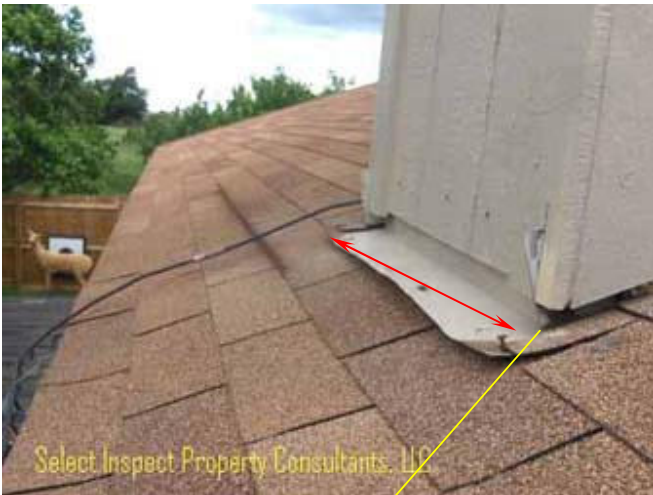
↑ deficient chimney flashing

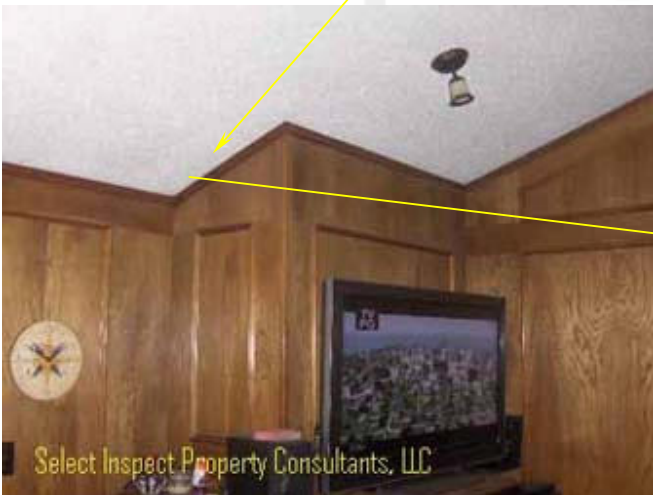
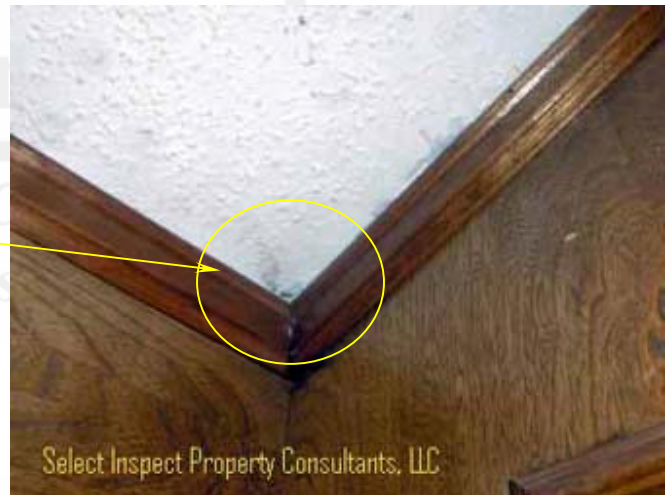
Moisture damage & fungus exist at the family room below the chimney chase, at the master bathroom cabinet, & kitchen cabinets. There may be some moisture damage & or compression/related structural conditions that were concealed & not discovered. Extent of damage is undetermined in concealed wall spaces; undetermined conditions include but are not limited to the presence and or condition of fungus, insulation, framing. We do not perform mold testing, and did not take fungus or air samples from the home. If you are concerned about health related issues, we recommend that you consult an indoor air quality firm for evaluation and options for cleaning. Researching and evaluating various firms and their methods for remediation would be prudent, if you plan to pursue those measures.

↑ moisture damage & fungus at family room interior below the deficient chimney flashing- inaccessible from the attic

↑ close view of image at left

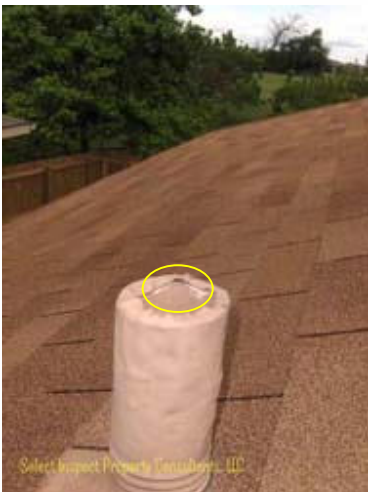
↑ inadequate wrap at plumbing vent; opening may allow moisture intrusion; not readily accessible from attic-west bathroom

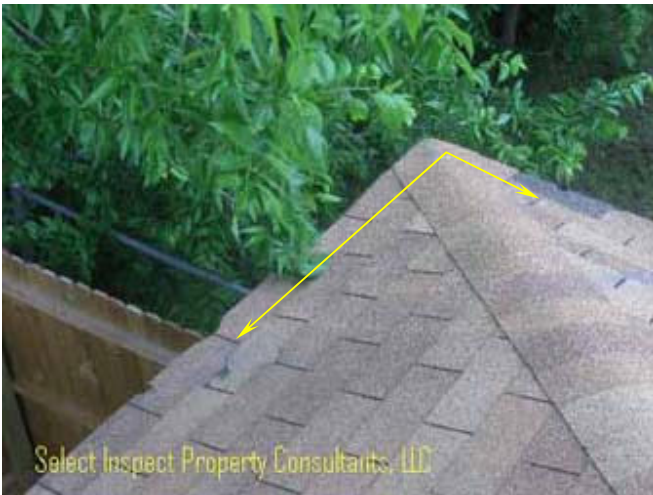
↑ tree damaged shingles at the northeast

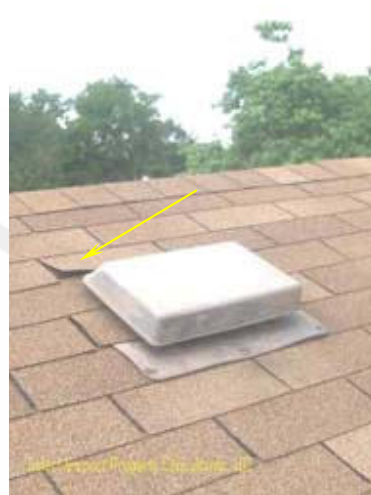
↑ example deficient shingle at roof vent

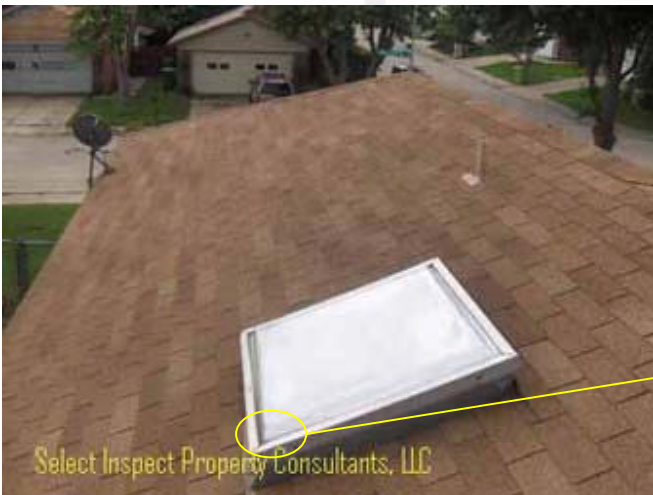
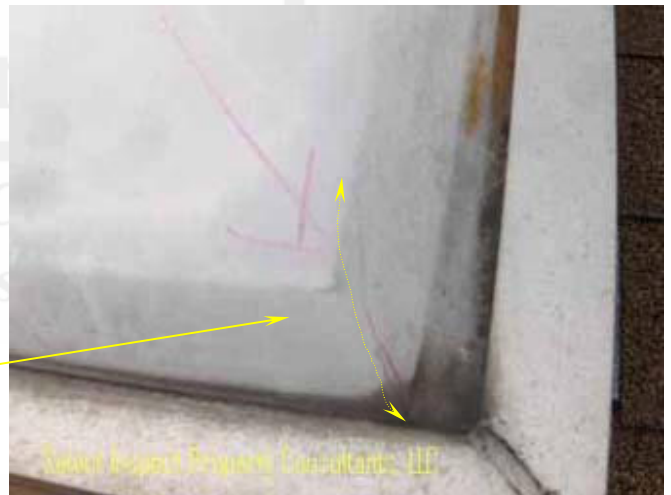
↑ cracked skylight

↑ close view of image at left

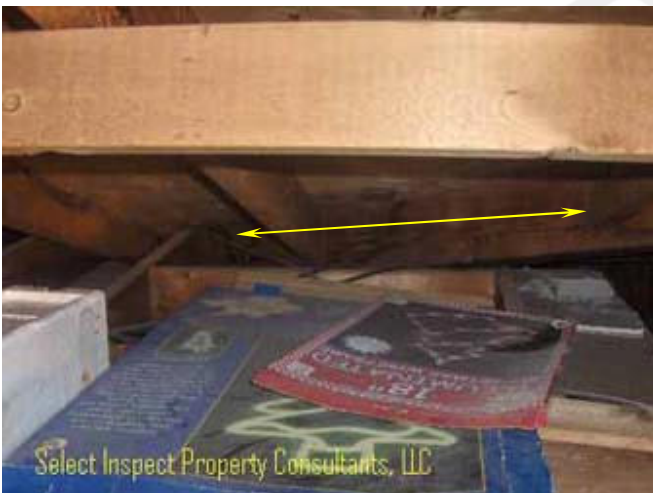
- Moisture intrusion evidence noted at garage southwest (valley rafters), fireplace, & skylight; correction/improvement of this and other related conditions is recommended; sealant is considered a "temporary repair".

↑ moisture staining at valley rafters; garage attic west

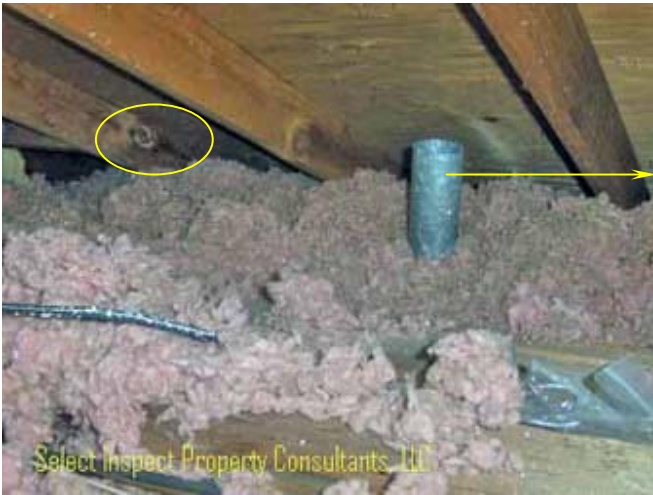
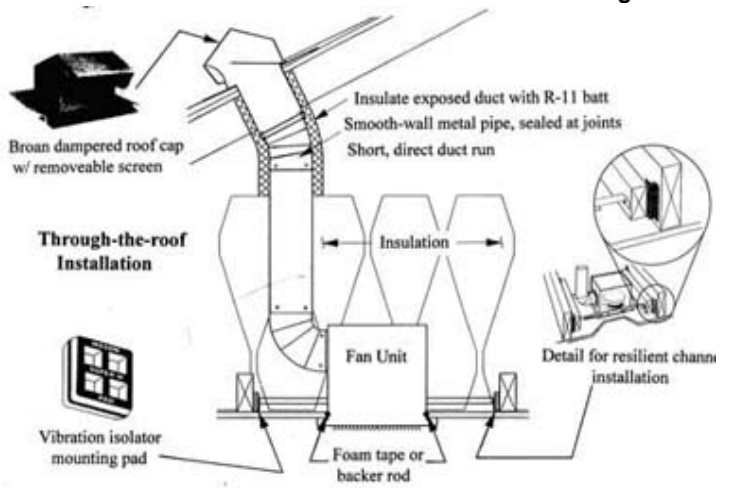
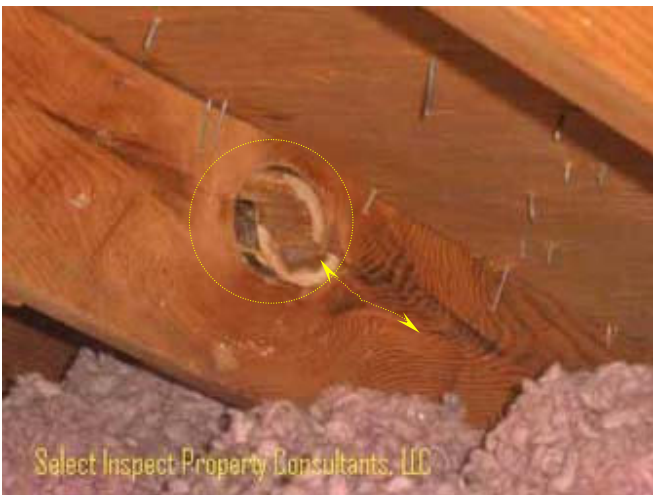
- Some / all bathroom /laundry exhaust fans appear to vent to the eaves/attic. Vent termination within the attic, at passive roof vents, or at eave vents does not meet most manufacturer guidelines. Current standards require venting of bathroom and utility room exhaust fully to the exterior. (IRC M1507). Texas Real Estate Commission considers this deficient, even on older homes. Related technical information can be found at: <http://www.toolbase.org/PDF/DesignGuides/spotventilation1.pdf>

↑ knot/crack & exhaust fans improperly terminate in the attic, rather than exterior

↑ close view of image above

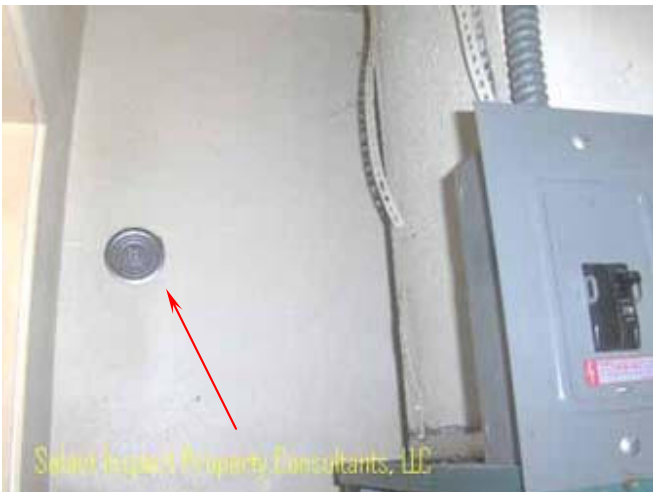
↑ tin can lid at mechanical closet wall- undetermined reason- not removed

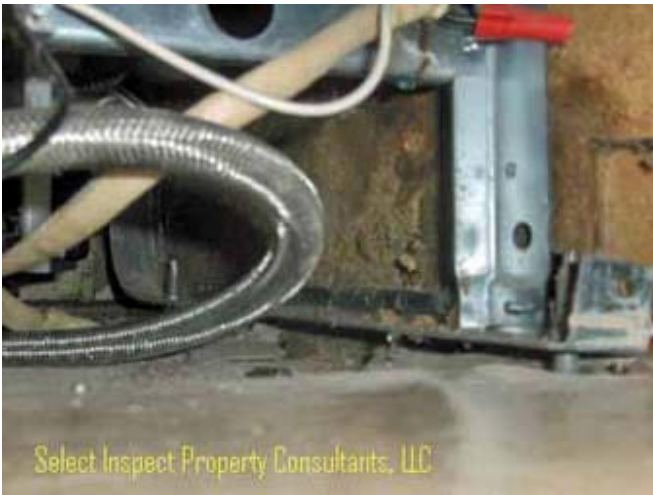
↑ moisture damage & fungus under dishwasher

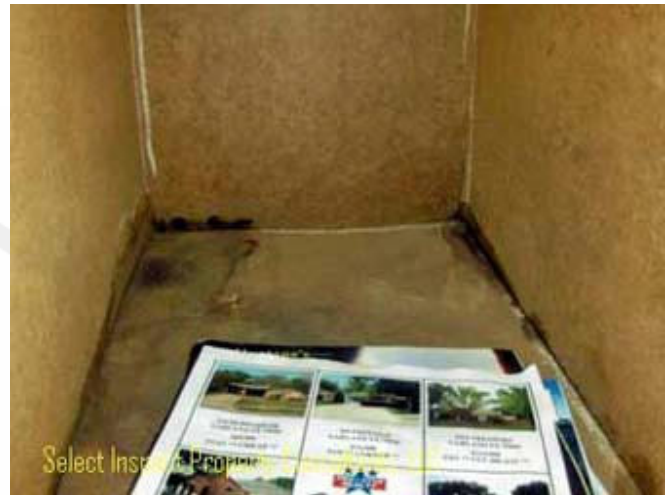
↑ moisture damage & fungus right kitchen cabinet-east

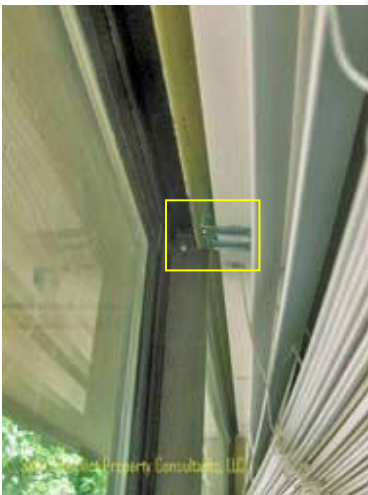
↑ unworkmanlike blind install- master- obstructed window; emergency escape concern

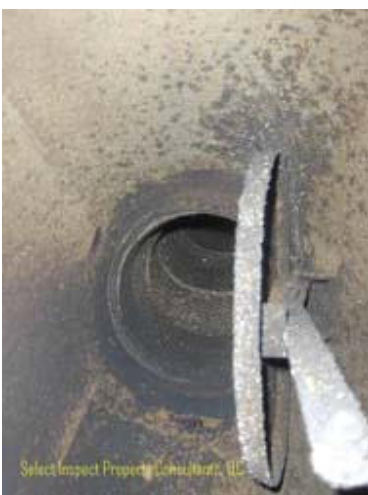
↑ fireplace interior & chimney flue need professional cleaning

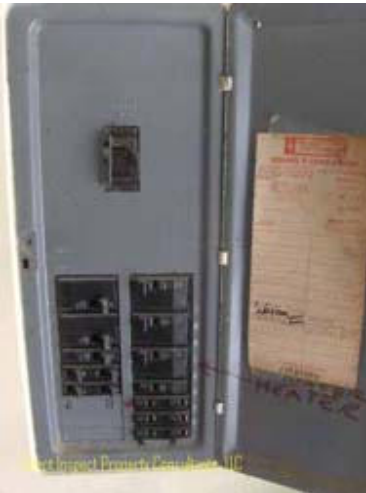
↑ black label square D overcurrent-protection-devices

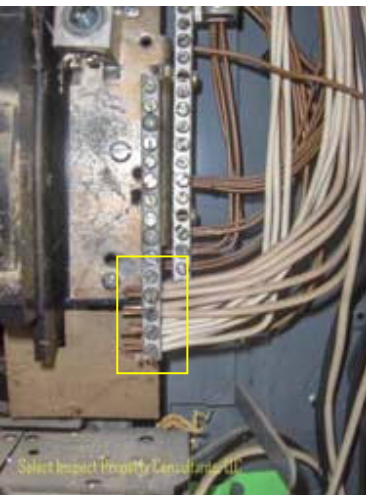
↑ conductors shall be terminated individually in lugs / breakers

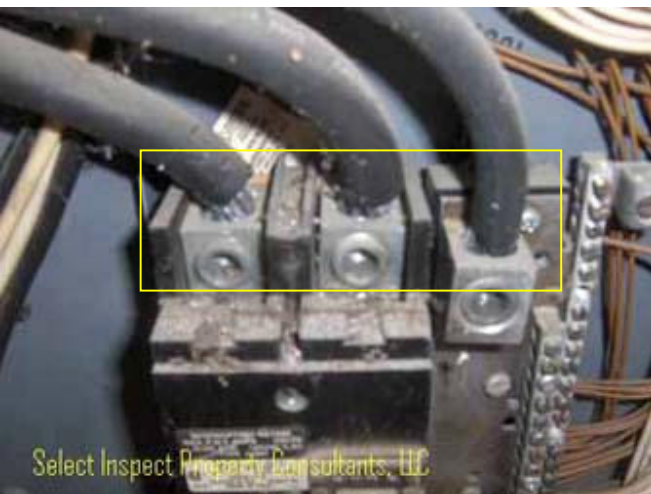
↑ missing antioxidant paste at aluminum conductors/terminals in service cabinet

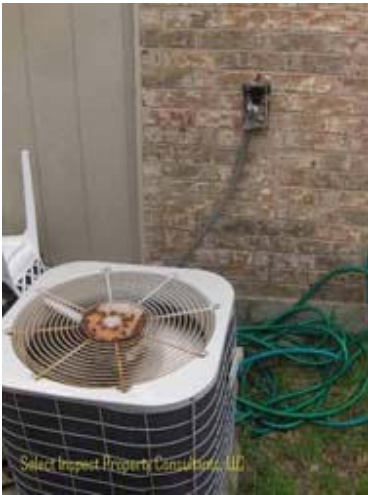
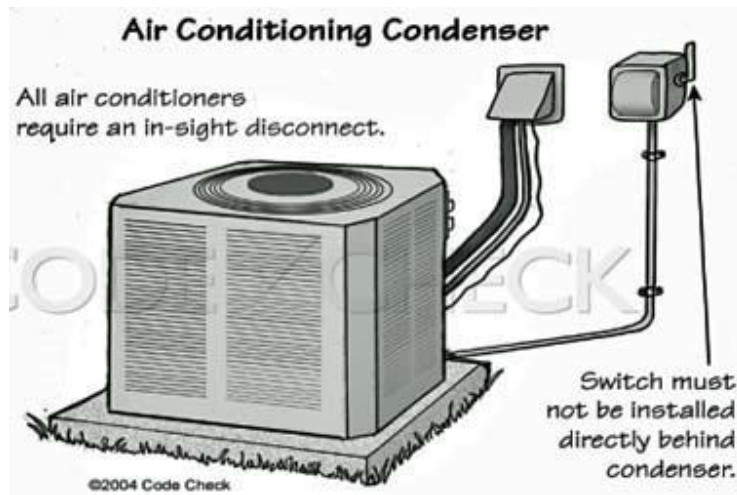
↑ incorrect location of air conditioning condenser(s) service disconnect; inadequate clearance of electrical panel for service personnel

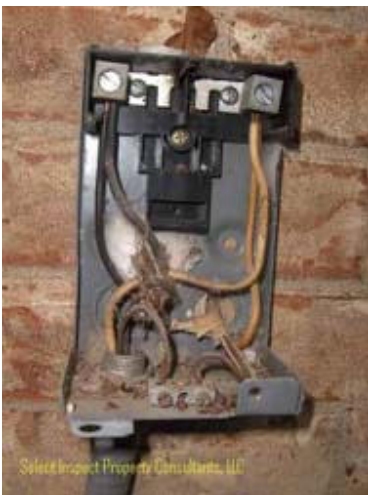
↑ missing overcurrent-protection-device at air conditioning disconnect (lack of disconnect) ; hardwired; unworkmanlike & unsafe

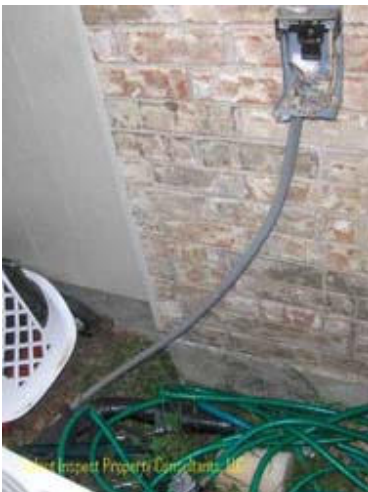
↑ inadequately secured conduit at air conditioning condenser

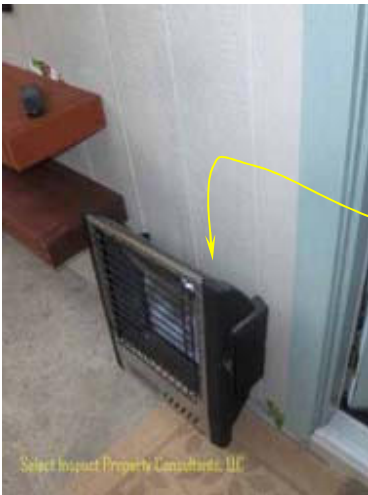
↑ obstructed receptacle

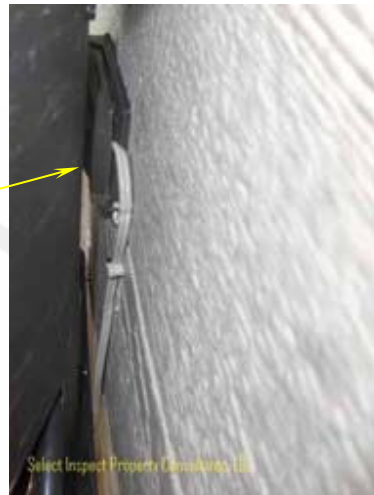
↑ crimped cord & improper permanent use cover

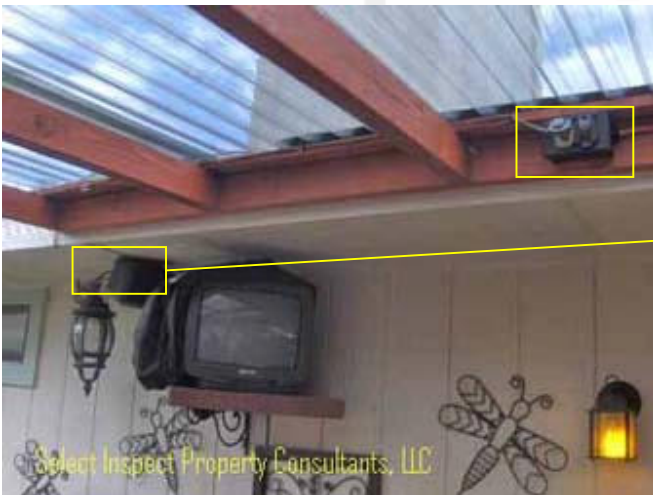
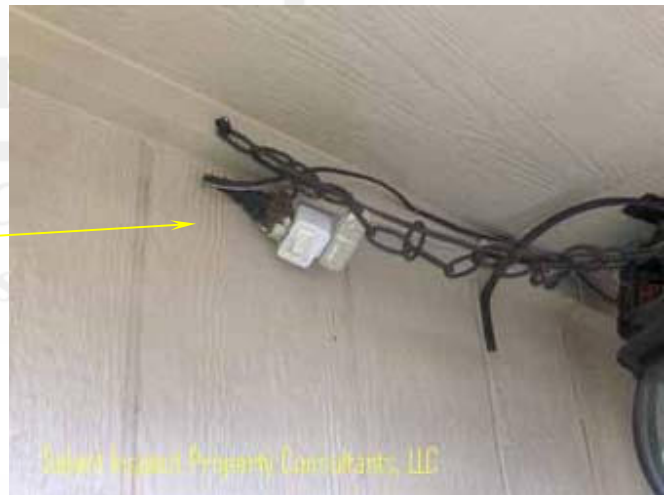
↑ multiple unworkmanlike/unsafe conditions at patio electrical

↑ close view of image at left non-exterior adaptor plugs & extension cords

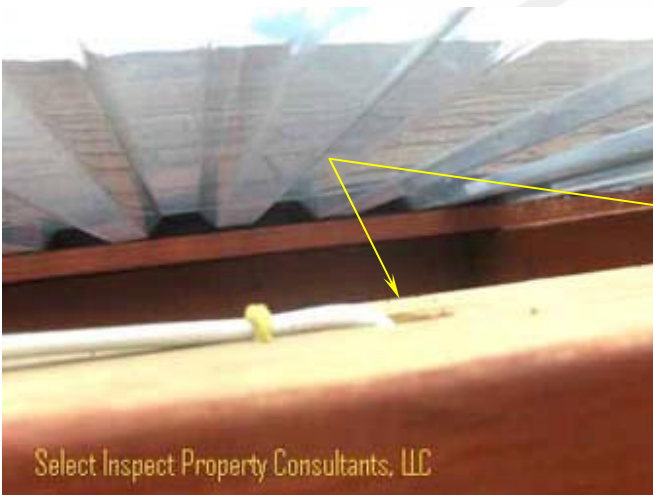
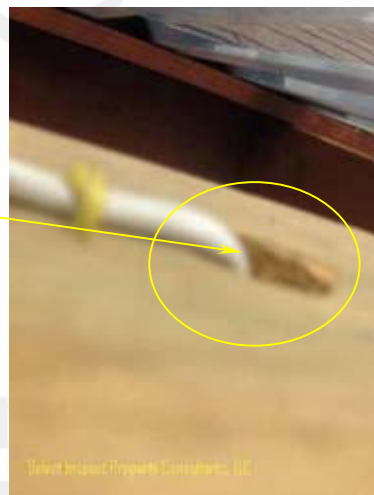
↑ Deficient excess reveal (opening) at patio fan electrical/mounting

↑ close view of image at left

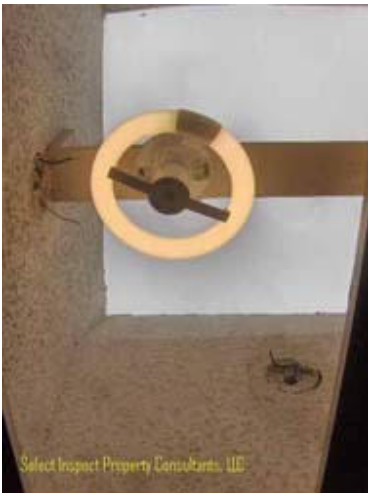
↑ unworkmanlike/unsafe electrical at skylight; open conductors

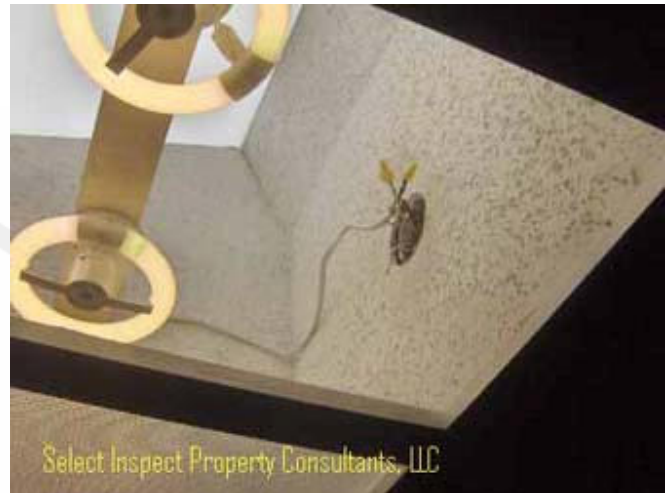
↑ unworkmanlike/unsafe electrical at skylight; splices, open conductors, Wires should be secured within 12 inches of junction boxes, switches, receptacles, fixtures

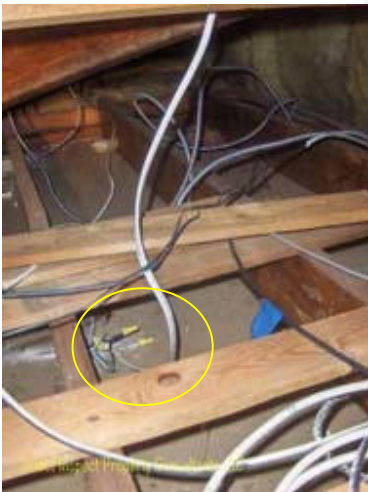
↑ unworkmanlike electrical in attic

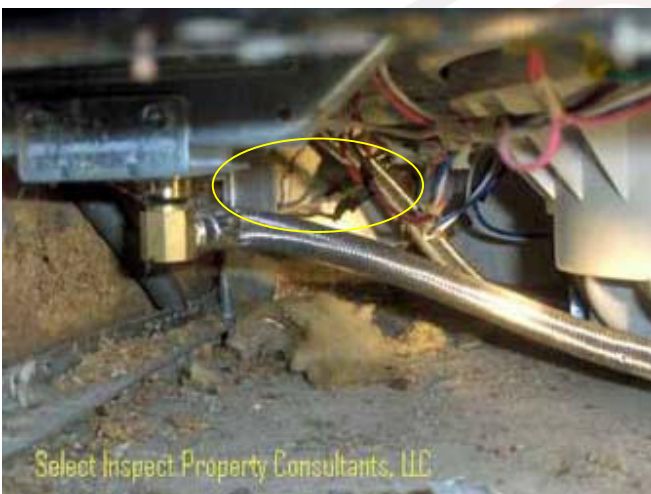
↑ unworkmanlike electrical below/behind dishwasher

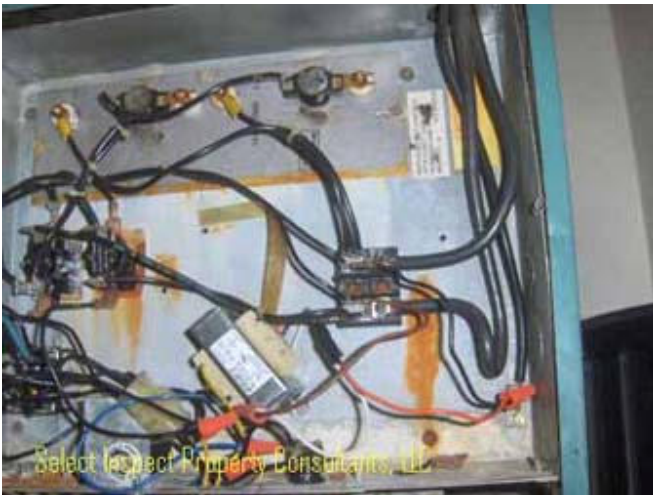
↑ corrosion at heat components; HVAC

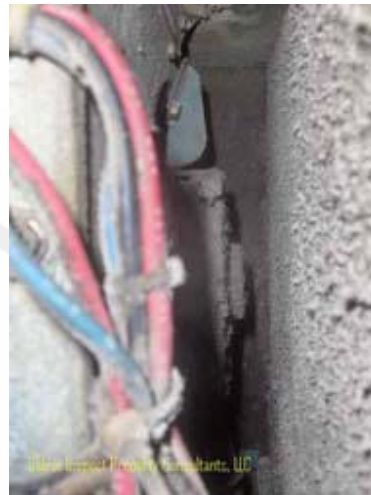
↑ unclean plenum & blower; HVAC

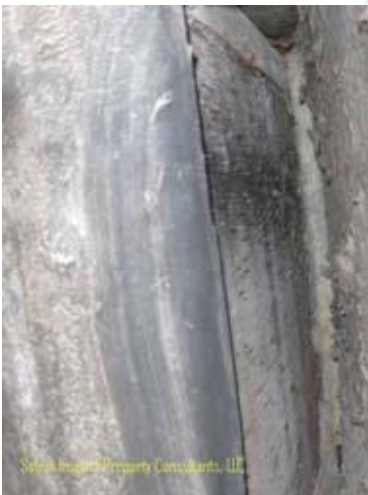
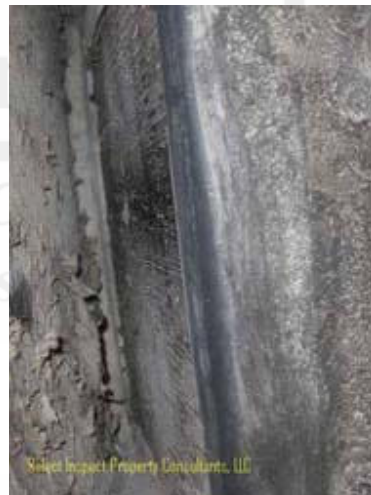
↑ unclean evaporator(s) coils & cabinet

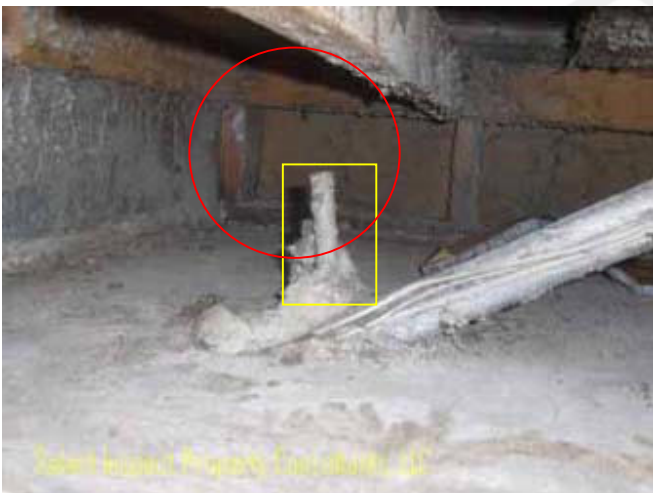
↑ unclean plenum; hollow stake (yellow), moisture staining (red); below the HVAC

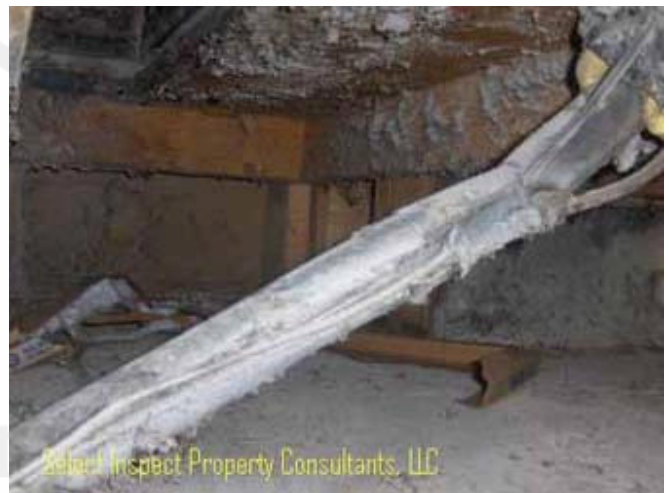
↑ unclean plenum & debris; below HVAC

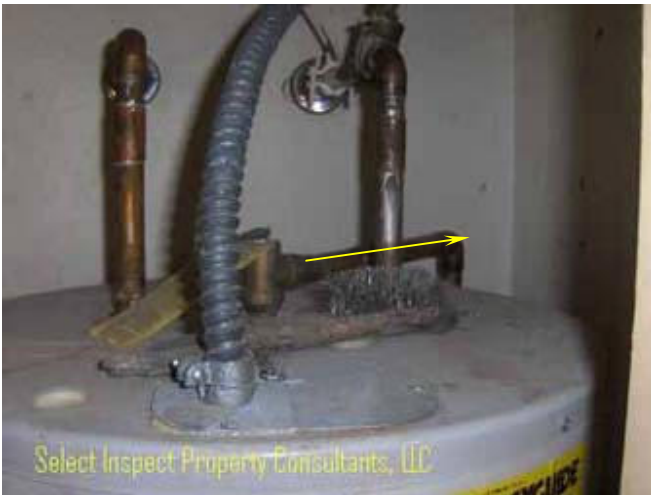
↑ water heater temperature/pressure relief drain improperly routed uphill
