Property Inspection Report

Concerning: 123 street Allen, Texas
(Address or Other Identification of Inspected Property)

By: Bruce W. Carr; TREC #5281 ASHI Member # 211804 Monday, May 16, 2011
(Name and License Number of Inspector) (Date)

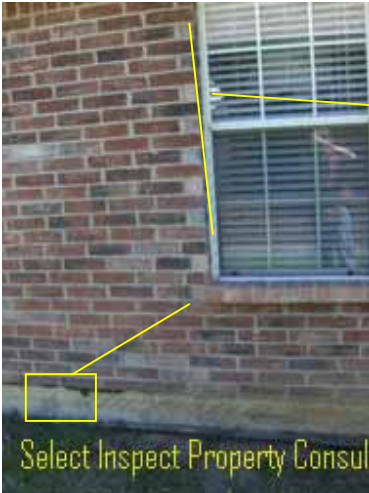
- Separation at veneer, & or framing at the breakfast nook window
- Exterior evidence of separation at window framing & veneer discovered at the north
- Out-of-square wall openings or separations at wall openings or between the cladding & window/door frames
- Sloping & or unsquare/difficult exterior doors indicate some degree of structural movement.
- Doors have been modified to accommodate unsquare jambs
- Separation of the garage door frame from adjacent siding/brick was noted. This indicates some foundation movement has occurred. Separations were approximately 1/4 of an inch at the time of inspection.
- Past garage separation is indicated by sealant at the joint of the garage door frame & adjacent veneer.
- Slab or perimeter beam (foundation) cracks/fissures discovered at the north lower left of the living room window & at the front porch.

↑ slab crack, wall crack, & window separation noted at the north

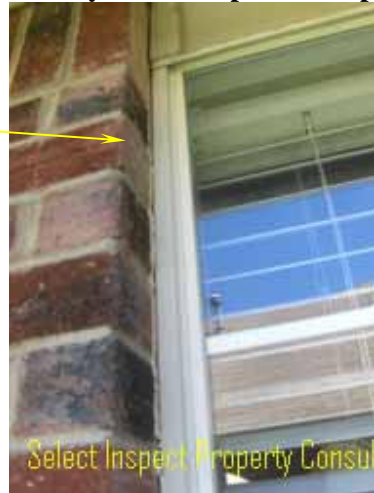
↑ close view of image at left; window separation

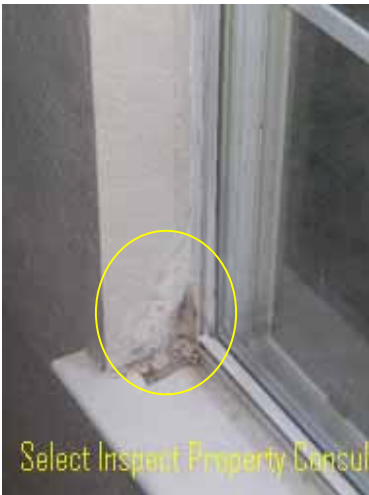
Moisture damage & fungus exist at the master bedroom window. I sprayed this window with water at the exterior, then checked at the interior; active leakage was confirmed; removal of siding & trim may be required to fully assess cause & determine repair needs. There may be some moisture damage & or compression/related structural conditions that were concealed & not discovered. Extent of damage is undetermined in concealed wall spaces; undetermined conditions include but are not limited to the presence and or condition of fungus, insulation, framing. We do not perform mold testing, and did not take fungus or air samples from the home. If you are concerned about health related issues, we recommend that you consult an indoor air quality firm for evaluation and options for cleaning. Researching and evaluating various firms and their methods for remediation would be prudent, if you plan to pursue those measures.

↑ leakage, moisture damage & fungus at master window

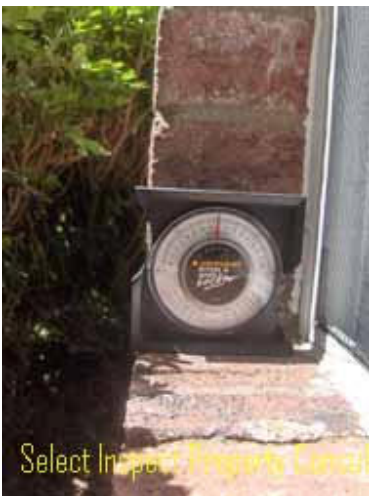
Exterior window sills did not have a recommended 15° slope for drainage at multiple locations; slope at random locations was approximately -1, 0, 5° Repair options may be limited. Condition & appropriateness of flashing & substrate components is undetermined.

↑ brick ledge(s) had inadequate slope

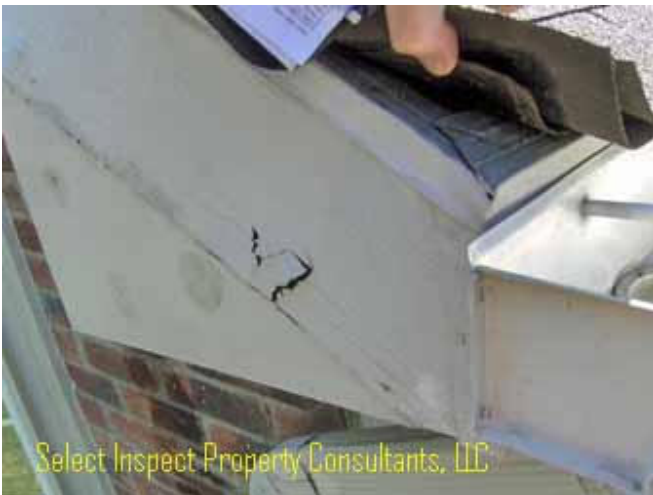
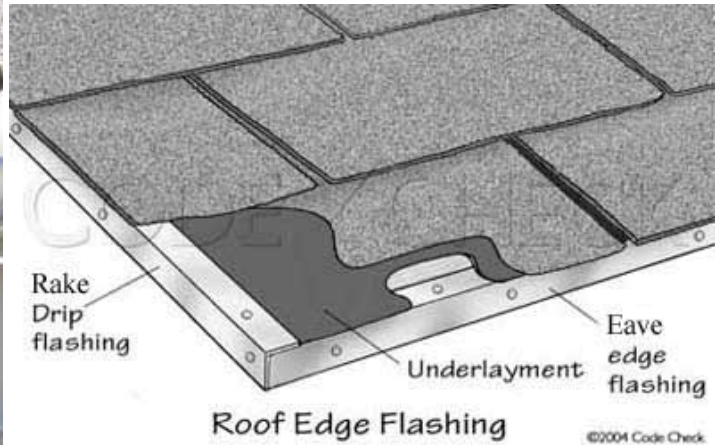
↑ moisture damage & fungus & example-unworkmanlike drip edge/felt; corners should have no gaps; rake (diagonal) edge & roof felt should be atop the eave (lower) edge flashing; roof underlayment should be under rake flashing; master northeast

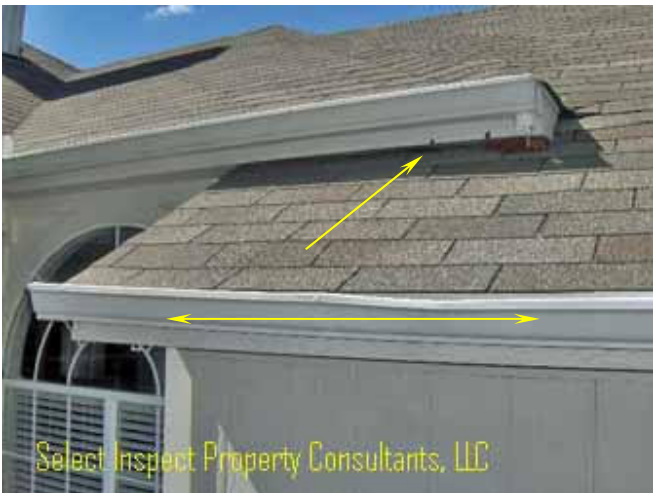
↑ moisture damage & fungus under eave & damaged guttering

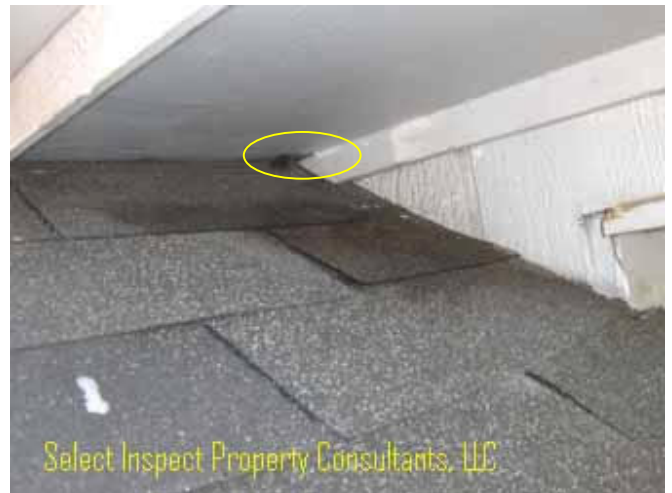
↑ missing shingles; opening, & low siding under eave; rear porch left

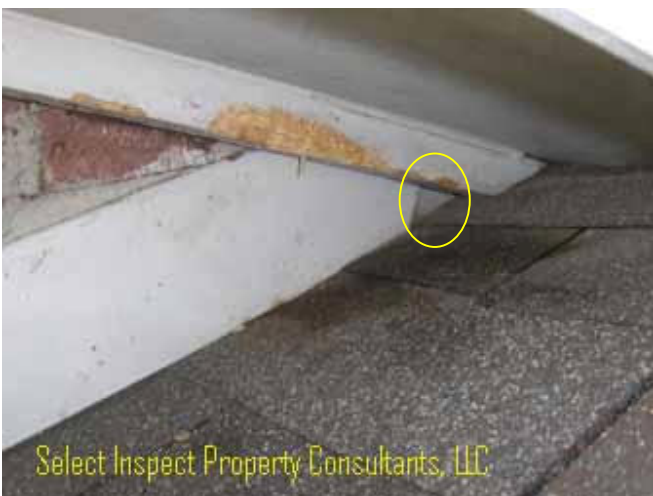
- Flashing is uplifted at the furnace & south attic fan. Recommend securing and sealing as needed to reduce moisture intrusion potential.
- Under eave locations did not have shingles installed higher (another course) & flashing was stopped short; openings exist.

↑ short flashing, shingles, & rodent damage under eave; front right

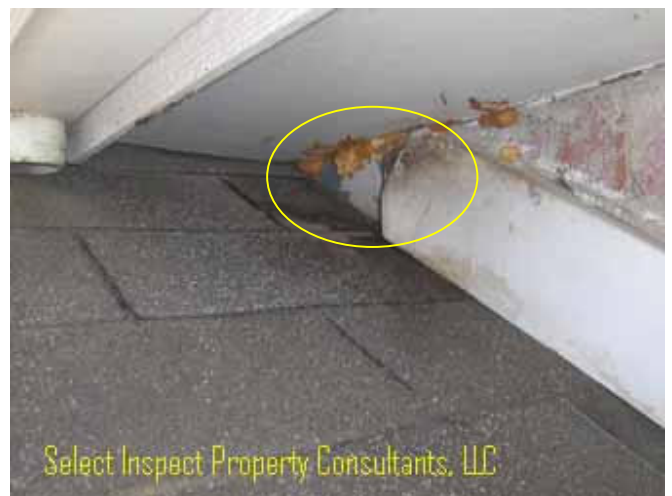
↑ short flashing, rodent damage under eave –front left

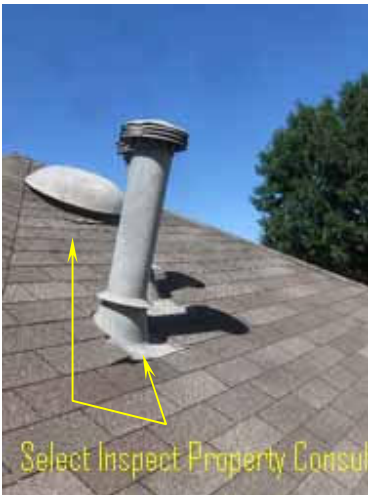
↑ lifted flashings

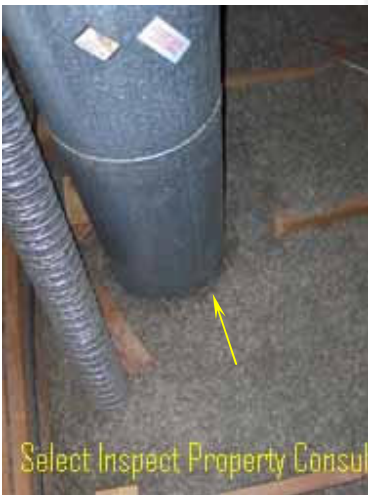
↑ fireplace flue did not meet clearance requirements to insulation

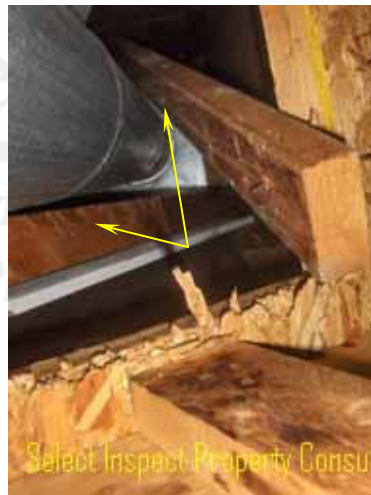
↑ inadequately secured framing & fireplace flue did not meet clearance requirements to combustibles

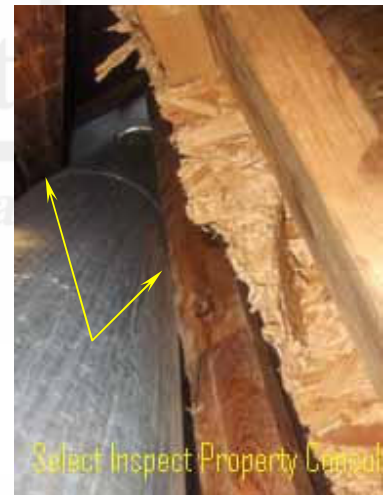
↑ fireplace flue did not meet clearance requirements to combustibles

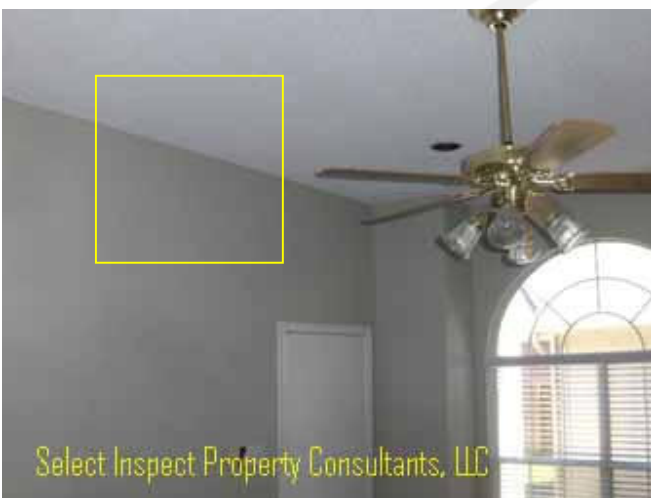
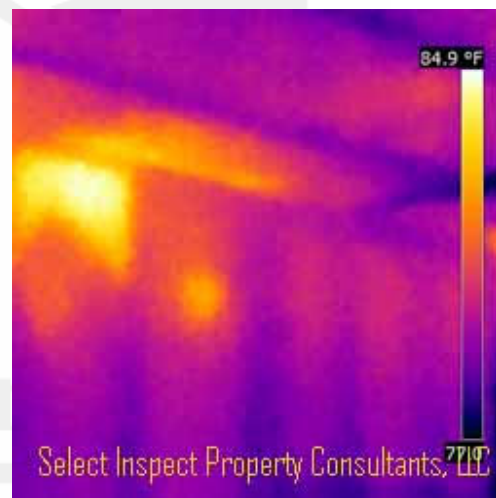
↑ Thermal imaging implies energy loss at living room

↑ Thermal imaging from square at left

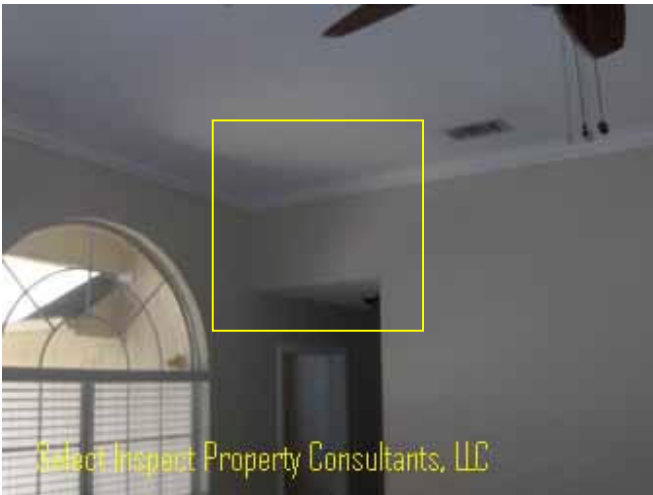
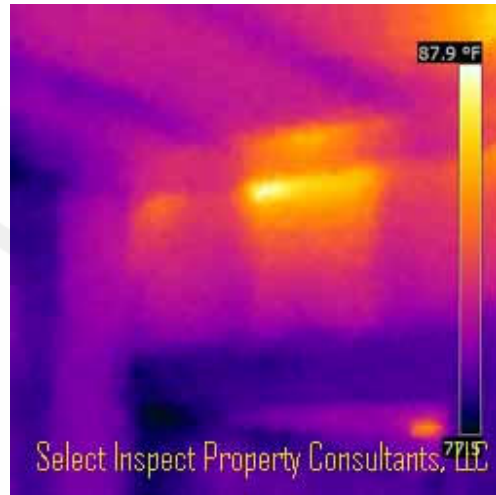
↑ Thermal imaging implies energy loss at family room

↑ Thermal imaging from square at left

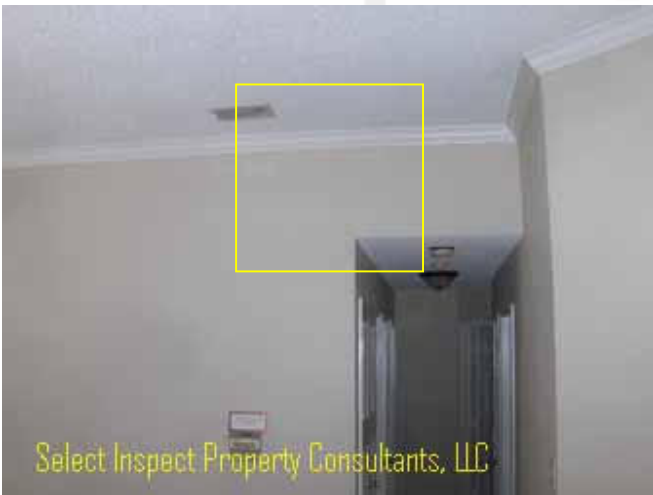
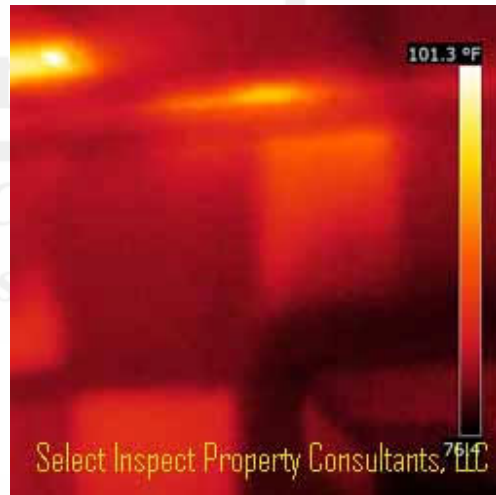
↑ Thermal imaging implies energy loss at family room adjacent the HVAC chase

↑ Thermal imaging from square at left

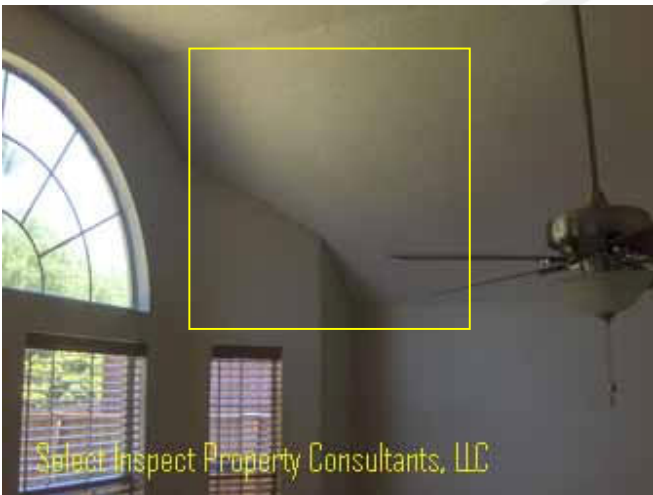
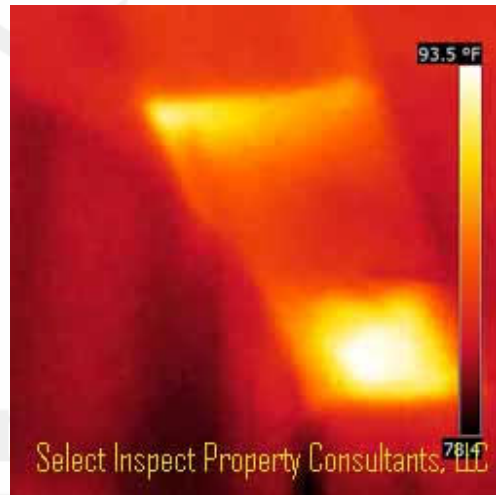
↑ Thermal imaging implies energy loss at master

↑ Thermal imaging from square at left

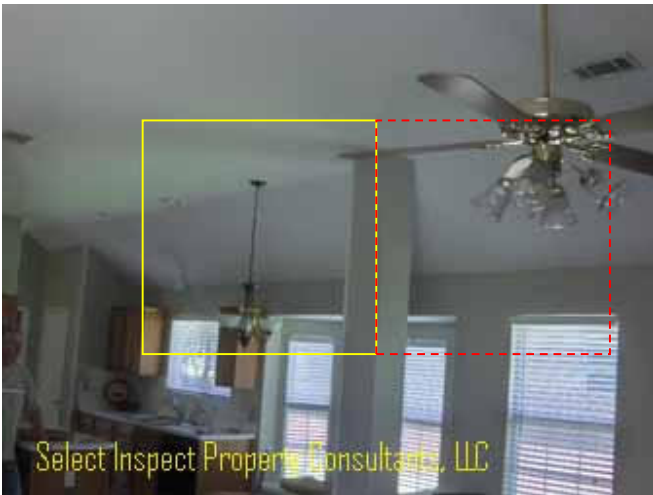
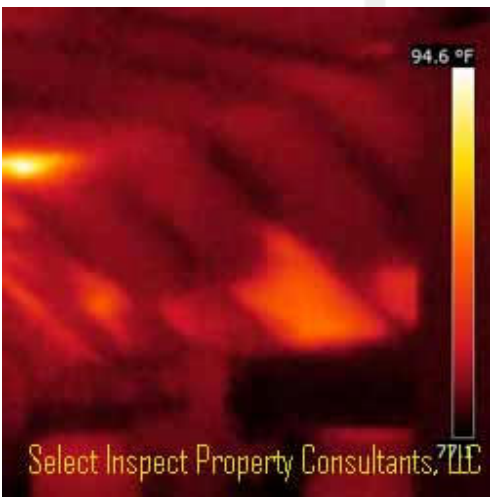
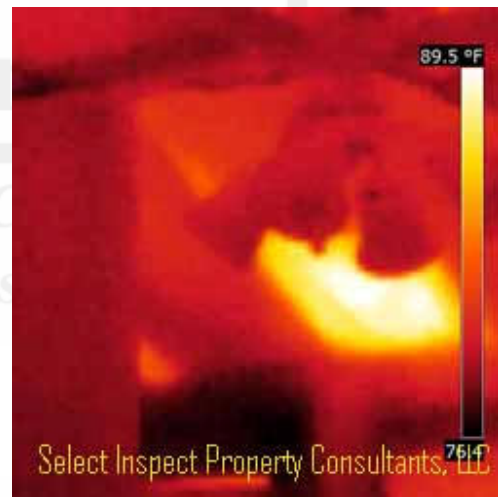
↑ Thermal imaging implies energy loss at kitchen, breakfast nook, living room

↑ Thermal imaging from square above left

↑ Thermal imaging from square above right

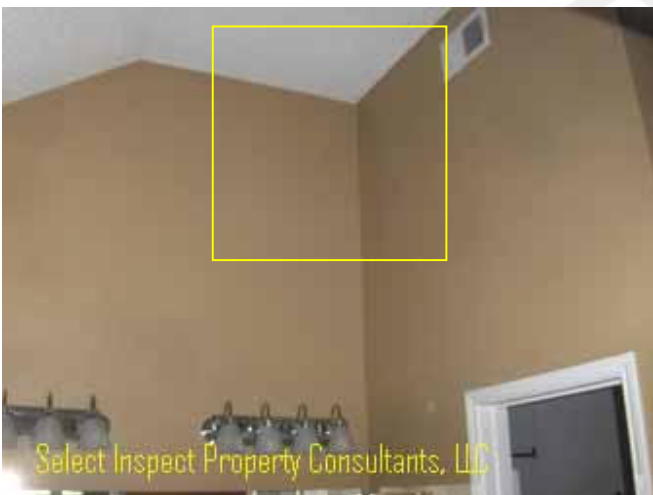
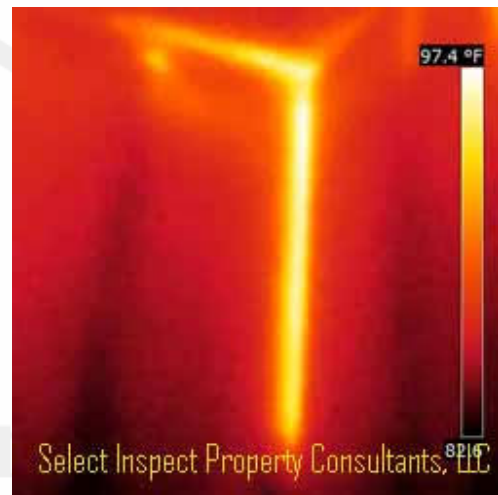
↑ Thermal imaging implies energy loss at master bathroom

↑ Thermal imaging from square at left

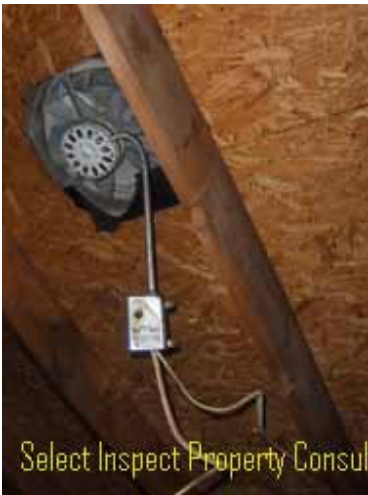
↑ unworkmanlike electrical & inoperable attic fan- 1 of 2 fans

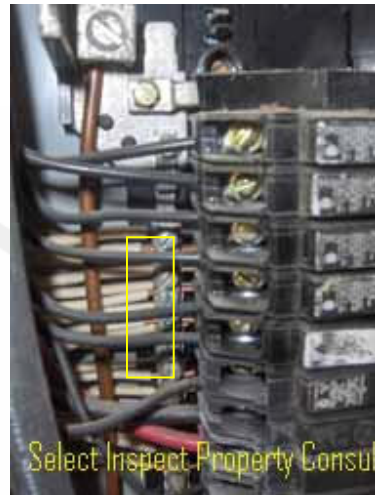
↑ conductors shall be terminated individually in lugs / breakers

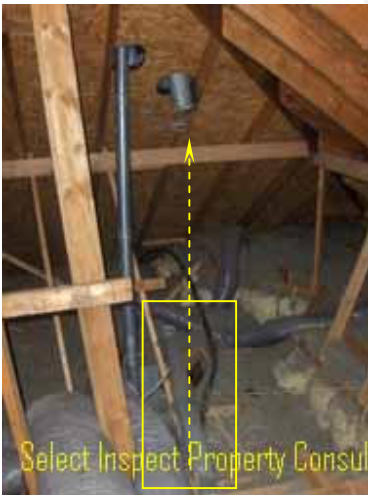
↑ deficient furnace flue & HVAC & water heater flues did not meet clearance requirements to combustibles

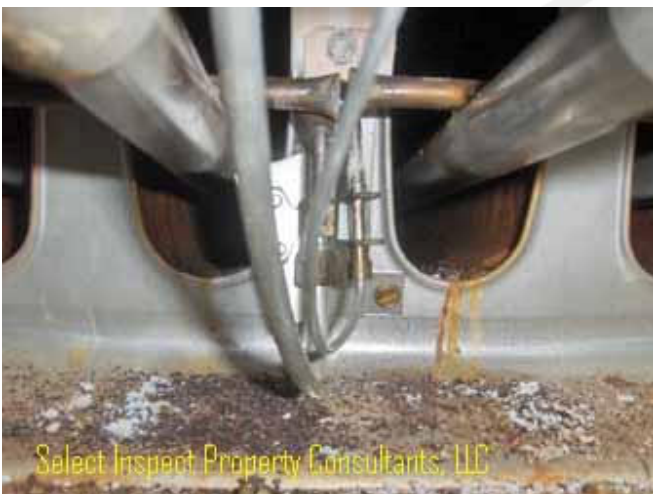
↑ aged furnace requires service

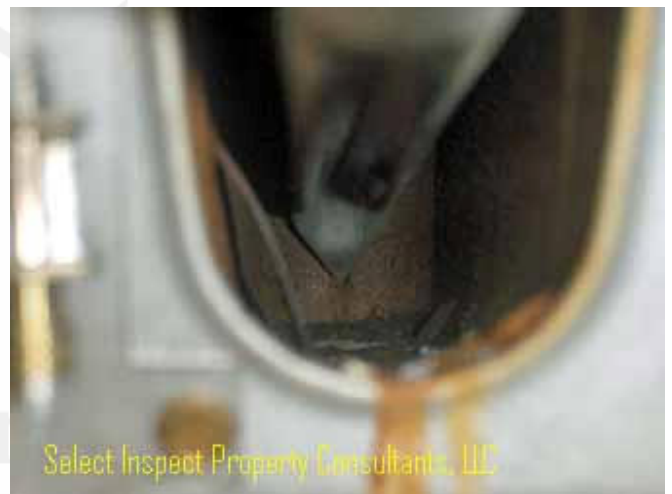
↑ rust & scale in burn chambers; example

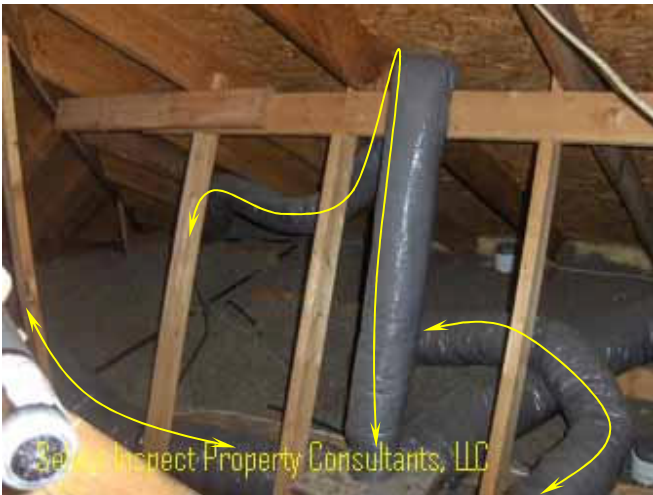
↑ inadequate support of air ducting; example; crimped air ducting; example

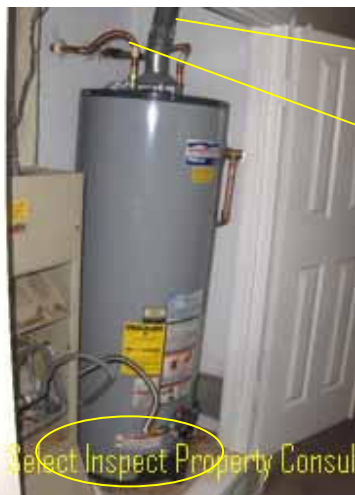
↑ out of level; missing auxiliary pan; moisture damage at deck

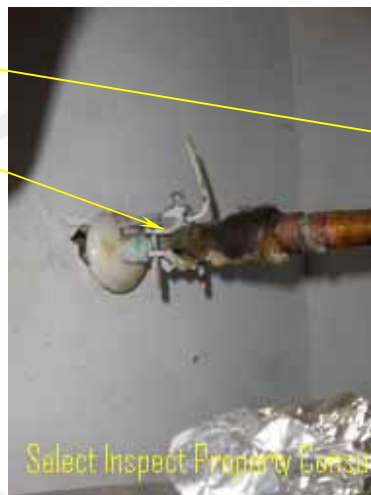
↑ seepage at shut-off-valve

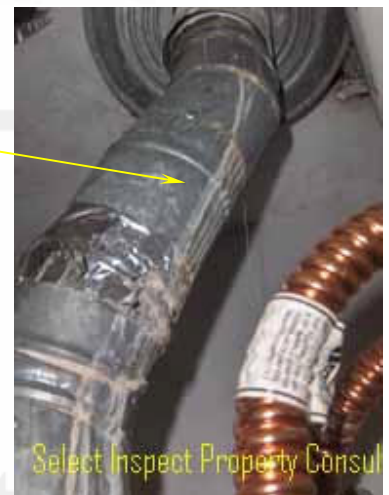
↑ moisture intrusion & rust/corrosion at water heater flue

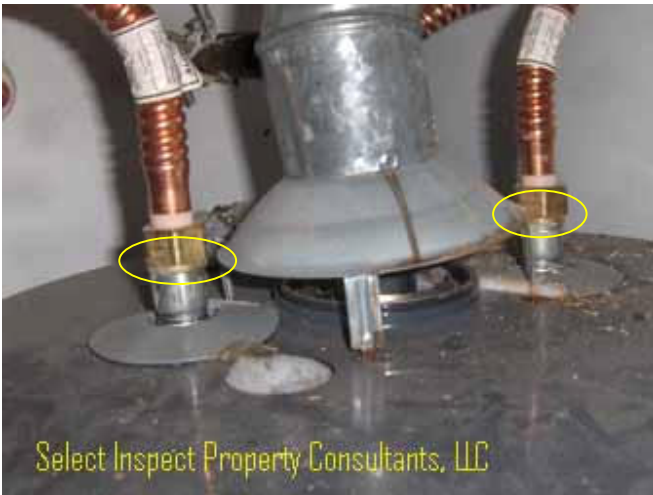
↑ water heater- monitor the compression fittings & copper/galvanized pipe connections for potential electrolysis

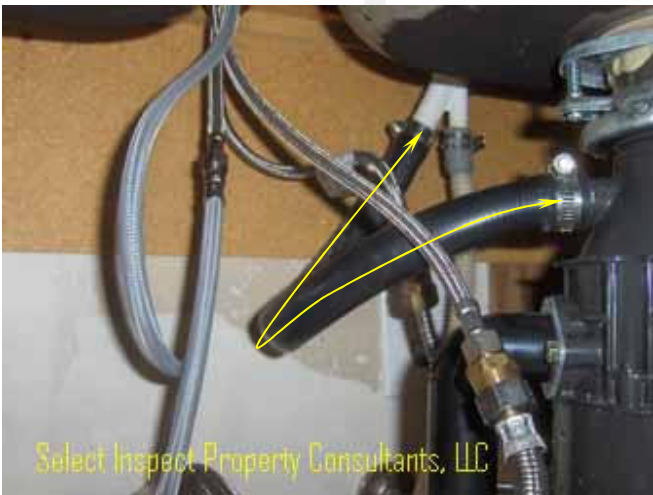
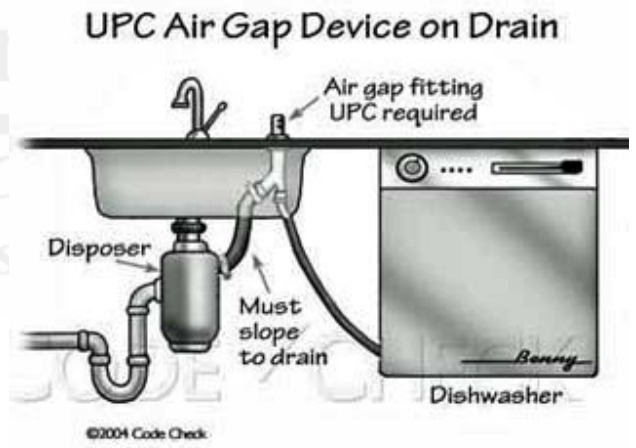
↑ drain for the dishwasher was improperly routed uphill; this should gravity drain from the backflow device
