Property Inspection Report

Concerning: 123 street McKinney, Texas
(Address or Other Identification of Inspected Property)

By: Bruce W. Carr; TREC #5281 ASHI Member # 211804 Saturday, April 02, 2011
(Name and License Number of Inspector) (Date)

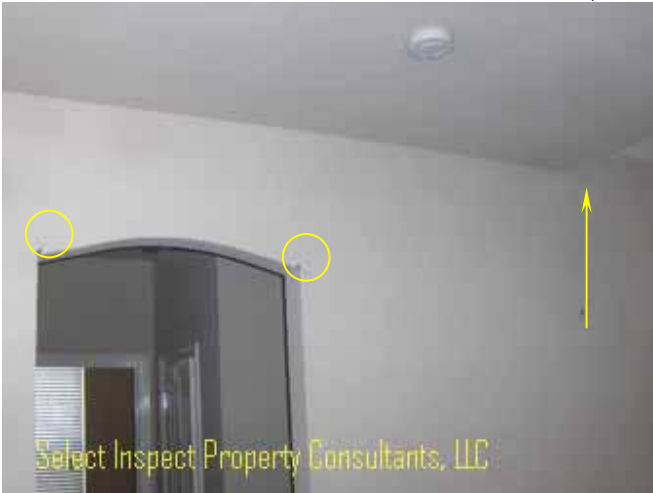
↑ cracks discovered at downstairs hall

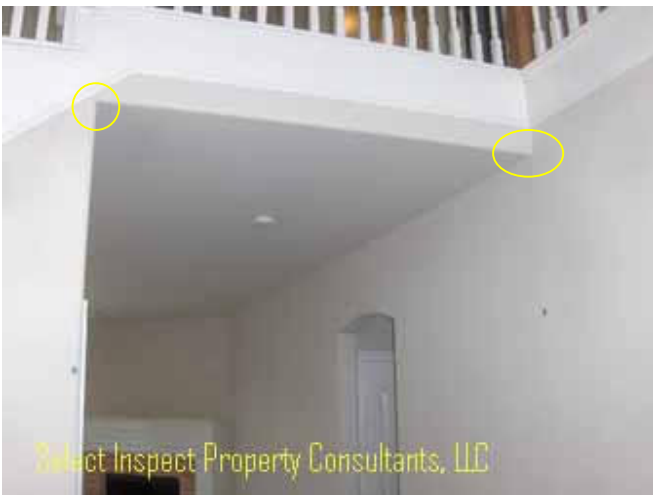
↑ cracks discovered at loft

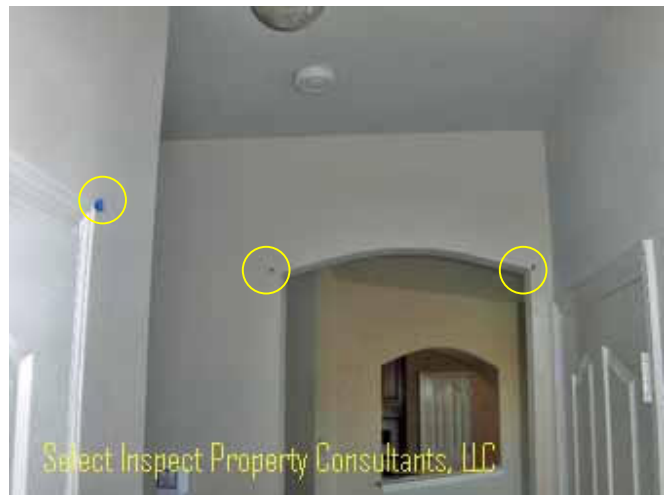
↑ cracks discovered at downstairs hall

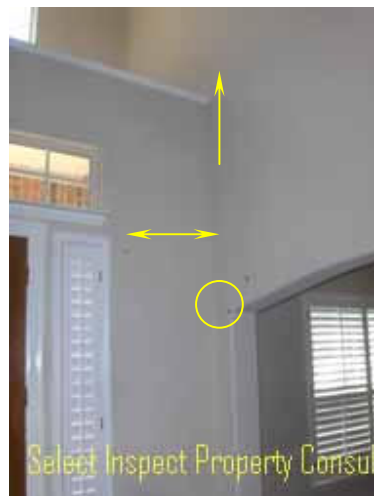
↑ cracks discovered at entry

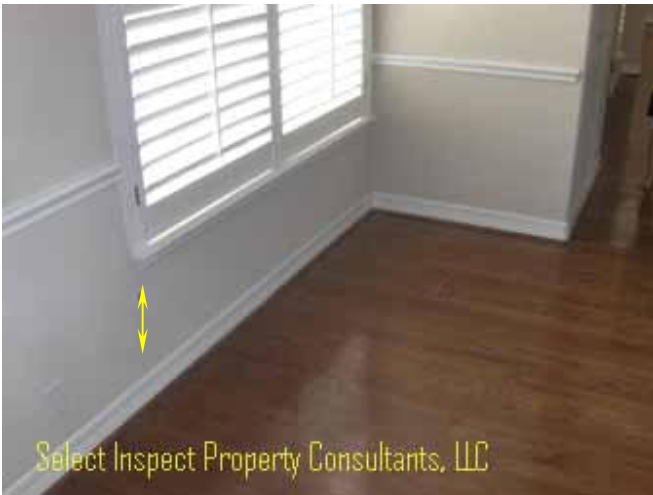
↑ cracks discovered at living room

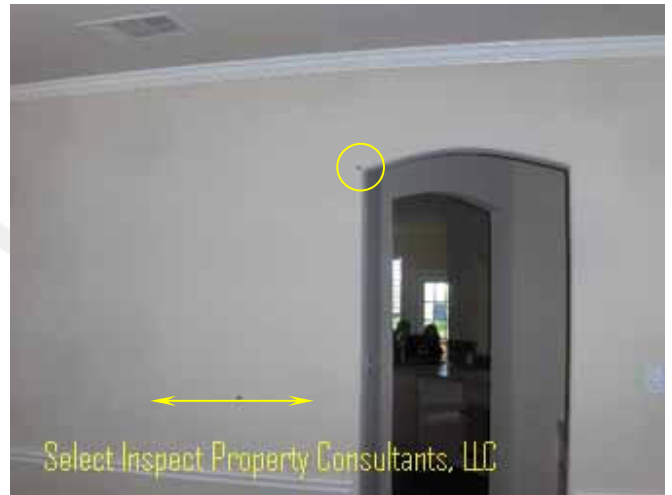
↑ cracks discovered at dining room

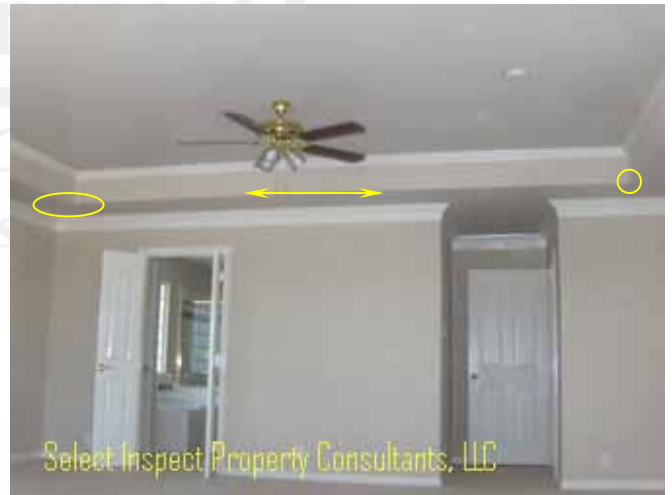
↑ cracks discovered at master

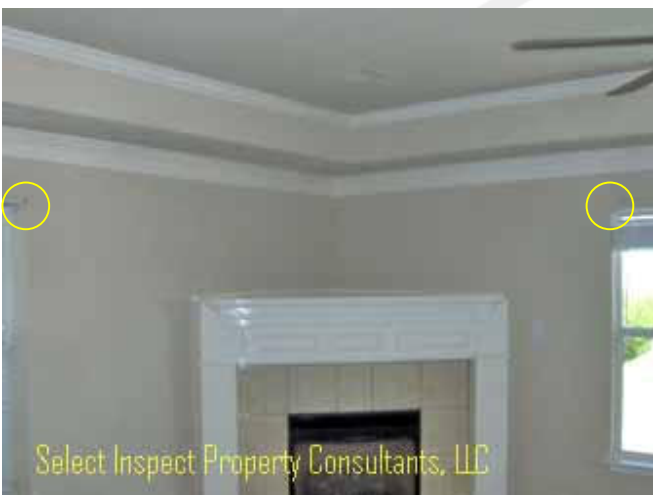
↑ cracks discovered at master

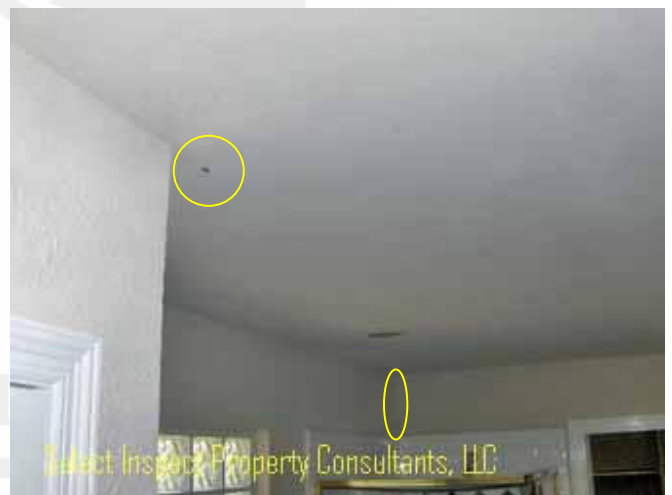
↑ cracks discovered at master bathroom

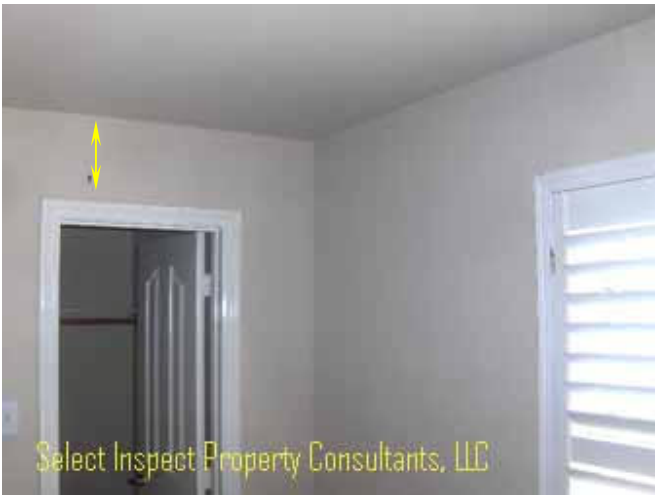
↑ cracks discovered at south bedroom

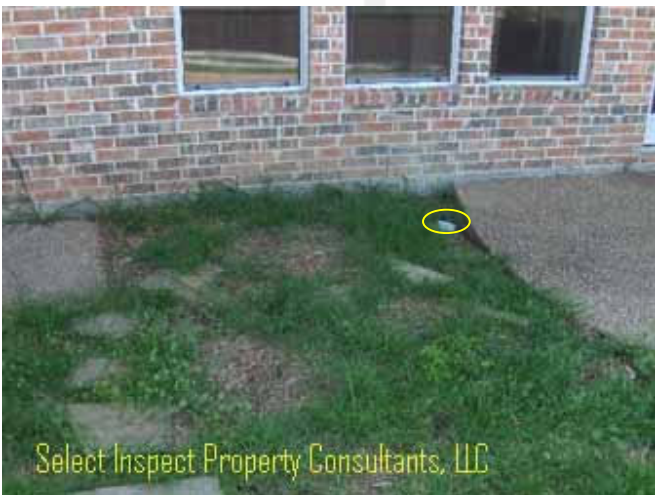
↑ area drain port not at low point & missing covers; negative grading adjacent the rear porch

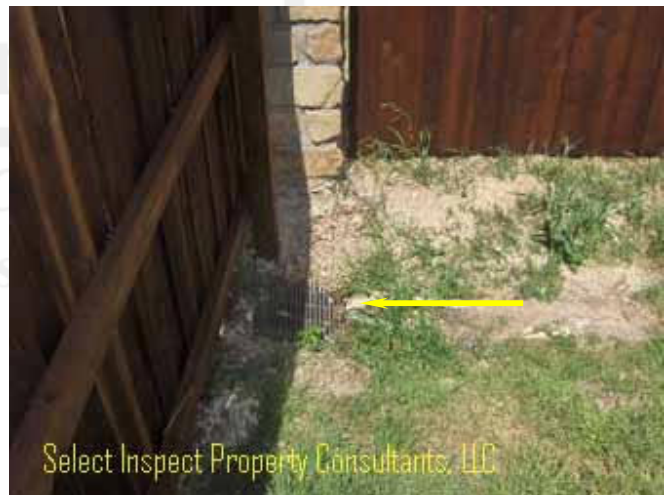
↑ an area drain termination was discovered at the far north corner

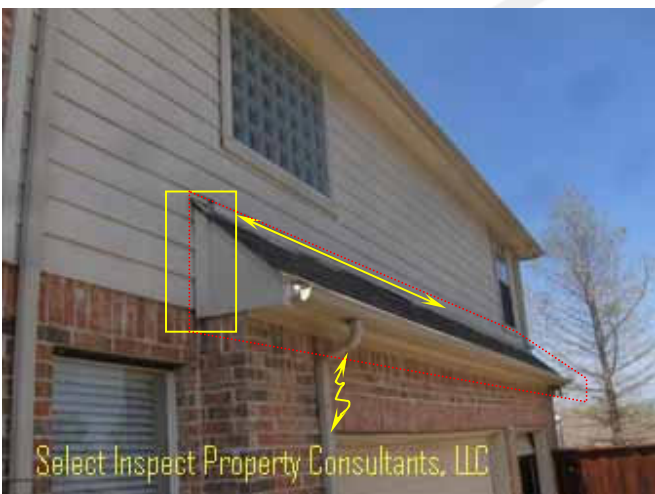
- Doors have been modified to accommodate unsquare jambs
 - Separation of the garage door frame from adjacent siding/brick was noted. This indicates some foundation movement has occurred. Separations were approximately $\geq 1/8$ of an inch at the time of inspection.

↑ openings (square); crack with differential movement & garage frame separation from adjacent brick; inadequately secured siding & raised flashing edge (upper arrow); unvented enclosed attic space (red)

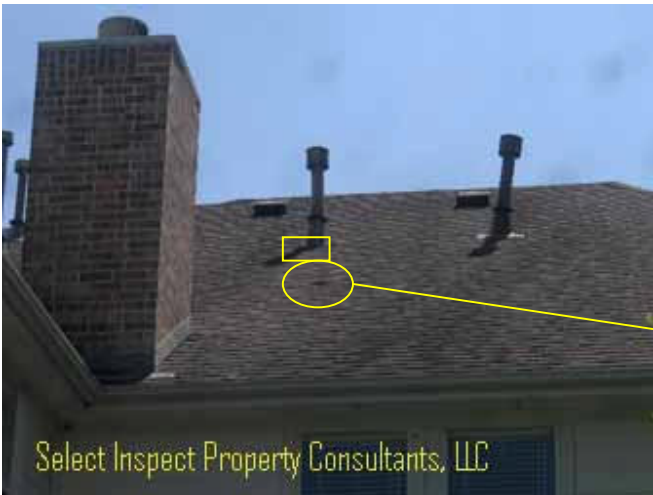
↑ raised flue flashing & deficient shingle

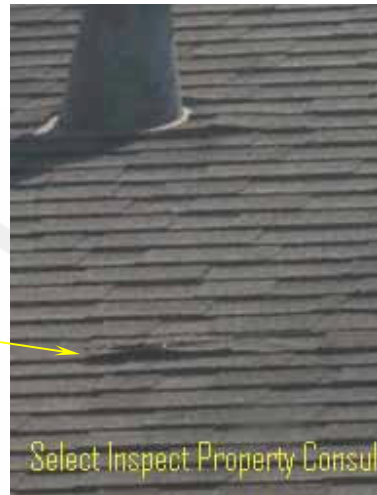
↑ close view of image at left

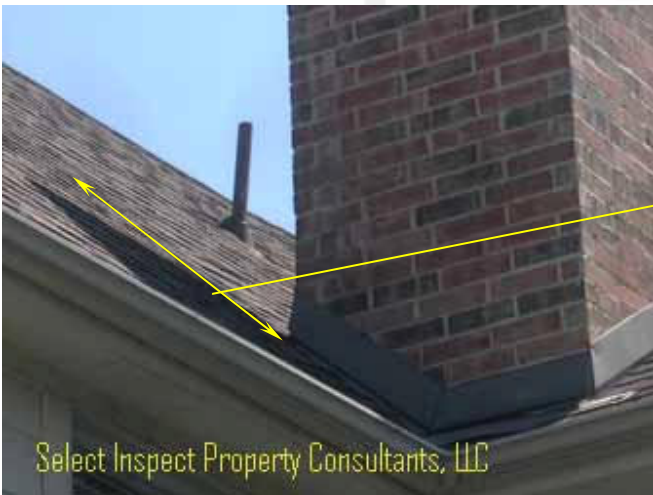
↑ deflection of roof noted adjacent the chimney

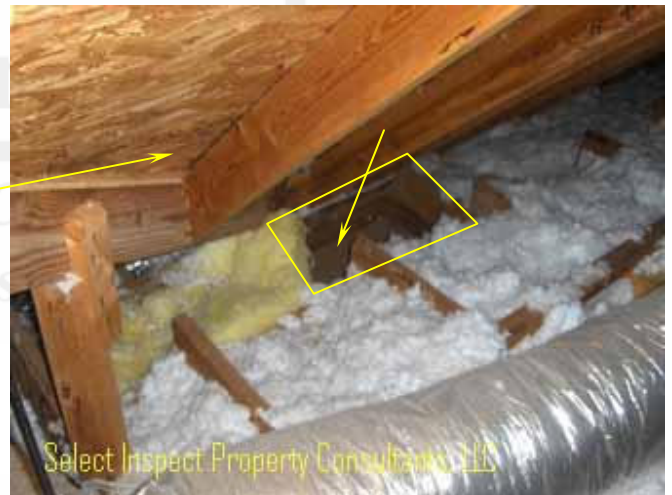
↑ cracks not discovered at framing in the attic; missing insulation was noted-not related to deflection

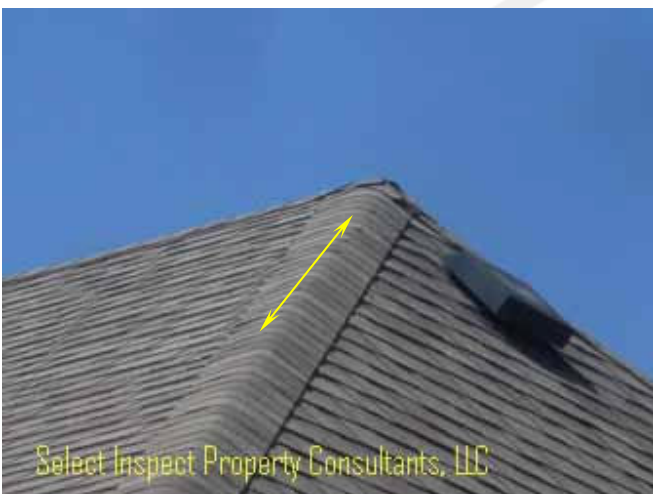
↑ damaged ridge at the south (front right when facing the house)

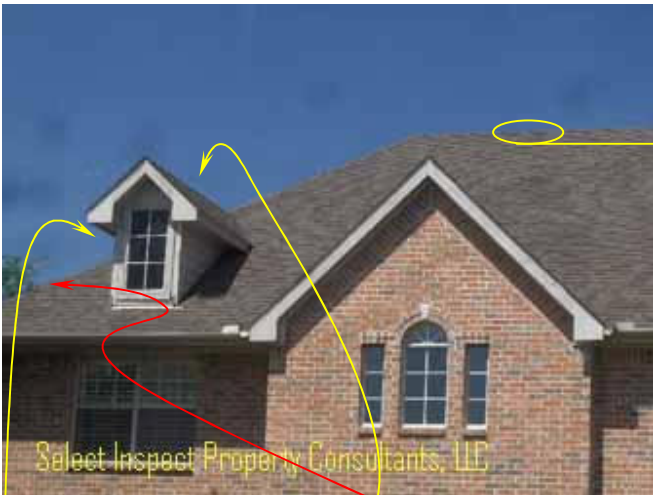
↑ damaged shingles discovered

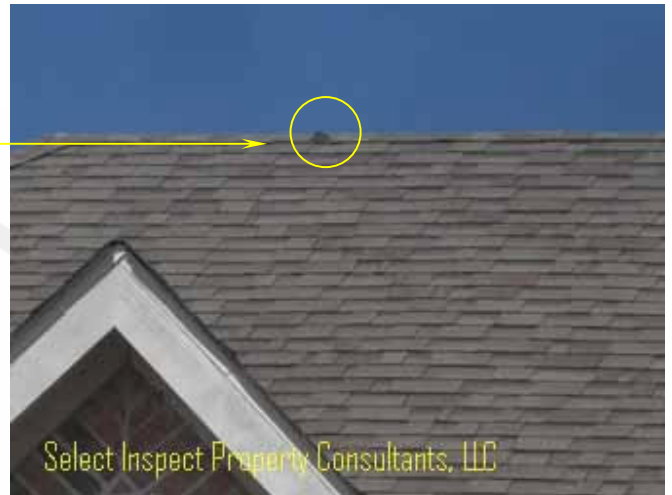
↑ close view of image at left

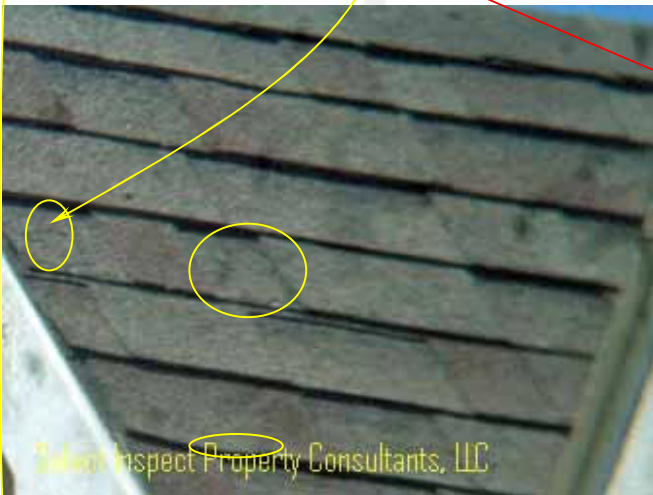
↑ close view of image above; weather damage

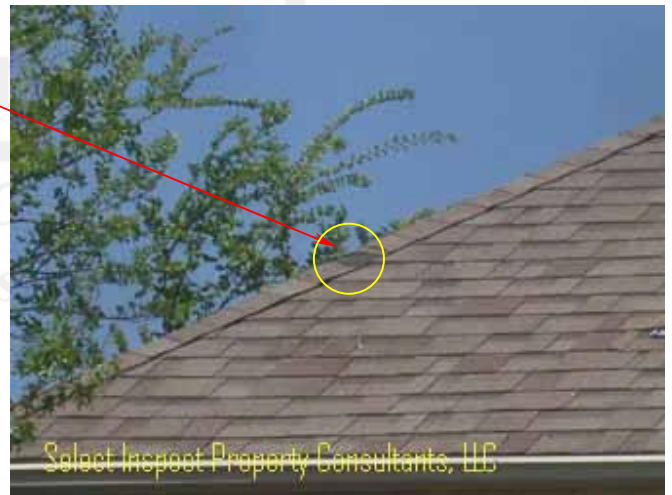
↑ close view of image above

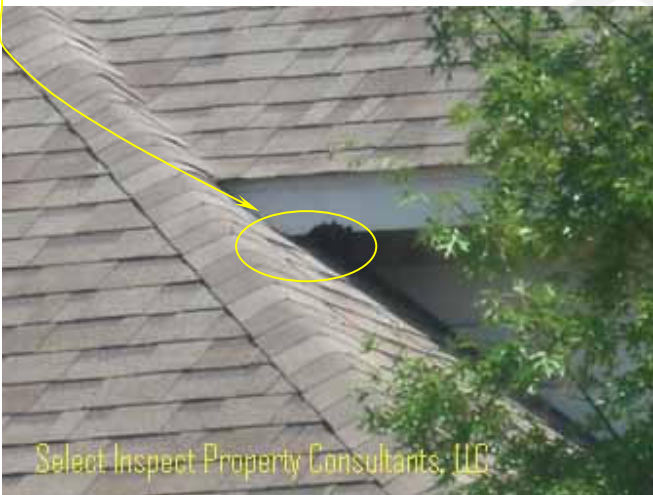
↑ close view of image above shingle damage & rodent damage

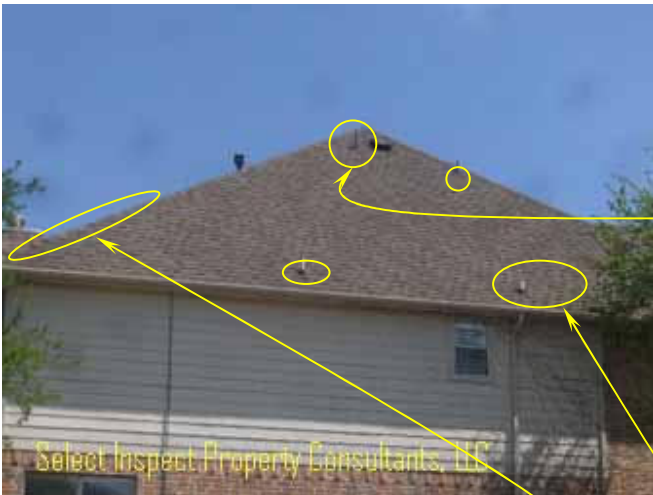
↑ damaged plumbing vent collars, damaged shingles, unpainted vent stacks

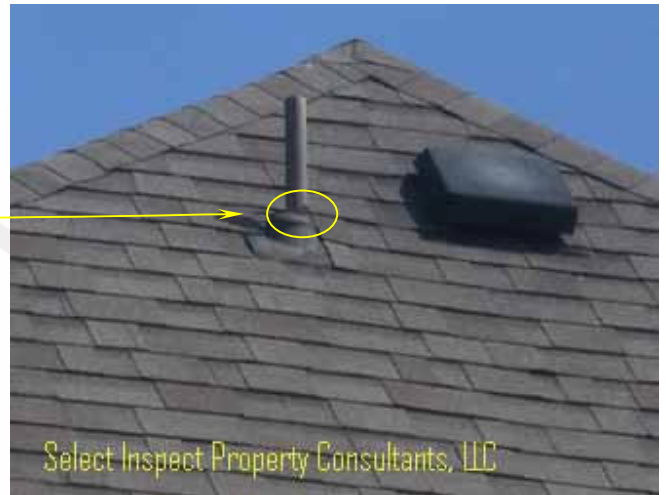
↑ damaged vent collar; example

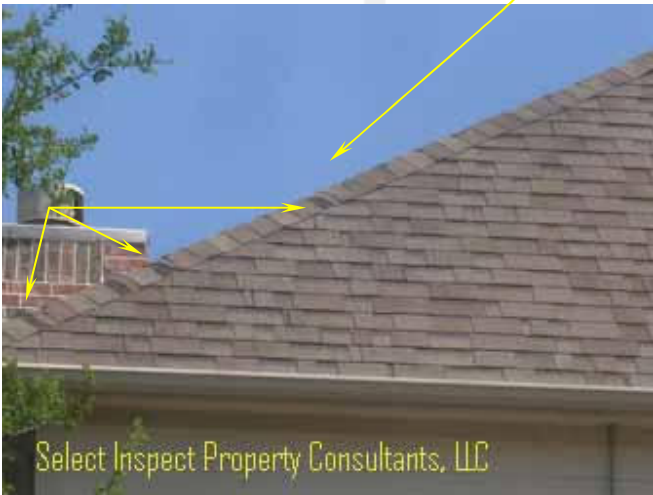
↑ close view of image above ridge damage

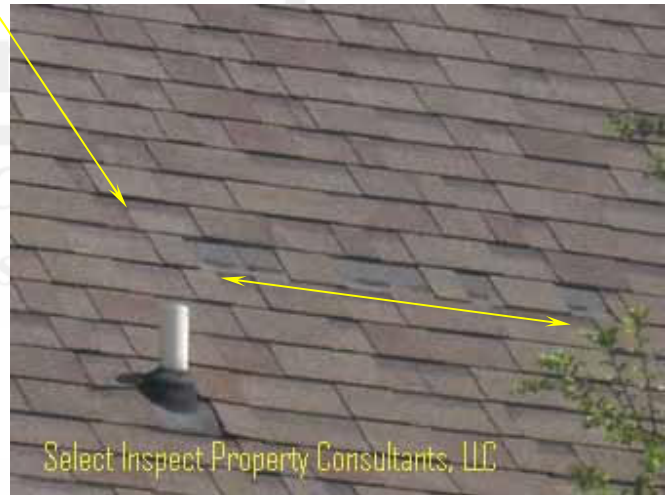
↑ close view of image above; damage & unpainted vent stack

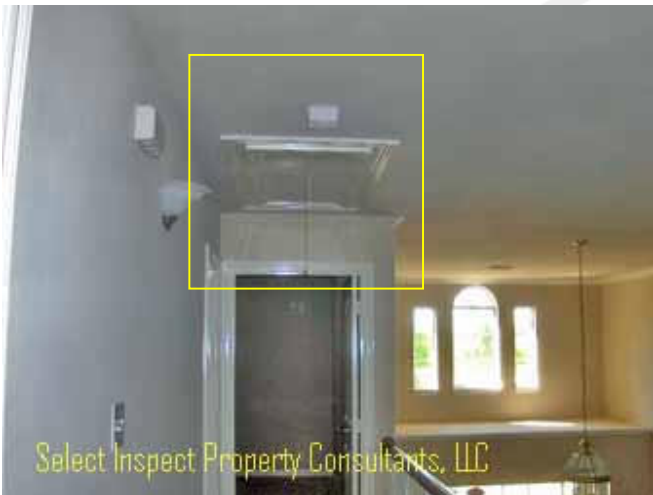
↑ energy loss at attic stair

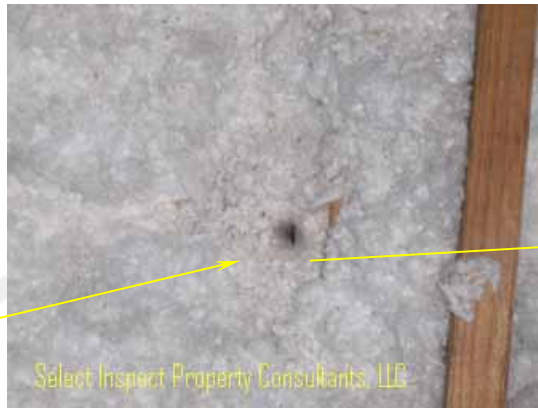
↑ moisture evidence at insulation

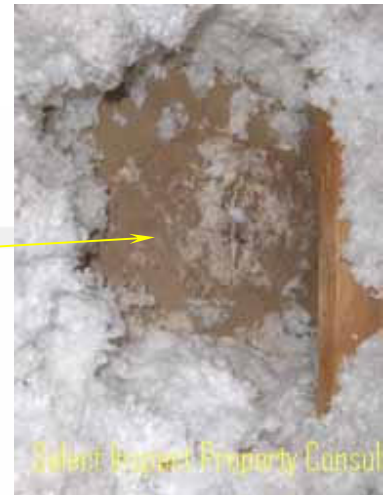
↑ moisture damage & fungus below insulation at ceiling drywall

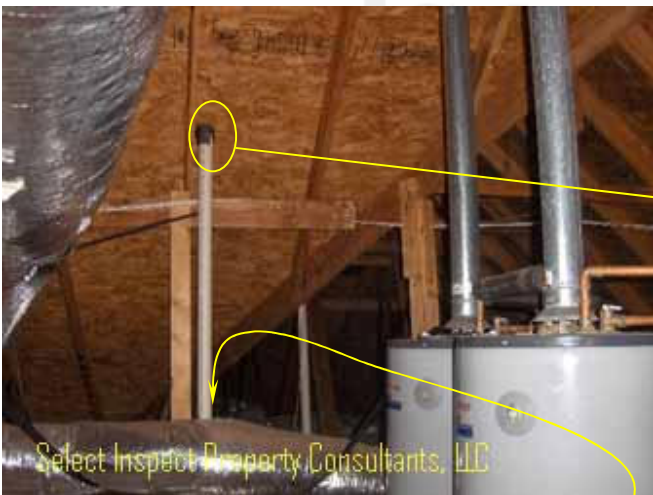
↑ moisture intrusion from deficient vent collars; example

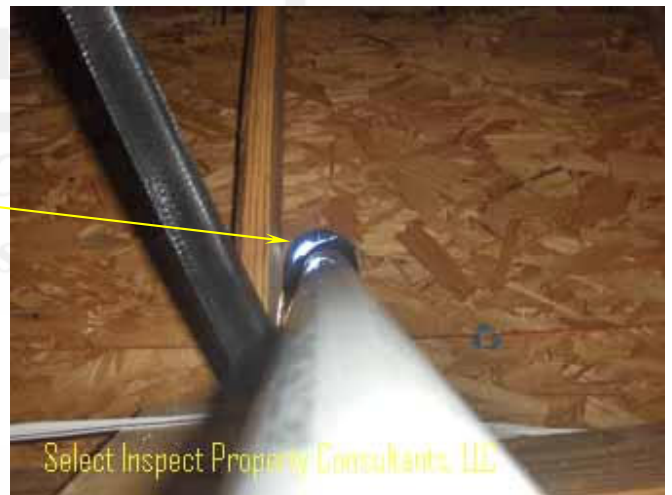
↑ close view of image at left; damaged collar- daylight visible from attic

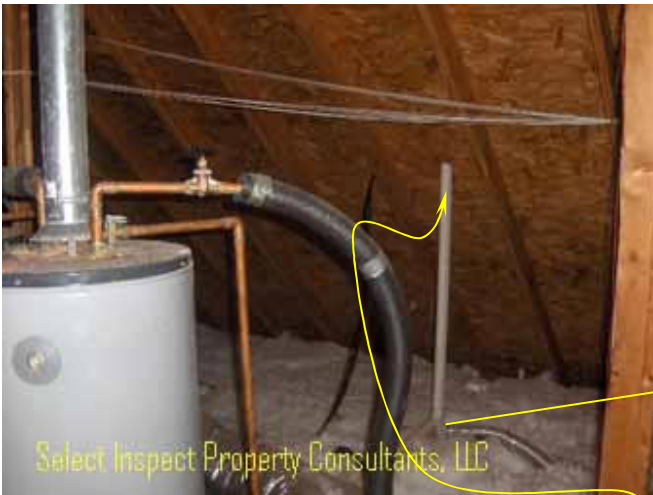
↑ moisture intrusion from deficient vent collars; example

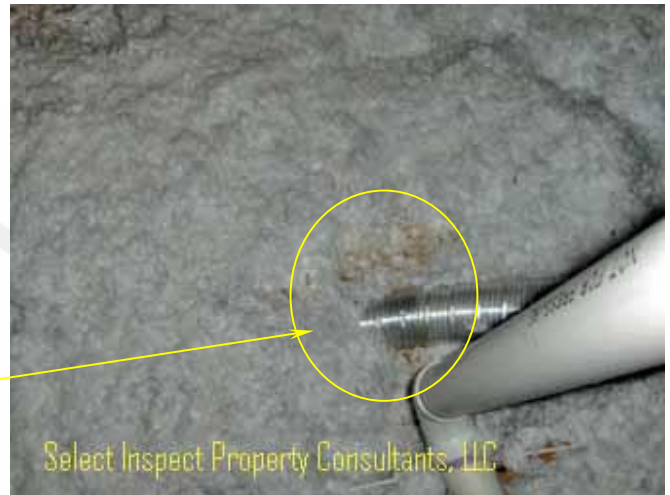
↑ moisture damage at insulation

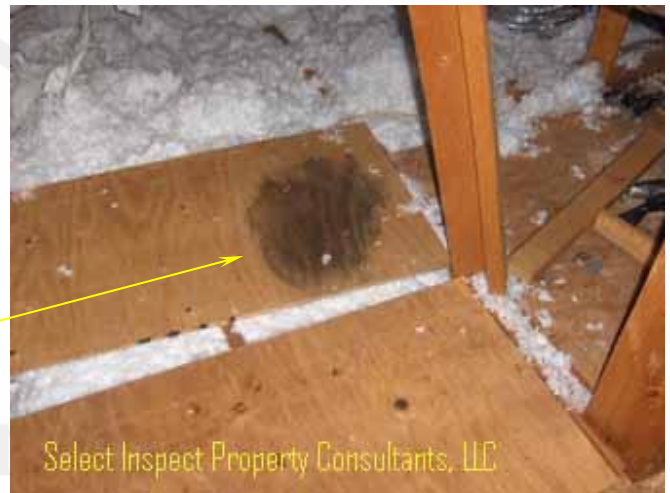
↑ moisture staining at attic floor –note, this plywood is NOT stable

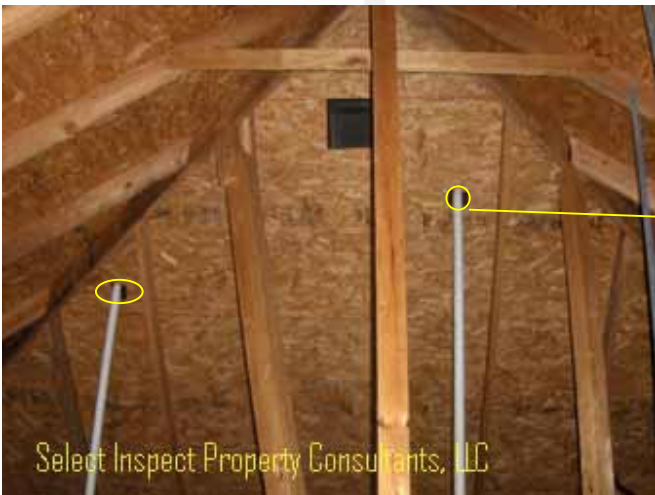
↑ moisture intrusion from deficient vent collars; example

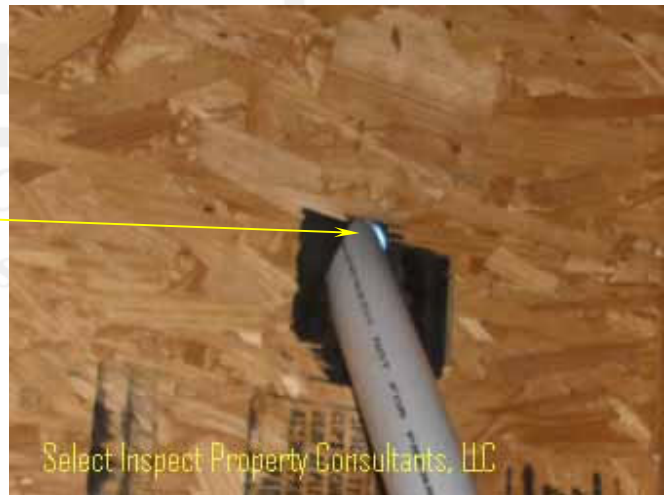
↑ close view of image at left; daylight visible from attic

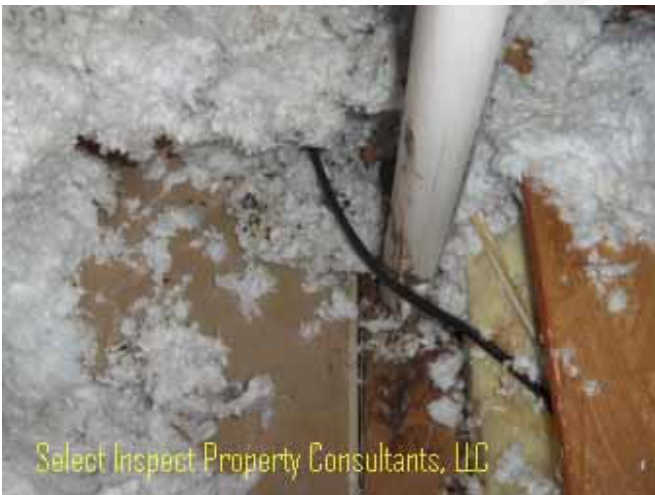
↑ moisture damage & fungus at framing & ceiling drywall- below image above also rodent feces discovered at this location

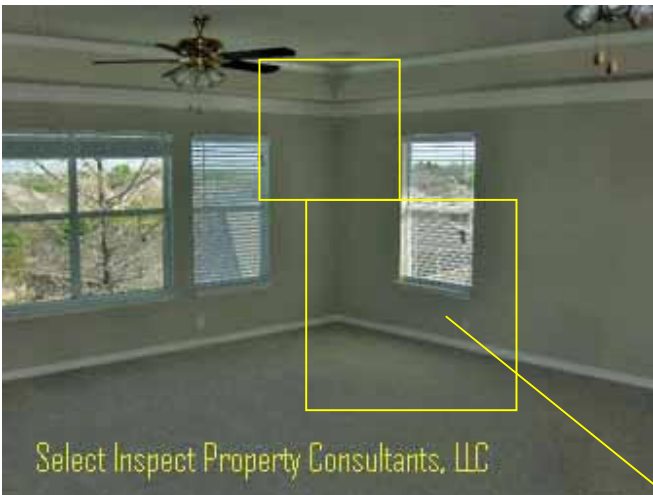
↑ Thermal imaging implies energy loss at master-east

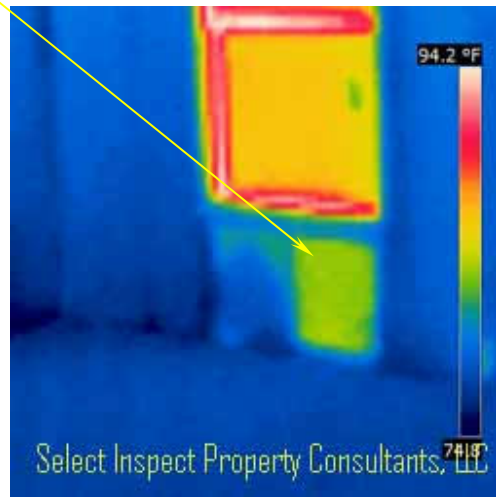
↑ Thermal imaging from square above-lower large square- appears to be missing insulation below the window

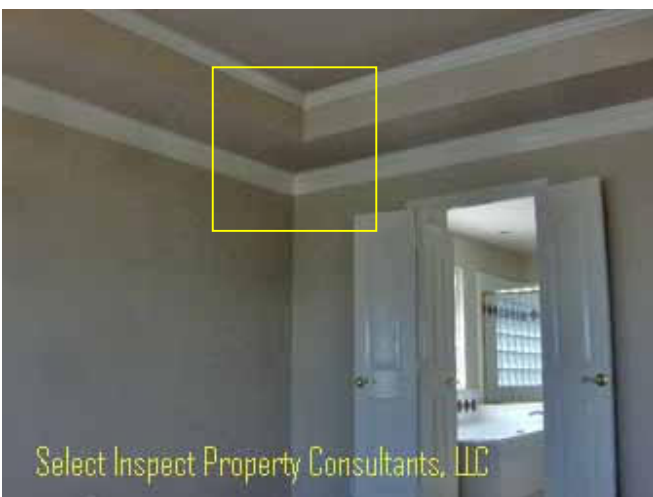
↑ Thermal imaging implies energy loss at master bedroom furr down- south corner

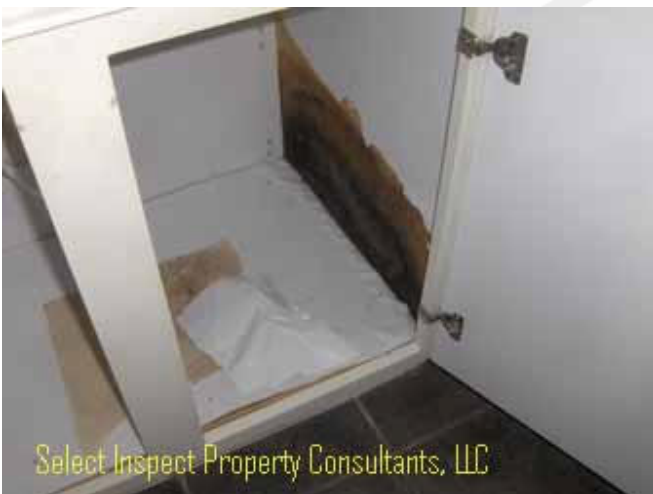
↑ moisture damage & fungus below downstairs bathroom cabinet

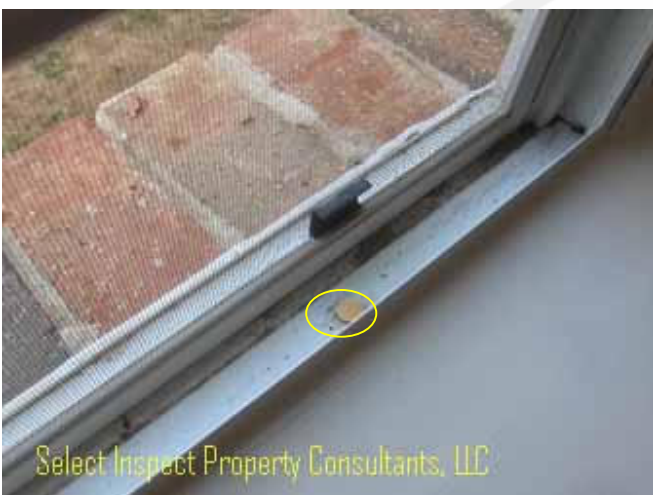
↑ Alarm holes at the lower portion of the window may allow moisture intrusion; caulk and monitor

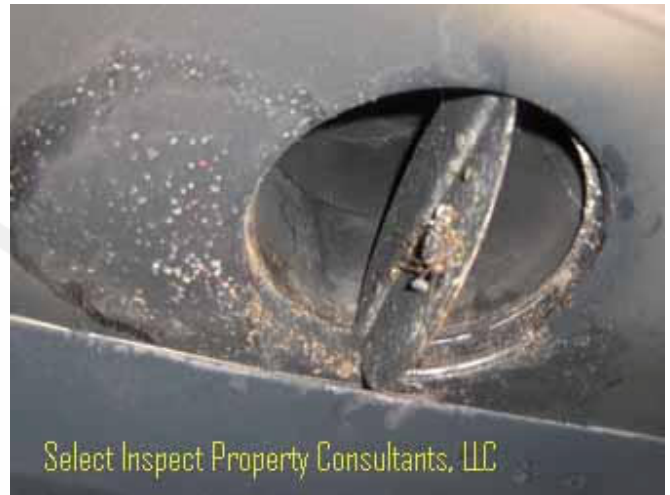
↑ moisture staining at flue & damper of fireplace

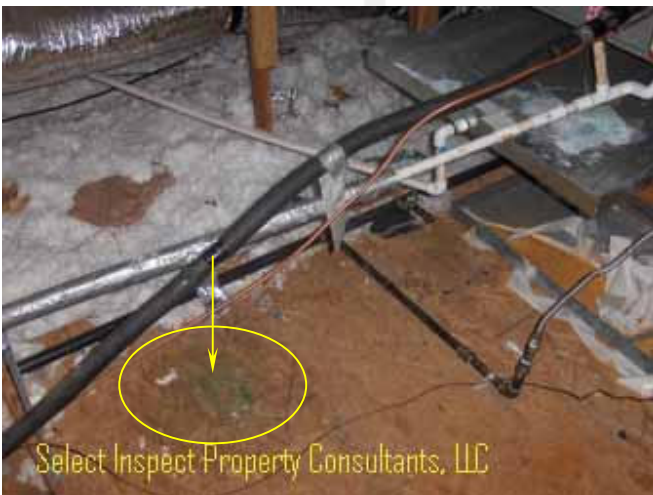
↑ green moisture staining implies copper, indicating refrigerant pipe insulation deficiency

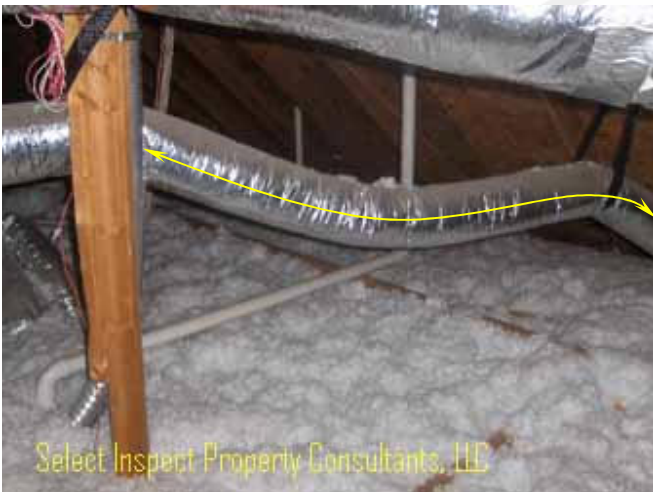
↑ inadequate support of air ducting; example

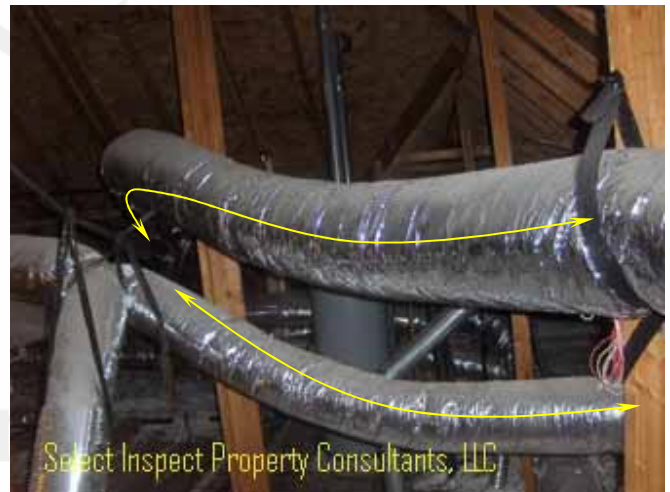
↑ inadequate support of air ducting; example

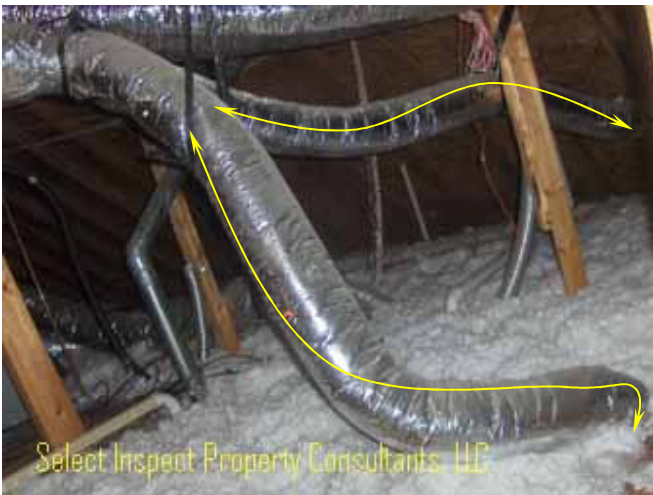
↑ inadequate support of air ducting; crimped air ducting; example

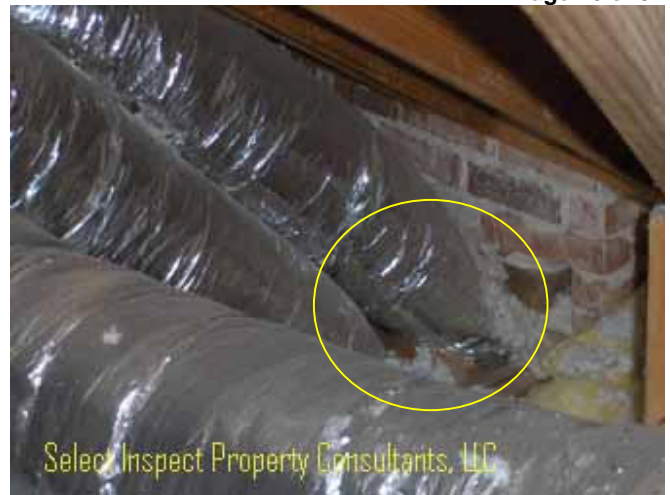
↑ crimped air ducting; example

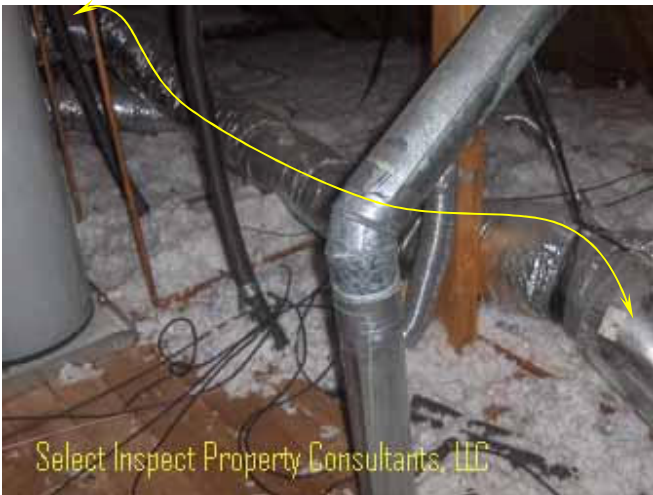
↑ inadequate support of air ducting; example

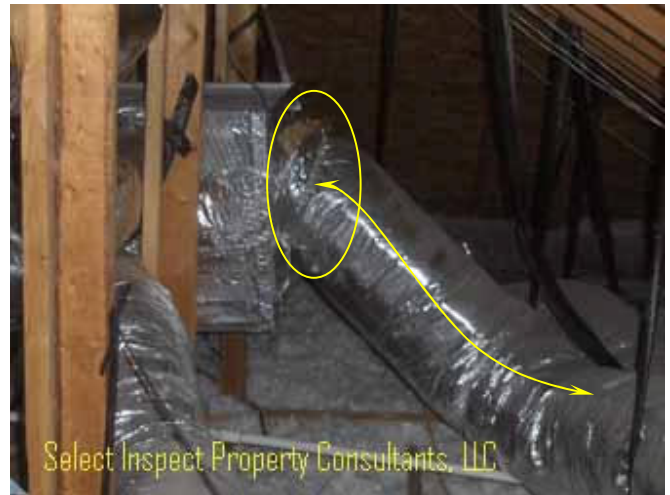
↑ inadequate support of air ducting; example-deficient connection to plenum; energy loss- upstairs HVAC

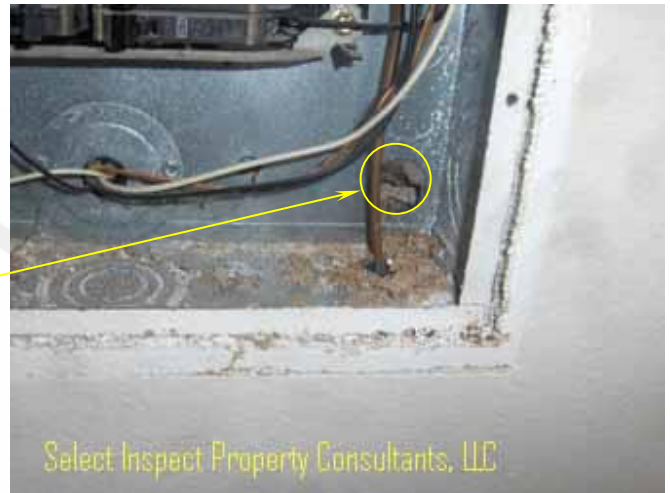
↑ close view of image at left; missing bushing at knock-out

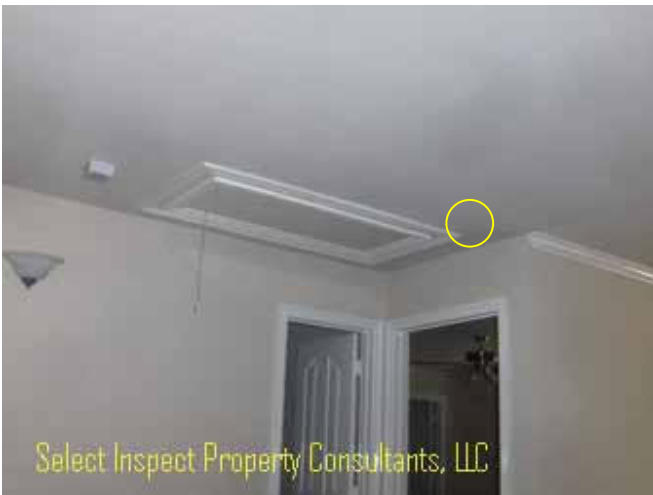
↑ recommend smoke detectors at halls directly adjacent the bedrooms; example at south bedroom hallway

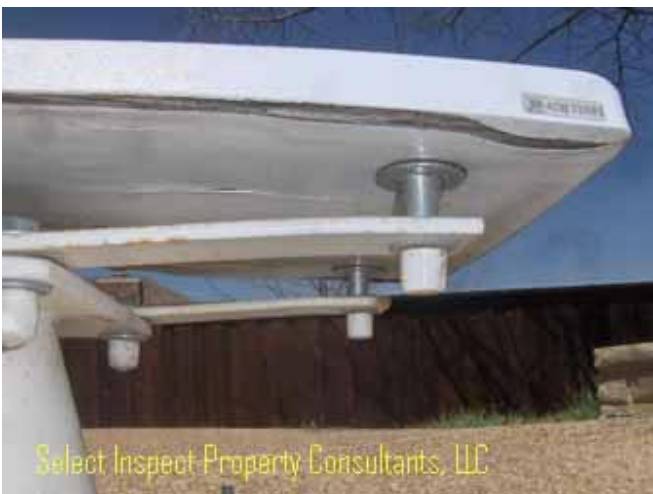
↑ corrosion & damage at diving board components

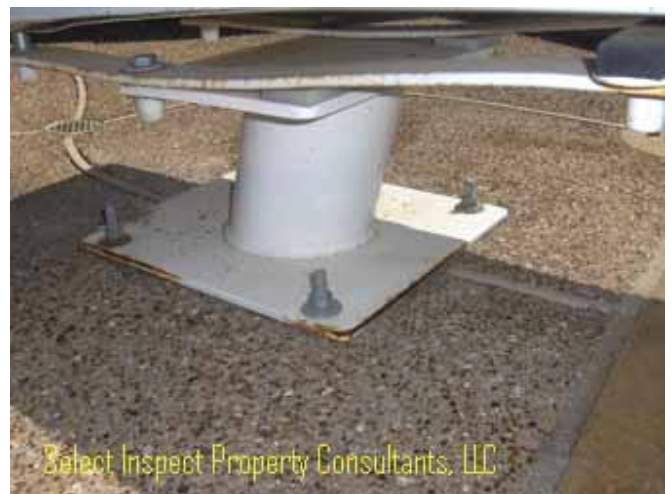
↑ corrosion & damage at diving board components

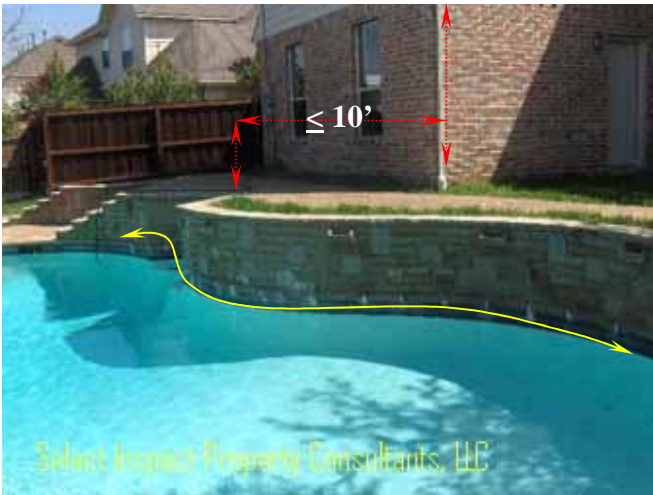
↑ efflorescence implies some amount of ground water seeping through the upper pool wall & gutter did not appear electrically bonded/grounded

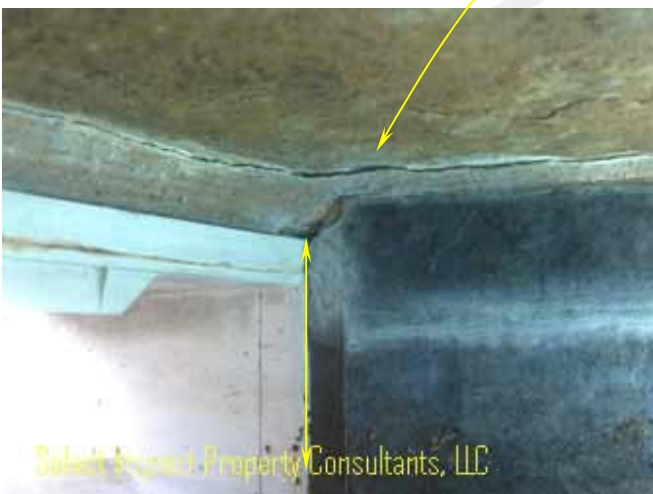
↑ cracks; holes at skimmer interior may allow leakage from the pool

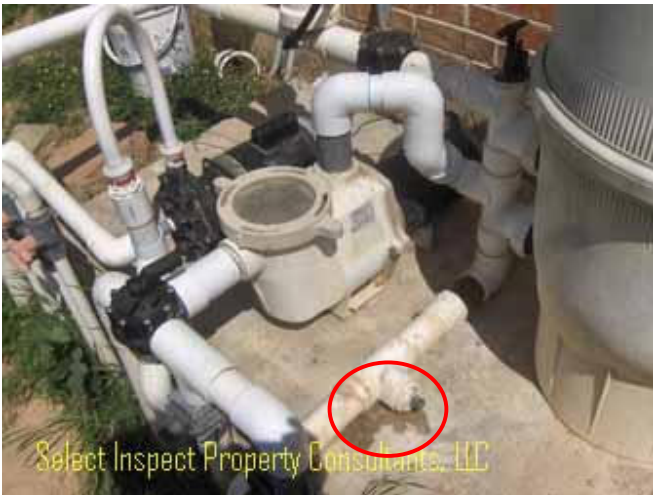
↑ leakage active

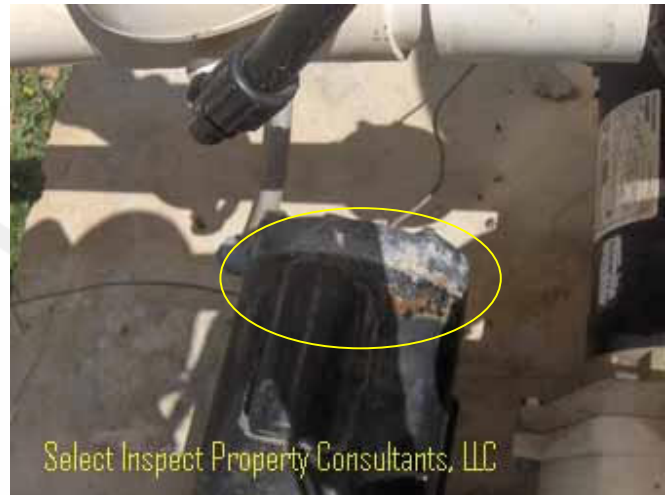
↑ corrosion at pool pump
