Property Inspection Report

Concerning: 123 street Southlake, Texas
(Address or Other Identification of Inspected Property)

By: Bruce W. Carr; TREC #5281 ASHI Member # 211804 Tuesday, February 22, 2011
(Name and License Number of Inspector) (Date)

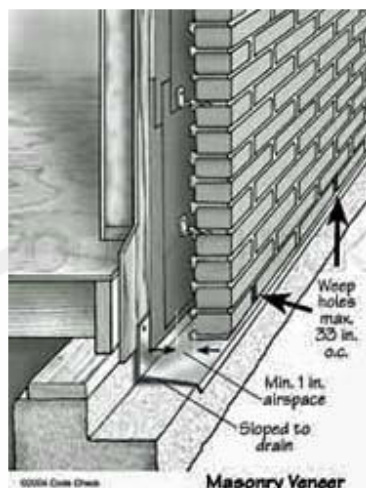
Weep openings appeared to have been omitted at the rear from the master bedroom patio area to the south side of the outdoor grill, & at the small southeast patio. Such is not recommended, as these provide drainage of condensation from within the wall voids. – *image on following page*

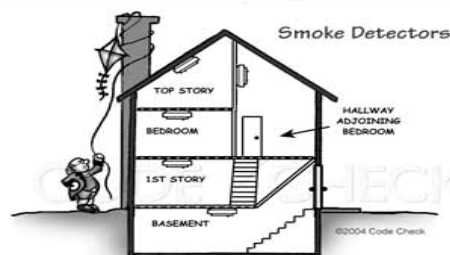
Smoke detectors are required in each bedroom

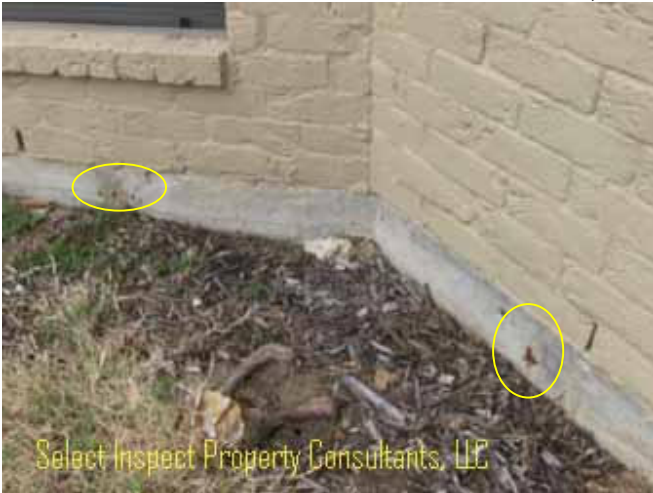
- Exposed or damaged post tension ends exists at the east. The exposed components should be sealed to prevent corrosion. This is commonly found, even on young homes, & is typically seen as a regular maintenance item. These areas should be cleaned thoroughly & sealed with water resistant mortar or an appropriate high performance epoxy. In some cases it may be necessary to cut & remove the cable, then replace it with a new cable that would then be stressed to tension. Extended / long-term exposure & subsequent corrosion may result in failure of the clamp/cable connection & expensive related repairs.

↑ discovered exposed post tension end(s) at the exterior master bedroom

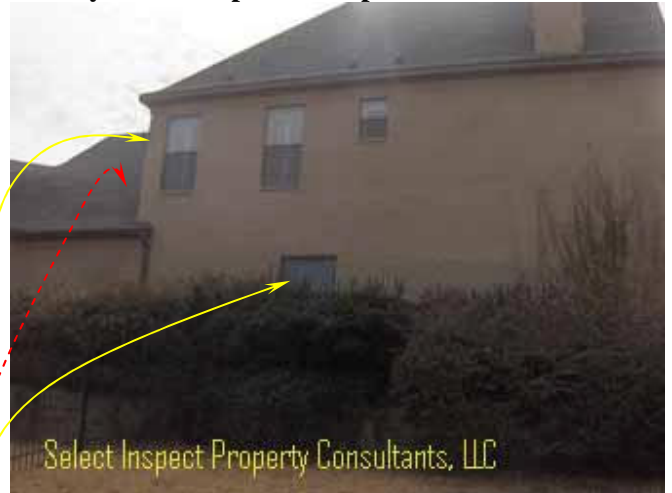
↑ stress evidence discovered at north

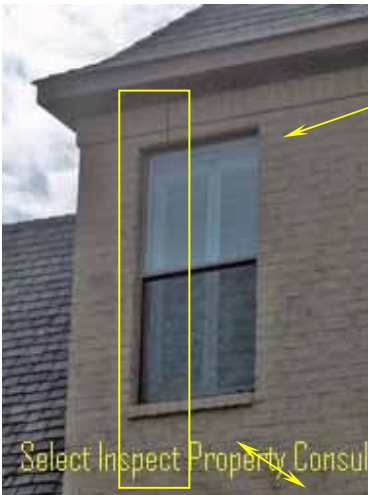
↑ 1/4" +- crack above window, thin cracks below window, & window separation from veneer/frame

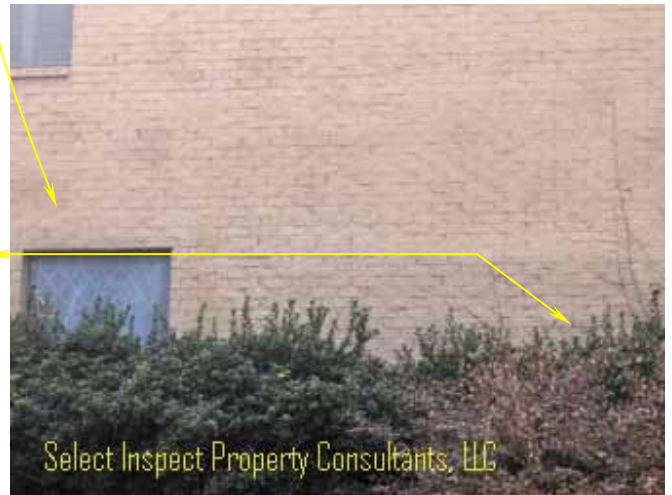
Horizontal cracks, step cracks, & vertical separation & cracks were discovered at the north (office/study, master bedroom & bath, & upstairs northeast bedroom). Some of the cracks were greater than 1/8", and appear excessive/abnormal; you should consult an engineer of your choosing or other specialist for evaluation and or details related to their findings and recommended course of action.

↑ diagonal/step cracks & horizontal crack(s)

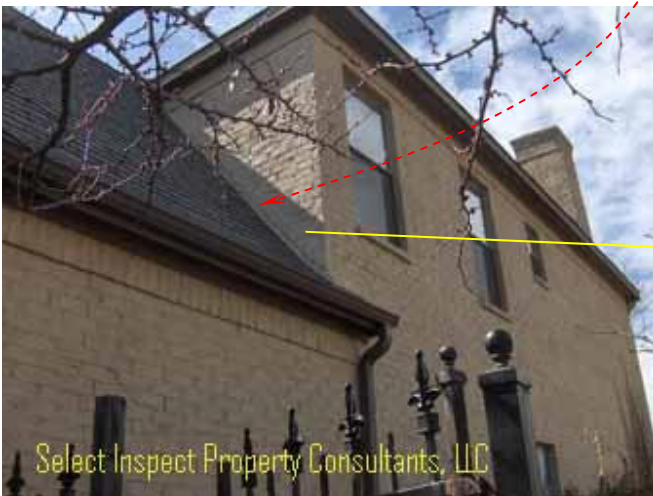
↑ flashing gap implies suspect deflection at roofline or wall stress

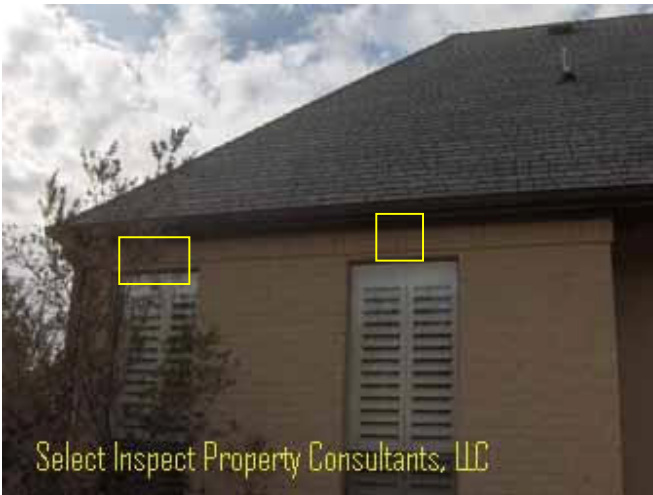
↑ stress cracks at the guest bedroom east

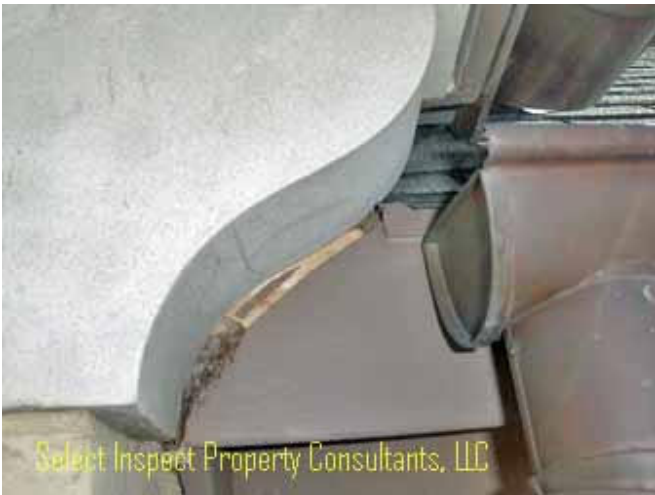
↑ stress, openings, & moisture damage above front porch; left

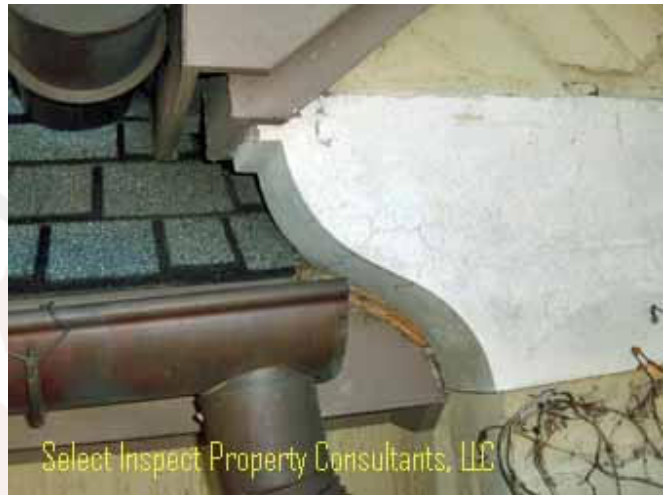
↑ stress, openings, & moisture damage above front porch; right

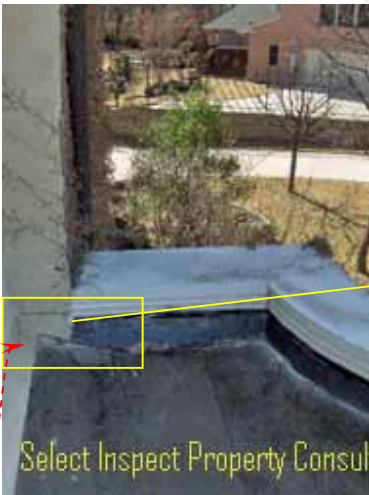
↑ deficiency flashing & openings; front porch right

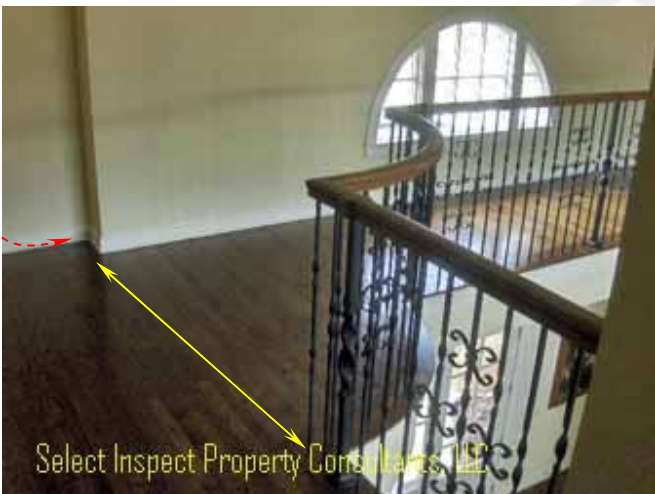
Separation of loft wood floor adjacent the front porch indicates possibility (suspect) moisture intrusion & swelling of structural frame/beam. Deficient flashing noted at the exterior adjacent.

↑ stress at loft floor; directly adjacent the deficient flashing shown above

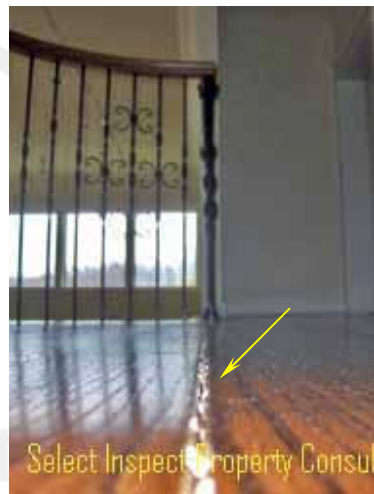
↑ close view of image at left; *suspect* moisture intrusion & swelling of subfloor framing

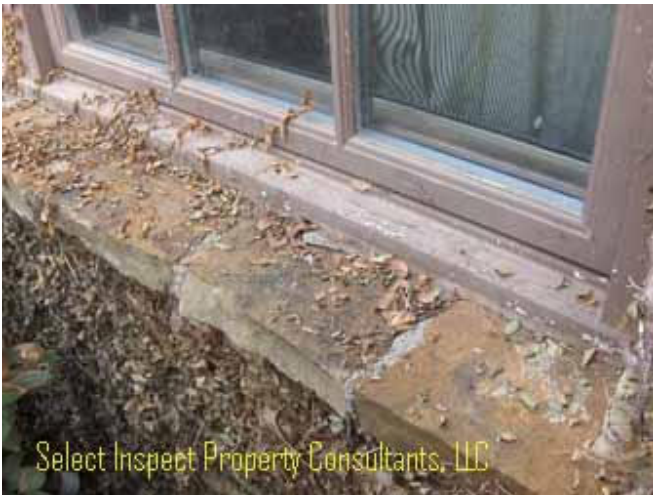
↑ example deficient mortar & sealant at windows; stone mortar is unconventional method/deep-set. This & excess ivy conditions are prone to premature wear & moisture intrusion

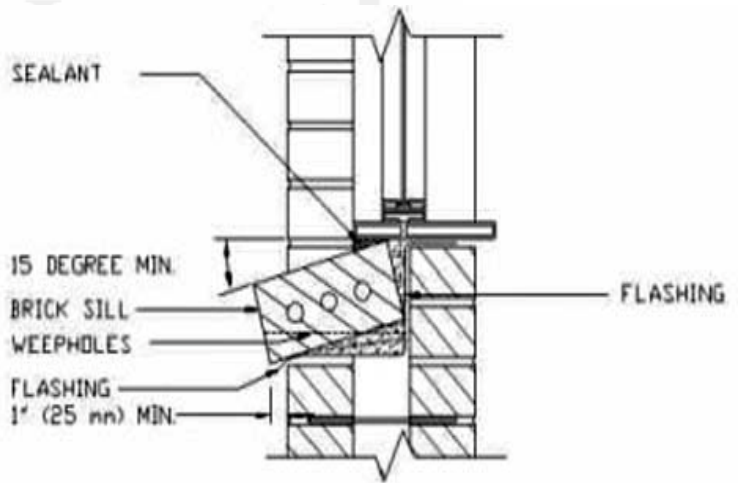
Exterior window sills did not have a recommended 15° slope for drainage at multiple locations; slope at random locations was approximately -2, 0, 3, 4° Repair options may be limited. Condition & appropriateness of flashing & substrate components is undetermined.

↑ brick ledge(s) had inadequate slope; example 1° rather than minimum 15°

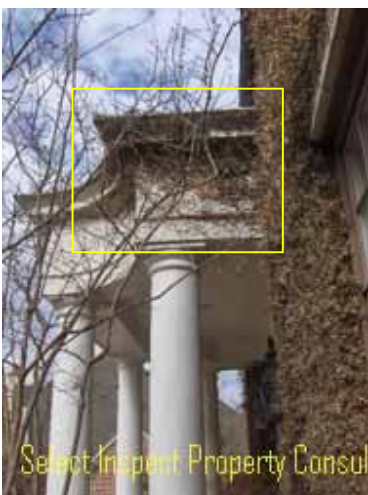
↑ moisture damage & fungus exists at the front porch components; example right side

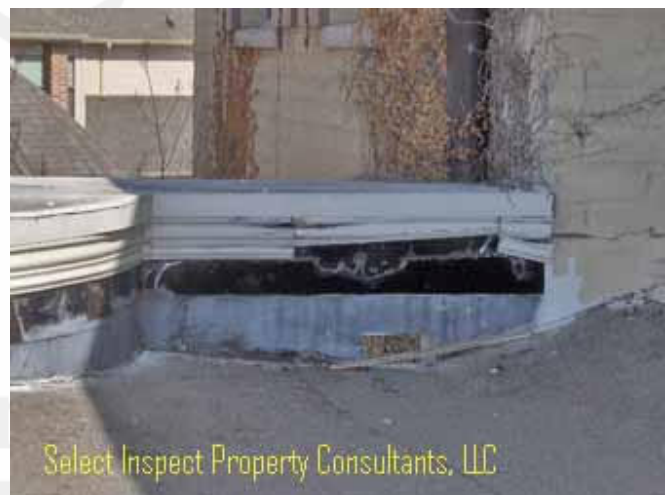
↑ moisture damage & aged roll roofing; front porch

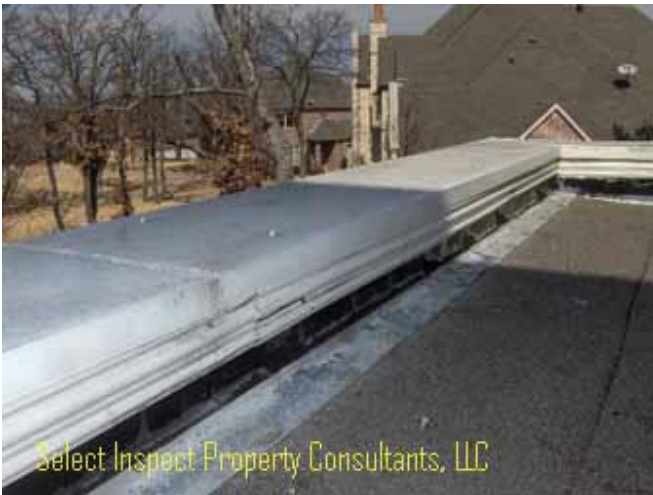
↑ moisture damage & aged roll roofing; front porch

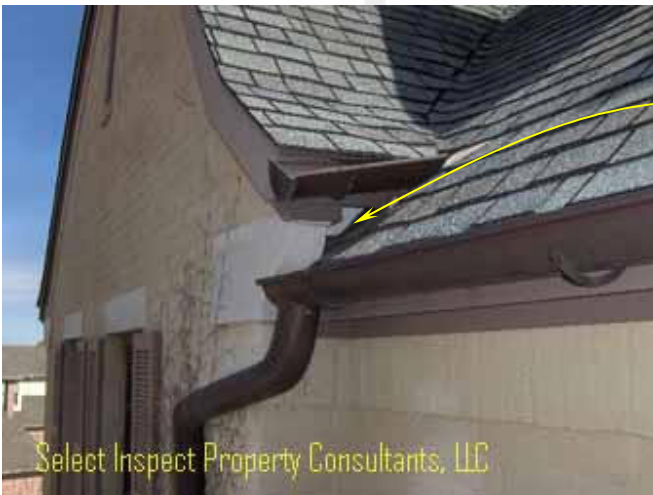
↑ deficient gutters & openings/unworkmanlike flashing; example at front porch left

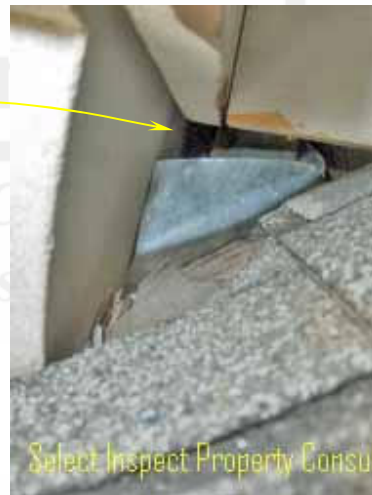
↑ close view of image above-behind cast stone; openings & moisture damage- suspect moisture intrusion exists

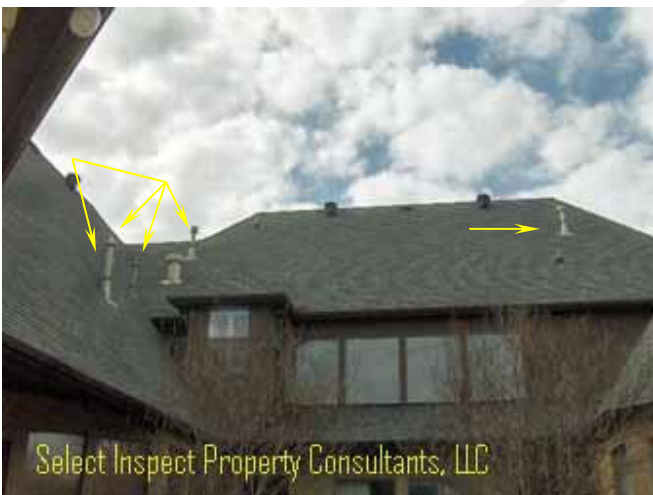
↑ flues & chimneys shall terminate at least 3 feet above the roof, and at least 2 feet above anything within 10 feet for appropriate drafting ability; *formal living area fireplace flue was not discovered in the attic or at the exterior-roof

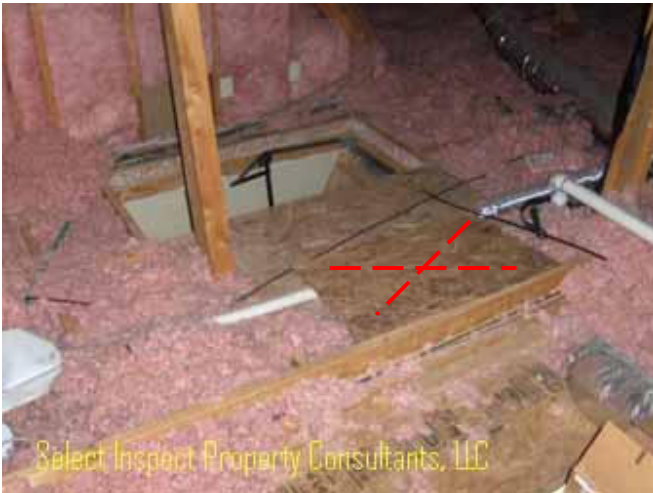
↑ there should be a minimum 24" pathway to the HVAC from the top of the access, with no gaps or obstructions; electrical wires/cables shall not be routed along walking surfaces or in any location prone to traffic damage; soft floor may be a trip risk (red "X")

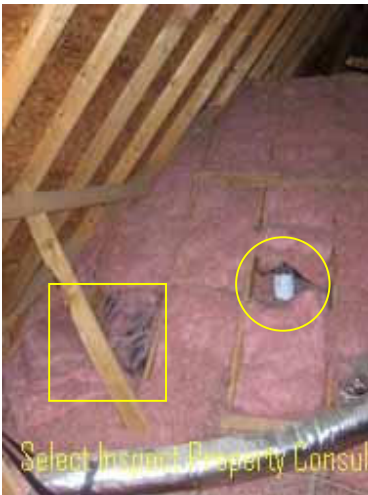
↑ example deficient insulation above family room east

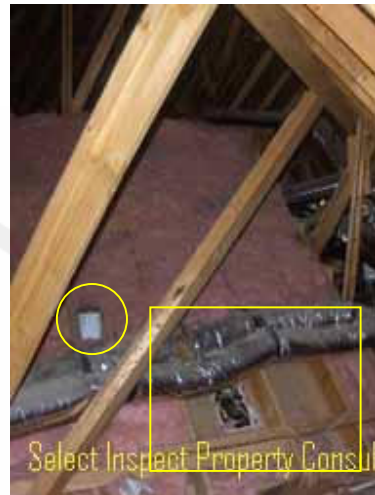
↑ example deficient insulation & location adjacent moisture staining above family room east

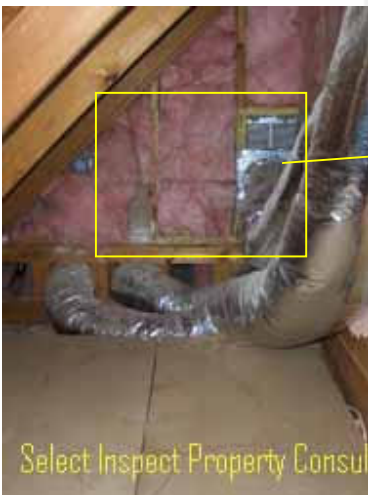
↑ example deficient insulation & unworkmanlike modification of return duct at exercise room south

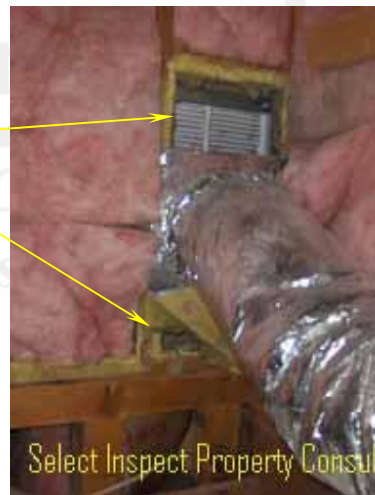
↑ close view of image at left; return is pulling air from the attic/unconditioned space

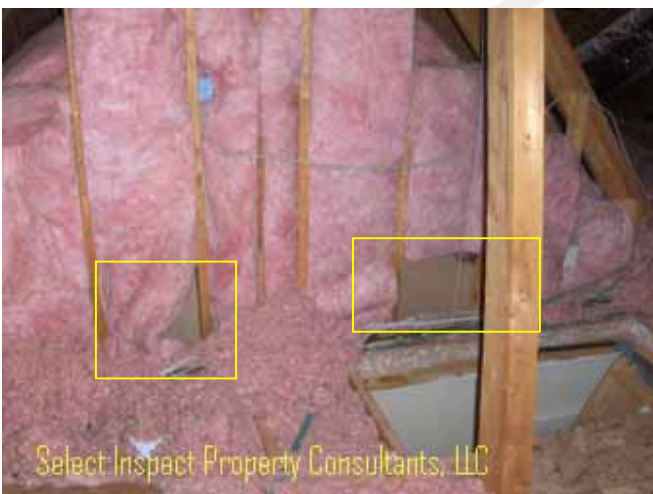
↑ example deficient insulation at upstairs bedroom south

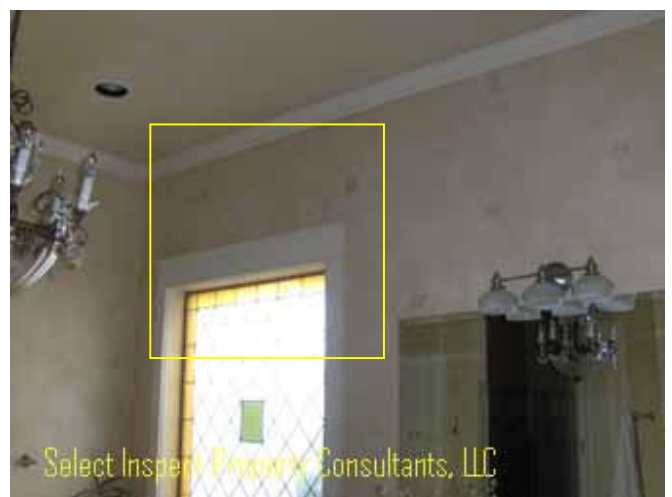
↑ Thermal imaging shows energy loss & or moisture at master bathroom window area

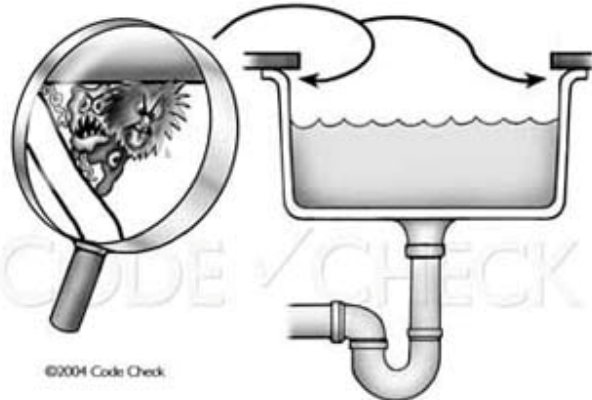
↑ fouling area at kitchen sink is prone to bacterial contamination

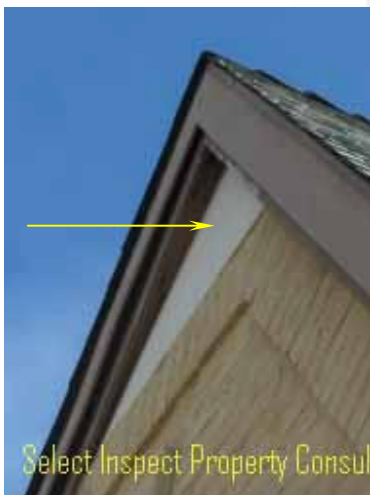
↑ northwest gable insert was inadequately secured; openings exist

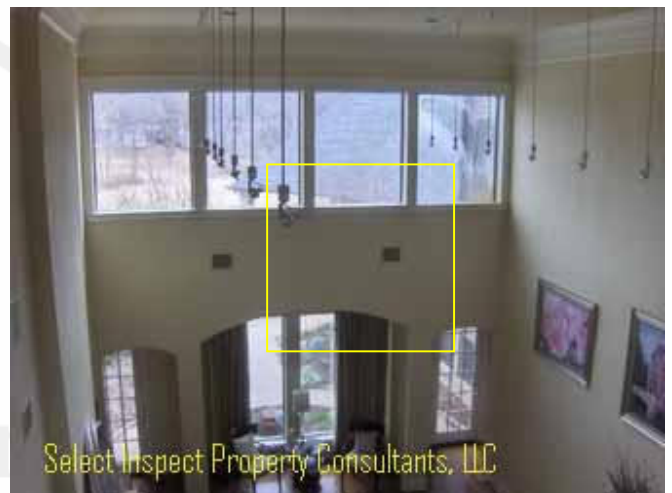
↑ Thermal imaging was inconclusive regarding moisture intrusion at the cracks & peeling paint below the formal living area window

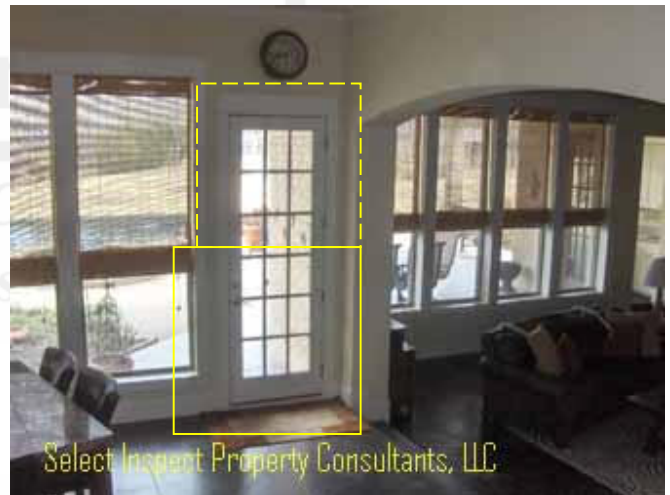
↑ Thermal imaging implies energy loss at receptacles & switches adjacent exterior walls & at exterior & attic doors; example at breakfast nook patio doorway

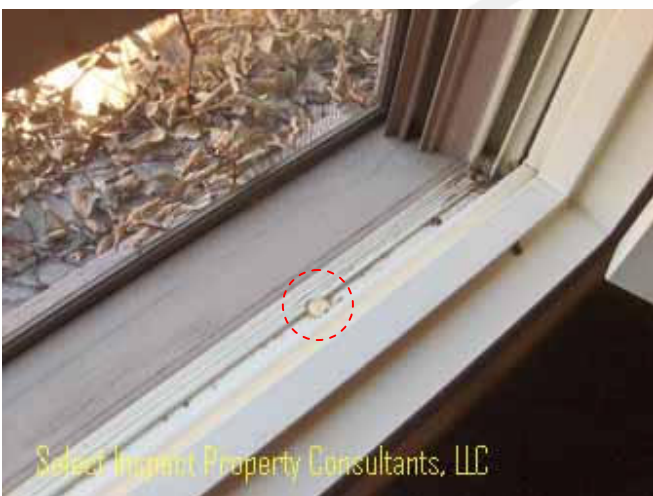
↑ Alarm holes at the lower portion of the window may allow moisture intrusion; caulk, maintain, and monitor

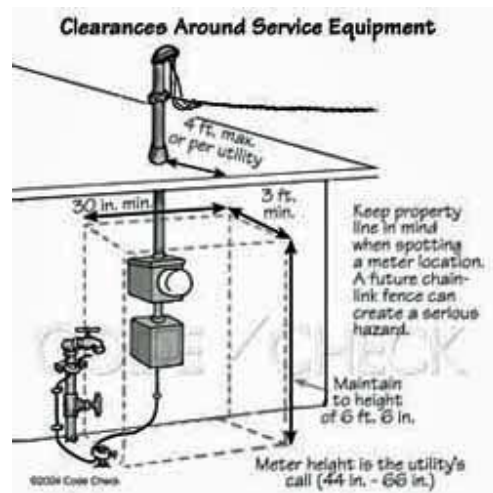
↑ Electrical service equipment requires minimum 36" clearance for access

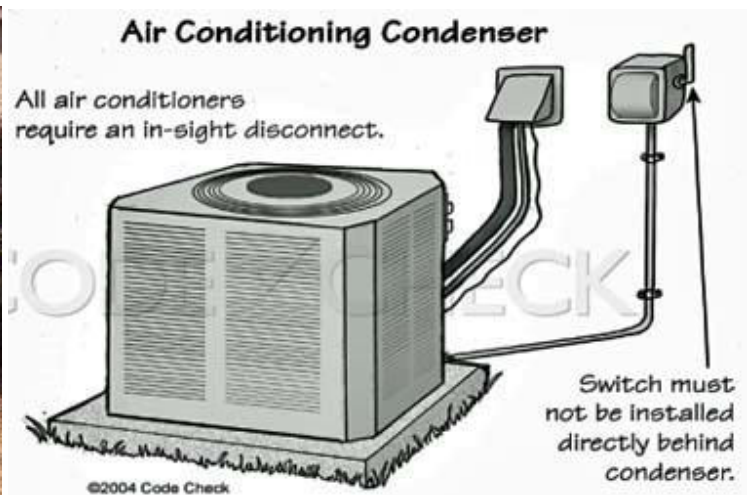
↑ incorrect location of air conditioning condenser(s) service disconnect; inadequate clearance of electrical panel for service personnel & Condensers were too low to grade- should be minimum 4" above soil

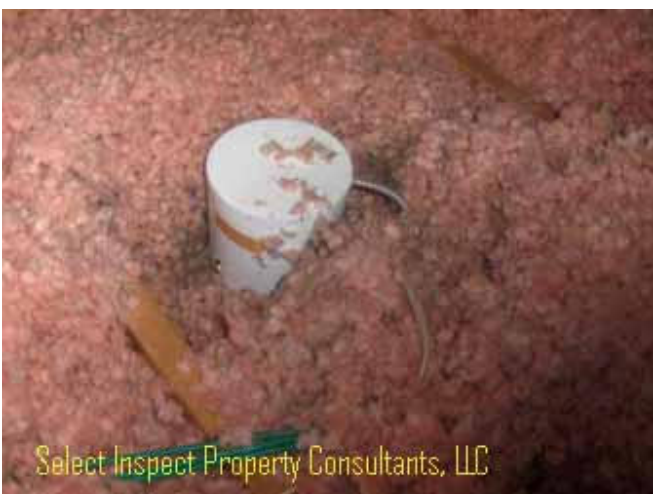
↑ recessed lights require minimum 3" clearance from insulation-per manufacturer label, to avoid overheating & fire hazard conditions; example one of many (all seen were amiss)

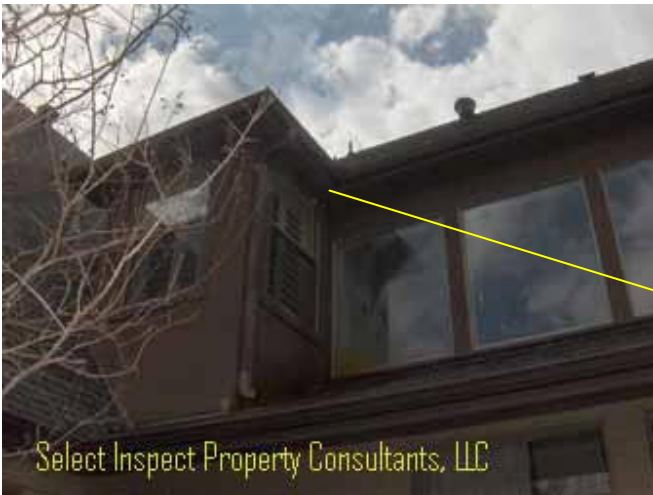
↑ auxiliary condensate drain appeared to have retracted into the eave; potential moisture damage condition

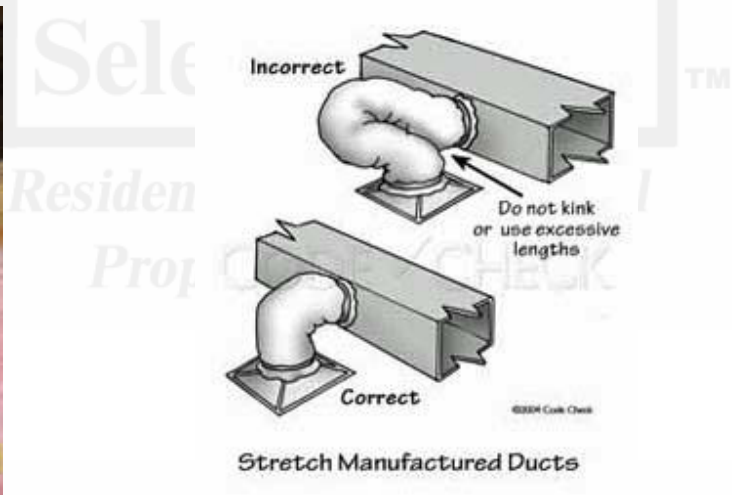
↑ walk-in attic southwest- crimped air ducting; example & deficient vapor barrier/insulation due to improper support

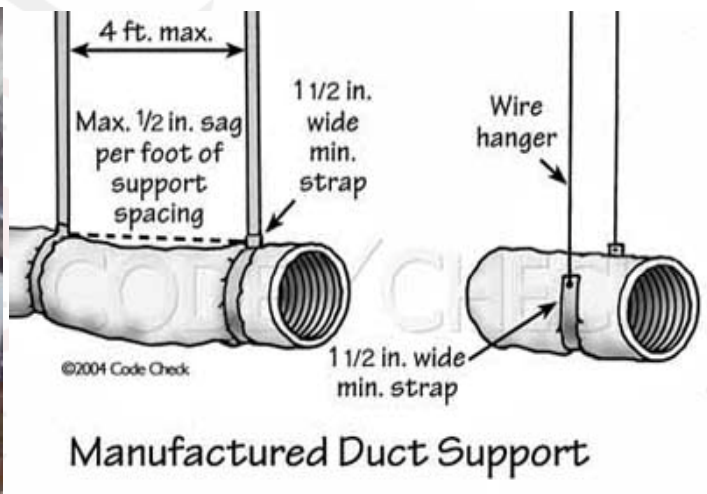
↑ inadequate support of air ducting; example location of multiple deficiencies discovered in all attic areas

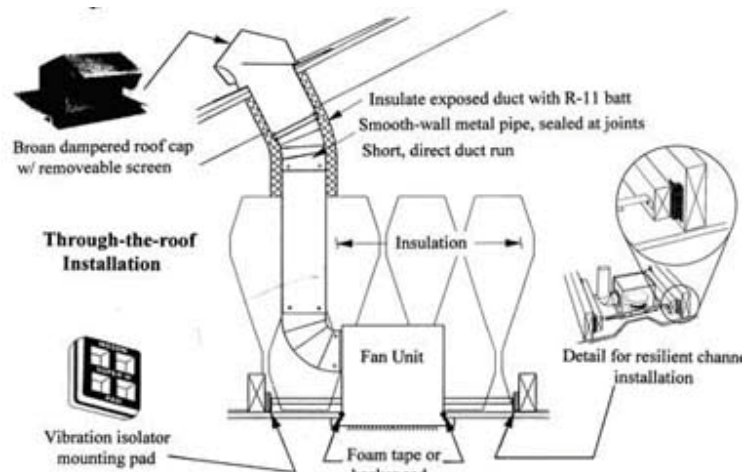
➤ Some / all bathroom /laundry exhaust fans appear to vent to the attic. Vent termination within the attic, at passive roof vents, or at eave vents does not meet manufacturer guidelines. Current standards require venting of bathroom and utility room exhaust fully to the exterior. (IRC M1507). Texas Real Estate Commission considers this deficient, even on older homes. Related technical information can be found at: <http://www.toolbase.org/PDF/DesignGuides/spotventilation1.pdf>

Exhaust fan(s) improperly terminate in the attic, rather than exterior

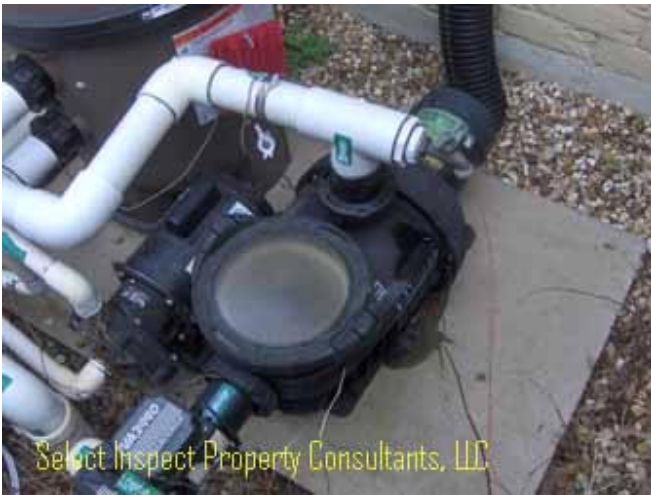
↑ leaks discovered at both pool pumps & at the chlorinator; main (filter) pump would not hold prime
