## Property Inspection Report

**Concerning:** 123 street Flower Mound, Texas  
**(Address or Other Identification of Inspected Property)**

**By:** Bruce W. Carr; TREC #5281 ASHI Member # 211804 Tuesday, May 10, 2011  
(Name and License Number of Inspector) (Date)

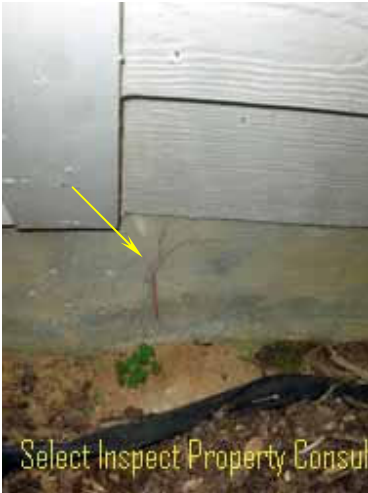
↑ slab crack discovered-east 1 of 2

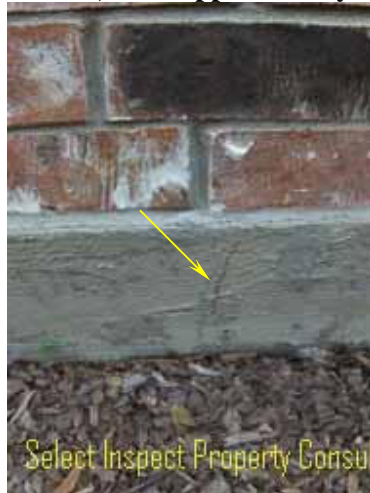
↑ slab crack discovered west

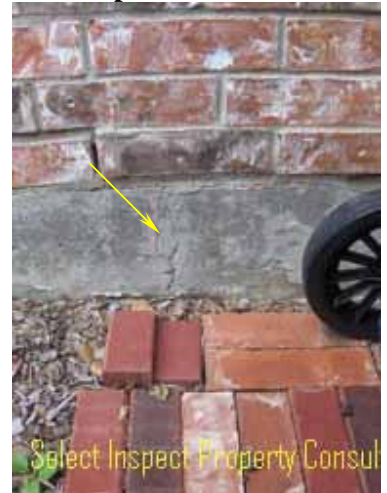
↑ slab crack discovered west

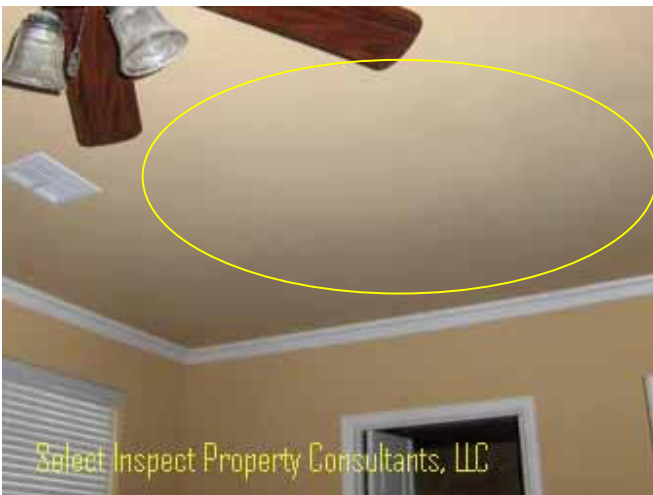
↑ repair evidence at master bedroom

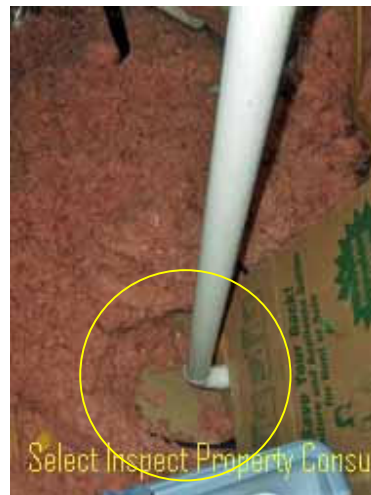
↑ moisture intrusion evidence above image at left

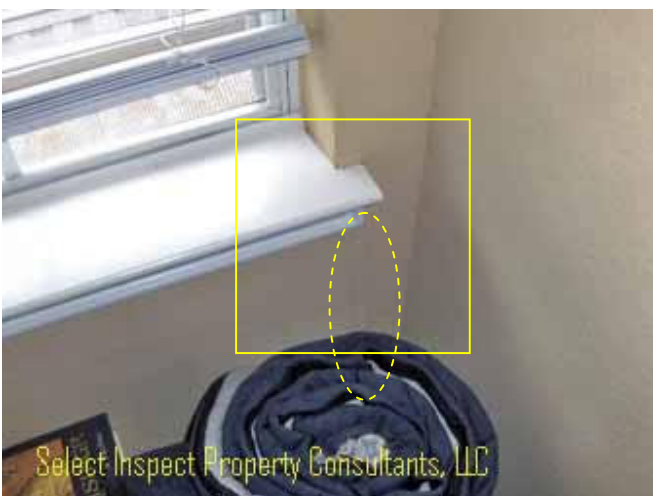
↑ moisture staining at northwest bedroom below window

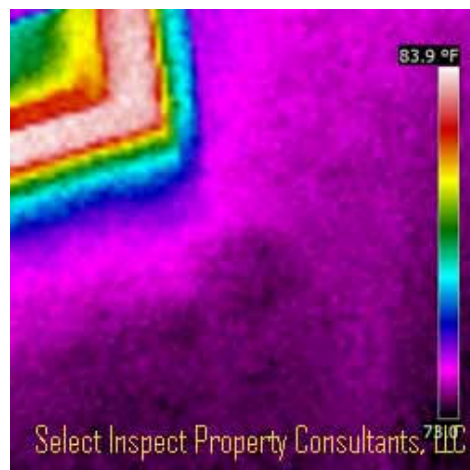
↑ Thermal imaging from square at left; anomalies not discovered during the inspection; active leakage not discovered

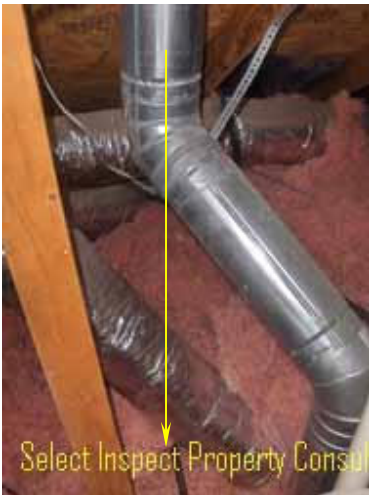
↑ moisture intrusion discovered around fireplace flue

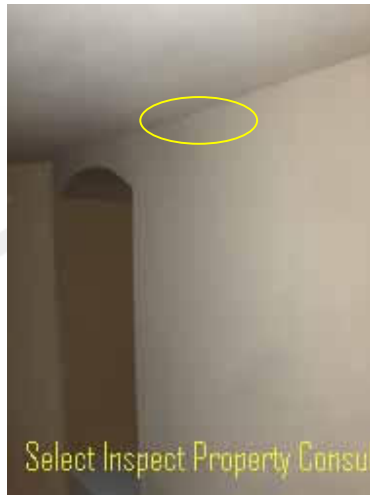
↑ moisture damage discovered at family room below image at left

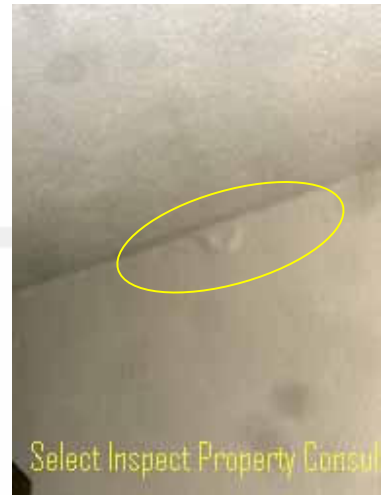
↑ close view of image at left

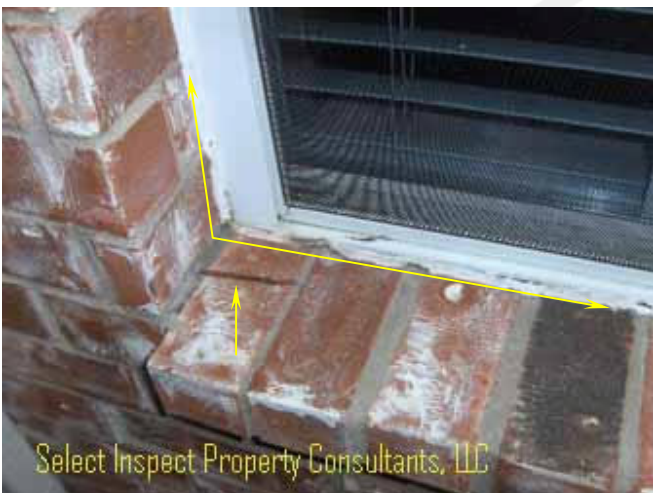
↑ cracked sill & window/veneer stress

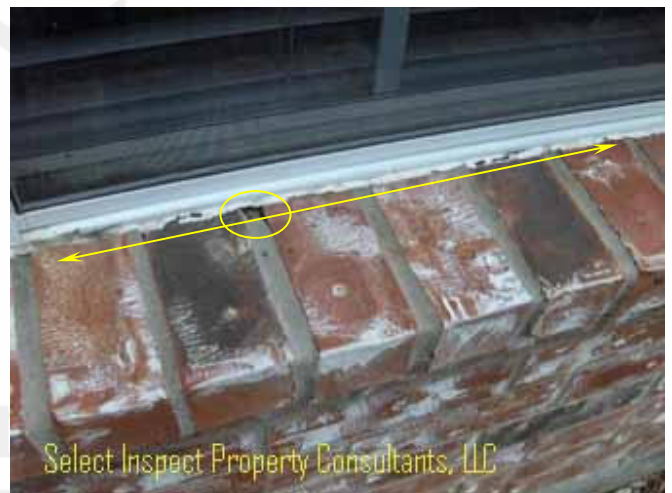
↑ openings & stress evidence at window sill

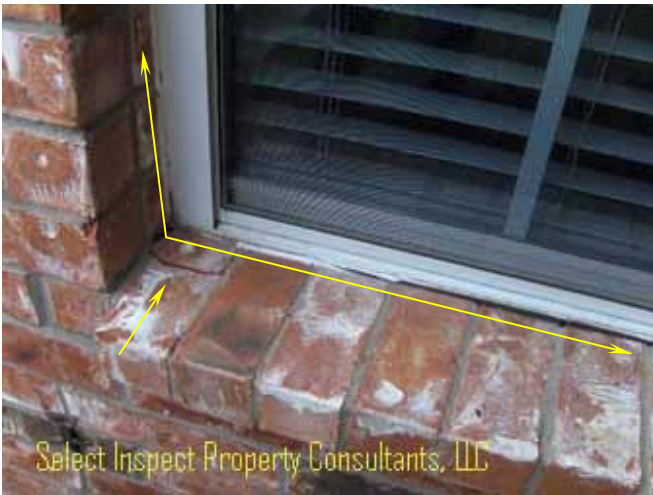
↑ cracked sill & window/veneer stress & deficient window moisture barrier/flashing

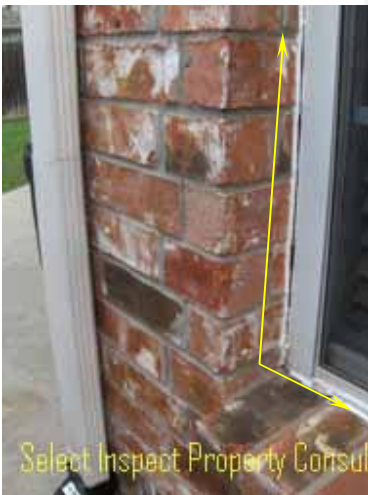
↑ window separation; stress

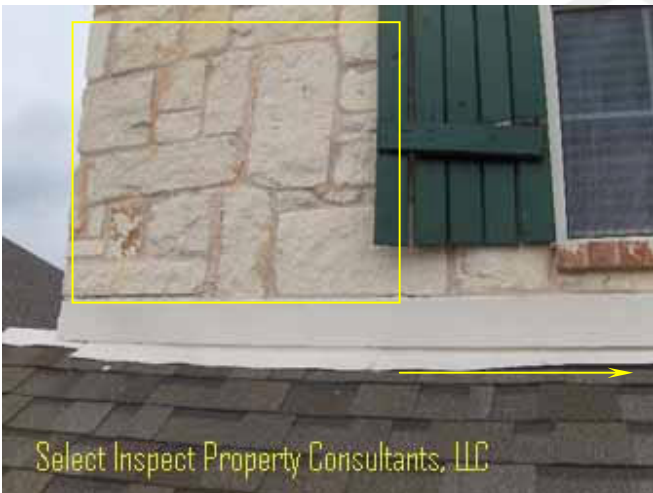
↑ stress cracks & mortar repair history with new cracks & lifted flashing

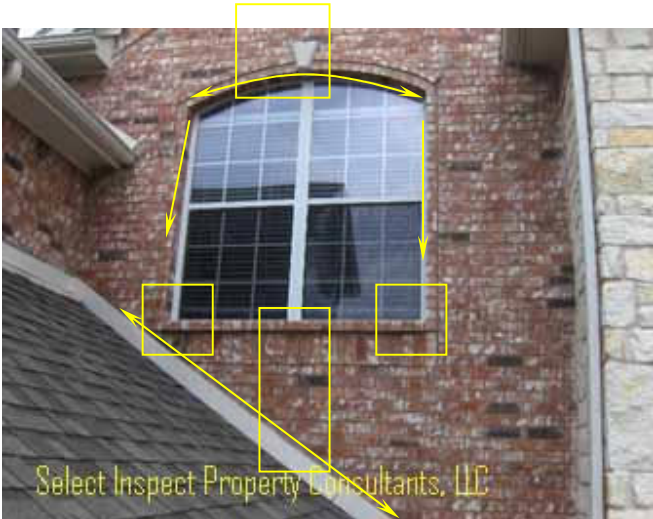
↑ multiple stress indicators and deficiencies

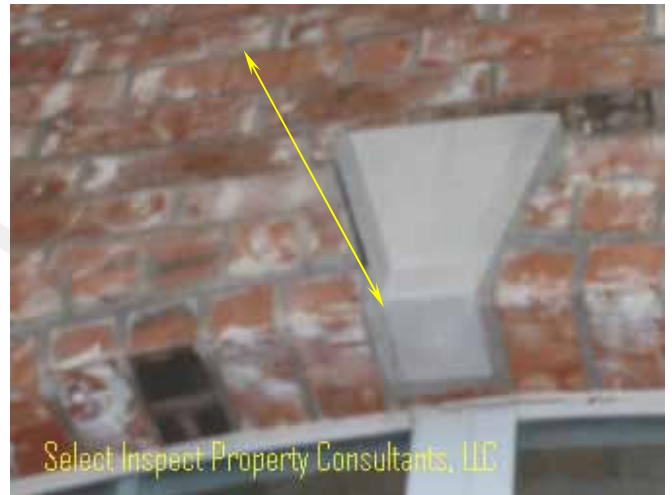
↑ stress cracks

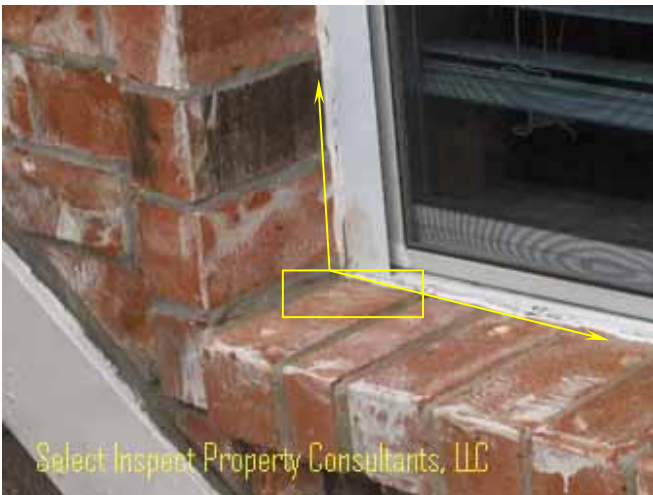
↑ cracked sill & window/veneer stress

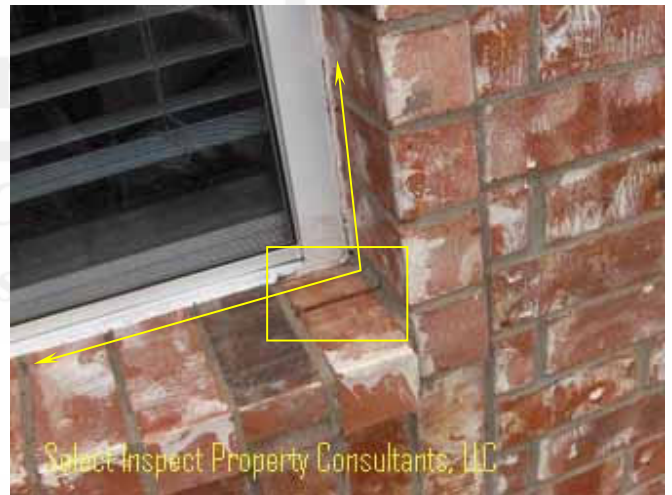
↑ cracked sill & window/veneer stress

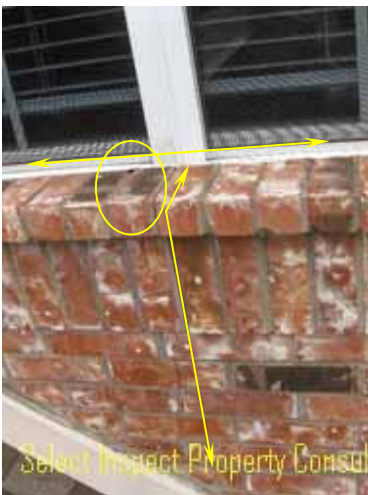
↑ cracked brick & or mortar & cracked sill & window/veneer stress & openings

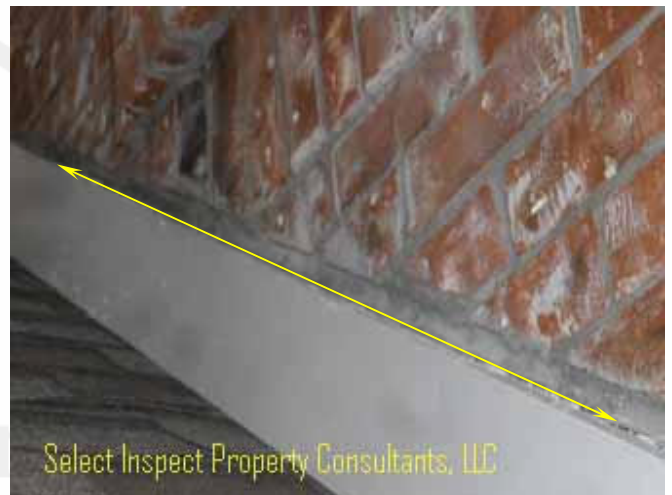
↑ deflection implied by mortar & flashing separation

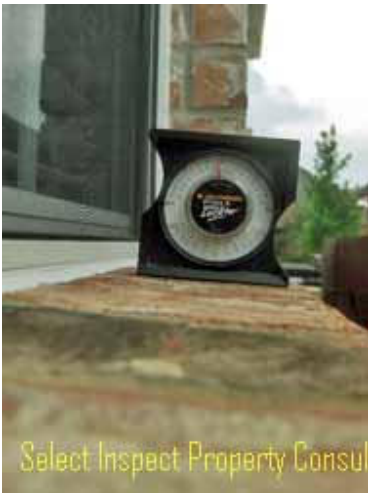
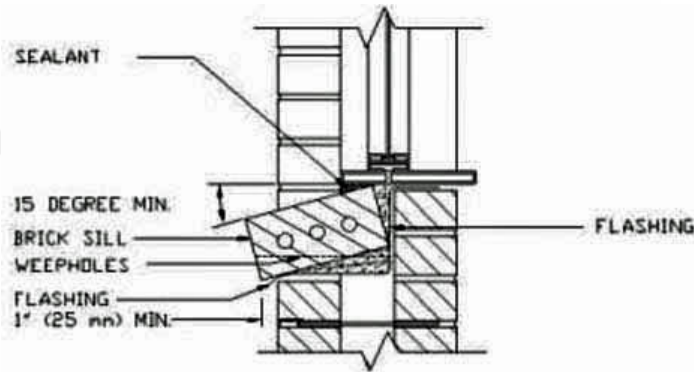
↑ brick ledge(s) had inadequate slope; example

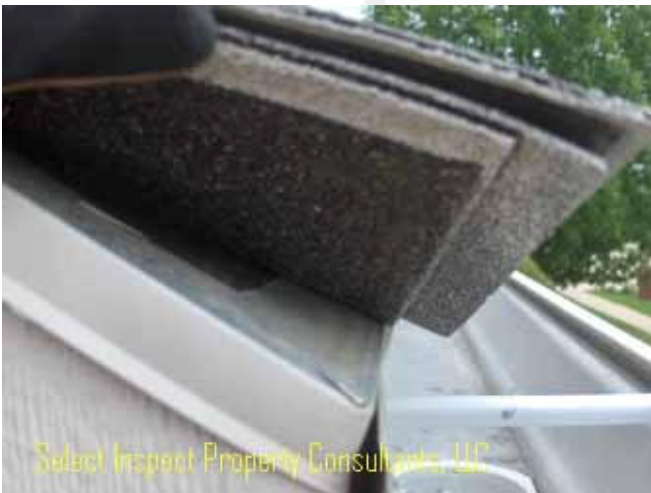
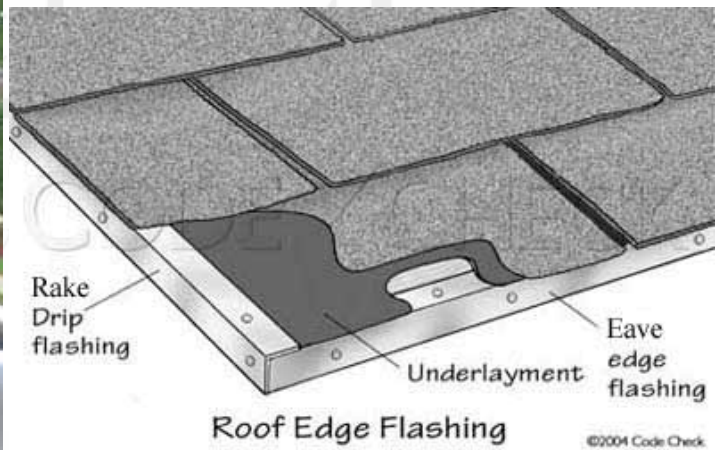
↑ example-unworkmanlike drip edge/felt; corners should have no gaps; rake (diagonal) edge & roof felt should be atop the eave (lower) edge flashing; roof underlayment should be under rake flashing

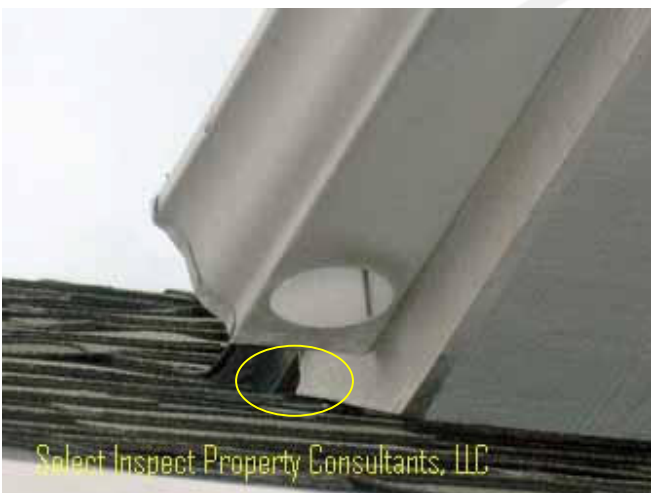
↑ opening; damaged fascia- upper left of front porch

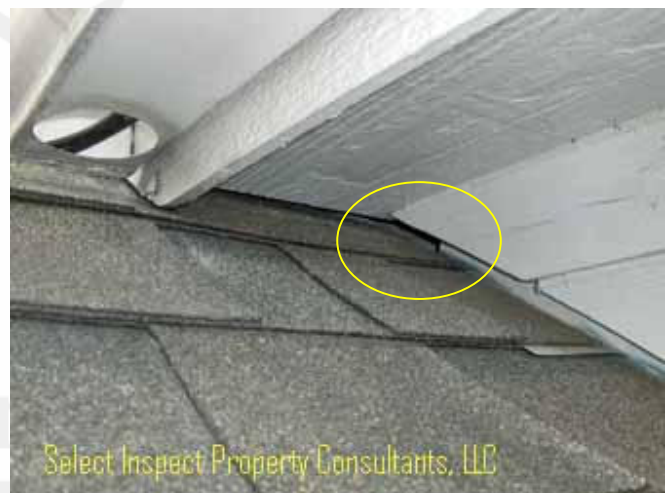
↑ opening; deficient flashing- example

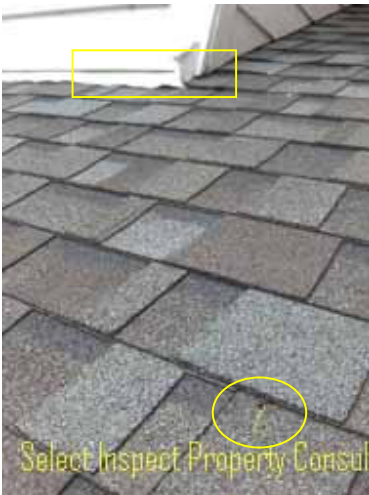
↑ deficient shingle fastener & raised flashing (moisture intrusion noted below in garage)

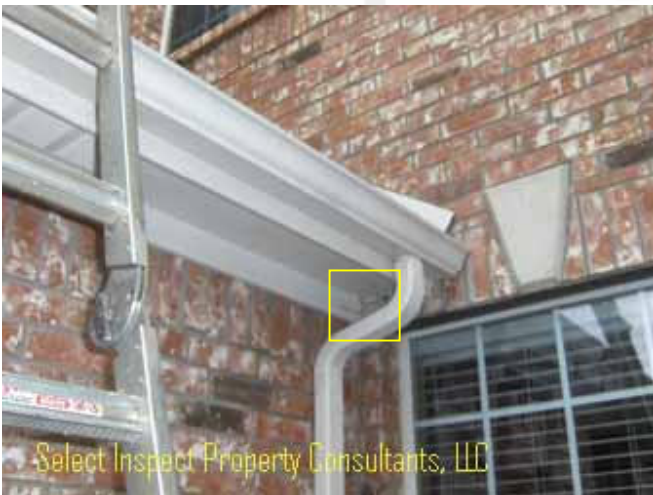
↑ moisture damage discovered at frieze-board left of front porch

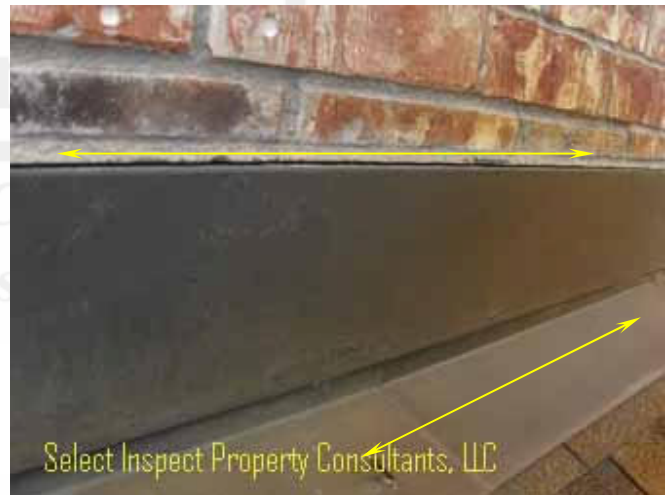
↑ unsealed counter flashing & uncaulked, exposed fasteners; example at master bathroom small roofs

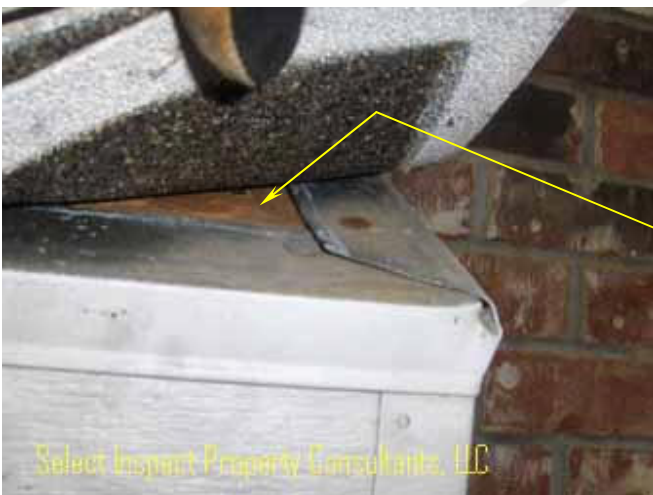
↑ missing roof underlayment at gable “eyebrow(s)” & master bathroom small roofs; example

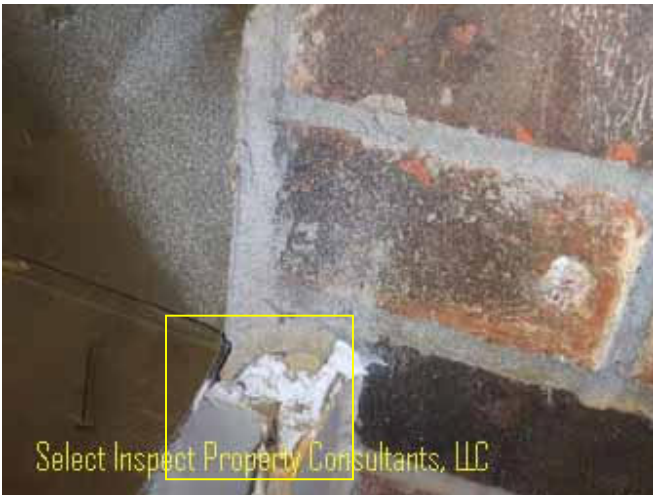
↑ inadequate seal at master bathroom small roof corners example

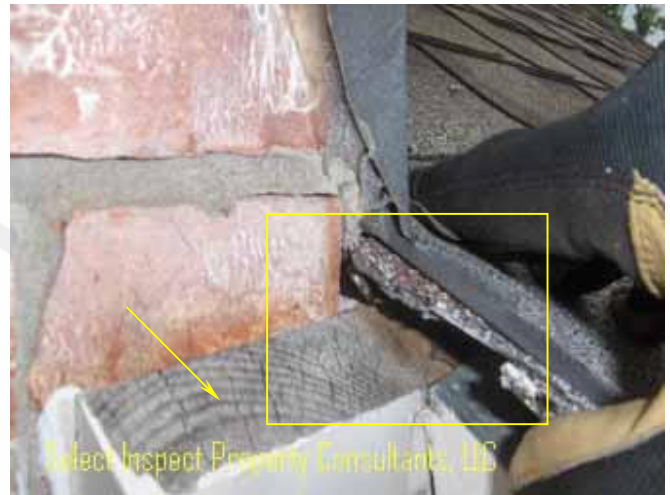
↑ openings; inadequate seal at master bedroom east-northeast

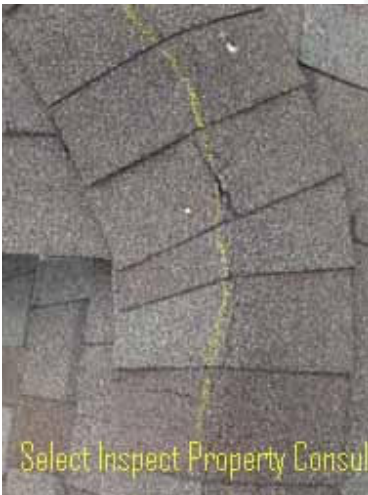
↑ example ridge/hip shingle cracks

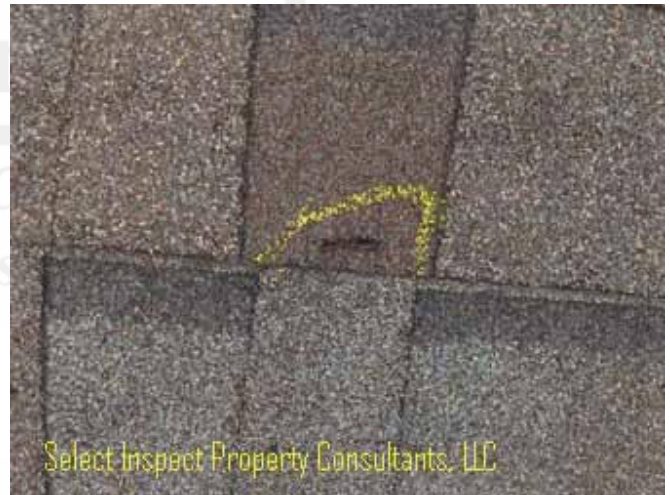
↑ popped/exposed roof staple; example

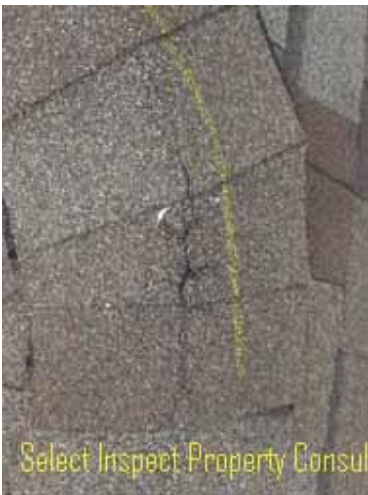
↑ example ridge/hip shingle cracks

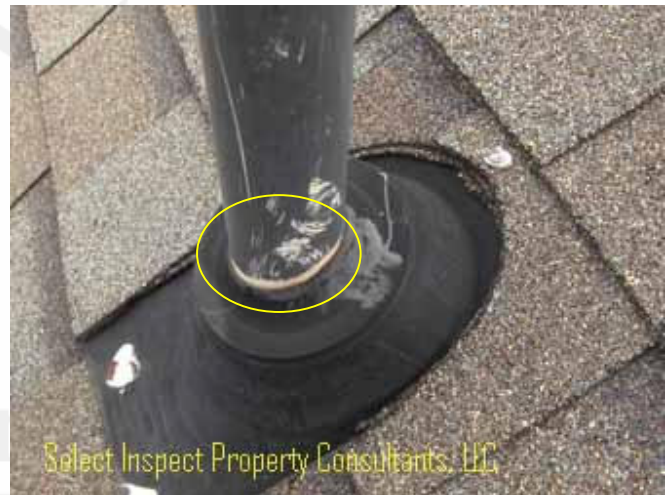
↑ vent separation & openings; example

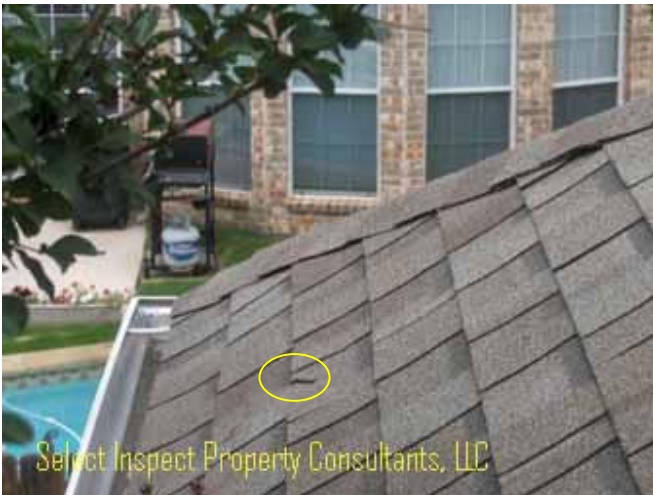
↑ damaged shingle at north

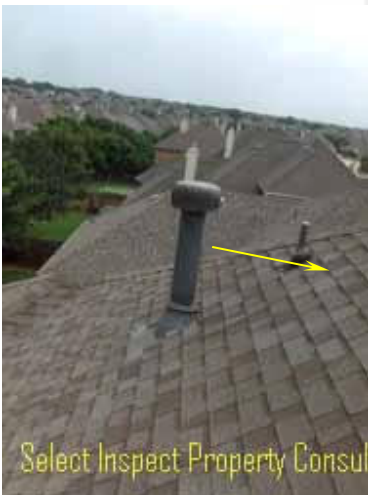
↑ flues & chimneys shall terminate at least 3 feet above the roof, and at least 2 feet above anything within 10 feet

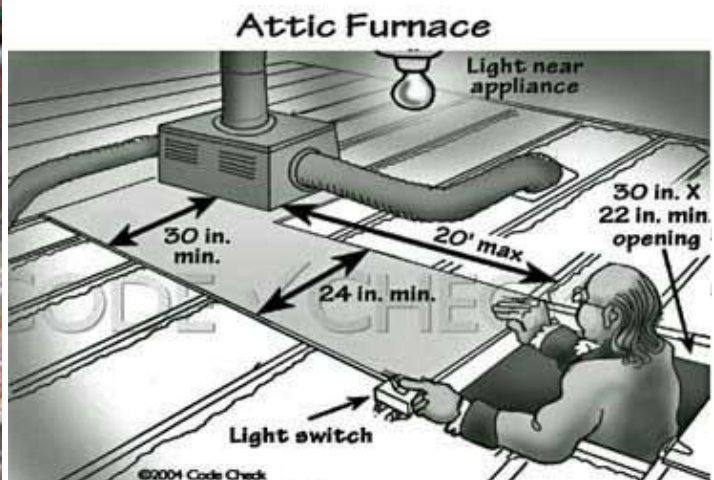
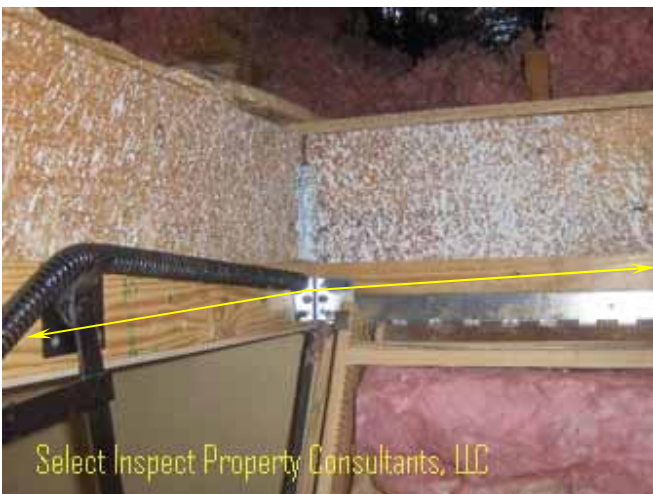
↑ improper/inadequate fasteners at attic stair; unworkmanlike & unsafe

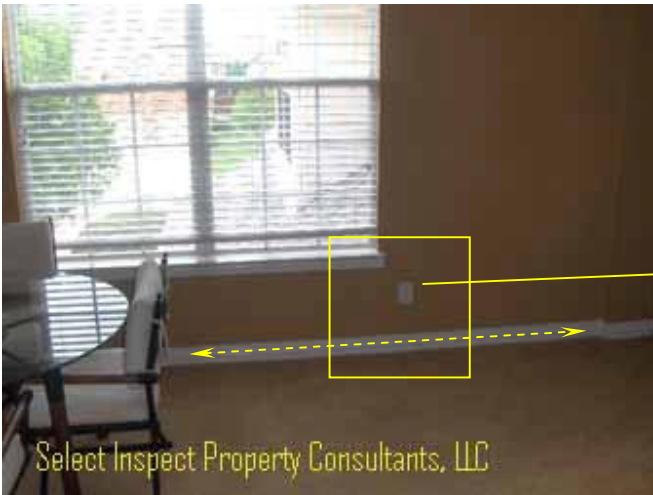
↑ example of slight energy loss at receptacle & sill plate

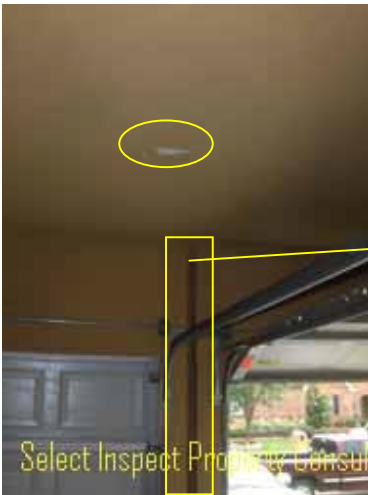
↑ moisture damage & garage drywall deficient; separation provisions compromised

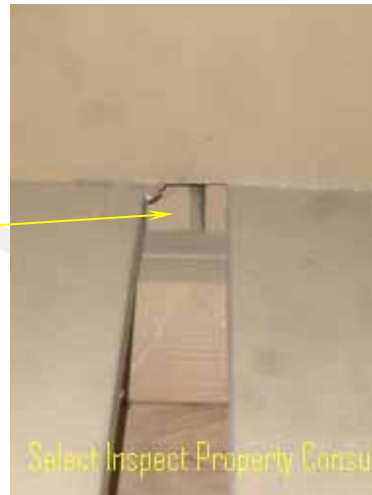
↑ close view of image at left opening at garage drywall between levels; visible framing

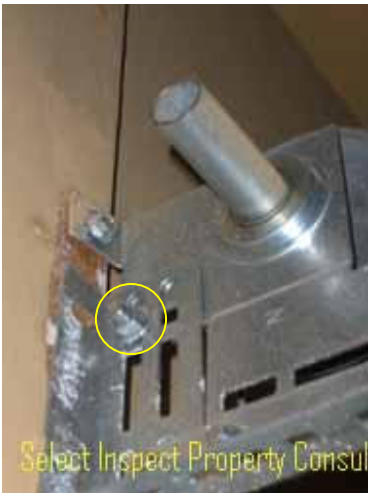
↑ inadequate fastening of overhead door spring assembly

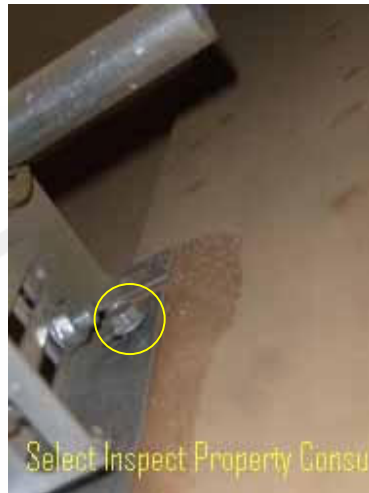
↑ inadequate fastening of overhead door spring assembly

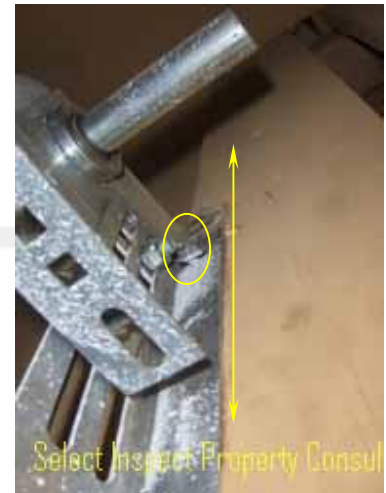
↑ inadequate fastening of overhead door spring assembly & cracked framing

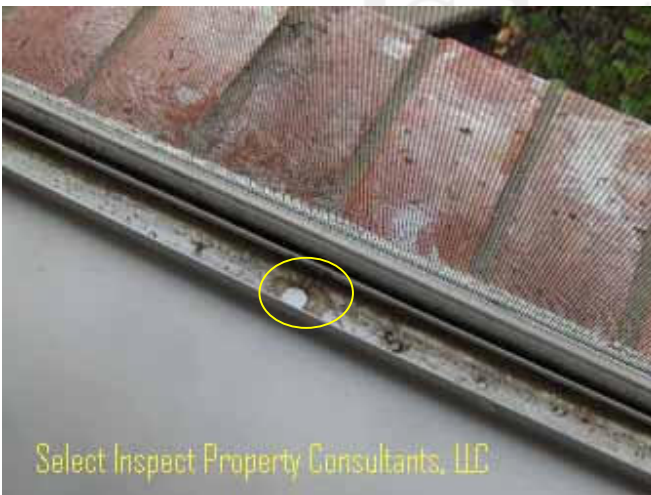
↑ Alarm holes at the lower portion of the window may allow moisture intrusion; caulk and monitor

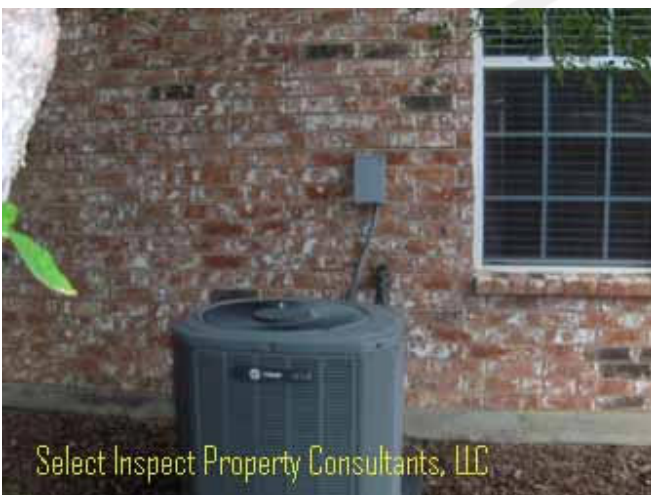
↑ example (1 of 3 discovered) incorrect location of air conditioning condenser(s) service disconnect; inadequate clearance of electrical panel for service personnel

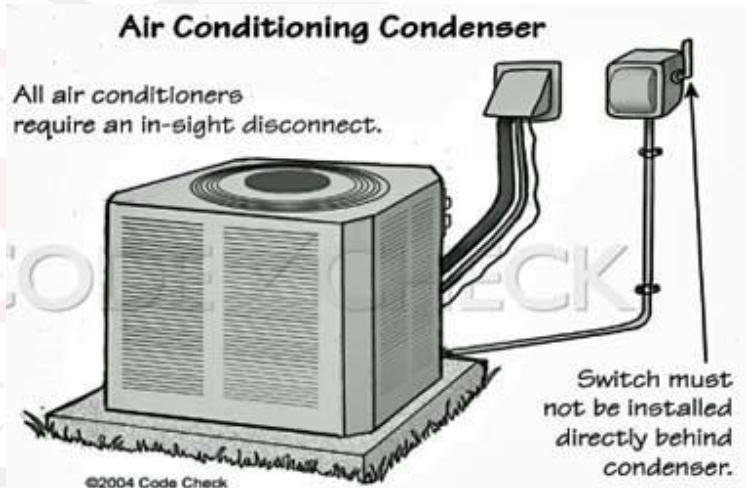
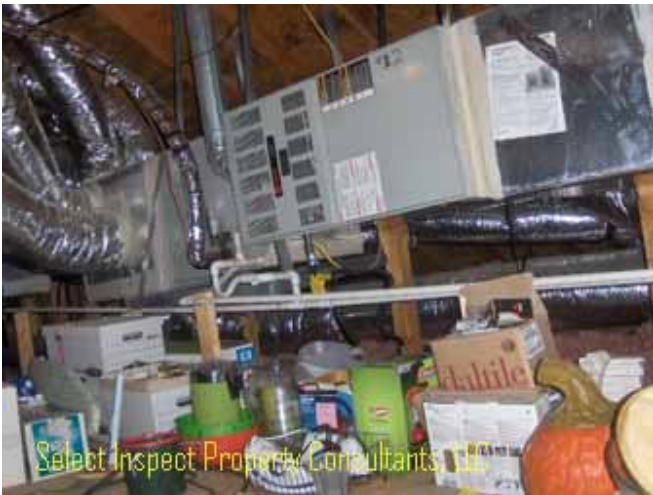
↑ 30" unobstructed service area was amiss at the HVAC

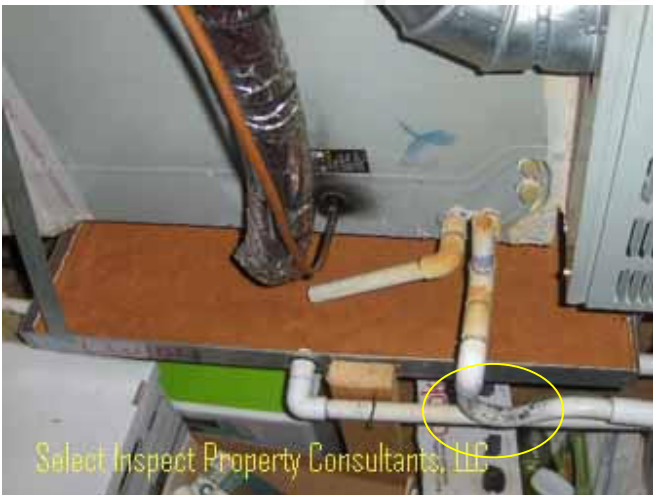
↑ rust at evaporator(s) auxiliary pan & air conditioning primary condensate drain should be insulated; fungus at condensate trap

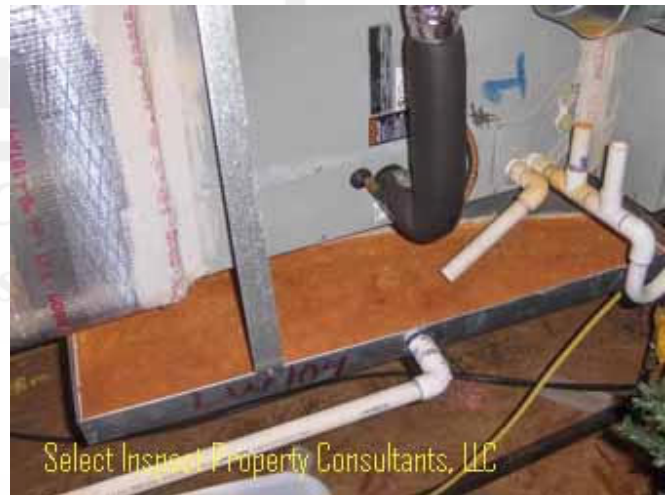
↑ same as left; other upper attic unit

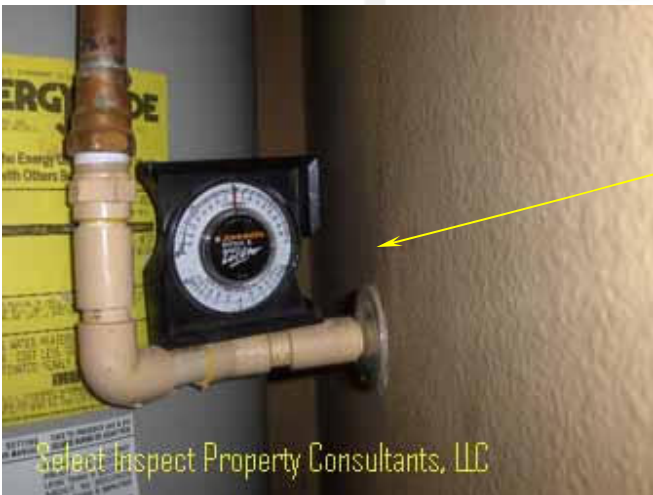
↑ temperature/pressure relief drain improperly routed uphill at this section

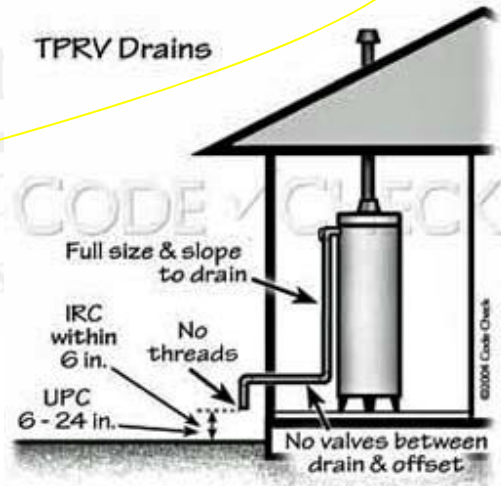
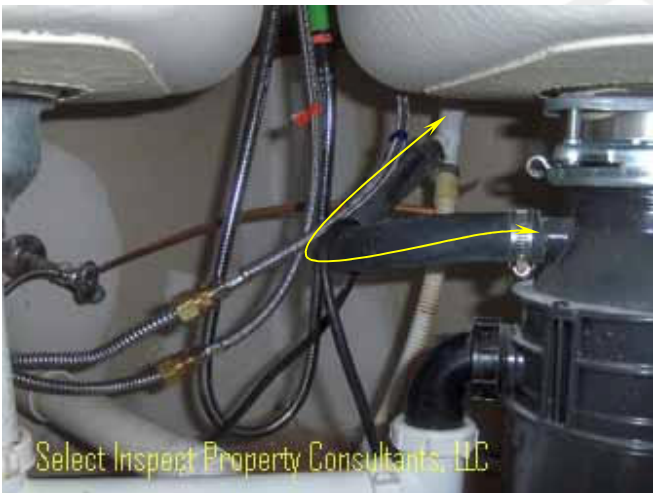
↑ dishwasher drain not appropriately routed for backflow protection

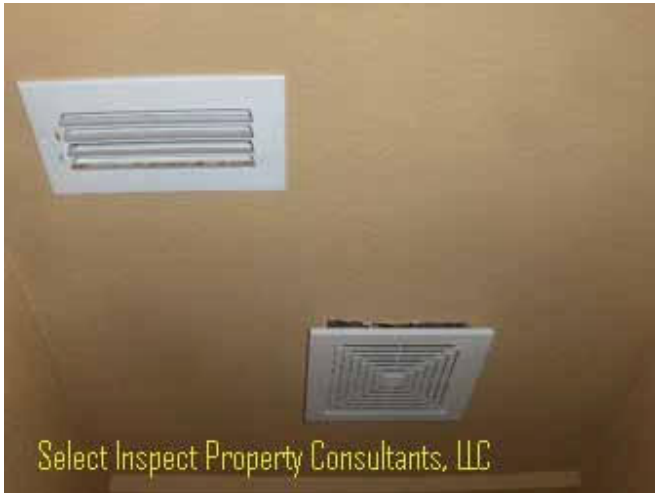
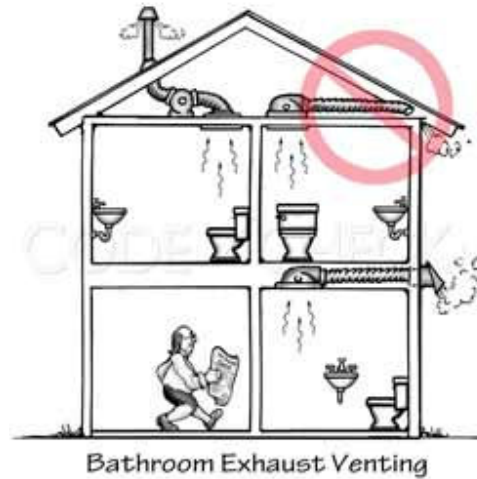
↑ moisture staining at air register & inadequately secured cover at exhaust fan- split bath.

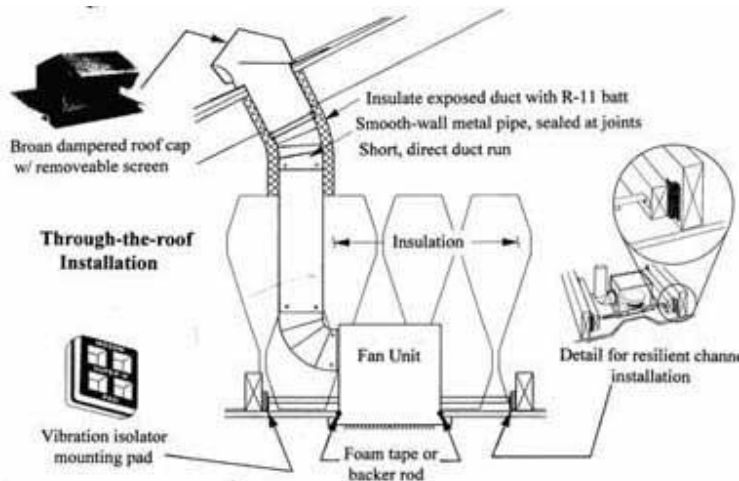
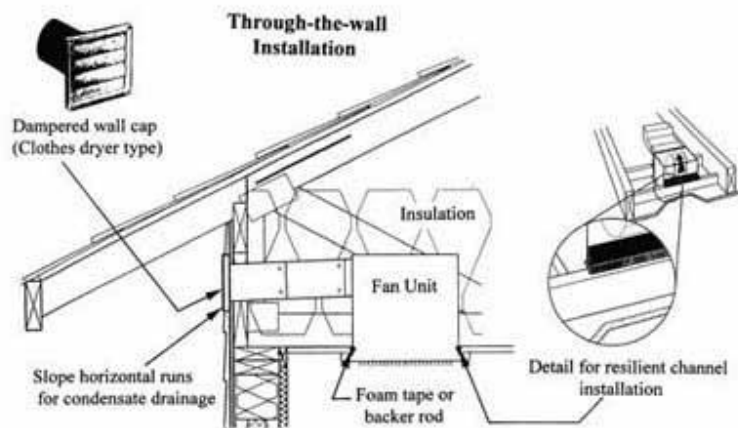
Exhaust fan(s) improperly terminate in the eaves, rather than to the exterior
