## Property Inspection Report

### PROPERTY INSPECTION REPORT

123 street

Friday, May 06, 2011

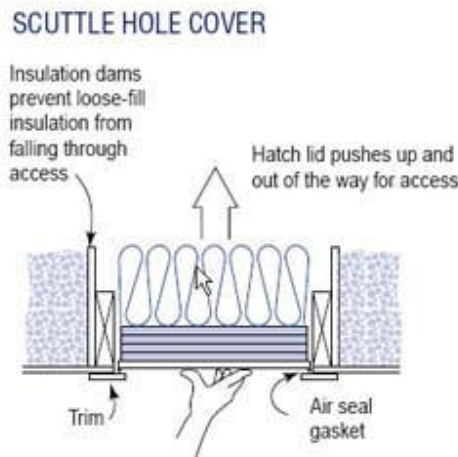
- Attic access was smaller than required. Where mechanical equipment is present, the opening must be large enough for removal of the largest appliance & at least 22” x 30”. The access must be in a hallway or other readily accessible location per IRC R807 & IRC M1305. Attic spaces in these areas were not readily accessible / inaccessible; Conditions in inaccessible locations remain undetermined.
- Attic access(es) was inadequately insulated & or seals poorly. Energy loss exists

- Attic floor was deficient or not present at the top/front of the access; this creates a hazard during entry and exiting the attic. Addition of appropriate deck/floor is recommended.

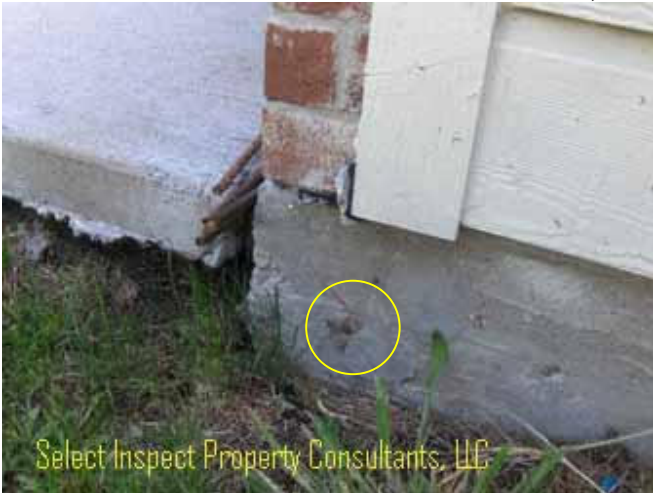
- ✦ INTERIOR:
  - None discovered
- ✦ EXTERIOR:
  - Exposed or damaged post tension ends exists at the west corner. The exposed components should be sealed to prevent corrosion. This is commonly found, even on young homes, & is typically seen as a regular maintenance item. These areas should be cleaned thoroughly & sealed with water resistant mortar or an appropriate high performance epoxy. In some cases it may be necessary to cut & remove the cable, then replace it with a new cable that would then be stressed to tension. Extended / long-term exposure & subsequent corrosion may result in failure of the clamp/cable connection & expensive related repairs.

↑ exposed post tension end(s) at the west

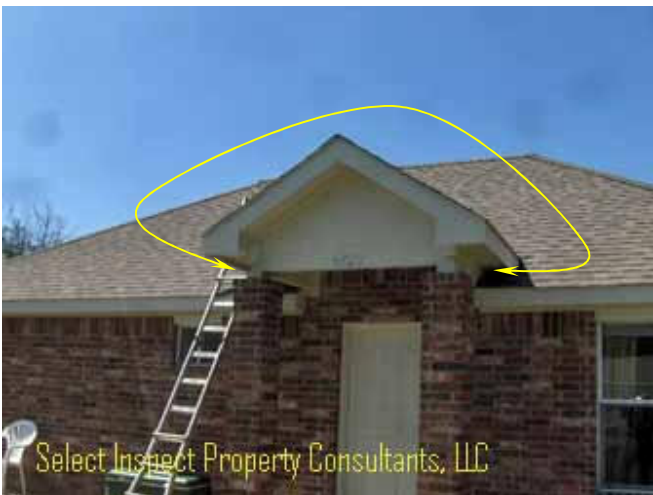
↑ missing flashing; openings; visible roof deck & attic components & example of wood too close to roofline

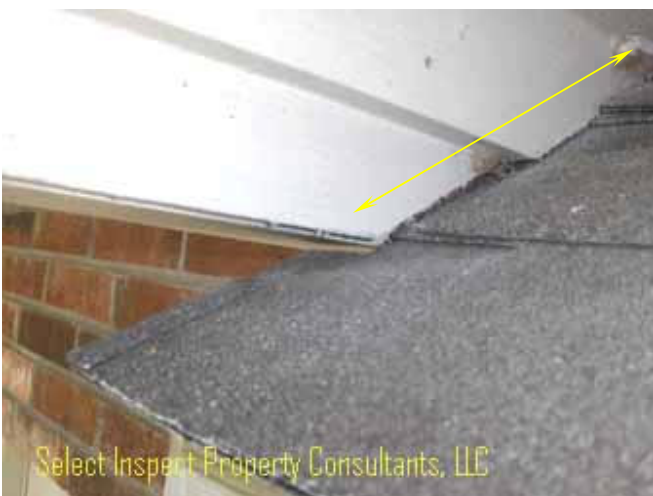
↑ close view of image above; right of entry

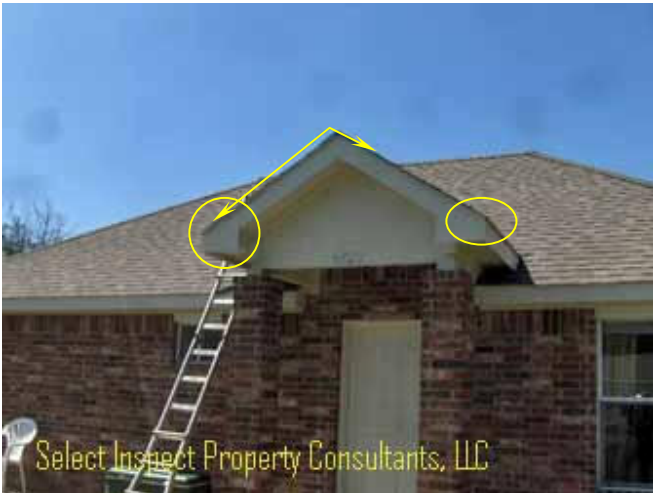
↑ example-unworkmanlike drip edge/felt; corners should have no gaps; rake (diagonal) edge & roof felt should be atop the eave (lower) edge flashing; roof underlayment should be under rake flashing

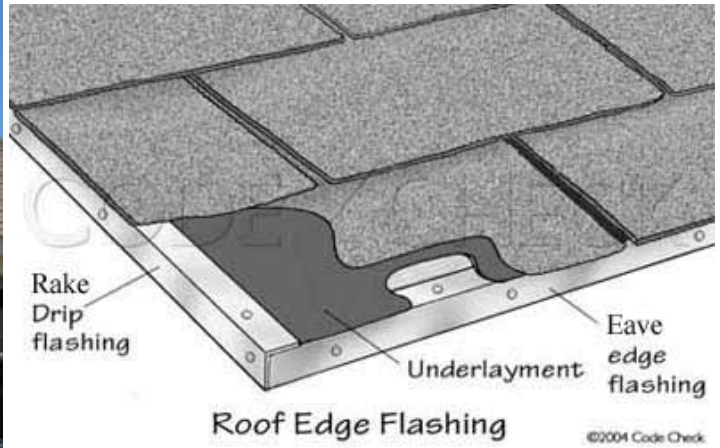
↑ close view of image above; roof underlayment incorrect

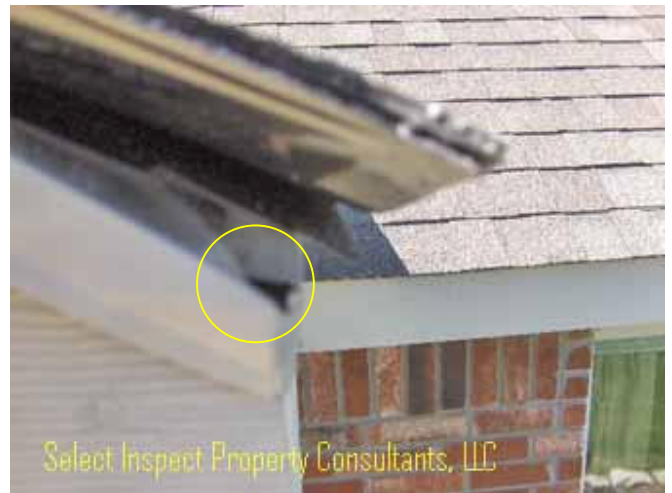
↑ close view of image above roof underlayment incorrect & gap/opening at incorrect drip edge flashing corner

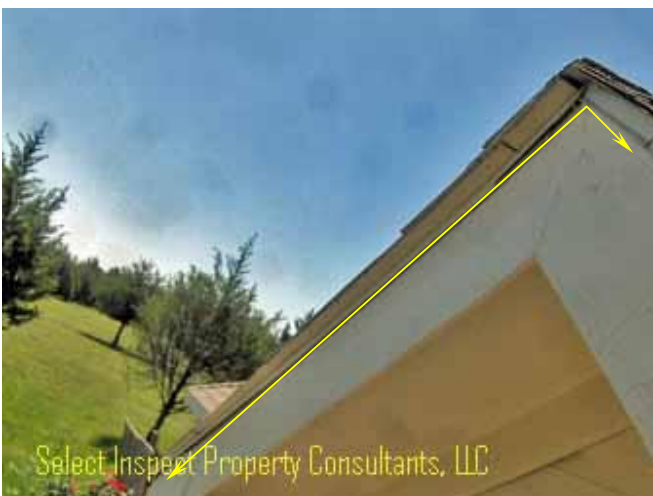
↑ close view of image above; gaps at drip edge flashing/fascia

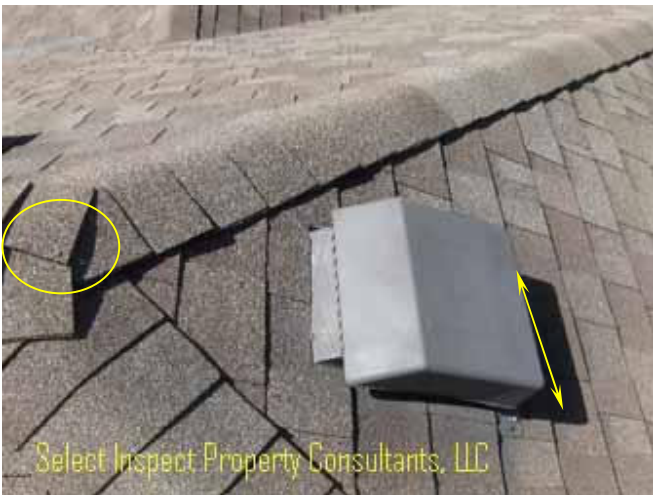
- Open-faced (uncaulked) fasteners exist at ridges, hips, flashing, vents. Though technically incorrect this is commonly found, even on new homes. Correction is generally simple, inexpensive, and is recommended.

↑ uncaulked, exposed fasteners; example

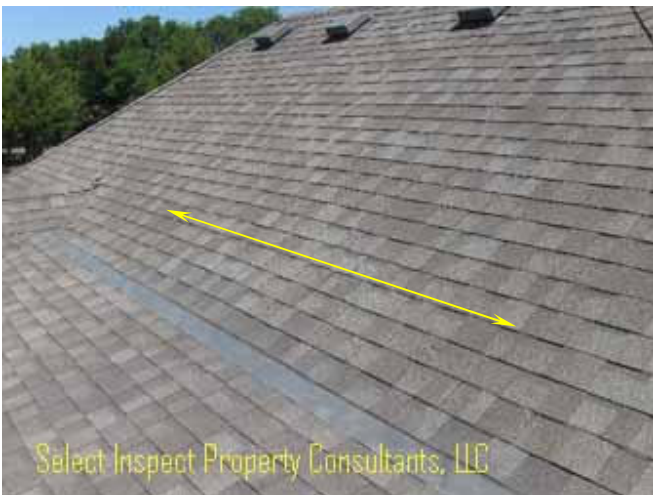
↑ minor damage discovered at rear roof Significant issues were not discovered regarding this specific condition; monitor & maintain

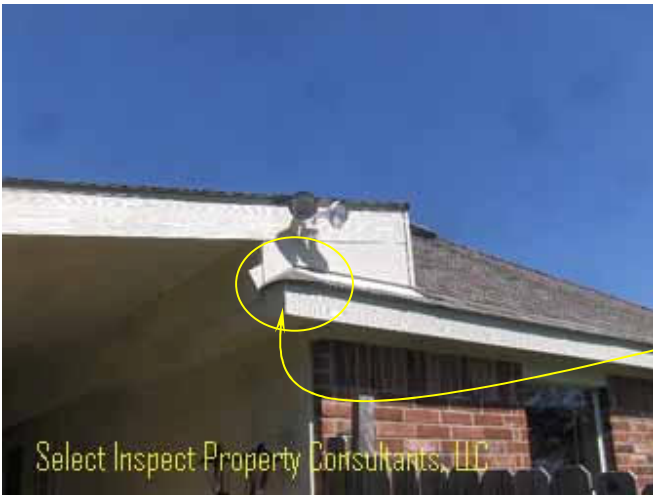
↑ missing/incomplete drip edge flashing

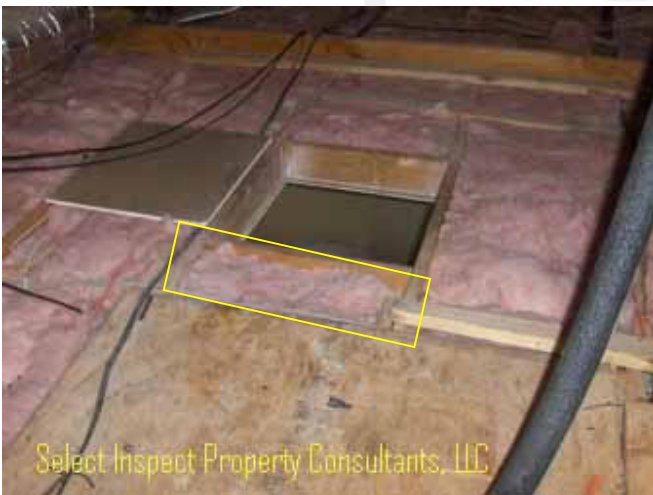
↑ there should be a minimum 24" pathway to the HVAC from the top of the access, with no gaps or obstructions; attic hatch was also too small for removal/service of mechanical equipment

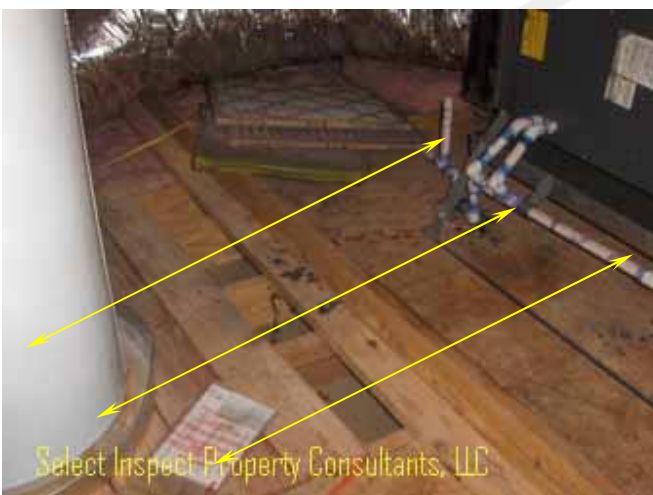
↑ missing insulation under mechanical decks

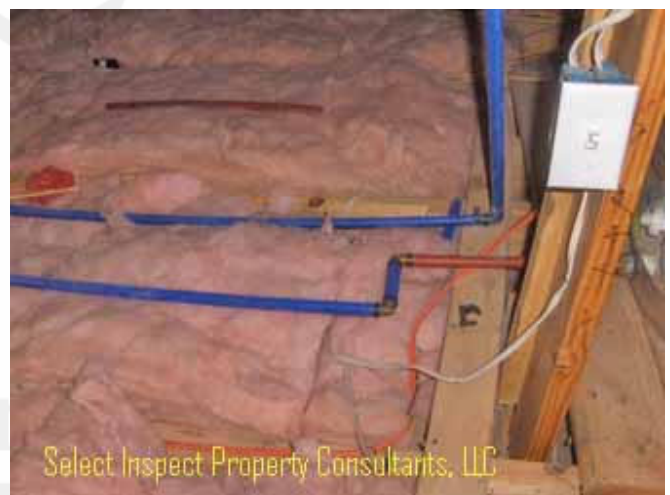
↑ unworkmanlike insulation

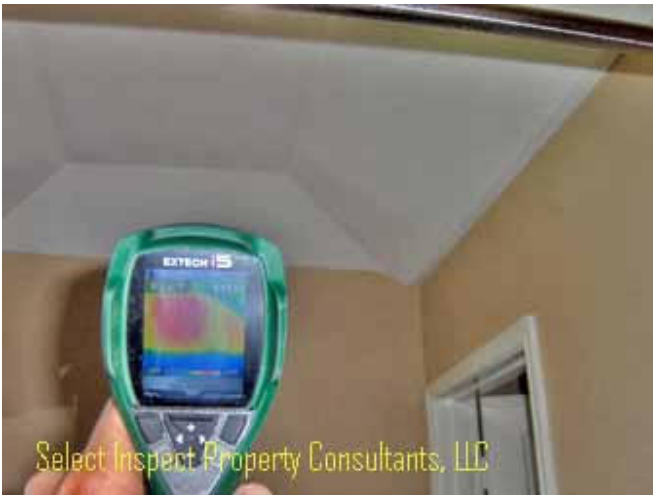
↑ unworkmanlike insulation in bathroom

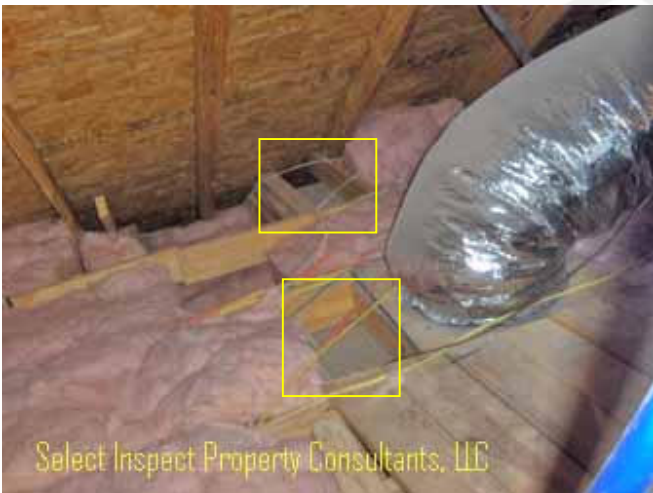
↑ unworkmanlike; missing insulation

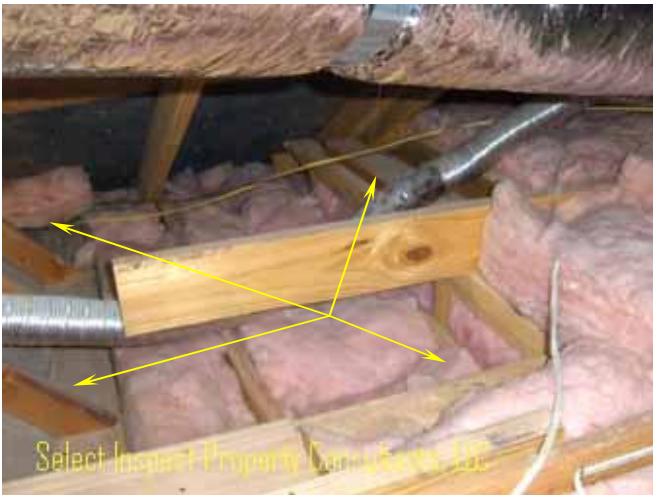
↑ unworkmanlike insulation

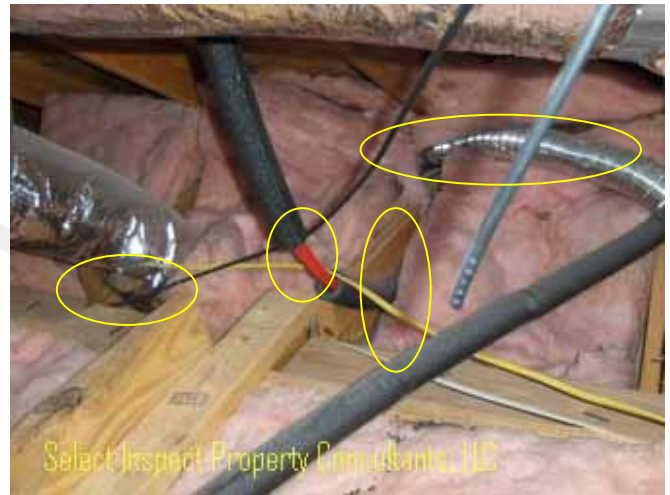
↑ unworkmanlike insulation & deficient plumbing insulation example

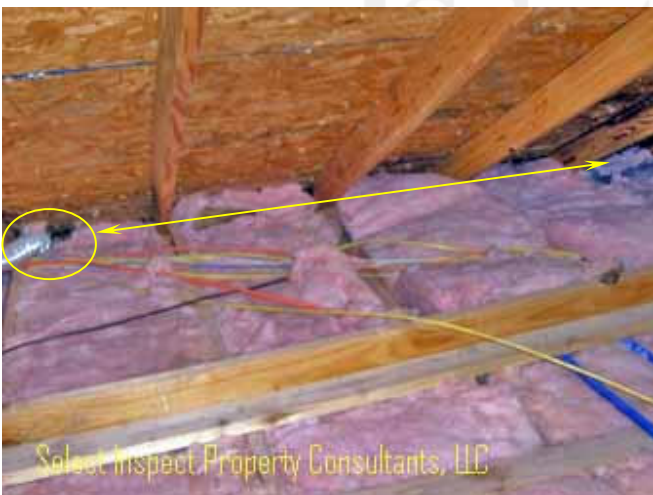
↑ unworkmanlike insulation; obstructing eave/soffit vents; also in this picture: exhaust fan(s) improperly terminate in the eaves, rather than to the exterior

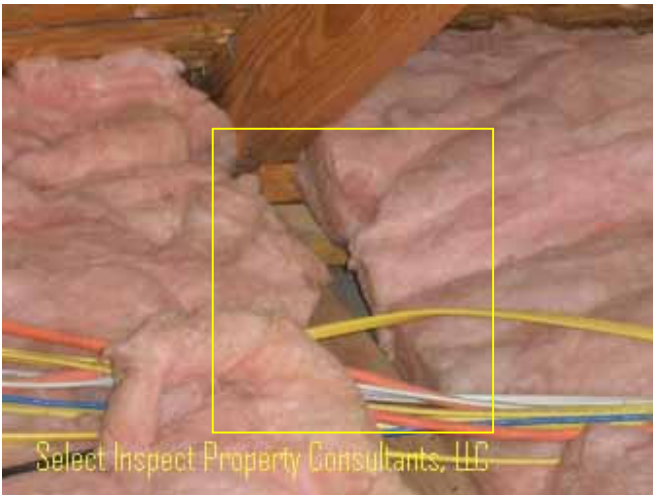
↑ unworkmanlike insulation

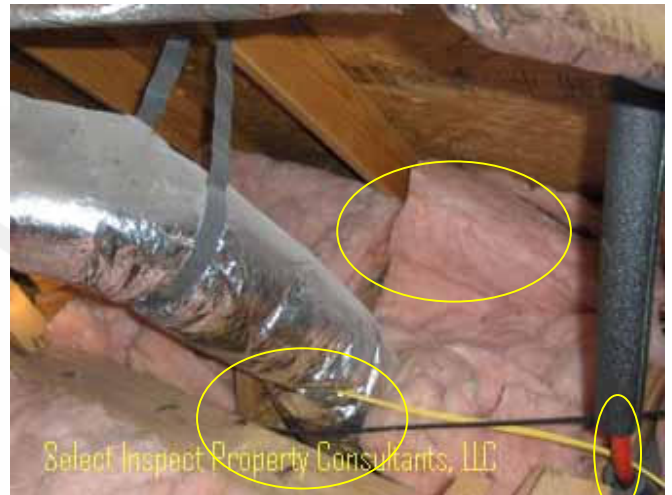
↑ unworkmanlike insulation & "same" deficient insulation at plumbing pipe

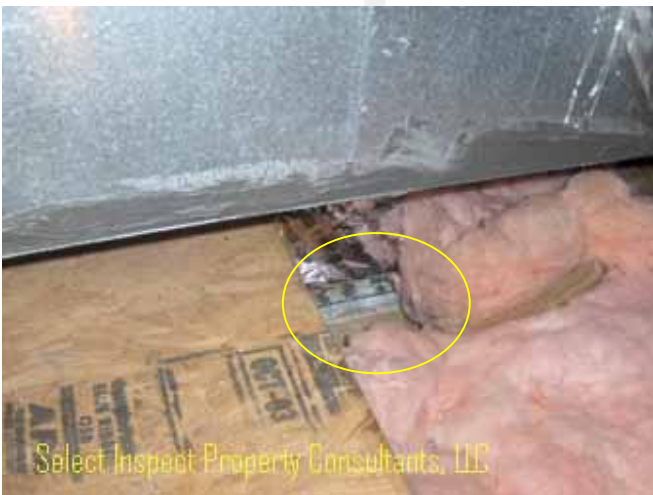
↑ unworkmanlike insulation under HVAC

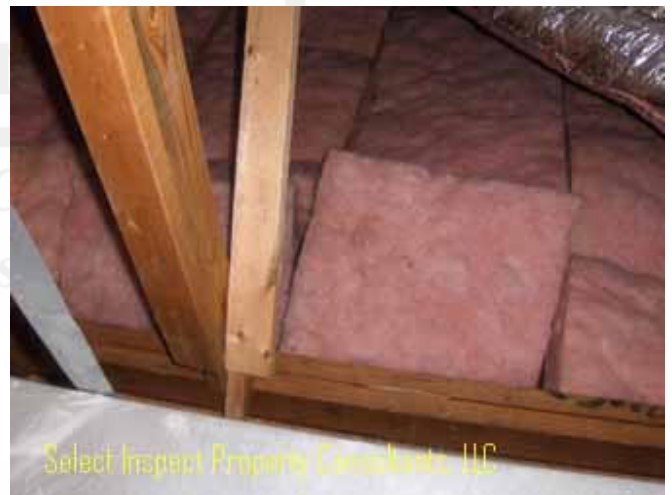
↑ unworkmanlike insulation

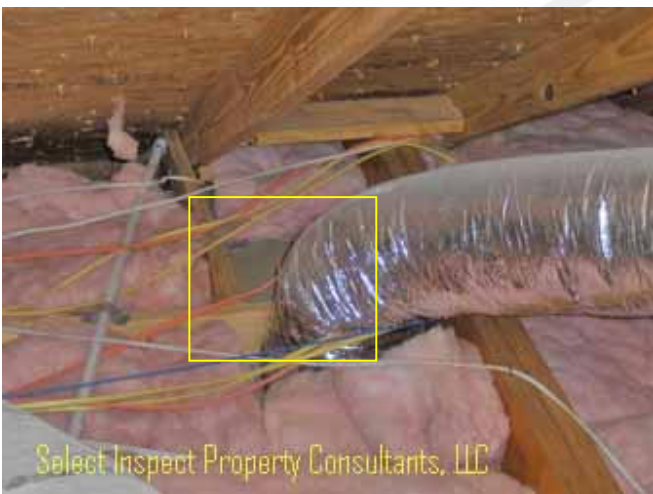
↑ unworkmanlike insulation at the southwest

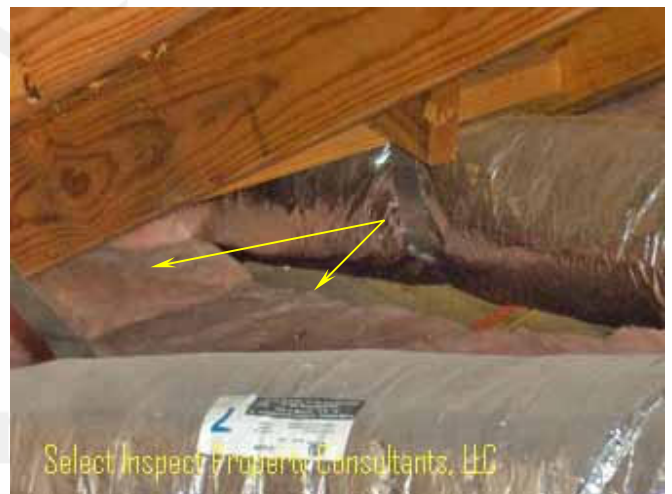
↑ unworkmanlike insulation

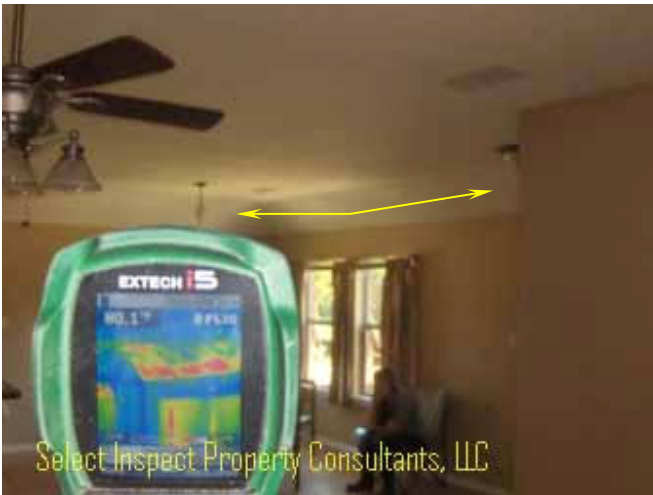
↑ Thermal imaging confirmed deficient insulation/venting

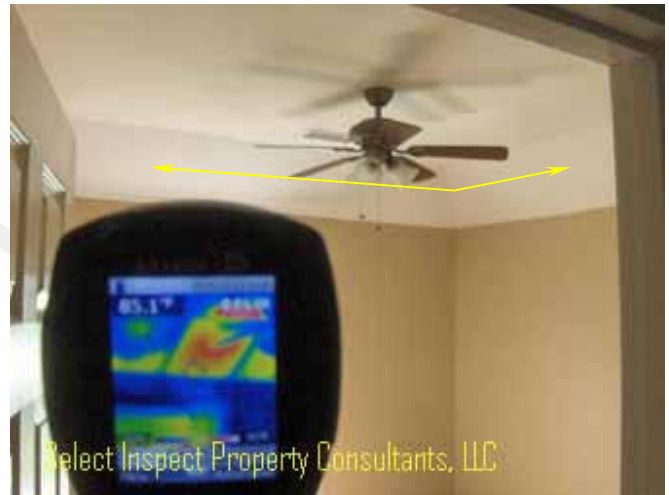
↑ Thermal imaging confirmed deficient insulation/venting

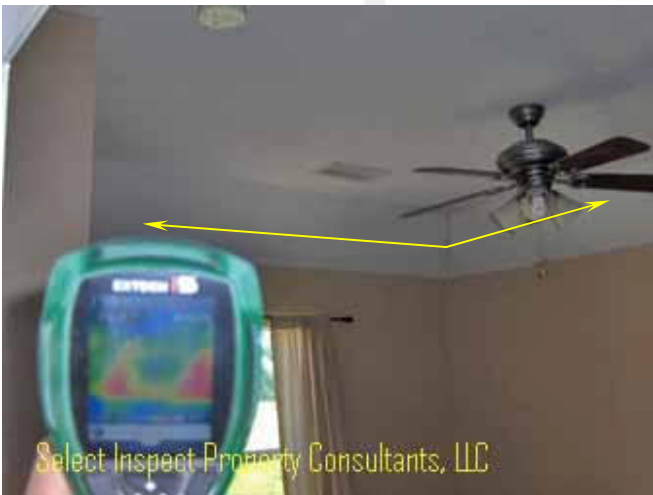
↑ Thermal imaging confirmed deficient insulation/venting

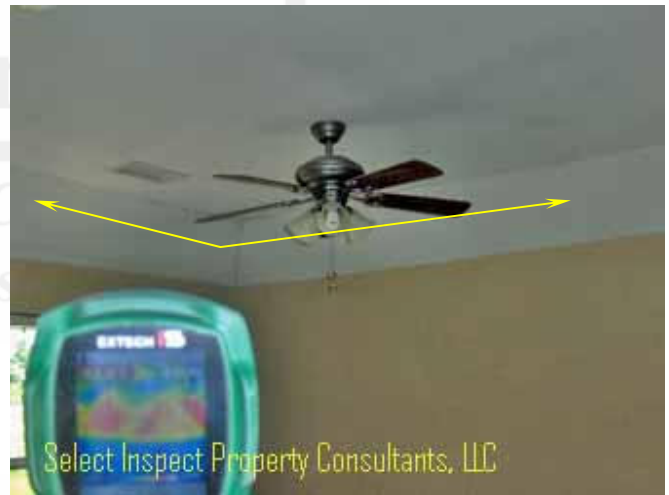
↑ Thermal imaging confirmed deficient insulation/venting

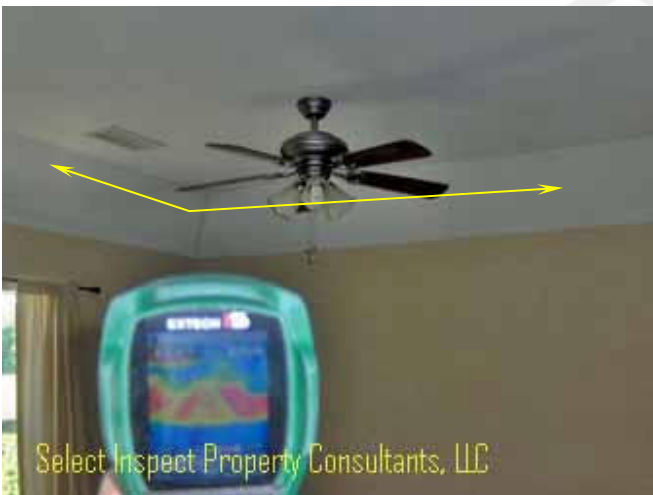
↑ Thermal imaging confirmed deficient insulation/venting

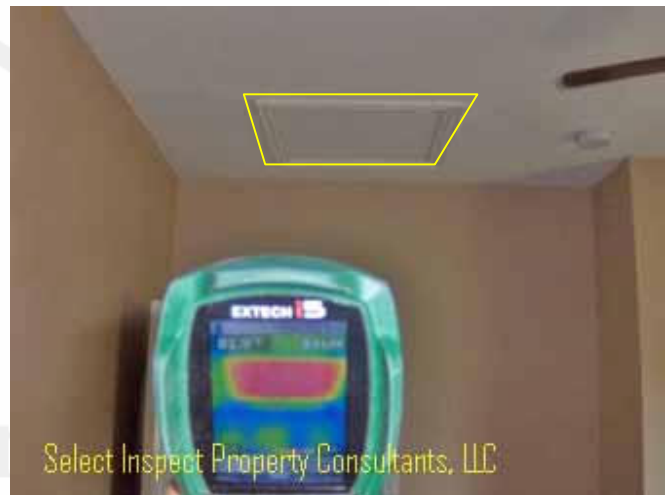
↑ Thermal imaging confirmed energy loss at the attic access

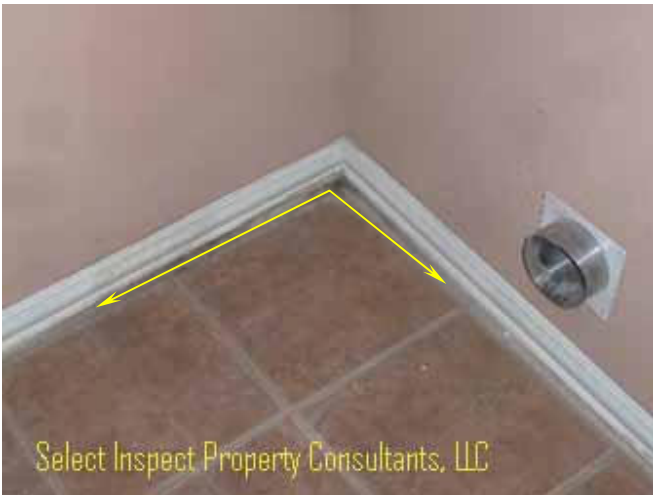
Moisture damage & fungus exist at the laundry room baseboard trim. There may be some moisture damage & or compression/related structural conditions that were concealed & not discovered. Extent of damage is undetermined in concealed wall spaces; undetermined conditions include but are not limited to the presence and or condition of fungus, insulation, framing. We do not perform mold testing, and did not take fungus or air samples from the home. If you are concerned about health related issues, we recommend that you consult an indoor air quality firm for evaluation and options for cleaning. Researching and evaluating various firms and their methods for remediation would be prudent, if you plan to pursue those measures.

↑ moisture damage & fungus at laundry room baseboard trim

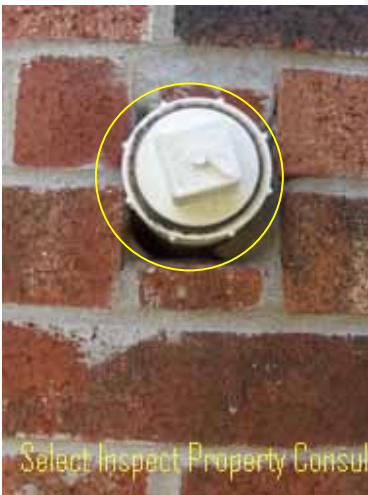
↑ opening should be sealed; northwest

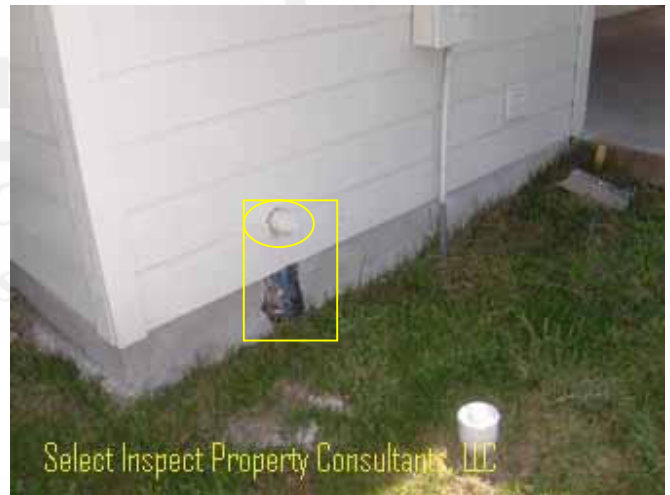
↑ opening should be sealed at plumbing clean-out & exposed piping is prone to freeze damage

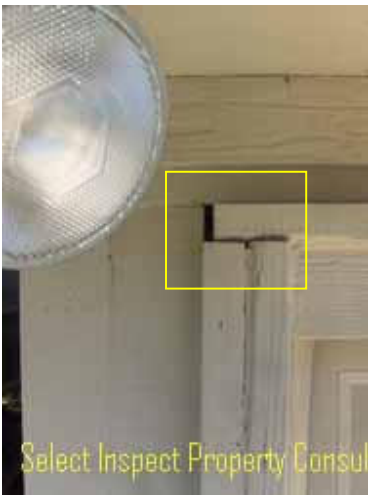
↑ holes at siding, trim, overhead doors, wall air conditioning etc. should be sealed; example at left overhead door

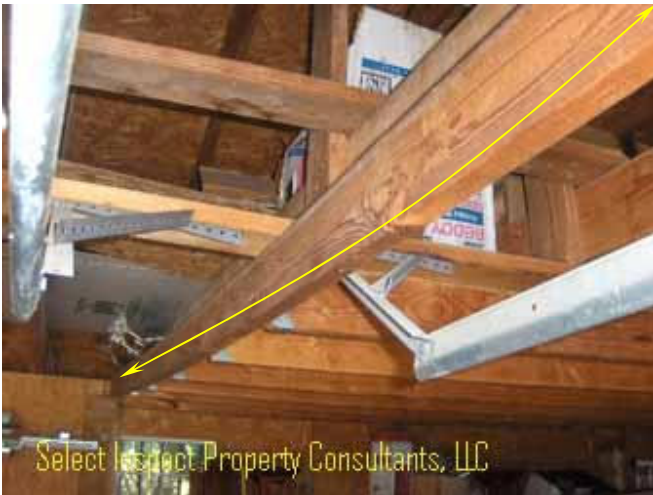
↑ cracks, deflection, undersized framing, & multiple unworkmanlike framing conditions discovered at the garage

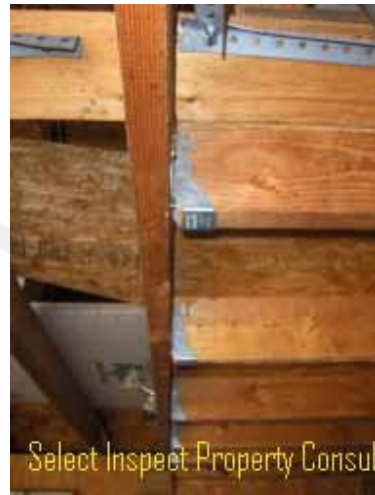
↑ unworkmanlike cut, connection & joist hangers; example

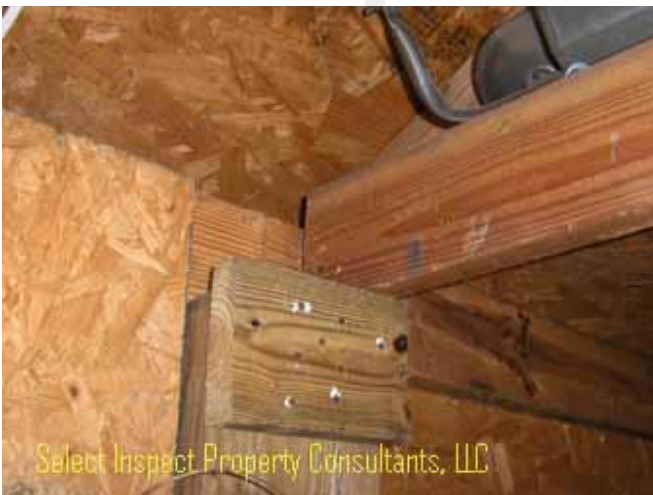
↑ undersized joist; inadequate connections; example

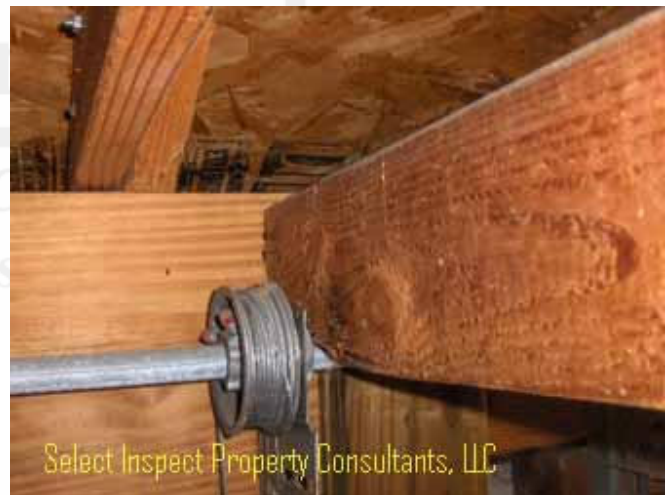
↑ undersized joist; inadequate connection; unworkmanlike notching; example of multiple similar conditions

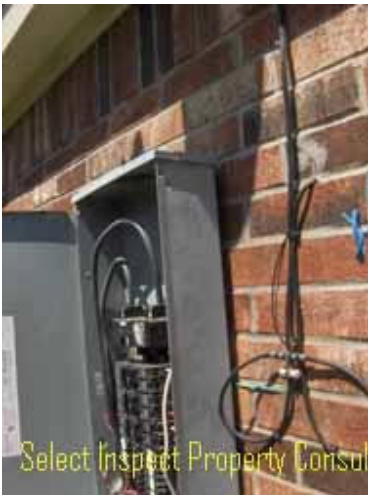
↑ inadequately secured electrical cabinet

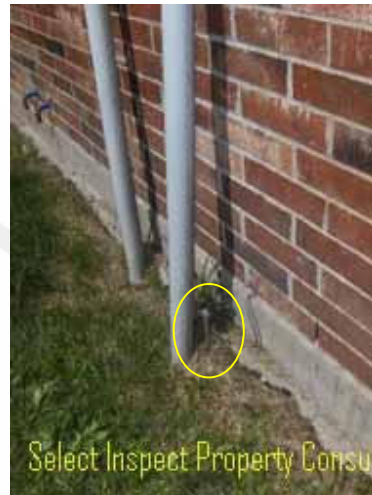
↑ grounding electrode protrudes grade; deficient

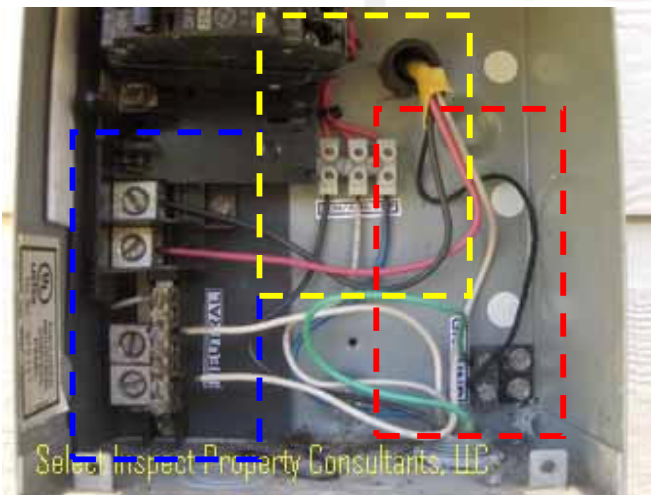
↑ Septic sub panel: black corrosion appears chemical related; Consult an electrician to examine all electrical components at the property and provide options for correction prior to closing.

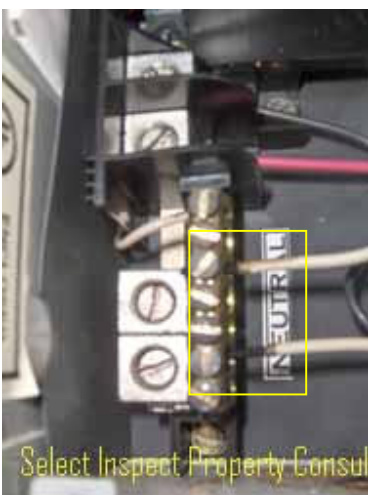
↑ close view of image above; blue

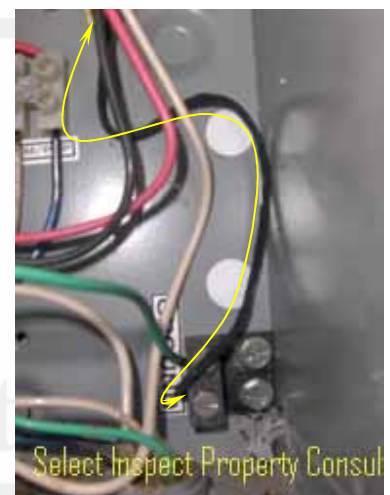
↑ close view of image above; red-grounding wire completely black with corrosion; should be bare copper

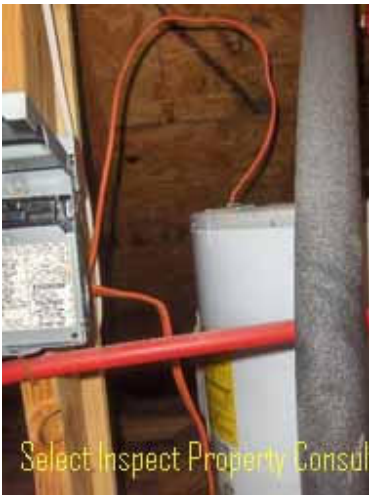
↑ Wires should be secured within 12 inches of junction boxes, switches, receptacles, fixtures

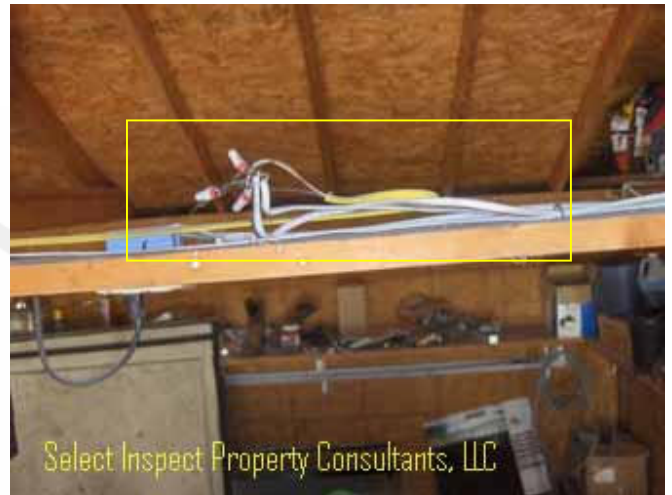
↑ unworkmanlike/unsafe wiring- example at east garage

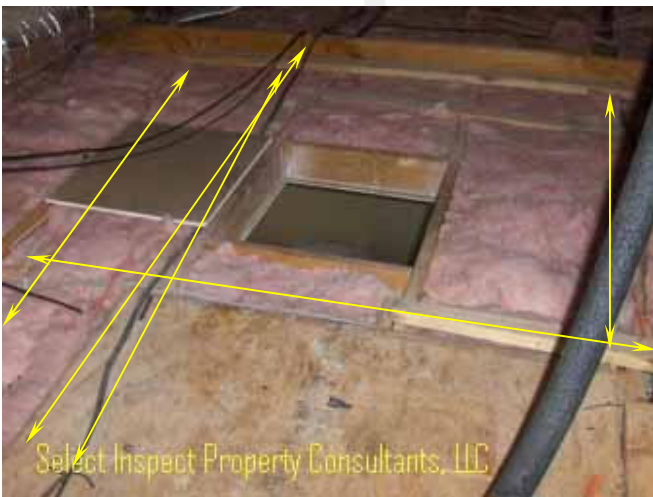
↑ electrical wires in the attic shall be adequately protected within 6' of attic scuttle or within 7' of attic stairs; & electrical wires/cables shall not be routed along walking surfaces or in any location prone to traffic damage

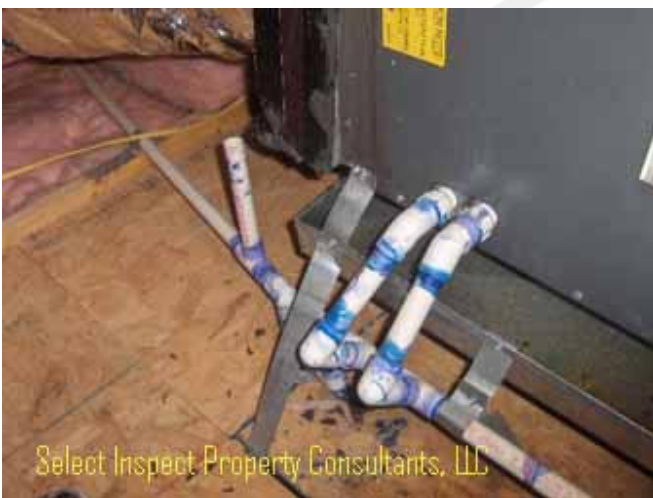
↑ unworkmanlike combining of primary condensate drain & auxiliary condensate drain drains; & air conditioning primary condensate drain should be insulated

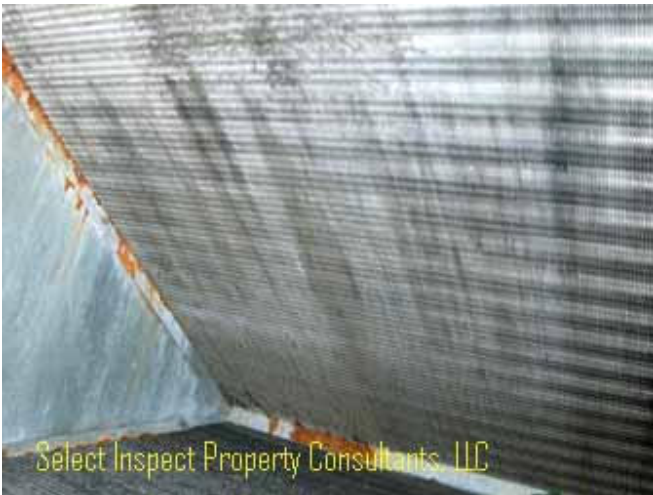
↑ air conditioning evaporator(s) coils should be serviced

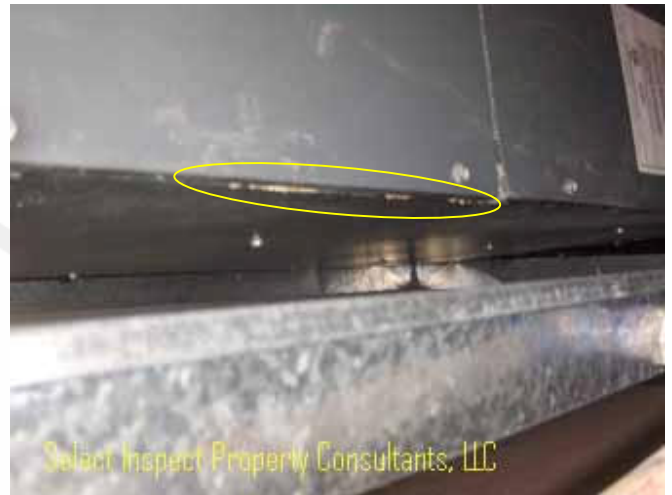
↑ sediment/leakage history at air conditioning evaporator(s) cabinet

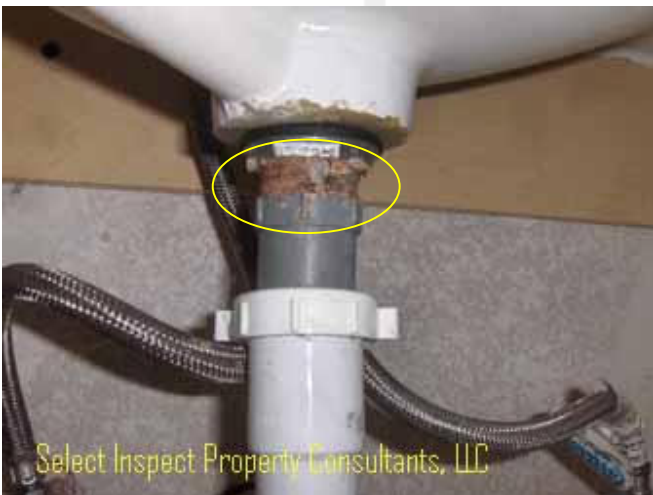
↑ leakage history under bathroom sink; drain stem

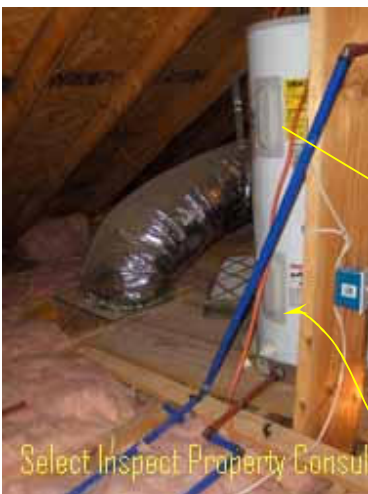
↑ inadequate clearance at service side of water heater

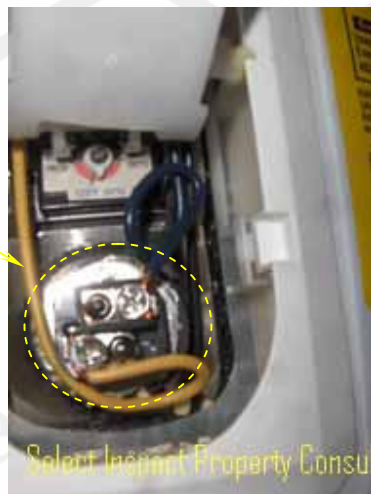
↑ seepage evidence at upper element
