Property Inspection Report

Concerning: 123 street McKinney, Texas
(Address or Other Identification of Inspected Property)

By: Bruce W. Carr; TREC #5281 ASHI Member # 211804 Thursday, April 28, 2011
(Name and License Number of Inspector) (Date)

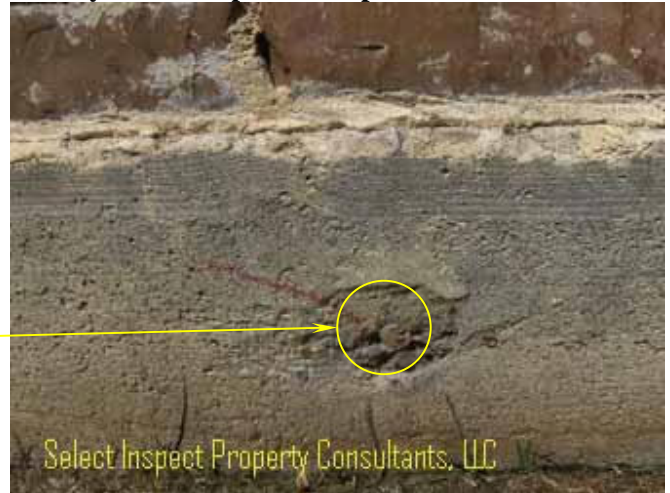
- **INTERIOR:**
 - None discovered
- **EXTERIOR:**
 - Exposed or damaged post tension ends exists at the east (southeast & northeast). The exposed components should be sealed to prevent corrosion. This is commonly found, even on young homes, & is typically seen as a regular

↑ exposed post tension end(s) at east; example

maintenance item. These areas should be cleaned thoroughly & sealed with water resistant mortar or an appropriate high performance epoxy. In some cases it may be necessary to cut & remove the cable, then replace it with a new cable that would then be stressed to tension. Extended / long-term exposure & subsequent corrosion may result in failure of the clamp/cable connection & expensive related repairs.

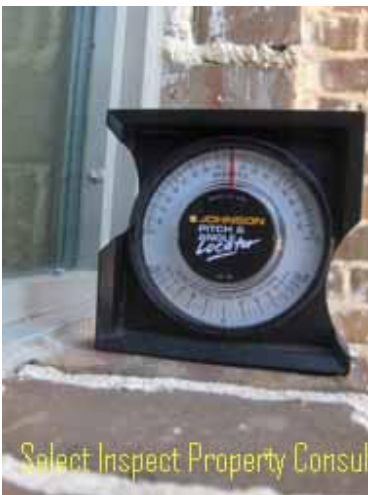
Exterior window sills did not have a recommended 15° slope for drainage at multiple locations; slope at random locations was approximately <0, 2, 5, 6° Repair options may be limited. Condition & appropriateness of flashing & substrate components is undetermined.

↑ brick ledge(s) had inadequate slope; example at front- 1 °

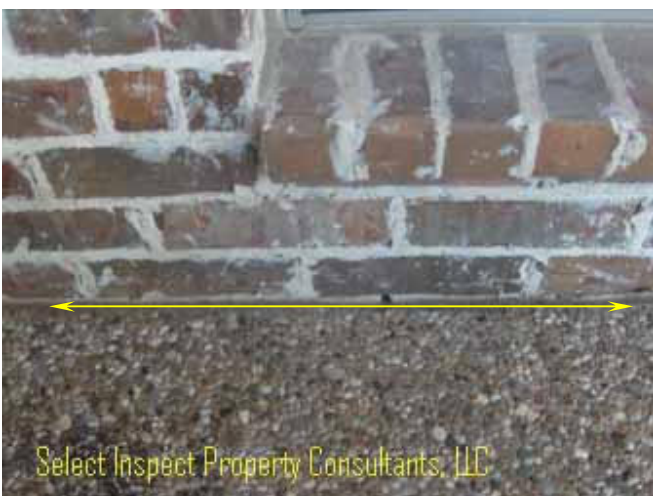
Weep openings appeared to have been obstructed by the raised rear patio slab. Such is not recommended, as these provide drainage of condensation from within the wall voids.

↑ obstructed weep openings at rear porch

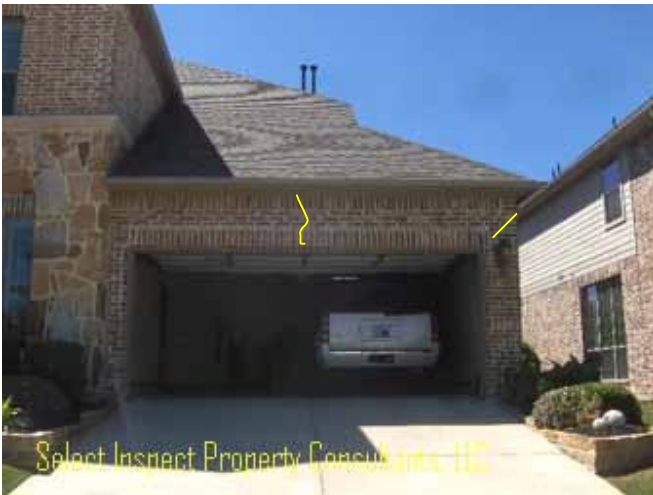
- **EXTERIOR:**
 - Open masonry/veneer cracks (*greater than 1/8" wide*) discovered at the overhead door- this appeared to be related to steel deflection & not foundation related, though I am required to report it in the foundation section of this report.

The steel lintel at the garage is deflected. The lintel has deflected possibly from the brick load above. Brick and mortar cracks were observed around the garage door framed area. The separation / cracks were approximately 1/8" or greater at the center & very thin/closed/less than 1/32" at the right side. It is recommended to closely monitor this or if you are concerned, have a specialist or tradesman evaluate the issue(s) and recommend appropriate permanent repair / improvement options. In the limited time the inspector is at the home, it is difficult to determine whether the conditions are ongoing, have recently occurred, or at what time in the past they were active. (see one or more related photos at the end of this report).

↑ deflection & 1/8" crack at overhead door

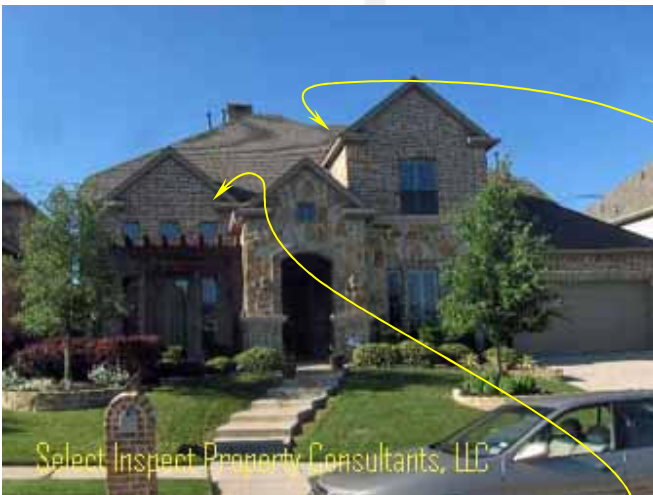
↑ unworkmanlike deck -unworkmanlike drip edge/felt;

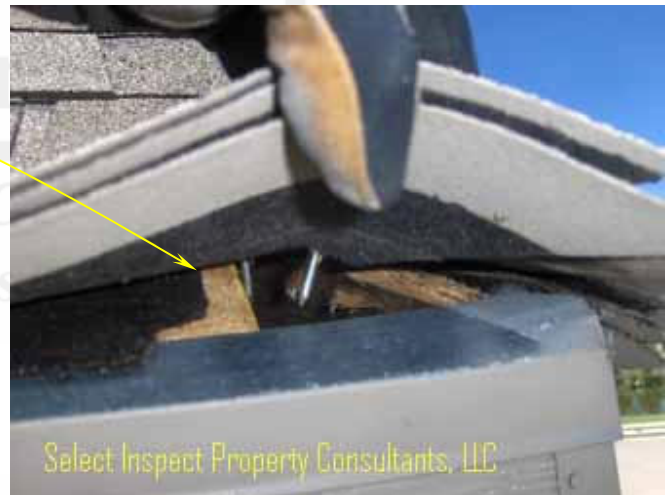
↑ unworkmanlike roof underlayment, openings, missing deck, unsecured roofing

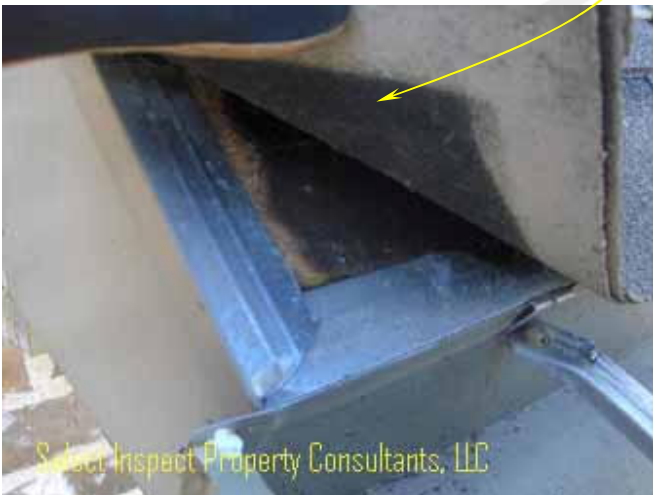
↑ short cut roof underlayment corners should have no gaps & rake (diagonal) edge & roof felt should be atop the eave (lower) edge flashing & under rake flashing

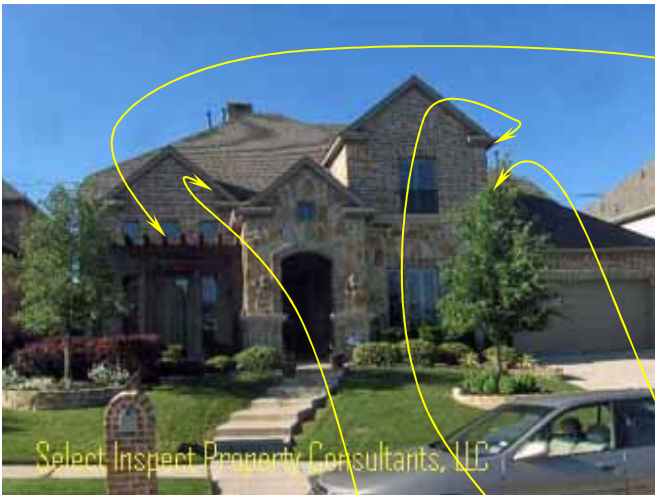
↑ various deficiencies

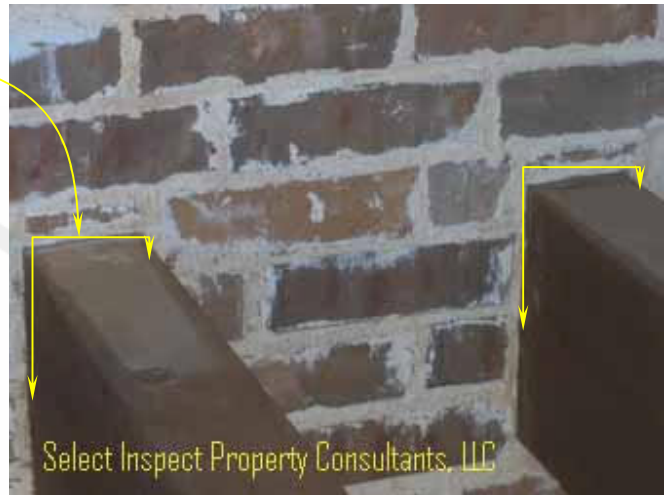
↑ sealant recommended at beam joints at brick

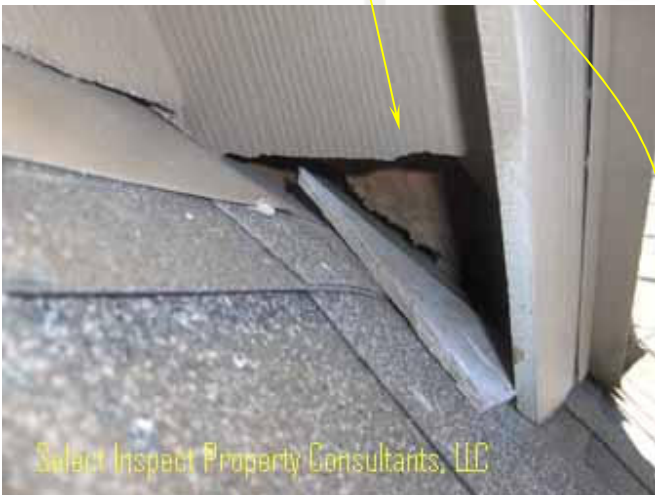
↑ damaged soffit; openings to attic/eave

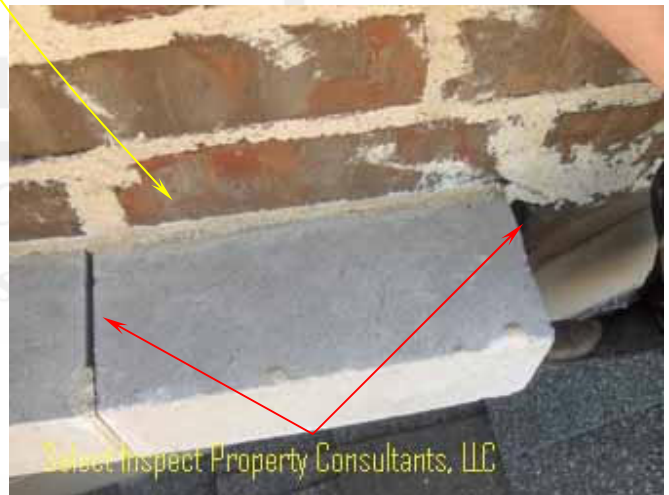
Mortar at multiple cast stone sill/ledges, & various areas of erosion should be tuck-pointed; missing mortar & pits/openings are prone to water infiltration & extended freeze-thaw conditions & further deterioration of mortar.

↑ deficient mortar; openings at cast stone ledge

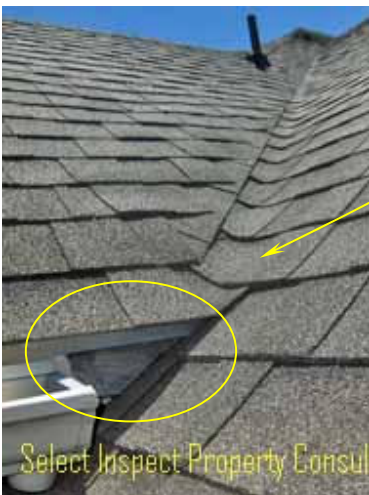
↑ deficient fascia; exposed framing

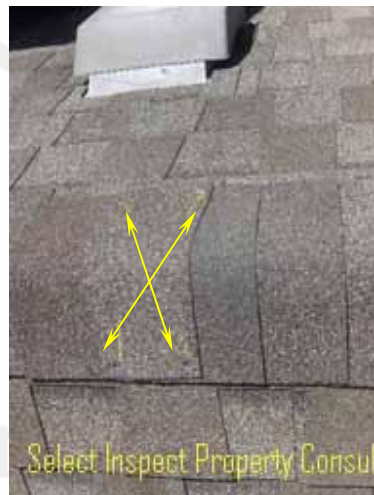
↑ uncaulked, exposed fasteners example at upper roof

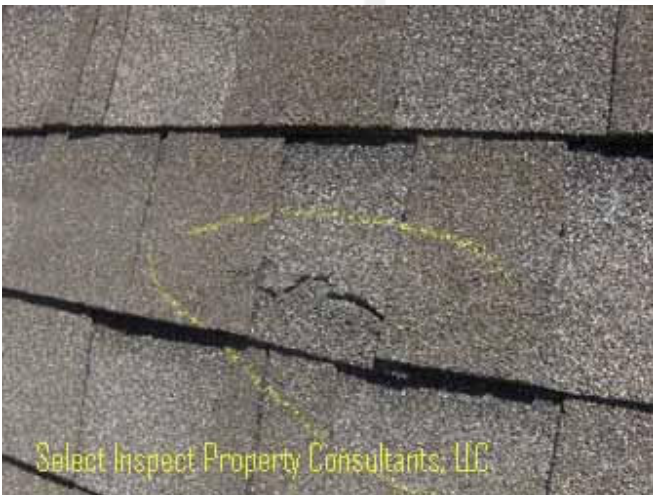
↑ damaged shingle; upper west-northwest

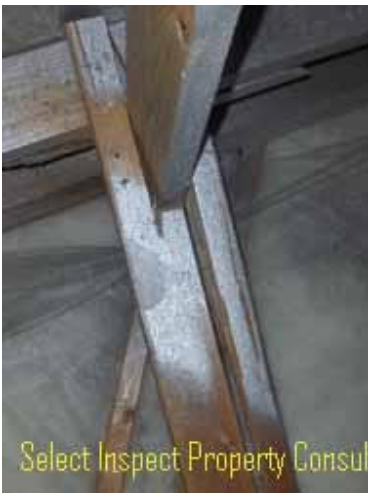
↑ marginal fastening/joints at northwest walk-in attic struts

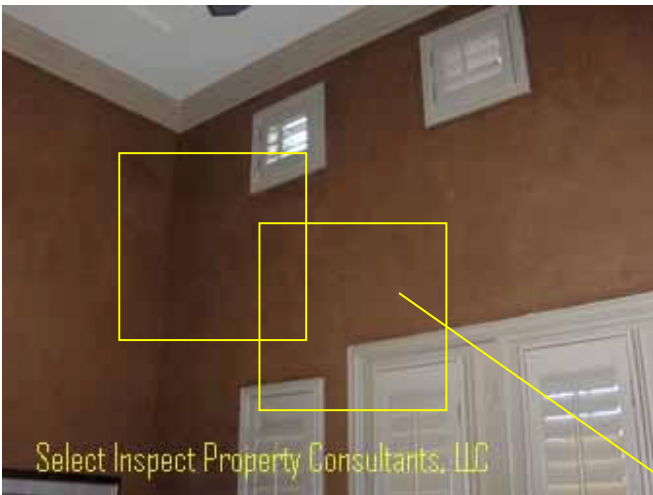
↑ Thermal imaging implies energy loss at the study

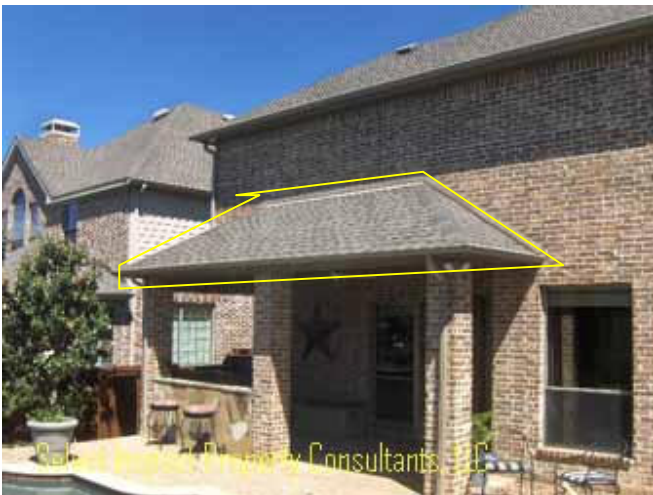
↑ unvented attic space

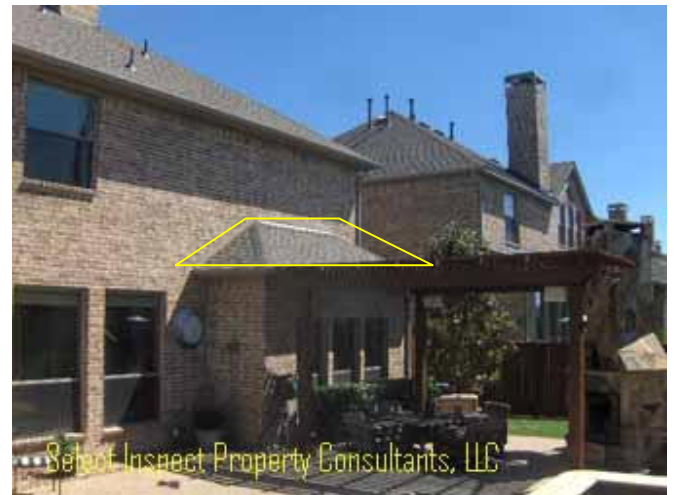
↑ unvented attic space

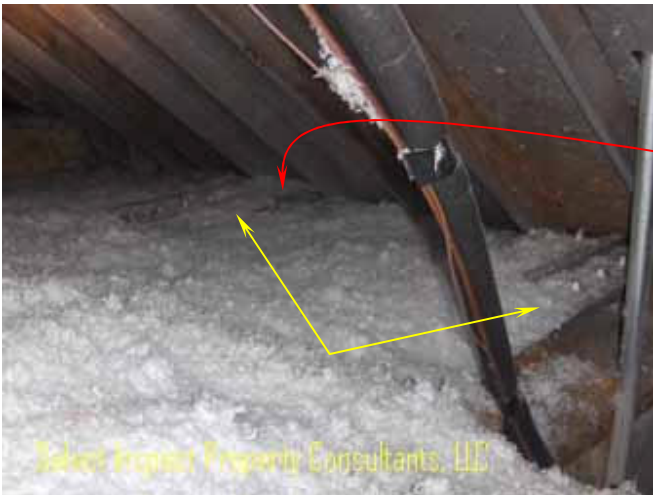
↑ deficient baffles lying on insulation; not secured in position; example in upper northwest attic

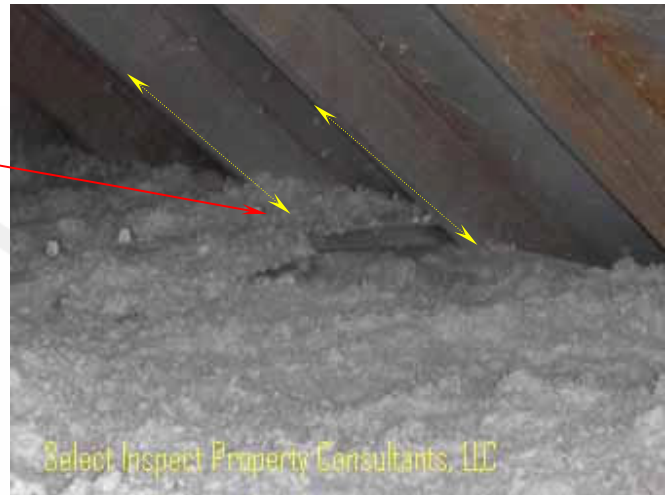
↑ close view of image at left; these should be parallel with the rafters/rafter bays to keep insulation from obstructing eave vents.

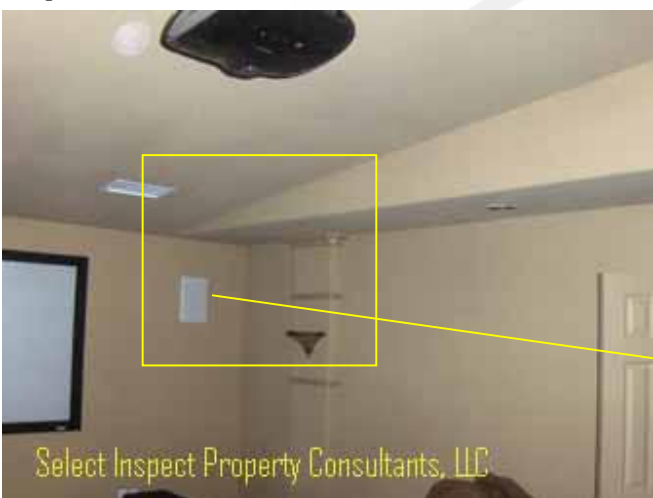
↑ Thermal imaging implies energy loss at media room speaker, & common vault, corner, framing areas; example

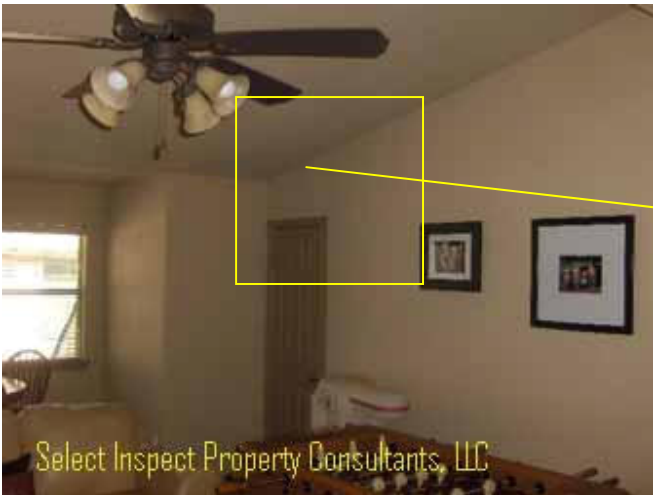
↑ deficient insulation discovered in attic; gameroom northwest

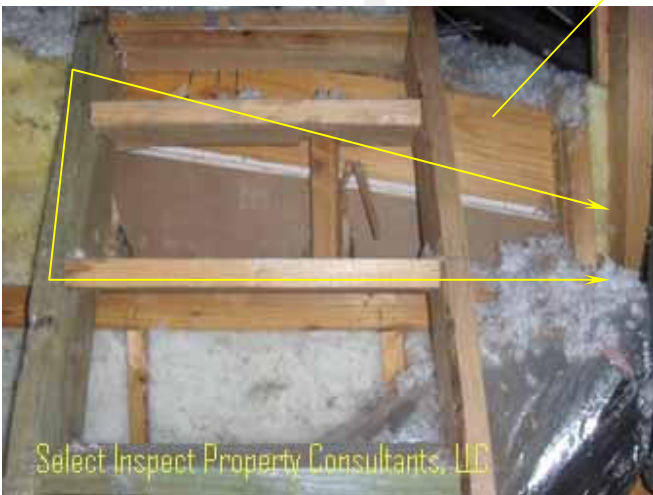
↑ attic view of images above- missing insulation

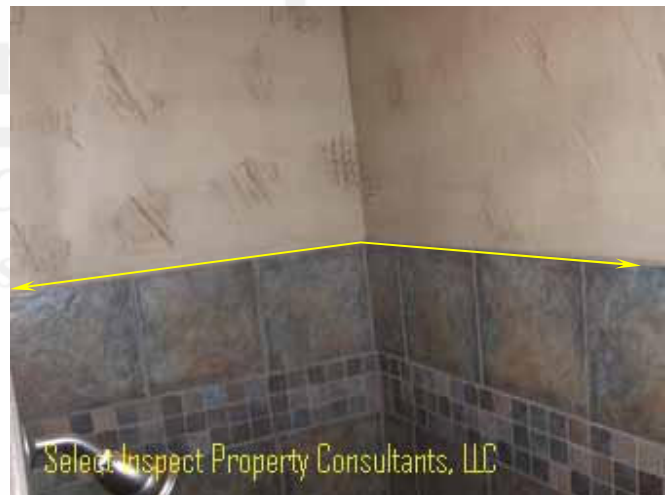
↑ caulking/sealant needed atop shower tile/panels; example

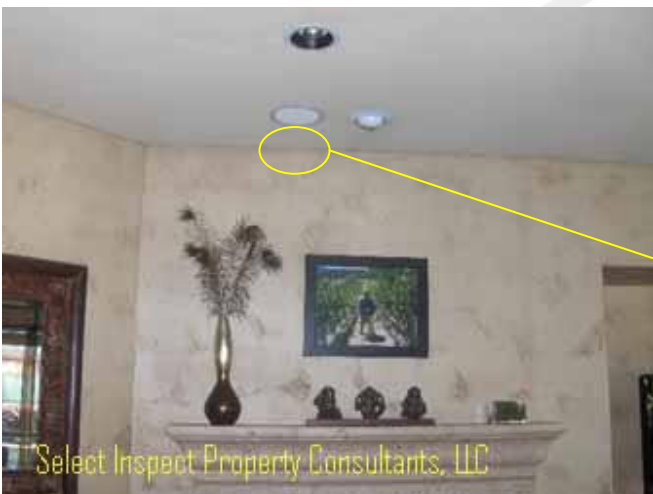
↑ stain ?? or paint variation at family room ceiling

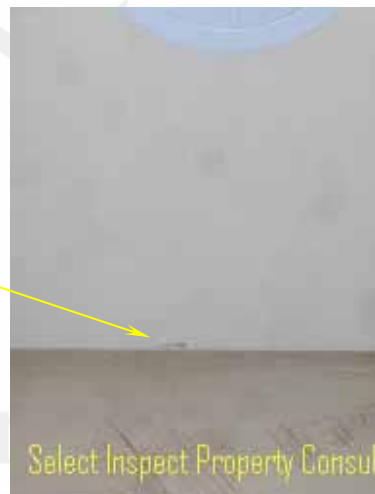
↑ close view of image at left; fireplace flue & chase were not readily accessible in the attic

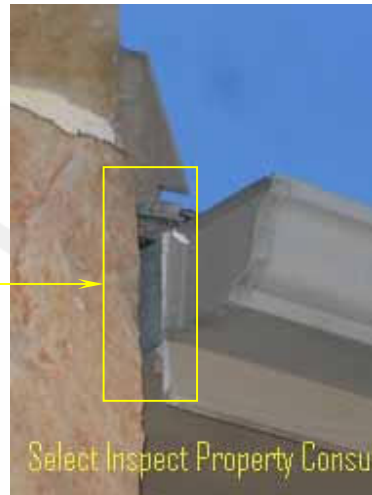
↑ close view of image at left; visible framing, missing fascia/trim, missing drip edge flashing

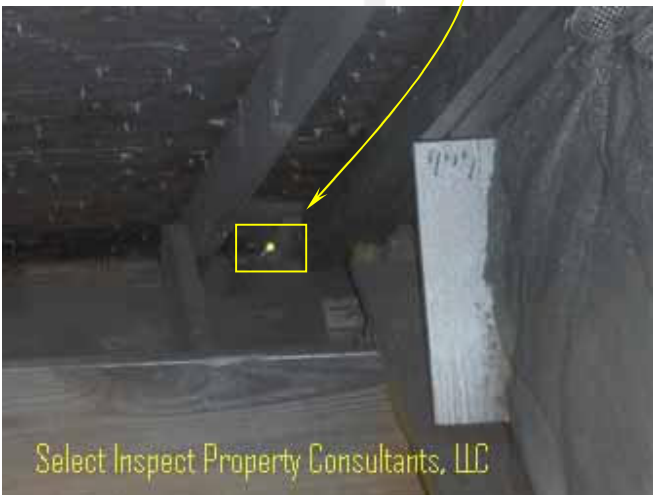
↑ attic location of above images; daylight seen from inside

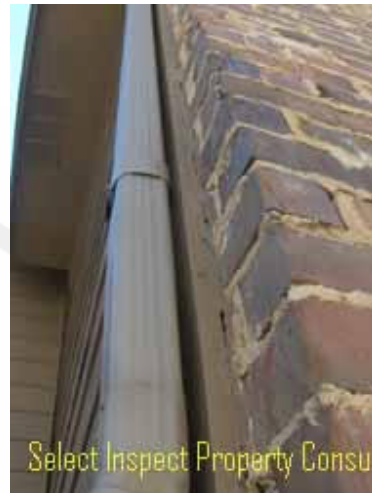
↑ sealant touch-up recommended at siding/trim joints; example at west upstairs

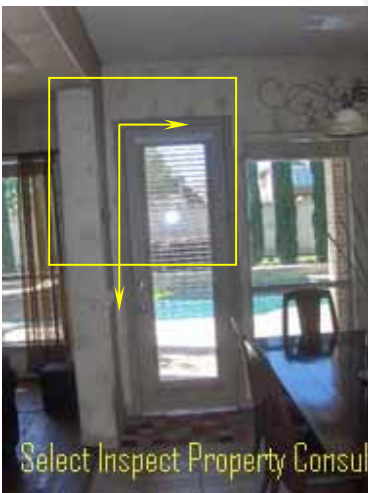
↑ Thermal imaging implies energy loss at framed area around the patio doorway

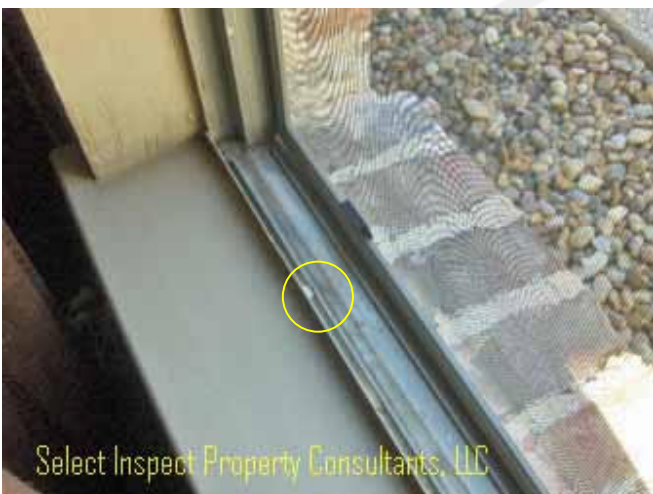
↑ Alarm holes at the lower portion of the window may allow moisture intrusion; caulk and monitor

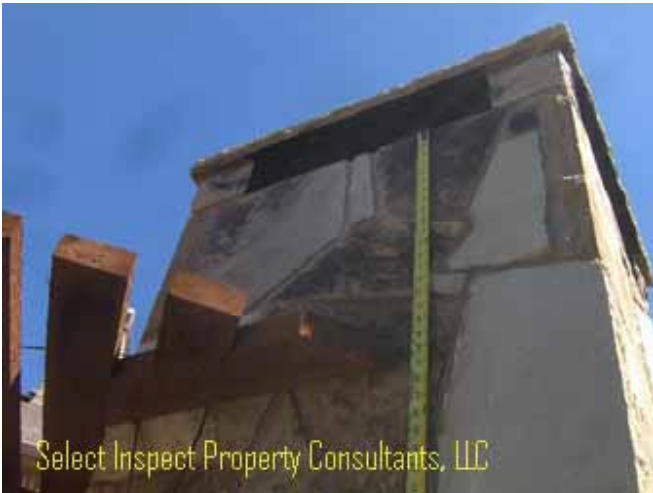
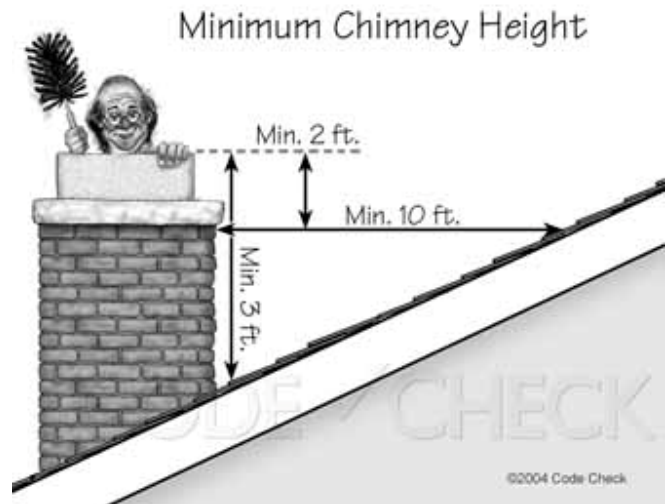
↑ Arbor was less than 2' below chimney termination; flues & chimneys shall terminate at least 3 feet above the roof, and at least 2 feet above anything within 10 feet

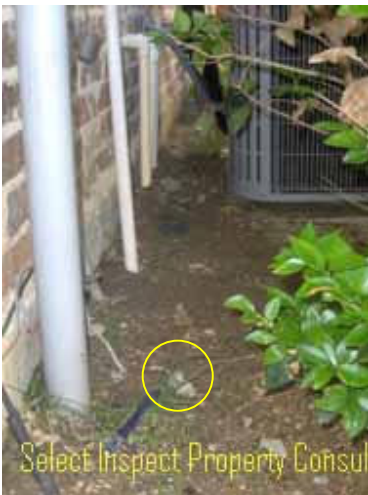
↑ grounding electrode protrudes grade; deficient

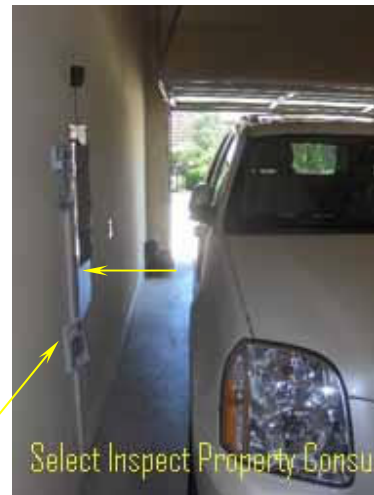
↑ inadequate clearance at electrical cabinet; cover not removed, interior not inspected

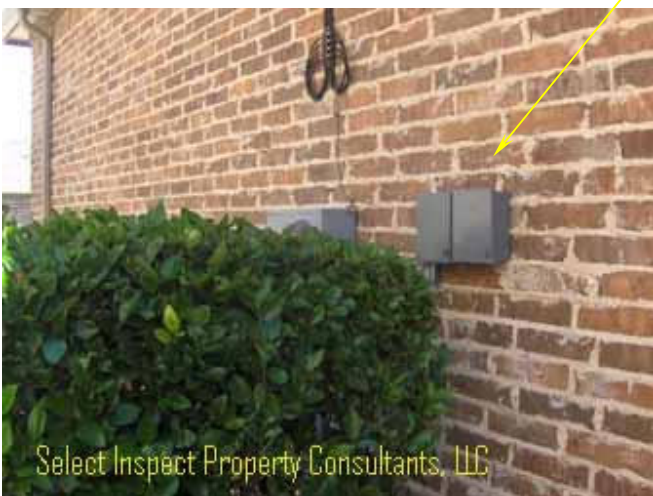
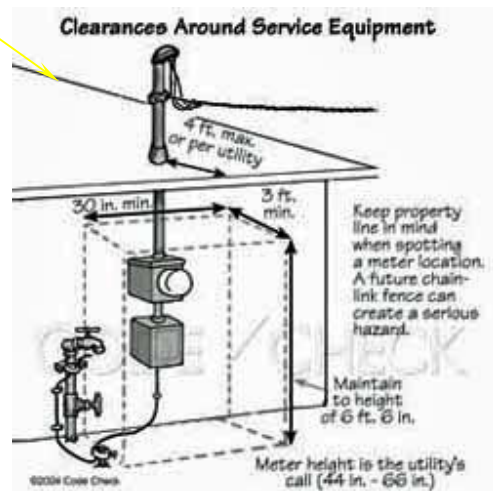
↑ inadequate clearance at air conditioning condenser(s) service disconnects

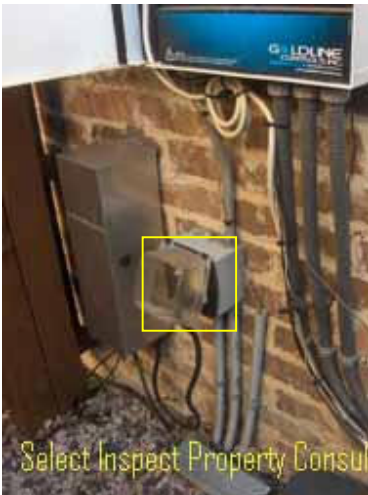
↑inadequate enclosure of electrical at exterior receptacle

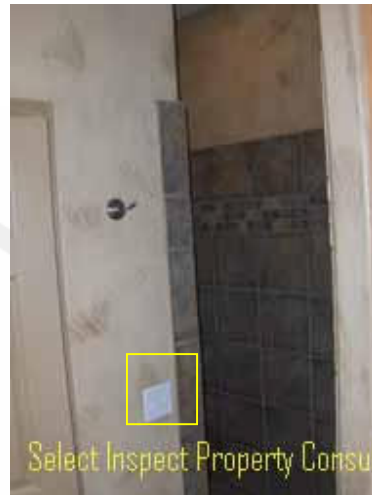
↑ electrical switch within 5' of shower

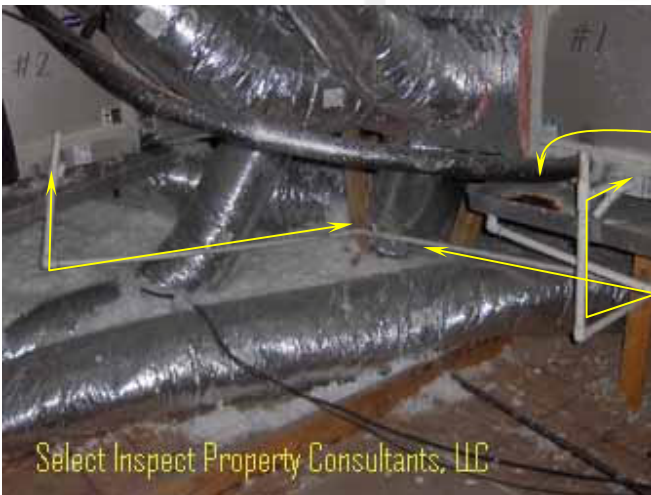
↑ air conditioning primary condensate drain should be insulated; traps not discovered

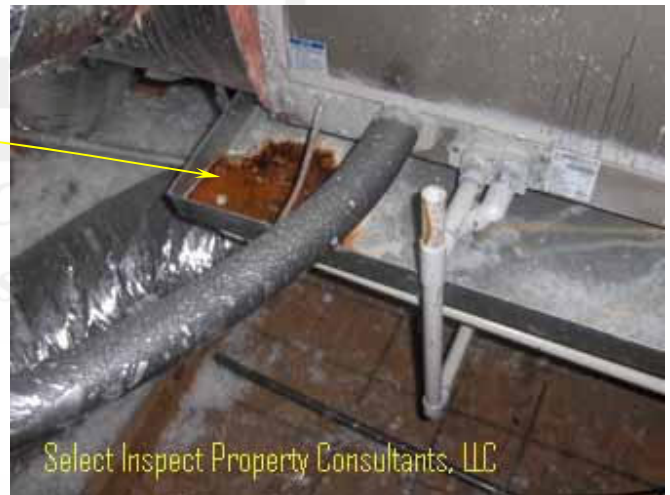
↑ active moisture/condensate in auxiliary pan & some corrosion seen at bottom of evaporator cabinet

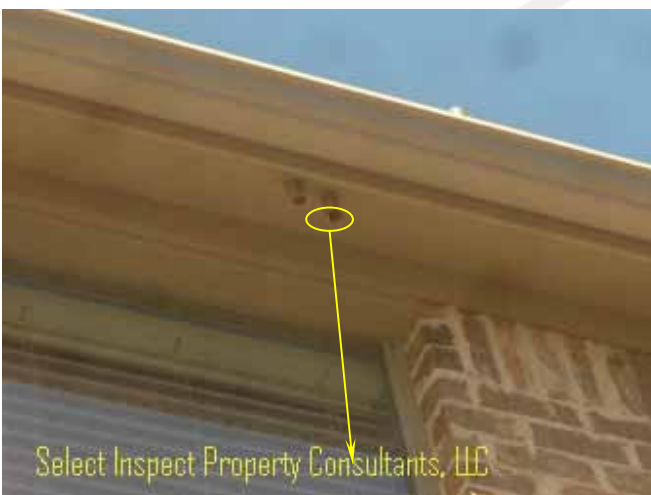
↑ stains indicate history of auxiliary condensate drainage

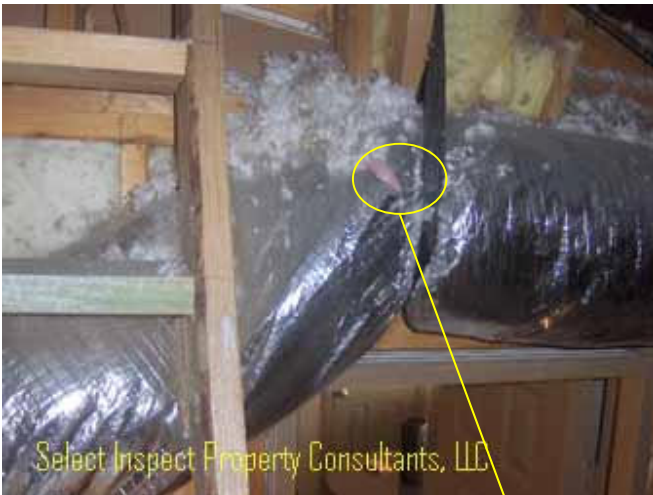
↑ deficient ducting

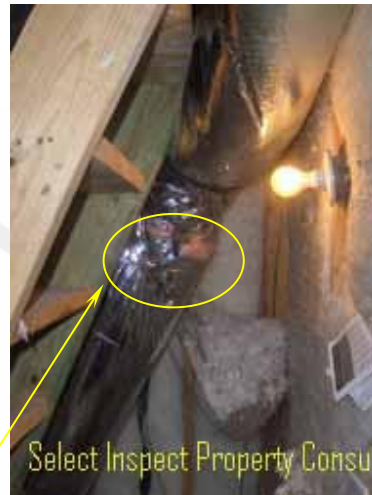
↑ deficient ducting & inadequate support of air ducting; example

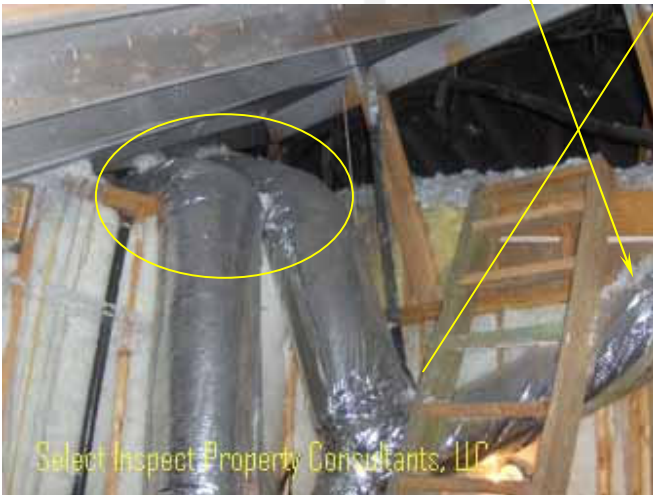
↑ crimped air ducting; example

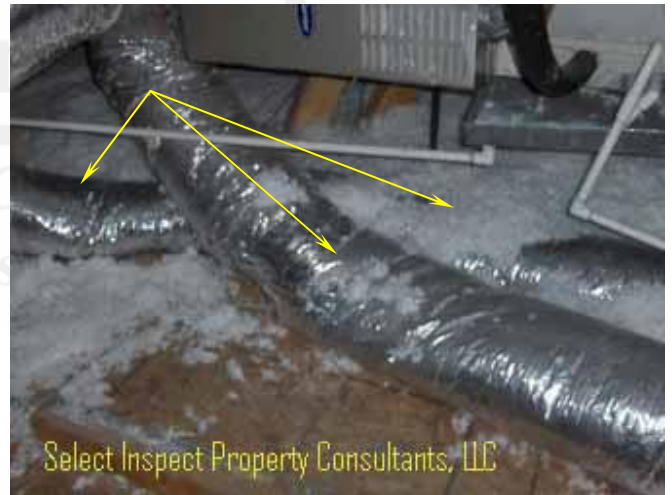
↑ crushed ducting below HVAC

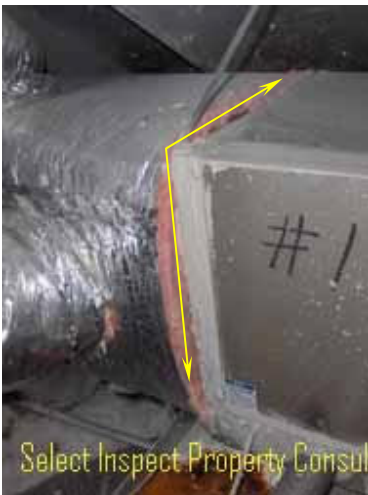
↑ inadequate seal at plenum/component joints & energy loss discovered; example

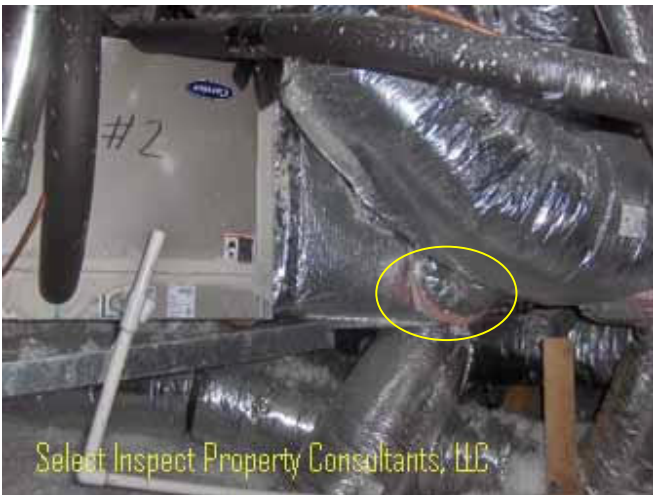
↑ inadequately sealed duct to plenum; corrosion (likely from condensation) & energy loss

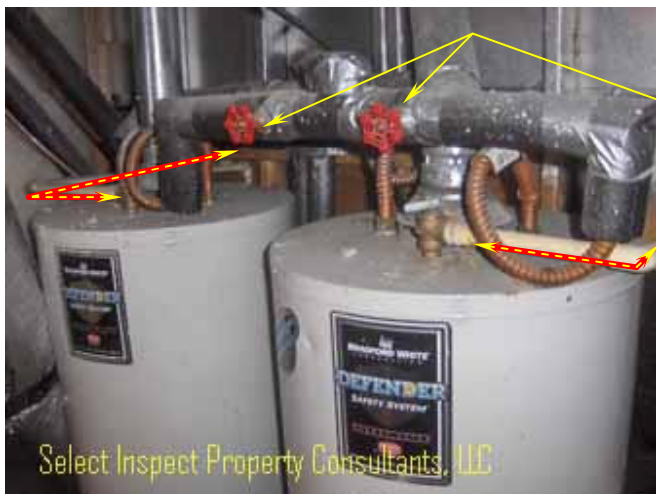
↑ temperature/pressure relief piping was smaller than required by the device manufacturer

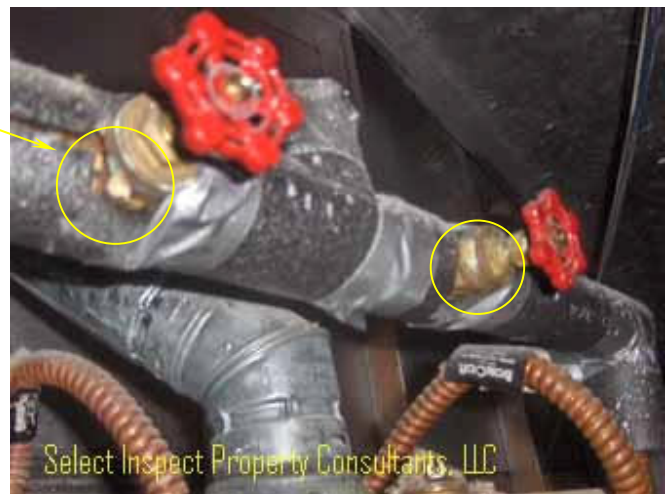
↑ seepage evidence discovered at shut-off-valves

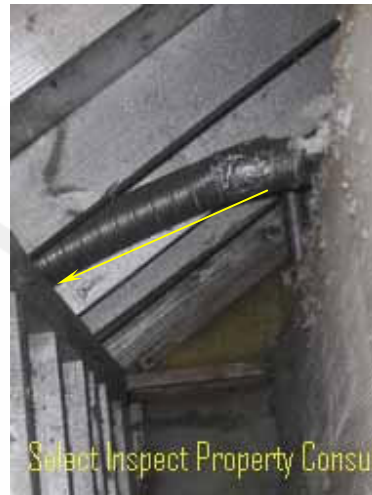
↑ exhaust fan(s) improperly terminate in the eaves, rather than to the exterior

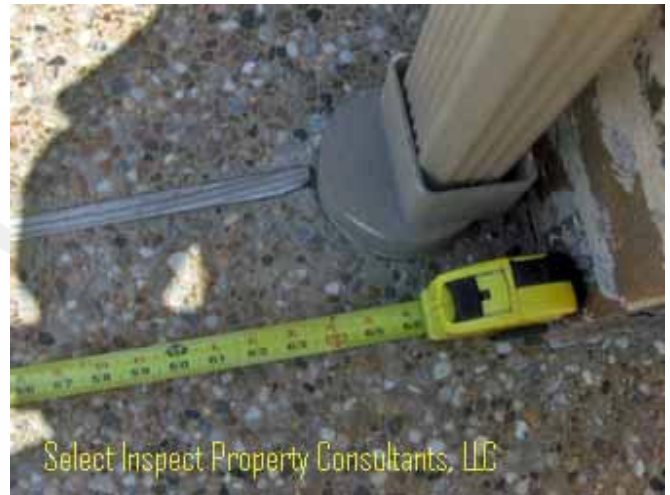
↑ metal gutter near pool; refer to an electrician for bonding options

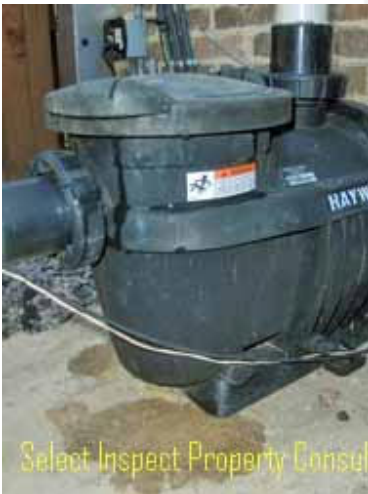
↑ leakage discovered at pool pump
