Property Consultants LLC

New Home Inspection Report
777 Grace St; Patriotville, TX 75071

Sept 22, 2007

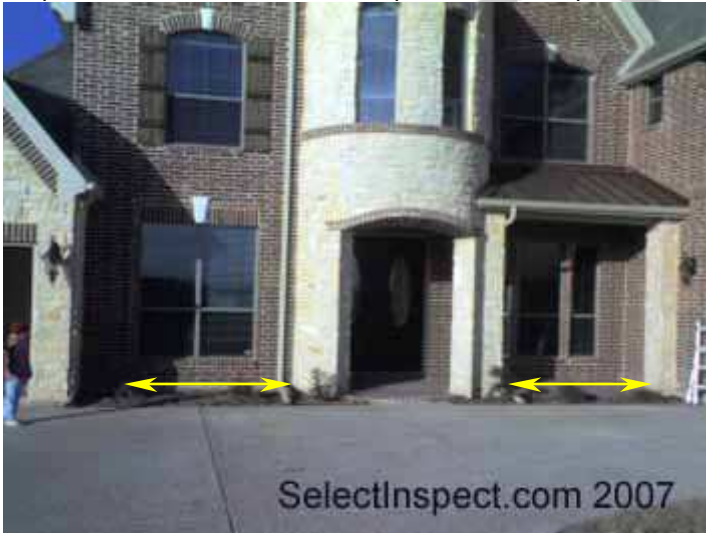
- Planter / garden areas at the front appeared marginal regarding draining ability, and may promote slow or poor drainage of irrigation and rain. Monitor this item over time and repair as needed.

↑ marginal drainage at front gardens

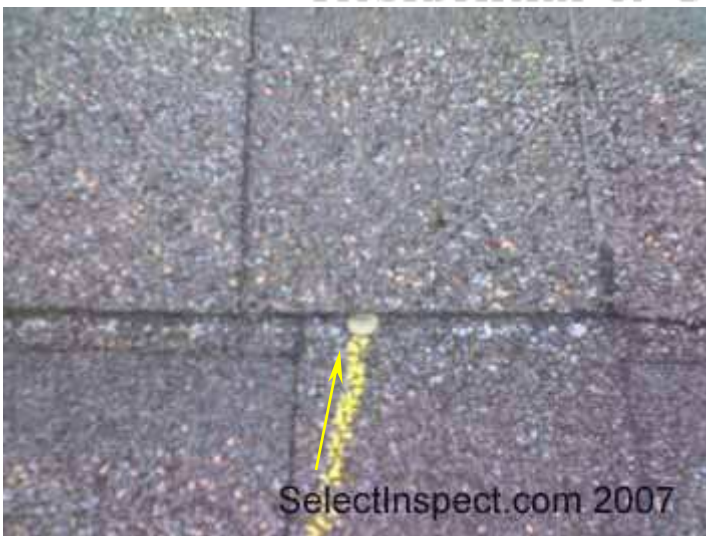
- Open-faced (uncaulked) fasteners were seen at roof vents, flashings, and ridges. Though technically incorrect this is commonly found, even on new homes. This is a relatively inexpensive item to correct, and the need for immediate corrective action is subjective and a matter of personal preference.
- Collapsed plumbing vent flange was noted at the lower west.
- Split ridge shingles were noted at the upper north. Seal and monitor.
- Nail holes remaining from toe-boards, during the roofing construction process, need to be sealed.

↑ example uncaulked fasteners at roof

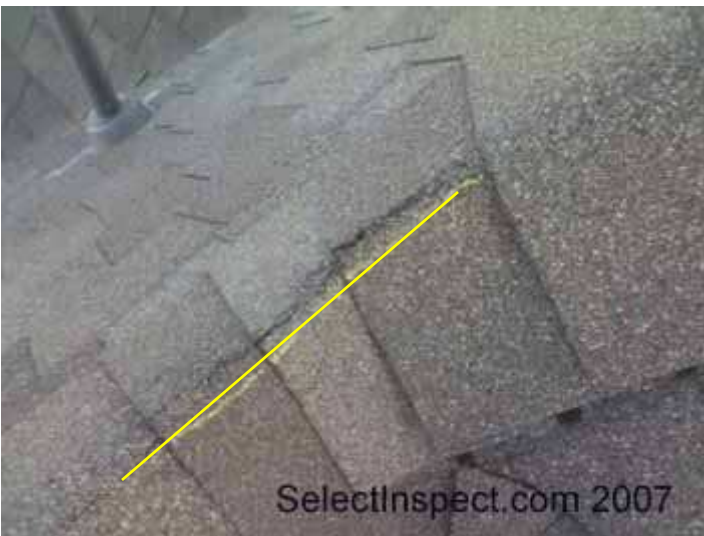
↑ split ridge shingles at roof

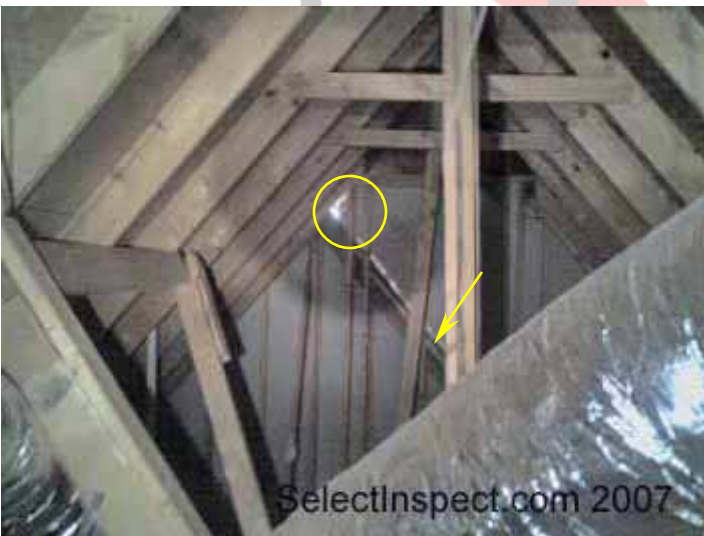
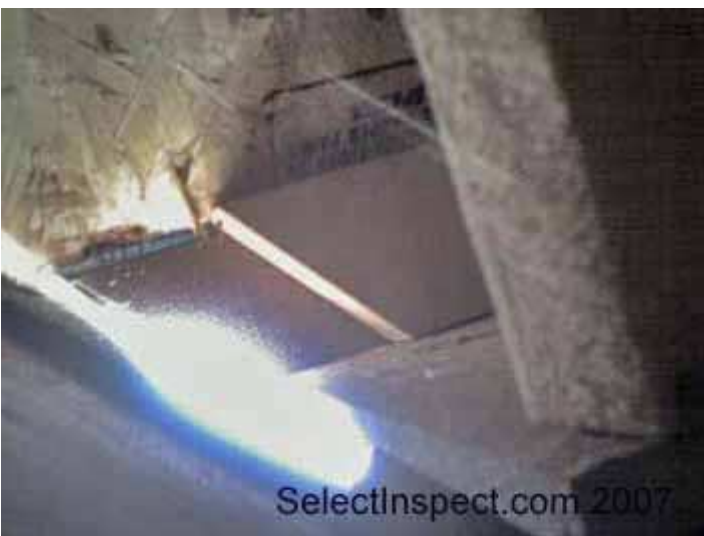
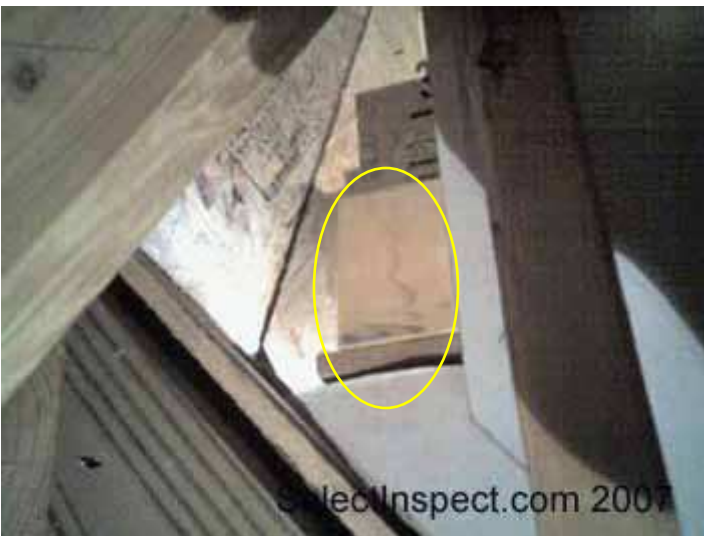
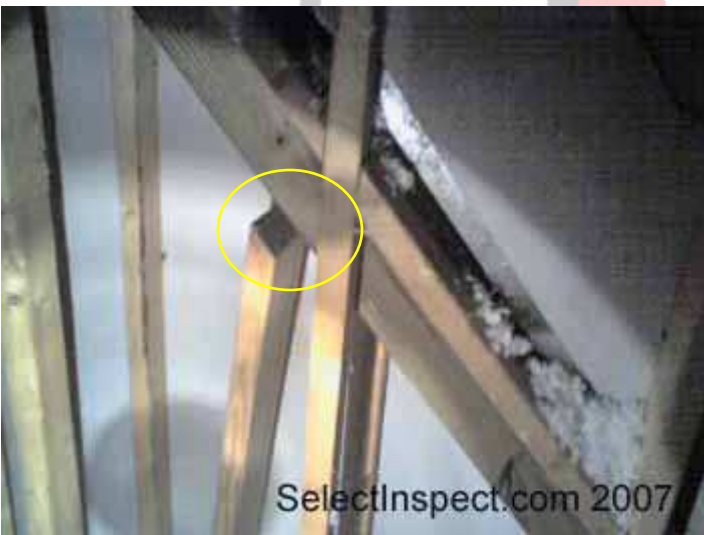
- Moisture staining/evidence was discovered on framing above the double garage. Daylight was visible adjacent this location from within the attic. Suggest appropriate sealant and monitoring.
- Vertical framing (intended to support the diagonal brick area at the upper southeast garage gable) was not secured (nailed) to related vertical framing. Secure and proceed.

↑ left- daylight visible from attic and moisture staining/evidence; right- unsecured vertical framing

↑ close view of prior image- opening / daylight visible

↑ close view- moisture staining/evidence; this may or may not be related to the opening- may be from earlier construction phase- prior to completion of roof.

↑ close view- unsecured framing- vertical support

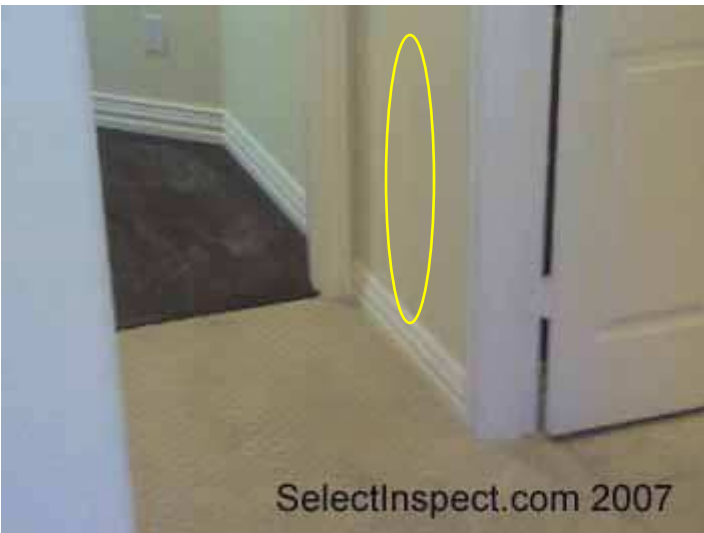
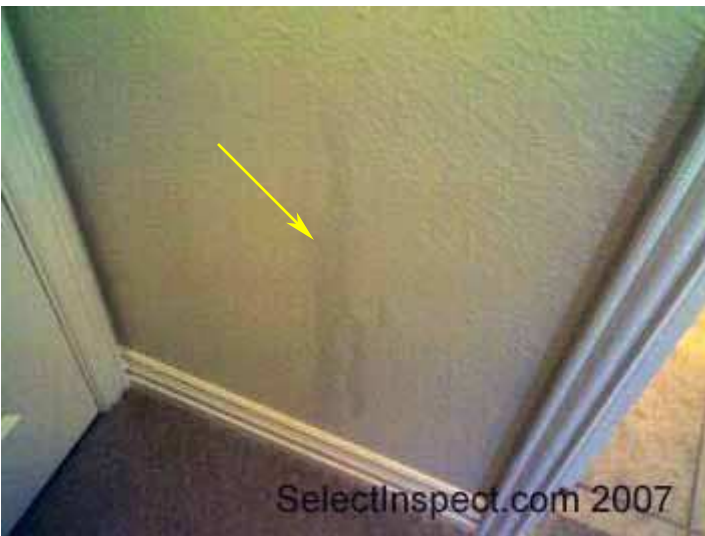
- Staining appearing to be from moisture was discovered at the master bedroom wall adjacent the east master bathroom sink. A leakage condition was not discovered at visible plumbing components. The area was tested with a moisture detector and found to be dry at the time of inspection. The condition may be from past leakage or someone may have spilled something on the wall. Refer to the builder for information regarding this item.
- Cosmetic details were not complete at the time of inspection; such as cabinetry, paint, grout, caulking details, and trim. Discovered at: kitchen, breakfast nook, study, dining room, laundry room, ½ bathroom, guest bathroom shower, game room, media room, foyer, family room.
- A nail is protruding from the wall at the left of the upstairs southeast bedroom window.

↑ moisture staining/evidence at master bedroom entry

↑ close view of prior image

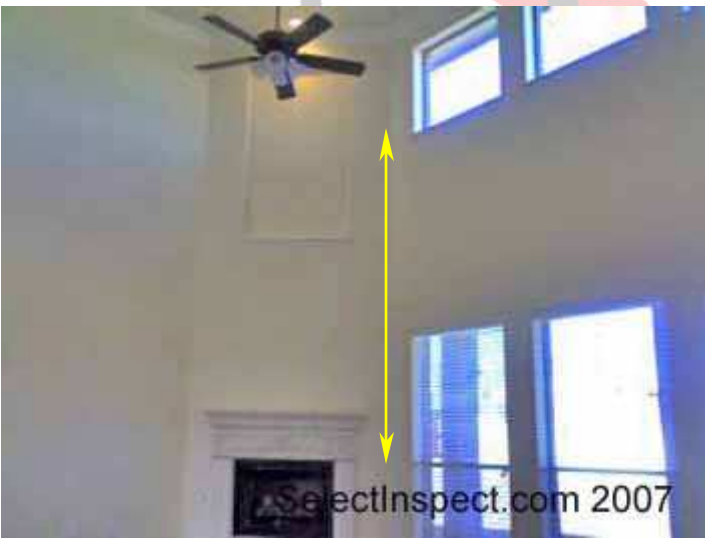
↑ cracks discovered

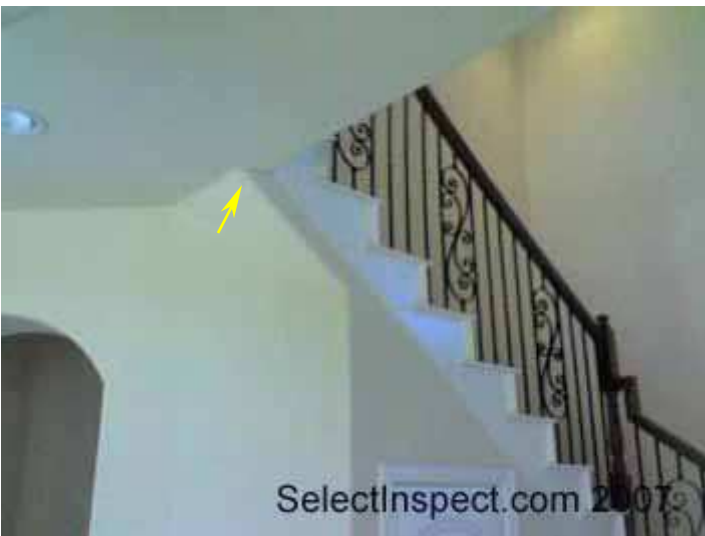
↑ cracks discovered

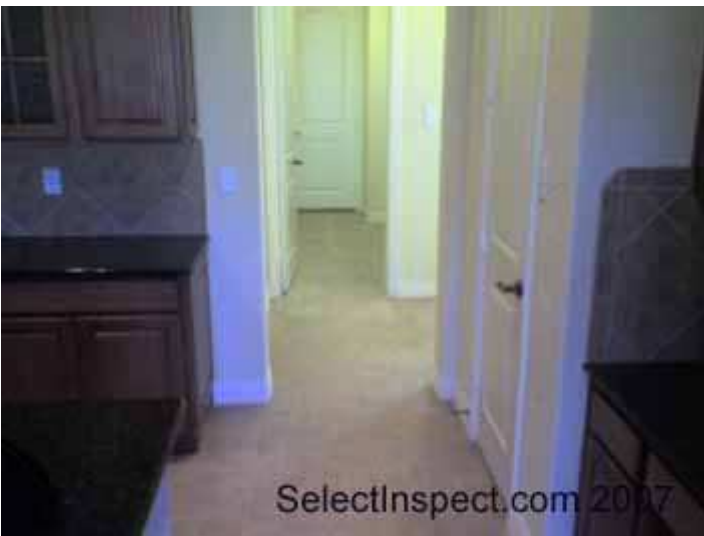
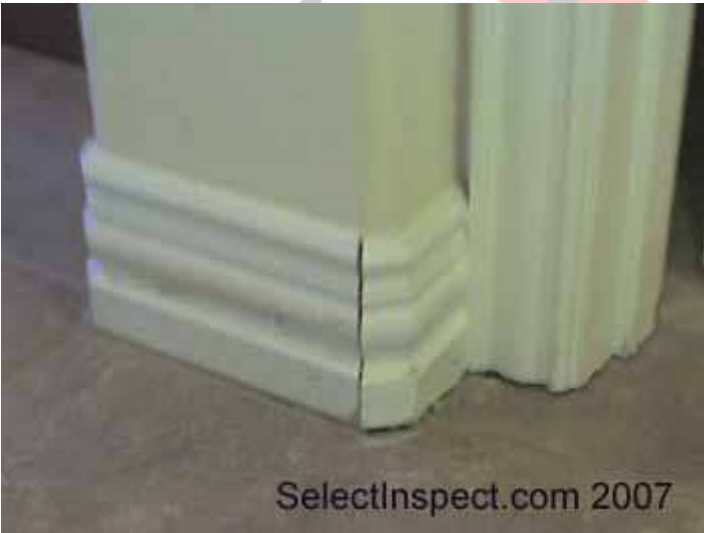
↑ unfinished trim, paint, sealant – example locations

↑ close view of prior image

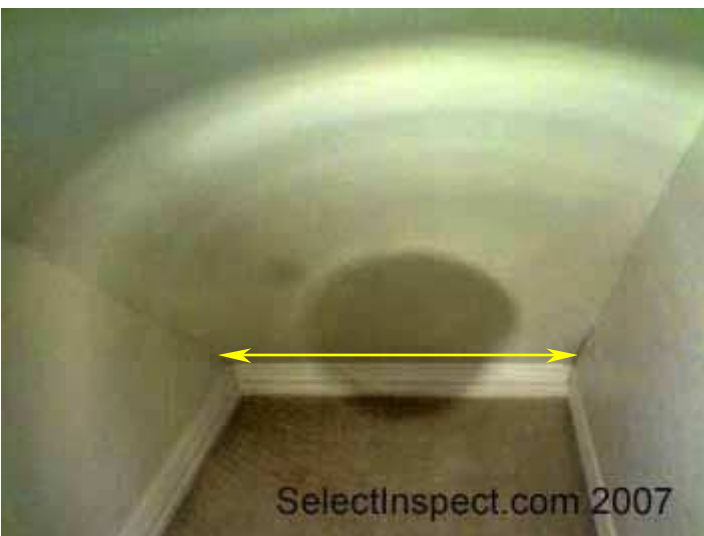
↑ unfinished wall joints below stairs

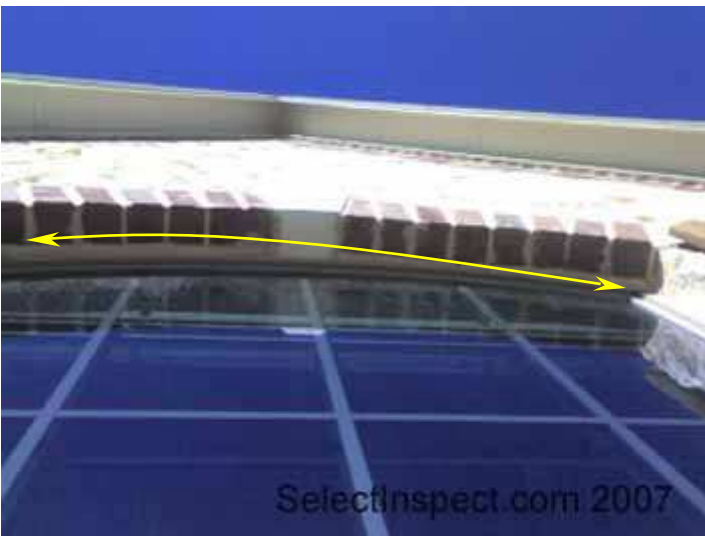
- Mortar cracks noted at the front entry, above southeast bedroom window, and at the master bedroom window areas. Brick separation from framing was noted above the southeast bedroom window.

↑ mortar separation at southeast window

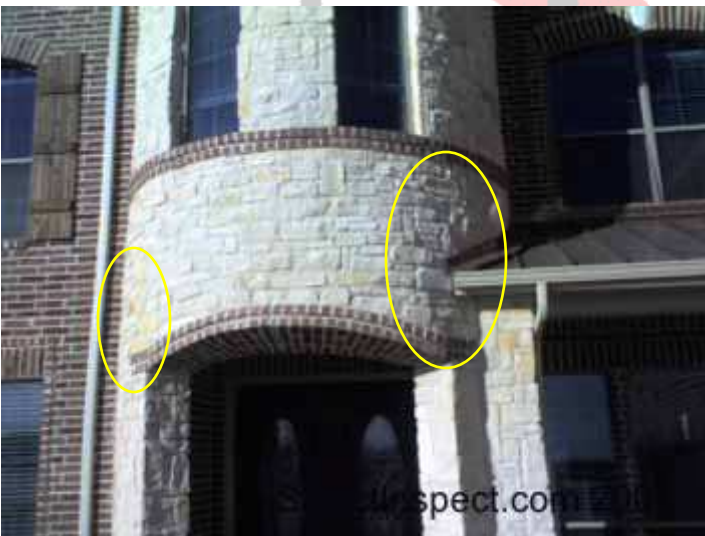
↑ exterior cracks discovered

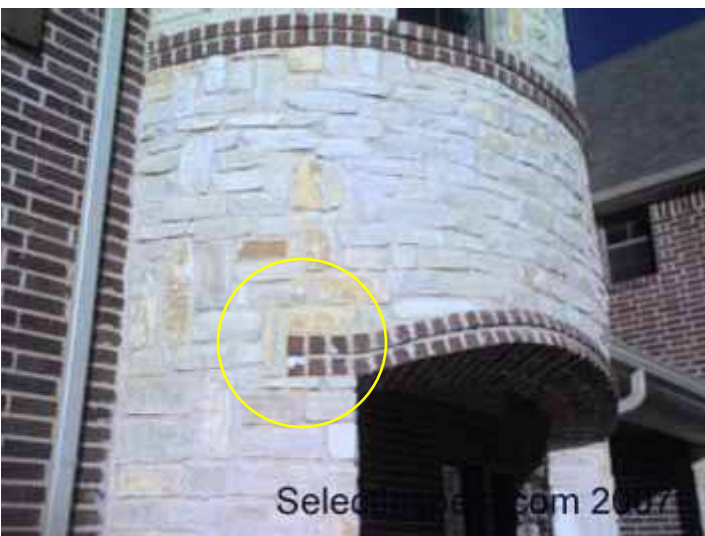
- Previous repair and new cracks were noted at the loft (above the front entry)
- Regularly monitor the property and its components and arrange for repair if / when needed. Repairs should be made by qualified specialists whenever possible.

↑ variant tone of mortar implies prior repair

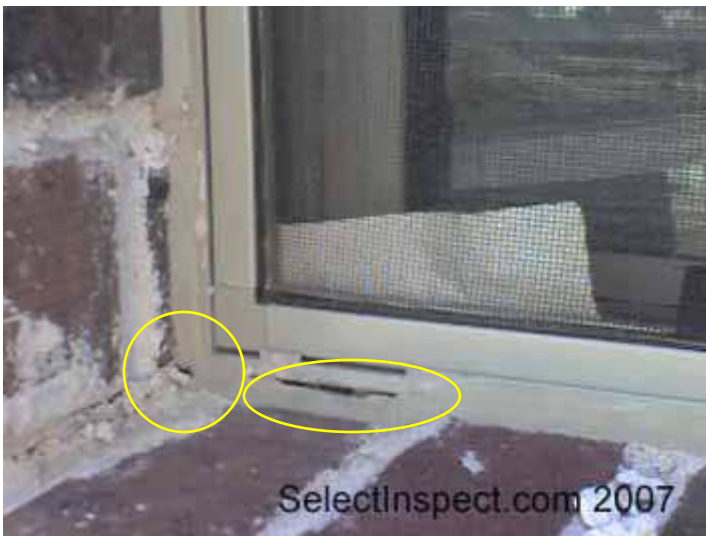
↑ example sealant repair location adjacent window

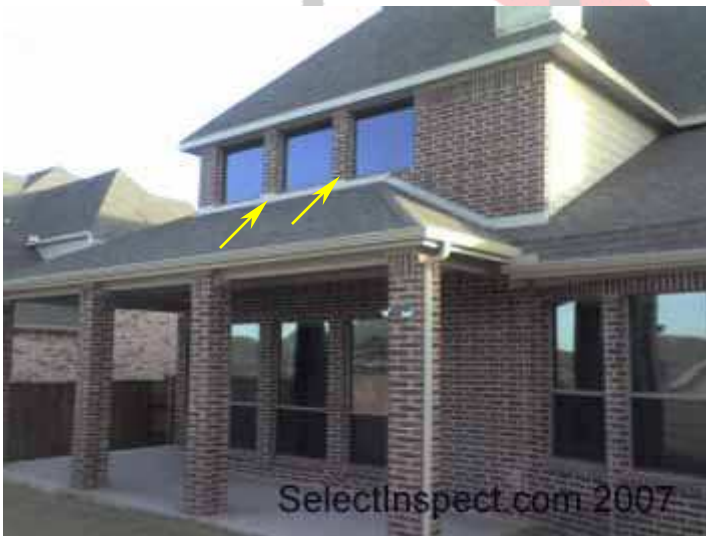
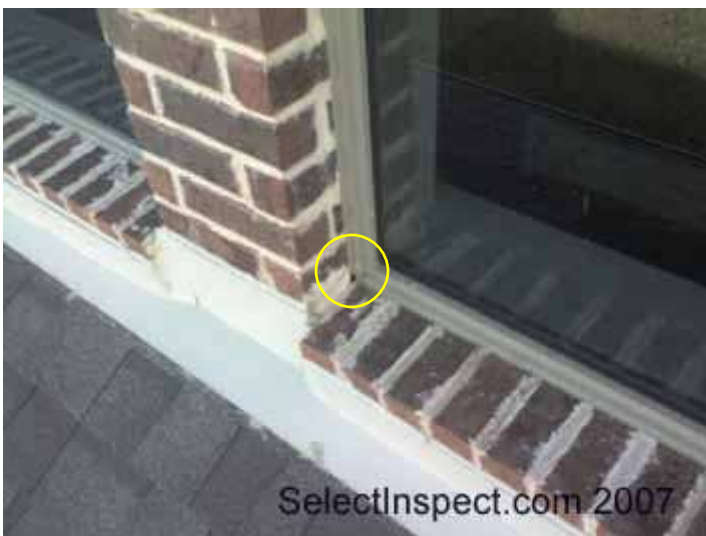
↑ flashing and window need sealant touch-up

↑ close view of prior image- sealant needing touch-up at corner- upper family room

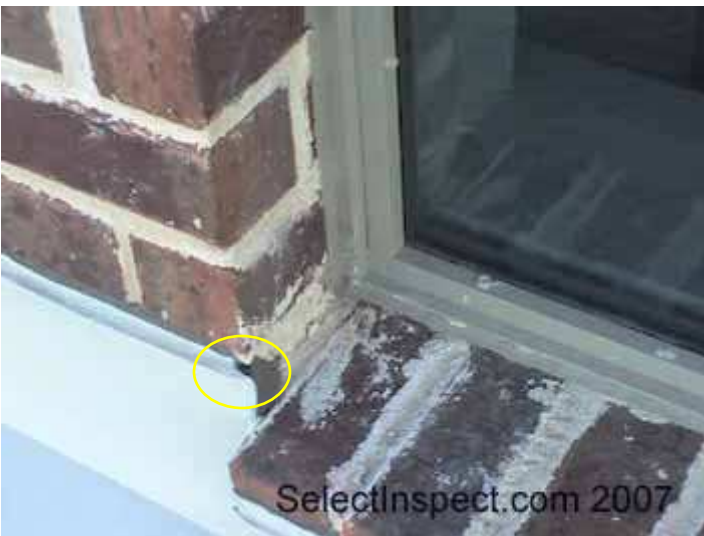
↑ sealant touch-up needed at flashing adjacent upper family room window

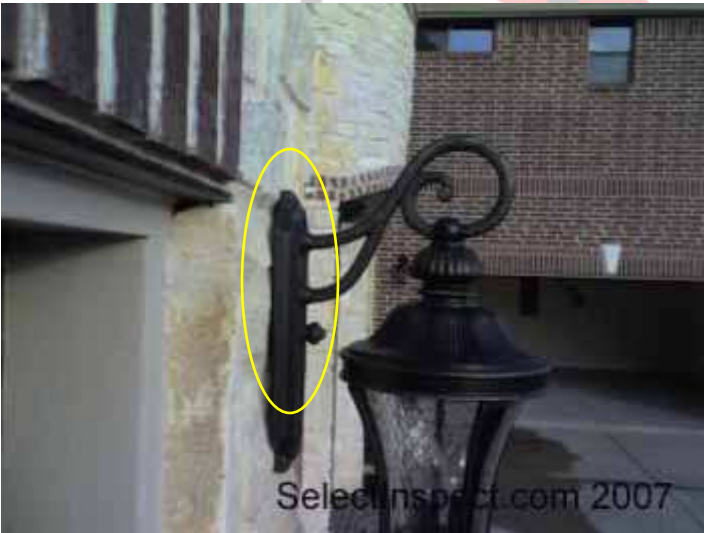
↑ Recommend caulking the top of exterior horizontally mounted lights to prevent moisture intrusion to the electrical conductors – example

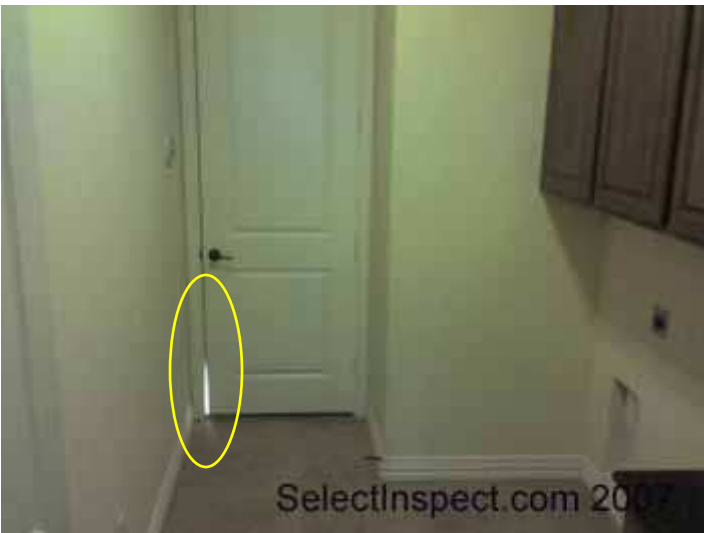
↑ door from laundry room to garage- poor seal and unsquare

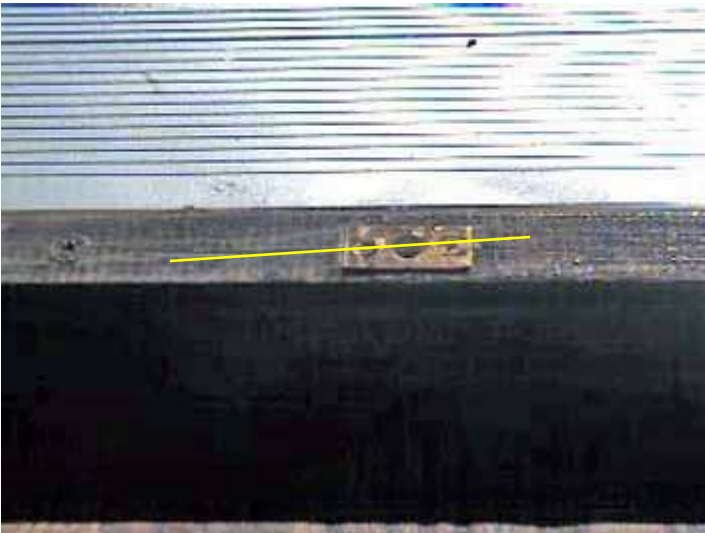
↑ cracked threshold at front entry doorway

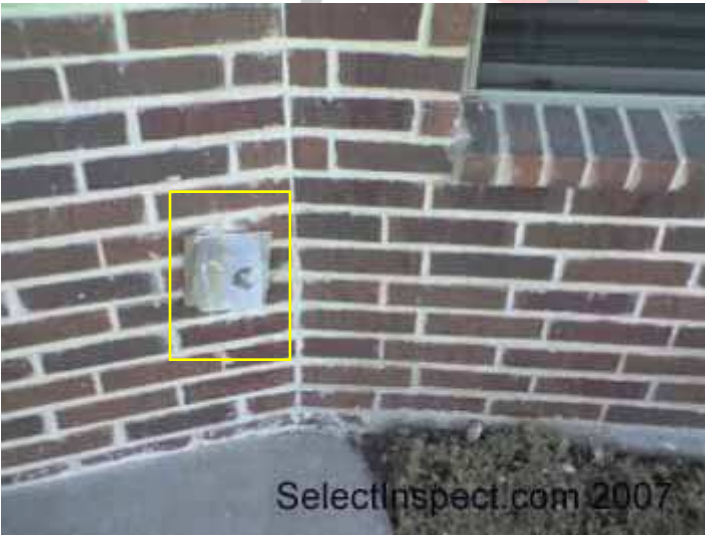
- Air vent intake cover was damaged.

↑ damaged fireplace air intake cover at rear porch

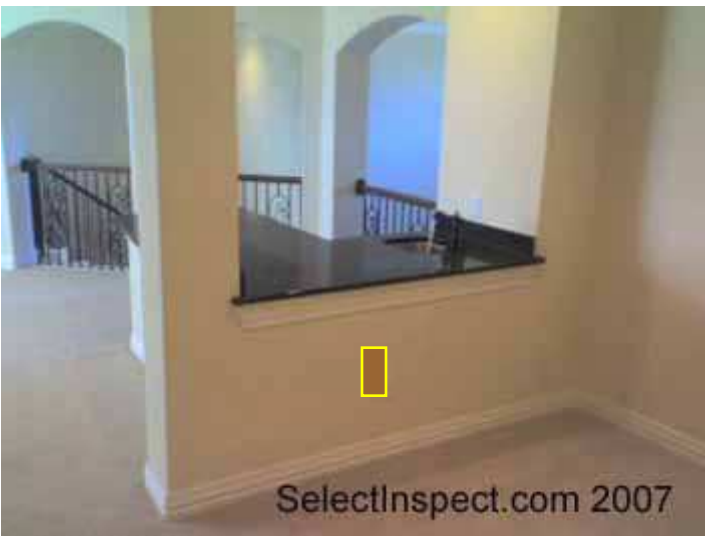
- Receptacle(s) at the media room side of the game room bar was within 6 feet of the sink and should ideally be GFCI protected; since it is below the sink and may be prone to water/liquid spilling onto/into the electrical receptacle(s). Replacement with a GFCI receptacle(s) is simple and generally inexpensive.

↑ non-GFCI receptacle(s) at bar

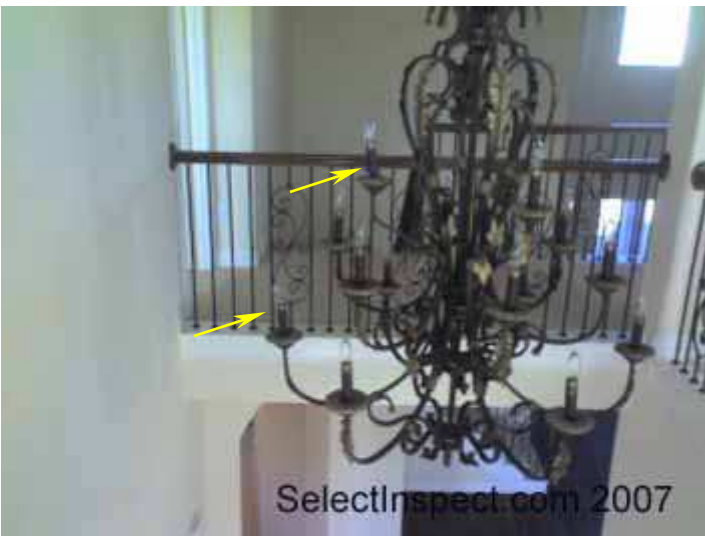
- Deficient bulb was discovered at the entry chandelier. An askew bulb riser was present at the entry chandelier.
- A bulb at the family room ceiling was inoperable.
- Fixtures were poorly secured at the single garage exterior right.

↑ amiss / deficient lights at chandelier

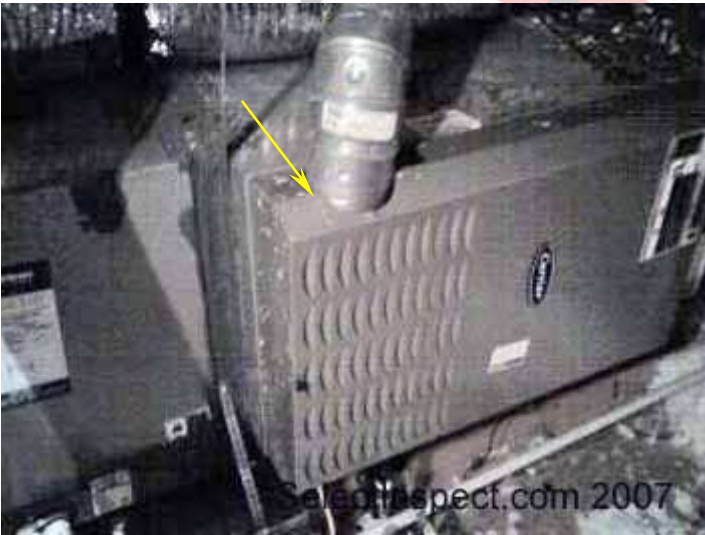
- The flue of the large unit (in the attic) obstructs the service panel from being properly secured.
- The units were operable with normal controls at the time of inspection.

↑ flue obstructed HVAC service panel- attic

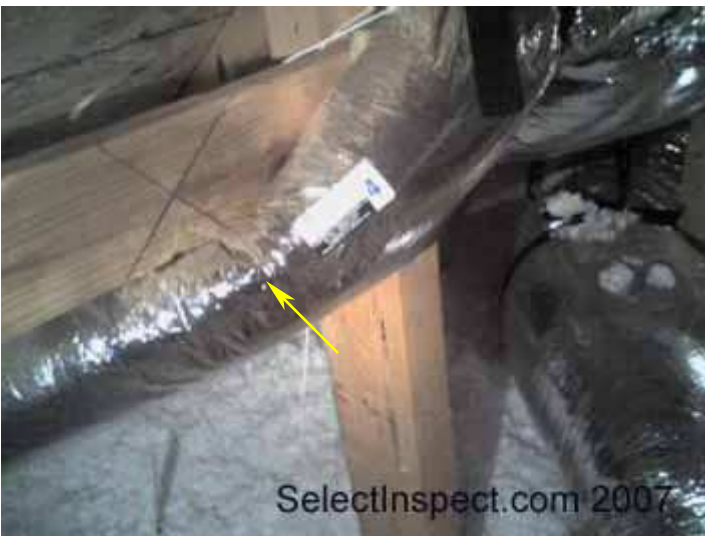
- Crimped and or partially constricted ducting was noted in various sections. Tight strapping or sharp turns can restrict efficient airflow. Correction / improvement would be prudent.
- Filter at the large unit is reversed. Air filters often become dirty during the construction process, and may need to be replaced at or shortly after closing, and accordingly thereafter.

↑ example- crimped air duct in attic

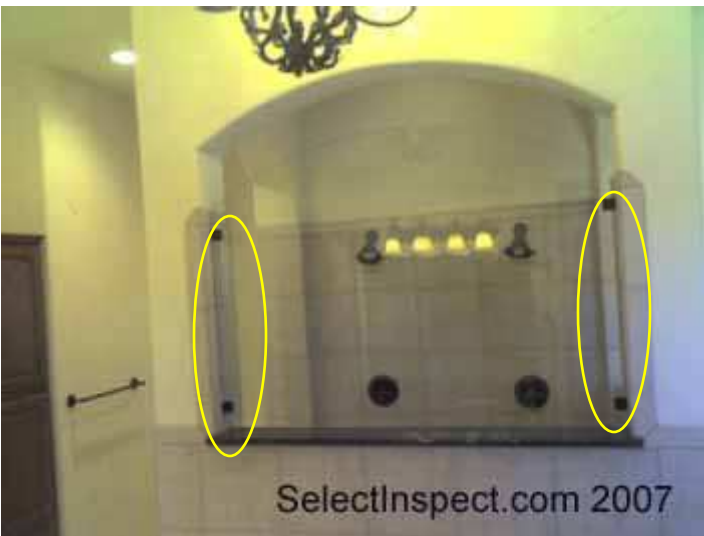
- Grout/caulk touch-up is needed at the gbt shower- back right corner.
- Master: glass door and west glass wall were missing/not present. Glass wall over the jetted tub should be sealed at the sides (vertical) to prevent overspray directing between the glass and tile. This can create moisture damage to nearby flooring and wall components.

↑ unsealed sides at master shower glass

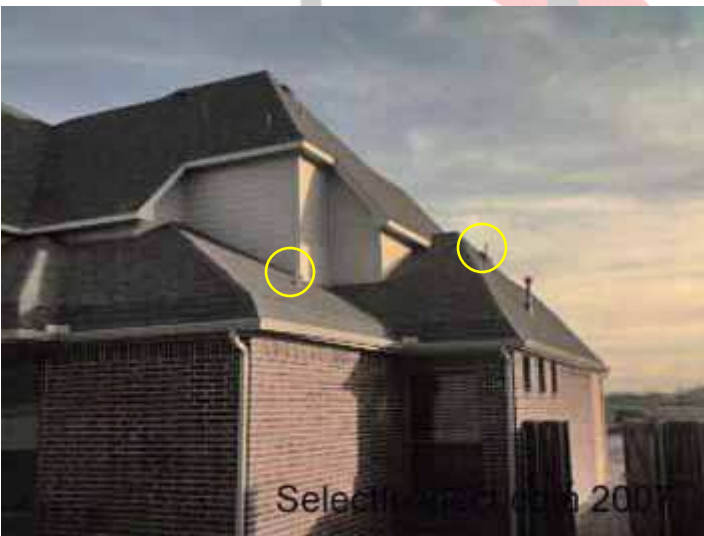
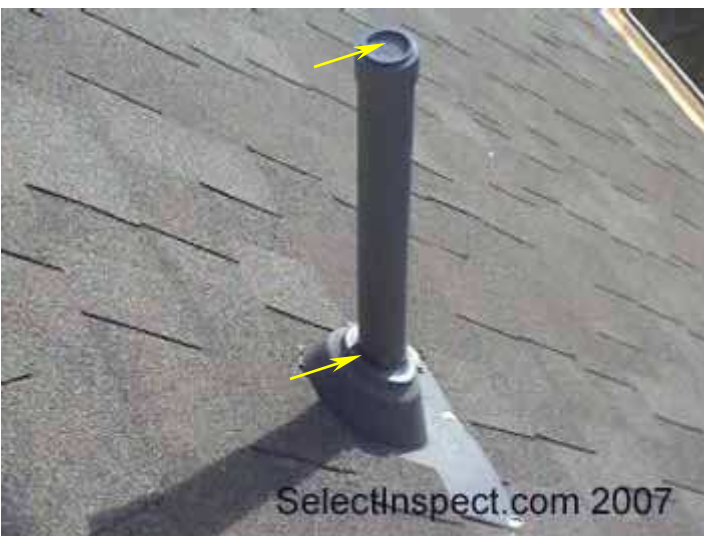
- Plumbing vents at the lower west-northwest remain capped. Caps should be removed for proper fixture drainage.

↑ capped plumbing vents at west-northwest

↑ close view of prior image and collapsed vent flange collar

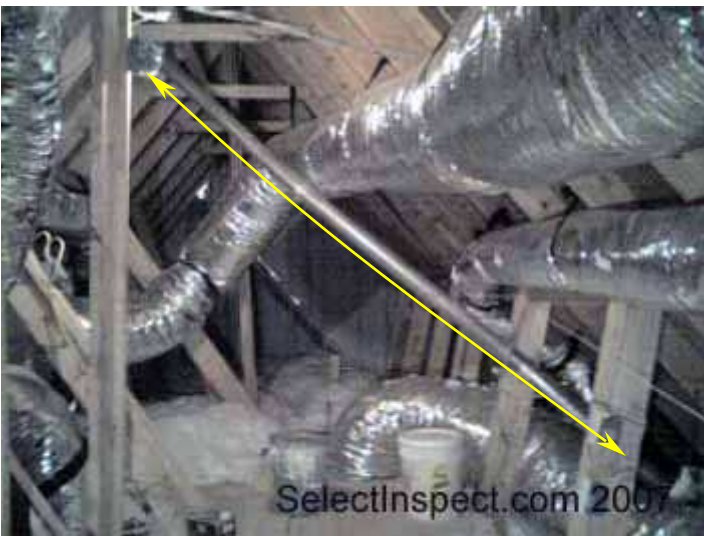
- Double garage/southeast: flue(s) was not adequately supported/strapped. IRC M1801.7; The system appeared otherwise serviceable at the time of inspection
- Single garage/southwest: Device was operable at the time of inspection; flue was not readily accessible. Conditions in inaccessible locations remain undetermined
- ADVISORY: It is recommended to have the temperature-pressure-relief tested annually, and have the temperature-pressure-relief removed and visually inspected every three years or sooner. Most manufacturers also recommend draining / flushing the water heater at least once annually. The unit was producing hot water and appeared generally operable at the time of inspection. Recommend having the unit(s) fully examined and serviced by a plumber at least every 2-3 years for routine maintenance. Average life of a water heater is 10-12 years.

↑ poorly supported water heater flue- southeast attic

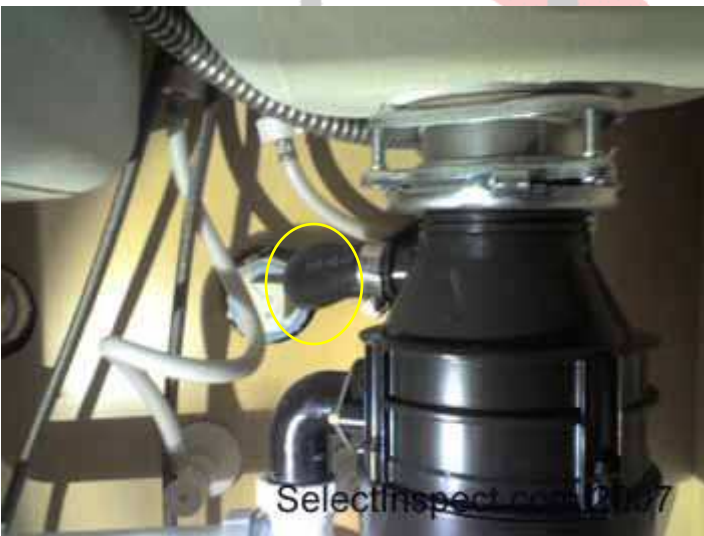
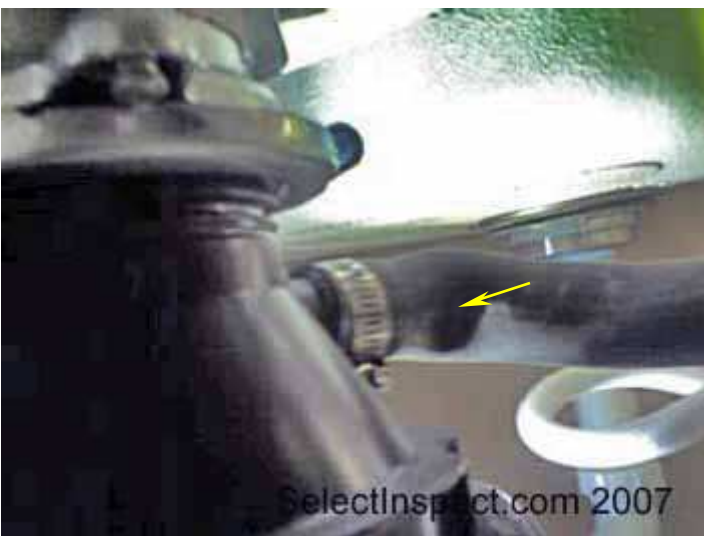
- dishwasher: crimp at the drain line adjacent the disposal connection was discovered. Recommend having a plumber examine for repair needs. The condition may be prone to congestion.
- disposal: operable
- doorbell: operable
- dryer vent: operable
- exhaust fan(s): operable
- garage door operator: operable
- kitchen vent: operable
- microwave: operable
- oven: operable
- range / stove: gas shut-off valve is located below the unit in the cabinet. Operable
- other appliance: The water line for the refrigerator(s) and or icemaker(s) may be dirty / unsanitary. Recommend discarding at least the first 3-4 batches of ice and water prior to consumption.

↑ crimped dishwasher drain tube

↑ alternate view of prior image (from behind disposal)
