Select Inspect

Inspection for Builder Warranty

at: **54321 New Street; The Colony, TX 75034**

November 29, 2010

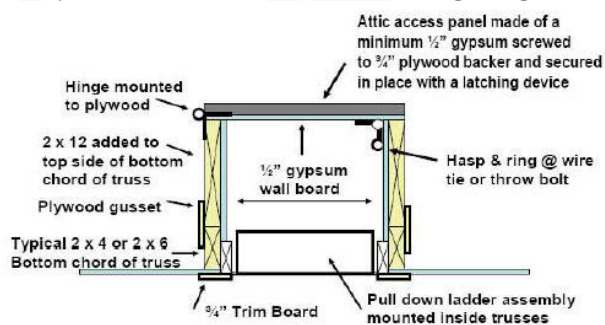
- The access panel at the garage attic access was not adequate material and would not meet separation required for fire-spread at attached garages. The access cover is a sheet of thin plywood. When installed in a garage ceiling, this replaces a portion of the required separation created by drywall board, thereby breaching the required separation. IRC R309.2
 Option 1: Minimum 1 hour fire-rated material should be installed on the garage side of the hatch/door. Edges around the covering shall be tight to the surrounding ceiling.
 Option 2: Installing 5/8" drywall to separate the garage attic and at the rafters to at least 4 feet into the then separated garage attic to isolate the garage attic from attic space(s) above or adjacent living areas; taping/bedding all seams should be made to finish the firewall.
 Option 3: Installing a fire-resistant enclosure in the attic above the garage access; An example of this is shown in the following image.

Pull down garage attic ladder installation requirements to maintain fire resistive separation

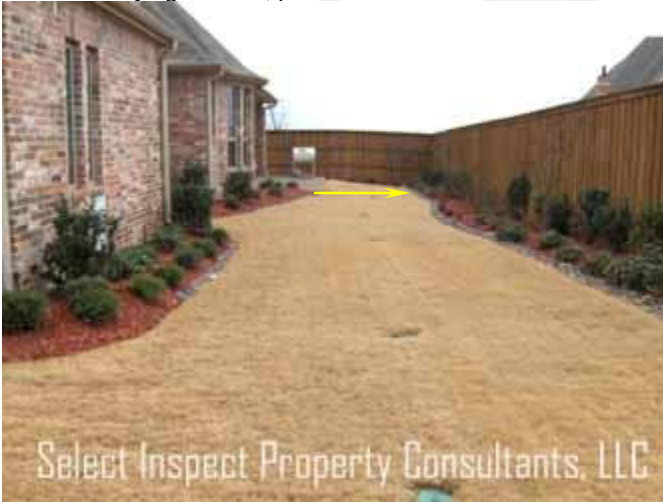
↑ satisfactory slope at west-southwest

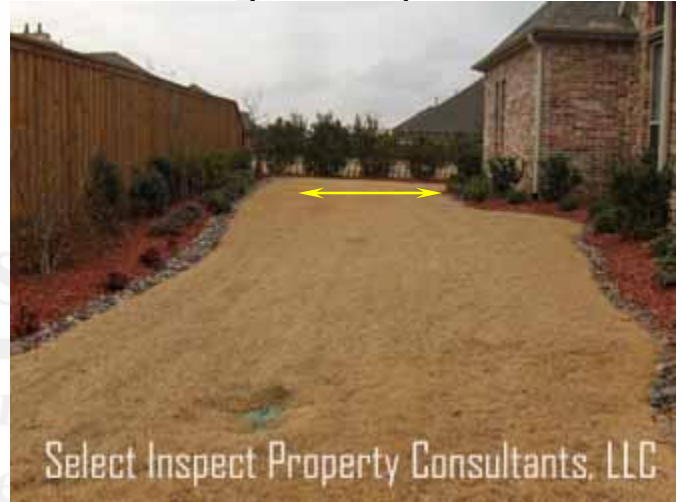
- Grading at the rear right (north corner) was somewhat flat, rather than a minimum 6" drop within the first 10' leading away from the home; Monitor; provide routine service, and maintain.
- Low fencing at the soil in the west-southwest, near the rear porch appears to restrict water from flowing adequately toward the street. Consider slightly lowering the soil at this location to assist in water relief.
- Bark at the north corner was at/above the foundation edge; ideally you would keep a minimum 4" spacing of visible slab below the brick at all locations. Significant issues were not discovered; monitor and maintain.

↑ flat/marginal slope at north

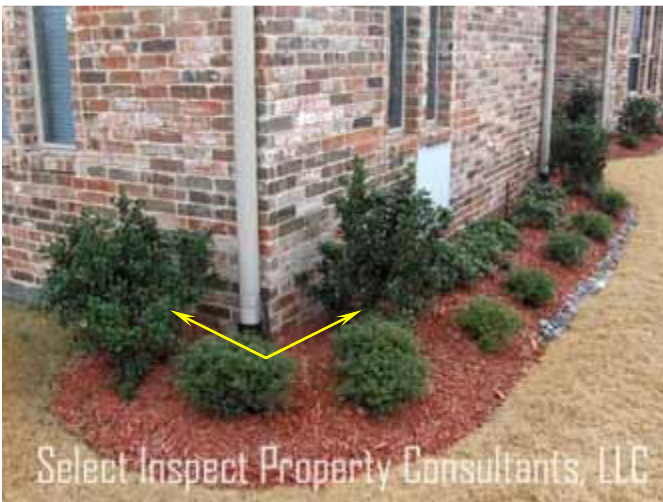
↑ bark is slightly higher than recommended at the north corner; Significant issues were not discovered; monitor and maintain

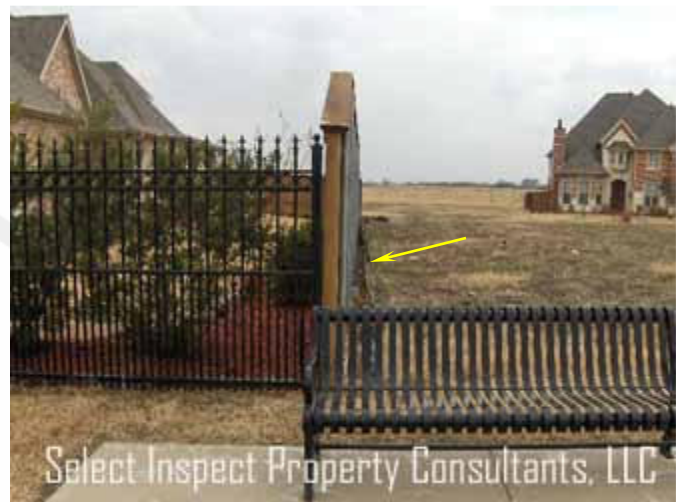
↑ monitor slope from neighboring property; Significant issues were not discovered during the inspection; monitor and maintain

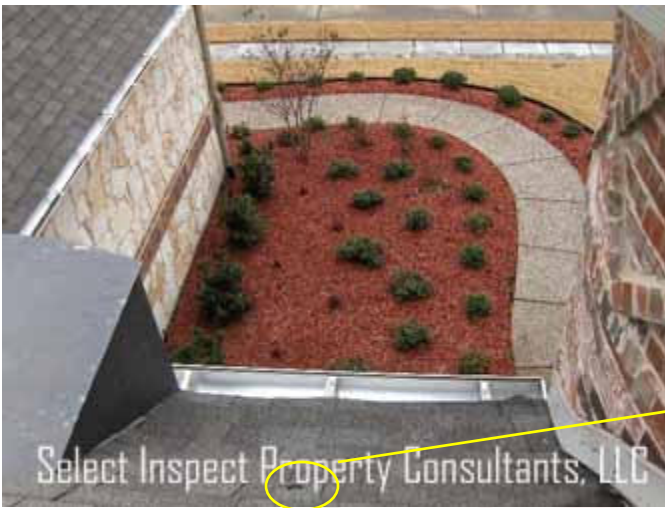
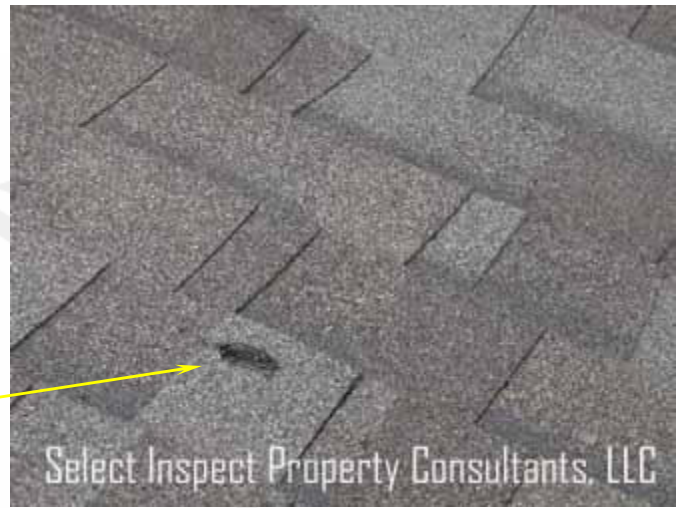
- Missing shingle tabs exist at the left (west) of the fireplace chimney. Damaged shingle was noted at the right of the front entry.
- The chimney cricket ridge has split and should be sealed.
- The dead valley right (east) of the fireplace chimney has marginal / poor slope, and may not drain properly. This is conducive to debris accumulation and potential moisture intrusion. Improving the slope is recommended.

↑ damaged shingle above front entry

↑ close view of image at left

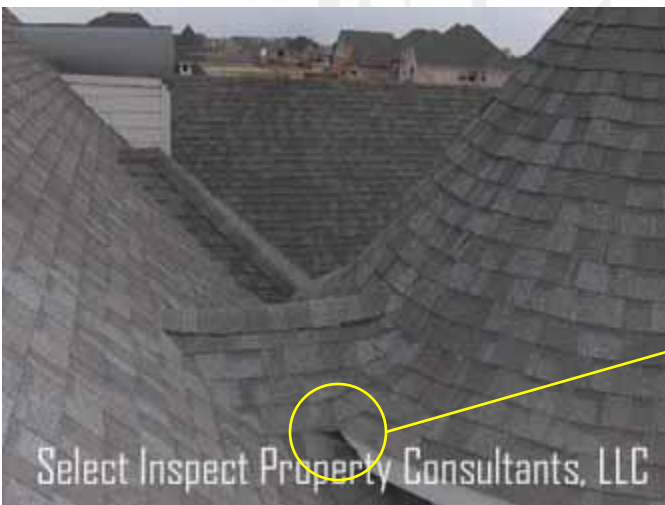
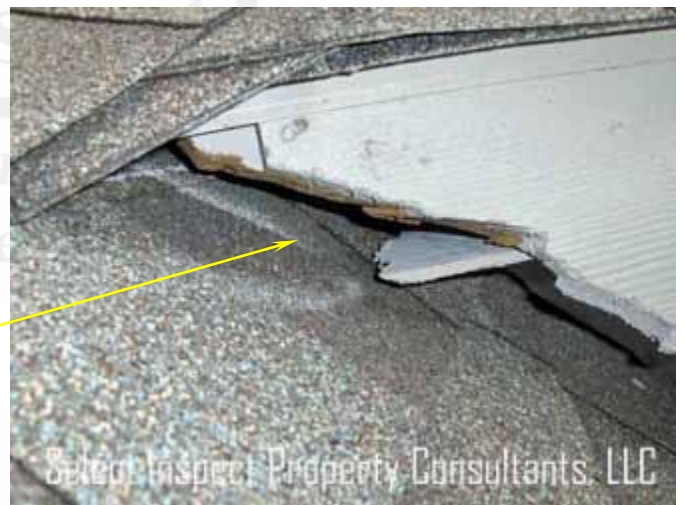
- Openings remain at: entry rotunda; left eave; large enough for bird/rodent entry
- Nails were retracted/inadequately secured at the central dormer; trim joints should be sealed.

↑ opening remains at rotunda fascia; attic framing visible from exterior

↑ close view of image at left; large enough for moisture intrusion & or rodent/bird entry

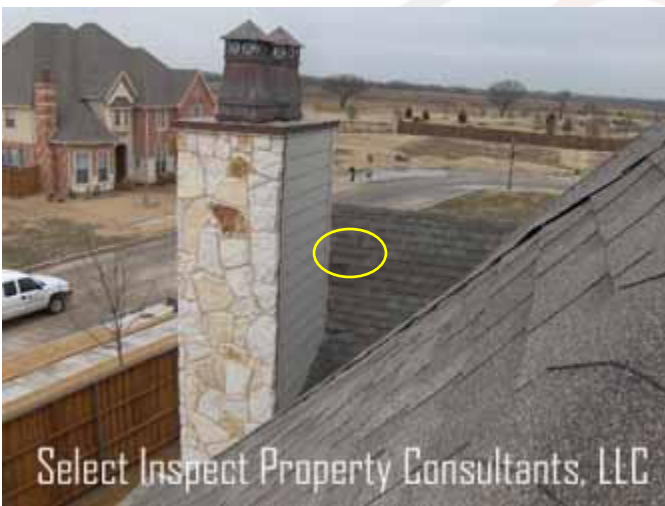
↑ missing shingle tabs at roof adjacent the chimney

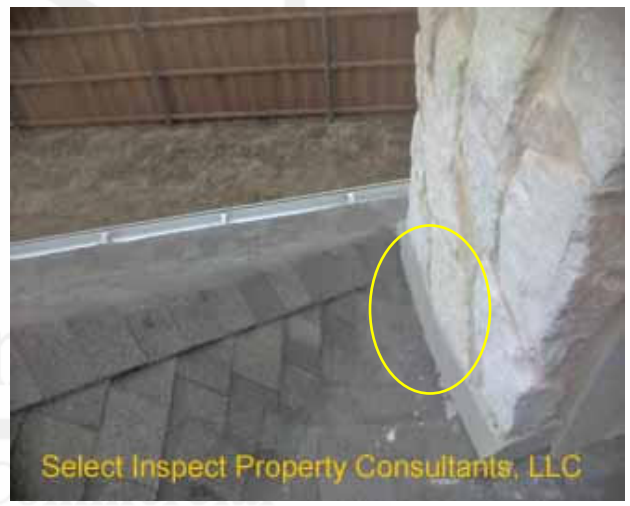
"Dead valley" description: A converging valley feature with a vertical wall joined by flashing at a convergence of one or more roof angles/valleys; this feature is commonly associated with a higher risk for leakage, due to water being directed toward rather than away from a wall, roof, and or flashing convergence. The roof, attic, and interior areas surrounding and below this feature should be inspected during different weather periods for leakage. These valleys will also create a higher risk of ice damming and potential moisture intrusion behind the shingles in winter.

↑ marginal slope at the converging valley adjacent the chimney; prone to ice damming, debris accumulation, & moisture intrusion.

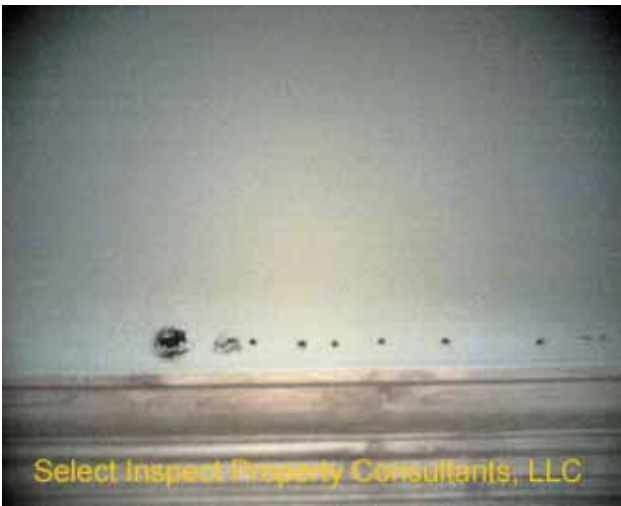
- Openings exist above the cabinets in both sides of the butler pantry.

↑ openings in the drywall at the butler pantry; above cabinets; both sides

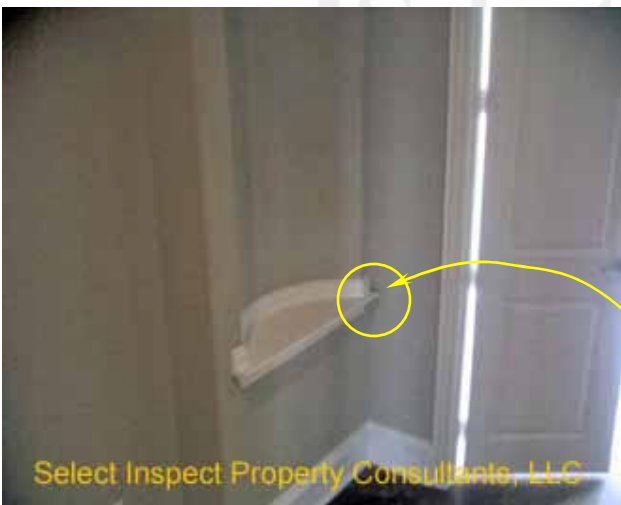
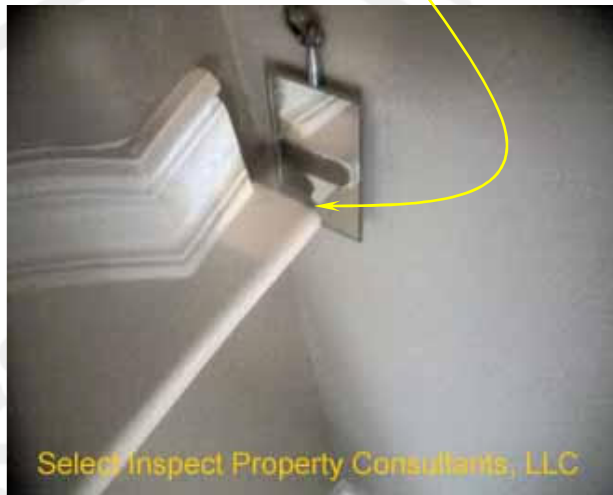
↑ various cosmetic details incomplete; example at master hallway

↑ close view of image at left

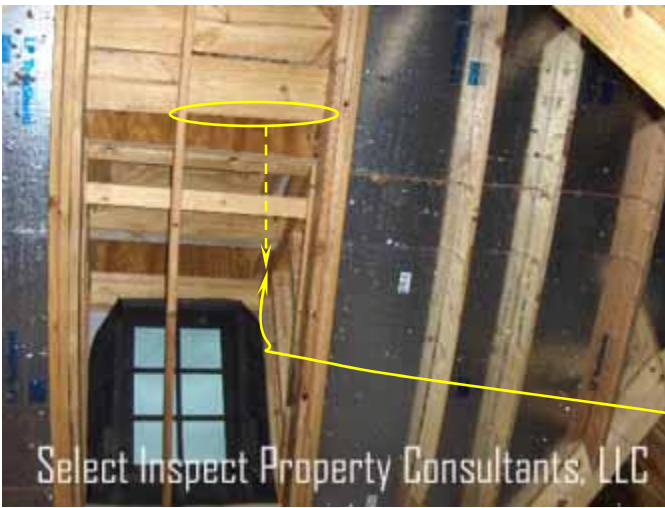
- Moisture intrusion was indicated by staining at the central dormer roof structure & insulation directly below this location.
- Have a roof professional examine all roof areas for repair needs when this & shingle issues are corrected.

↑ wood at this location of the dormer appeared stained, when viewed from below.

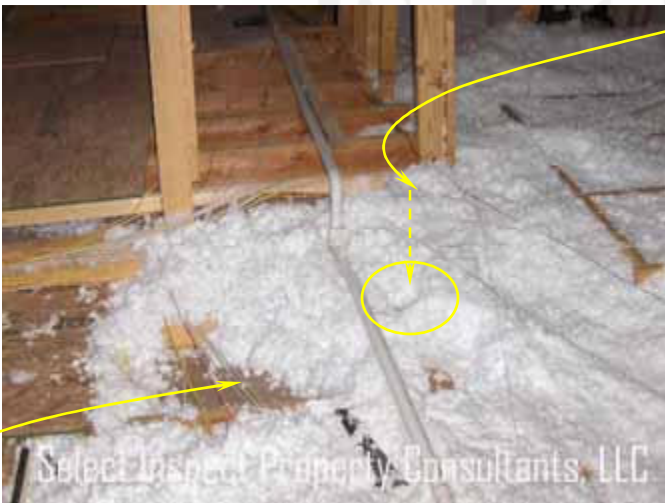
Missing insulation

- Insulation was absent, or otherwise amiss at the area above the mudroom where drywall repair was made, due to moisture intrusion

↑ moisture staining at insulation below location in image above; in proximity to moisture damage repaired at the mudroom ceiling.

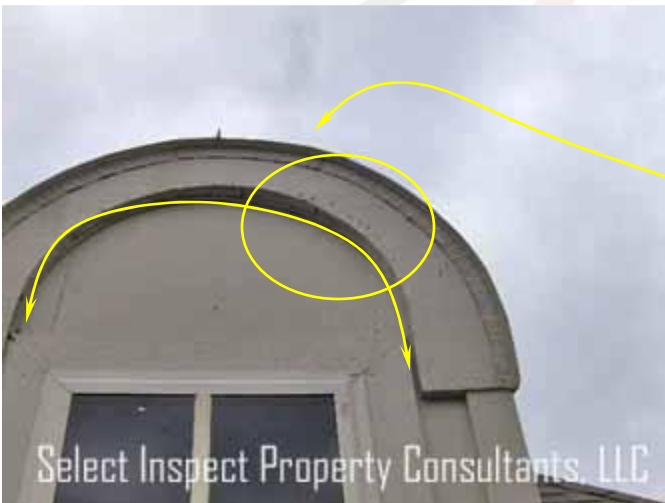
↑ retracting nails & lacking sealant in seams at the central dormer

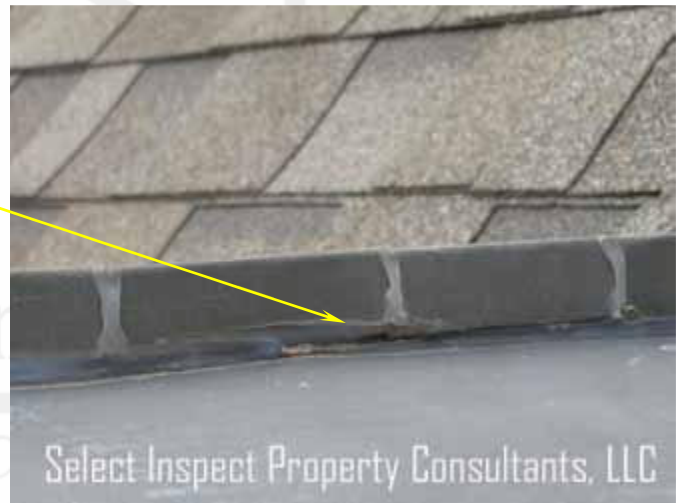
↑ small gap at top of central dormer may contribute to moisture intrusion

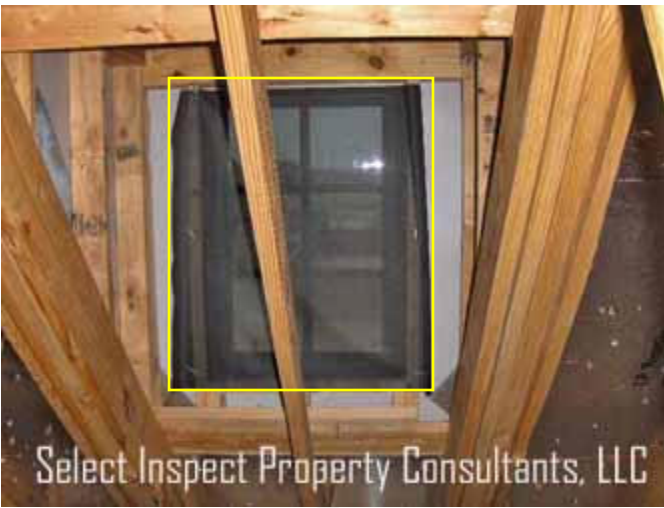
- Window flashing was noted as inadequate at dormers; it is undetermined if flashing component(s) were corrected between the framing & final inspection.
- NOTE: Some windows were partially inspected or had limited access, due to furnishings, lighting conditions, window treatments, etc. Some conditions may remain undetermined.

↑ flashing not visible at dormer windows.

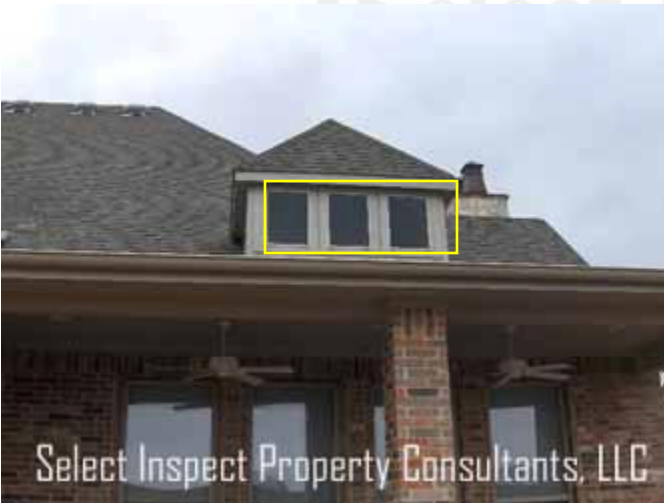
- Upper family room windows need sealant touch-up at the perimeters.

↑ sealant repair needed at upper family room window perimeters

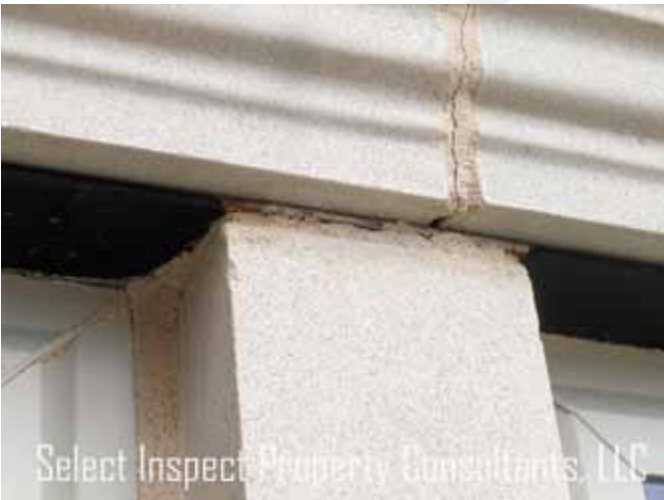
↑ mortar fallen from office/study window at lintel; satisfactory; the steel does not "hold" mortar well; this is common & not considered a deficiency

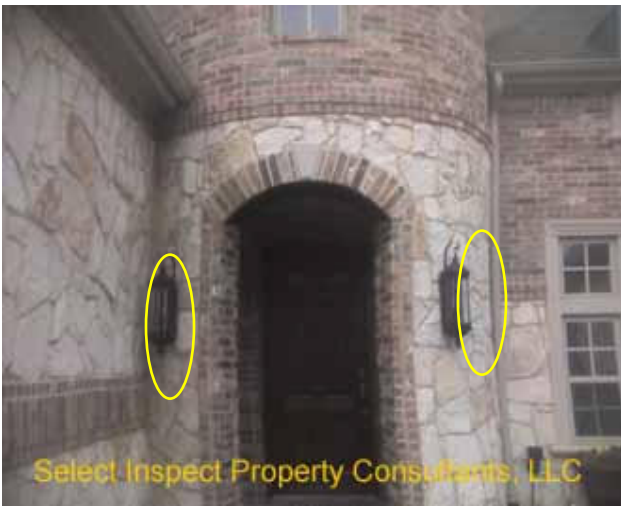
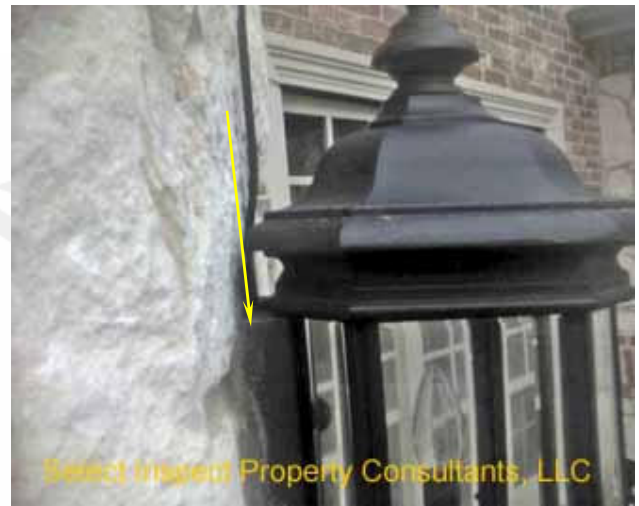
- Exterior lights at the front entry and garage should be properly sealed at the top of the fixtures to prevent moisture intrusion and related corrosion / overheating possibilities of the electrical components. NEC 410-4 & IRC E3903.9.

↑ seal top of exterior lights; example front entry

↑ close view of image

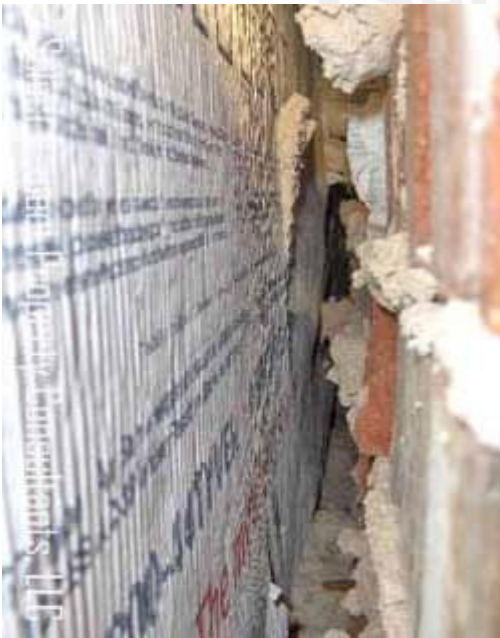
- Mortar & brick debris was noted between the exterior brick veneer and wall structure; this may impede designed drainage of condensate within the wall void. Repair options are limited. Monitor this item periodically and maintain as needed. The condition was seen at the exterior jetted tub access.

↑ mortar & brick debris in exterior wall void; example

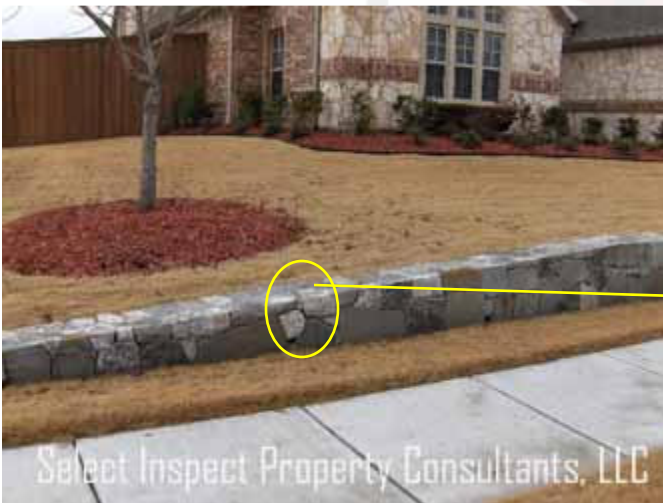
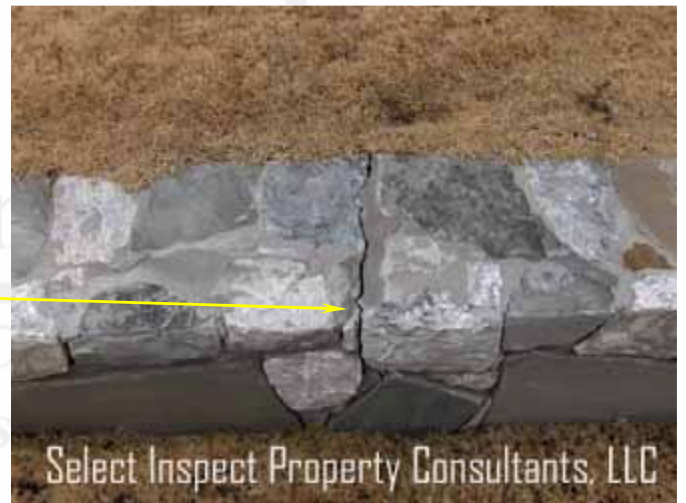
- **RETAINING WALL:** Crack at the south end of the front retaining wall appears to be from settling of the south end of this feature; the crack was approximately ¼" wide during the inspection. Random thin/closed cracks were noted at other locations. Significant issues were not discovered; monitor and maintain.

↑ crack discovered at retaining wall

↑ close view of image at left

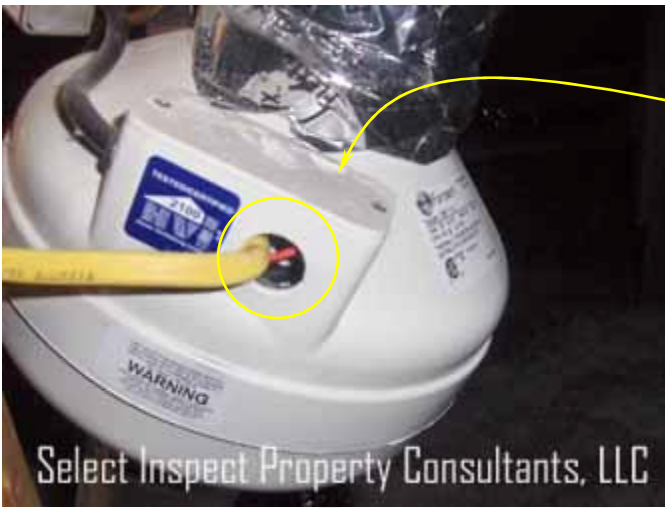
- Wires entering the dryer vent boost fan junction box did not have an appropriate clamp or grommet in place.
- Extension cords were being used for permanent power at the humidifier/hepa filter component(s) in the attics. Electrical receptacles should be installed within reach of the appliance primary power cord(s). Consult a qualified electrician for options.

↑ missing clamp at dryer vent blower in attic

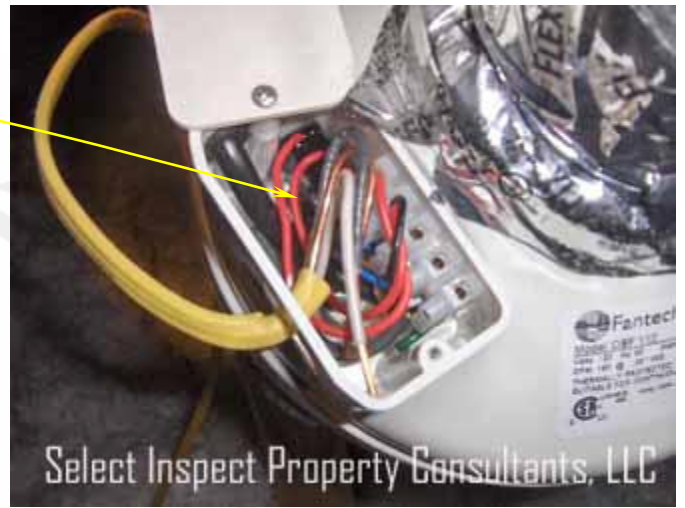
- Dryer vent booster fan was not wired; wires are routed to & into the junction box of the device, though they had not been connected. These wires were energized & not appropriately capped within the junction box. Consult an electrician to examine all electrical components at the property and provide options for correction.

↑ unworkmanlike; incomplete wiring of dryer vent blower

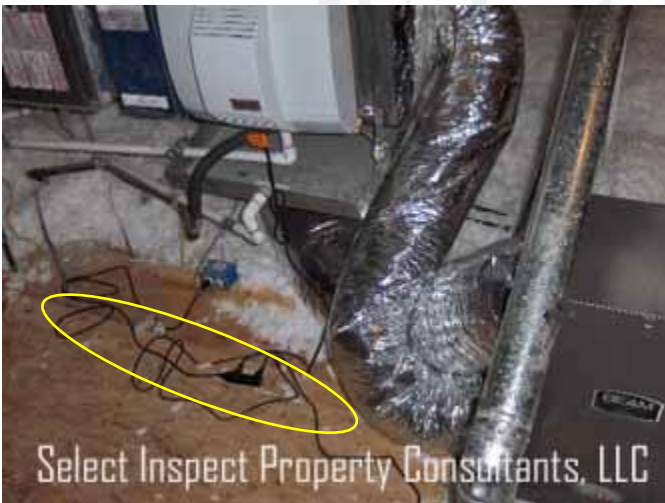
↑ extension cord for permanent use; example at northeast HVAC

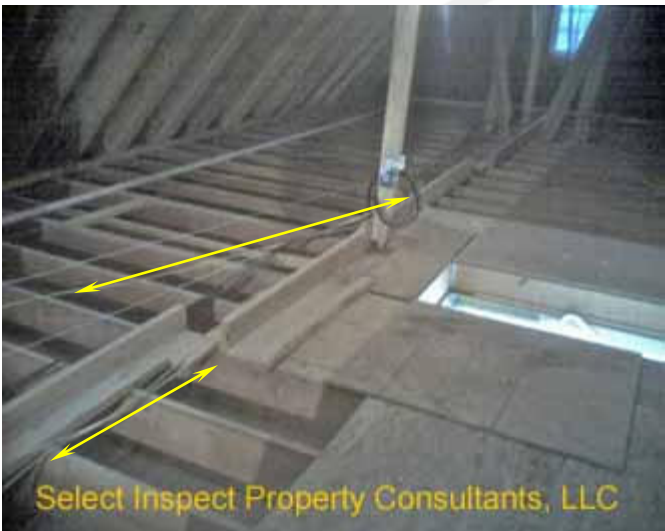
- There are electrical wires at the attic access that are not properly secured and protected from damage by traffic. Within 7 feet of the access, where run on joists, face of rafters or studding, in attics or roof spaces that are provided with access, the cable (electrical wires/conductors) shall be protected by substantial guard strips that are at least as high as the cable. When the attic(s) is not provided with access by permanent stair or ladders, protection shall be required within 6 feet of the attic entrance. E7202.2.1.
If wires are installed parallel on the side of the framing; additional protection is not required. See related image with the photo pages.

↑ Unprotected electrical wires within 6 feet of scuttle or 7 feet of attic stair

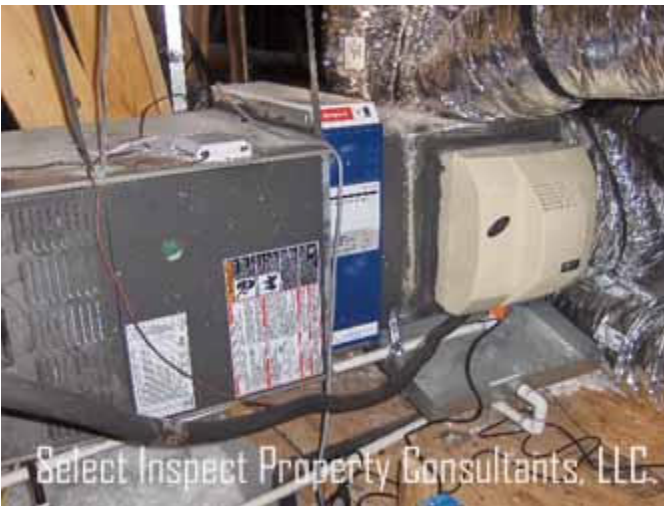
- Humidifier: the Aprilaire 700 model is not recommended for horizontal systems, like the two in your home; refer to the "NOTE" on the upper right of page 2 in the manufacturer installation guide: http://electronicaircleaners.com/database/documents/aprilaire_700_installation.pdf
- In most cases the humidifier would ideally be placed at the supply end of the HVAC system; though you should consult an HVAC specialist to determine which setup would best meet your needs with the style of HVAC equipment in this home.

↑ multiple questionable conditions/deficiencies regarding humidifier model and installation

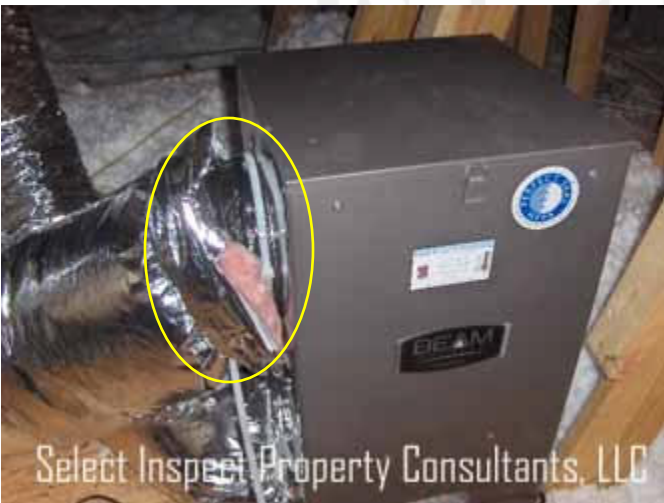
- Southeast hepa duct connection had vapor barrier & insulation that was inadequately secured.
- Crimped and or partially constricted ducting was noted at the south attic. Tight strapping or sharp turns can restrict efficient airflow. Correction / improvement would be prudent.
- Filters advisory: Hepa prefilters were starting to collect duct as intended; Significant issues were not discovered; monitor and maintain.

↑ deficient duct connection at south HVAC hepa

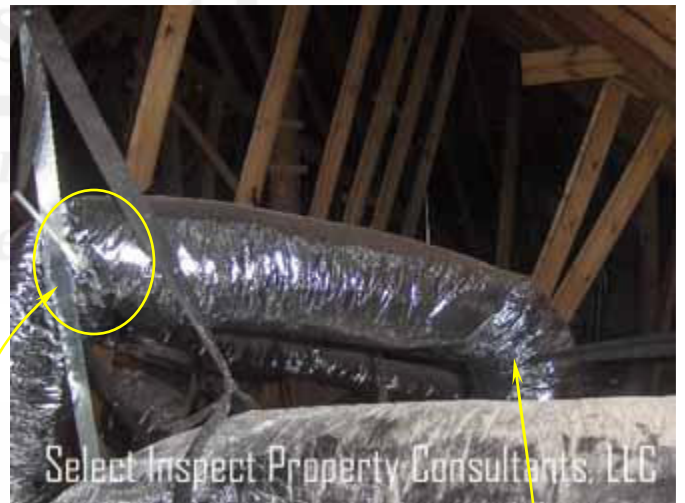
↑ crimped air ducting; example

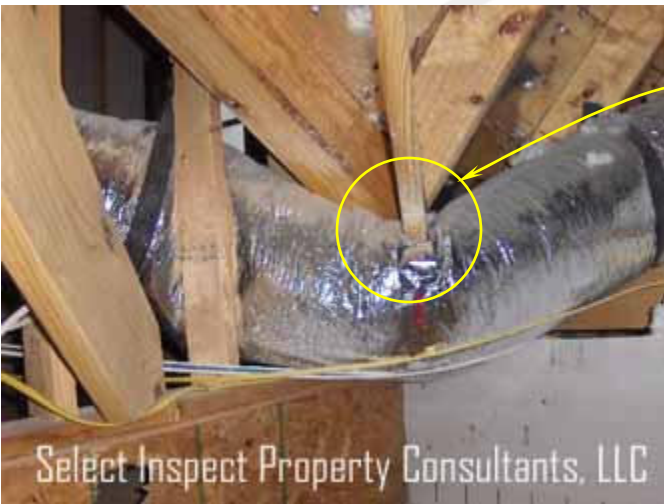
↑ crimped air ducting; example

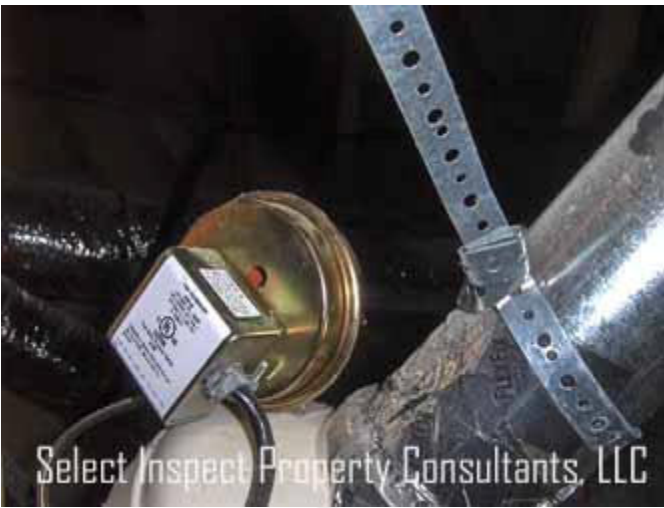
↑ http://www.fantech.net/dbf4xl_i.pdf ; other than electrical deficiencies; installation of the inline dryer boost fan appeared satisfactory.

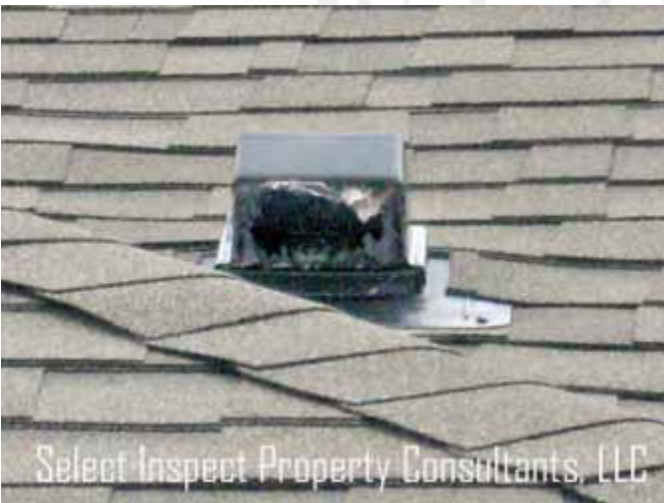
↑ dryer vent termination appeared congested; flapper appeared stuck open
