Property Consultants LLC

New Home Inspection Report **1492 Columbus; Freedom, TX**

March 11, 2008

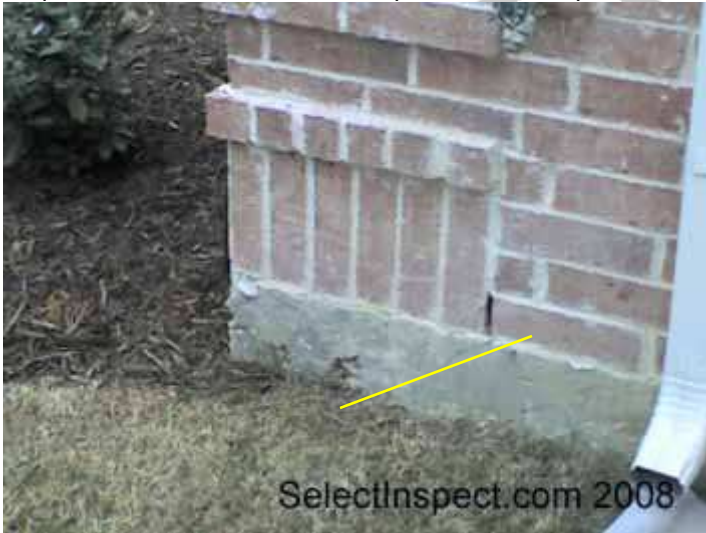
- The corner of the foundation is cracked at the west. This is common, even on young homes, and is typically not structurally significant. The joint of the cracked corner and the adjacent foundation is obstructed and conducive to termite entry.

↑ corner crack at north - Repair needs were not discovered at the time of inspection

- Regularly monitor the property and its components and arrange for repair if / when needed. Repairs should be made by qualified specialists whenever possible.

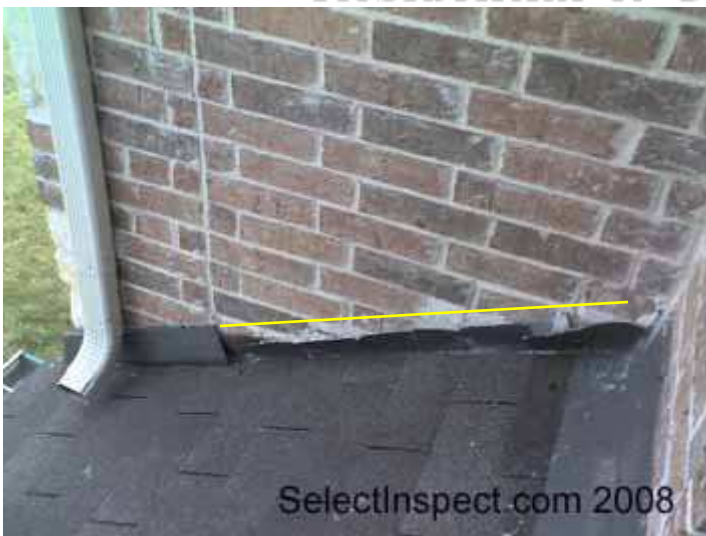
- Counter flashing was amiss / deficient at the left side of the front porch.
- The dead valley at the right rear of the garage and above the patio door have marginal / poor slope, and may not drain properly. This is conducive to debris accumulation and potential moisture intrusion. (see one or more related photos)
"Dead valley" description: A converging valley feature with a vertical wall joined by flashing at a convergence of one or more roof angles/valleys; this feature is commonly associated with a higher risk for leakage, due to water being directed toward rather than away from a wall, roof, and or flashing convergence. The roof, attic, and interior areas surrounding and below this feature should be inspected during different weather periods for leakage. These valleys will also create a higher risk of ice damming and potential moisture intrusion behind the shingles in winter.

↑ amiss / deficient counter flashing at porch roof - moisture intrusion concern

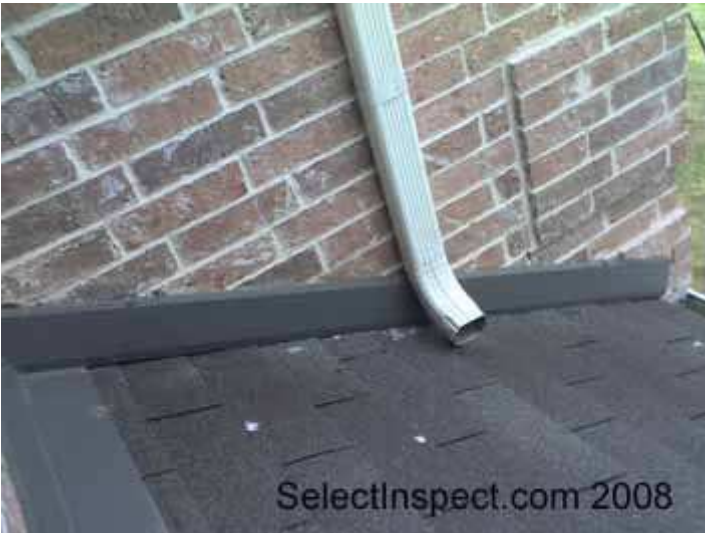
↑ correct counter flashing at opposite side of front porch roof

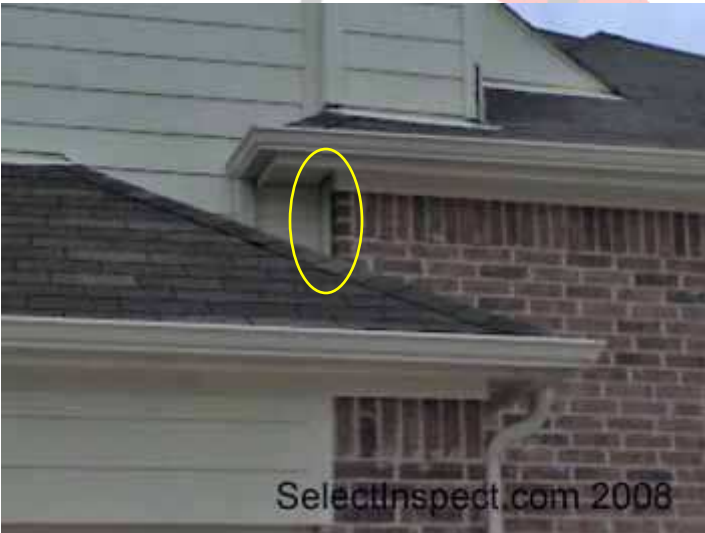
- Opening exists at the upper right of the garage and at the small roof feature above the master bathroom window . Correction / improvement would be prudent.

↑ openings and converging valley example at right garage

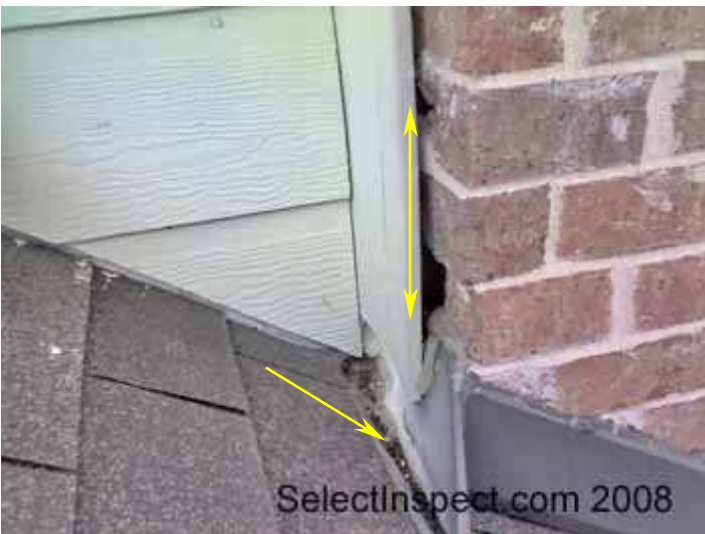
↑ close view of prior image- openings and low slope at small valley- upper right garage

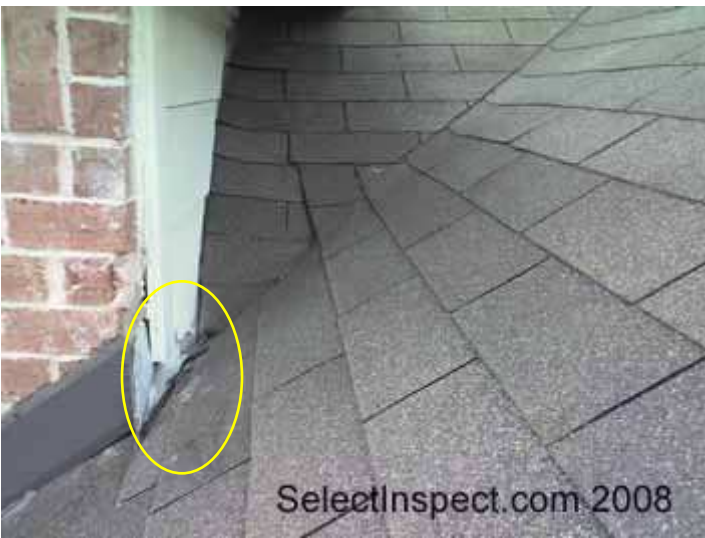
↑ low slope at small valley above patio door

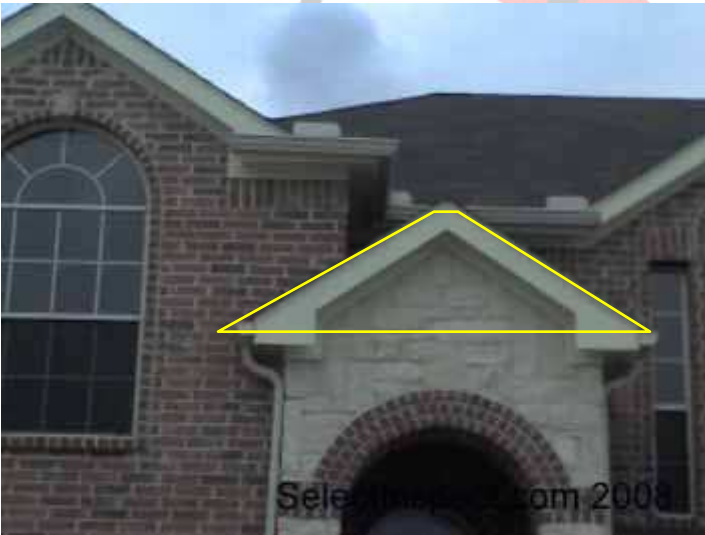
- The attic of the garage, entry arch, and above the breakfast nook appears poorly ventilated. Ideally any enclosed attic space would be vented; This can result in humidity, condensation, and fungal issues. Recommend installing one or two eave vents at the lowest eave, and a vent at the upper eave to allow this area to vent. IRC 806

↑ unvented entry ceiling/attic

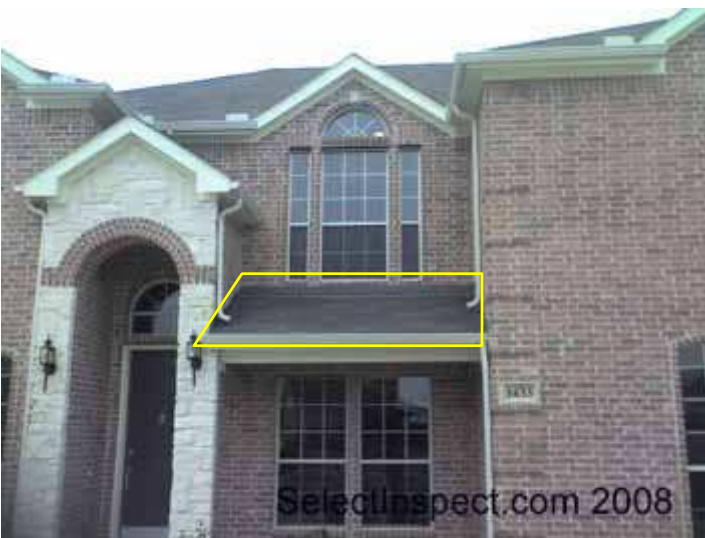
- The attic of the front porch appears unvented or poorly ventilated. Technically, any enclosed attic space should be vented. Inadequate ventilation can result in humidity, condensation, and fungal issues. Recommend professional correction to properly vent this space. IRC 806
- The small roof/attic above window(s) at the master bathroom appear(s) poorly or un-ventilated. Ideally any enclosed attic space would be vented; Lack of venting can result in humidity, condensation, and fungal issues. Recommend installing vents at the side or lower eaves depending on style of roof/eave. IRC 806 (see one or more related photos)

↑ unvented porch

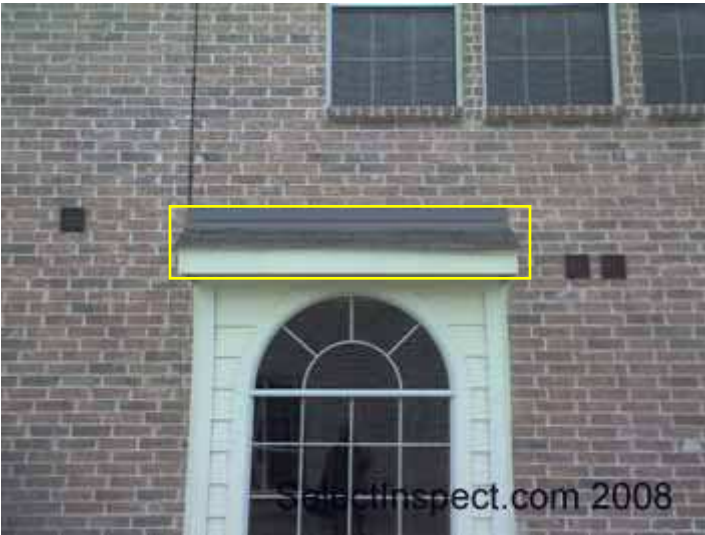
↑ unvented enclosed attic at master bathroom window

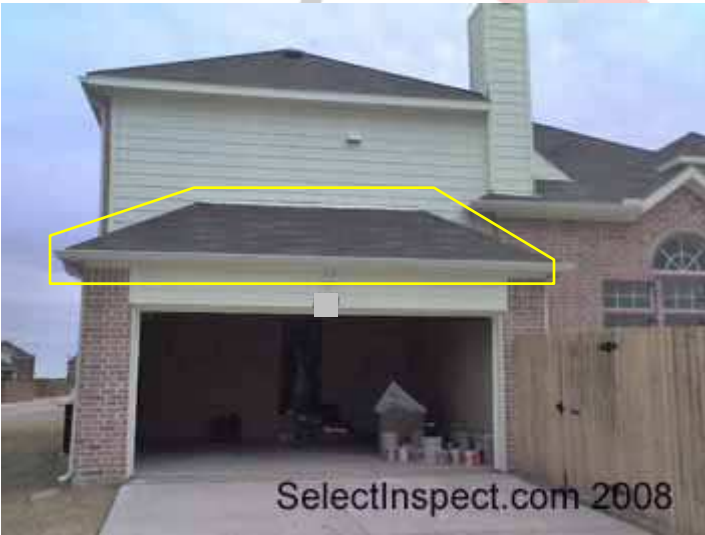
↑ unvented garage attic

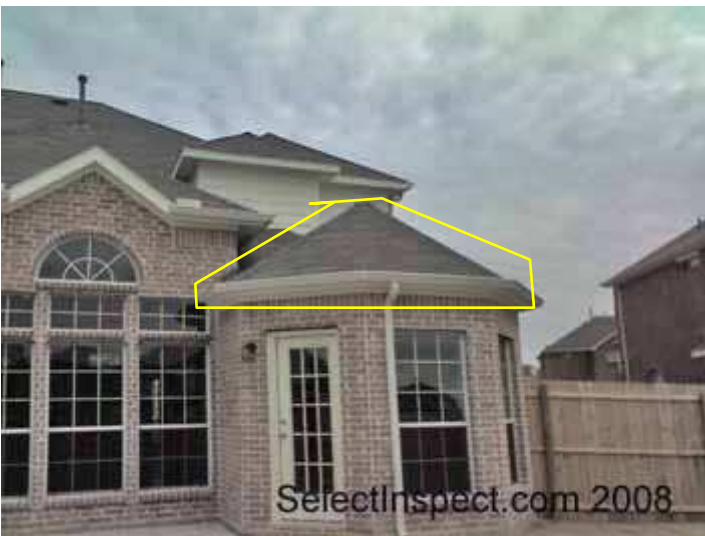
↑ only eave vents/ marginal venting- at breakfast nook enclosed attic

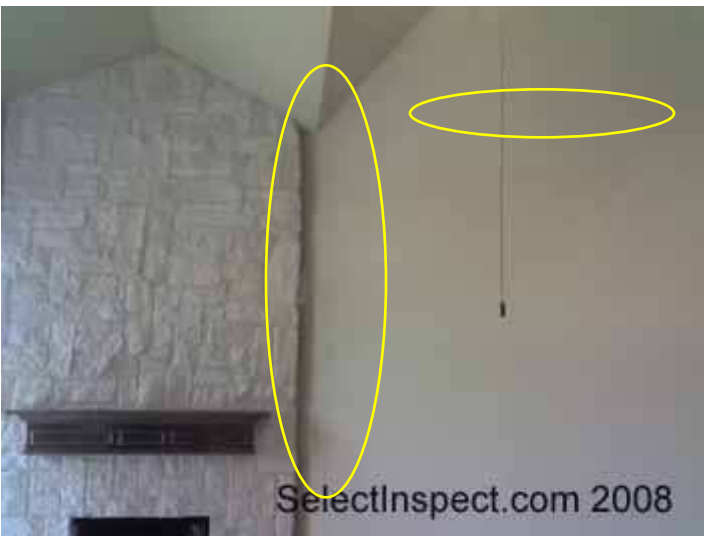
- Moisture intrusion was discovered adjacent the chimney at the family room/fireplace. Chimney flashing appeared satisfactory at the roof and the builder reported that drywall/interior component repair had been arranged. We do not perform mold testing, and did not take fungus or air samples from the home. If you are concerned about health related issues, we recommend that you consult an indoor air quality firm for evaluation and options for cleaning. Researching and evaluating various firms and their methods for remediation would be prudent, if you plan to pursue those measures.
- Cosmetic details were not complete at the time of inspection; such as cabinetry, paint, grout, caulking details.

↑ moisture intrusion evidence at family room/fireplace

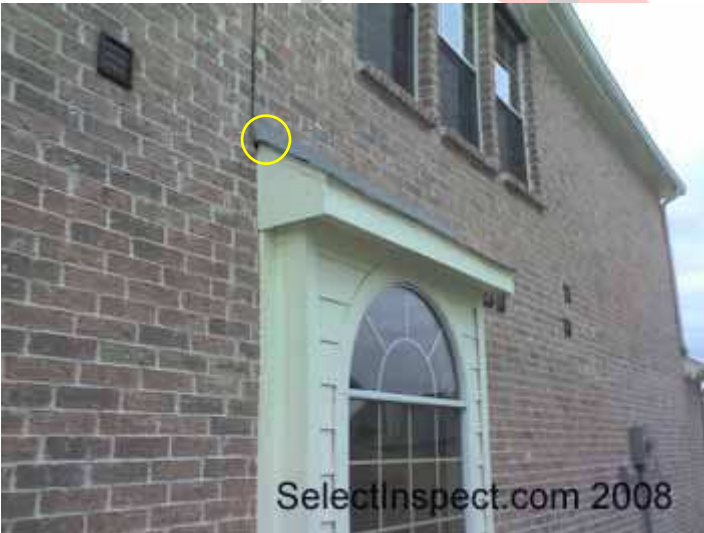
↑ opening adjacent master bathroom window

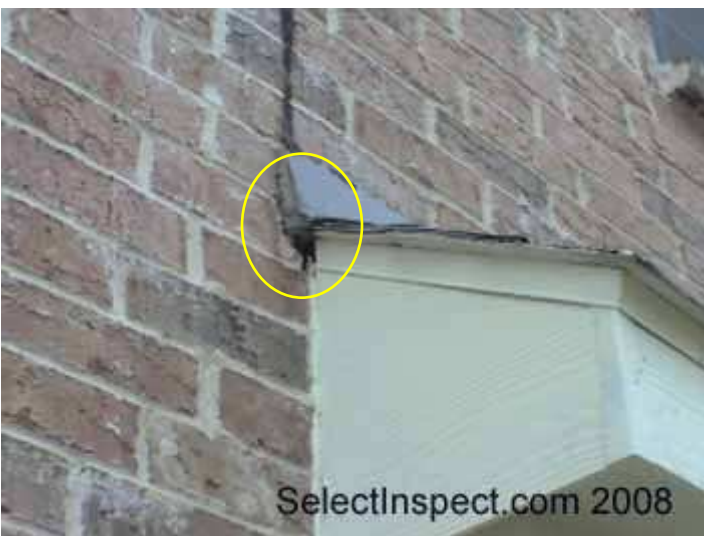
↑ close view of prior image- moisture and pest intrusion concern

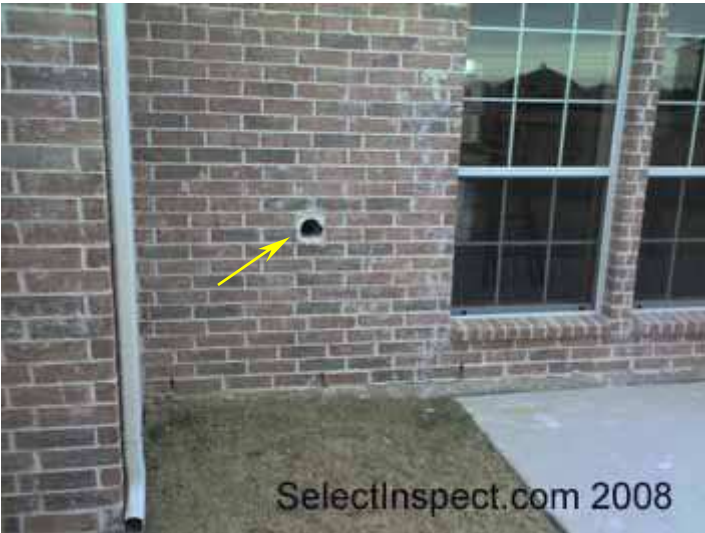
↑ missing cover at fireplace air intake vent

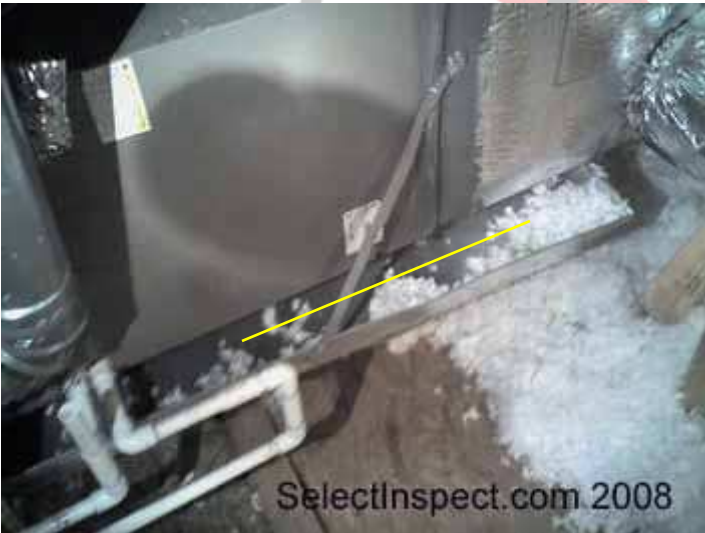
- Evaporator pans have debris (insulation) that may obstruct the auxiliary condensate line(s) in the event the primary condensate line does not function properly. The pan debris should be removed.

↑ insulation debris in auxiliary pan- air-conditioner

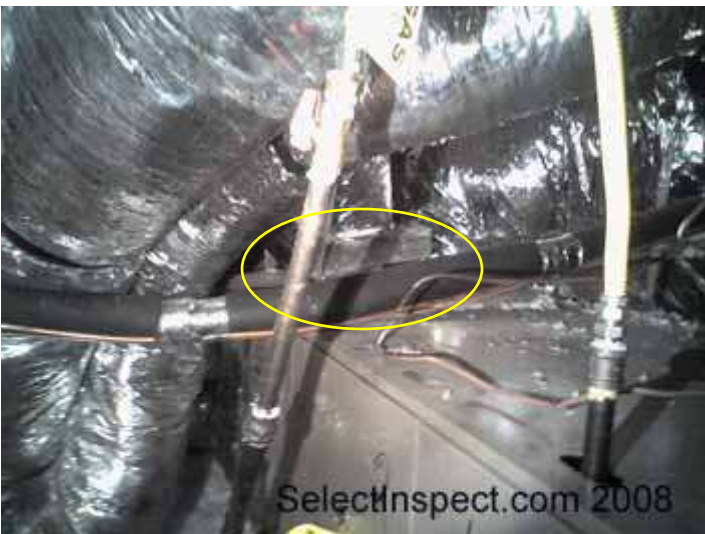
↑ auxiliary filter location- unit #2

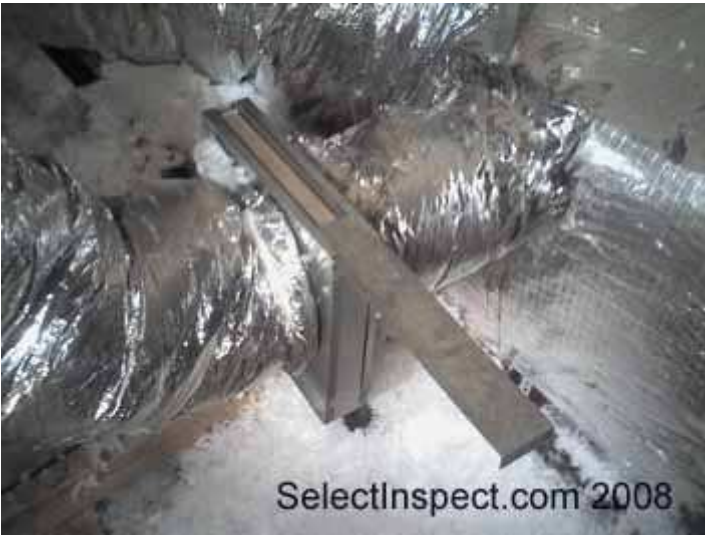
↑ auxiliary filter location- unit #1

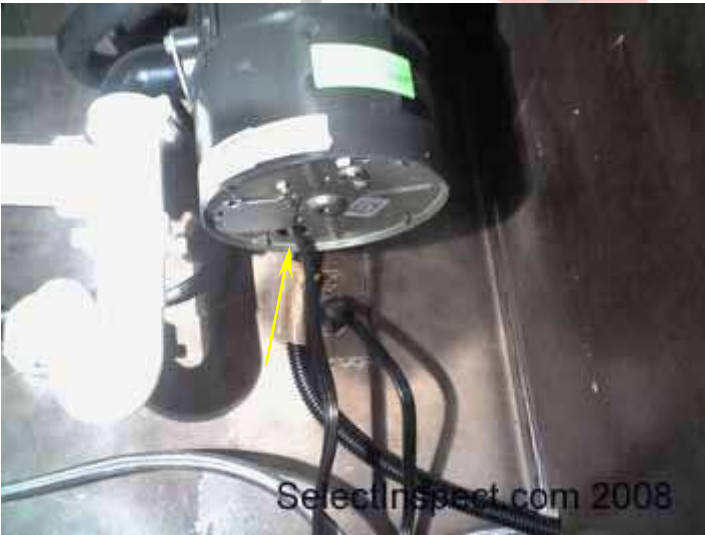
- **dishwasher:** The dishwasher was not properly secured and or leveled.
- **disposal:** The clamp to secure the electrical wires where they enter the disposal unit was amiss / deficient. This is inexpensive and easy to do. Repair is recommended.
- **doorbell:** operable
- **dryer vent:** Repair needs were not discovered at the time of inspection
- **exhaust fan(s):** Repair needs were not discovered at the time of inspection
- **garage door operator:** operable
- **kitchen vent:** operable
- **microwave:** operable
- **oven:** operable
- **range / stove:** operable – gas shut-off valve located below in cabinet

↑ missing electrical clamp at disposal base
