New Construction Phase 1; Pre-pour Inspection

at: **54321 New Street; The Colony, TX 75034**

New Construction Phase Inspection; day of the pour

Sept. 22, 2008

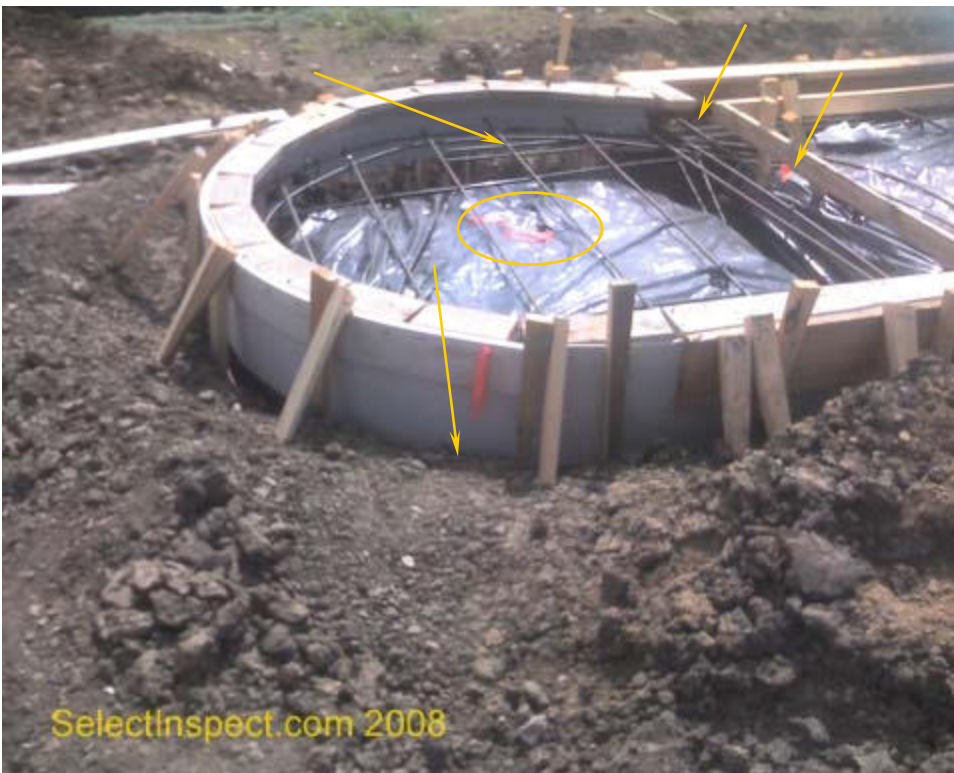
↑ debris in trenches, torn vapor barrier, and less than 3" separation of reinforcing steel to soil

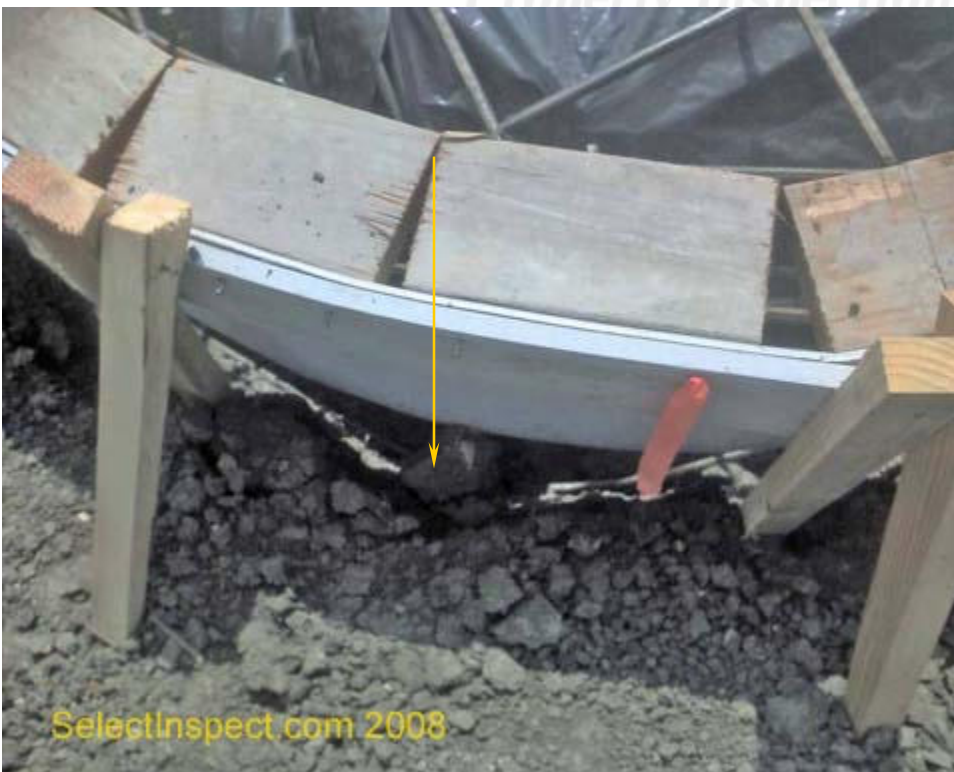
↑ dirt chunks in trench, and less than 3" separation of reinforcing steel & soil

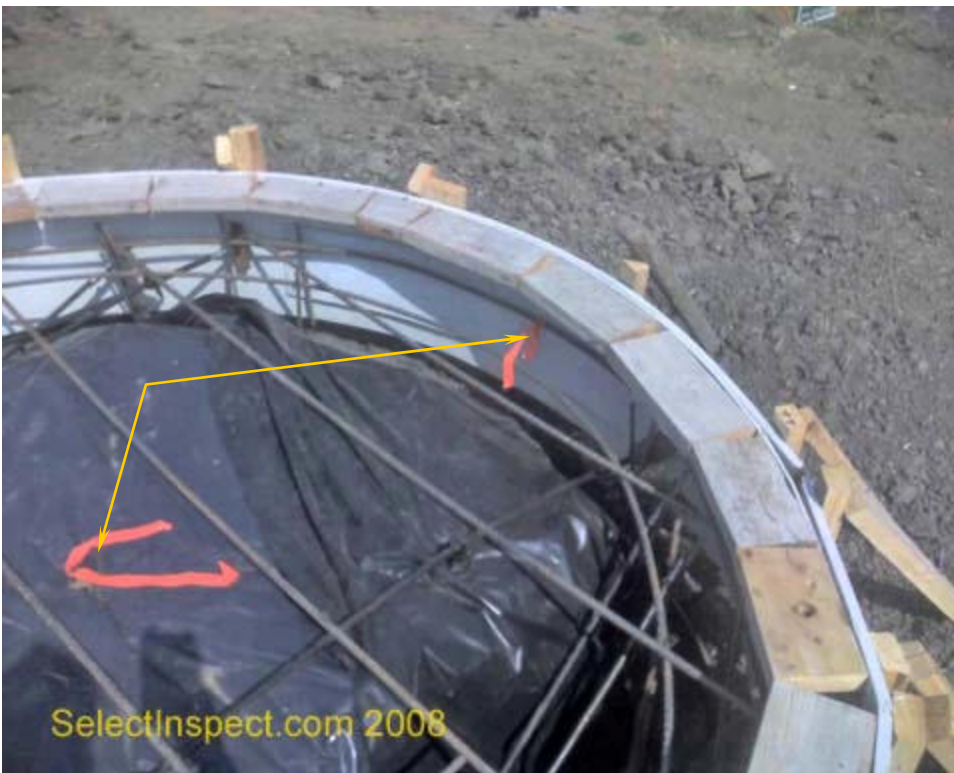
↑ torn vapor barrier and less than 3" separation of reinforcing steel & form

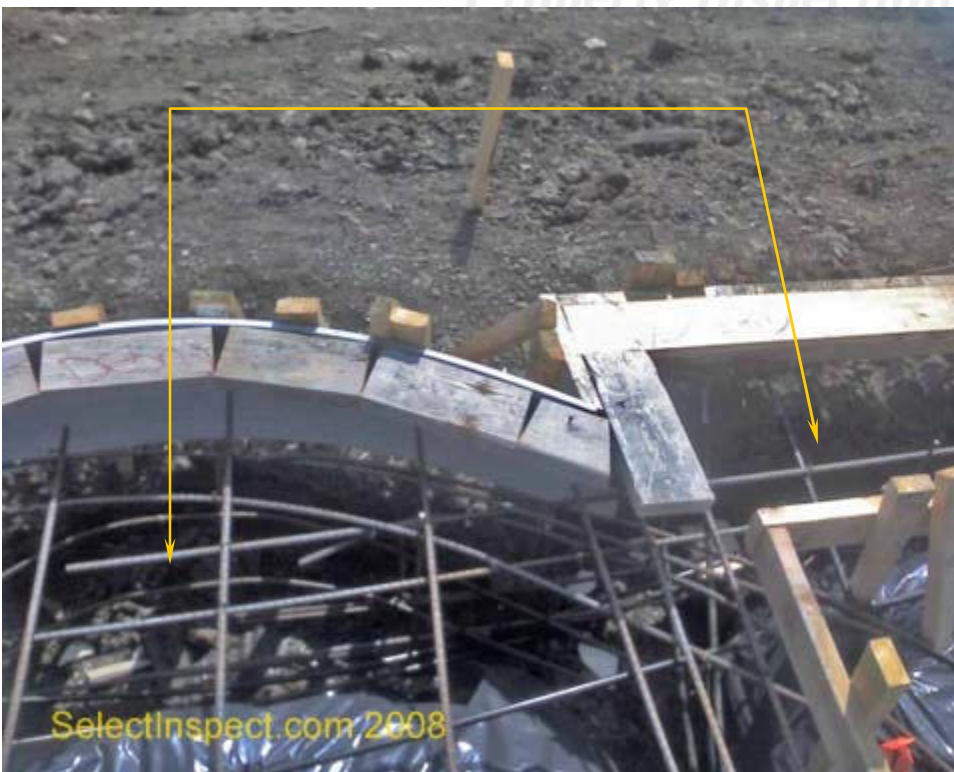
<input type="checkbox"/>	<input checked="" type="checkbox"/>	<input type="checkbox"/>	Construction debris/trash exists in trenches	Debris and large pieces of soil should be removed from the trenches at the northeast & southeast.
Electrical			Electrical	
<input type="checkbox"/>	<input type="checkbox"/>	<input checked="" type="checkbox"/>	Electric grounding (Ufer) appropriate	Not discovered
<input checked="" type="checkbox"/>	<input type="checkbox"/>	<input type="checkbox"/>	Electric conduit in place for kitchen island or similar	Satisfactory
<input checked="" type="checkbox"/>	<input type="checkbox"/>	<input type="checkbox"/>	Electric Temporary service pole secured	Satisfactory
<input type="checkbox"/>	<input type="checkbox"/>	<input checked="" type="checkbox"/>	Electric GFCI protected 15, 20, & 30 amp circuits	
<input type="checkbox"/>	<input type="checkbox"/>	<input checked="" type="checkbox"/>	Electric; other	Repair needs were not discovered at the time of inspection

↑ debris in trenches

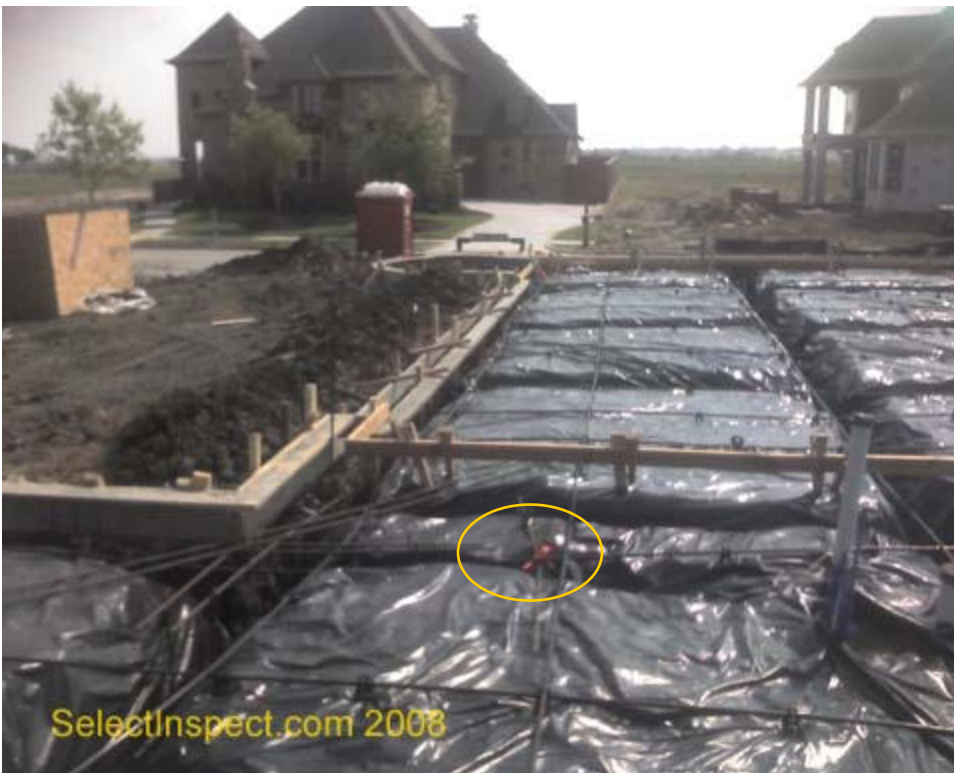
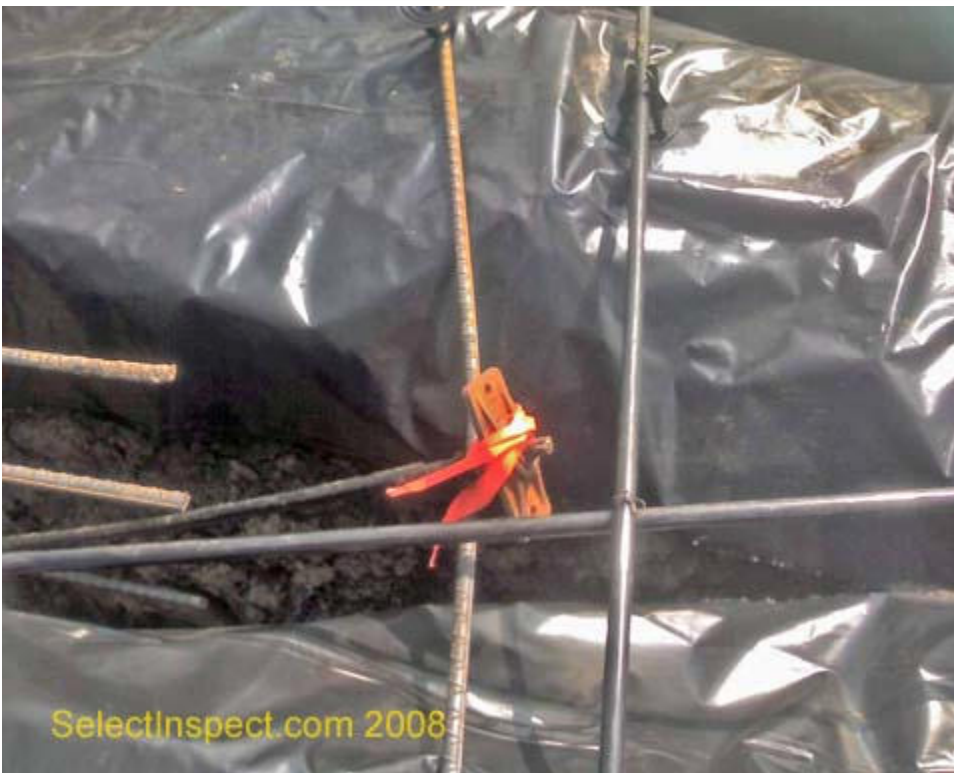
↑ unsecured dead end of post tension cable; after the concrete cures, this may be stable enough by the lateral reinforcing steel it is attached to, but the condition is unconventional, and I recommend the builder's engineer examine and determine if additional bracing is required.

↑ close view of image above

The post tension cable dead end that was noted as questionable in your pre-pour report, was confirmed as approved in the plans; satisfactory.

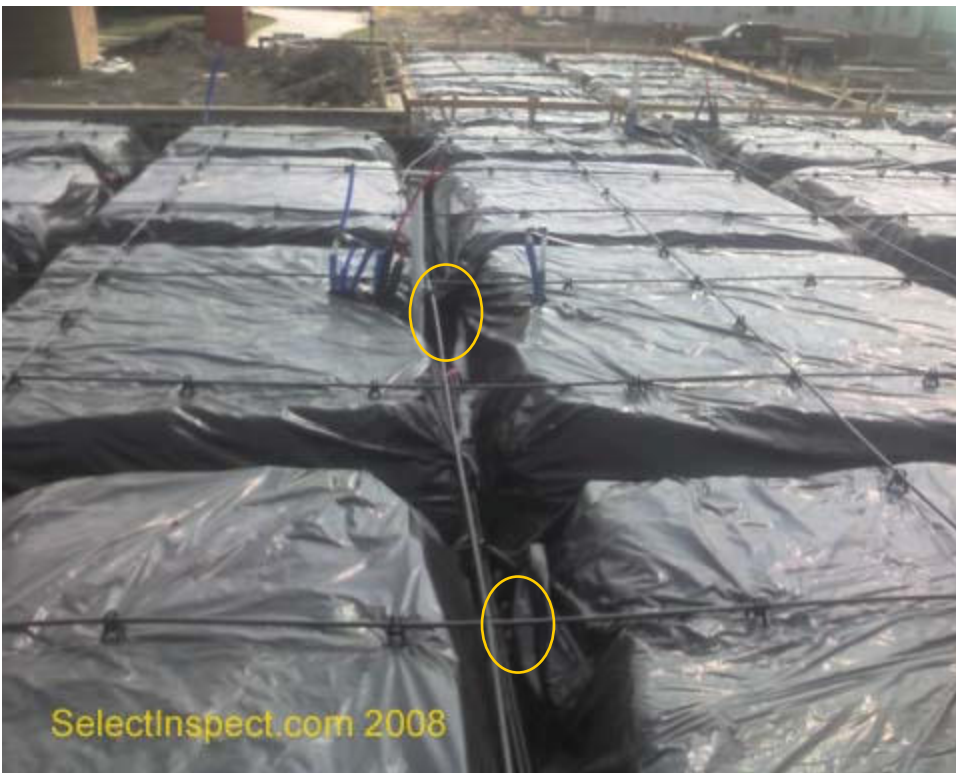
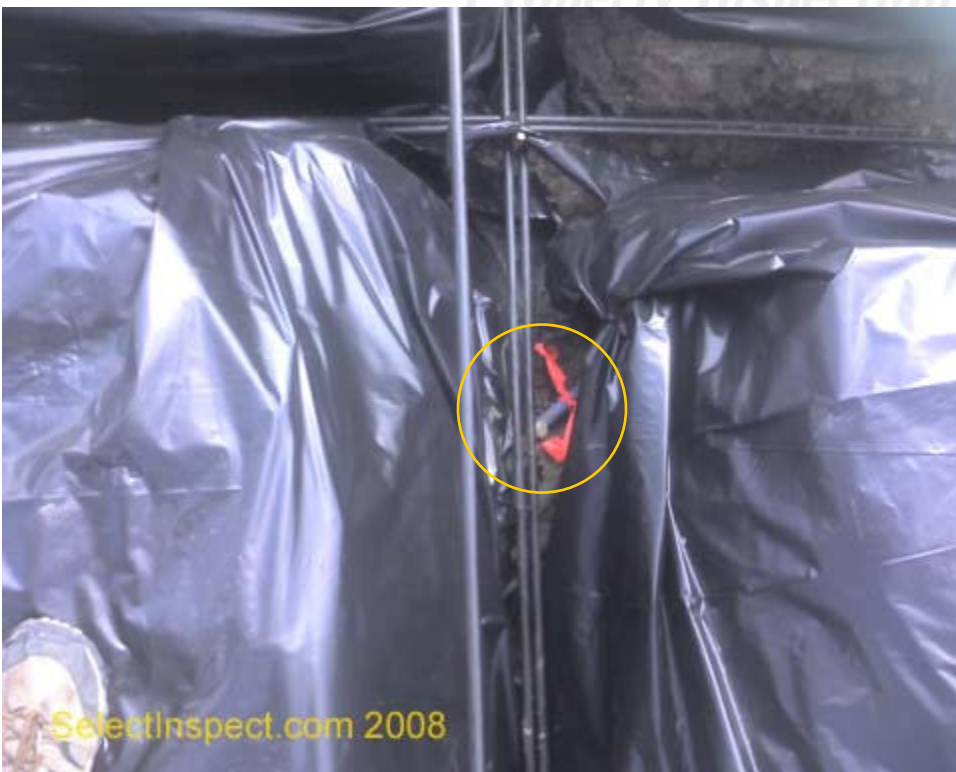
Plumbing			Plumbing	Plumbing
<input type="checkbox"/>	<input checked="" type="checkbox"/>	<input type="checkbox"/>	Plumbing: wrapped / sleeved appropriately at concrete penetrations	Unprotected supply pipes exist at the west, northwest, central, and central north areas; discovered deficiencies were marked with orange ribbon.
<input type="checkbox"/>	<input type="checkbox"/>	<input checked="" type="checkbox"/>	Plumbing: copper & galvanized- no contact allowed	Satisfactory
<input checked="" type="checkbox"/>	<input type="checkbox"/>	<input type="checkbox"/>	Plumbing: not located within 45 ° below footing	Satisfactory; issues not discovered
<input checked="" type="checkbox"/>	<input type="checkbox"/>	<input type="checkbox"/>	Plumbing: pipes fully supported	Satisfactory
<input checked="" type="checkbox"/>	<input type="checkbox"/>	<input type="checkbox"/>	Plumbing: drains slope min 1/4" per foot	Satisfactory

↑ unprotected plumbing supply pipe that will be routed through the concrete.

↑ close view of image above

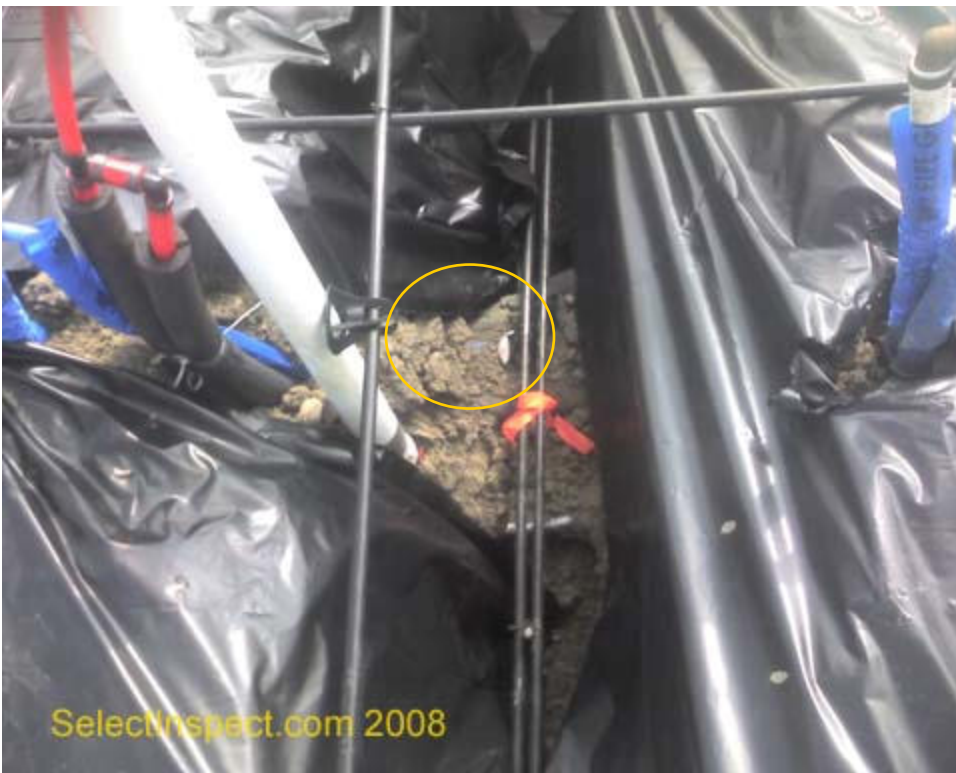
↑ unprotected plumbing supply pipe that will be routed through the concrete. Upper area of top image on prior page

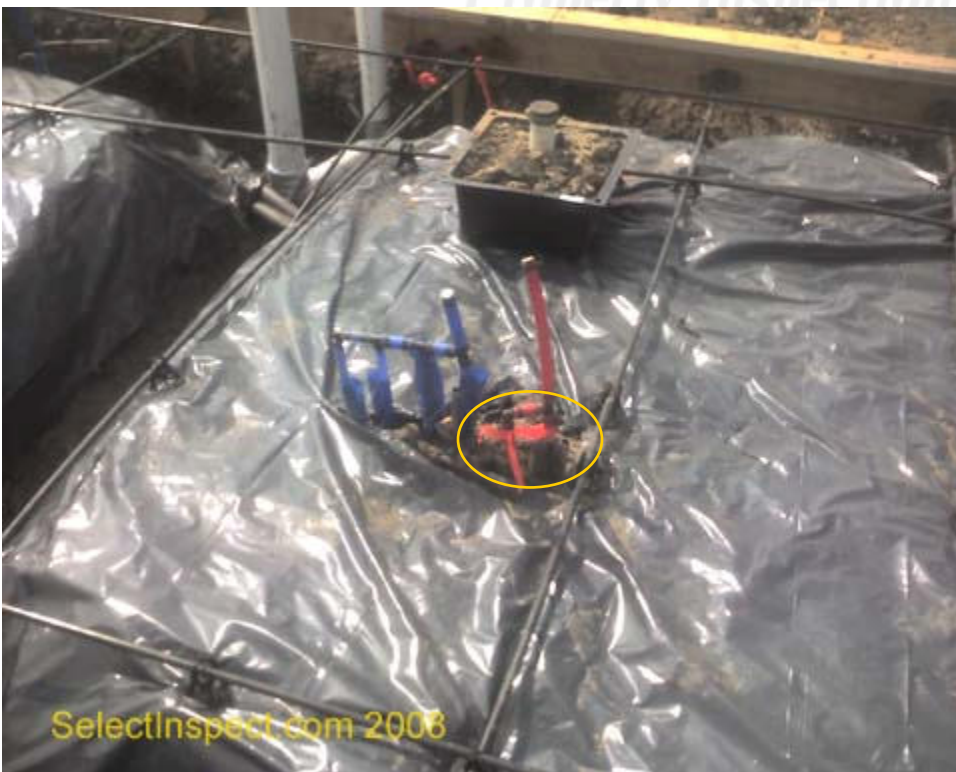
↑ unprotected plumbing supply pipe that will be routed through the concrete. South

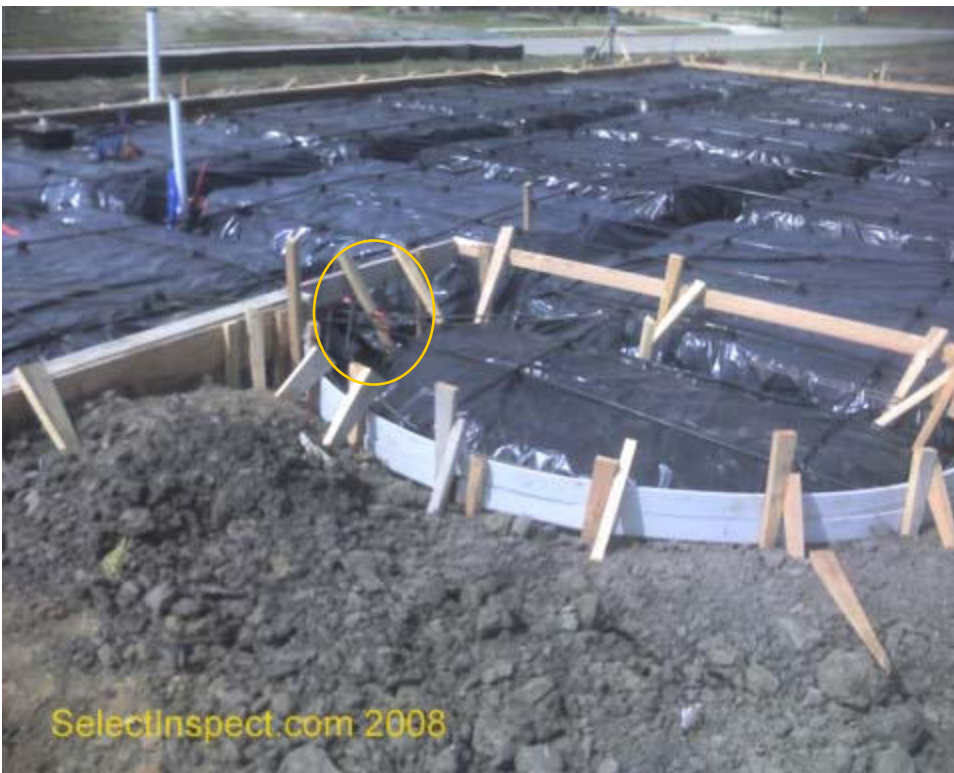
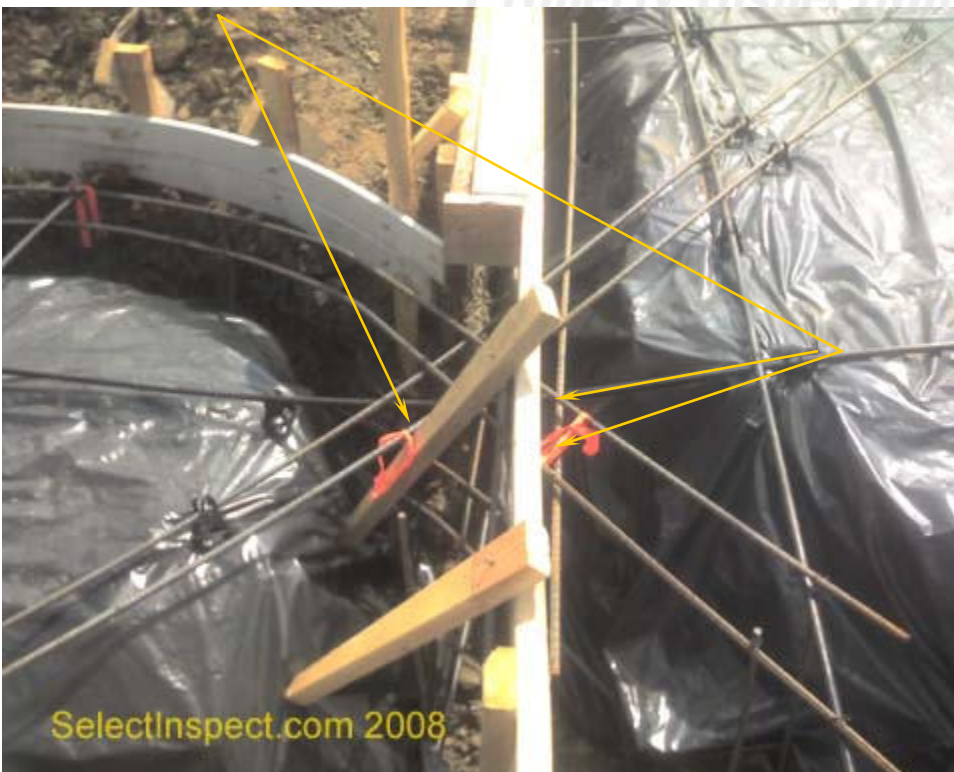
↑ reinforcing steel is touching the forms at the front rounded feature.

↑ close view of prior image; reinforcing steel is touching the forms at the front rounded feature. Recommended an offset of at least $\frac{3}{4}$ " for concrete to pass on all sides.

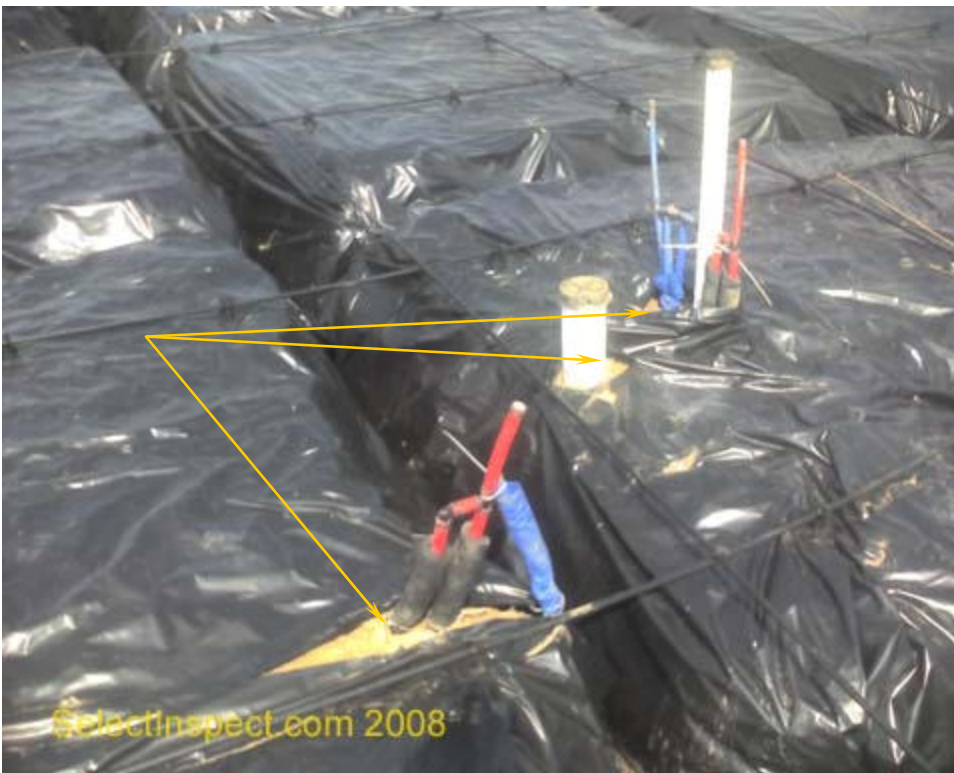
↑ large gaps at vapor barrier should be better sealed with minimum 6" overlap. This is to resist moisture seepage up from the soil into the concrete.

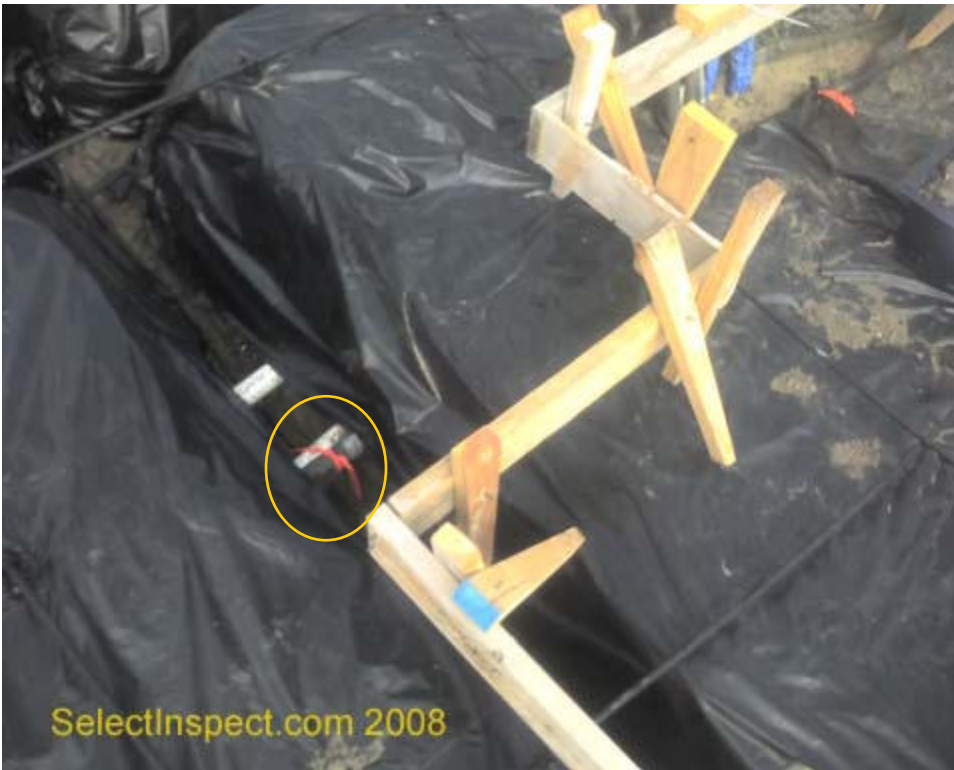
↑ unprotected plumbing supply pipe that will be routed through the concrete. Insulation was open and deficient.

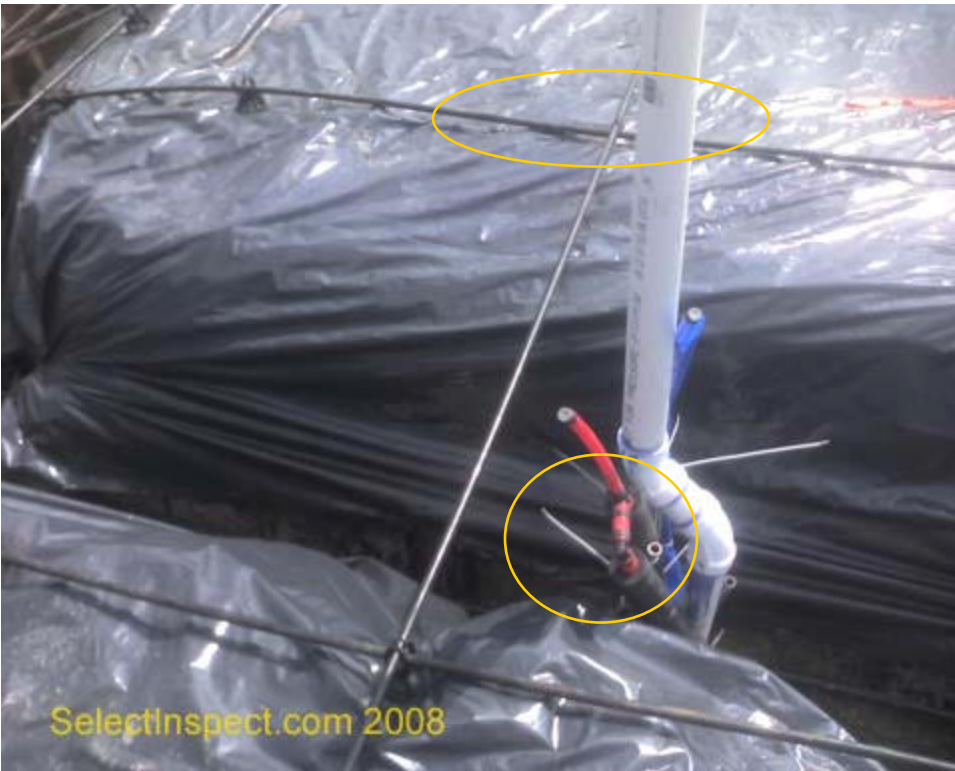
↑ upper- chair needed to raise the post tension cable off the vapor barrier/pad; example lower- unprotected plumbing supply pipe that will be routed through the concrete.

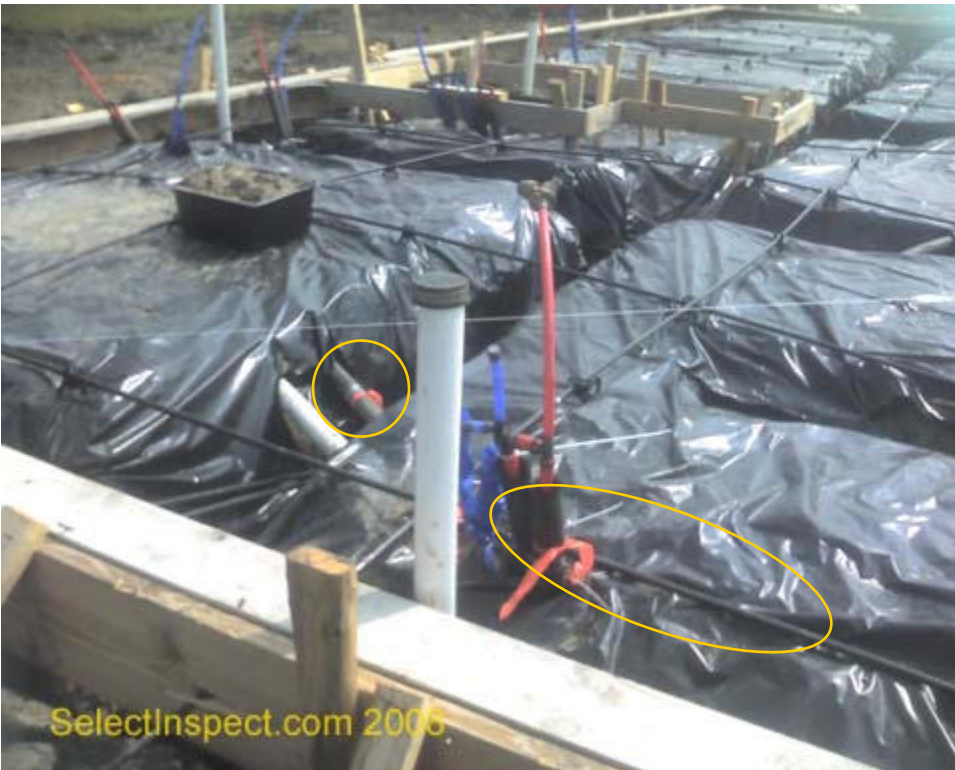
↑ chair needed to raise the post tension cable off the vapor barrier/pad; example and deficient insulation/protection of plumbing supply at northwest

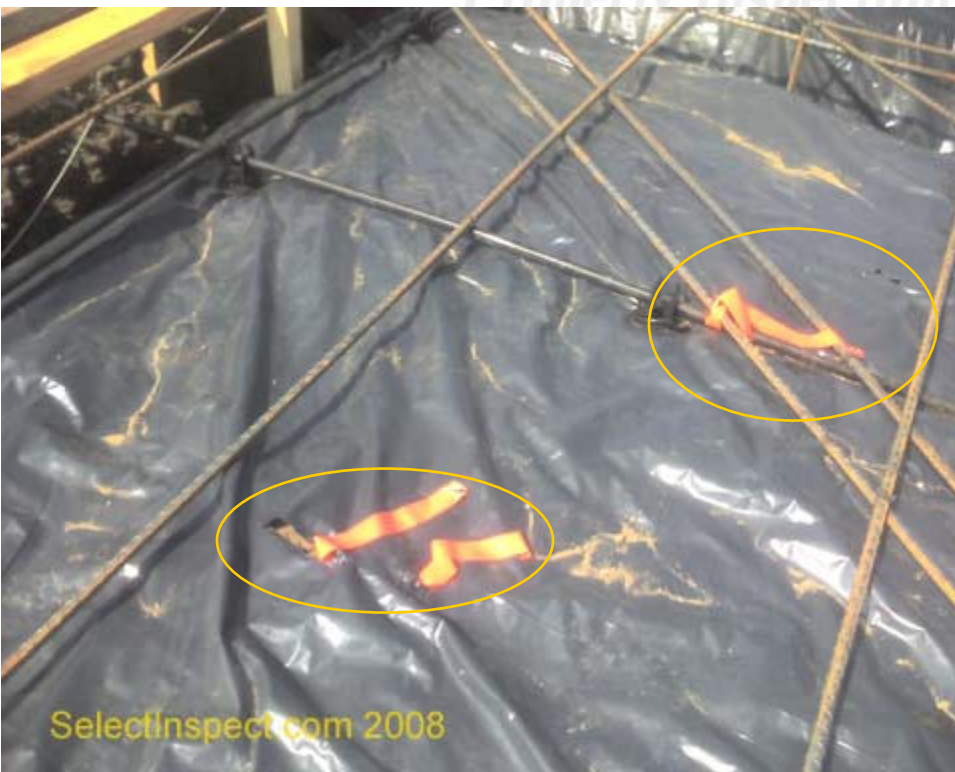
↑ chair needed to raise the reinforcing steel off the vapor barrier/pad & openings in the vapor barrier; reinforcing steel shall be supported on chairs, not by post tension cables; example

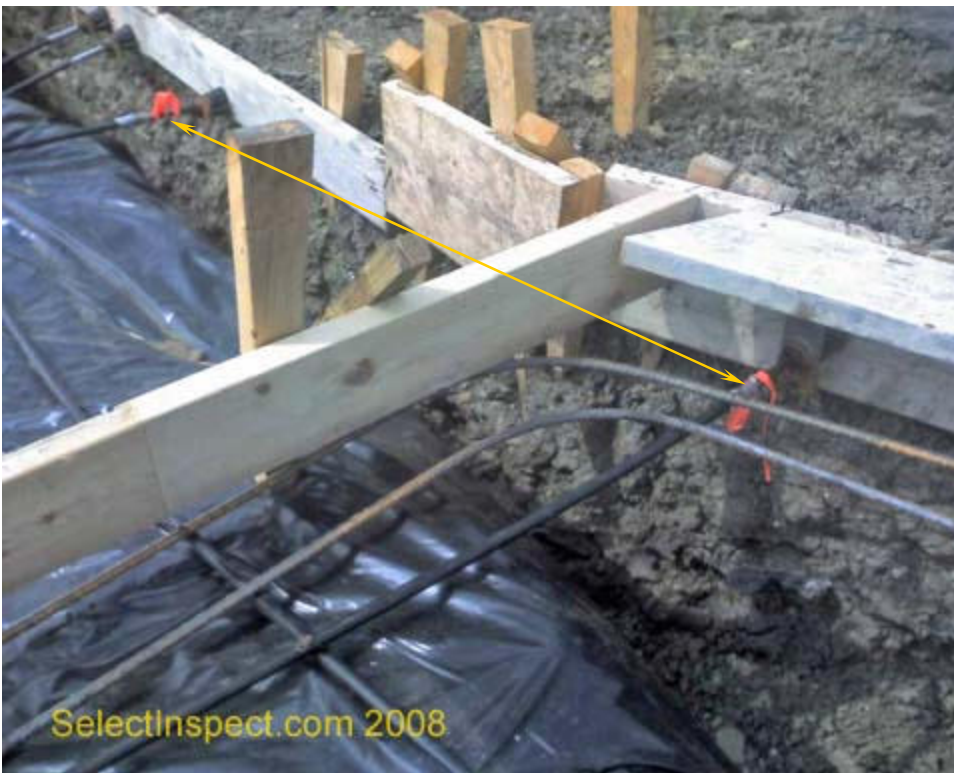
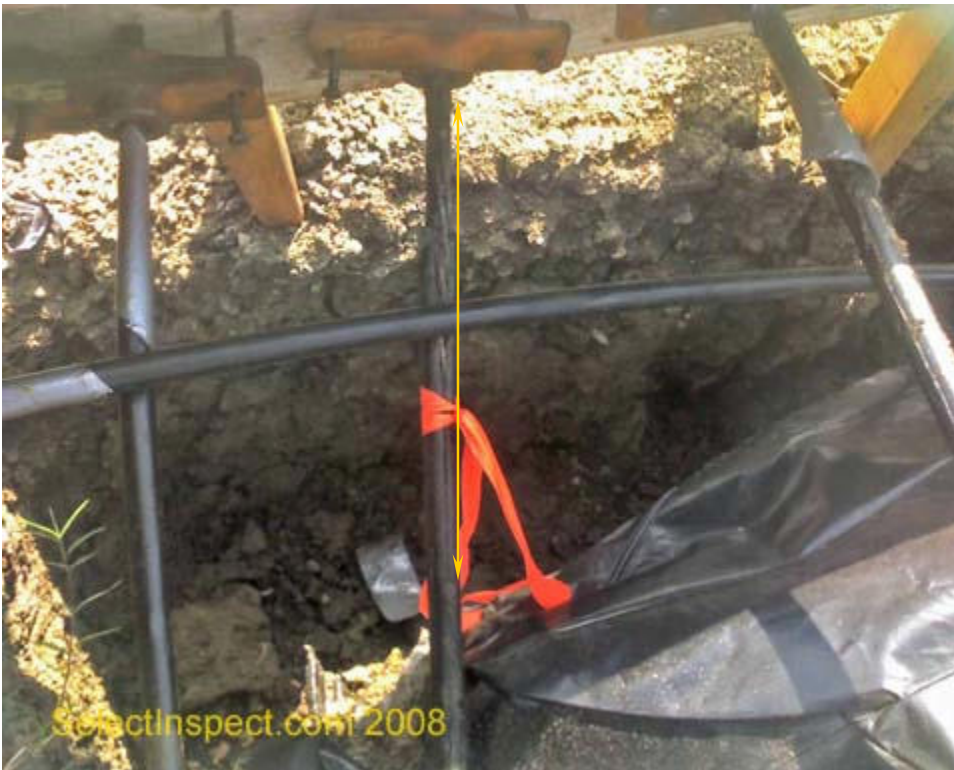
↑ post tension cable sleeve ends need better tape to protect the steel from the corrosive ingredients of concrete; example

↑ close view of prior image post tension cable sleeve ends need better tape to protect the steel from the corrosive ingredients of concrete.

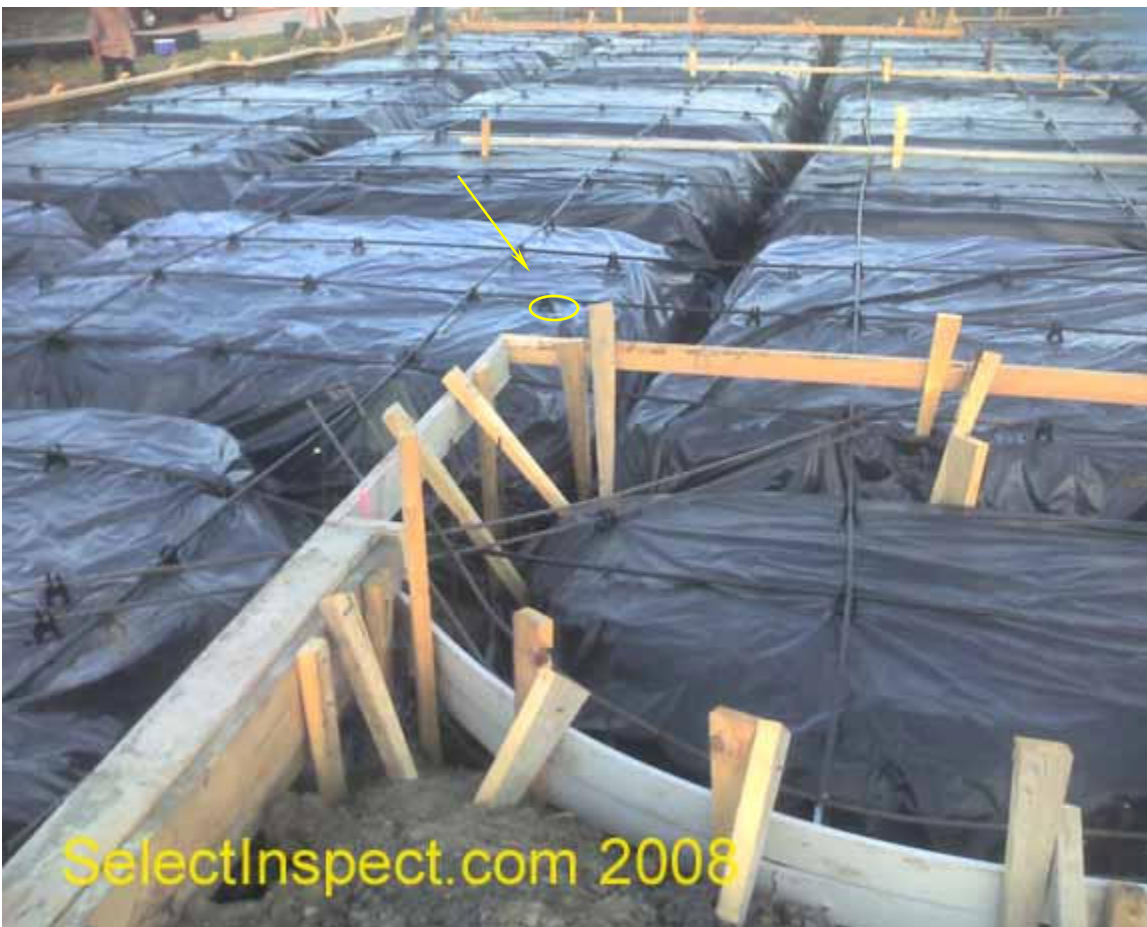
↑ wood stake was broken off below the soil at this location; I removed as much as possible without compromising the vapor barrier and soil pad. This will not significantly affect the foundation, though over time the wood will decay and this location may be more prone to wood destroying insect entry.

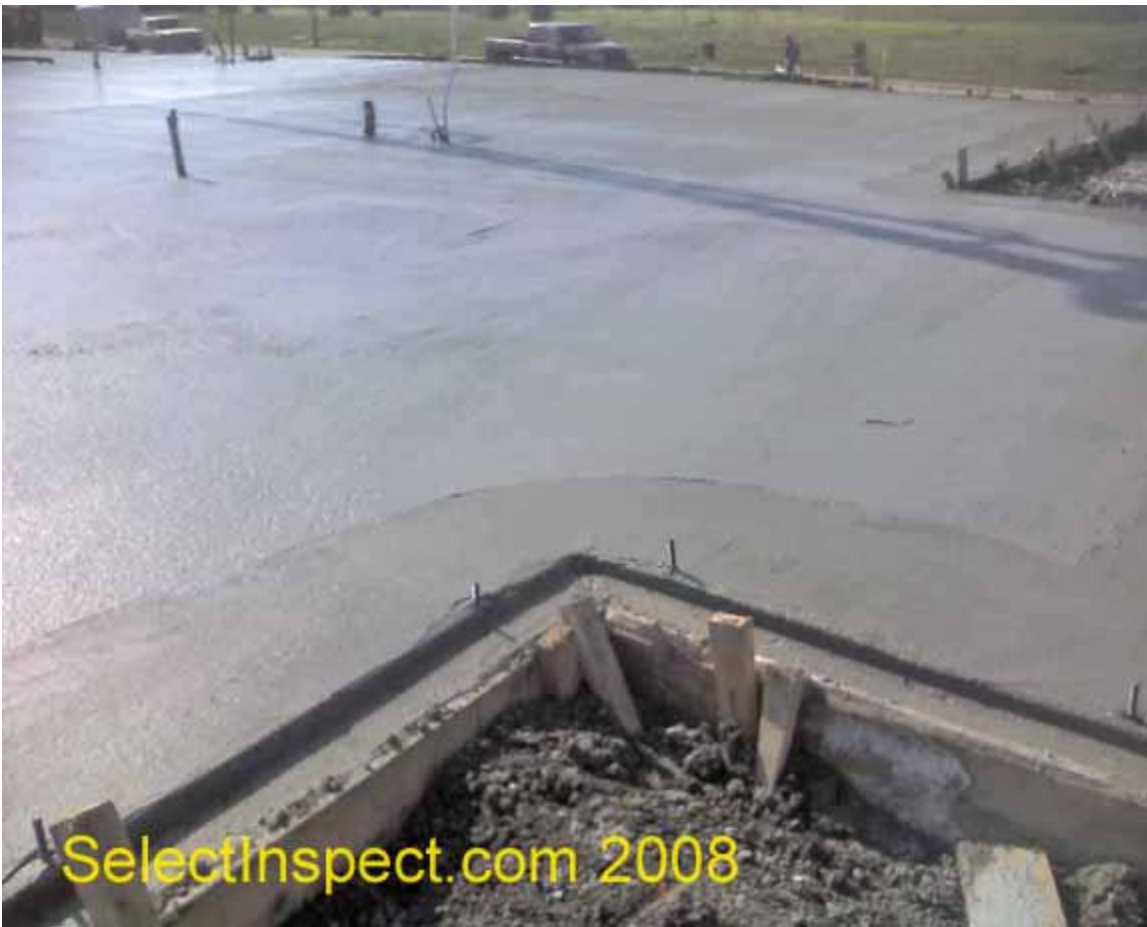
↑ placement of anchor bolts was made after smoothing and the brick ledge forms removed as the concrete begins to firm. Remaining forms should be removed after curing @ approximately 5-7 days. The slab should be kept consistently moist to aid in curing. Wetting and covering with a moisture barrier may be necessary if temperature remains in the upper 80° - 90° range.

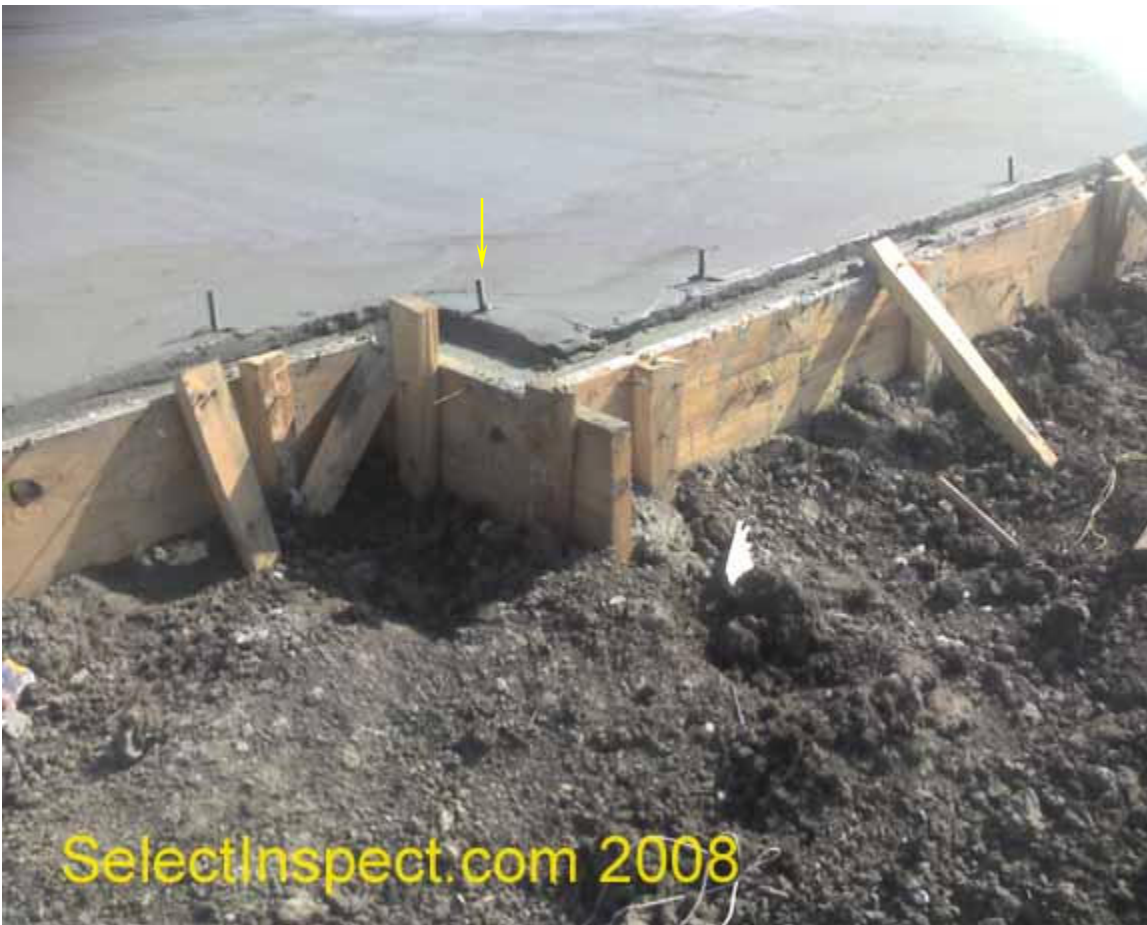
↑ a few of the anchor bolts were not completely vertical; Generally the framers can work with this without issue. Significant issues were not found or observed concerning this item at the time of inspection, this can be improved by drilling out and replacing with an approved concrete epoxy or other architect approved method.
