# Select Inspect

## New Construction Phase Inspection

at: **54321 New Street; The Colony, TX**

October 29<sup>th</sup>, 2008

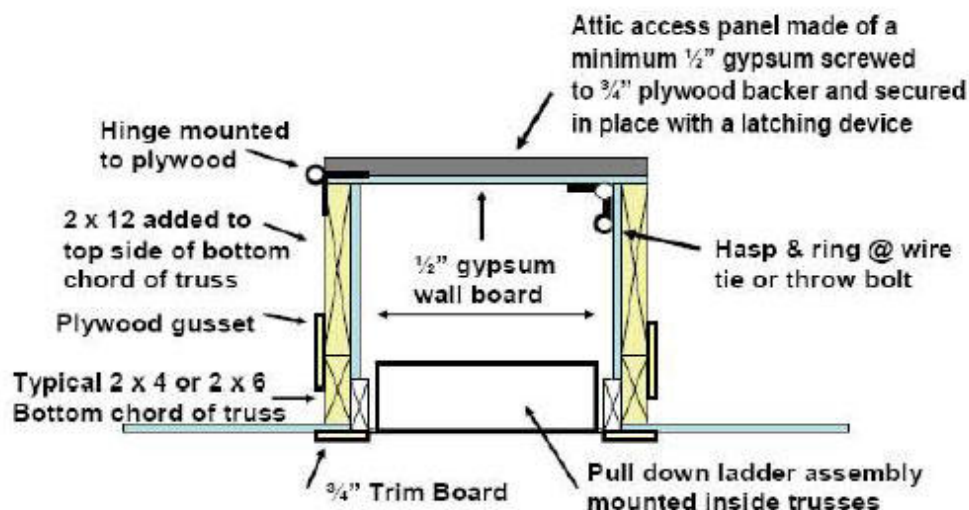
- If a common access door will be installed; it will breach the firewall provisions for attached garages. The ladder door/cover at the garage attic access would then be deficient and not meet IRC R309.2 separation required for fire-spread at attached garages. The partition wall between a modern home and an adjoining garage typically is covered by 5/8 inch drywall, to slow the spread of a garage fire to the dwelling. If the garage attic and house attic are not also divided by a firewall, then the garage ceiling becomes part of the fire separation and must also be finished with 5/8 inch drywall or equivalent fire-rated material. The access cover on a folding ladder is a sheet of 1/4 inch plywood. When installed in a garage ceiling, this thin wood membrane replaces a portion of the fire-resistant drywall board, thereby breaching the required fire separation.

**Pull down garage attic ladder installation requirements to maintain fire resistive separation**

Option 1) Minimum 1 hour fire-rated material should be installed in the attic, creating a solid wall, including 4' of material at the rafters to adequately separate the garage attic.

Option 2) Minimum 1 hour fire-rated material should be installed on the garage side of the enclosure. The door shall be positioned to self-close (less than 90 degrees opening). Edges around the stairway gypsum covering shall be tight to the surrounding ceiling.

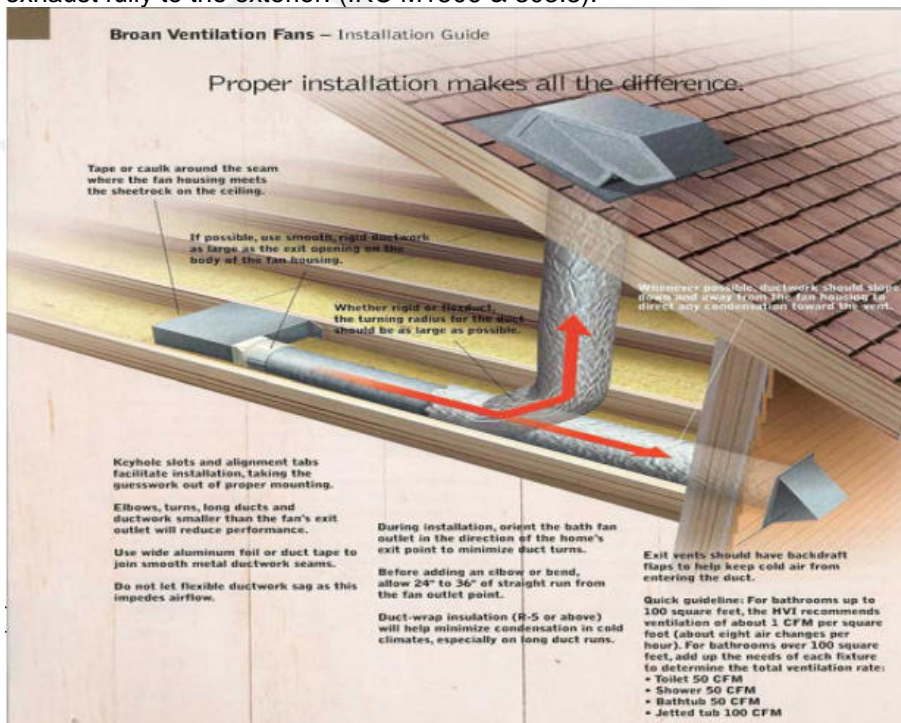
- Some or all bathroom /laundry exhaust fans appear to be intended vent terminations to the eaves. Vent termination within the attic, at passive roof vents, or at eave vents does not meet manufacturer guidelines. Current standards require venting of bathroom and utility room exhaust fully to the exterior. (IRC M1506 & 303.3).

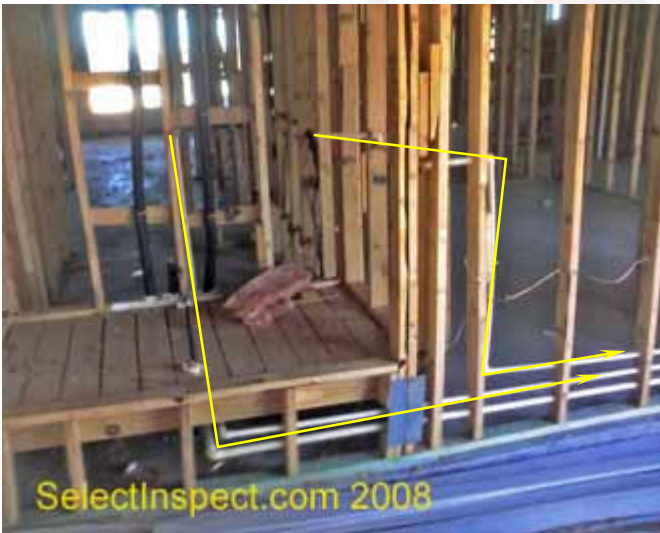
- The temperature-pressure-relief valve piping was deficient for this application; ¾" cpvc (hot water PVC) as found in this home is frequently used and is inappropriately accepted by city code around the USA, however, the ¾" material does not meet manufacturer requirements. T&P valve manufacturers require that the interior diameter of the drain line not be less than the interior diameter of the discharge section of the valve – a standard ¾". The ¾" CPVC tubing in use measures an average 0.715" interior diameter (technically .035" less than required). If CPVC is to be used it and all cpvc connectors must be 1" O.D. to conform to IRC P2803.6.1.
- Water heaters had not yet been installed.

↑ deficient piping size at water heater temperature-pressure-relief lines

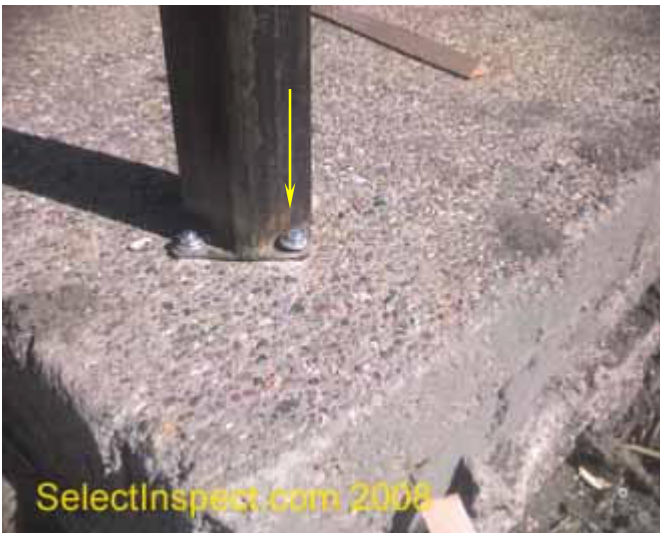
- Southwest post bolt fastener was poorly secured. Correct the condition and proceed.

↑ unsecured bolt nut at southwest porch column/post

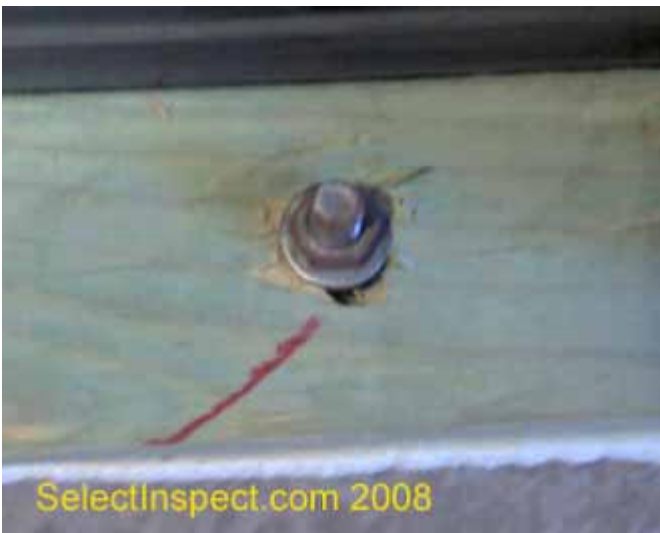
- Anchor bolts at family room southwest have missing or otherwise deficient washers (between the nut and sill plate).
- Anchor bolt holes at guest bedroom, master closet, and hall bathroom (behind the shower pan) have been over-drilled (a hole greater than 5/8") which creates reduced lateral resistance. The bolt manufacturer offers bearing plates (BP/LBP/BPS/LBPS) to correct the condition and distribute the load more appropriately.

↑ excessive drill hole at anchor; example

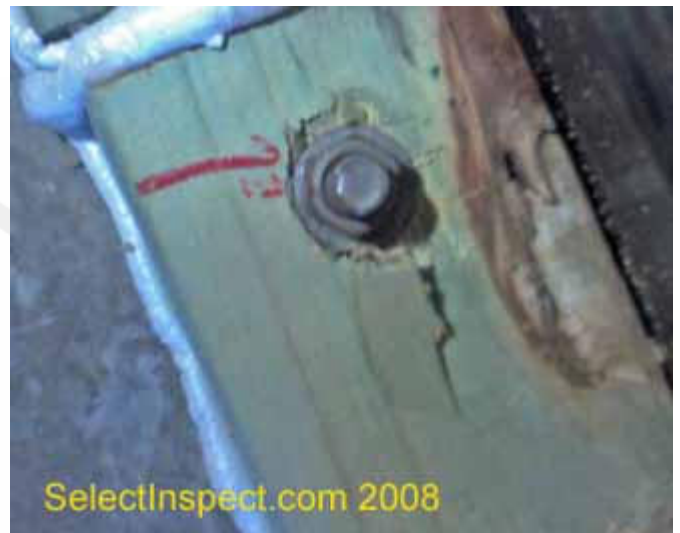
- Anchor bolts at master bedroom and family room central west have nuts that were not tightened enough/properly.
- Anchor bolts at guest bedroom, master closet, bedroom 2, bedroom 3, family room northwest have been over-tightened; compressing and cracking the sills. This deviates from manufacturer fastening requirements.

↑ over tightened anchor; example

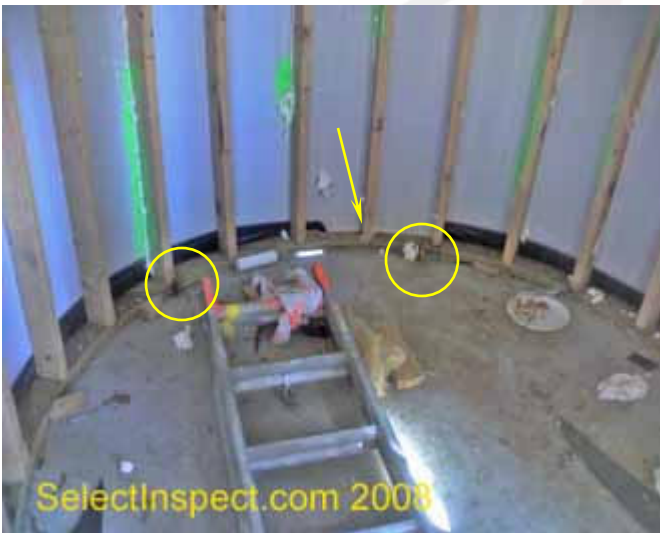
- Anchor bolts at the rotunda were misplaced (or the sill was misplaced). The bolts were not in a position to secure the sill plate(s) to the foundation. The sills should be appropriately secured to the foundation, and the protruding bolts cut off without damaging adjacent

- Vapor barrier was deficient at the north side of the rotunda; lower edge.
- Foam touch-up is needed at guest bedroom windows, bedroom 2 upper left corner of the central window, master bedroom windows.

↑ misplaced anchors and deficient vapor barrier at rotunda

construction materials. The building's architect or engineer should examine the condition and prescribe a repair.

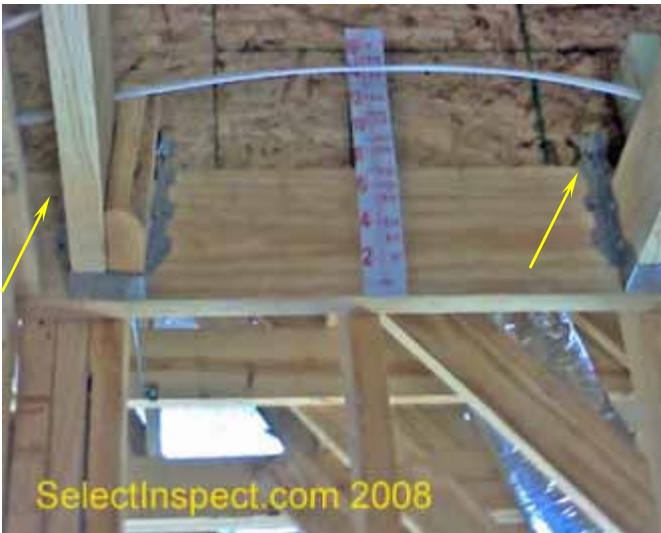
- Joist hangers/or similar steel brackets were incorrectly fastened at the southeast bathroom at two upper east locations. Hangers should be fit to the related framing; and all nail openings should be filled with appropriate fasteners. -see related photo(s)

↑ deficient fasteners at southeast bathroom joist hangers

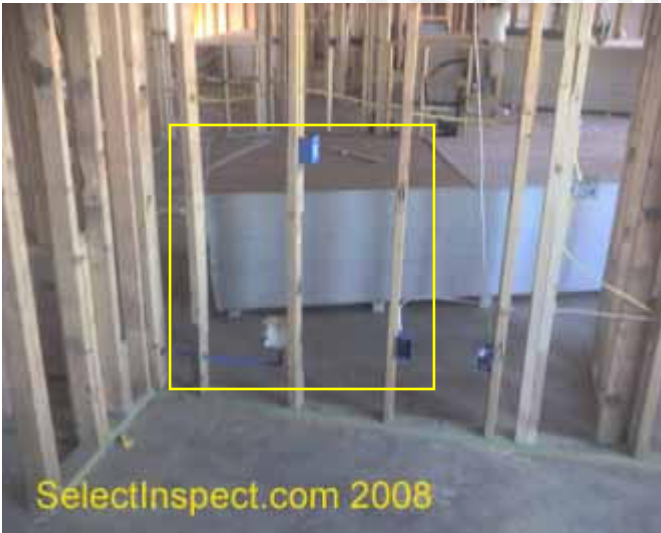
- Studs at the kitchen, where the refrigerator water supply is mounted, had been deflected and compromised when workers installing (moving) the upper beam cover piece for the family room collided and twisted the beam cover with the kitchen framing. Recommended additional bracing/blocking.

↑ compromised vertical framing at kitchen

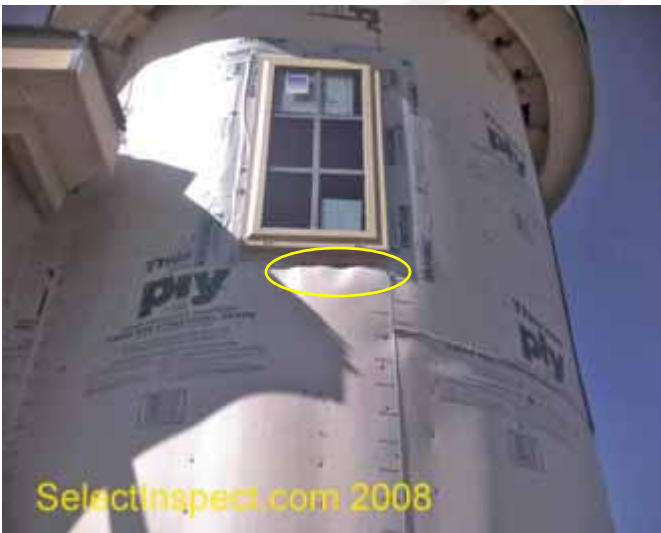
- Loose tyvek tape was noted at the west master bathroom windows. Repair and proceed.
- Openings exist at the thermoply and forti-flash at the east garage.
- Forti-flash was marginally short at the lower window areas at; family room, bedroom 2, and rotunda.
- Forti-flash or similar window flashing materials should be installed so that upper (vertically) sections are at the outside (horizontally) of lower sections. The condition was not this way at multiple front (east) locations. -see related photo(s)

↑ marginal flashing at window

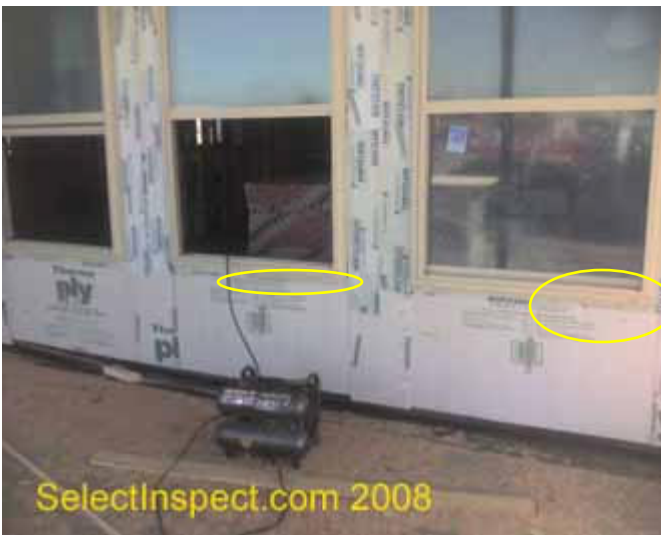
↑ marginal flashing at windows

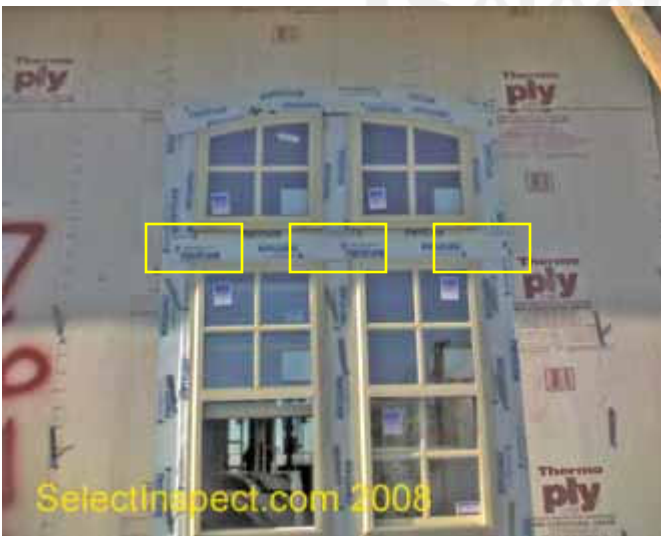
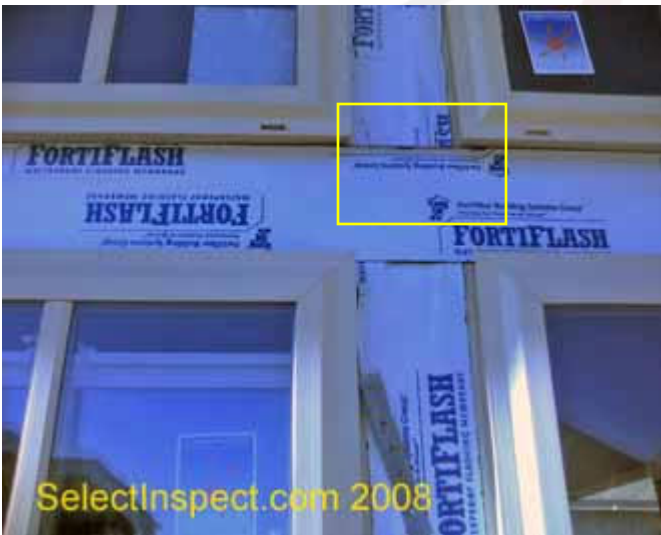
↑ improper lapping of window flashing; example

↑ close view of image above

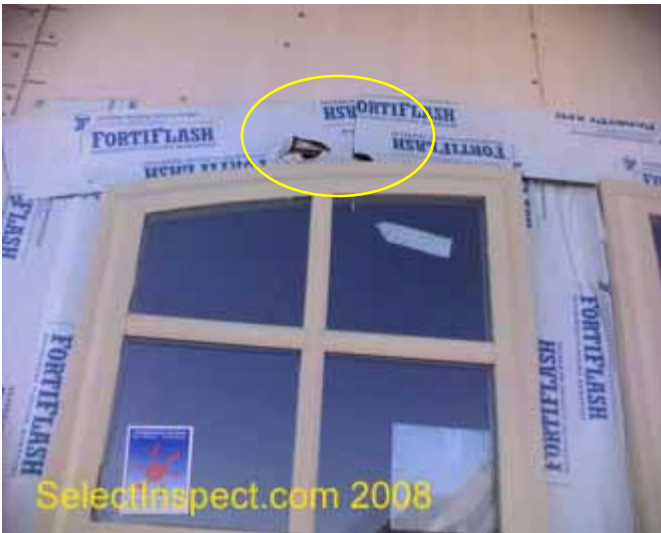
↑ damaged flashing and opening at thermoply sheathing; garage

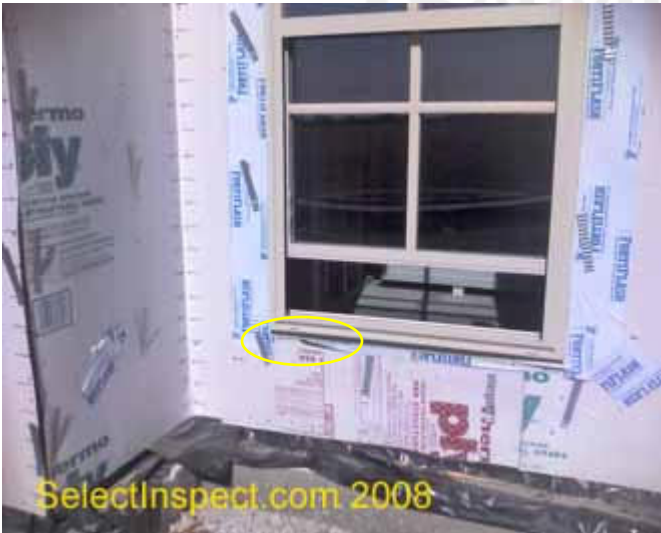
↑ marginal flashing at bedroom 2 south window
