New Home Final Inspection

at: **54321 New Street; Colony, TX 75034**

February 6, 2009

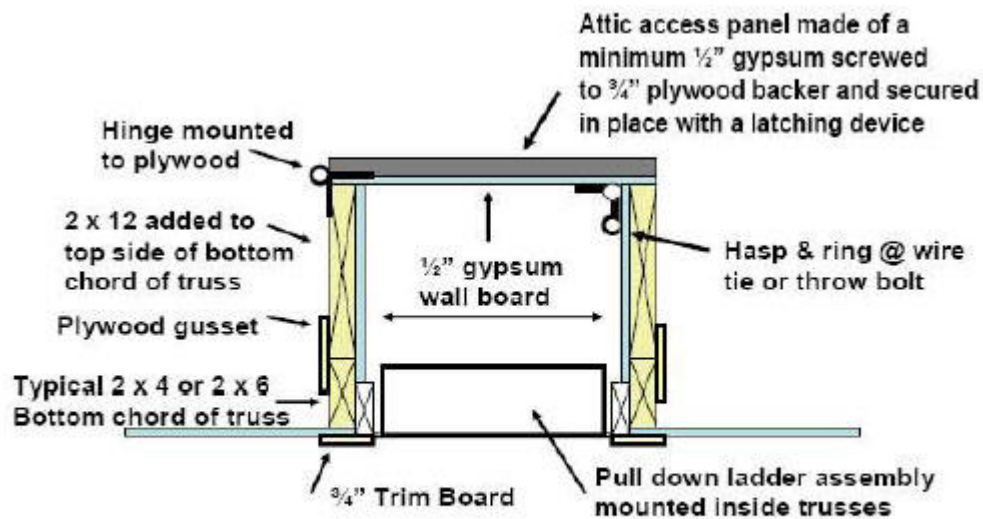
- The access panel at the garage attic access was not adequate material and would not meet separation required for fire-spread at attached garages. The partition wall between a modern home and an adjoining garage typically is covered by 5/8 inch drywall, to slow the spread of a garage fire to the dwelling. If the garage attic and house attic are not also divided by a firewall, then the garage ceiling becomes part of the fire separation and must also be finished with 5/8 inch drywall or equivalent fire-rated material. The access cover is a sheet of thin plywood. When installed in a garage ceiling, this replaces a portion of the fire-resistant drywall board, thereby breaching the required fire separation. IRC R309.2
 Option 1: Minimum 1 hour fire-rated material should be installed on the garage side of the hatch/door. Edges around the covering shall be tight to the surrounding ceiling.
 Option 2: Installing 5/8" drywall to separate the garage attic and at the rafters to at least 4 feet into the then separated garage attic to isolate the garage attic from attic space(s) above or adjacent living areas; taping/bedding all seams should be made to finish the firewall.

Pull down garage attic ladder installation requirements to maintain fire resistive separation

Option 3: Installing a fire-resistant enclosure in the attic above the garage access; An example of this is shown in the following image.

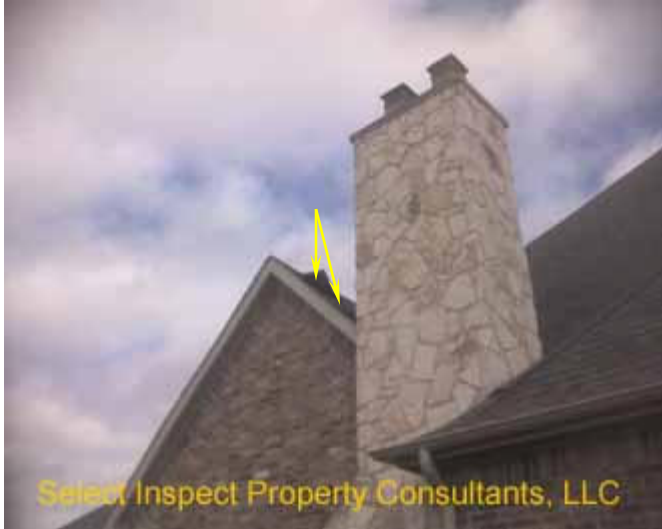
- Wind damage exists at the left of the fireplace chimney. The chimney cricket ridge has split and should be sealed.
- The dead valley right (east) of the fireplace chimney has marginal / poor slope, and may not drain properly. This is conducive to debris accumulation and potential moisture intrusion. Improving the slope is recommended.

↑ wind damaged shingles adjacent the chimney

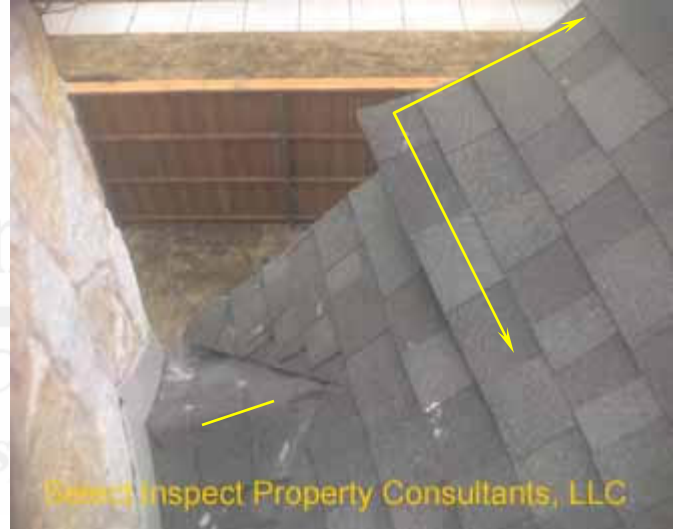
↑ split cricket, & view from above of image at left

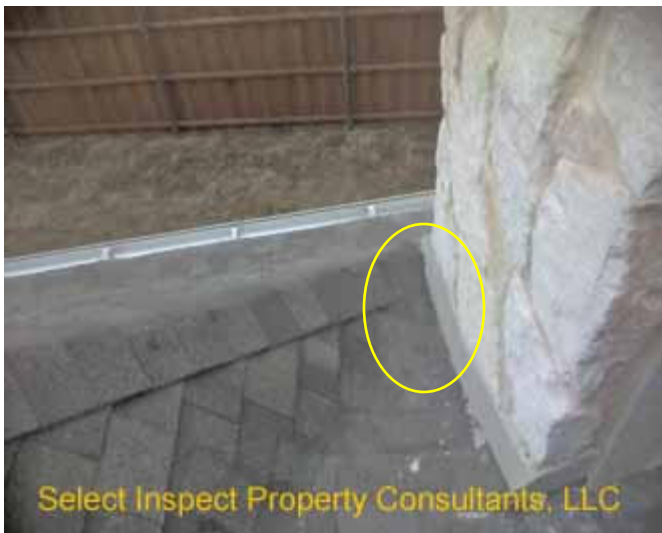
"Dead valley" description: A converging valley feature with a vertical wall joined by flashing at a convergence of one or more roof angles/valleys; this feature is commonly associated with a higher risk for leakage, due to water being directed toward rather than away from a wall, roof, and or flashing convergence. The roof, attic, and interior areas surrounding and below this feature should be inspected during different weather periods for leakage. These valleys will also create a higher risk of ice damming and potential moisture intrusion behind the shingles in winter.

↑ marginal slope at the converging valley adjacent the chimney; prone to ice damming, debris accumulation, & moisture intrusion.

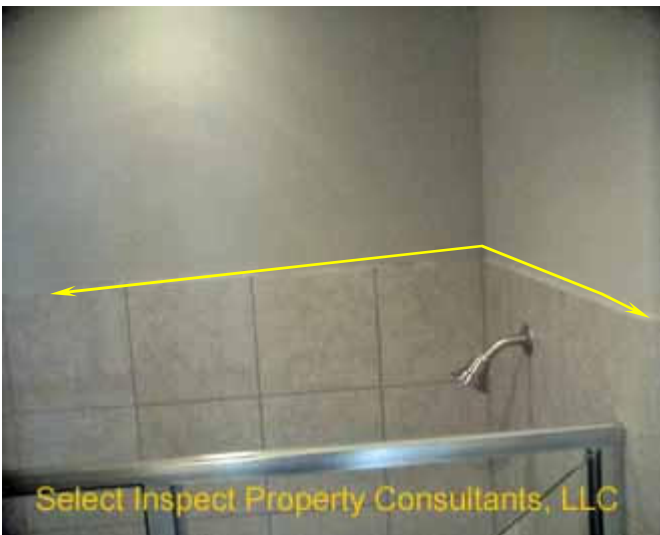
↑ Seal the top tile edge at the shower walls- example at split bathroom

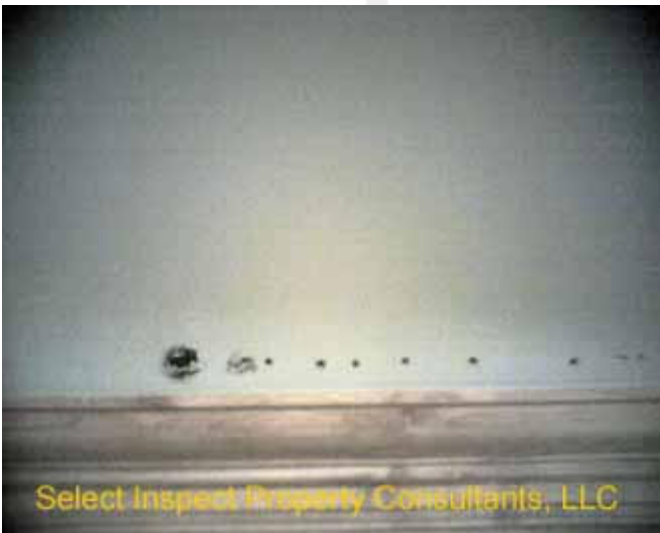
- Openings exist above the cabinets in both sides of the butler pantry.
- Paint overspray exists at the top beam in the family room. Cosmetic details were not complete at the time of inspection; such as cabinetry, paint, grout, caulking details.
- Cosmetic deficiencies include: paint drippings, remaining tape between the kitchen and east hall, missing paint at the trim in the master hall.
- Recommend sealing the top tile/panel edge at the wall of the shower(s) to reduce potential for moisture intrusion and fungal accumulation at the shower substrate (between the shower and walls)

↑ openings in the drywall at the butler pantry; above cabinets; both sides

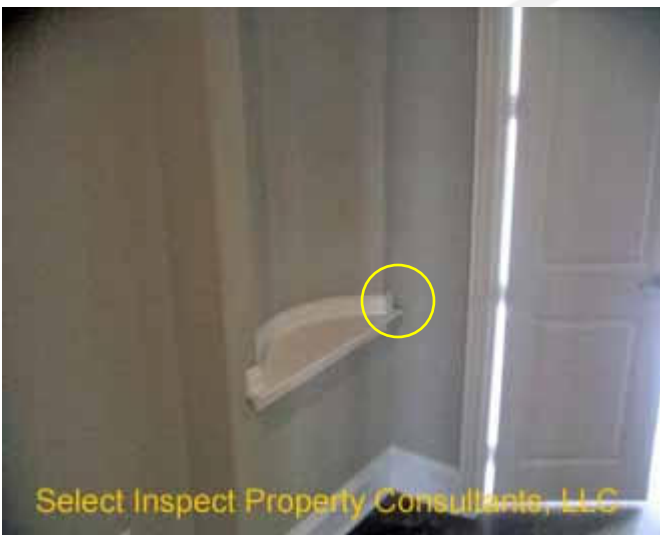
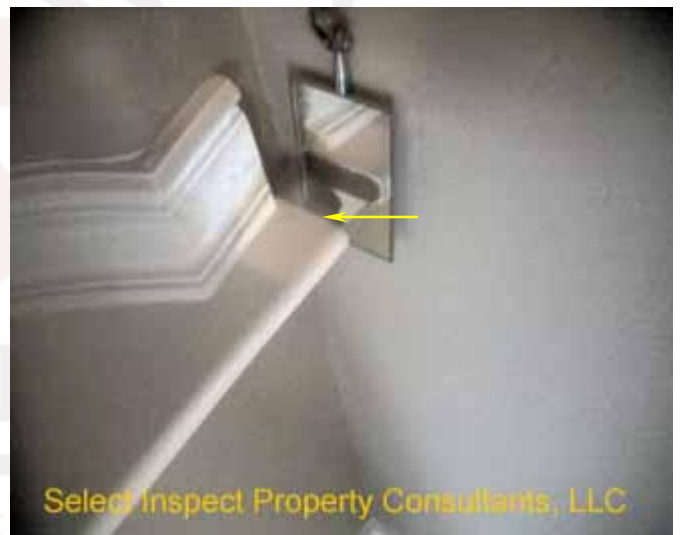
↑ various cosmetic details incomplete; example at master hallway

↑ close view of image at left

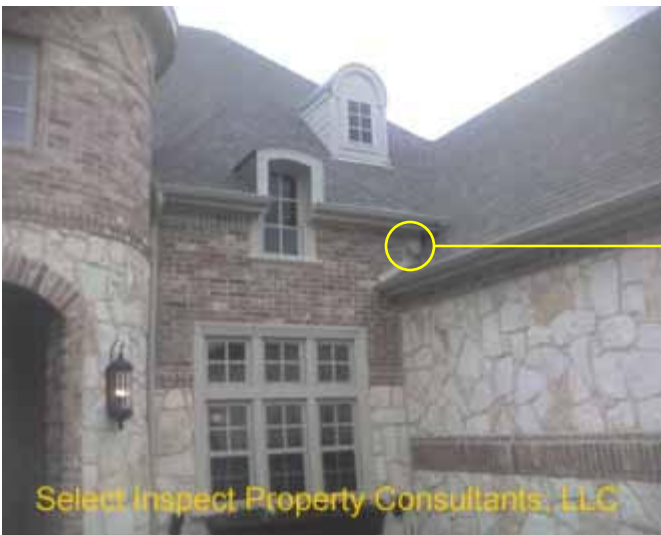
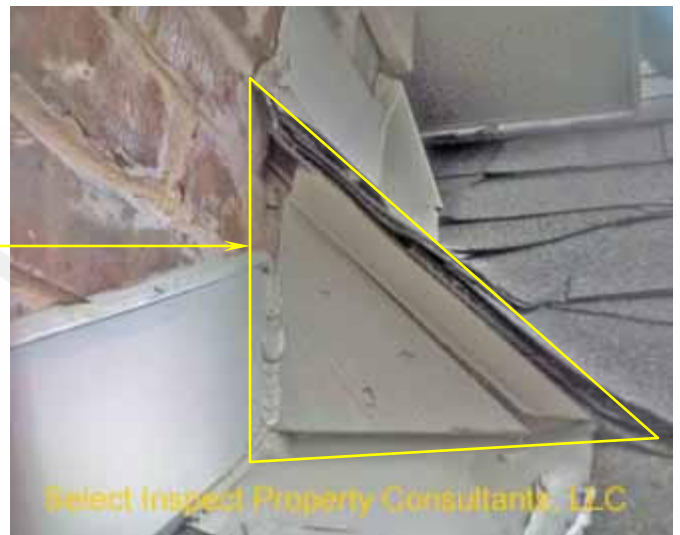
↑ unworkmanlike flashing/trim; exposed decking

↑ close view of image at left

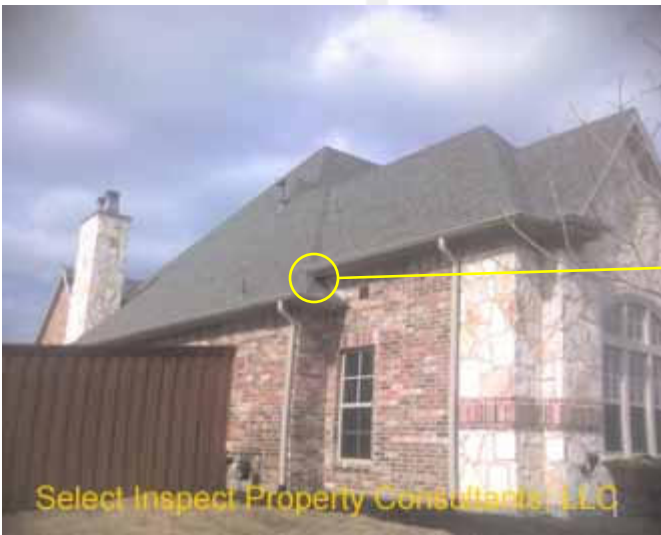
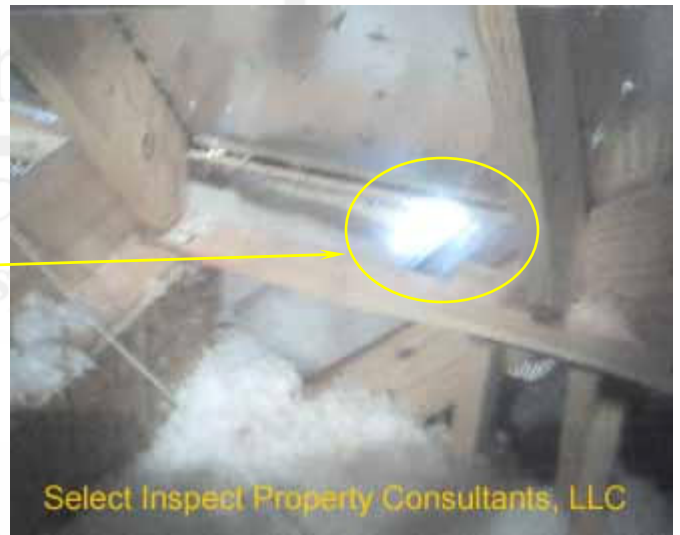
↑ unworkmanlike flashing/trim; opening to attic

↑ attic view of image at left; opening & daylight visible

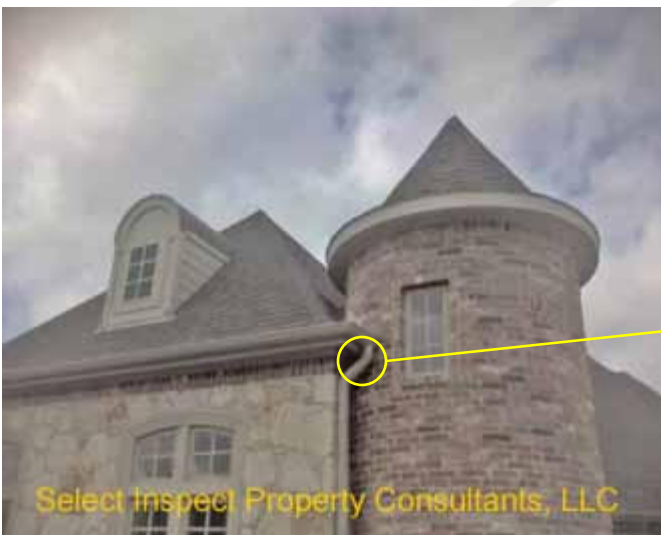
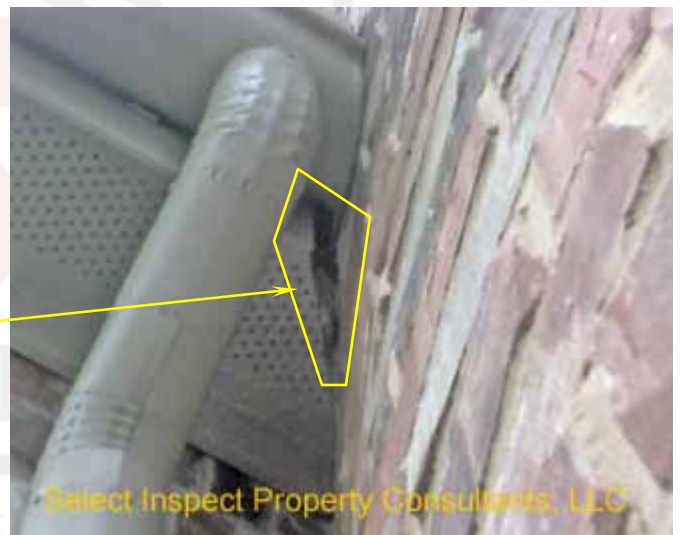
↑ unworkmanlike eave/brick joint; open to eave

↑ close view of image at left

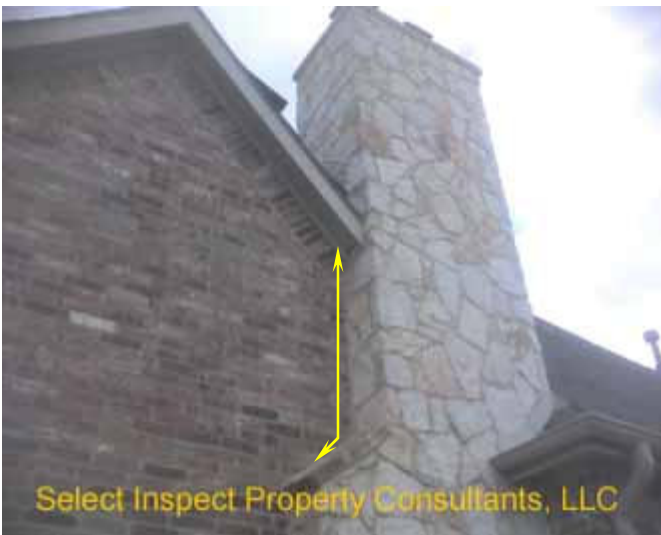
- Structural repair needs were not evident at the time of inspection. Cosmetic repair may be available through your builder's warranty. Settlement was indicated by the following:
- Mortar cracks noted at the brick & stone joint left of the fireplace
- Hairline drywall crack(s) exist at the four corners of the master bedroom ceiling step-down.
- Regularly monitor the property and its components and arrange for repair if / when needed. Repairs should be made by qualified specialists whenever possible.
- Refer to your "Guide to Your Home Inspection" through the link in your email with this report, for information regarding foundation maintenance and monitoring.

↑ thin mortar crack discovered at joint of stone & brick veneers; Significant issues were not observed concerning this

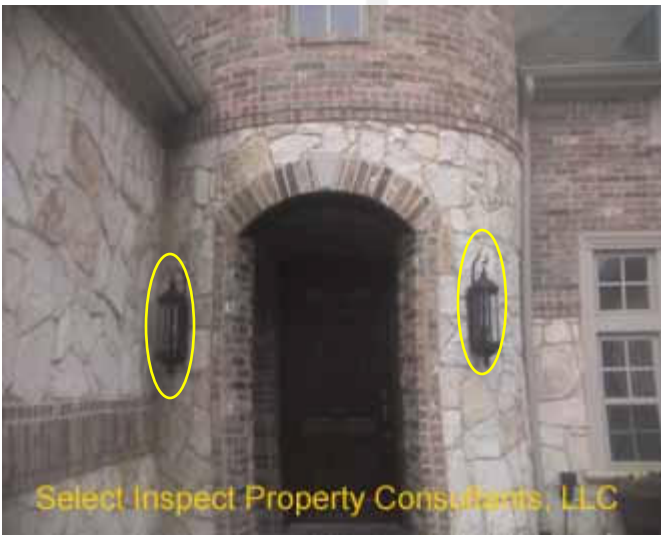
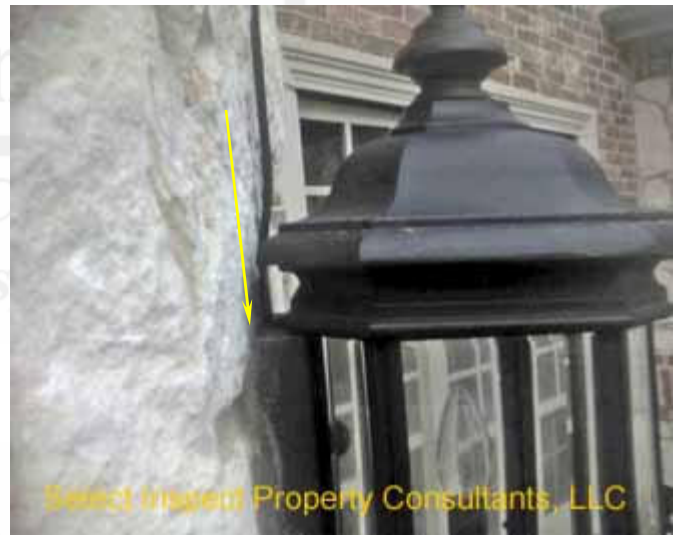
↑ seal top of exterior lights; example front entry

↑ close view of image at left

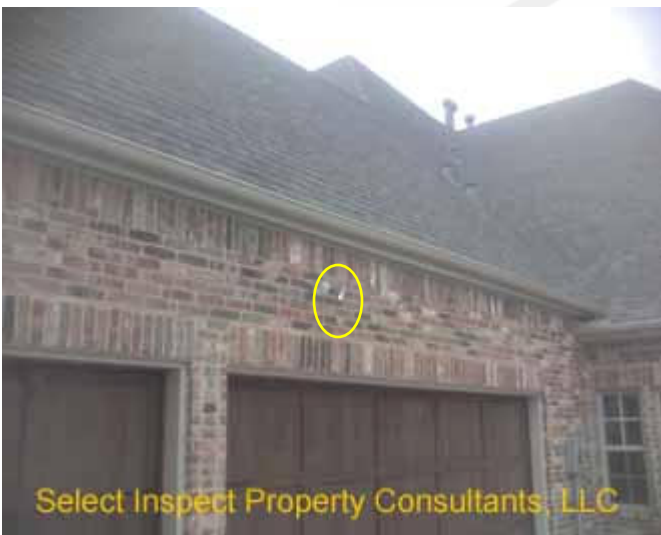
↑ seal top of exterior lights; garage

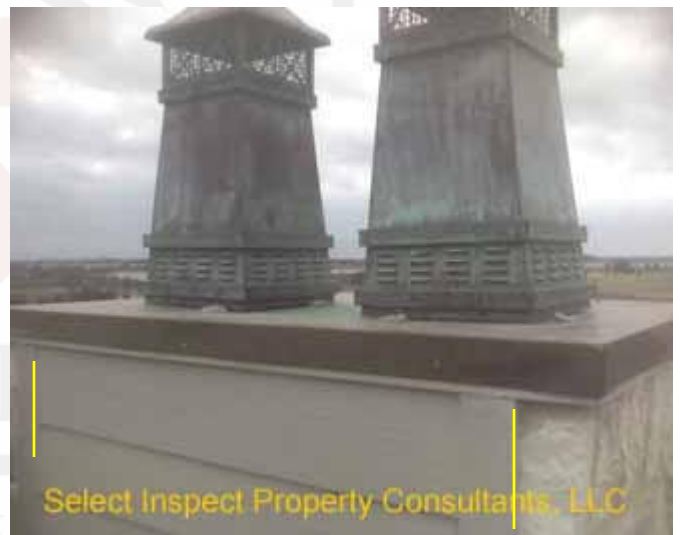
- Trim to stone joints at the chase should be sealed

- The metal cap is slightly concave, rather than convex. This can create pooling water, and may lead to premature corrosion or failure of the metal components. Options are limited. Evidence of failure was not seen at the time of inspection. Monitor this item over time and repair as needed.

↑ chimney cap is concave rather than convex & trim/stone joints should be sealed / caulked

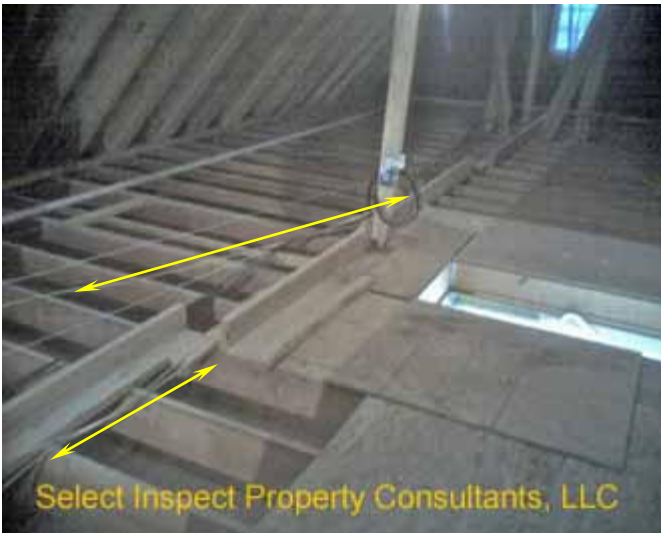
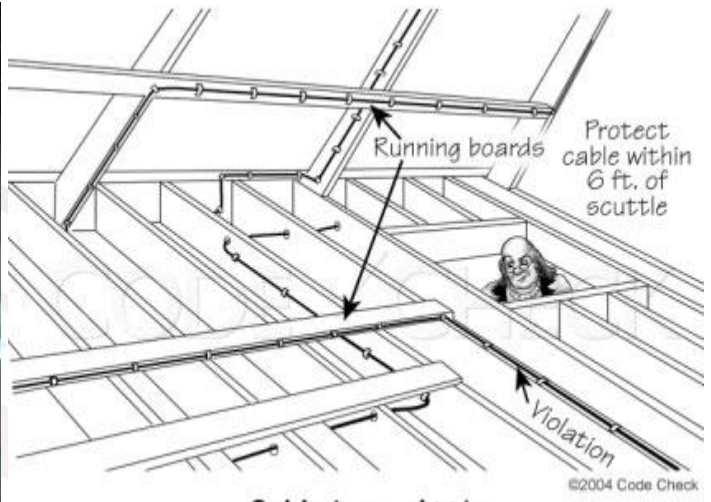
- There are electrical wires at the attic access that are not properly secured and protected from damage by traffic. Within 7 feet of the access, where run on joists, face of rafters or studding, in attics or roof spaces that are provided with access, the cable (electrical wires/conductors) shall be protected by substantial guard strips that are at least as high as the cable. When the attic(s) is not provided with access by permanent stair or ladders, protection shall be required within 6 feet of the attic entrance. E7202.2.1.
If wires are installed parallel on the side of the framing; additional protection is not required. See related image with the photo pages.
- Grounding electrode conductor for the jetted tub is unprotected at the exterior of the master bathroom. This is prone to damage by landscaping personnel and should be secured to the wall.

↑ Unprotected electrical wires within 6 feet of scuttle or 7 feet of attic stair

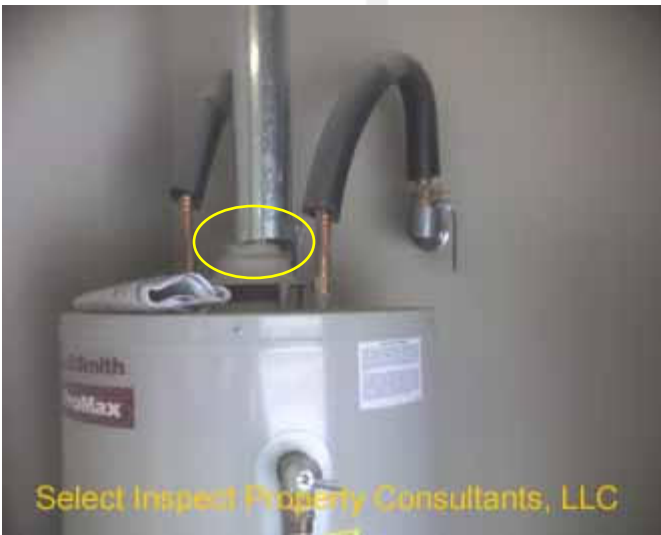
↑ disconnected water heater flue; should be seated & secured.

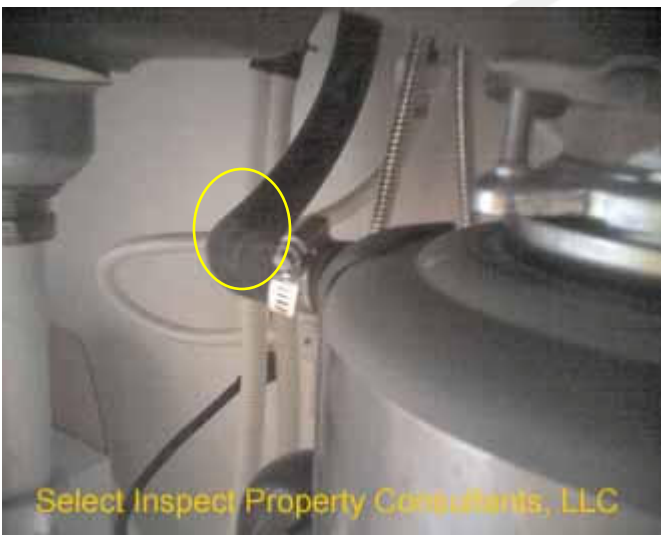
- **dishwasher**: crimp at the drain line adjacent the disposal connection was discovered. The condition may be prone to congestion and leakage.
- **disposal**: operable
- **doorbell**: operable
- **dryer vent**: The dryer vent is routed upward. Measuring the exact length is beyond the scope of this inspection. Upward venting dryer ducts are more prone to clogging than shorter horizontal vents.
- **exhaust fan(s)**: Some or all bathroom /laundry exhaust fans vent to the eaves. Vent termination within the attic, at passive roof vents, or at eave vents does not meet most manufacturer guidelines. Current standards require venting of bathroom and utility room exhaust fully to the exterior. (IRC M1506 & 303.3). Texas Real Estate Commission considers this in need of repair even on older homes.

↑ dishwasher drain has a "kink" that will be prone to congestion, backup, and failure of the drain
