Select Inspect

Property Consultants, LLC

Inspection for Builder Warranty

at: 123 street; Little Elm, TX 75068

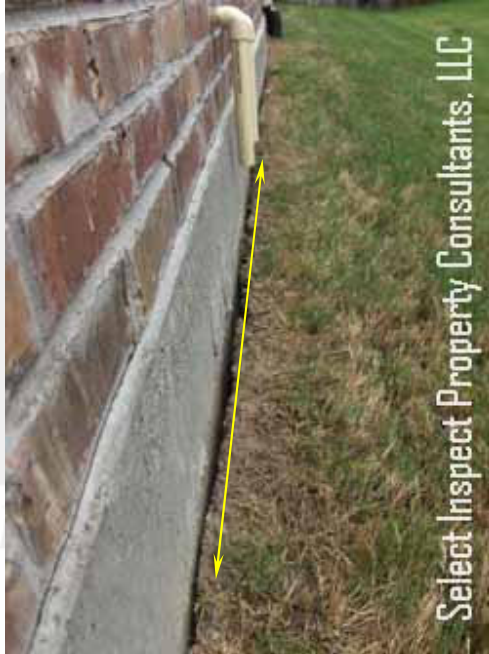
- Soils around the home are dry, cracking, and pulling away from the foundation. This can cause foundation instability. Soils should be slowly, consistently rehydrated to provide support to the foundation. Moisture maintenance is imperative when living in areas of expansive clay soils, such as many regions of North Texas.
- Example dehydrated soils at the east

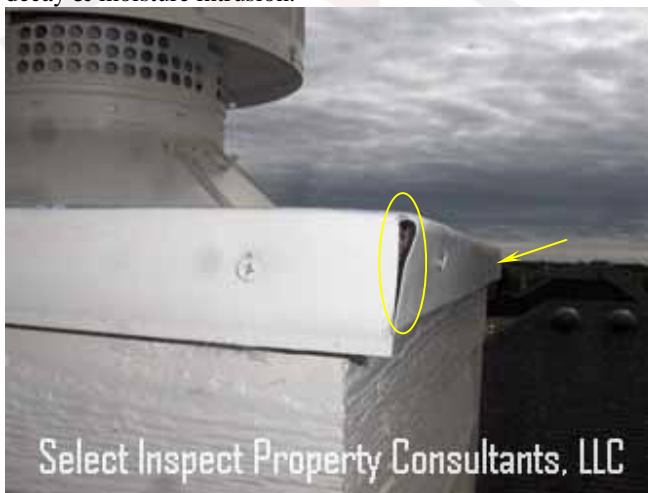
- Recommend sealing the corners of the chimney cap; exposed wood was visible beneath & is prone to decay & moisture intrusion.

- Sealant is needed to prevent moisture intrusion at the cap corners.

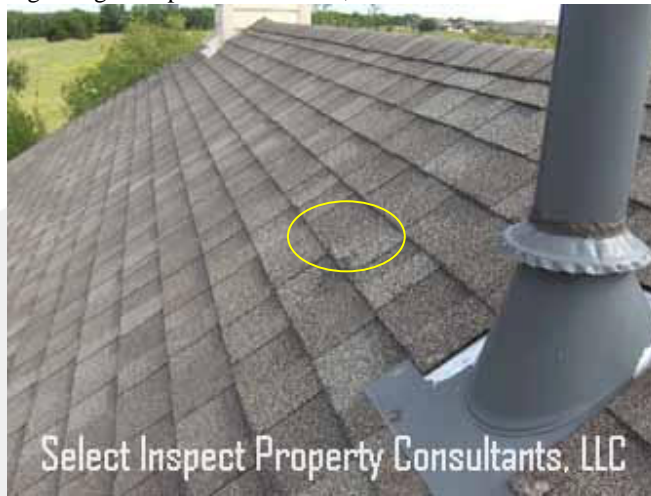
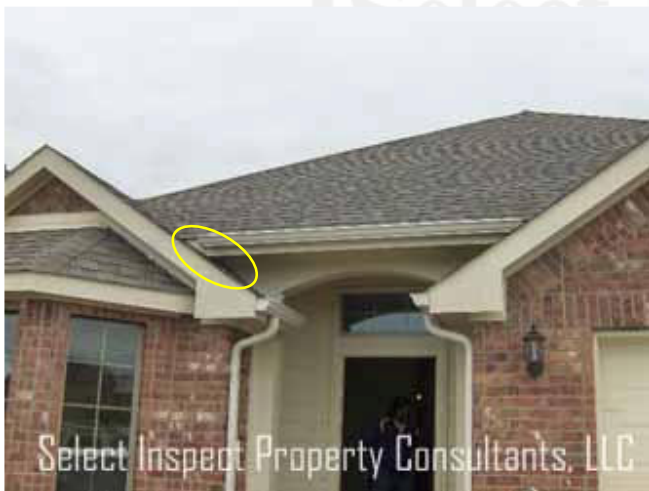
- ✦ Slight wear discovered at shingles adjacent the furnace flue; Significant issues were not discovered regarding this specific condition; monitor & maintain.

↑ short flashing remains; openings may allow moisture intrusion in driving rains

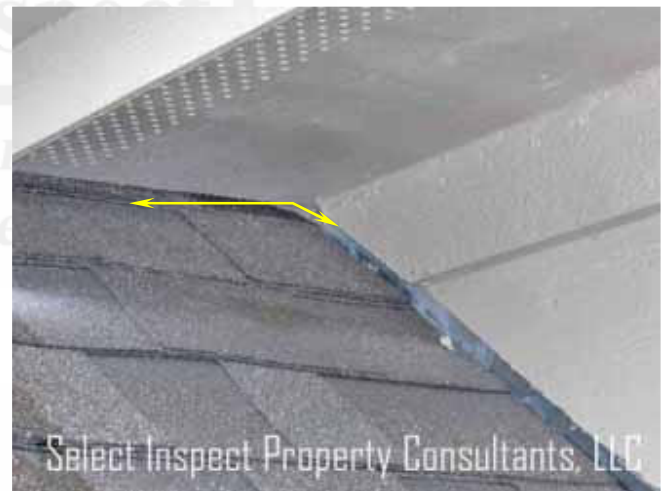
↑ close view of image at left

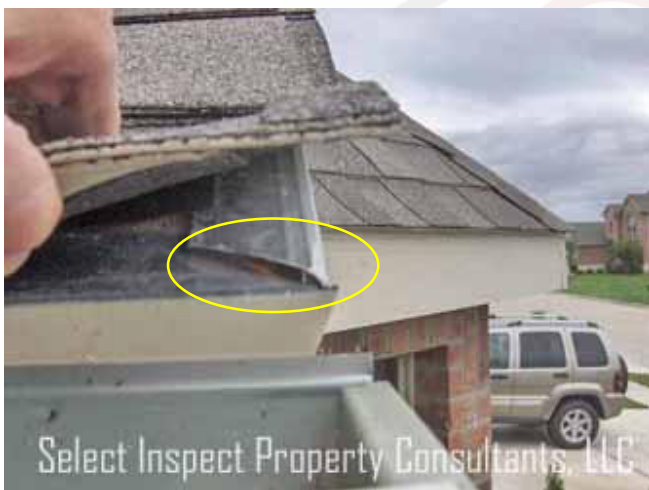
↑ unworkmanlike drip edge flashing & felt remains at southwest; poor/excess cut & opening

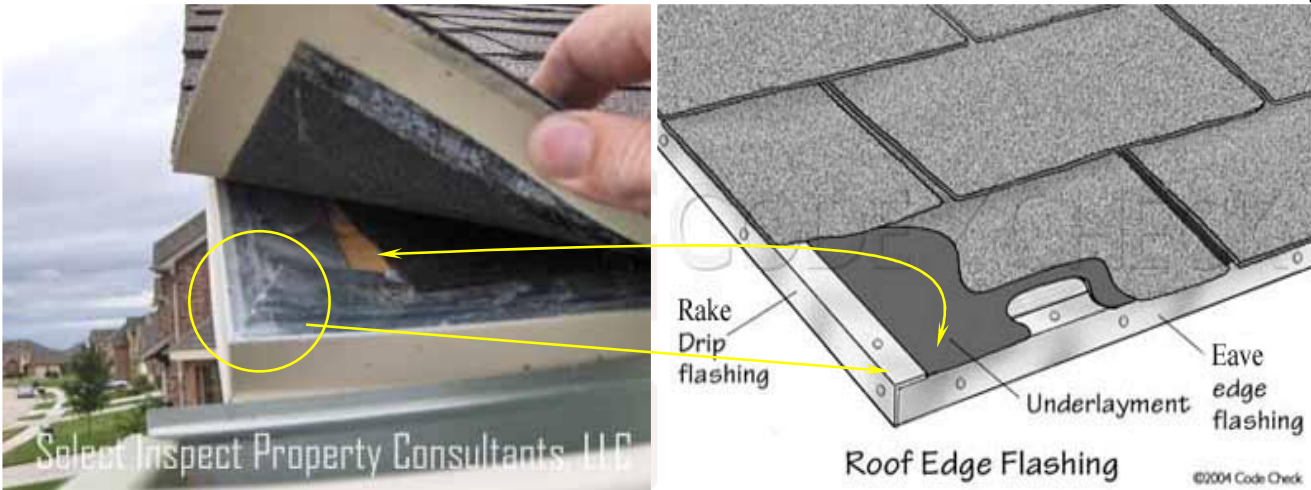
↑ unworkmanlike drip edge flashing & felt remains at southeast; high side should be folded atop the low side.

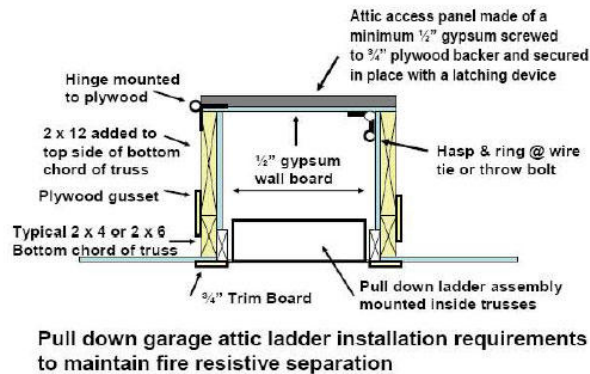
- ✦ The access panel at the garage attic access was not adequate material and would not meet separation required for fire-spread at attached garages. The access cover is a sheet of thin plywood. When installed in a garage ceiling, this replaces a portion of the required separation created by drywall board, thereby breaching the required separation. IRC R309.2

- Option 1: Minimum 1 hour fire-rated material should be installed on the garage side of the hatch/door. Edges around the covering shall be tight to the surrounding ceiling.

- Option 2: Installing 5/8" drywall to separate the garage attic and at the rafters to at least 4 feet into the then separated garage attic to isolate the garage attic from attic space(s) above or adjacent living areas; taping/bedding all seams should be made to finish the firewall.

- Option 3: Installing a fire-resistant enclosure in the attic above the garage access; An example of this is shown in the following image.

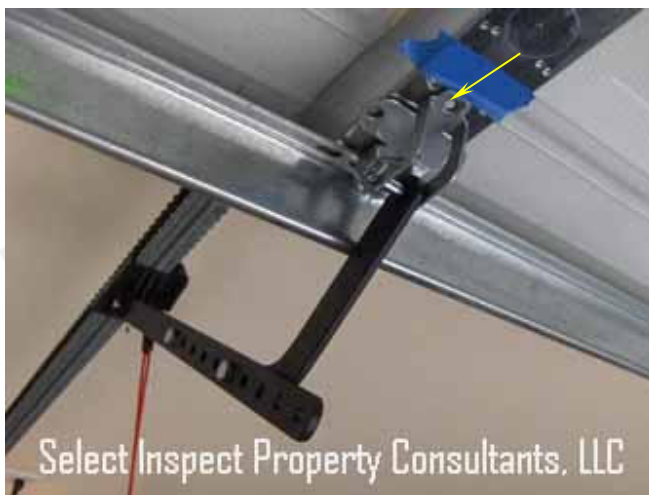
- Garage door operator bracket was inadequately secured to the door; stress was noted at steel door & bracket/bolt

- Bracket was inadequately secured to the door component(s)

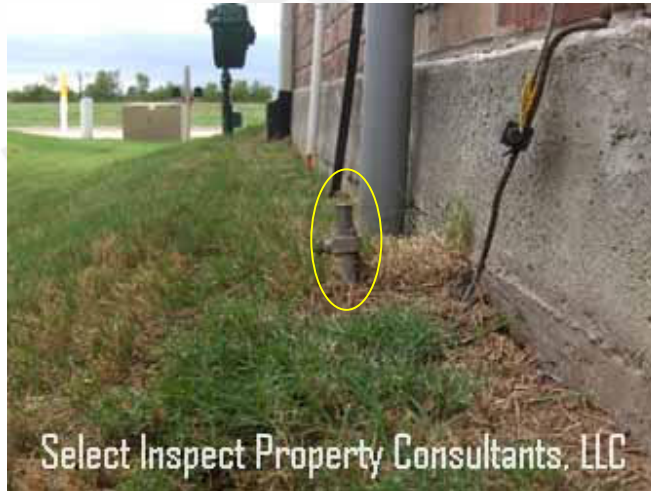
- Electrical ground rod was not flush with the grade. "Electrical ground rod shall have at least 8' of length in contact with the soil and the upper end of the electrode must be flush with / below ground level unless above ground portion and grounding electrode conductor attachment is protected against physical damage. NEC 250-52 (c) (3)". This includes rod electrodes installed inside through concrete slabs.

Grounding rods are typically sold as 8 foot lengths; since the upper end of the rod has been left above grade, it is most likely not in contact with the soil for 8 feet as required. Since much of the rod is buried, the suspected condition cannot be confirmed nor discredited during this limited visual inspection. The grounding electrode connection is prone to physical damage and should be protected and secured to the structure or service riser. The rod should be covered with compacted soil or driven deeper into the soil. A grounding rod that protrudes from the ground / grade may also present an impalement hazard. Repair options are limited; and though this is technically incorrect, proper installation methods are rarely discovered, and frequently ignored by installers and city building code officials.

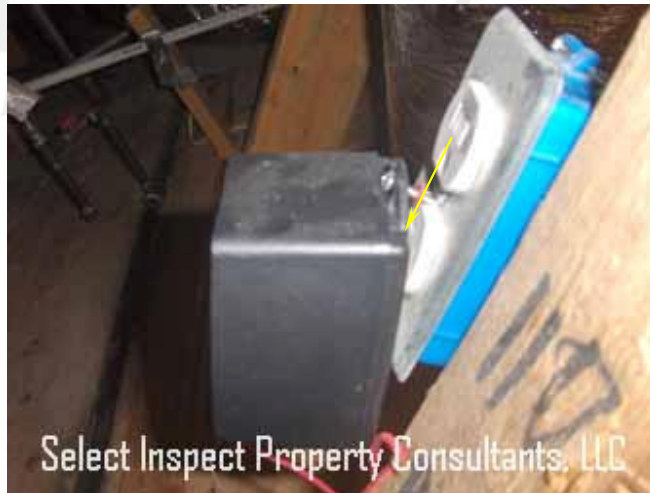
- ✦ Alarm system plug at the attic was inadequately secured; need to remove plug, remove receptacle cover screw, secure plug to receptacle with screw provided with the plug; both screws are phillips head.

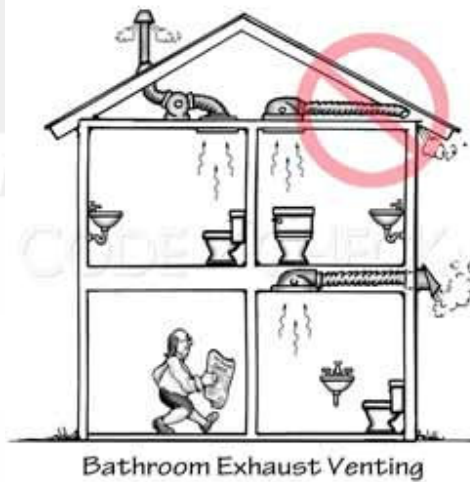
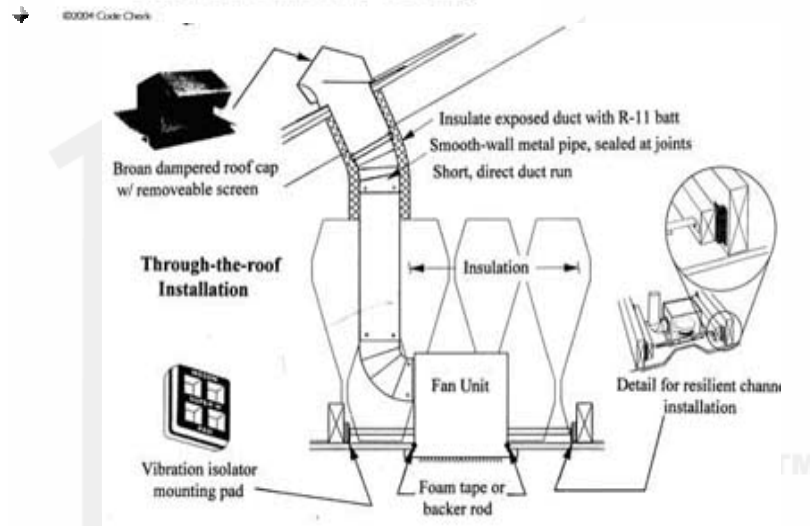
- Some / all bathroom /laundry exhaust fans appear to vent to the eaves/attic. Vent termination within the attic, at passive roof vents, or at eave vents does not meet most manufacturer guidelines. Current standards require venting of bathroom and utility room exhaust fully to the exterior. (IRC M1507). Texas Real Estate Commission considers this deficient, even on older homes. Related technical information can be found at: <http://www.toolbase.org/PDF/DesignGuides/spotventilation1.pdf>
