# Select Inspect

## New Home Punch-out Inspection

**Custom Home Builder**

at: **2009 New Street; Flower Mound, TX 75022**

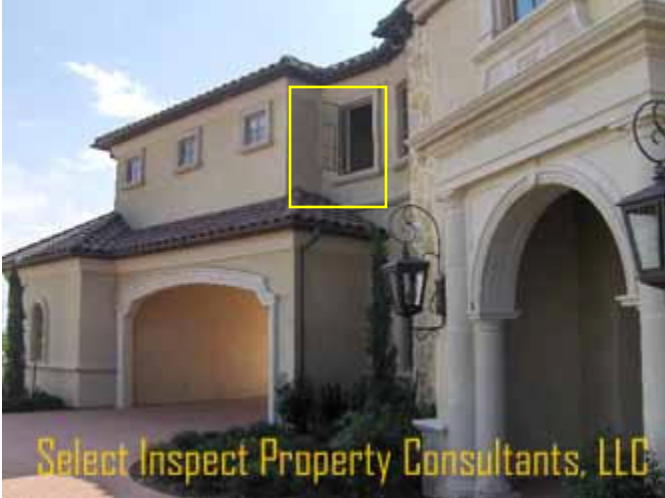
↑ cracked tile; missing mud seal/gaps; window not functioning as intended

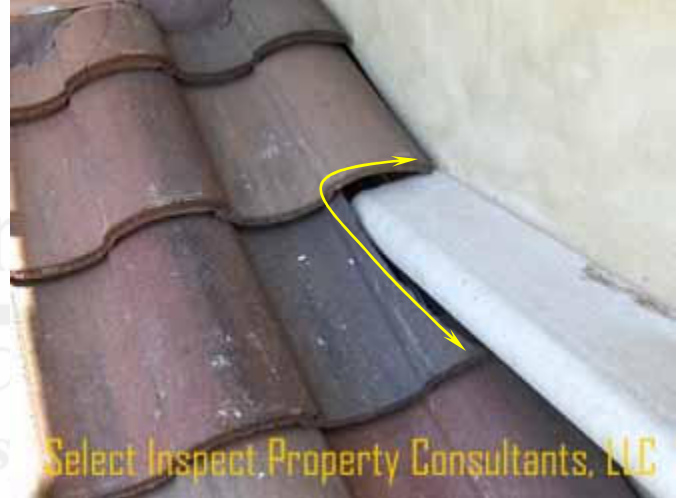
↑ close view of image at left; mud/flashing missing; slats visible

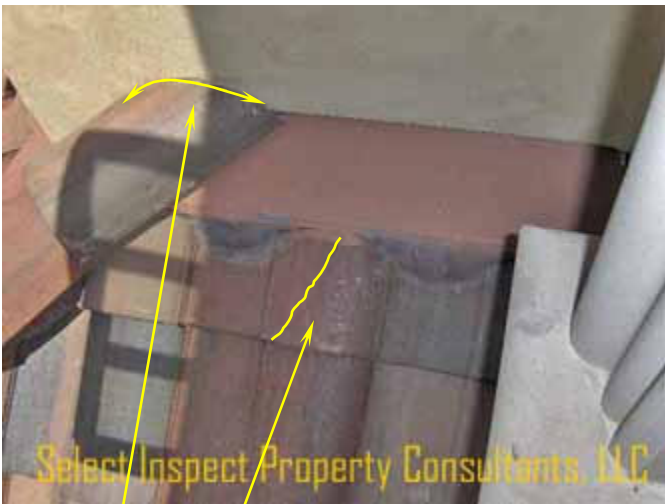
↑ slipped tile; cracked tile; close view of image above

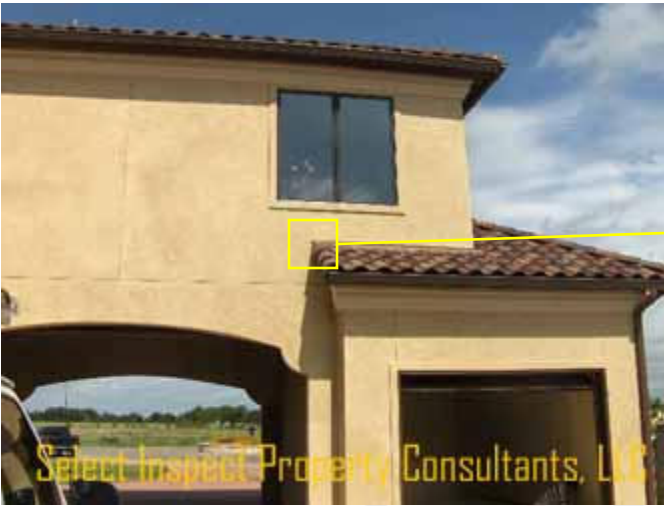
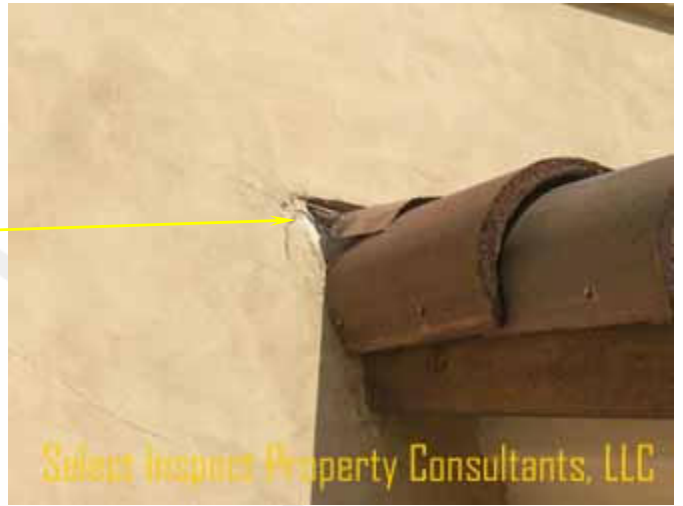
↑ seal flashing joint and stucco touch-up needed

↑ close view of image at left

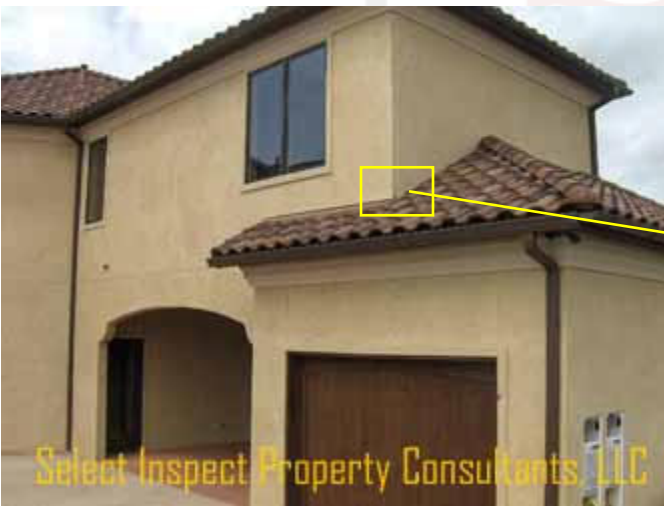
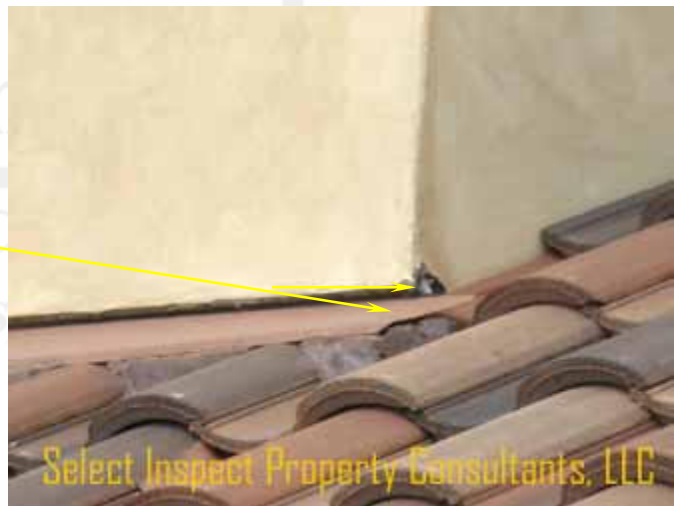
↑ seal flashing joint and stucco touch-up needed

↑ close view of image at left

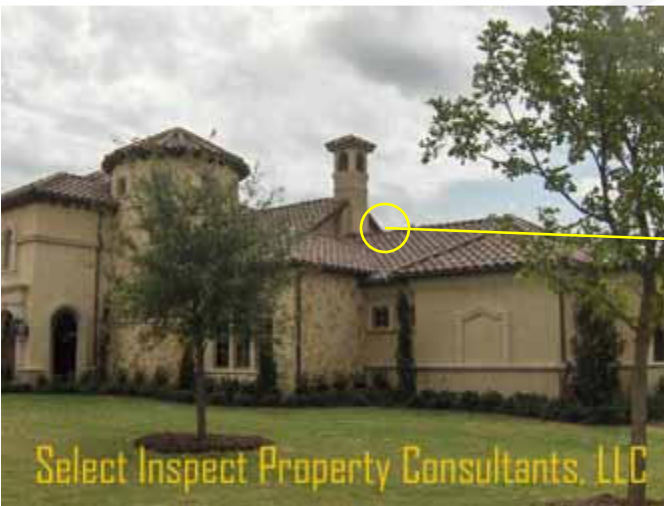
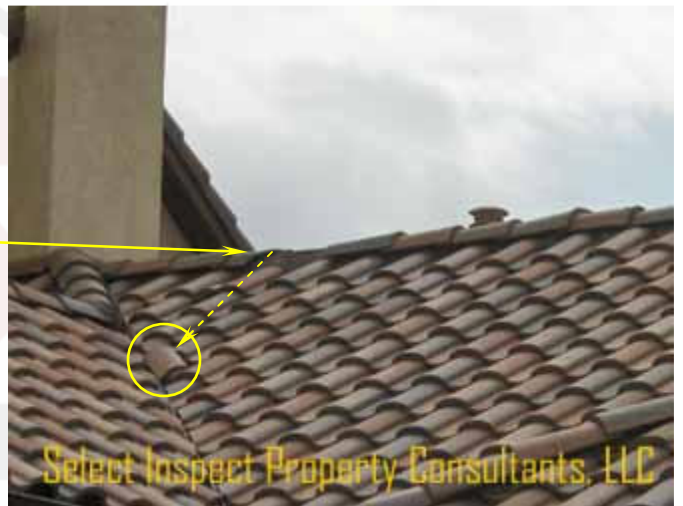
↑ deficient tile

↑ close view of image at left; tile is in the valley

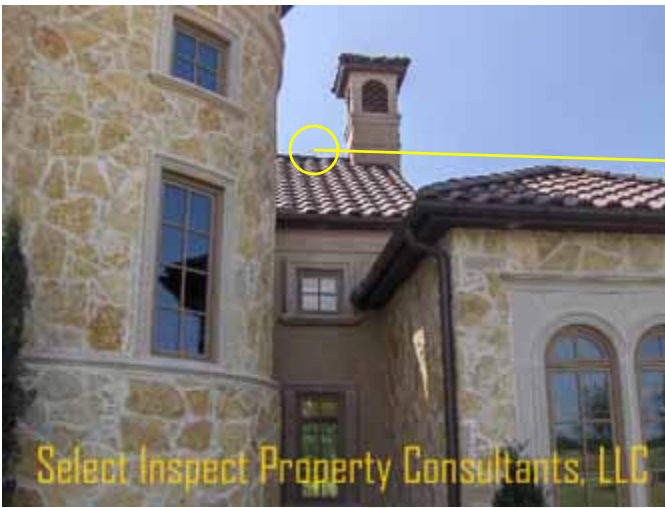
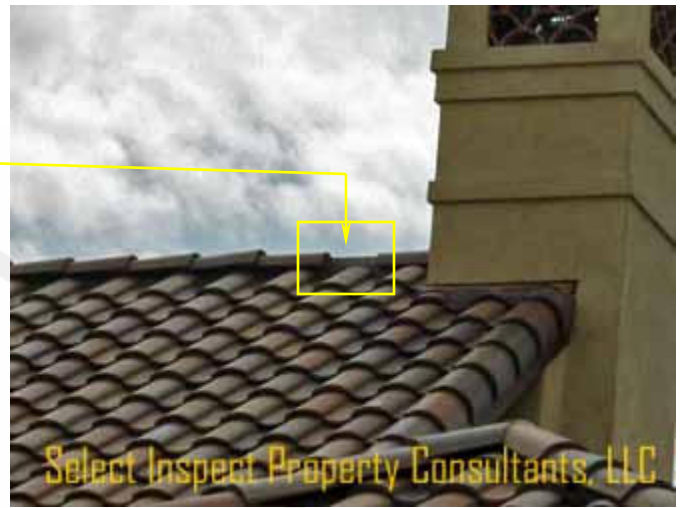
↑ deficient tile

↑ close view of image at left

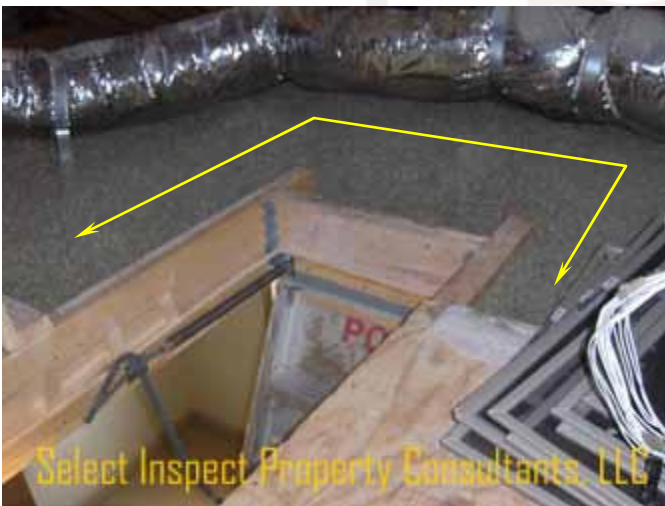
- Attic floor was not present at the top/front of the access; this creates a hazard during entry and exiting the attic. Addition of appropriate deck/floor is recommended.
- Upstairs north hall and upstairs east bedroom Attic hatch was deficient, seals poorly. Some degree of energy efficiency loss is likely.
- NOTE: drop stairs at the upstairs east and master closet are difficult to reach, difficult to open, and difficult to close; even with use of the provided pole. Repair options may be limited; though this will be a convenience issue for occupants and service personnel unless improved.

↑ lack of decking at top of north hall attic stair

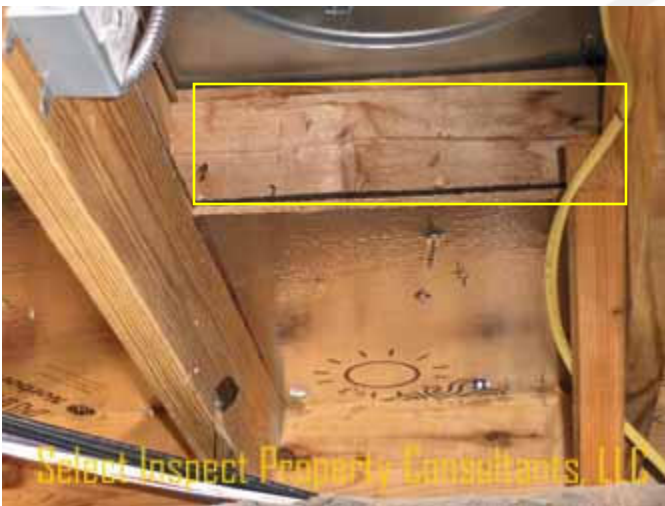
↑ moisture staining at the electrical fan above HVAC #2; north attic

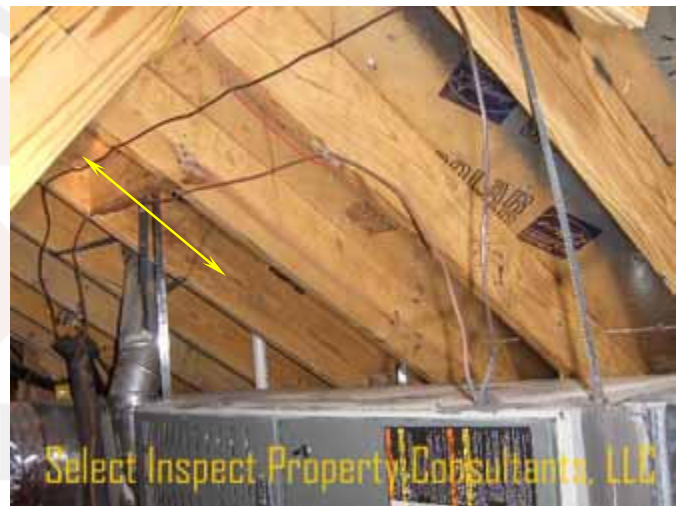
- Cracked rafter was noted above HVAC #3 in the north hall attic. This is in proximity to the mounting support for the HVAC unit and may be related to load stress added by the weight of the HVAC system. Consider additional bracing to prevent/reduce risk of future deflection.

↑ cracked rafter discovered above HVAC #3; north attic

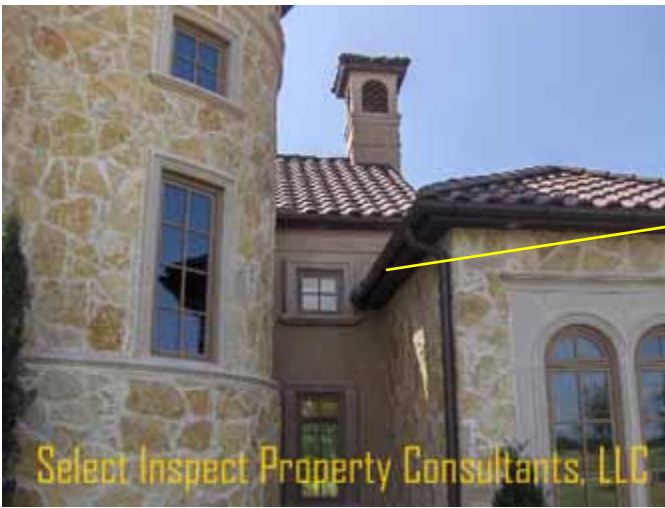
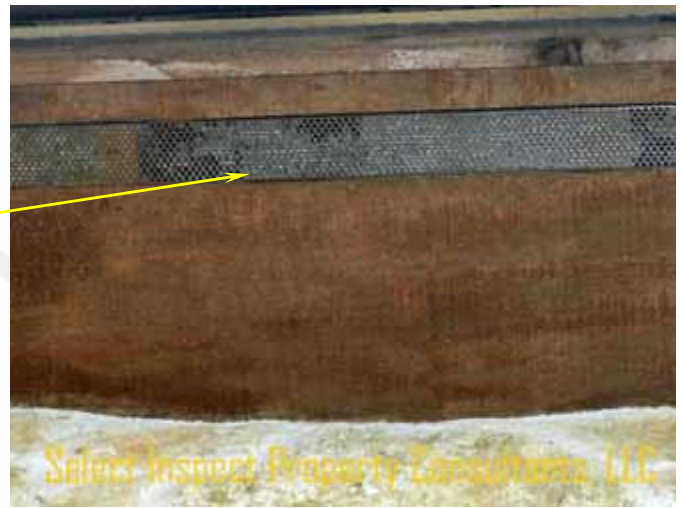
- Some insulation was noted as obstructing various sections of soffit vents. Significant issues were not discovered; monitor and maintain.

↑ insulation seen obstructing some soffit vents

↑ close view of image at left

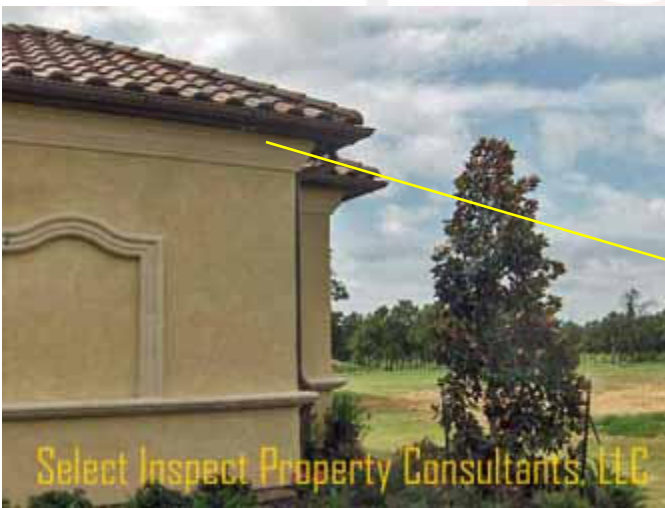
↑ slightly askew soffit vent example; Significant issues were not discovered

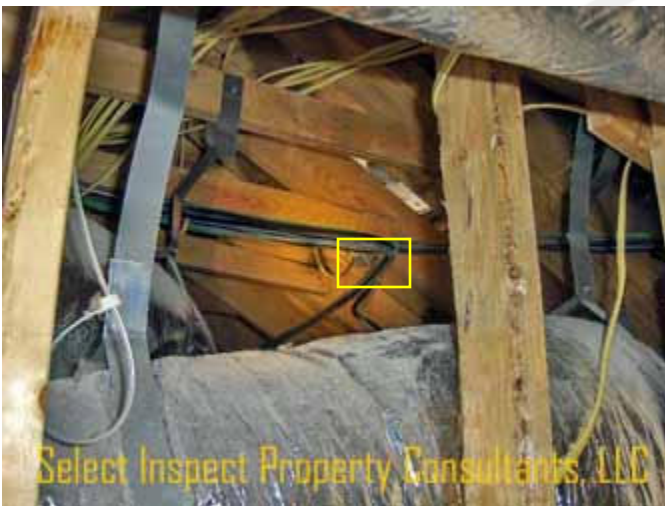
↑ some electrical attic fan thermostat(s) were not readily accessible and these devices were not tested; example at the master attic

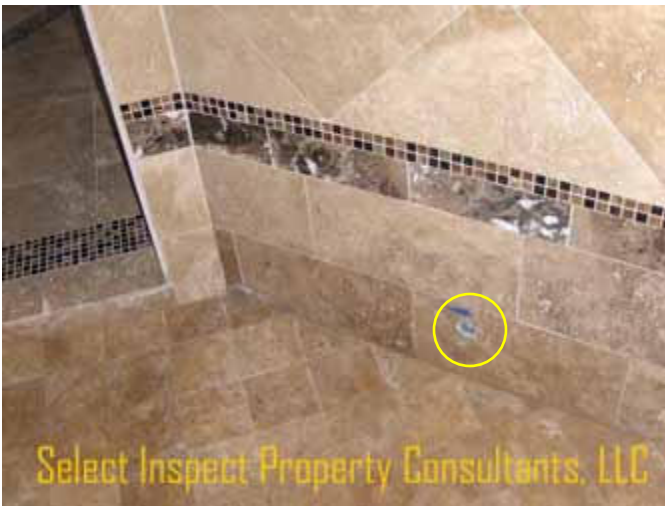
↑ opening at master shower tile

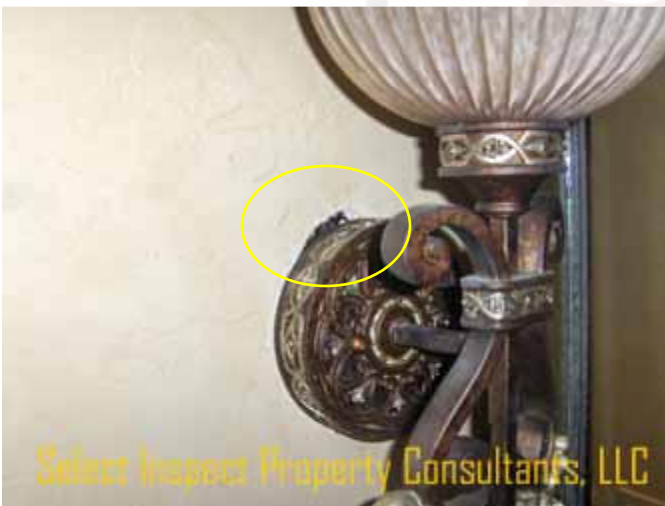
- Media room and northwest bedroom cabinet light fixtures were missing; boxes were enclosed.
- powder bath left fixture was loosely secured.
- Fixture(s) at powder bath left. Excess "reveal" exists at electrical components. Fixtures and related covers shall be flush (*ideally within 1/8"*) and adequately secured to the finished wall/ceiling where mounted. This is to control potential fire-spread, and not necessarily for cosmetic reasons.

↑ opening/reveal at the powder bath light

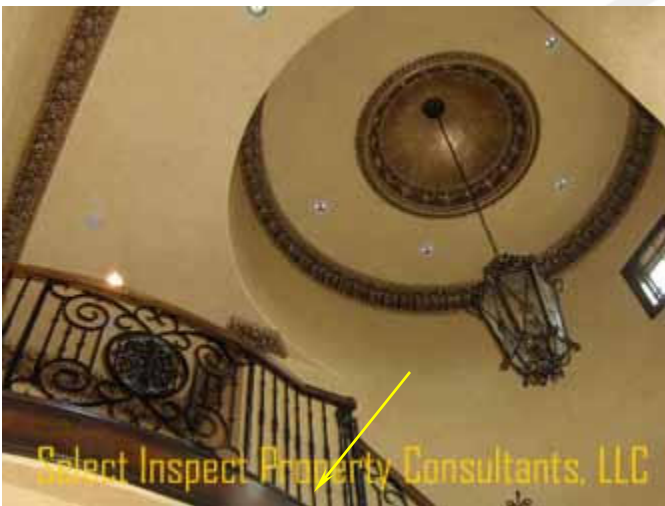
↑ various trim joints were not flush; example at main stair loft

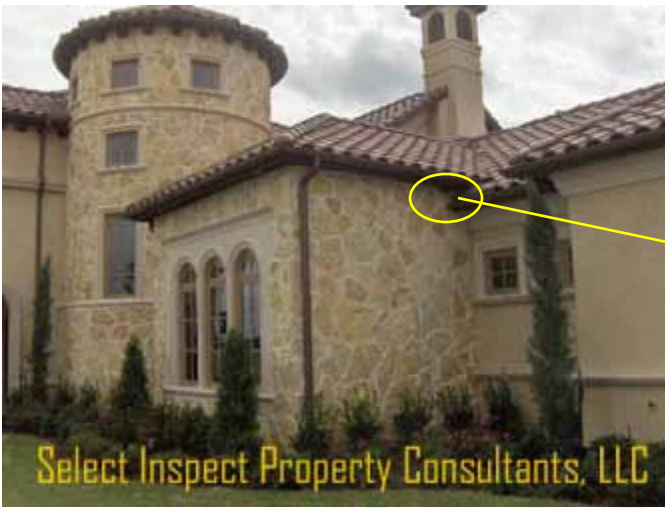
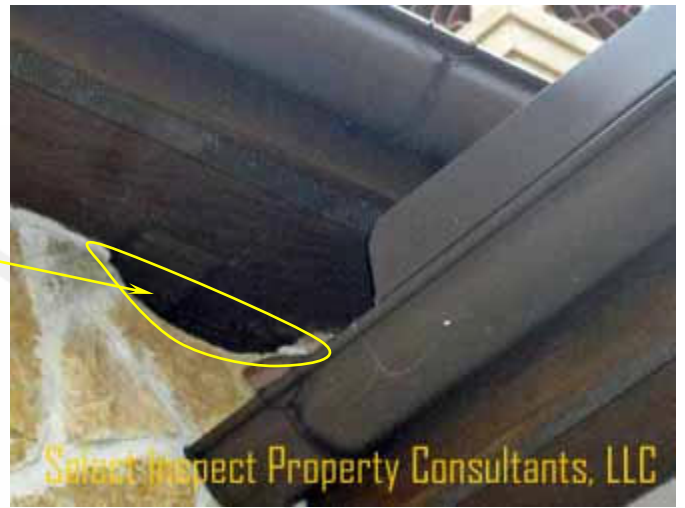
- Stone was missing and an opening exists at the west-southwest of the office/study.
- Master patio ceiling/eave was incomplete and unenclosed.
- All stucco wall penetrations including lights, screws, exterior faucet(s), gutter down-spout brackets should be sealed to resist moisture penetration into the structure/substrate.

↑ stone was incomplete/missing at the southwest office/study

↑ close view of image at left

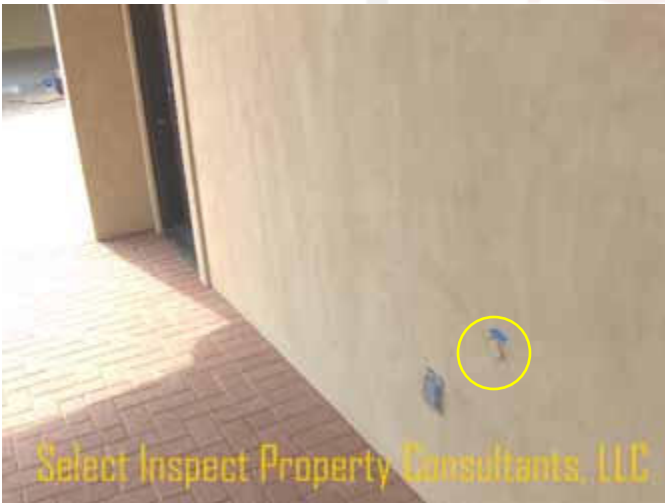
- Stucco was covering/obstructing the plumbing clean-out at the porte-cochere outside the laundry room.
- Exterior lights mounted to vertical walls should be properly sealed to prevent moisture intrusion and related corrosion / overheating possibilities of the electrical components. NEC 410-4 & IRC E3903.9.

↑ stucco obstructs this plumbing clean-out at the porte-cochere

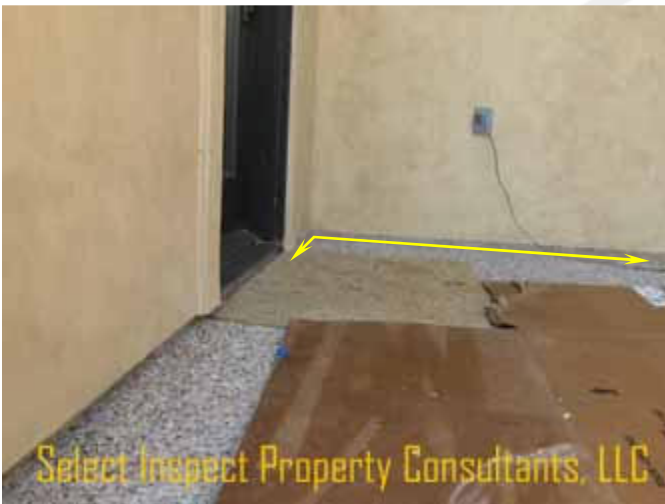
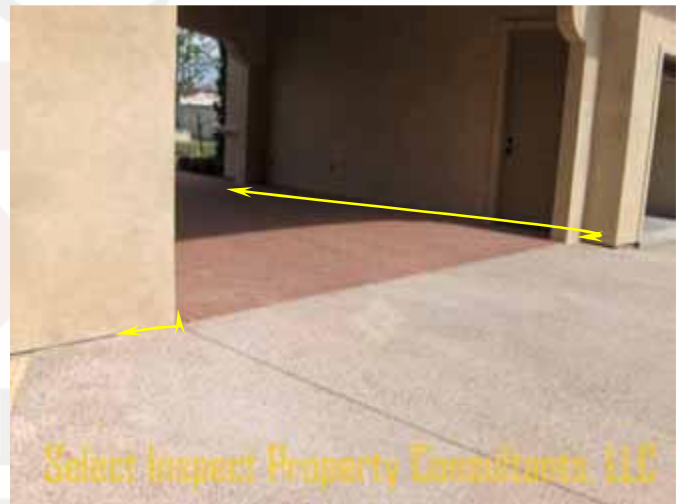
- Stucco is lower than recommended, where it meets the patio and various garage surfaces. Technically the siding and trim should be at least two or more inches above the grade surface to allow proper drainage of moisture and avoid subsequent moisture damage. Low stucco also obstructs inspection for termites and appropriate drainage provisions. Repair options are limited. Consult the stucco manufacturer for acceptability.

↑ stucco was low/hidden foundation edge; example

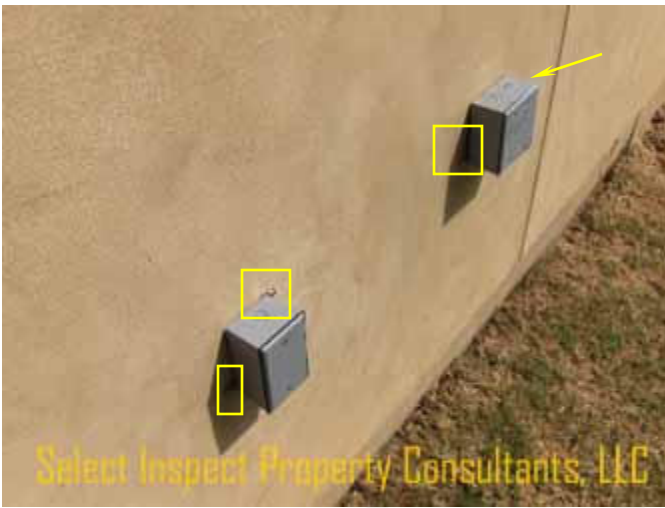
↑ recommended sealing all penetrations of stucco walls; example

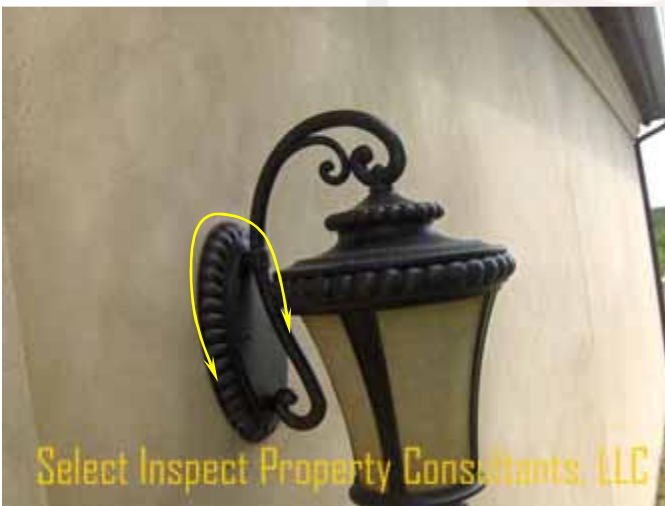
↑ caulking/sealant needed atop exterior lights; example

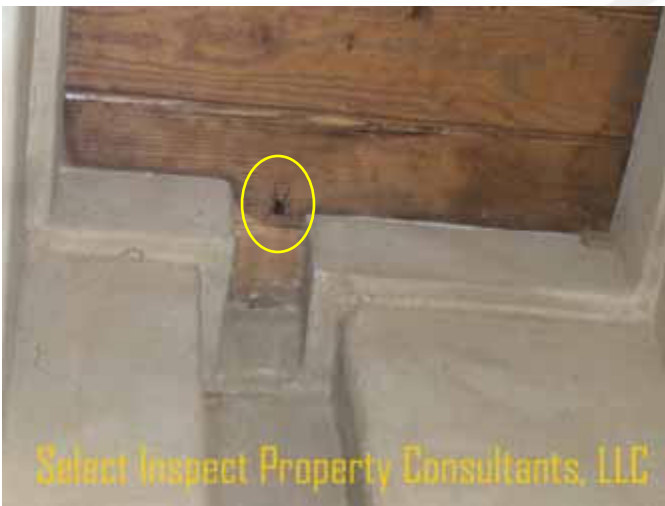
↑ black widow & egg sac discovered above the den/family room exterior door

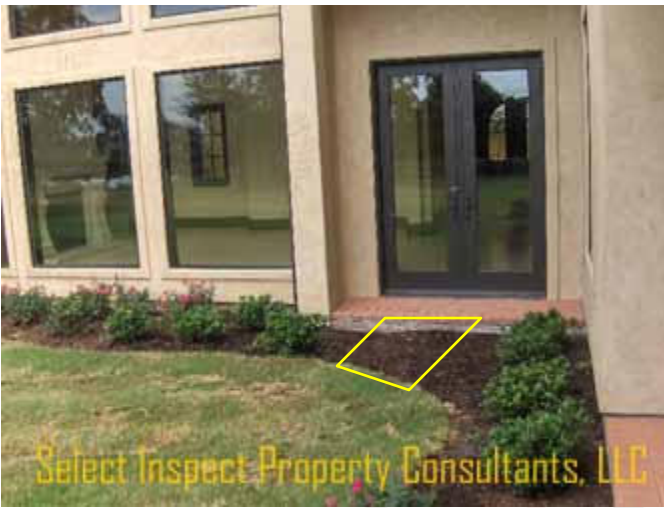
↑ this area seemed empty without some type of paver/stone leading from the patio to the grass

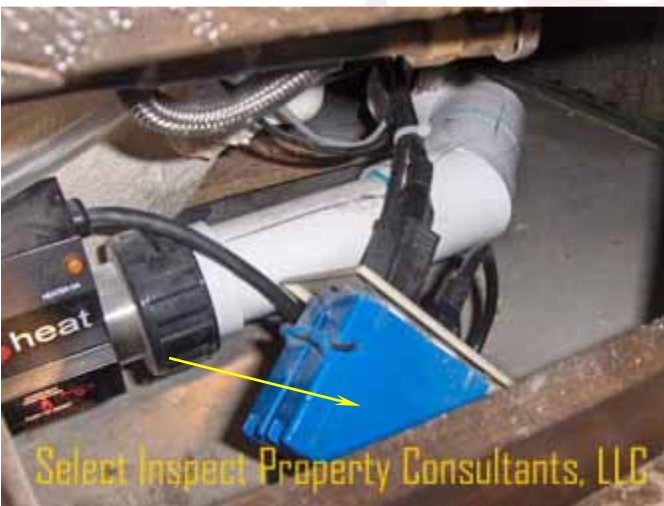
- Cover plate is damaged at the east attic.
- Receptacle junction box below the jetted tub was unsecured.
- Grout should be removed from the ground orifice at the kitchen east receptacle

↑ unsecured electrical box below the jetted tub

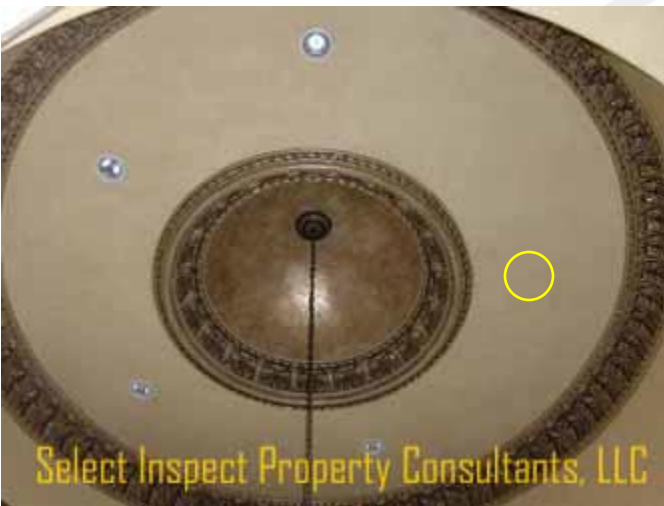
↑ it appeared that a recessed light was missing (visually unusual; empty space) above the stairway

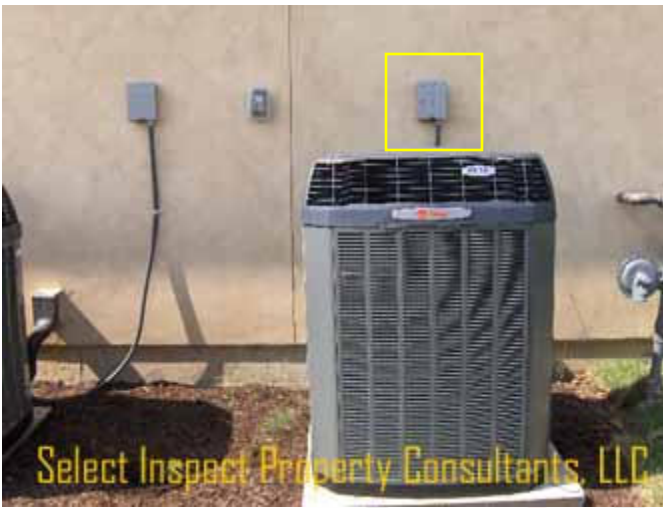
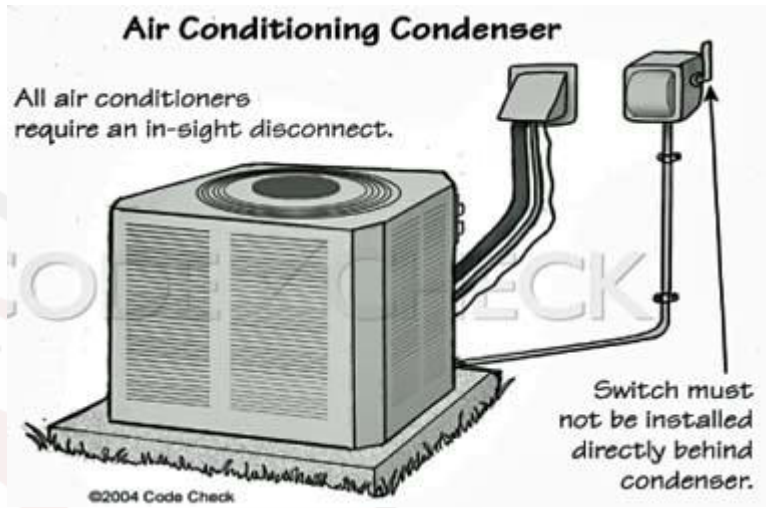
- The electrical disconnect panels for the air conditioner condenser unit(s) did not meet recommended clearance; the disconnect is considered a service panel and requires 30" lateral clearance and 36" front clearance from grade up to six feet in height. Disconnecting means shall be located within sight and readily accessible from the air conditioning or refrigeration equipment. Immediate repair needs may be subjective, and may be cost prohibitive pending your level of concern.

↑ incorrect location of air conditioning condenser(s) service disconnect; example

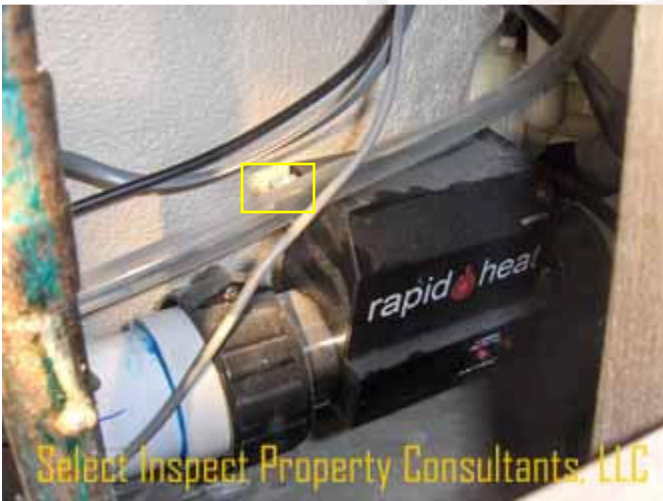
- Heater did not have a bond wire connected to the terminal lug, though it was bonded electrically to the water piping through the electrical cord. The motor / pump was not readily accessible and not confirmed as electrically bonded. The motor was out of level, but appeared operable.
- The underside of the spa was only partially accessible. One or more "accesses" were present, but visibility was very limited. Pump and motor components were not fully accessible. Some electrical and plumbing conditions under the bathtub remain undetermined.
- Jetted tub piping is dirty and may be unsanitary. Cleaning is recommended; most pool supply companies sell products for this purpose.

↑ jetted tub heater was bonded through the electrical cord, though the bonding / grounding terminal was unused.

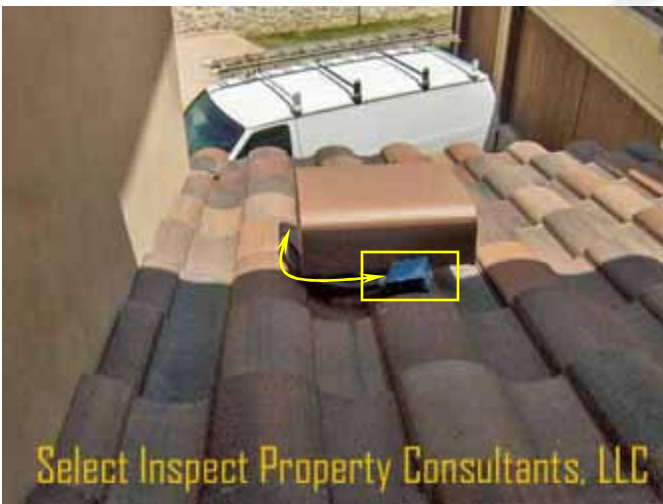
- Electrical covers were missing/incomplete at kitchen ceiling, and pantry
- Electrical conduit and junction box rest atop the roof adjacent the vent at the northeast roof. The attic here is not readily accessible, though the placement of the electrical component(s) appears unworkmanlike from the window.
- Various receptacles were askew.
- Shims were loose at master bathroom mirror receptacles.

↑ junction box and conduit at the northeast roof looks out of place.

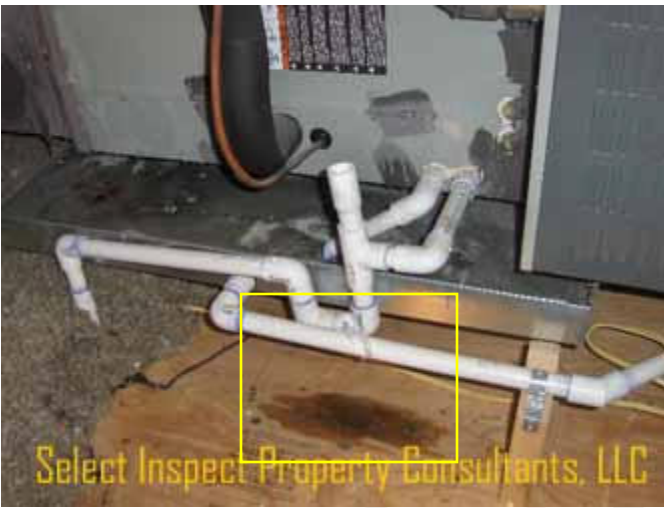
- Service disconnect for the unit 3 condenser was removed prior to the inspector's arrival.
- Evaporator(s) plug was missing at #3 in the upstairs north attic.
- Condensate lines were not adequately insulated: Mildew and or accumulation of moisture was noted as present on or below the primary condensate line(s), and / or staining present at attic components below the traps of units #1, 2, 3, 5. This may be prone to related moisture damage to attic flooring, insulation, drywall, and other attic / interior building components. Recommend addition of appropriate insulation past the trap and related components of the primary condensate line, as deemed necessary by an HVAC specialist. After that time, monitor the system / components periodically.

↑ example; primary condensate drain non-insulated; condensate staining/dripping below the traps @ master, east, & 2 north attic HVAC.

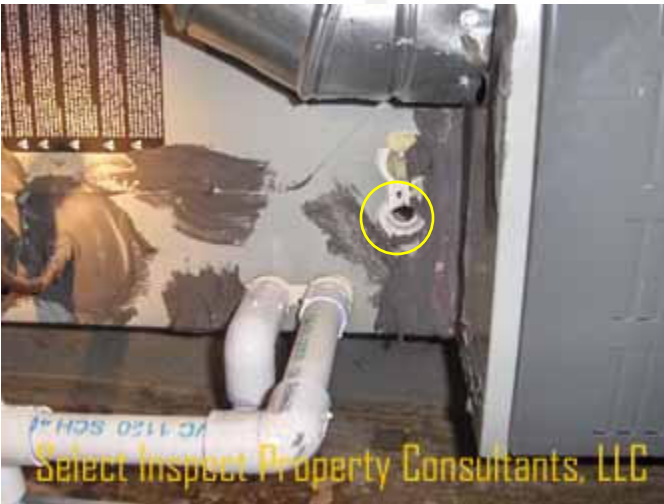
↑ missing evaporator(s) plug at the north #3 HVAC

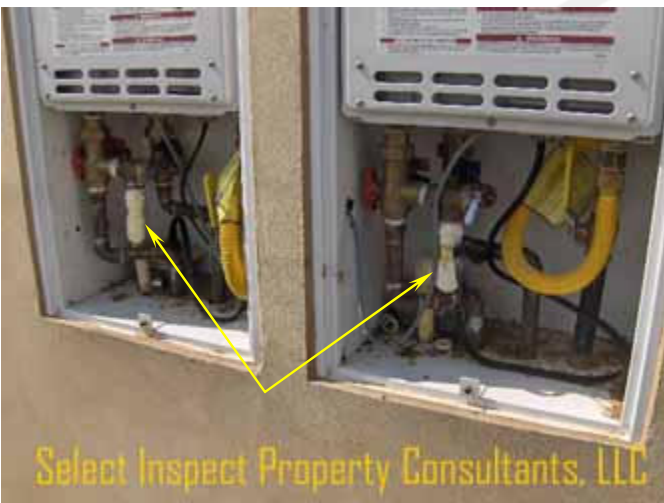
- The temperature-pressure-relief valve piping was deficient for this application; ¾" plastic piping as found in this home is frequently used and is inappropriately accepted by city code around the USA, however, the ¾" material does not meet most manufacturer requirements. T&P valve manufacturers generally require that the interior diameter of the drain line not be less than the interior diameter of the discharge section of the valve – a standard ¾". The ¾" CPVC tubing in use measures an average 0.715" interior diameter (technically .035" less than required). If plastic piping is to be used it must be 1" O.D. to conform.

↑ temperature/pressure relief piping was smaller than required by most device manufacturers

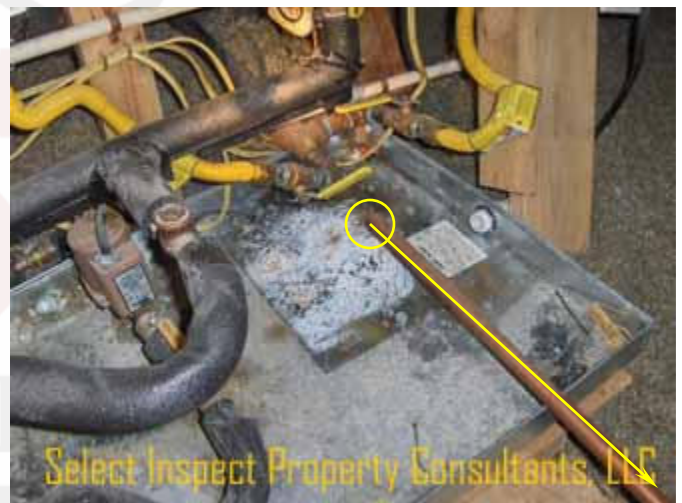
↑ this copper pipe in the master attic had undetermined purpose & undetermined termination; discovered at the water heater auxiliary pan
