New Home Punch-out Inspection

Custom Home Builder

at: **2009 New Street; Flower Mound, TX 75022**

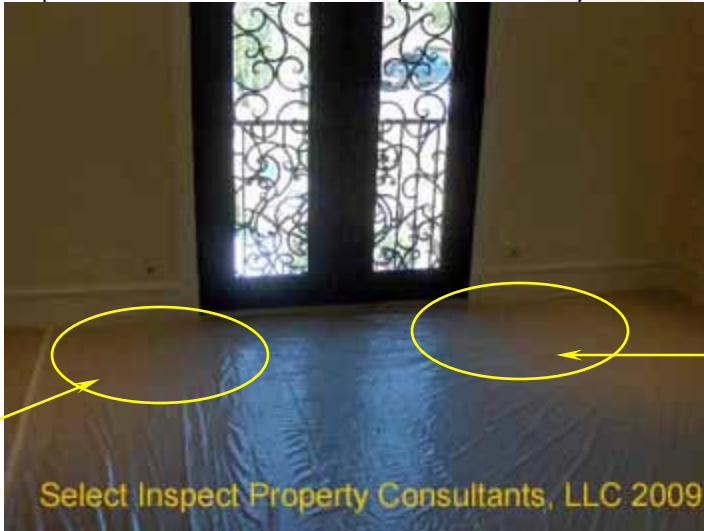
- North balcony door perimeter is unsealed. Dampness was noted at the carpet below the plastic sheeting in the northern bedroom. I pulled back the plastic to help the moisture escape and reduce likelihood of fungal accumulation at this area. Considering the unsealed door; warm interior, and cool morning air outside, I suspect this was a condensation issue. Leakage concerns were not discovered inside, outside, above, or below this location at the time of inspection.

↑ moisture discovered at the northern bedroom balcony area; interior flooring

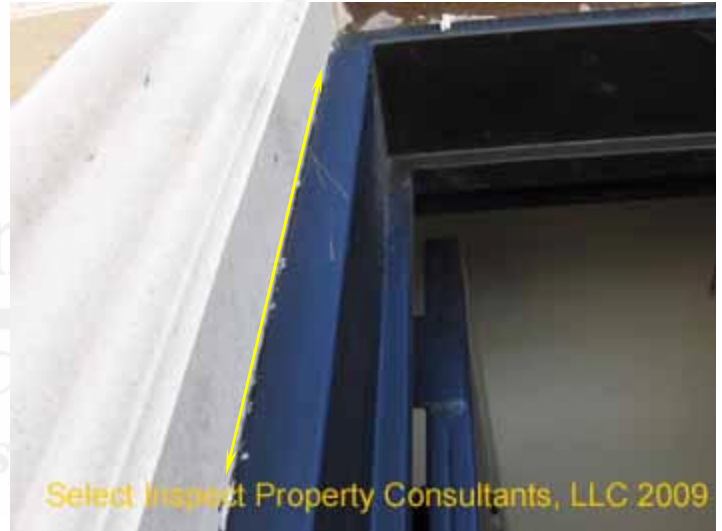
↑ unsealed exterior perimeter

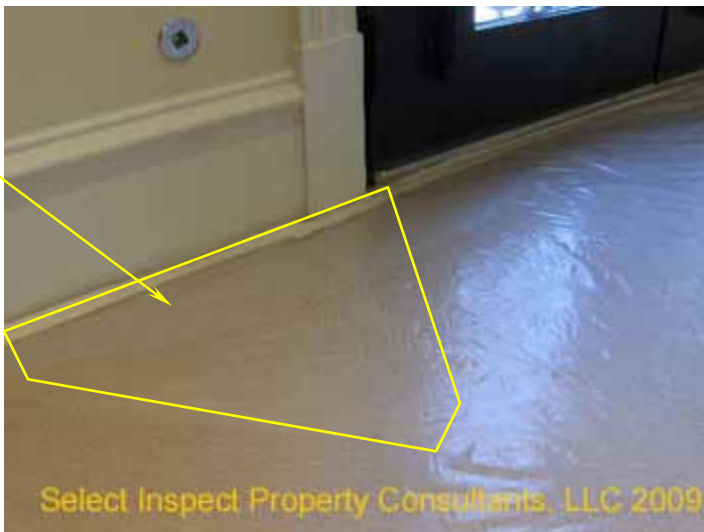
↑ close view of image above

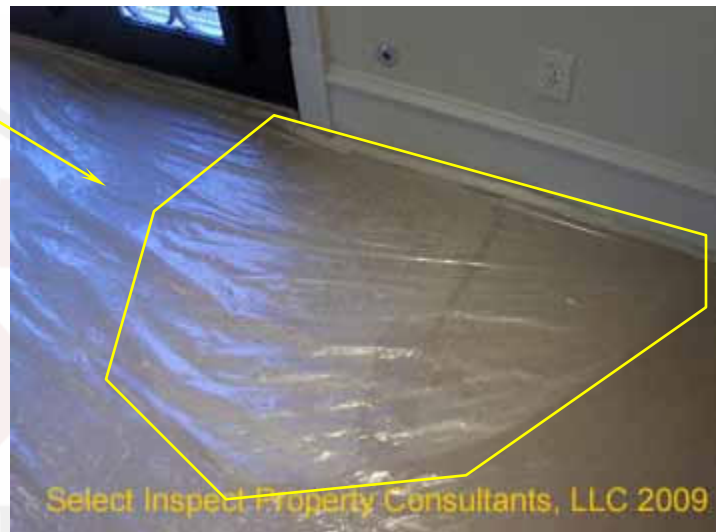
↑ close view of image above

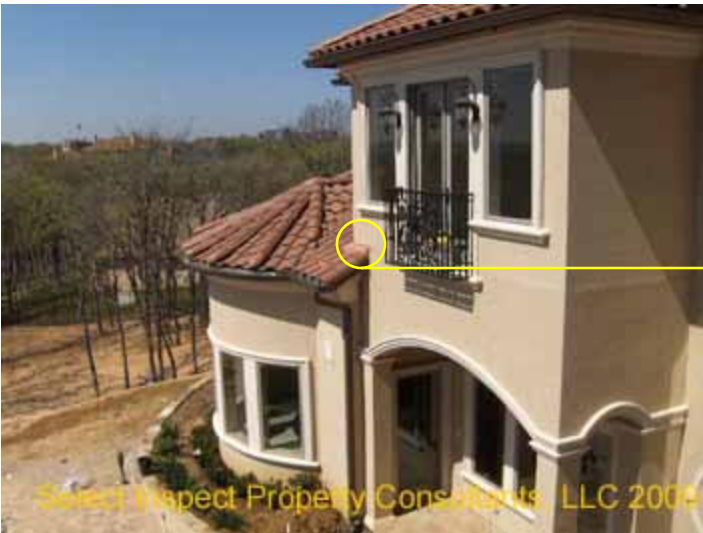
↑ opening exists at flashing

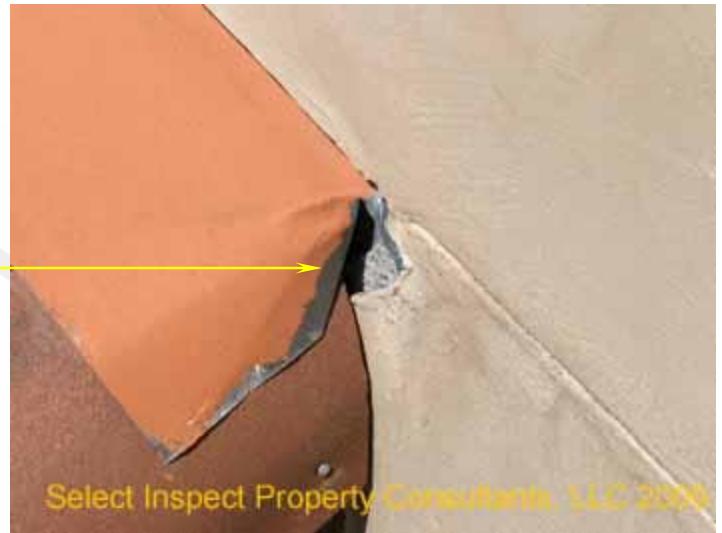
↑ close view of image at left

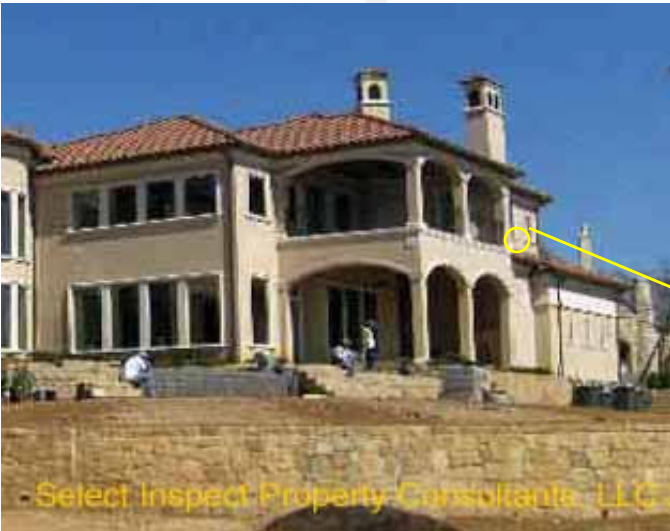
↑ opening exists at flashing

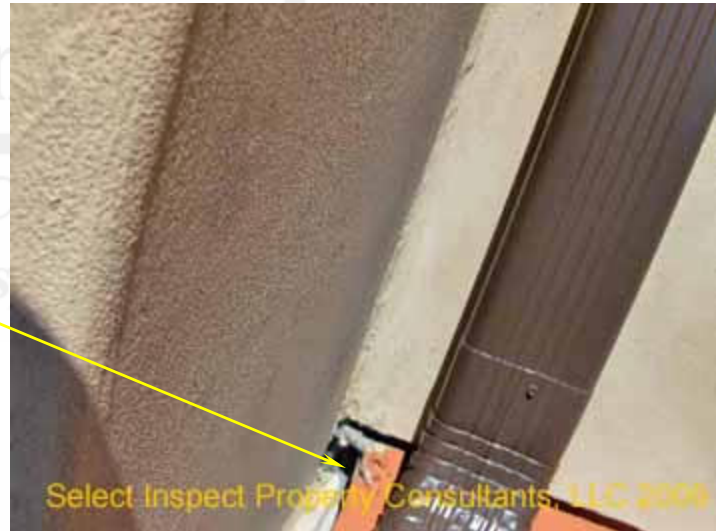
↑ close view of image at left

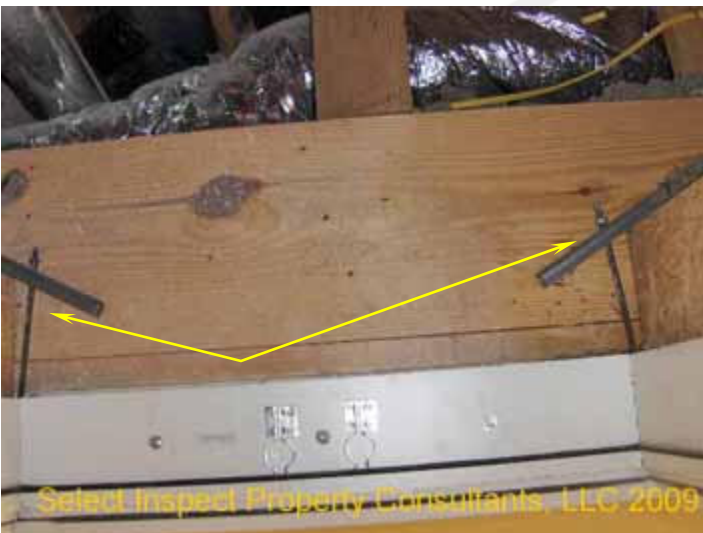
- Scissor ladder at the master closet was not properly secured at the toggle bolts; these bolts were incorrect and not offering full anchorage as intended. This image is from page 5 of the installation manual;
http://www.rainbowatticstair.com/images/pdfs/installation_guide_prestige.pdf

↑ deficient installation of scissor ladder

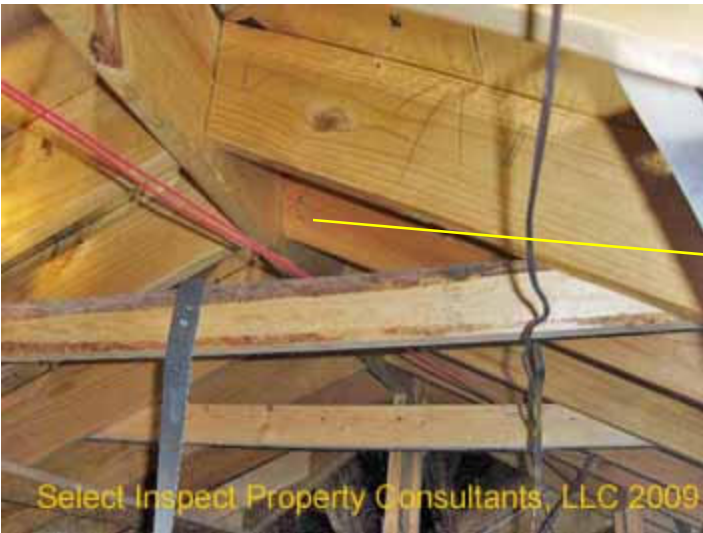
- Slightly cracked rafters were discovered upper left and right of HVAC unit #5 at the media room attic. Recommend additional blocking to prevent future deflection.

↑ cracked rafter at right of HVAC #5

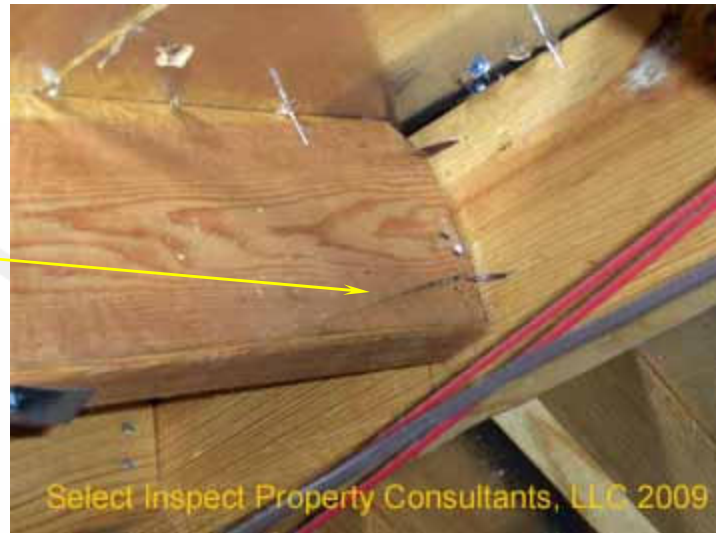
↑ close view of image at left

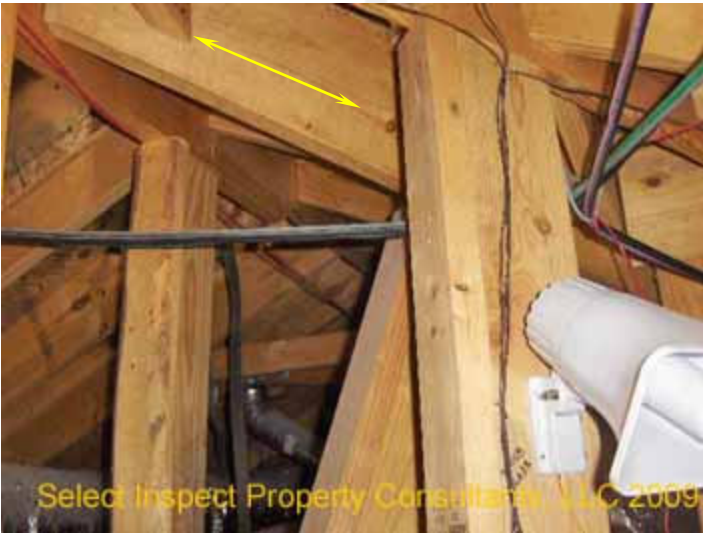
↑ cracked rafter at left of HVAC #5

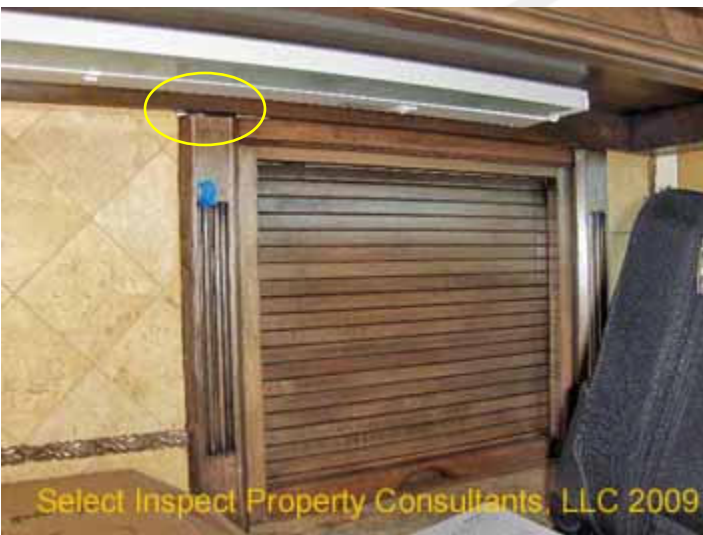
↑ gap at trim; roll top cabinet in kitchen

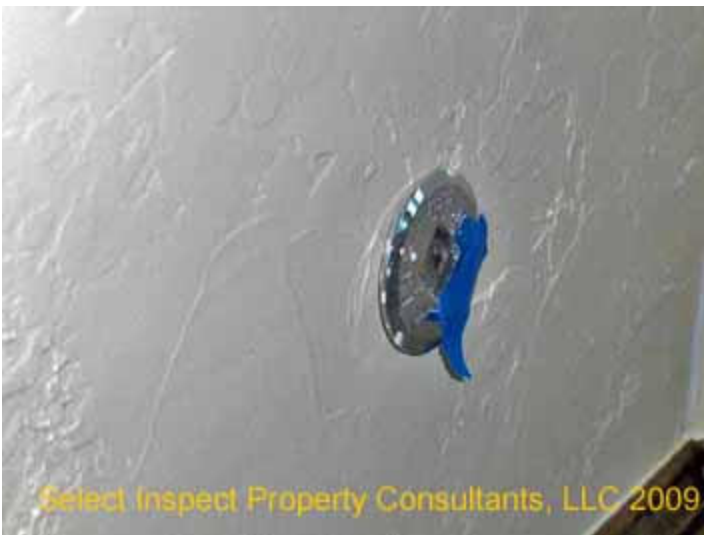
↑ reveal at gas shut-off valve

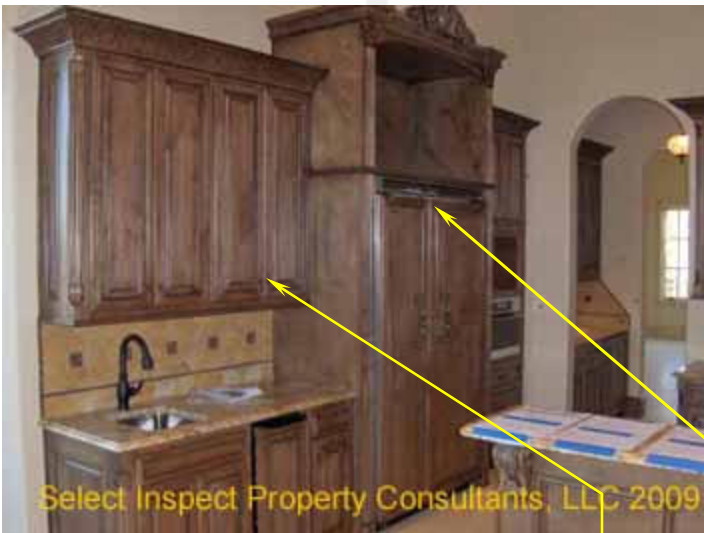
↑ askew cabinet hardware & refrigerator panels

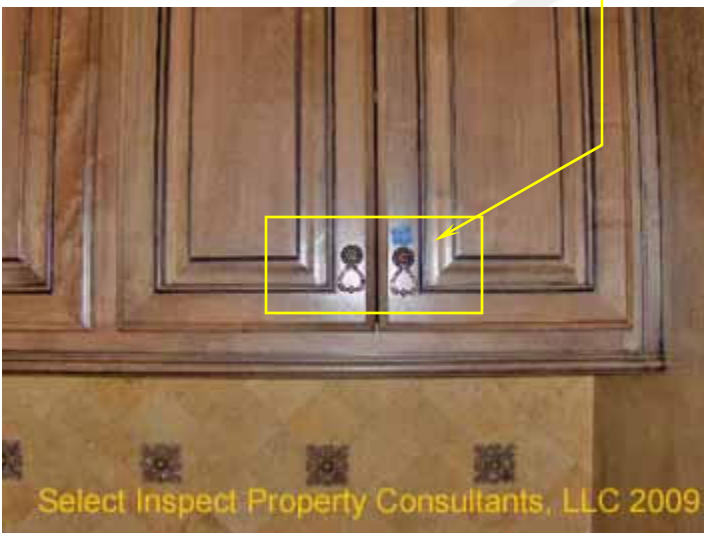
↑ right handle is lower than the left

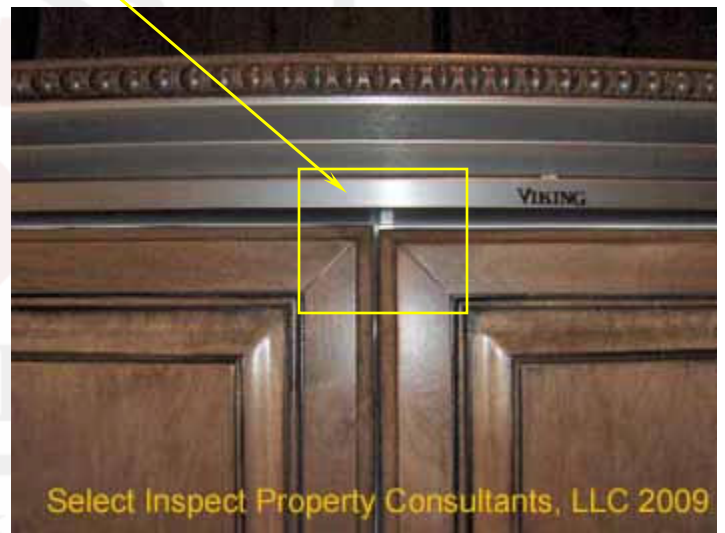
↑ slightly askew refrigerator panels

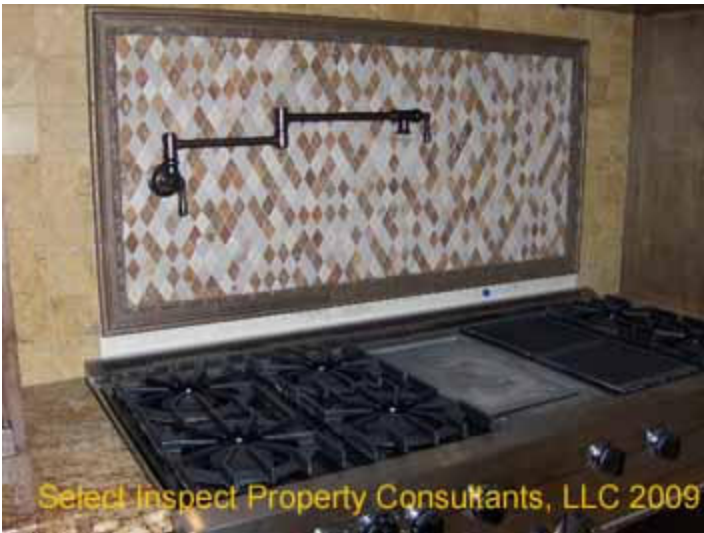
- Multiple cosmetic items remain needing punch-out
- Tile backsplash was missing just above the kitchen stove.
- Paint drippings and deficiencies exist at multiple backside top areas of cabinets in bathrooms and master closet.
- Granite countertops, if present, are not tested for presence of or levels of uranium or radiation. Related information can be found at: <http://selectinspect.com/links1.htm#radonlink>

↑ missing tile at stove backsplash

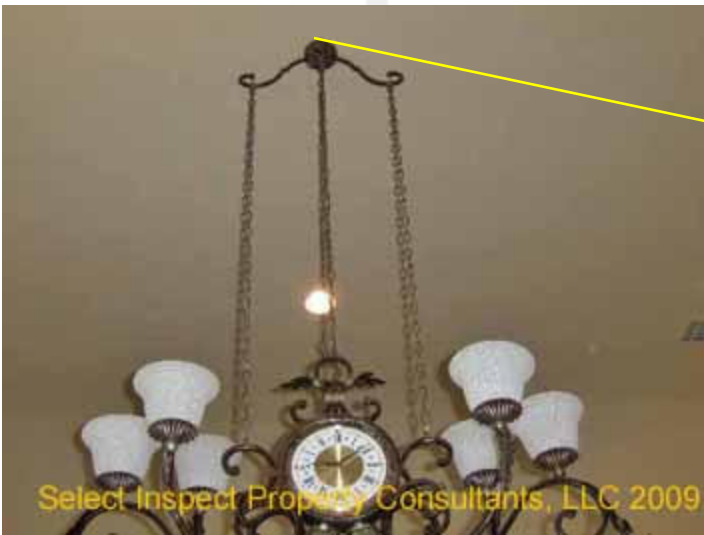
↑ reveal at kitchen light

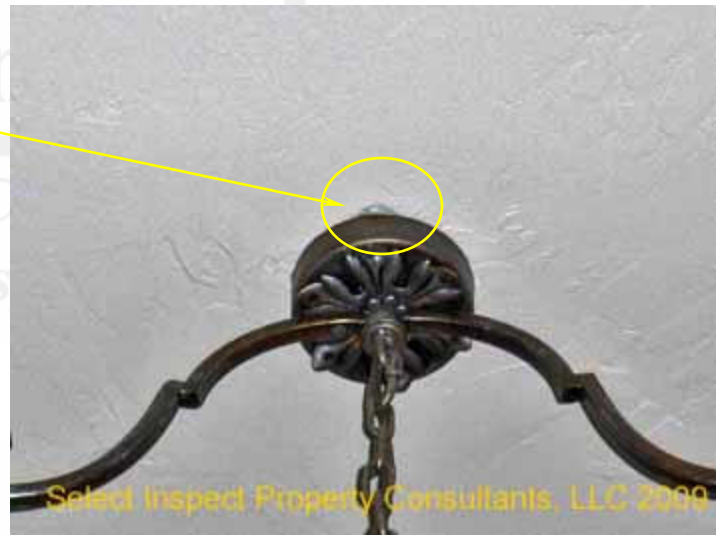
↑ close view of image at left

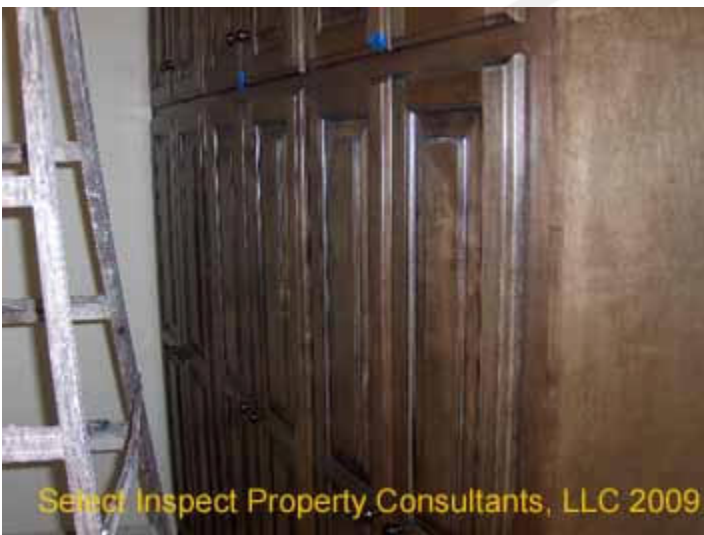
↑ uneven mudroom cabinets

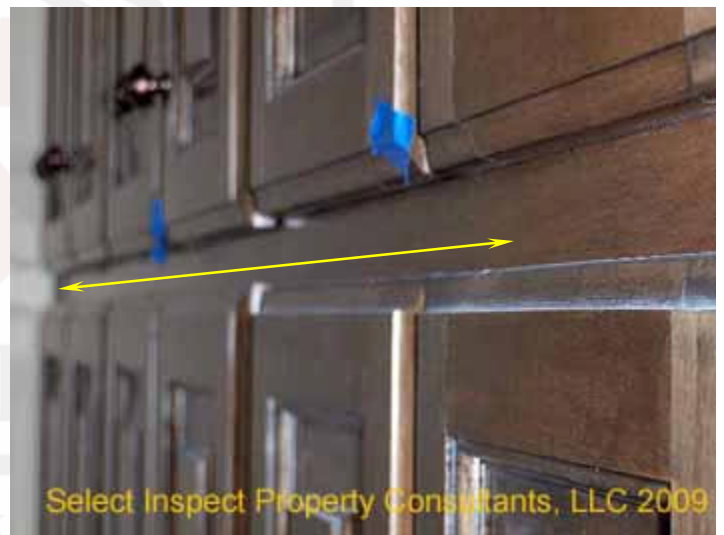
↑ close view of image at left

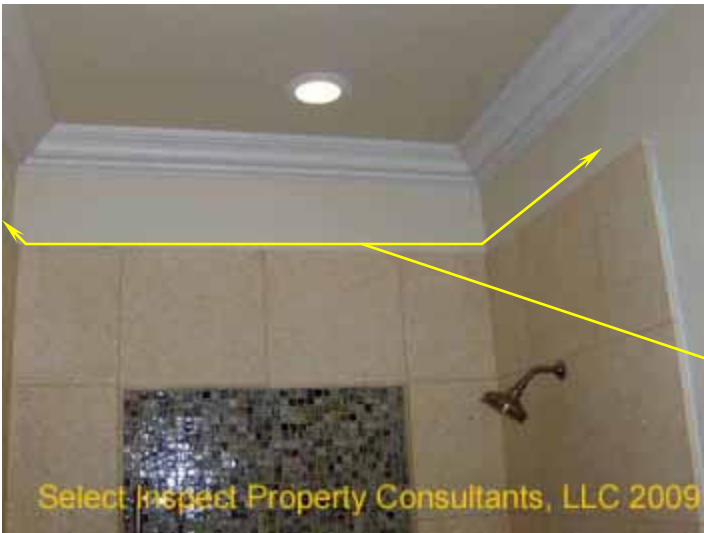
- Recommend sealing the top tile/panel edge at the wall of the shower(s) to reduce potential for moisture intrusion and fungal accumulation at the shower substrate (between the shower and walls)
- Multiple cosmetic items remain needing punch-out.
- Media room trim has separated at painted joints; "hard-board" type remains unfinished below the downstairs ½ bathroom sink; glazing incomplete at various features; etc.
- Reveals at the kitchen bar overhead light mount and family room fireplace gas valve.

↑ Seal the top tile edge at the shower walls- example

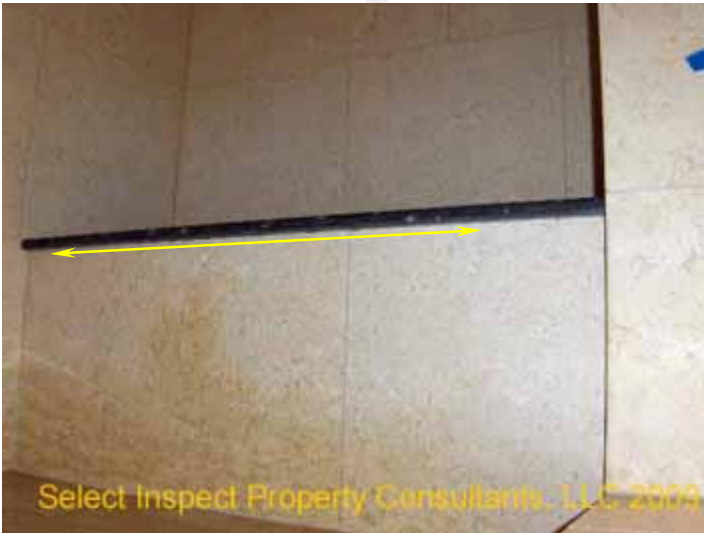
- Grout was amiss at the underside front edge of the seat at the upstairs southeast shower.
- Grout repair is needed at the laundry room and upstairs north showers.
- Steam equipment would not turn on at the shower control panel. Debris exists in the steam equipment auxiliary pan in the attic above.

↑ incomplete grout at the shower seat

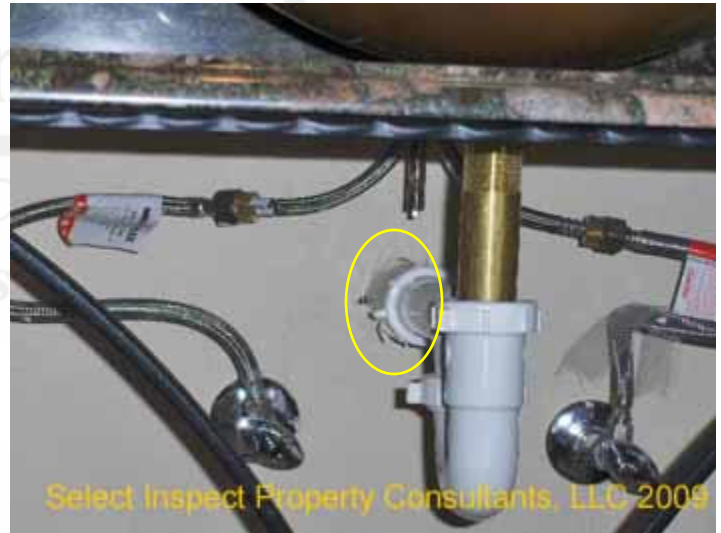
↑ cosmetic reveal below sink; southeast downstairs

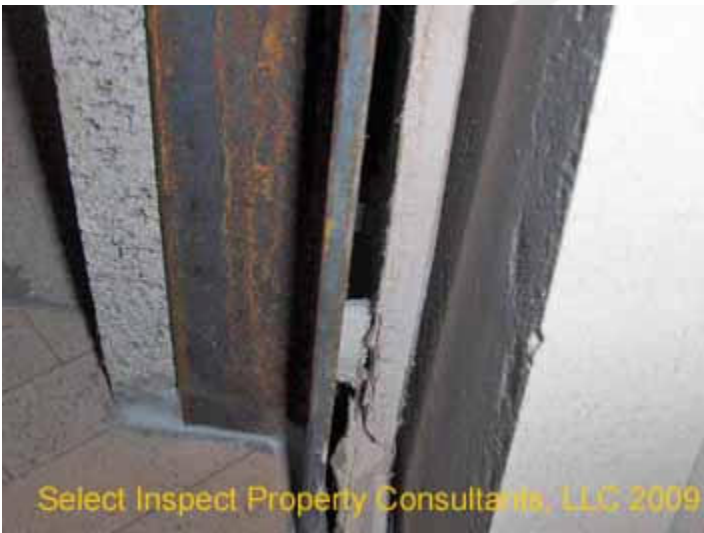
- The perimeter between the firebox and hearth stone has not been sealed at the living room side of the living room/study fireplace.

↑ unfinished seal at the living room fireplace

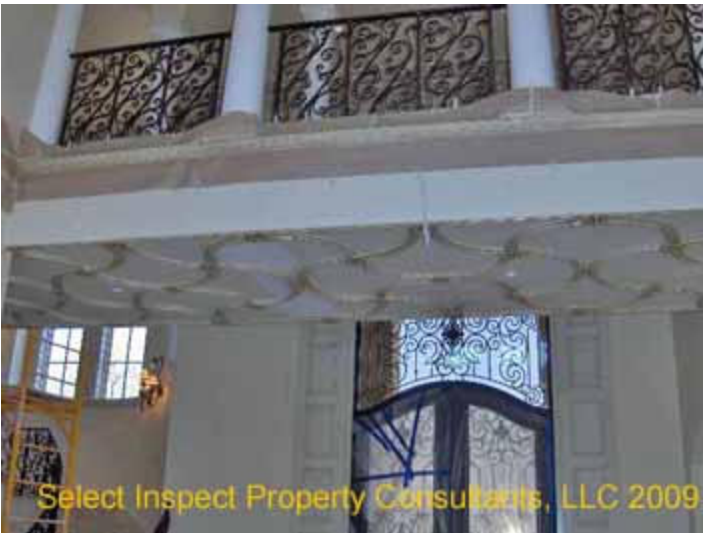
↑ custom finishing still in process

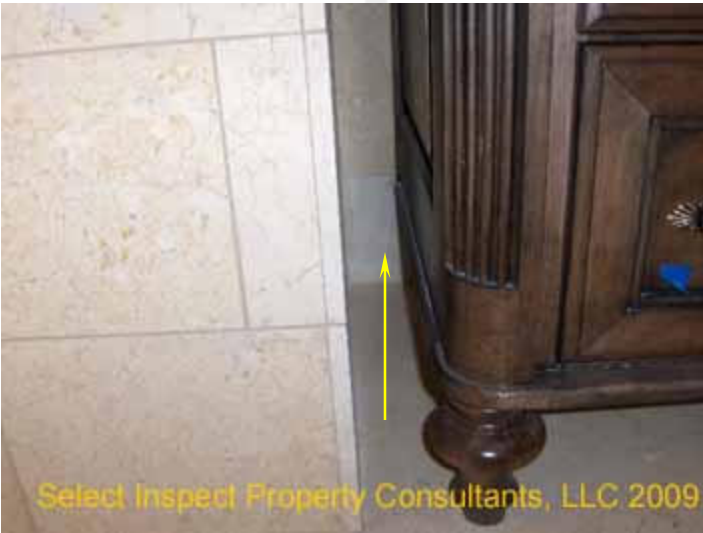
↑ unfinished "hard-board" material at the downstairs 1/2 bathroom.

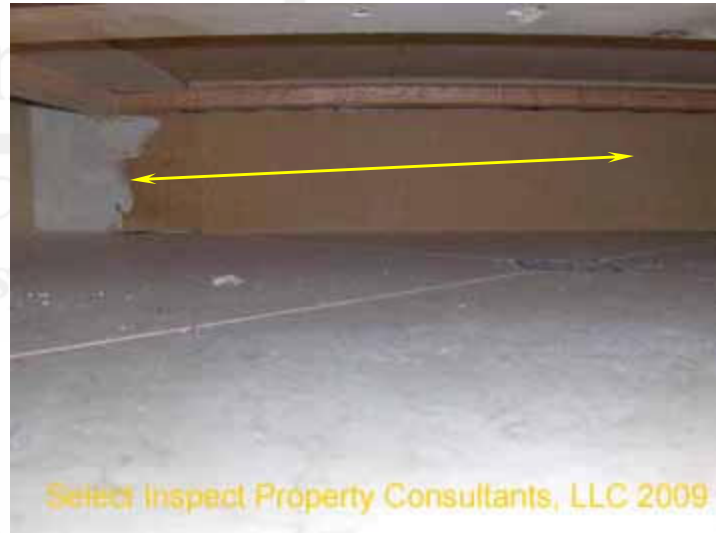
↑ same as image at left; under sink cabinet

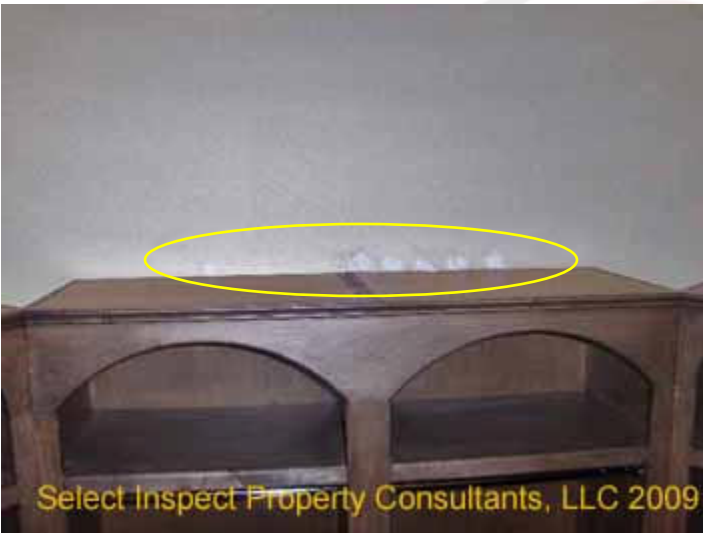
↑ incomplete paint finish; example above master closet cabinets

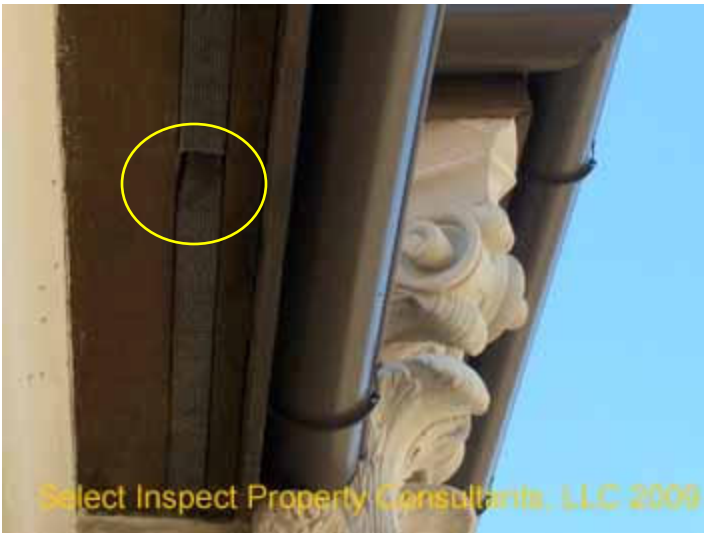
- Soffit vent was bent and amiss at the upper west of the northern bedroom balcony.

↑ deficient soffit vent near north balcony

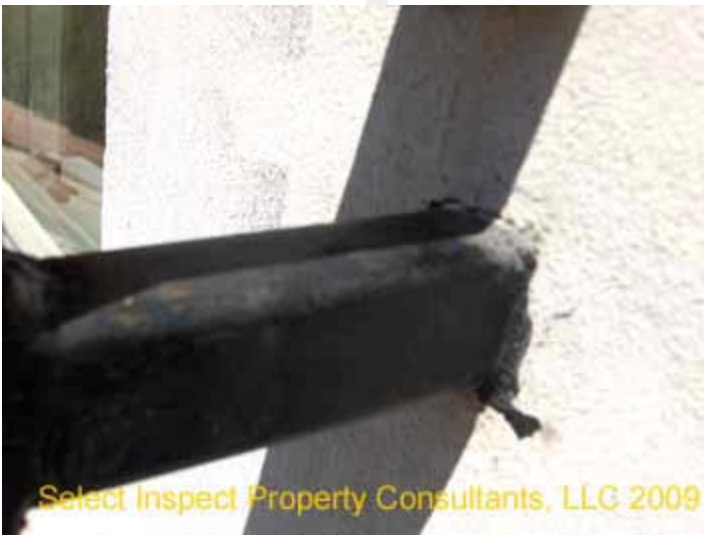
- Railing mount points should be appropriately sealed at the stucco walls. Significant issues were not found or observed concerning this item at the time of inspection.

↑ balcony rail mountings should be sealed at stucco wall

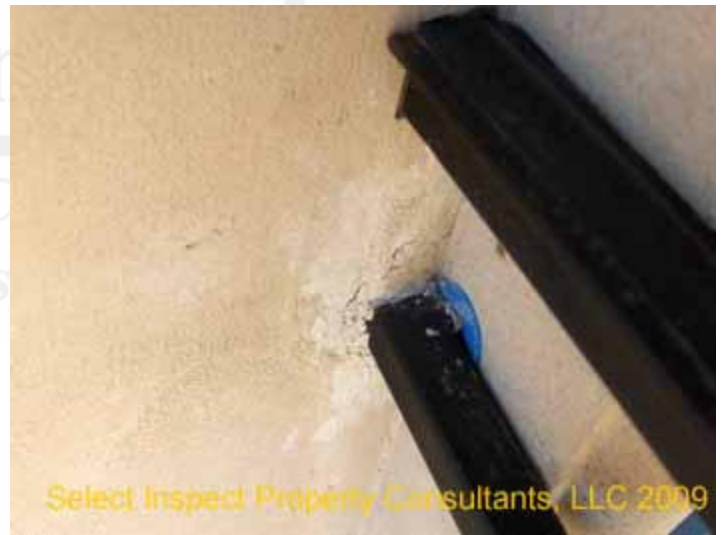
↑ additional example of railing at stucco wall

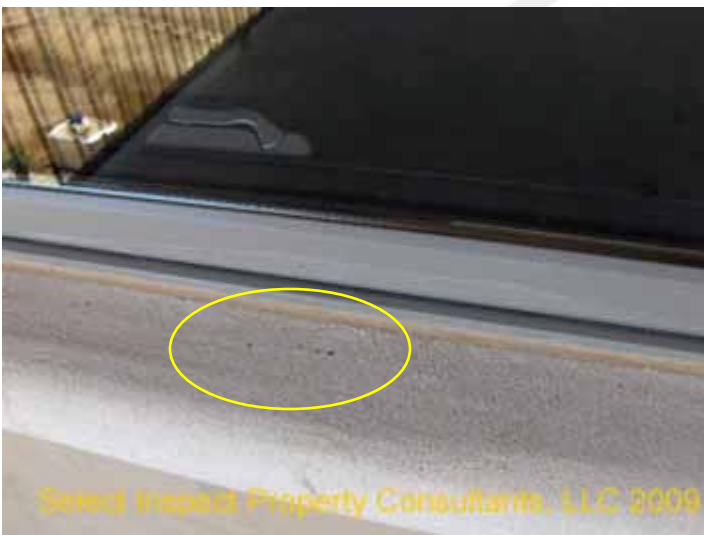
↑ pits at game room patio window sill

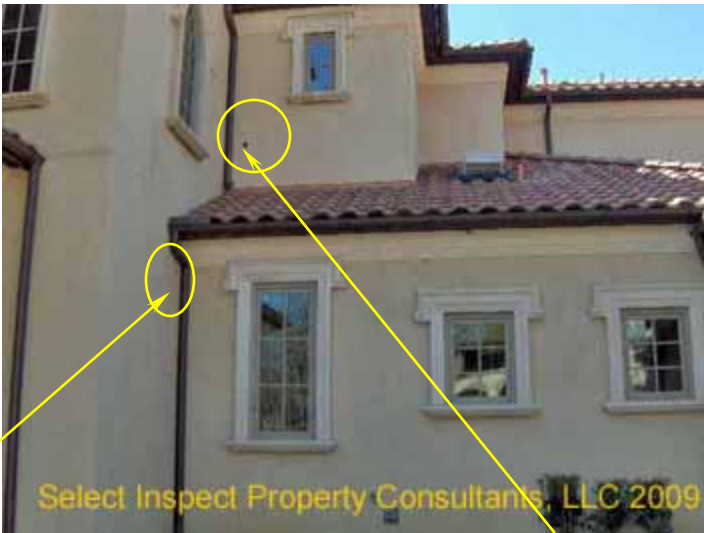
- 2 large openings exist at the north exposure near the northwest corner of the garage, and at the nearby upper east facing wall.
 - Damaged Artificial Stucco / EIFS was noted at the northeast garage doorway trim.

↑ openings at eastern walls near garage

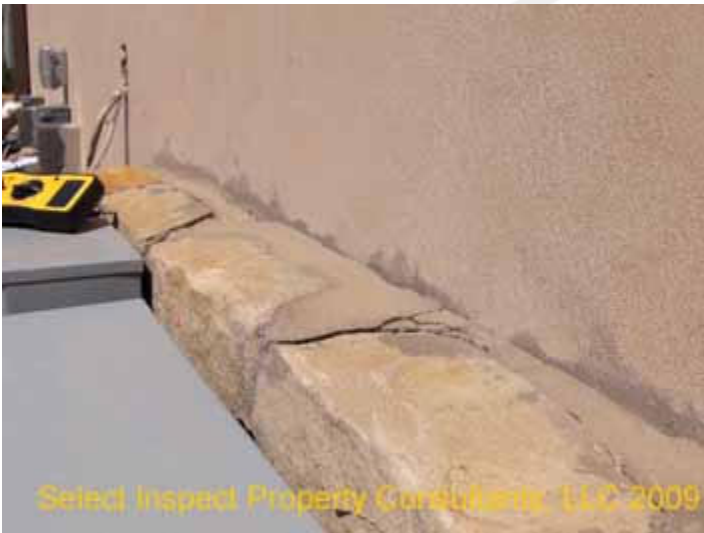
- Thin Artificial Stucco / EIFS crack exists at the window sill of the rounded master bedroom area.
- Stone and mortar is cracked and openings exist at the electrical service.

↑ cracked stone mortar at the electrical service

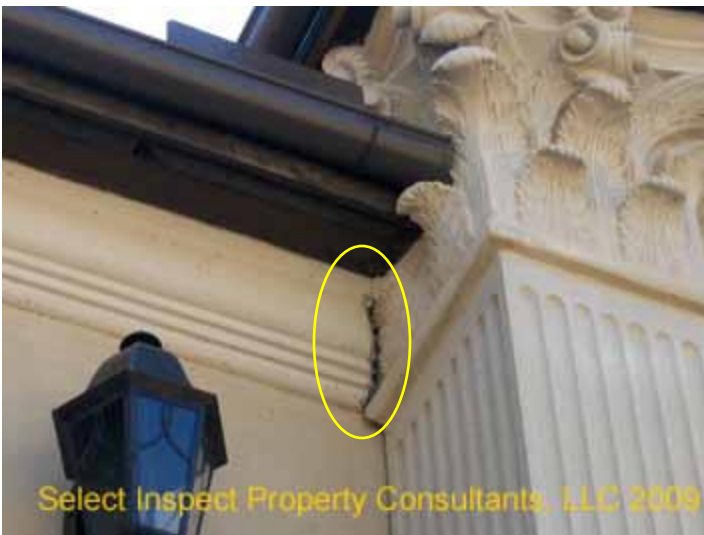
- Unfinished edge exists at the upper left column of the front entry.
 - Air-conditioner condenser disconnects should be sealed at the walls.
 - Top 2/3 of exterior horizontally mounted light fixtures should be sealed. Exterior lights should be properly sealed to prevent moisture intrusion and related corrosion / overheating possibilities of the electrical components. NEC 410-4 & IRC E3903.9.

↑ unfinished stucco edge at the upper front column

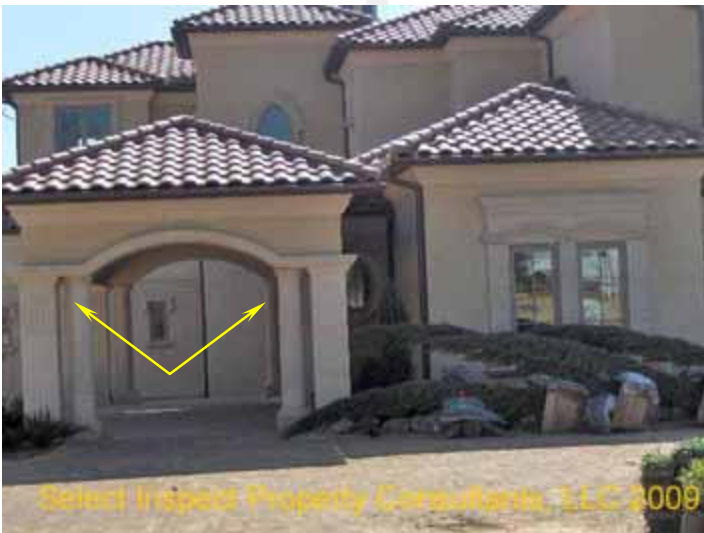
↑ incomplete mortar at porte-cochere columns

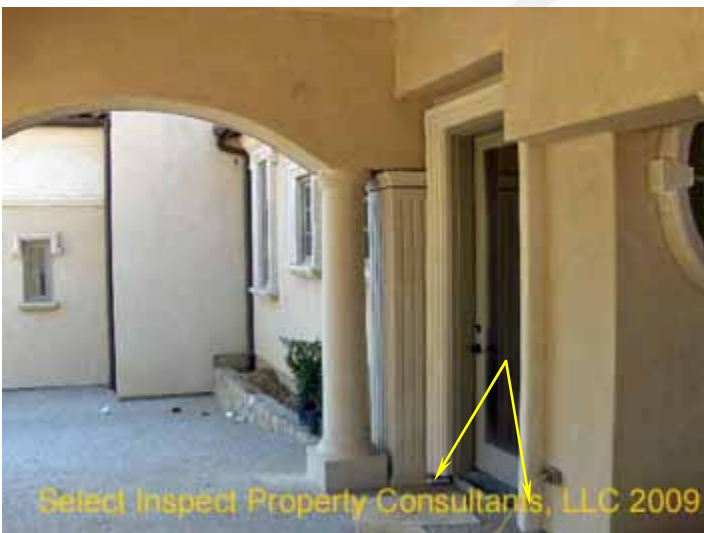
↑ exposed framing/substrate below eastern exterior door

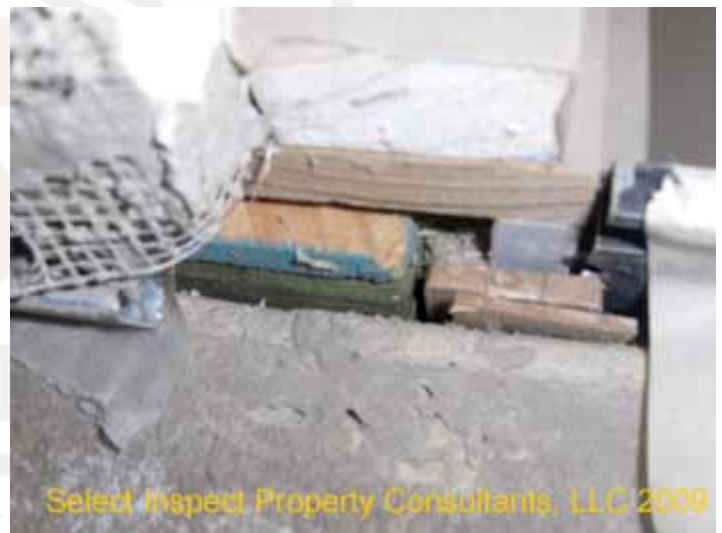
↑ close view of image at left

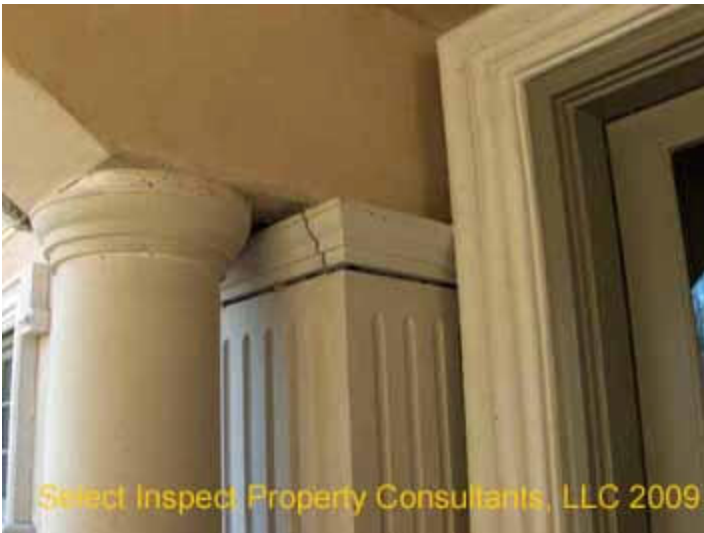
↑ incomplete mortar at the porte-cochere columns; example

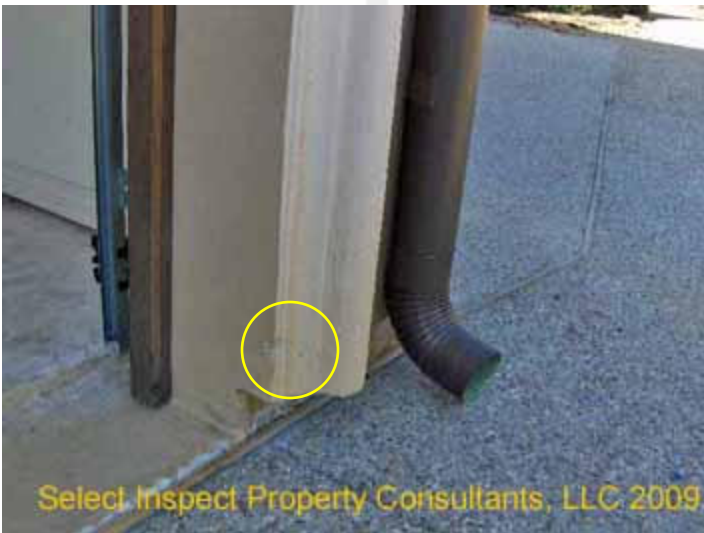
↑ damaged Artificial Stucco / EIFS at the garage trim

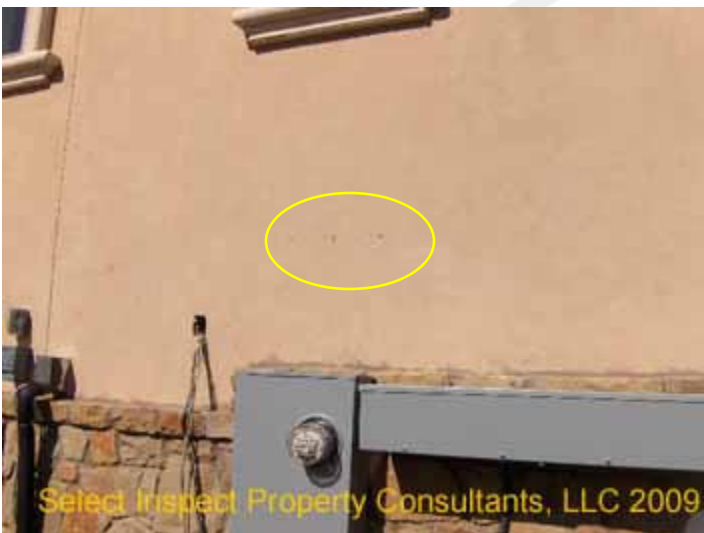
- Openings above the electrical service; unfinished edges/seams at balcony railing mount points; game room patio window sill; round feature of the dining room round windows; reveal at the smart system control near the patio door closest to the exterior fireplace, and the exterior fireplace gas shut-off valve mounting point reveal.

↑ openings above the electrical service

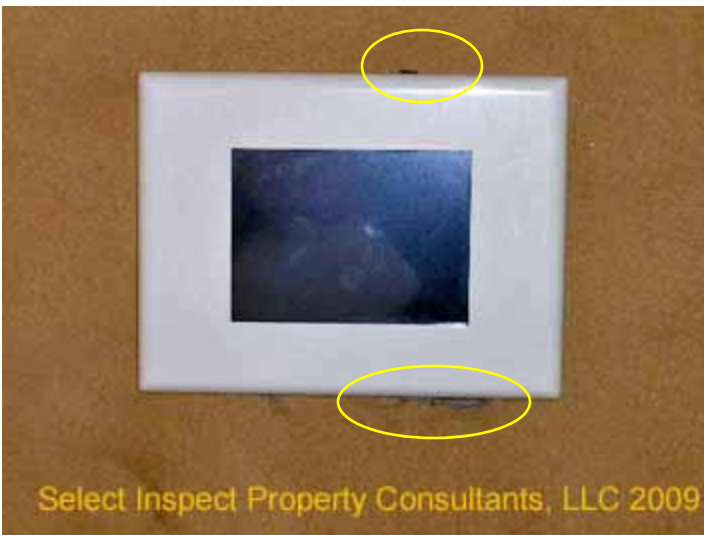
↑ openings at the patio smart system control

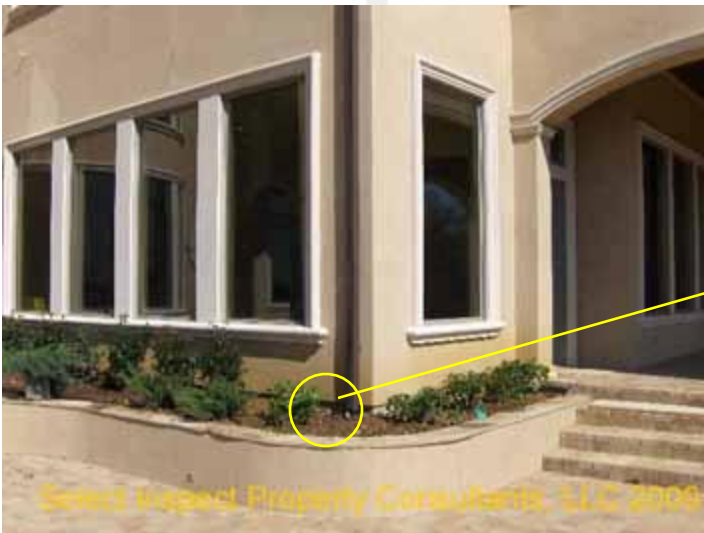
↑ exposed conduit at slab adjacent the family room

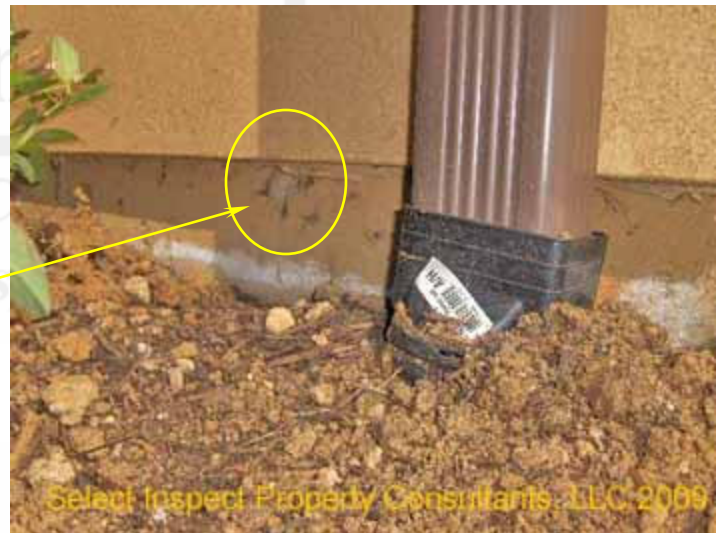
↑ close view of image at left

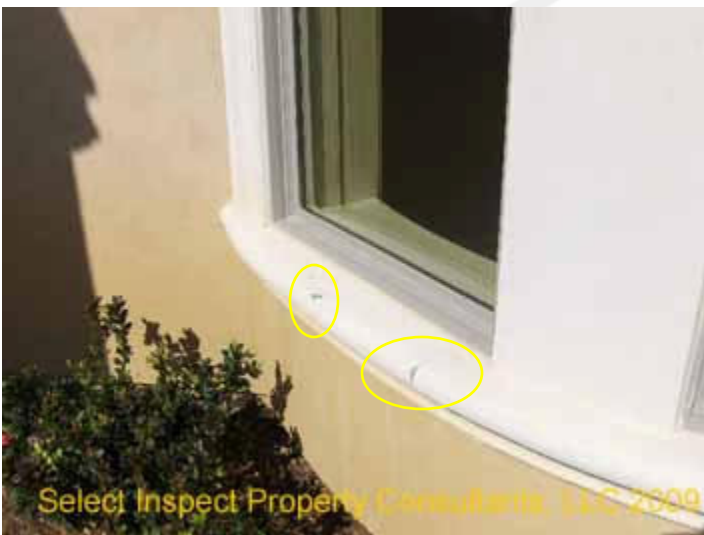
↑ damage/openings at the dining room window sill

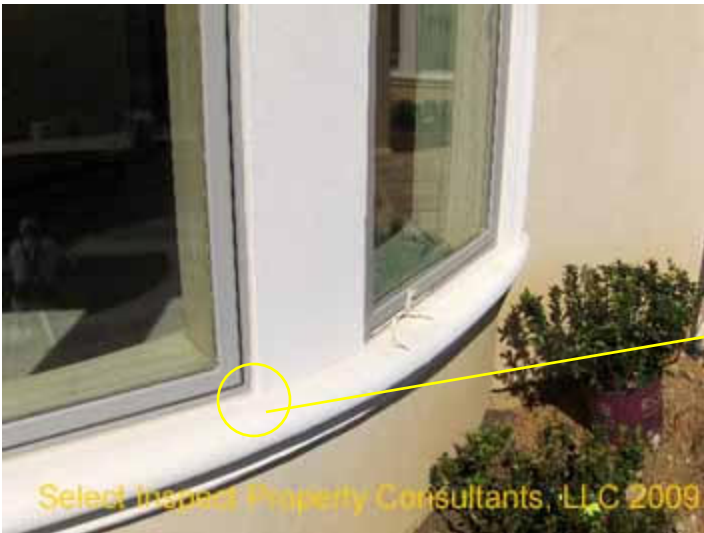
↑ cracked veneer at the master bedroom sill

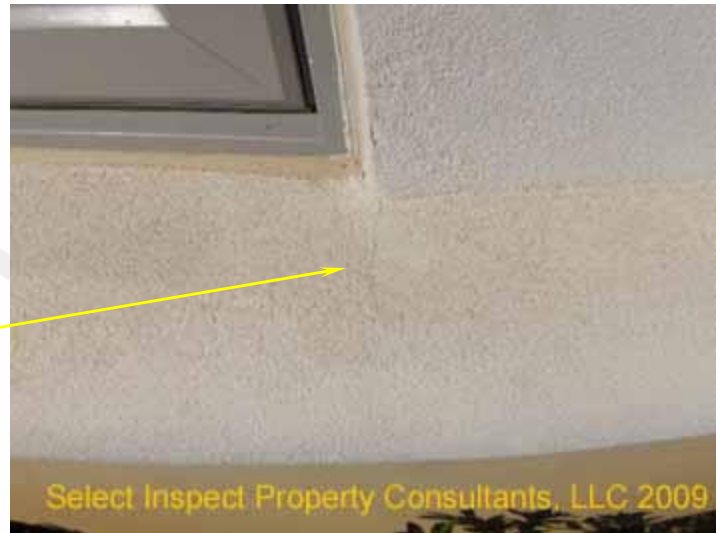
↑ close view of image at left

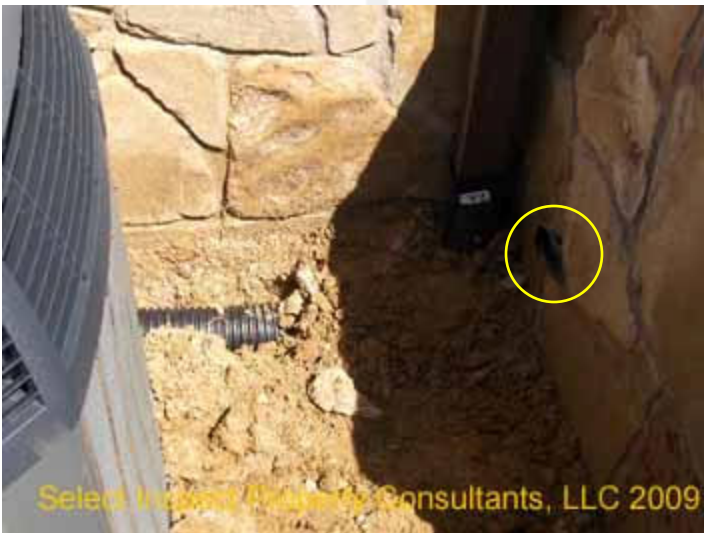
↑ improper termination of area drain at the southeast

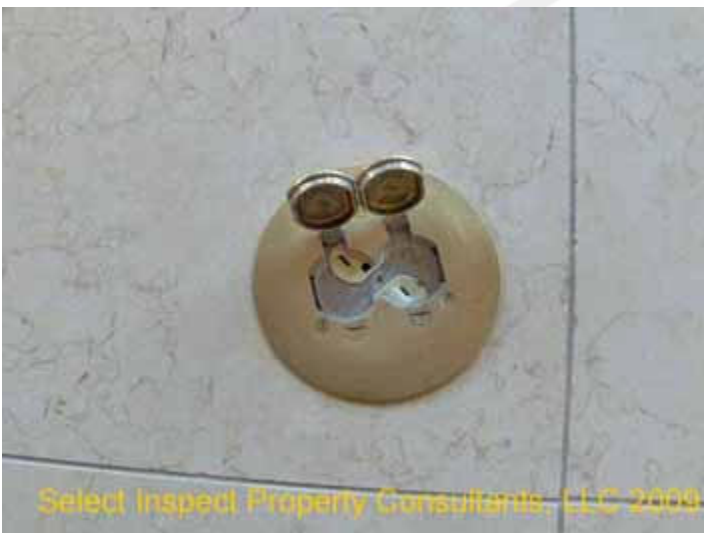
- Family room floor receptacle(s) cover was askew as compared to the receptacle(s); the receptacle(s) is unusable in this configuration.
- Exterior cover was deficient at the southeast air-conditioner condenser area.
- Quad receptacle(s) at the master closet was inoperable.

↑ unworkmanlike electrical at the family room floor receptacle(s)

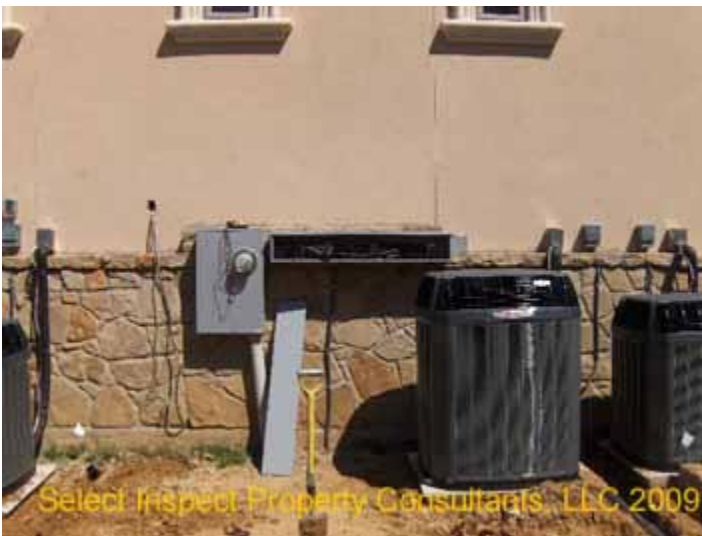
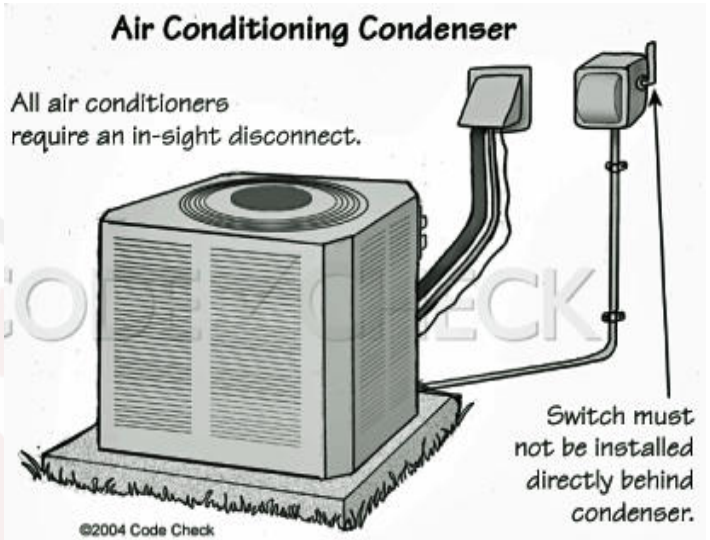
- The electrical disconnect panels for the air conditioner condenser unit(s) did not meet recommended clearance; the disconnect is considered a service panel and requires 30" lateral clearance and 36" front clearance from grade up to six feet in height. Disconnecting means shall be located within sight and readily accessible from the air conditioning or refrigeration equipment. Immediate repair needs may be subjective, and may be cost prohibitive pending your level of concern.

↑ improperly located air-conditioner electrical disconnect(s)

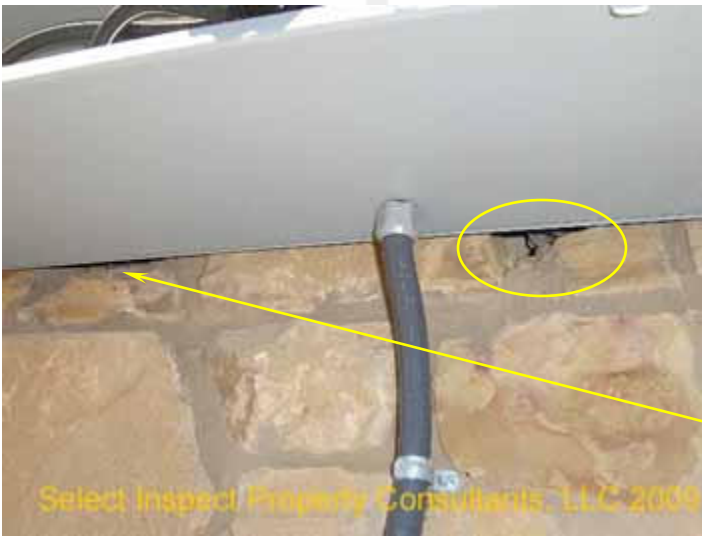
- Conduit nut was not secured below the raceway adjacent the electrical service meter.

↑ unworkmanlike conduit (lack of securing nut) and openings below raceway

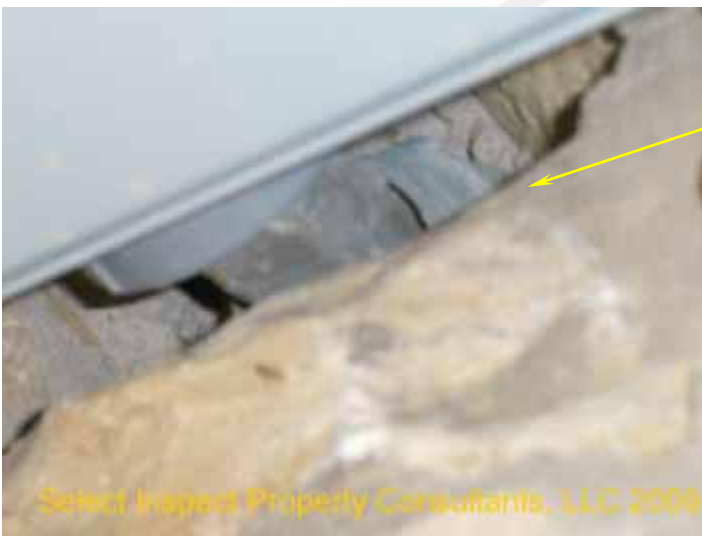
↑ close view of image above

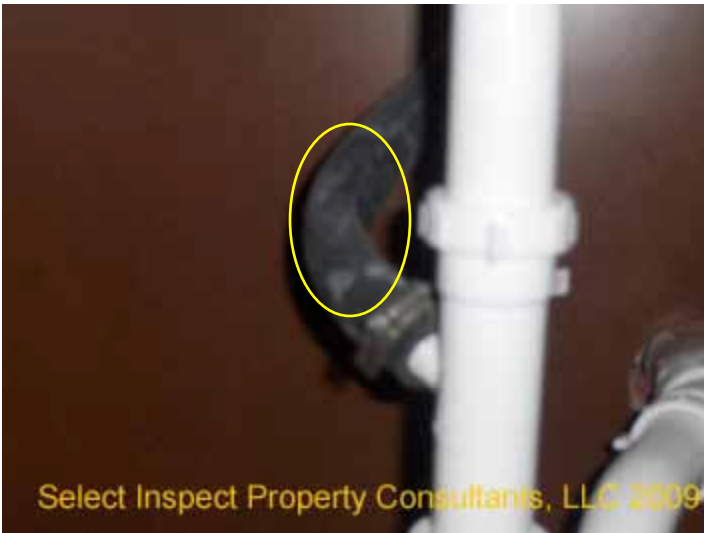
- The primary condensate lines were crimped at / near the drain connection below the game room bar sink(s). This is conducive to congestion and potential failure of the air-conditioner drain system. Improvement / repair should be simple and is recommended.

↑ crimped air-conditioner primary condensate line is prone to failure; game room bar sink
