New Home Punch-out Inspection

Custom Home Builder

at: **2009 New Street; Flower Mound, TX 75022**

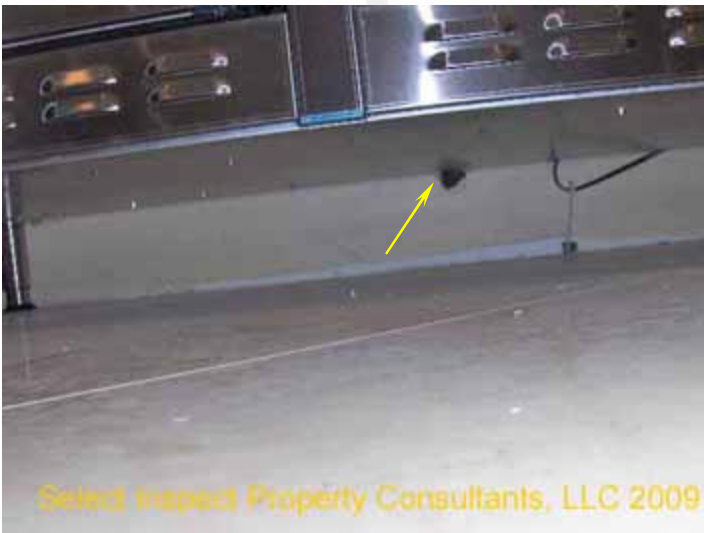
↑ not readily accessible gas shut-off valve at stove/oven

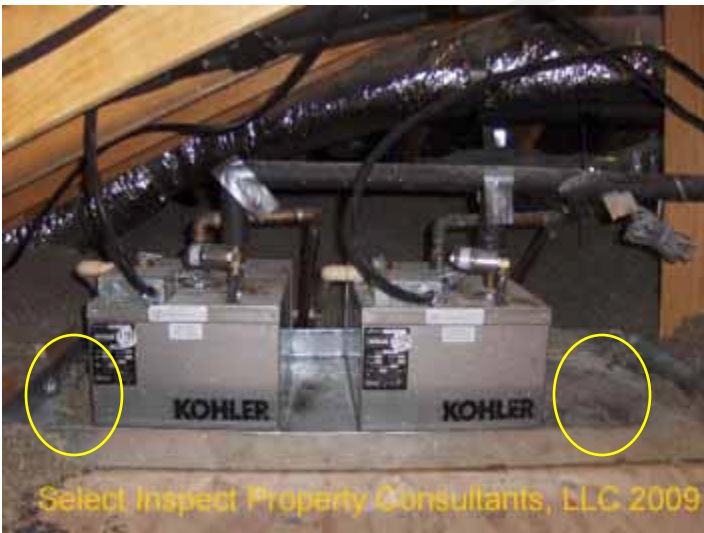
- Grout was amiss at the underside front edge of the seat at the upstairs southeast shower.
- Grout repair is needed at the laundry room and upstairs north showers.
- Steam equipment would not turn on at the shower control panel. Debris exists in the steam equipment auxiliary pan in the attic above.

↑ debris should be cleared from the auxiliary pan of the steam equipment

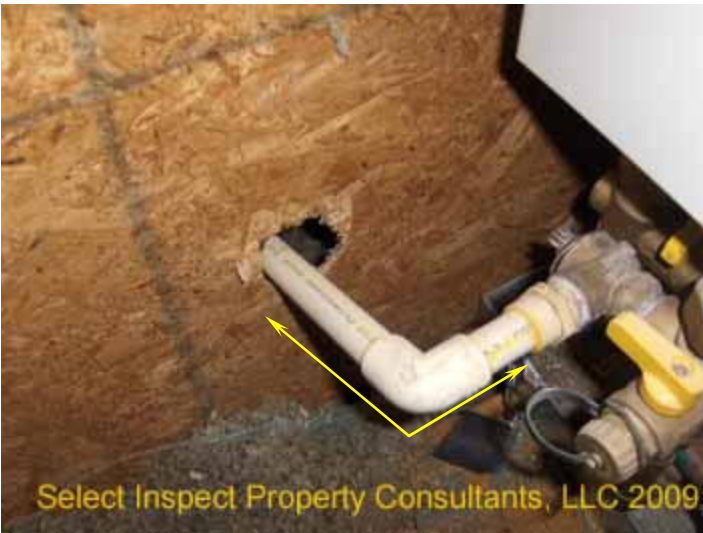
- The temperature-pressure-relief valve piping was deficient for this application; 3/4" cpvc (hot water PVC) as found in this home is frequently used and is inappropriately accepted by city code around the USA, however, the 3/4" material does not meet manufacturer requirements. T&P valve manufacturers require that the interior diameter of the drain line not be less than the interior diameter of the discharge section of the valve – a standard 3/4". The 3/4" CPVC tubing in use measures an average 0.715" interior diameter (technically .035" less than required). If CPVC is to be used it must be 1" O.D. to conform to IRC P2803.6.1.
- The 10 gallon storage tank at the master closet attic was off at the water shut-off valve.

↑ drain piping is +- .035" less inside diameter than required by the temperature-pressure-relief manufacturers.

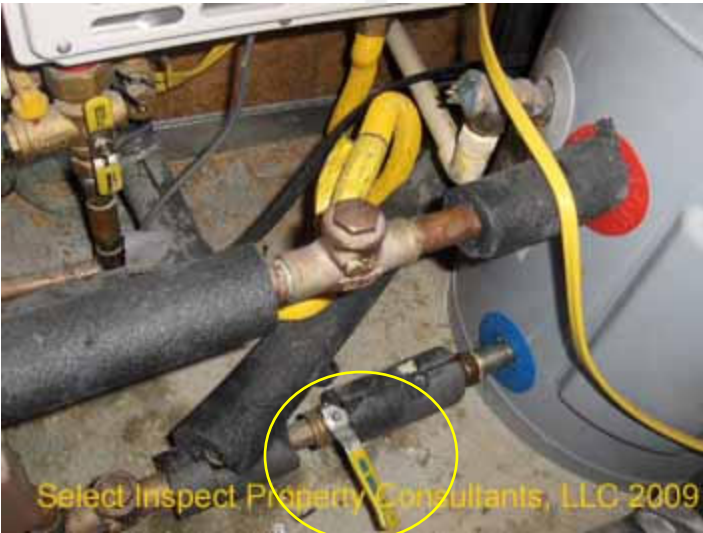
↑ water heat; storage tank shut-off valve was off
