New Home Punch-out Inspection

Custom Home Builder

at: **2009 New Street; Flower Mound, TX 76051**

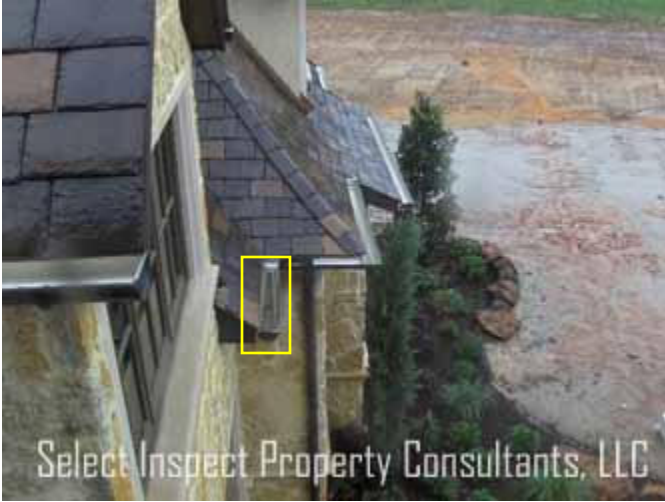
- Deficient slope & pooling water was noted at the porte-cochere & rear porch

↑ negative gutter slope at porte-cochere

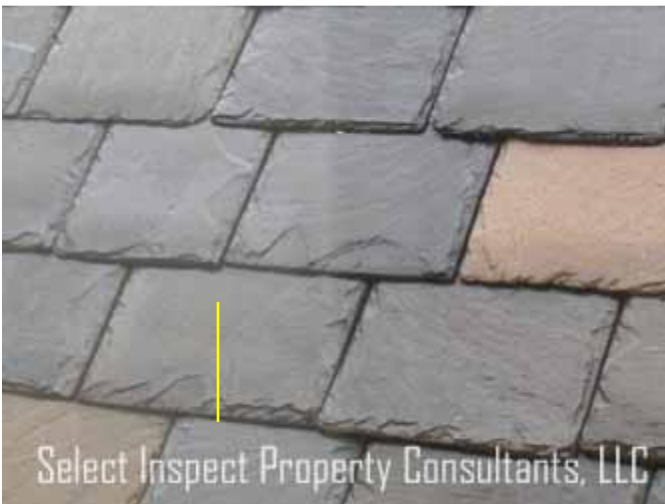
↑ cracked slate north of bedroom 2 front window; minor

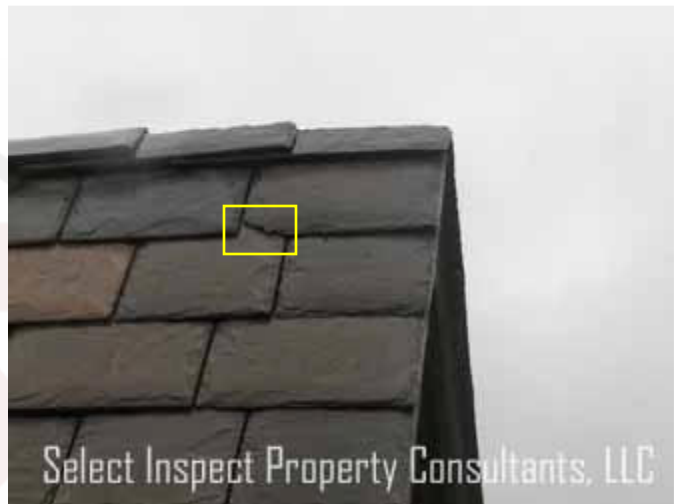
- Minimally chipped slate corner was noted at the peak above the media room
- Flashing at a eave wall / roof joint is amiss / incorrect at multiple front gable "eyebrows, and is a potential moisture intrusion risk. Sealing is recommended.

↑ chipped slate corner at peak above media room

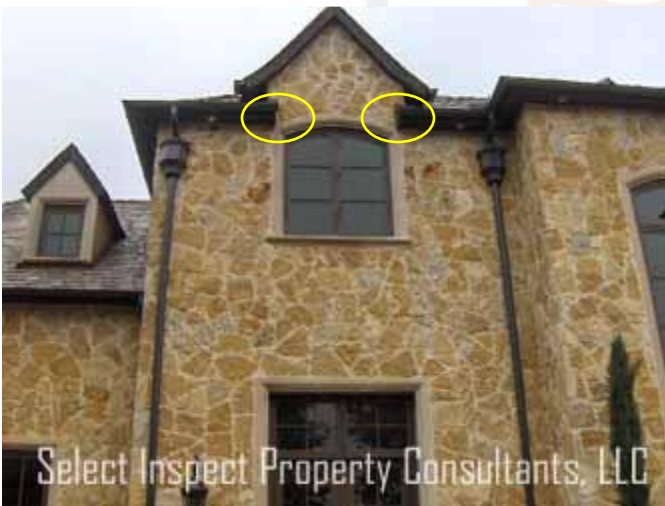
↑ recommend sealant at eave/wall

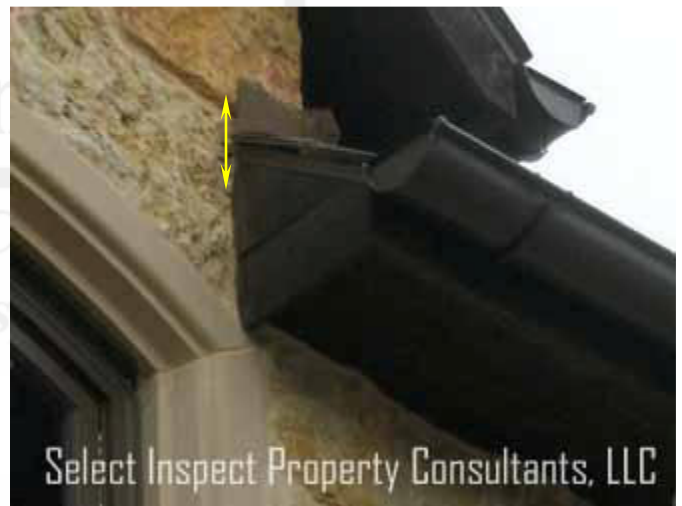
↑ close view of image at left

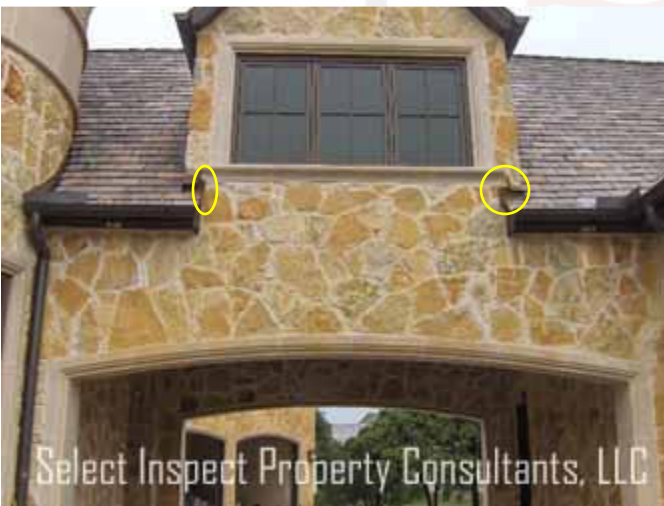
↑ sealant recommended at flashing details

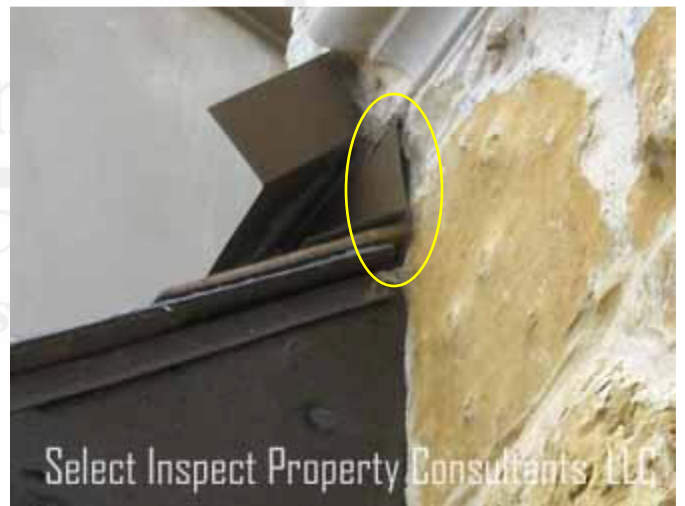
↑ close view of image at left

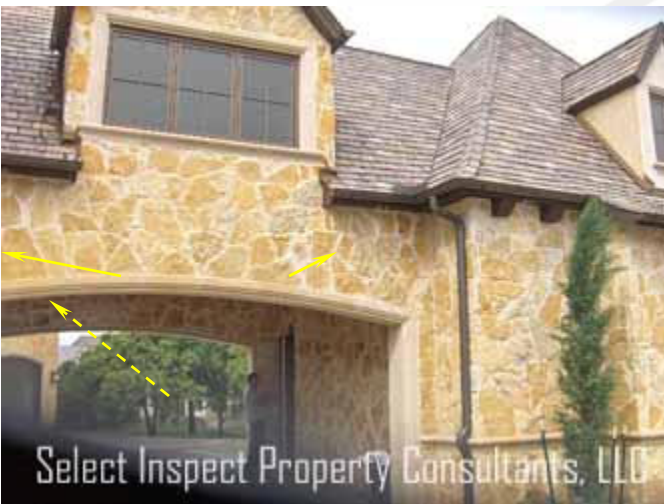
↑ same as above & cracks discovered

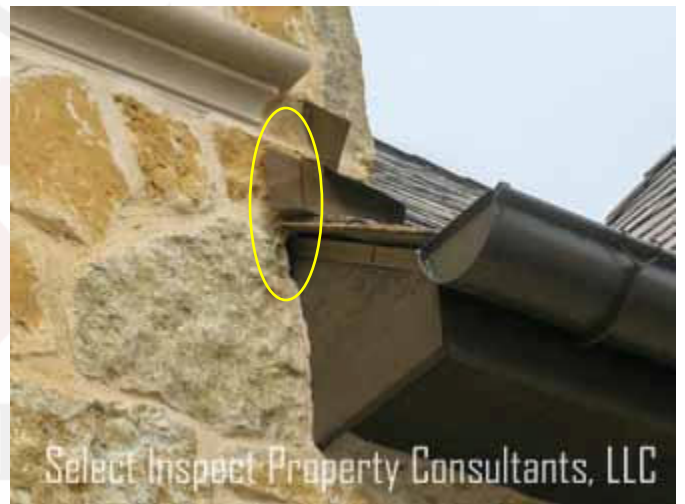
↑ close view of image at left; flashing detail

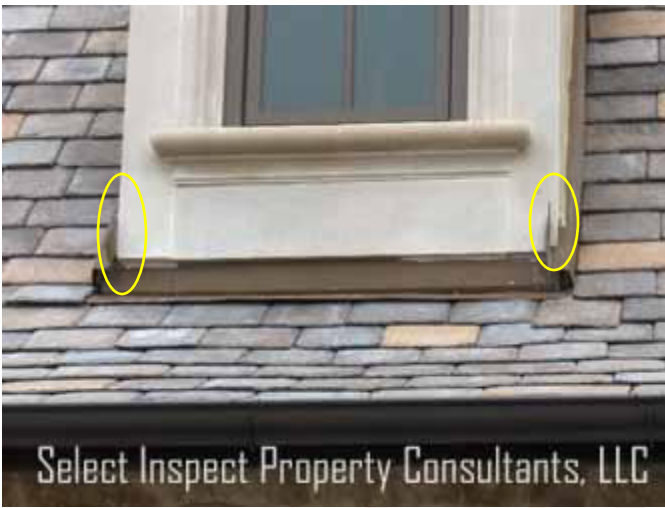
- Flashing was short cut & openings exist at the left dormer & detached garage dormer.
- Various uneven (possibly inadequately secured) slate were noted at the three-car garage & rear exposure(s).

↑ recommend sealant at flashing details; detached garage dormer

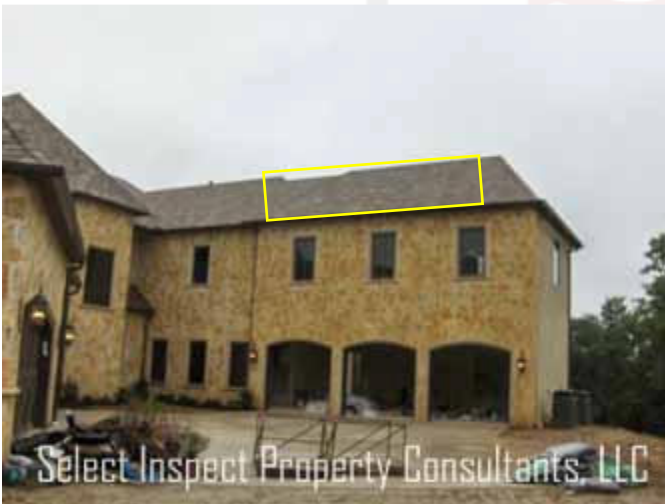
↑ example uneven slate at roof

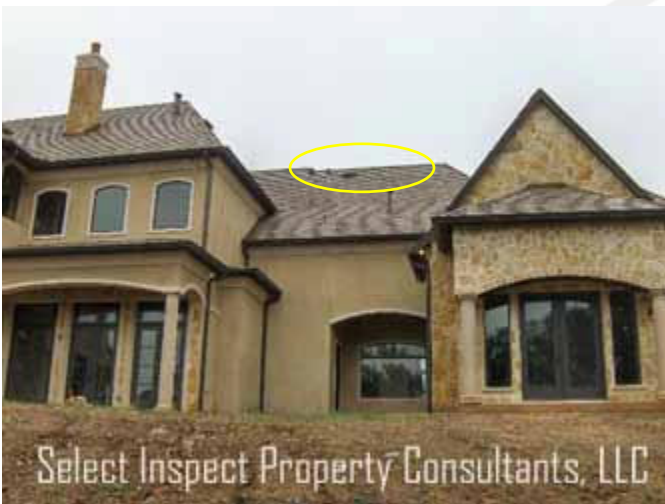
↑ missing shingles at west roof ridge

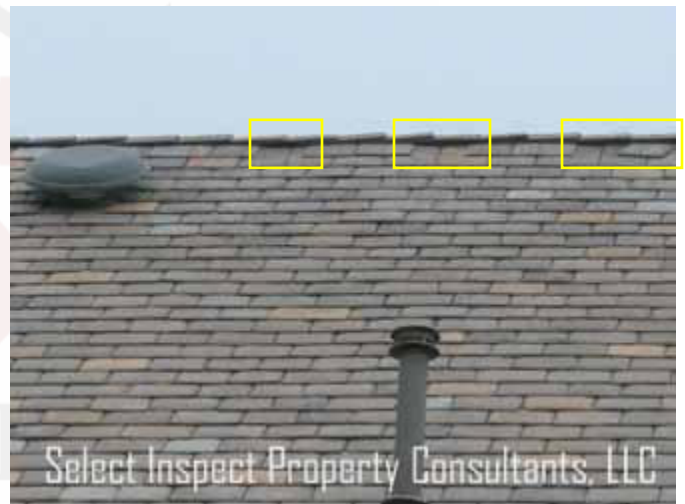
↑ close view of image at left; see also first image on the next page.

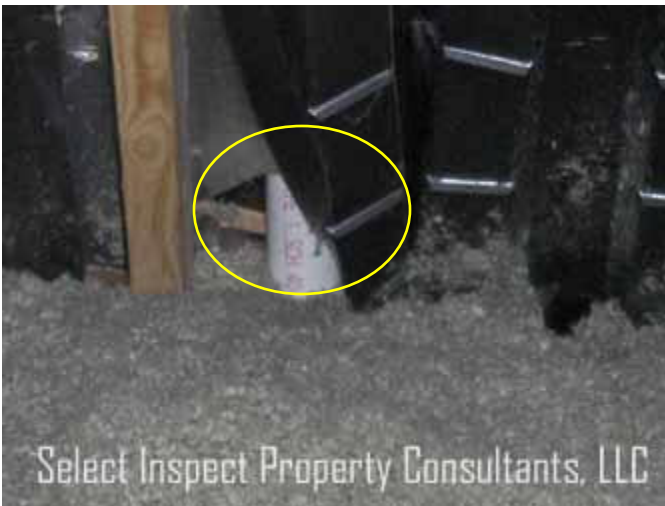
↑ no obvious deficiencies found in the attic below the image above

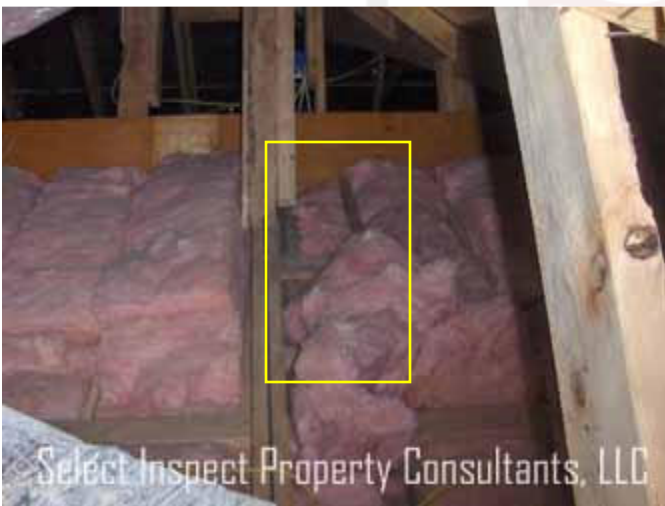
- Insulation was fallen or otherwise deficient at the family room vault & above the laundry room.

↑ deficient insulation above the family room

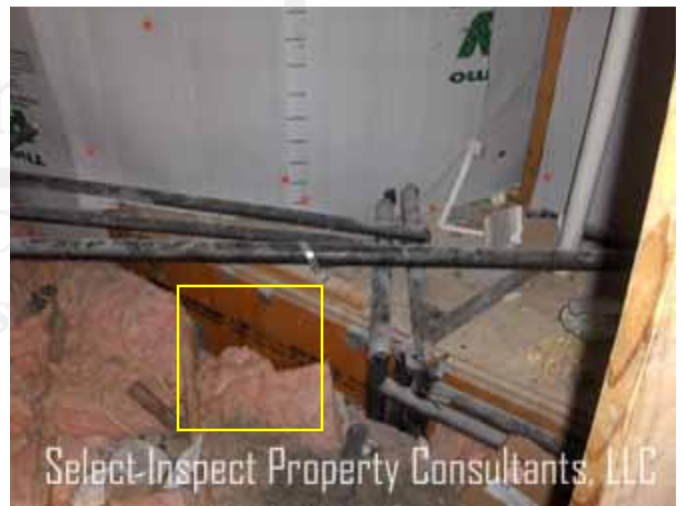
↑ deficient insulation above laundry room

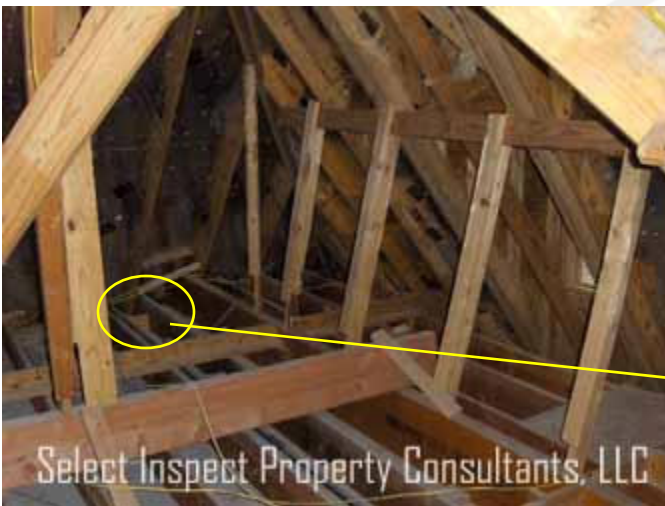
↑ marginal boring; metal reinforcement plate not seen at gas penetration through top plate at detached garage attic

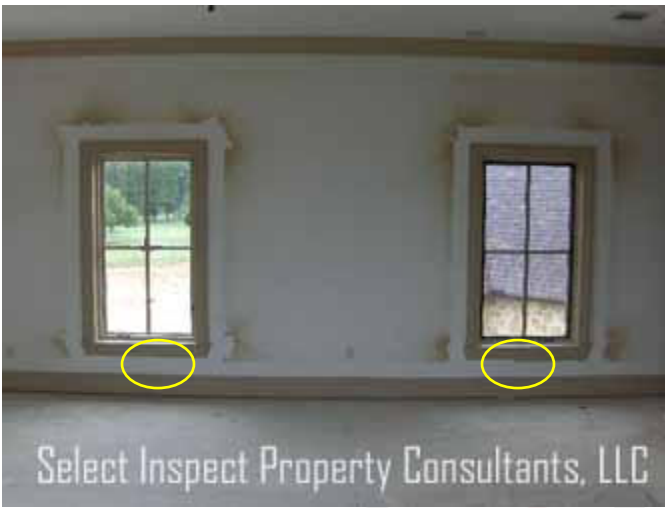
- Settlement & or stress was indicated by the following:
Drywall / tape-joint crack(s) at ceiling, vaulted walls, corners are generally related to common settlement, and are typically of little concern; discovered at gameroom vault south, west, north corners
- Closed, small drywall / tape-joint fissures at wall locations; not of significant concern; discovered at east wall of gameroom #2

↑ stress cracks at gameroom #2

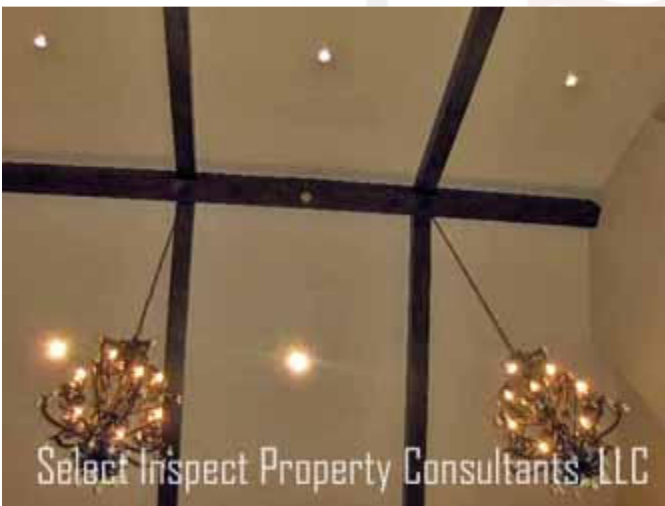
- Family room; opening at central ceiling beam
 - Guest bedroom; unworkmanlike paint at air registers
 - Guest bath; opening at shower grout; openings & missing light at closet; incomplete seal & paint upper front at toilet cabinet.

↑ opening at family room central beam

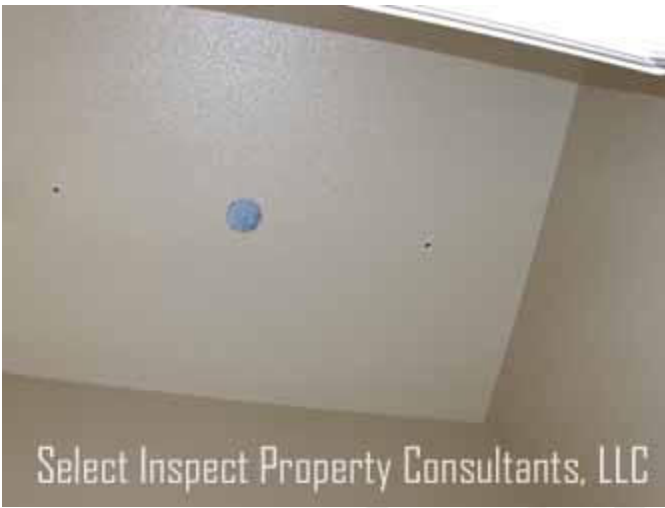
↑ openings & missing light; guest bath closet

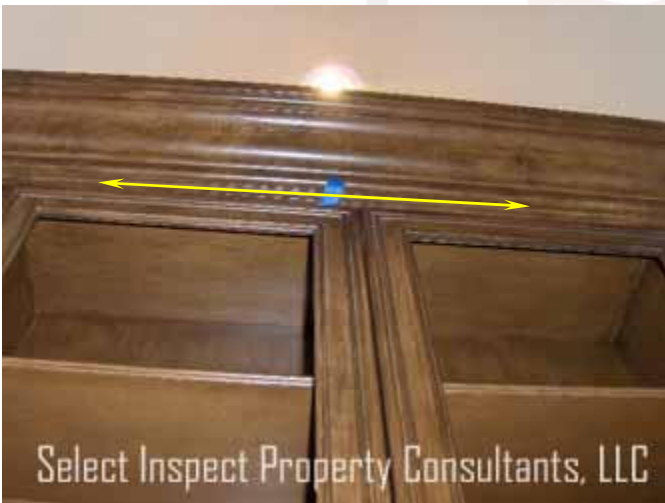
- Breakfast nook/keeping; inadequately sealed crown at upper cabinets
 - Wine grotto; trim, paint; door was difficult – may be due to protective plastic

↑ unsealed breakfast nook/keeping crown; example at left cabinet

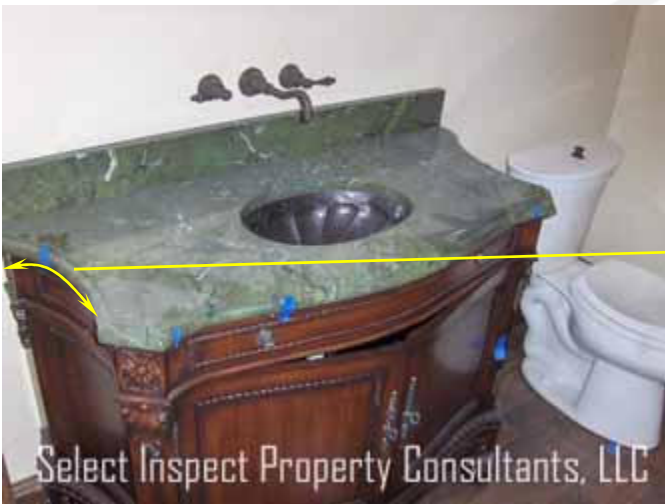
- Breakfast nook/keeping right doors were unsquare & not functioning as intended.
- North powder bath sink cabinet was damaged at the left.
- Balcony cabinets were incomplete & not functioning as intended.
- Glass was missing at breakfast nook/keeping cabinet doors.
- Bathroom #5 lower left & central right drawers were not functioning as intended.
- Construction debris remains atop various upper cabinets.
- Various handles were missing, kitchen & bathrooms
- Granite countertops, if present, are not tested for presence of or levels of uranium or radiation. Related information can be found at: <http://selectinspect.com/links1.htm#radonlink>

↑ damaged north powder bath cabinet

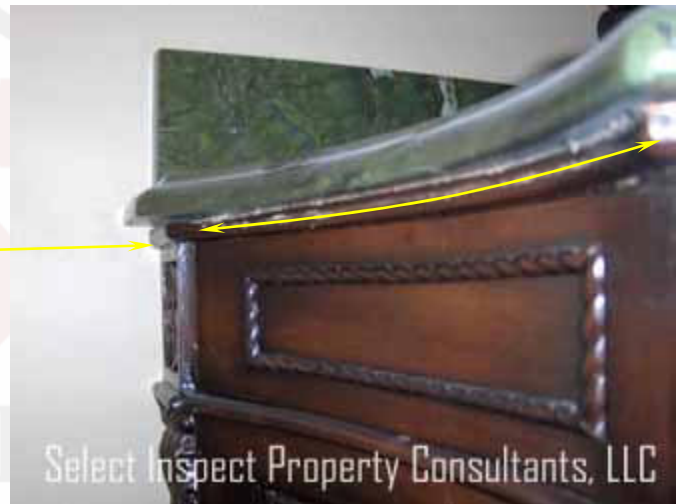
↑ close view of image at left

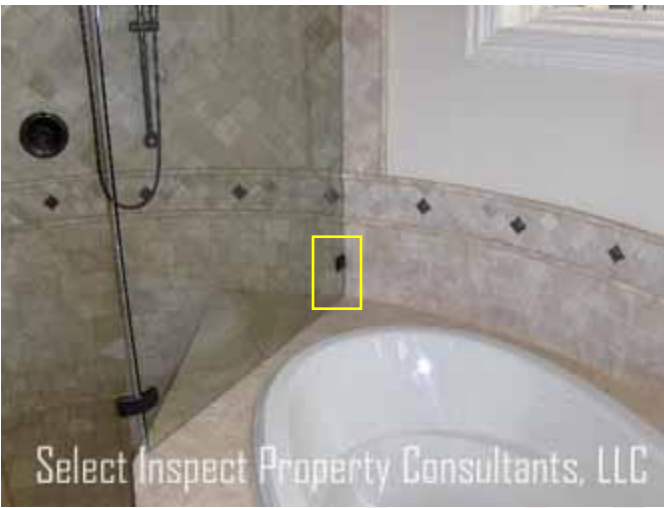
- Leakage through/below the glass wall(s) was noted at the mounting hardware of bathroom #2.
- Grout/caulk touch-up is needed at the master shower(s). Condition of substrate and other inaccessible areas remains undetermined.
- Steam device was operable; controls reset to "as found"

↑ glass wall leaks at bathroom #2 mounting component(s)

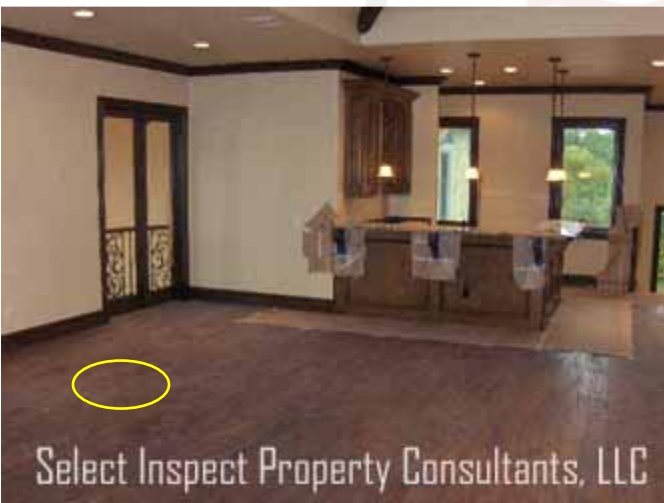
- Wood floor at the gameroom appeared inadequately secured at one small location; (related image(s) at the end of this document).
- Various exterior door thresholds were not yet stained.
- Floor covering was not installed at various locations.

↑ "popping" heard when walking on this area of gameroom floor

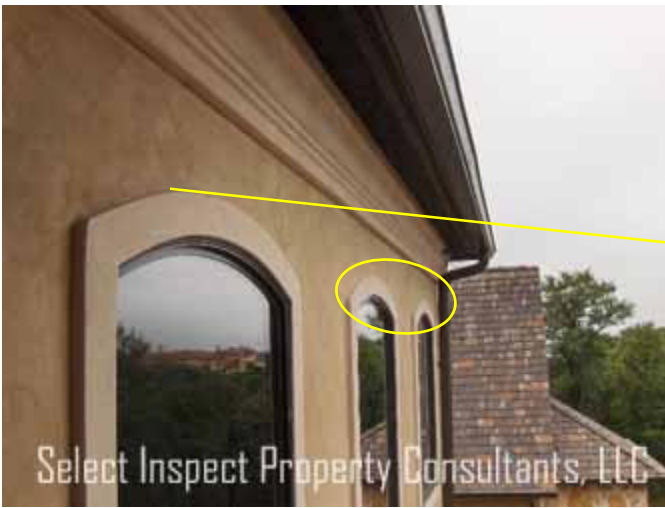
- Damaged artificial stucco at living room & bedroom #5 windows.
- Inadequately sealed penetrations including junction boxes, air conditioning condenser(s) service disconnects

↑ damaged artificial stucco at top of living room windows

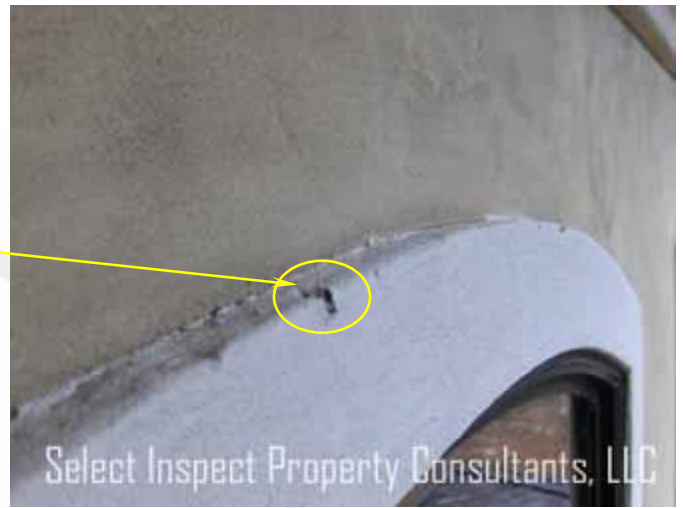
↑ close view of image at left

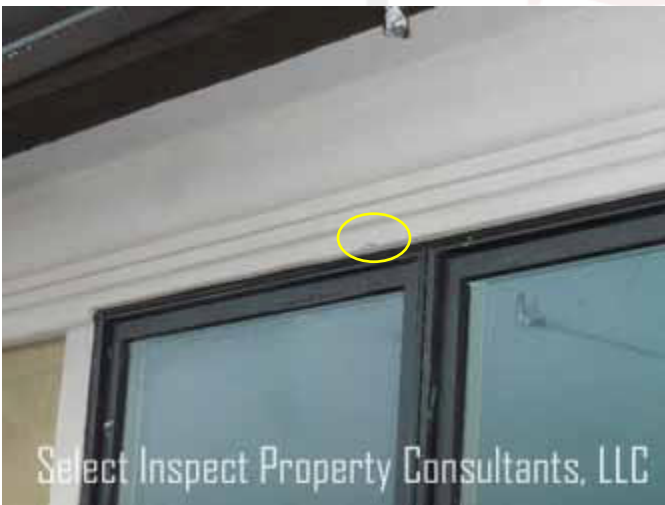
↑ damaged artificial stucco at top of bedroom #5 window

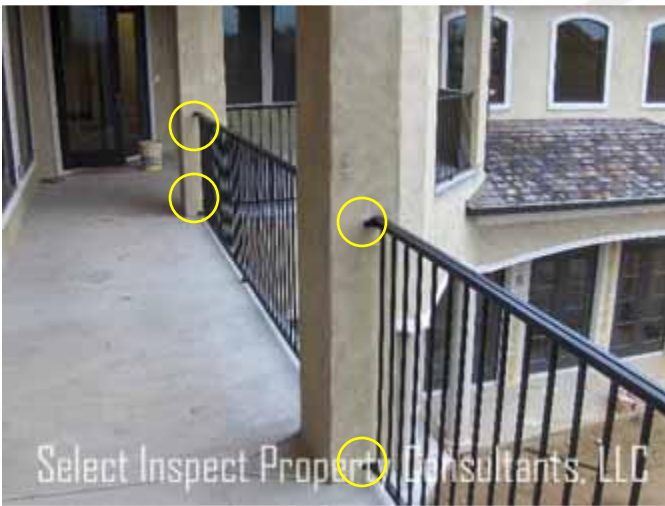
- Balcony rail installation has scuffed the finish at columns.
- Multiple exhaust fan(s) terminations were incomplete; covers missing. Master, guest bath, laundry room areas; (related image(s) at the end of this document)

↑ railing install has scratched finish at balcony columns; example

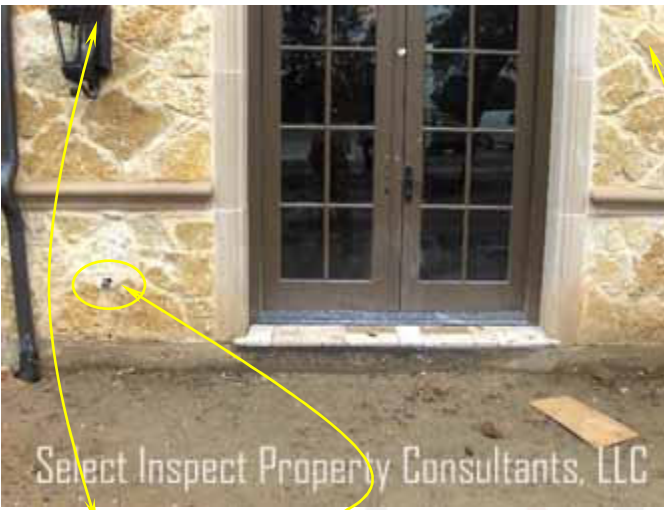
↑ openings & unsealed wall at gas valve component(s); right lamp was missing

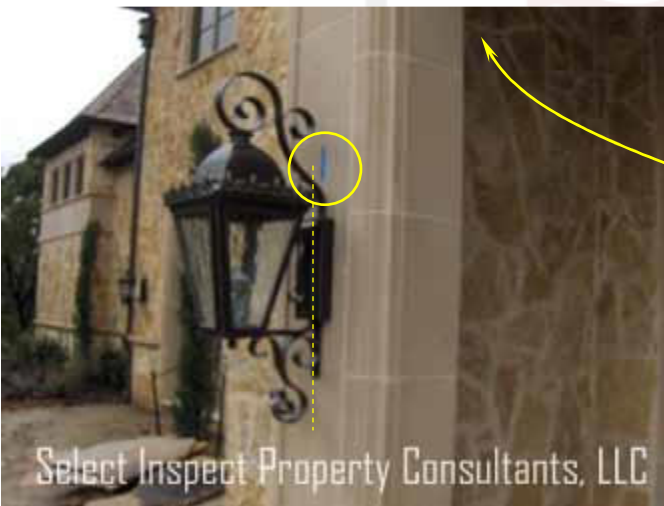
↑ holes & pencil marks at front coaches

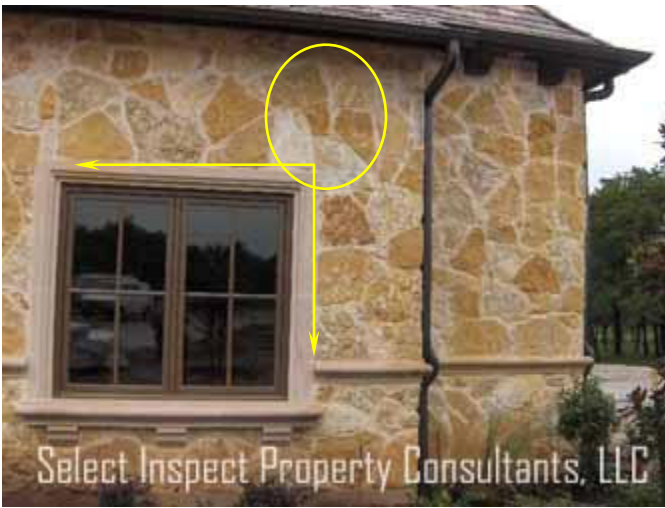
↑ nails & stress crack at detached garage window

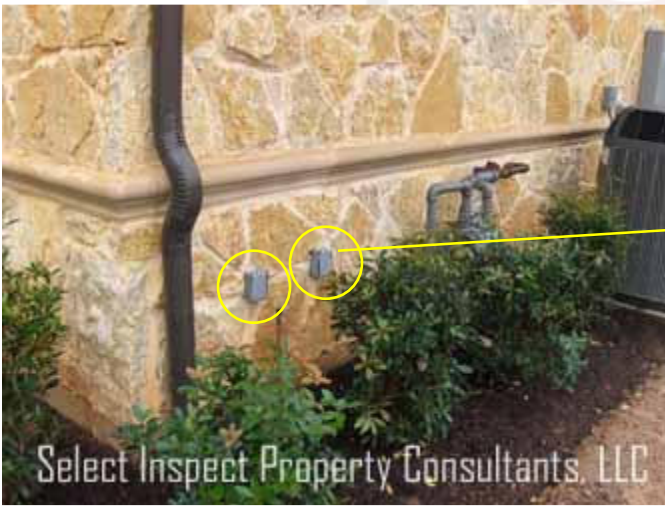
↑ recommend sealant at garage exterior junction boxes

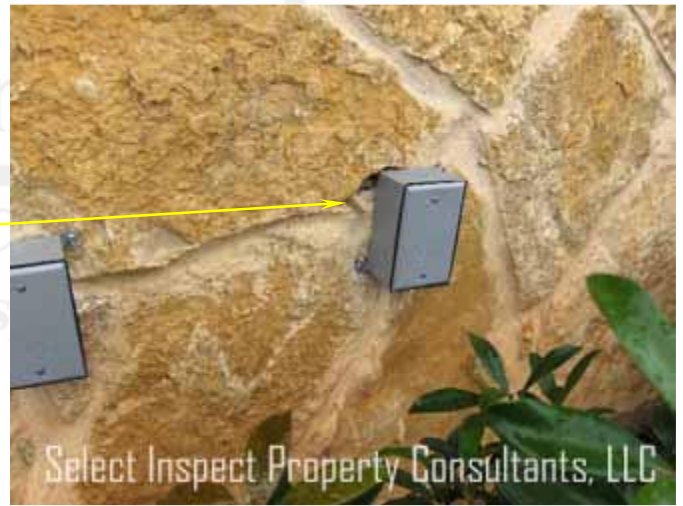
↑ close view of image at left

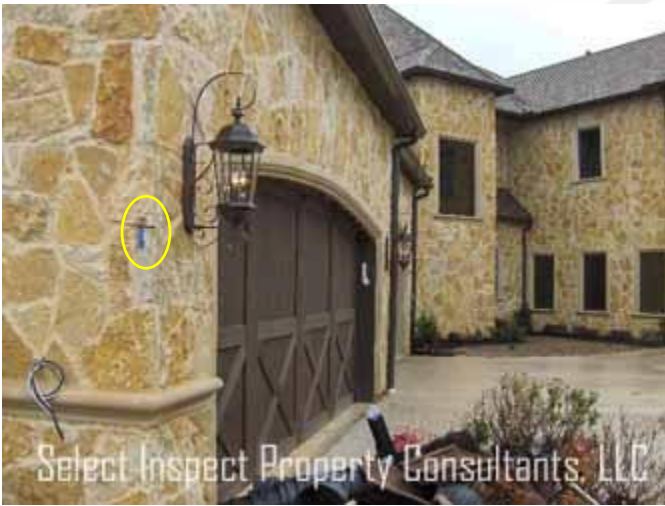
- Exterior lights should be properly sealed to prevent moisture intrusion and related corrosion / overheating possibilities of the electrical components. NEC 410-4 & IRC E3903.9.

↑ caulking/sealant needed atop exterior lights; example & mortar deficient at detached garage

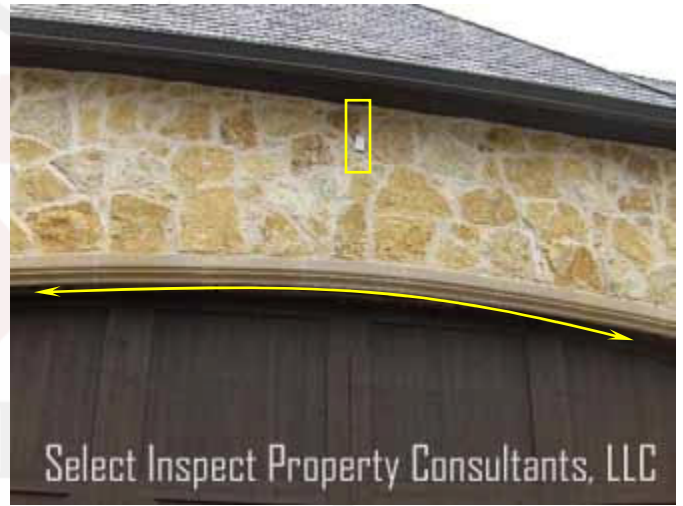
- Detached garage header was incomplete / amiss at the overhead door.
- Stucco material is present at exterior walls. Some of material at this home appeared to be masonry stucco and some synthetic (EIFS) stucco. This material must be well maintained, including keeping all joints, cracks, pits, penetrations (outlets, lights, etc) and edges properly sealed. The bottom edge should ideally be at least 4 inches (ideally 6 inches) above grade/soil.

↑ recommend sealant at detached garage junction box & header was incomplete

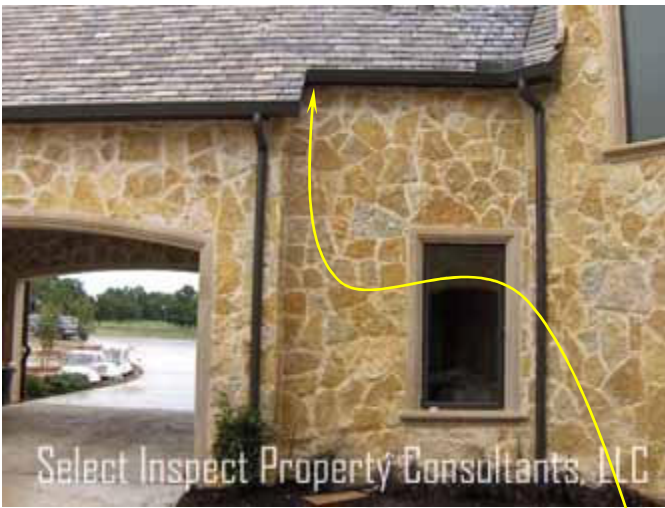
↑ deficient termination of exhaust fan(s)

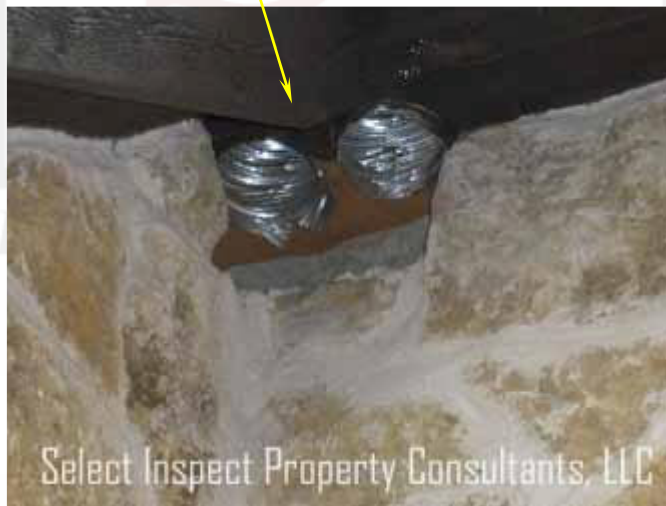
↑ close view of image above

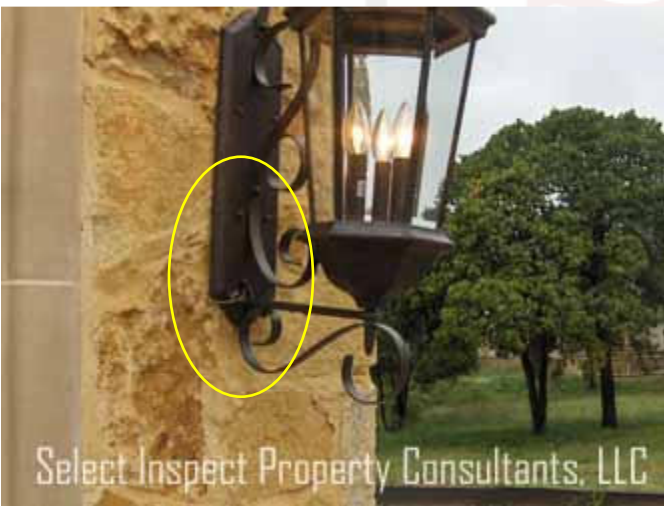
- Three-car garage right light is damaged.
- Various bulbs or fixtures were not functioning as intended at the time of inspection. It is recommended that all fixtures be made operable prior to closing. This typically is corrected by replacing the light bulbs, though it is possible the fixture or other component may be amiss / deficient. Discovered at north powder bath, north hall, bedrooms, bathrooms.
- Media room fixtures were inadequately secured.
- Various fixtures were missing (junction box were enclosed)

↑ damaged coach at east corner of three-car garage

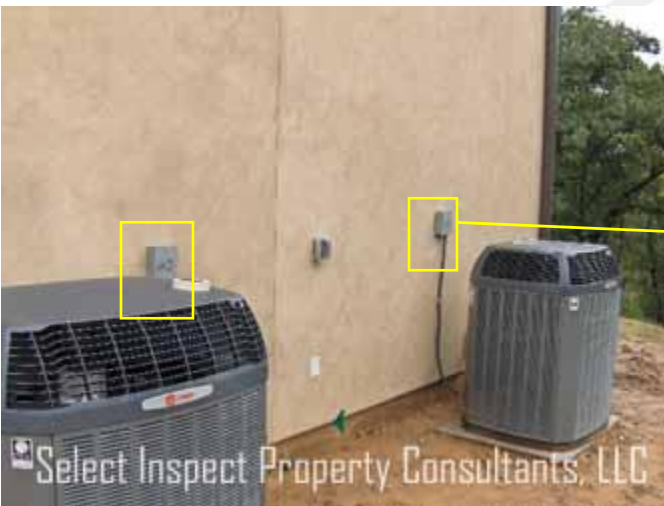
↑ sealant needed at condenser(s) service disconnects

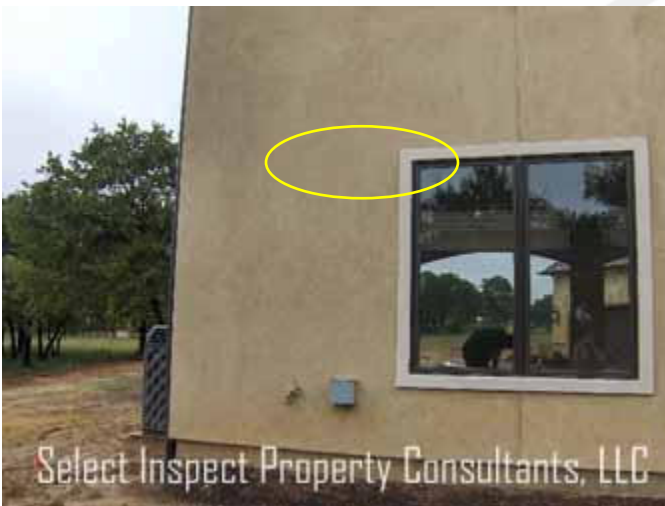
↑ stress crack at north

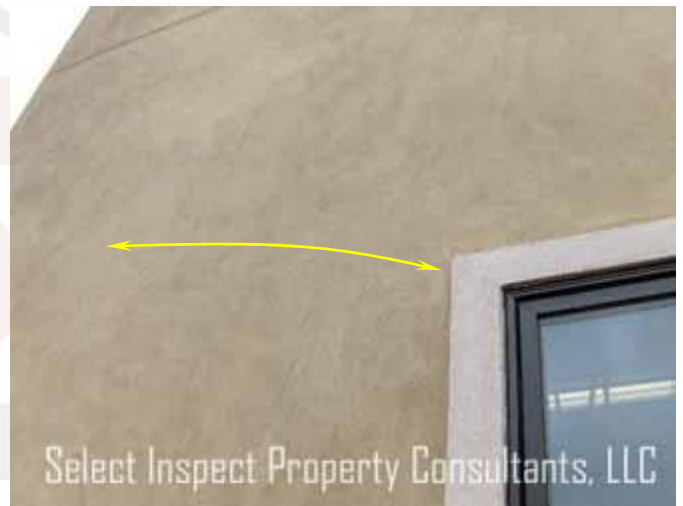
↑ close view of image at left

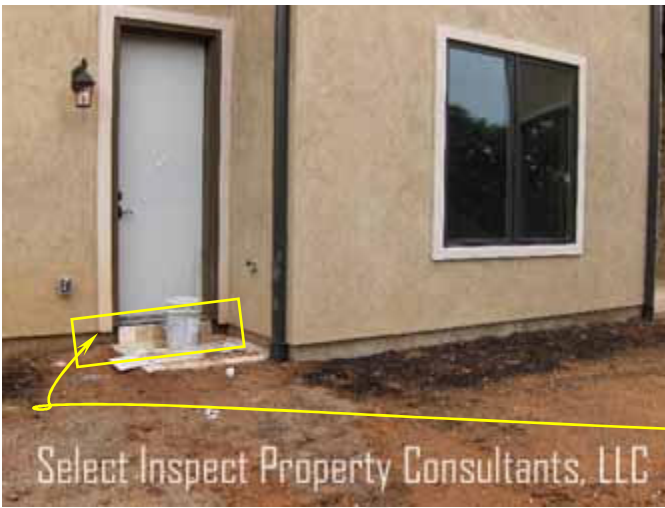
- Unpainted/unsealed wood was noted at exterior door trim/jamb; recommend protective finish out.
- Multiple openings & component(s) mounting locations should be sealed to resist insect and moisture penetration into the structure. (related image(s) at the end of this document)

↑ recommend painting/sealing all exposed wood; example

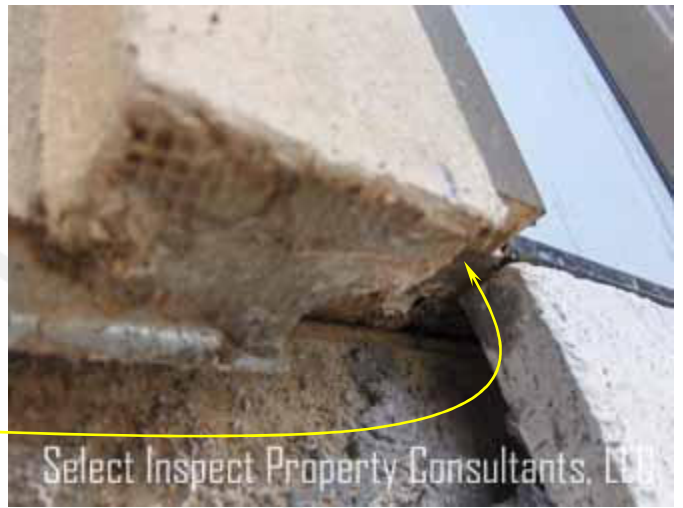
↑ close view of image at left

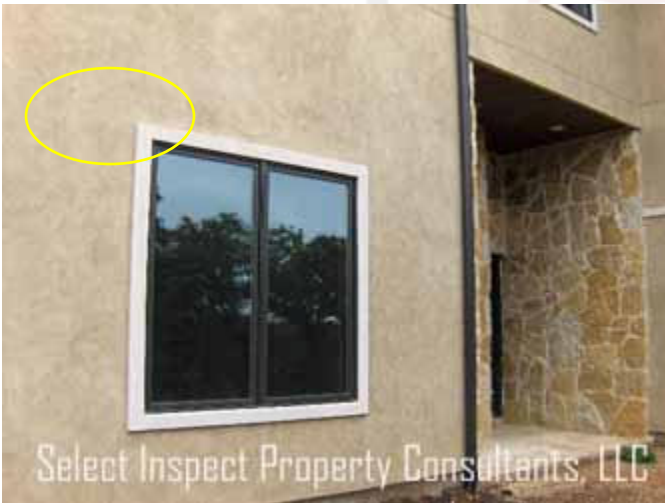
- Settlement & or stress was indicated by the following:
Compression/stress cracks at stucco veneer discovered at three-car garage at north window; guest bedroom upper left of window; living room patio upper left at arch.
- Veneer cracks less than 1/8" discovered above office/study door, porte-cochere, upper right of window at detached garage, three-car garage upper left of overhead door & at left column, living room left of door & left column.
- Exterior Veneer cracks greater than 1/8" not discovered
- Common cracking of the garage floor and or driveway concrete was noted.

↑ stress crack at guest bedroom window

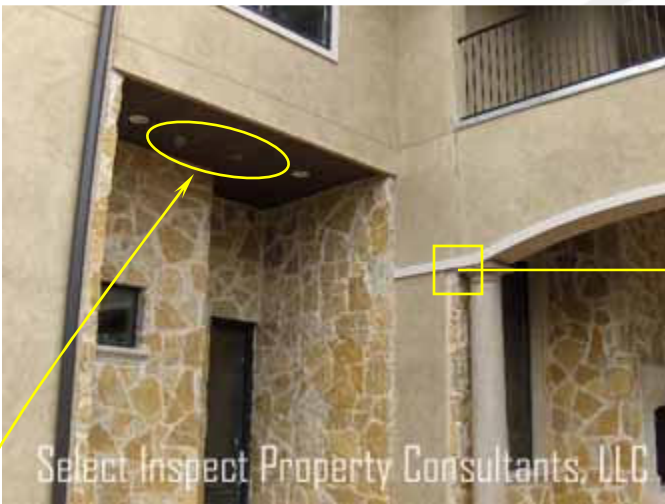
↑ deficient exhaust fan(s) termination & mortar tuck-pointing needed at north patios

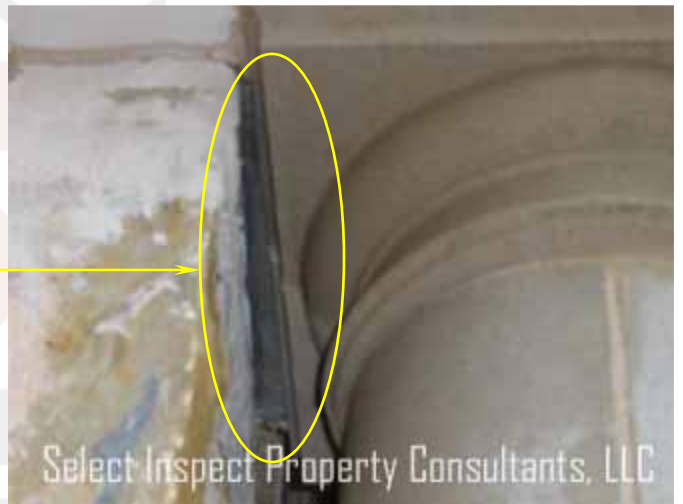
↑ close view of image at left

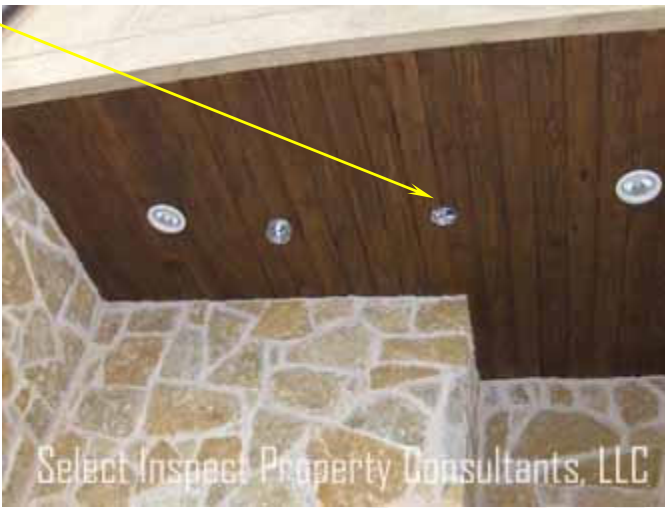
↑ close view of image above

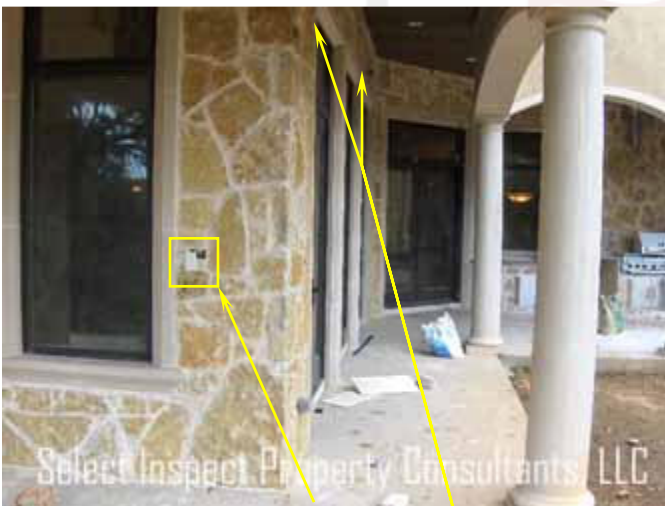
↑ deficient junction box cover & junction box seal at rear porch

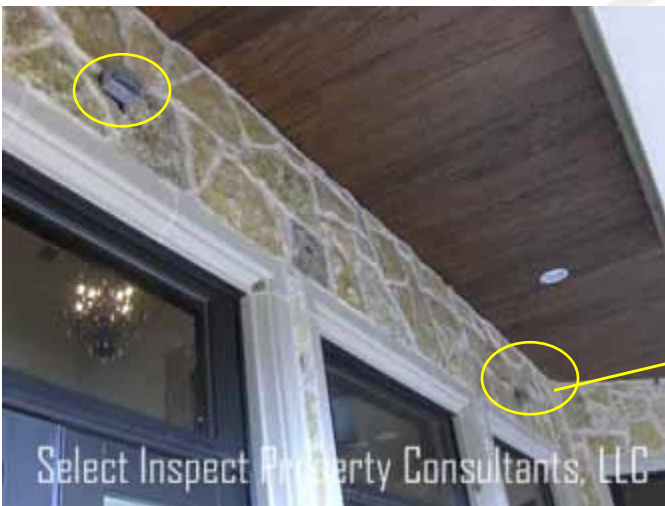
↑ close view of image above

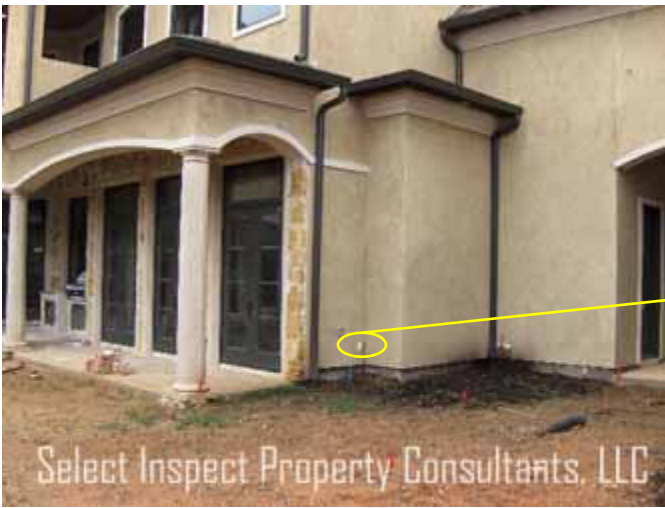
↑ deficient stucco at living room west

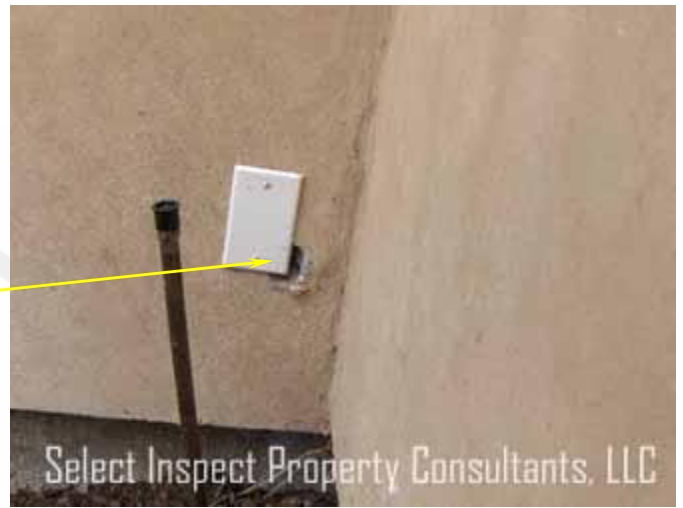
↑ close view of image at left

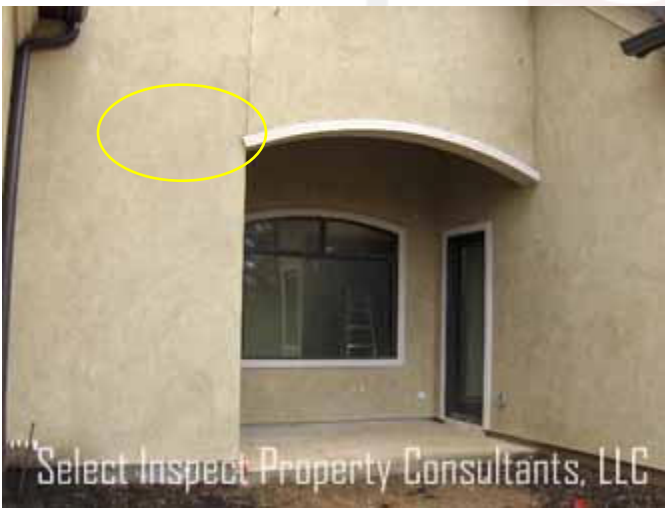
↑ stress crack at master north patio

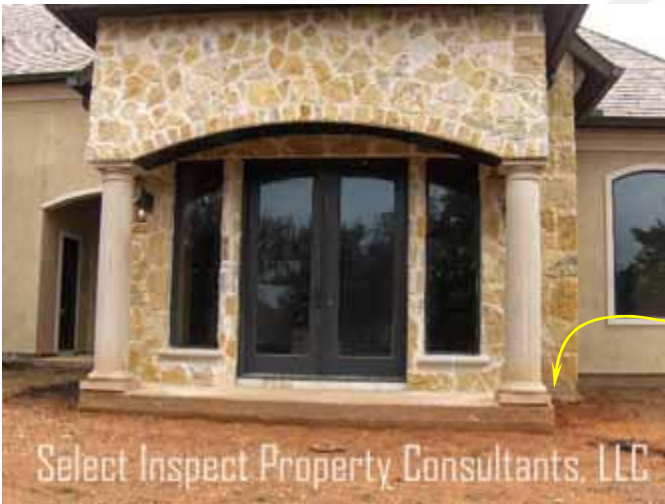
↑ uncaulked windows & door perimeter at master

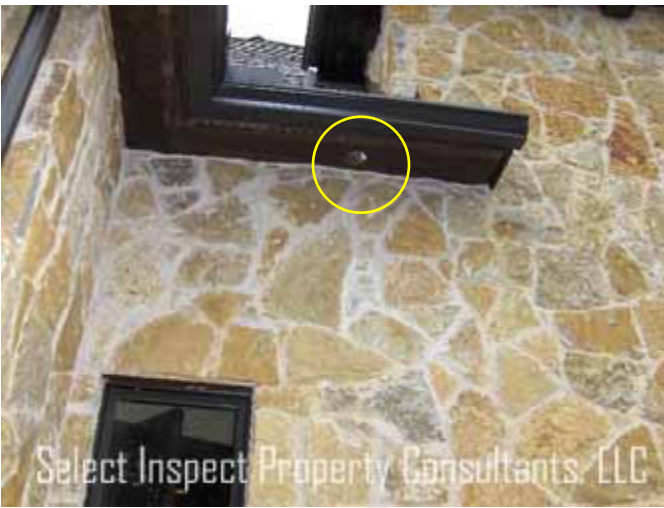
↑ deficient exhaust fan(s) termination at master bathroom

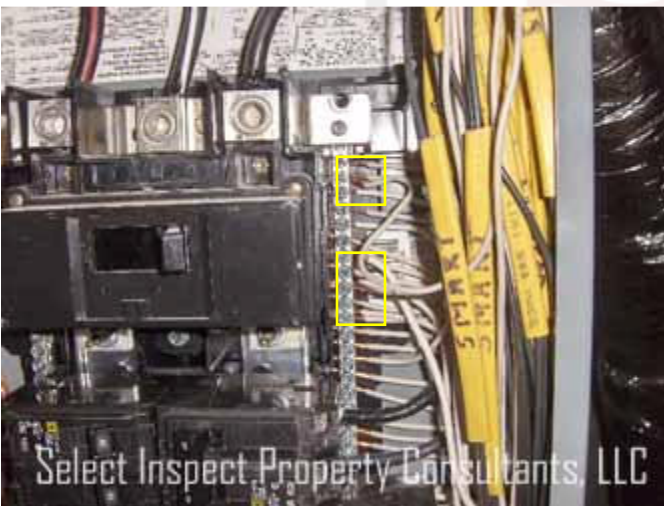
- Neutral wires are to be secured independently in individual terminal lugs, and not "bundled" with other neutral conductors or grounding conductors; Deficient wiring methods regarding this requirement were discovered at the time of inspection.
- Breakers are not properly/legibly labeled for location. There are 5 air conditioning condenser(s); two are labeled #1; two are labeled #2; none are labeled #4 & 5
- NOTE: the smart-home system was incomplete & not fully functional during the inspection; some lights, fans, etc were inoperable. Some conditions remain undetermined

↑ conductors shall be terminated individually in lugs / breakers; example at panel #4 in the south attic

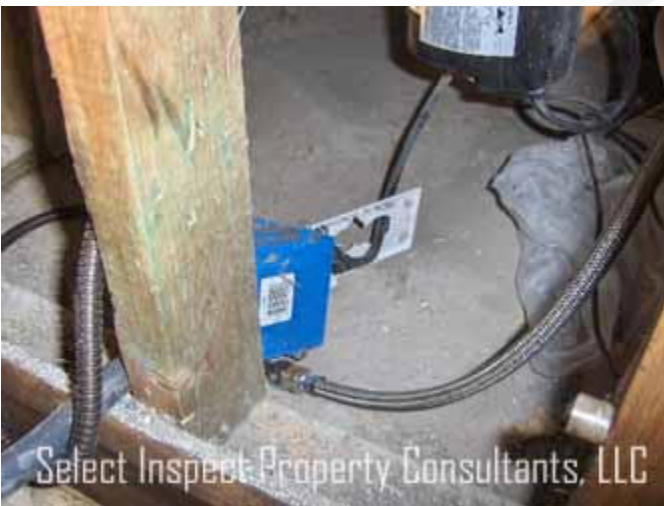
- Receptacle over the outdoor grill was askew.
- Covers deficient at the laundry room & below the jetted tub
- Inoperable below the main stair & left of the living room fireplace.
- ADVISORY: Many new homes have "tamper-resistant receptacles" as required by newer standards; this home did not have this newer safety feature at one or more locations.
- ADVISORY: Many new homes have modern "weather-resistant receptacles" as required by newer standards; this home did not have this newer safety feature at one or more exterior locations.

- Junction box below the jetted tub was inadequately secured
- Upper north attic fan thermostat(s) control had receded into the junction box & was not readily accessible; not functioning as intended.

↑ deficient cover & unsecured receptacle below jetted tub

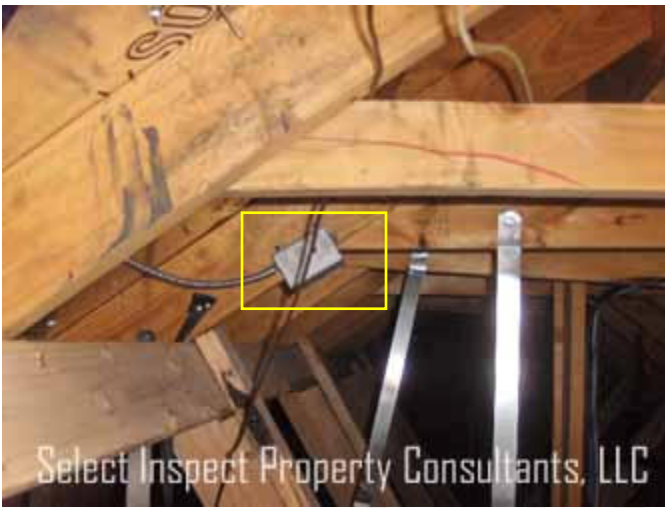
↑ deficient thermostat(s) control at upper north attic; from bedroom #5; control was recessed into the junction box

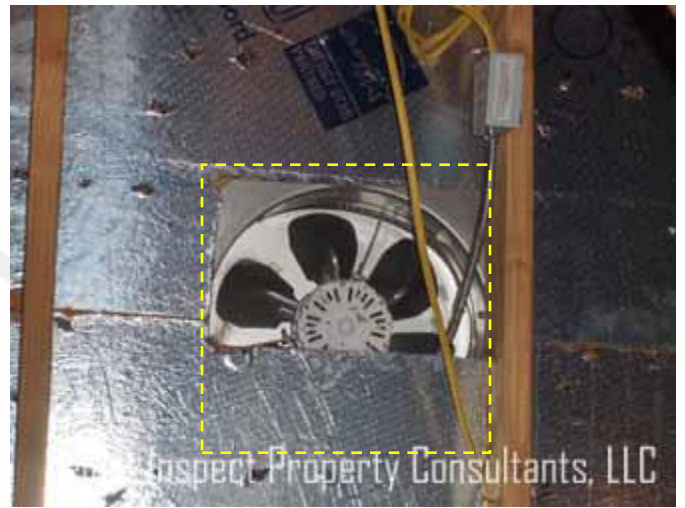
- Roof vent at the central upper attic above air conditioning #4 has a small opening cut in the attic sheathing. This is not as effective as properly sized vent openings. Consider improvement when roofing repairs or improvements are made.

↑ small fan opening above HVAC #4; upper attic from bedroom #3

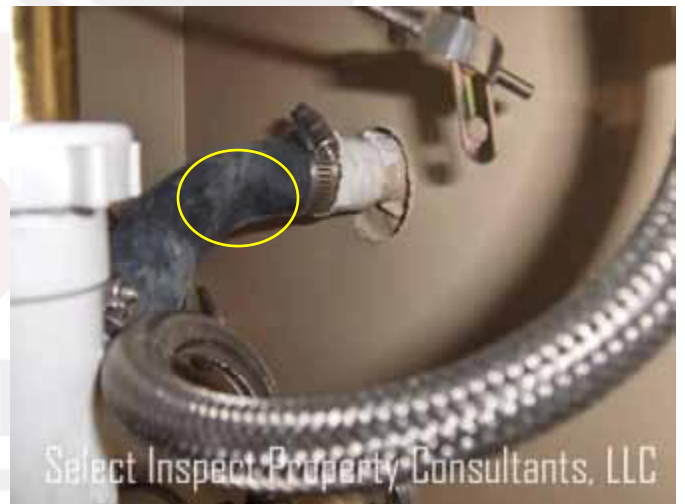
↑ crimped condensate drain may be prone to failure; condition minor during the inspection; bathroom #4
