New Home Punch-out Inspection

Custom Home Builder

at: **2009 New Street; Flower Mound, TX 76051**

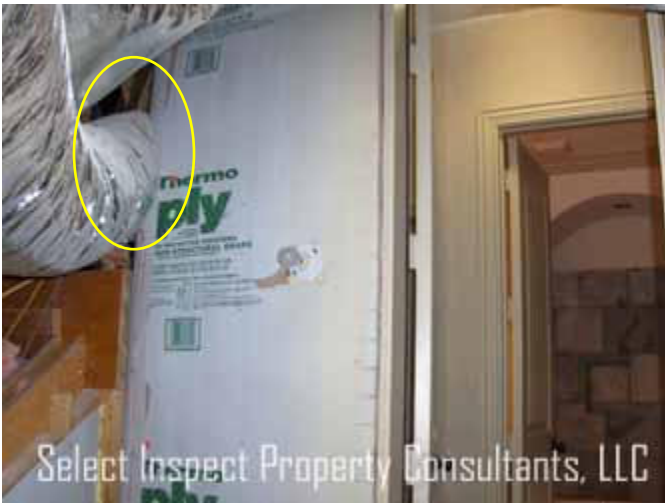
- Crimped and or partially constricted ducting was noted at south walk-in attic, above & below unit #2.
- Deficient vapor barrier & insulation/connection to plenum exists at unit #1; supply side
- Register cover was missing at the pantry

↑ crimped air ducting; example at south walk-in attic

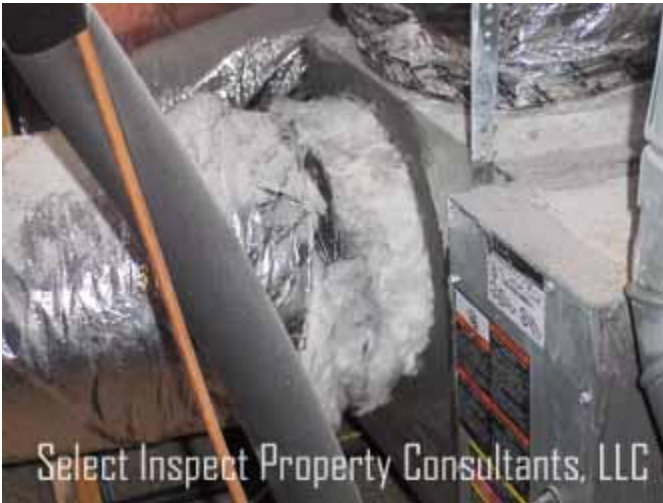
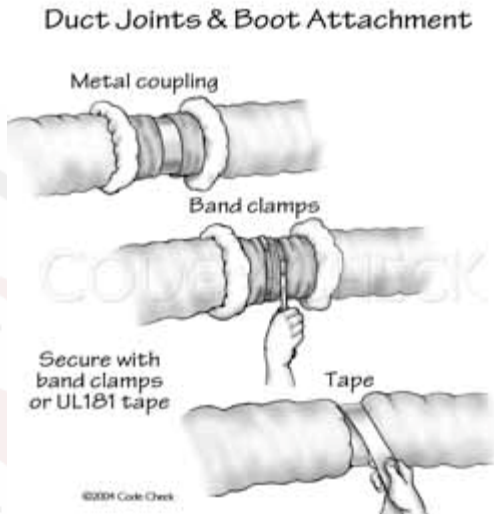
↑ deficient insulation & vapor barrier at HVAC #1; north attic

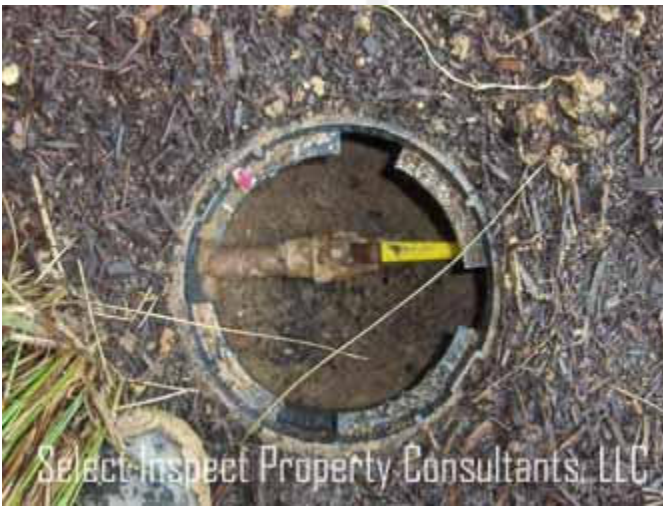
- Kitchen cold supply was leaking
- Shut-off valve did not have recommended 3" clearance from soil.

↑ Shut-off-valves require 3" clearance from soil; handle is corroded; right of front entry

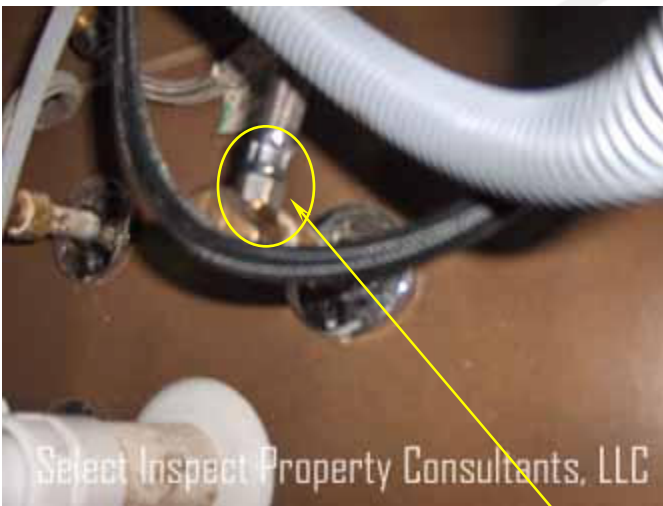
- Leakage condition exists at the disposal connection to the drain at the kitchen.
- Leakage condition exists at the north powder bath sink.

↑ leaks discovered below kitchen sink at cold supply & disposal drain

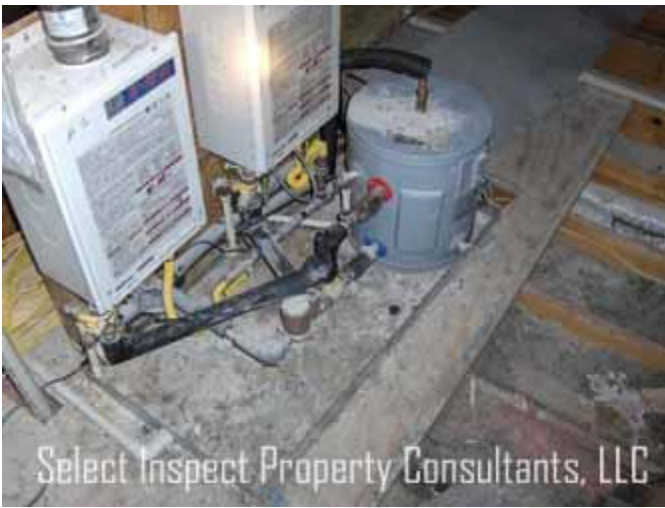
↑ debris in water heater pans should be cleared

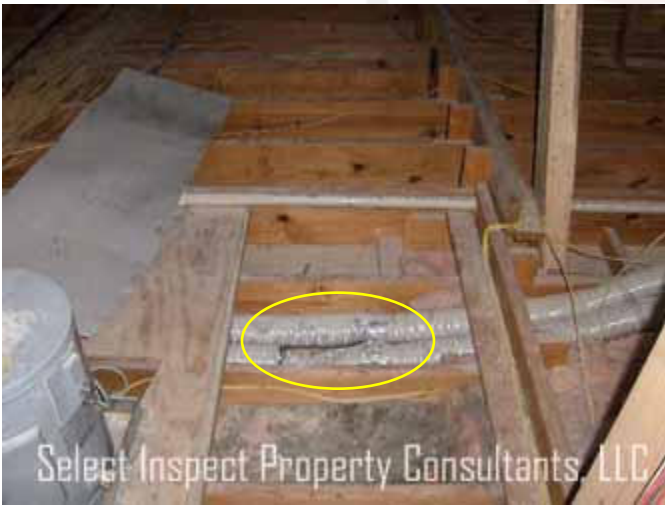
- Damaged ducting exists at the east walk-in attic; north powder bath device was operating noisily.

↑ damaged exhaust fan(s) duct in east walk-in attic

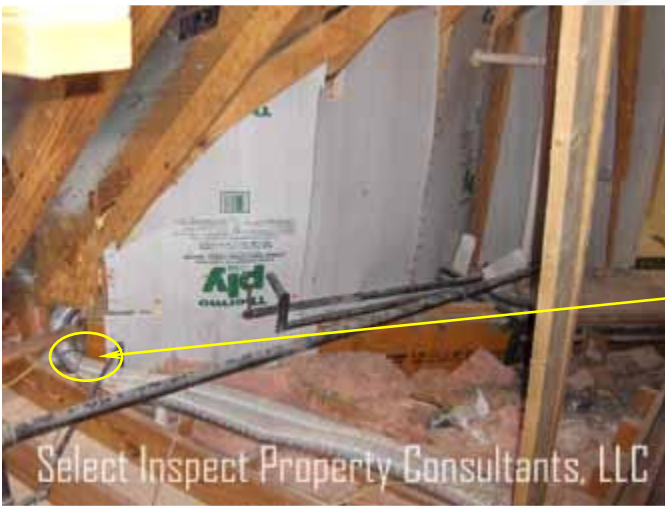
↑ damaged/disconnected exhaust fan(s) duct in east walk-in attic

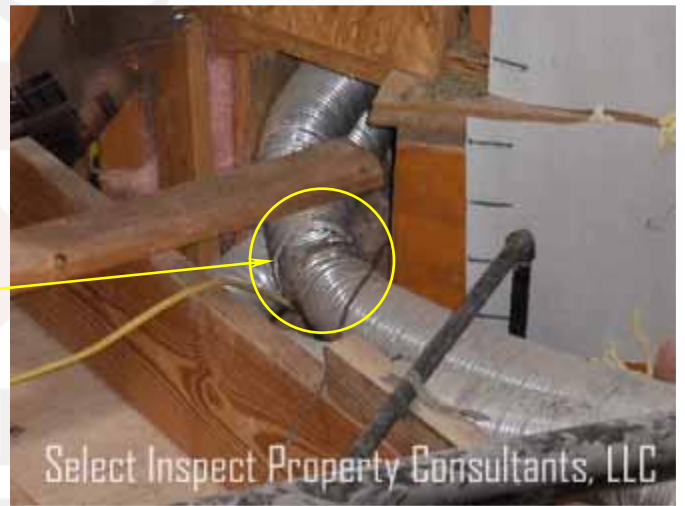
↑ close view of image at left
