Select Inspect
Property Consultants, LLC

Inspection for Builder Warranty

at: **123 street; McKinney, TX 75071**

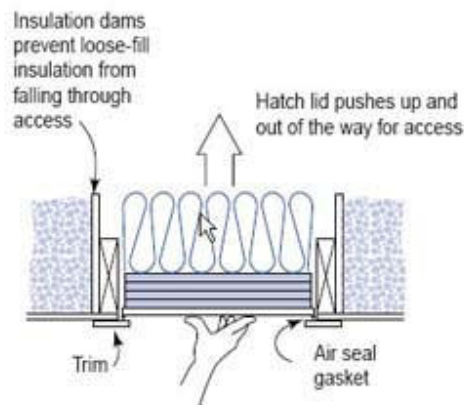
**SCUTTLE HOLE COVER**

- ✦ Ladder hardware (nuts, screws, etc) is loosely secured or missing at stair components. The unit is unsteady and repair would be prudent to reduce risk of failure and injury.
- ✦ Attic access(es) was inadequately insulated & or seals poorly. Energy loss exists

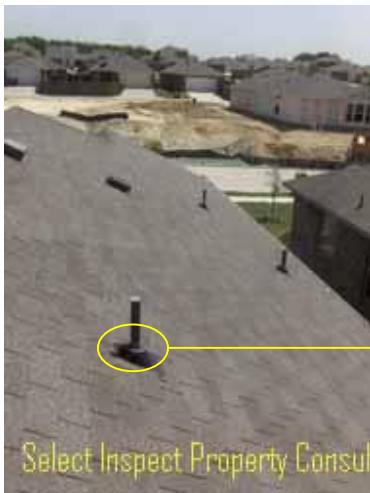
Unpainted rings at plumbing vents imply raising/upheaval of the vent stack(s) and or subsidence/settling of the roof/attic structure. (related image(s) at the end of this document) It is not reasonable to determine on one visit if stress cracks are related to foundation or structural movements, or a combination of both. We recommend that you observe the area(s) over time. If issues are discovered, you should contact a specialist to examine the situation, and prescribe options for permanent repair.

↑ plumbing vent separation implies settlement of the roof structure & or raising of the vent stack

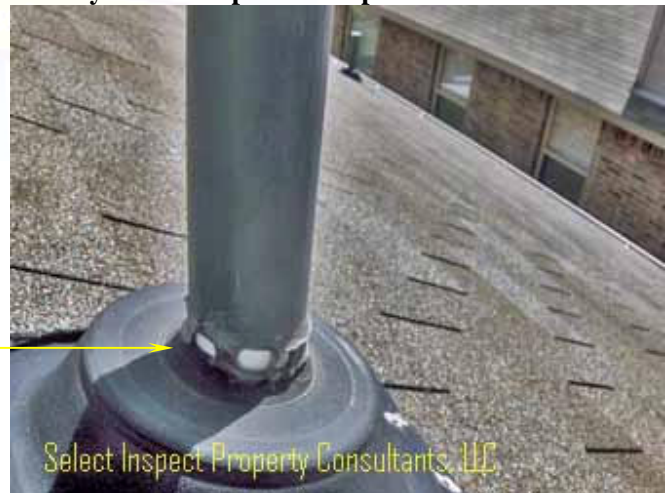
↑ close view of image at left; seal & monitor

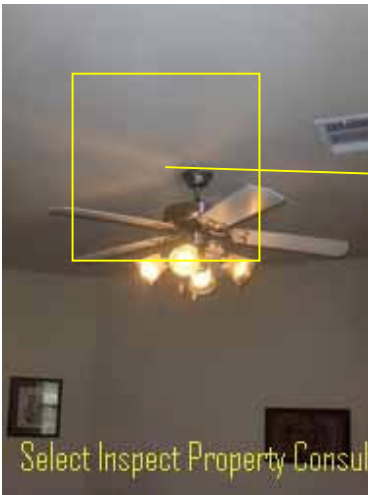
- ✦ Thermal imaging indicated slight temperature variance at the ceiling above the master bedroom fan; Significant issues were not discovered during the inspection; monitor & maintain.
- ✦ Insulation is inspected in a very general manner from limited accessible locations; Conditions in not readily accessible/inaccessible locations remain undetermined; this is general in nature & is not a comprehensive investigation of all areas.

↑ Thermal imaging indicated slightly warmer area at master ceiling

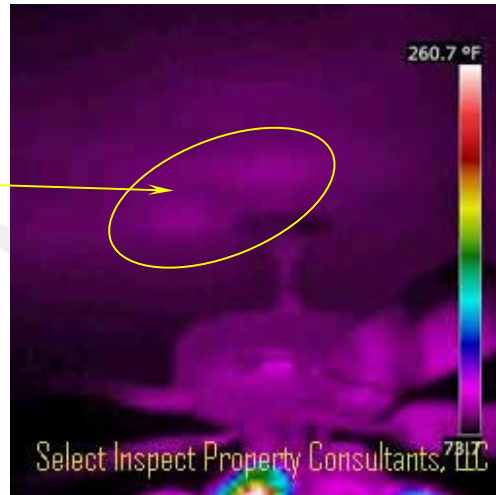
↑ Thermal imaging from square at left; may have been heat from the fan/light; only 2-3 ° temp difference

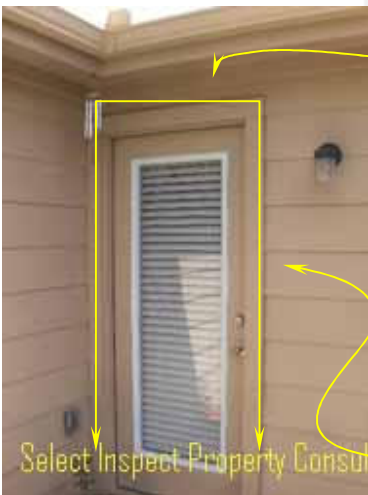
↑ sealant needed at door perimeter & trim / siding joints

- Recommend caulking vertical & horizontal siding / trim joints & touch-up at windows.
- Top header at the overhead door has exposed wood; painting of exposed wood is needed to resist decay

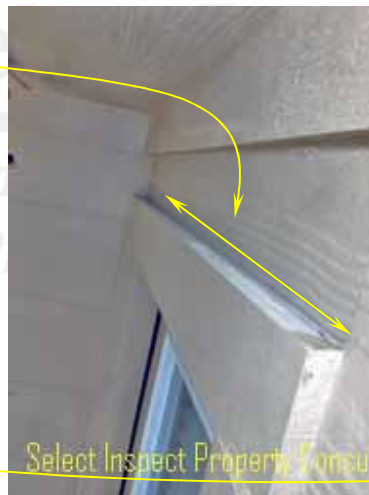
↑ close view of image at left; open at top of door trim

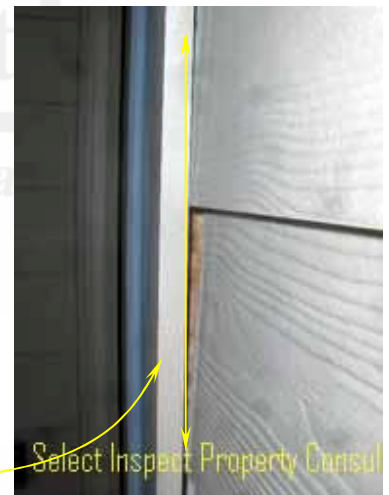
↑ close view of image at left; wall substrate/vapor barrier visible

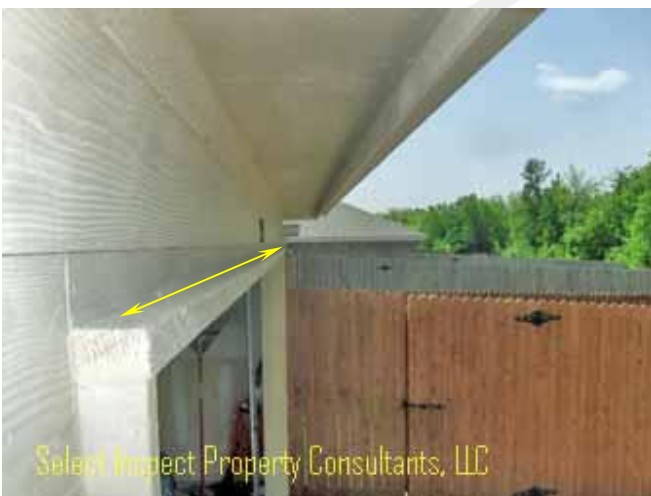
↑ inadequate paint (exposed wood) at overhead door header

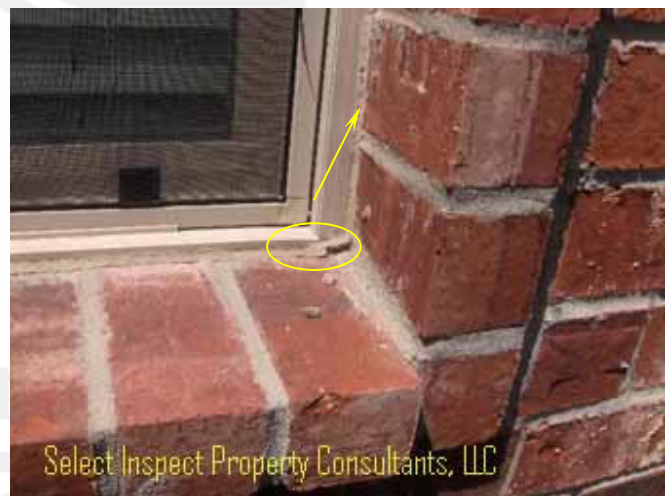
↑ sealant touch-up needed at windows; example

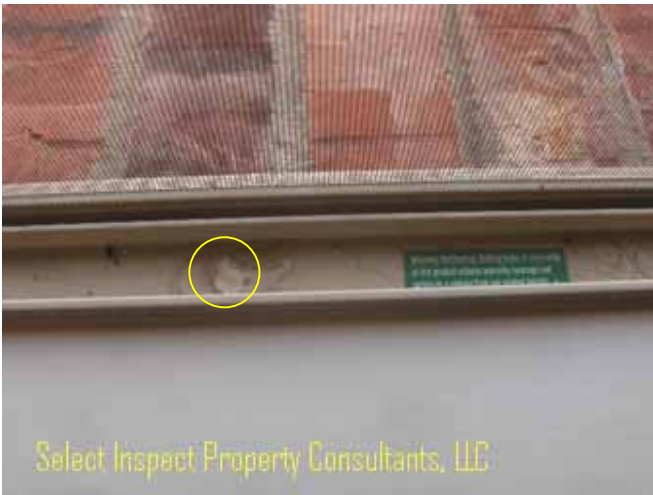
- Master closet window is broken/cracked glass.
- Security components should not have been installed at the bottom frame of the windows, as this compromises the integrity of the manufactured windows’ ability to keep water out of the wall void. It is likely that this installation has created an opening in the moisture barrier/window flashing; and that too is likely compromised. Small openings around the sensors may be prone to moisture intrusion into the wall void and adjacent materials. Check each window, Seal and repair deficiencies where discovered, and monitor- repair if necessary in the future. The condition voids manufacturer warranty in most cases. Presence & or extent of moisture damage & fungus in the wall void below & adjacent these areas is undetermined.
If the person/firm responsible for this condition is unwilling to correct it, you should obtain from them documentation stating that they will unconditionally warrant proper performance & if there is ever an issue with this component/system due to the current configuration, all related repairs will be at their sole expense.

↑ Alarm holes at the lower portion of the window voids the manufacturer warranty

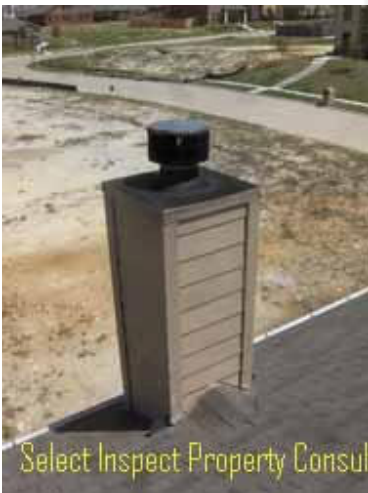
- ✚ Excess soot & residue exists at the chase cover & flue cap; cause may be related to type of wood, or another reason; recommend you check with a specialist for options

↑ soot staining at chimney cap

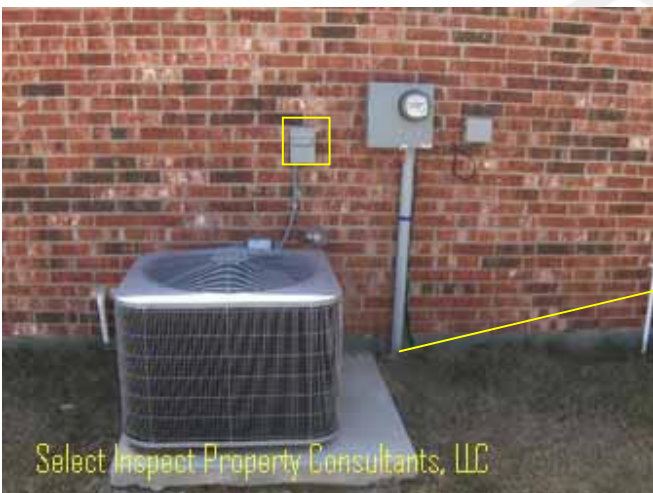
- ✚ The electrical disconnect panels for the air conditioner condenser unit(s) did not meet recommended clearance; the disconnect is considered a service panel and requires 30" lateral clearance and 36" front clearance from grade up to six feet in height. Disconnecting means shall be located within sight and readily accessible from the air conditioning or refrigeration equipment. Immediate repair needs may be subjective, and may be cost prohibitive pending your level of concern. This is mostly an access inconvenience for service personnel & not a safety hazard or urgent condition.

↑ incorrect location of air conditioning condenser(s) service disconnect; inadequate clearance of electrical panel for service personnel

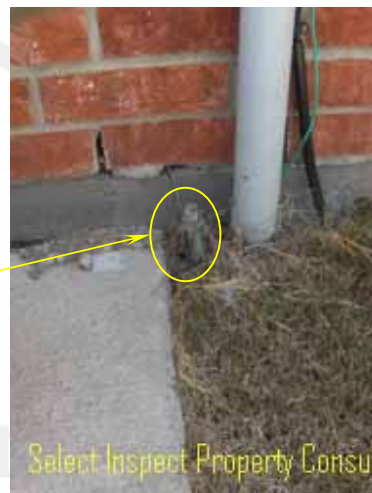
- ✚ Electrical ground rod was not flush with the grade. "Electrical ground rod shall have at least 8' of length in contact with the soil and the upper end of the electrode must be flush with / below ground level unless above ground portion and grounding electrode conductor attachment is protected against physical damage. NEC 250-52 (c) (3)". This includes rod electrodes installed inside through concrete slabs.

Grounding rods are typically sold as 8 foot lengths; since the upper end of the rod has been left above grade, it is most likely not in contact with the soil for 8 feet as required. Since much of the rod is buried, the suspected condition cannot be confirmed nor discredited during this limited visual inspection. The grounding electrode connection is prone to physical damage and should be protected and secured to the structure or service riser. The rod should be covered with compacted soil or driven deeper into the soil. A grounding rod that protrudes from the ground / grade may also present an impalement hazard. Repair options are limited; and though this is technically incorrect, proper installation methods are rarely discovered, and frequently ignored by installers and city building code officials.

↑ grounding electrode protrudes grade; deficient

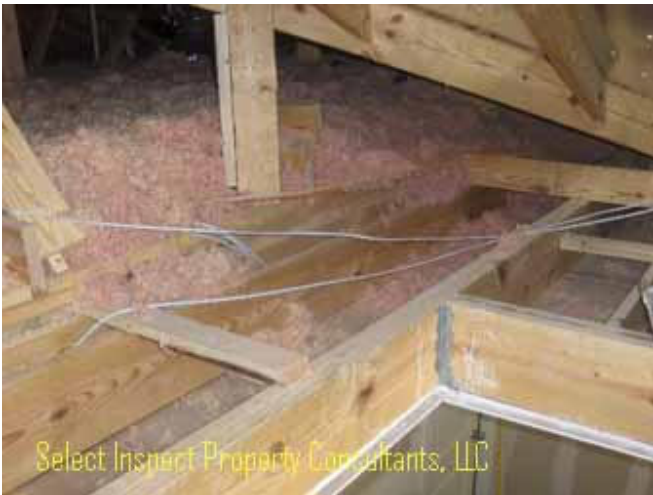
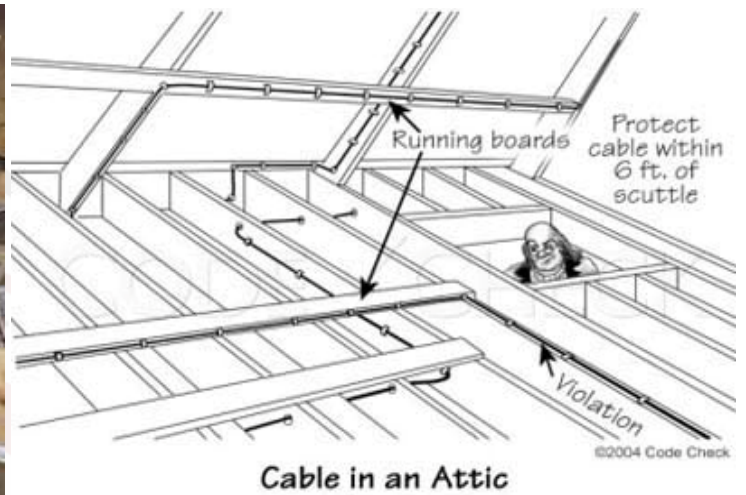
- There are electrical wires at the attic(s) that are not properly secured and protected from damage by traffic. Where run across the top of floor joists, or run within 7 feet (2134mm) of floor joists across the face of rafters or studding, in attics & roof spaces that are provided with access, the cable shall be protected by substantial guard strips that are at least as high as the cable. Where such spaces are not provided with access by permanent stairs or ladders, protection shall only be required within 6 feet (1829mm) of the nearest edge of the attic entrance. Where cables are installed parallel to the sides of rafters, studs or floor joists, guard strips & running boards shall not be required.....
Electrical wires/cables shall not be routed along walking surfaces or in any location prone to traffic damage. (E3702)

↑ electrical wires in the attic shall be adequately protected within 6' of attic scuttle; unworkmanlike electrical remains in the attic

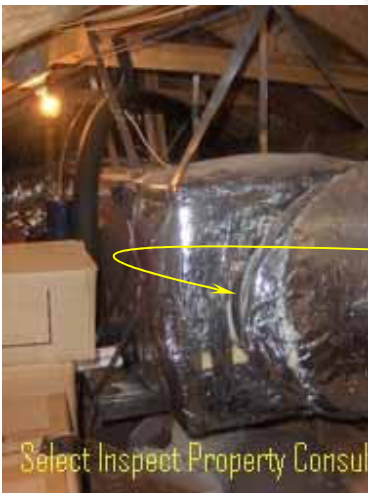
- Component connections were inadequately sealed; energy loss was detected.
- Filter(s) were dirty. Replacement or cleaning is necessary.

↑ return air duct remains inadequately secured & inadequately sealed

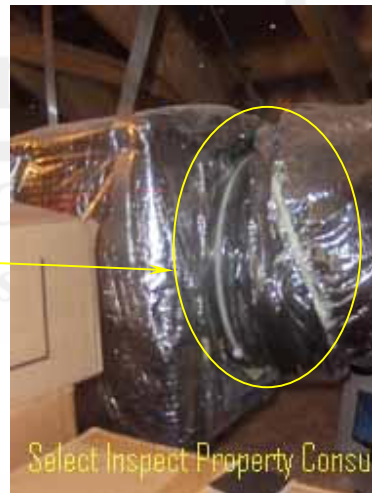
↑ close view of image at left

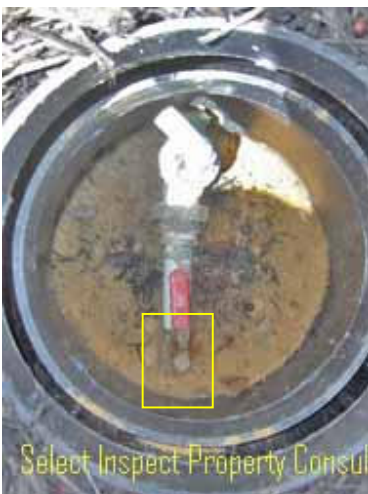
- ✦ Shut-off valve did not have recommended 3" clearance from soil; handle was rusted/corroded

↑ rust/corrosion at auxiliary water shut-off-valve; Shut-off-valves require 3" clearance from soil

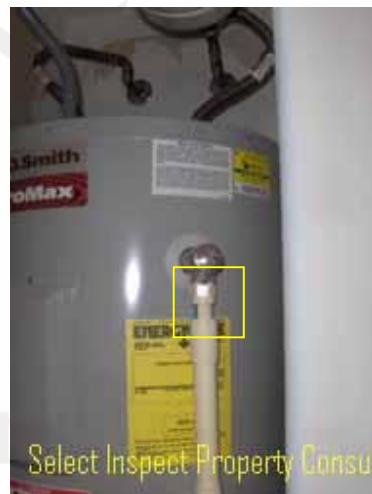
- ✦ The temperature-pressure-relief valve piping was smaller than required by temperature/pressure relief device manufacturers for this application; 3/4" cpvc (hot water PVC) as found in this home is frequently used and is commonly accepted by city code around the USA, however, the 3/4" material does not meet manufacturer specific requirements. T&P valve manufacturers require that the interior diameter of the drain line not be less than the interior diameter of the discharge section of the valve – a standard 3/4". The 3/4" CPVC tubing in use measures an average 0.715" interior diameter (technically .035" less than required). If CPVC is to be used it would need to be 1" O.D. cpvc to conform to IRC P2803.6.1. immediate corrective/improvement needs may be subjective.

↑ temperature/pressure relief piping at this section was smaller than required by the device manufacturer
