Select Inspect
Property Consultants, LLC

Inspection for Builder Warranty

at: 123 street; Allen, TX 75013

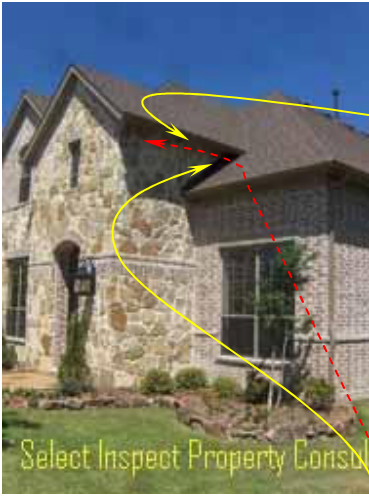
Southeast brick/stone facing supported by wood framing has deflected as indicated by diagonal crack(s). Related attic was not directly accessible; deflection of related framing was not discovered at the time of inspection. It is recommended to have a structural specialist or engineer evaluate the issue and prescribe appropriate permanent repair options. (related image(s) at the end of this document)

↑ structural stress evidence at the southeast

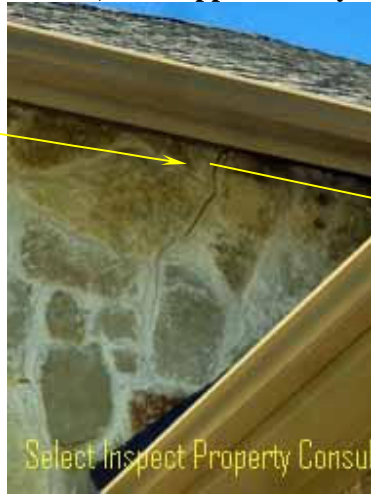
- Mortar cracks noted at the southeast
- Hairline drywall crack(s) in ceilings are generally signs of settlement of the upper/roof structure & not typically foundation related, & generally not significant.

↑ close view of image at left; mortar crack

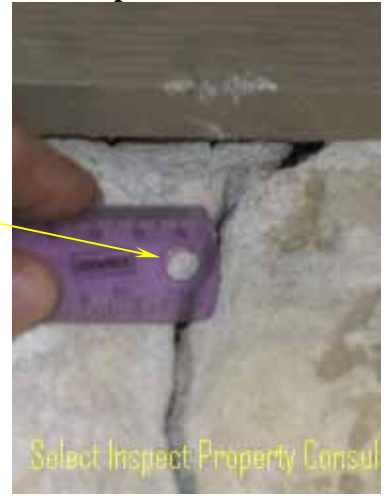
↑ + 1/8" during the inspection

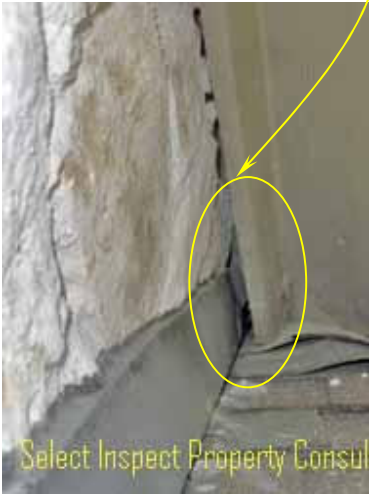
↑ openings under eave

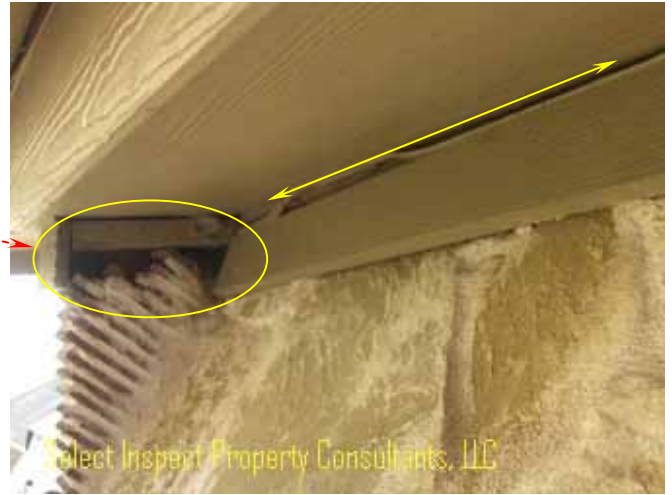
Frieze-board separation from the soffit was noted at the southeast.

Missing trim/frieze-board discovered at the southeast.

↑ missing trim & sealant stress separation at frieze-board/soffit

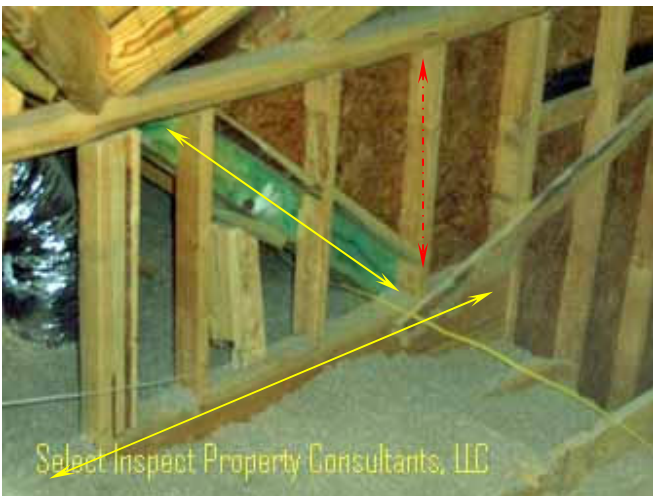
↑ attic adjacent the images above- red line is approximately location of exterior mortar crack

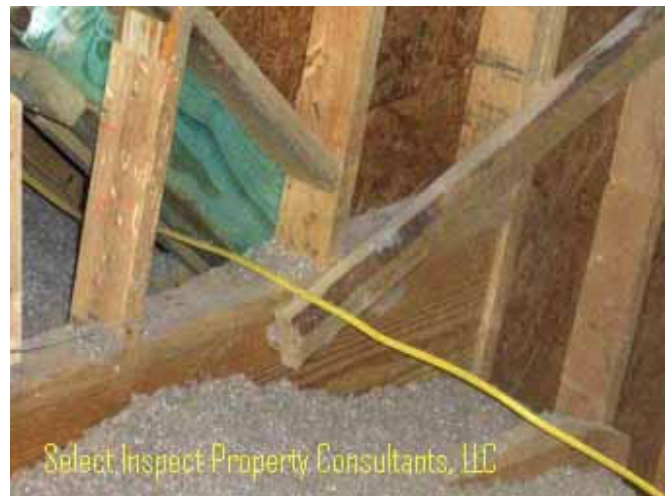
↑ close view of image at left; obvious stress not discovered, though suspect down load stress toward the south of the diagonal beams (green/treated)

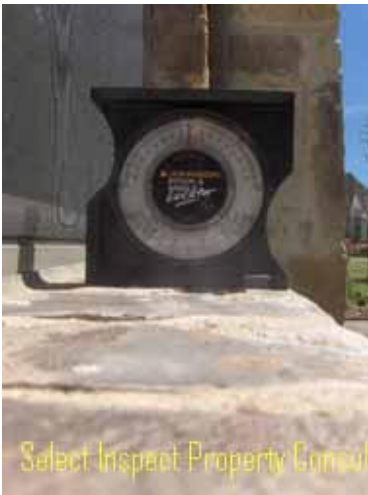
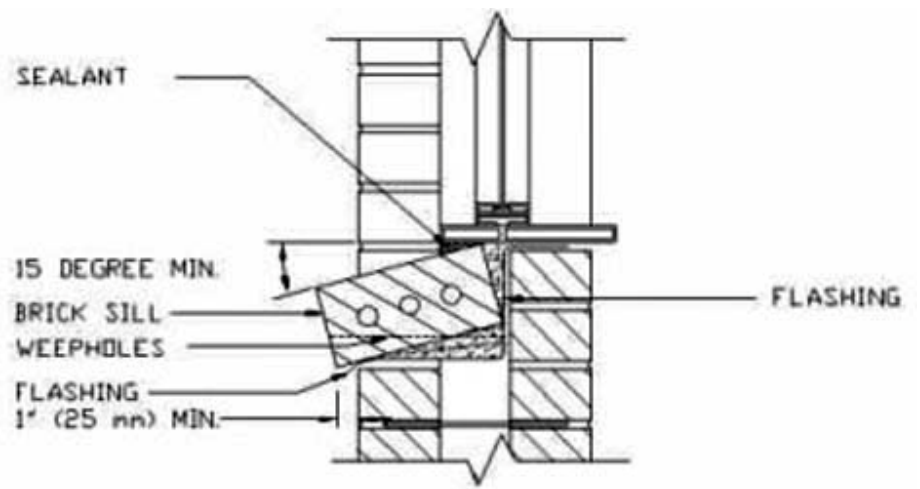
Exterior window sills did not have a recommended 15° slope for drainage at multiple locations; slope at random locations was approximately 2, 5, 7° Repair options may be limited. Condition & appropriateness of flashing & substrate components is undetermined.

↑ brick ledge(s) had inadequate slope; example of 2 ° at front window

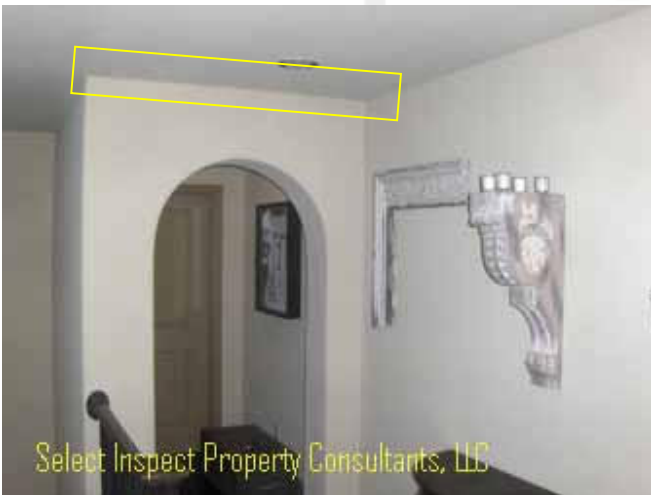
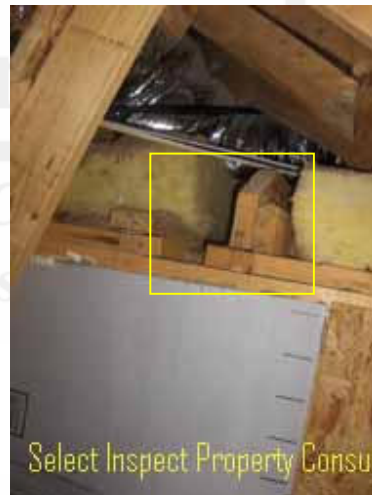
↑ thin insulation noted in the walk-in attic; though Thermal imaging did not indicate issues

↑ attic view of location at left

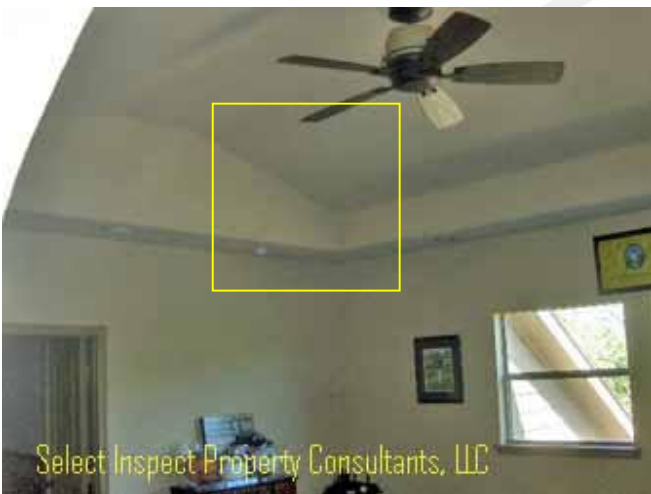
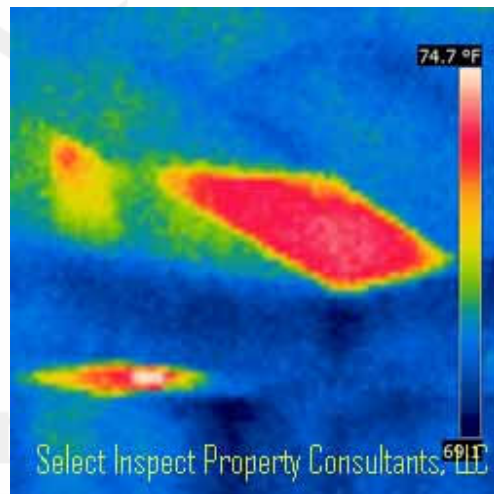
- Thermal imaging indicated areas that may have deficient insulation, air barrier/sealant, & or ventilation deficiencies at the gameroom & laundry room/master closet & commonly found general areas including vaulted corners (walls & ceilings), framing convergences, perimeter floor sills, electrical switches & receptacles adjacent exterior walls, & plumbing & HVAC chases.
- Insulation is inspected in a general manner from limited accessible locations; Conditions in not readily accessible/inaccessible locations remain undetermined; this is general in nature & is not a comprehensive investigation of all areas.

↑ Thermal imaging implies energy loss at gameroom northwest

↑ Thermal imaging from square at left

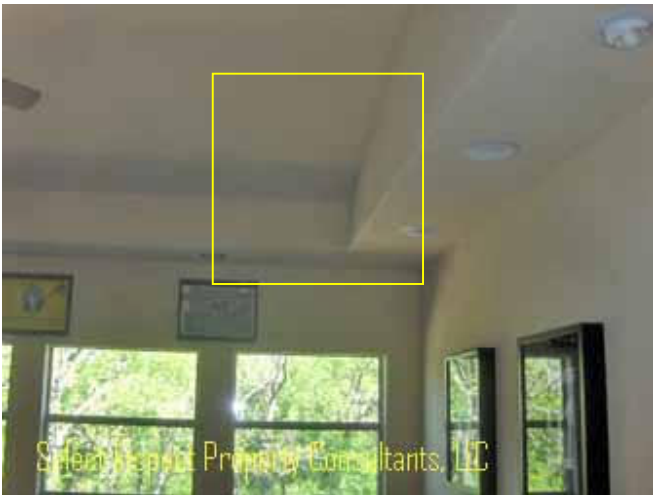
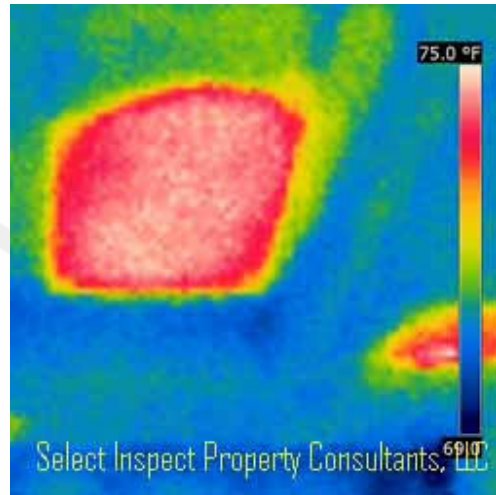
↑ Thermal imaging implies energy loss at gameroom northeast

↑ Thermal imaging from square at left

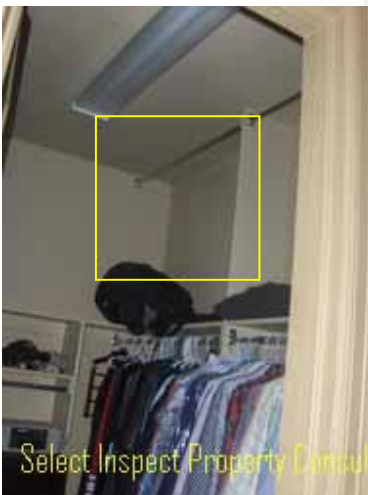
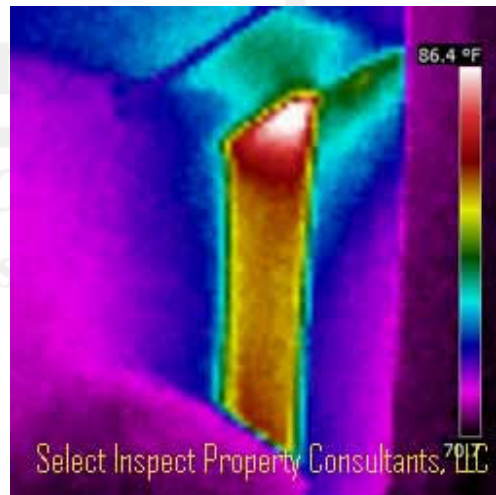
↑ Thermal imaging implies energy loss at master closet adjacent the dryer vent

↑ the dryer vent during operation is naturally warmer than the wall, though there may be lacking insulation in the wall void at this chase

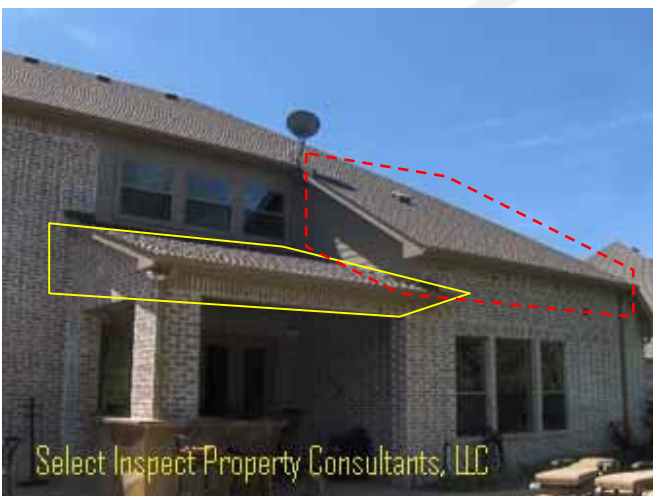
- The master bedroom/media room (northwest) attic did not have access present. Attic access opening shall be provided to attic areas that exceed 35 sq ft and have vertical height of 30" or greater. Rough framed opening shall be at least 22" X 30" and located in a readily accessible location (IRC 807). Conditions in inaccessible locations remain undetermined, including moisture intrusion, framing, insulation, etc.
- Rear porch attic was not readily accessible.

- The rear porch attic(s) did not have vents at the upper portion(s) and were poorly ventilated. This may result in humidity, condensation, and fungal issues, as well as undue stress on mechanical equipment. Addition of upper (roof) venting is recommended.

↑ missing upper venting at rear porch attic-inaccessible; missing access to attic above the master bedroom

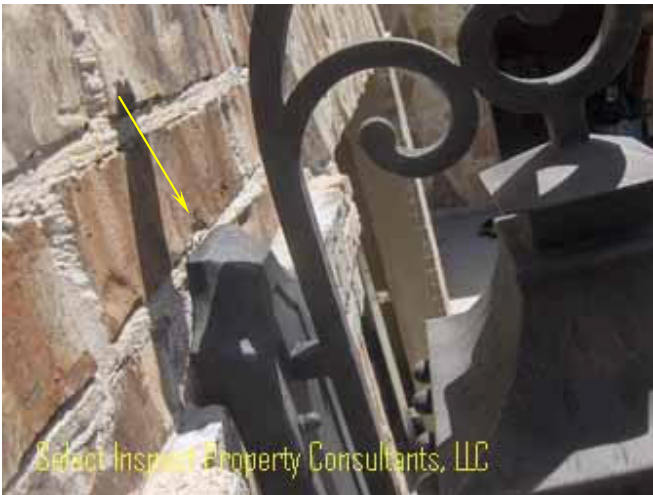
- ✦ Exterior lights should be properly sealed to prevent moisture intrusion and related corrosion / overheating possibilities of the electrical components. NEC 410-4 & IRC E3905.

↑ caulking/sealant needed atop exterior lights; example

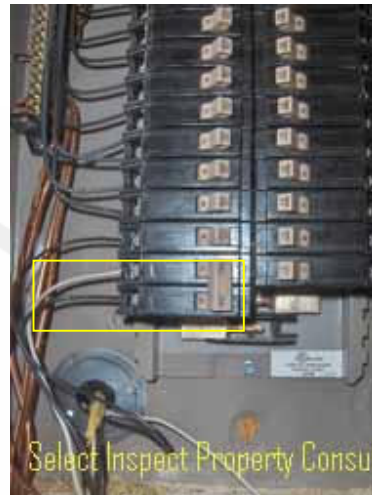
- Labels at the systems in the **Attic**- #1 upstairs ; #2 downstairs ; #3 master
- Wires at pool equipment 30 amp overcurrent-protection-device are smaller than recommended for the size of breaker they were connected to. This is considered an incorrect and unsafe condition. Repair is strongly recommended.

↑ inadequately sized electrical conductors at pool equipment 30amp overcurrent-protection-device; unworkmanlike.

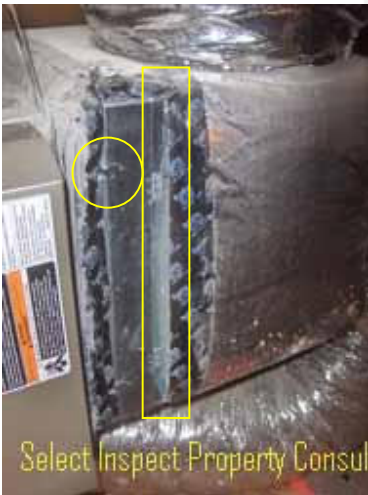
↑ inadequate seal & deficient filter door latch- HVAC #3 in attic

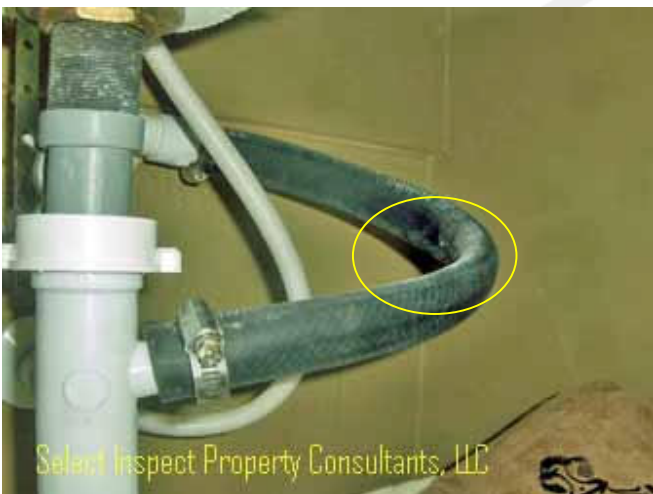
- The primary condensate lines were crimped at / near the drain connection below the upstairs bathroom east sink(s). This is conducive to congestion and potential failure of the air-conditioner drain system. Improvement / repair should be simple and is recommended.
- Temperature differential between the return(s) and supply at the HVAC unit(s) was approximately 22 downstairs, 17 master, & 16 upstairs at the time of inspection; 15°-22° is generally the acceptable range.
- It is recommended to have the evaporator(s) serviced/cleaned at least every 2 years. Monitor this item periodically and repair if / when needed. If documented history of service is unavailable, recommend you consider having this professionally examined and cleaned before closing.

↑ crimped condensate drain is prone to failure

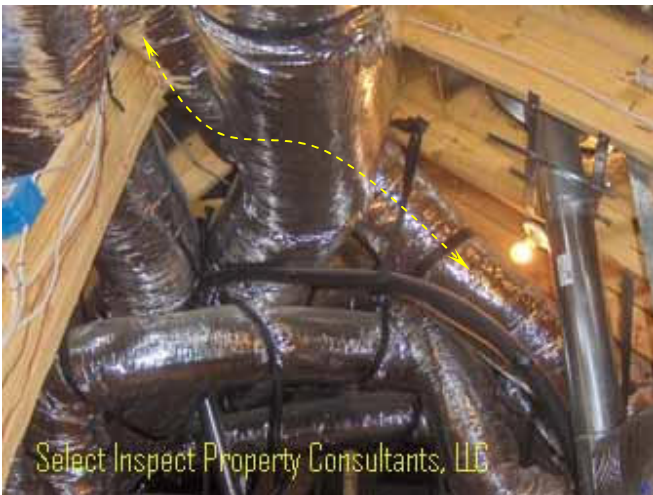
- Component connections were inadequately sealed; energy loss was detected.
- Crimped and or partially constricted ducting was noted above unit #3. Tight strapping or sharp turns can restrict efficient airflow. Correction / improvement would be prudent.
- Filter(s) were dirty. Replacement or cleaning is necessary.

↑ crimped air ducting; example

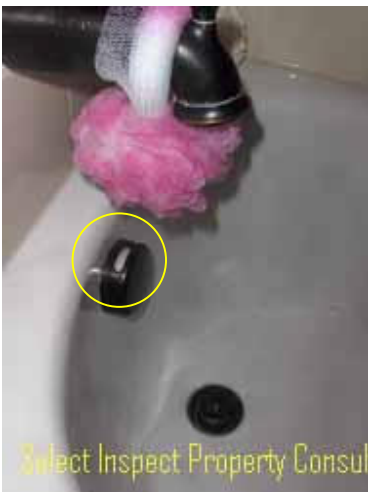
↑ inverted overflow at upstairs bathroom east

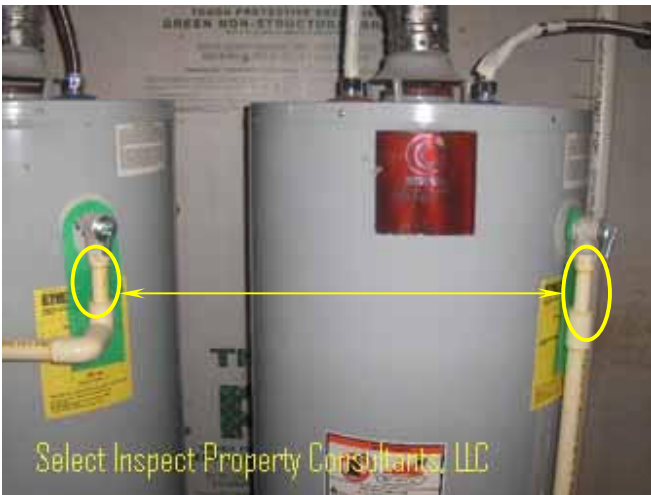
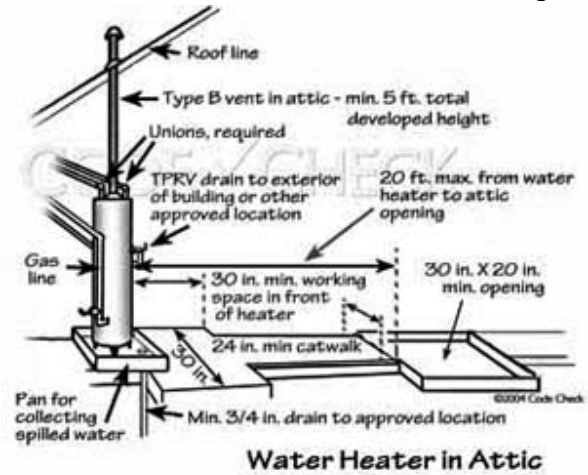
- The temperature-pressure-relief valve piping was smaller than required by temperature/pressure relief device manufacturers for this application; ¾" cpvc (hot water PVC) as found in this home is frequently used and is commonly accepted by city code around the USA, however, the ¾" material does not meet manufacturer specific requirements. T&P valve manufacturers require that the interior diameter of the drain line not be less than the interior diameter of the discharge section of the valve – a standard ¾". The ¾" CPVC tubing in use measures an average 0.715" interior diameter (technically .035" less than required). If CPVC is to be used it would need to be 1" O.D. cpvc to conform to IRC P2803.6.1. immediate corrective/improvement needs may be subjective.

↑ temperature/pressure relief piping at these sections was smaller than required by the device manufacturer

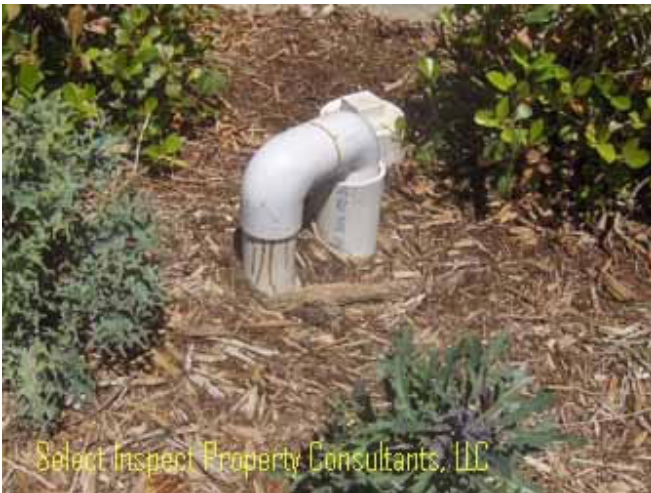
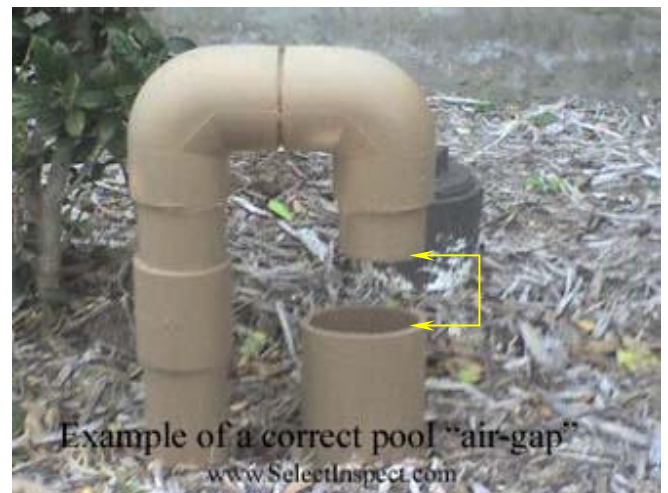
↑ "air-gap" (atmospheric pressure break) was not present / inadequate for the pool system
