Select Inspect

New Home Punch-out Inspection

at: **12345 YourStreet; Frisco, TX 75035**

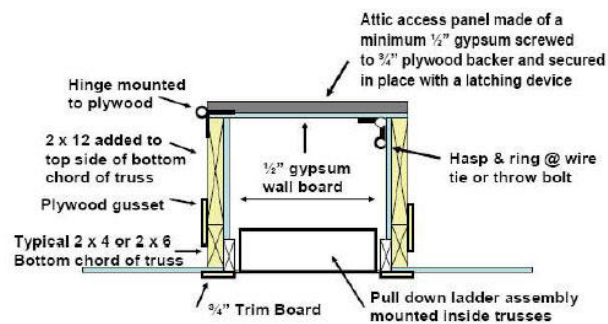
- The access panels at the garage attic accesses was not adequate material and would not meet separation required for fire-spread at attached garages. The access cover is a sheet of thin plywood. When installed in a garage ceiling, this replaces a portion of the required separation created by drywall board, thereby breaching the required separation. IRC R309.2 Option 1: Minimum 1 hour fire-rated material should be installed on the garage side of the hatch/door. Edges around the covering shall be tight to the surrounding ceiling. Option 2: Installing 5/8" drywall to separate the garage attic and at the rafters to at least 4 feet into the then separated garage attic to isolate the garage attic from attic space(s) above or adjacent living areas; taping/bedding all seams should be made to finish the firewall. Option 3: Installing a fire-resistant enclosure in the attic above the garage access; An example of this is shown in the following image.

Pull down garage attic ladder installation requirements to maintain fire resistive separation

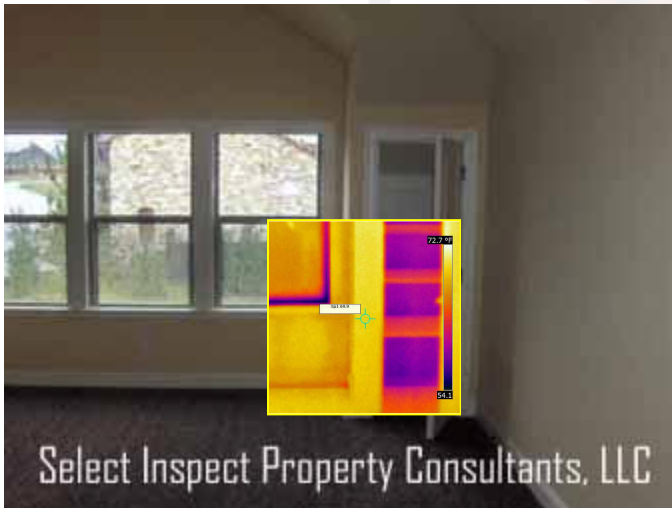
- Inadequate/deficient insulation was discovered at the gameroom closets, library, master closet, gameroom upper west, breakfast nook, dormers, bedroom 4 southeast, & at various recessed lights. If access is made at the rear porch attic, the breakfast nook insulation could be corrected from that location.

↑ darker thermal areas imply gameroom closets to have lacking insulation at exterior wall; example at right side closet

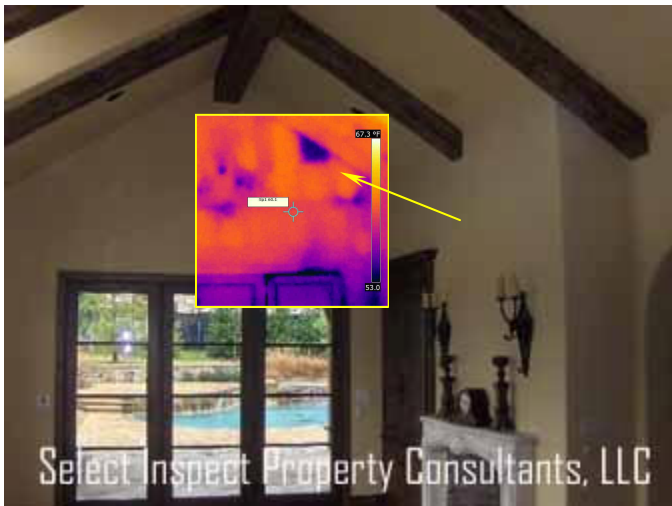
↑ darker thermal areas imply apparent missing insulation at breakfast nook vault wall & slight air infiltration at the doorway (common)

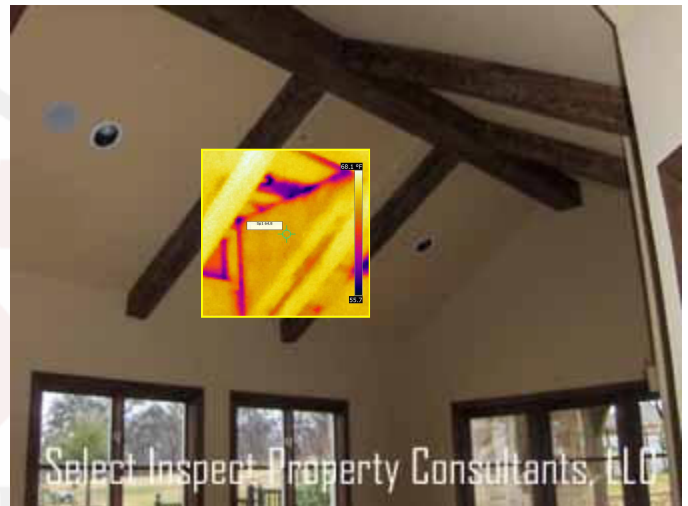
↑ darker thermal areas imply apparent lacking insulation or other "cooler" areas from suspected air infiltration discovered at vaults & recessed lights; example at breakfast nook dormer

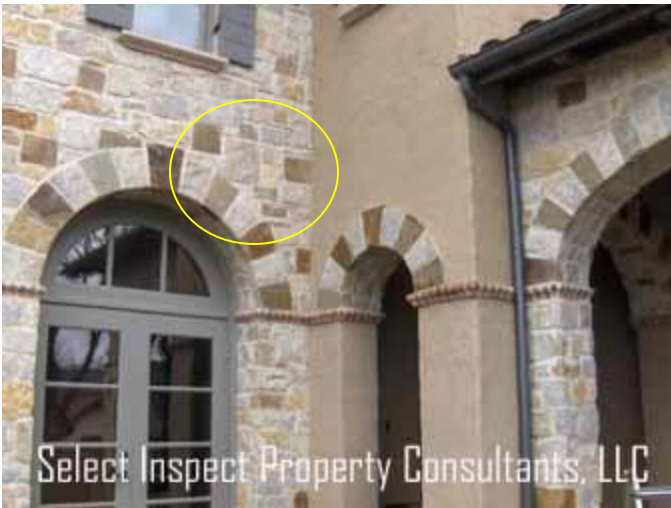
- EXTERIOR:
- Veneer cracks less than 1/8" at the front entry, upstairs bathroom & bedroom 4 corner, rear porch, multiple stucco locations (related image(s) at the end of this document);

↑ crack at mortar

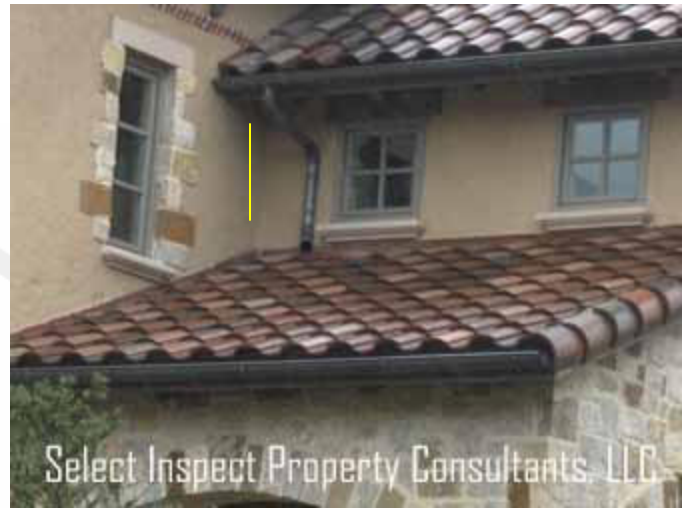
↑ crack at stucco

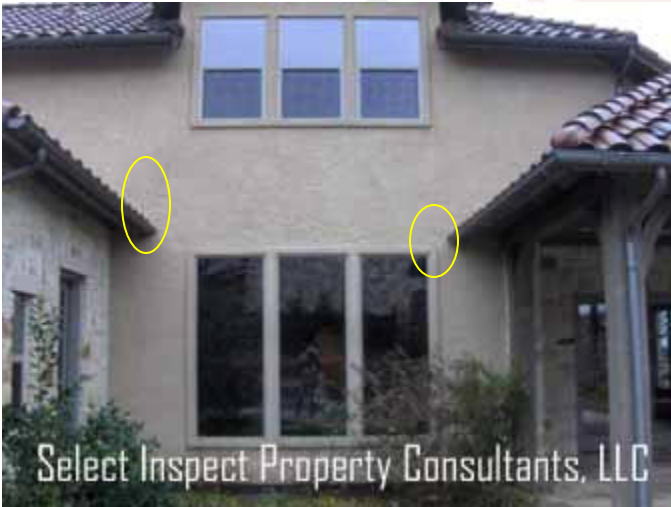
↑ cracks at stucco

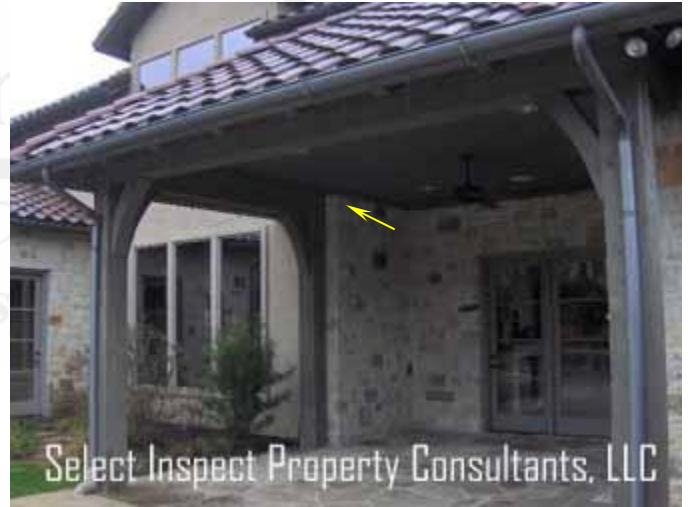
↑ crack at mortar

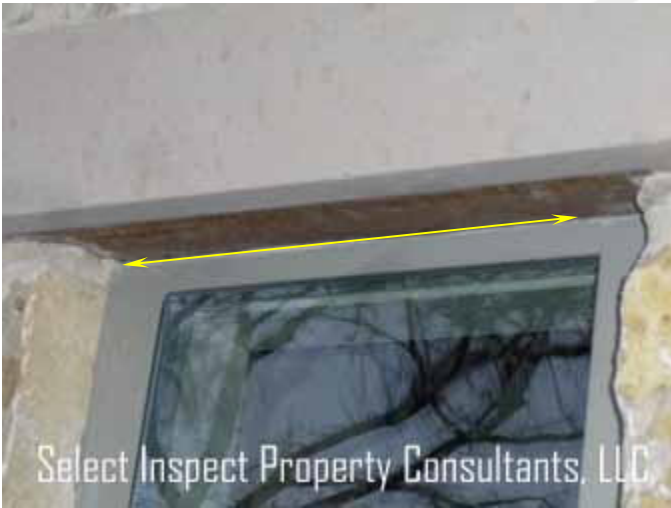
Flashing was not visible/discovered as recommended behind & above steel lintels at door/window locations; this may create improper drainage of condensate from the wall voids.

↑ undetermined flashing & sealant recommended at window lintels; example

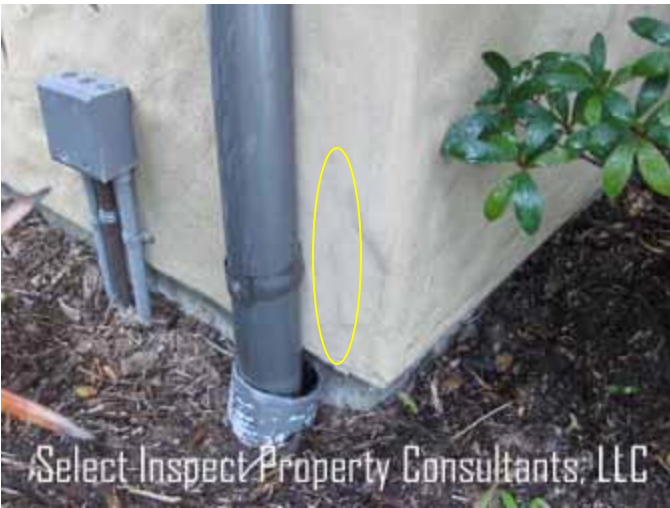
↑ crack at stucco; & sealant needed at penetrations; master east

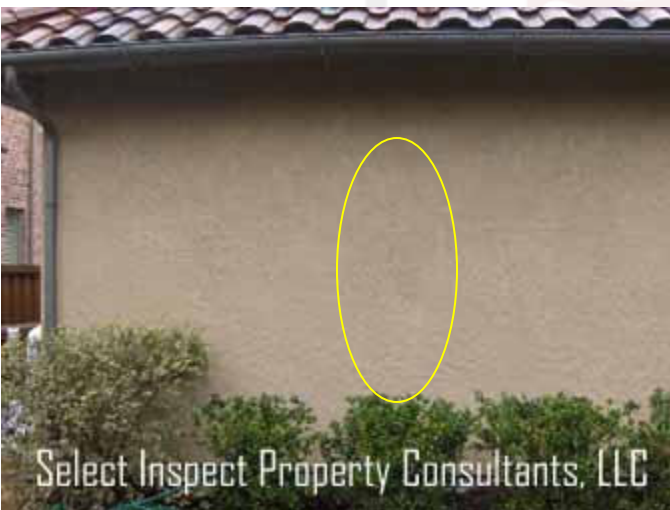
↑ cracks at stucco; master east

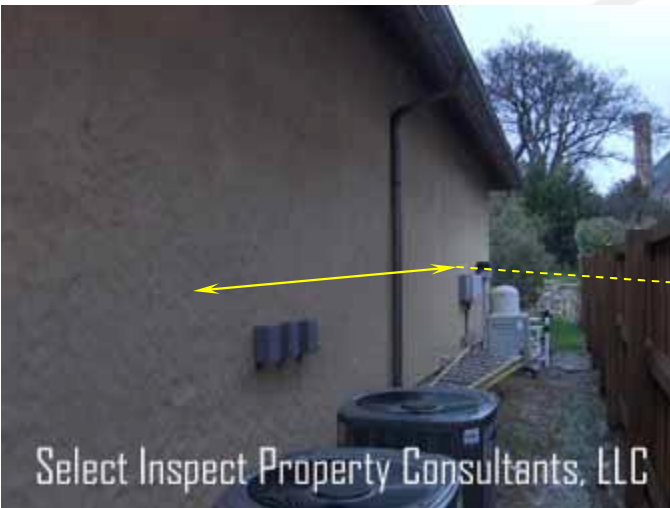
↑ cracks at south stucco

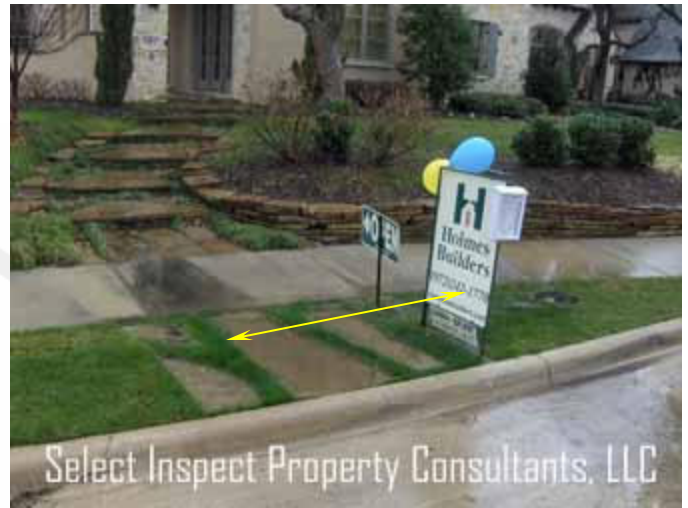
↑ poor drainage at front walk

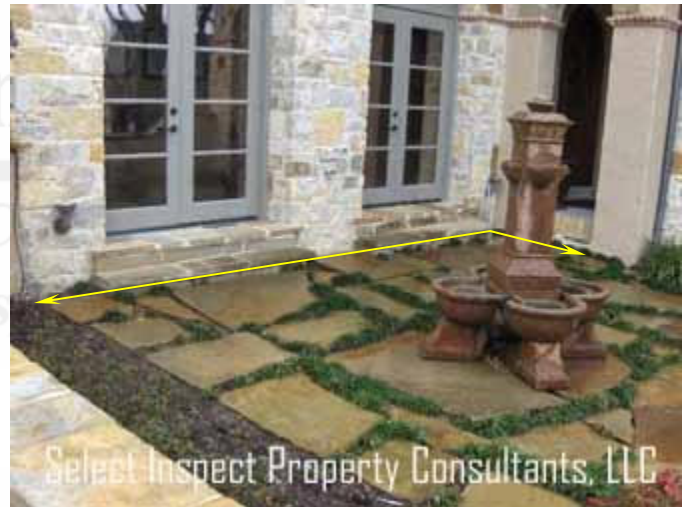
- Weep openings appeared to have been omitted at the front patio area. Such is not recommended, as these provide drainage of condensation from within the wall voids.

↑ high soil example & weep openings not discovered at front porch

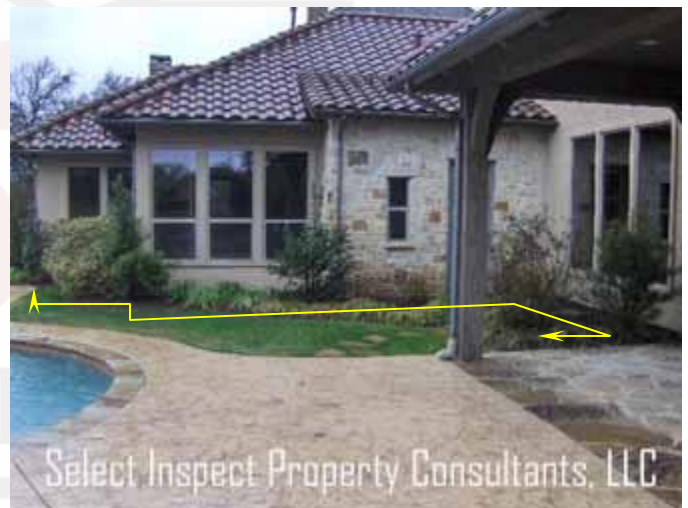
- Deficient drainage & pooling water noted at the east & south adjacent the home & at the front walk near the street.
- Area drain ports were not at the lowest portion of the grade at the east, adjacent the family room, powder bath, & master bedroom. This did not allow ground water to efficiently flow to the drain and be removed from the site. Recommend a drainage specialist offer repair options. Sub grade drains may be necessary at the east & south.

↑ poor drainage at rear; multiple locations & pooling water

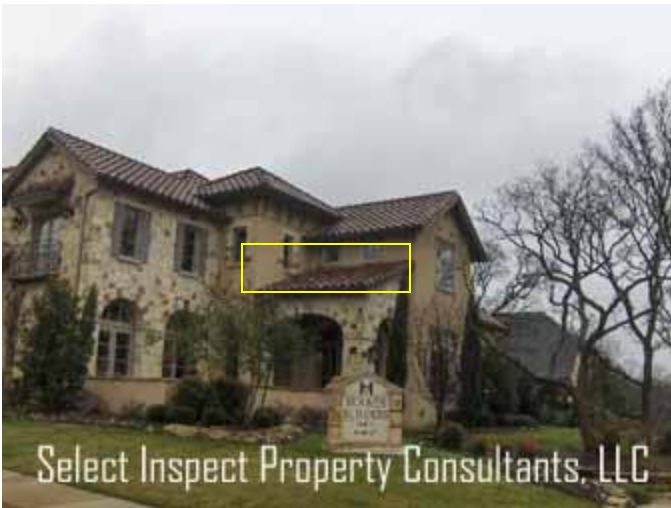
↑ cracked tile had been patched; chipped tile noted

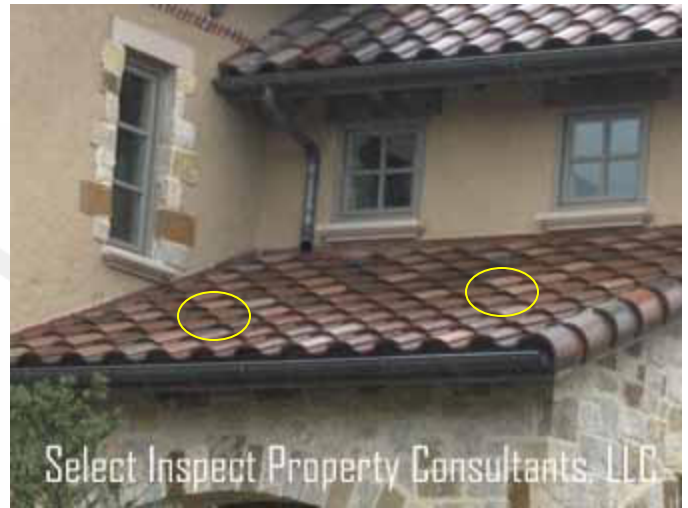
↑ close view of location in image at left

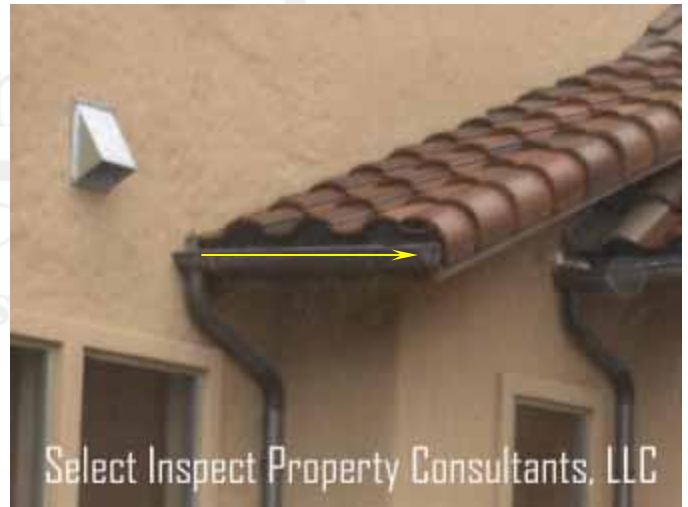
↑ close view of image at left

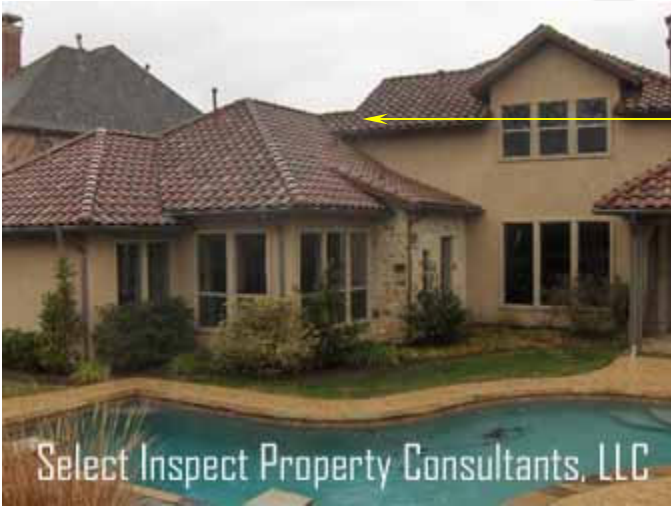
- Damaged roof tiles noted at various locations. All discovered deficient tiles were pictured at the end of this document. Have the rest of the roof examined & any deficiencies corrected when these are addressed.
- Missing tile noted at the top of the fireplace chimney cap.
- Moisture intrusion was implied by moisture staining at the breakfast nook beam/drywall adjacent the dormer; (related image(s) at the end of this document)

↑ deficient tile

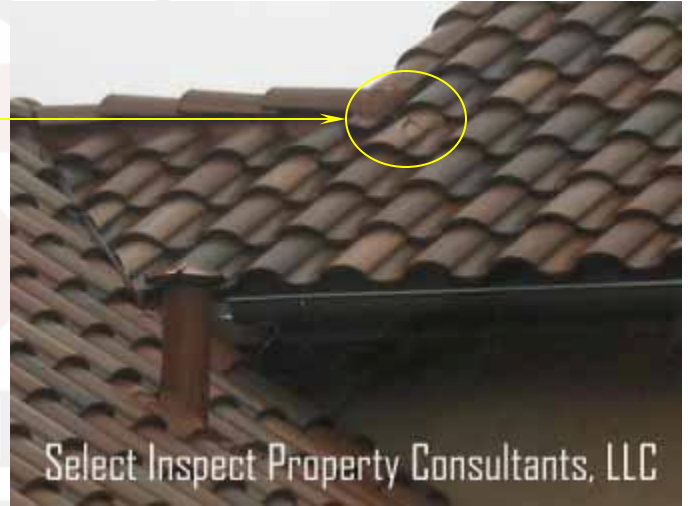
↑ close view of image at left

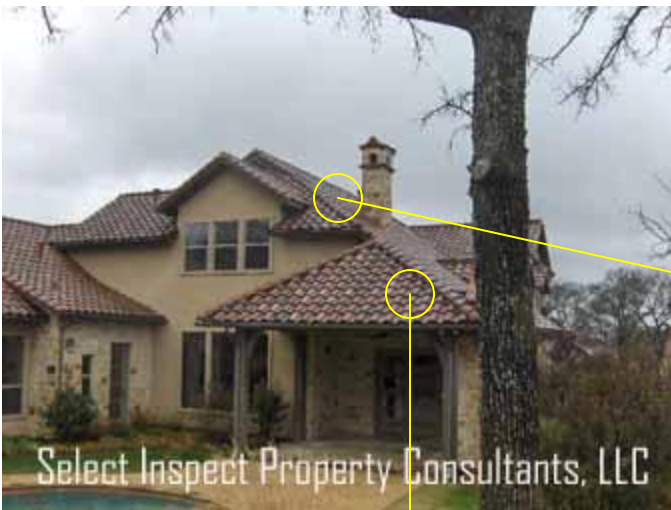
↑ deficient/cracked tiles

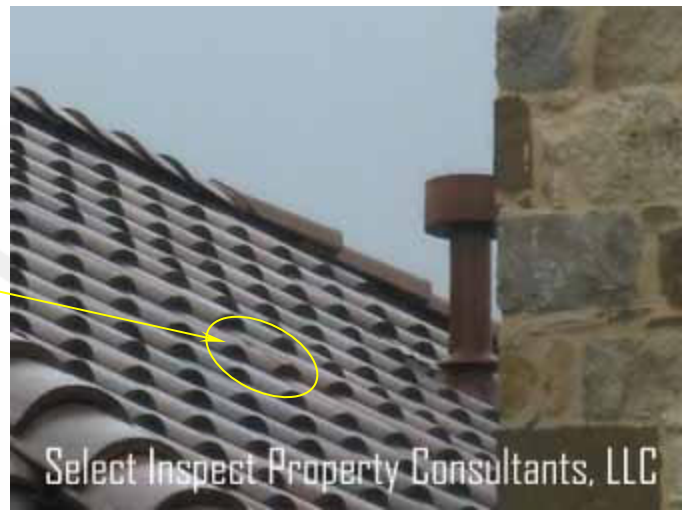
↑ cracked tile

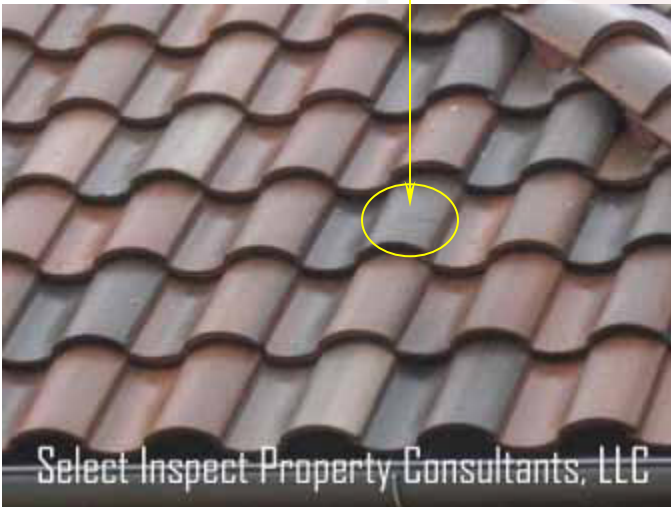
↑ cracked tile

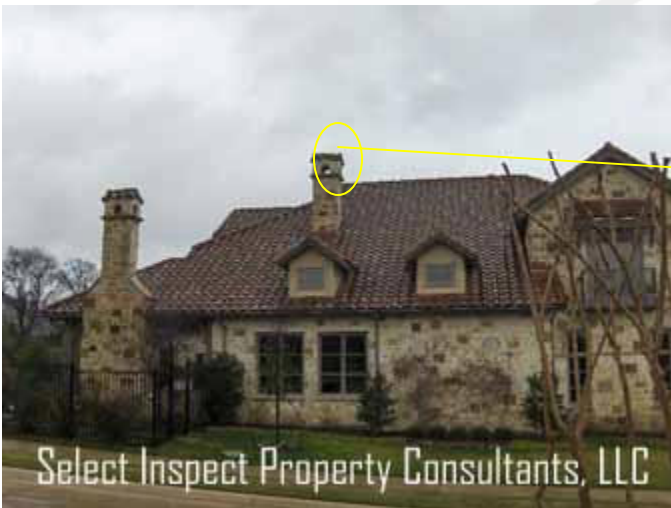
↑ missing tile at chimney;
back side of chimneys & some other high or otherwise
concealed roof areas were inaccessible/undetermined

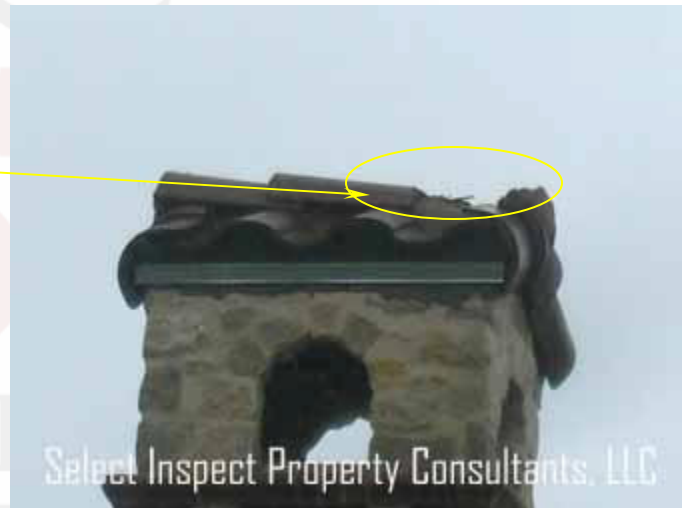
↑ close view of image at left

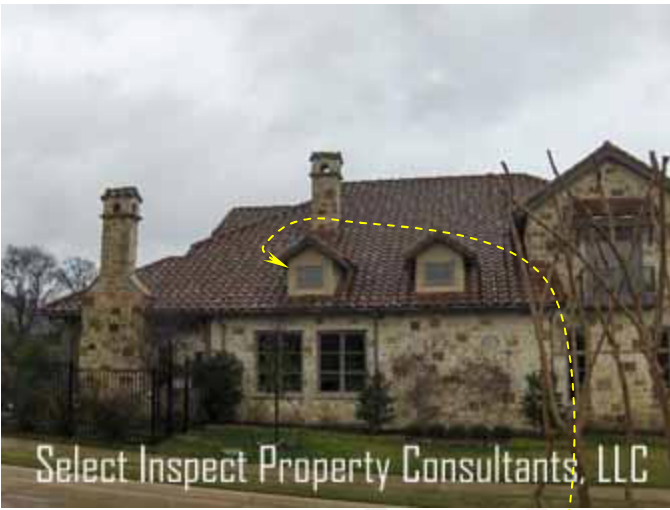
- Moisture evidence was indicated by stains at the breakfast nook dormer/beam area. Refer to the roof section & photos for related information. Presence of fungus and the extent of damage is not determined in inaccessible areas. Moisture source and any damaged insulation in the attic(s) above should be identified and permanently repaired.

↑ moisture staining at interior of dormer

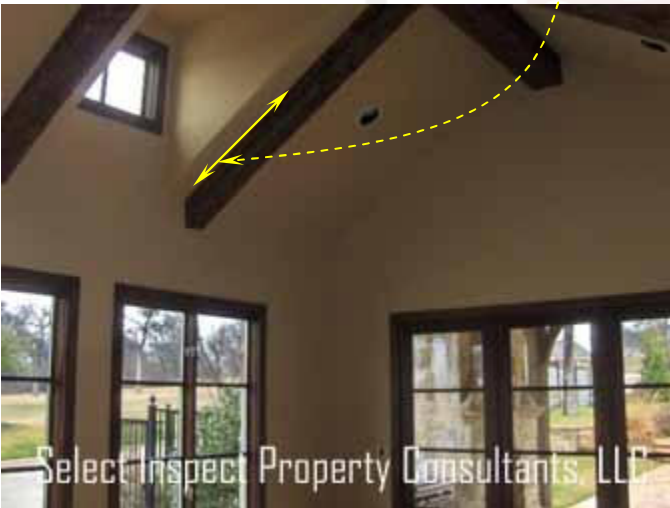
↑ moisture staining at interior drywall

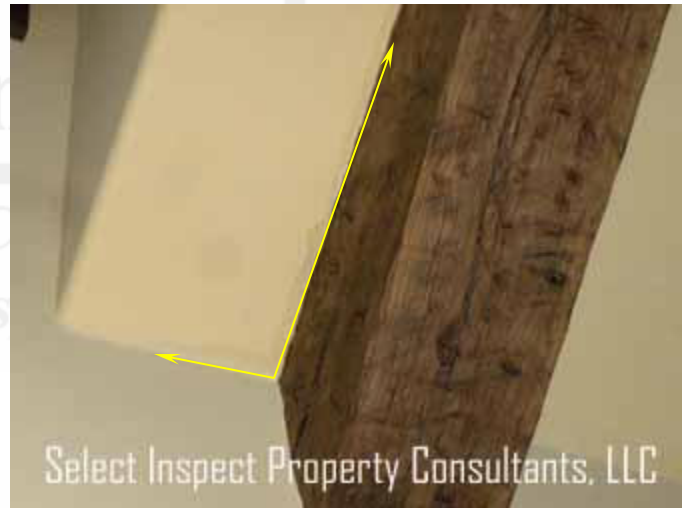
↑ close view of image at left

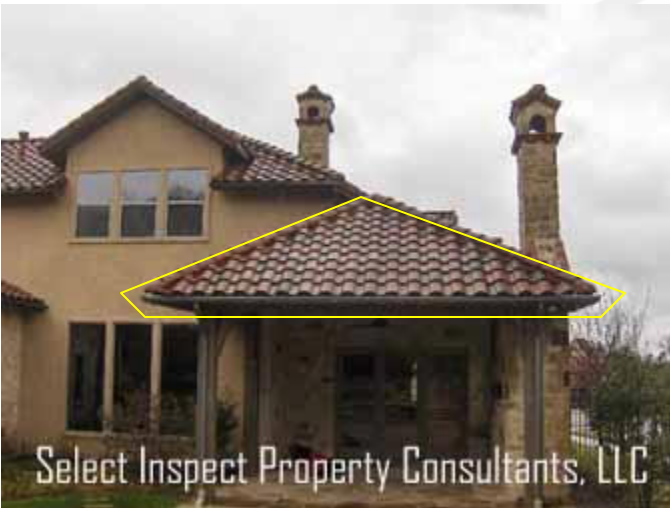
- The rear porch attic(s) did not have access present. Attic access opening shall be provided to attic areas that exceed 35 sq ft and have vertical height of 30" or greater. Rough framed opening shall be at least 22" X 30" and located in a readily accessible location (IRC 807). Conditions in inaccessible locations remain undetermined, including moisture intrusion, framing, insulation, etc.

↑ rear porch attic did not have an access; Conditions in not readily accessible/inaccessible locations remain undetermined

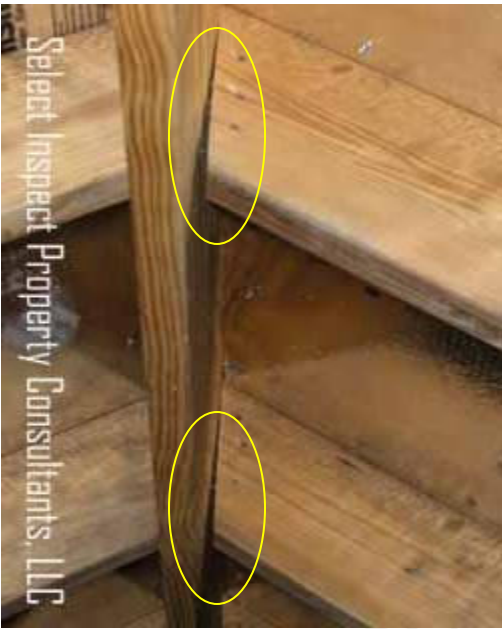
- Rafters were not flush/tight with adjacent ridge or hip framing at single garage southwest ridge. This is indication of structural movement or improper installation. This can impair the intended load path; causing structural stress that can result in veneer deflection, compression, cracks, etc. Correction / improvement would be prudent; and should be made with other roof related repairs.

↑ slight separation at rafter in single garage attic

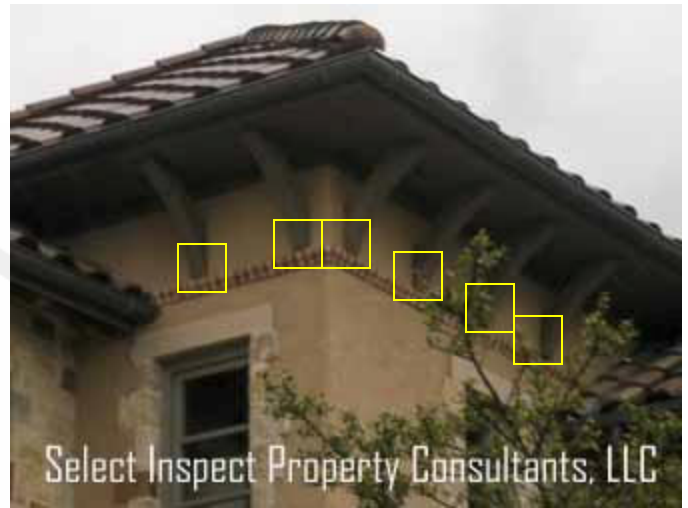
↑ sealant needed; example; close view of image at left

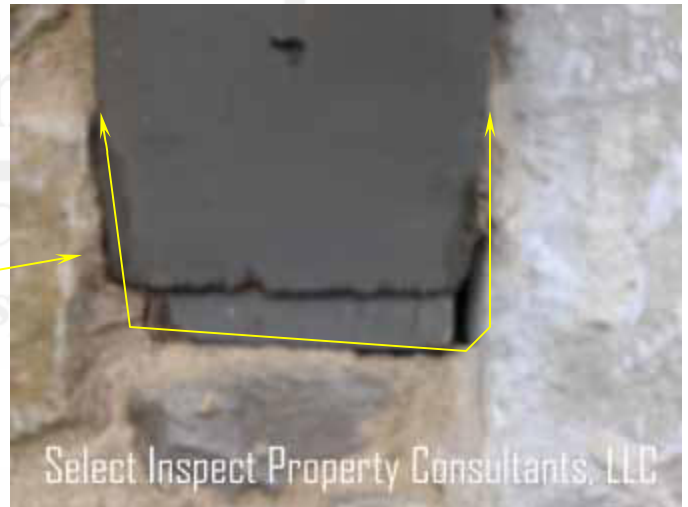
↑ close view of image at left

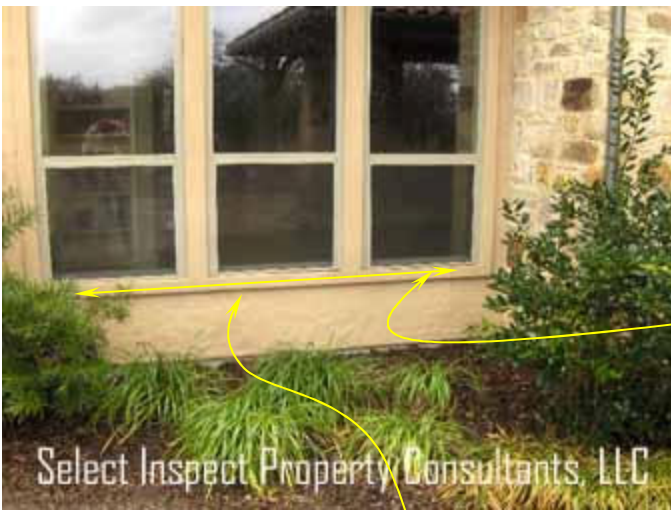
↑ sealant needed

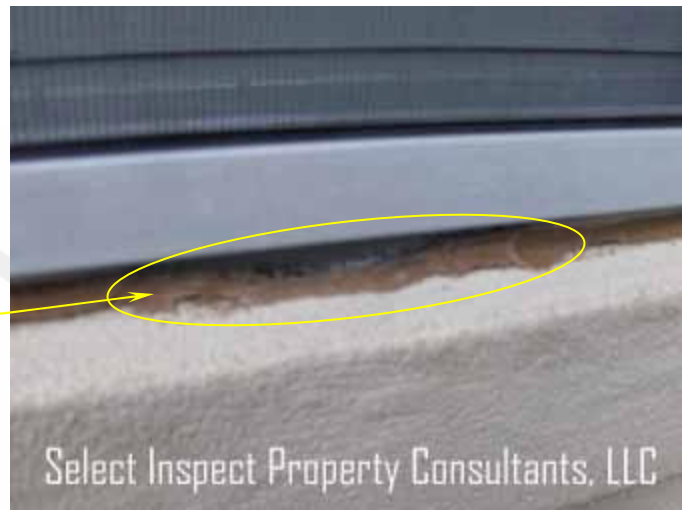
↑ close view of image at left; openings at stucco along window; example

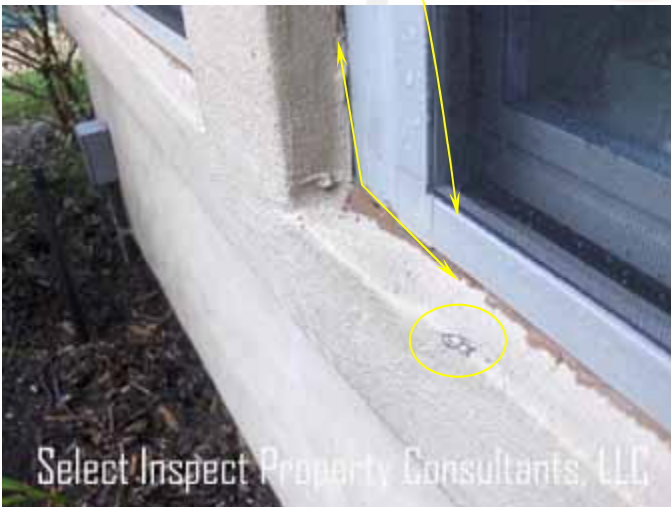
- Damaged stucco noted at master window areas; (related image(s) at the end of this document)
- Multiple cracks noted; (related image(s) at the end of this document)
- All equipment penetrations and mounting fastener locations shall be sealed & weather-tight. (related image(s) at the end of this document)
- All stucco penetrations shall be sealed & weather-tight including dec & or structural eave beams, & similar beams at the balcony, sills, cast stone joints, windows.

↑ damaged stucco/artificial stucco trim & sealant needed

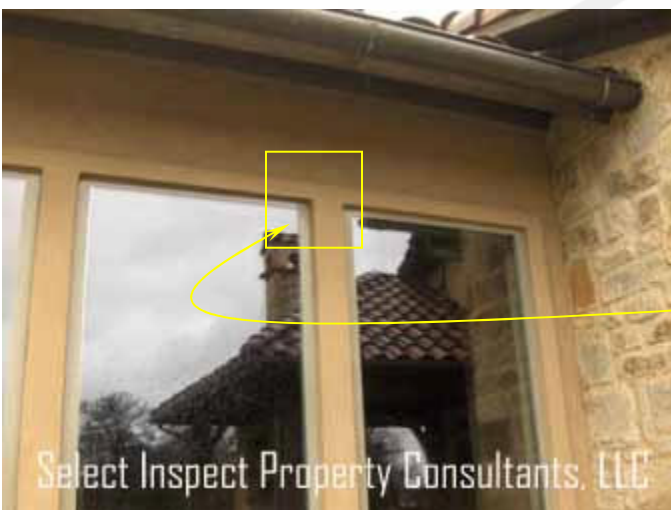
↑ unworkmanlike window corner example

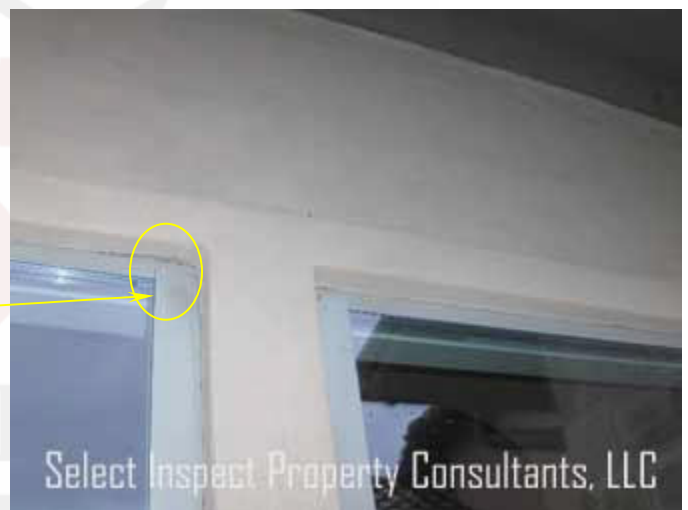
↑ close view of image at left; Significant issues were not discovered; monitor & maintain

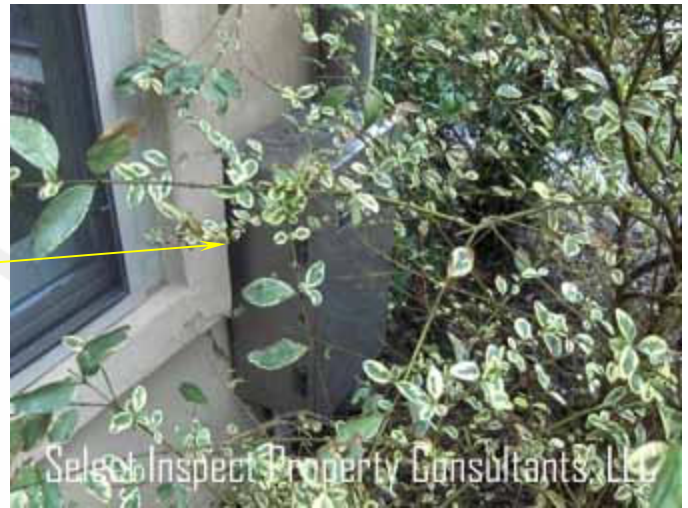
↑ close view of image at left; electrical box was also inadequately secured

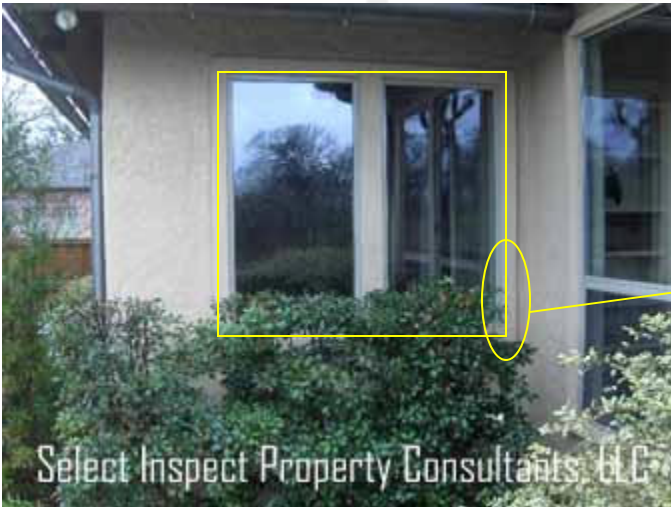
↑ damaged stucco/artificial stucco & sealant needed

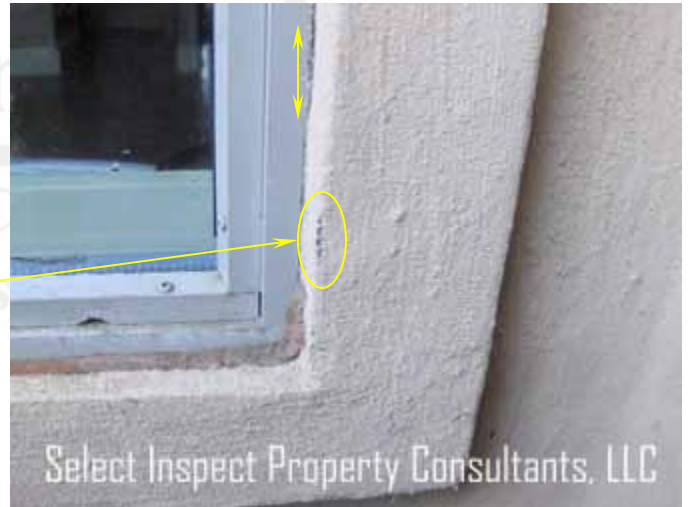
↑ close view of image at left

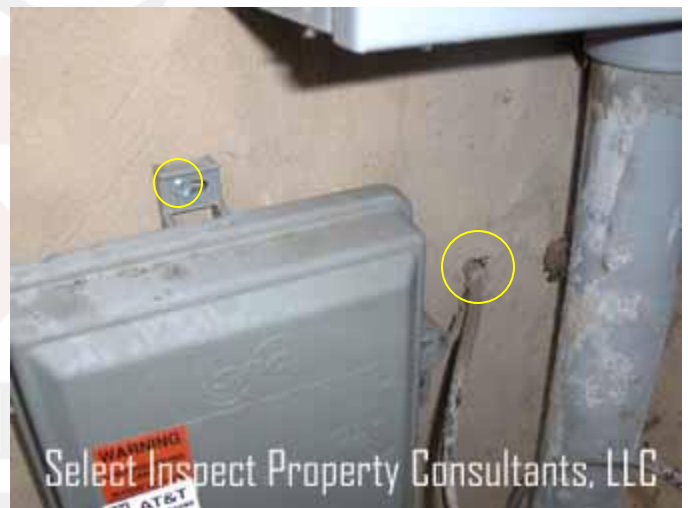
↑ close view of image at left

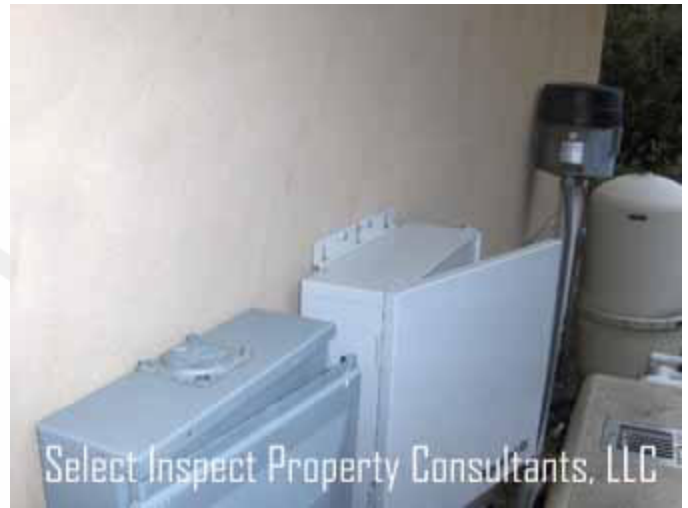
↑ sealant needed at all equipment boxes/penetrations

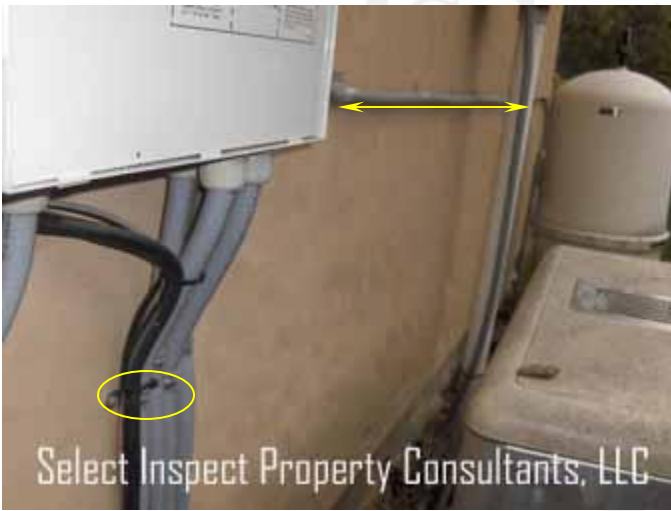
↑ sealant needed at equipment boxes/penetrations

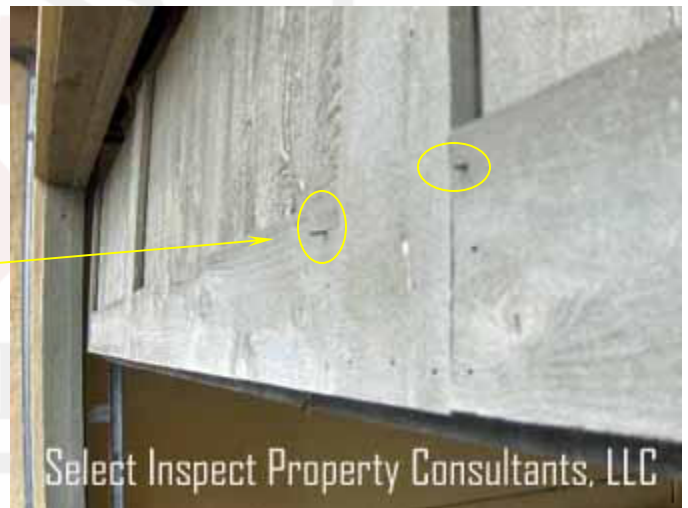
↑ close view of image at left

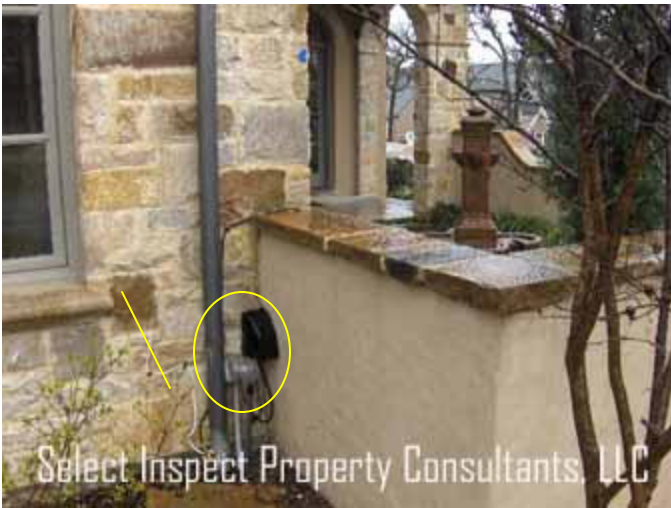
↑ crack at mortar & deficient electrical weatherproofing

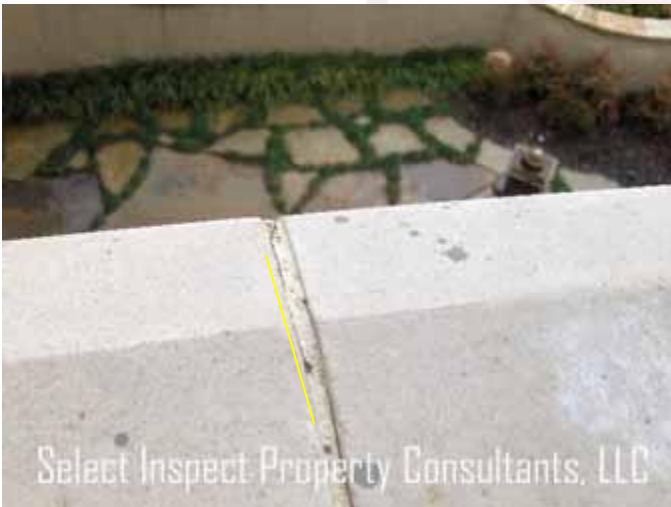
↑ cracks at cast stone mortar; example

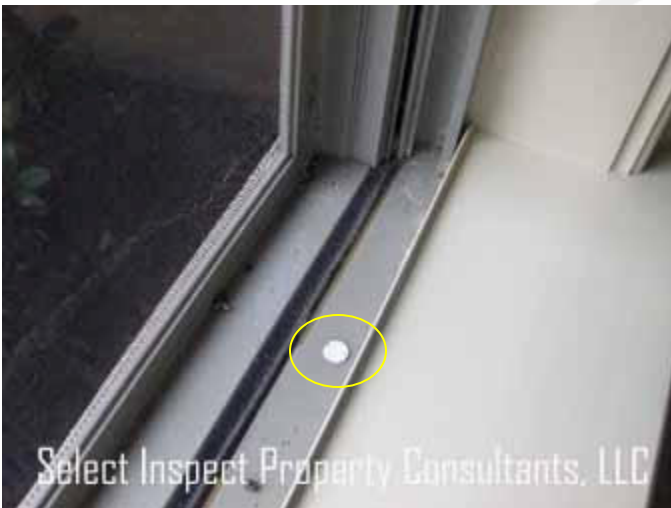
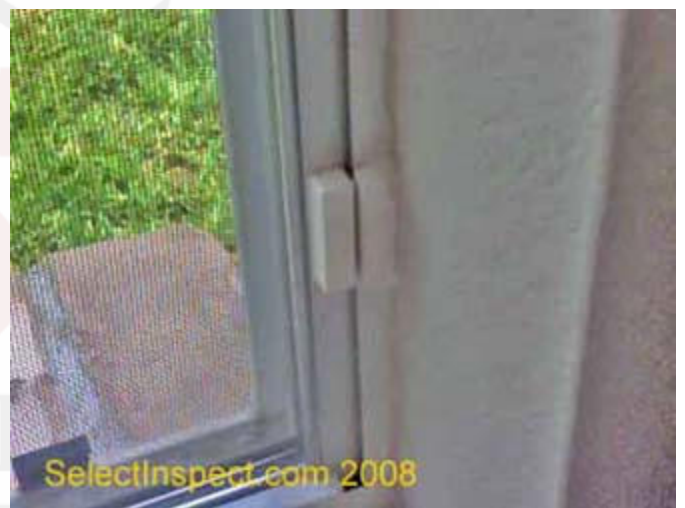
- Security components should not have been installed at the bottom frame of the windows, as this compromises the integrity of the manufactured windows' ability to keep water out of the wall void. It is likely that this installation has created an opening in the moisture barrier/window flashing; and that too is likely compromised. Small openings around the sensors may be prone to moisture intrusion into the wall void and adjacent materials. Check each window, Seal and repair deficiencies where discovered, and monitor- repair if necessary in the future. The condition voids manufacturer warranty in most cases. Presence & or extent of moisture damage & fungus in the wall void below & adjacent these areas is undetermined.

↑ Alarm holes at the lower portion of the window may void manufacturer warranty; ** recommended method

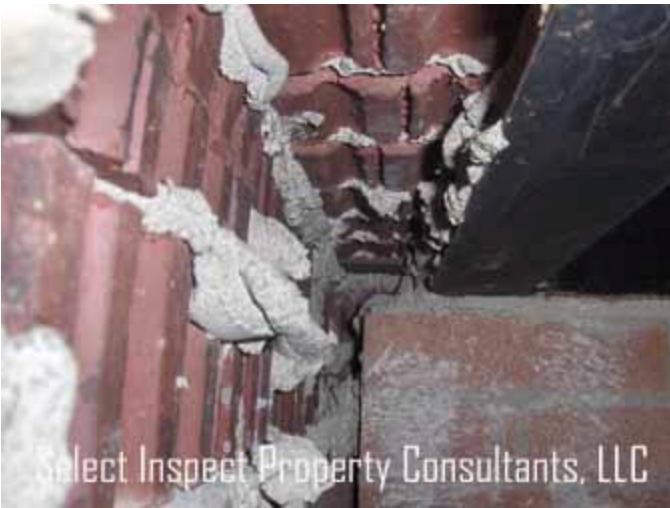
- The lintel & or smoke shelf is not sealed appropriately and may present a fire hazard. Repair is recommended.

↑ inadequate seal at fireplace lintel/smoke shelf

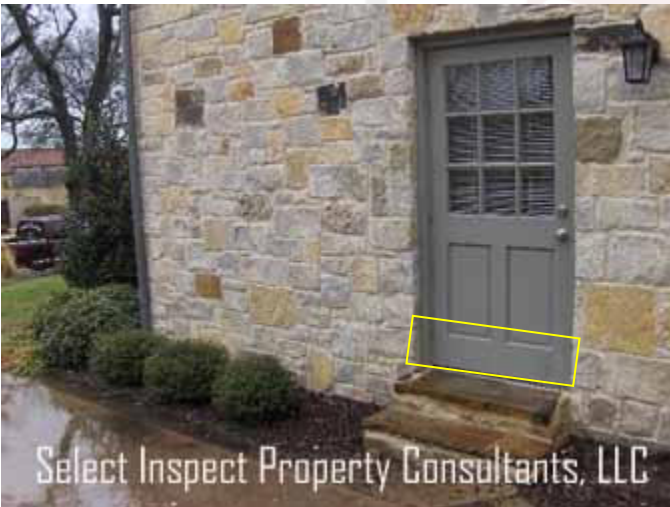
↑ exterior door damage

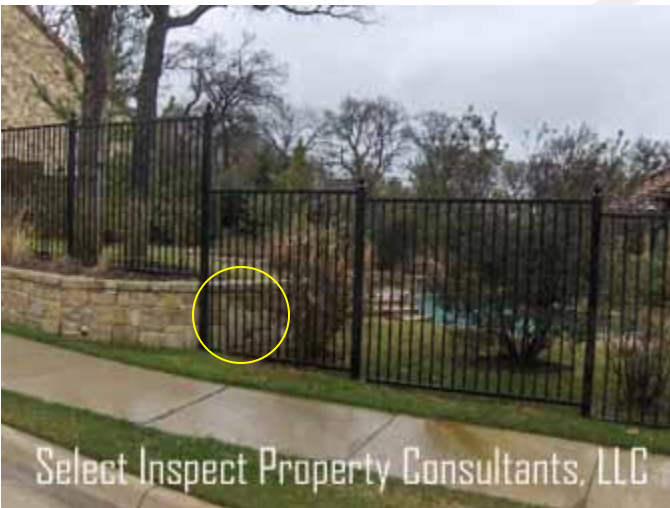
- Drain system should be present behind the retaining wall at the east; ports were seen, though may not be adequate as some wall stress was indicated by stone & mortar cracks & loose stones.

↑ loosely secured stone & example location of retaining wall cracks

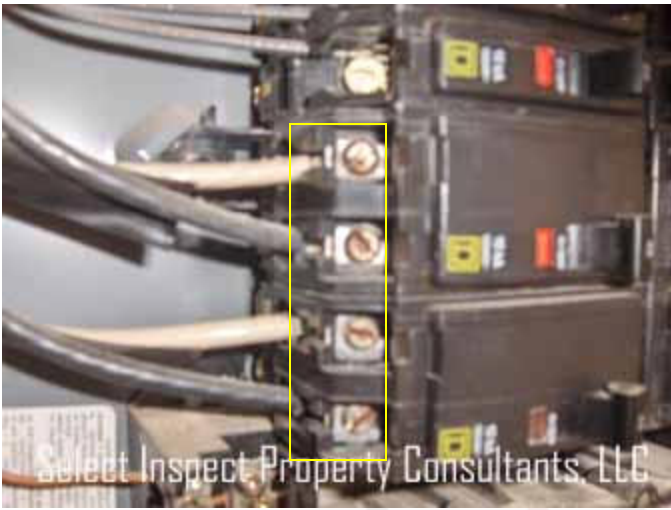
- Corrosion was noted at conductors & terminal component(s) in the right side panel; Consult an electrician to examine all electrical components at the property and provide options for correction prior to closing.

↑ moisture evidence/corrosion at electrical component(s); right panel

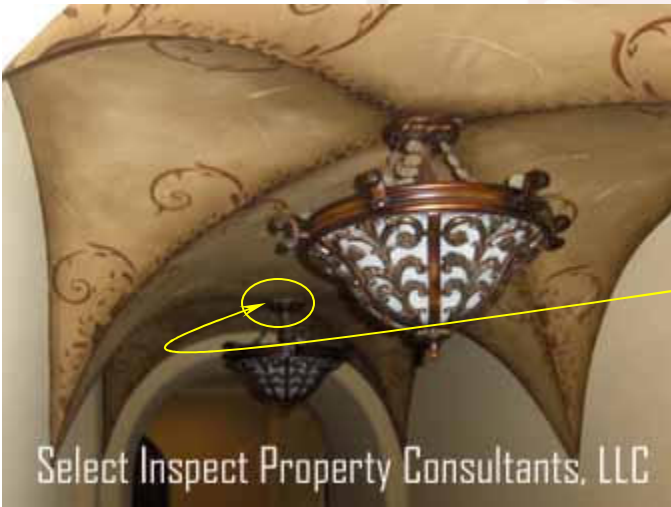
↑ excess reveal; example at gallery lights

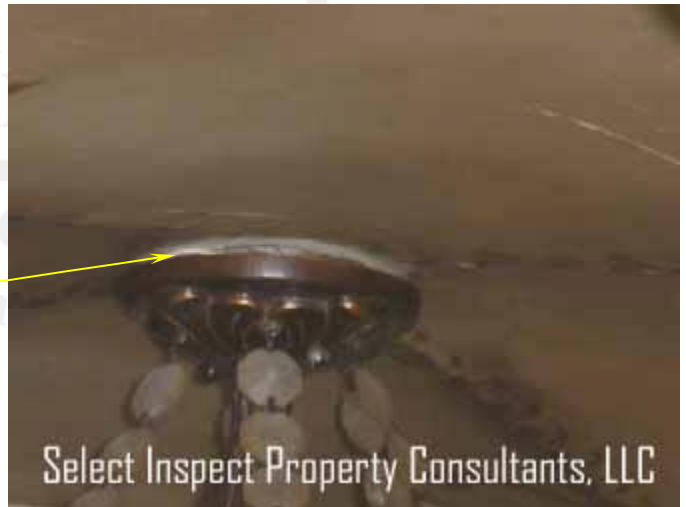
↑ close view of image at left; may be inadequately secured

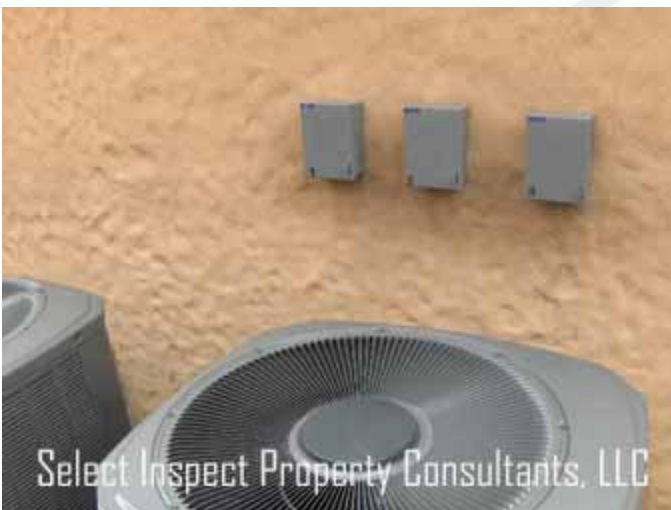
- The electrical disconnect panels for the air conditioner condenser unit(s) did not meet recommended clearance; the disconnect is considered a service panel and requires 30" lateral clearance and 36" front clearance from grade up to six feet in height. Disconnecting means shall be located within sight and readily accessible from the air conditioning or refrigeration equipment. Immediate repair needs may be subjective, and may be cost prohibitive pending your level of concern. This is mostly an access inconvenience for service personnel & not a safety hazard or urgent condition.

↑ incorrect location of air conditioning condenser(s) service disconnect

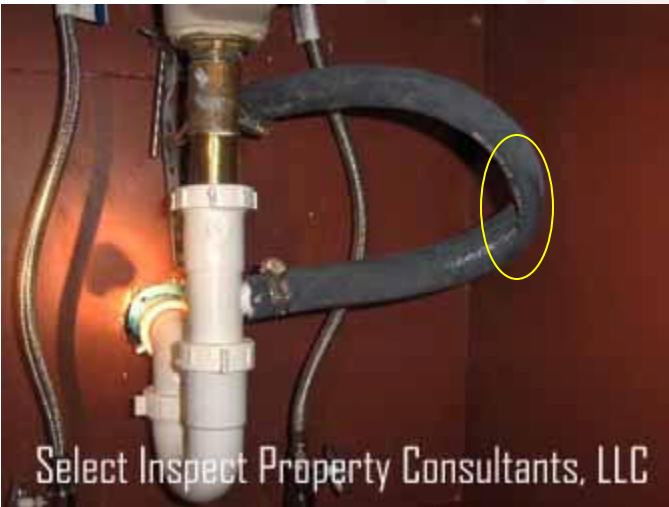
- The primary condensate lines were crimped at / near the drain connection below the split bath sink(s). This is conducive to congestion and potential failure of the air-conditioner drain system. Improvement / repair should be simple and is recommended.

↑ crimped condensate drain is prone to failure; split bath

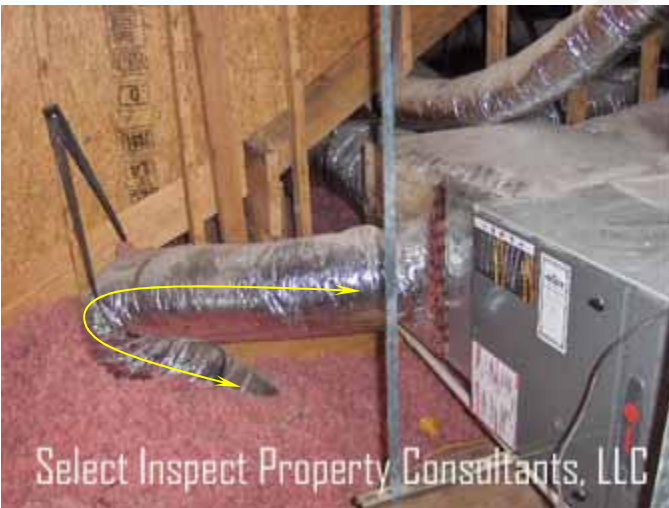
↑ crimped air ducting; example

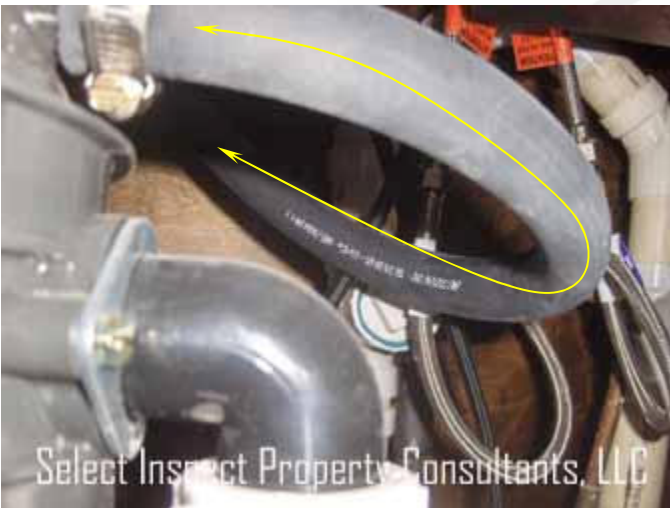
↑ drain for the dishwasher was improperly routed uphill; this should gravity drain from the backflow device

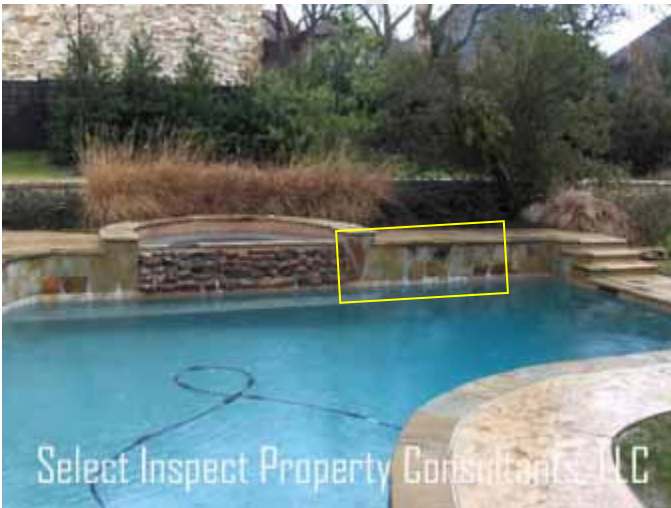
↑ thin cracks & efflorescent noted at pool wall; Significant issues were not discovered; monitor & maintain.
