Select Inspect

New Home Punch-out Inspection

at: **12345 YourStreet; Frisco, TX 75035**

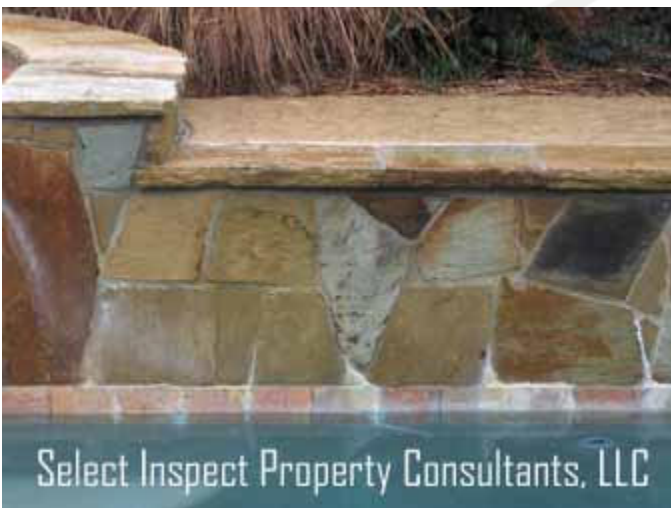
↑ close view of image above
