Select Inspect
Property Consultants, LLC

New Home Punch-out Inspection

at: 123 street; McKinney, TX 75070

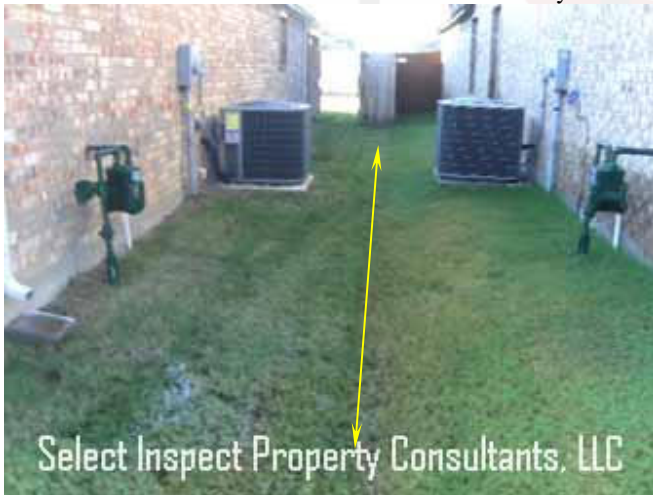
- ✦ Swale areas do not appear to properly direct water offsite at the west. This often promotes poor drainage conditions that would be conducive to foundation movement and wood destroying insect/pest activity. Modifying and compacting swales or installing area drains to properly direct water to an appropriate offsite location necessary.

↑ pooling water at west swale; Monitor; should drain within 48 hours of rain

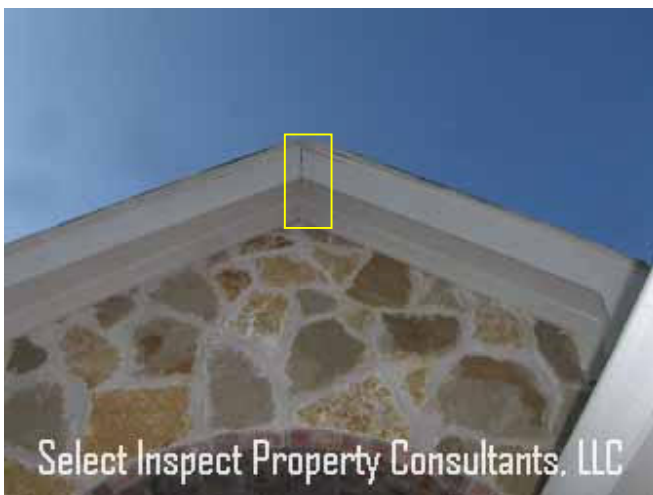
- Frieze-board separation noted at the northwest & front porch.
- Separation of the garage door frame from adjacent siding/brick was noted. This is common, though it does indicate some foundation movement has occurred. Separations were approximately 1/8 of an inch at the time of inspection. Monitor, and if the cracks grow, you should consider having a specialist examine the area.

↑ frieze-board separation at front porch gable

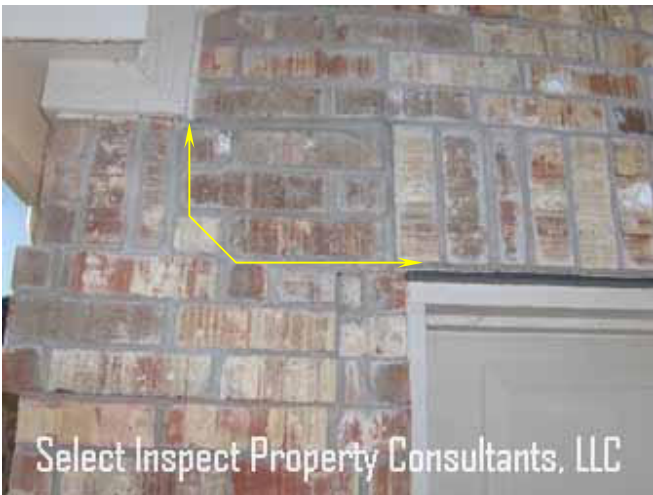
- Mortar cracks noted at the garage northeast.
- Drywall crack noted at the wall of the family room adjacent the bedroom hall & ceiling of the northeast bedroom.

↑ mortar cracks at garage left

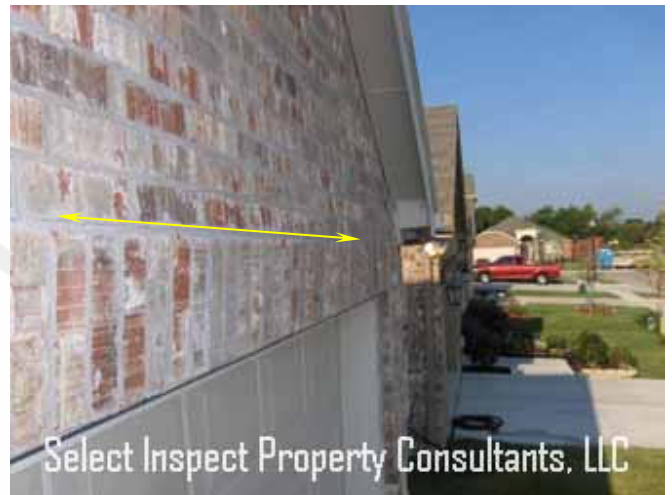
The steel lintel at the garage appeared to be deflected slightly; possibly from the brick load above. Brick and mortar cracks were observed above the overhead door. This condition appeared to be slight structural steel deflection, but not foundation related. Monitor this item periodically and repair if / when needed. In the limited time the inspector is at the home, it is difficult to determine whether the conditions are ongoing, have recently occurred, or at what time in the past they were active. We recommend that you observe the area(s) over time. If issues are discovered, you should contact a specialist to examine the situation, and prescribe options for permanent repair.

↑ sag/mortar cracks at garage overhead door

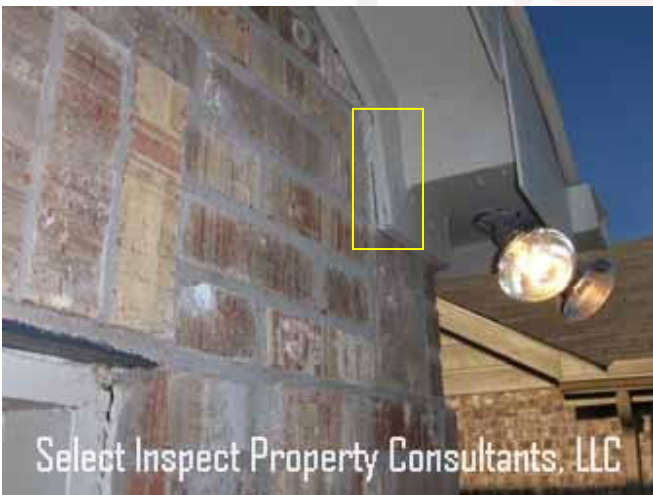
↑ frieze-board separation at northwest/garage

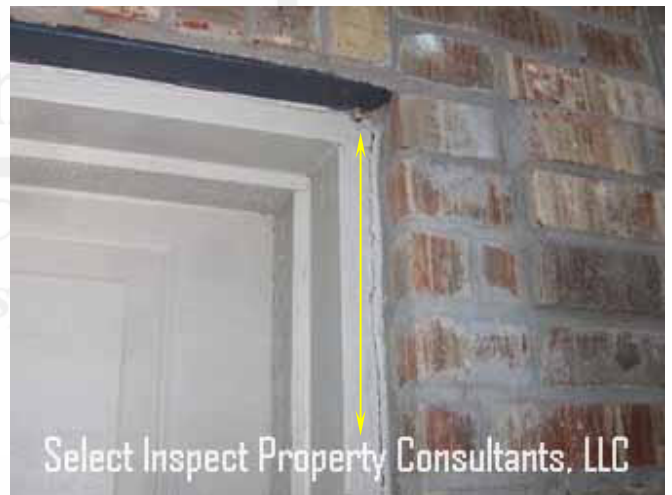
↑ garage overhead door frame separation at right

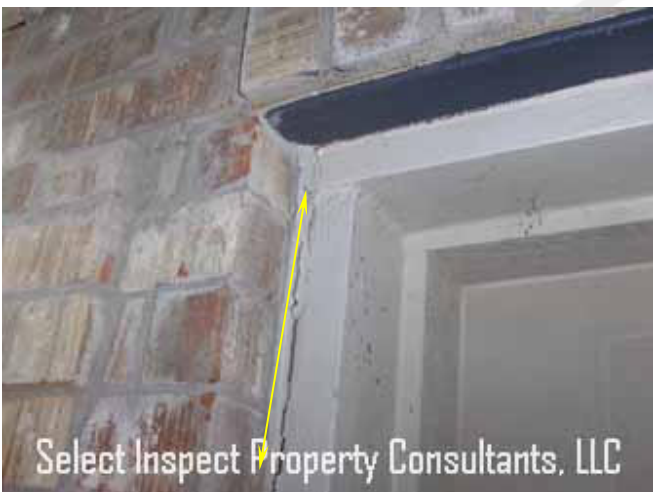
↑ garage overhead door frame separation at left

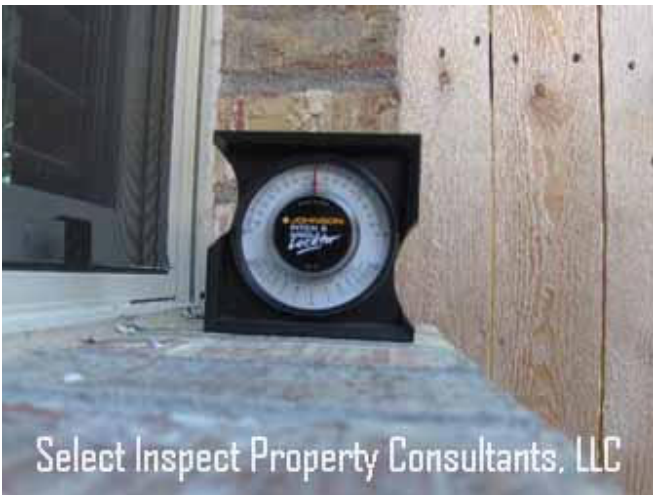
Exterior window sills did not have a recommended 15° slope for drainage at multiple locations; slope at random locations was approximately 1-5° Condition & appropriateness of flashing & substrate components is undetermined at locations other than visible open sections around the master bathroom window.

↑ brick ledge(s) had inadequate slope; example

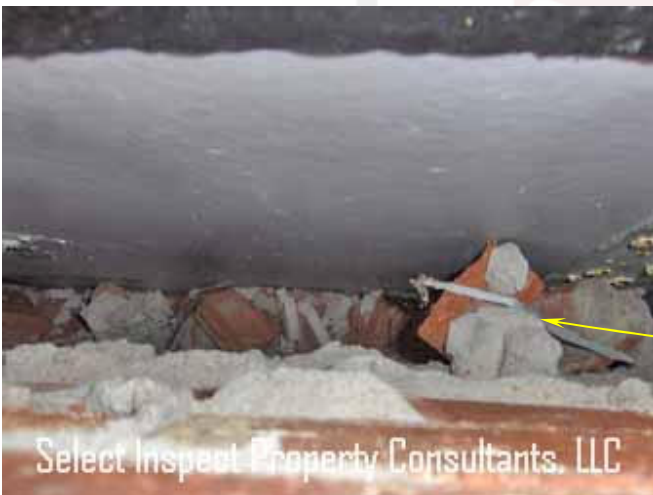
Mortar and debris was noted between the exterior brick veneer and wall structure; this will impede designed drainage of condensate within the wall void.

↑ debris in wall void

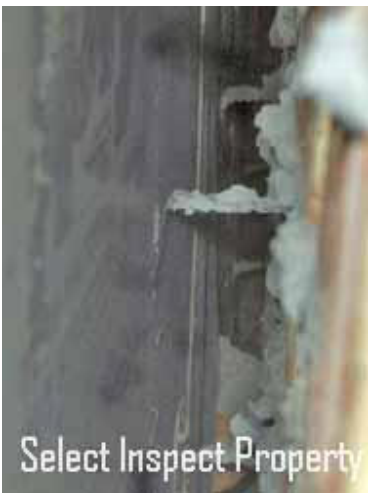
↑ debris in wall void

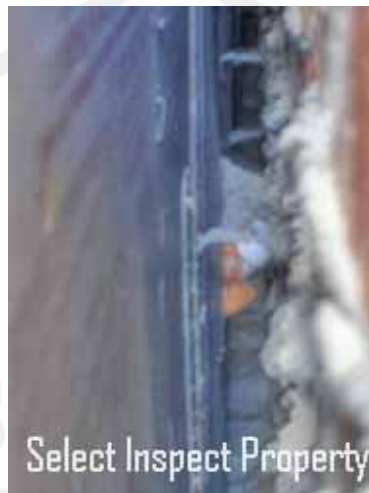
↑ debris in wall void

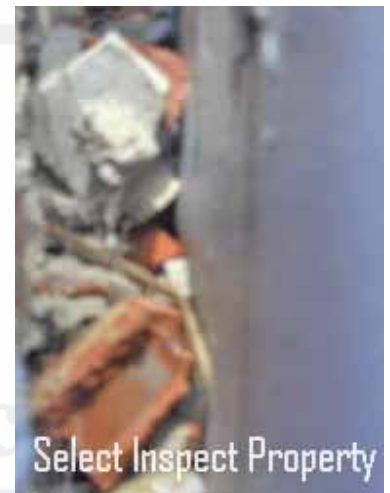
↑ debris in wall void

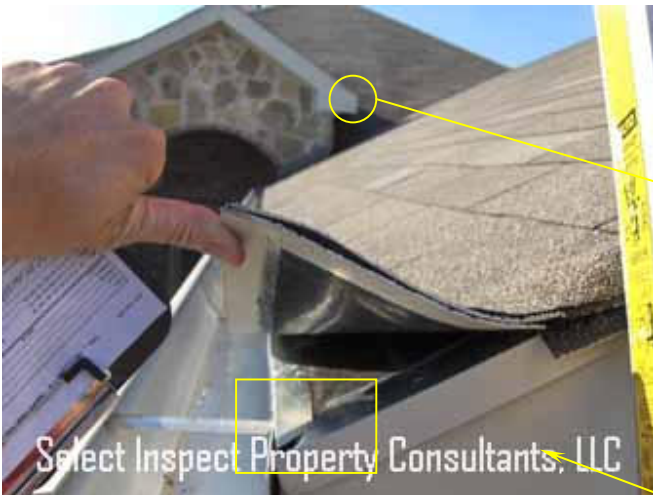
↑ unworkmanlike drip edge/felt; corners should have no gaps & rake (diagonal) edge & roof felt should be atop the eave (lower) edge flashing

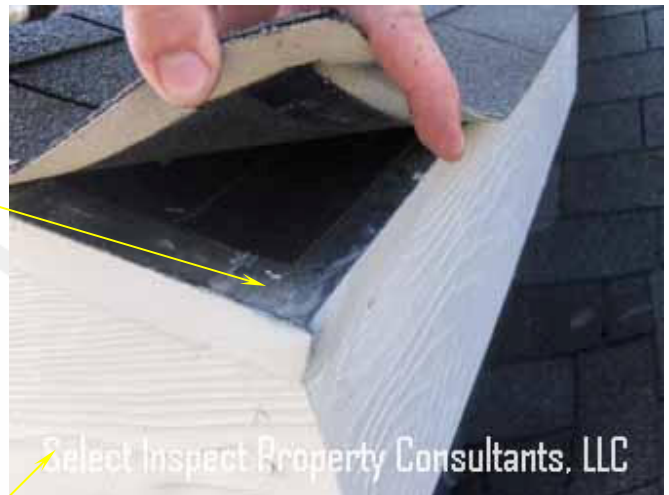
↑ unworkmanlike drip edge flashing at front gable

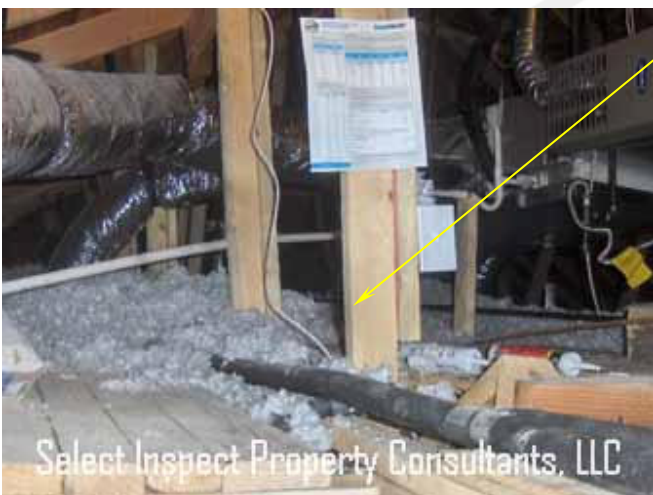
↑ there should be a minimum 24" pathway to the HVAC from the top of the access, with no gaps or obstructions

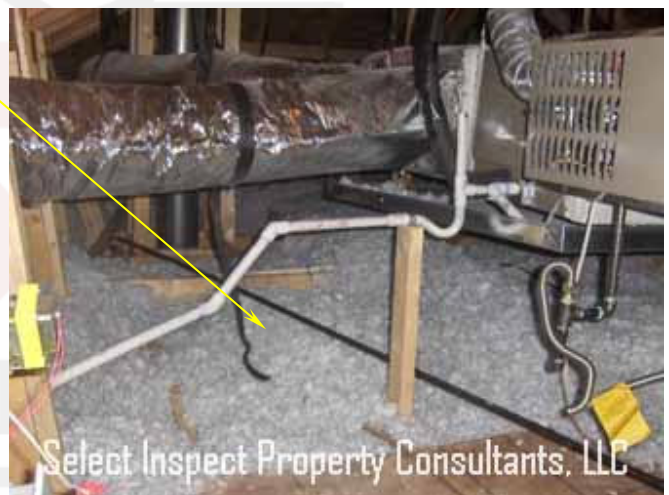
↑ 30" unobstructed service area was amiss at the HVAC

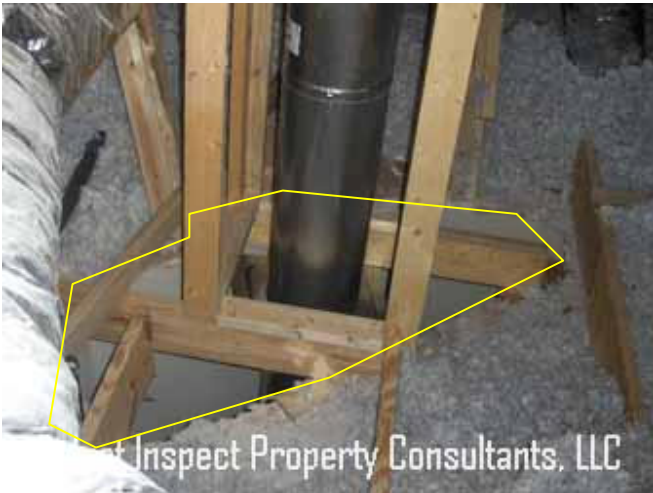
- ✦ Proper firestopping provisions were not present or are amiss in the attic area surrounding the metal flue. Consult a chimney/fireplace repair specialist for options.

↑ fire-blocking was amiss/deficient at the fireplace flue/chase

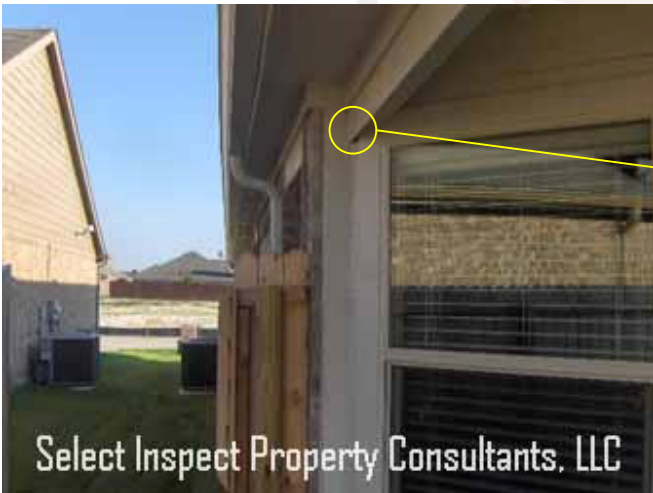
↑ opening exists at rear porch

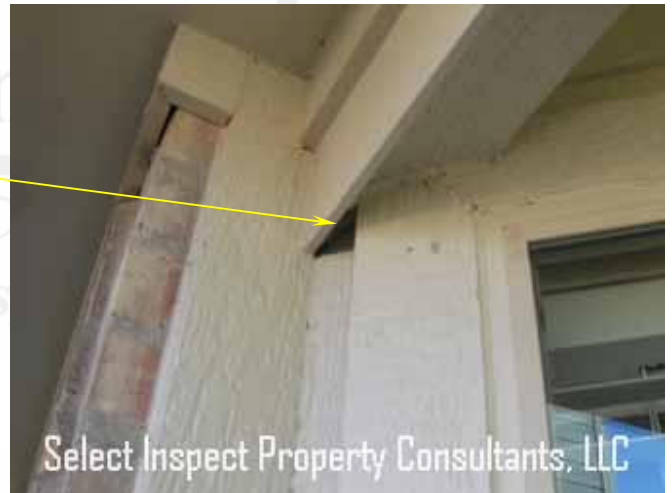
↑ close view of image at left

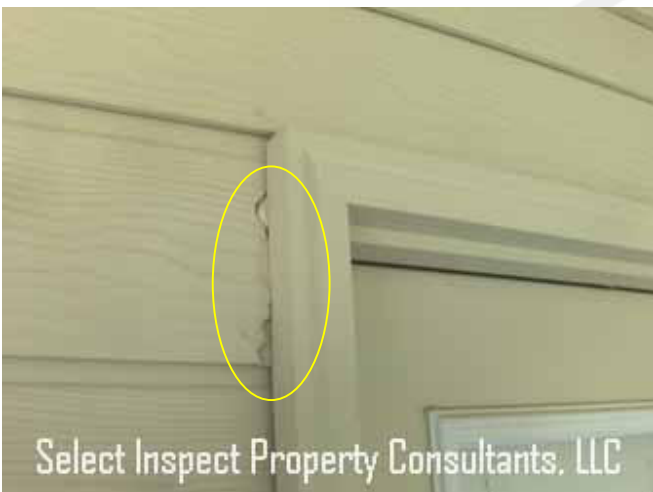
↑ damaged siding at rear porch door area

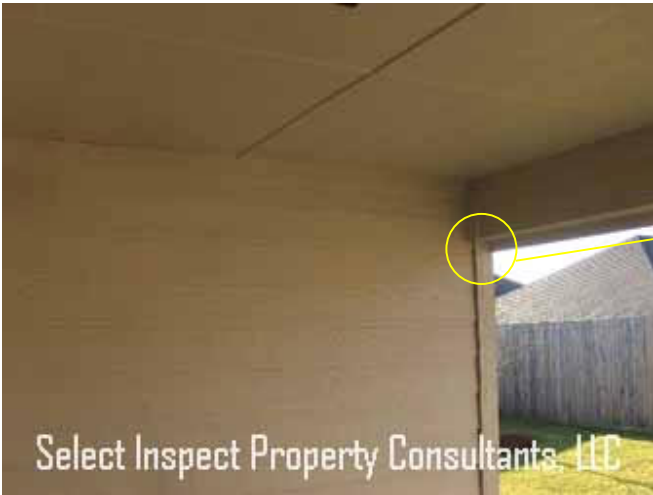
↑ opening & short cut siding exist at rear porch

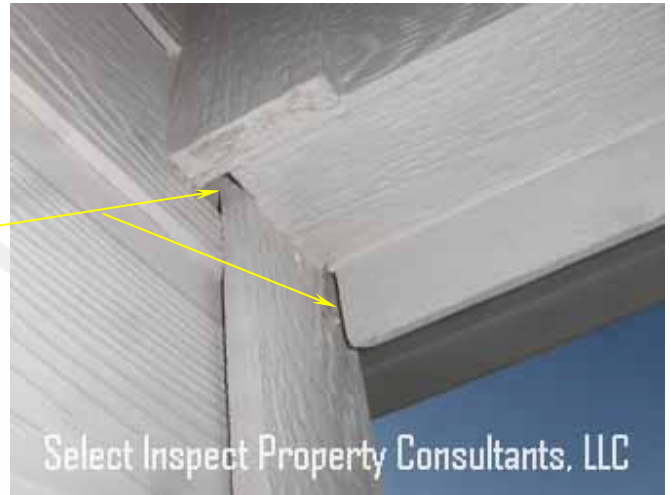
↑ close view of image at left

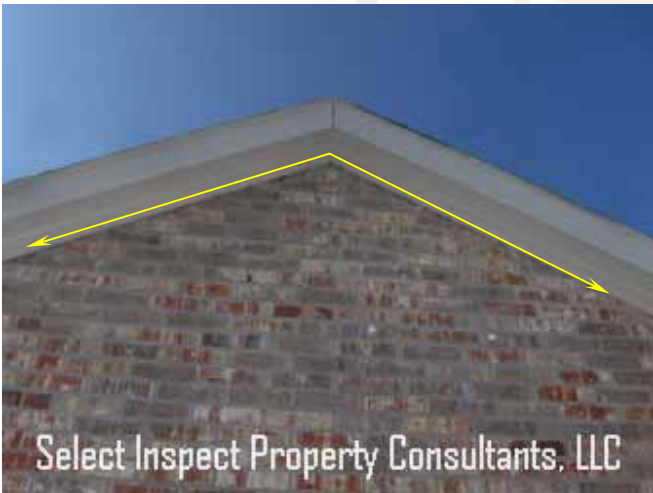
↑ short brick/openings exist; garage

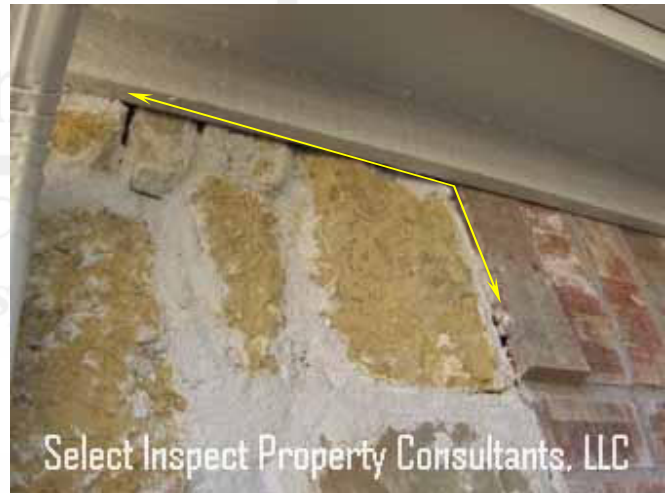
↑ short brick/stone; openings exist; northeast bedroom/front porch

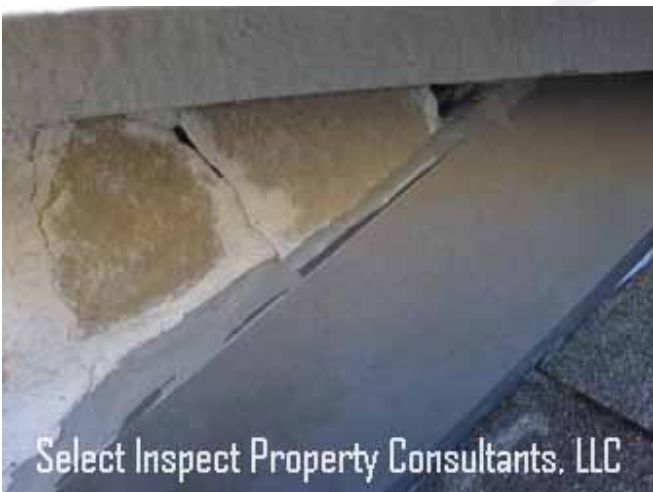
↑ openings & mortar cracks; front porch under right eave

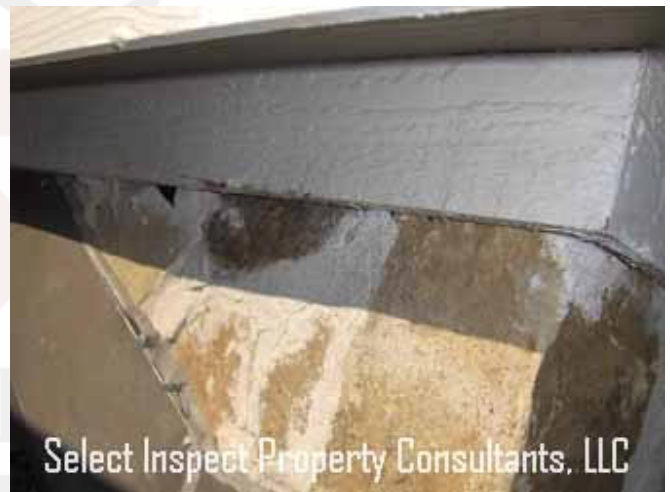
↑ openings & mortar cracks; front porch under left eave

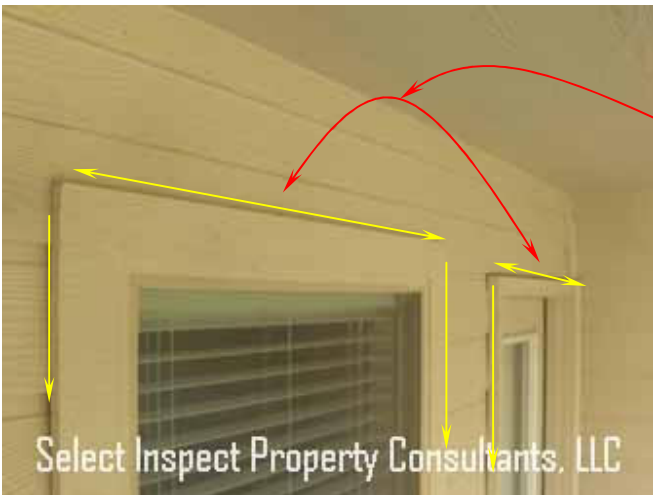
- “Z” flashing was not present, not visible, or deficient above siding clad doors & windows. This is recommended to direct water out and away from the interior substrate/envelope.
- Exterior lights should be properly sealed to prevent moisture intrusion and related corrosion / overheating possibilities of the electrical components. NEC 410-4 & IRC E3905.
- Recommend caulking vertical siding / trim joints.
- Windows need caulk touch-up / repair at exterior perimeters
- Openings exist; Stone & brick was not adequately finished/trim was short cut or otherwise did not adequately cover at multiple locations including front porch gable, garage gable, northeast bedroom, rear porch
- Chimney was incomplete; sealant & paint remain needed.

↑ missing z-flashing; example locations & unsealed trim/siding joints

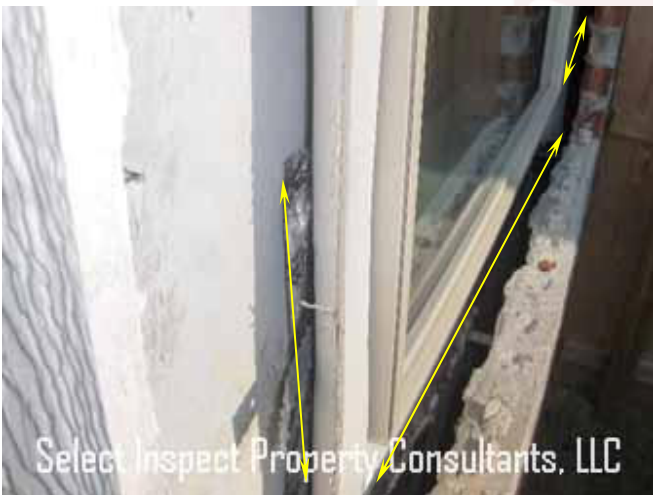
Tape-seal at window master bathroom was deficient; seen around the master bathroom window, where the wall veneer was not present.

↑ deficient window tape seal needs replacement

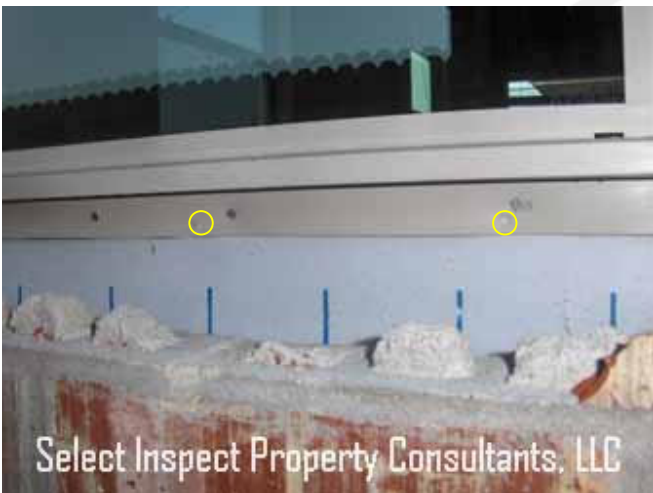
- Exposed master bathroom window was not nailed in accordance with manufacturer specifications; manufacturer nail holes were not used & cracks may occur; suspect similar conditions may exist at other (concealed) window locations.
- Master bathroom was inadequate at the exposed master bathroom window; suspect similar conditions may exist at other (concealed) window flashing.
- NOTE: Some windows were partially inspected or had limited access, due to furnishings, lighting conditions, window treatments, etc. Some conditions may remain undetermined.

↑ unworkmanlike nailing of windows; example; suspected most/all other windows also incorrect.

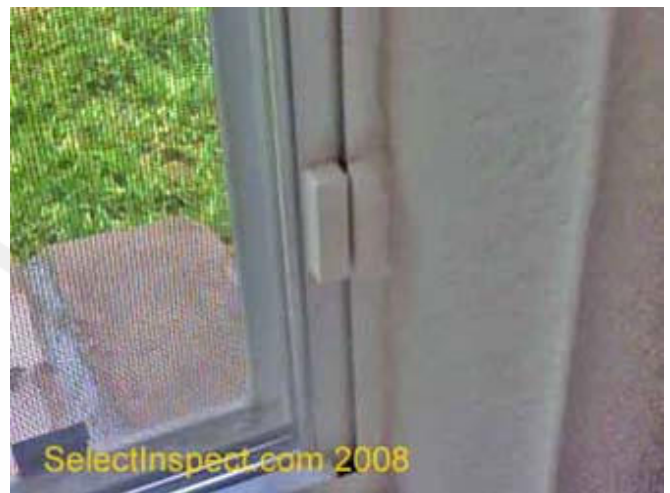
↑ Alarm holes at the lower portion of the window void manufacturer warranty; ** recommended method

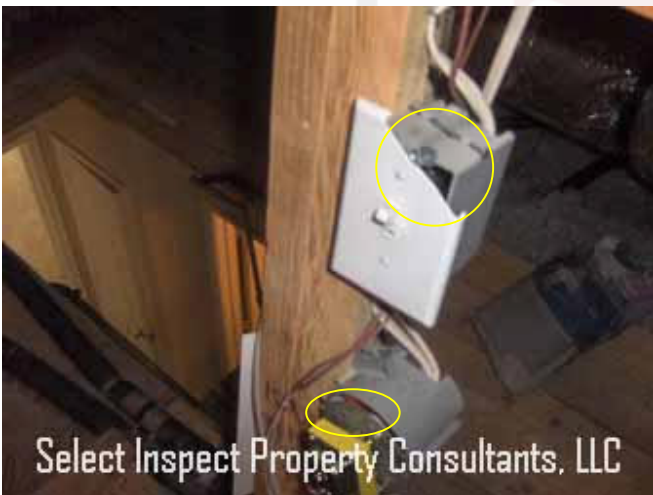
↑ damaged switch cover & excess reveal at junction box; attic

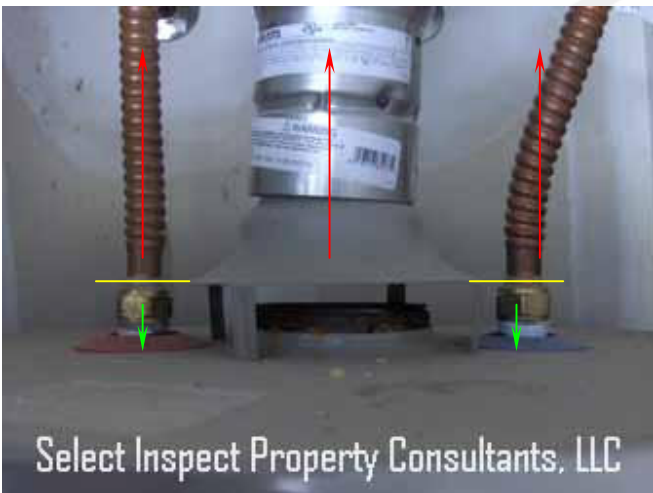
↑ electrical bond was not continuous above plastic compression fittings or at flue; water heater

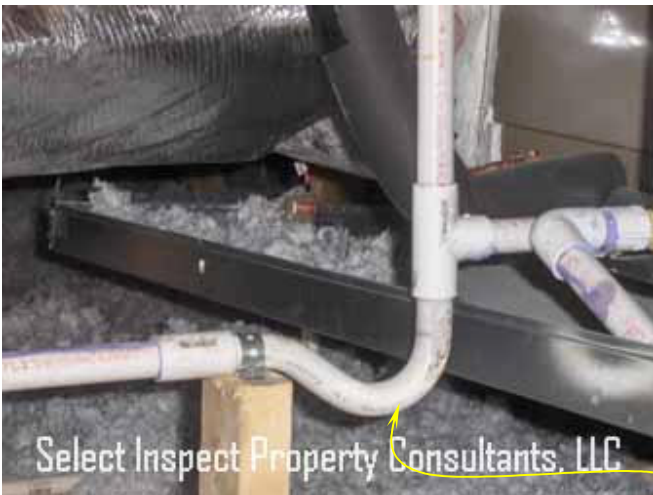
- ✦ Condensate lines were not adequately insulated: Mildew and or accumulation of moisture was noted as present on or below the primary condensate line(s), and / or staining present at attic components below the traps. This may be prone to related moisture damage to attic flooring, insulation, drywall, and other attic / interior building components. Recommend addition of appropriate insulation past the trap and related components of the primary condensate line, as deemed necessary by an HVAC specialist. After that time, monitor the system / components periodically.

↑ debris in air conditioning auxiliary pan & non-insulated primary condensate drain

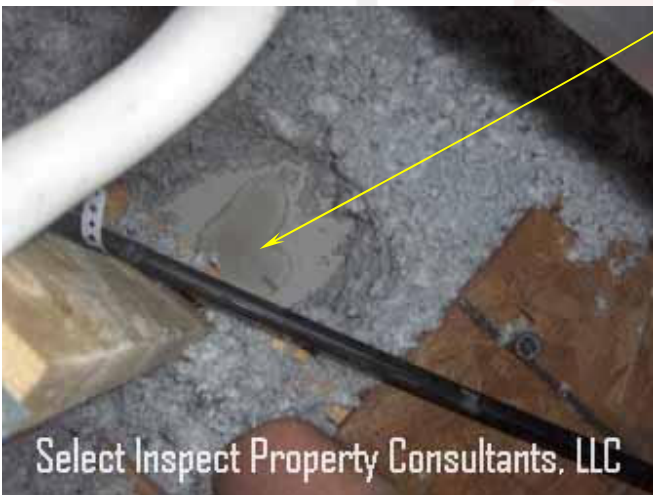
- Moisture damaged drywall noted below the air conditioning primary condensate drain trap.

↑ active condensate dripping & moisture damage at ceiling drywall below the primary condensate drain trap

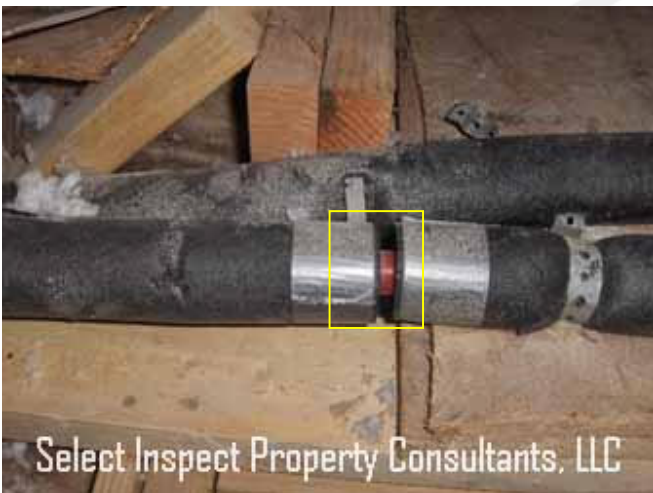
↑ inadequate insulation at hot water piping, adjacent the attic access

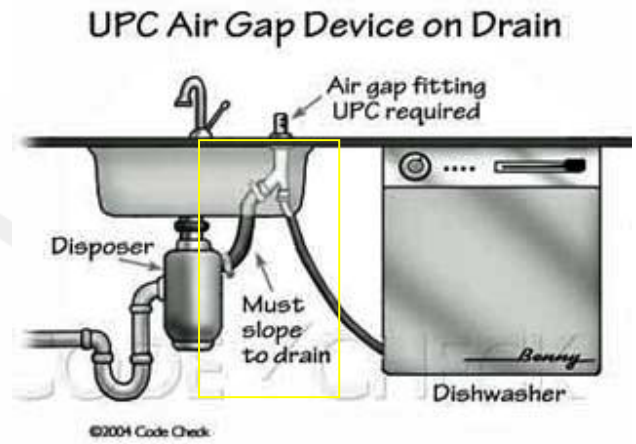
- ✦ The anti-siphon device at the dishwasher was not properly routed for gravity drainage to the disposal/drain. Correction is recommended & usually simple.

↑ drain for the dishwasher was improperly routed uphill; this should gravity drain from the backflow device

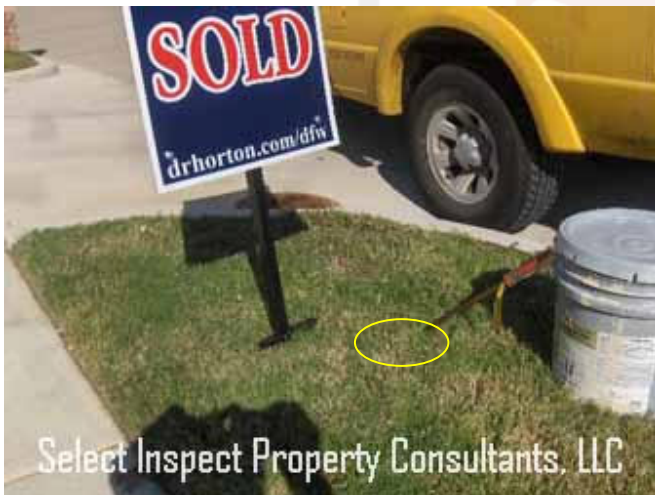
↑ irrigation tube was damaged near the driveway at this location
