Select Inspect

New Construction Phase Inspection

at: **123 New Street; McKinney, TX 75071**

Thursday, October 21, 2010

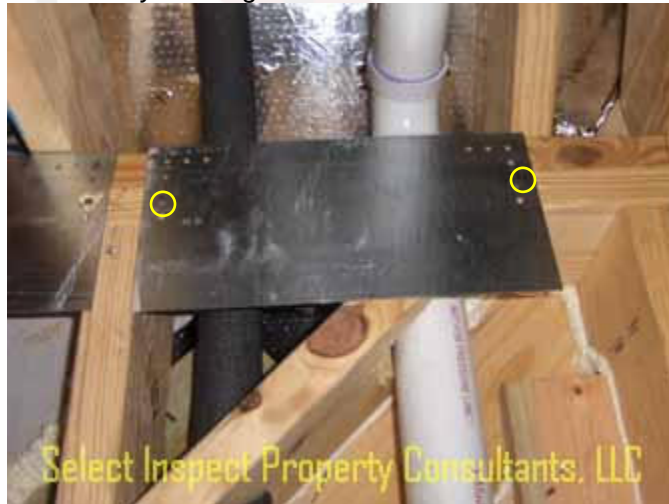
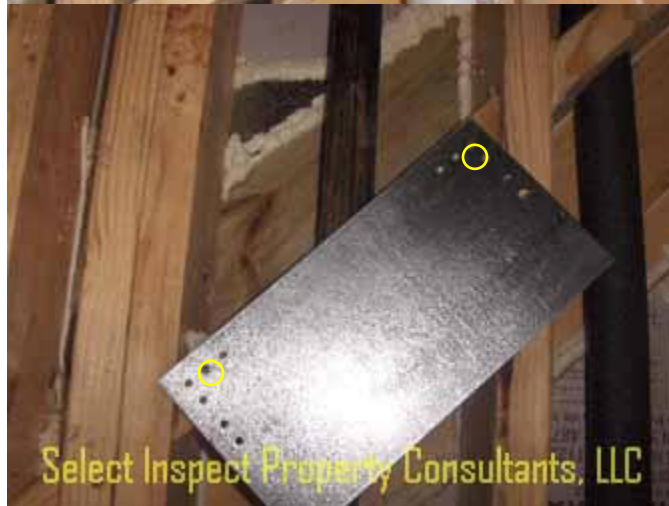
Bath 3; up east :

- Steel plates had been added by Friday morning; However, there was only one nail per side at the braces, recommend additional nailing to resist rotation / pivoting potential; *images below taken Friday morning*

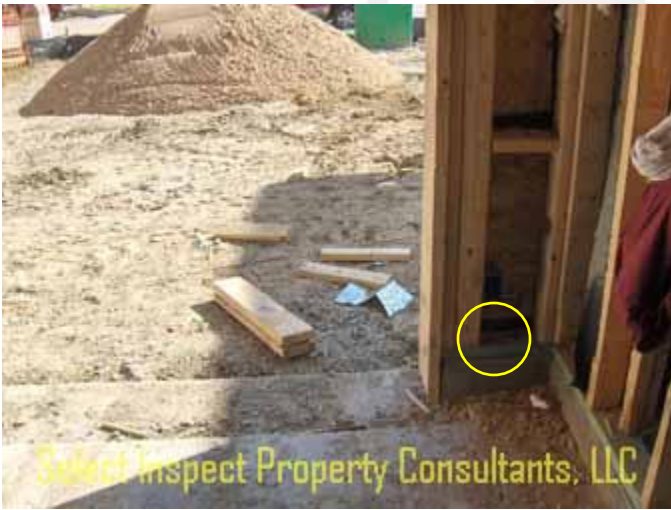
- Anchor bolt nut was missing at the single garage southeast corner.
- Unworkmanlike/bent holdown anchor at the exterior fireplace. Refer to the architect &/or manufacturer for approved correction
- Exposed post tension end(s) cap at the northwest corner should be sealed in an approved method.
- Regularly monitor the property and its components and arrange for repair if / when needed. Repairs should be made by qualified specialists whenever possible.
- Refer to your "Guide to Your Home Inspection" at the web link emailed with your report, for information regarding foundation maintenance and monitoring.

↑ missing anchor bolt nut single garage

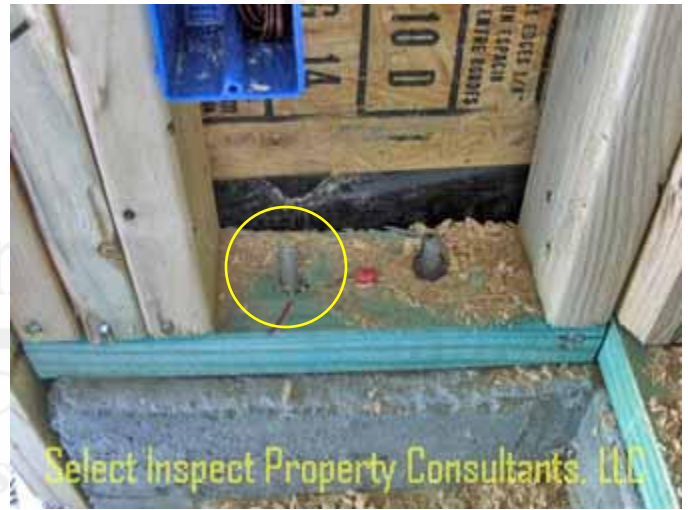
↑ close view of image at left

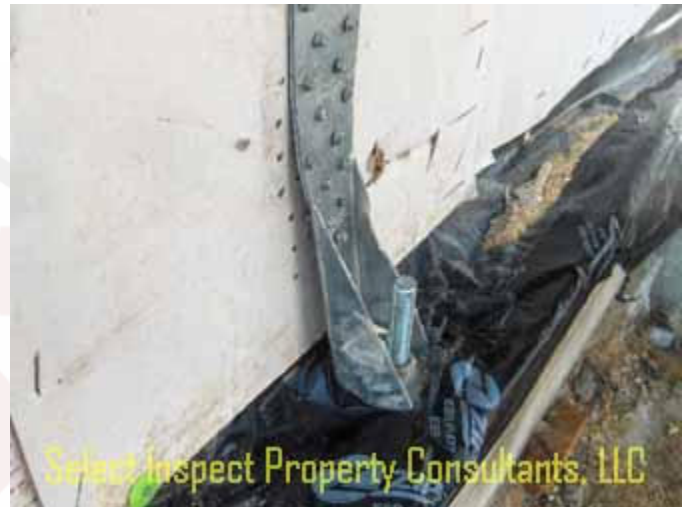
↑ close view of image at left

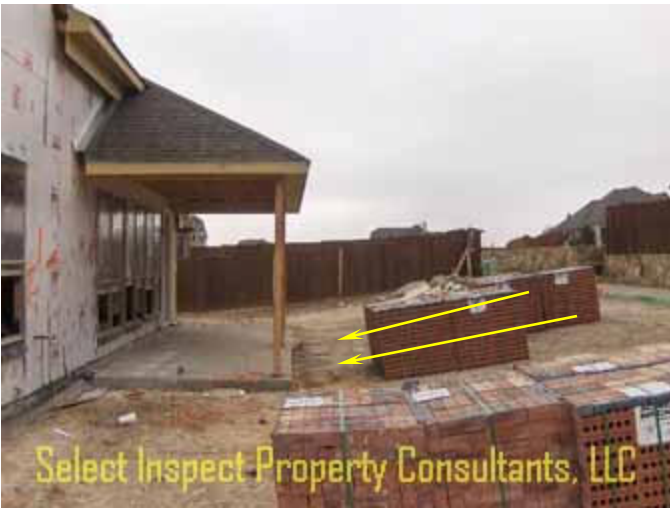
-
- Inadequate grading at the west; rear porch. Area drain should be considered; swale grading may be acceptable for drainage, though this would increase the slope of & possibly reduce effective personal use of that area of the back yard. Some form of correction is necessary.
- Form stakes & or boards should be removed from soil adjacent the structure- condition(s) discovered at the north side of two-car garage, east face of living room. This is conducive to decay and wood destroying insects; examination for wood destroying insects in related wood is recommended at the time of removal.

↑ inadequate / negative drainage at west; consider area drains

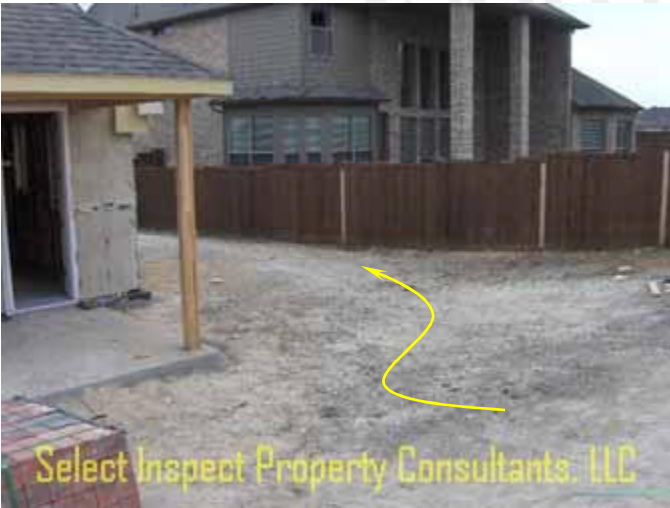
↑ swale at southwest appeared adequate

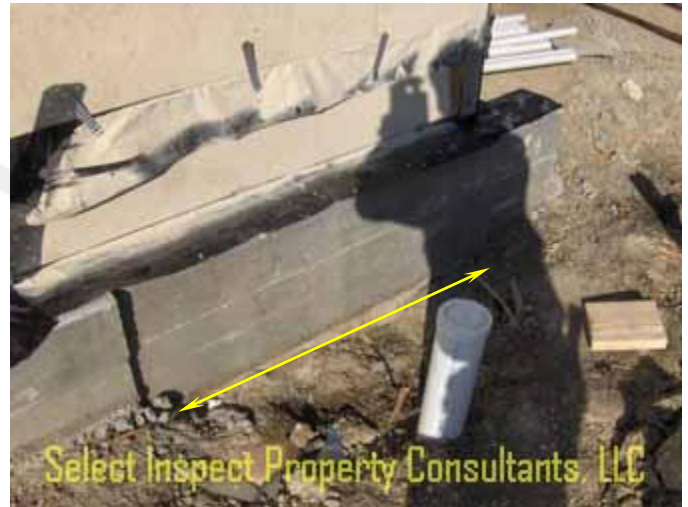
↑ form board remains at two-car garage east

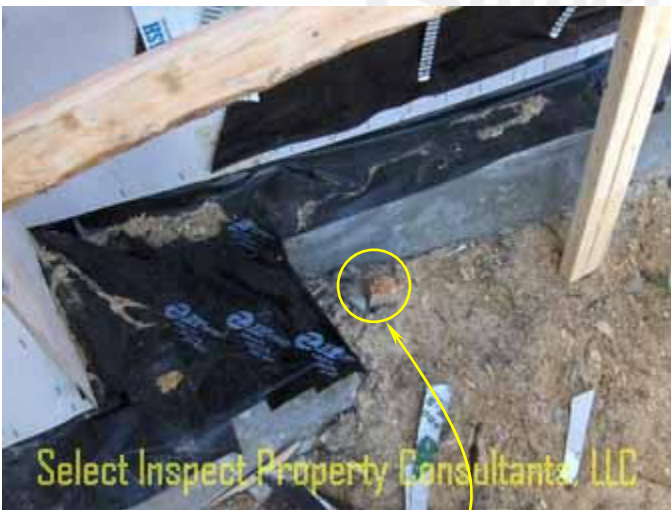
↑ form stake; living room

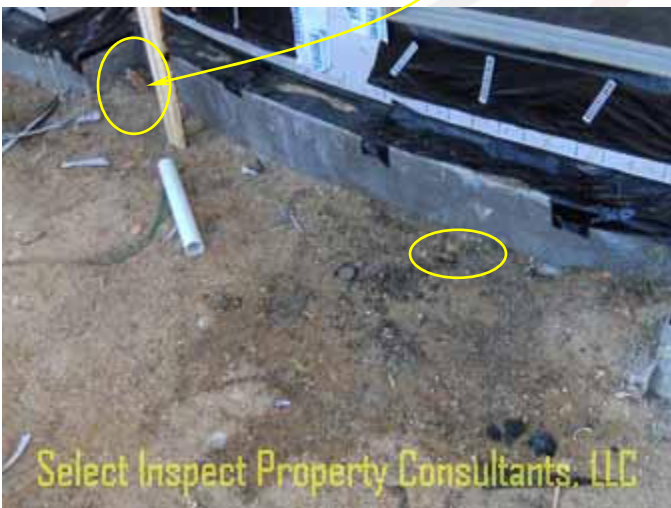
↑ form stakes; living room

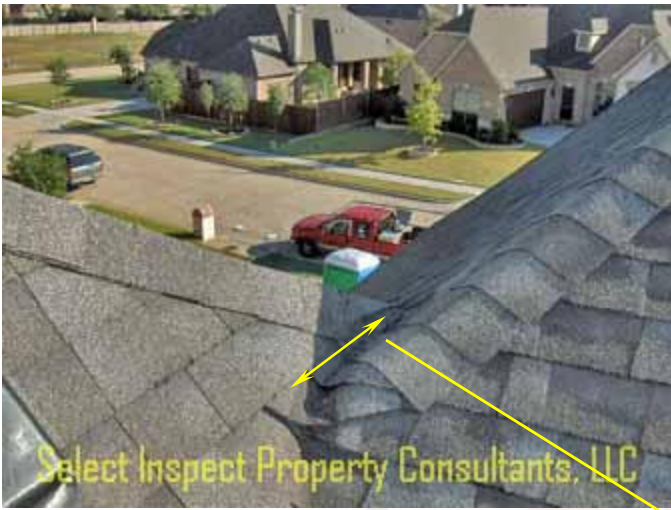
- Converging valley at the upper southeast has inadequate slope; this small section was holding water during the inspection, & will be prone to moisture intrusion *if* there is not an adequate membrane below the shingles (such could not be visually confirmed from the roof or attic). Refer to the builder for related information & have these items documented as warrantable or arrange improvement
- Toe boards should be removed; openings in the roof surface from prior use of toe boards should be sealed.
- Debris should be cleared from the roof, as to not congest gutters (installed later) & to avoid nails from washing off & being an injury risk after future rains.
- Uncaulked, exposed fasteners noted at the upper south-southeast exposure(s).
- Chimney cap not present at this phase

↑ inadequate slope at converging valley

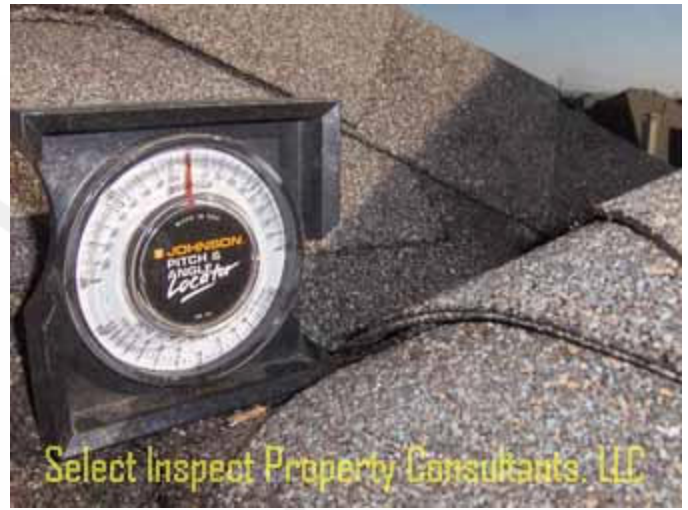
↑ less than 1 ° pitch; close view of image at left

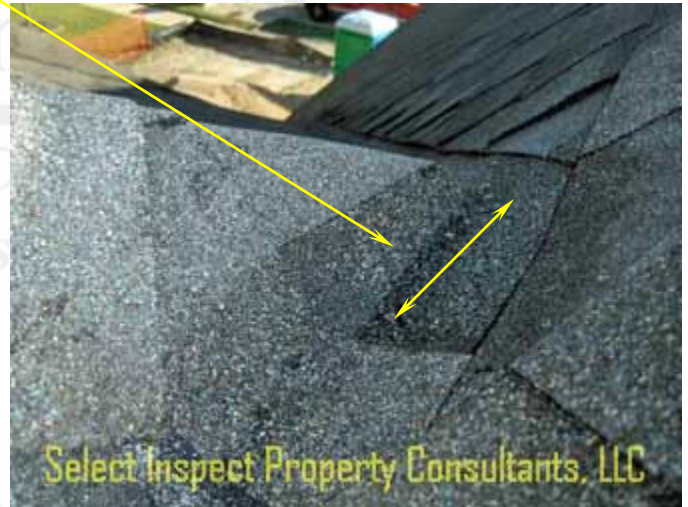
↑ moisture remains at this flat/negative section

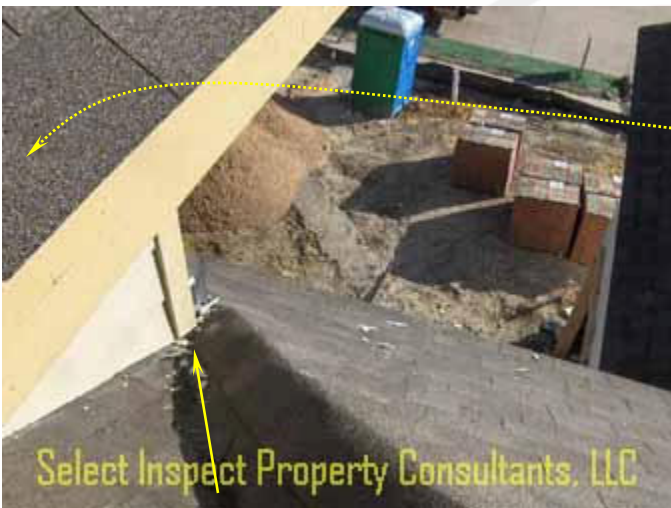
↑ debris should be cleaned from roof; example at front converging valley

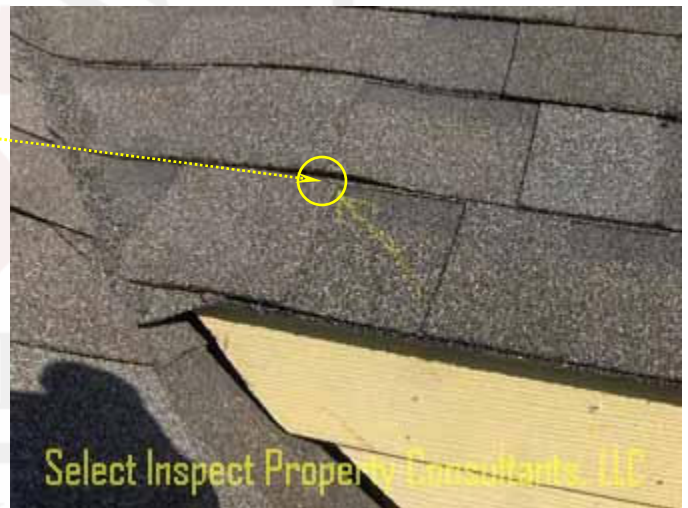
↑ uncaulked, exposed fasteners upper front

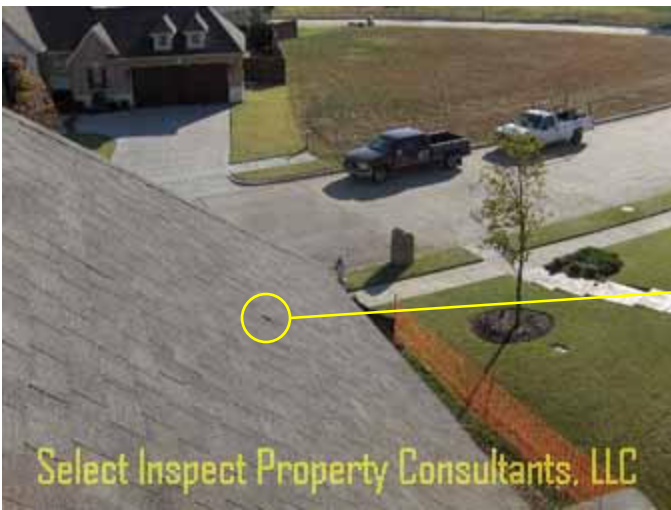
↑ undetermined damage at south-southeast roof

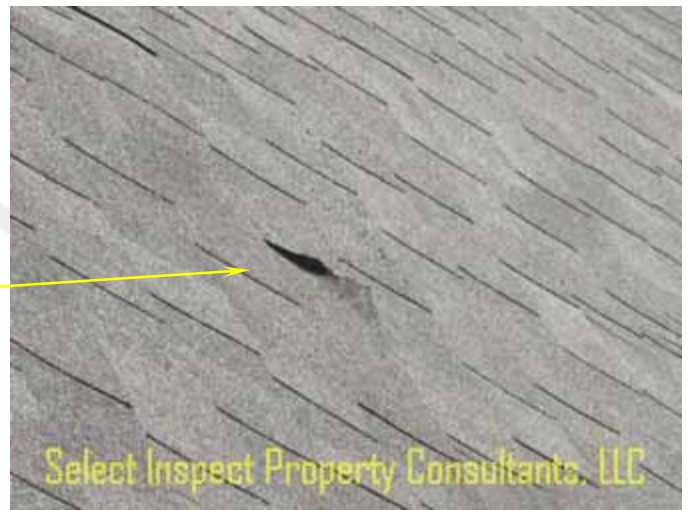
↑ close view of image at left

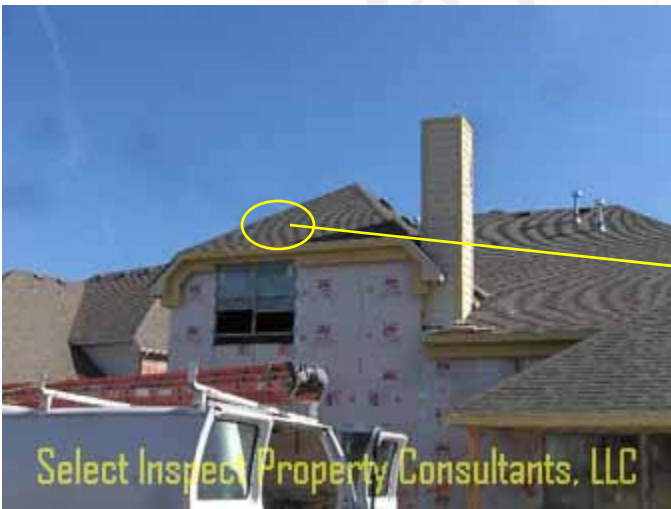
↑ undetermined debris upper west-northwest

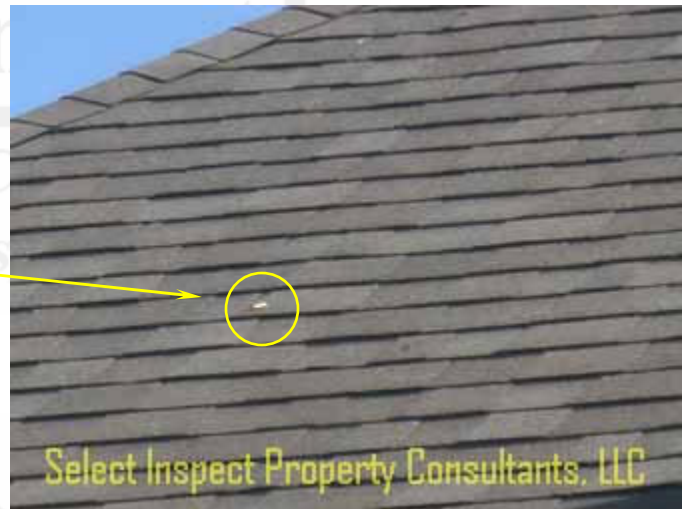
↑ close view of image at left

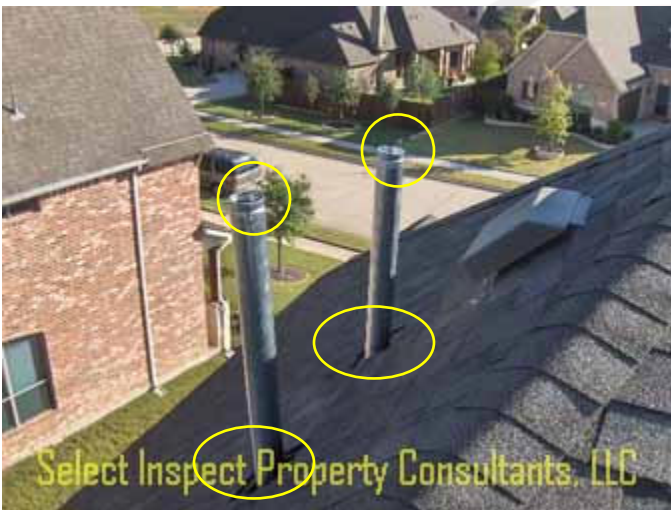
↑ flue caps & boots had been installed by Friday morning

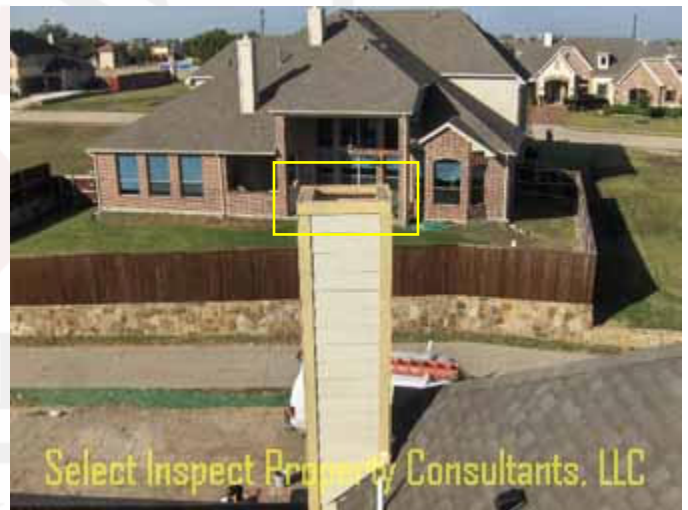
↑ chimney cap not present during the inspection

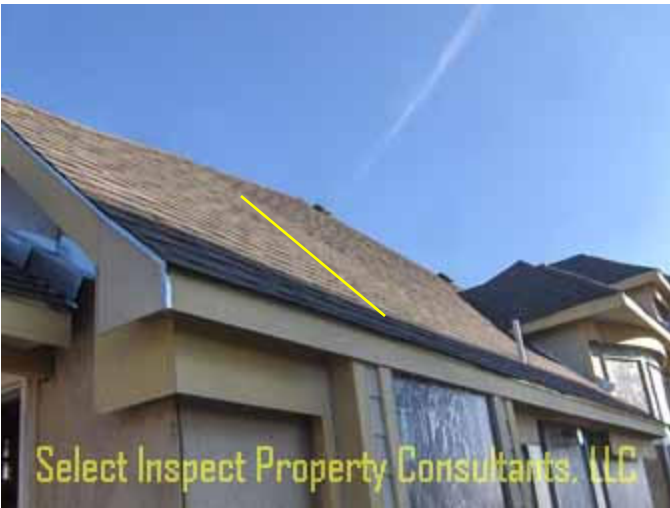
- Slight sag at roof noted above the breakfast nook; framing at the interior had no obvious deficiencies such as cracks or deflection. Monitor. Obvious/significant deficiencies were not discovered; monitor and maintain

↑ slight sag noted at breakfast nook roof; issues not discovered at interior/framing

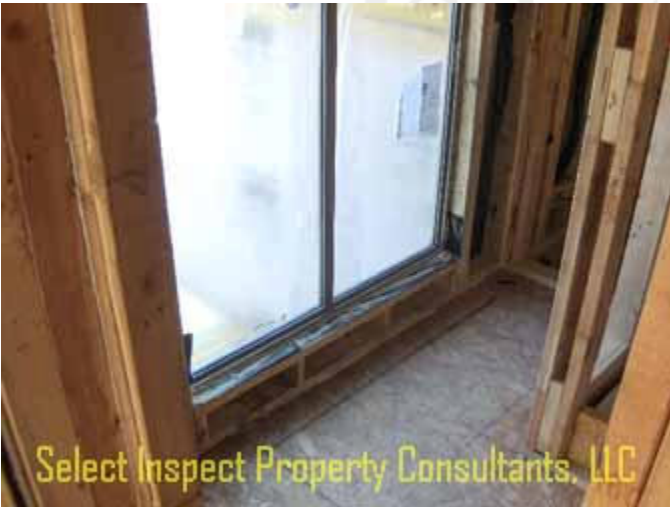
↑ low window at east bedroom closet; safety advisory, depending on intended use

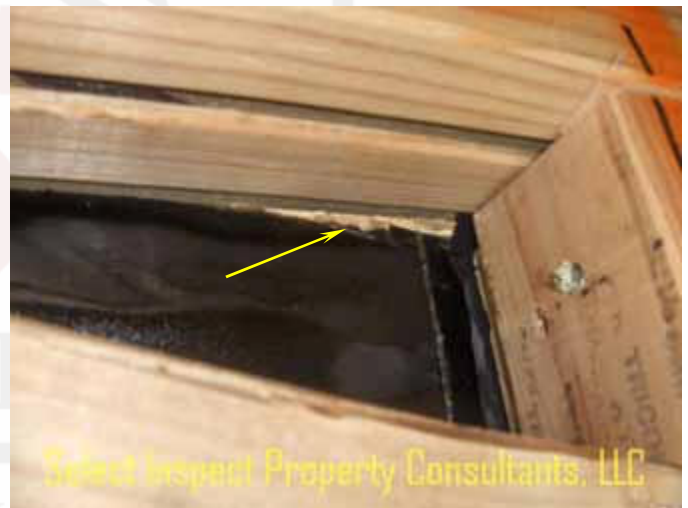
↑ close view of image at left

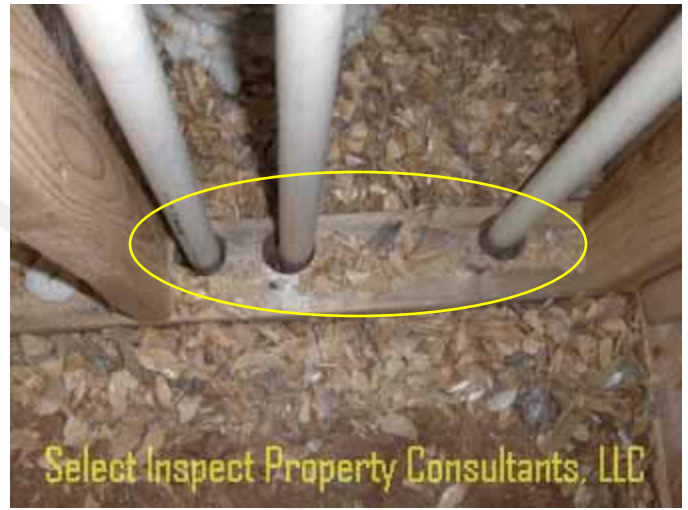
↑ sealant needed; example; bottom of pic at left

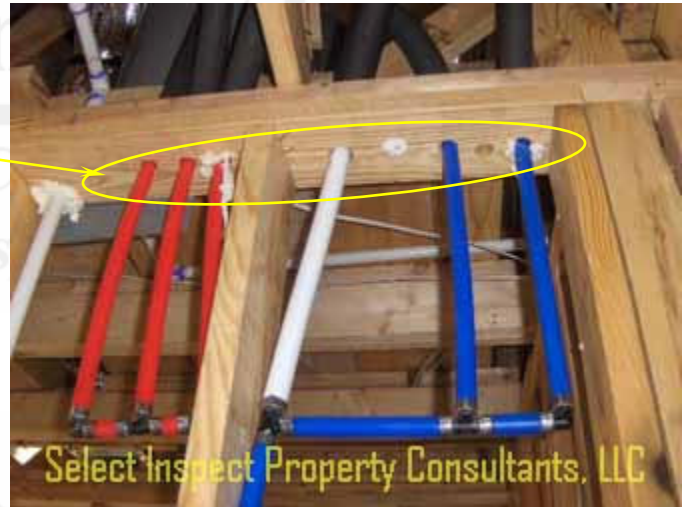
↑ close view of image at left

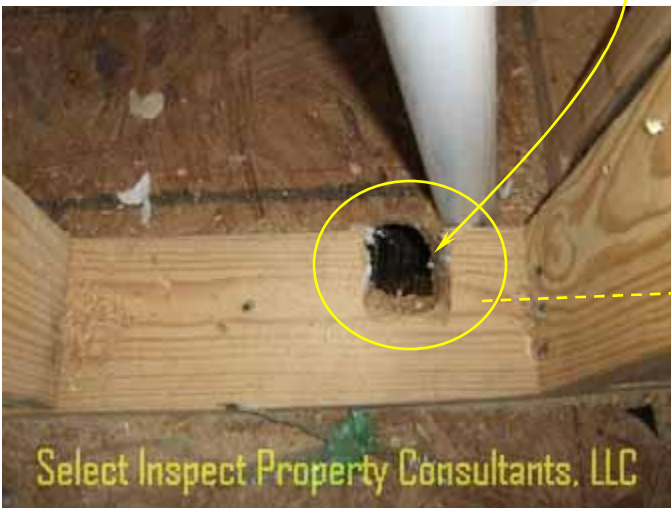
- Sealant & steel brace needed at openings at electrical & or plumbing penetrations through ceiling/floor/wall framing at the northeast closet/chase upstairs.

↑ sealant & bracing needed; close view of image above; Thursday

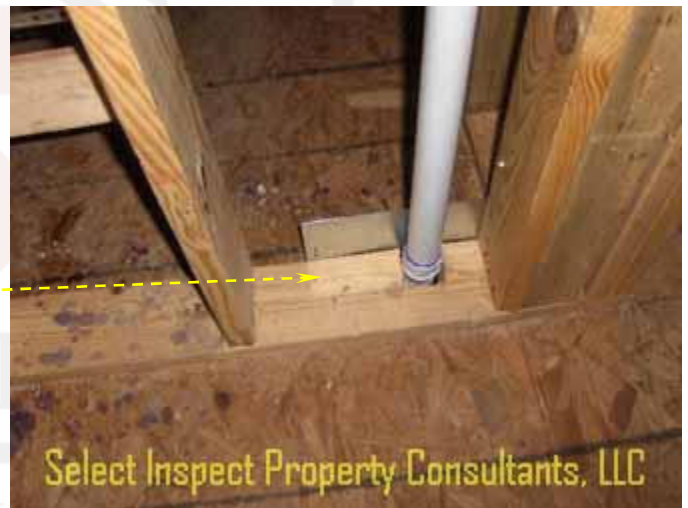
↑ sealant still needed; pipe & steel plate had been added as of Friday morning

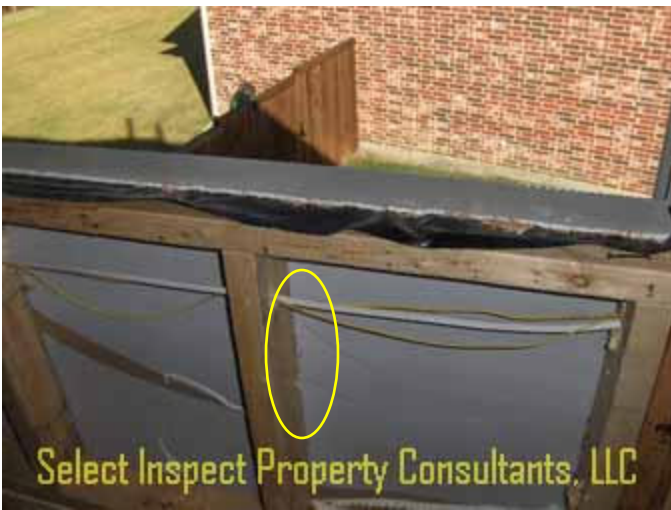
↑ sealant needed; example; north bedroom

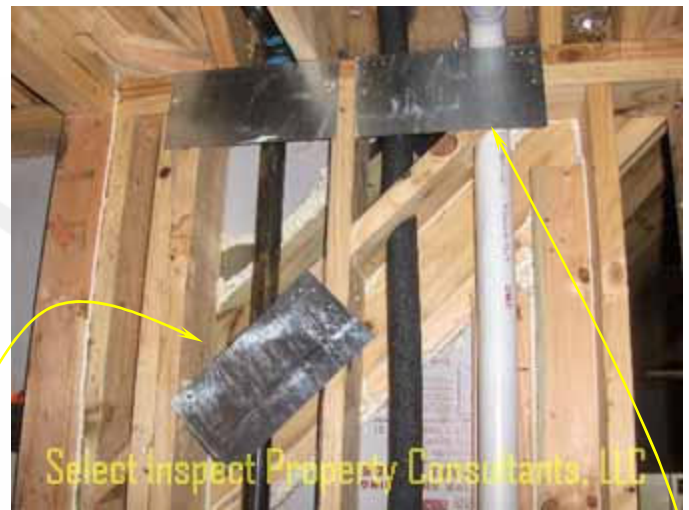
plates had been added as of Friday morning; see text above in the *Interior Structure* section; pg 5

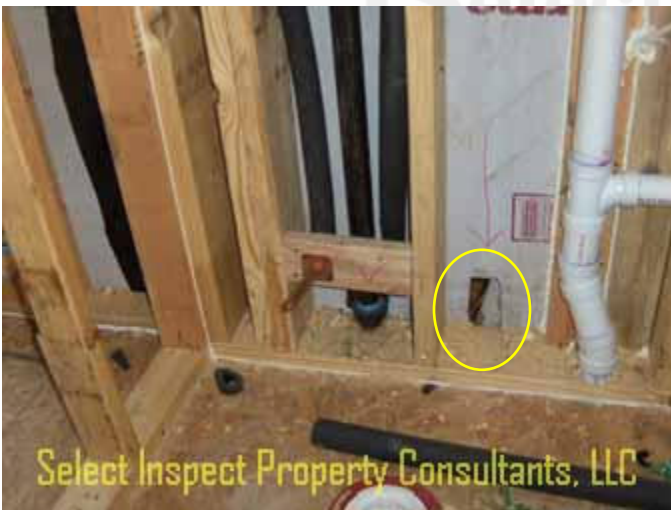
↑ sealant needed; example; at east bathroom

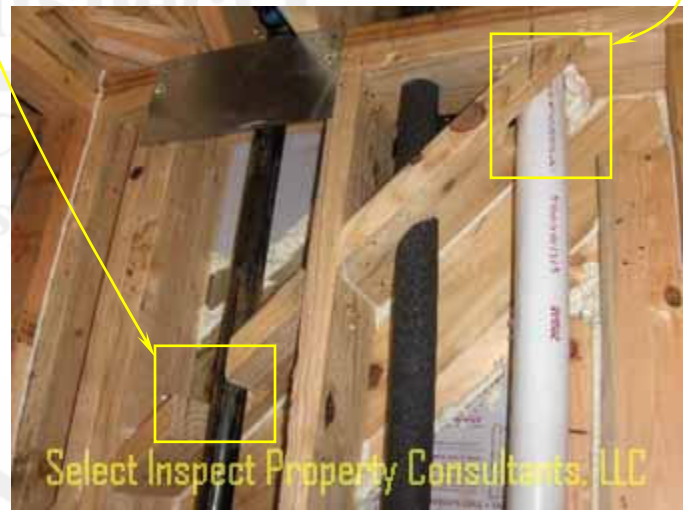
↑ *Thursday*; sealant needed; & excess notching; west bathroom; related image below ↓

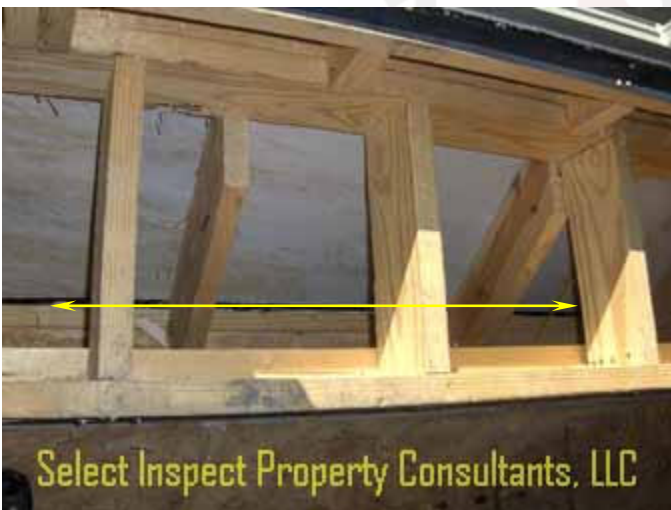
- Sealant & or sheathing improvement needed at openings in the exterior wall sheathing/building thermal envelope at the window bench

↑ sealant needed; example; at south bedroom bench

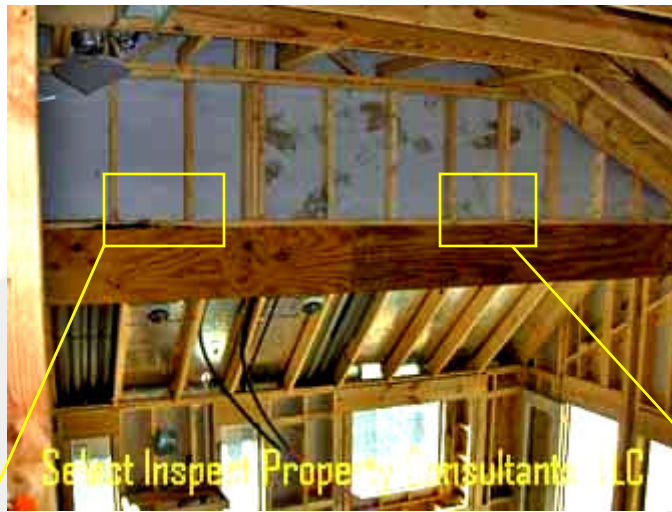
↑ sealant needed; example; at family room

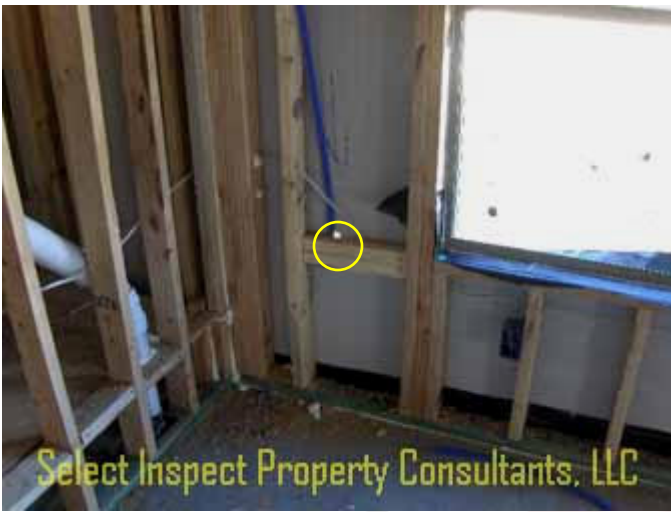
- Sealant & or sheathing improvement needed at openings in the exterior wall sheathing/building thermal envelope; southwest

↑ sealant needed; example; at master bedroom southwest

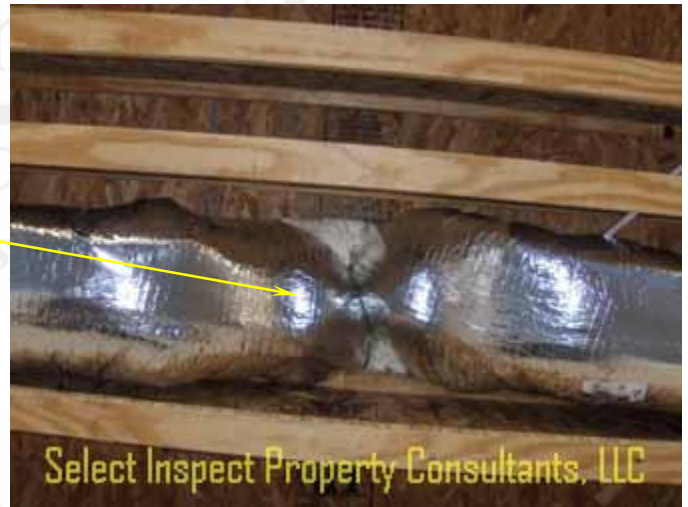
↑ close view of image at left

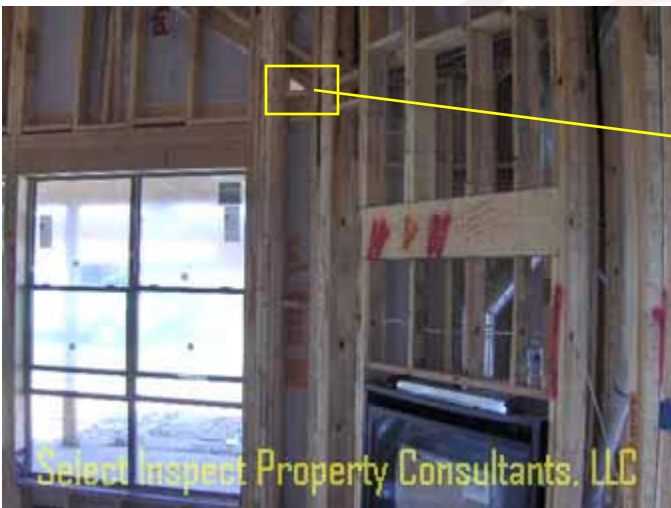
↑ sealant needed; example; at family room

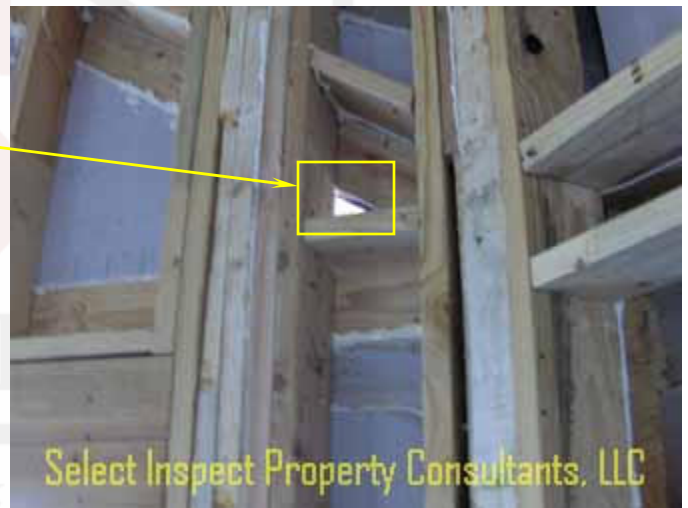
↑ close view of image at left

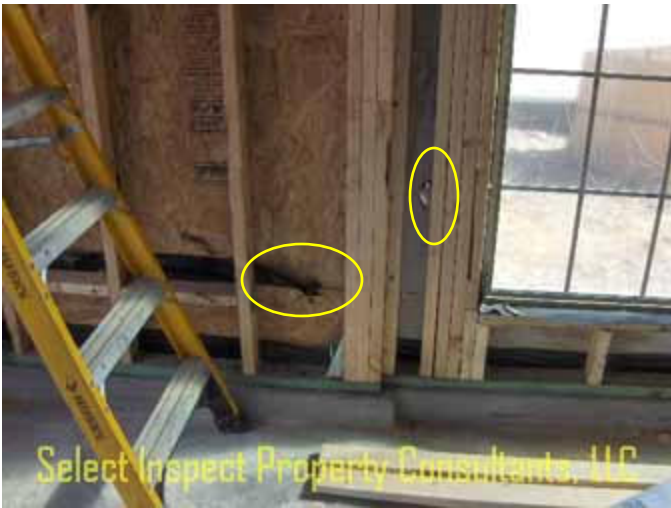
↑ sealant needed; example; at two-car garage

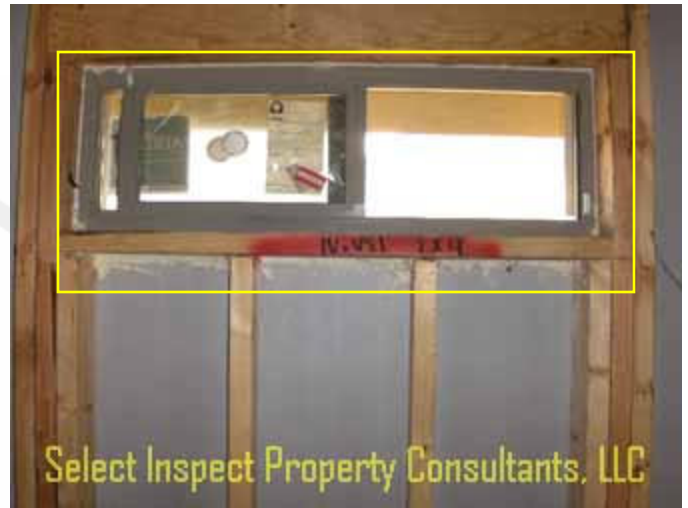
↑ sealant needed; example; at upstairs bathroom south; this window also had incomplete flashing at exterior and no visible moisture barrier
* related exterior image on page 24 lower left in this report

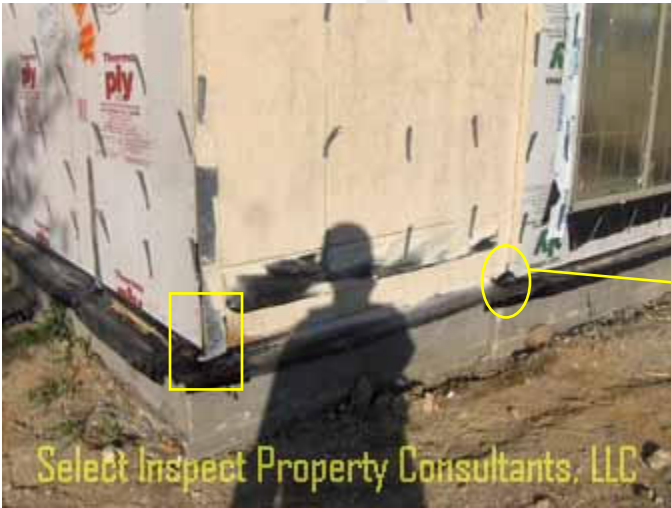
↑ tape flash improvement recommended at strap-tie holddown; southeast

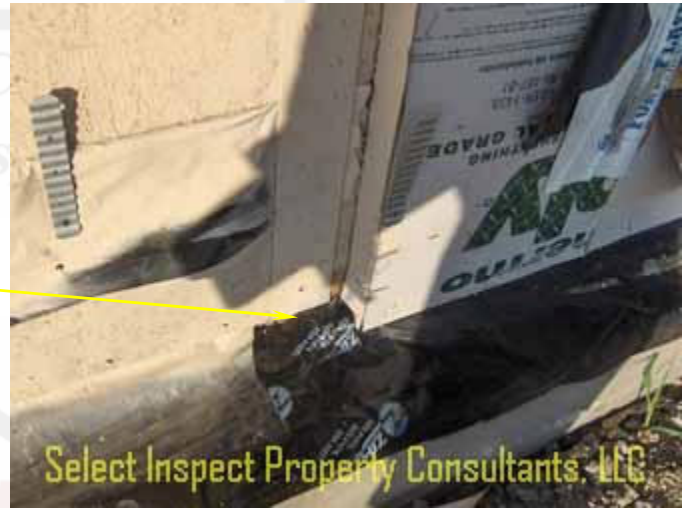
↑ tape flash improvement recommended at strap-tie holddown

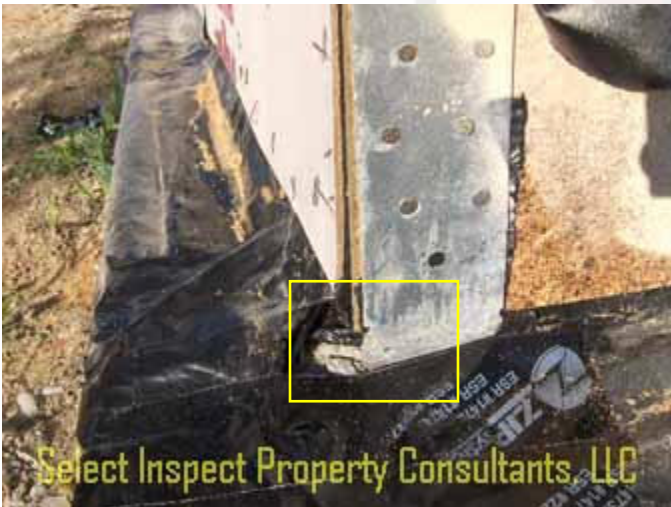
↑ close view of image above

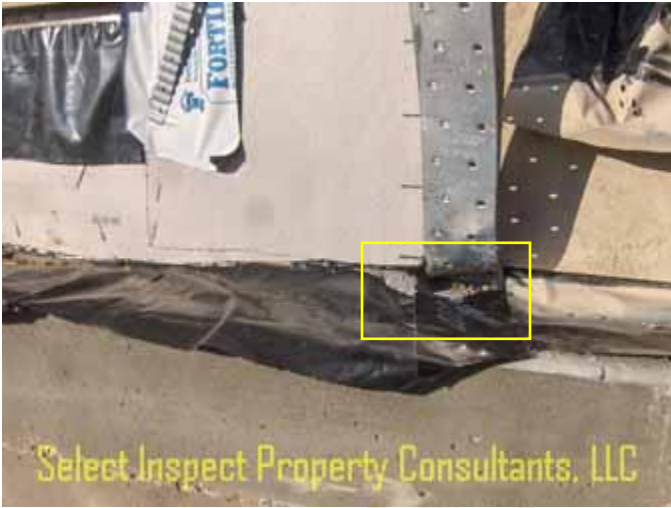
↑ better tape flash; example; east at strap-tie holddown

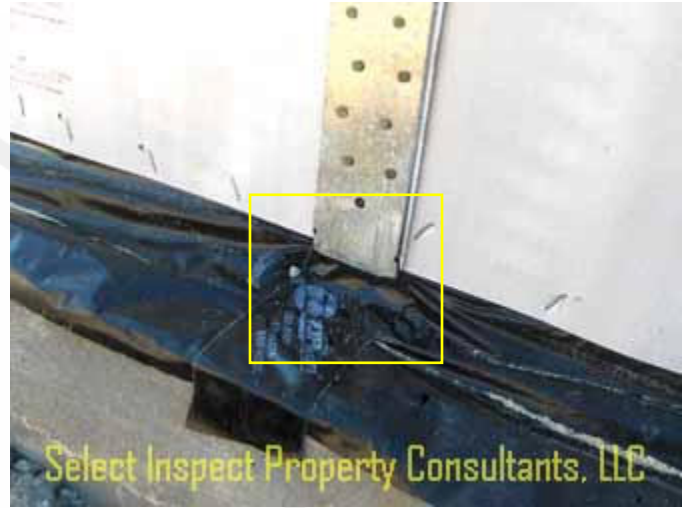
↑ good tape flash example; north at strap-tie holddown

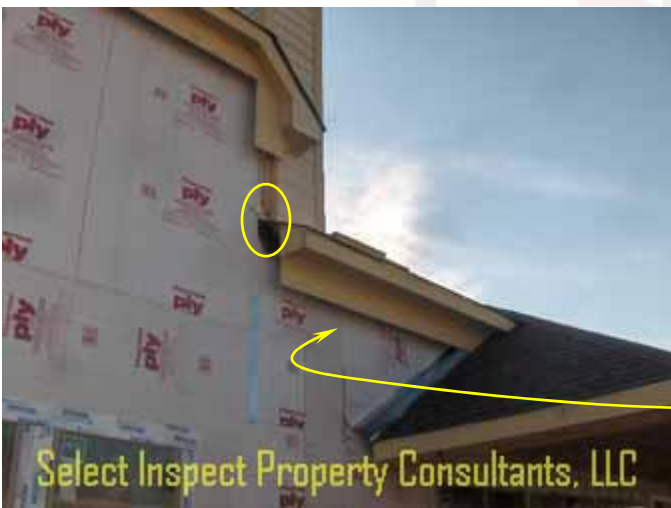
↑ tape flash & sealant improvement recommended

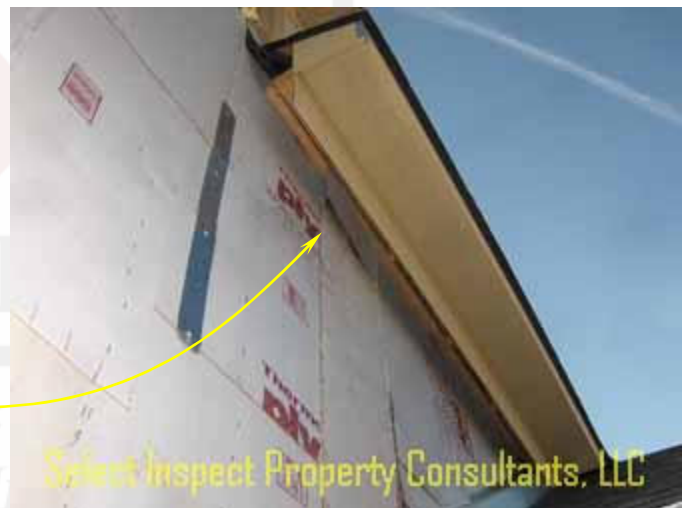
↑ close view of image at left

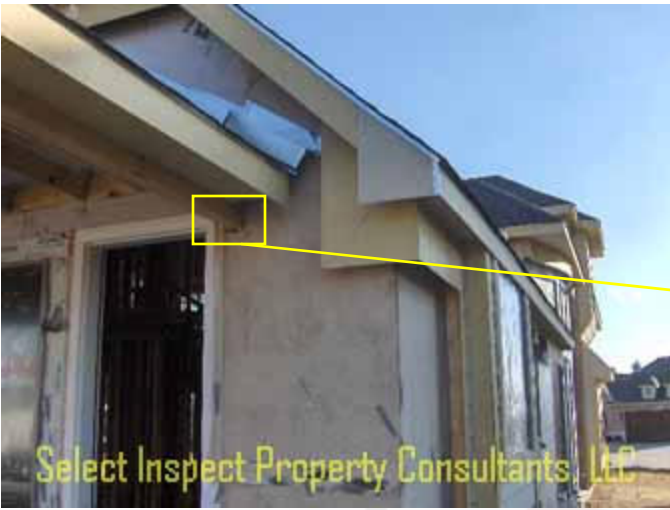
↑ undetermined intention of flashing this area

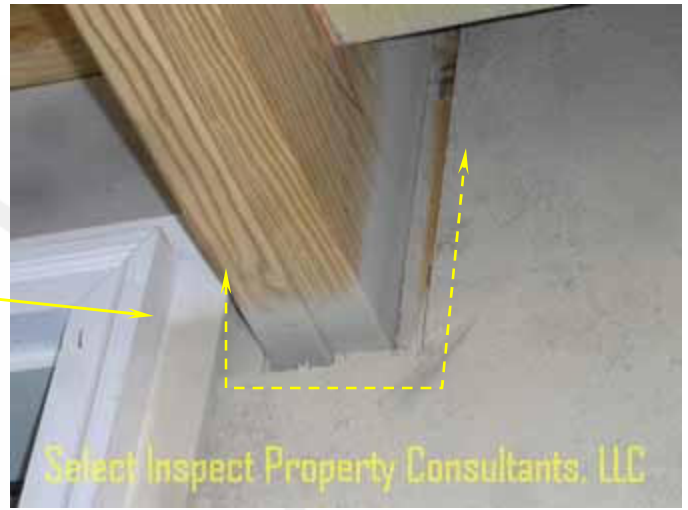
↑ close view of image at left

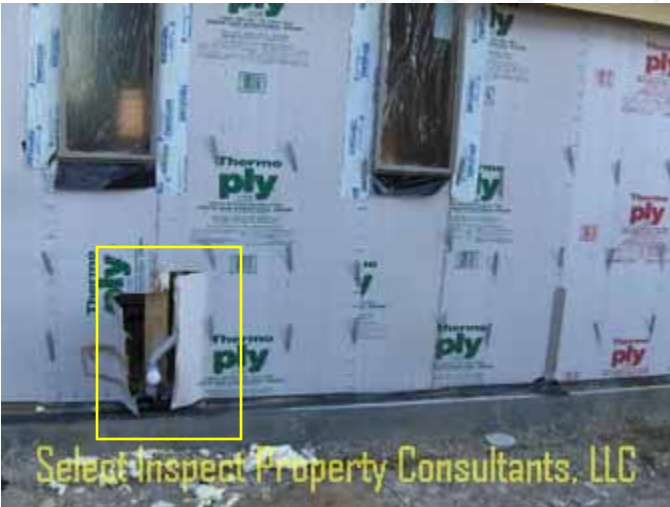
↑ tape flash & sealant improvement recommended

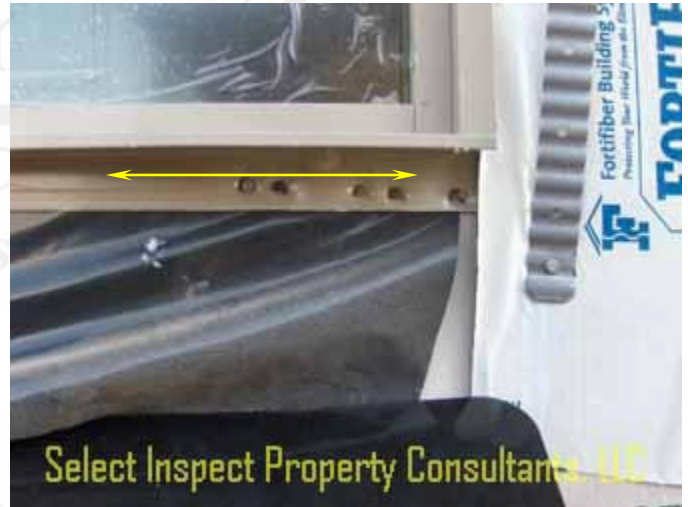
- Broken glass noted at the east bedroom
- Nailing was incorrect/unworkmanlike at kitchen, family room, master bedroom & bath locations. Refer to the architect &/or manufacturer for approved correction or approval.

↑ unworkmanlike nailing of windows; example

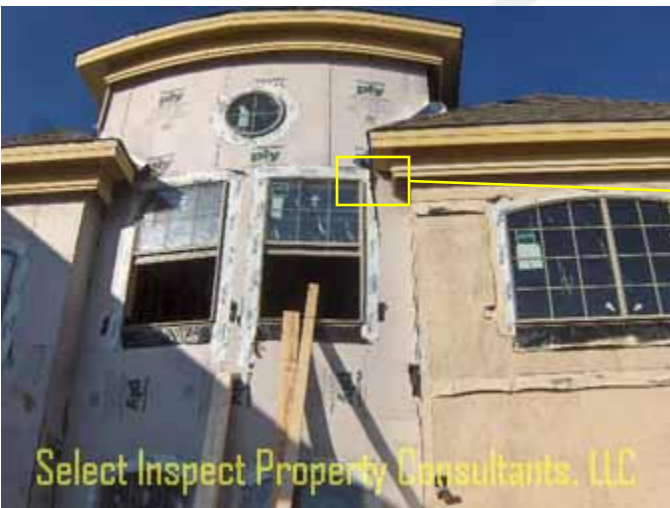
↑ tape flash & sealant improvement recommended

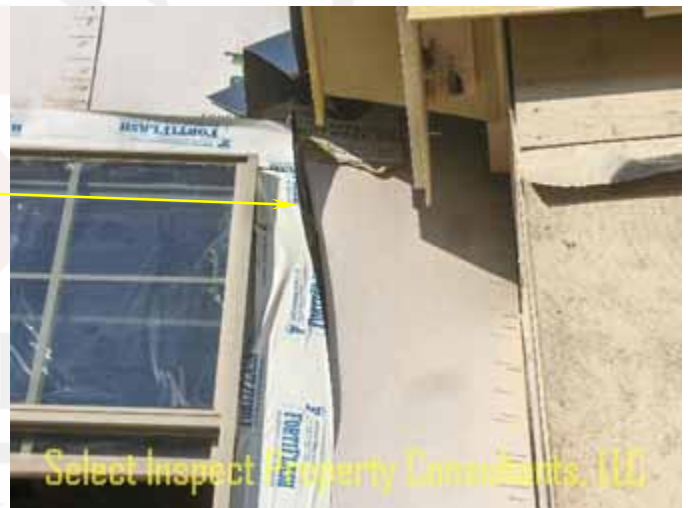
↑ close view of image at left

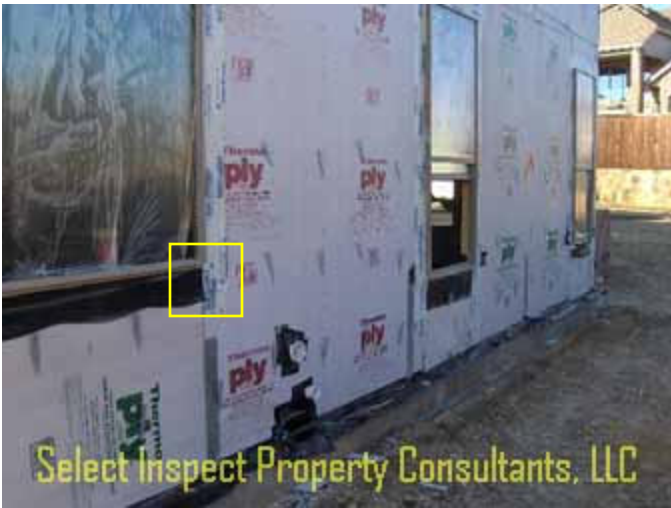
↑ tape flash & sealant improvement recommended

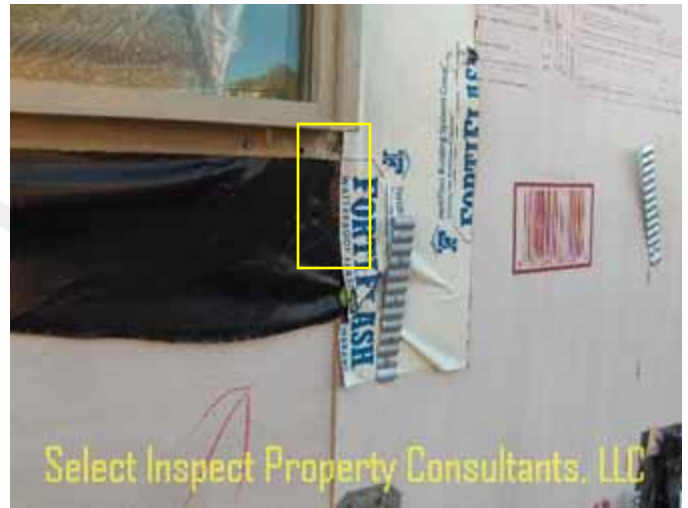
↑ close view of image at left

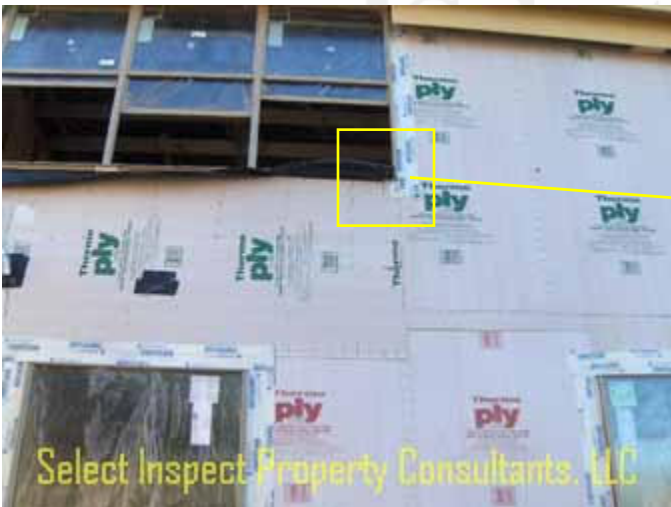
↑ tape flash & sealant improvement recommended

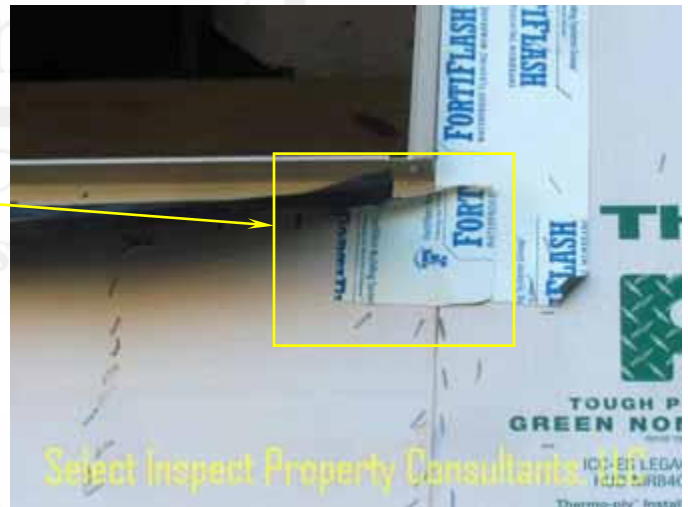
↑ tape flash is below, rather than above the moisture barrier flashing

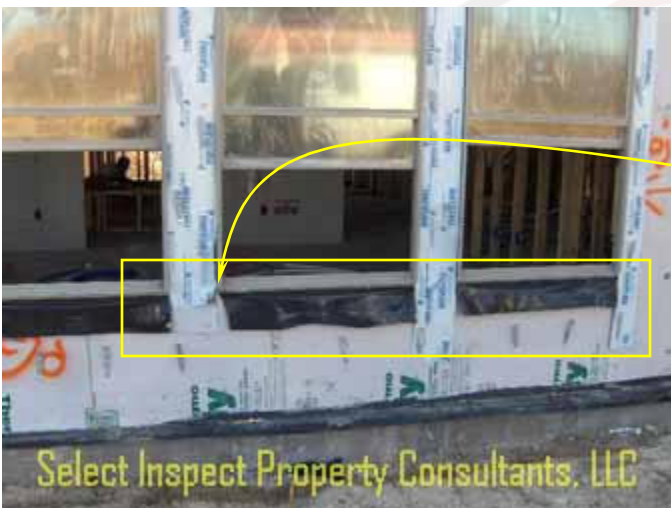
↑ tape flash & sealant improvement recommended

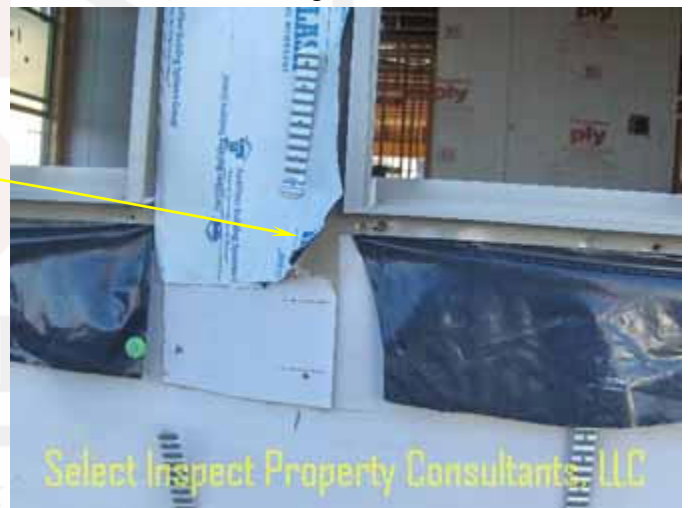
↑ close view of image at left

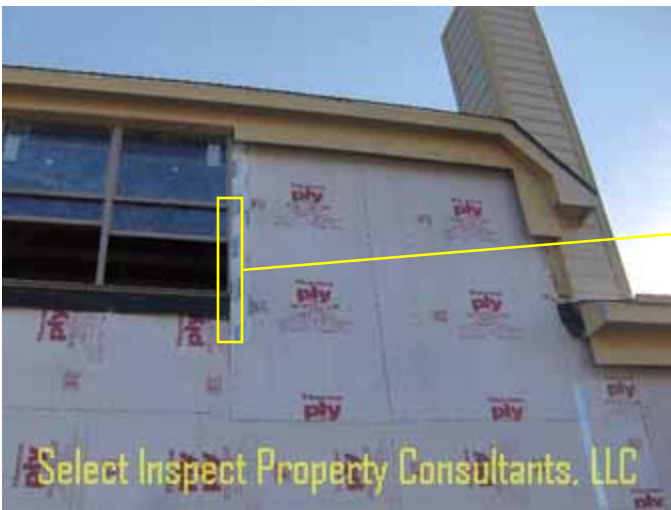
↑ tape flash & sealant improvement recommended

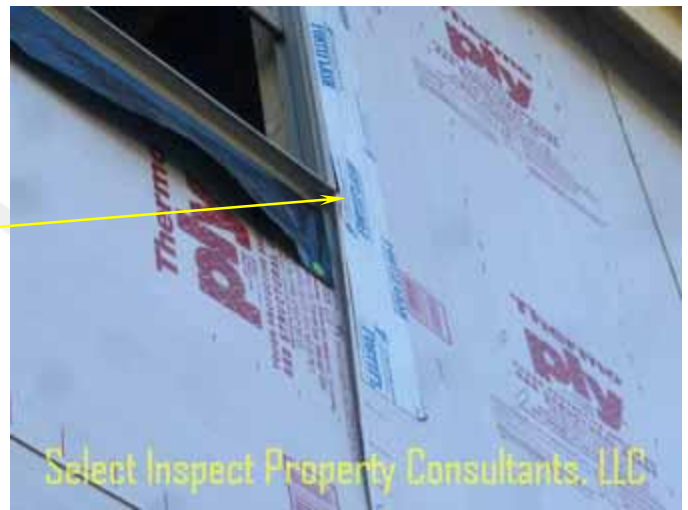
↑ close view of image at left

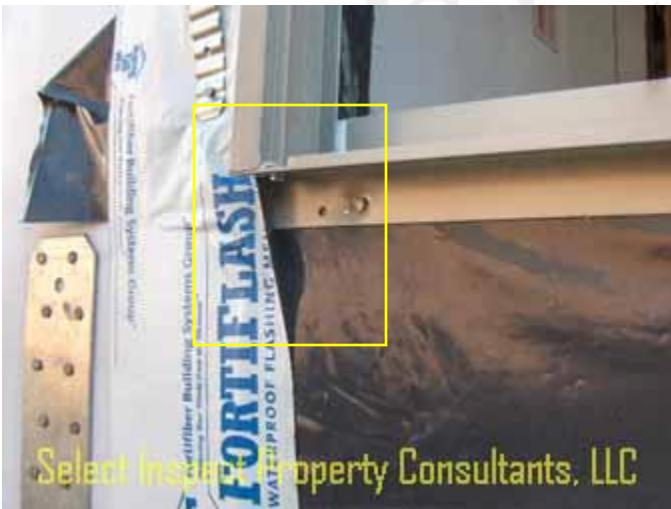
↑ tape flash & sealant improvement recommended; & example unworkmanlike window nailing
