Select Inspect

New Construction Phase Inspection

at: **123 New Street; McKinney, TX 75071**

Thursday, October 21, 2010

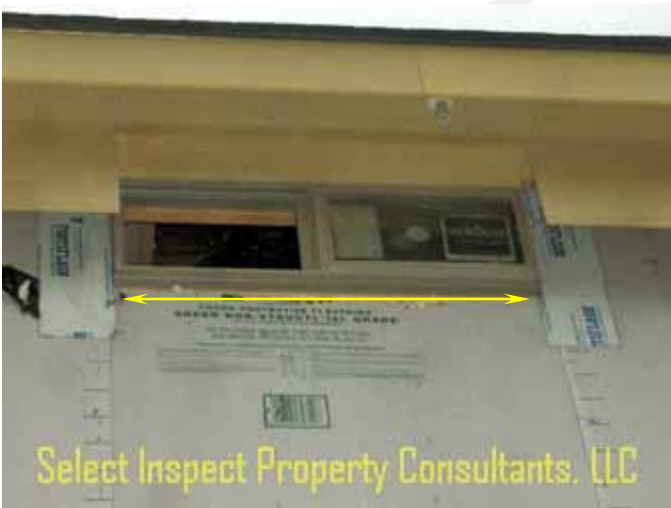
- Plastic moisture barrier/sheathing at upstairs north bathroom window was missing.
- Plastic sheathing at windows should be extended to the edge of the fenestration. Some were appropriate, some were short cut. Many times the plastic is cut the appropriate size, but the edges shift when the window is being put into the fenestration. This is often overlooked, though is technically incorrect and could be a potential moisture intrusion source in the future.

↑ window moisture barrier/flashing missing at the upstairs bathroom north window; window would need to be removed to install properly; or check with *manufacturer* for *approved alternatives*

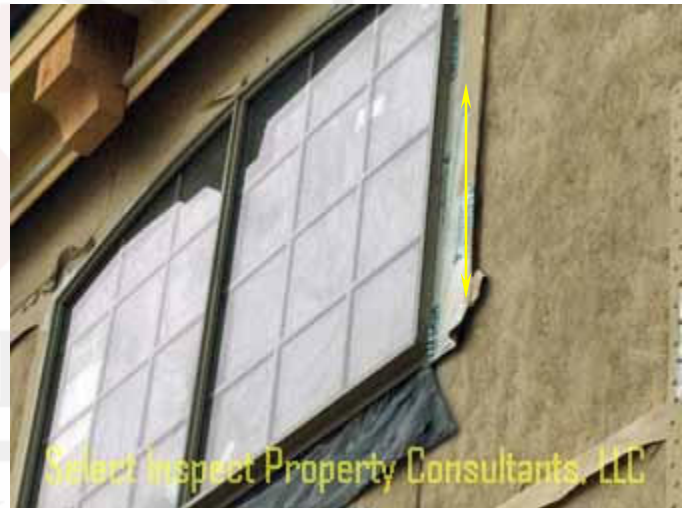
↑ tape flash & sealant improvement recommended; east-northeast bedroom upstairs (over single garage); poor adhesion

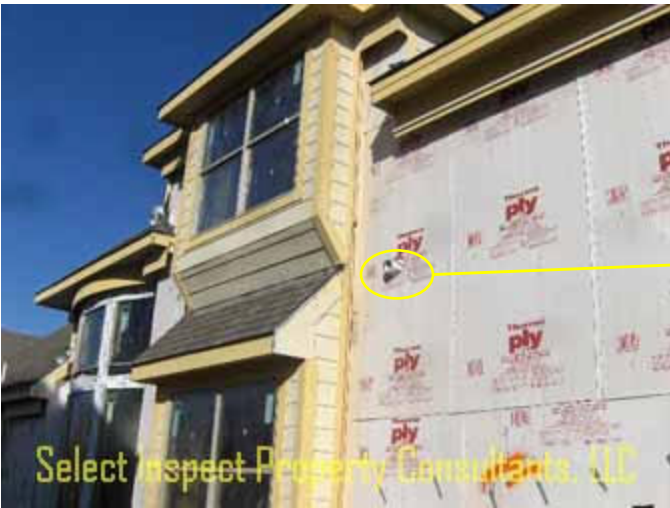
↑ tape flash & sealant incomplete at exhaust fan(s)

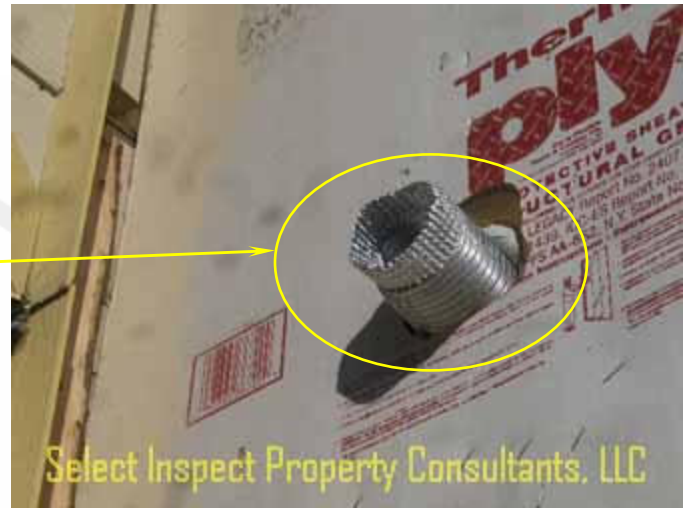
↑ close view of image at left
