Select Inspect
Property Consultants, LLC

Inspection of New Property

at: **123 street; McKinney, TX 75071**

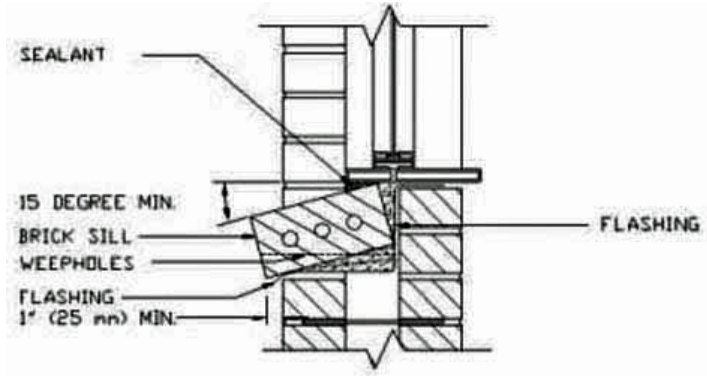
Exterior window sills did not have a recommended 15° slope for drainage at multiple locations; slope at random locations was approximately 3, 5, 7, 10° Repair options may be limited. Condition & appropriateness of flashing & substrate components is undetermined.

↑ brick ledge(s) had inadequate slope

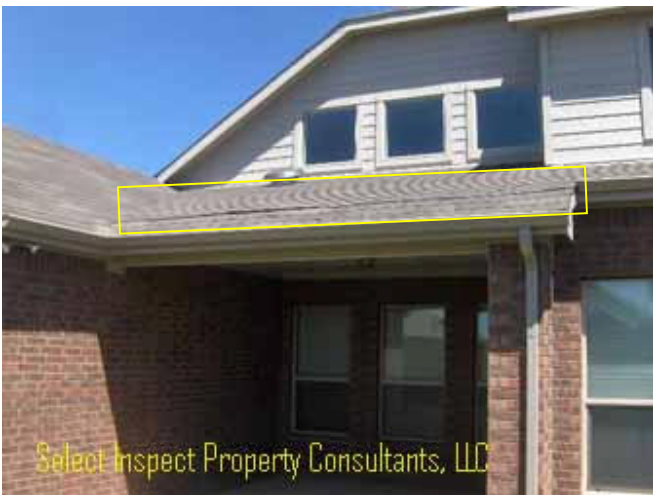
- ✦ Damaged shingles were discovered at the west & south exposures
- ✦ Lifted ridge shingles noted at the rear porch.

↑ raised shingles

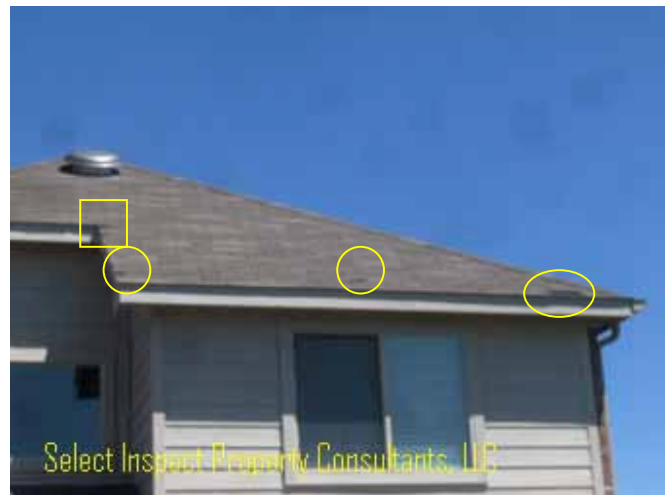
↑ damaged shingle tabs

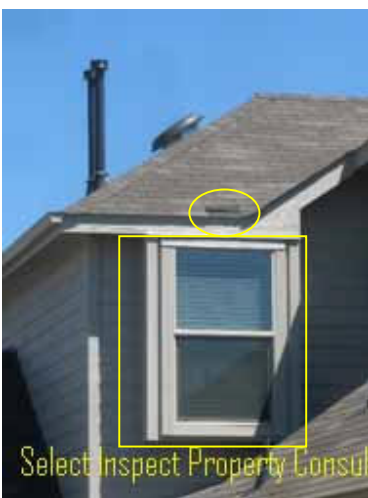
↑ damaged shingle tab & inverted trim

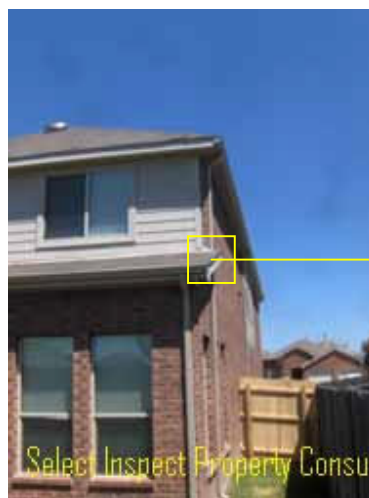
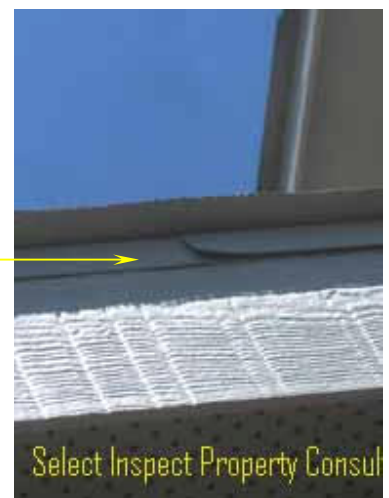
- Drip edge flashing was noted as not properly overlapped at the southeast & northwest locations at the eave perimeter; general rule is minimum 6", though some manufacturers allow as little as 2"

↑ short lap at drip edge flashing

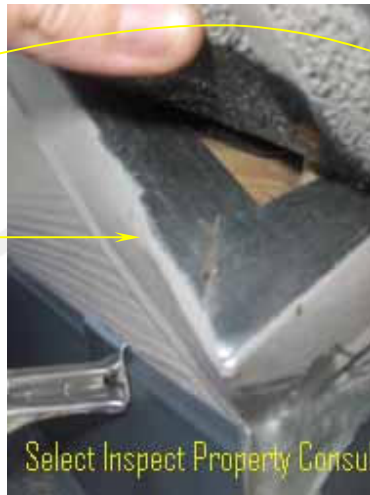
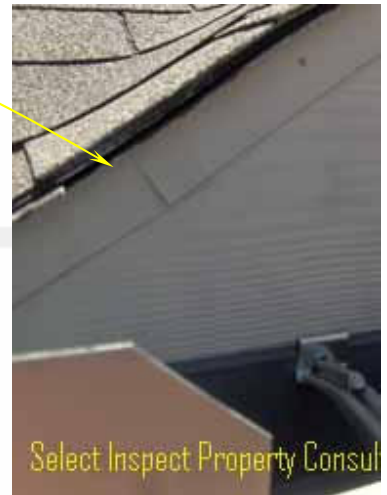
- Felt paper is cut short, rather than atop drip-edge-flashing at various valleys. Ideally, felt would be long enough to overlap the drip-edge-flashing. This is a common roofing error and is incorrect according to the Roofing Manufacturer's Association. Evidence of leakage or failure was not seen regarding this condition at the time of inspection. Repair options are limited; and best addressed when the roof is replaced in the future.

↑ short roof underlayment & short drip edge flashing lap

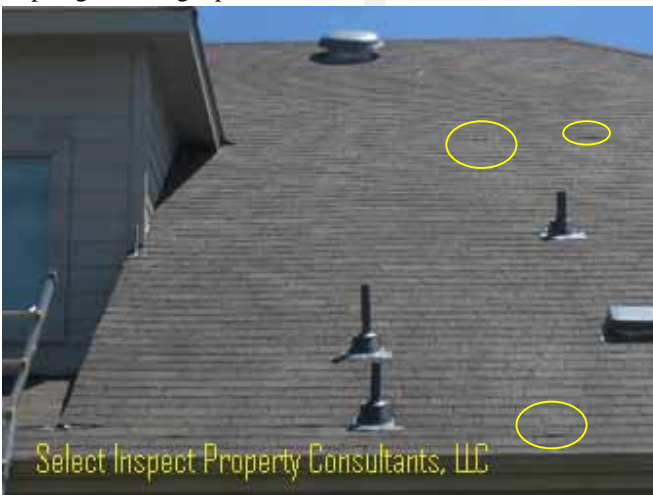
- Unworkmanlike eave/roofline joint exists with openings at the southwest.
- Nails/fastener(s) were inadequately secured (popped through shingles) at various locations. This may imply improper adjustment & use of the roofing nail gun(s) during shingle installation & or shifting of the structure & should be evaluated by a professional roofer.

↑ Popped nail/fasteners & worn shingles at the west

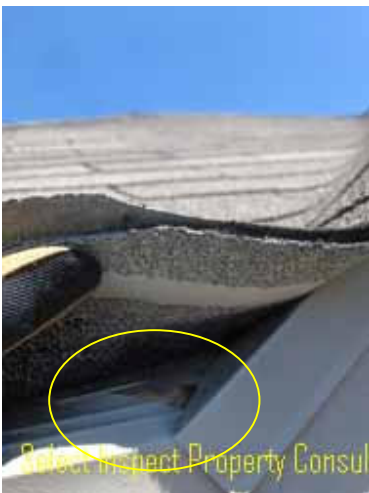
↑ deficient roof underlayment & drip edge flashing; over media room window

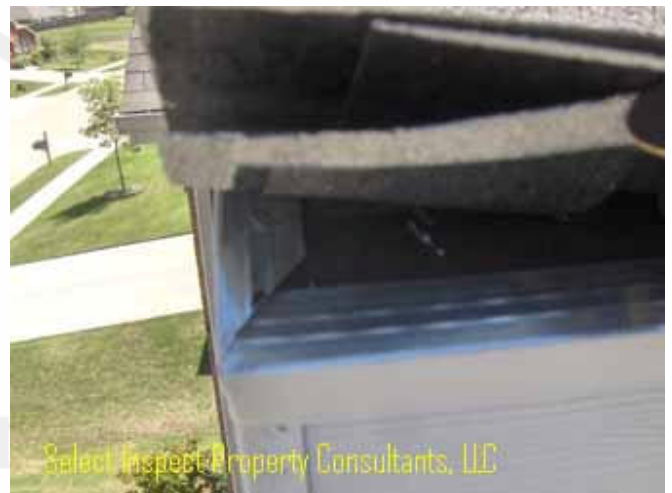
- Felt paper is improperly below, rather than atop drip-edge-flashing at eaves & above rather than below at rakes. Felt is to be below the drip-edge-flashing at the rake (gable sides) but not at the eaves. This is a common roofing error and is incorrect according to the shingle manufacturer; National Roofing Contractors Association's Roofing and Waterproofing Manuals; and IRC. Evidence of leakage or failure was not seen regarding this condition at the time of inspection. Repair options are limited.

↑ unworkmanlike roof underlayment under drip edge flashing

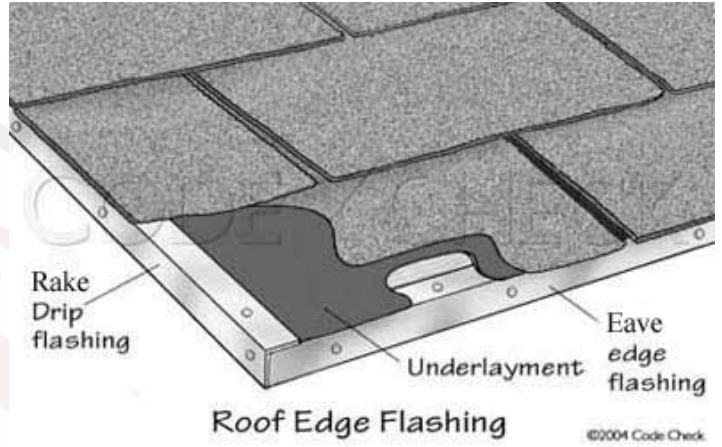
↑ example-unworkmanlike drip edge/felt; corners should have no gaps; rake (diagonal) edge & roof felt should be atop the eave (lower) edge flashing; roof underlayment should be under rake flashing

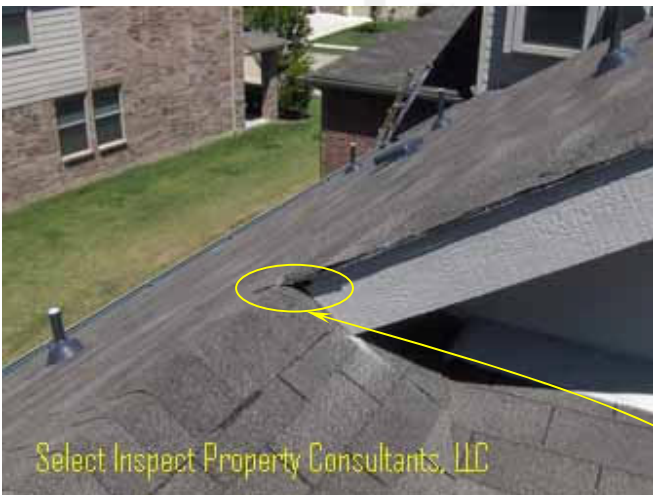
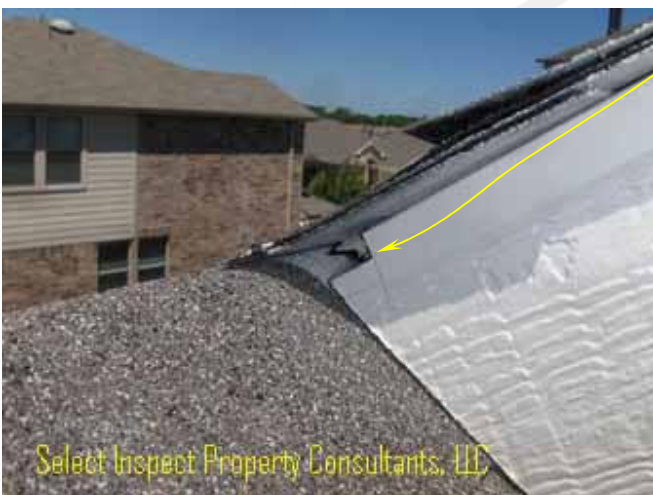
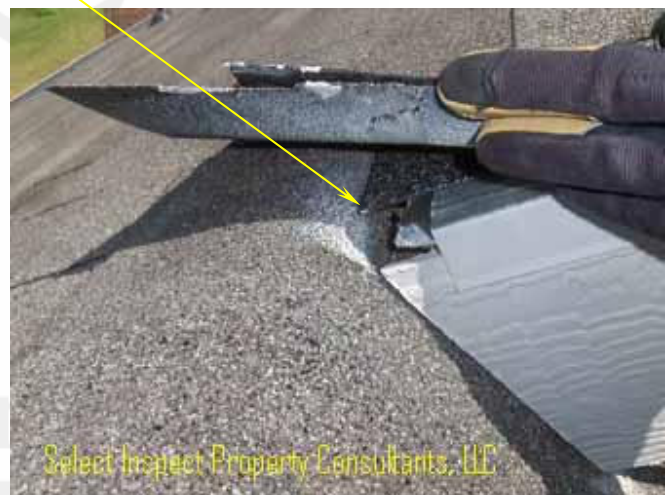
↑ unworkmanlike eave/roof connection; openings & visible decking

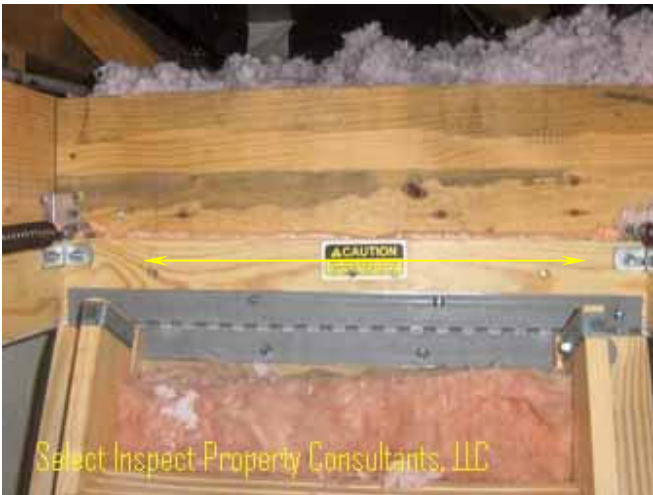
- ✦ The attic stairs were not installed to manufacturer's guidelines. Manufacturers recommend securing the stair to framing with 16D nails or ¼" lag screws (missing at header & footer). Commonly appropriate fasteners were not seen at the perimeter (mounting to the ceiling joists) and or hinges/corner hardware of the ladder(s), and would not meet sheer strength requirements for installation. NOTE: framing gun nails labeled as 16D are unacceptable, as these are more like a smaller 10D common nail. These are often used, but are inappropriately labeled and do not offer adequate shear strength. The stairs should be considered unsafe. Recommend securing the stairs to manufacturer specifications.

↑ deficient attic stair install; missing proper fasteners

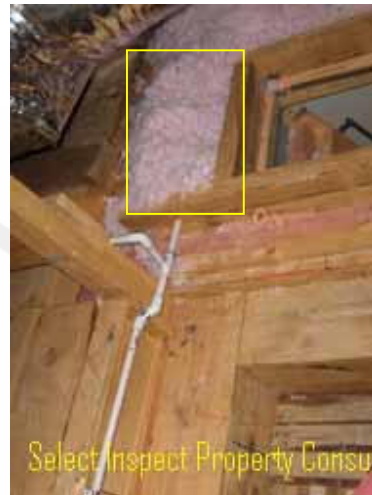
- ✦ Attic floor was deficient or not present at the top/front of the access; & air ducting is low over the access; this creates a hazard during entry and exiting the attic. Addition of appropriate deck/floor is recommended.

↑ there should be a minimum 24" pathway to the HVAC from the top of the access, with no gaps or obstructions

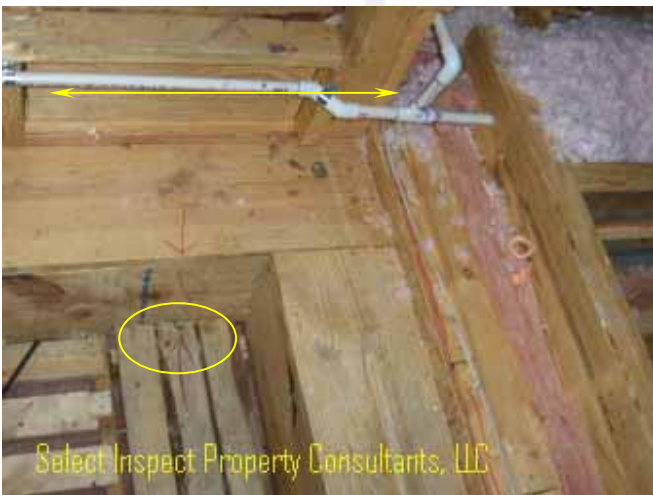
↑ protruding nails near attic access & primary condensate drain is prone to damage in this location

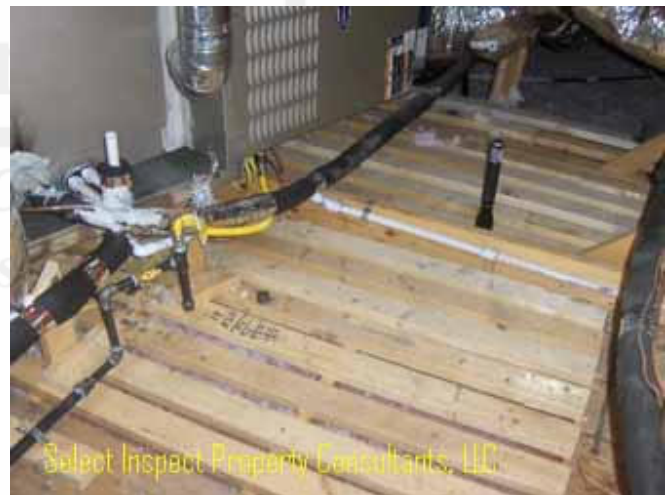
↑ gaps at attic floor service area

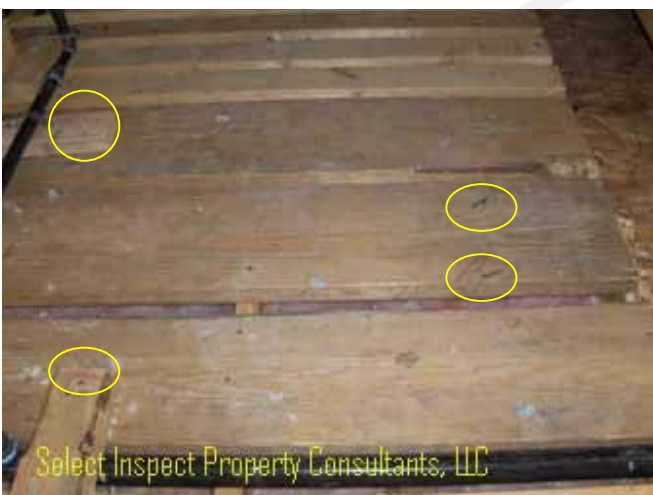
↑ protruding nails, may snag/cut service personnel

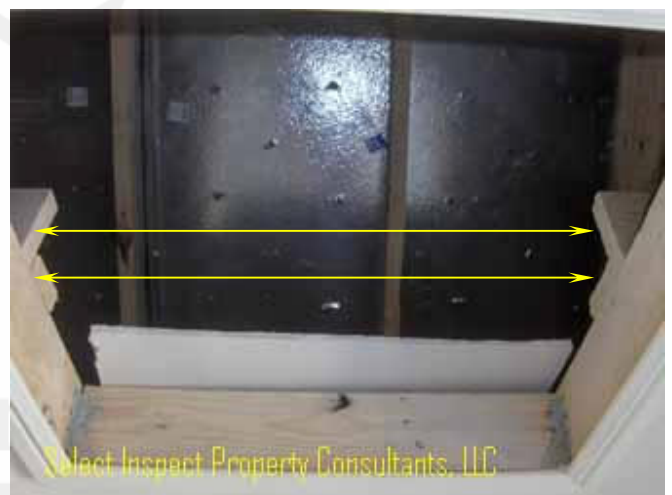
- ✦ Joist lateral bracing was cut at the garage attic access; have the architect or engineer examine & either approve or prescribe repair. Obtain documentation of their decision
- ✦ There was not a clear, solid (having no gaps), unobstructed 24" floored pathway to the mechanical system(s) from the access. This is considered a safety risk for persons examining or servicing the mechanical systems (HVAC, water heater, etc).
- ✦ The attic(s) were not fully accessible due to lack of decking & HVAC obstructions. The attic areas were inspected from limited decked areas only.
- ✦ Nails protrude from attic floor & may be an injury hazard for service people.

↑ lateral joist bracing cut at garage attic hatch

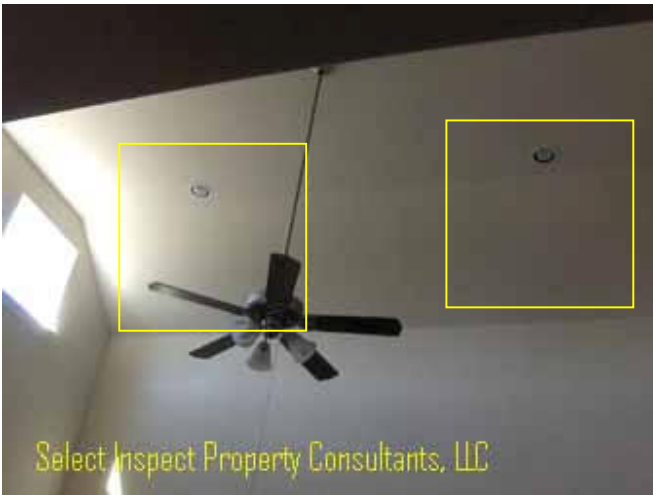
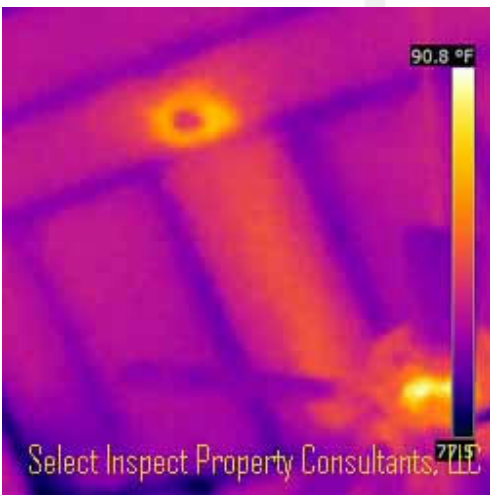
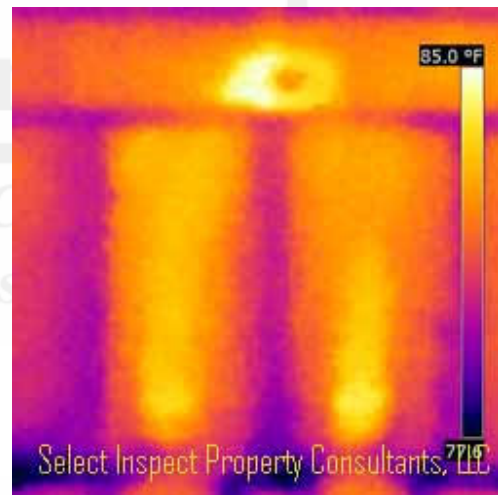
↑ Thermal imaging implies minimal energy loss at the family room

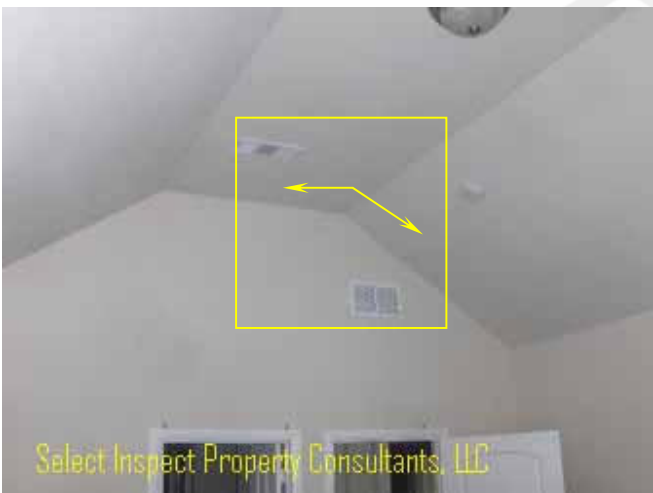
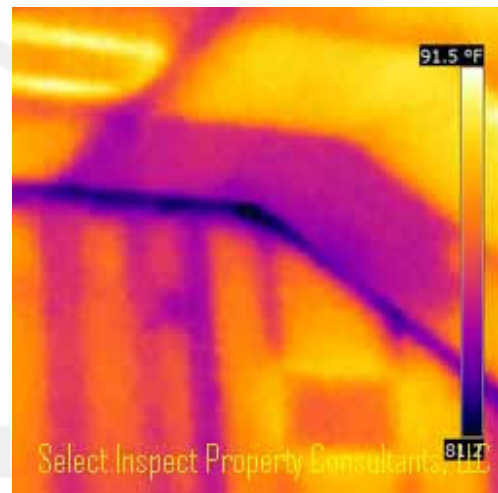
- ✦ Thermal imaging indicated areas that may have deficient insulation, air barrier/sealant, & or ventilation deficiencies at family room, master, master closet, foyer & commonly found general areas including vaulted corners (walls & ceilings), framing convergences, perimeter floor sills, electrical switches & receptacles adjacent exterior walls, & plumbing & HVAC chases.
- ✦ Insulation is inspected in a very general manner from limited accessible locations; Conditions in not readily accessible/inaccessible locations remain undetermined; this is general in nature & is not a comprehensive investigation of all areas.

↑ Thermal imaging implies energy loss at master

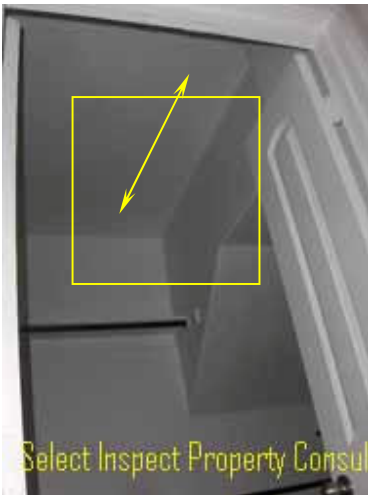
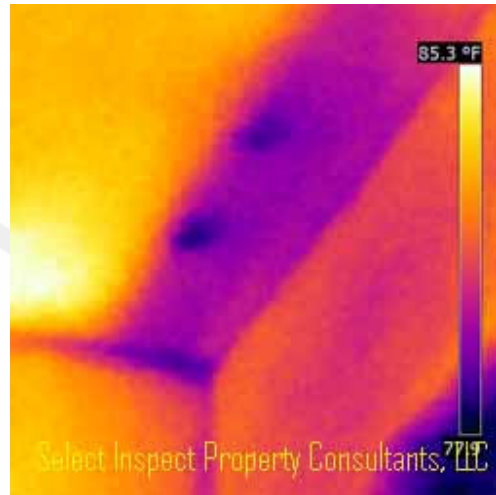
↑ Thermal imaging shows energy loss & or moisture at master closet

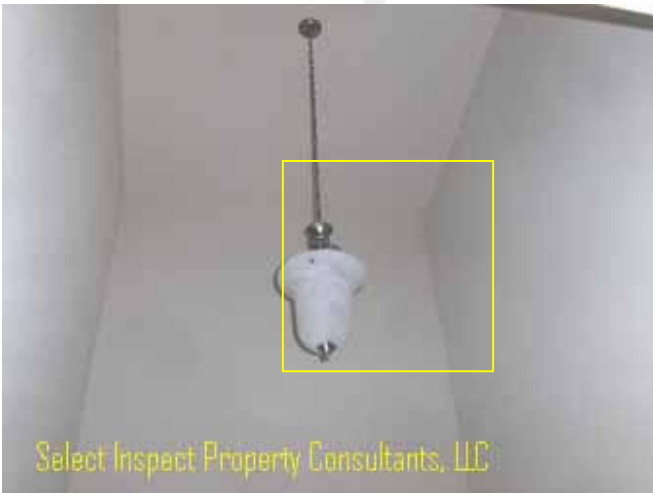
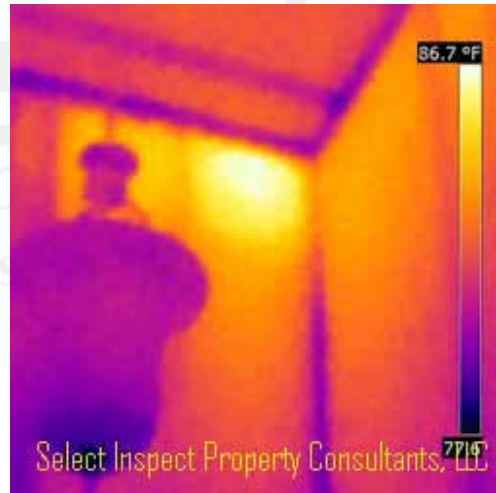
↑ Thermal imaging implies energy loss at foyer; closet window adjacent this at the upstairs

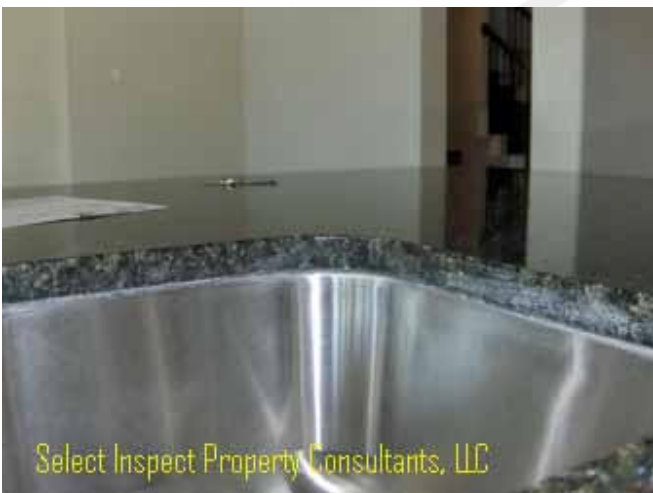
- ✦ The kitchen sink(s) is installed with the counter overlapping the sink edge. This is called a "fouling area" and is prone to unsanitary bacterial accumulation under the edge, and is difficult to keep clean for food preparation / sanitation concerns. Fungus or bacteria may be present in the overlapping edges. Options are limited. Caulking the joint may improve the condition, though ideally the counter should be cut to not overlap the sink. At the least, keep the area clean and monitor the caulked joint for touch-up/repair needs. (UPC 401.1)
- ✦ Master bathroom lower left drawer was unsquare.
- ✦ Debris remains atop the work-station cabinets.
- ✦ Master bathtub access doors were not flush; not square
- ✦ Granite countertops, if present, are not tested for presence of or levels of uranium or radiation. Related information can be found at: <http://selectinspect.com/links1.htm#radonlink>

↑ fouling area at kitchen sink is prone to bacterial contamination

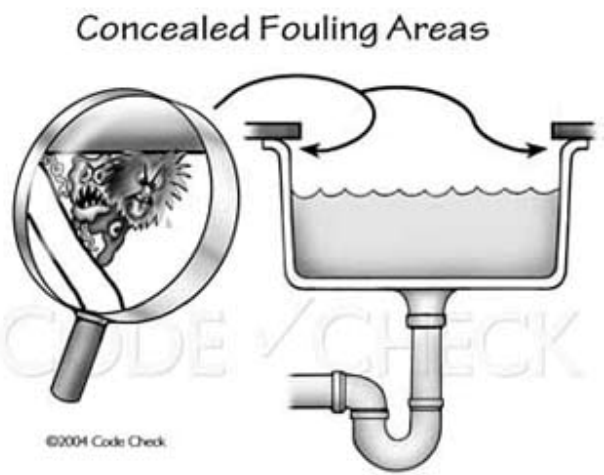
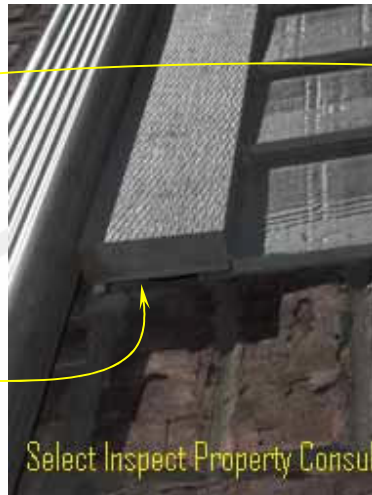
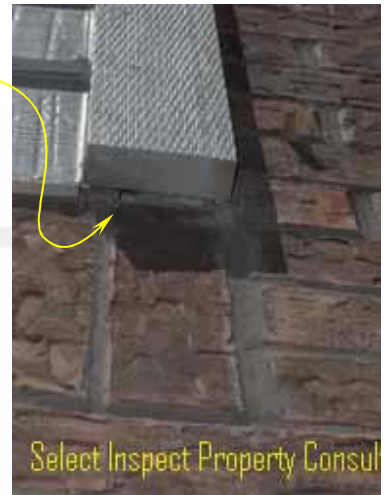
- Openings noted at the upper north-northwest & at east trim.
- Multiple trim & frieze-board trim were inverted/ back-side-out.
- Patio windows were uncaulked.
- Windows need caulk touch-up / repair at exterior perimeters
- Exterior lights should be properly sealed to prevent moisture intrusion and related corrosion / overheating possibilities of the electrical components. NEC 410-4 & IRC E3905.

↑ openings & inverted trim

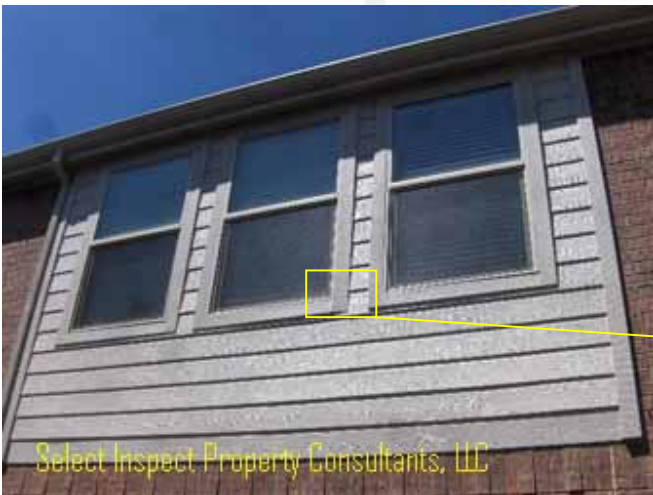
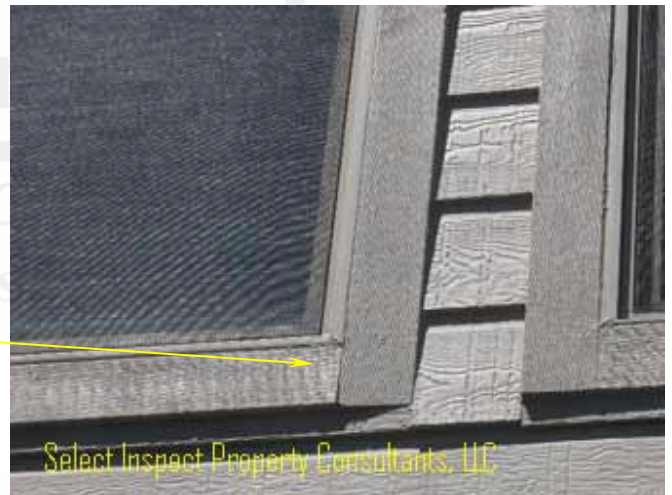
↑ unworkmanlike-uneven window trim; also reversed – inverted at all trim on this side of home.

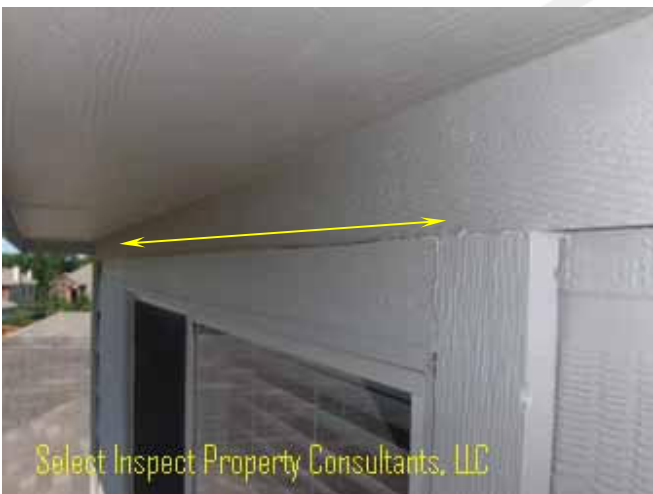
↑ gap over rear upstairs window; frieze-board & some trim here also reversed

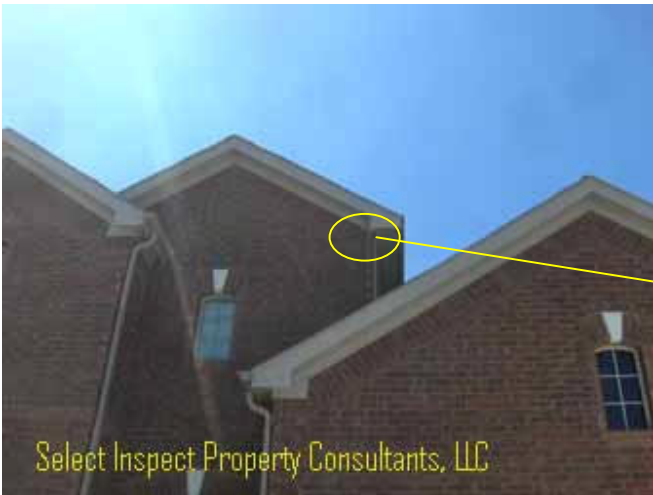
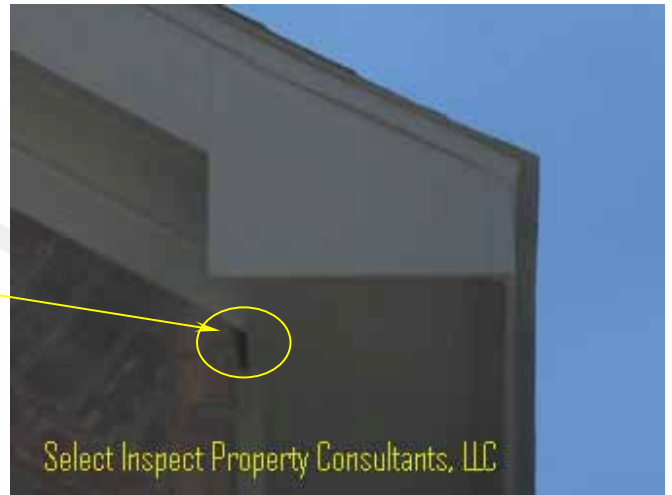
↑ opening; upper front

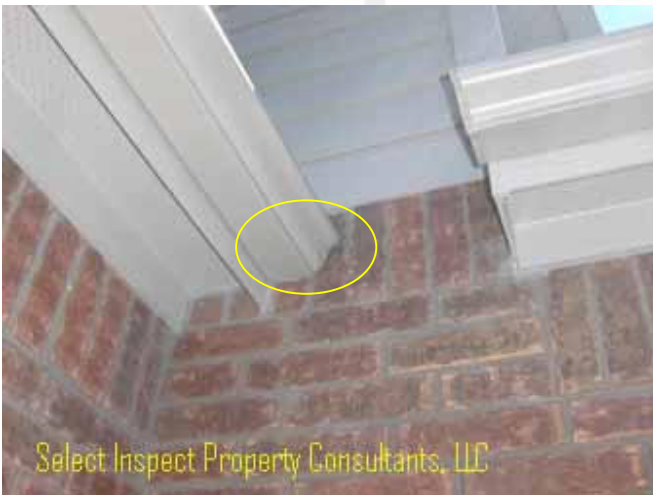
↑ bent gutter end prone to cap leakage; west near the air conditioning condenser(s)

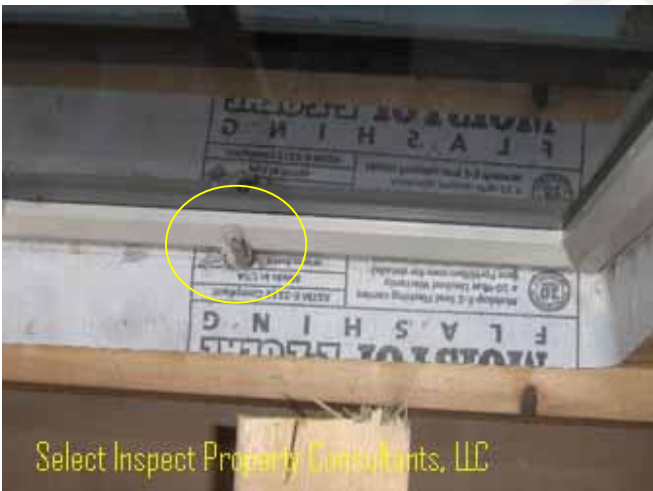
- Window glass is cracked at the master right. Correction / improvement would be prudent.
- Southeast upstairs bathroom window appeared scratched.
- Garage gable window was drilled through the glazing, fram/sill, & flashing. Reason undetermined.
- NOTE: Some windows were partially inspected or had limited access, due to furnishings, lighting conditions, window treatments, etc. Some conditions may remain undetermined.

↑ drilled window & flashing; undetermined reason; garage attic

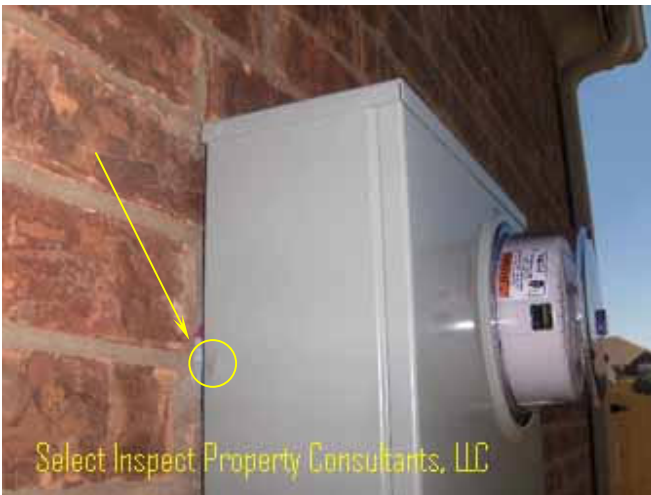
↑ dent & cracked paint; early rust starting; electrical meter; immediate corrective/improvement needs may be subjective.

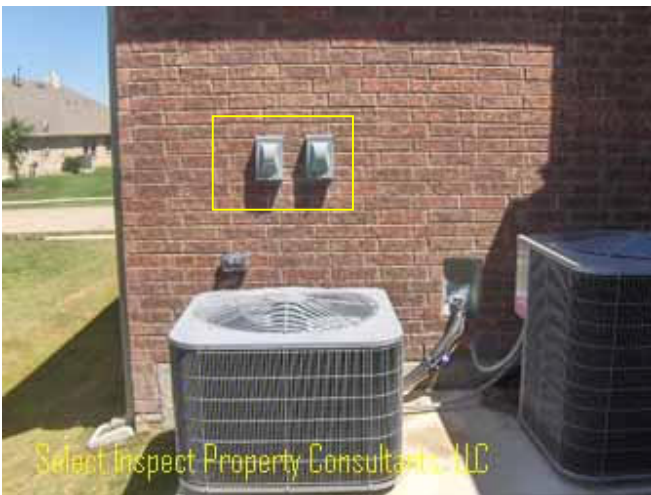
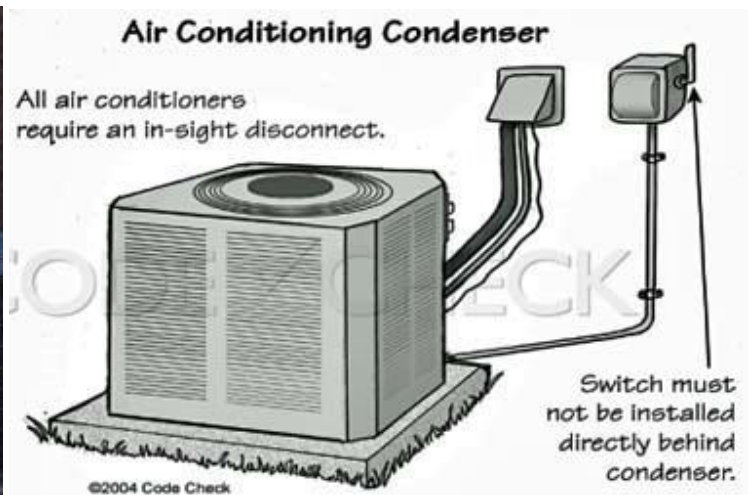
- ✦ The electrical disconnect panels for the air conditioner condenser unit(s) did not meet recommended clearance; the disconnect is considered a service panel and requires 30" lateral clearance and 36" front clearance from grade up to six feet in height. Disconnecting means shall be located within sight and readily accessible from the air conditioning or refrigeration equipment. Immediate repair needs may be subjective, and may be cost prohibitive pending your level of concern. This is mostly an access inconvenience for service personnel & not a safety hazard or urgent condition.

↑ incorrect location of air conditioning condenser(s) service disconnect; inadequate clearance of electrical panel for service personnel

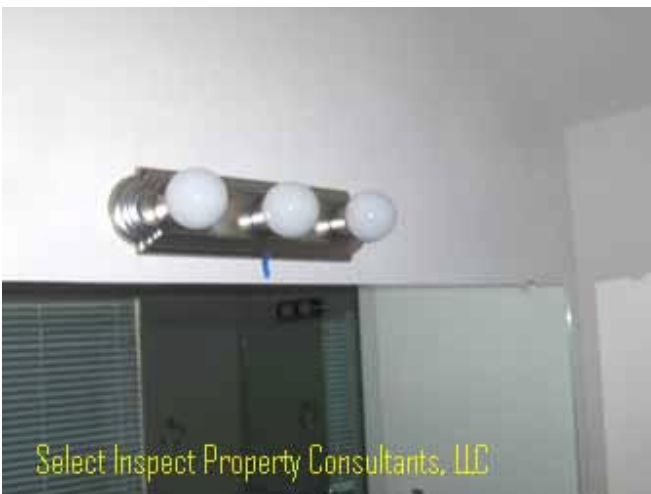
↑ uneven master bathroom lights –spacing over mirrors was inconsistent; east sink

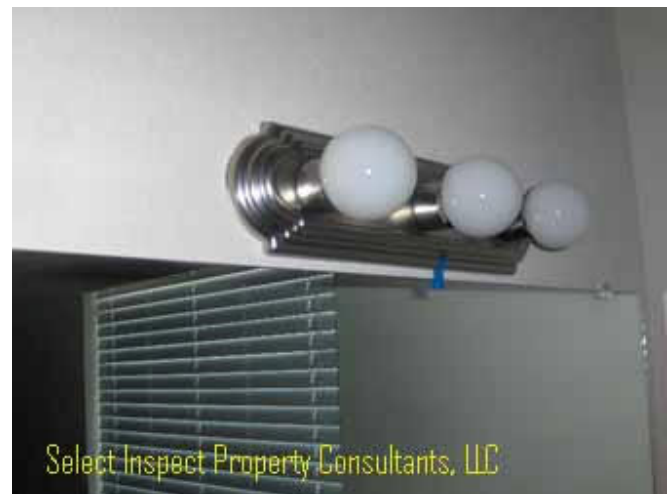
↑ south sink

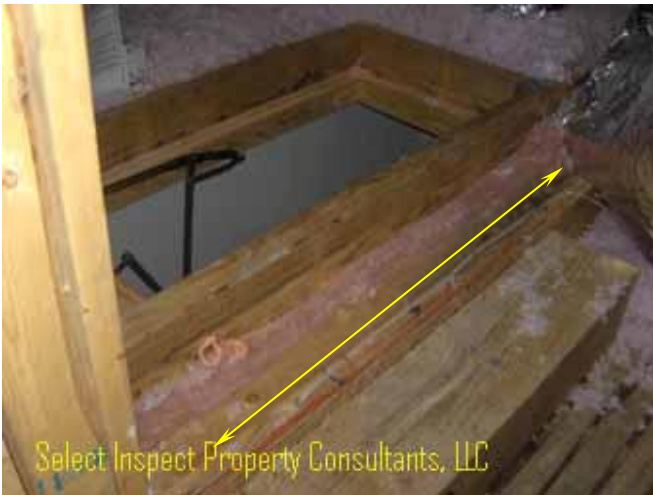
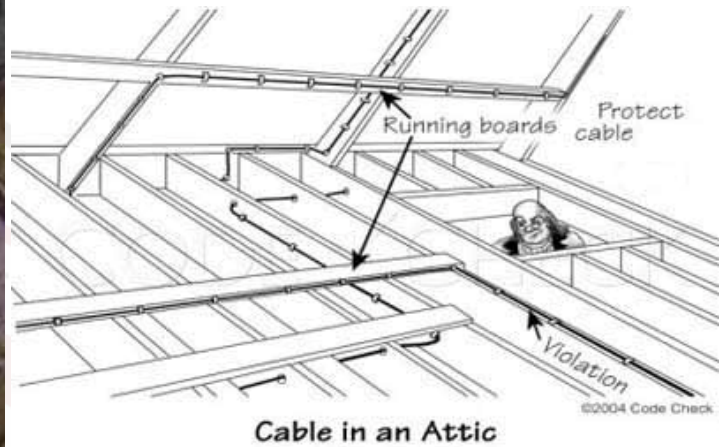
- ✦ There are electrical wires at the attic(s) that are not properly secured and protected from damage by traffic. Where run across the top of floor joists, or run within 7 feet (2134mm) of floor joists across the face of rafters or studding, in attics & roof spaces that are provided with access, the cable shall be protected by substantial guard strips that are at least as high as the cable. Where such spaces are not provided with access by permanent stairs or ladders, protection shall only be required within 6 feet (1829mm) of the nearest edge of the attic entrance. Where cables are installed parallel to the sides of rafters, studs or floor joists, guard strips & running boards shall not be required.....

Electrical wires/cables shall not be routed along walking surfaces or in any location prone to traffic damage. (E3702)

↑ electrical wires in the attic shall be adequately protected within 7' of attic stairs & electrical wires in the attic shall be adequately protected within 6' of attic scuttle & electrical wires/cables shall not be routed along walking surfaces or in any location prone to traffic damage

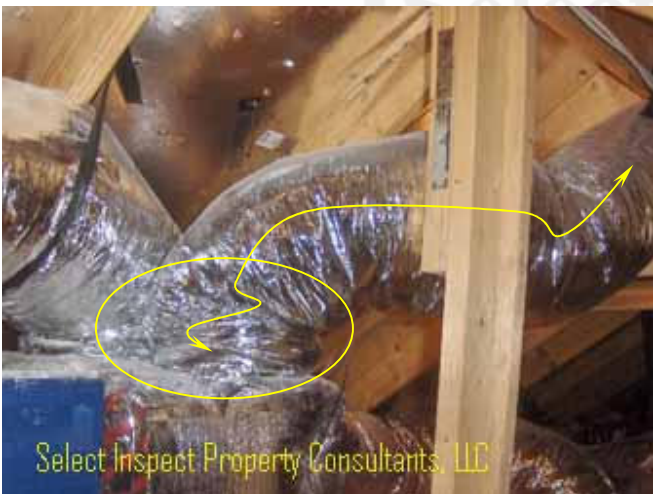
- ✦ Crimped and or partially constricted ducting was noted at multiple locations. Tight strapping or sharp turns can restrict efficient airflow. Correction / improvement would be prudent.
- ✦ Ducts in various sections are inadequately secured. Repair would likely improve HVAC efficiency. You should contact an HVAC specialist to examine all related HVAC components and recommend improvement, repair or replacement options as needed.

↑ crimped & inadequate support of air ducting; example

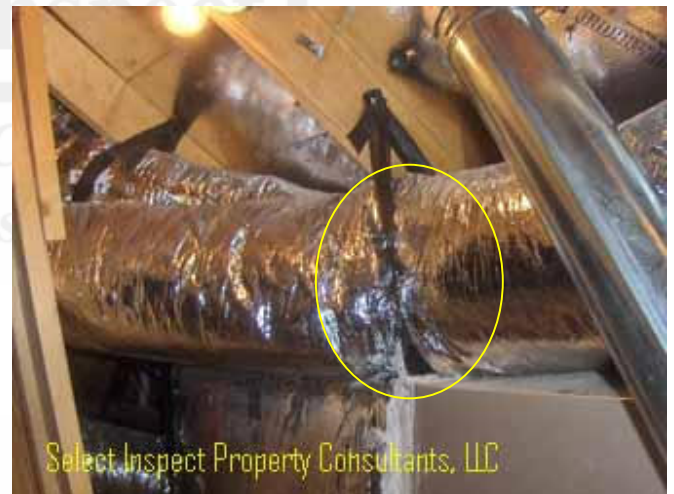
↑ crimped air ducting; example

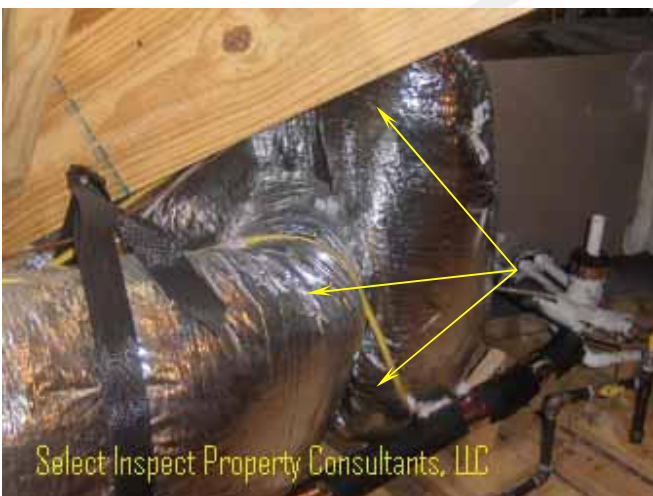
↑ crimped air ducting; example

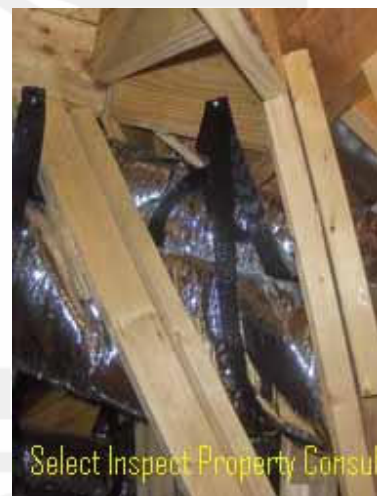
↑ crimped air ducting; example

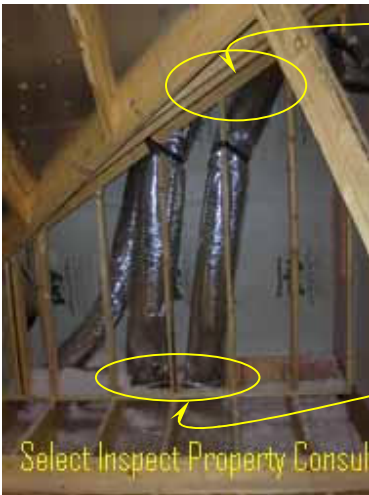
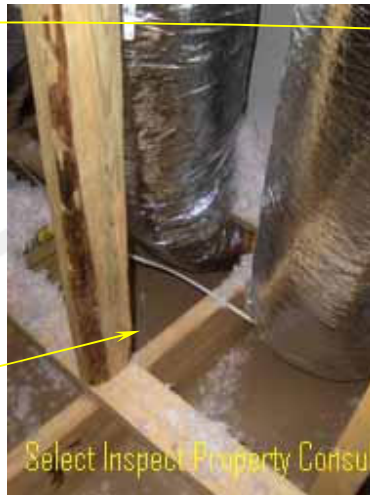
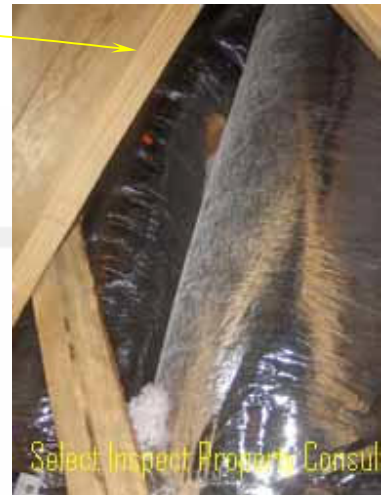
↑ crimped & inadequate support of air ducting; example at garage attic

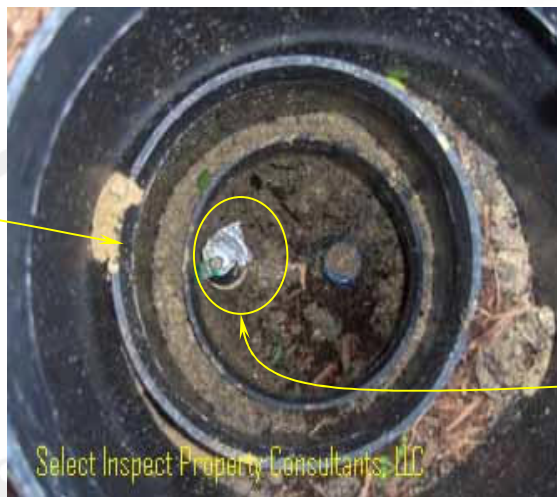
- ✦ Pressure regulator strain cap did not have recommended 3" clearance from soil.
- ✦ Shut-off valve did not have recommended 3" clearance from soil.
- ✦ Water piping was not adequately insulated at various locations (IRC 2603)
- ✦ Upstairs bathroom southeast hot at the shower had low flow as compared to other fixtures
- ✦ NOTE: Water pressure was approximately 65psi; 40-80 psi is recommended range.

↑ pressure reducing valve had inadequate clearance from soil; Shut-off-valves require 3" clearance from soil

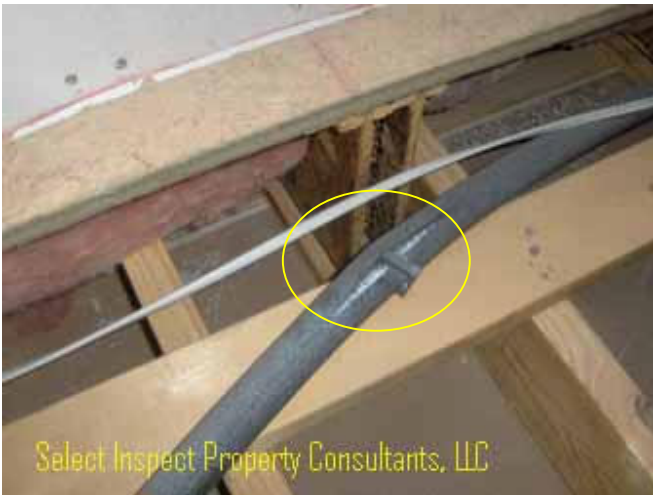
↑ unworkmanlike securing of plumbing pipe; insulation amiss; garage attic

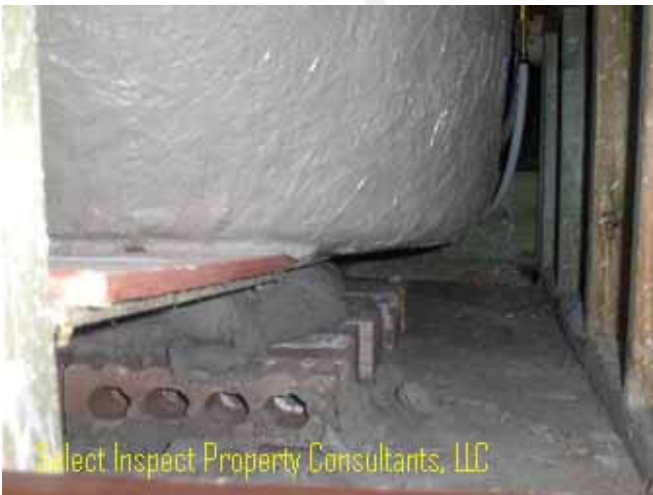
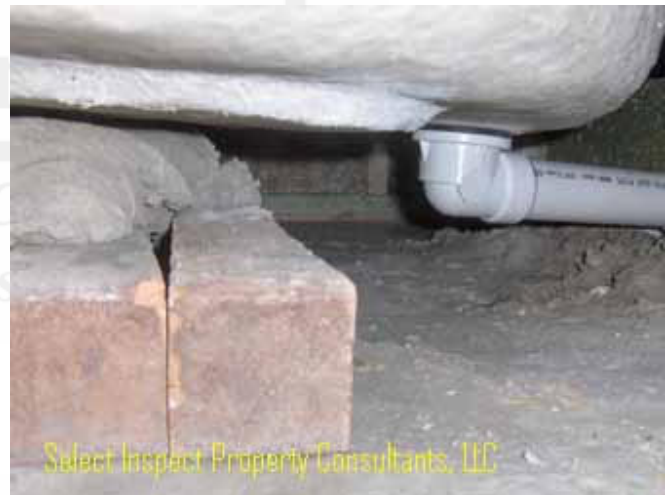
- ✦ Upstairs bathroom southeast faucet leaks when in "off" position
- ✦ Master bathtub was inadequately supported below.

↑ inadequate support of master bathtub

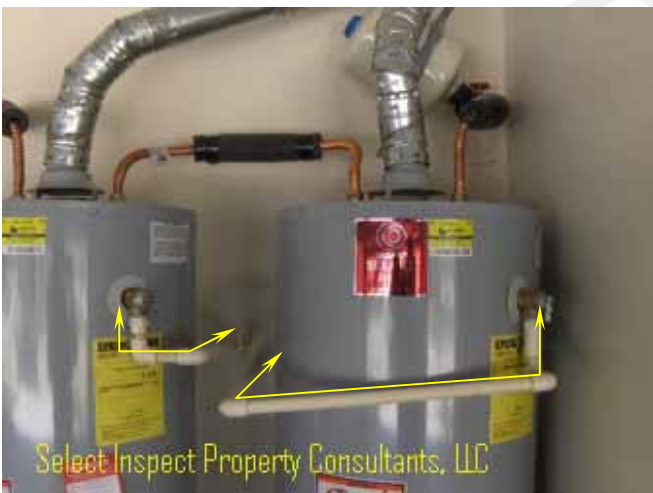
- ✦ The temperature-pressure-relief valve piping was smaller than required by temperature/pressure relief device manufacturers for this application; 3/4" cpvc (hot water PVC) as found in this home is frequently used and is commonly accepted by city code around the USA, however, the 3/4" material does not meet manufacturer specific requirements. T&P valve manufacturers require that the interior diameter of the drain line not be less than the interior diameter of the discharge section of the valve – a standard 3/4". The 3/4" CPVC tubing in use measures an average 0.715" interior diameter (technically .035" less than required). If CPVC is to be used it would need to be 1" O.D. cpvc to conform to IRC P2803.6.1.

↑ water heater temperature/pressure relief piping was smaller than required by the device manufacturer

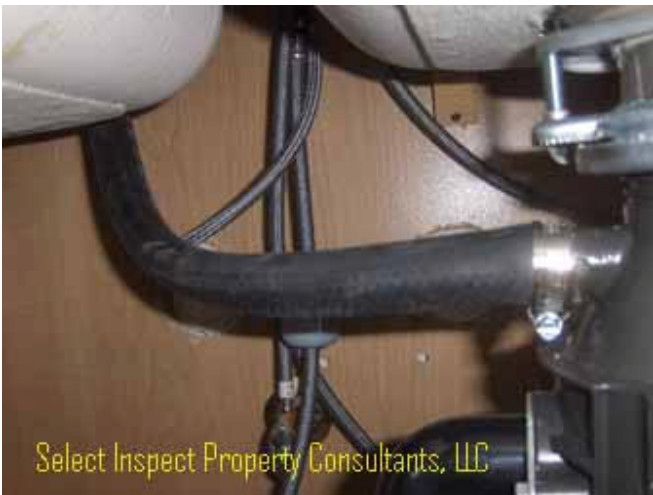
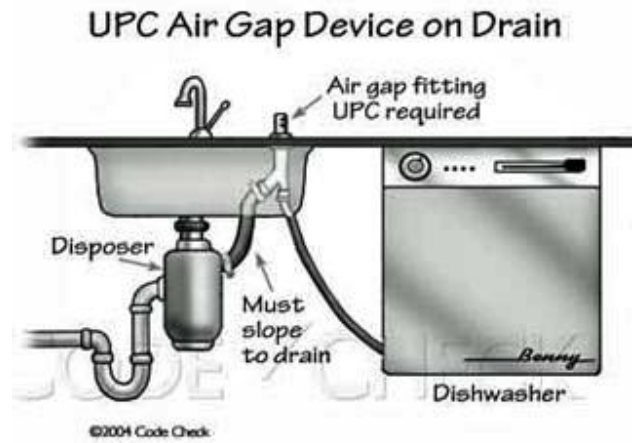
- ✦ The anti-siphon device at the dishwasher was not properly routed for gravity drainage to the disposal/drain. Correction is recommended & usually simple.
- ✦ Dishwasher Not present

↑ drain for the dishwasher was slightly routed uphill; this should gravity drain from the backflow device
