Select Inspect
Property Consultants, LLC

Inspection of New Property

at: 123 street; Parker, TX 75002

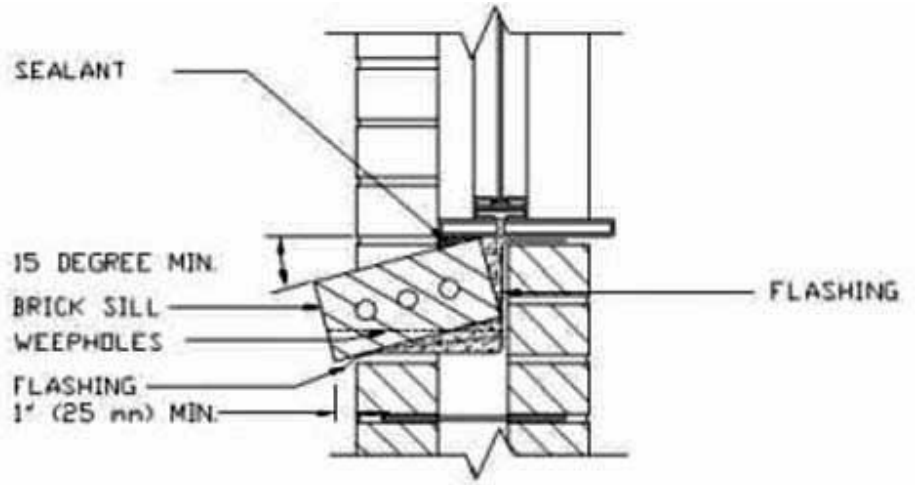
Exterior window sills did not have a recommended 15° slope for drainage at multiple locations; slope at random locations was approximately -1, 1, 3, 5, 9° Repair options may be limited. Condition & appropriateness of flashing & substrate components is undetermined.

↑ brick ledge(s) had inadequate slope

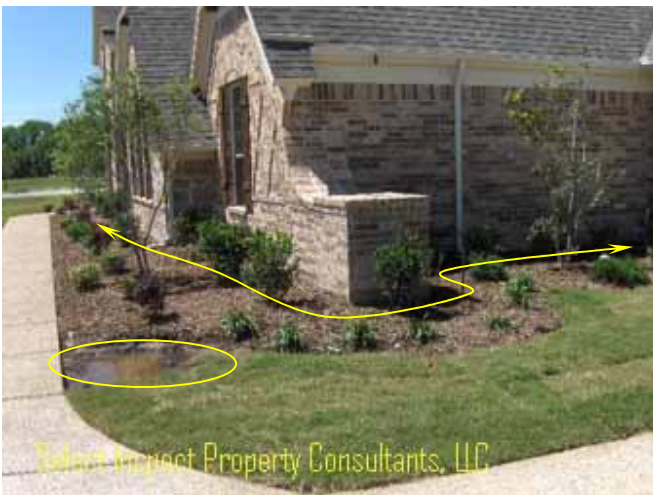
- Low areas were observed that promote slow or poor drainage discovered at the north adjacent the driveway & at the northeast. Filling and compacting native soils in these areas is recommended. Modifying soils to properly direct water to an appropriate offsite location is recommended. After soil repair is done, monitor these and other areas for appropriate drainage; repair when necessary.
- Erosion condition discovered at the east-southeast, adjacent the front porch
- Drainage is questionable at the front, north, & west. Recommend monitoring and arranging repair as needed.

↑ pooling water & marginal grading

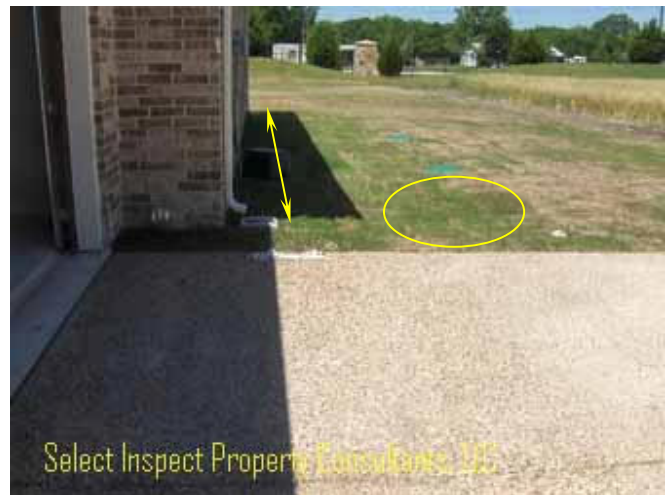
↑ marginal grading/slope & low point at soil

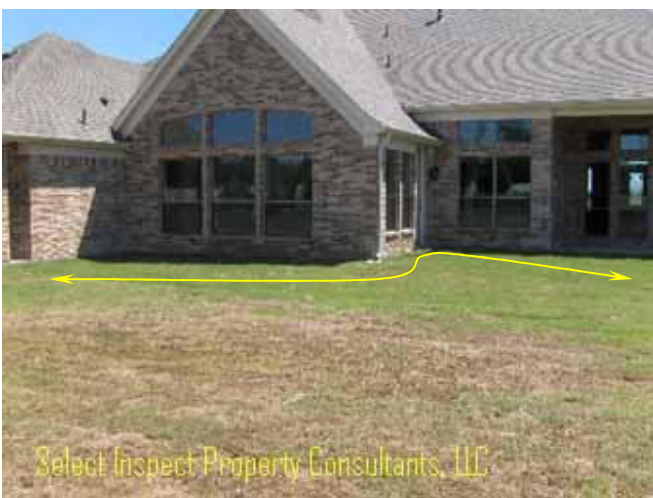
↑ marginal grading/slope

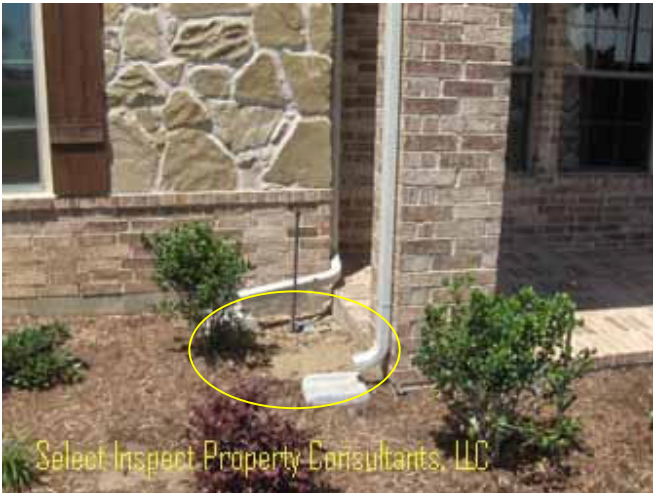
- Gutter-downspouts/drains should terminate at least 6 feet away from the home. This is intended to control erosion that can adversely affect the foundation; especially in areas of expansive soils or easily eroded soil such as sandy loam. However, above ground extension components are often obstructive to lawn equipment and traffic and may be prone to damage. As long as water is directed to an appropriate location at least 6 feet from the home, the need for extensions is very subjective.
- Various splash blocks were noted as being reversed. Technically, the "closed end" of the block should be furthest from the home (to splash and disperse water), and the open end should be directly below the gutter-downspout termination. This is a common error.

↑ erosion left of front porch & reversed splash blocks; rain not directed to terminate minimum 6 feet from structure

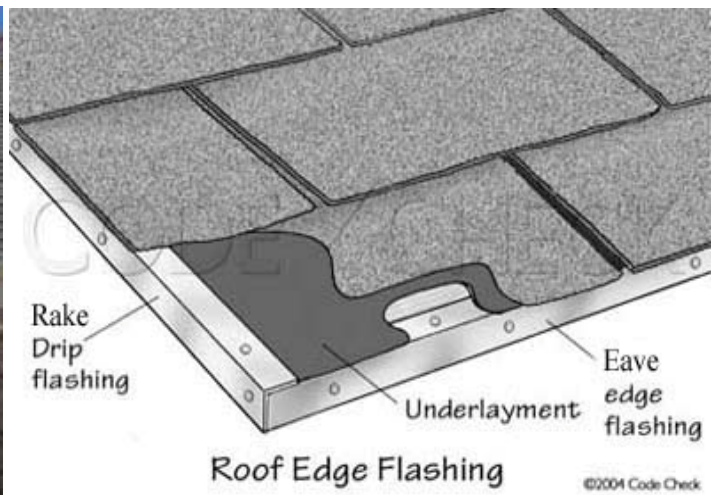
- ✦ Felt paper is improperly below, rather than atop drip-edge-flashing at eaves & above rather than below at rakes. Felt is to be below the drip-edge-flashing at the rake (gable sides) but not at the eaves. This is a common roofing error and is incorrect according to the shingle manufacturer; National Roofing Contractors Association's Roofing and Waterproofing Manuals; and IRC. Evidence of leakage or failure was not seen regarding this condition at the time of inspection. Repair options are limited.

↑ example-unworkmanlike drip edge/felt; corners should have no gaps; rake (diagonal) edge & roof felt should be atop the eave (lower) edge flashing; roof underlayment should be under rake flashing. Also shown- metal protruding below shingle

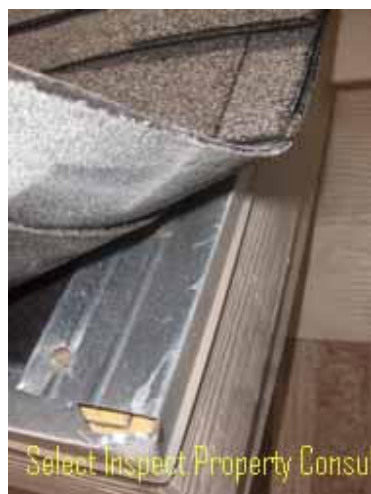
↑ unworkmanlike drip edge flashing & roof underlayment

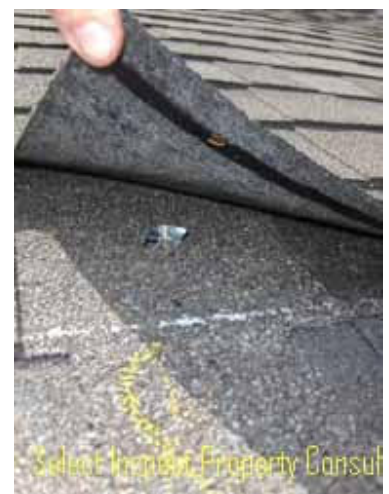
- ✦ Worn shingles discovered at the west & south.
- ✦ Bent metal of undetermined purpose was discovered below a shingle at the north-northeast.
- ✦ Split/damaged shingle tabs discovered at the southwest, west, northwest.

↑ metal beneath shingle

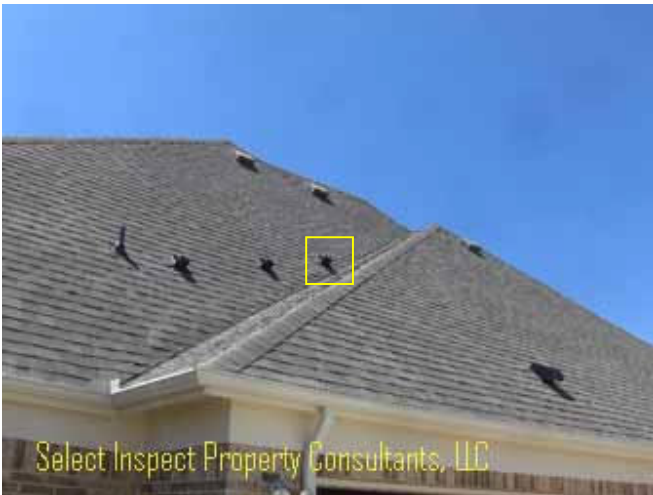
- ✦ Flashing is amiss / incorrect at multiple locations; (related image(s) at the end of this document) Correction / improvement would be prudent.
- ✦ Exhaust fan vent was closer to a ridge or valley than recommended by the Asphalt Roofing Manufacturer Assoc. Vents, flues & fenestrations should be minimum 6 inches away from valleys & ridges, to reduce likelihood of moisture intrusion at these roof penetrations.

↑ vent/flashing closer than minimum 6" from valley; north

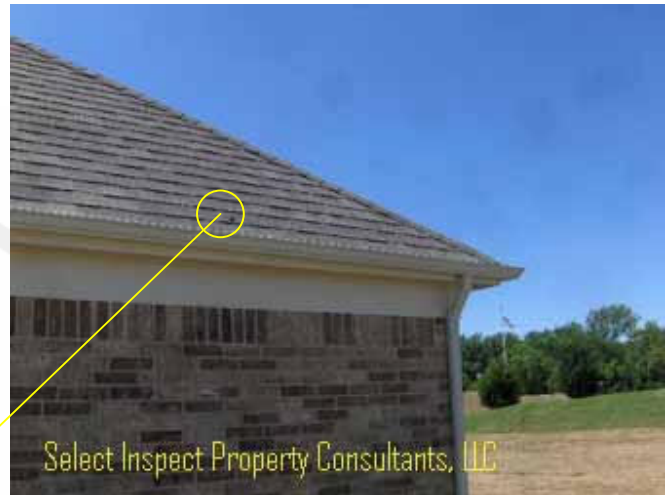
↑ example damaged shingle tab; northwest

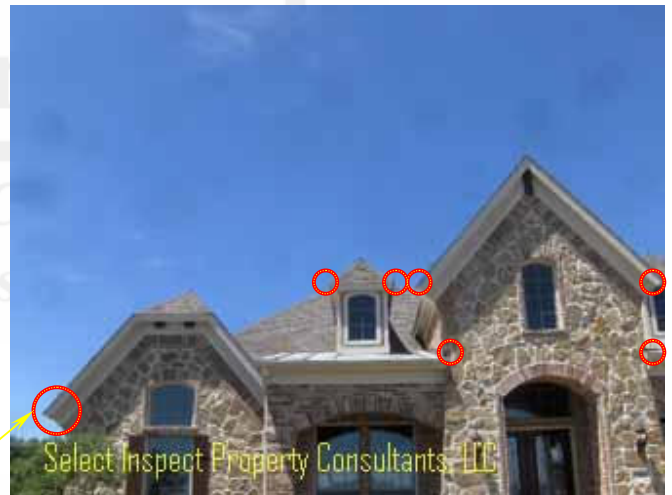
↑ example-unworkmanlike drip edge/felt; corners should have no gaps; rake (diagonal) edge & roof felt should be atop the eave (lower) edge flashing; roof underlayment should be under rake flashing

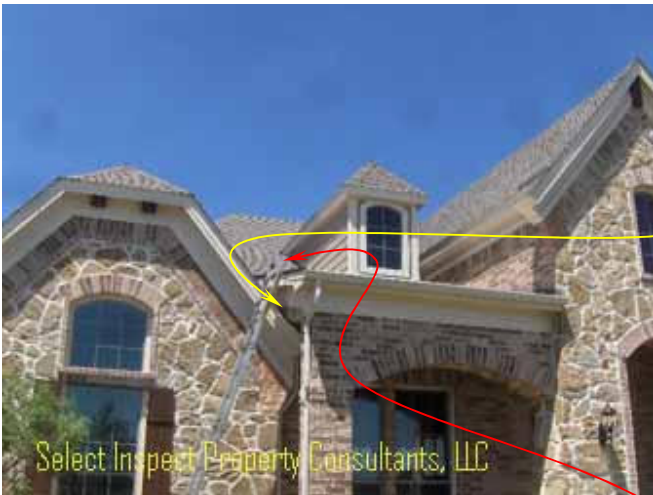
- ✦ Flashing is uplifted at the west-southwest flue. Recommend securing and sealing as needed to reduce moisture intrusion potential.
- ✦ Step flashing at the rear porch converging valley was inadequately lapped.

↑ unworkmanlike flashing & converging valley; very prone to moisture intrusion

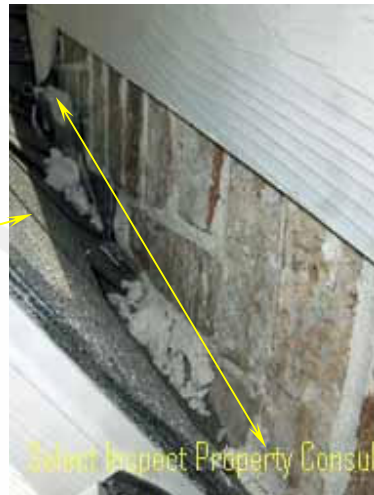
↑ close view of image at left; amiss flashing, debris; openings

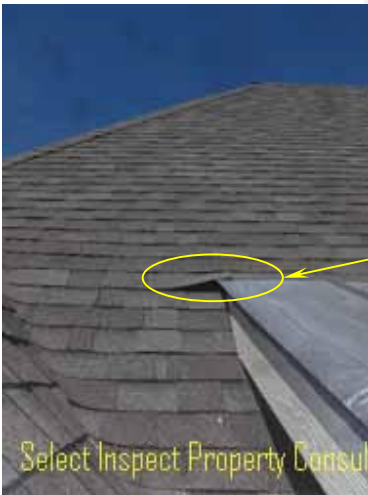
↑ inadequately sealed shingle lap

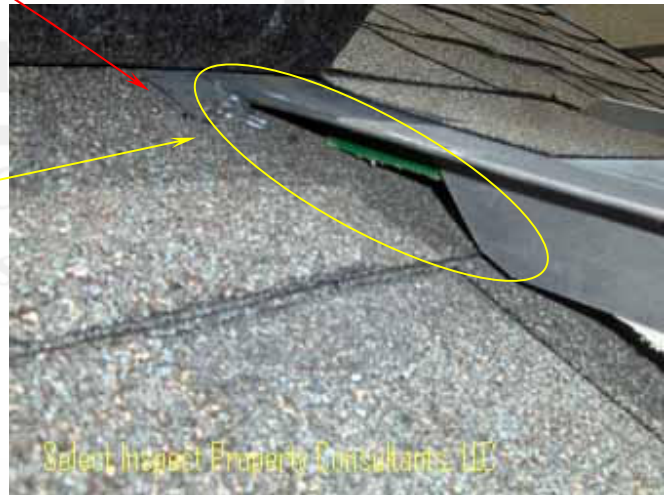
↑ short flashing; openings, visible roof deck; prone to moisture intrusion

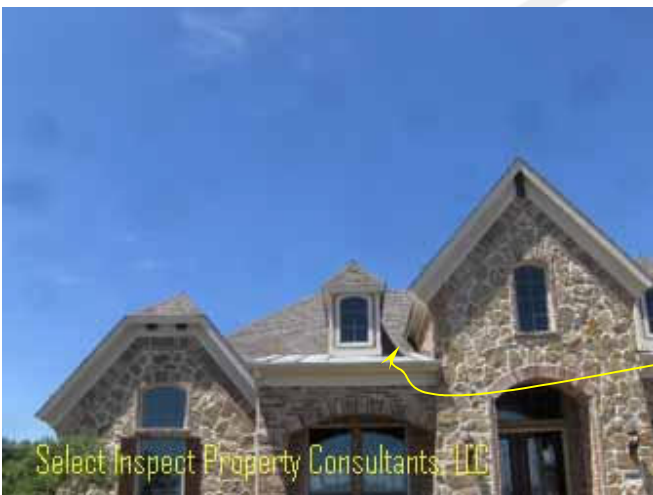
↑ opening; daylight seen from attic

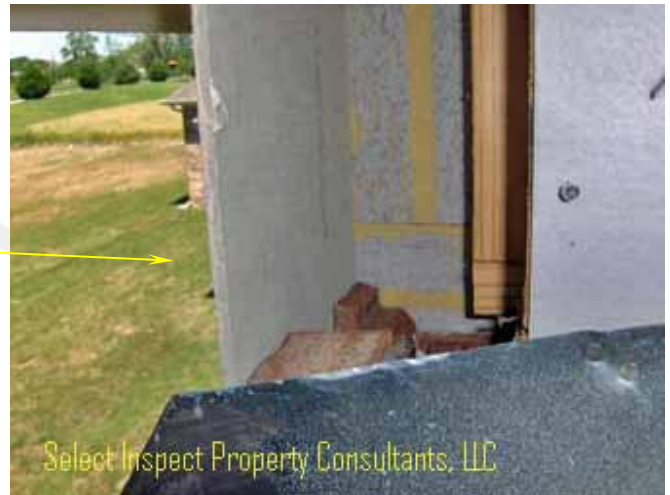
↑ close view of image at left; incomplete vapor barrier/sheathing, exposed framing; opening to wall void & attic space

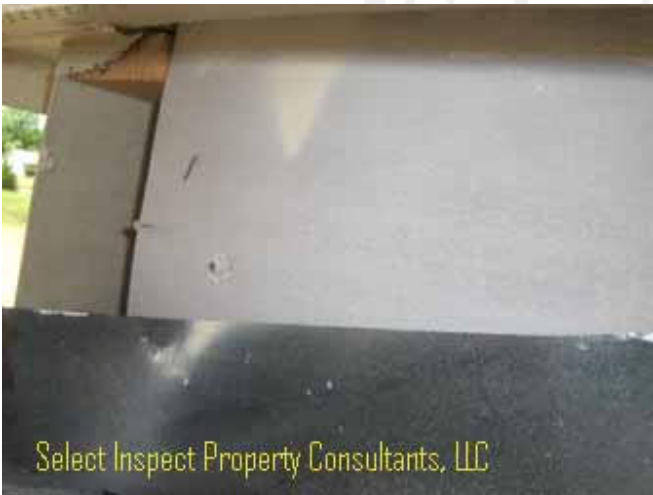
↑ close view of image above; missing siding, trim & exposed framing

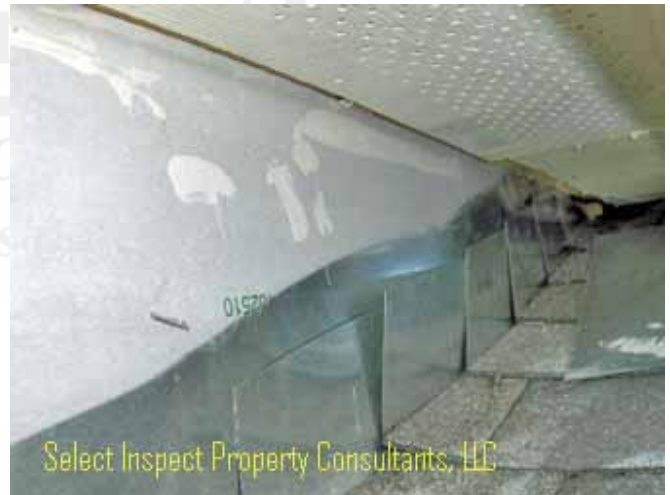
↑ close view of image above; openings & inadequate lapping of step flash; missing wall/counter flashing

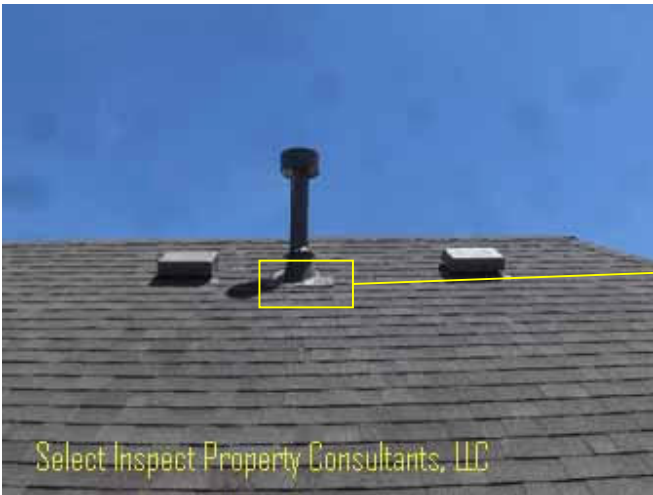
↑ lifted flashing at flue; west-southwest

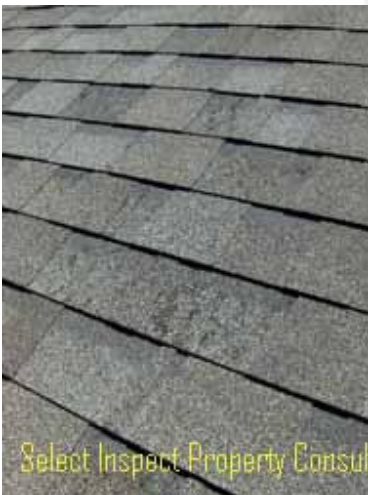
↑ worn shingles discovered at the west & south; example at the west

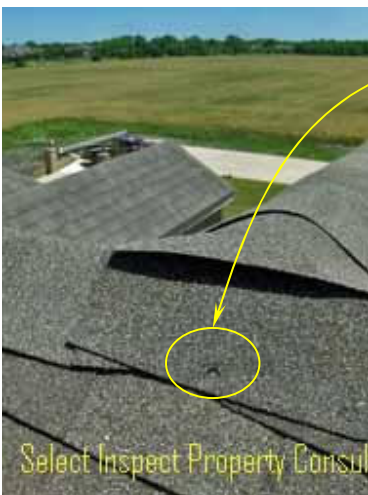
↑ example overdriven nails & uncaulked, exposed fasteners

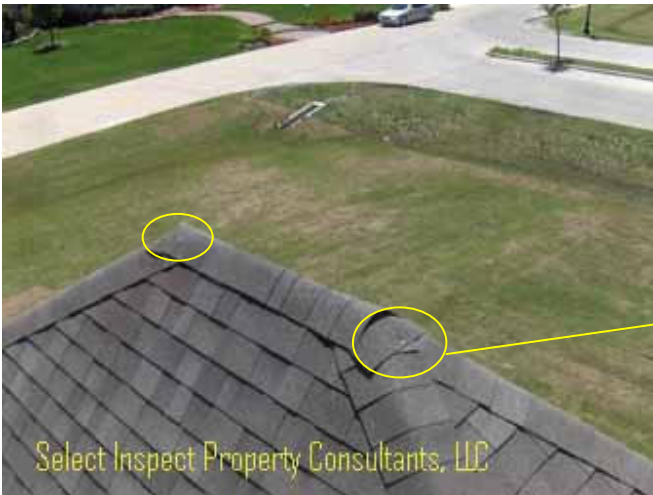
↑ unworkmanlike nailing; example

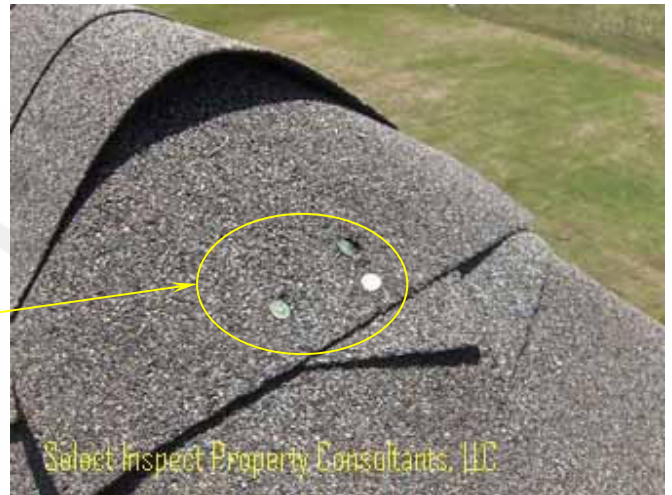
↑ askew/crooked, overdriven, & uncaulked, exposed fasteners

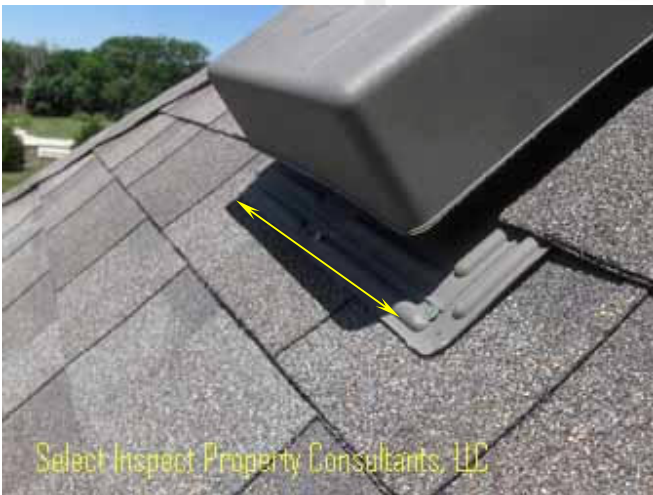
↑ example uncaulked, exposed fasteners at roof vent; center nail under driven

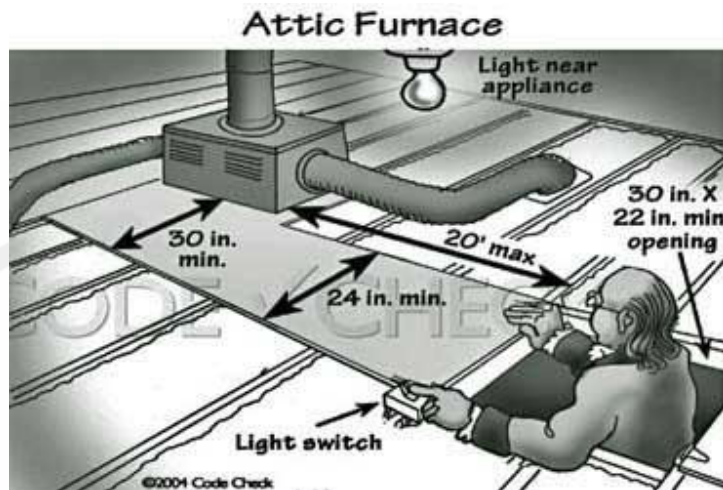
- ✦ Attic floor is unworkmanlike; deck has multiple inadequately secured boards, multiple level changes, openings/gaps, etc.
- ✦ There was not a clear, solid (having no gaps), unobstructed 24" floored pathway to the mechanical system(s) from the access. This is considered a safety risk for persons examining or servicing the mechanical systems (HVAC, water heater, etc).

↑ there should be a minimum 24" pathway to the HVAC from the top of the access, with no gaps or obstructions; need to add appropriate decking at sides or reverse the stair/ladder

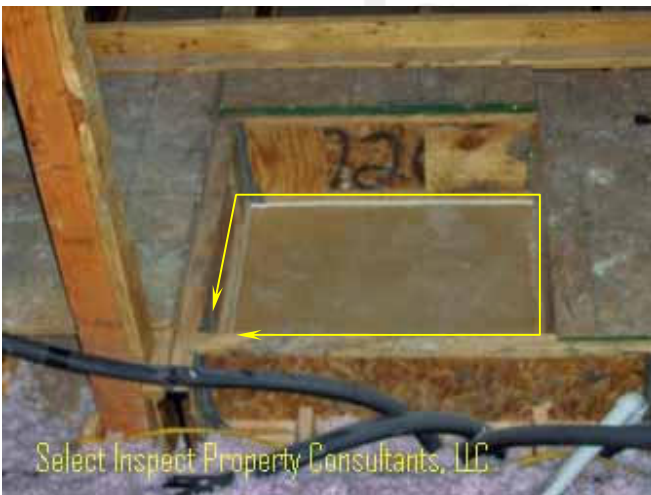
- ✦ Garage Attic hatch was deficient, seals poorly. Some degree of energy efficiency loss is likely; in an attached garage, the condition also deviates from smoke separation / fire spread provisions.

↑ inadequate seal at garage attic hatch

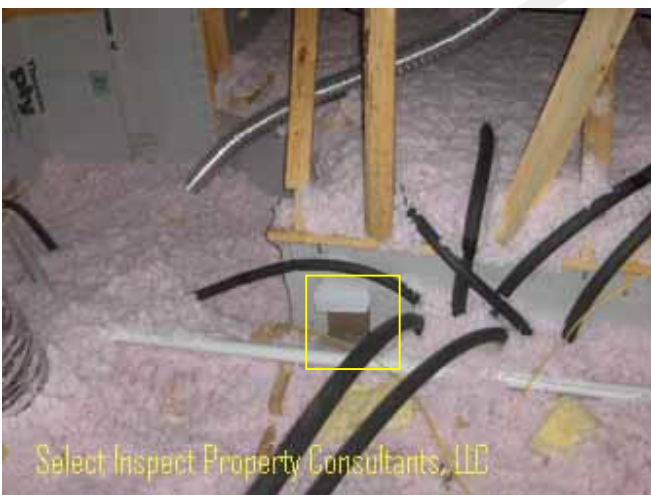
- ✦ Missing section of insulation was discovered at the northeast corner of the master bathroom area.

↑ missing insulation section adjacent the master bathroom-northeast

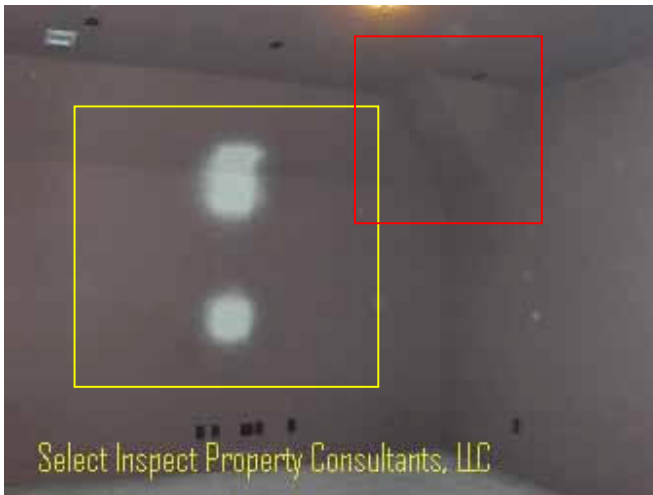
↑ Thermal imaging implies energy loss at the media room; *patches may have missing insulation behind, or may still be cooler from recent drywall work

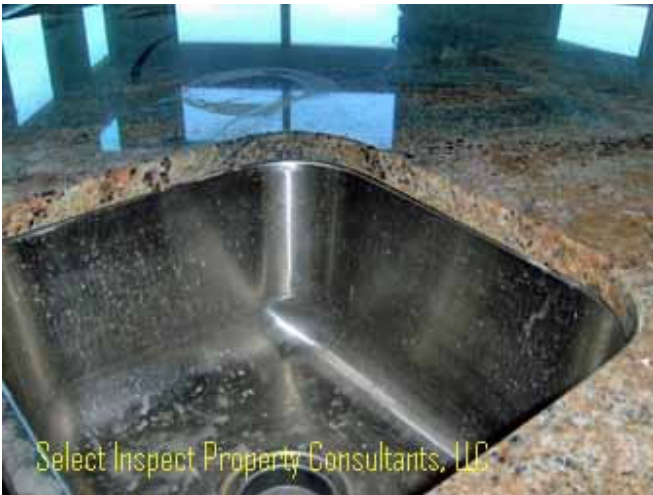
- ✦ Hinges rub doors at the bar upper right.
- ✦ The kitchen sink(s) is installed with the counter overlapping the sink edge. This is called a “fouling area” and is prone to unsanitary bacterial accumulation under the edge, and is difficult to keep clean for food preparation / sanitation concerns. Fungus or bacteria may be present in the overlapping edges. Options are limited. Caulking the joint may improve the condition, though ideally the counter should be cut to not overlap the sink. At the least, keep the area clean and monitor the caulked joint for touch-up/repair needs. (UPC 401.1)
- ✦ Granite countertops, if present, are not tested for presence of or levels of uranium or radiation. Related information can be found at: <http://selectinspect.com/links1.htm#radonlink>

↑ fouling area at kitchen sink is prone to bacterial contamination

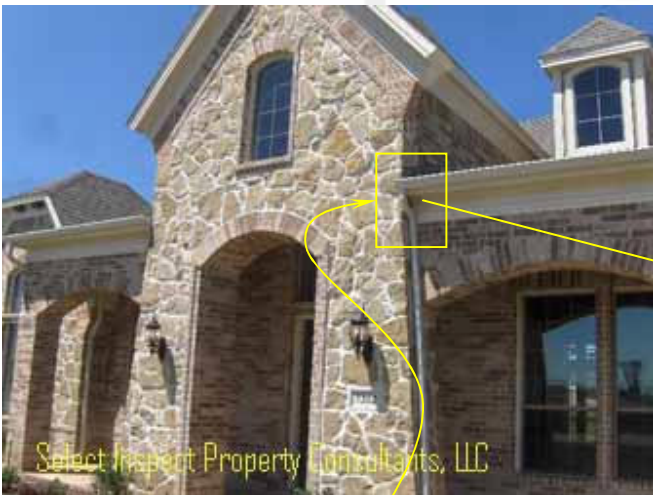
↑ openings discovered

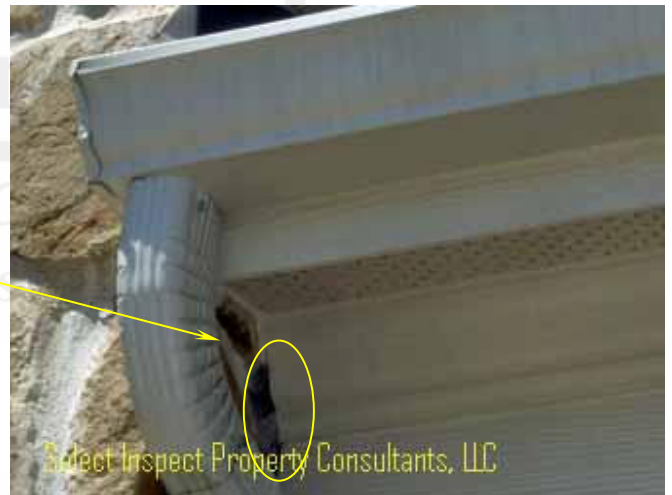
↑ close view of image at left; sealant needed

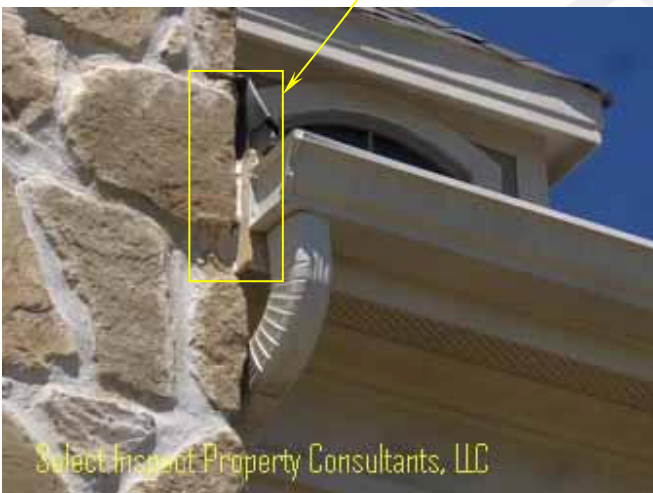
↑ close view of image above; sealant needed & unpainted frieze-board

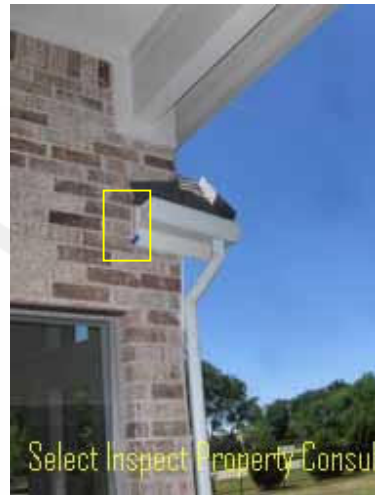
↑ unpainted exterior trim

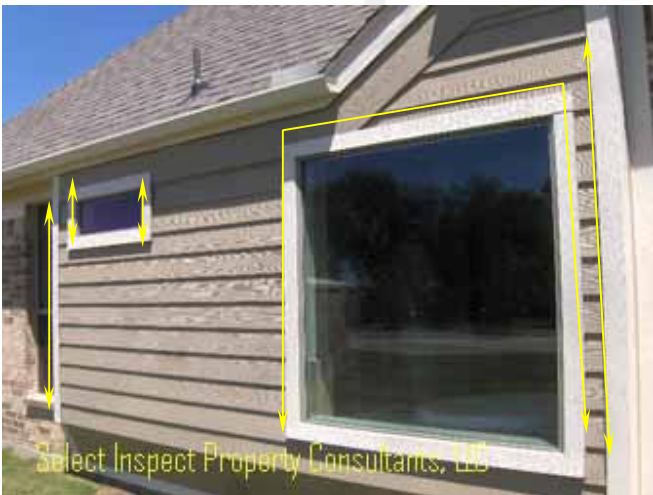
- ✦ Recommend caulking vertical & horizontal siding / trim joints & all nail heads at siding & trim, dormers, windows, etc.
- ✦ Trim / flashing is amiss at a roof eave / wall junction at the east & west. Technically there should be no openings greater than 1/4” at the exterior.
- ✦ Incomplete siding, trim, flashing exists at the rear porch southwest.
- ✦ Unpainted siding/trim discovered at the rear porch southwest, over the gameroom door, & at the right of the front porch.

↑ trim, siding, window joints should be sealed; examples

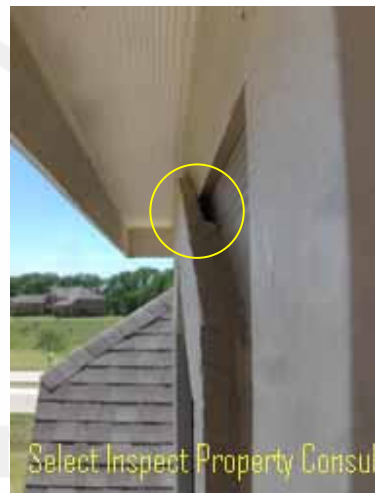
↑ openings discovered above dormer window trim

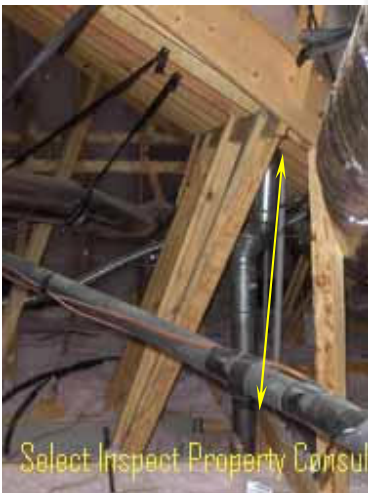
- ✦ Flue was inadequately secured; discovered at the attic. Correction/improvement of this and other related conditions is recommended.

↑ fireplace flue (this image), east water heater flue, & east HVAC flues were inadequately secured in the attic.

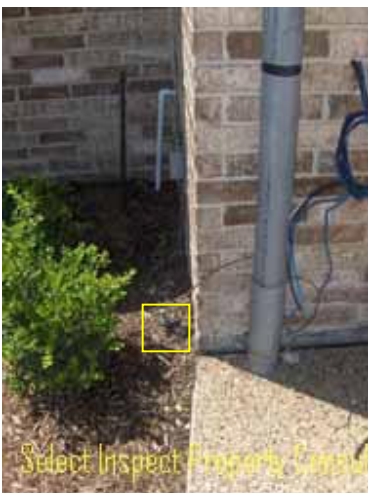
- ✦ Electrical ground rod was not flush with the grade. "Electrical ground rod shall have at least 8' of length in contact with the soil and the upper end of the electrode must be flush with / below ground level unless above ground portion and grounding electrode conductor attachment is protected against physical damage. NEC 250-52 (c) (3)". This includes rod electrodes installed inside through concrete slabs.

Grounding rods are typically sold as 8 foot lengths; since the upper end of the rod has been left above grade, it is most likely not in contact with the soil for 8 feet as required. Since much of the rod is buried, the suspected condition cannot be confirmed nor discredited during this limited visual inspection. The grounding electrode connection is prone to physical damage and should be protected and secured to the structure or service riser. The rod should be covered with compacted soil or driven deeper into the soil. A grounding rod that protrudes from the ground / grade may also present an impalement hazard. Repair options are limited; and though this is technically incorrect, proper installation methods are rarely discovered, and frequently ignored by installers and city building code officials.

↑ grounding electrode protrudes grade; deficient

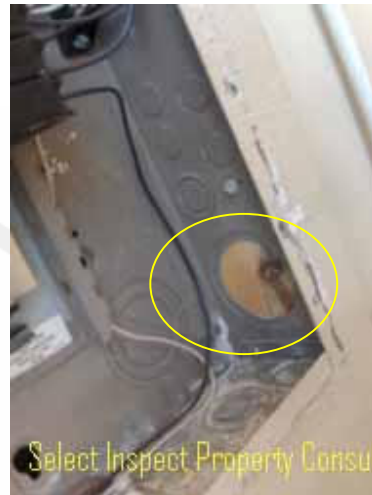
- ✦ Knockouts were amiss at the panel box. Excess "reveal" exists at the electrical box. Junction boxes and related covers shall be flush and adequately sealed where mounted; Ideally no openings greater than 1/8". This is to control potential fire-spread, and not for cosmetic reasons.
- ✦ Texture or paint overspray exists in the panel(s). This can cause poor connection between the breakers and related electrical equipment. Consult an electrician for options.
- ✦ This new home only has arc-fault-circuit protection serving bedroom circuits. As of 2009, the National Electric Code (NEC) requires Arc-Fault protection (AFC) at circuits serving: *family rooms, dining*

↑ missing knock-out; Deficient excess reveal exists in electrical cabinet

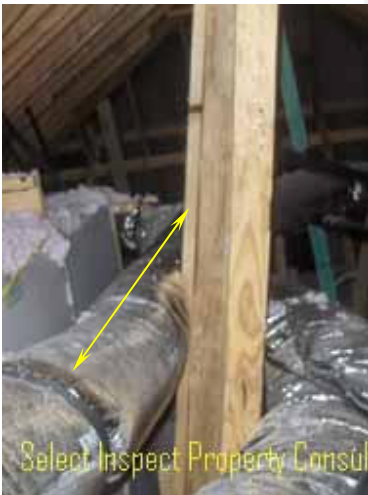
- ✦ Duct at the west of the foyer was crimped between the foyer wall & adjacent framing; raising this section of duct with appropriate support should correct the condition.

↑ crimped air ducting; example at the west side of the foyer

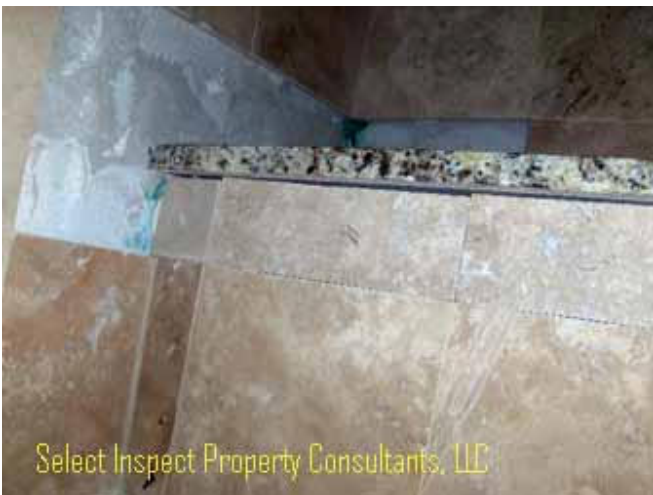
- ✦ Sealant needed at the top tile/panel edge at the wall of the master & east-northeast showers to reduce potential for moisture intrusion and fungal accumulation at the shower substrate (between the shower and walls)
- ✦ NOTE: Multiple cosmetic details that could use touch-up were marked with easy-release blue tape; some of these areas include: trim, walls, ceiling

↑ openings, missing tile, damaged cement board joints, & missing grout at master shower; appears to be "in progress"

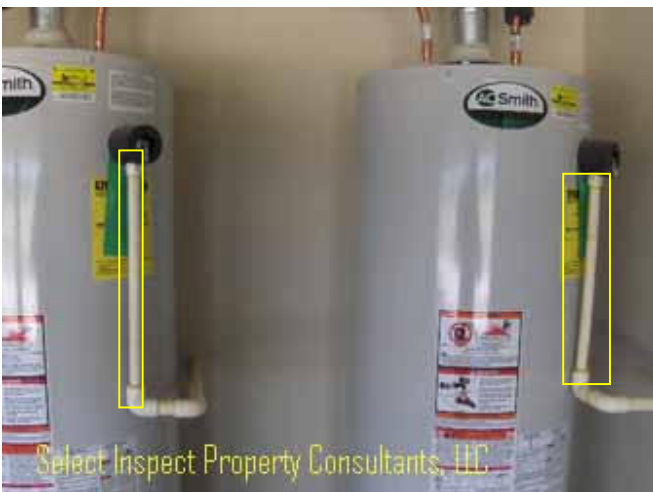
↑ water heater temperature/pressure relief piping was smaller than required by the device manufacturer
