1776 Coast Guard Blvd
Inspected Address

**TEXAS OFFICIAL WOOD DESTROYING INSECT REPORT**  
**Diagram of Structure(s) Inspected**

**Addendum to the Texas Wood Destroying Insect Report**  
Page 1 of 3 that supports the SPCB WDI report

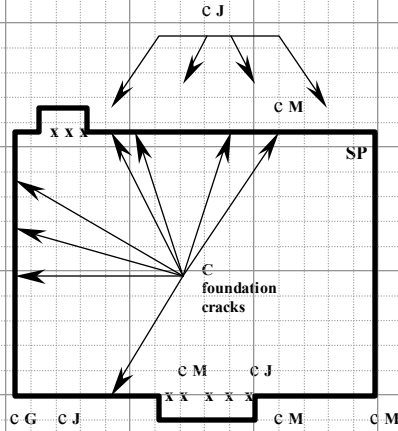
The inspector must draw a diagram including approximate perimeter measurements and indicate active or previous infestation and type of insect by using the following codes: E-Evidence of Infestation, A-Active; P-Previous; D-Drywood Termites; S-Subterranean Termites; F-Formosan Termites; C-Conducive Conditions; B-Wood Boring Beetles; H-Carpenter Ants; Other(s) – Specify \_\_\_\_\_ **SEE ADDENDUM for comments about discovered evidence of prior or current wood destroying insects.**

Evidence of some form of past treatment was indicated by markings of drilled holes at the front and rear porches. The extent of treatment, type of chemical(s), effectiveness of treatment, and other conditions remain undetermined. Refer to the seller or occupant for possible related information. Prior evidence of subterranean termites was indicated by tunnel material at the southwest corner of the garage. Refer to the seller's disclosure for possible information regarding this item. The extent of damage is undetermined, and often requires removing building materials. Excavation and subsequent repair of hidden damage and related areas is often not cost effective, though sometimes considerable damage is discovered. Depending on the risk you are willing to accept, the cost of invasive investigation may be subjective.

Refer to the diagram for locations of evidence, if such evidence was discovered.
