**Complimentary
Wood Destroying Insect
Report**

at
2468 Army Rd; Patriot, TX

Select Inspect Property Consultants, LLC

March 4, 2008

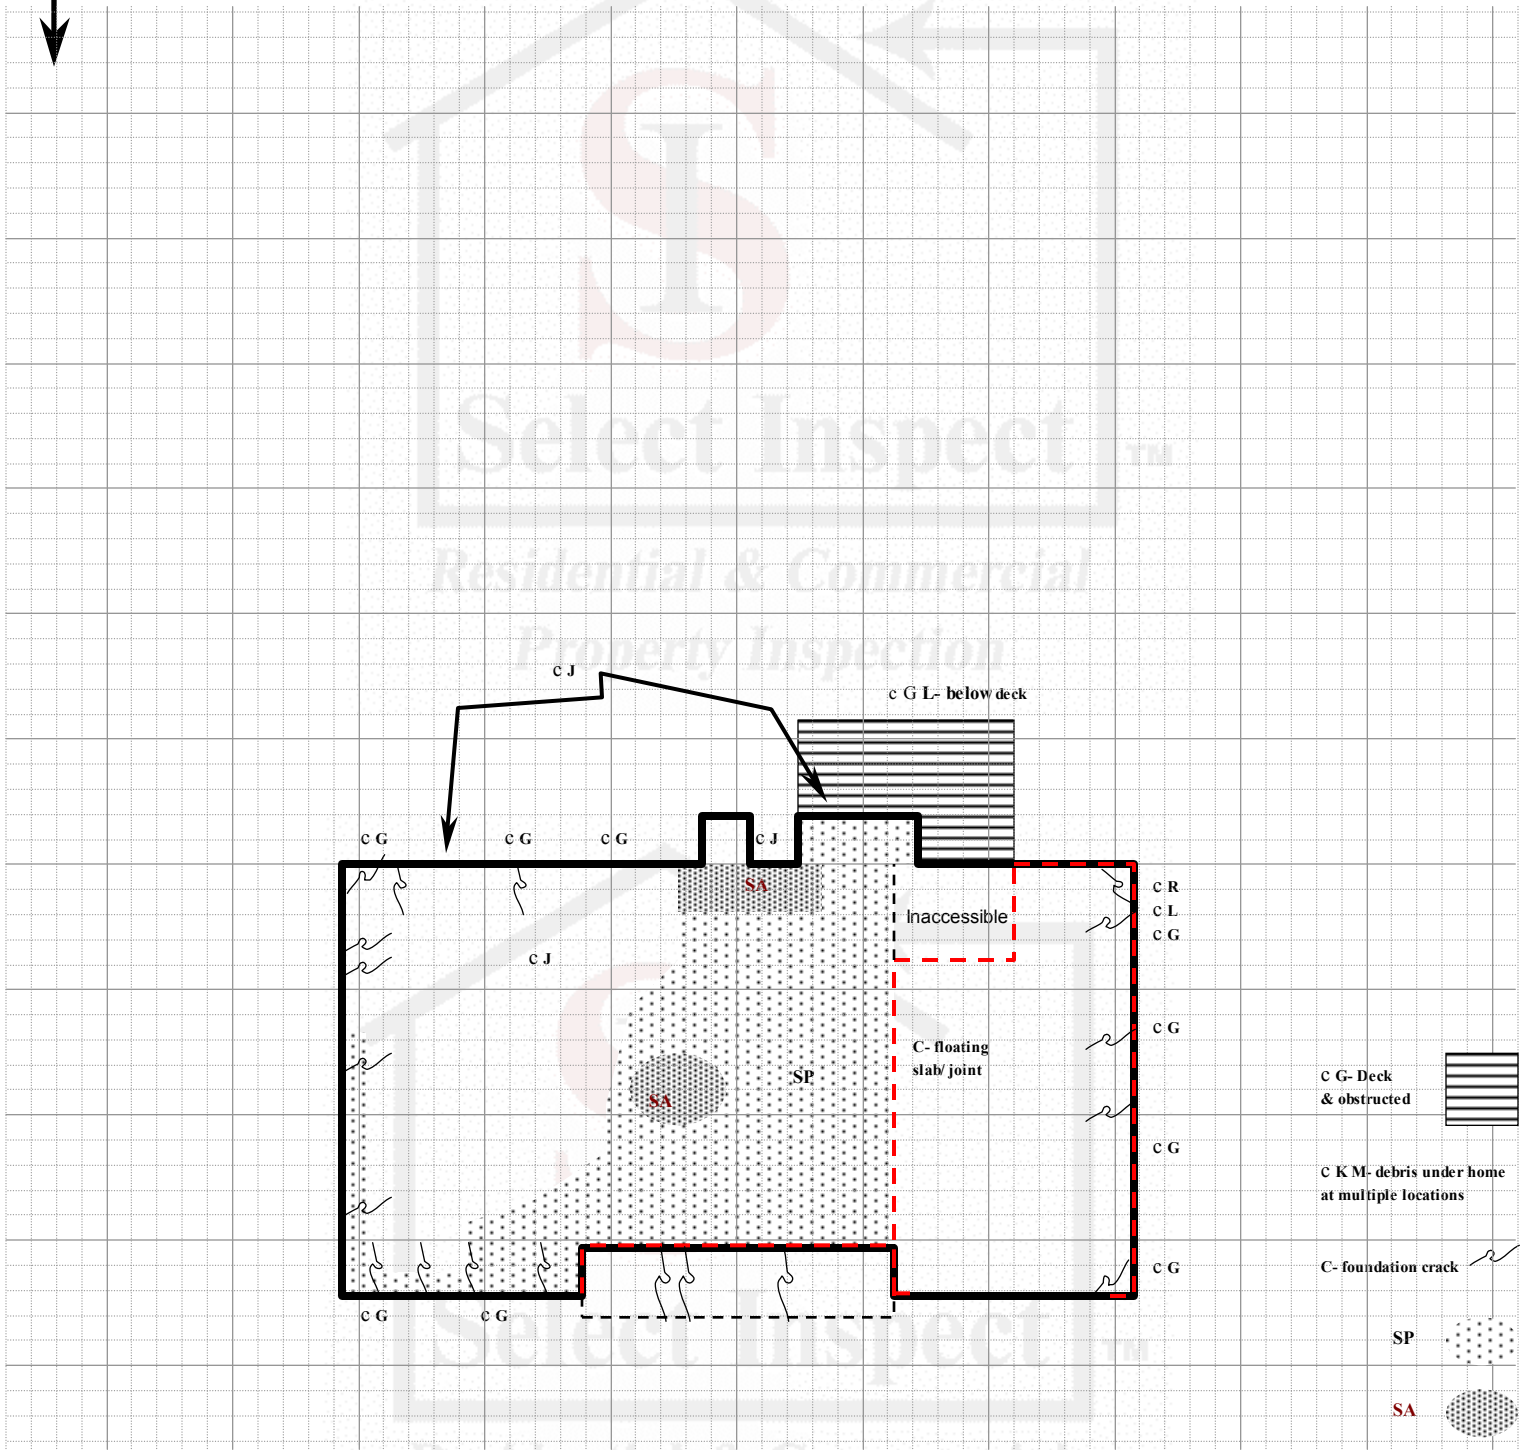
Diagram of Structure(s) Inspected

Refer to the diagram for locations of evidence, if such evidence was discovered. Photo images are on the last page of this document

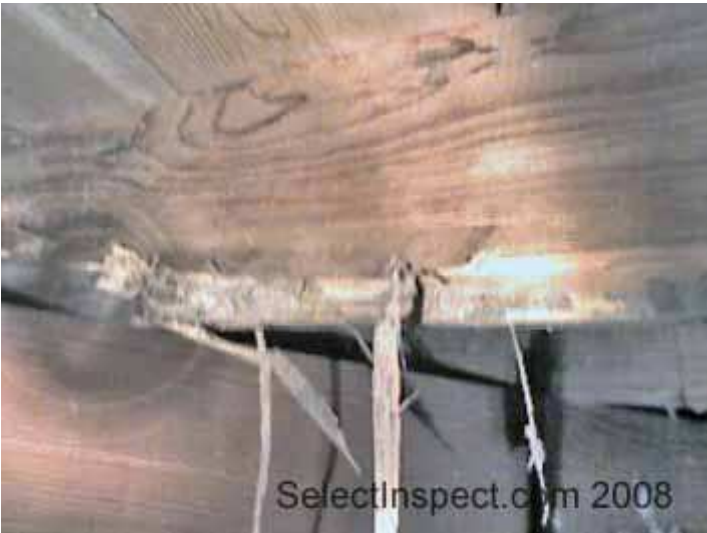
Prior evidence of subterranean termites was indicated by damaged woods and shelter tubing at the crawl space below the bathrooms, hall, family room, dining room, bedrooms, kitchen, living room. Refer to the seller's disclosure for possible information regarding this item. The extent of damage is undetermined, and often requires removing building materials. Excavation and subsequent repair of hidden damage and related areas is often not cost effective, though sometimes considerable damage is discovered. Depending on the risk you are willing to accept, the cost of invasive investigation may be subjective.

↑ wood destroying insect damage at sub floor

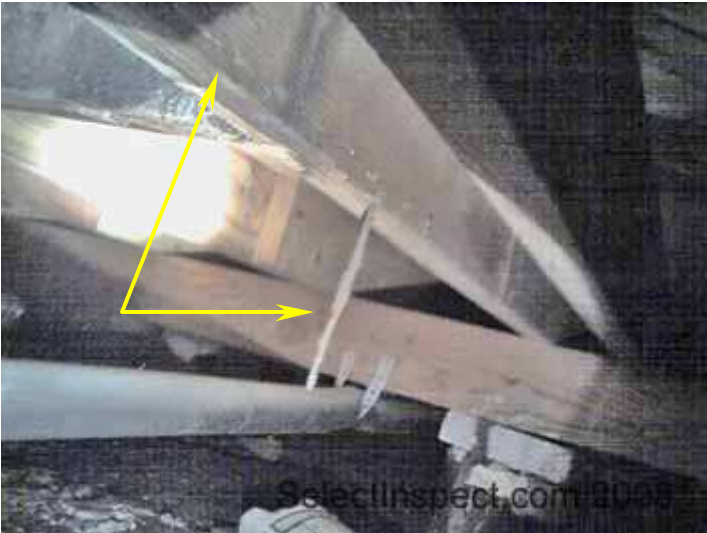
↑ subterranean termite shelter tubes and damage at crawl space framing

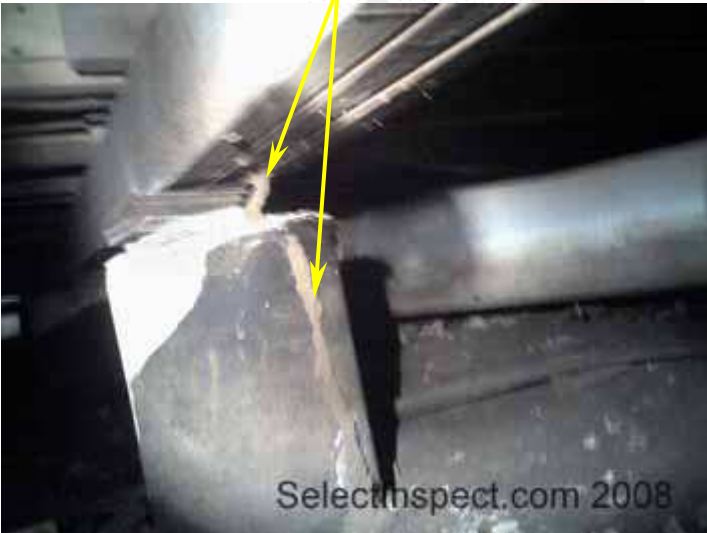
Active subterranean termites were observed at the crawl space below the entry/family room hall. Treatment is recommended. The specie of termite is not specifically identified by this inspection, and should be conclusively determined by the company performing treatment, prior to treating the property. Extensiveness of damage is undetermined, especially in concealed areas including but not limited to stucco (artificial or real), foamed insulation, inaccessible crawl space locations, wall voids, siding substrate, etc.

↑ active subterranean termites at crawl space- pier

Treatment is recommended - Active wdi discovered;

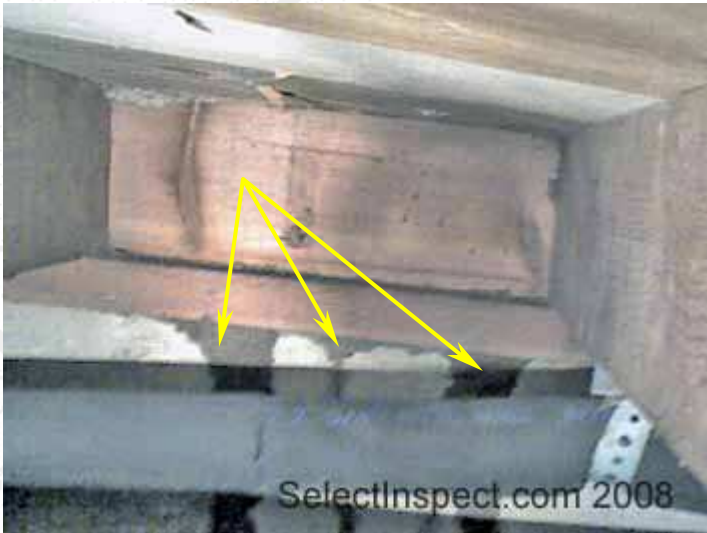
Large inaccessible subterranean termite shelter tubes were discovered behind the HVAC ducting on the west foundation wall and framing below the family room. Suspect these have active termites within.

↑ large subterranean termite shelter tubes inaccessible at west crawl space; suspect active subterranean termites inside
