**Complimentary
Wood Destroying Insect
Report**

at
104 Ranger Pl; Freedom, TX

Select Inspect Property Consultants, LLC

February 25, 2008

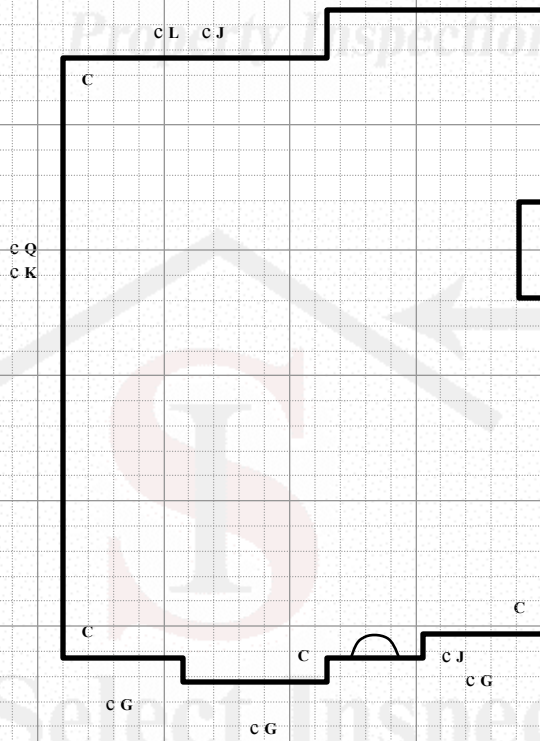
Diagram of Structure(s) Inspected

- Plumbing penetrations through slab foundations are conductive by design. It is undetermined if this home was pre-treated during construction.
- Refer to diagram for general location of conductive conditions noted below and other important information.

ADVISORY: Recommend correction of conductive conditions when economically feasible if you are unwilling to accept the risk and responsibility of monitoring and maintaining the property.
