**Complimentary  
Wood Destroying Insect  
Report**

at  
**789 Airborne; Freedom, TX**

**Select Inspect Property Consultants, LLC**

March 3, 2008

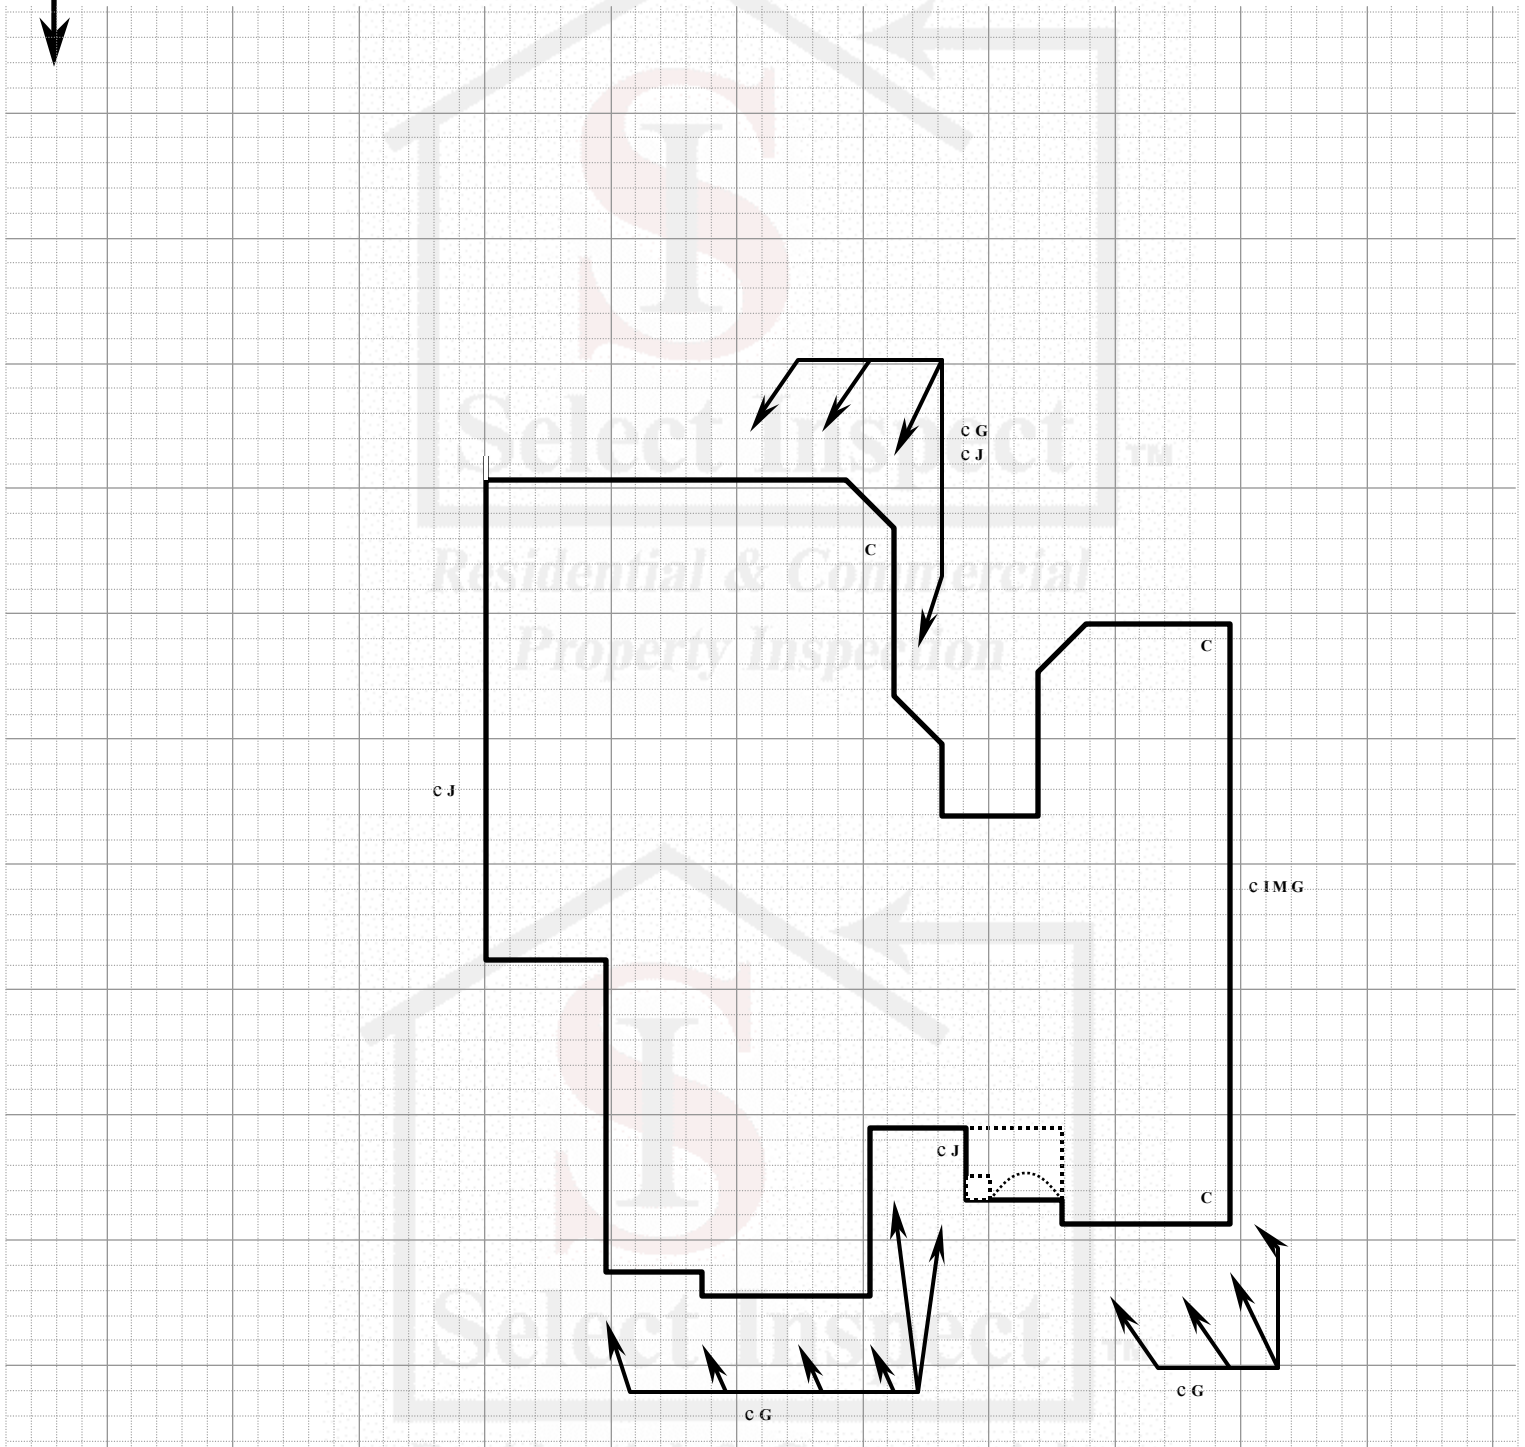
**Diagram of Structure(s) Inspected**

Evidence of prior activity or ongoing activity regarding wood destroying insects was not found at the time of inspection. There may be some conditions found to be conducive; and if present, such is listed in the following comments.

- A foundation corner is cracked at one or more perimeter locations This is common, even on young homes; structural significance is not addressed by this inspection. The joint of the cracked corner and the adjacent foundation is obstructed and conducive to termite entry.
- Attics are obstructive by design. Perimeters, under decking, insulated areas, etc are obstructed, and are not comprehensively inspected. The home in general has obstructed areas including but not limited to wall voids, insulation, floor coverings, cabinets, etc. Even when vacant, the home is NOT inspected on an "inch by inch" basis. This is a limited, visual, cursory inspection. Refer to "Scope of Inspection" on page one.
- Home was Occupied or furnished; many areas not readily accessible and obstructed from inspection.

<input checked="" type="checkbox"/>	<input type="checkbox"/>	<input checked="" type="checkbox"/> <b>(cM) Rot</b> : - moisture damaged wood in, on, or in proximity to the structure.
		<b>Foliage;</b> should be minimum 6 inches from structure
<input type="checkbox"/>	<input type="checkbox"/>	<input type="checkbox"/> <b>(cN) Foliage</b> touching the building; <input type="checkbox"/> <b>Trees</b> touching walls / roof; <input type="checkbox"/> <b>ivy</b> or similar growing on the building
<input type="checkbox"/>	<input type="checkbox"/>	<input type="checkbox"/> <b>(cN) Red-tip-photenias</b> . In proximity to the structure; may also include rot conditions within the shrub.
		<b>Planters; wood piles; fencing; ventilation</b>
<input type="checkbox"/>	<input type="checkbox"/>	<input type="checkbox"/> <b>(cO) Planters</b> - Soil filled; This feature often also includes (L) high soil, and (J) poor drainage conditions

**ADVISORY:** Recommend correction of conductive conditions when economically feasible if you are unwilling to accept the risk and responsibility of monitoring and maintaining the property.
