1924 Sample Street

1A. North Texas Termite Specialists Name of Inspection Company 1B. TPCL 12920 SPCB Business License Number

NTTS Addendum to the Texas Wood Destroying Insect Report

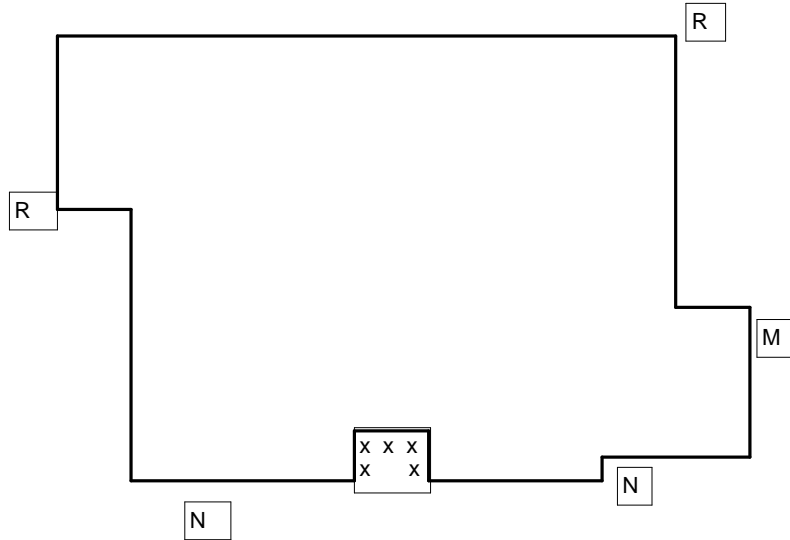
Diagram of Structure(s) Inspected

8G. Visible evidence of: SEE ADDENDUM & Diagram (pg 3) has been observed in the following areas: SEE ADDENDUM & Diagram (pg 3) for comments about discovered evidence of prior or current wood destroying insect activity. Also, refer to the seller's disclosure for possible related information.
