**Select Inspect**  
**Property Consultants, llc**  
 2001 Reston; McKinney, TX 75070  
 214-770-6954  
[www.SelectInspect.com](http://www.SelectInspect.com)

**PROPERTY CONDITION ASSESSMENT**

Street Address:	<b>1234 xxxxx</b>	Tracker #		
City:	<b>Dallas</b>	State:	<b>TX</b>	Zip: <b>75220</b>

Property Type:	Multifamily	# of Bldgs:	6	# of Units:	84	Year Built:	1971
----------------	-------------	-------------	---	-------------	----	-------------	------

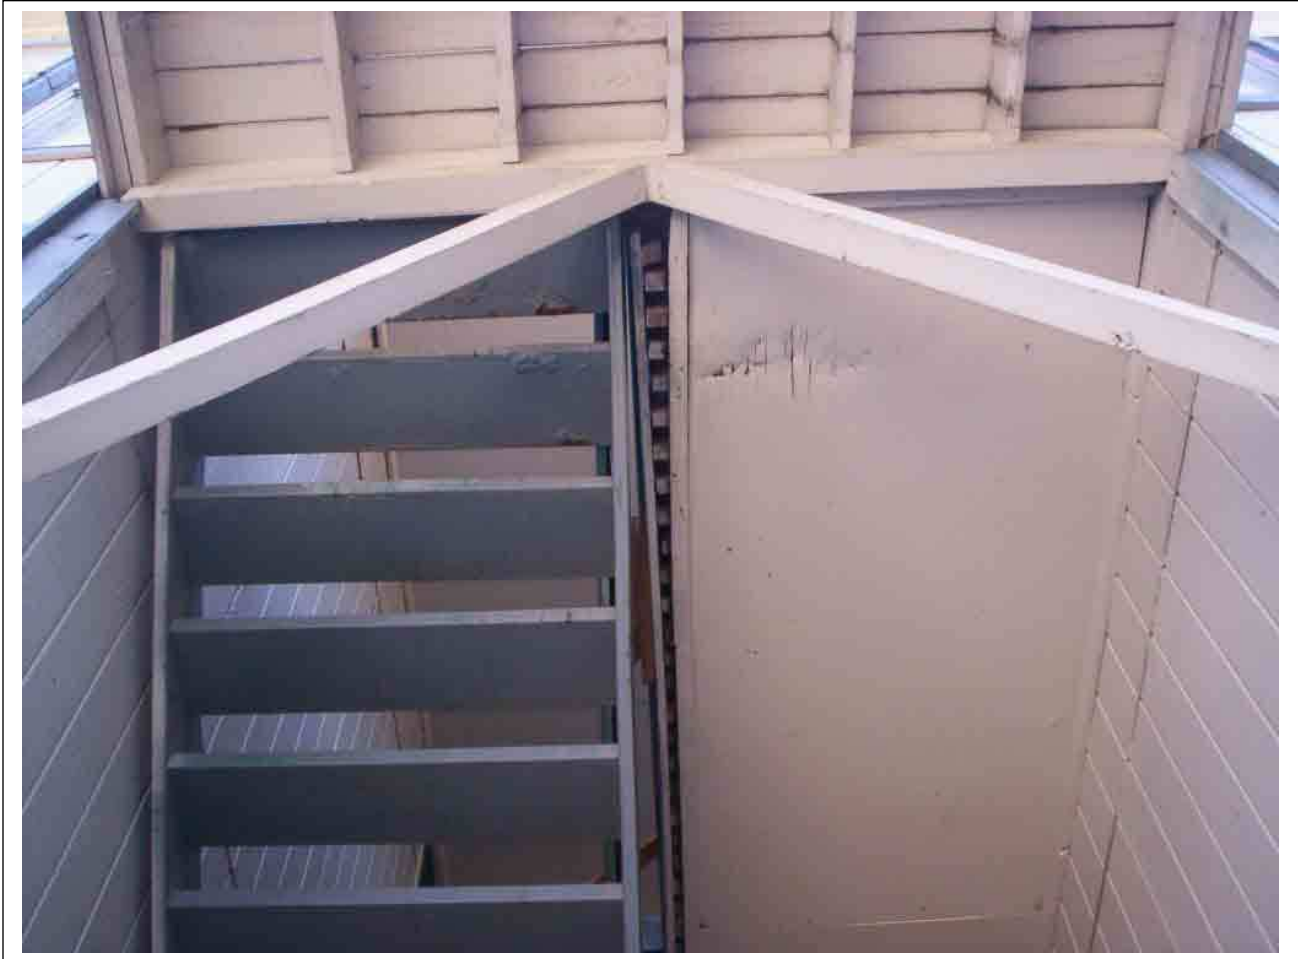
**3. Comments: Bldg 2- decay at under stair components.**

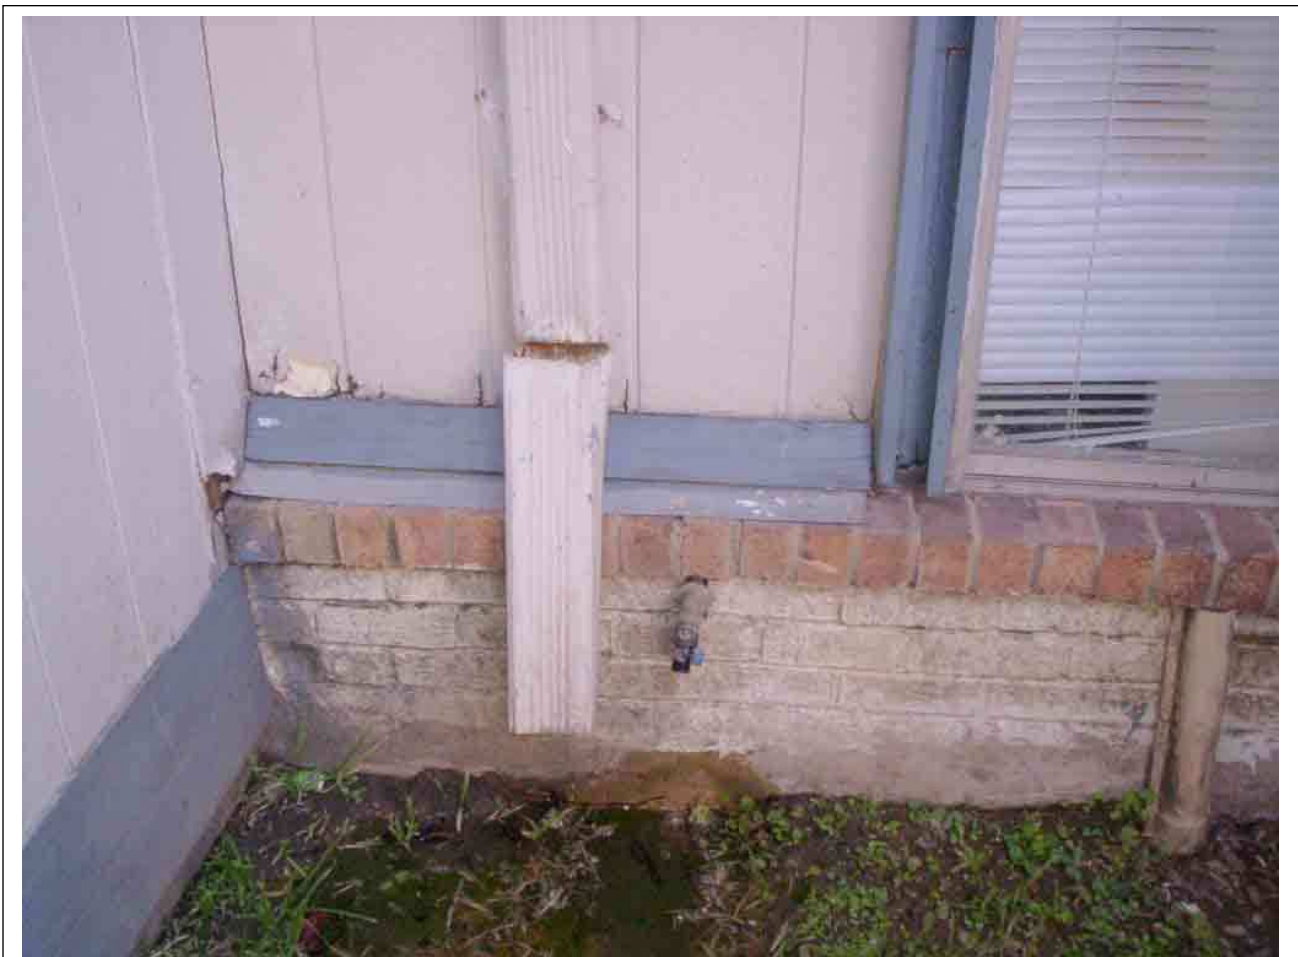
**4. Comments: Bldg 2- amiss / deficient gutter and exterior faucet components. Rot/moisture damage at siding and trim**

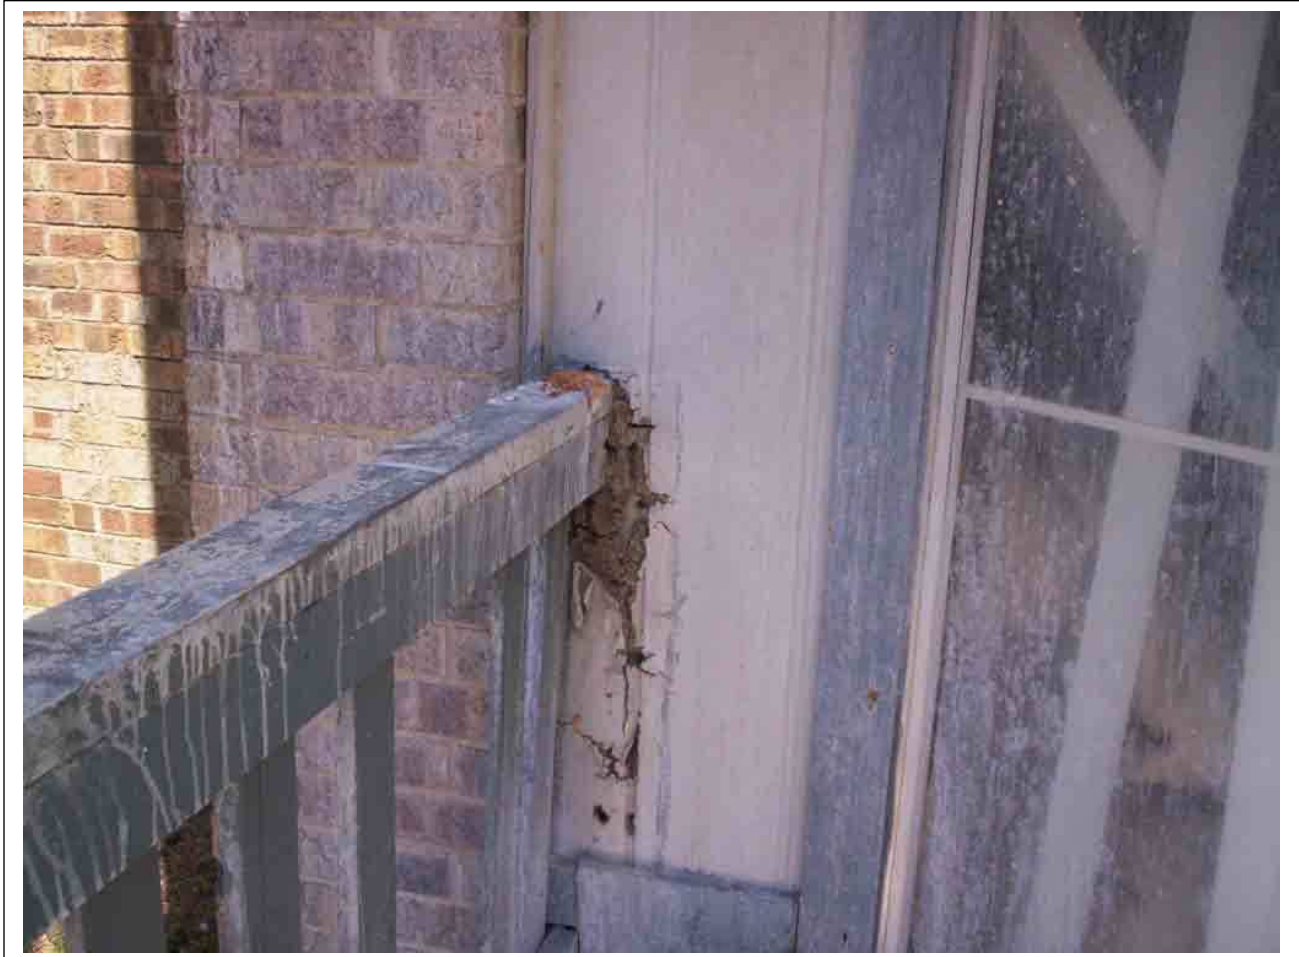
**5. Comments: Bldg 3 -wood destroying insect and rot/moisture damage**

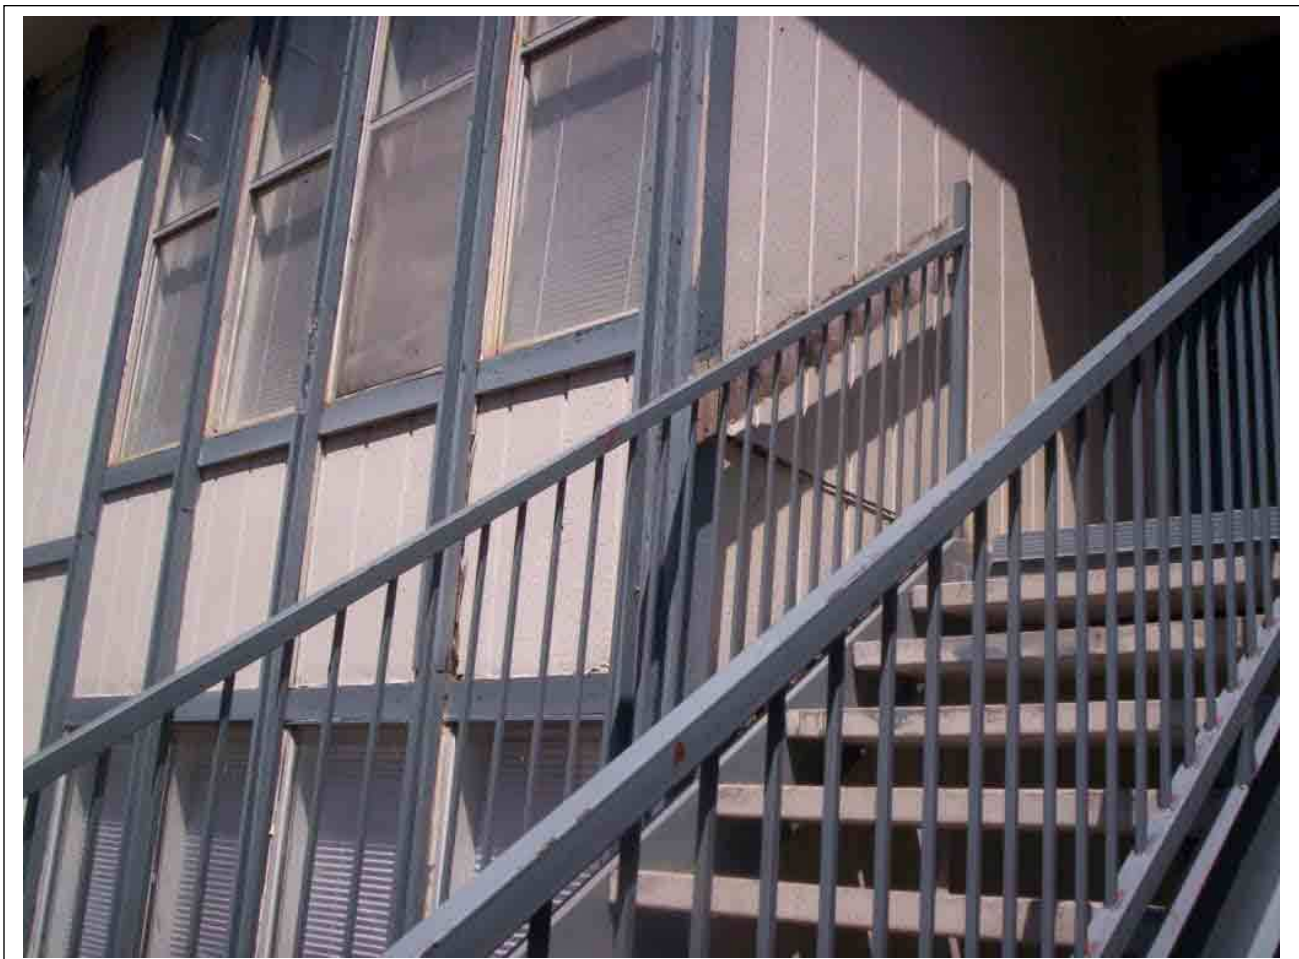
**6. Comments: Bldg 4- rot/moisture damage at siding / trim**

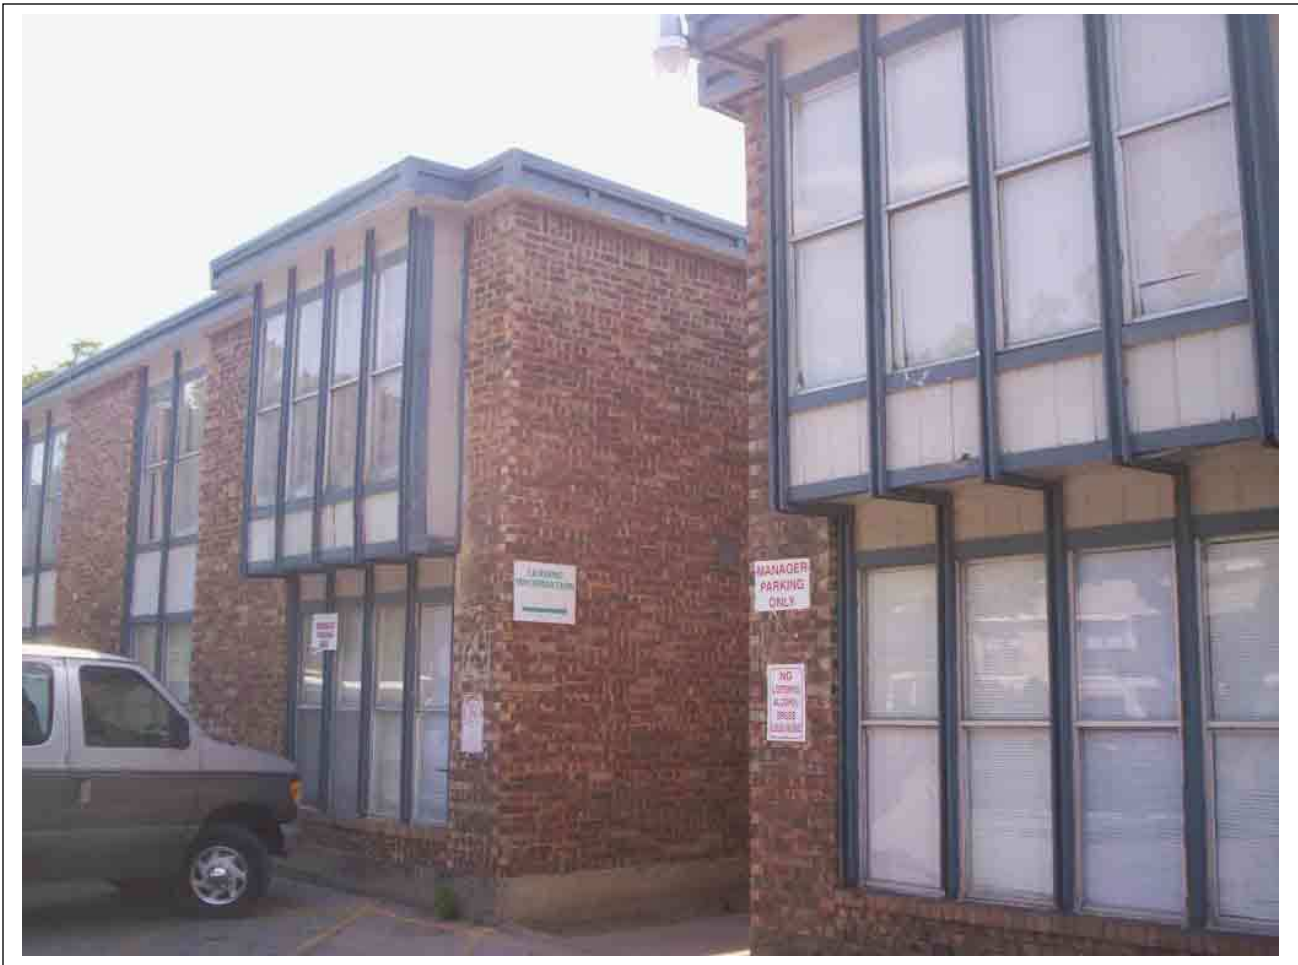
7. Comments: Bldg 3 & 4- rot/moisture damage at siding/trim (upper overhanging window features)

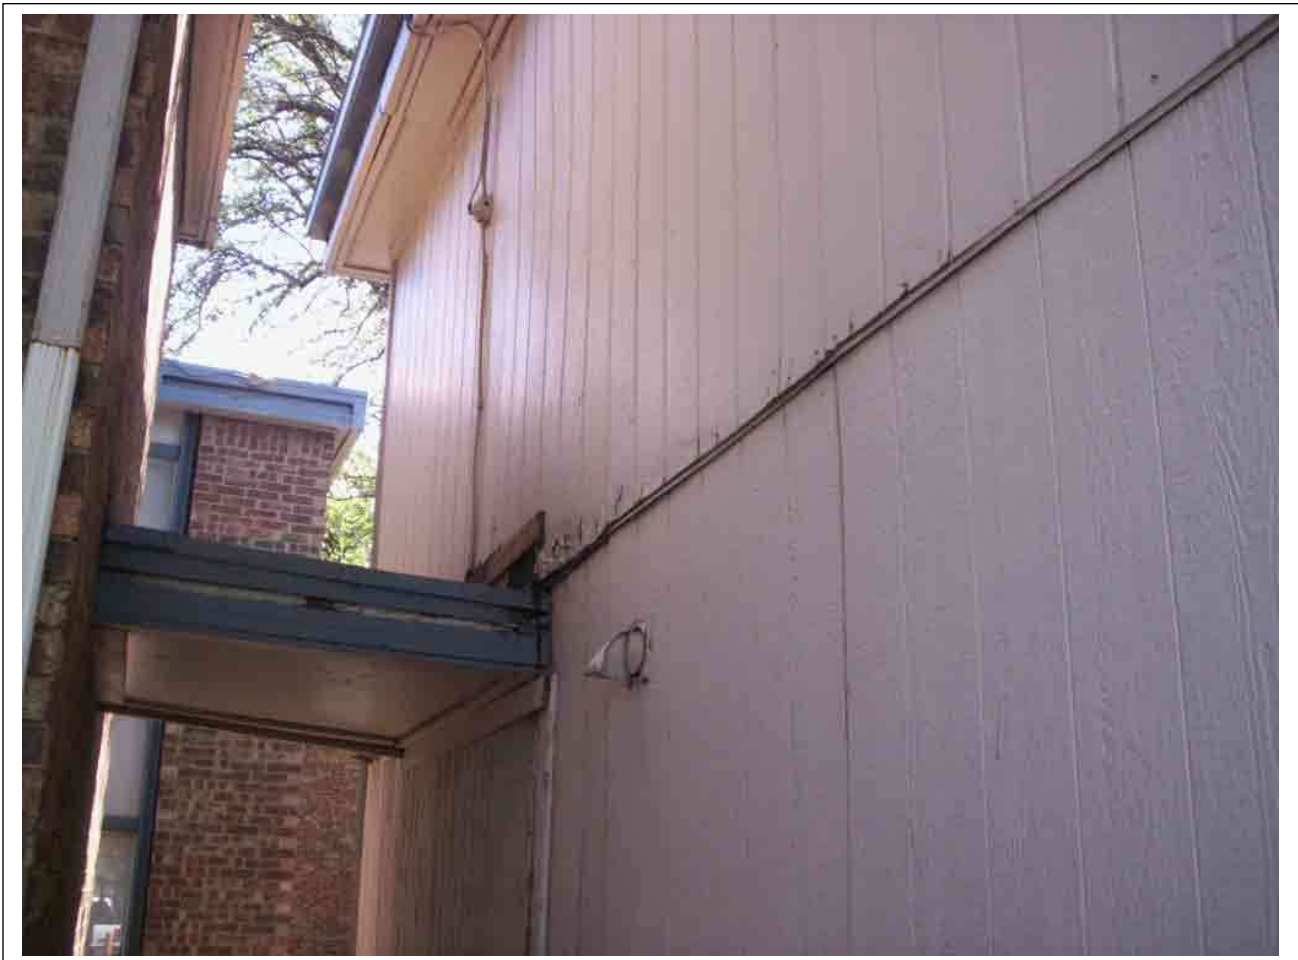
8. Comments: Bldg 6- rot/moisture damage at cladding

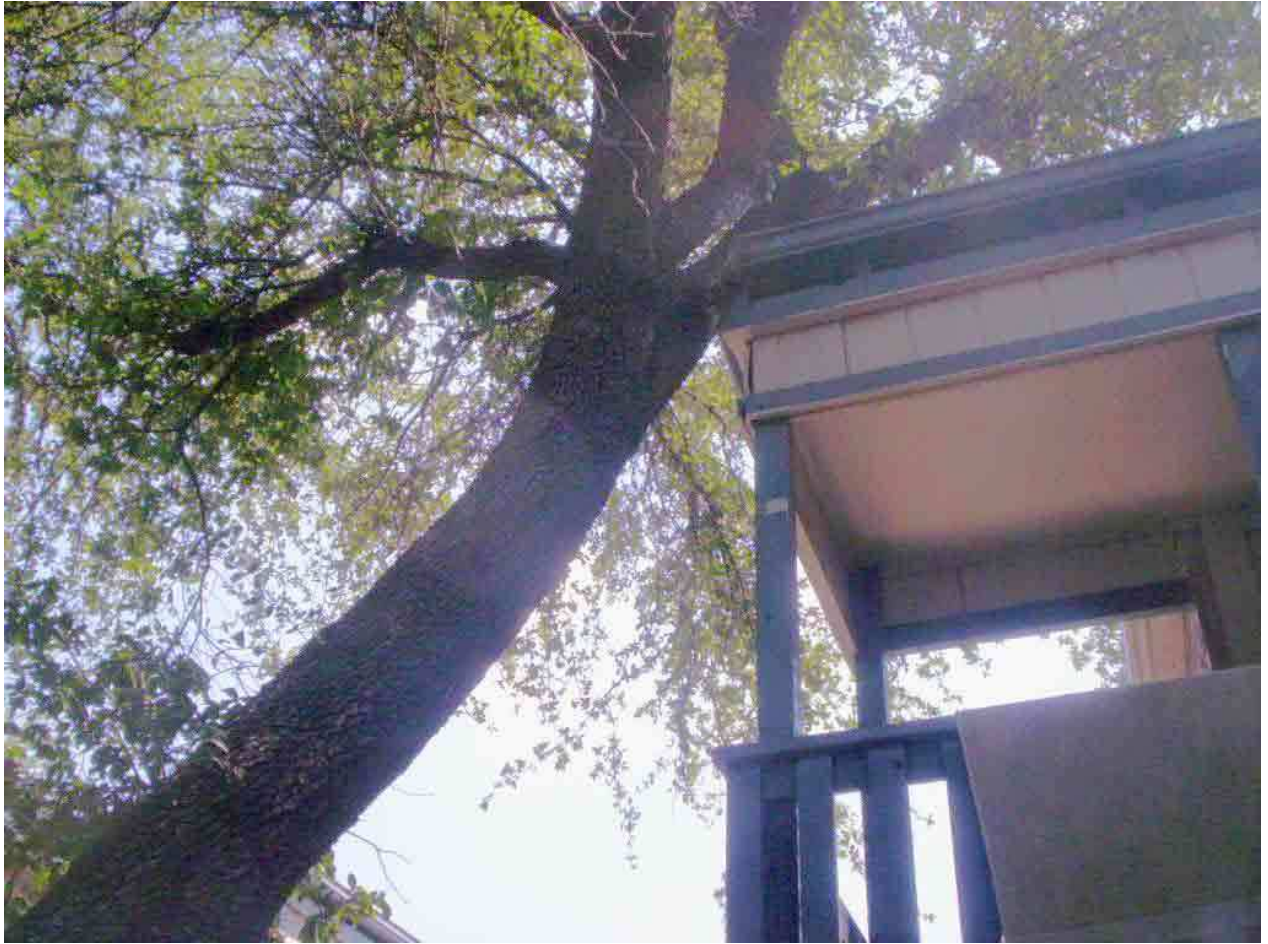
**9. Comments: Bldg 2- tree impeding structure**

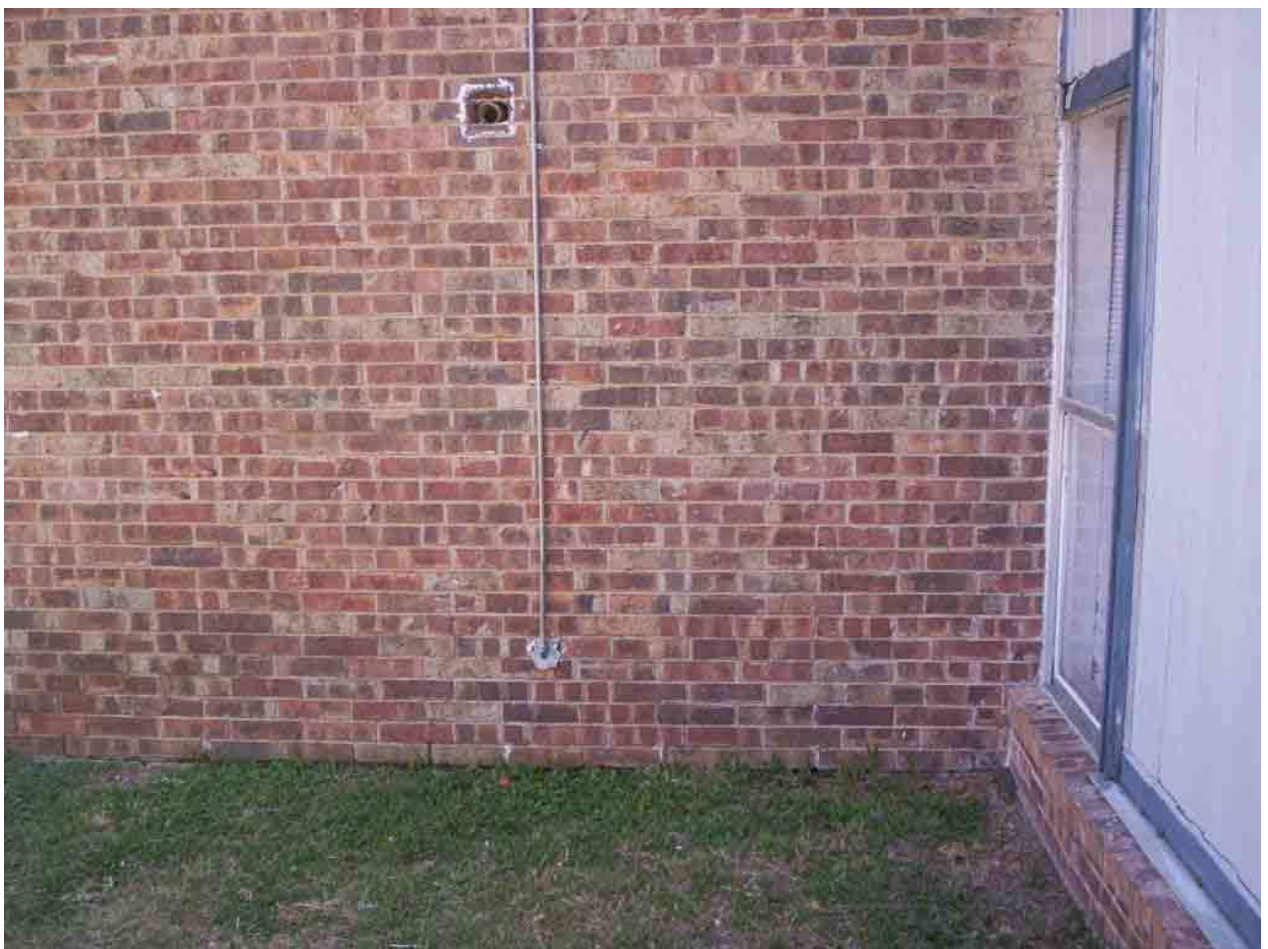
**10. Comments: Bldg 2- moisture seepage from within- lower  
amiss vent cover- upper**

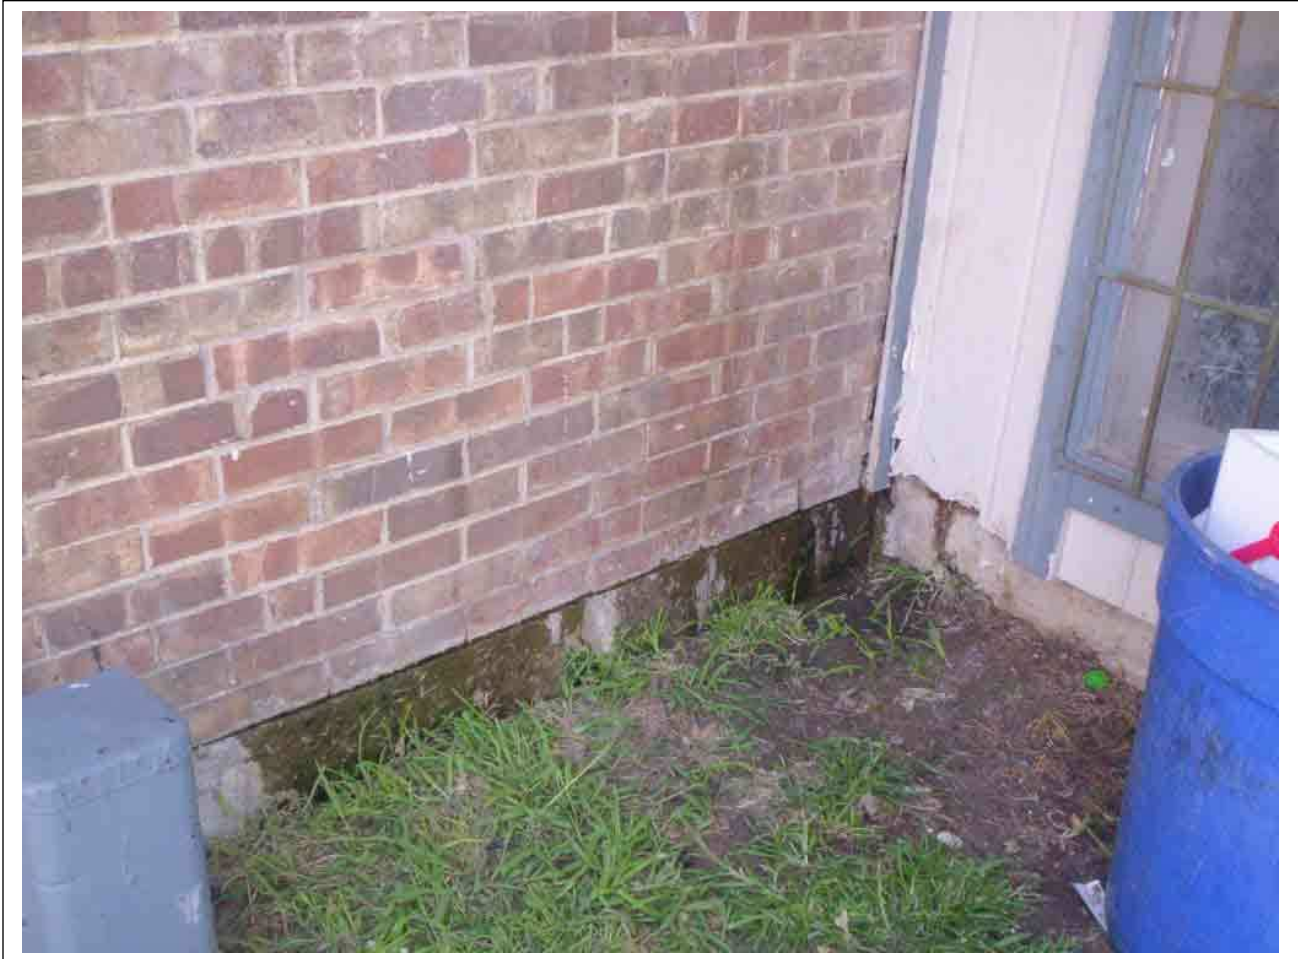
**11. Comments: moisture seepage from within building- example 2**

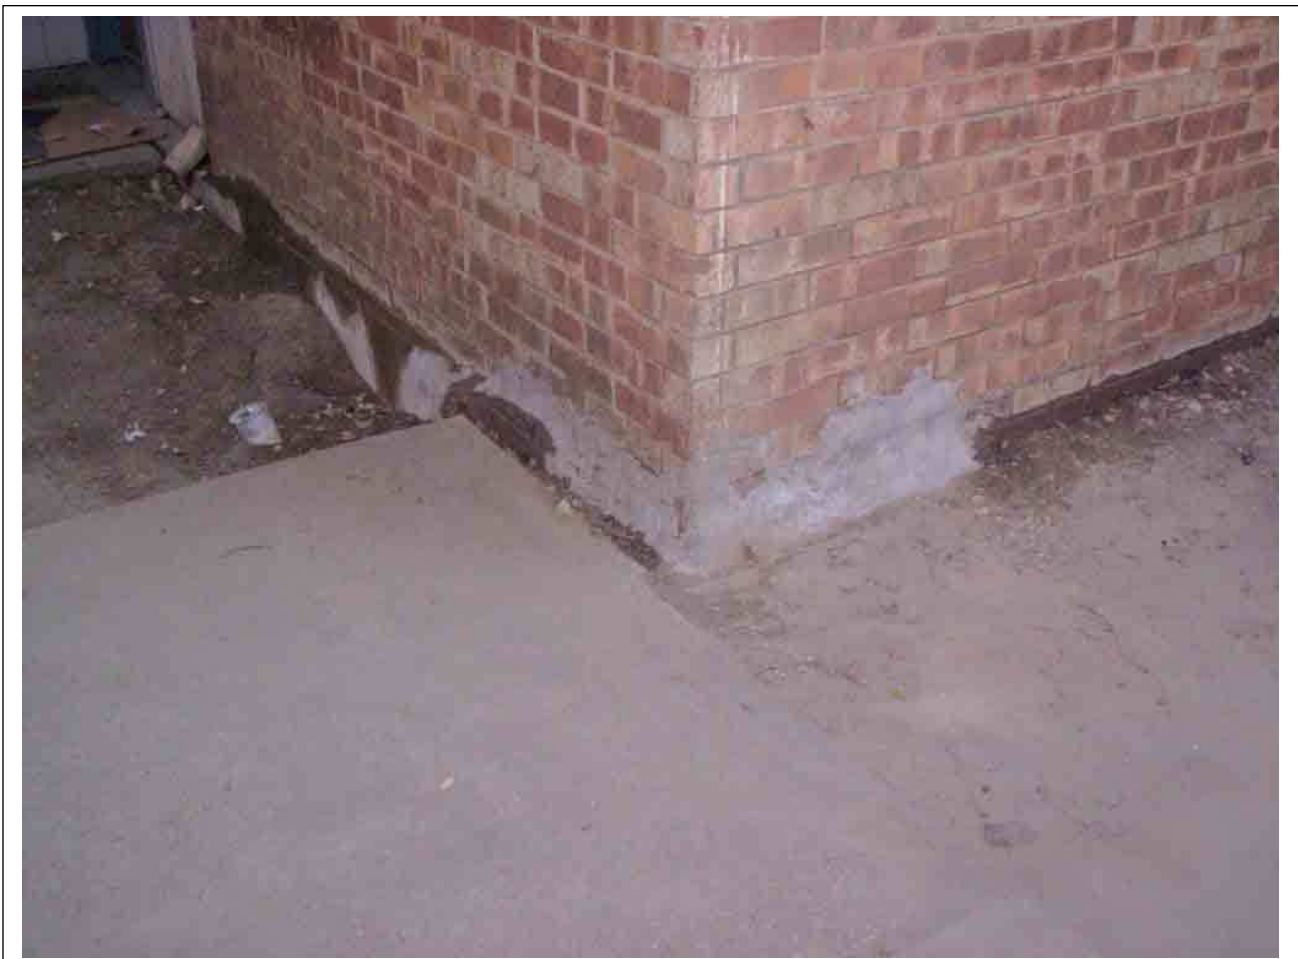
**12. Comments: moisture seepage from within building- example 3**

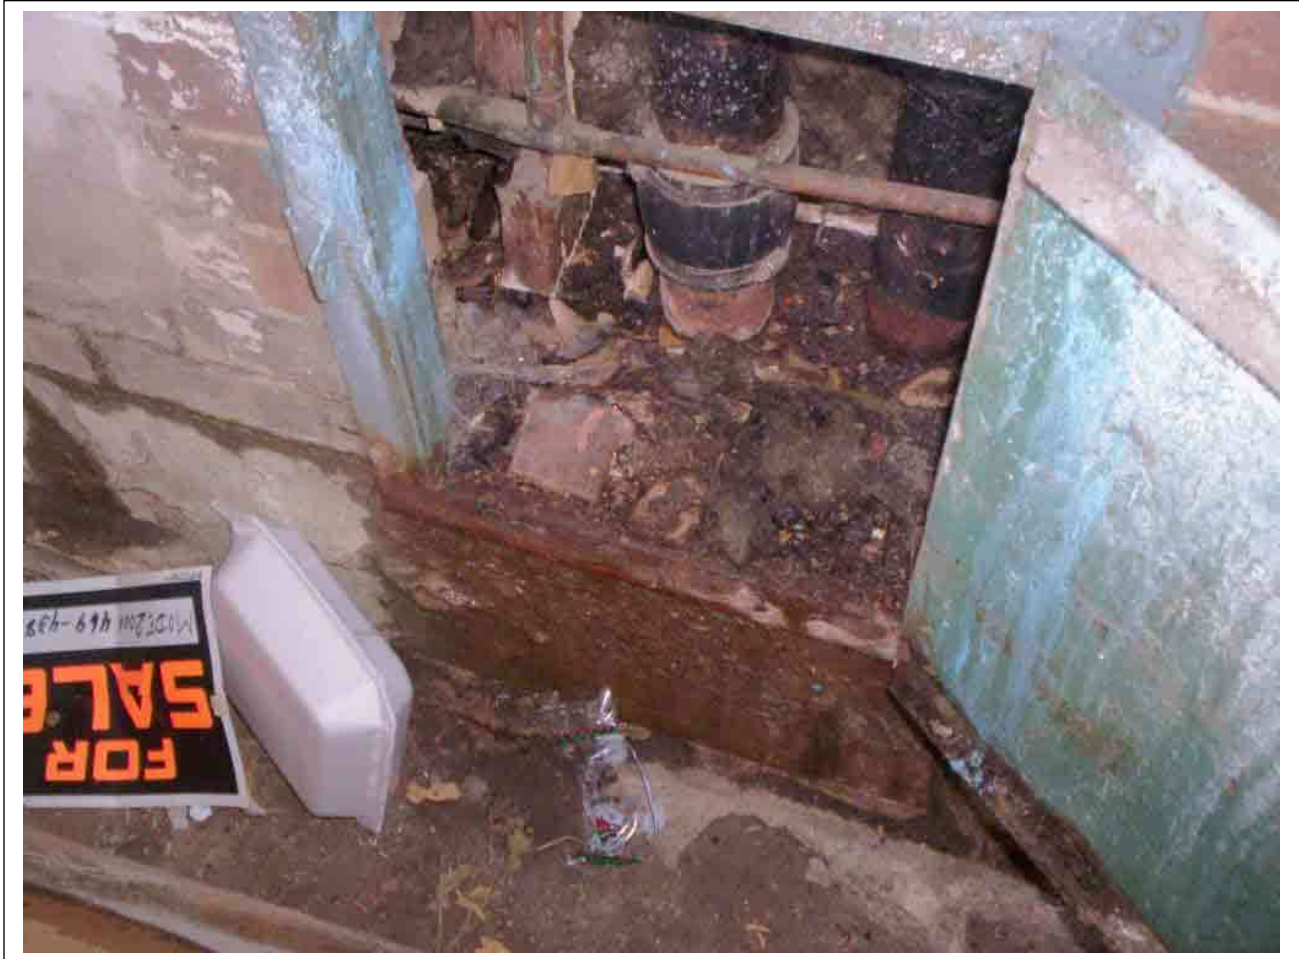
13. Comments: Seepage and apparent plumbing leak at exterior access- example

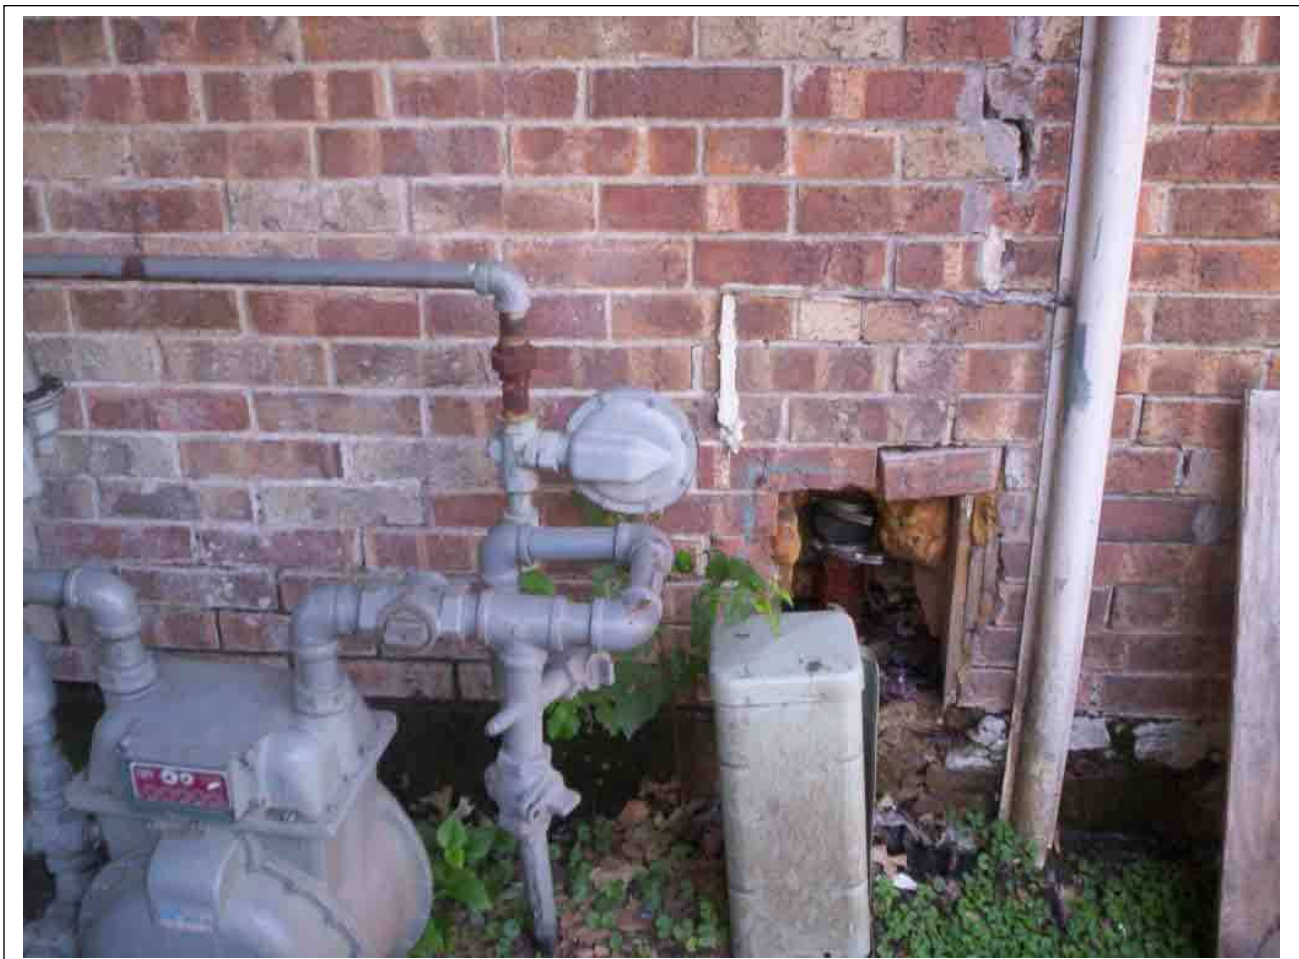
14. Comments: Seepage and apparent plumbing leak at exterior access- example 2

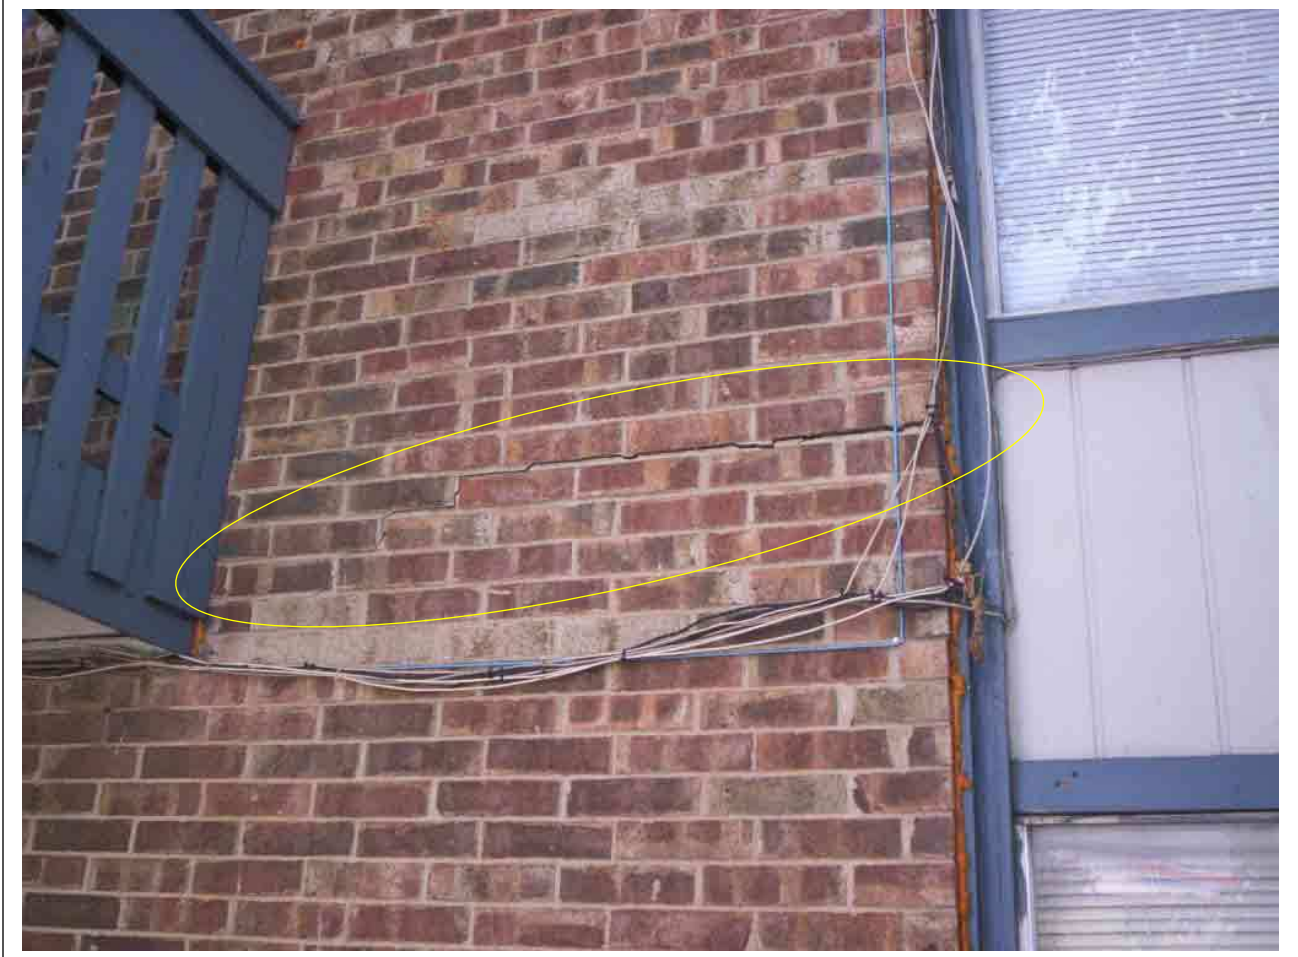
**15. Comments: large (+- 3/8") brick / mortar crack at southern side of Bldg 5**

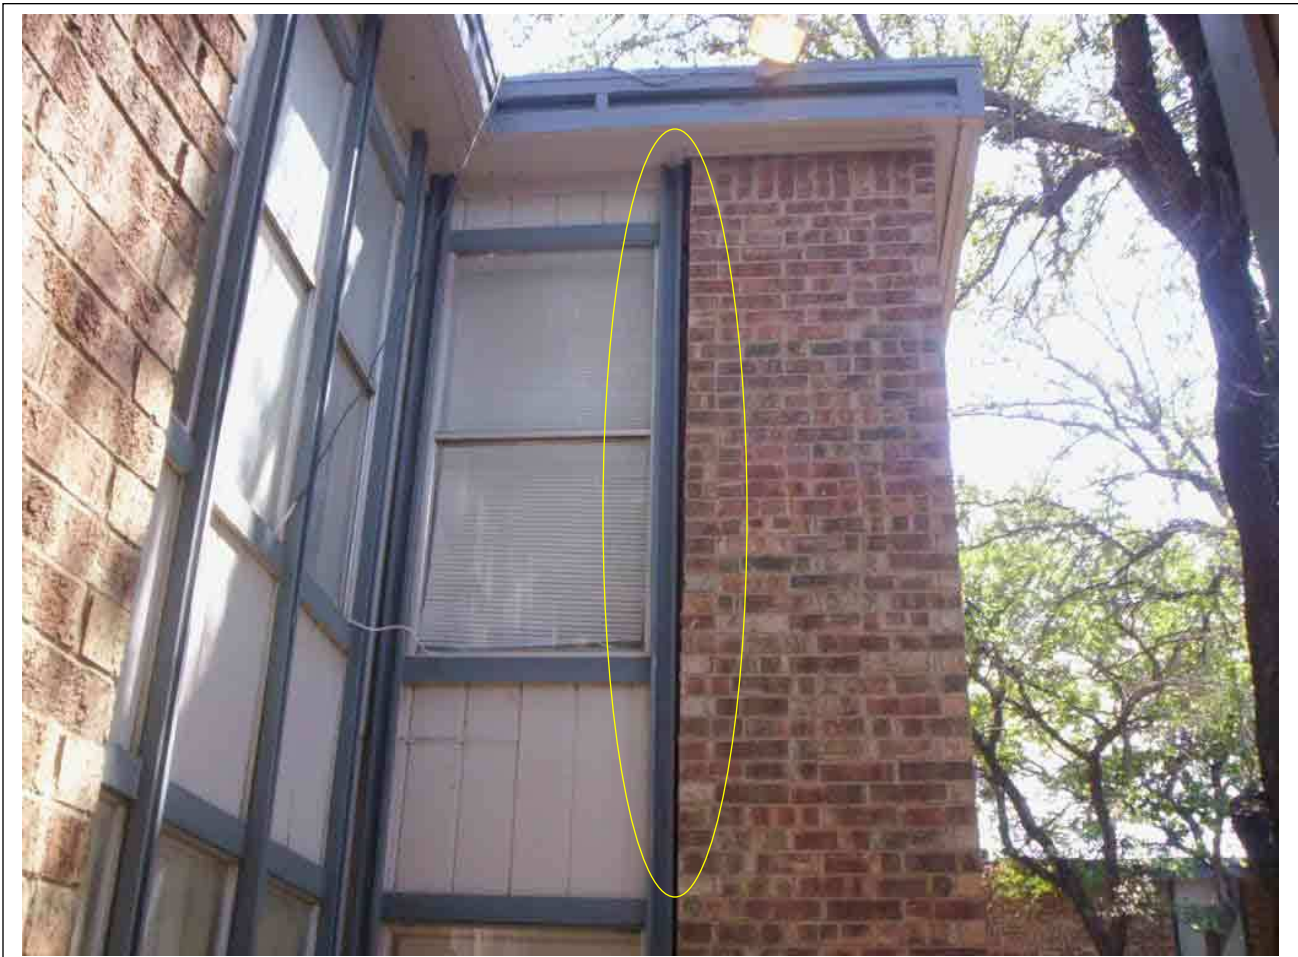
**16. Comments: brick / framing separation example at Bldg 5**

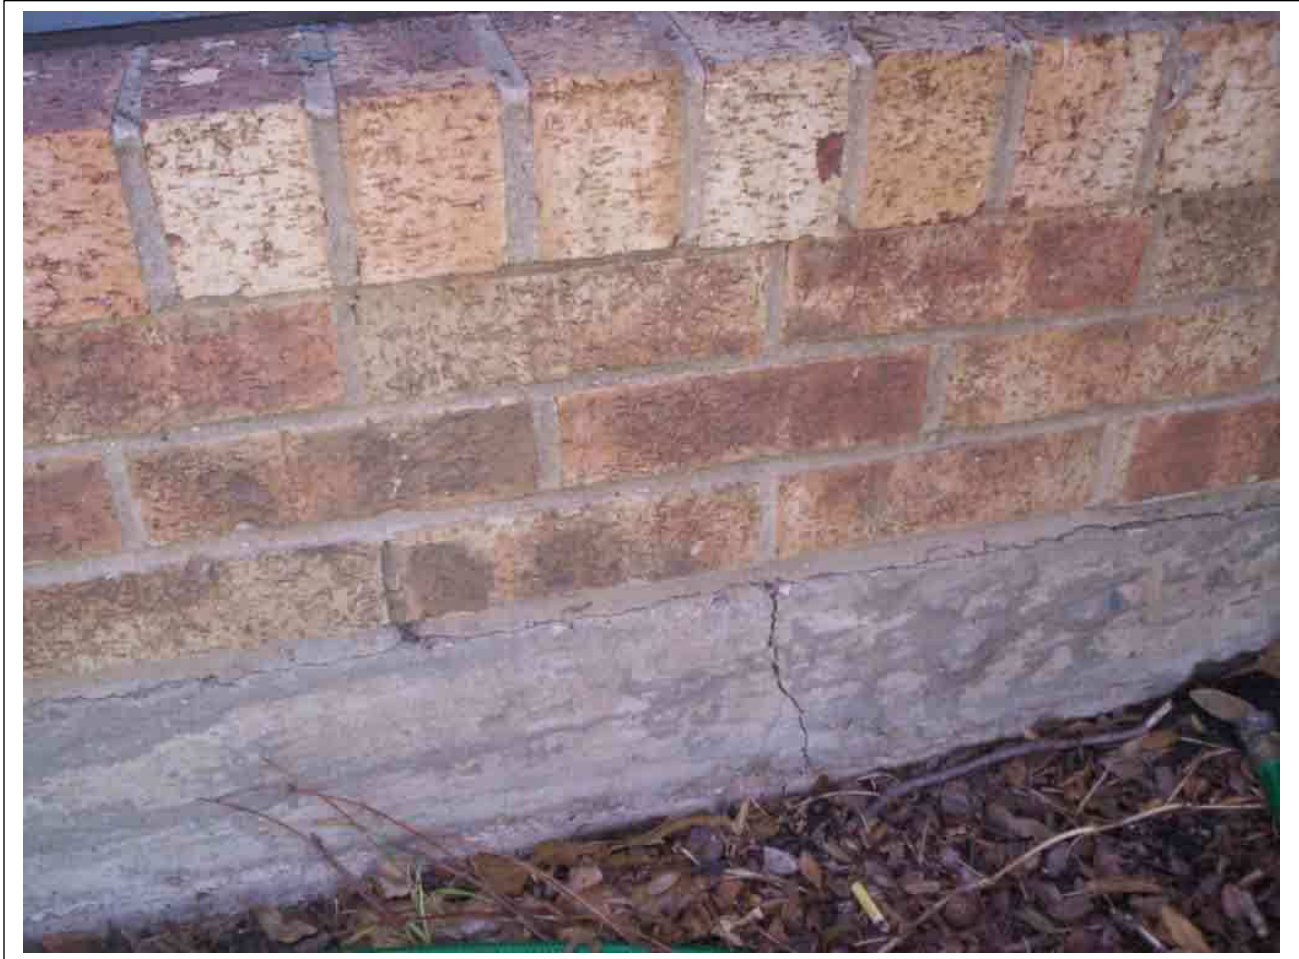
17. Comments: foundation slab crack- example

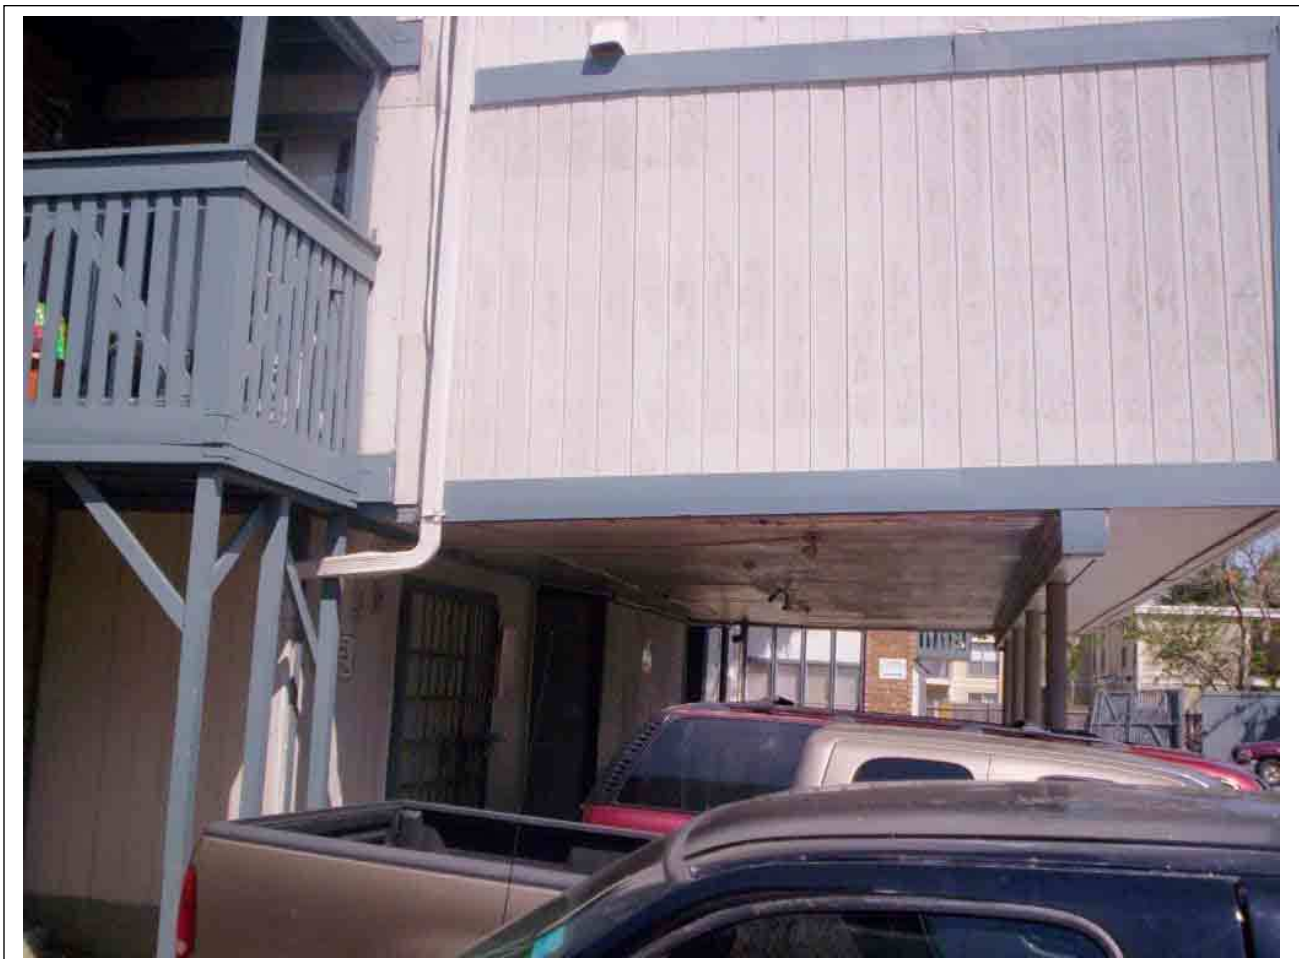
- Cantilevered feature at the north end of Bldg #2 was visibly out of square, and appears to have moved differentially from the building. ( 11/2 ) Moisture leakage from within the cantilevered feature was discovered- source undetermined ( 12/1 )

18. Comments: questionable integrity of cantilevered structure- north side of Bldg 2

- Consider structural specialist evaluation of Bldg #2 cantilever features, as these support tenant dwellings and failure may result in costly liability and related expenses.

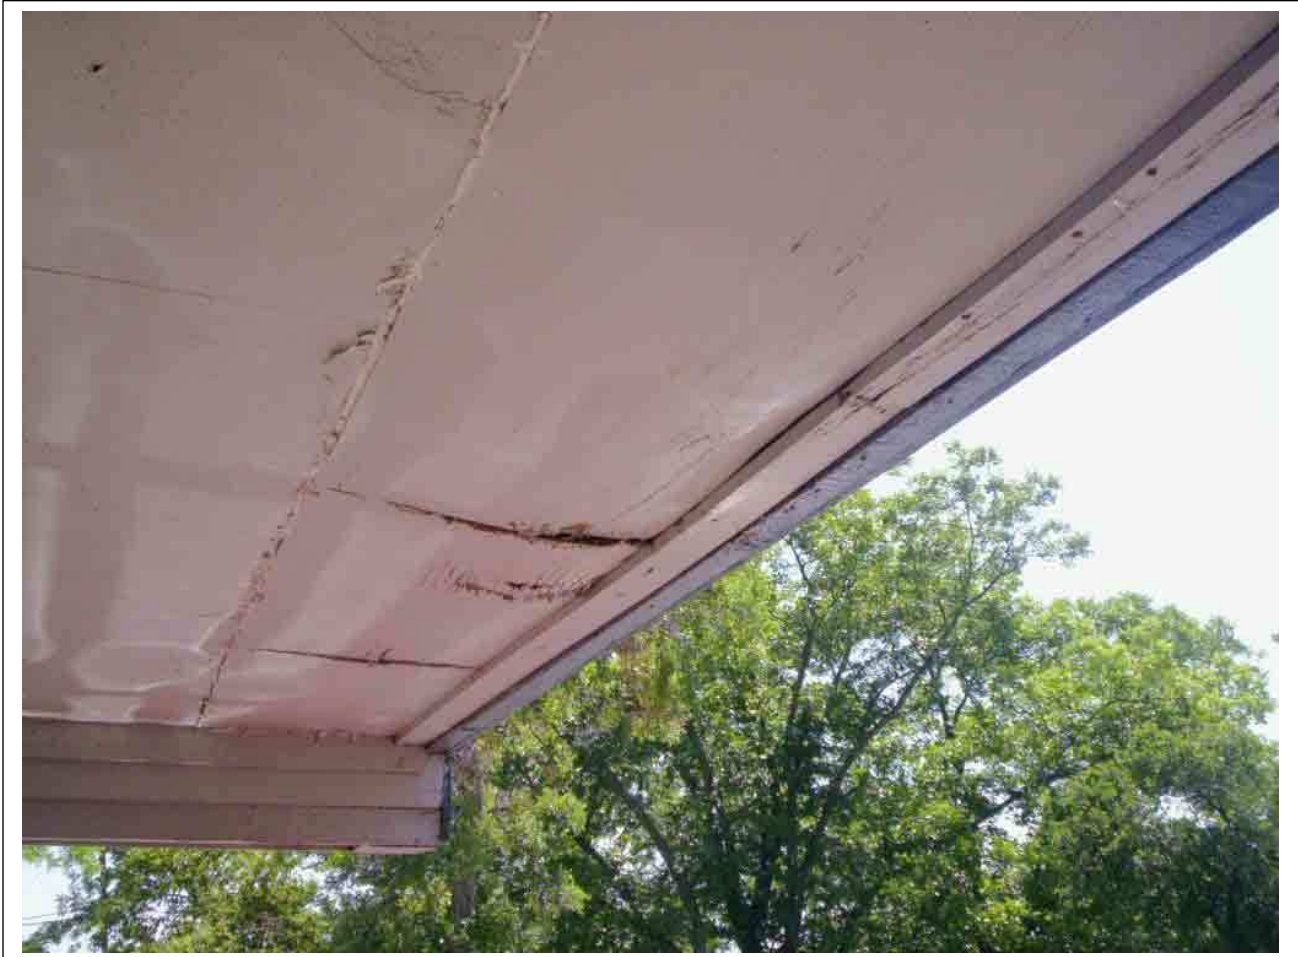
**19. Comments: moisture leakage and rot/moisture damage at underside of cantilevered structure**

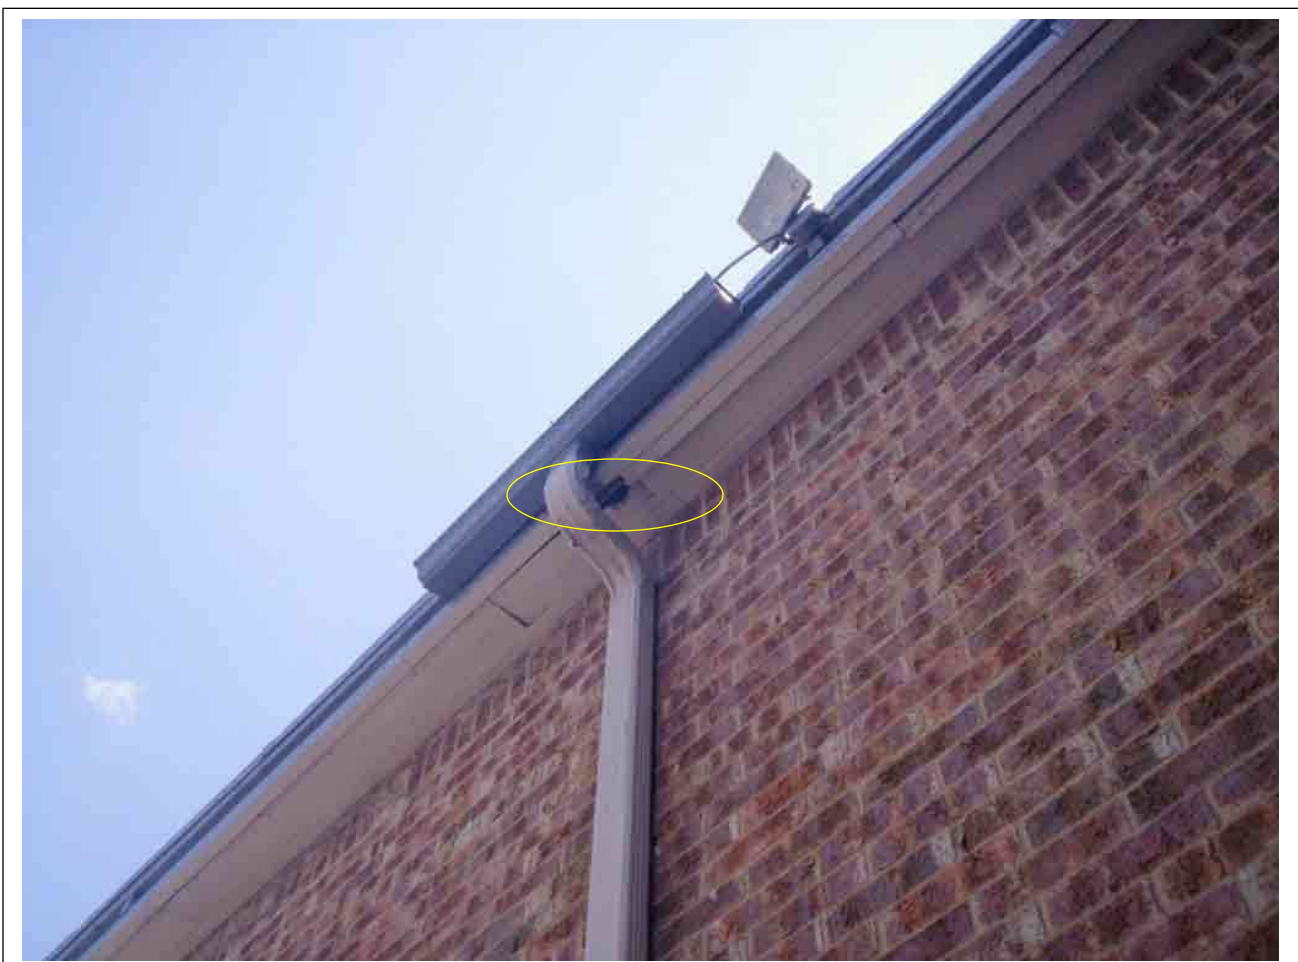
**20. Comments: eave rot/moisture damage south Bldg 5. Suspect amiss gutter.**
