**Select Inspect**  
**Property Consultants, llc**  
 2001 Reston; McKinney, TX 75070  
 214-770-6954  
[www.SelectInspect.com](http://www.SelectInspect.com)

**PROPERTY CONDITION ASSESSMENT**

Street Address:	<b>1234 xxxxx</b>	Tracker #		
City:	<b>Dallas</b>	State:	<b>TX</b>	Zip: <b>75220</b>

Property Type:	Multifamily	# of Bldgs:	6	# of Units:	84	Year Built:	1971
----------------	-------------	-------------	---	-------------	----	-------------	------

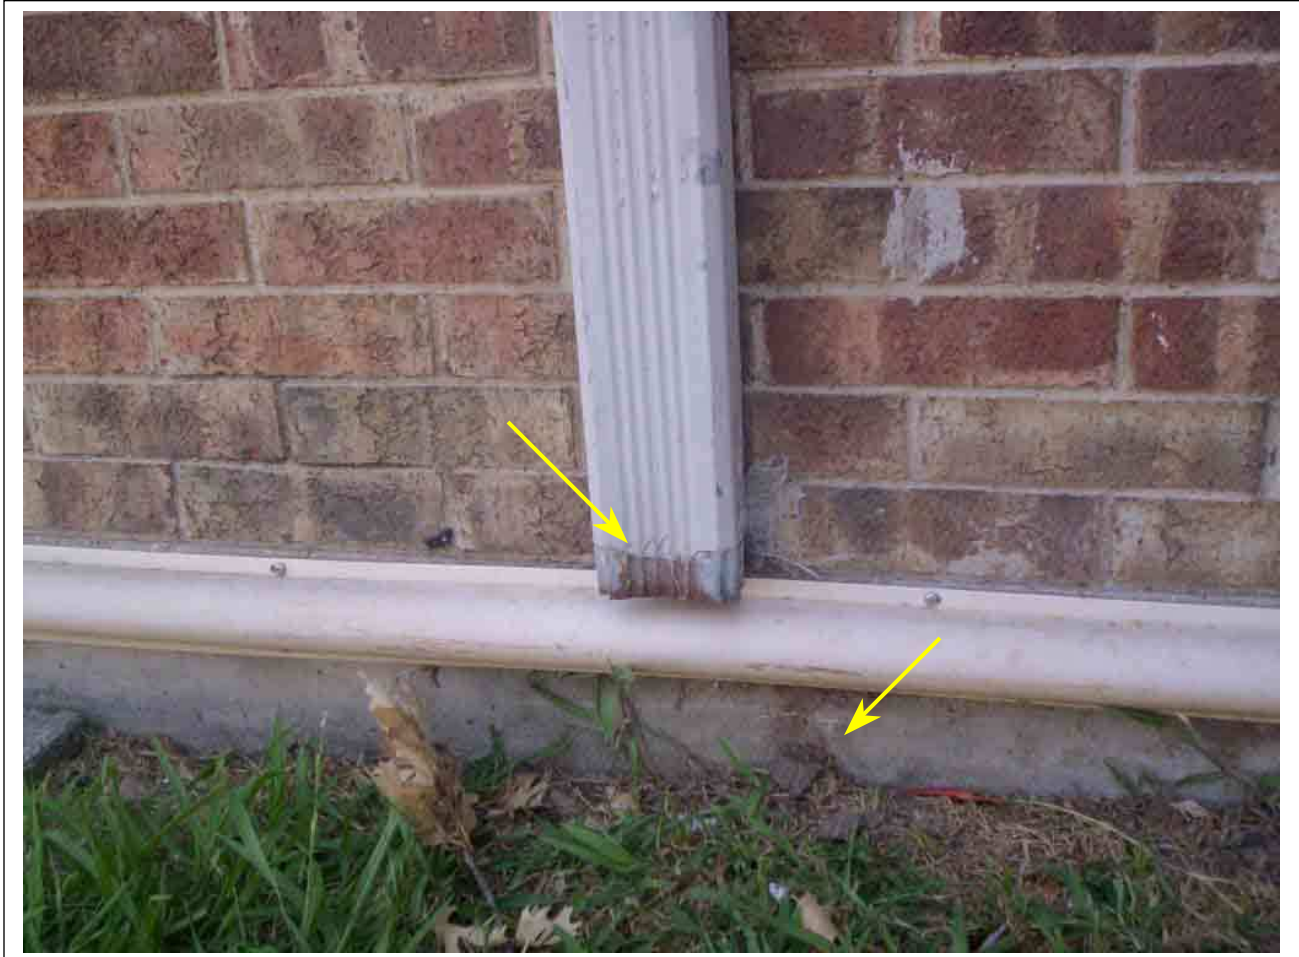
21. Comments: amiss gutter- left

active termites, example Bldg 5- right

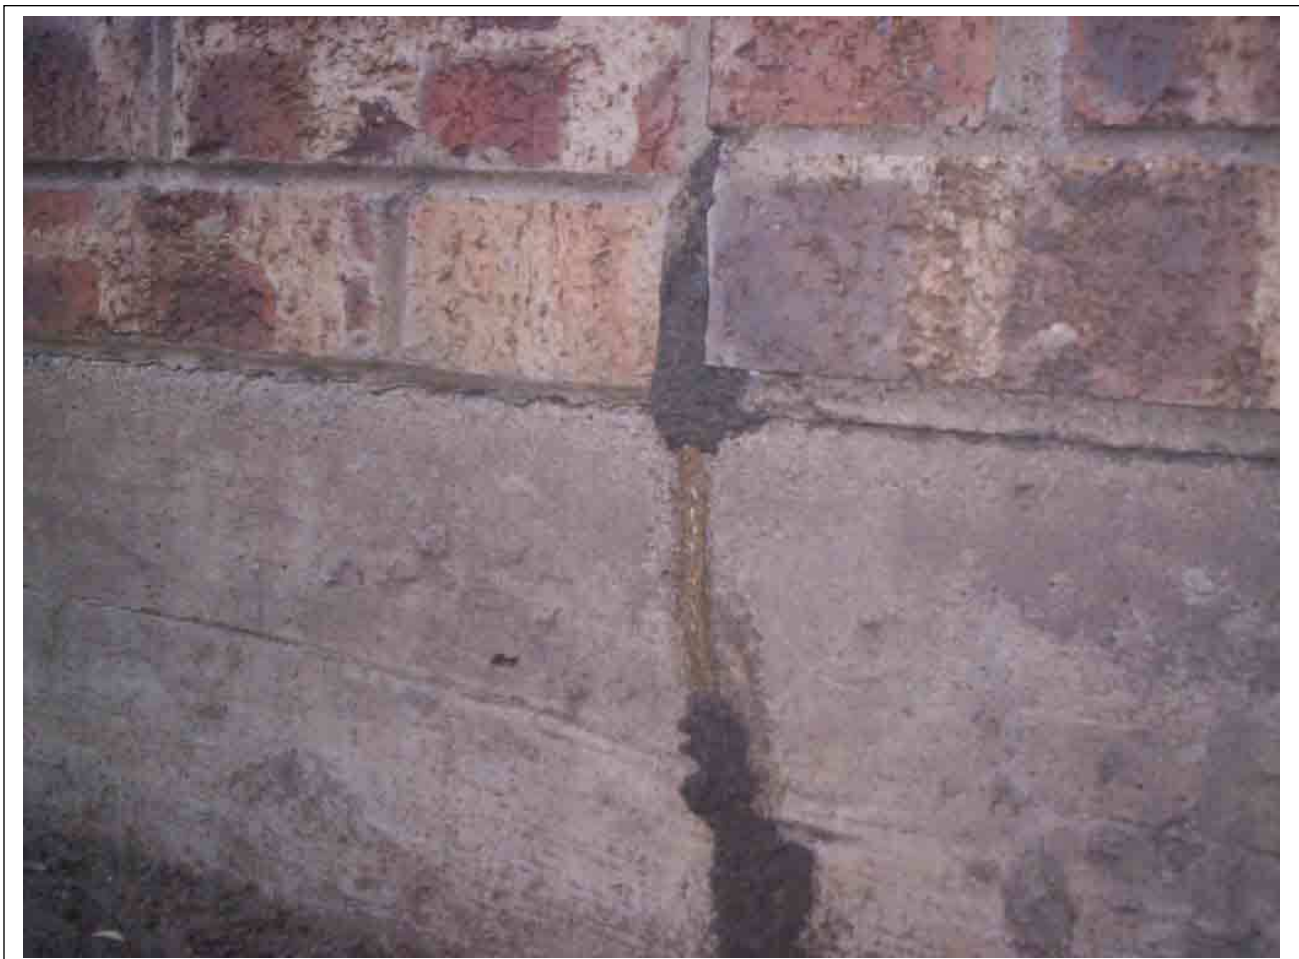
22. Comments: active termites- example Bldg 2

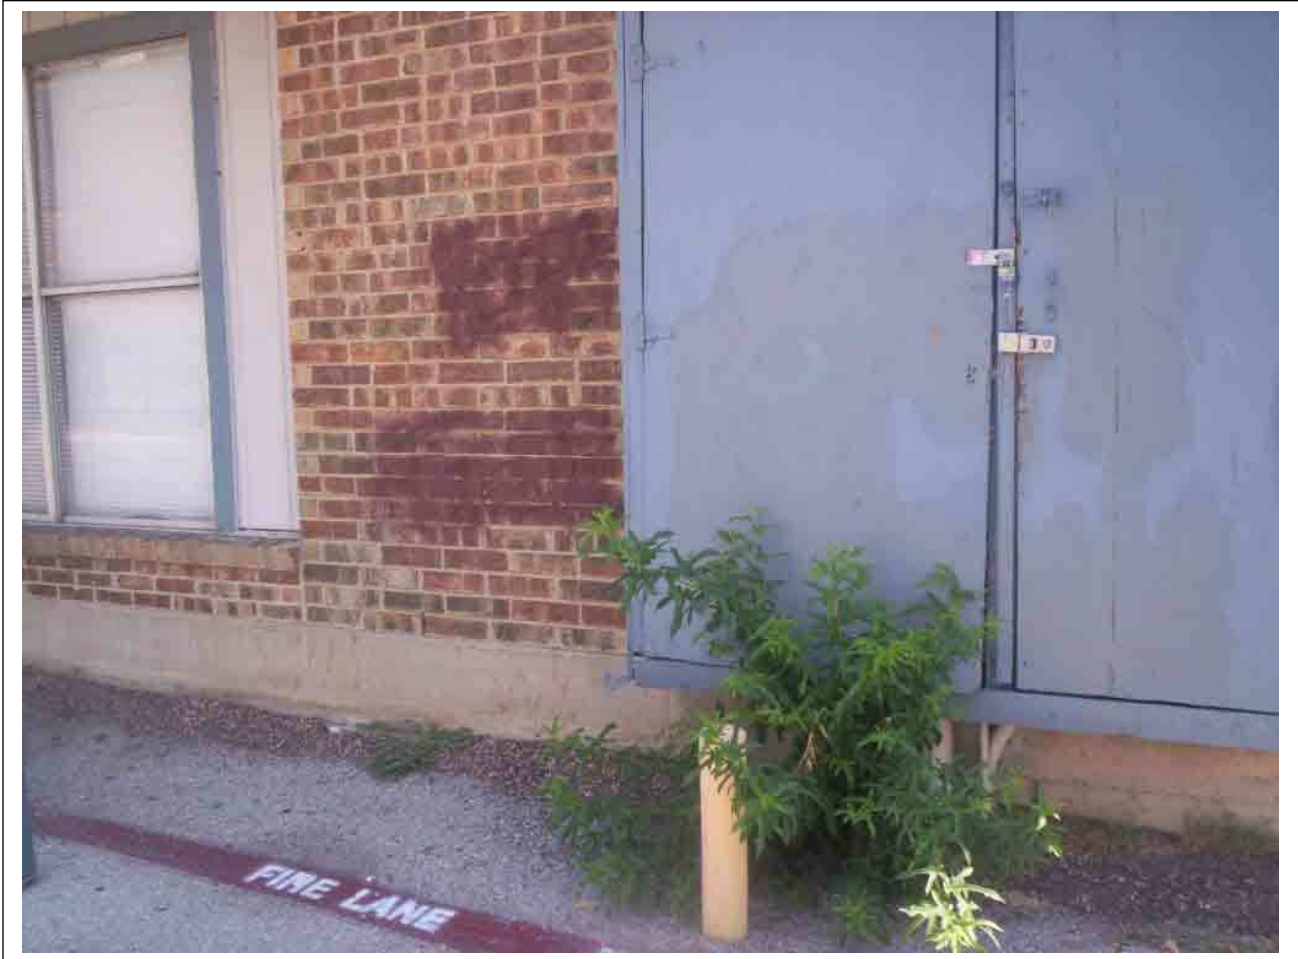
**23. Comments: Bldg 4 graffiti evidence**

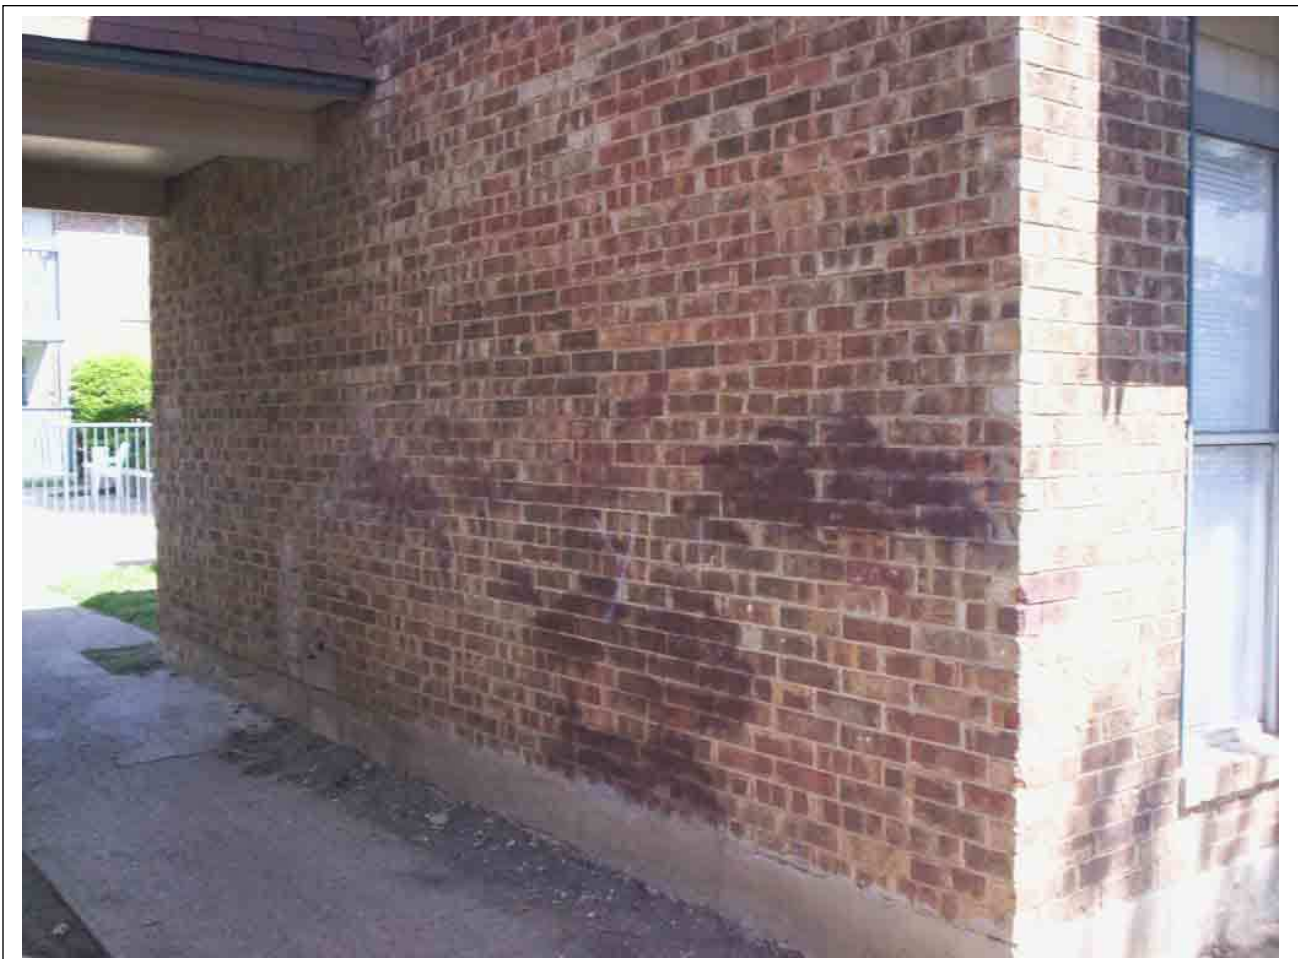
**24. Comments: Bldg 1- graffiti evidence**

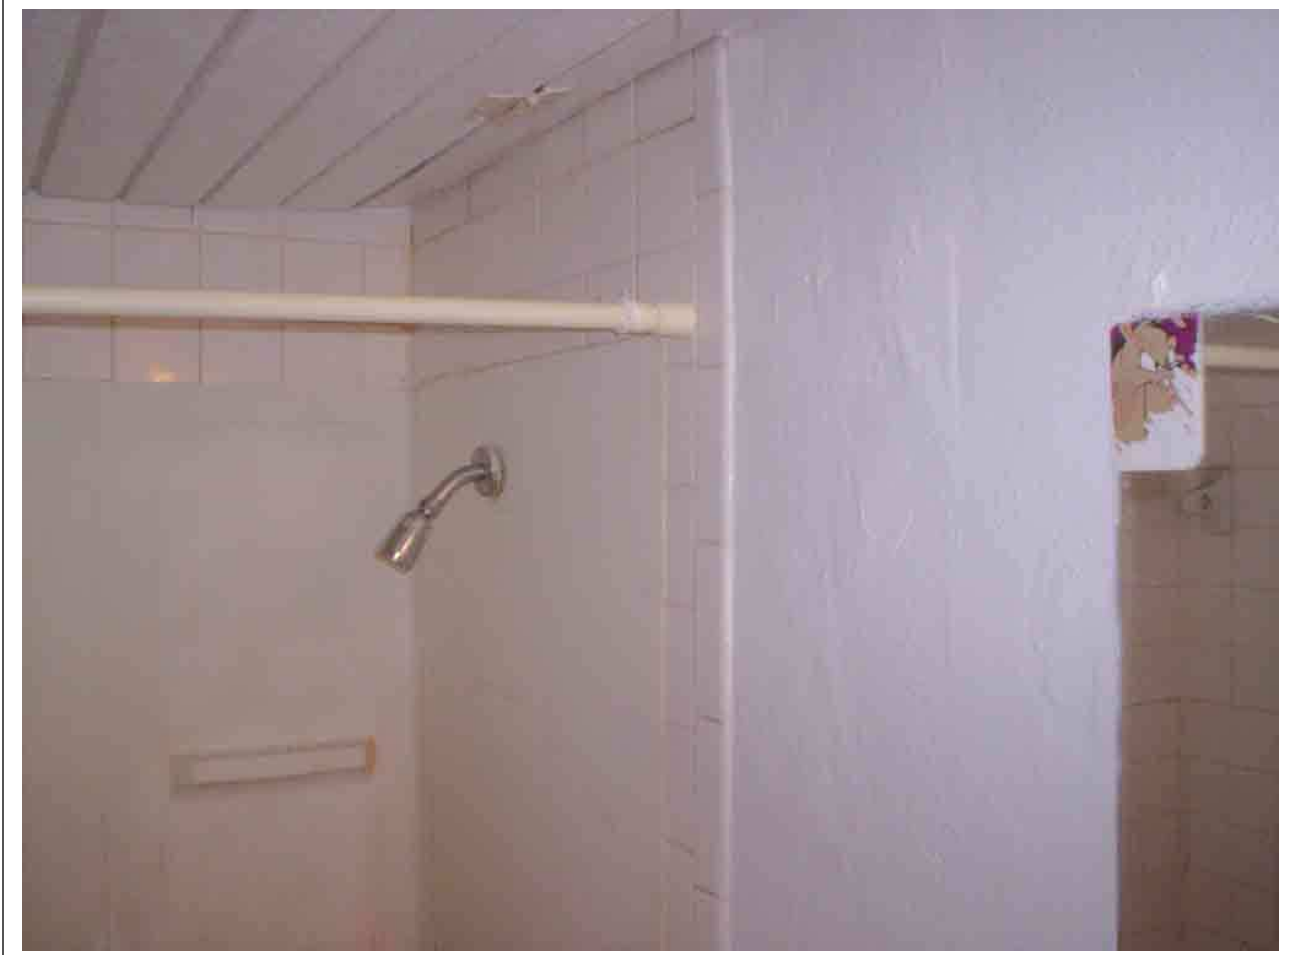
**25. Comments: unit 106 moisture intrusion wall and ceiling H&S**

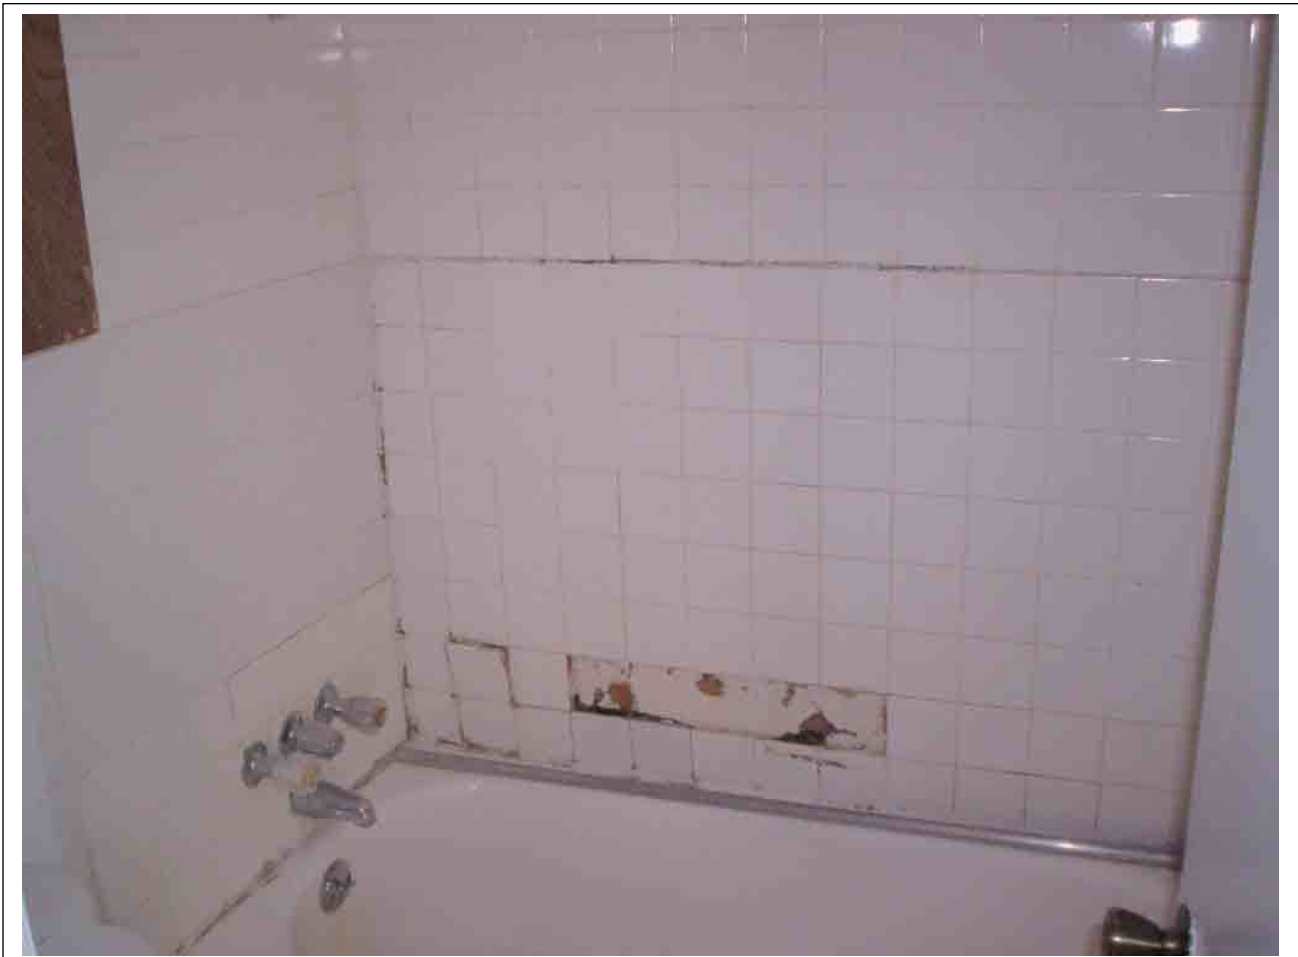
**26. Comments: unit 106 amiss / deficient shower enclosure**

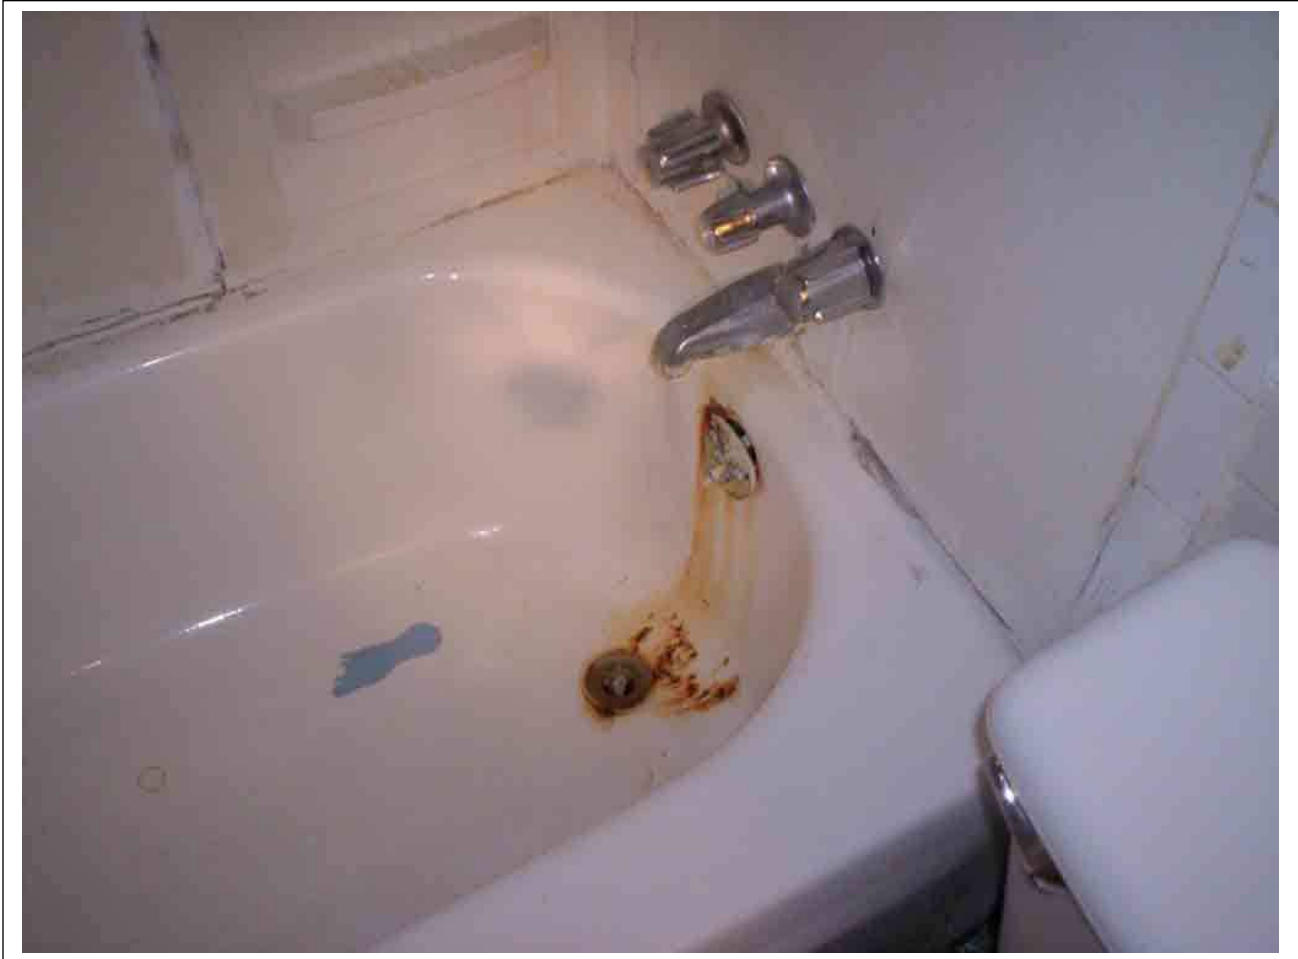
**27. Comments: unit 106- amiss / deficient bathtub**

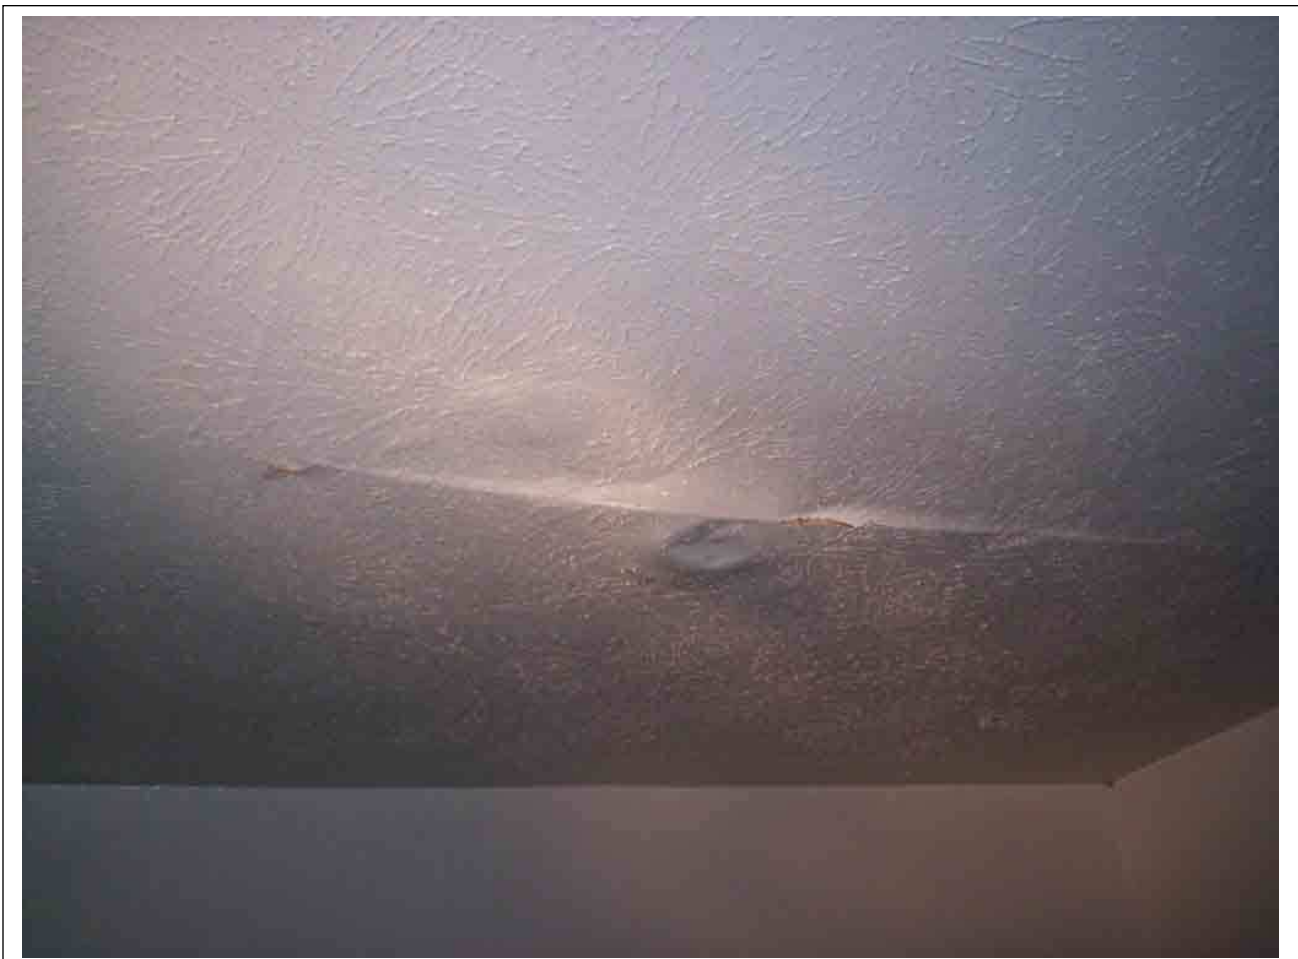
**28. Comments: unit 224 – moisture intrusion evidence H&S**

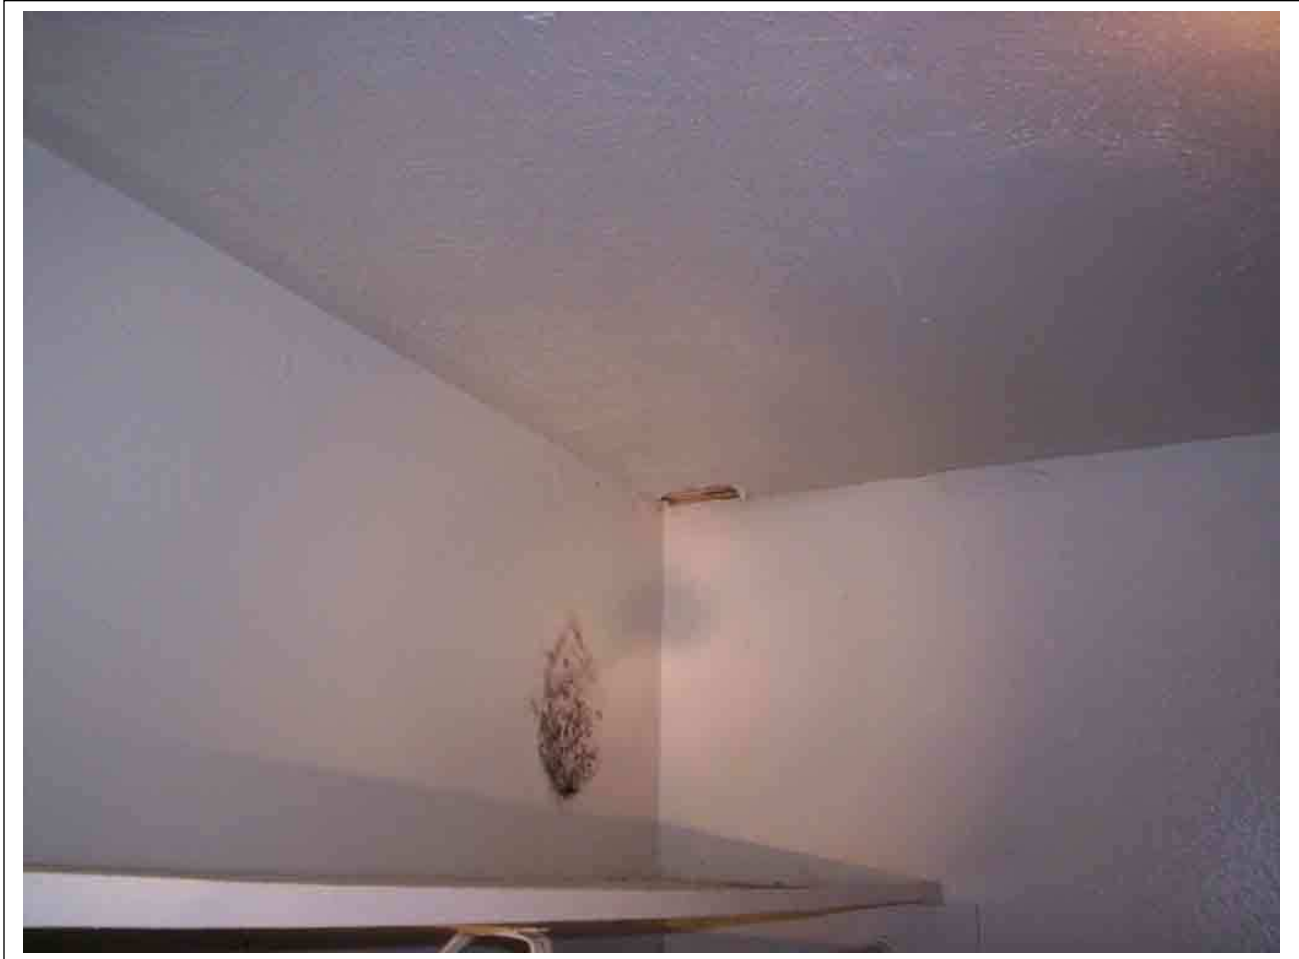
**29. Comments: unit 109- moisture intrusion / fungus H&S**

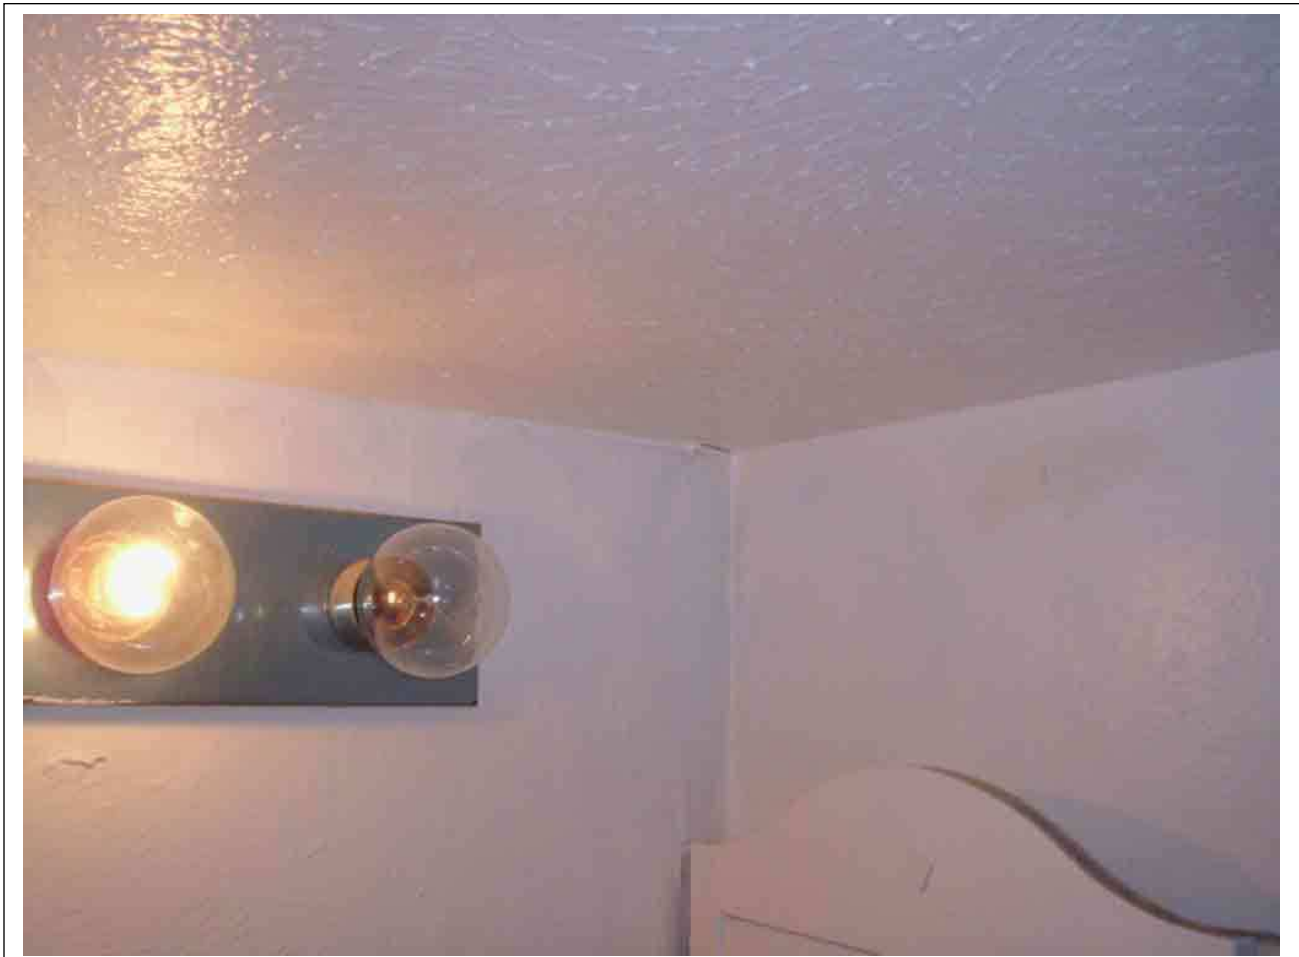
**30. Comments: unit 109- moisture intrusion evidence H&S**

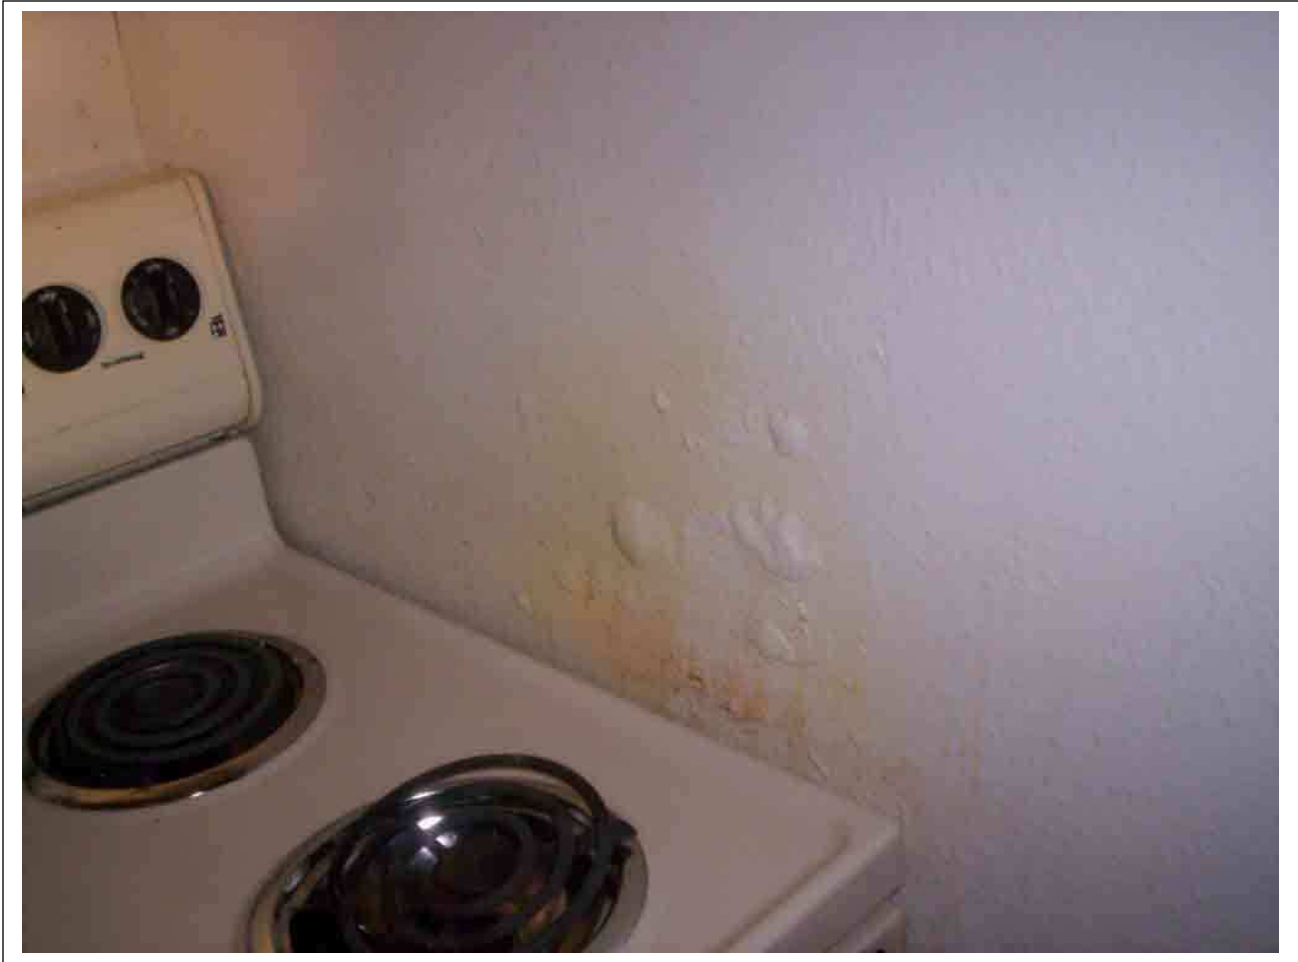
31. Comments: unit 119- heat damaged wall adjacent stove- H&S

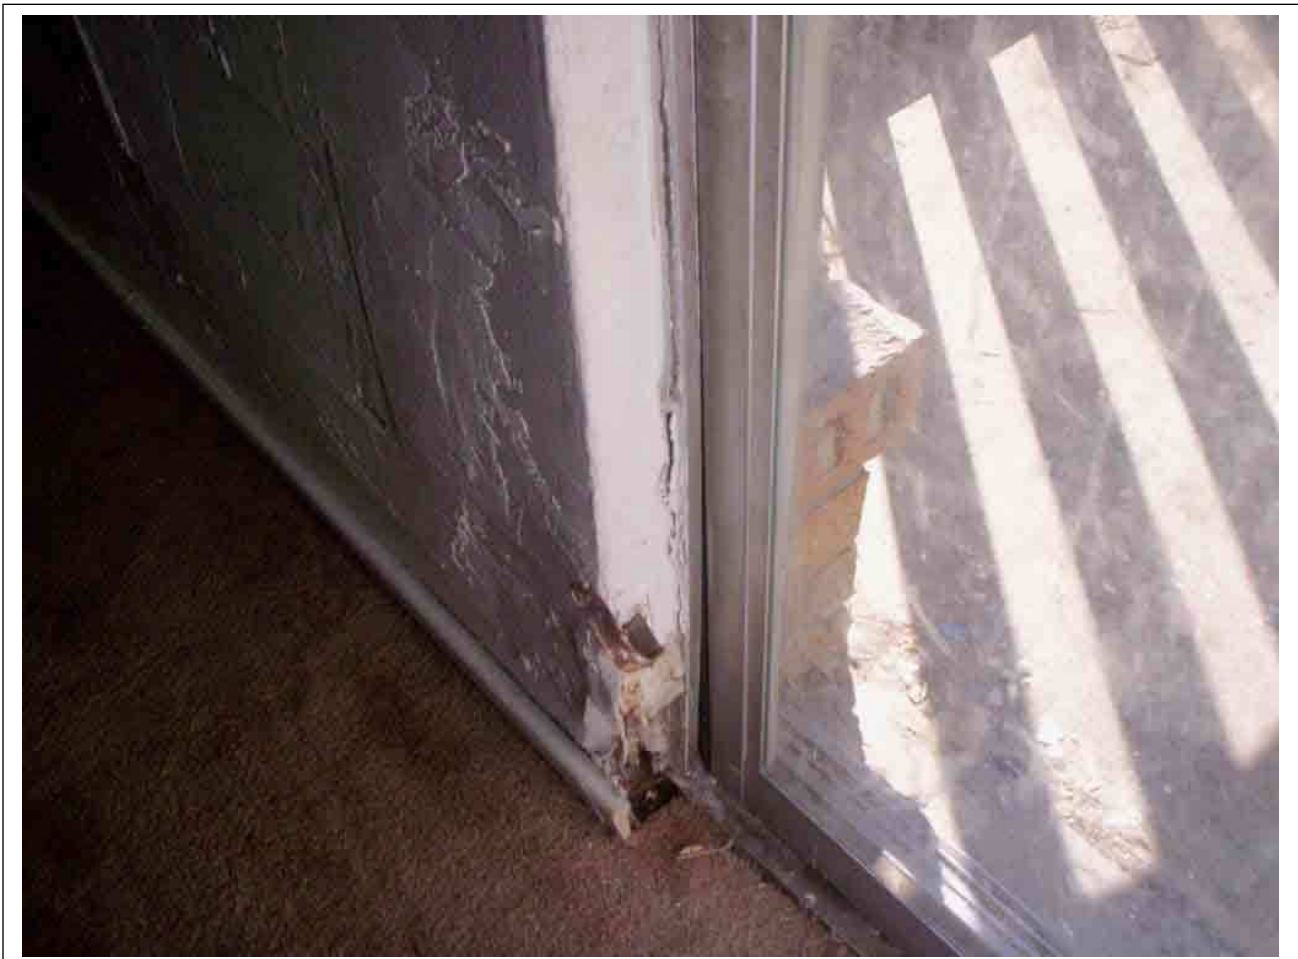
32. Comments: unit 119- rot/moisture damage at patio interior H&S

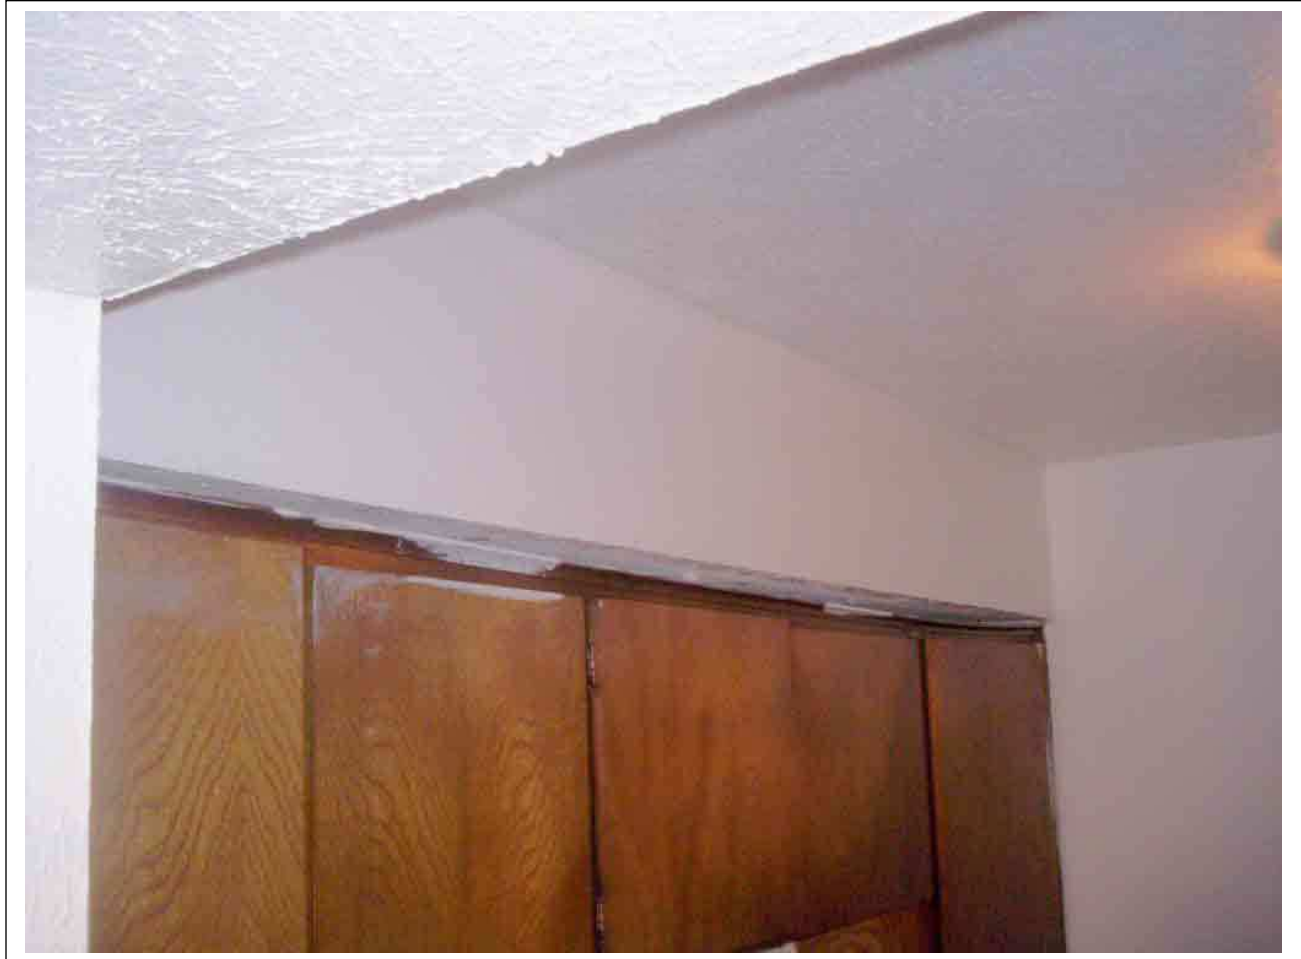
**33. Comments: unit 120- marginally secured cabinetry**

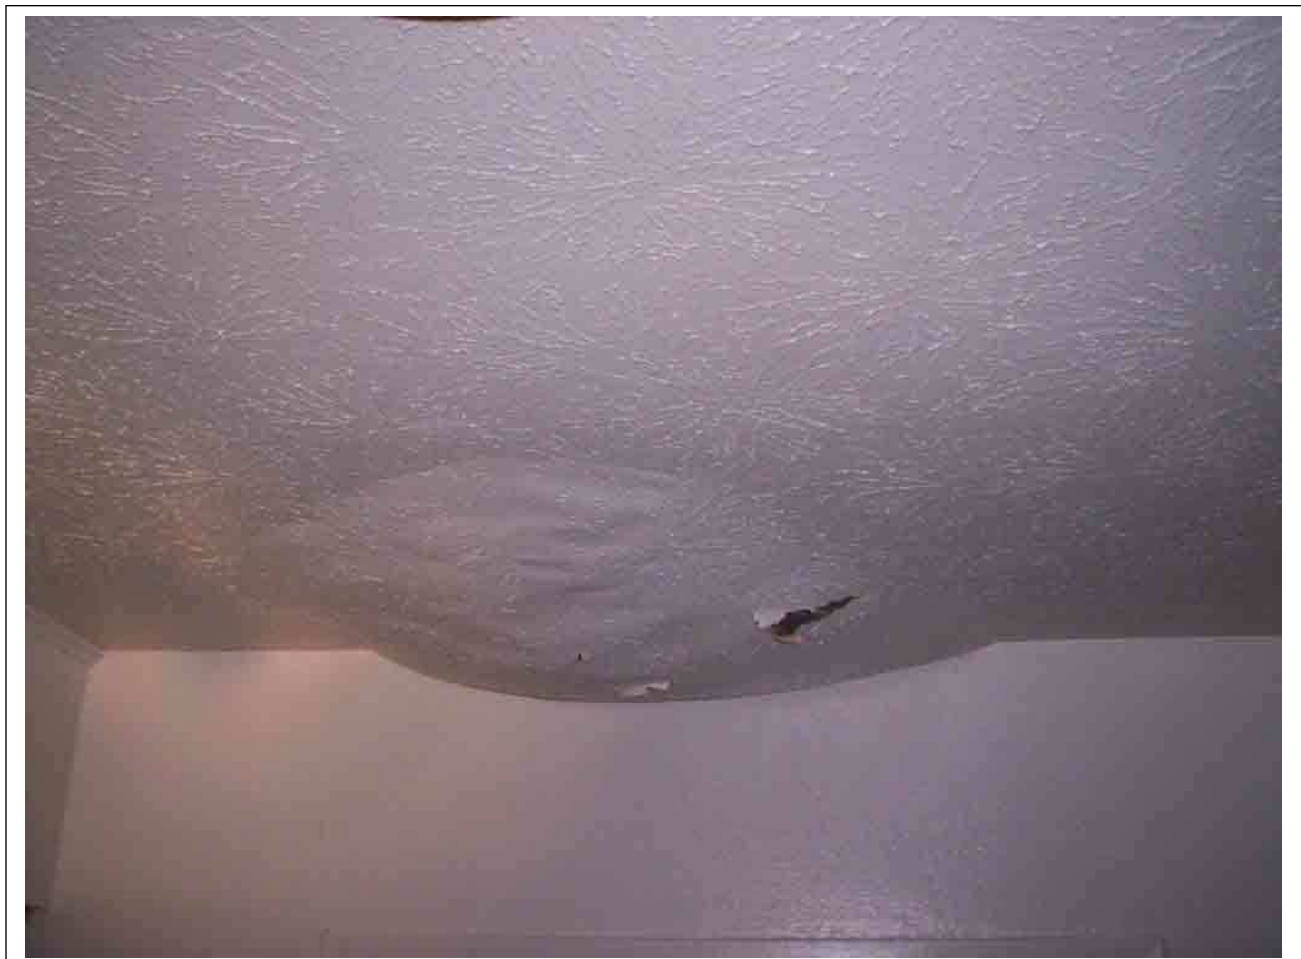
**34. Comments: unit 123- moisture intrusion evidence**

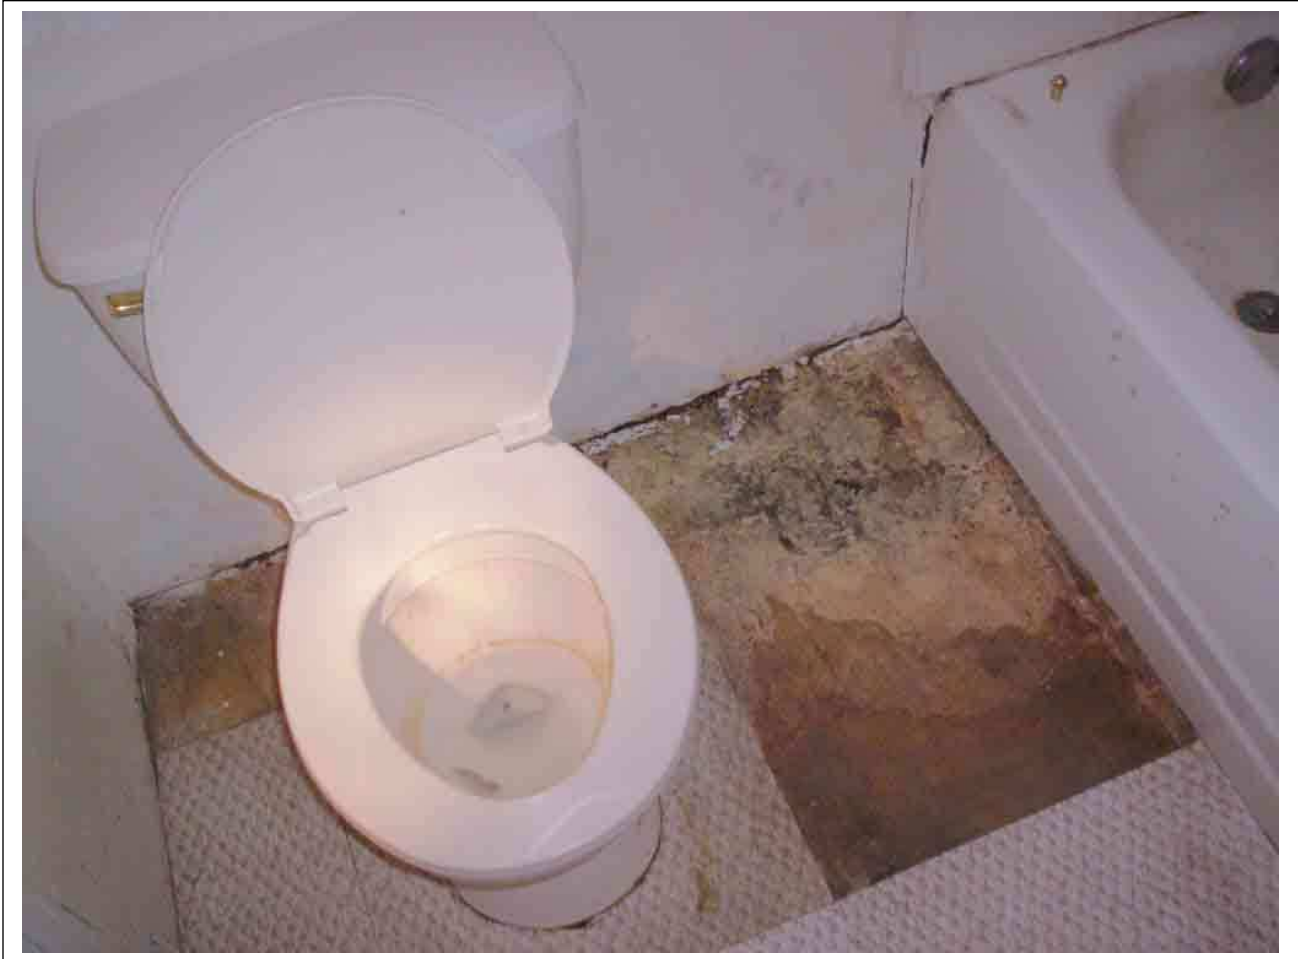
**35. Comments: unit 135 leakage ongoing, moisture intrusion / fungus.**

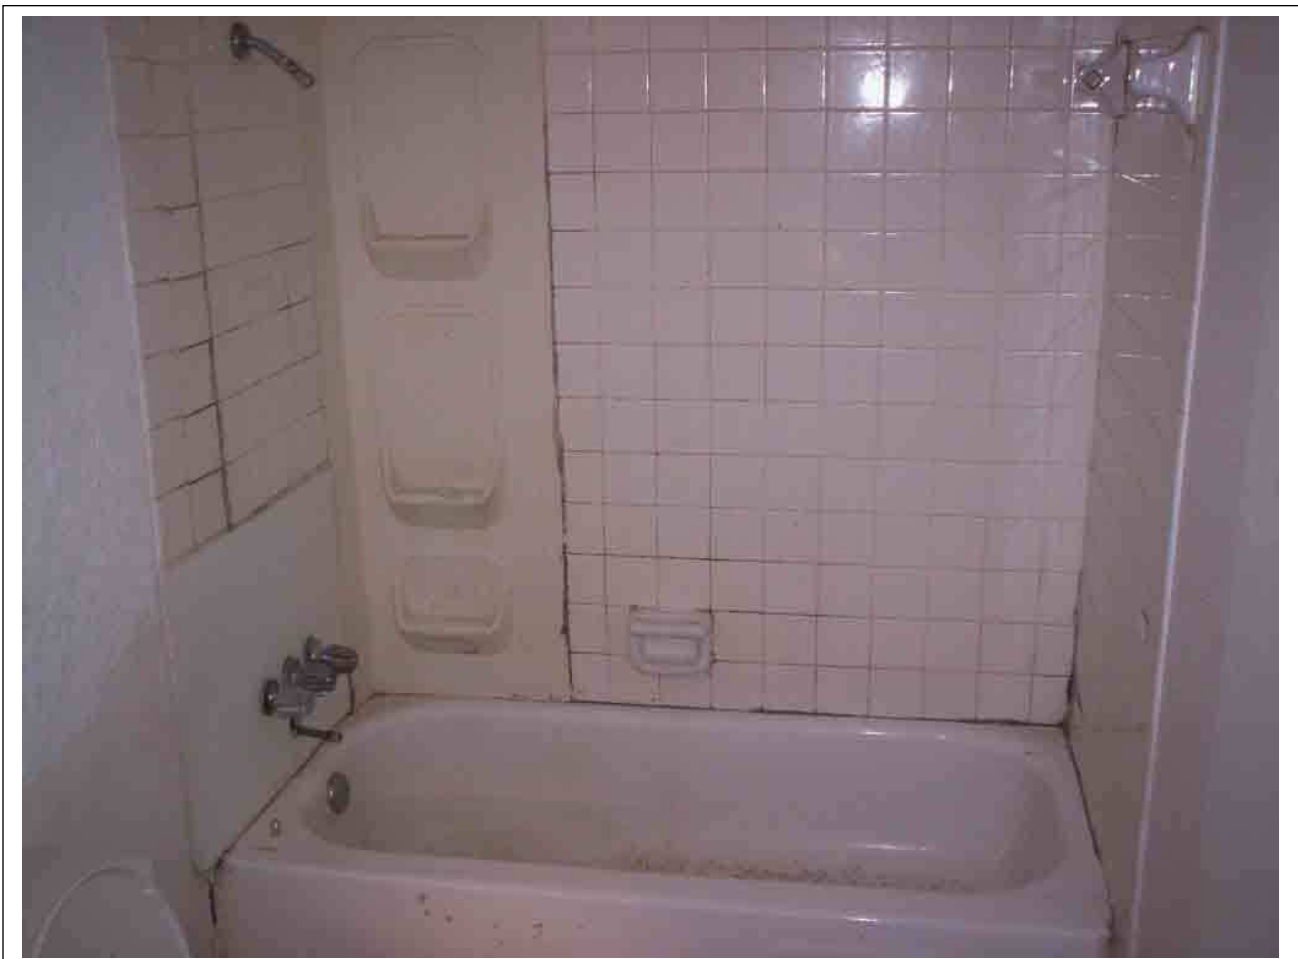
**36. Comments: unit 135- amiss / deficient shower enclosure**

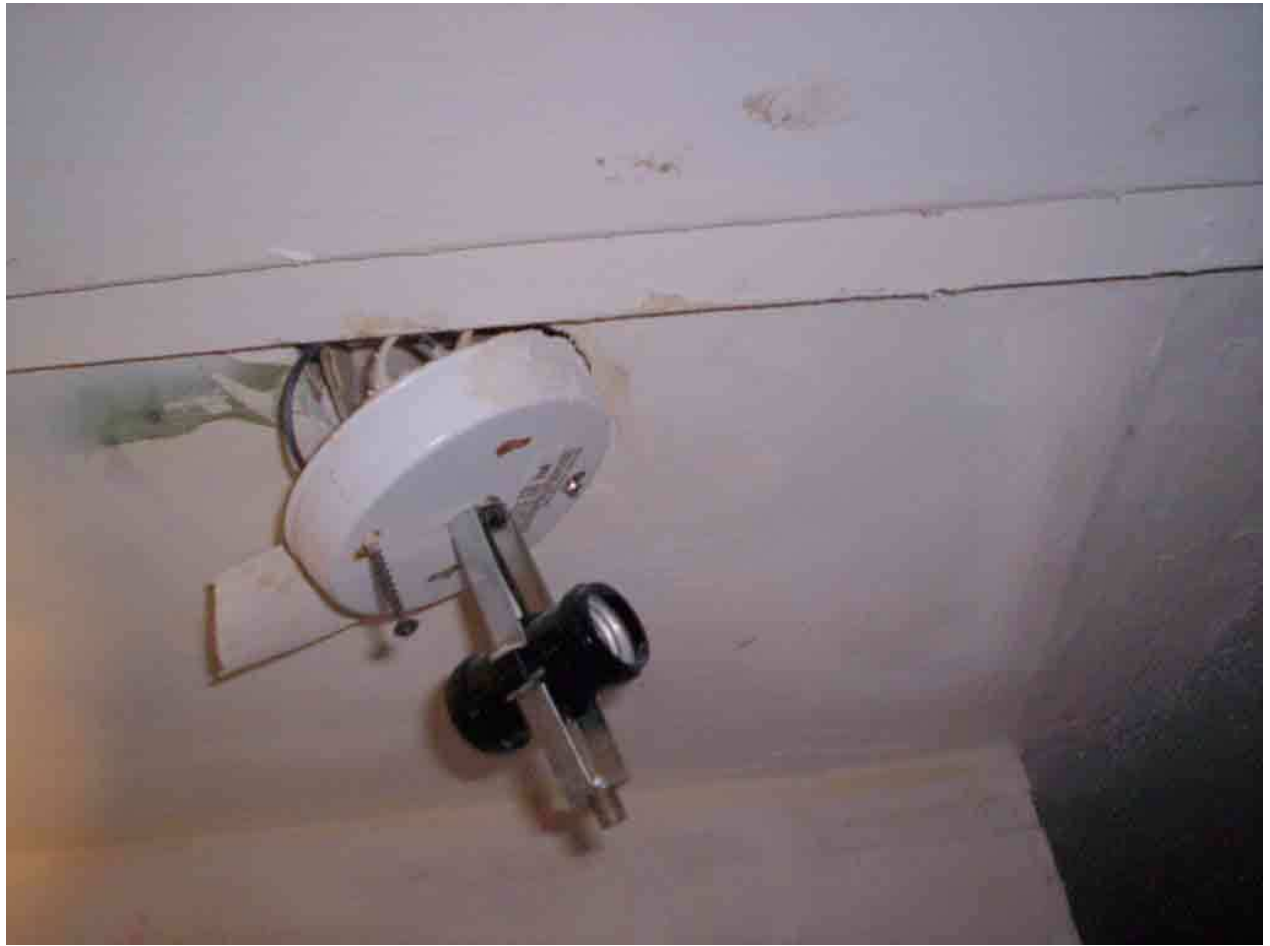
**37. Comments: unit 135- amiss / deficient electrical fixture H&S**

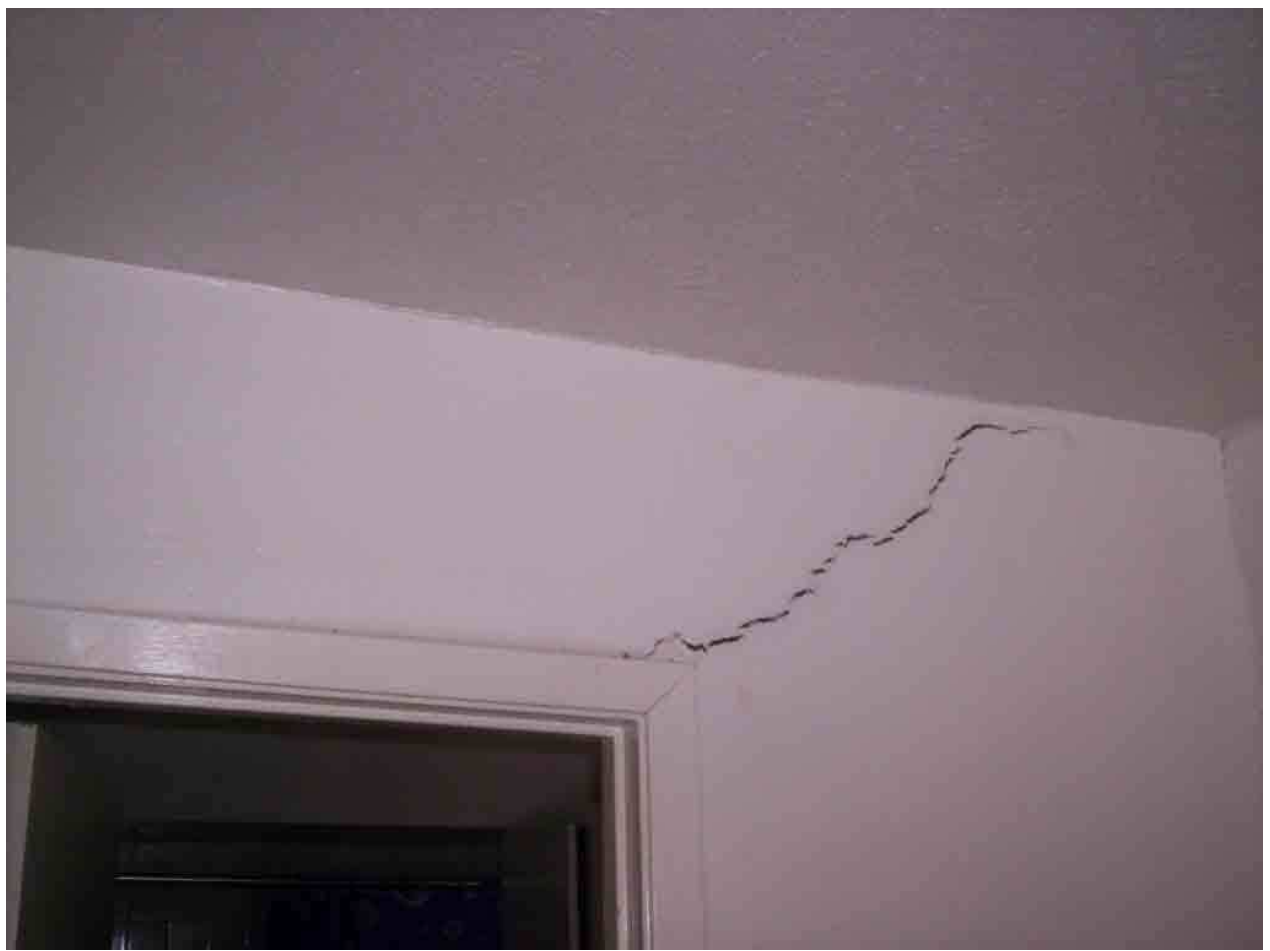
**38. Comments: unit 204 – foundation stress indication**
