**Select Inspect**  
**Property Consultants, llc**  
 2001 Reston; McKinney, TX 75070  
 214-770-6954  
[www.SelectInspect.com](http://www.SelectInspect.com)

**PROPERTY CONDITION ASSESSMENT**

Street Address:	<b>1234 xxxxx</b>	Tracker #		
City:	<b>Dallas</b>	State:	<b>TX</b>	Zip: <b>75220</b>

Property Type:	Multifamily	# of Bldgs:	6	# of Units:	84	Year Built:	1971
----------------	-------------	-------------	---	-------------	----	-------------	------

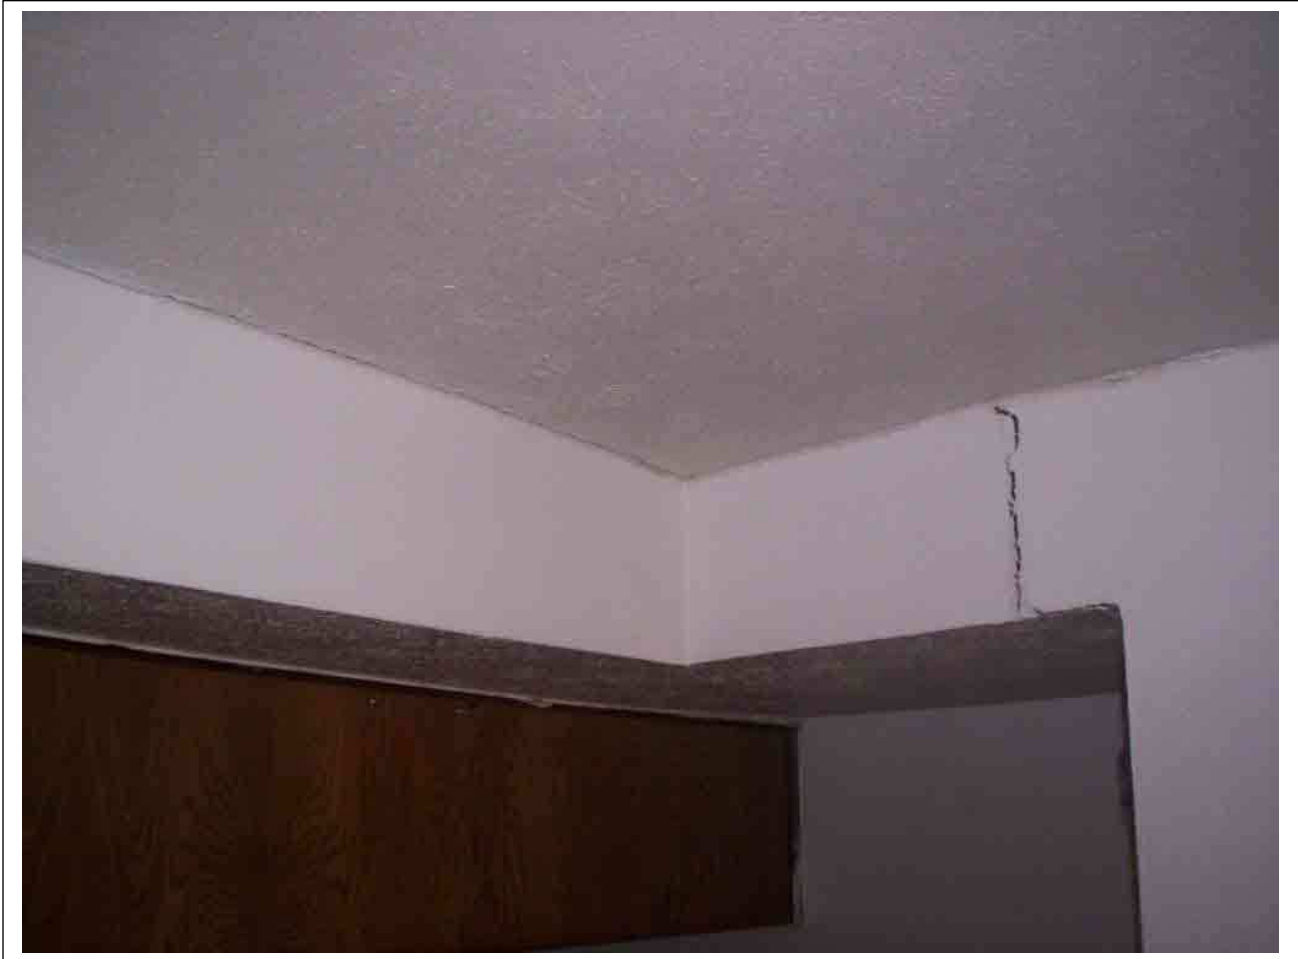
**39. Comments: unit 204 foundation stress indication**

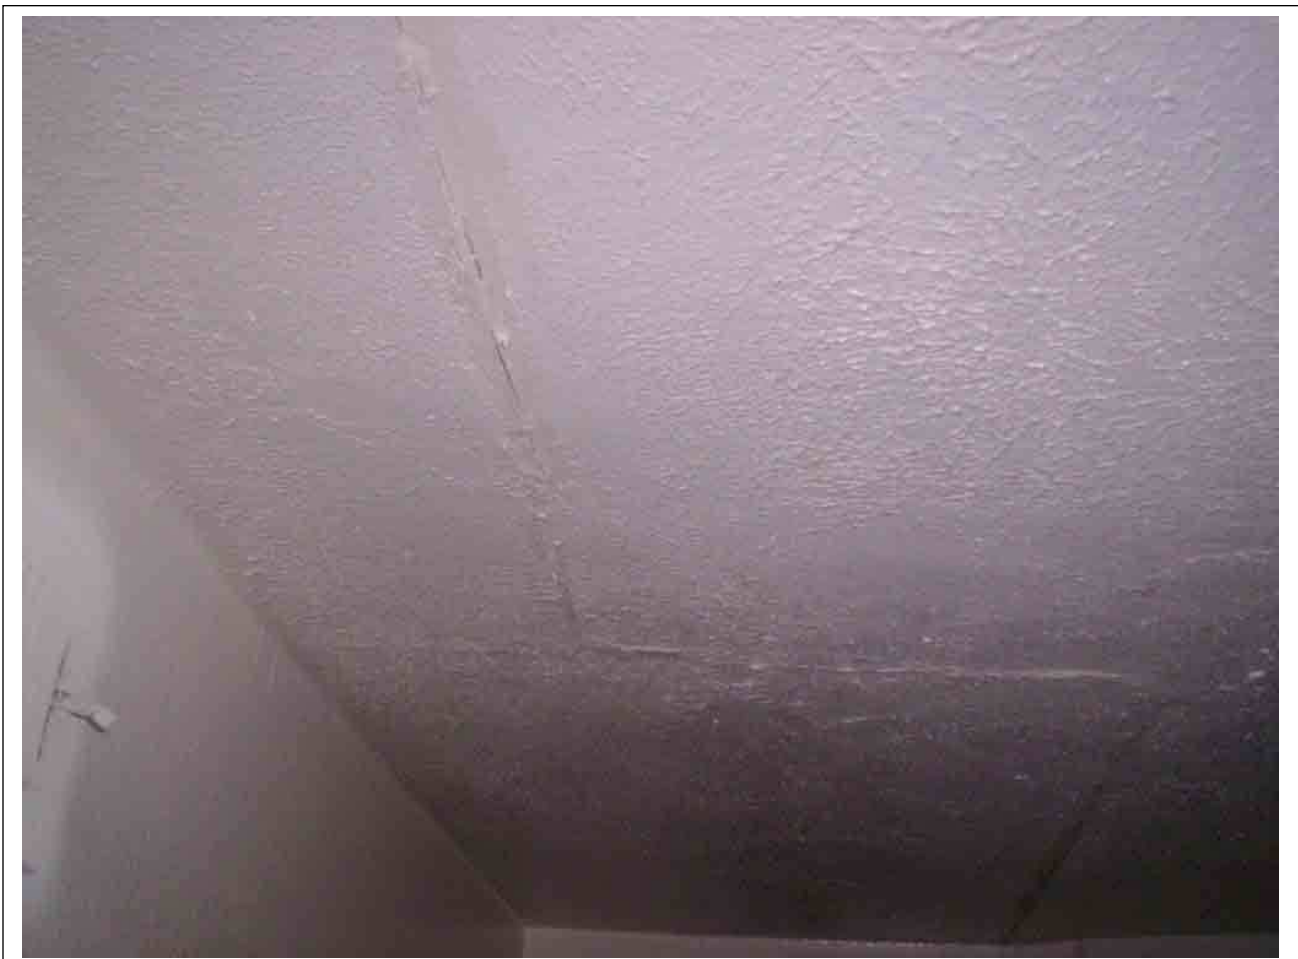
**40. Comments: unit 216 foundation stress indication**

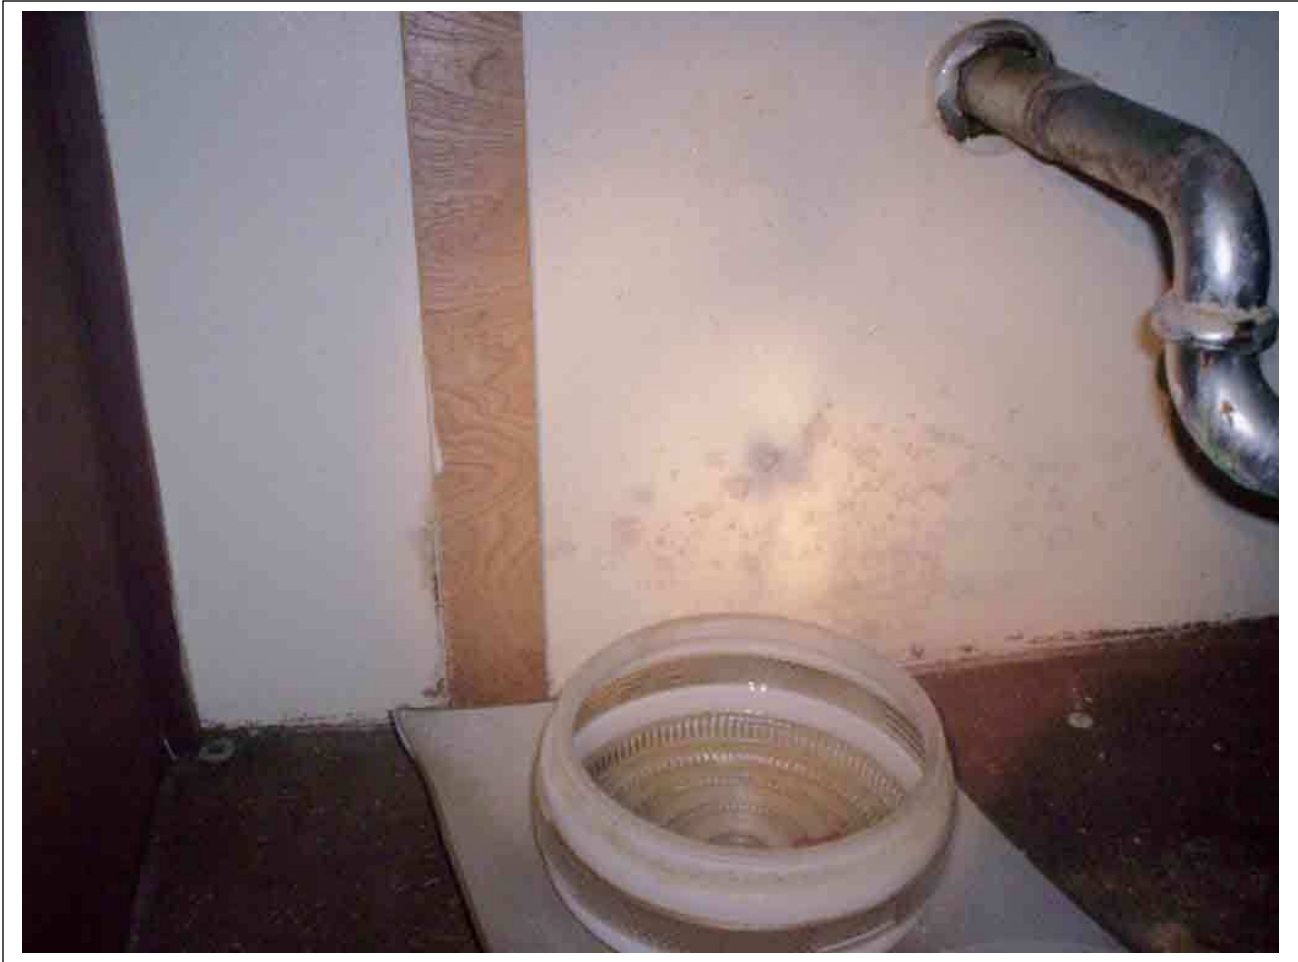
**41. Comments: unit 221- moisture intrusion / fungus below bar sink H&S**

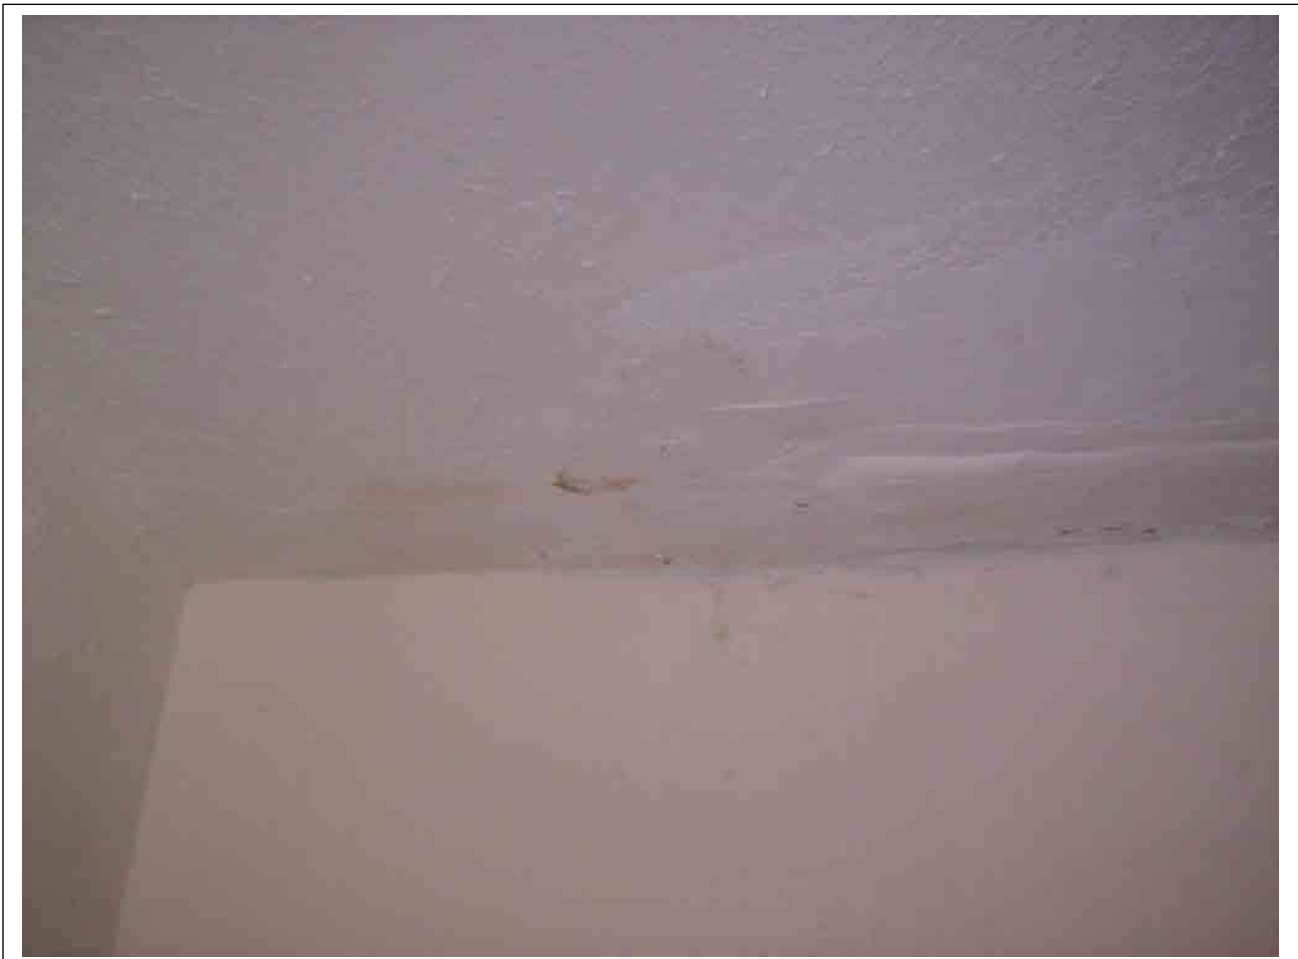
**42. Comments: unit 225- moisture intrusion evidence H&S**

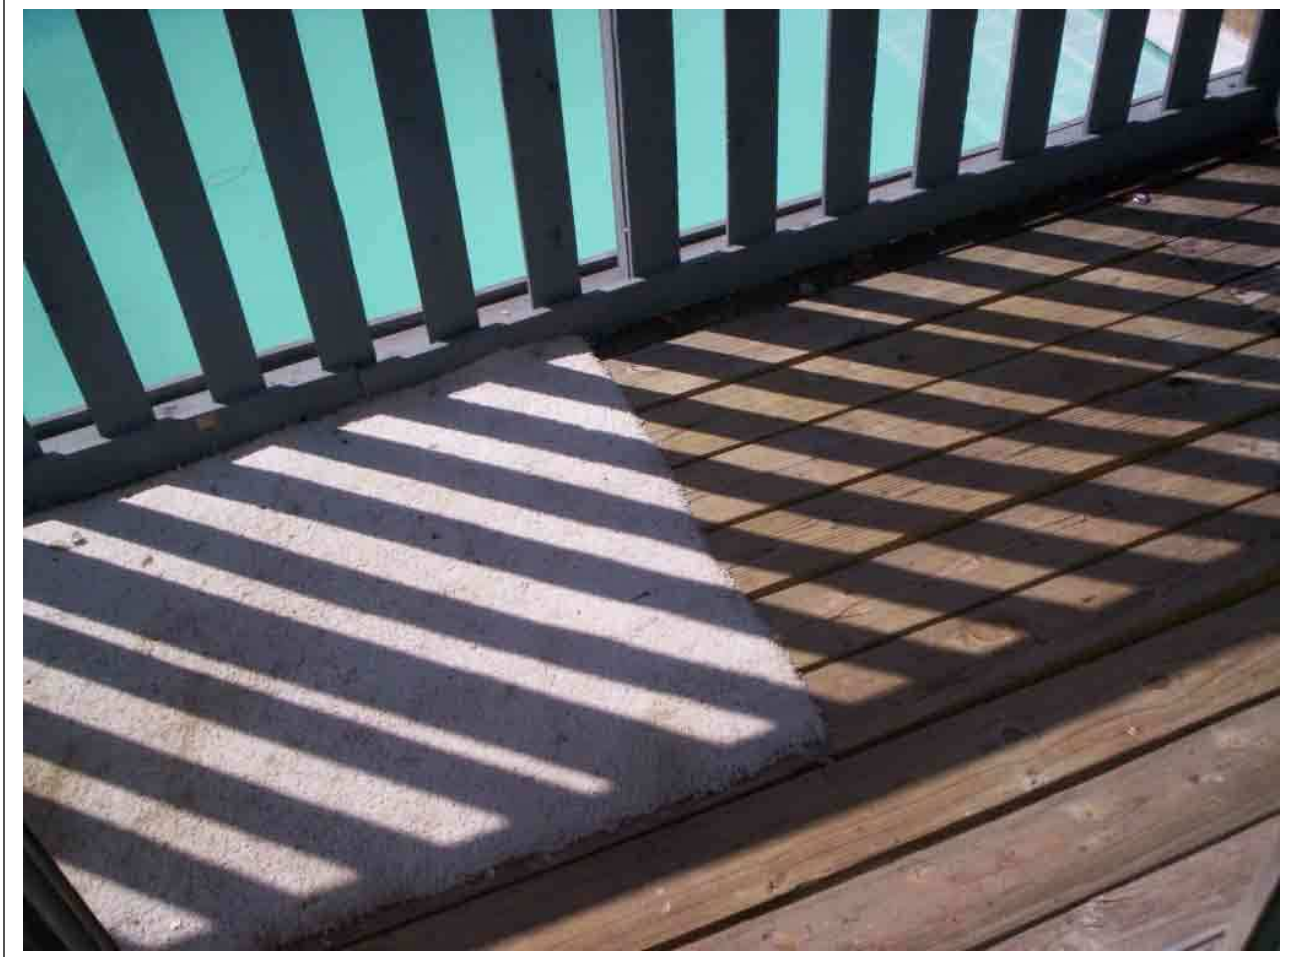
**43. Comments: unit 232- unsteady balcony floor structure H&S**

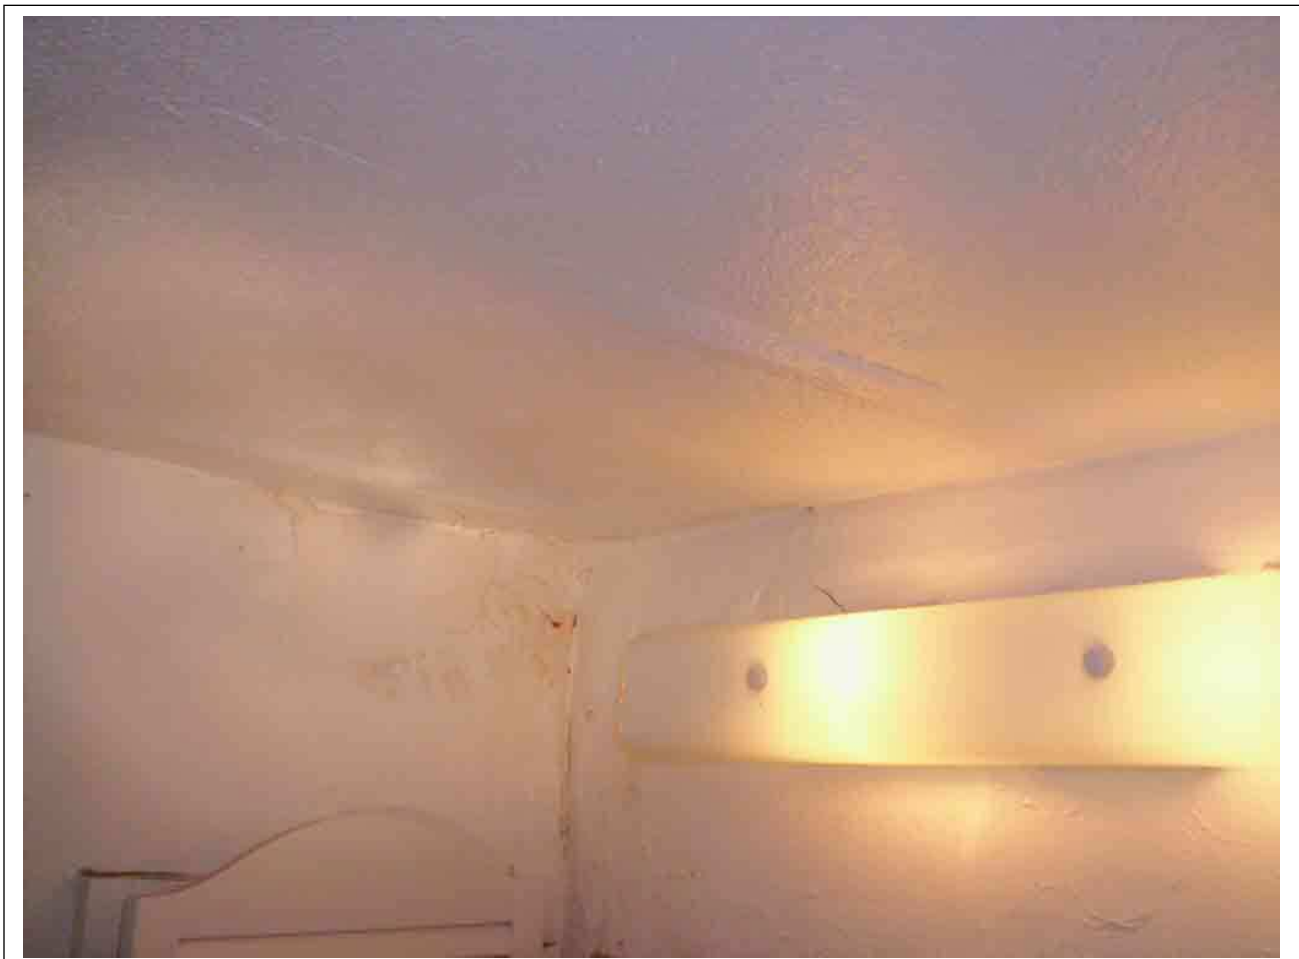
**44. Comments: unit 233 – moisture intrusion evidence H&S**

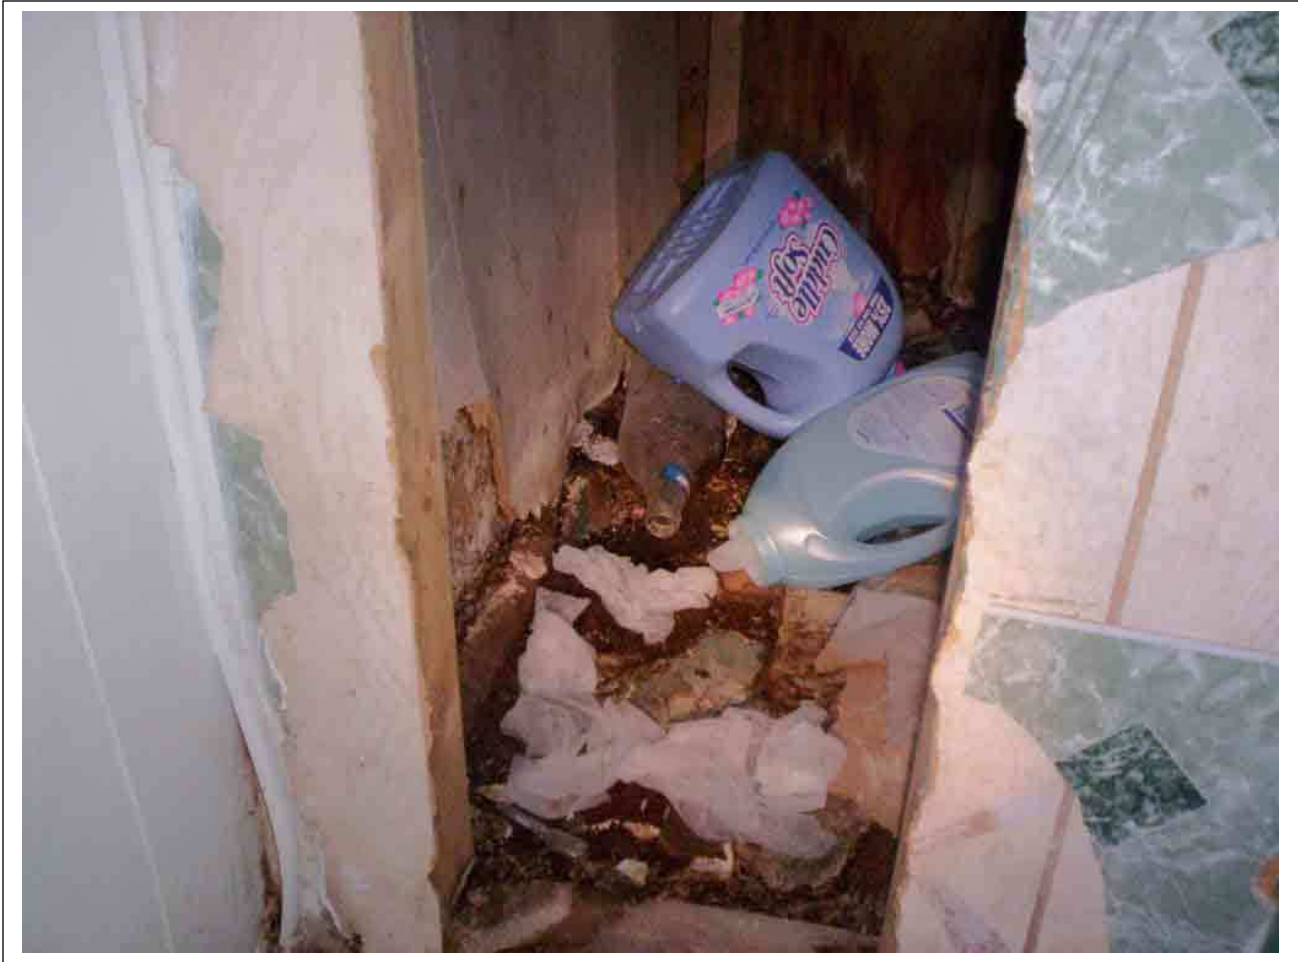
**47. Comments: ongoing leakage, rot/moisture damage, fungus under shelf unit southwest corner of laundry room**

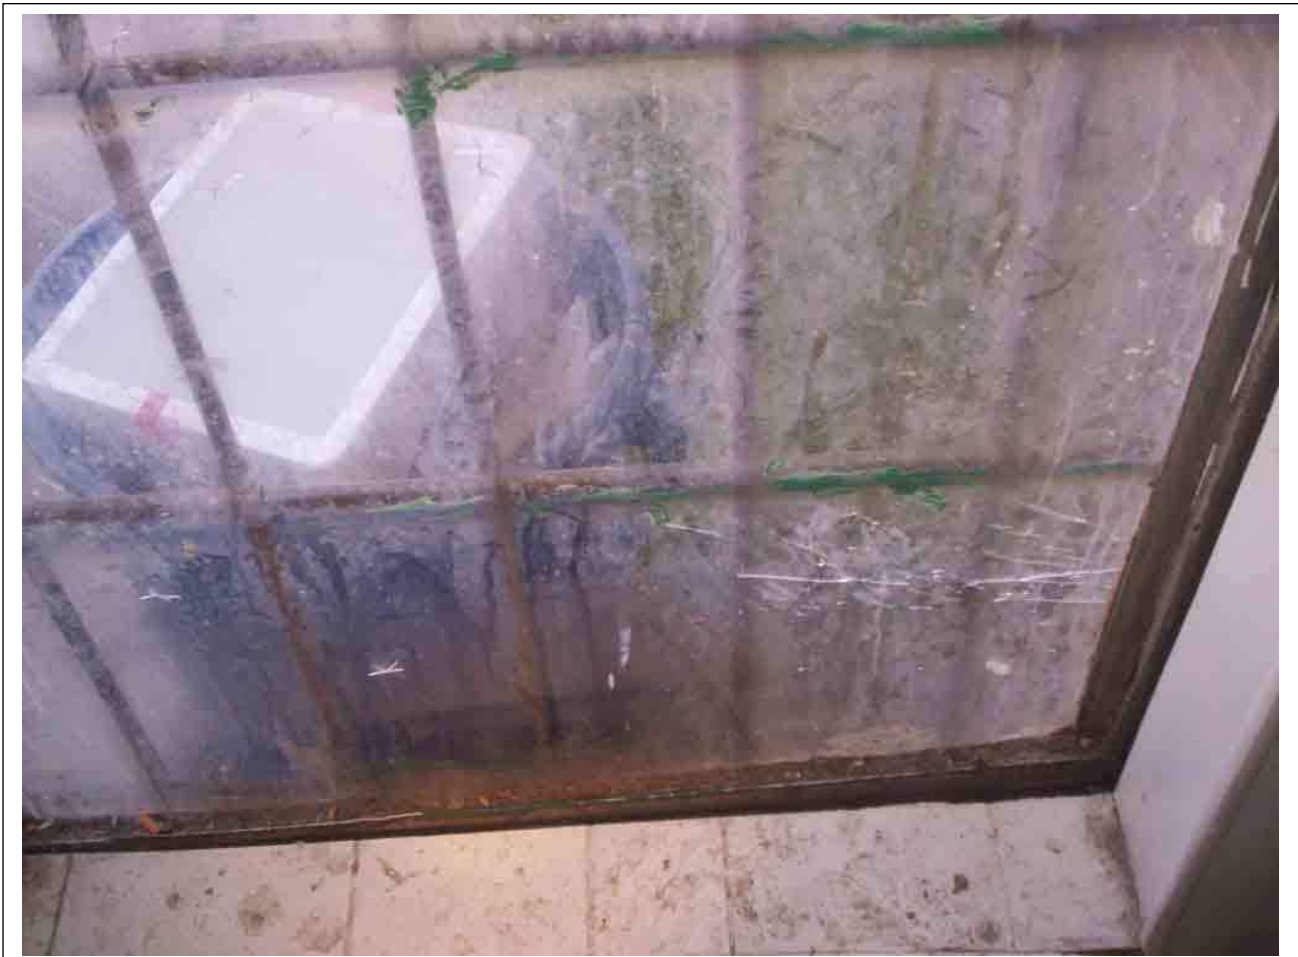
**48. Comments: damaged window at laundry room**

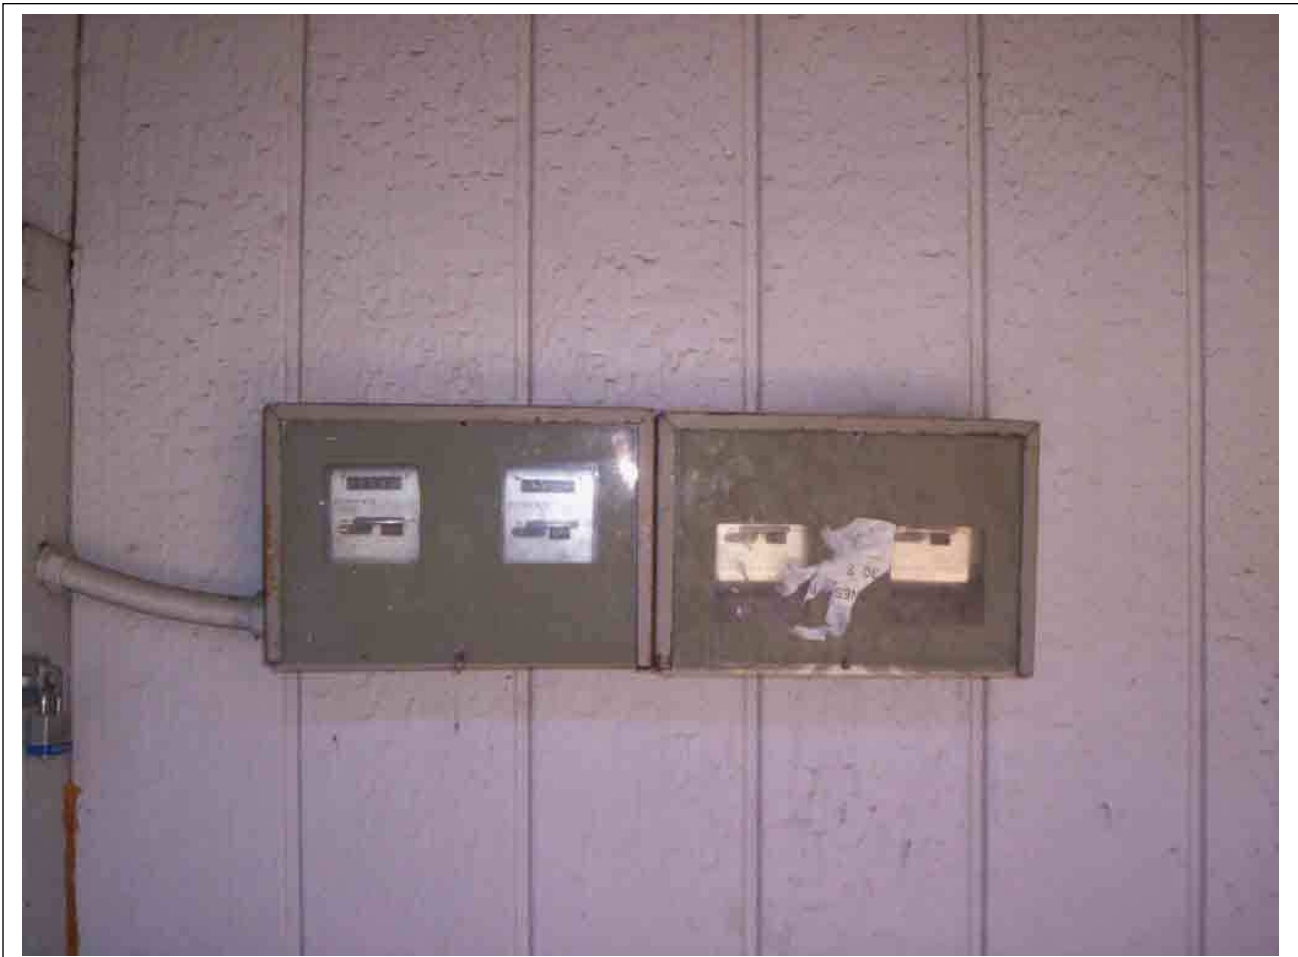
**50. Comments: Typical electric meter- discovered services were 90 amp**
