DISCOVERIES		
Exterior Comments	Building or General Area discovered	N/A
Foundation	Common stress indications including vertical stucco cracks at various perimeter locations and moderate horizontal crack at the east. Significant issues were not found or observed concerning this item at the time of inspection.	
Structural	Building structure and steel components appeared visibly stable. Condition of substrate behind stucco is questionable, as moisture intrusion evidence was noted at multiple exterior and interior locations. I suspect there is at least moderate framing decay and possible wood destroying insect evidence/activity in inaccessible wall voids. Such determination would require invasive measures, and such was not in the scope of this inspection. Wood and stucco sign components were in disrepair and full removal should be considered. These components were unstable, and potentially unsafe for tenants and patrons. One section was marginally supported by rope- integrity is very questionable, and failure is imminent, unless corrected.

Select Inspect Property Consultants LLC © 2007

Digital Photographs- Supplementary to the Inspection

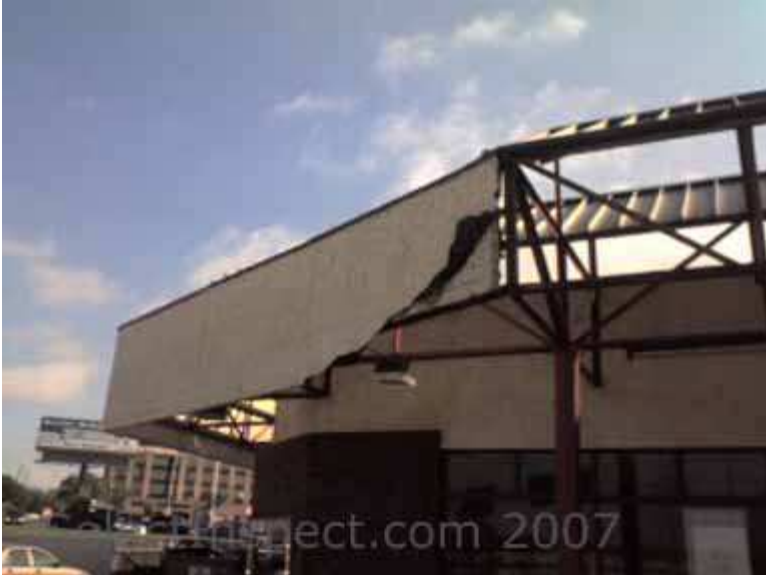
↑ deficient wood and stucco at sign structure- front view

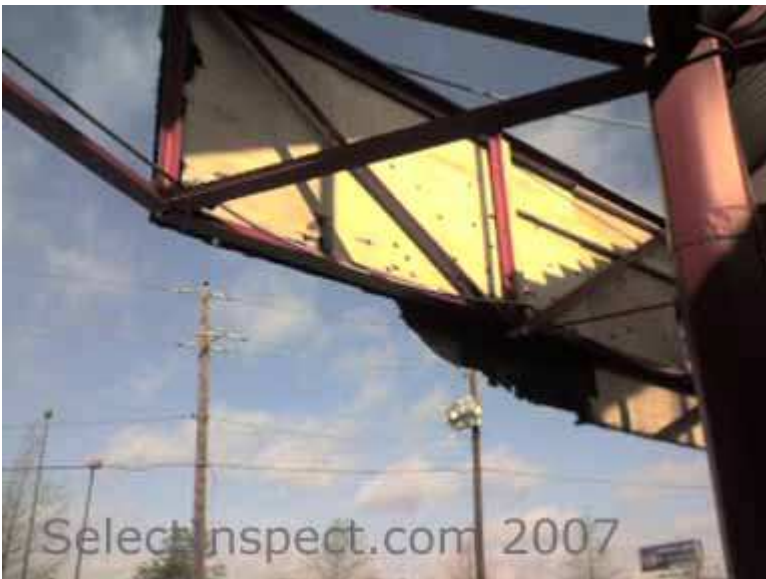
↑ deficient wood and stucco at sign structure- rear view

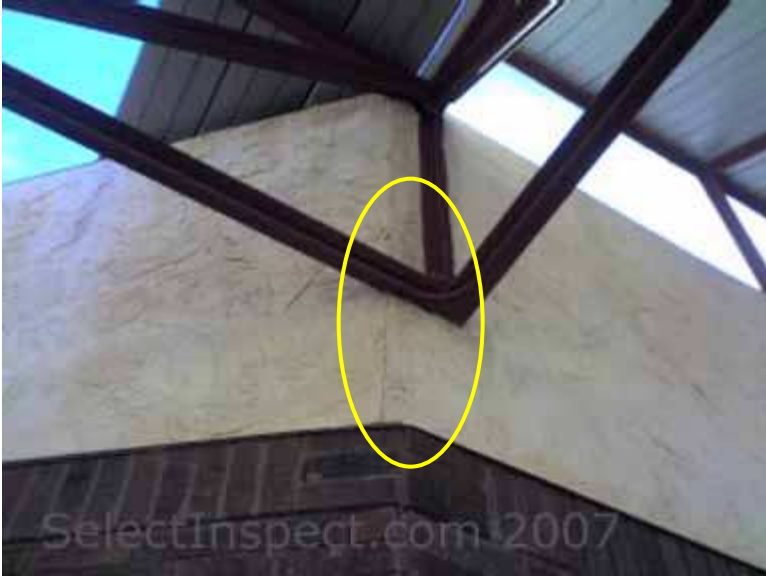
↑ moisture intrusion evidence and cracking at stucco- example

Flatwork & Drives	Significant issues were not found or observed concerning this item at the time of inspection -Not inspected in a comprehensive manner- very limited visual observation	
Soil Grading/Drainage	Repair needs were not discovered at the time of inspection	
Roof Surfaces	Surfaces appeared satisfactory, evidence of pooling water and inadequate drainage was discovered. Significant issues were not found or observed concerning this item at the time of inspection, Multiple locations of tar repair were discovered. evidence of moisture intrusion to the interior and behind stucco finishes was discovered at upper walls in the ceiling crawl space.	
Gutter	Scupper (drain) at the east parapet was not at a low point of the roof; evidence of pooling water and inadequate drainage was discovered.	
Flashing	Cap flashing appeared satisfactory	
Exterior Walls	Stucco cracks should be sealed and periodically maintained

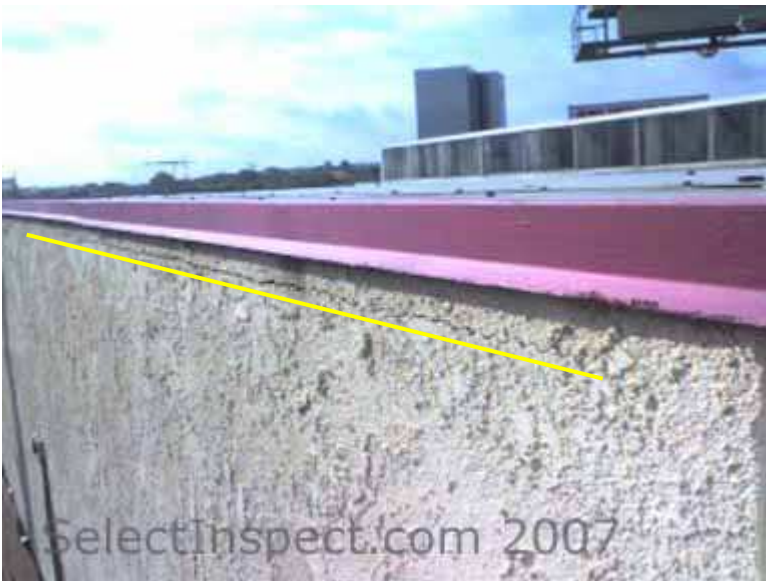
↑ horizontal cracking at east / rear area of bldg below roof parapet

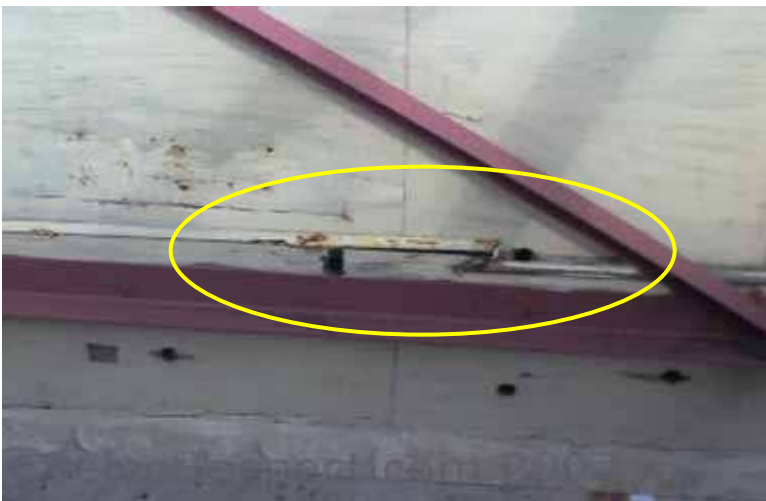
↑ amiss / deficient electrical at north behind sign structure

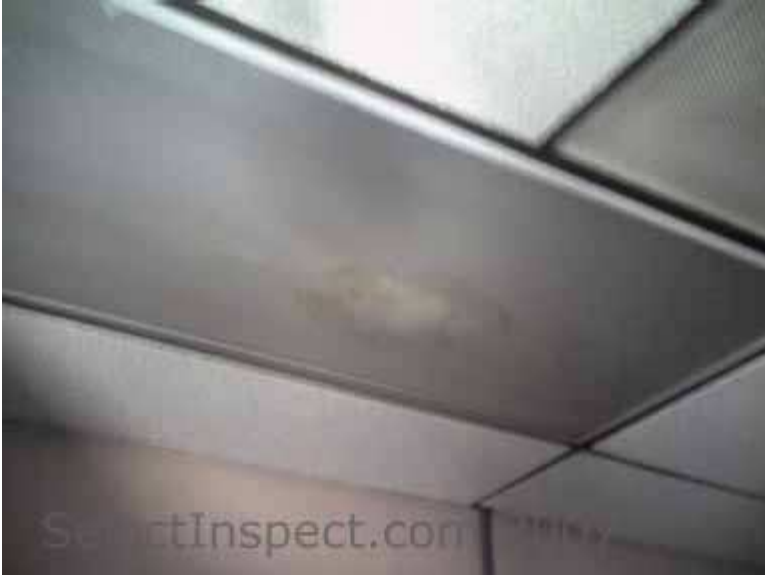
↑ moisture intrusion at light fixture in bathroom

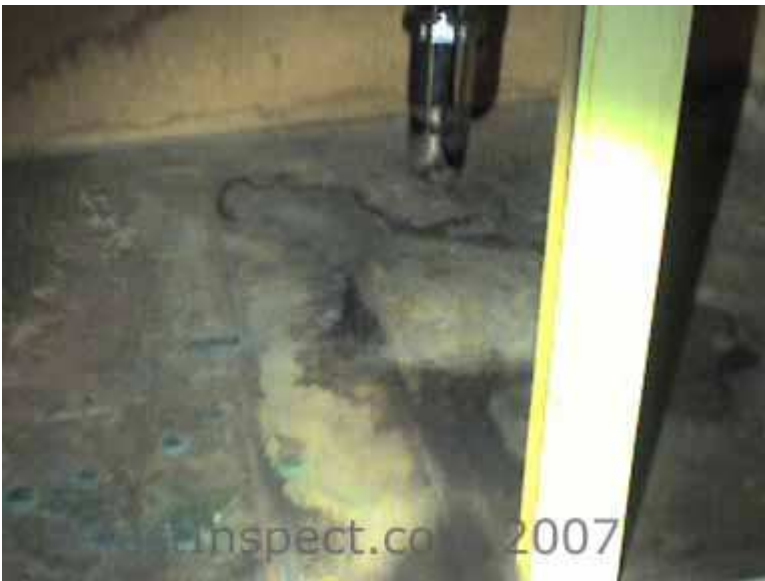
↑ moisture intrusion / fungus under breakroom sink
