Stairway	Stair railing is unsteady. Repair is recommended.

**Select Inspect Property Consultants LLC © 2007**

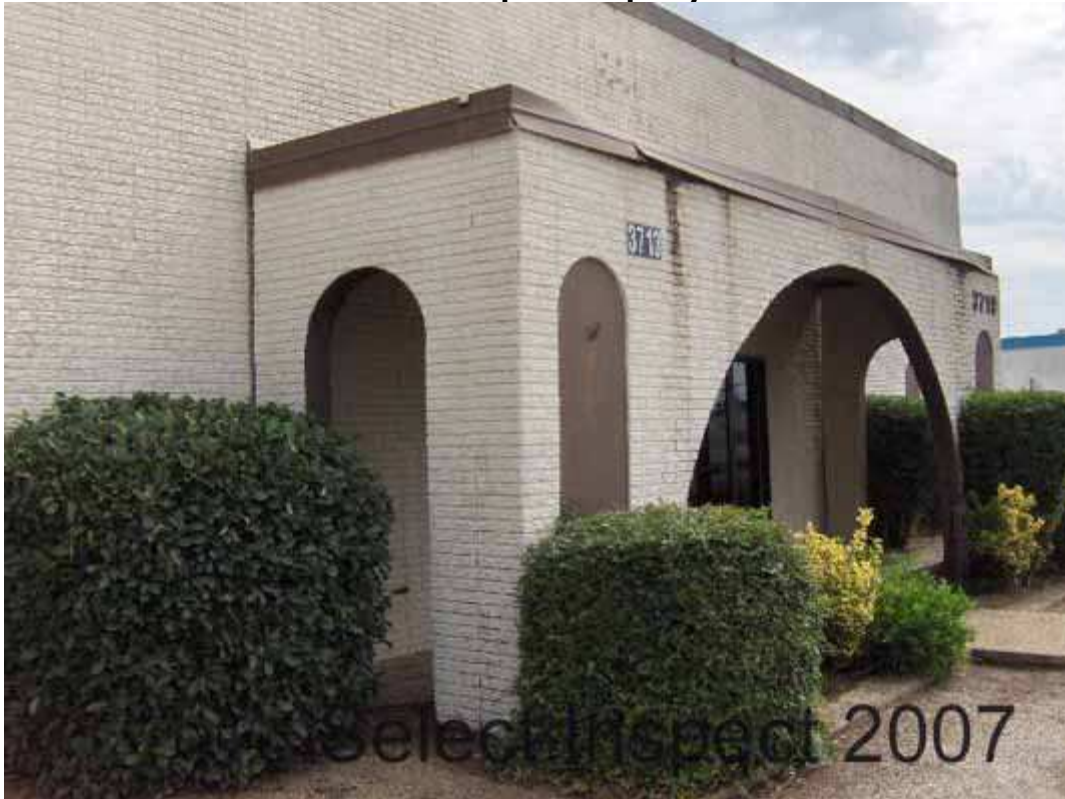
↑ porch feature at unit xxxx leaning from structure, amiss / deficient roofing and flashing.

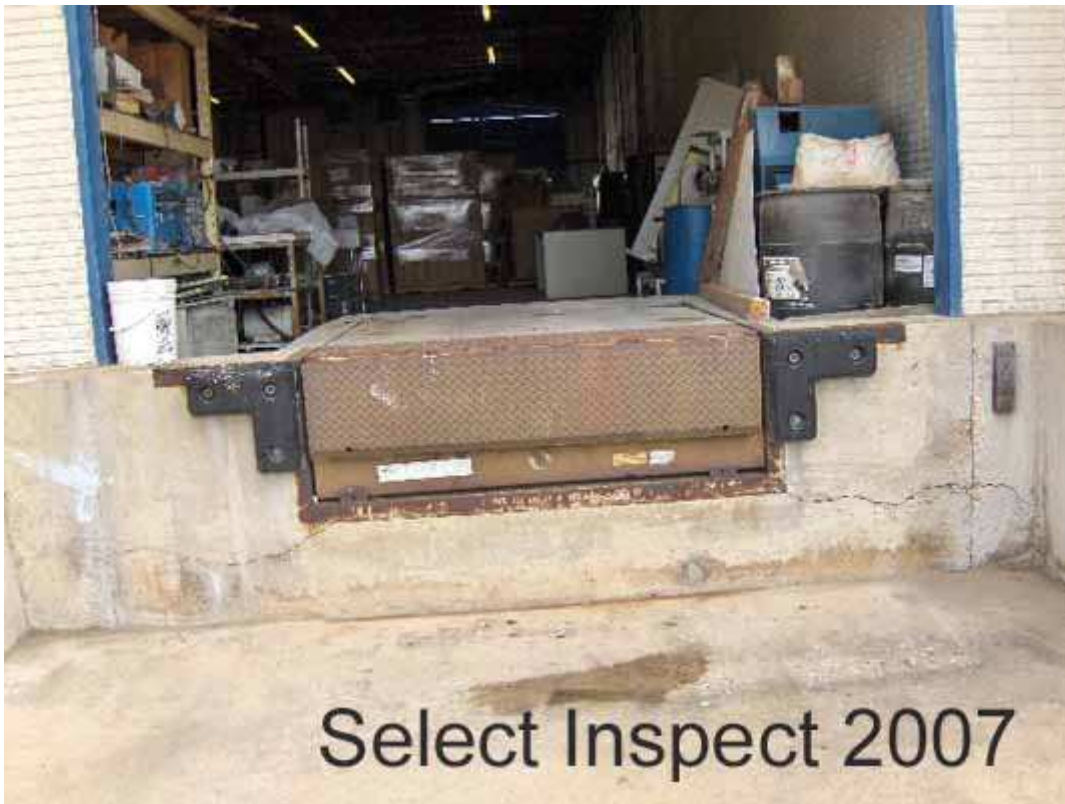
↑ foundation stress at loading dock- Monitor this item periodically and maintain as needed.

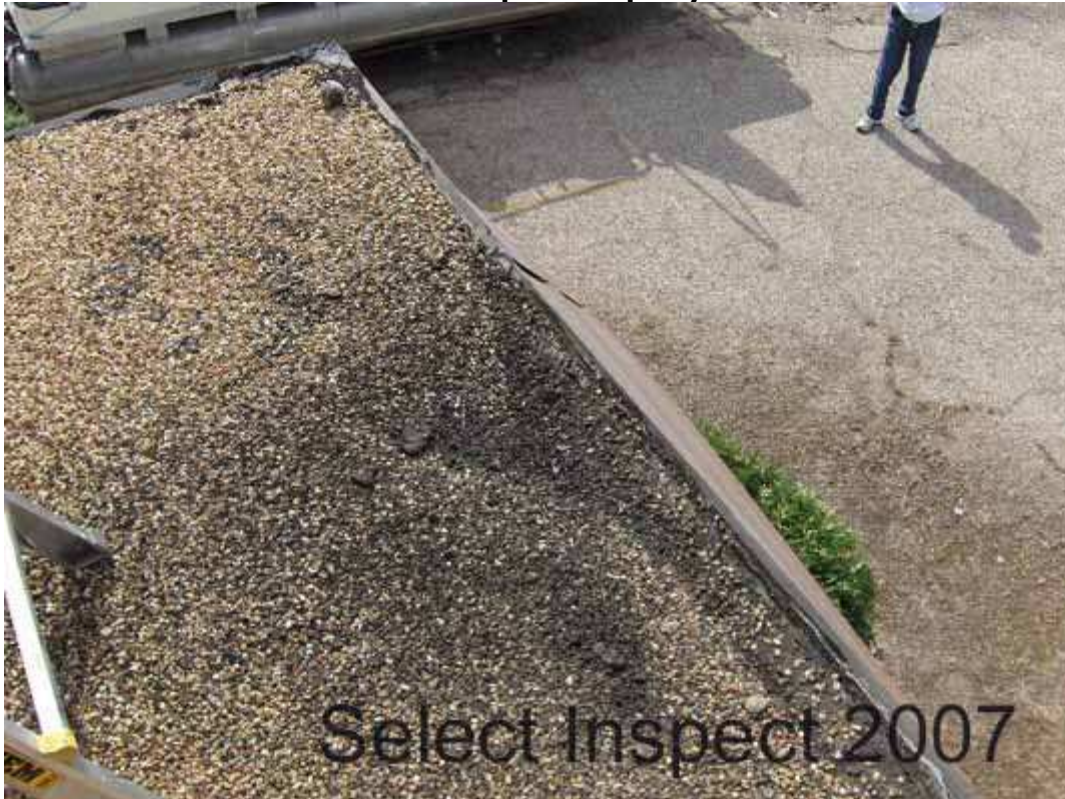
↑ southeast corner of xxxx porch – sunken and amiss flashing, deflection, suspected rot of supporting framing

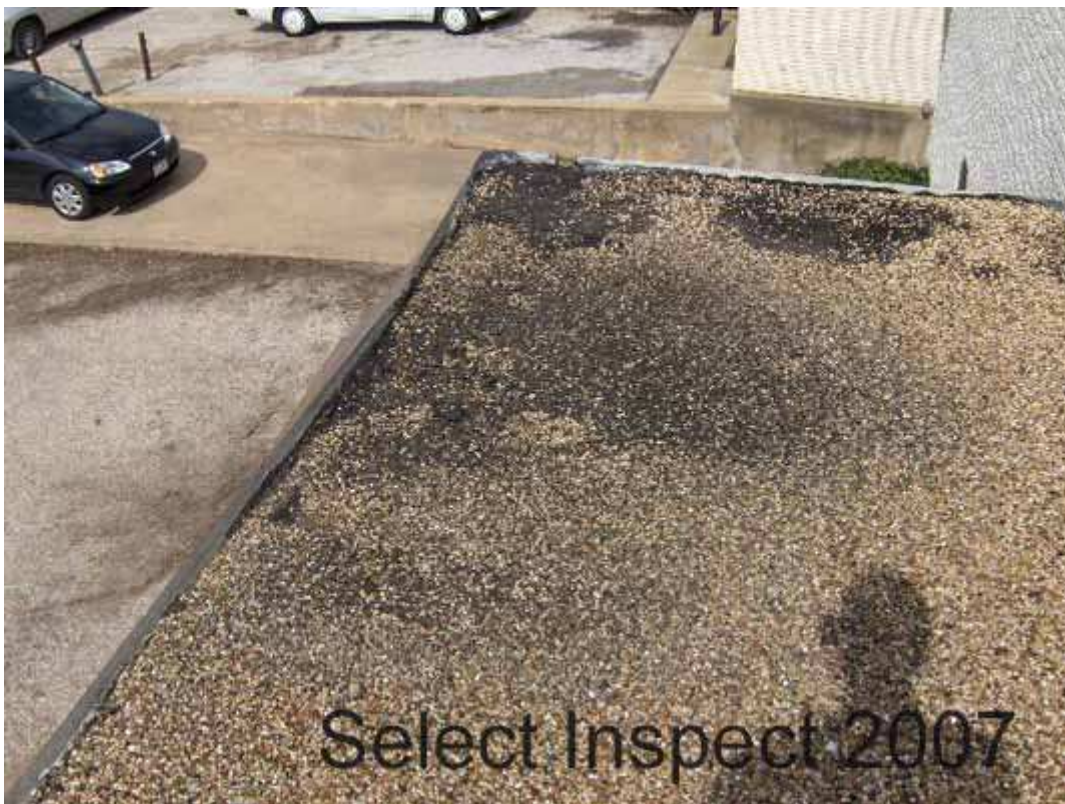
↑ southwest corner of xxx porch – sunken and amiss flashing, deflection, suspected rot of supporting framing

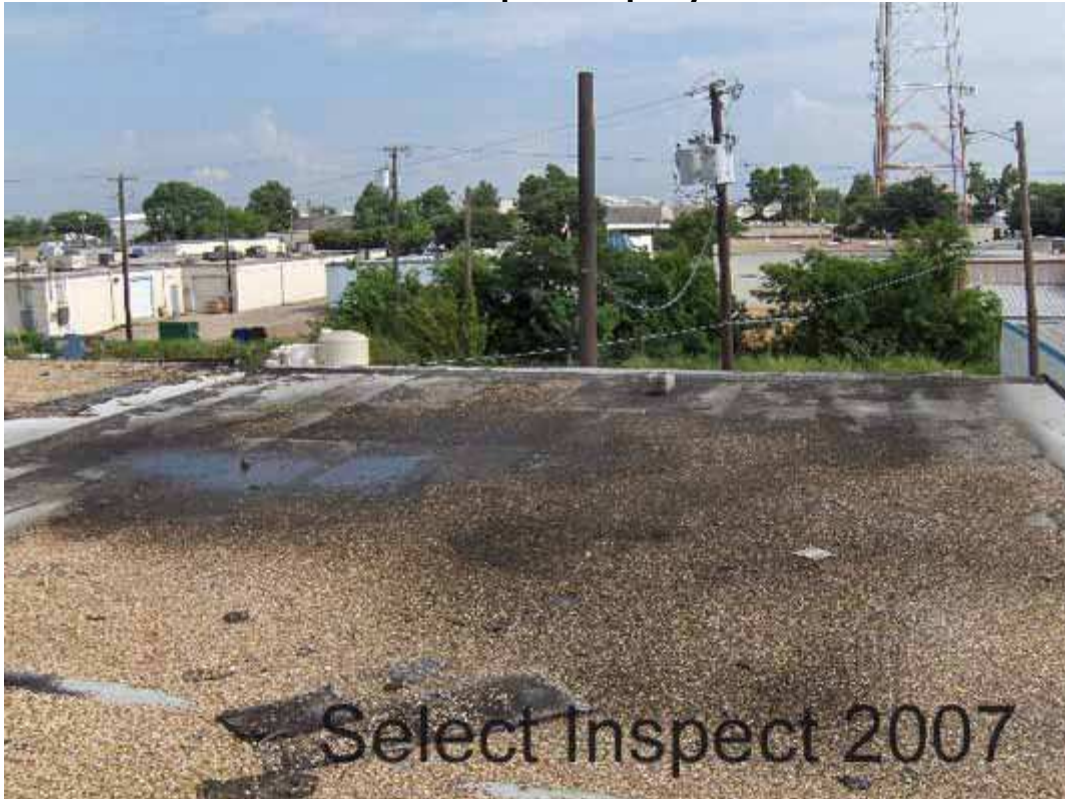
↑ northeast roof- pooling water and poor drainage conditions

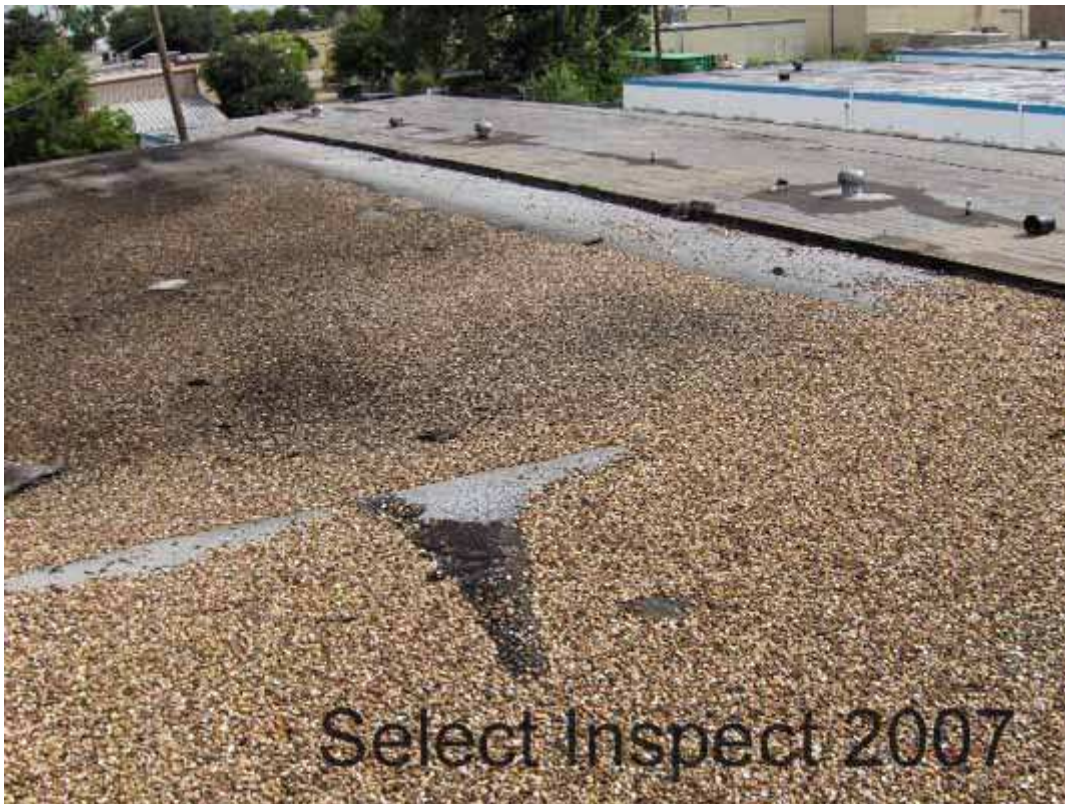
↑ example roof surface- bulges, and exposed fiberglass mat

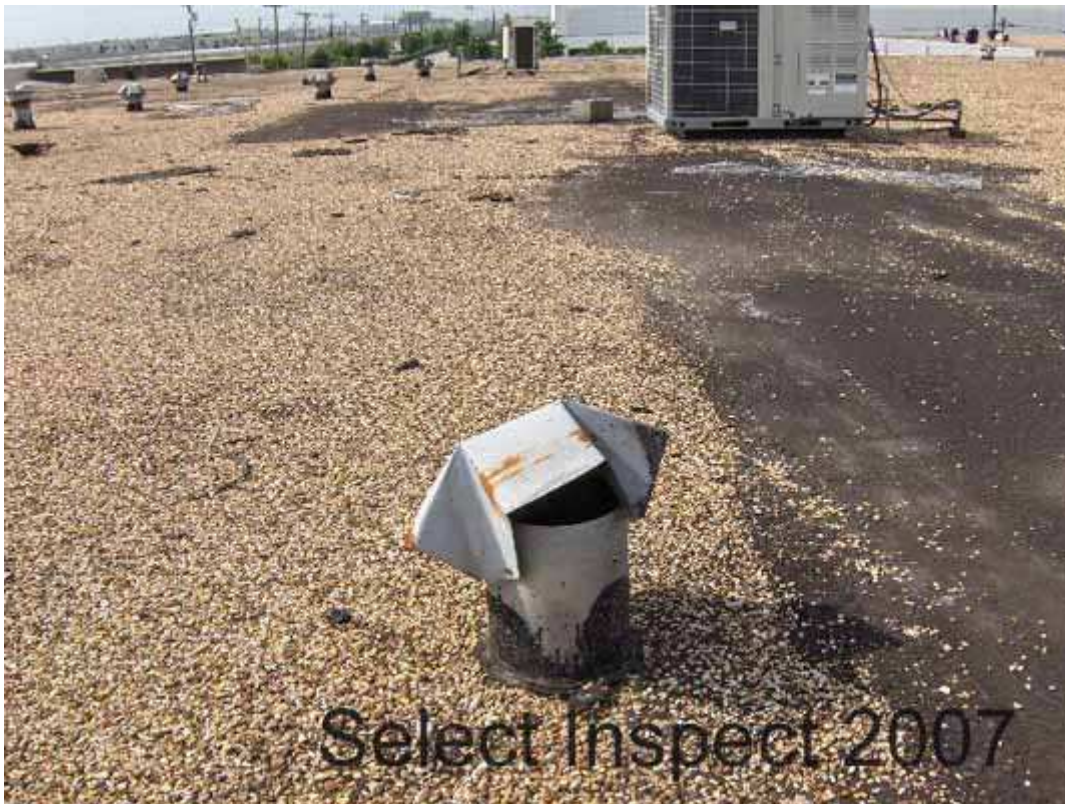
↑ amiss / deficient roof vent cap- may allow moisture intrusion

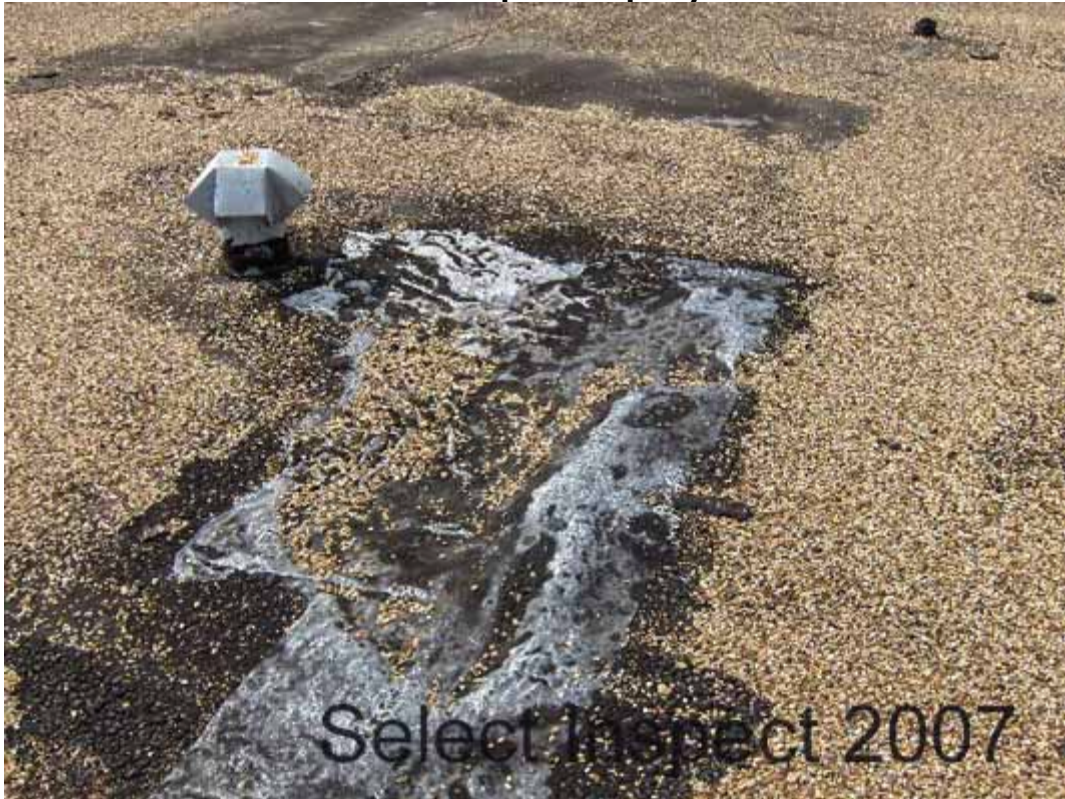
↑ example roof surface- bulges, and exposed fiberglass mat

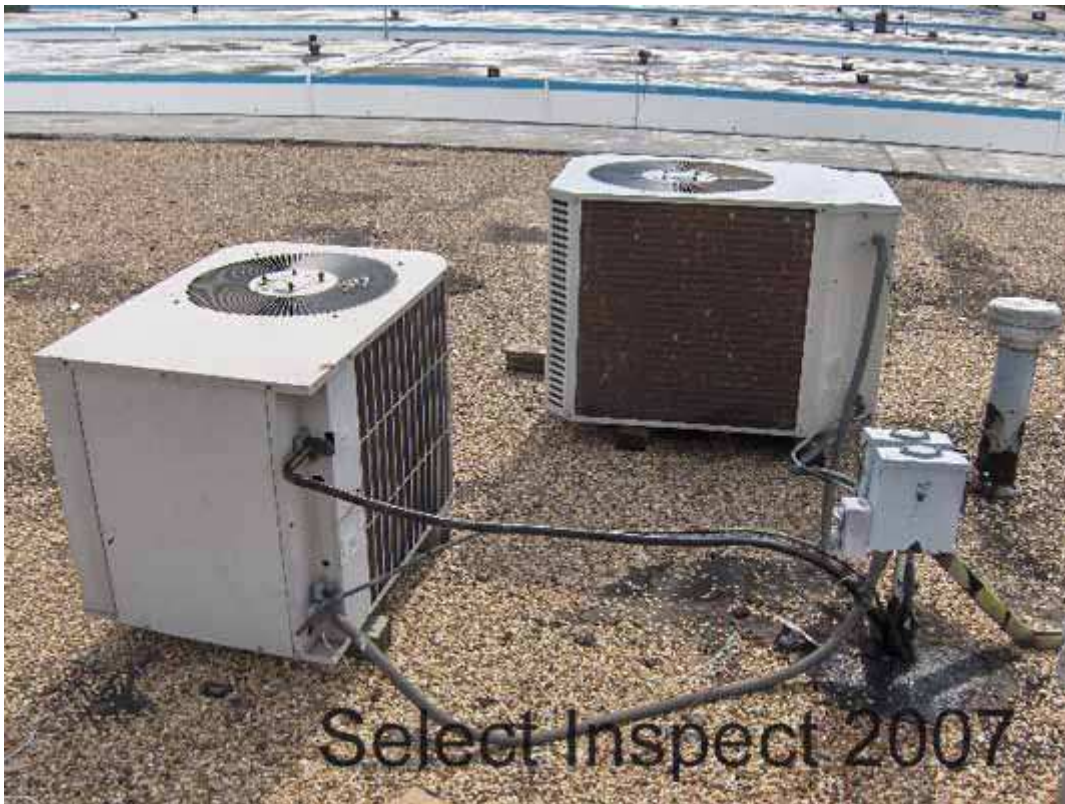
↑ example- air-conditioner condensers and related equipment

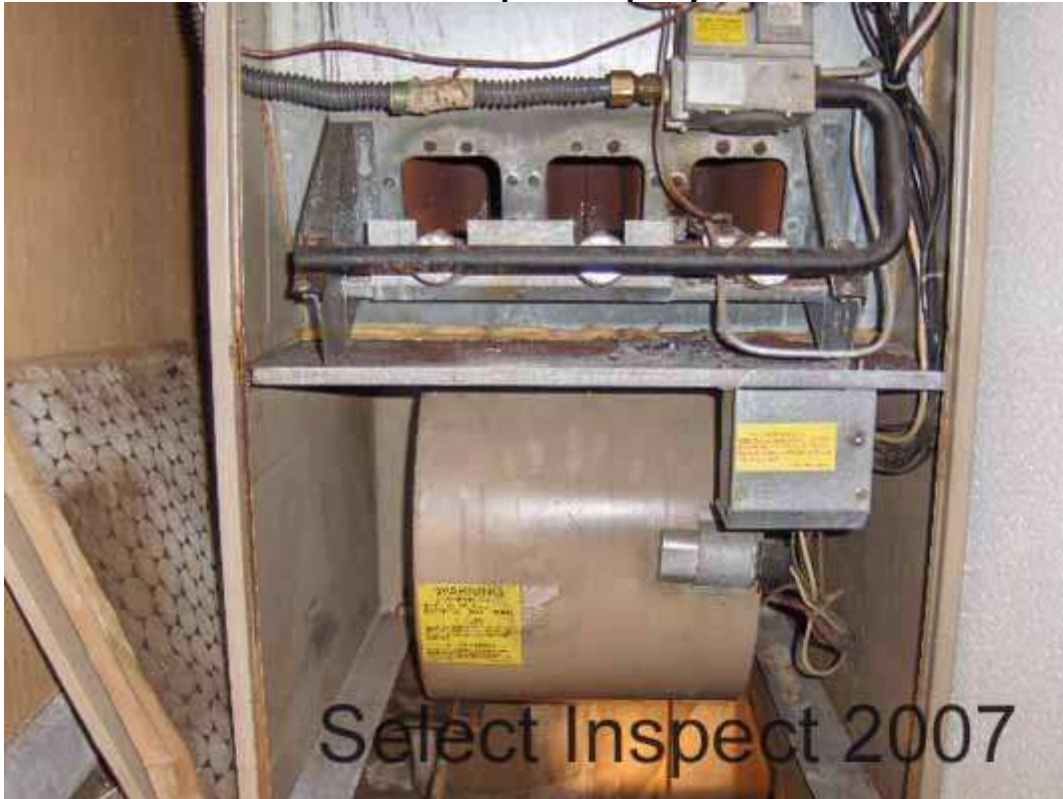
↑ HVAC interior system- typical corrosion and aged components- Reinstall heat shield (was next to the unit at the time of inspection) and monitor this item periodically; maintain as needed

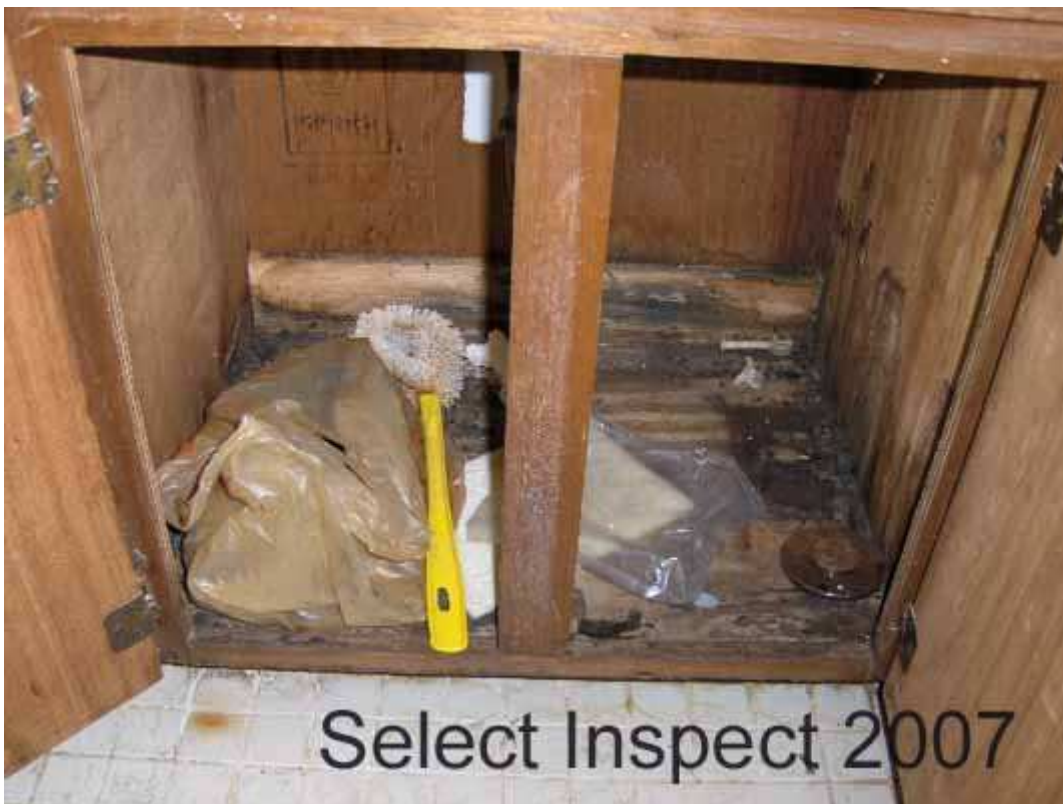
↑ moisture intrusion, fungus, and decay (rot) below men's bathroom sink

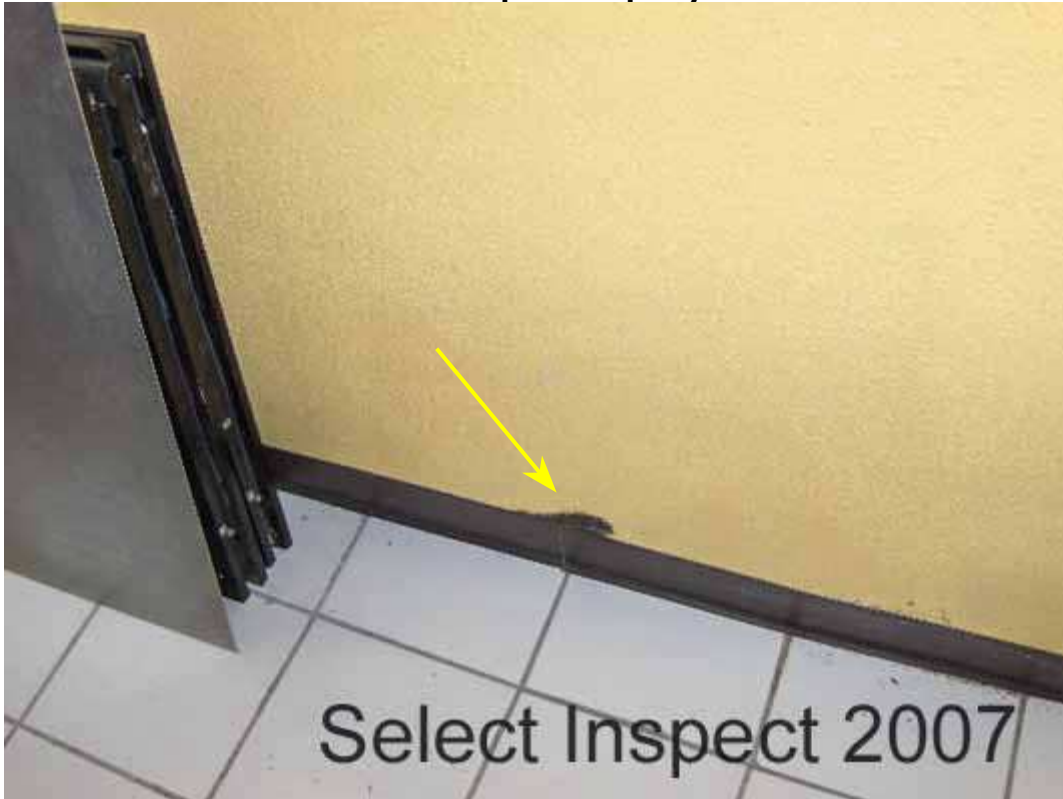
↑ moisture intrusion / fungus discovered at central right clean room- north wall and adjacent wall in the room to the north of this location

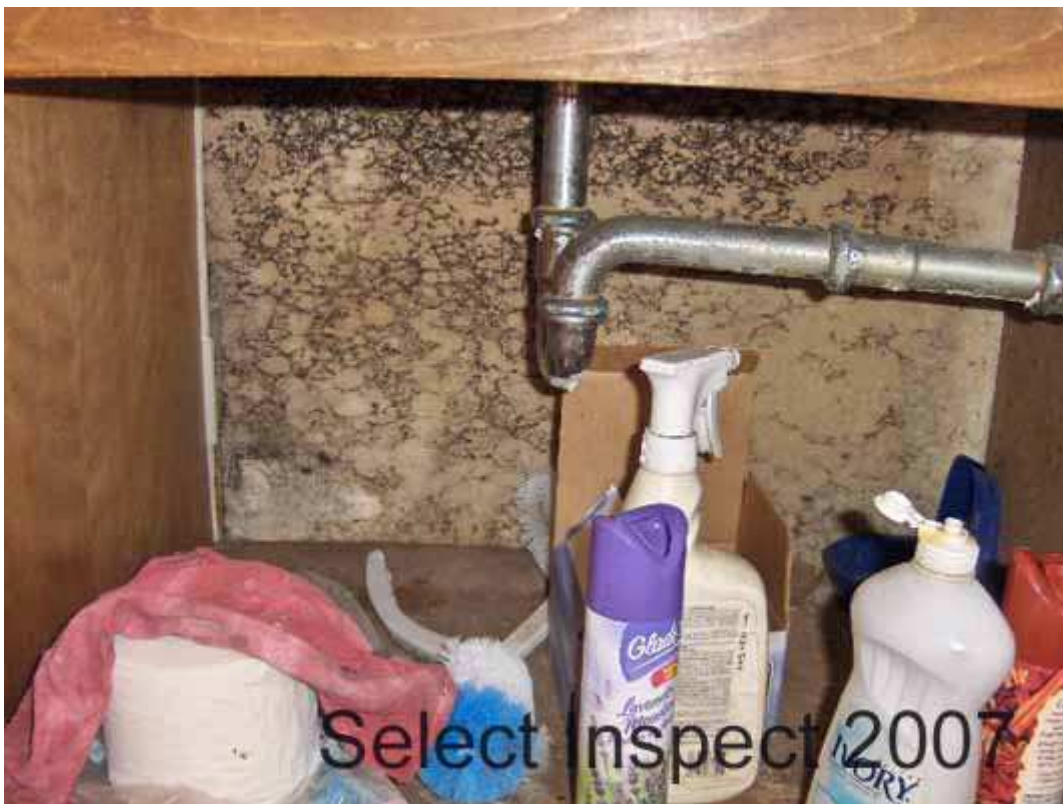
↑ moisture intrusion / fungus at men's sink right side bathroom unit xxx

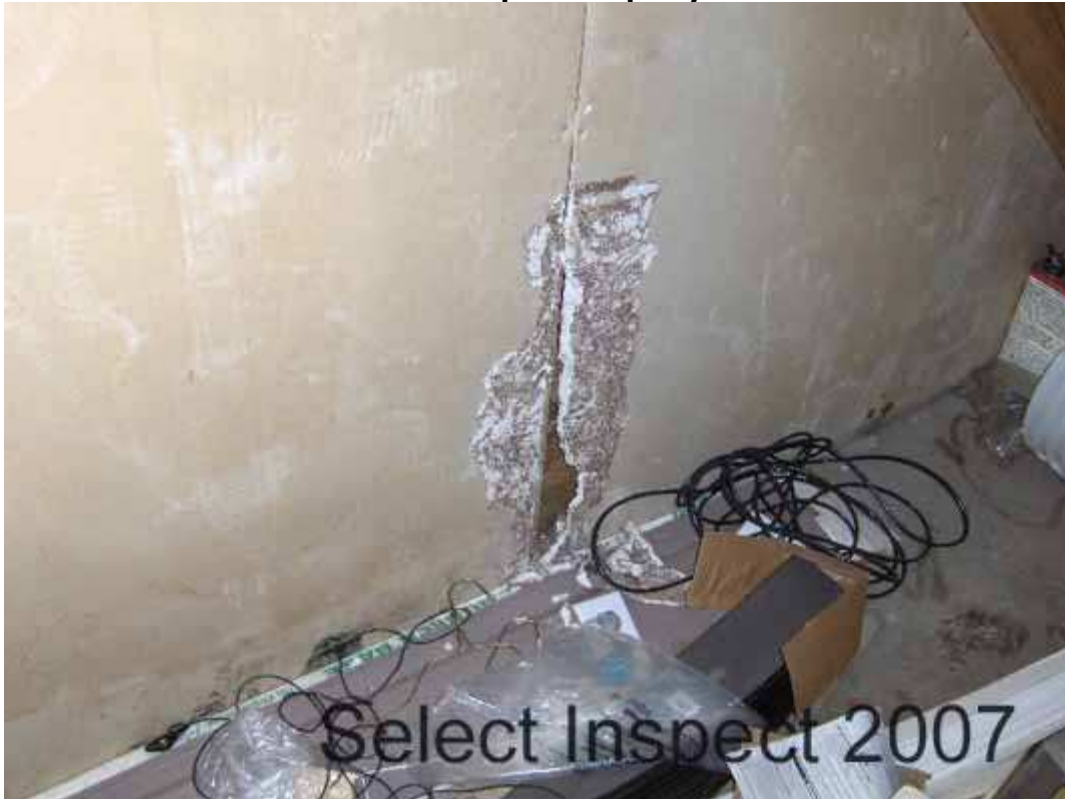
↑ evidence of Prior subterranean termite activity under stairway

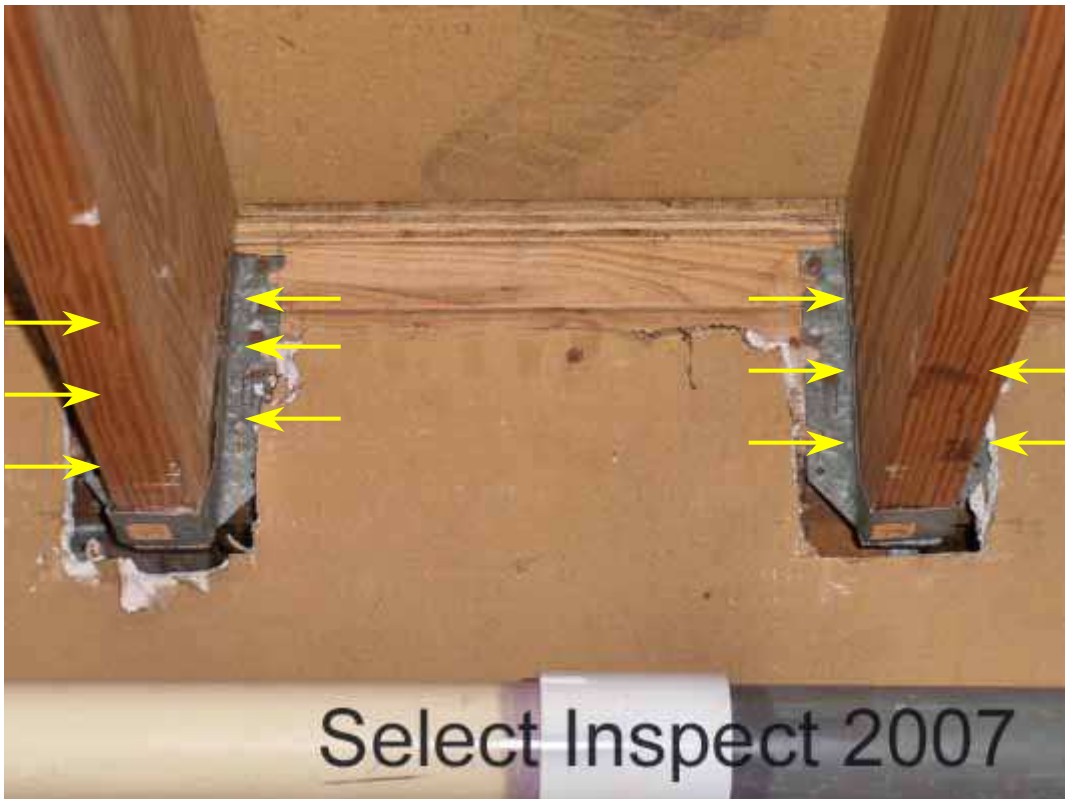
↑ Joist hangers were incorrectly fastened at the downstairs mechanical closet Hangars should be fit to the related framing; and all nail openings should be filled with appropriate fasteners.- fasteners were missing at joist connections

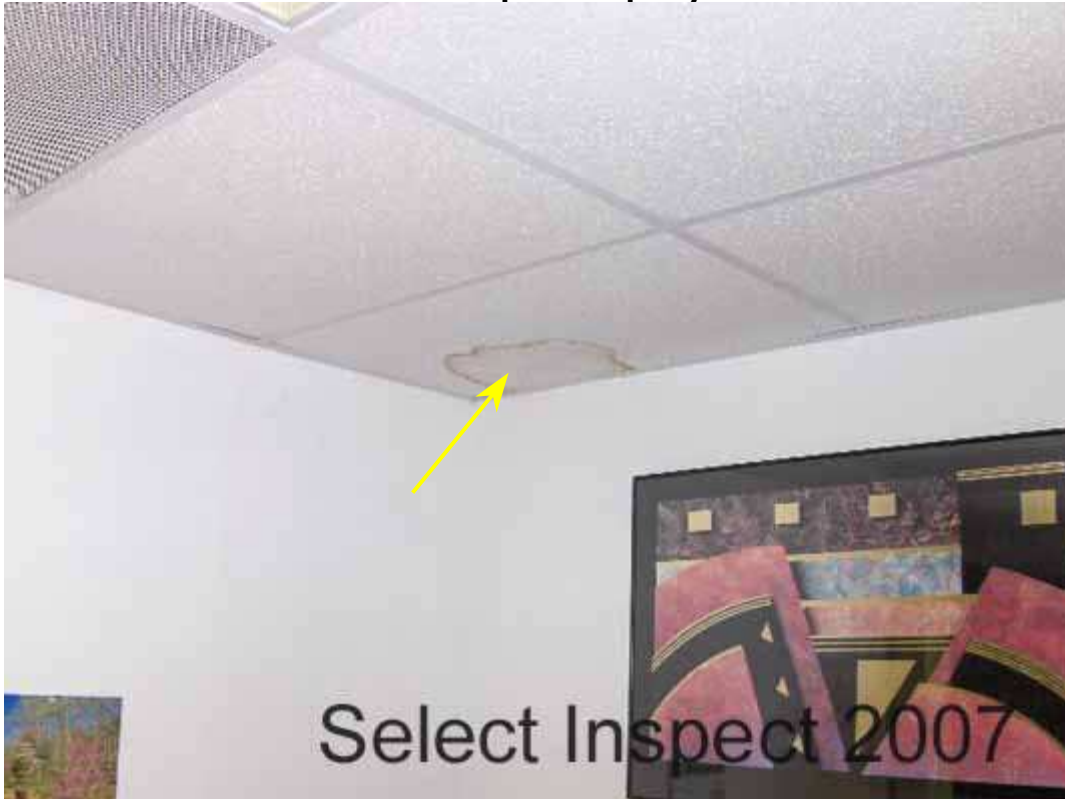
↑ moisture intrusion discovered at ceiling- right front office

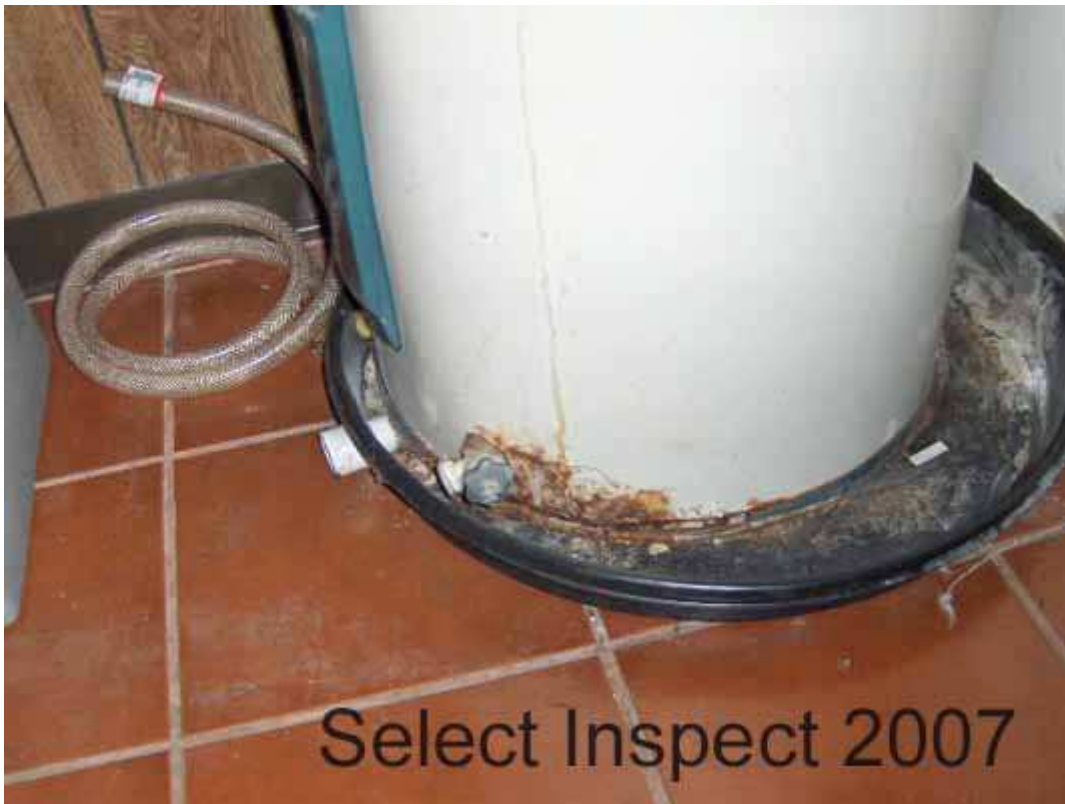
↑ excess corrosion at water heater

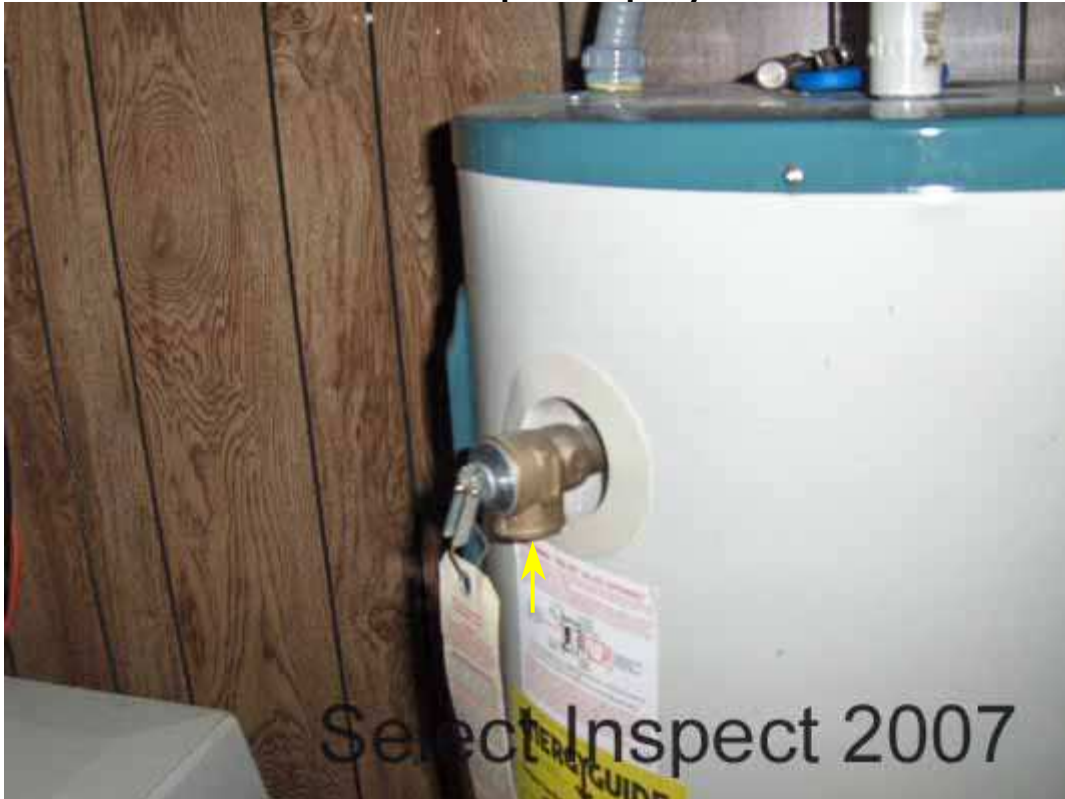
↑ temperature-pressure-relief missing a drain pipe extension to an appropriate exterior termination point

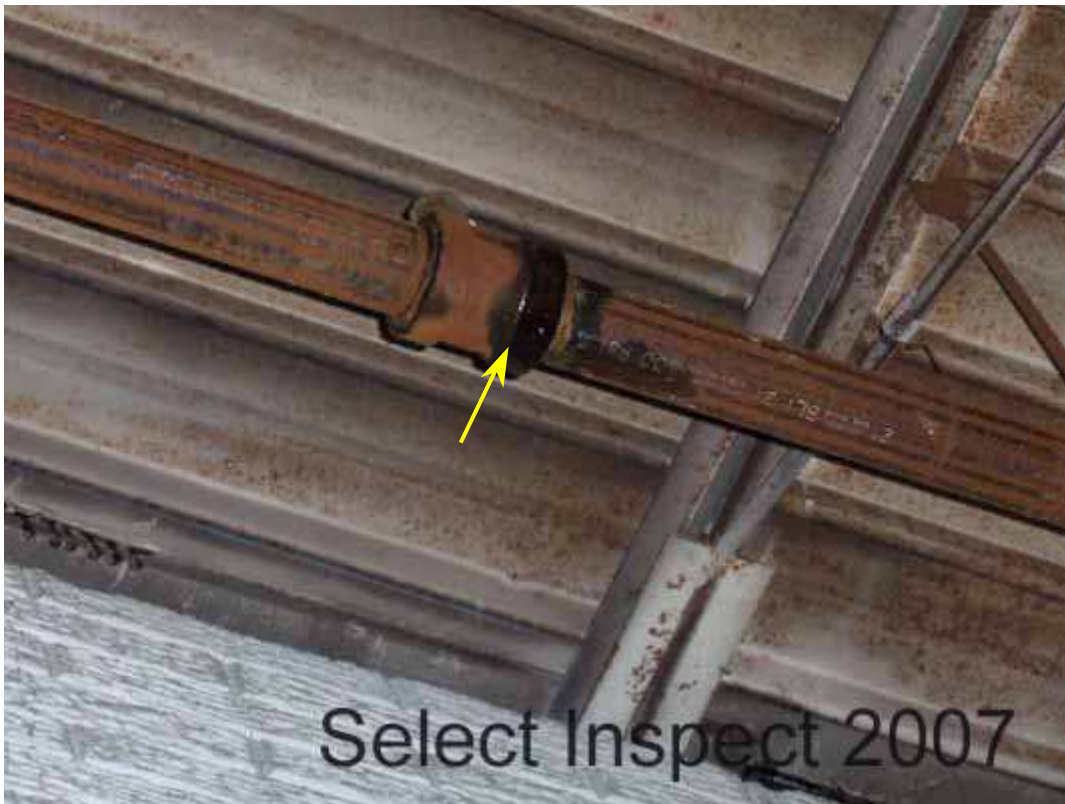
↑ suspected leakage evidence at fire sprinkler piping at the warehouse.
