PROPERTY CONDITION REPORT- PCR

Street Address:	7043 & 7075 Christmas Street			
City:	Frisco	State:	TX	Zip: 75034
Client:	Your name here	Phone:	789.654.3210

Inspected by:	Bruce W. Carr	Inspector's Phone #:	214-770-6954	
Inspection Date:	03/02/2010	Report Date:	03/05/2010

Property Description: Retail- One level General use- commercial							
No. of Bldgs:	3	No. of Units present:	3	No. of units inspected	3	Est. Yr Built:	1948, 1953, & other

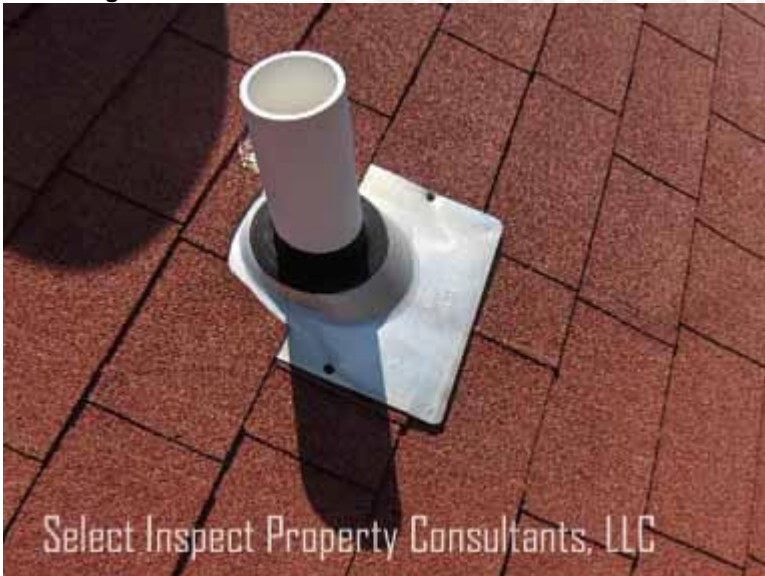
↑ uncaulked, exposed fasteners & unpainted vent stack; example

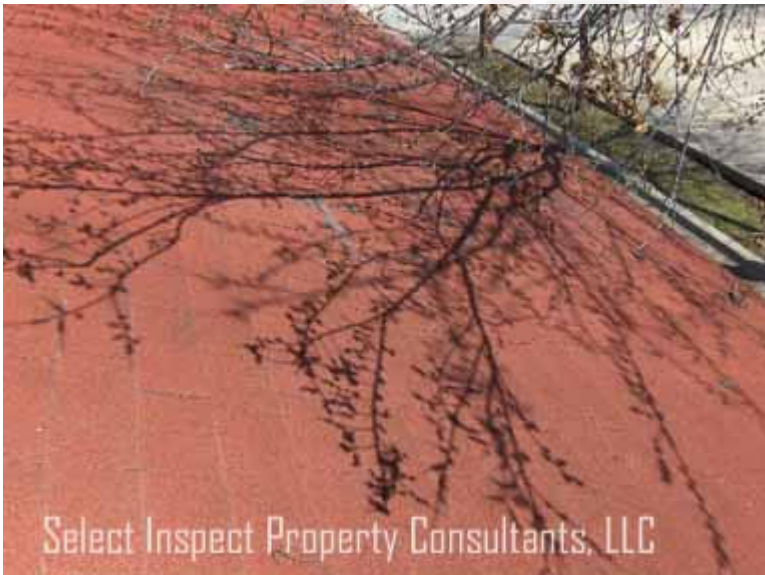
↑ tree damaged shingles

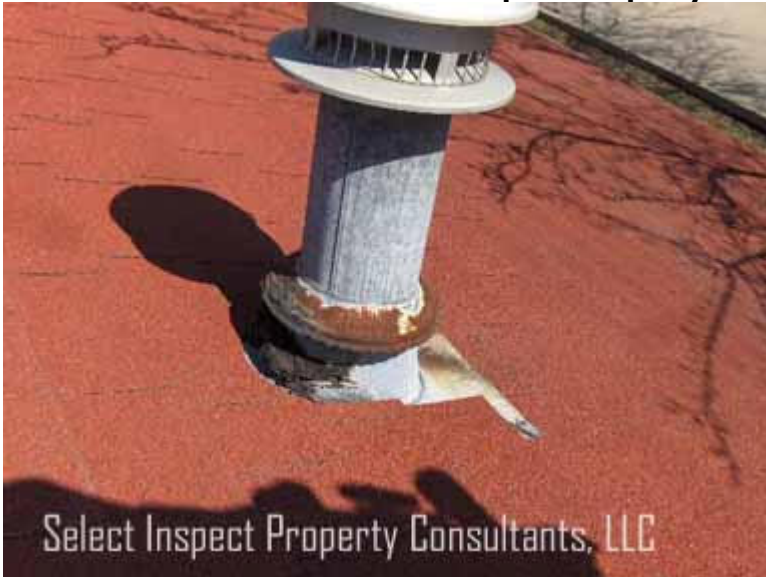
↑ corroded flue component(s); flues had been abandoned & could be removed

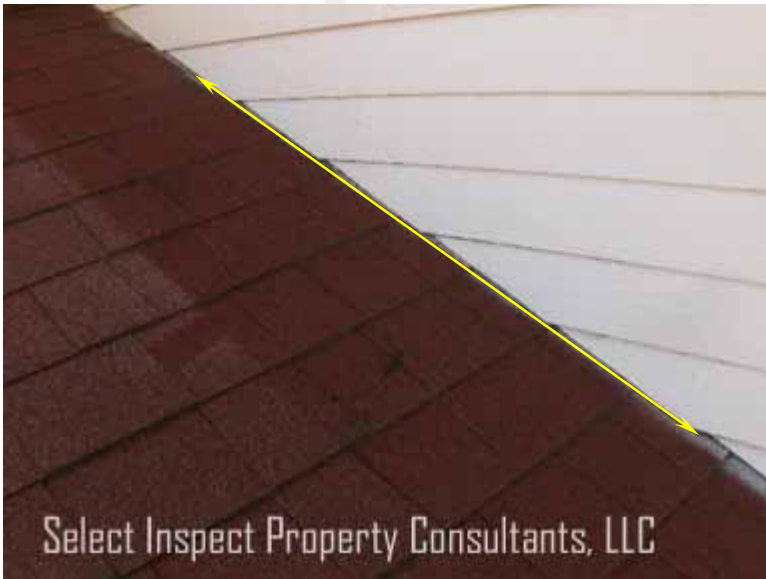
↑ low siding; prone to moisture damage; moisture damage was noted at some locations; example

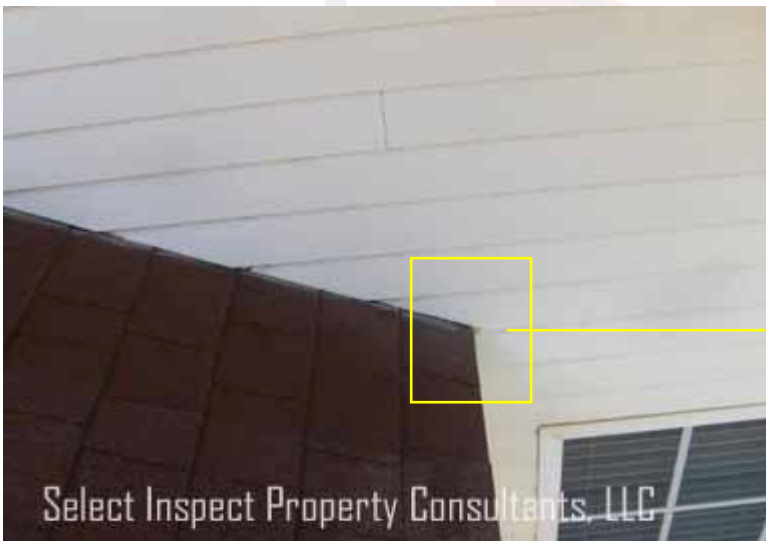
↑ missing kick-out-flashing; example

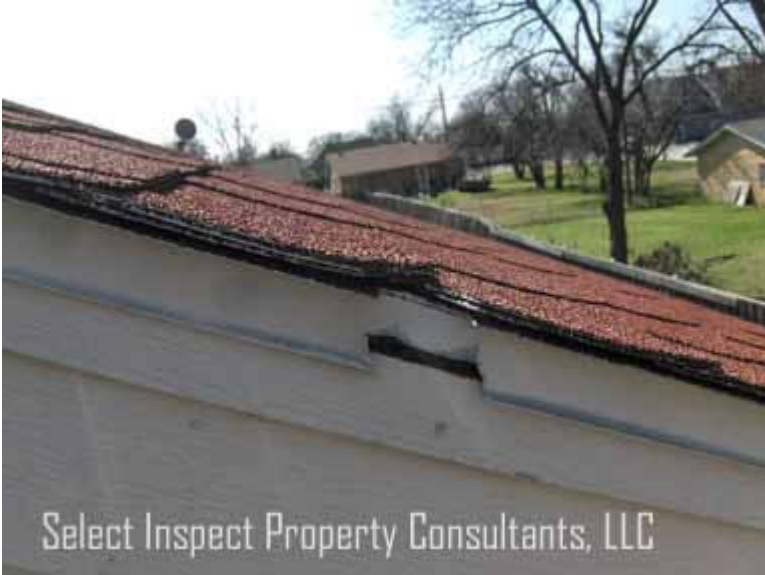
↑ minor damage at rake shingles & missing drip edge flashing; 7043

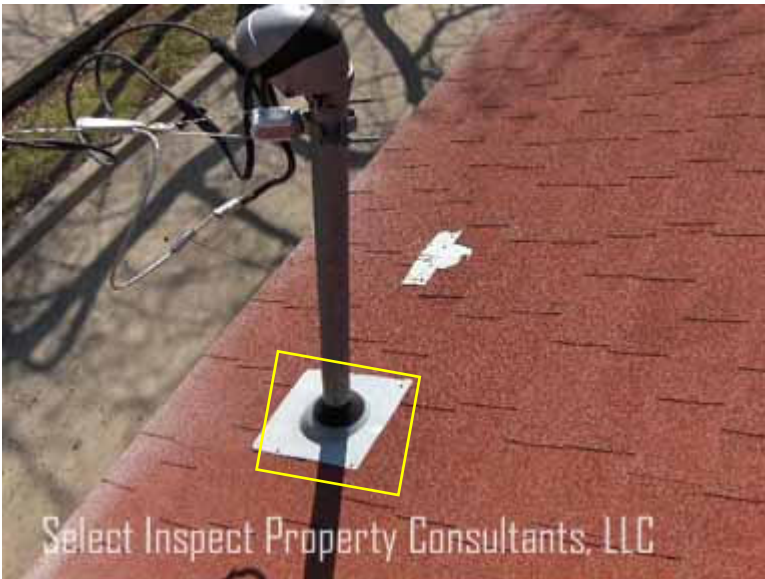
↑ unworkmanlike electrical mast penetration & flashing boot

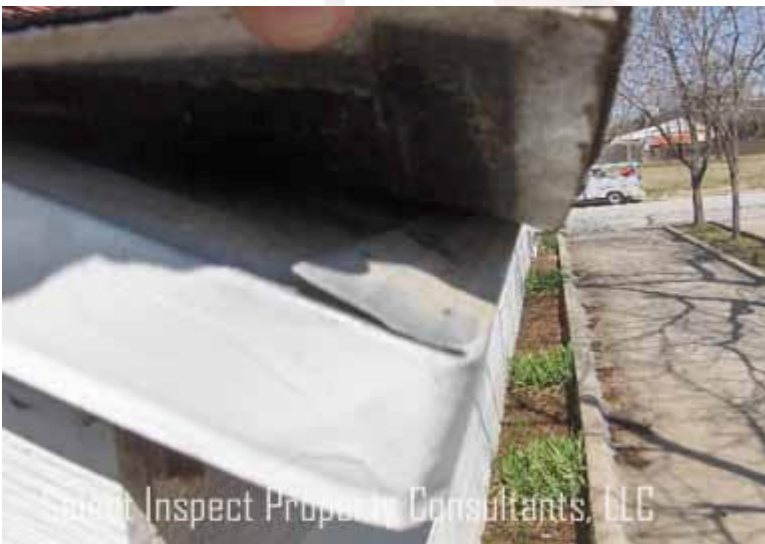
↑ deficient drip edge flashing corner; example

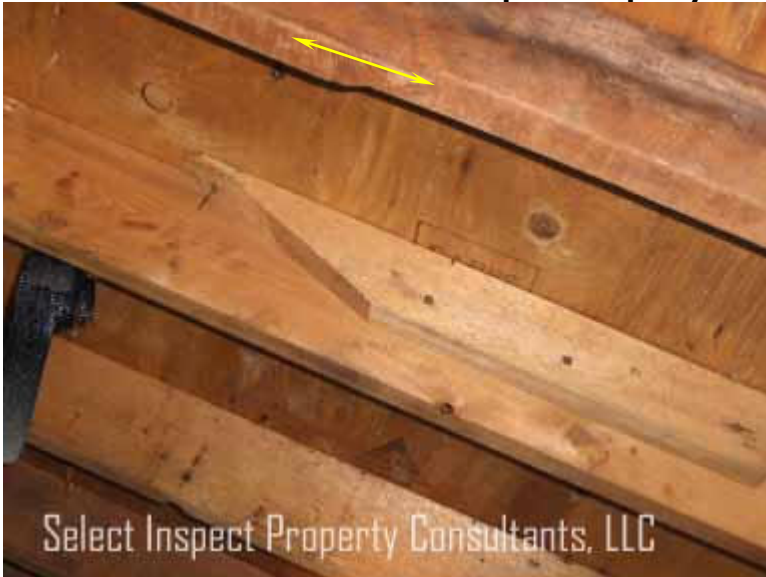
↑ cracked attic framing; example

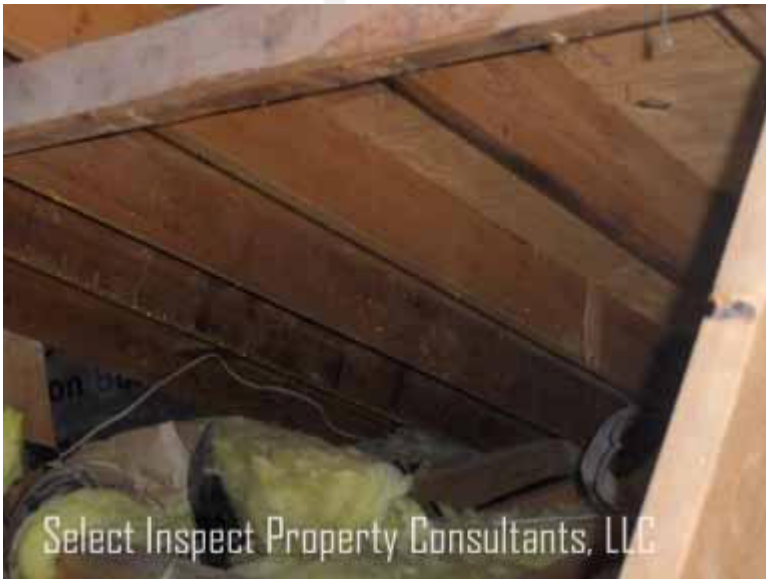
↑ deficient insulation; example

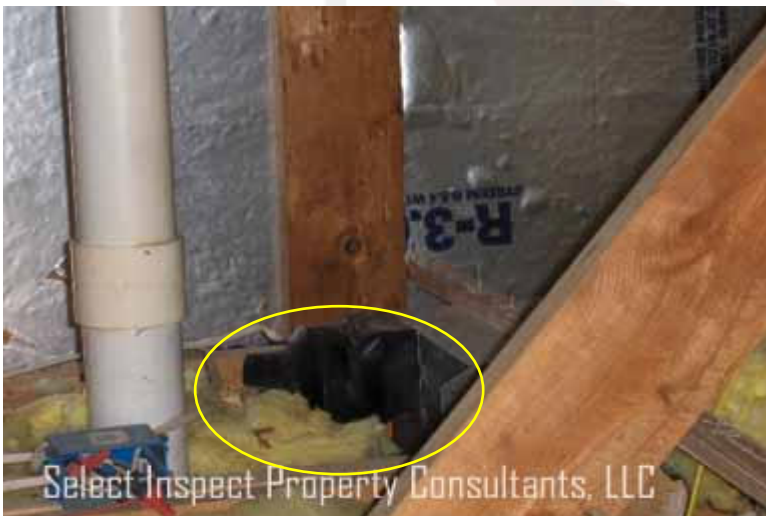
↑ exhaust fan(s) improperly terminate in the attic, rather than exterior ; example

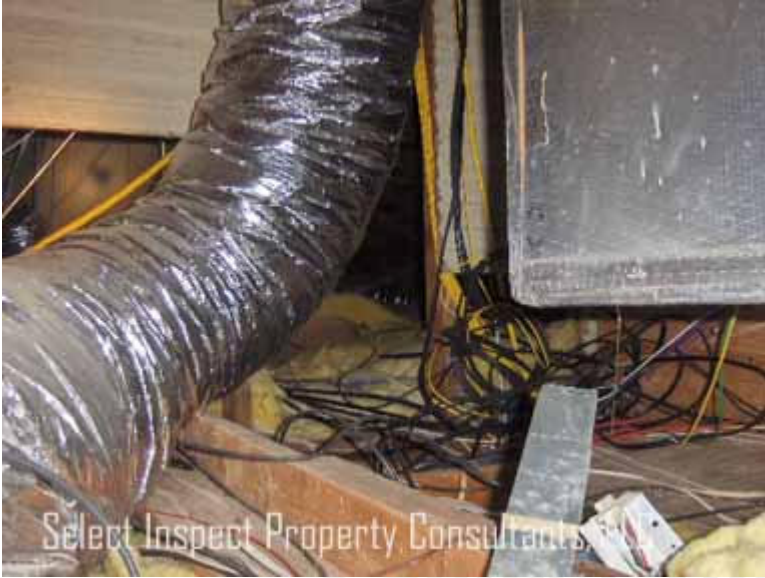
↑ multiple deficiencies at HVAC; example

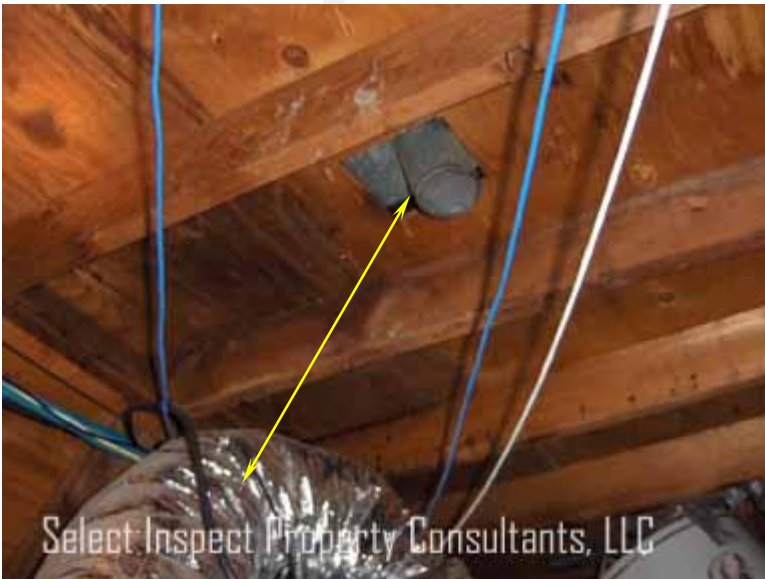
↑ crimped air ducting; example & abandoned furnace flue

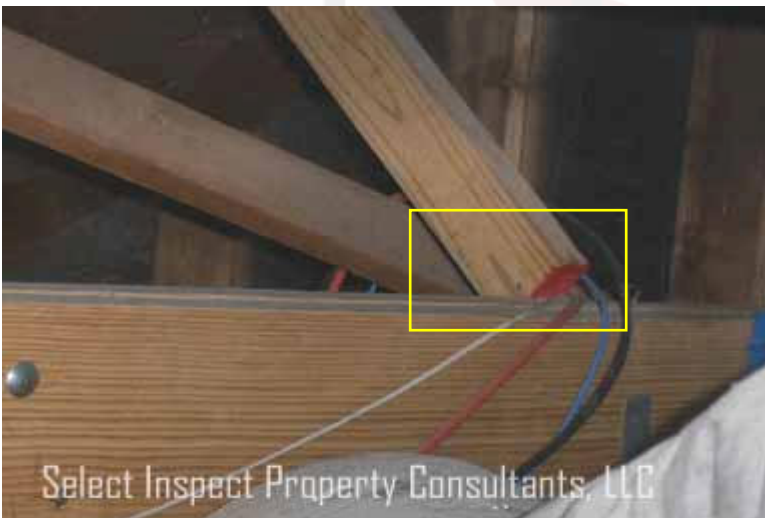
↑ unworkmanlike strut connection to attic beam; example

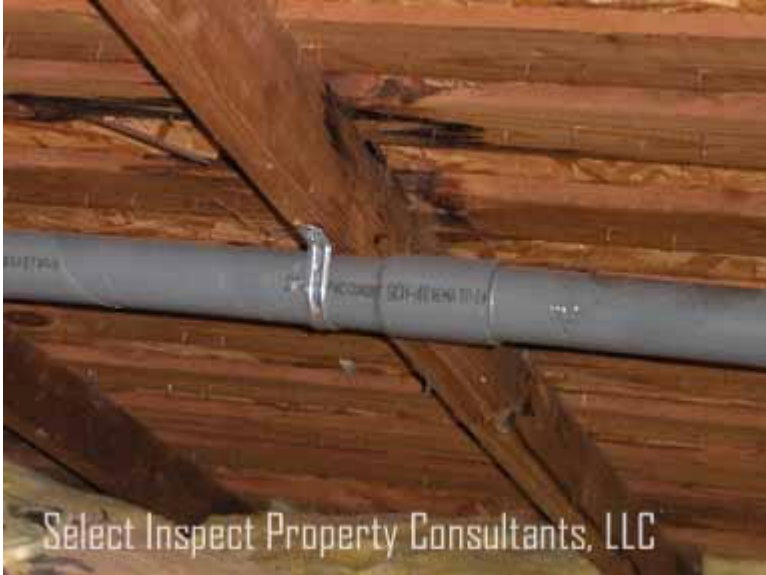
↑ example moisture intrusion in attic

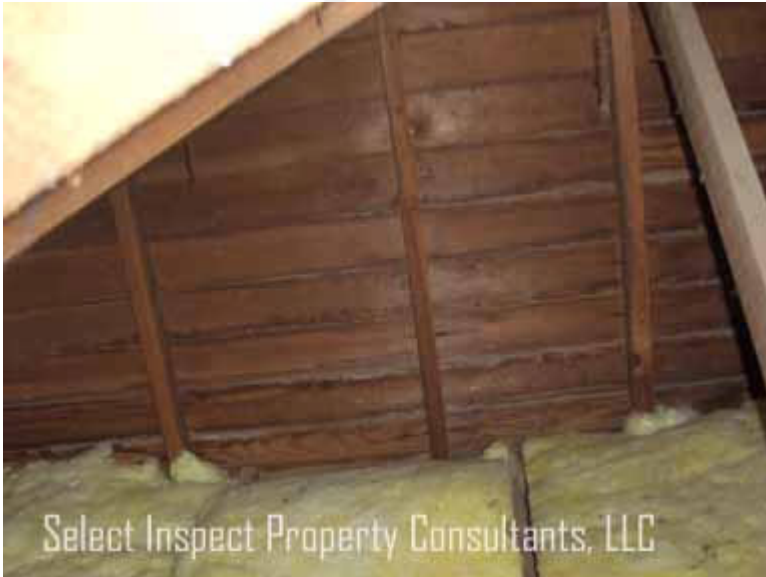
↑ example moisture intrusion in attic at gable wall siding

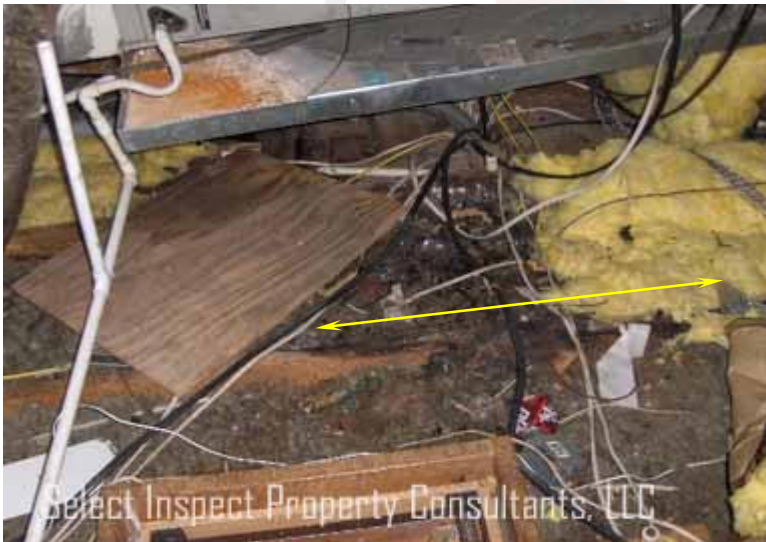
↑ fire damage at 7043 attic

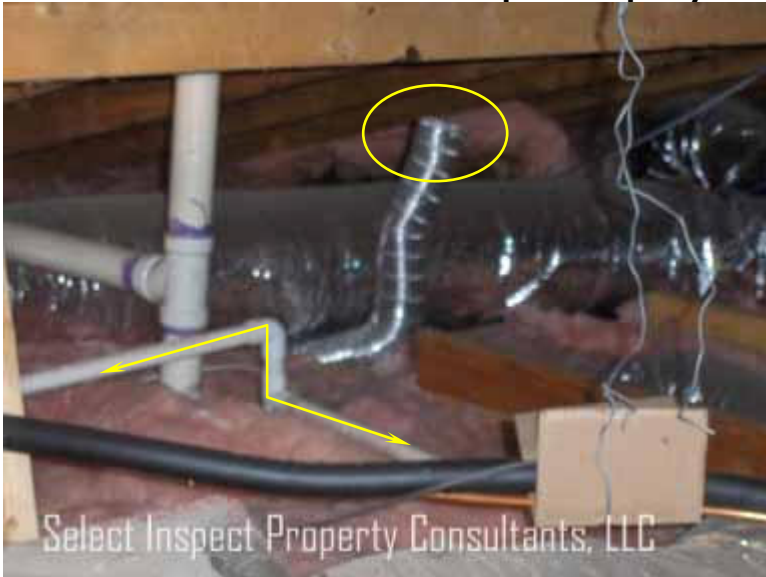
↑ exhaust fan(s) improperly terminate in the attic, rather than exterior & unworkmanlike routing of air conditioning condensate drains

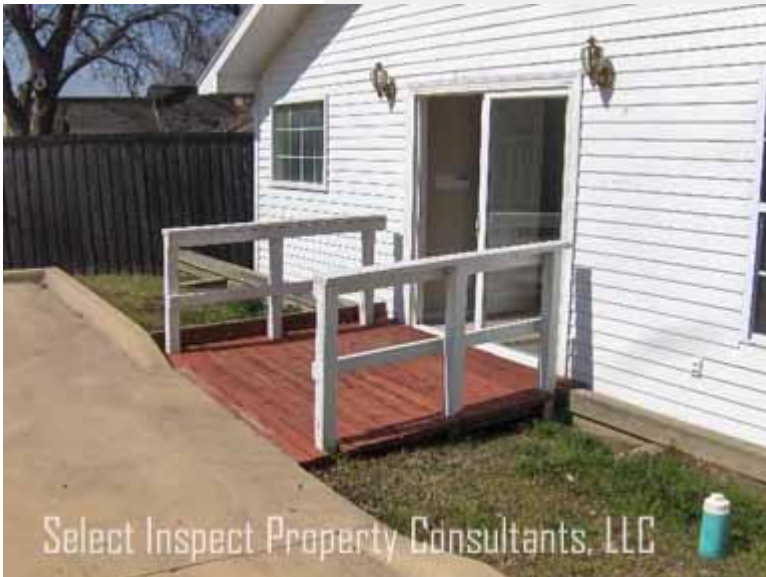
↑ handicapped door was not wide enough

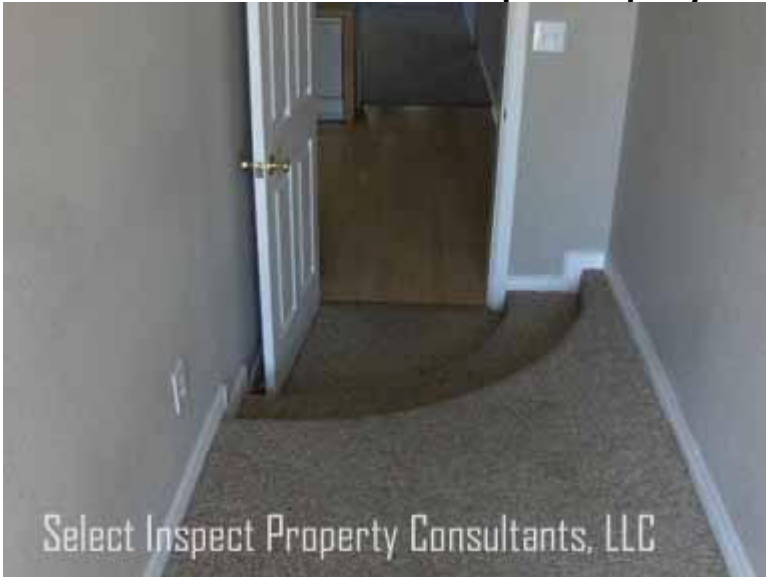
↑ steps & not wide enough doorway for handicapped access

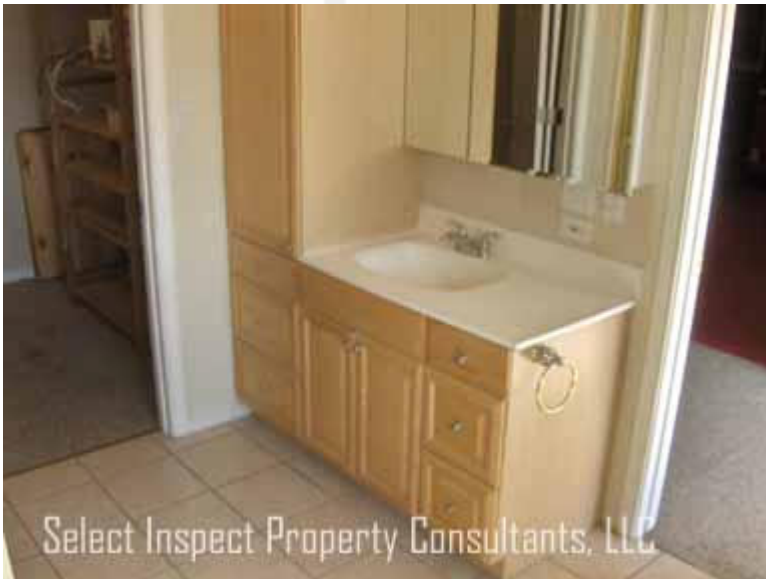
↑ sink not handicapped accessible

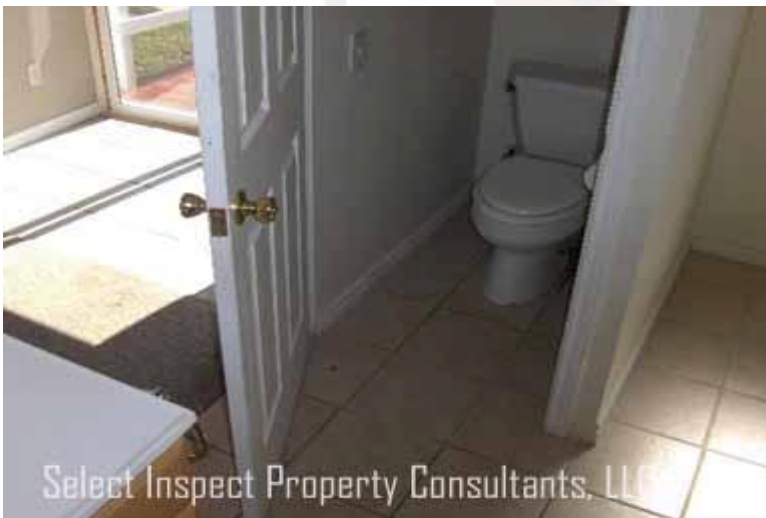
↑ toilet not handicapped accessible

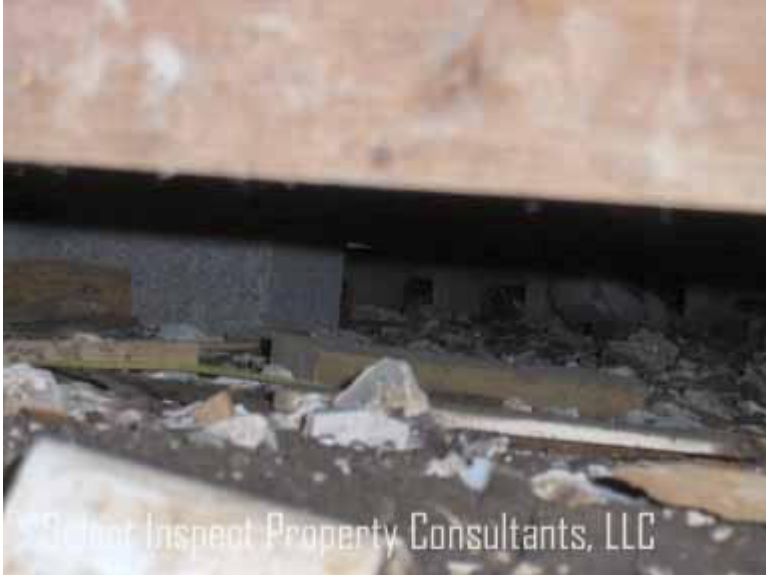
↑ low clearance in crawl space; wood-to-ground debris; inaccessible

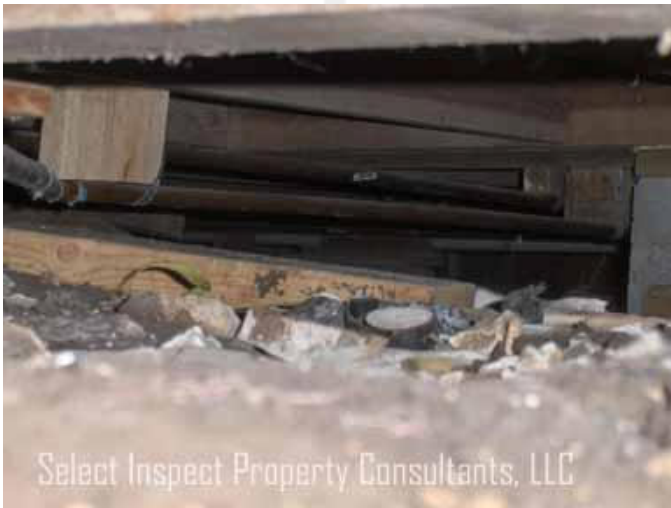
↑ low clearance in crawl space; wood-to-ground debris; inaccessible

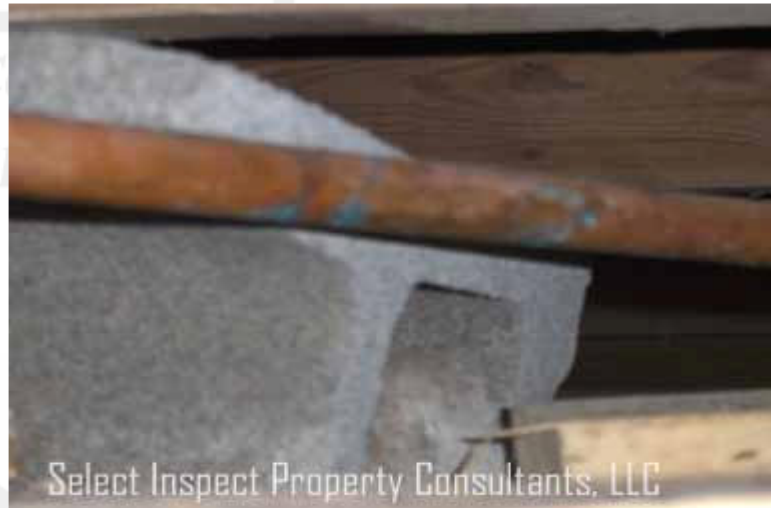
↑ unworkmanlike broken block support under beams

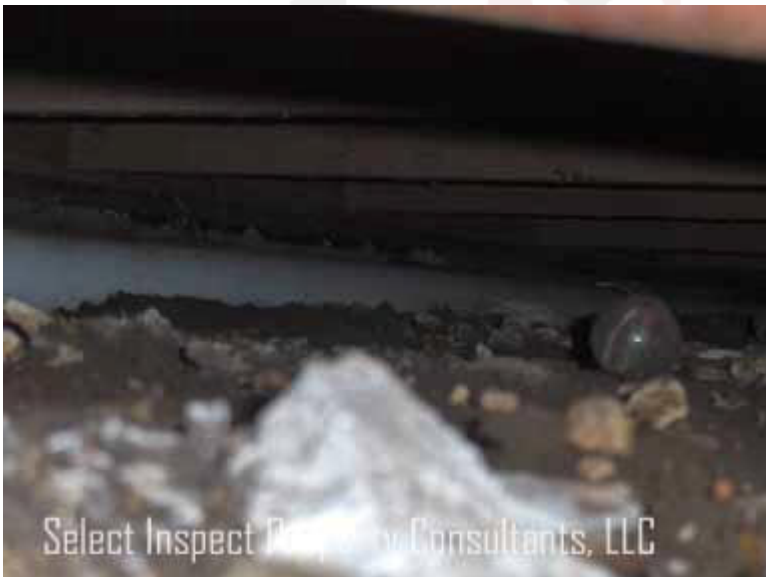
↑ low clearance; inaccessible

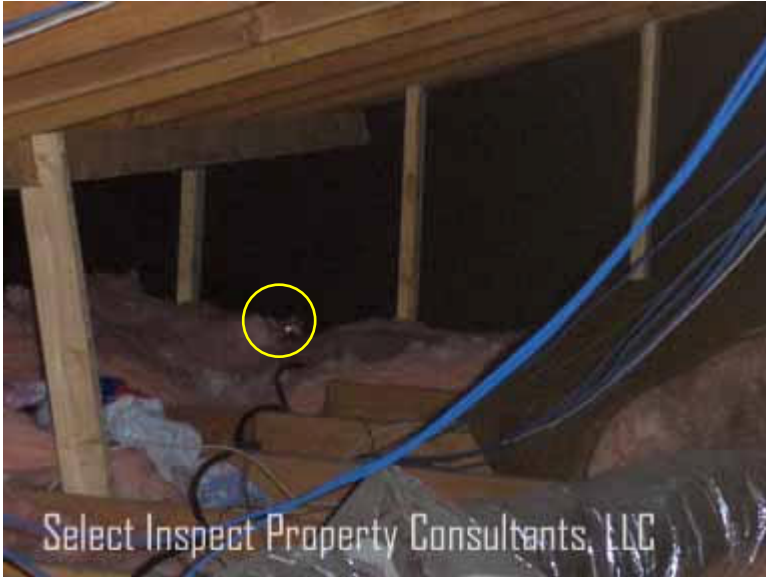
↑ daylight seen from attic; small hole at gable wall; 7075 south

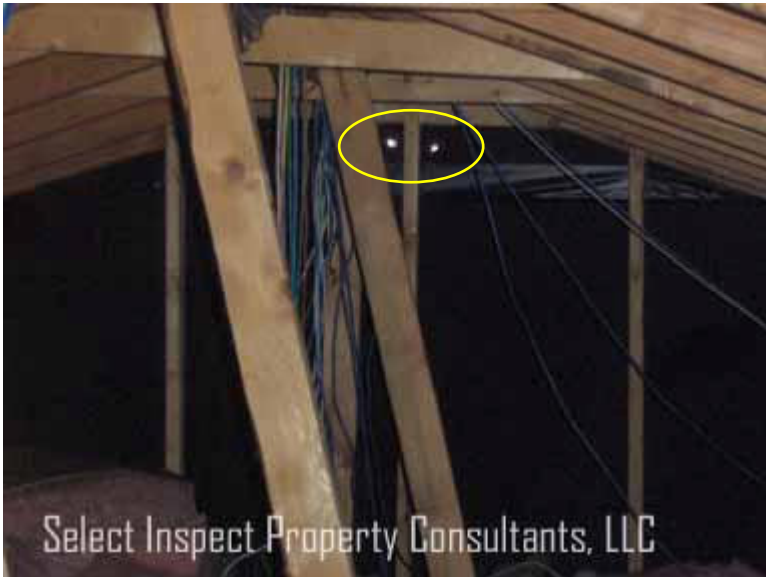
↑ daylight seen from attic; small holes at gable wall; 7075 south

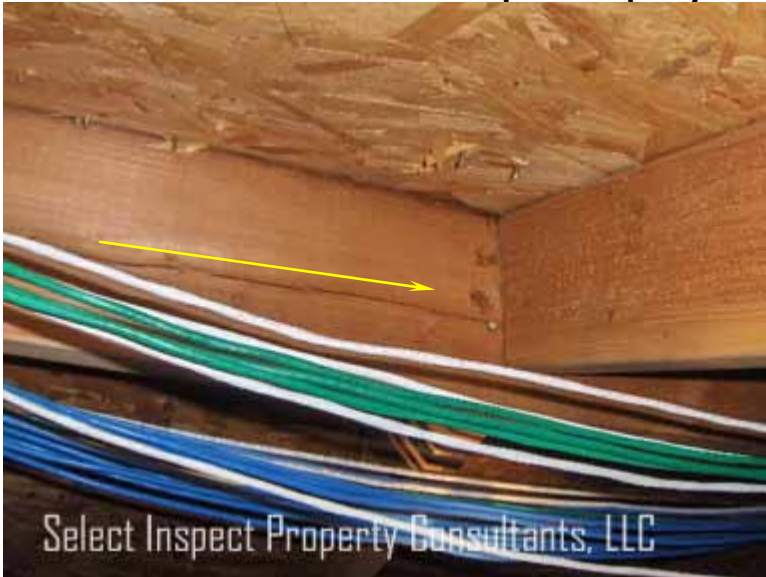
↑ example cracked framing in attic

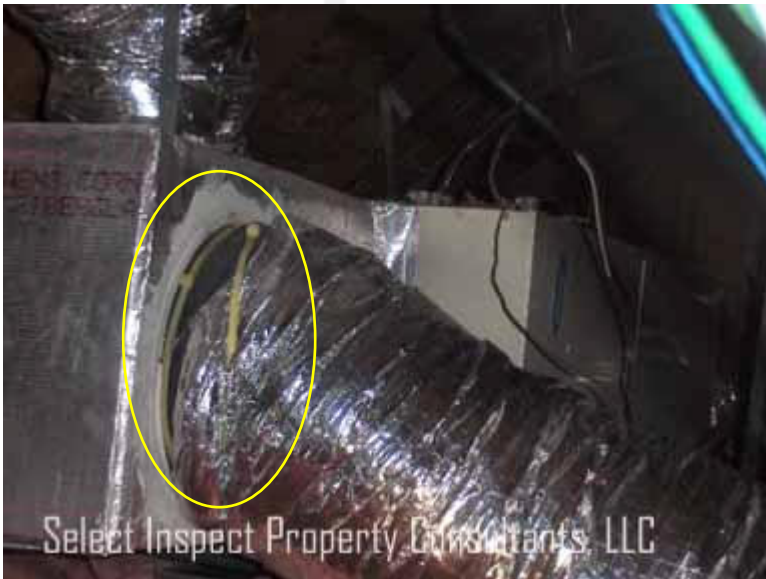
↑ amiss air duct connection to plenum; example

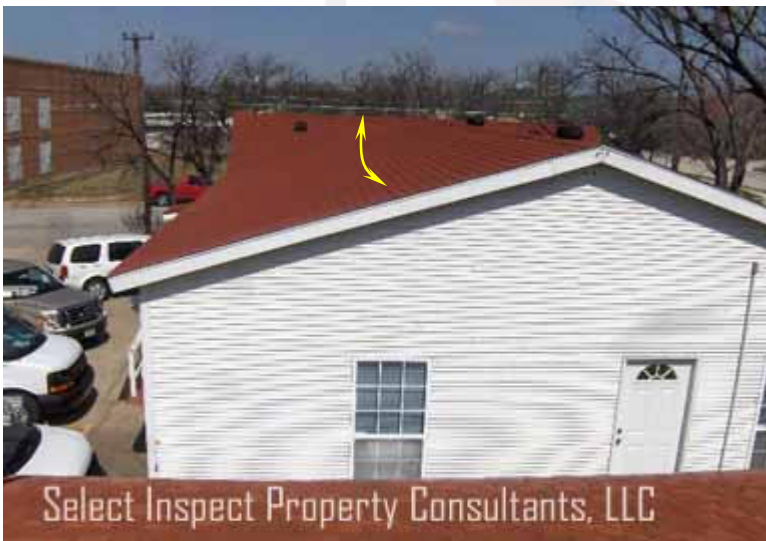
↑ deflection noted at roof

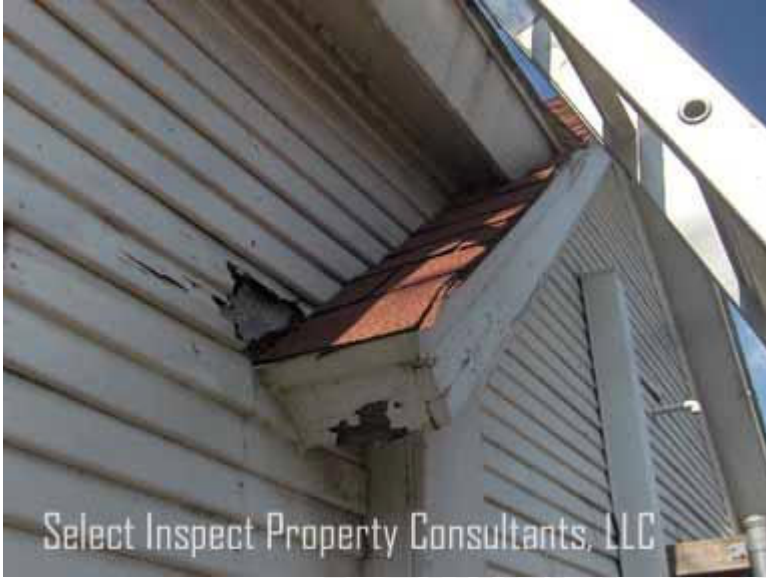
↑ amiss flashing & moisture damage; east wall

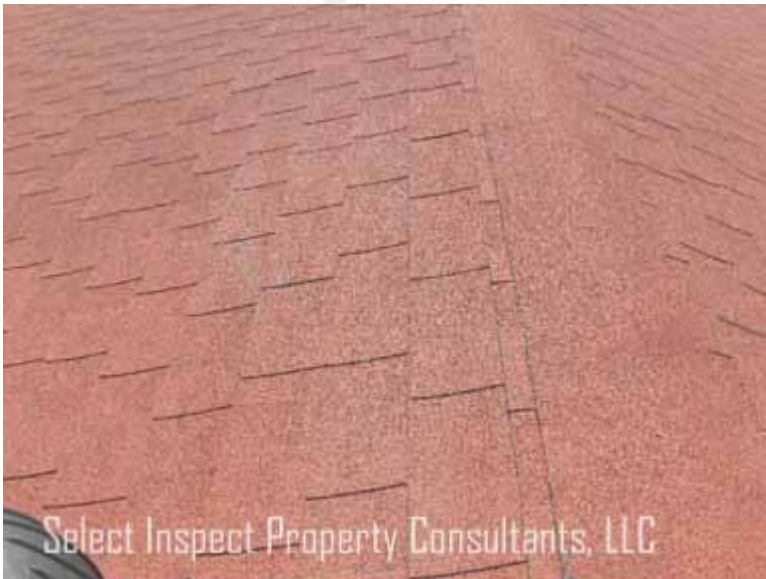
↑ worn shingles

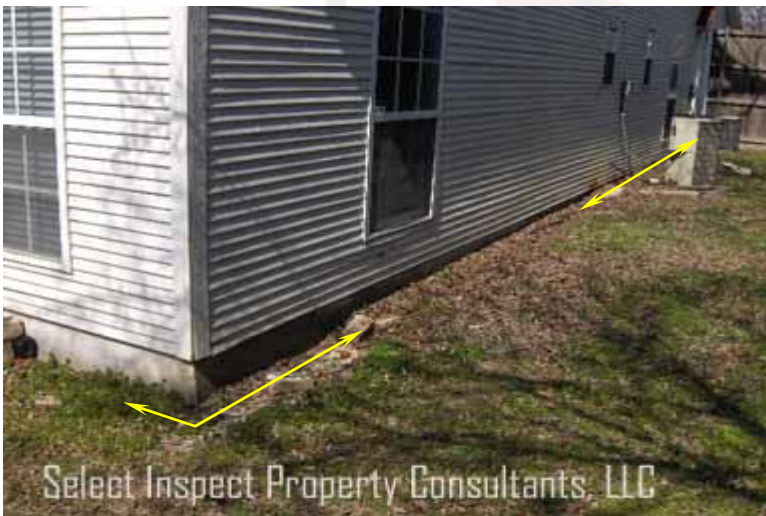
↑ deficient grading; example

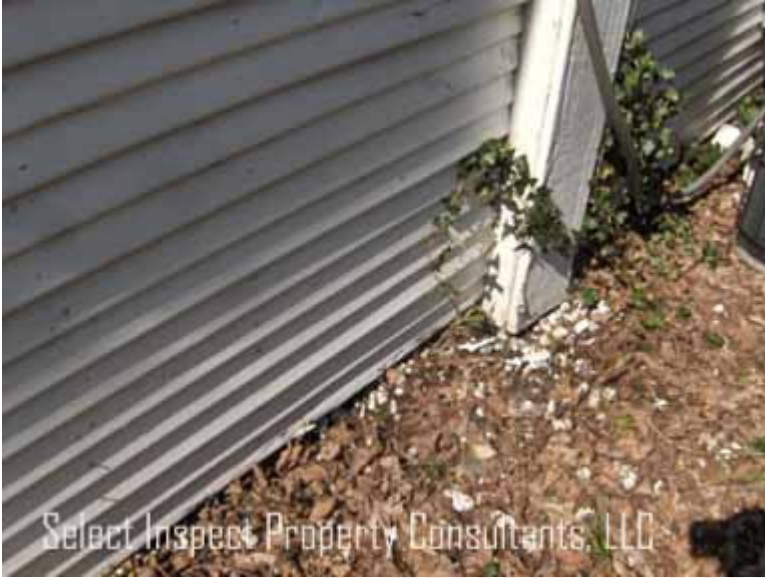
↑ high soil; low siding; prone to wood destroying insects & decay

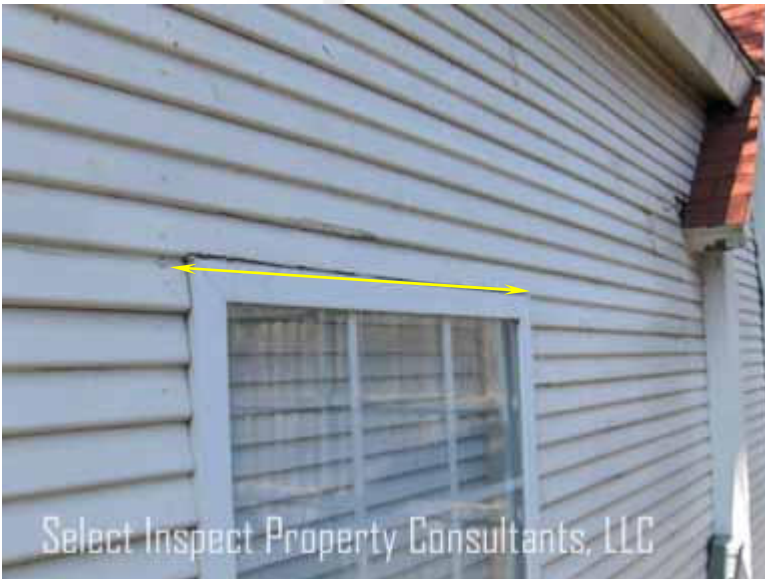
↑ missing flashing above windows & doors; example at window

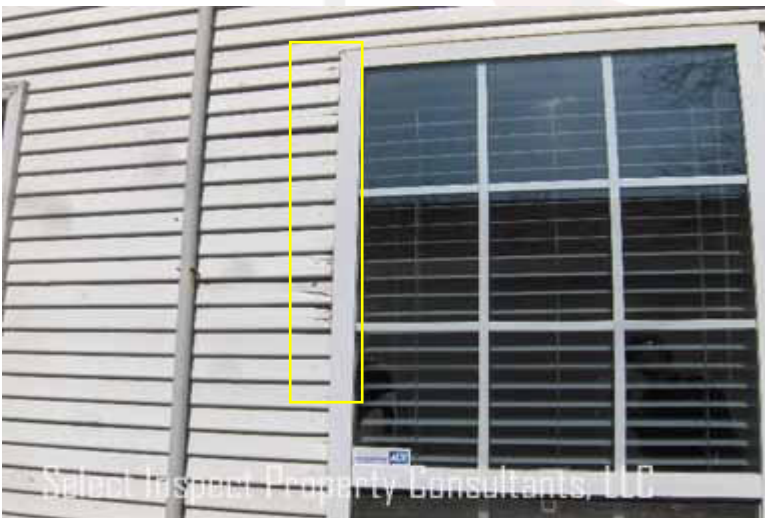
↑ moisture damage at siding adjacent window; example

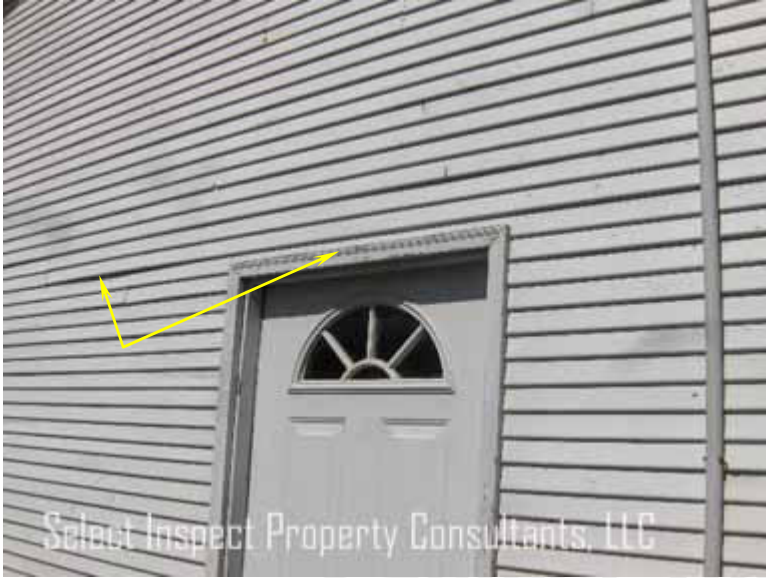
↑ wavy siding & missing flashing above door

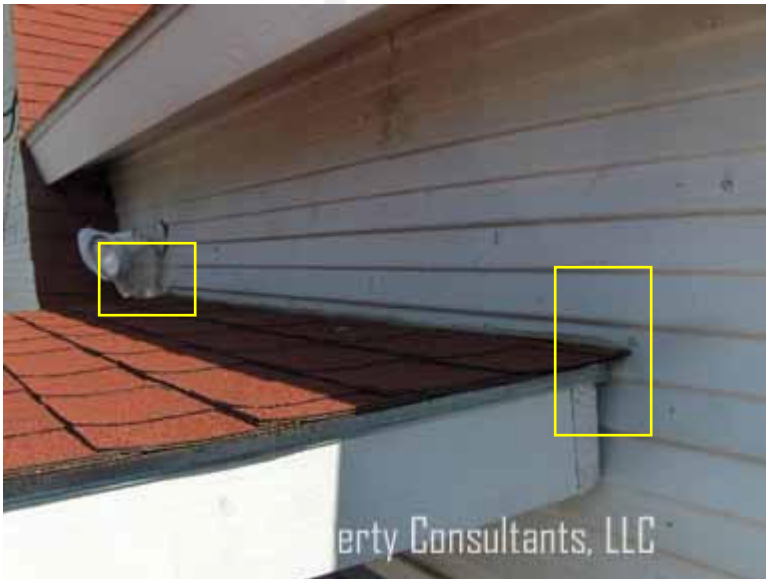
↑ missing flashing; kick-out-flashing; at ramp entry roof

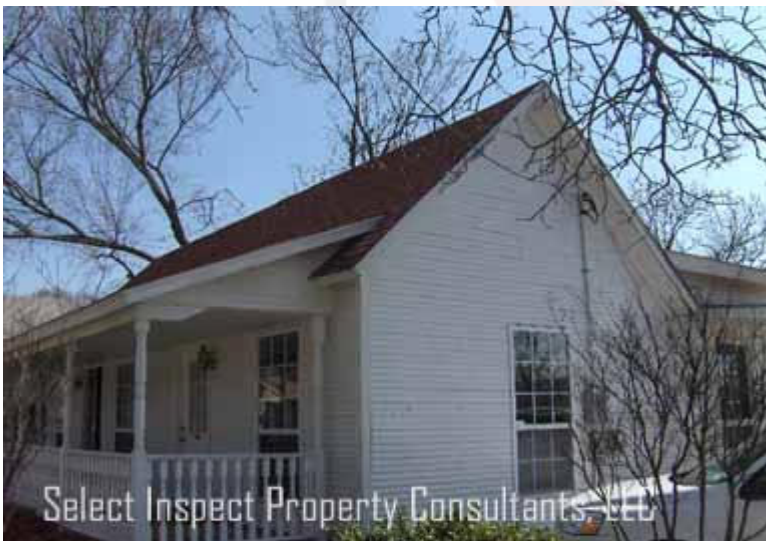
↑ service entry should not be routed through trees

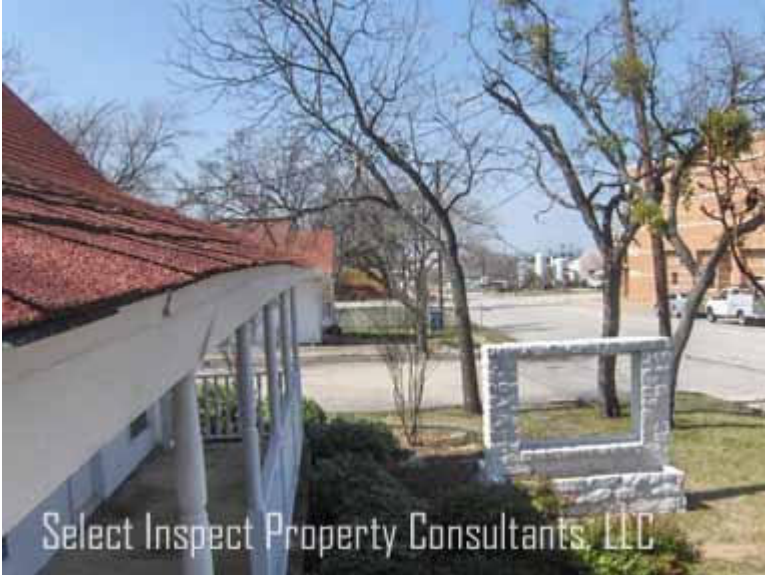
↑ deflection at front porch roofline

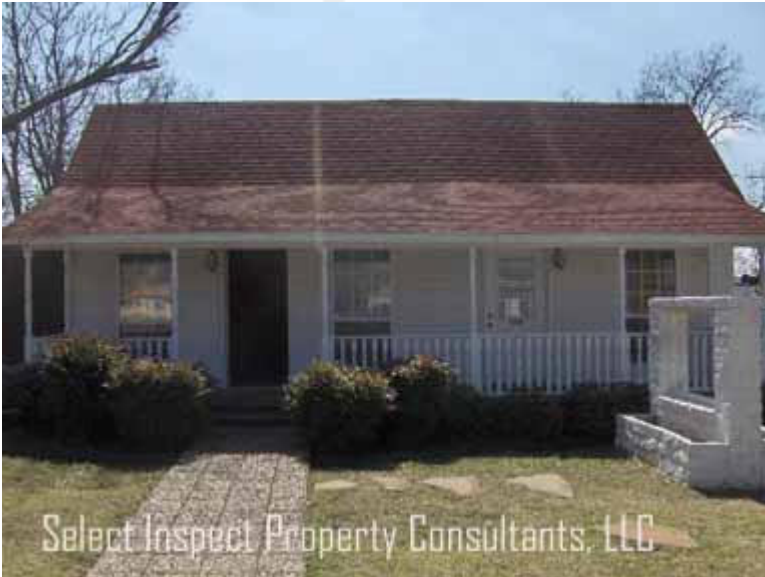
↑ deflection at front porch roofline

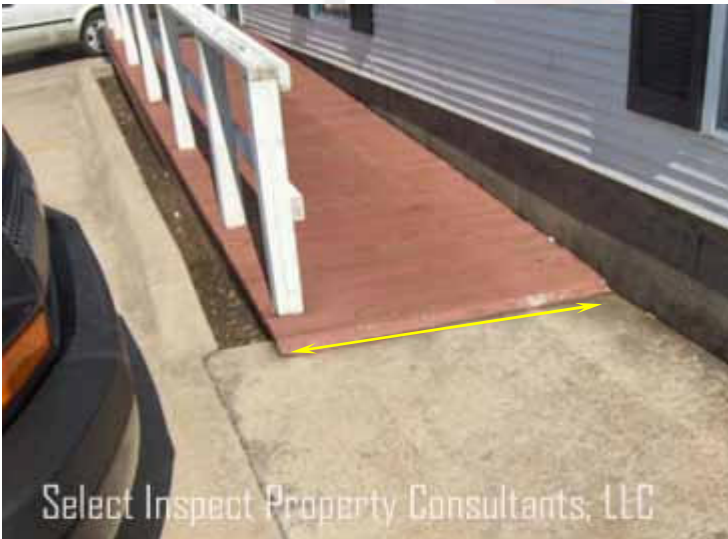
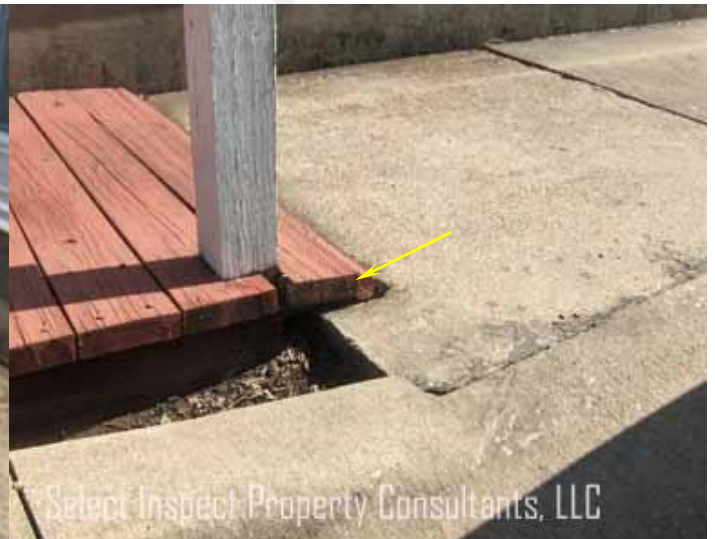
↑ lip at ramp is too high/steep

↑ close view of image at left

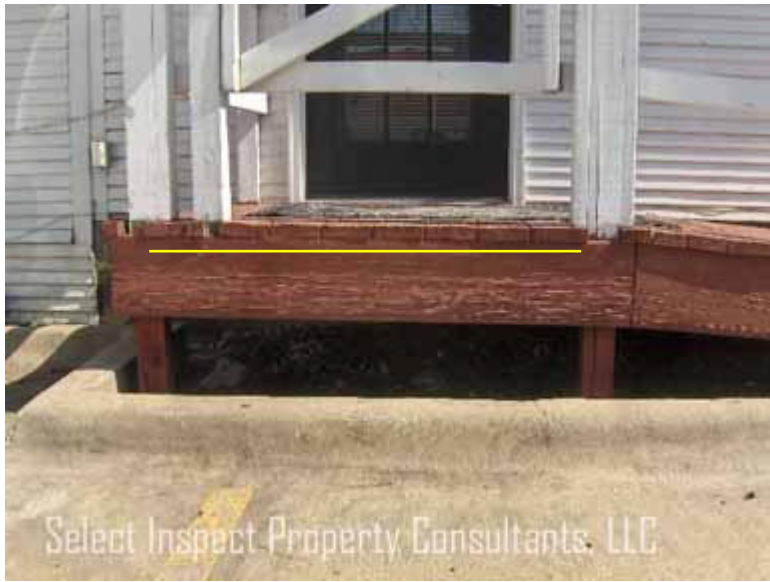
↑ ramp platform was not level
