PROPERTY CONDITION REPORT- PCR

Address:	777 Happy Road				
City:	Garland	State:	TX	Zip:	75044
Client:	xxxx	Phone:	321 456 7890

Inspector; Bruce W. Carr	Inspection Date: 03/31/2010
214-770-6954; Bruce@SelectInspect.com	Report Date: Wednesday, March 31, 2010

Property Description: Retail- One level General use- commercial							
No. of Bldgs:	1	No. of Units present:	1	No. of units inspected	all	Est. Yr Built:	1955

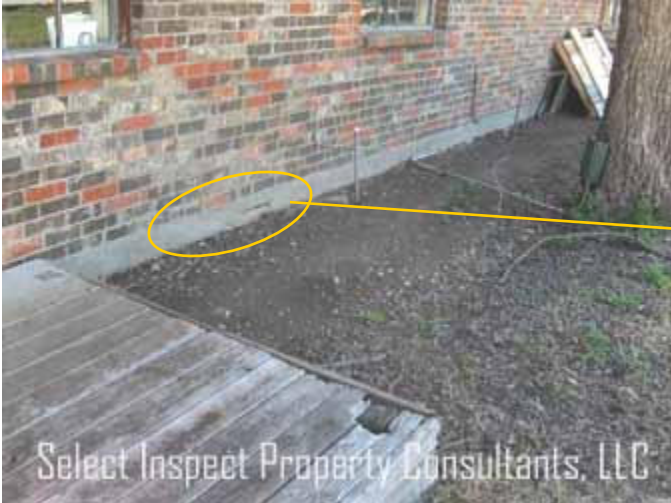
↑ spalling concrete & exposed corroding reinforcement steel at the west.

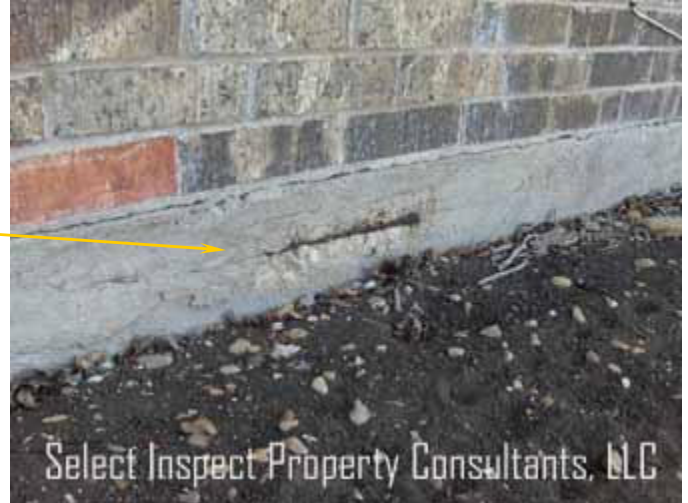
↑ close view of image at left

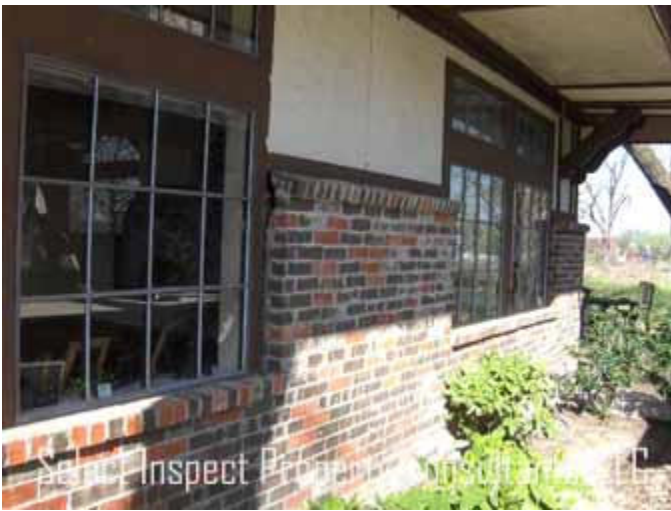
↑ excess stress & rodent opening at the east

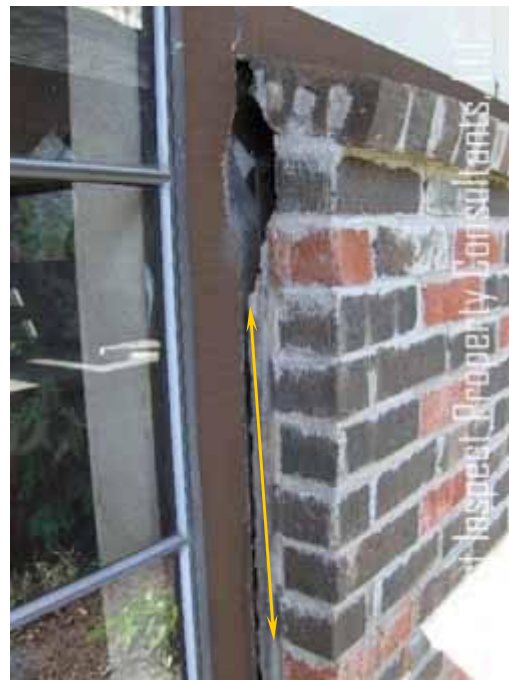
↑ close view of image at left

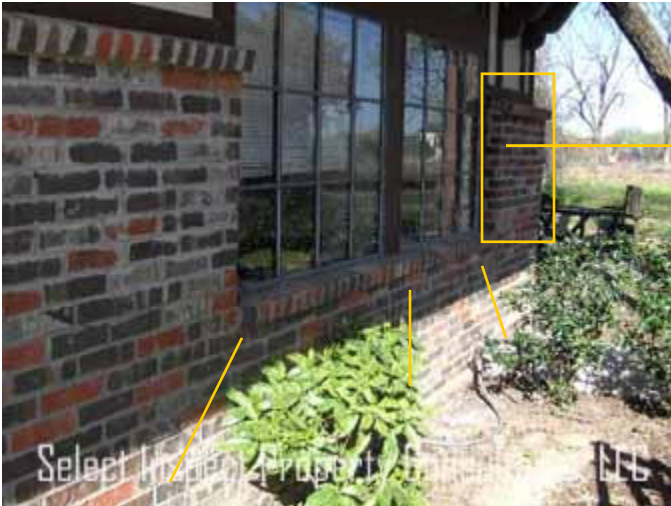
Excess structural stress was indicated by differential movement & separation of brick from structural framing at the east & north & differential movement of rear porch columns from the eave at the north. Various brick & mortar cracks were noted at all sides. Spalling concrete & exposed reinforcement steel exist at the west; this should be repaired to prevent failure of the steel & additional issues. Unworkmanlike modification of interior wall structure was noted at the east office closet. It appeared that the vertical studs had been cut to accommodate a larger closet doorway, & an adequate header was not installed; very poor workmanship; deflection of wall was implied by stress cracks at both sides of the wall above this location.

↑ brick & or mortar cracks & stress separation at the east-northeast

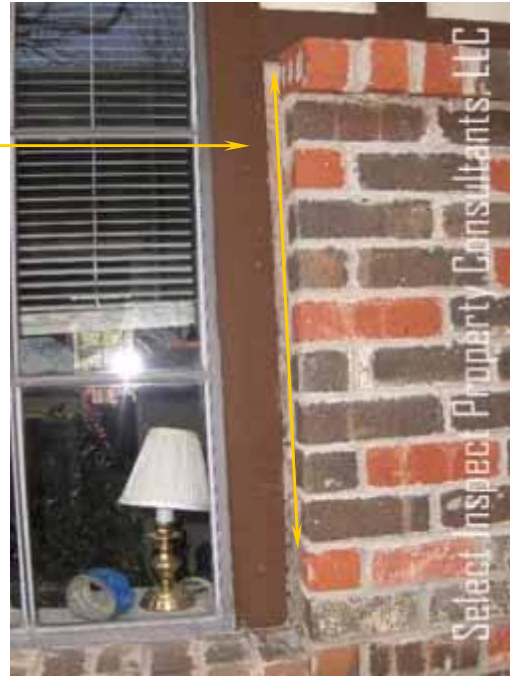
↑ close view of image at left

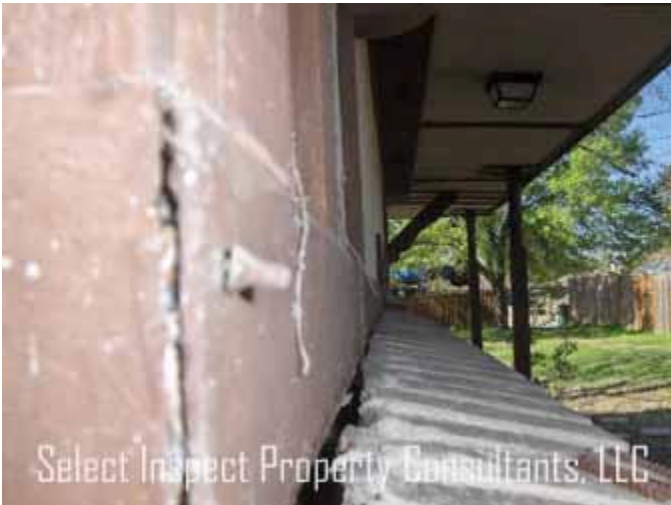
↑ excess stress separation at the northeast.

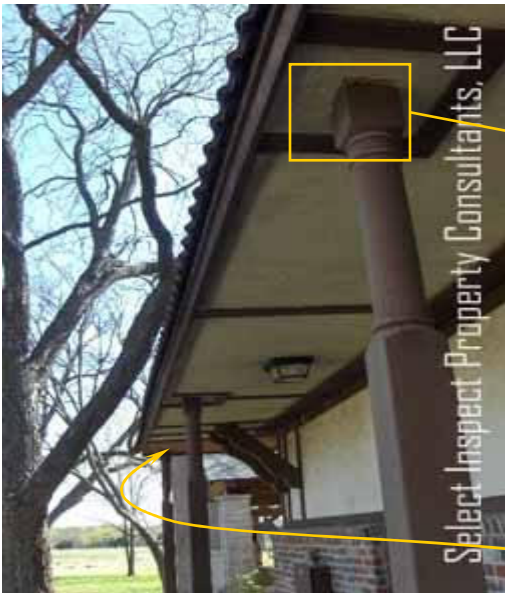
↑ separation & differential movement at rear porch columns

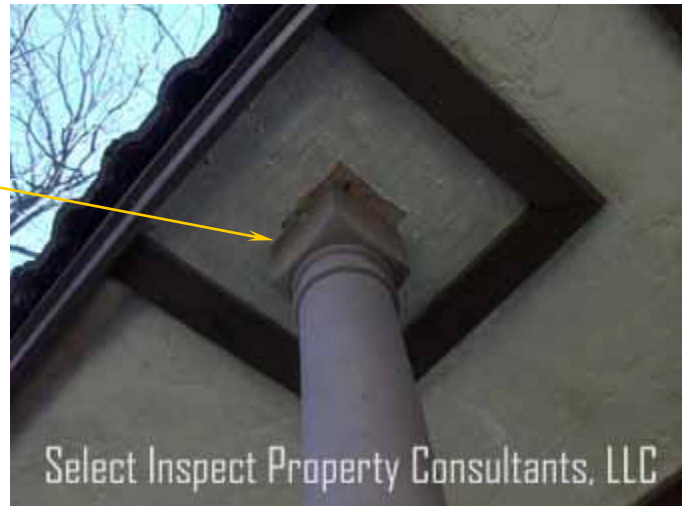
↑ close view of image at left

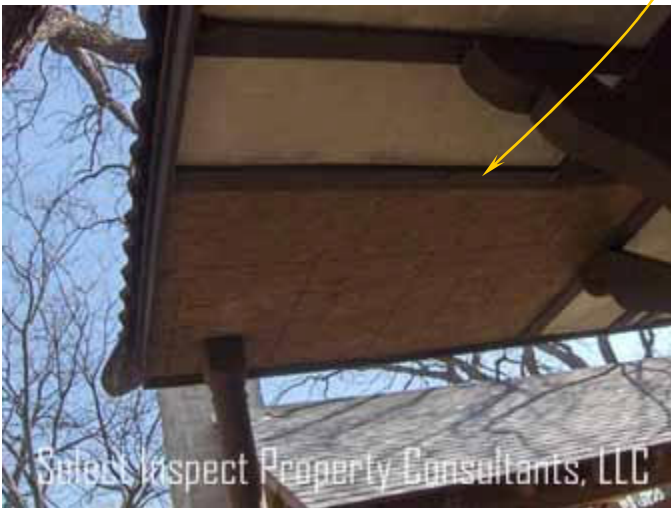
↑ repair of eave; likely rot history

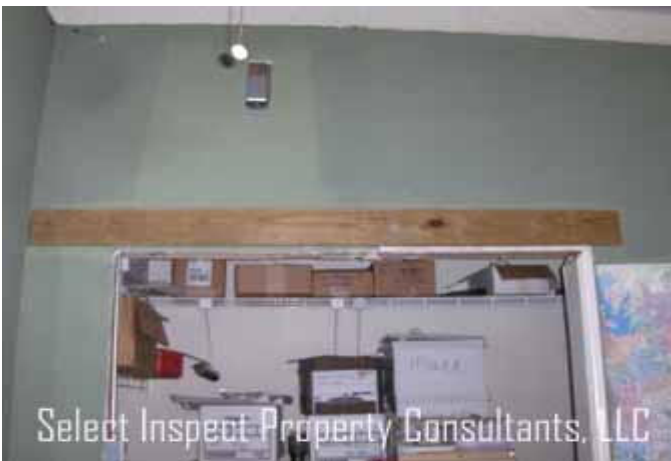
↑ unworkmanlike modification of wall structure at east office/study

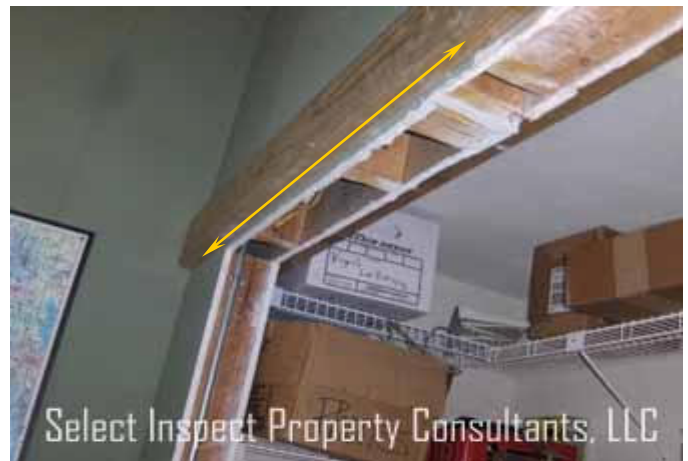
↑ cut framing with unworkmanlike "intended header"; close view of image at left

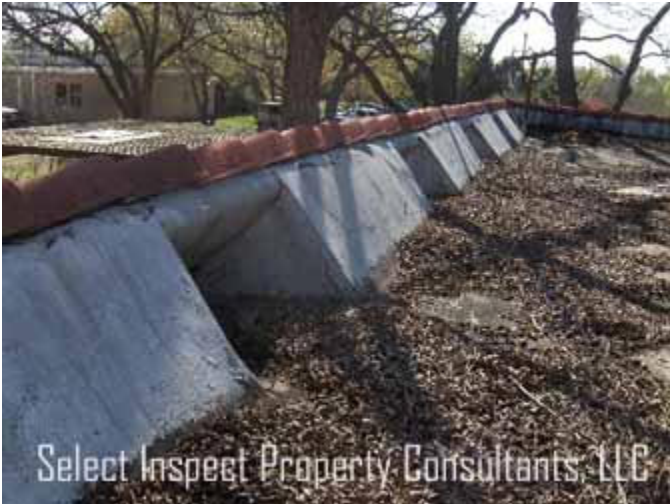
- Scuppers have deficient flashing/membrane & exposed framing was noted at various locations.

↑ roof scuppers were not functioning as intended, congested & deficient; excess debris

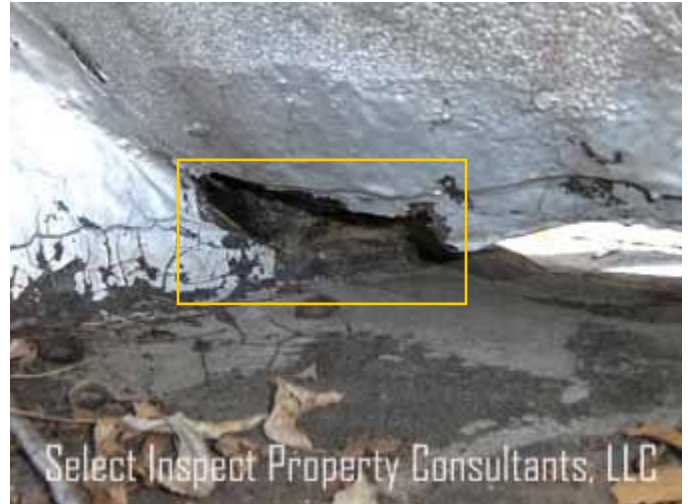
↑ opening at scupper flashing will allow moisture intrusion; example

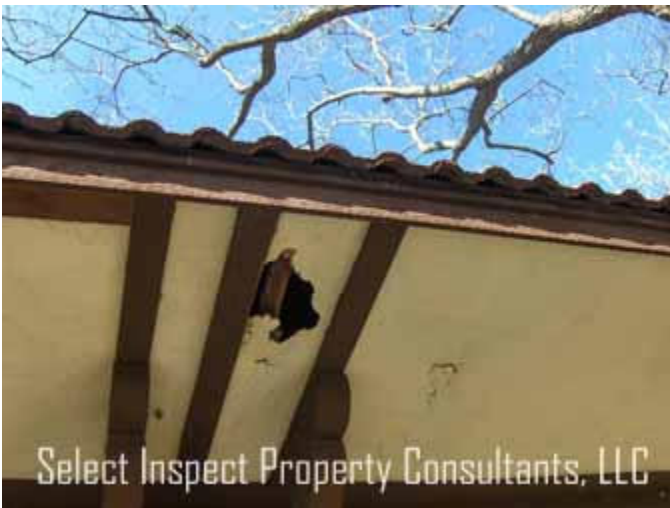
↑ rot & or rodent opening at east eave

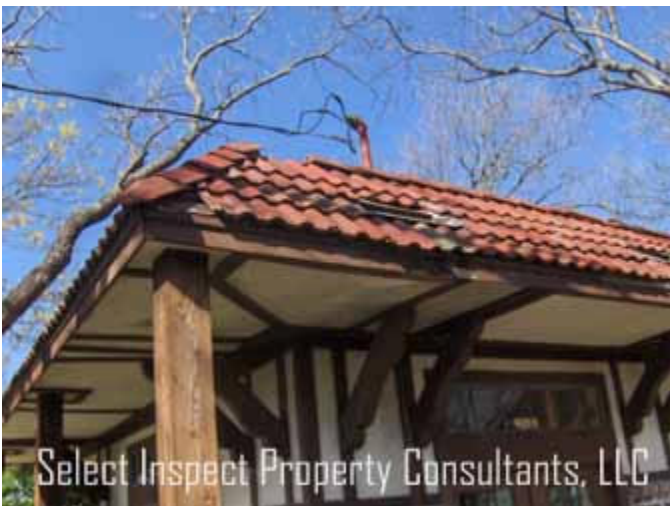
- Most tile roofs last approximately 50 years; if this is the original roof it is about 55 yrs of age; the tiles were worn, many were damaged & some missing
- holes exist that allow moisture intrusion. moisture intrusion to the interior was implied by moisture staining & similar damage evidence throughout the office.

↑ aged roof tiles; many missing & damaged

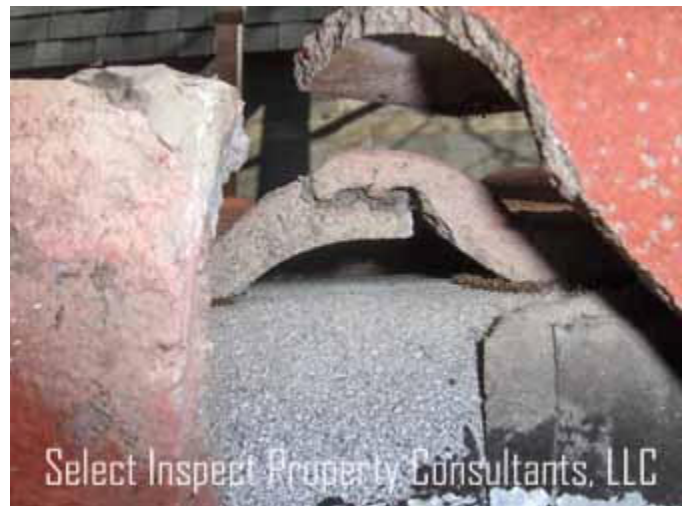
↑ damaged roof tiles; openings will allow moisture intrusion

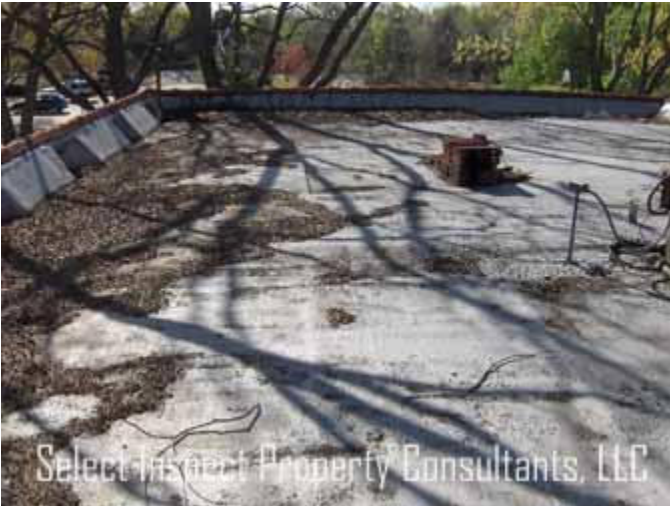
↑ flat roof appeared in fair/good condition; under debris was not readily accessible; though some was moved away for random inspection

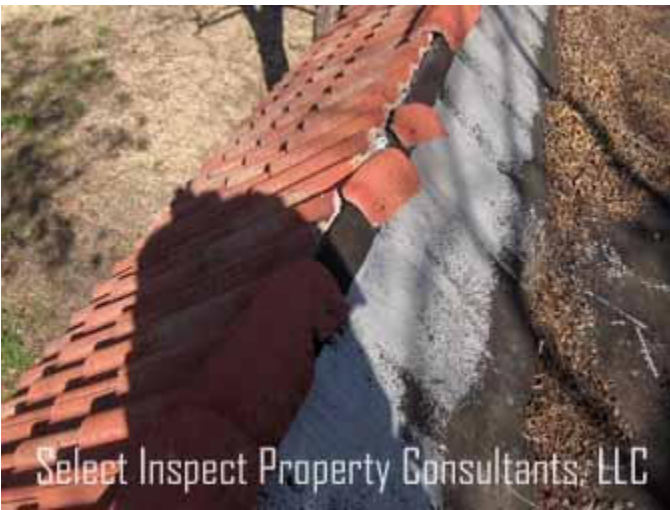
↑ deficient roof tiles; example

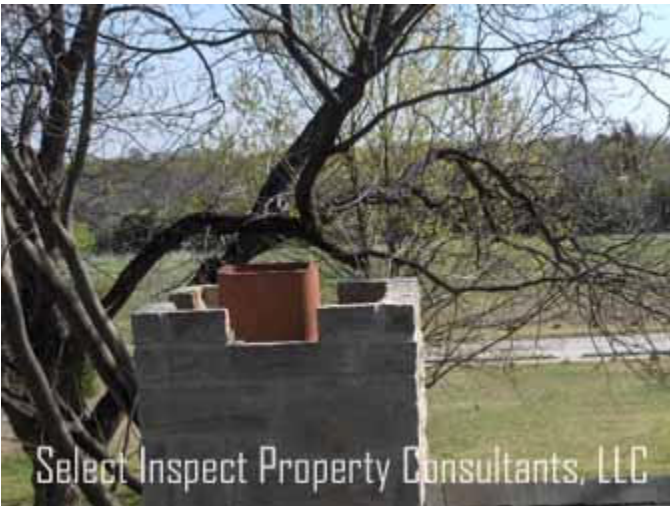
↑ northeast cabana chimney did not have a cap

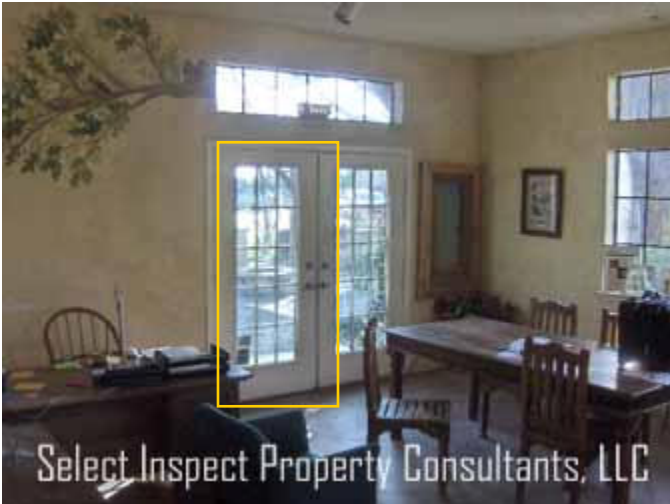
↑ left door was not functioning as intended; various stress cracks noted throughout the interior

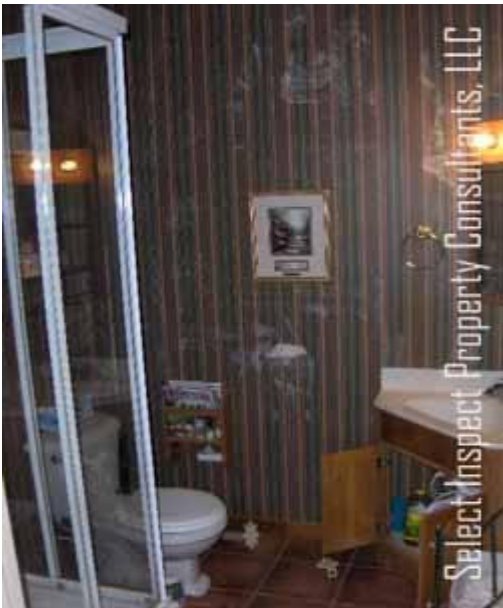
↑ close view of image at left

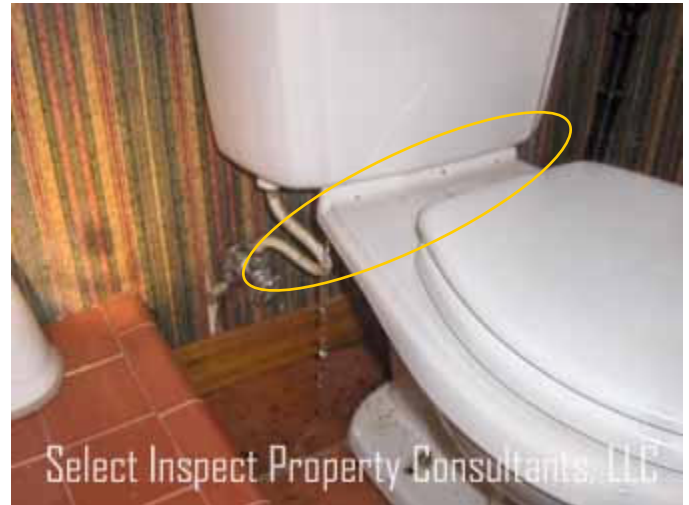
- East bathroom toilet leaks at the tank slowly when idle, & exsively when flushed.
- West bathroom toilet was shut down & appeared inoperable

↑ toilet leaks; I turned off the water supply at this fixture; moisture damage & fungus noted below the sink

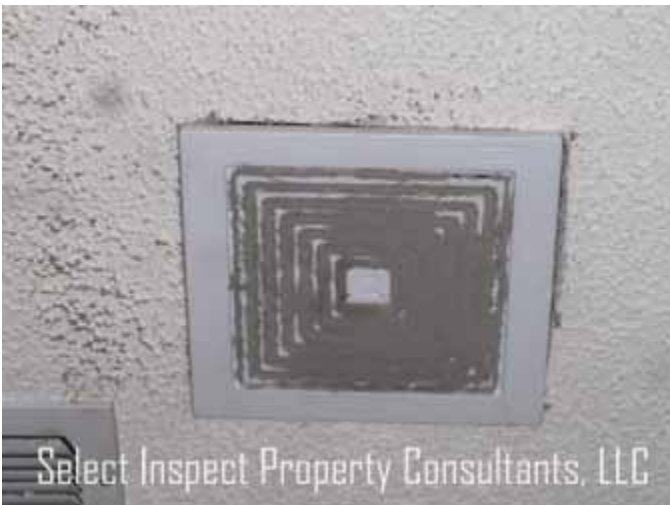
↑ congested exhaust fan(s) is a potential fire hazard if the motor overheats

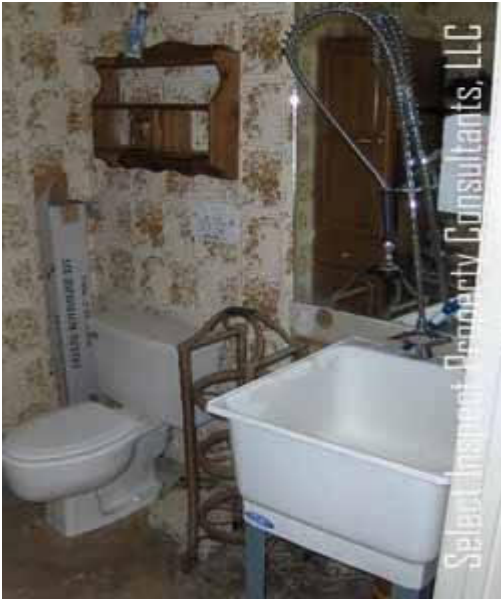
- moisture damage & fungus exists at the west bathroom;
- the east bathroom toilet leaks, & some degree of moisture damage & fungus should be expected at the separation wall between the two bathrooms.

↑ moisture damage & fungus below west bathroom sink & along the wall; may be from adjacent leaking toilet

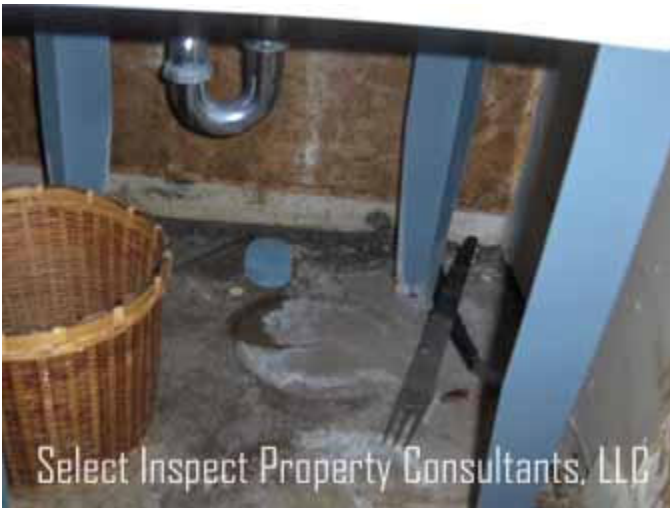
↑ moisture damage & fungus below west bathroom sink

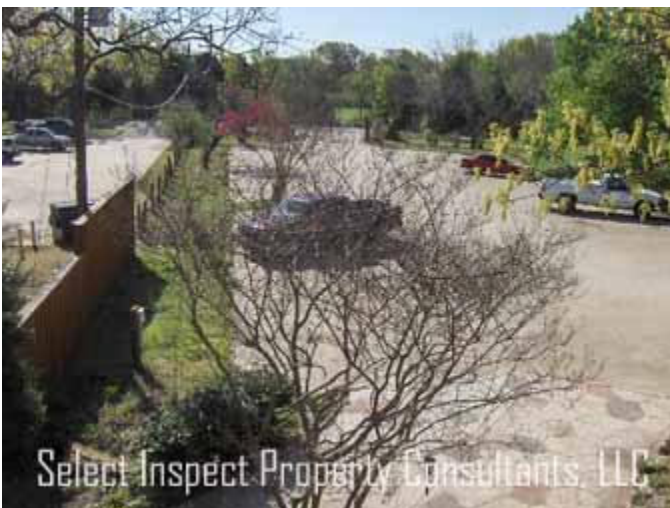
↑ inadequate handicapped parking & access

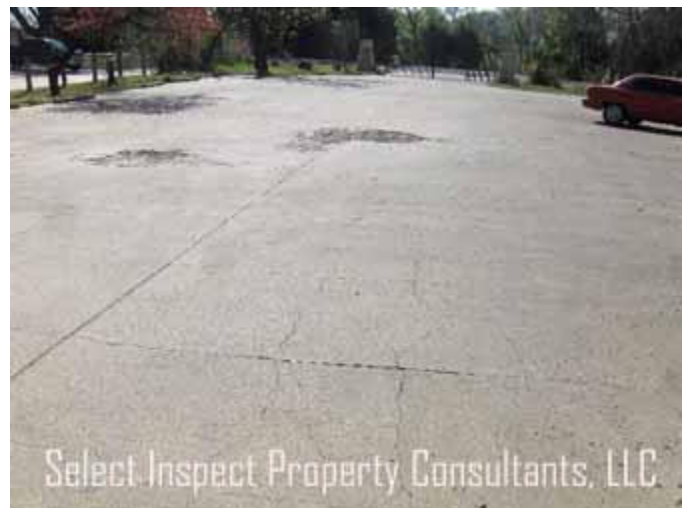
↑ potholes at entry drive

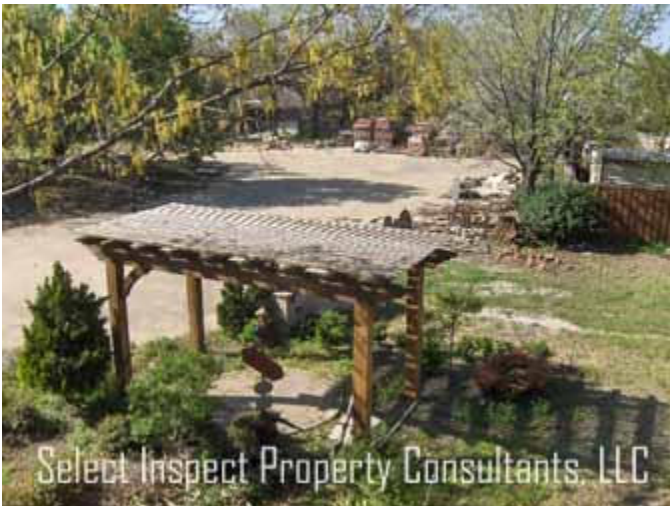
↑ potholes at stone lot

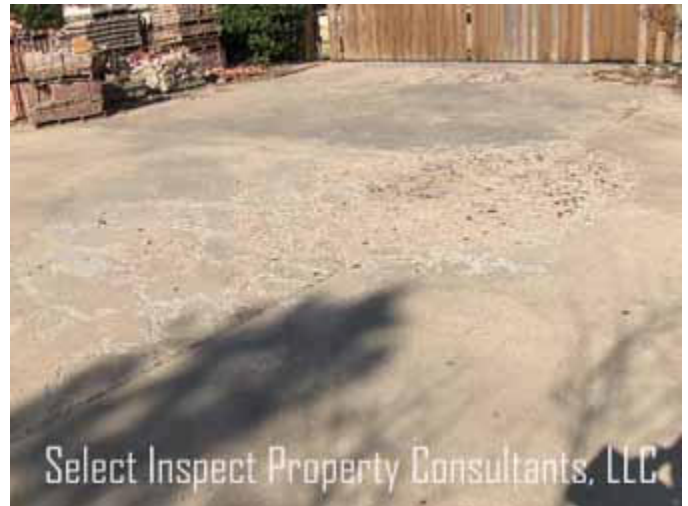
↑ close view of image at left

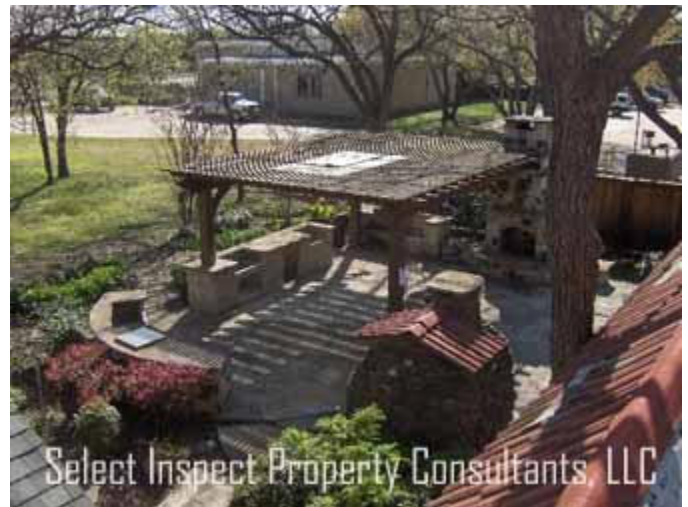
↑ outdoor showroom electrical & appliances were not tested; & were minimally inspected; I suspect you intend to update & personalize these.

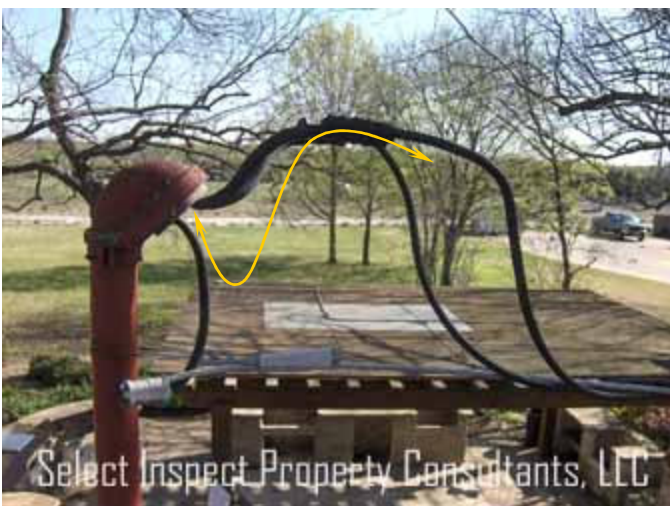
Drip loops at the exterior mast / service entry are improper, as the conductor connection is at the low end of the loop. This can allow rain/water to seep into the conductor and cause corrosion. Corrosion causes resistance; resistance causes overheating; this could potentially be a fire hazard.

↑ inadequate drip loop at electrical service; to prevent rain dripping into the electrical mast head & conductors

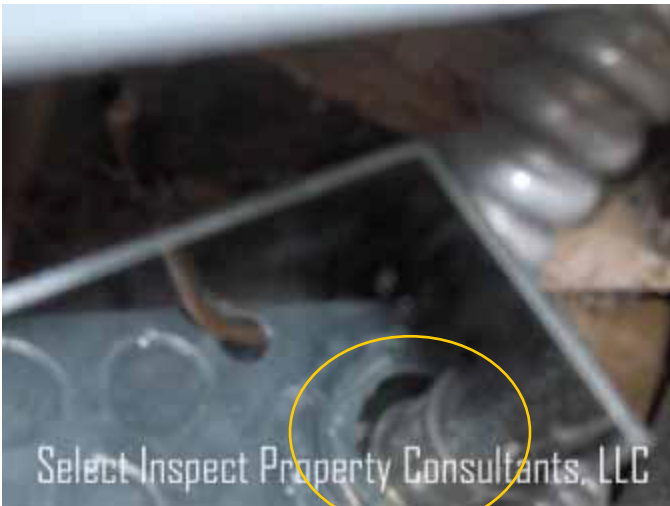
↑ unworkmanlike electrical in interior service panel; deficient conduit connection

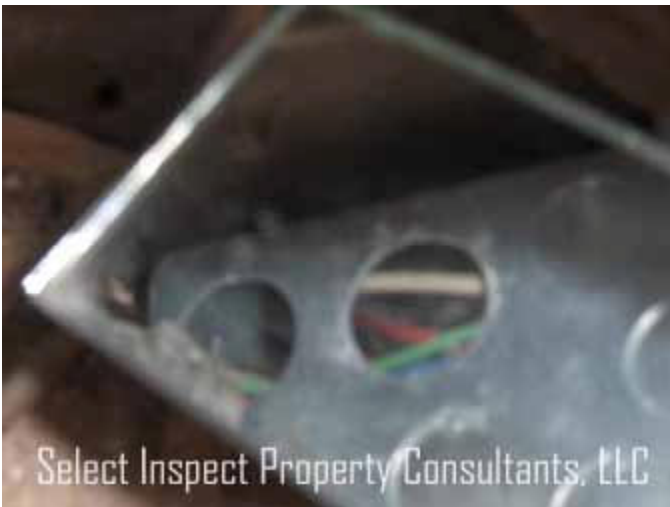
↑ unworkmanlike electrical at interior service panel; missing bushings at knock-outs.

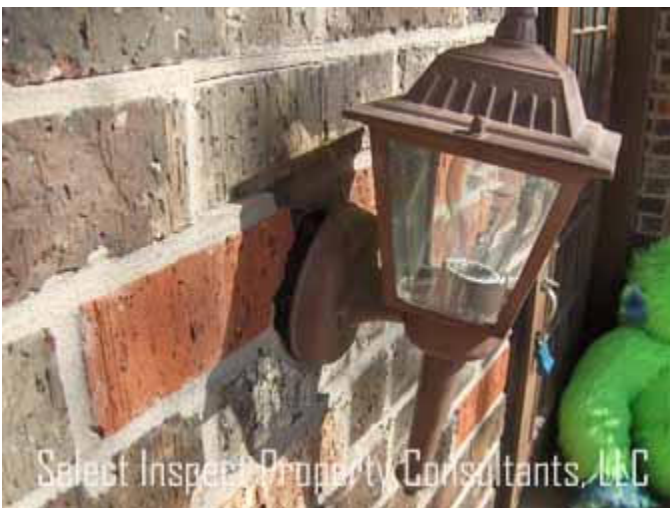
↑ inadequately secured electrical at exterior; example

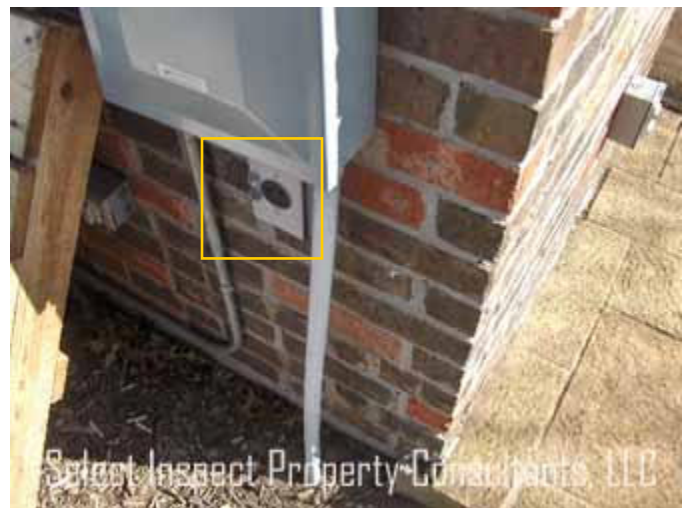
↑ missing exterior electrical receptacle cover example

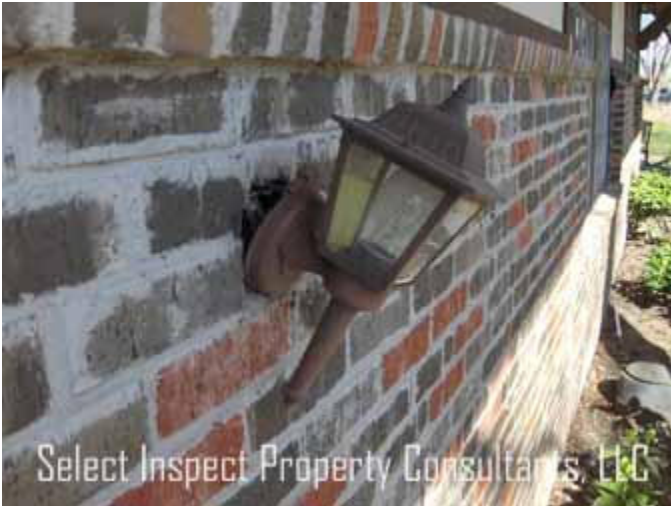
↑ inadequately secured electrical at exterior; example

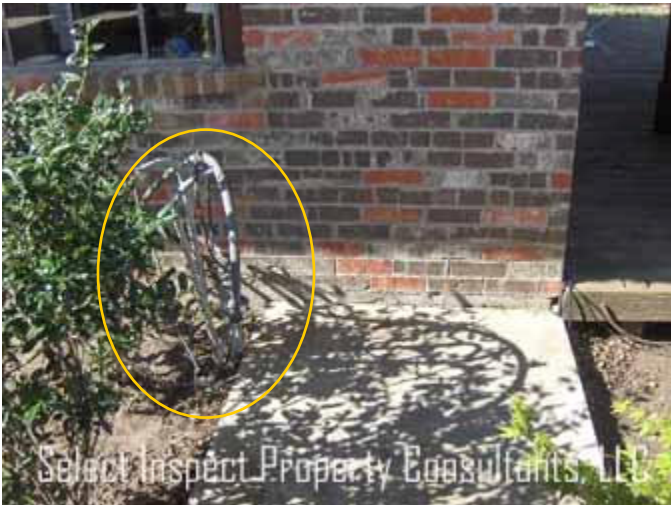
↑ abandoned electrical at the northeast; these were not energized during the inspection.

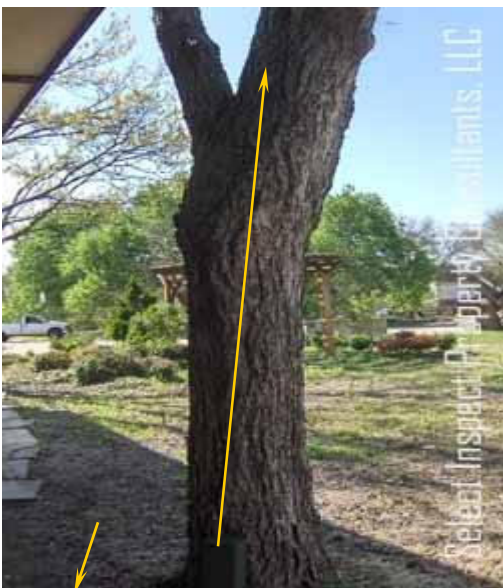
↑ tree light electrical should be secured & in conduit for at least 8 feet from grade; & the conduit on the soil was unprotected from foot traffic/damage

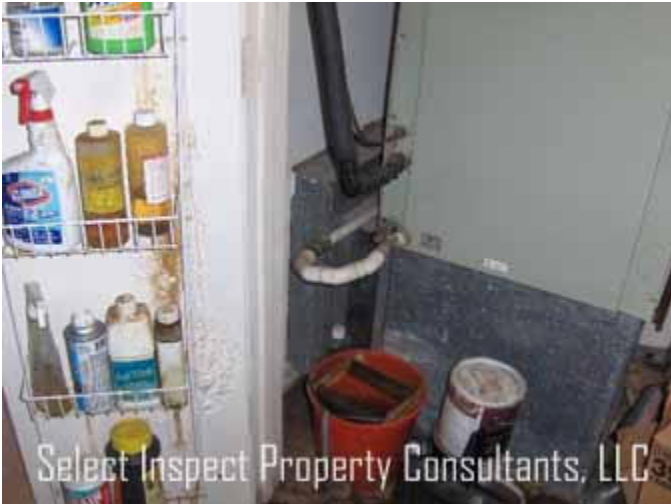
- Chemicals were stored (& spillage noted) in the mechanical closet; plenum & HVAC system were not sealed & could pull in fumes, then distribute through the building's air supply. This is very unhealthy & potentially dangerous for workers & clients.
- Air conditioning condenser(s) is located on the roof; it appeared in fair/good condition, though with the restriction of air at the evaporator(s); this entire system is overworked. Condenser may be salvageable, though the interior system likely needs replacement.

↑ do not store chemicals in the HVAC plenum/mechanical closet area

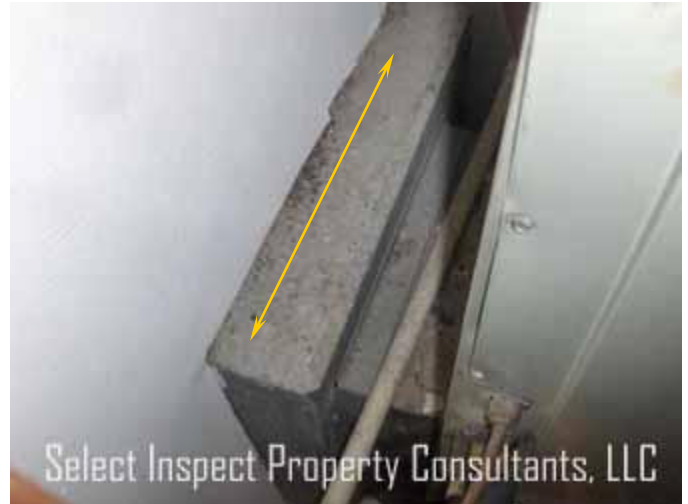
↑ rodent/pest droppings present at the HVAC equipment; unsanitary

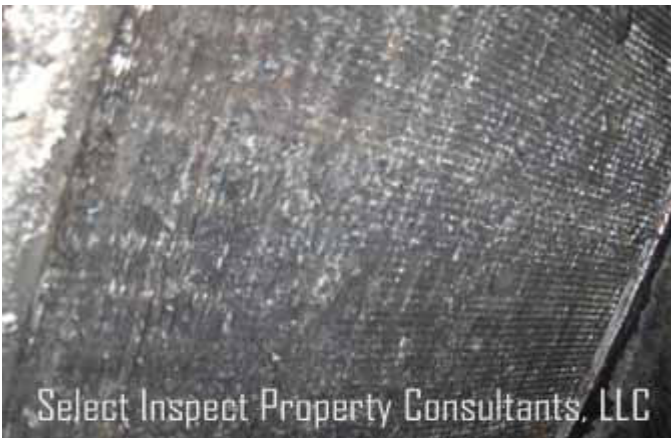
- Evaporator(s) coils were unclean. Air flow is restricted & system was not cooling properly.

↑ evaporator(s) coils were filthy; congested

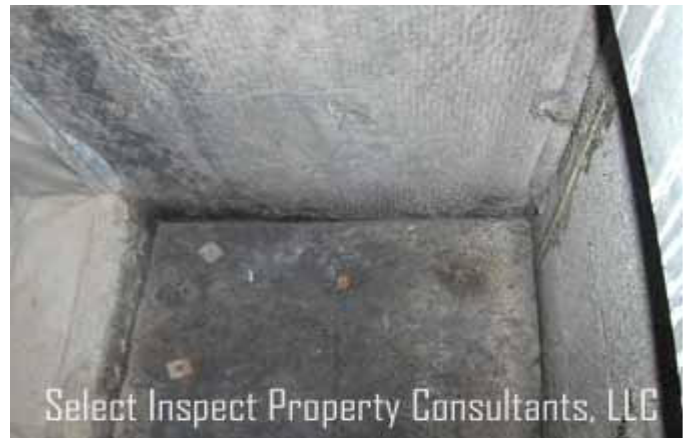
↑ HVAC plenum was dirty

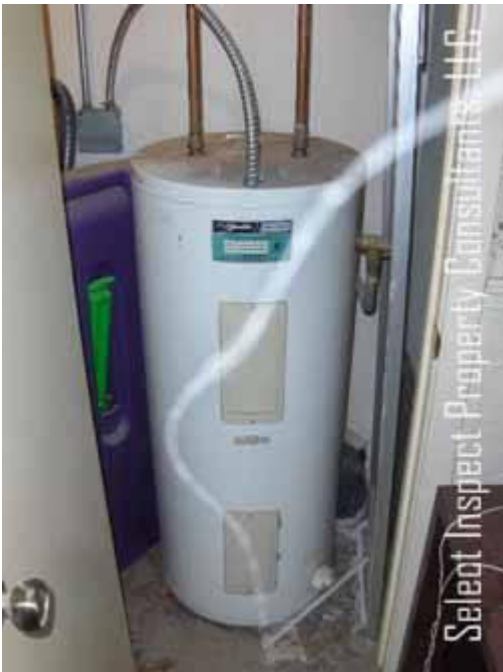
↑ antiquated water heater; no auxiliary pan & drain.

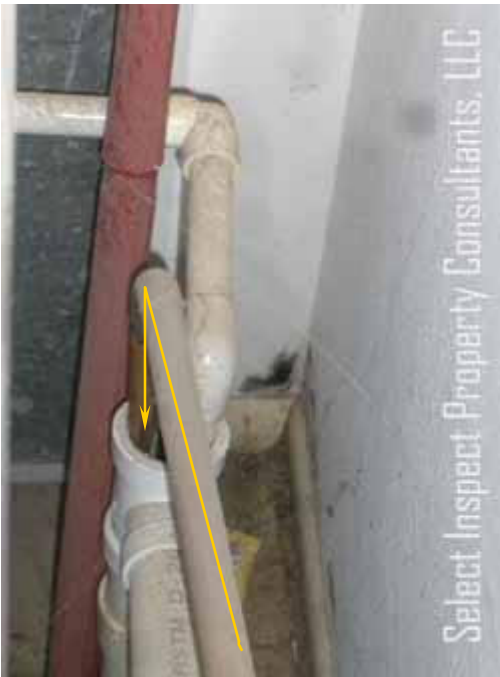
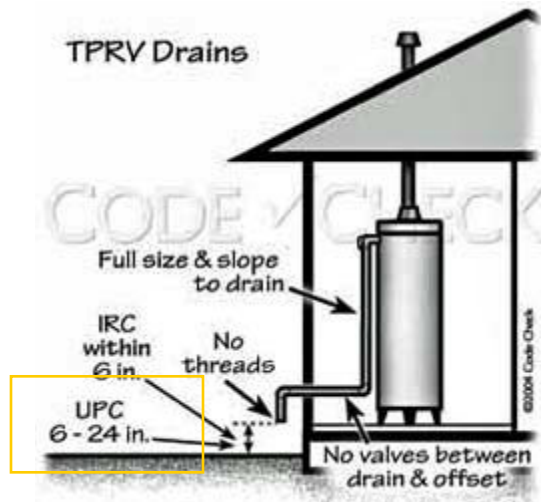
- The temperature-pressure-relief valve is routed to drain with the primary condensate line for the air-conditioner (evaporator). Consult a licensed plumber for options.

↑ water heater temperature/pressure relief improperly drains to a plumbing drain with the HVAC
