PROPERTY CONDITION REPORT- PCR

Address:	123 Business Street		
City:	Arlington	State:	TX
		Zip:	76011
Client:	xxxx	Phone:	1234567890

Inspector:	Bruce W. Carr	Inspection Date:	07/23/2010
	214-770-6954; Bruce@SelectInspect.com	Report Date:	07/23 & 24/2010

Property Description: Light Industrial Warehouse Office						
No. of Bldgs:	1	No. of Units present:	2+	Additions discovered y <input checked="" type="checkbox"/> n <input type="checkbox"/>	Est. Yr Built:	1980s

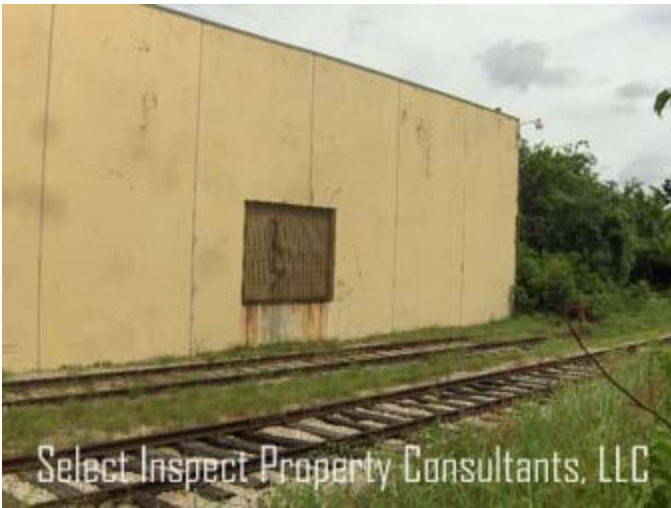
↑ stress cracks & deteriorating concrete & steel

↑ close view of image at left

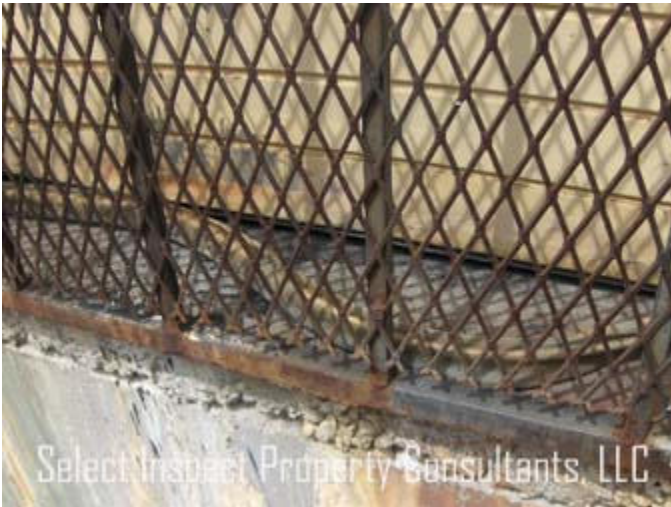
↑ deficient weatherstrip at east dock door

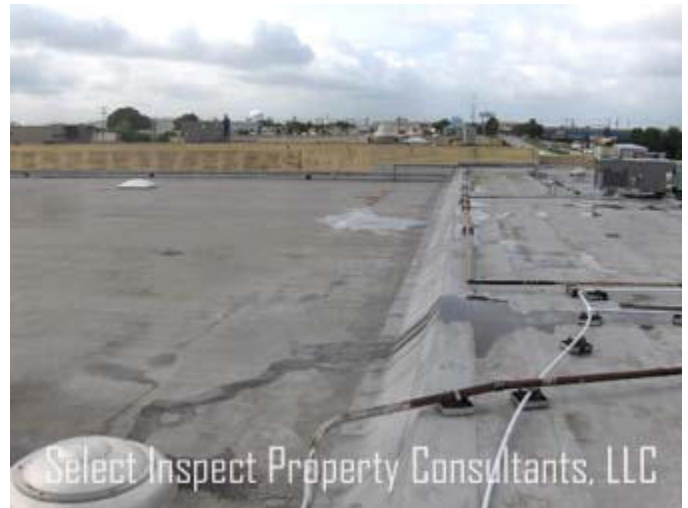
- *Air conditioning primary condensate drains terminate at the roof & or gutters; this is generally acceptable, as long as the roof/gutter is adequately sloped to allow the condensate to drain off, rather than accumulate on the roof or in the gutters.

↑ air conditioning condensate should drain off, rather than be allowed to pool on the roof.

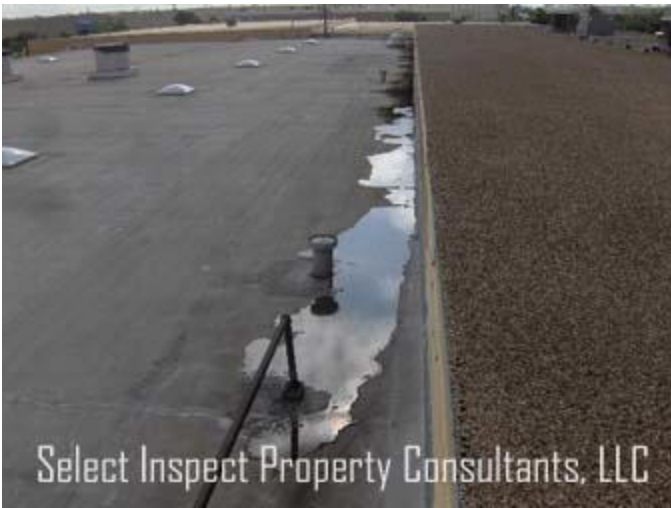
↑ inadequate slope at junction of warehouse & conditioned warehouse roofs

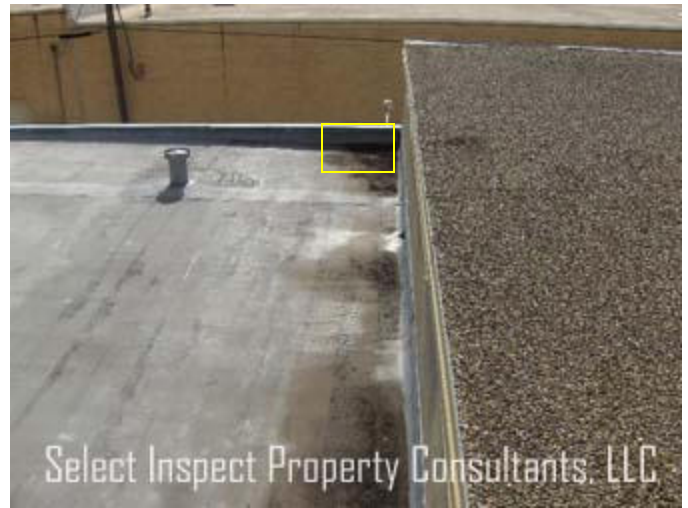
↑ water runs to the east & does not immediately run off; consider adding a scupper at this location.

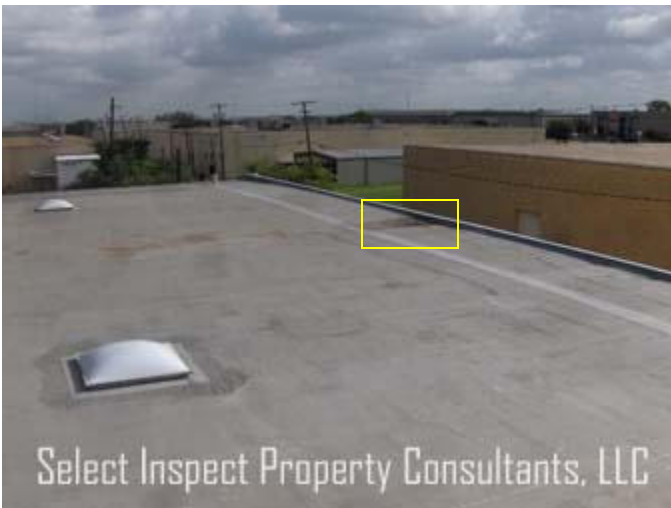
↑ rear (east) warehouse scupper is not at obvious low point to receive rain water for disposal

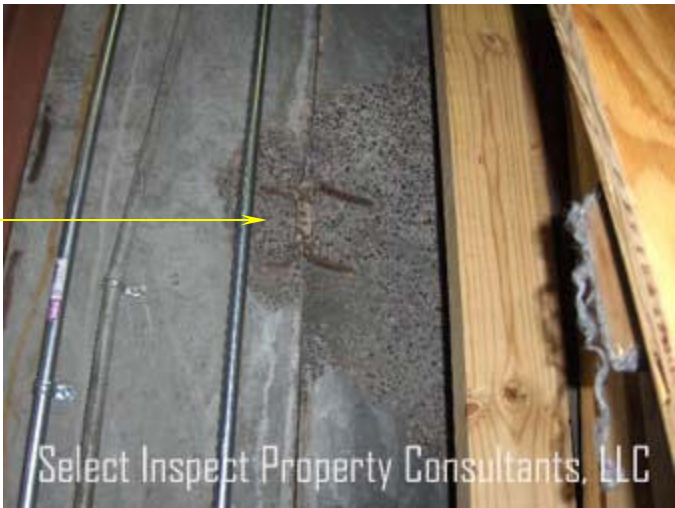
Central north dock bay doorway had a moderate section of concrete chipped/broken; steel reinforcement was exposed. The area should be patched & sealed to reduce risk of corrosion & degradation of the steel.

↑ chipped concrete wall & exposed reinforcement steel

↑ close view of image at left

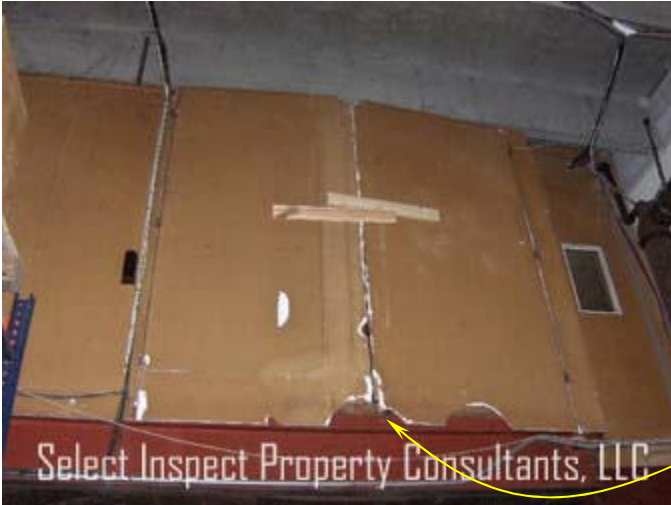
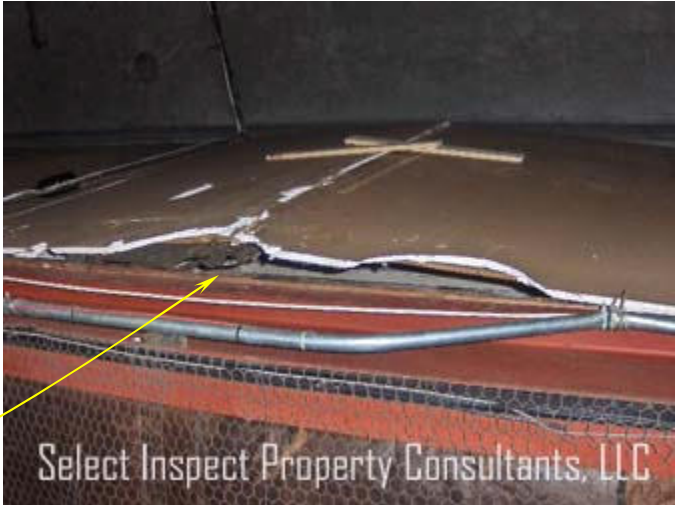
- Upstairs office closet adjacent the warehouse has “hinged walls” for access to install & remove large equipment/furniture upstairs; the hinged wall (door at the back of the closet) is unsteady & could pose a fall/injury risk for unassuming personnel.

↑ upstairs office closet has hinged wall; caution

↑ unsteady/hinged wall viewed from below

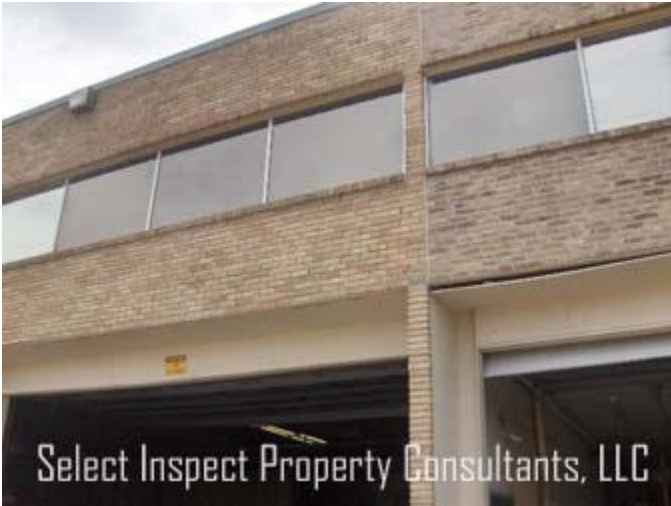
- Glass was broken at the upper office west-northwest & gallery west.
- NOTE: Some windows were partially inspected or had limited access, due to furnishings, lighting conditions, window treatments, etc. Some conditions may remain undetermined.

↑ cracked windows discovered at the gallery

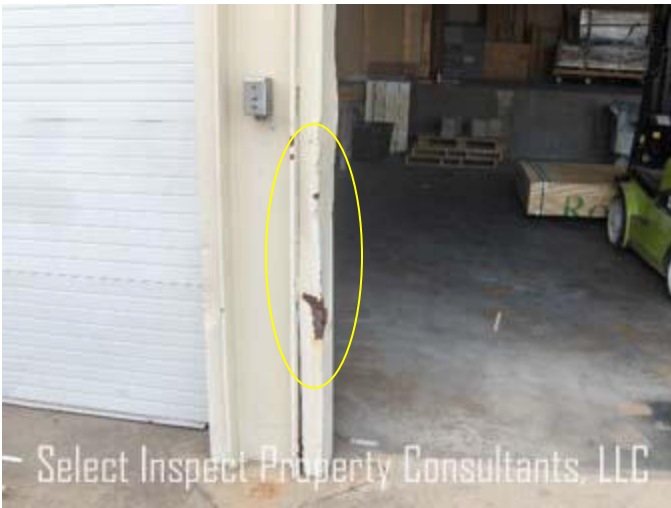
- West facing overhead door areas had inadequately secured header eave/trim.
- Various gutters & exterior metal component(s) could use rust inhibitive coatings to prevent extended corrosion.

↑ exposed steel/metal at exterior should be cleaned of loose paint & rust then painted to resist corrosion; example at the west shop doorway
