## Select Inspect Property Consultants

This is an individual service provided independently of a property inspection regarding:  
7043 & 7075 Christmas Street, Frisco, TX 75034

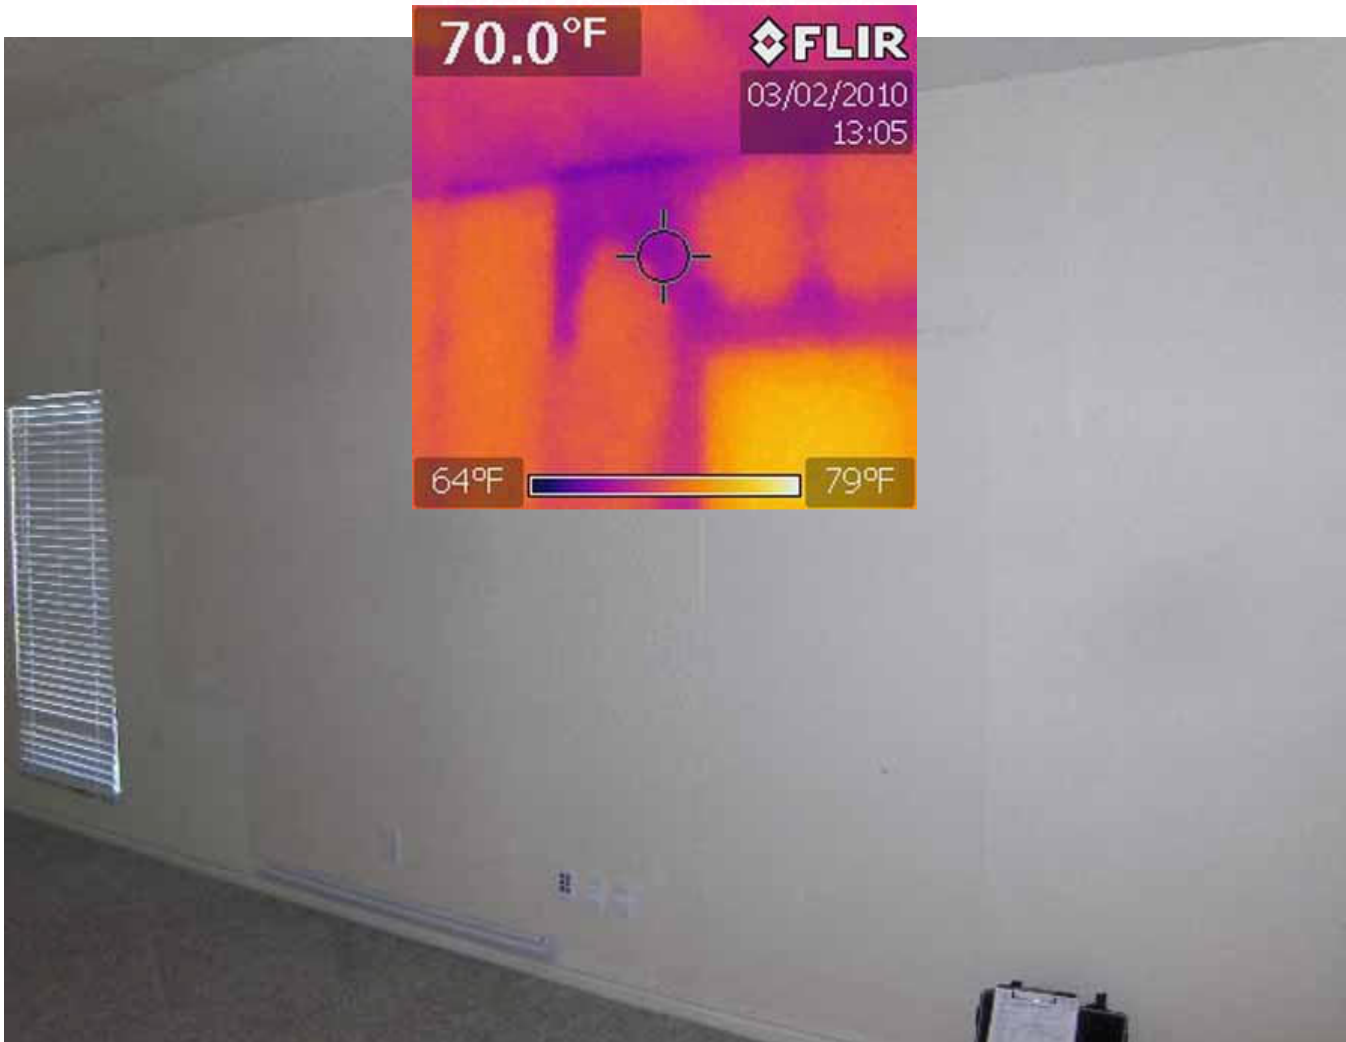
↑ suspected inadequate insulation above an abandoned window & energy loss at the abandoned window adjacent the handicapped ramp.

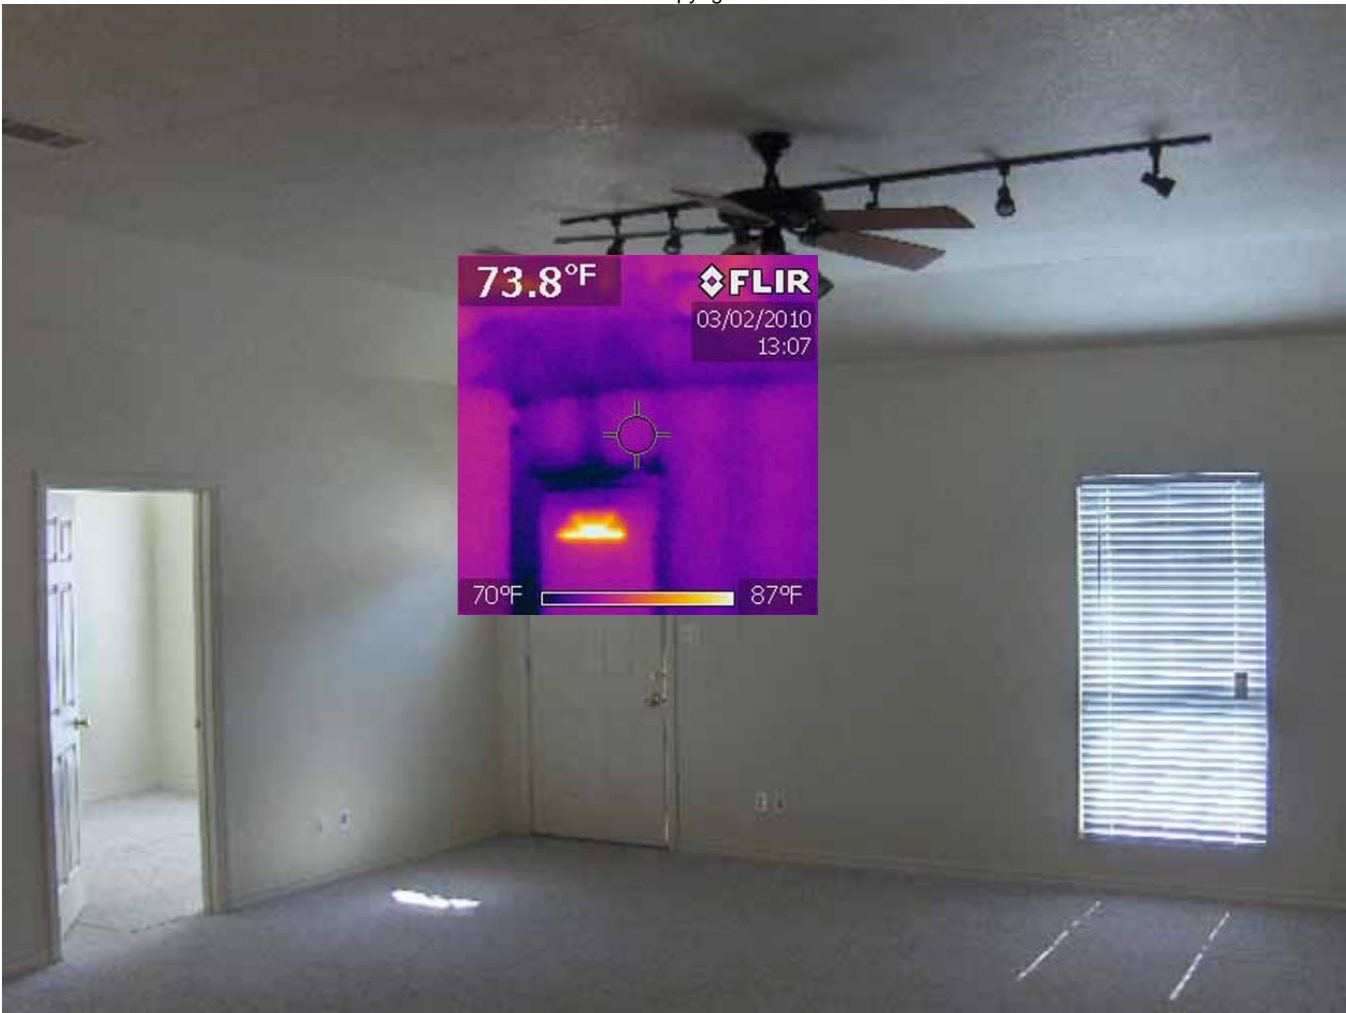
↑ suspected inadequate insulation above & beside the rear door, facing the garage

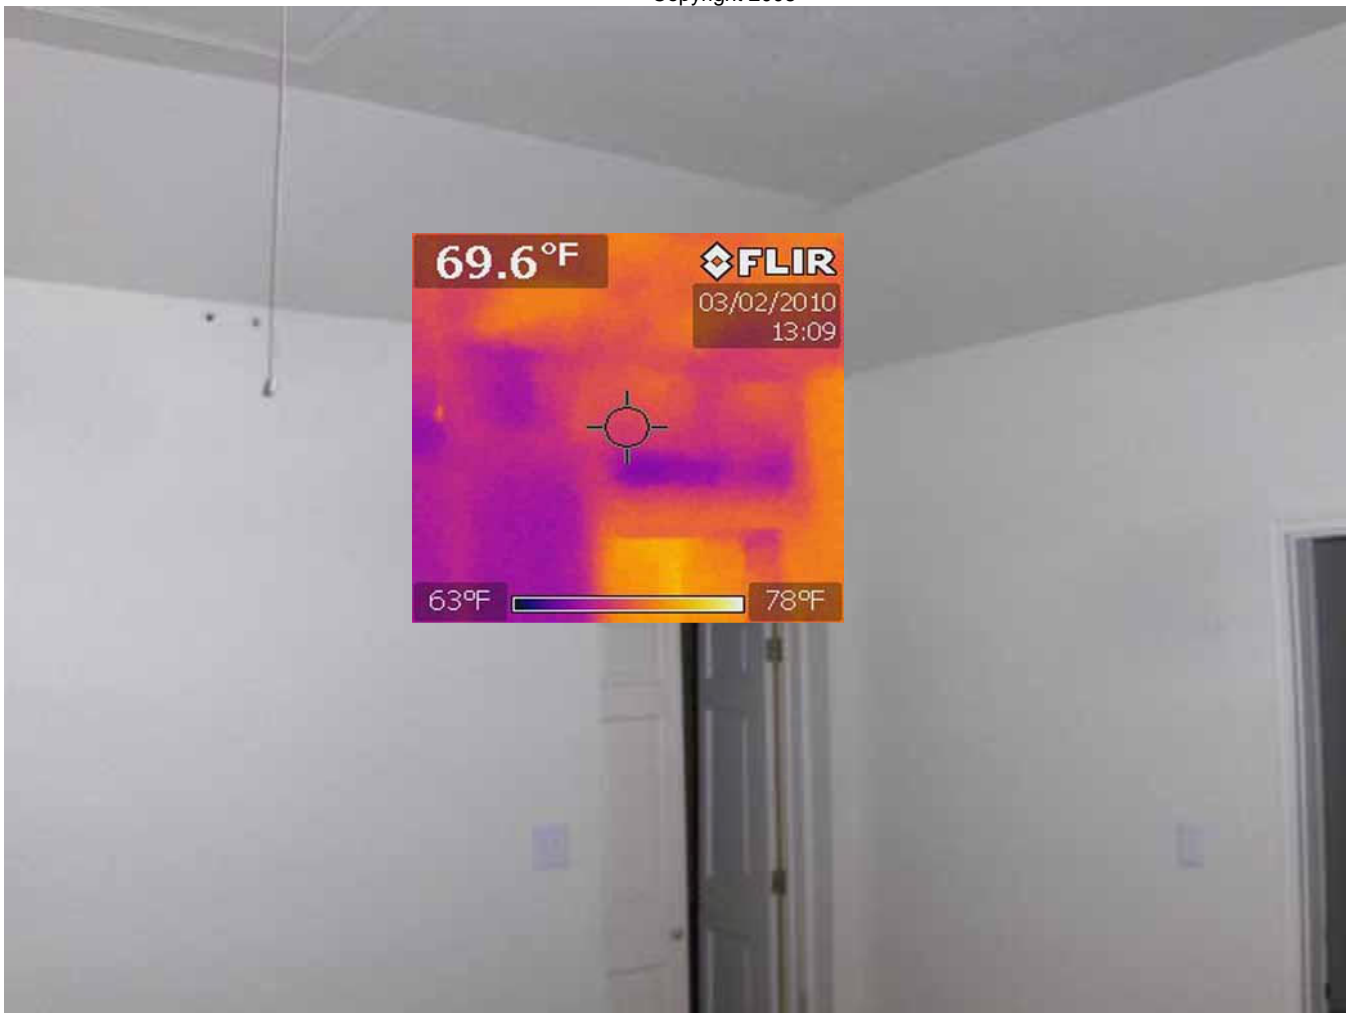
↑ suspected inadequate insulation at vaulted ceiling; example at main room doorway to the front northeast room 7075

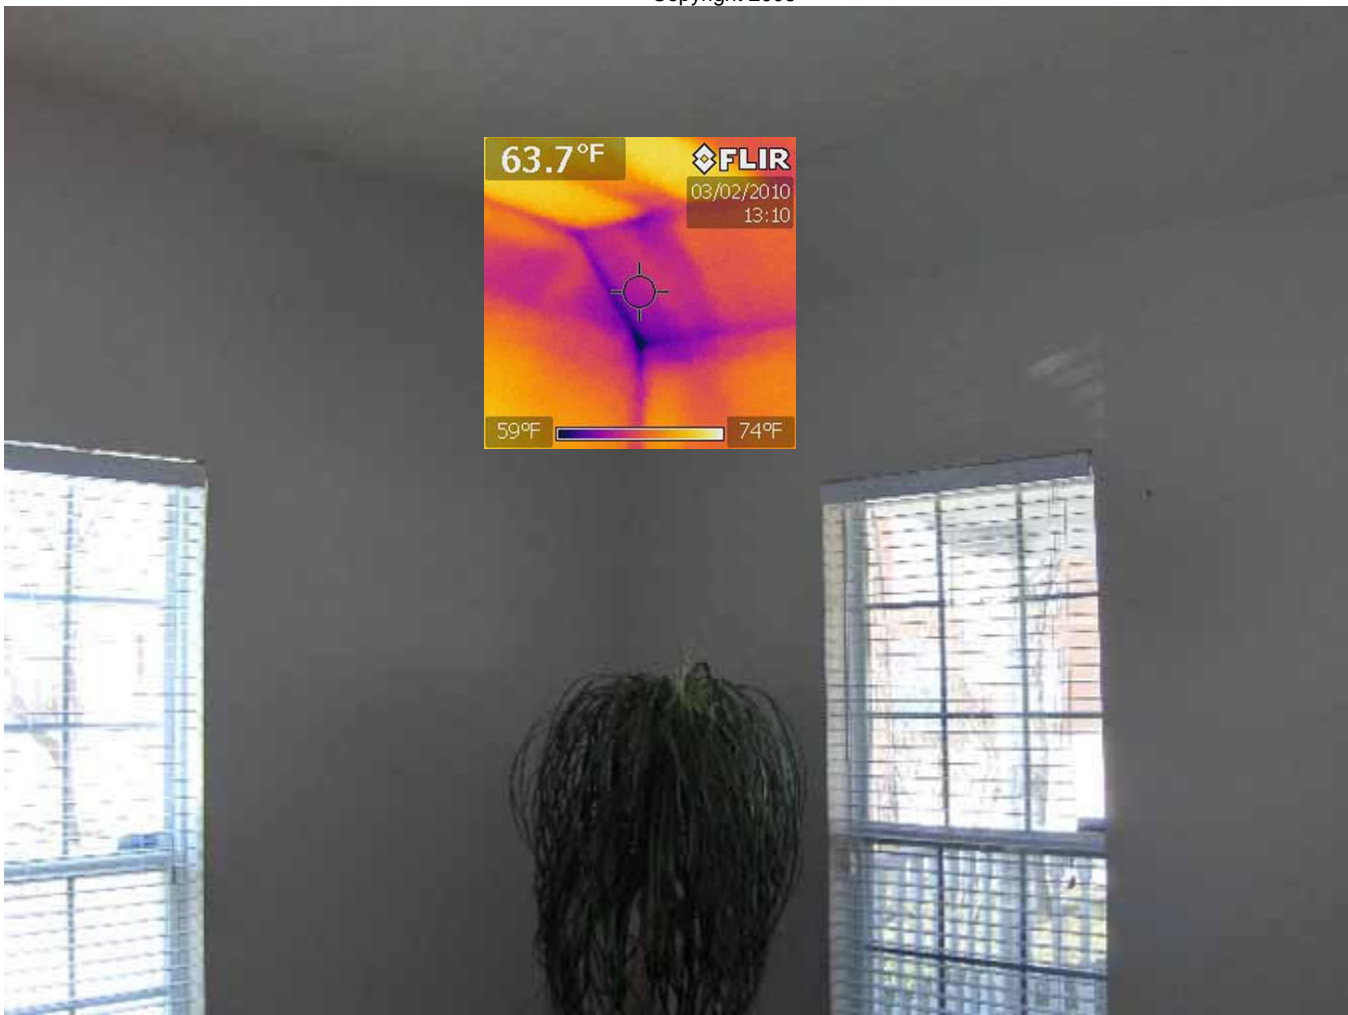
↑ suspected inadequate insulation at 7075; example at one vaulted ceiling

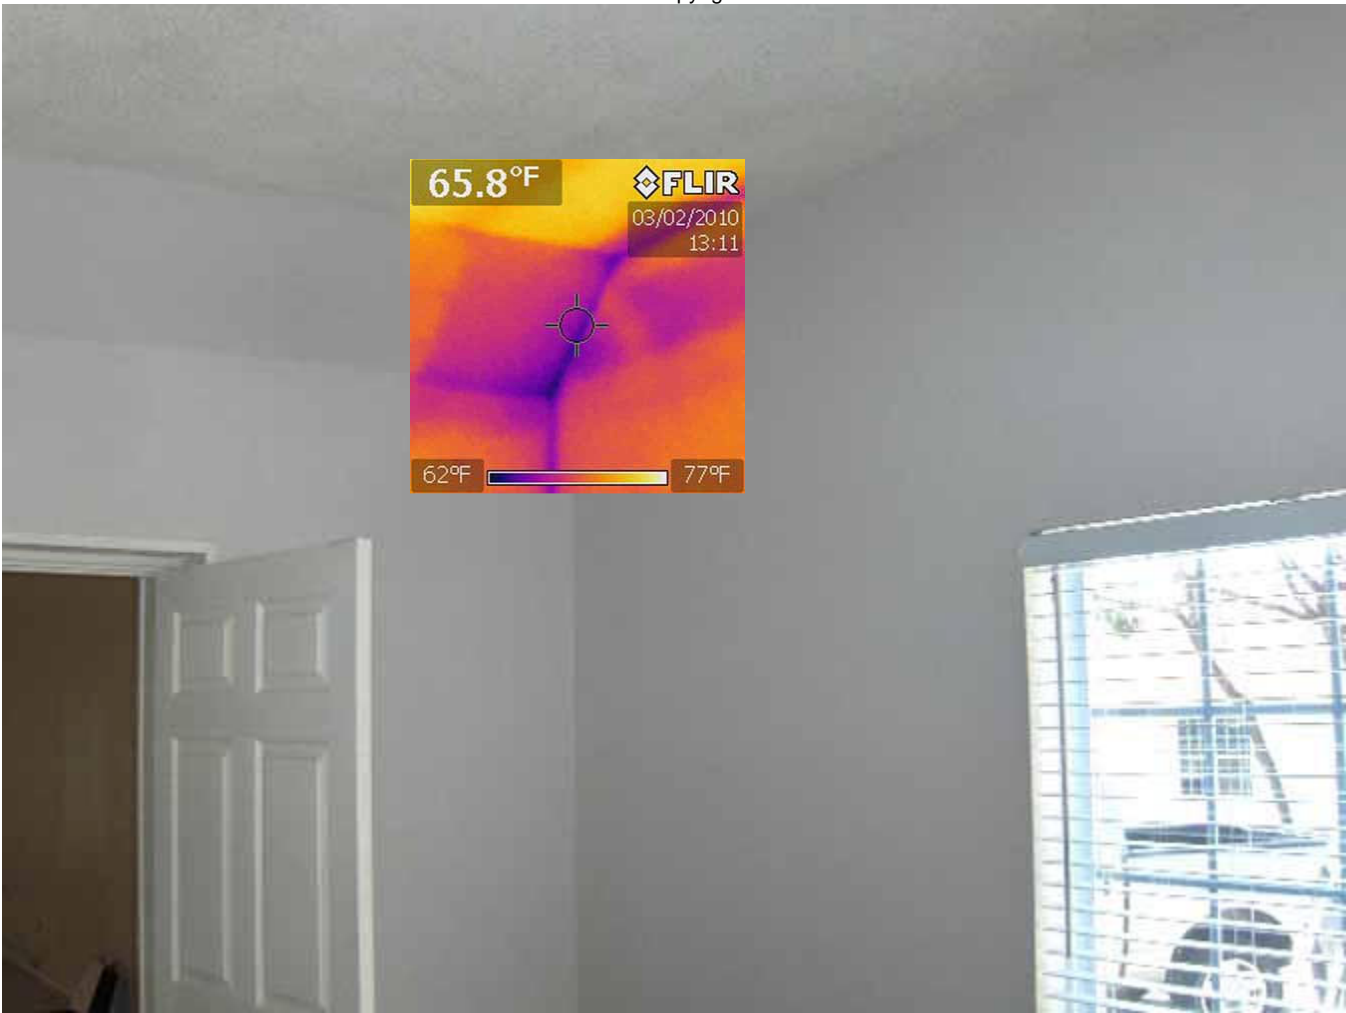
↑ suspected inadequate insulation at vault ceiling; example

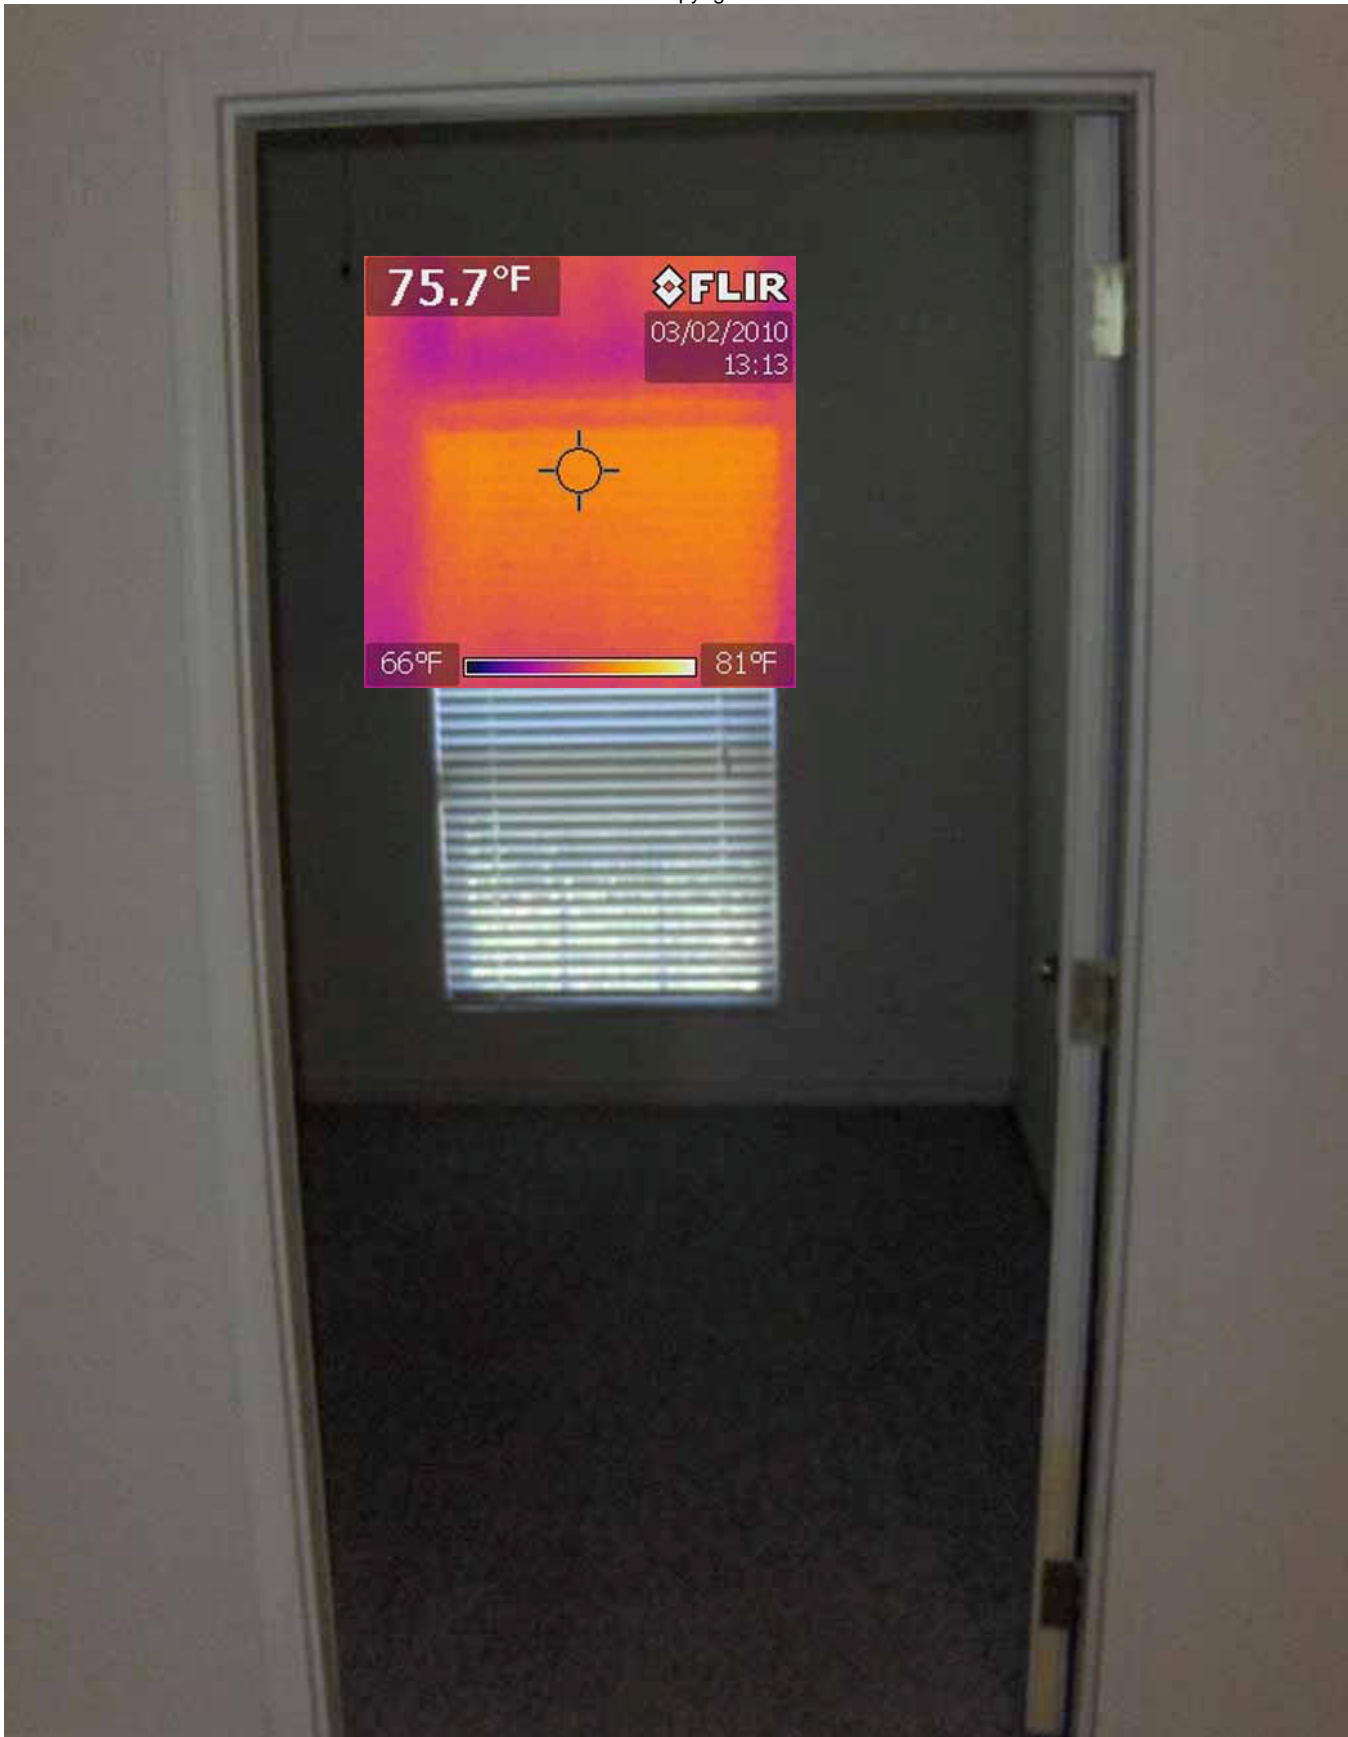
Decent; but not perfect insulation example above window; Obvious/significant deficiencies were not discovered; monitor and maintain

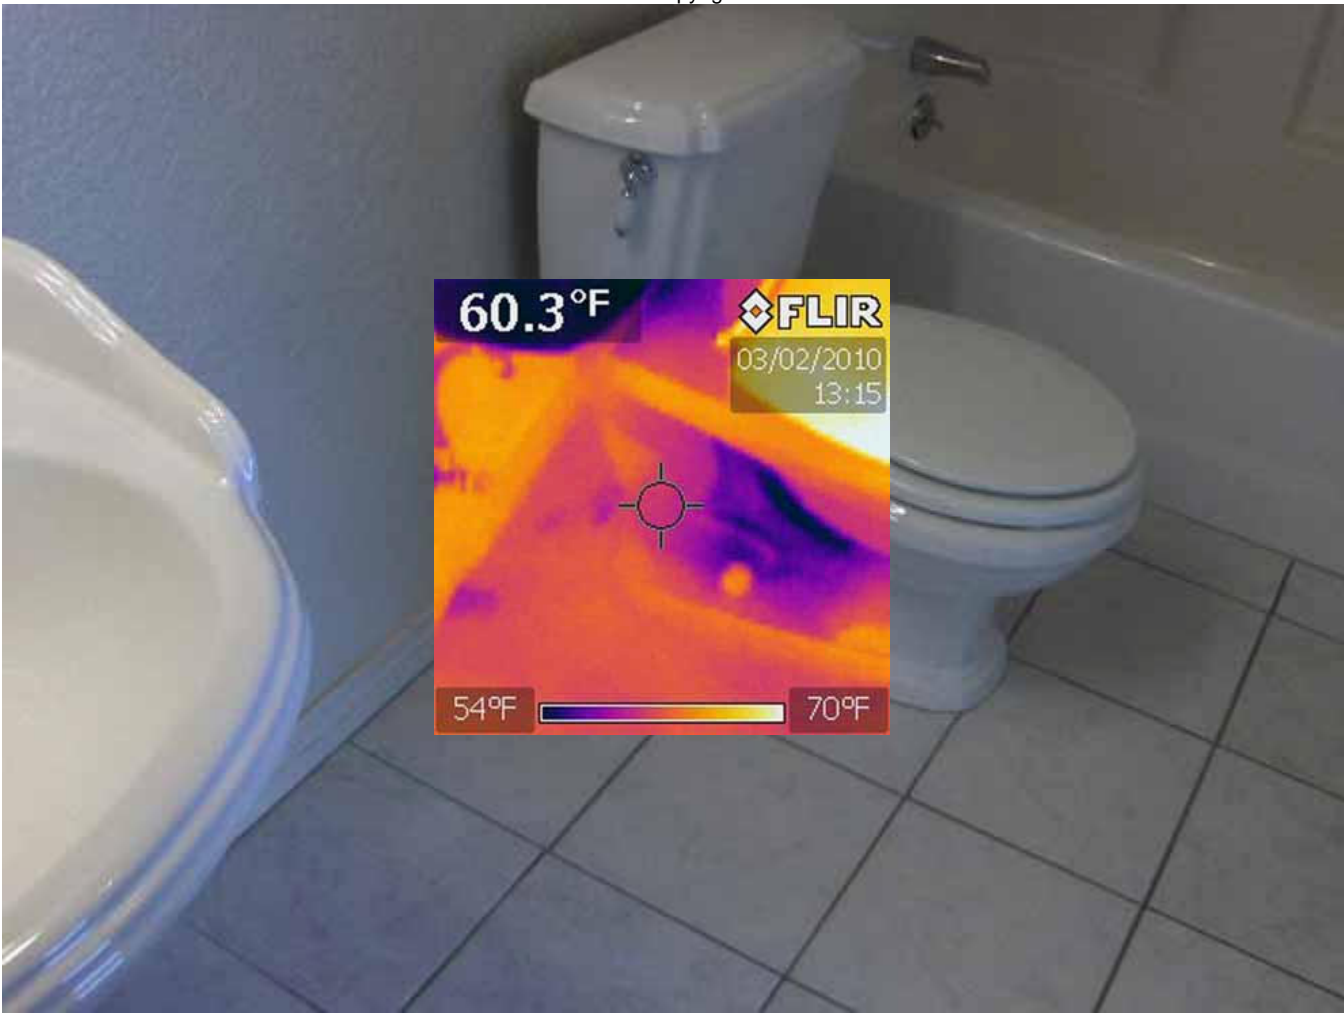
↑ leakage not discovered; thermal image appears satisfactory; though some slight anomalies were noted below the toilet supply pipe & shut-off-valve; active moisture was not discovered.

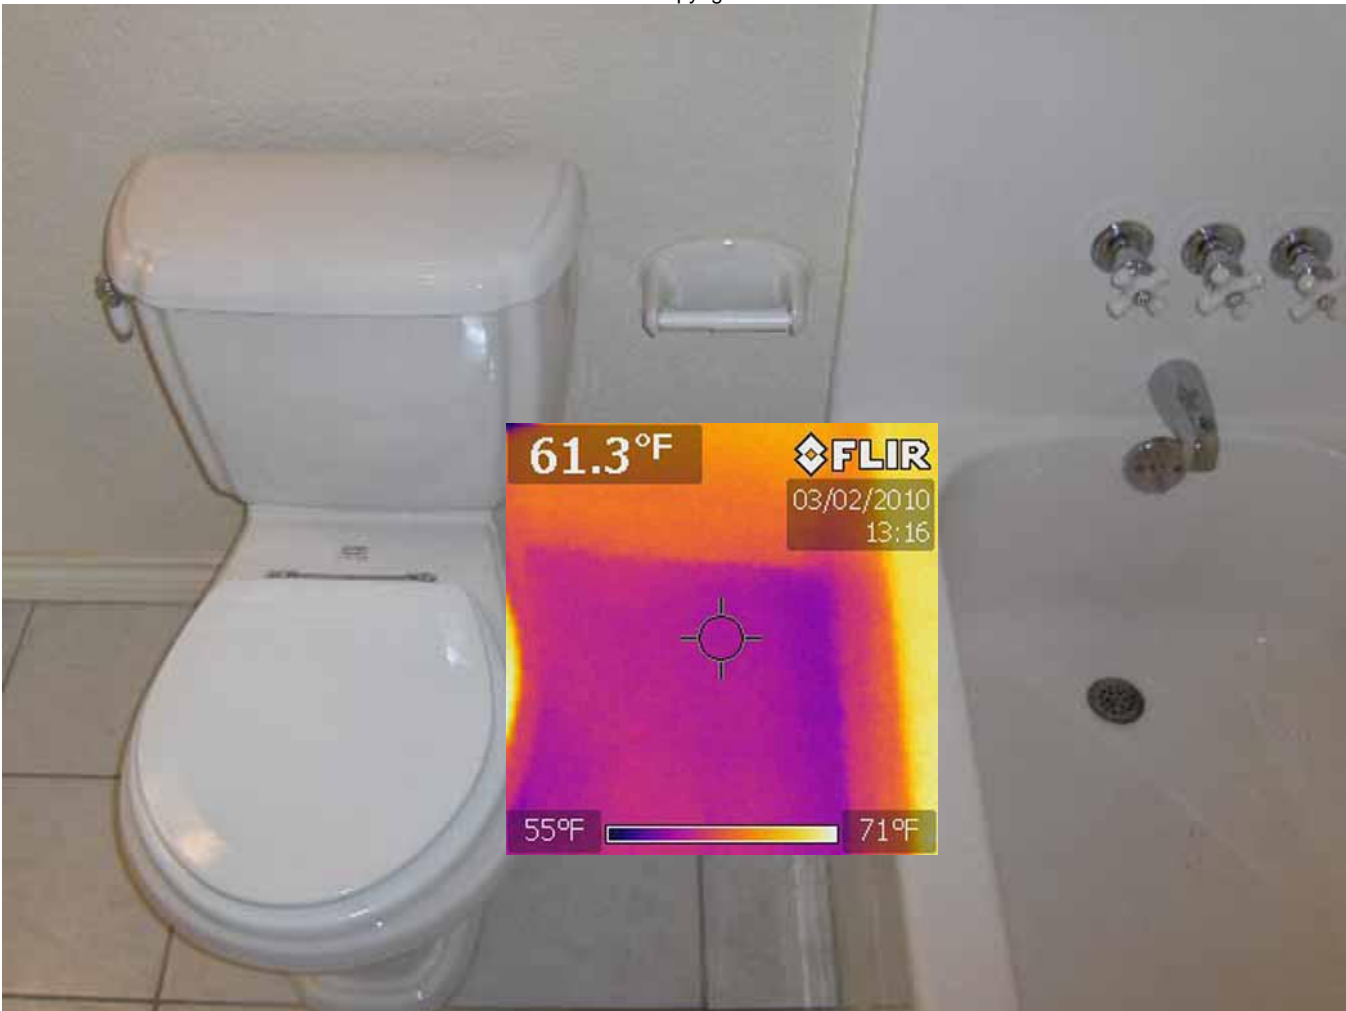
↑ thermal image appears satisfactory; Monitor; provide routine service, and maintain

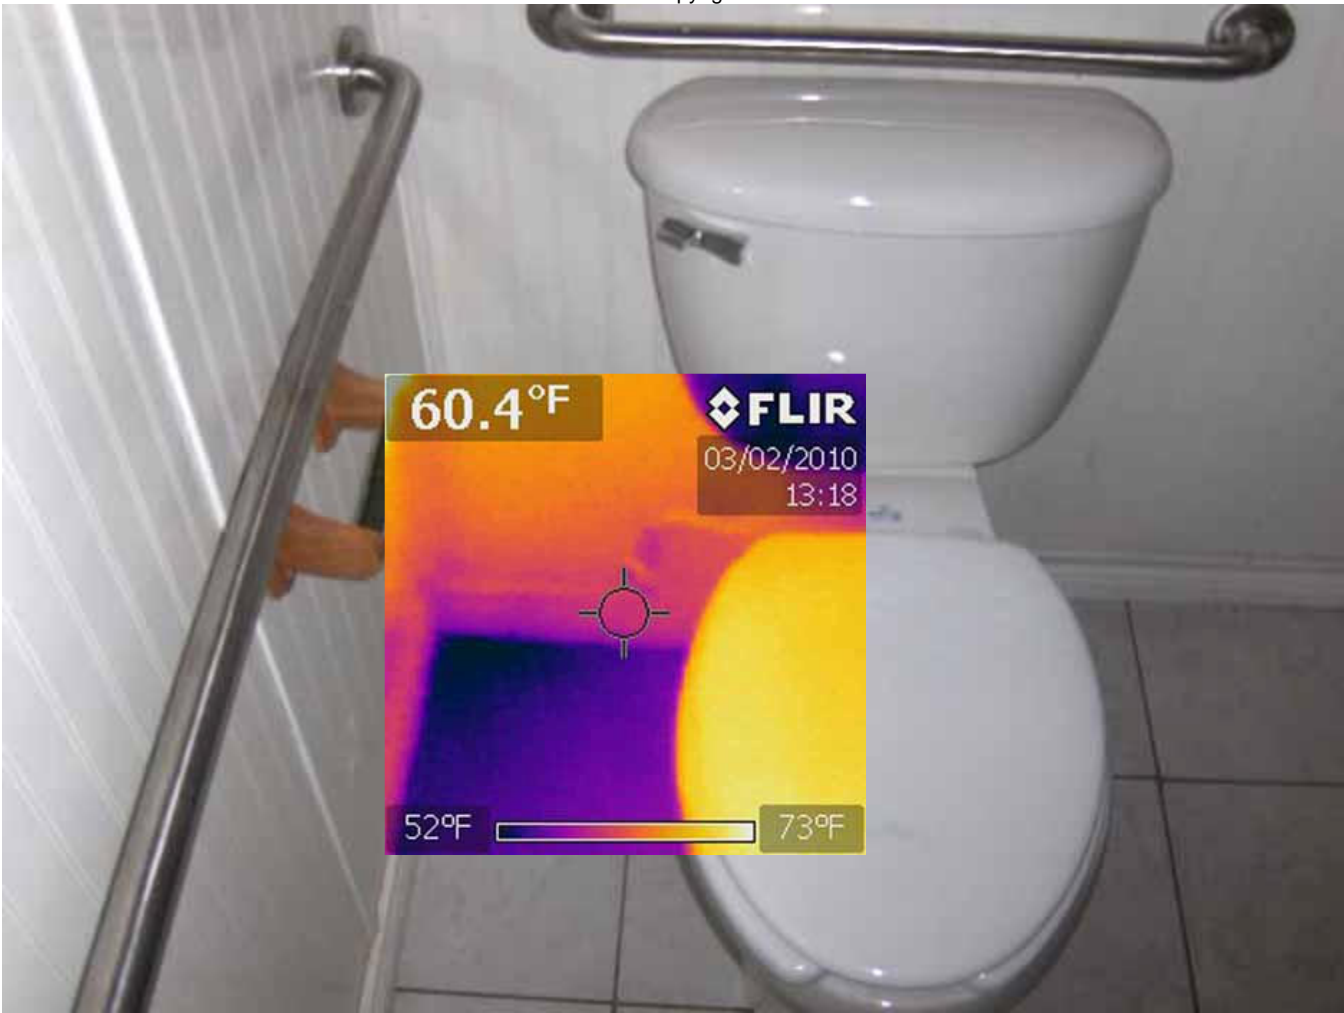
↑ suspected air infiltration from below & at baseboards, common for older property; or possible leakage below the toilet; could be improved with other upgrades, such as foam or similar sealants/insulation & or toilet repair

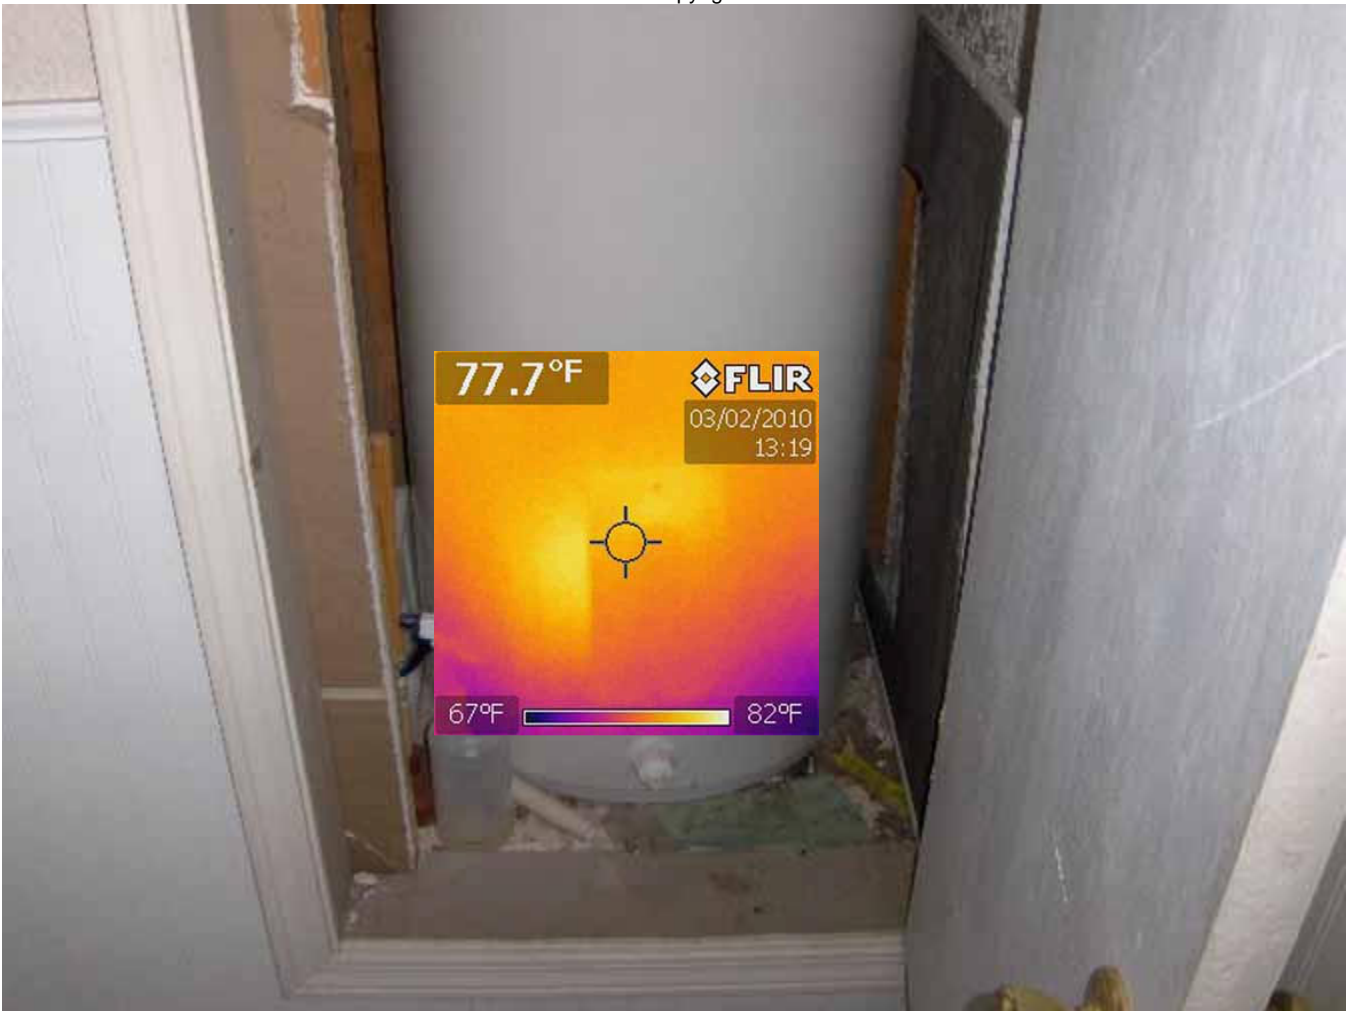
↑ heating of water heater element did not appear excessive; Monitor; provide routine service, and maintain.

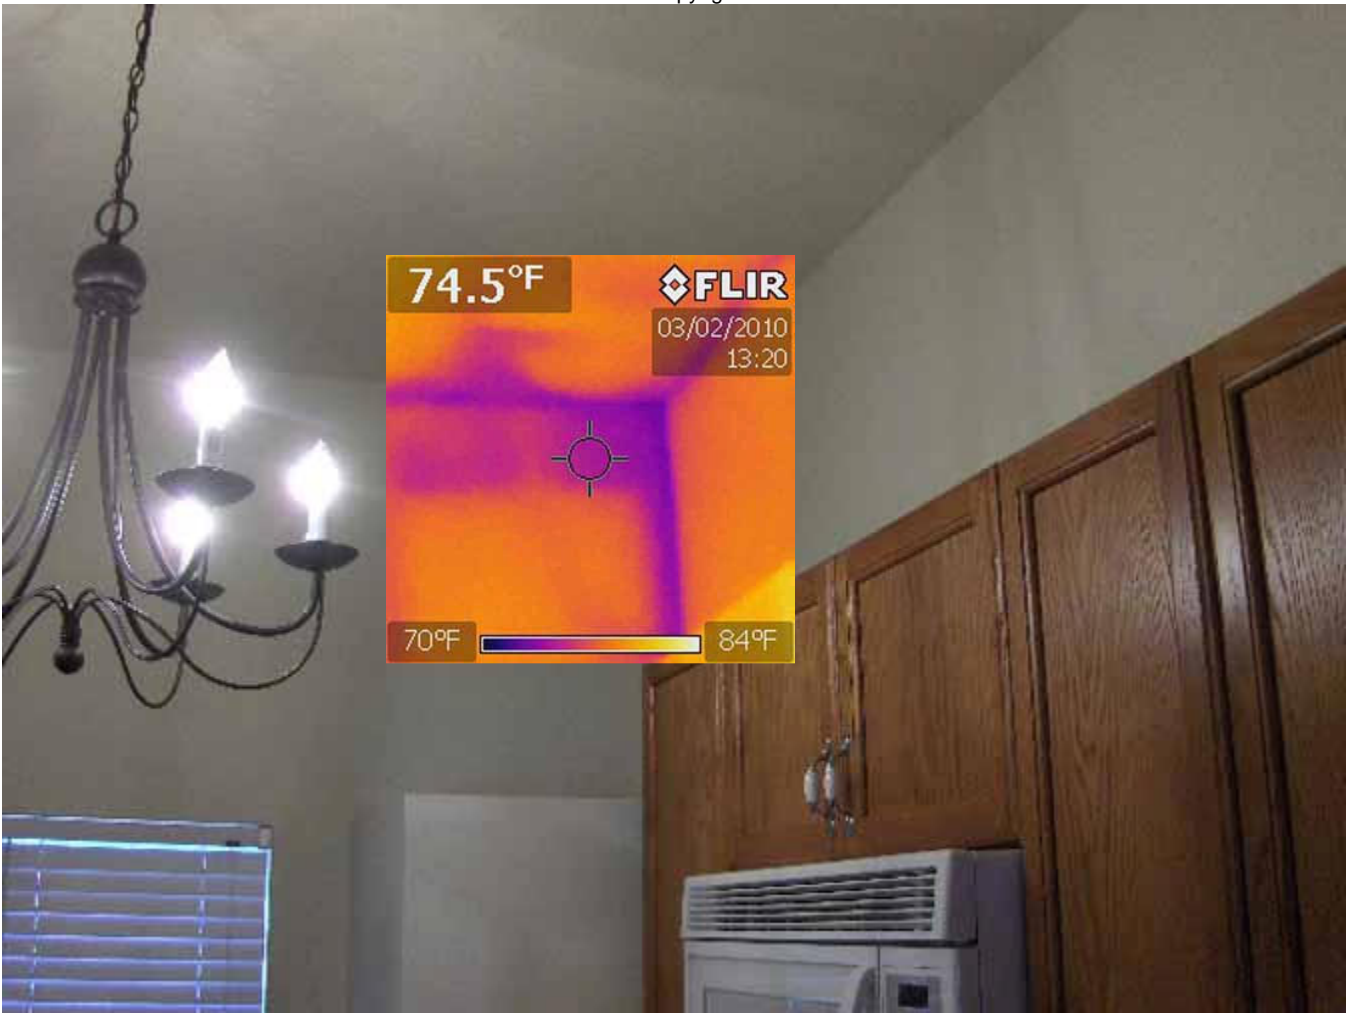
↑ suspected inadequate insulation & or air infiltration at kitchen upper wall & ceiling corner

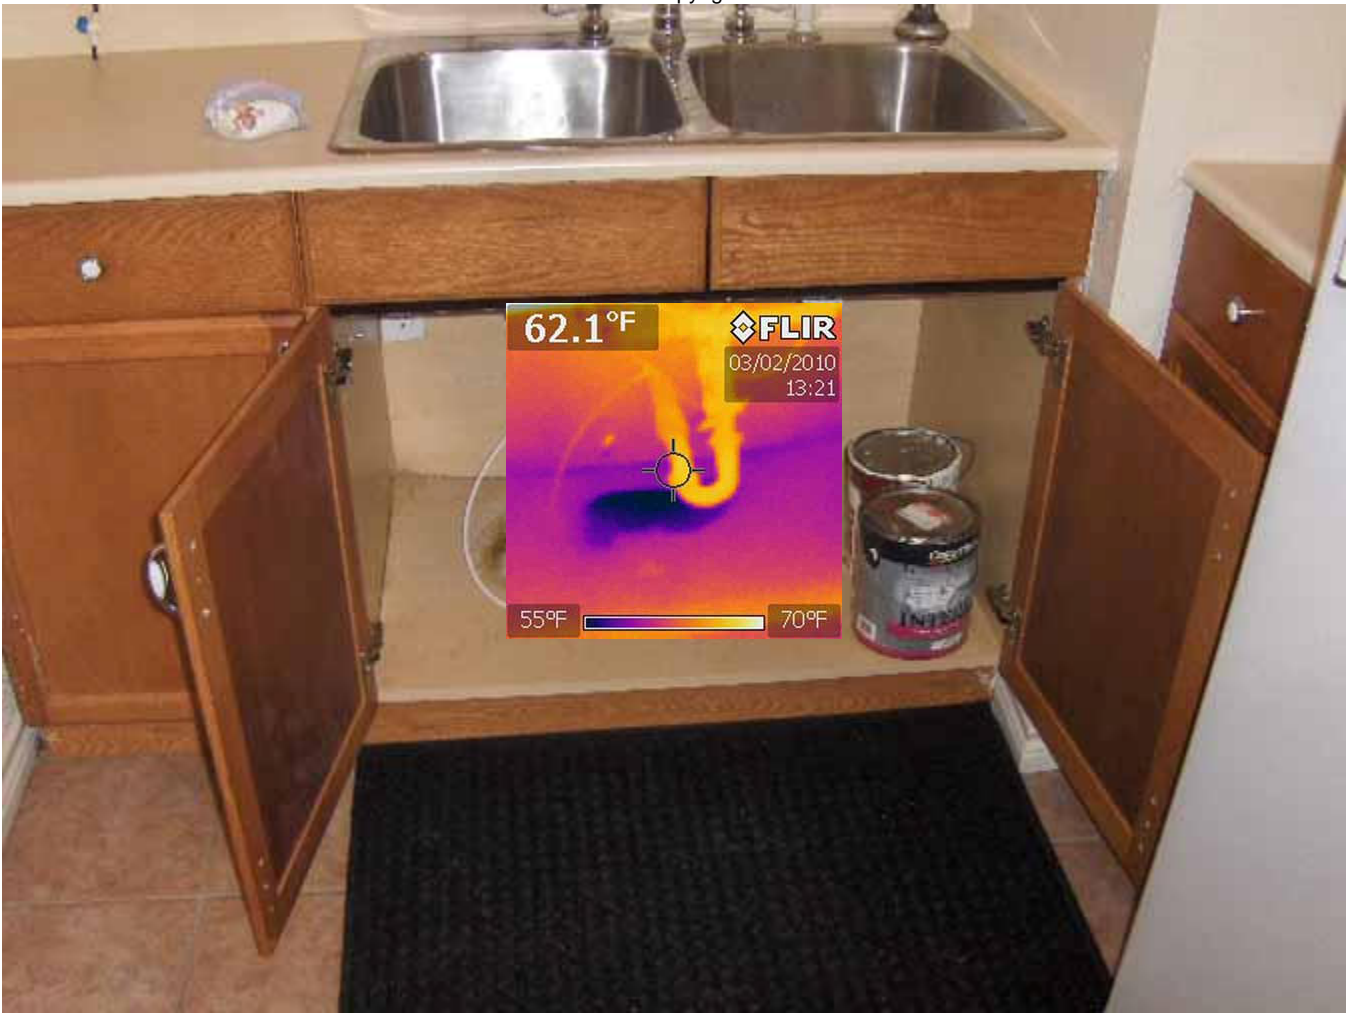
↑ active moisture was present a the kitchen sink area; may have been leakage or from the plumber; moisture damage at the cabinet base would imply leakage history.

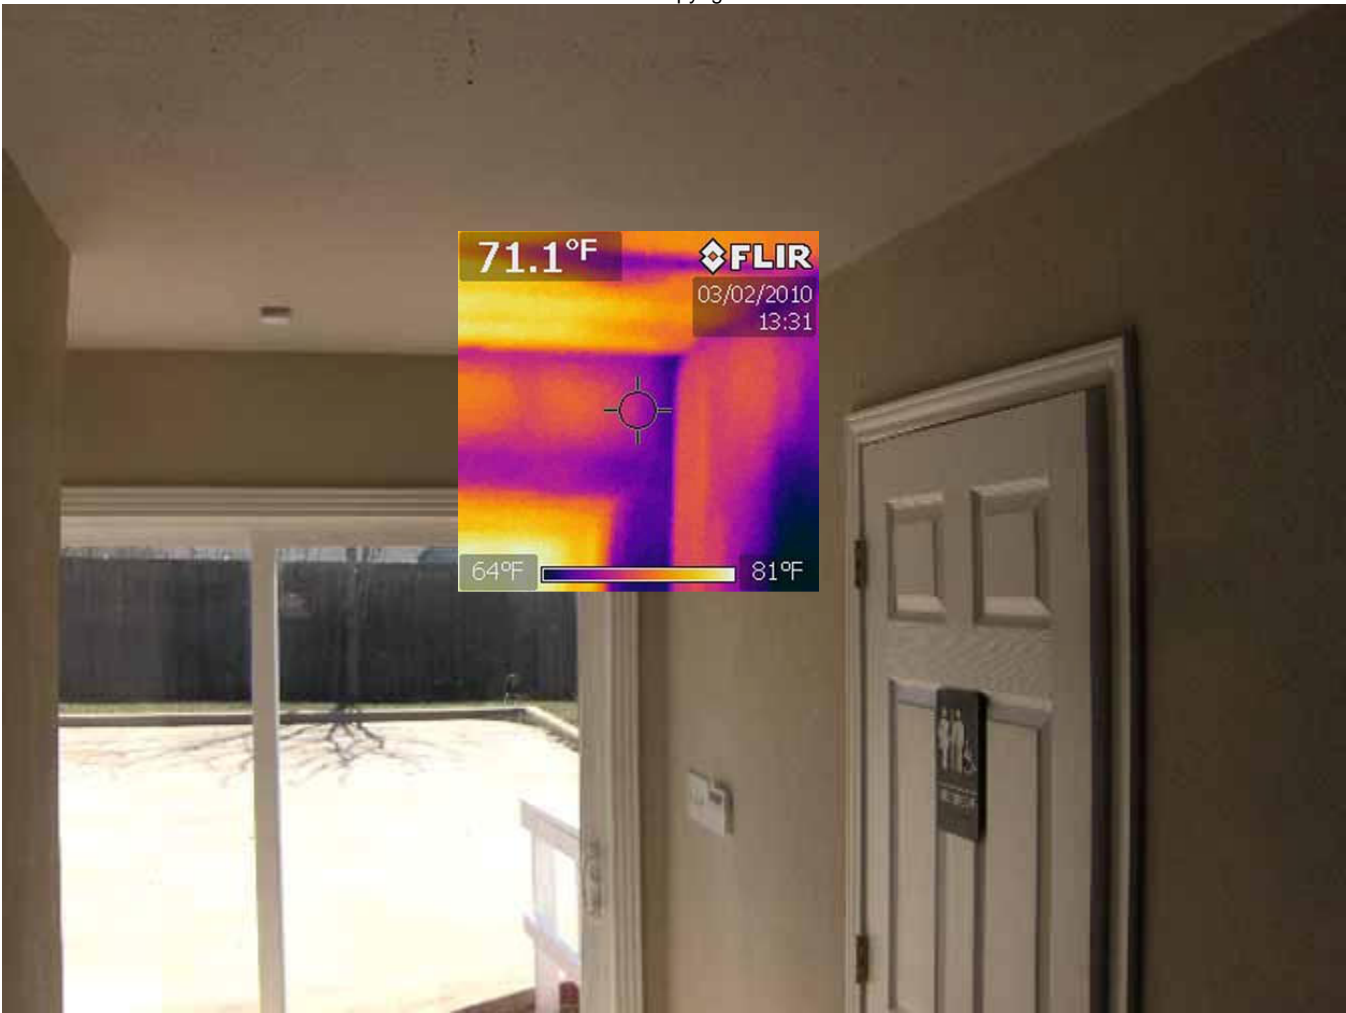
↑ suspected inadequate insulation & or air infiltration above the handicapped entry.

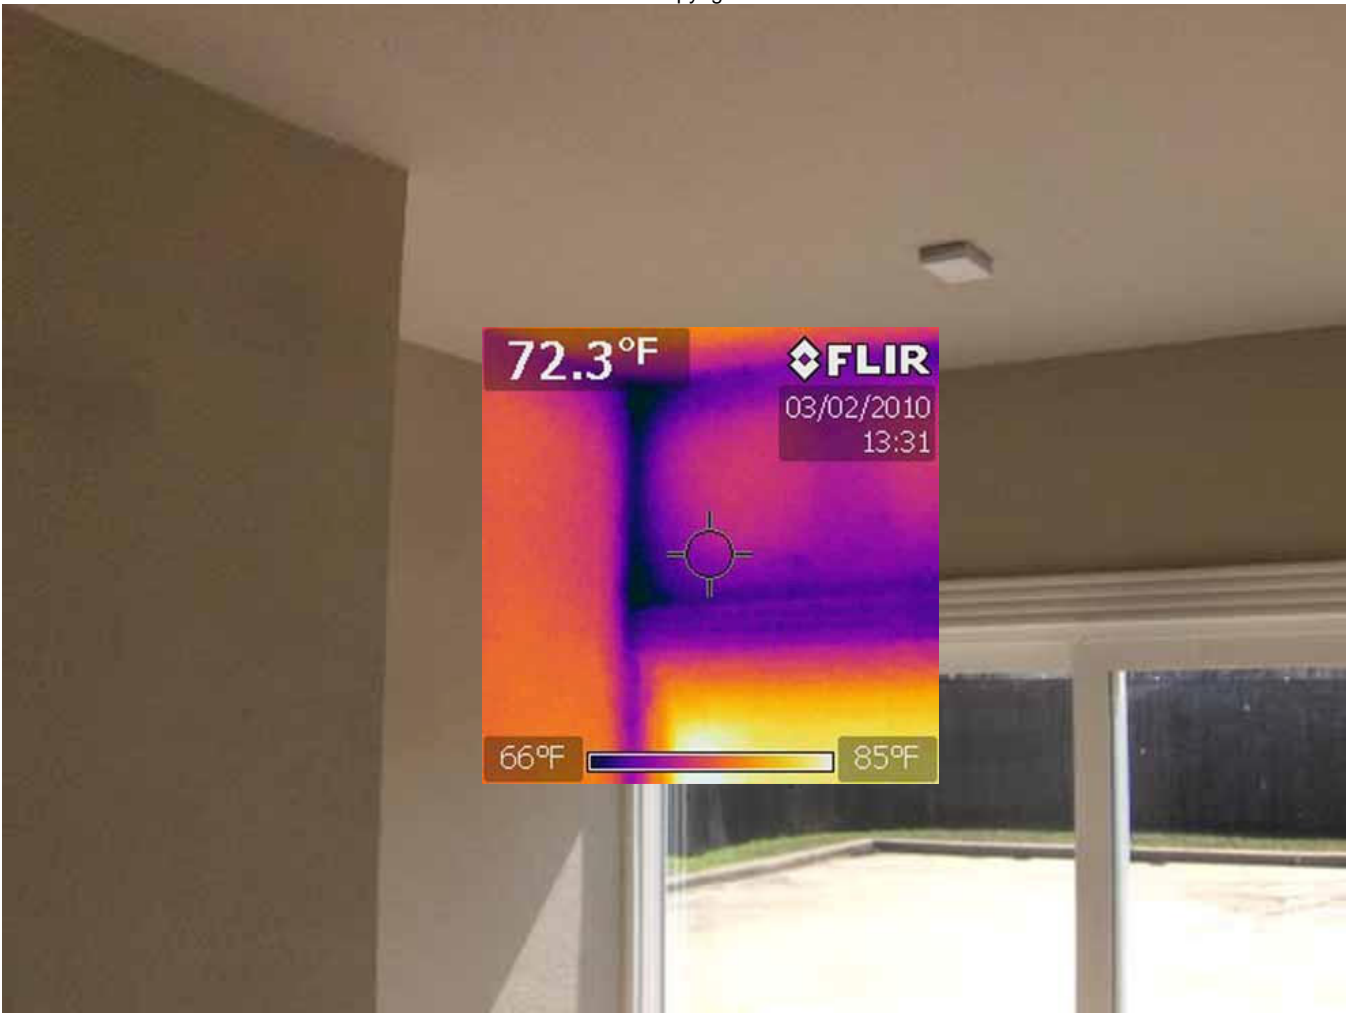
↑ suspected air infiltration above handicapped entry;

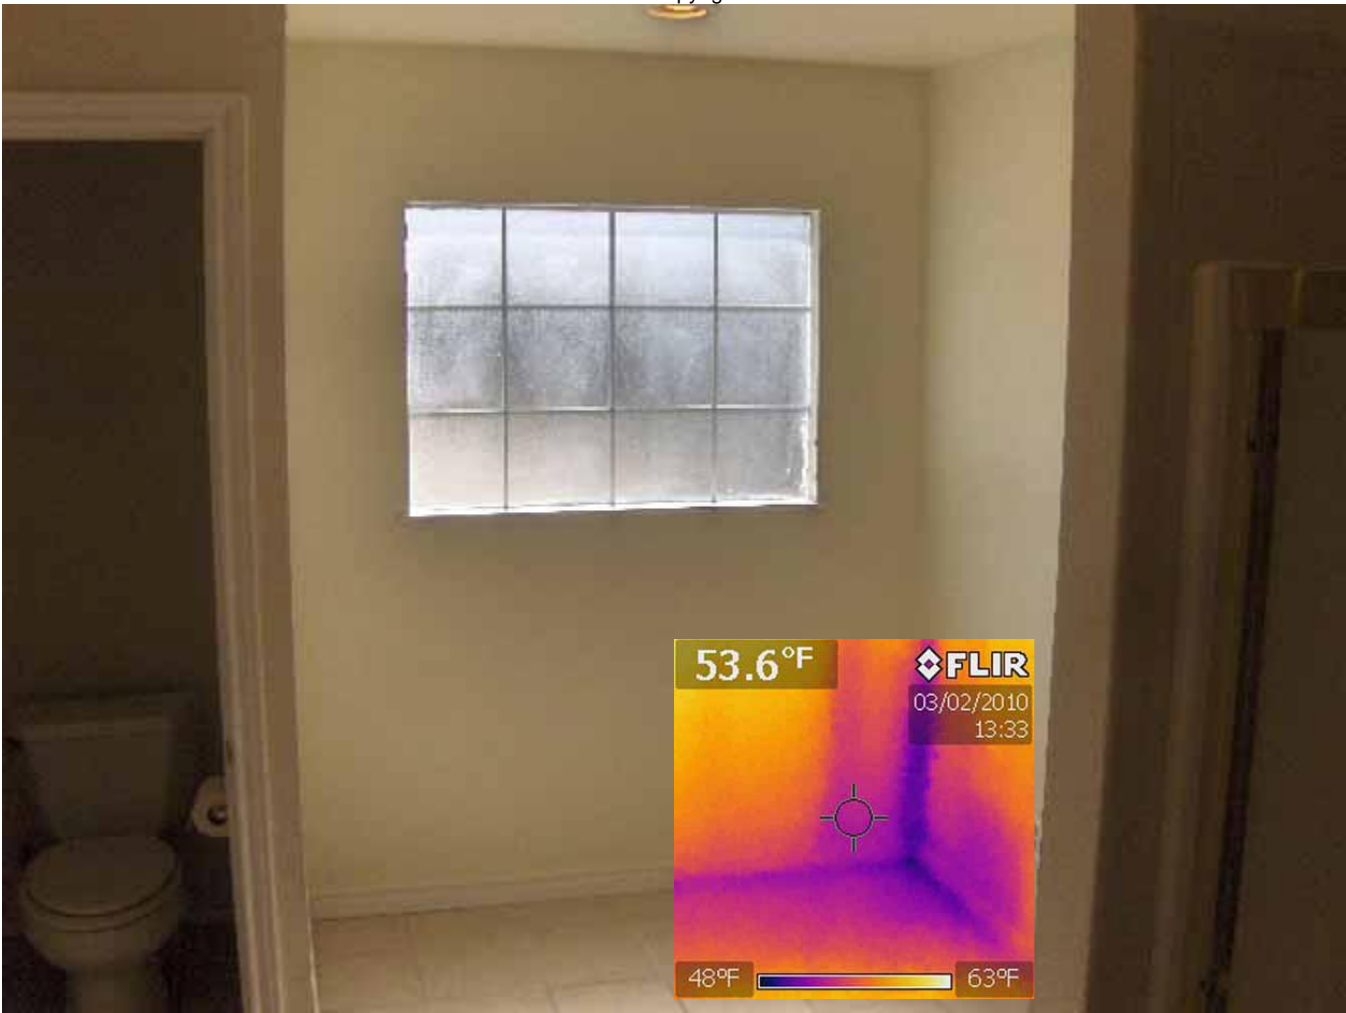
↑ suspected slight air infiltration likely from poor seal/insulation; common with older property, but could be improved with other energy upgrades. 7043 bathroom.

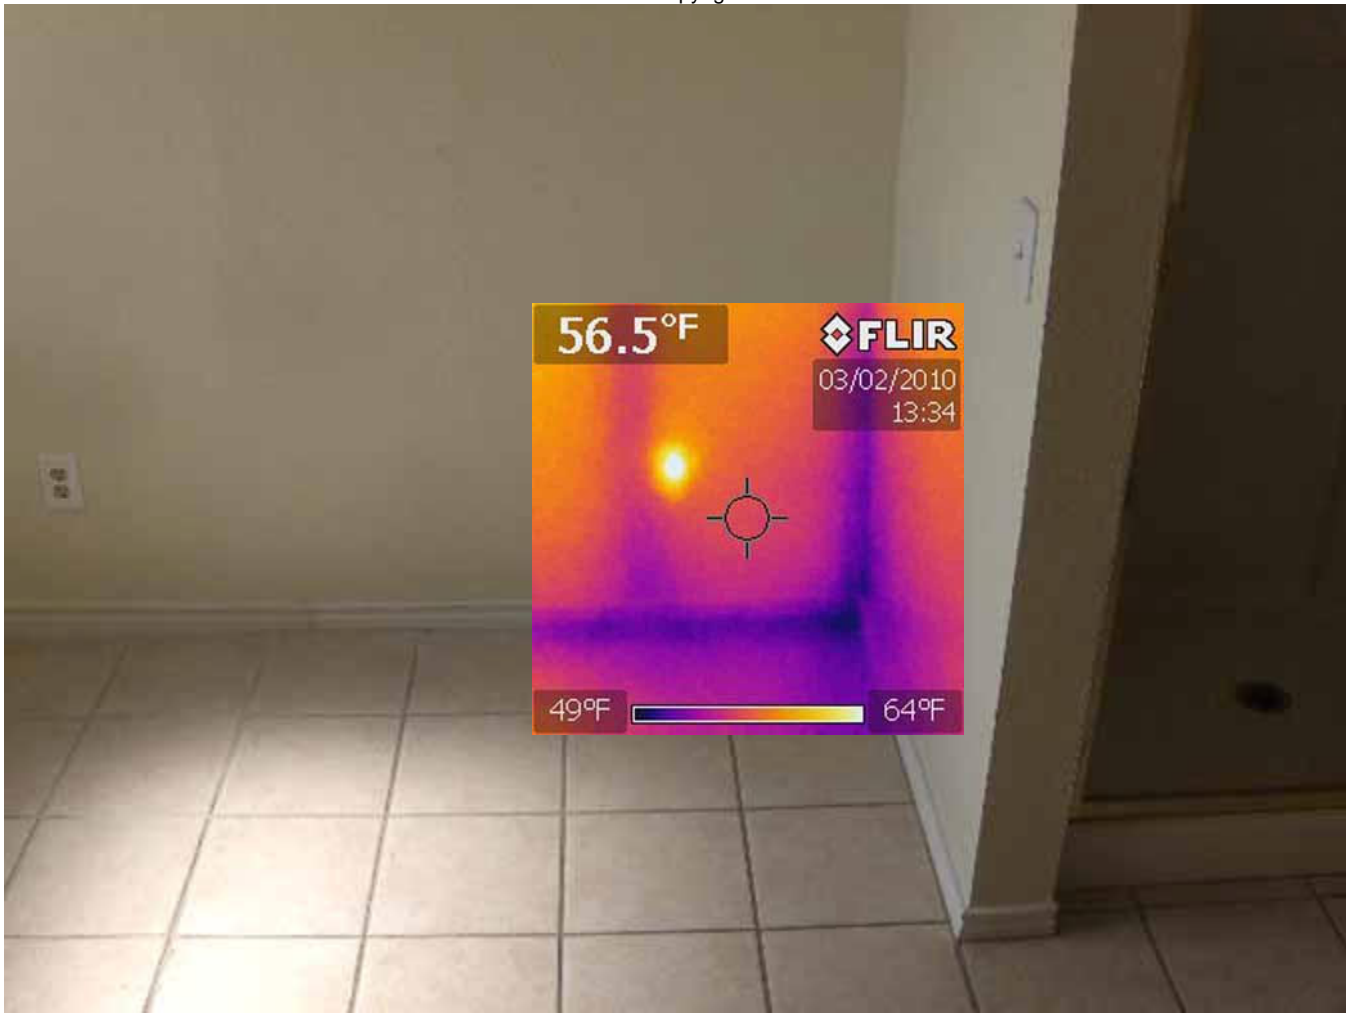
↑ bright spot is the ground-fault circuit interrupt (GFCI) receptacle in the 7043 bathroom; noted as deficient in the electrician report; heat did not appear excessive; dark areas imply air infiltration
