## Select Inspect Property Consultants

This is an individual service provided independently of a property inspection regarding:  
7043 & 7075 Christmas Street, Frisco, TX 75034

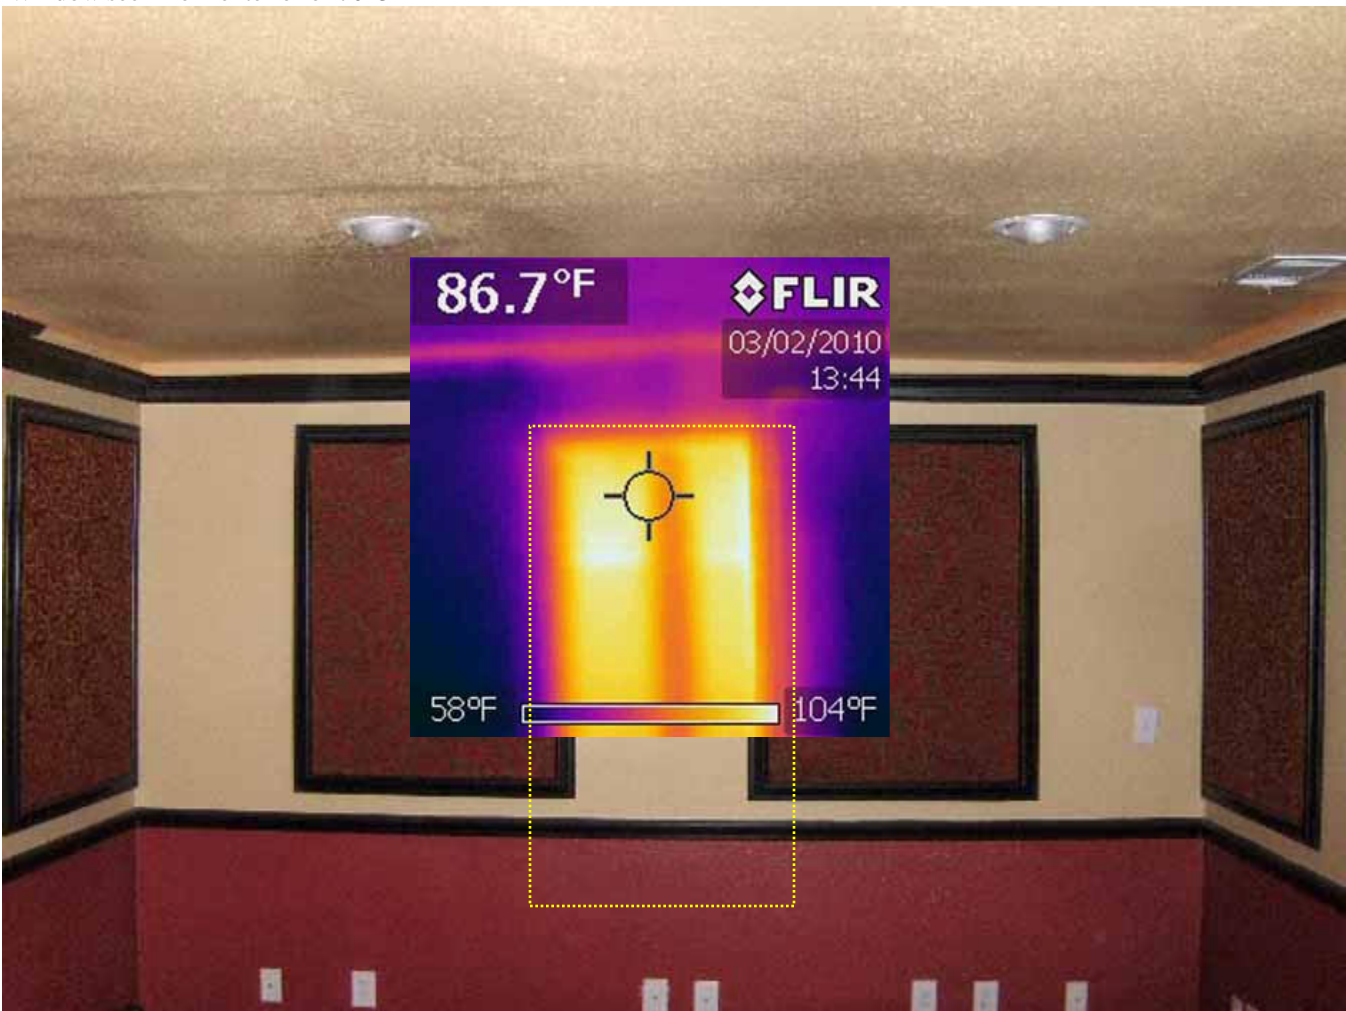
↑ inside adjacent the image above; abandoned window; energy loss

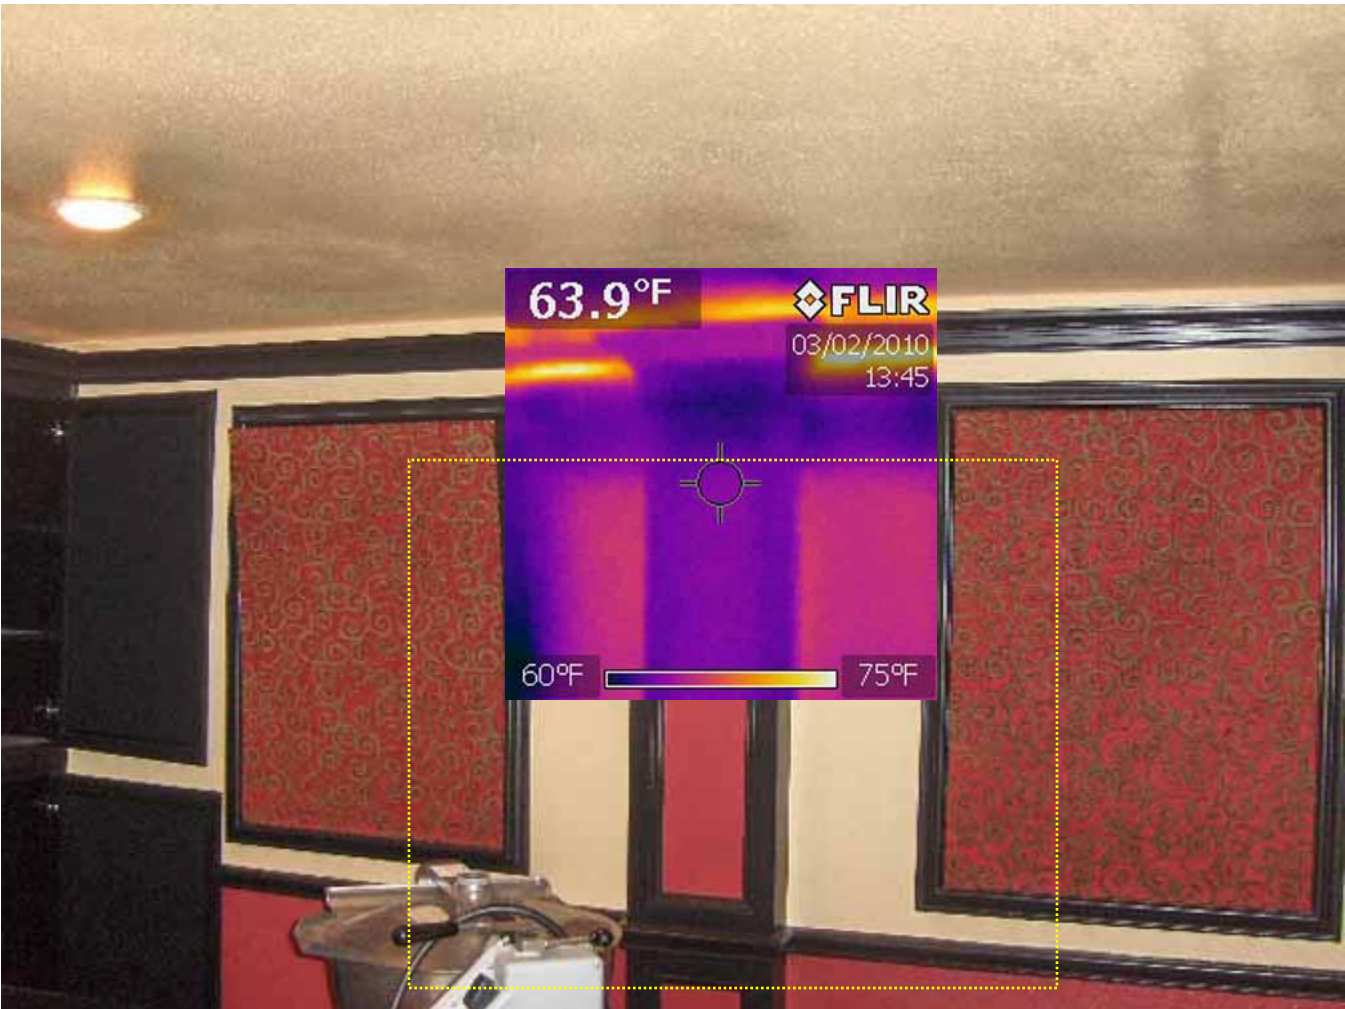
↑ inside adjacent the image above; abandoned window; energy loss

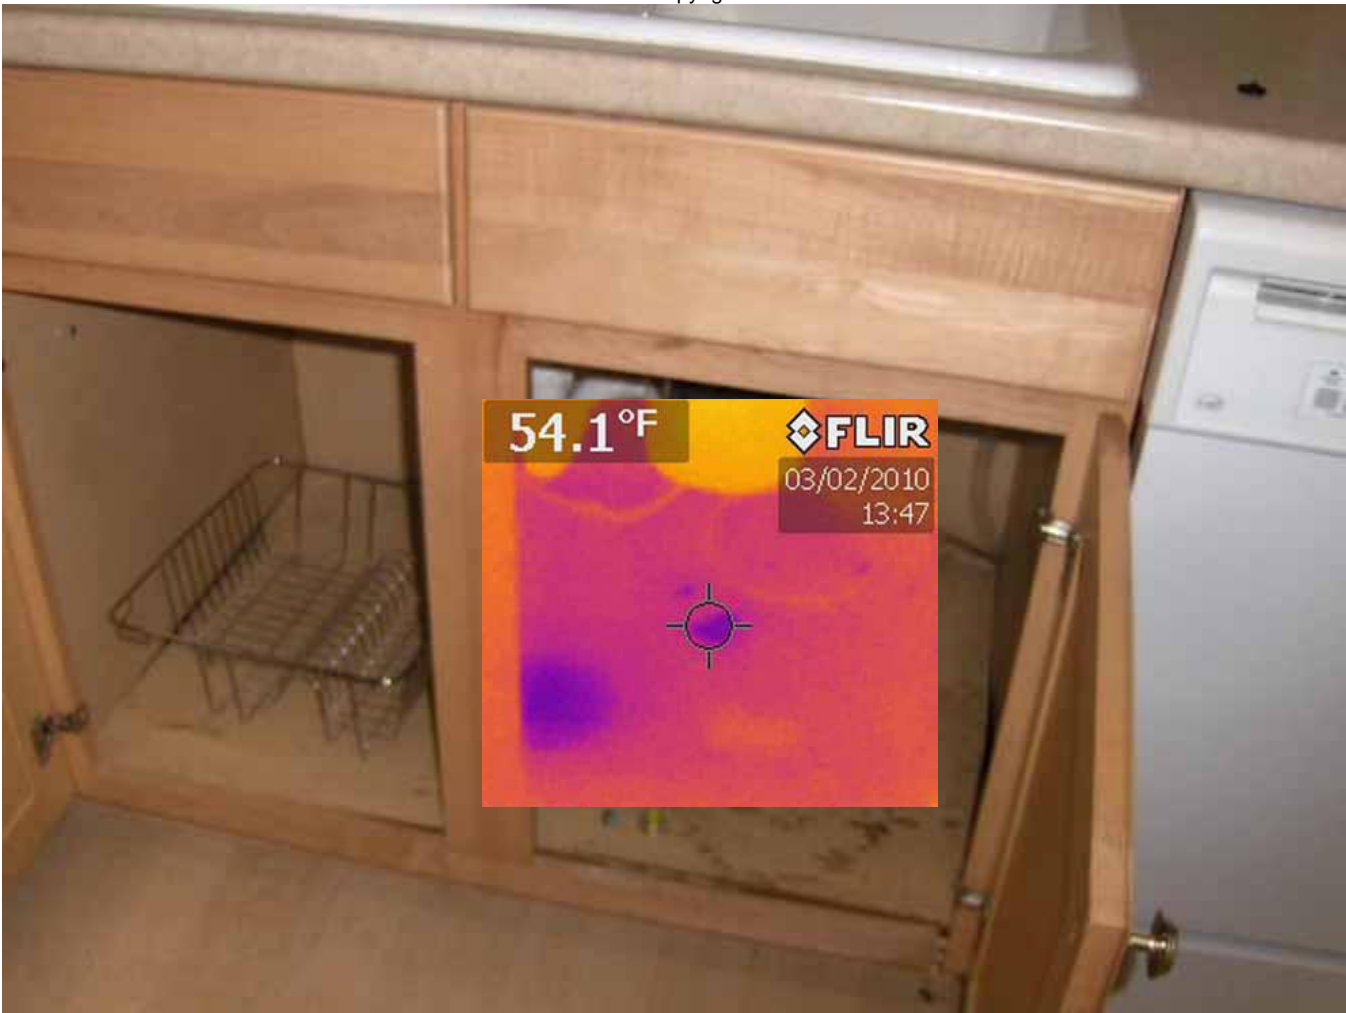
↑ moisture staining evidence & leakage history below the kitchen sink at 7043

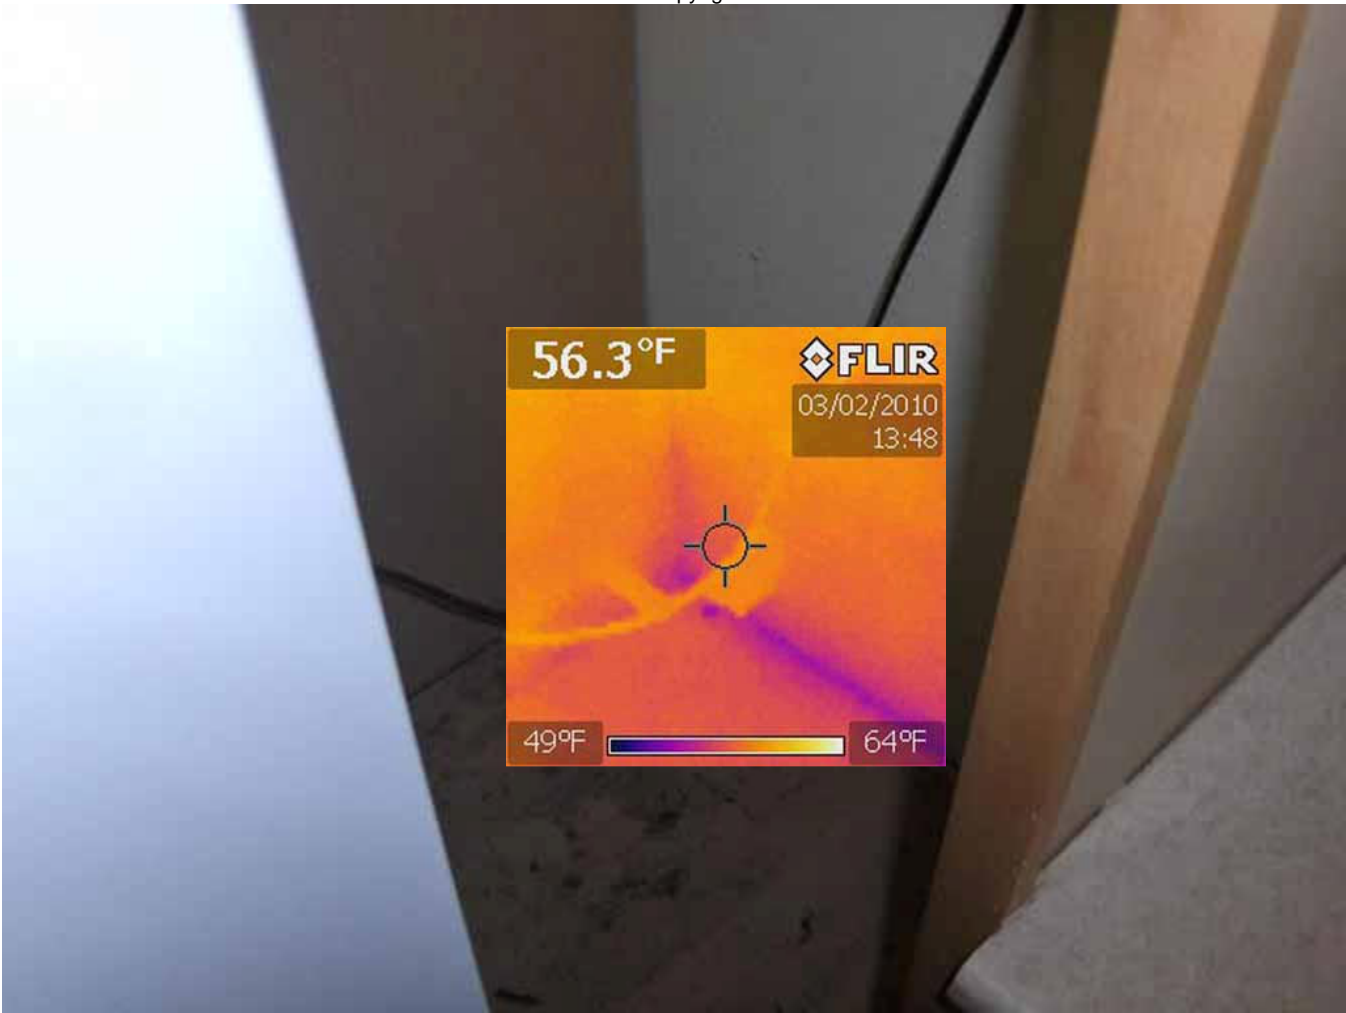
↑ fungus behind the refrigerator did not show to be “cooler”, & such was determined to be dormant & not actively moist. Some slight air infiltration was suspected at the baseboards

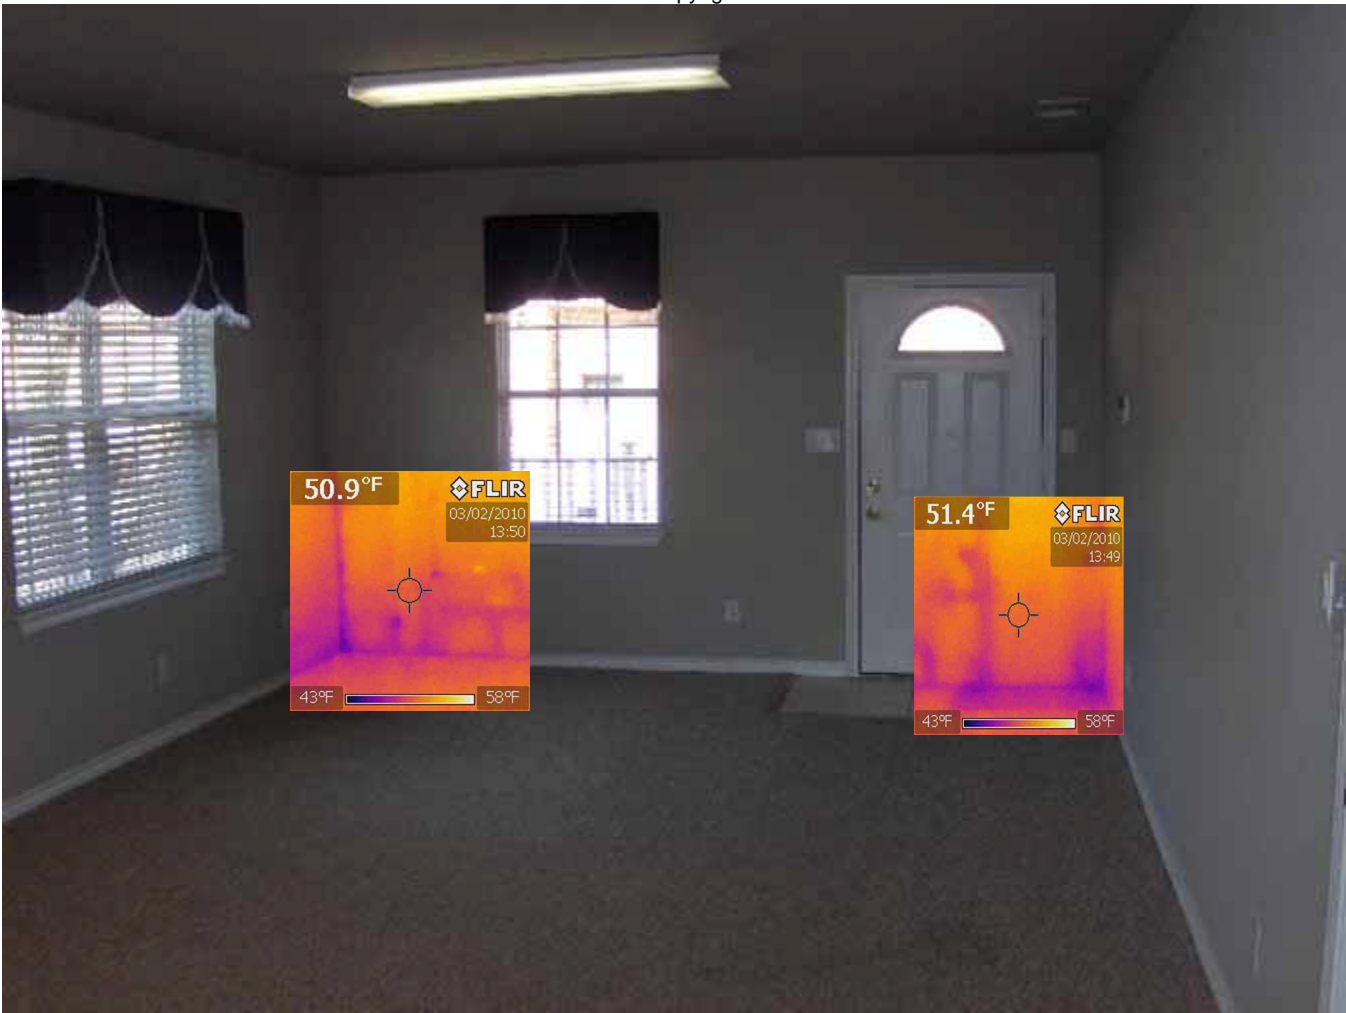
↑ slight air infiltration suspected at the front of 7043; Significant issues were not discovered; monitor & maintain. Door appeared workmanlike/in good order & insulated type

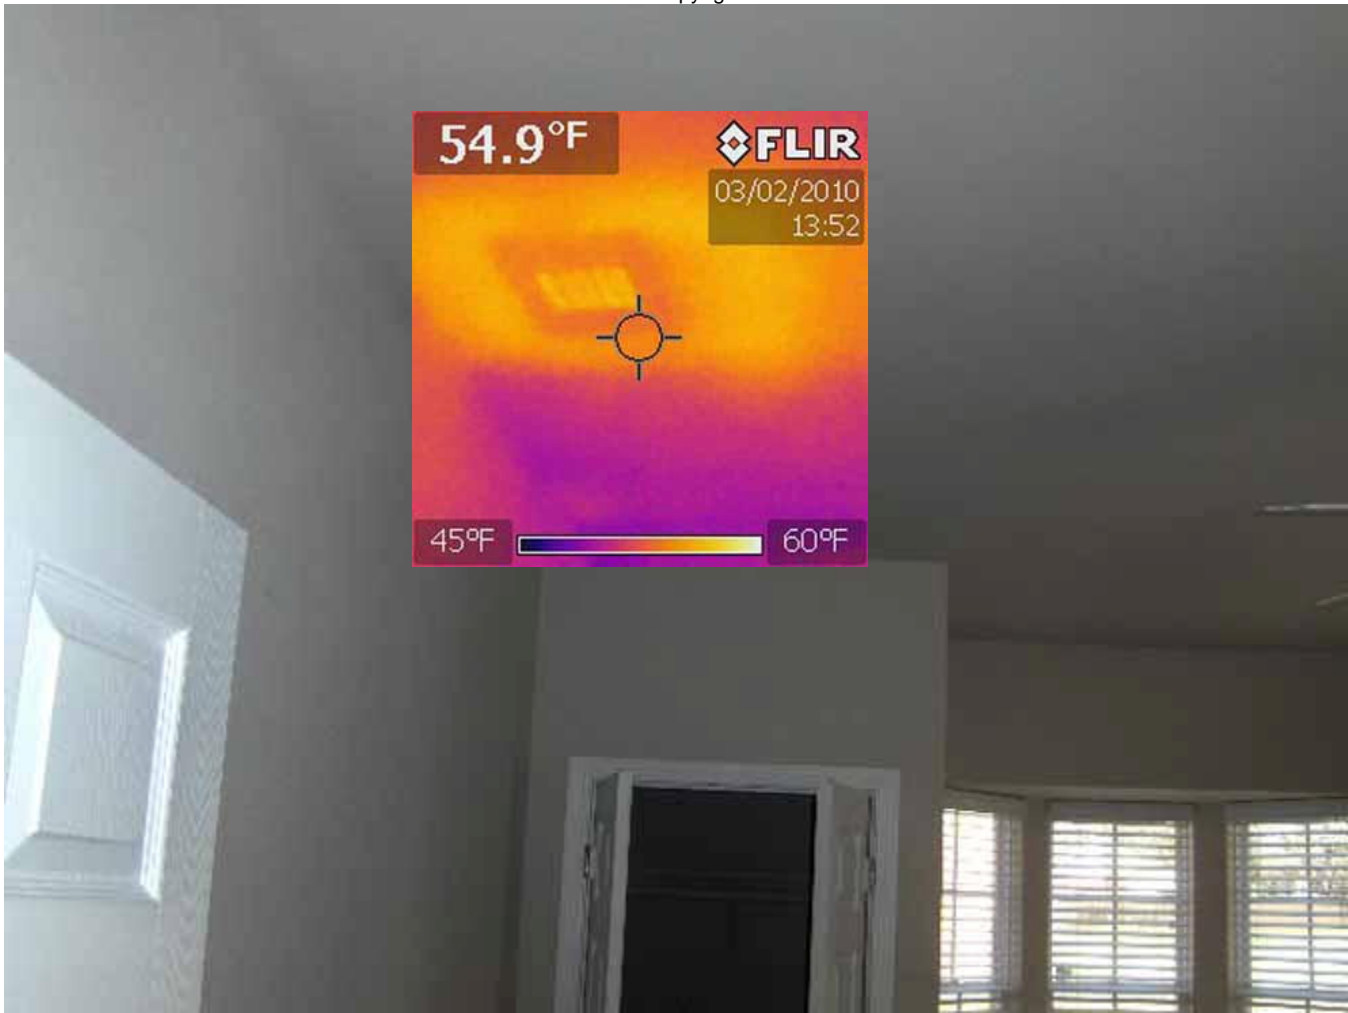
↑ slight air leakage/infiltration noted around air registers; example; also example of inadequate insulation around air registers.

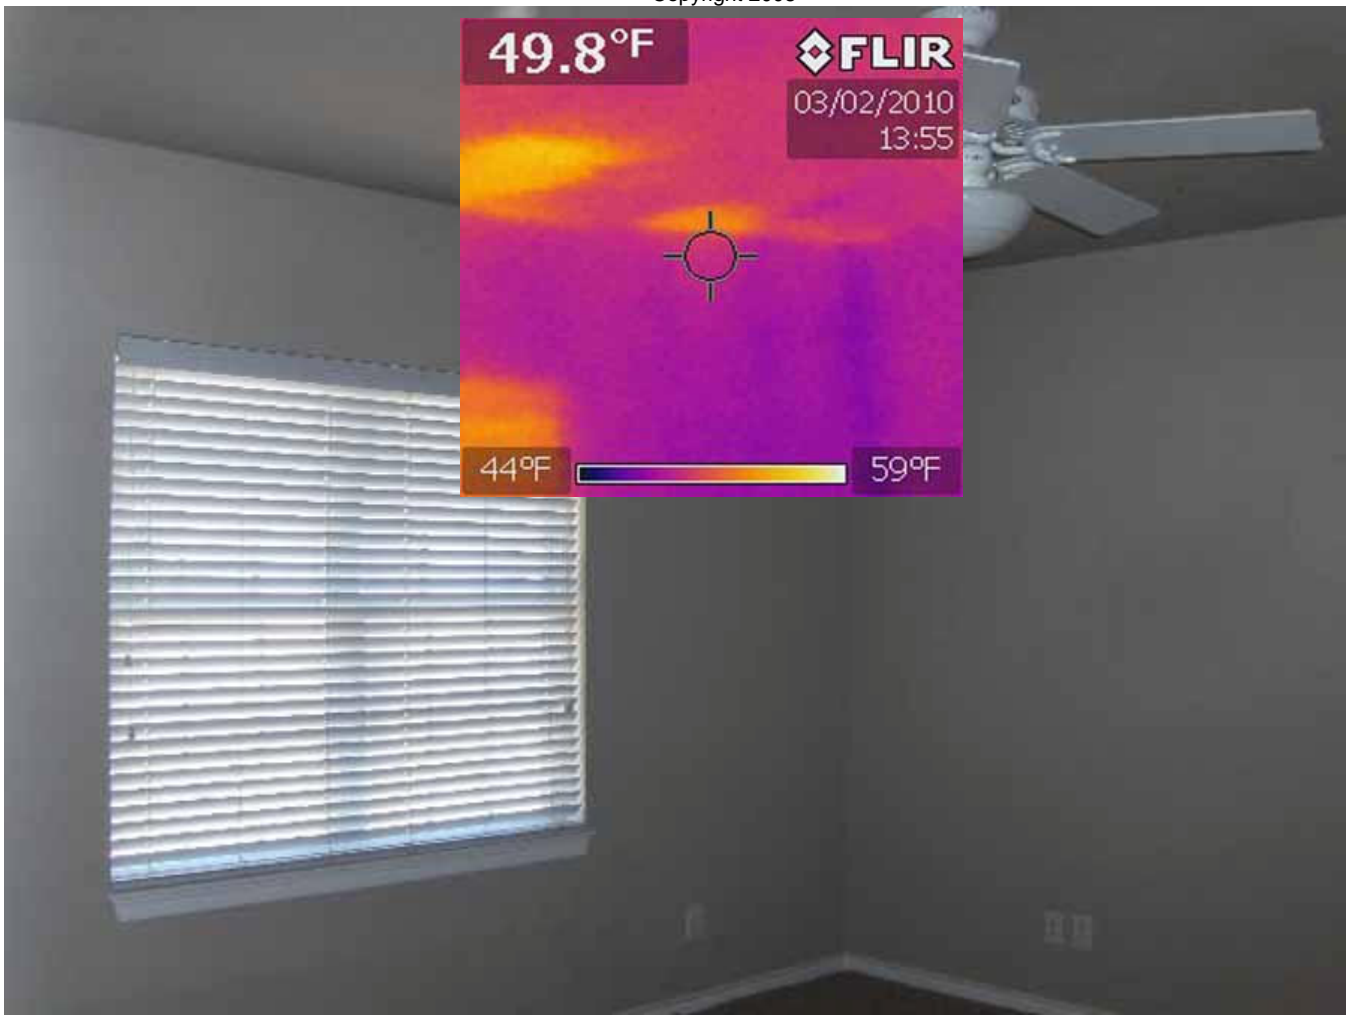
↑ suspected inadequate insulation at ceiling; example

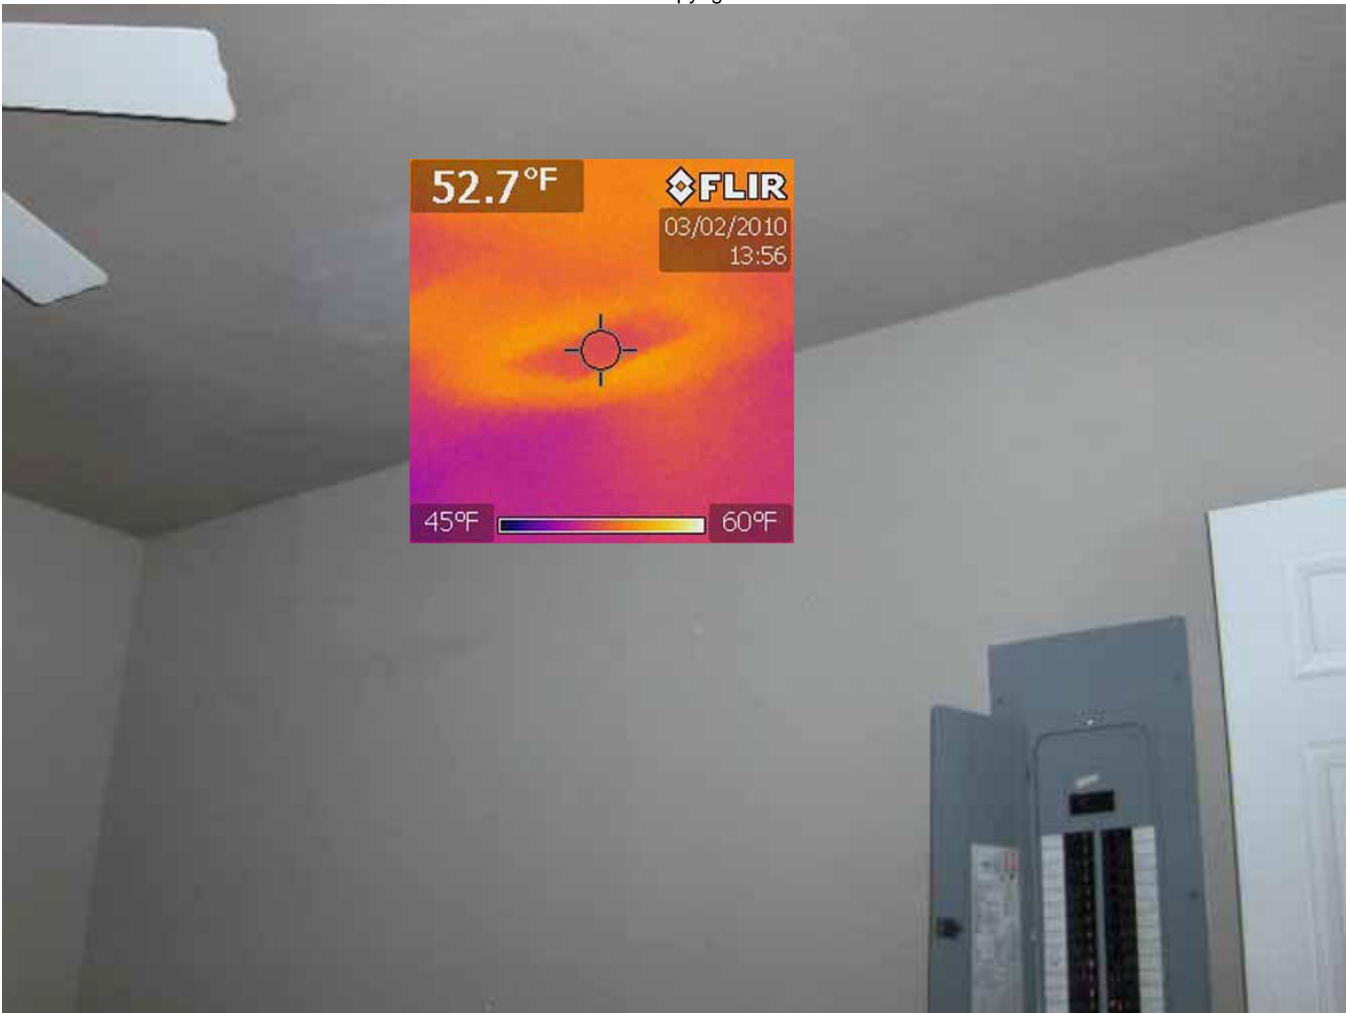
↑ slight air leakage/infiltration noted around air registers; example; also example of inadequate insulation around air registers.

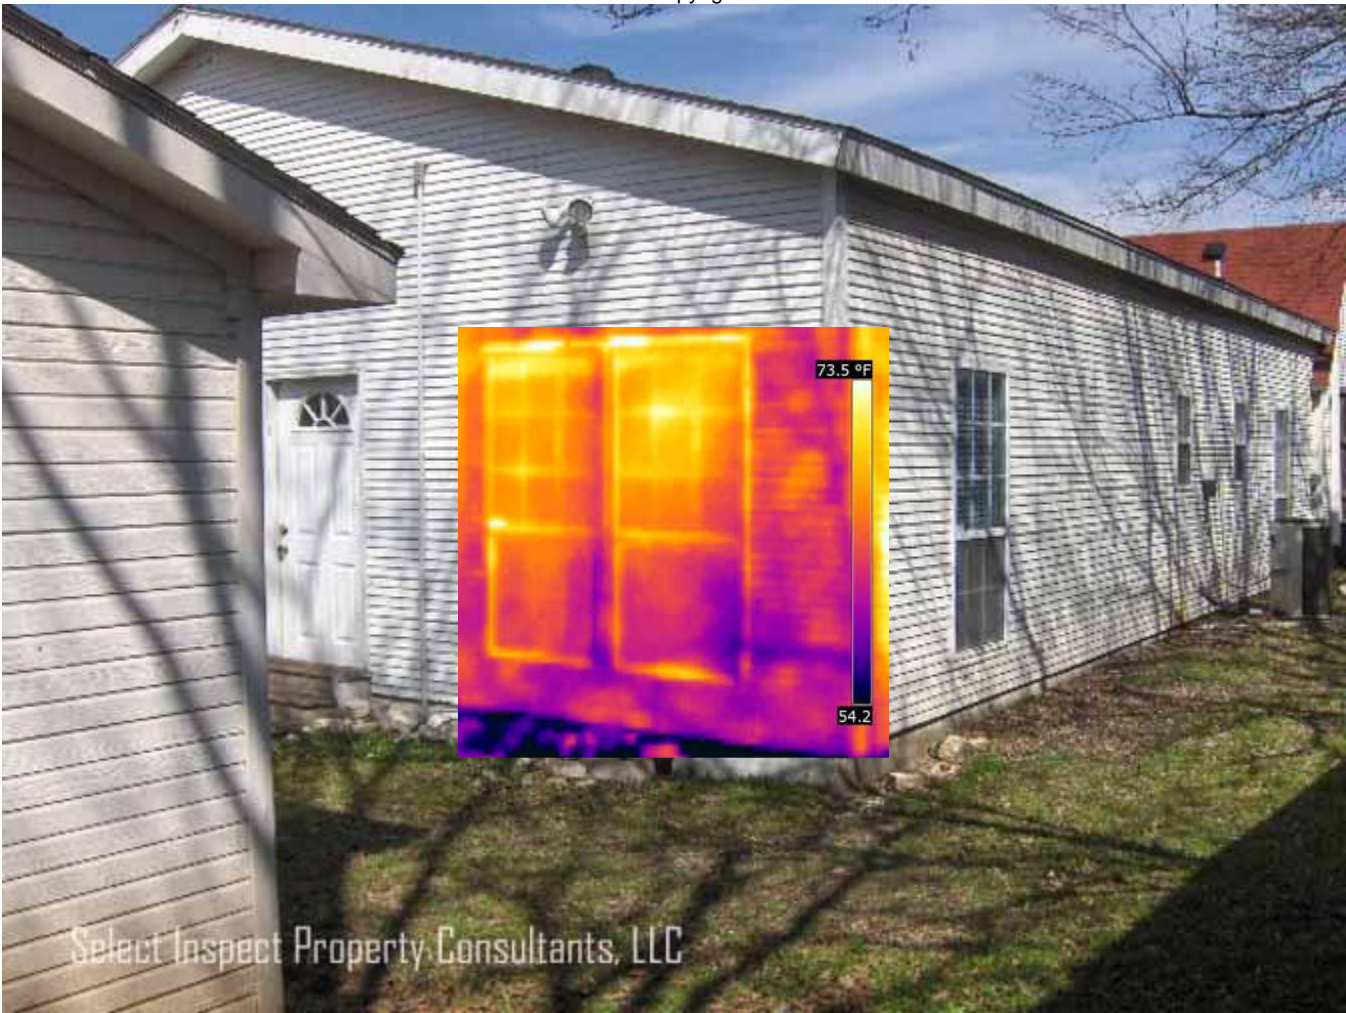
↑ Significant issues were not discovered; monitor & maintain; variances in many areas were obscured by reflection & shadows at the exterior. Due to these obscurities, deficiencies/anomalies may have gone unnoticed.

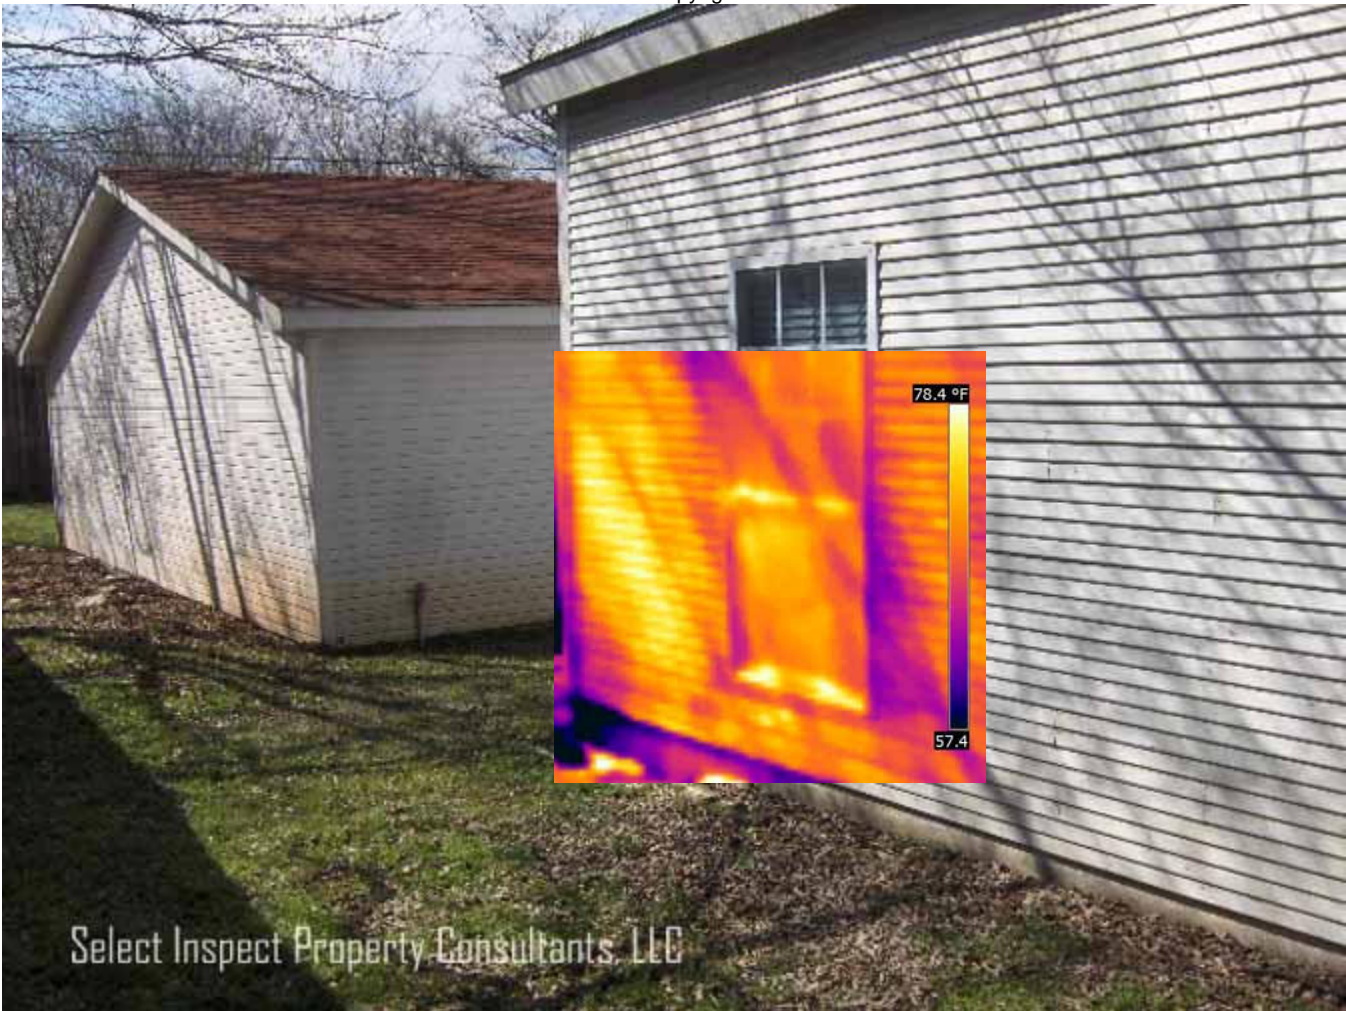
↑ Significant issues were not discovered; monitor & maintain; variances in many areas were obscured by reflection & shadows at the exterior. Due to these obscurities, deficiencies/anomalies may have gone unnoticed

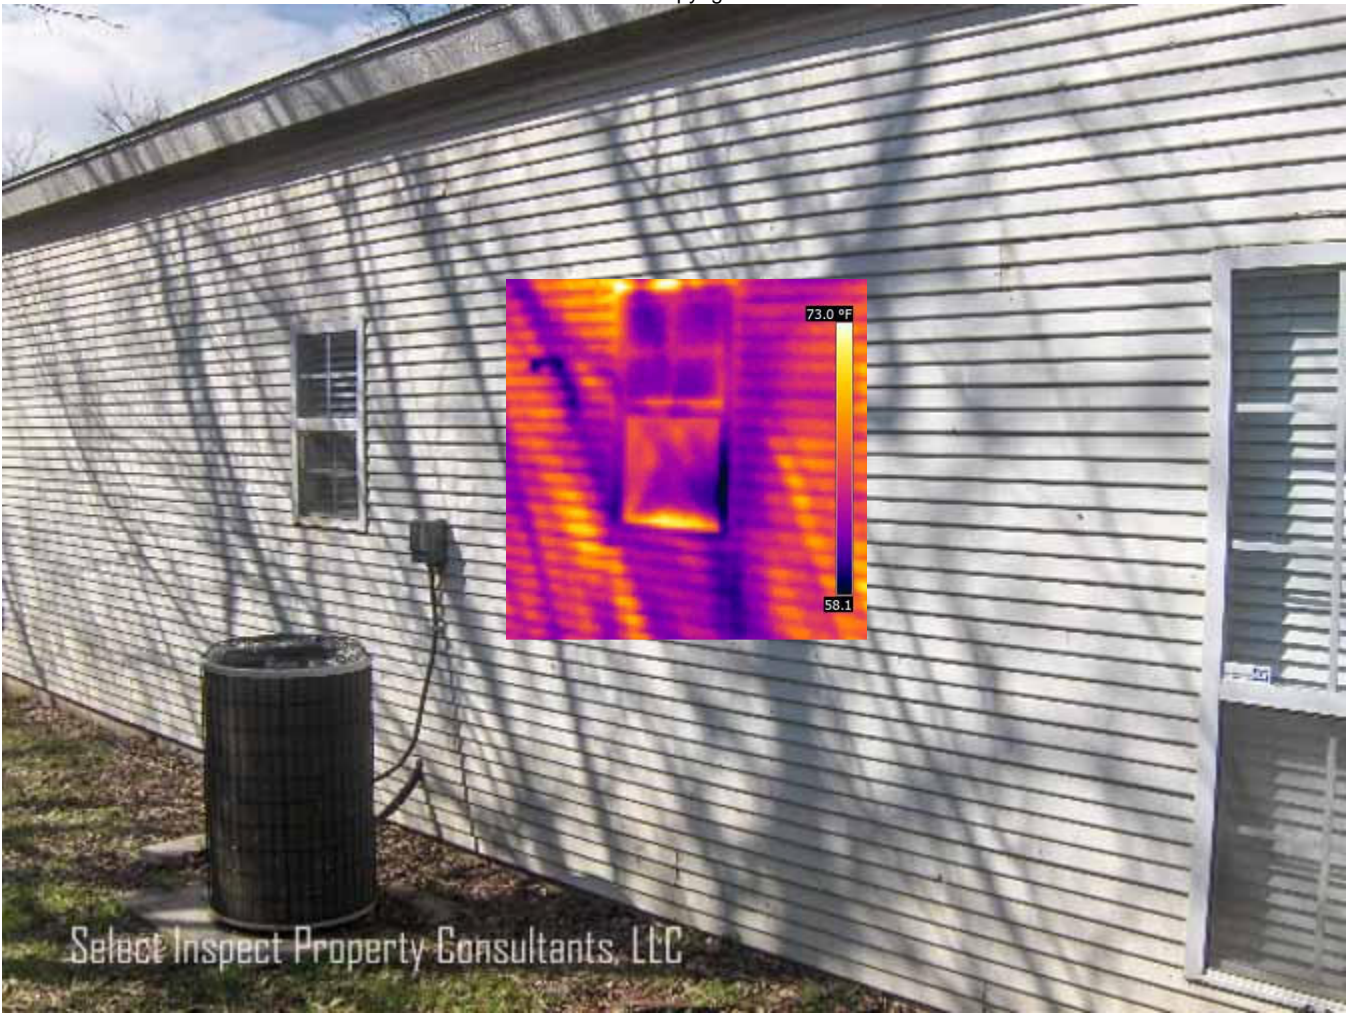
↑ Significant issues were not discovered; monitor & maintain; variances in many areas were obscured by reflection & shadows at the exterior. Due to these obscurities, deficiencies/anomalies may have gone unnoticed

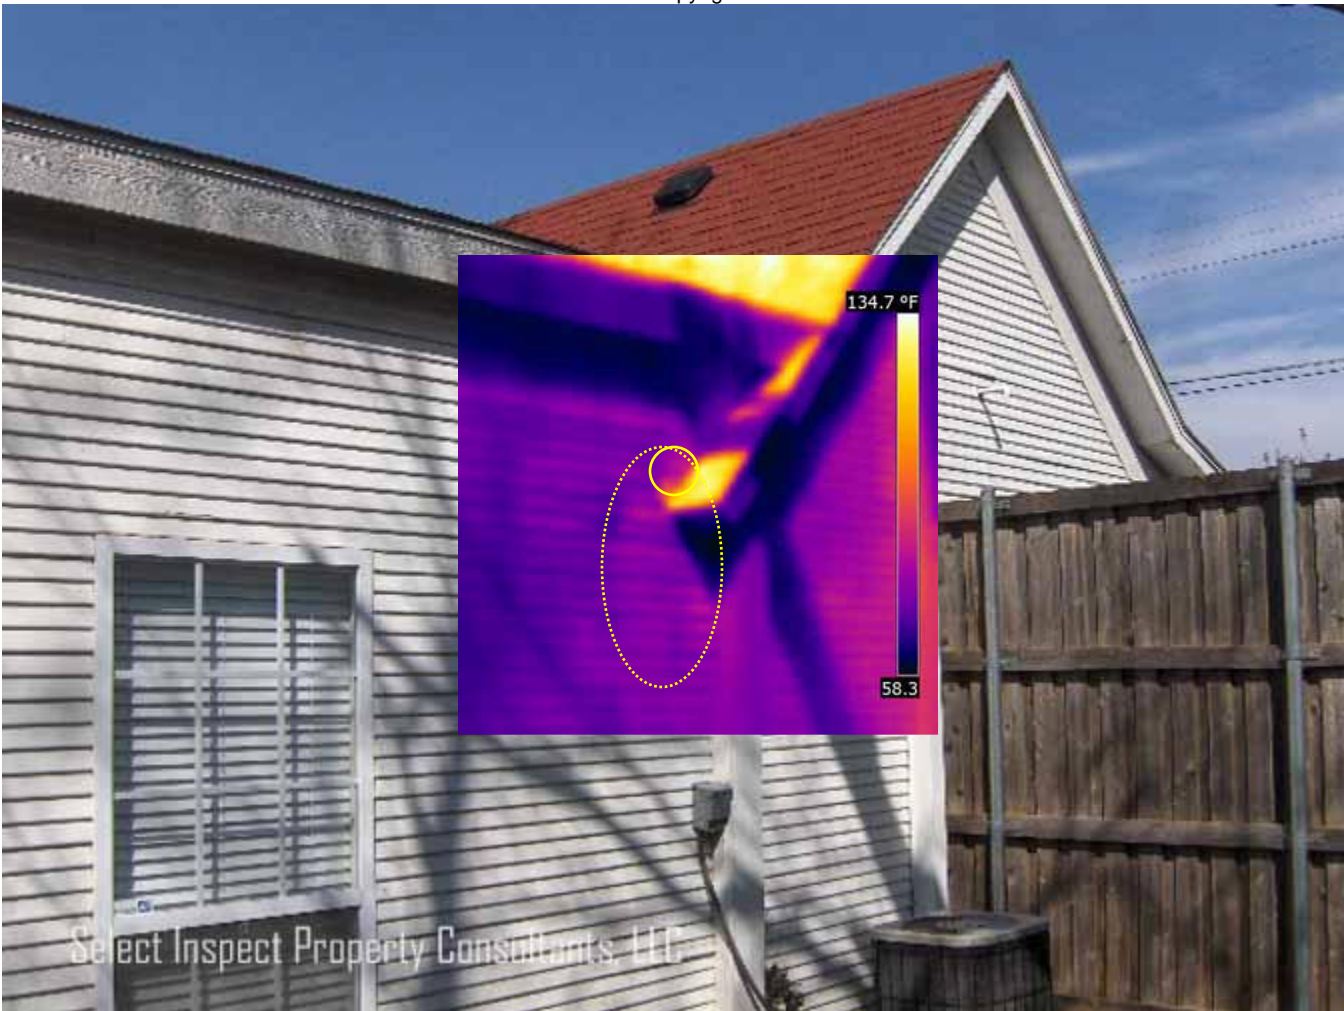
↑ Active wood decay was seen, & the brighter purplish tone below the leakage intrusion point imply suspected additional decay exists; such should be addressed when flashing & wood repairs are made. variances in many areas were obscured by reflection & shadows at the exterior. Due to these obscurities, deficiencies/anomalies may have gone unnoticed

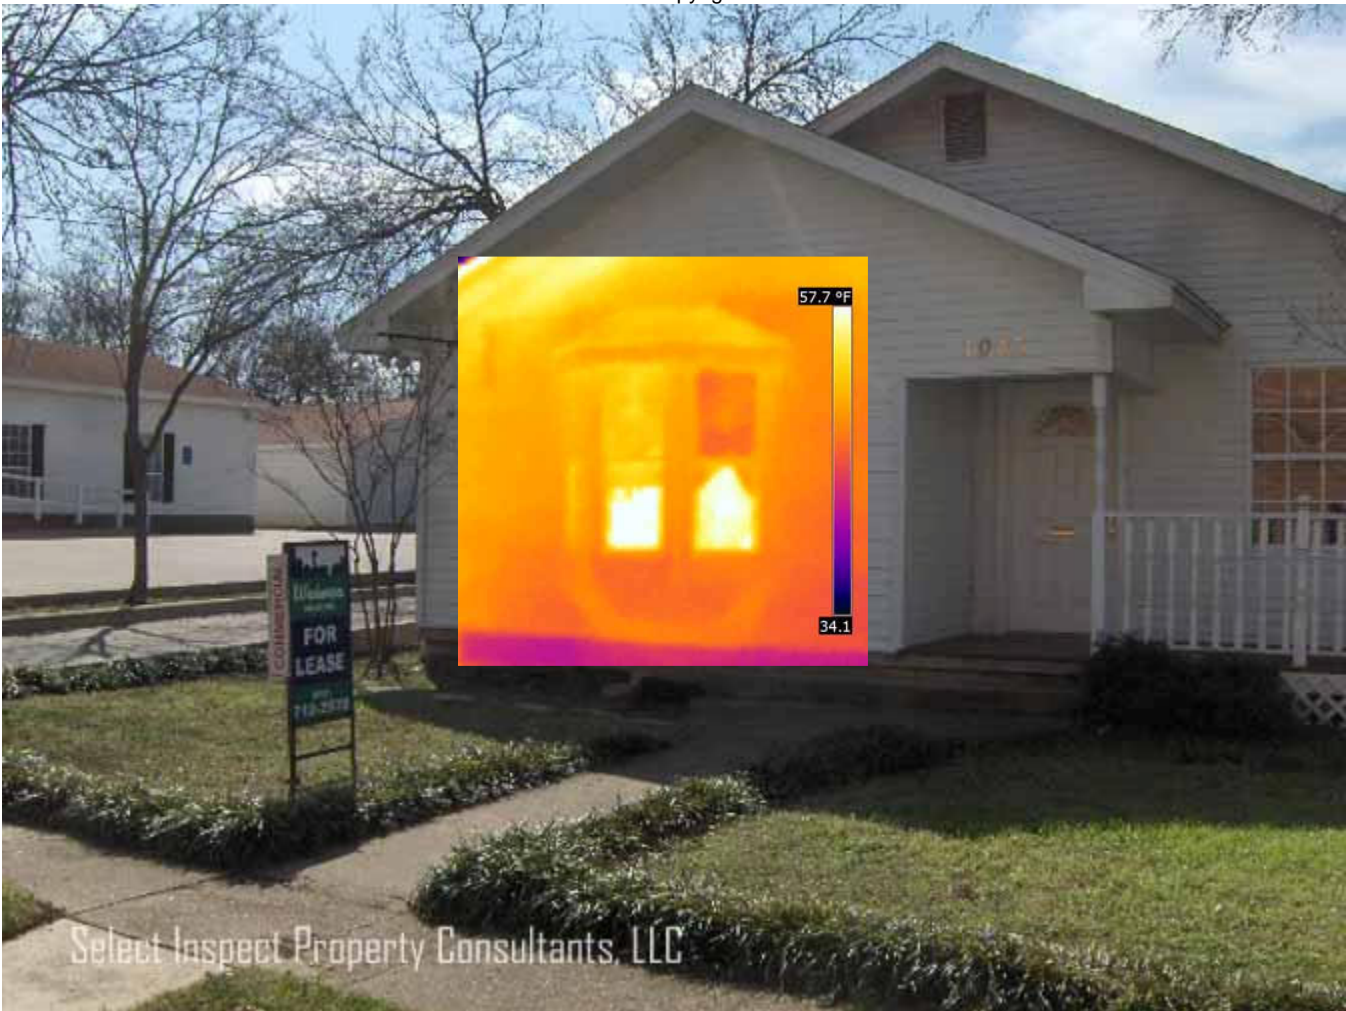
↑ Significant issues were not discovered; monitor & maintain; variances in many areas were obscured by reflection & shadows at the exterior. Due to these obscurities, deficiencies/anomalies may have gone unnoticed

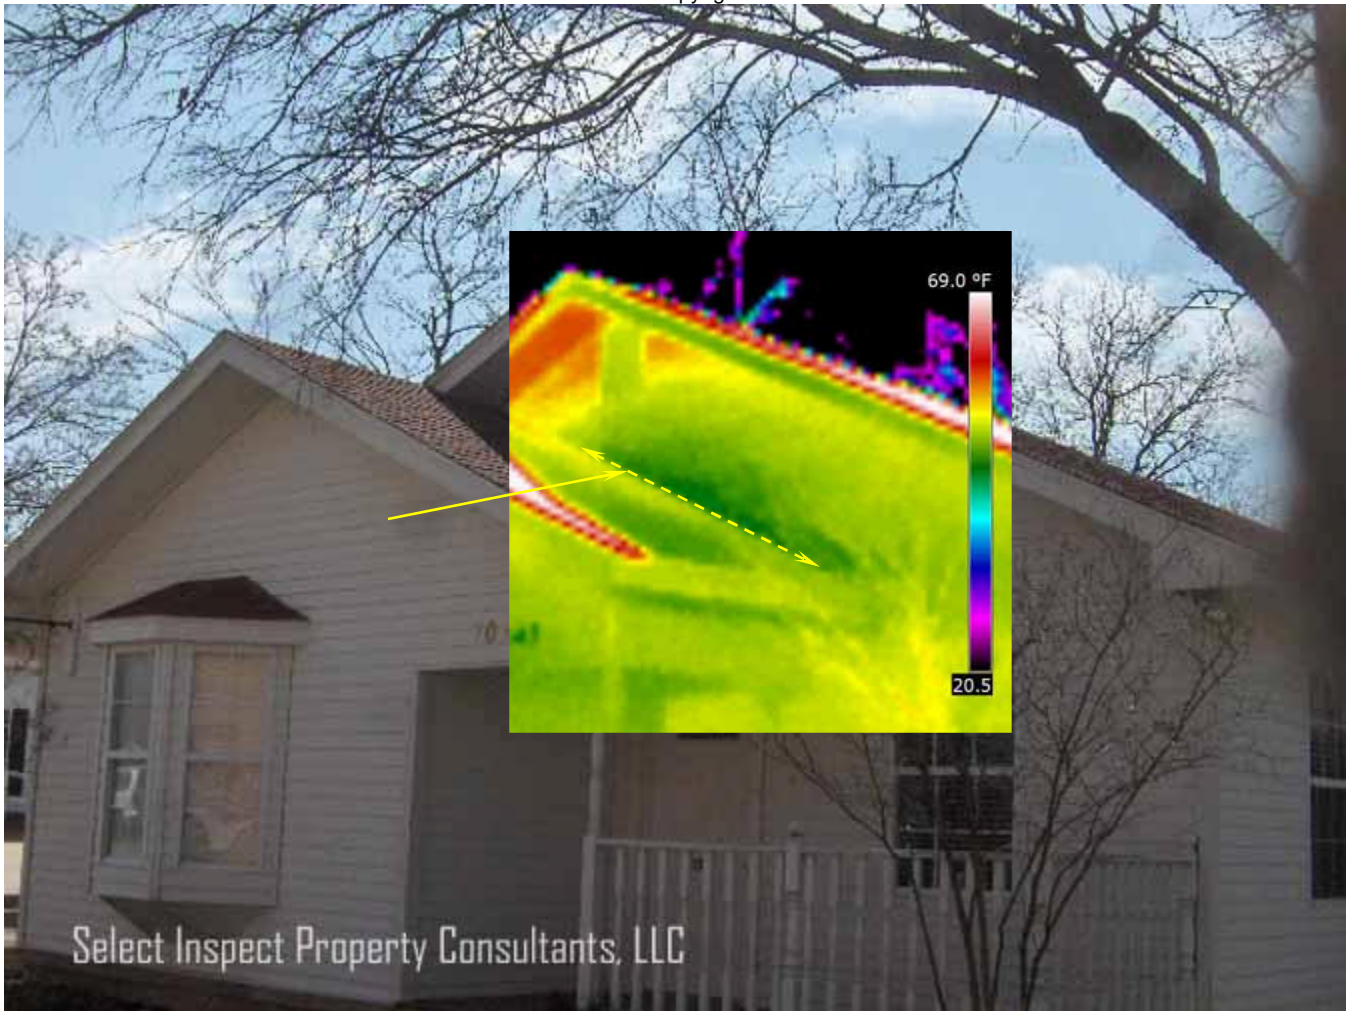
↑ some moisture damage was noted at the diagonal wall, where the siding was too close to the roof shingles (highlighted darker green area).

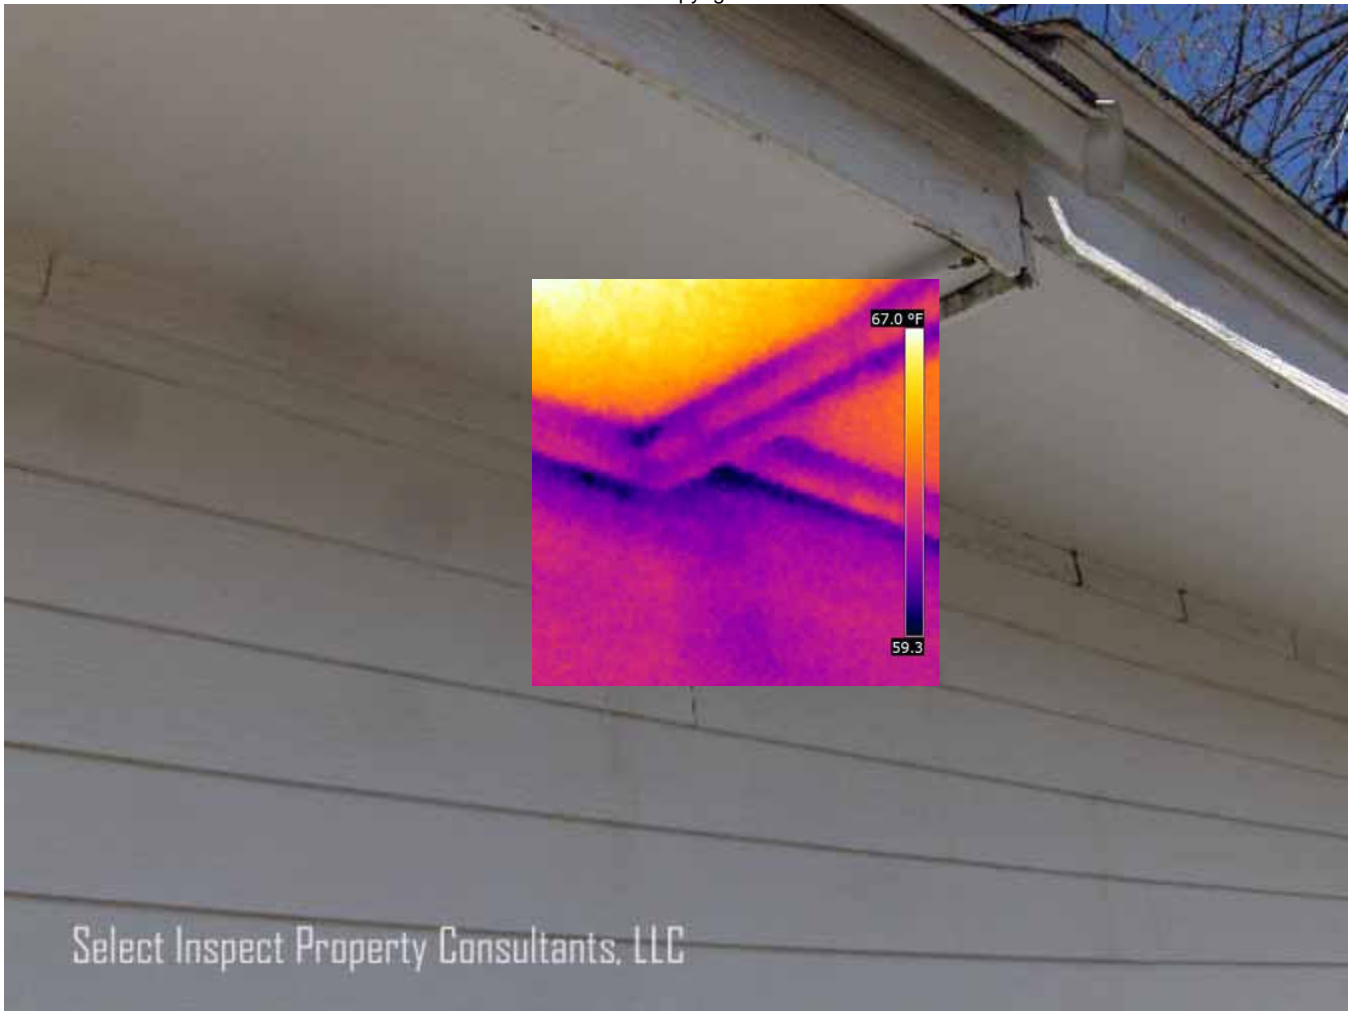
↑east eave of 7043; moisture damage & fungus was noted at the surface, though excess active moisture damage was not implied by this thermal image.
