Select Inspect

Property Consultants, LLC

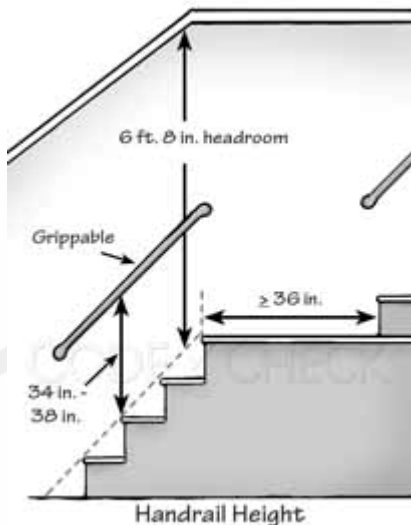
- Front porch steps were unworkmanlike, inadequately secured, bouncy, uneven, unsafe.

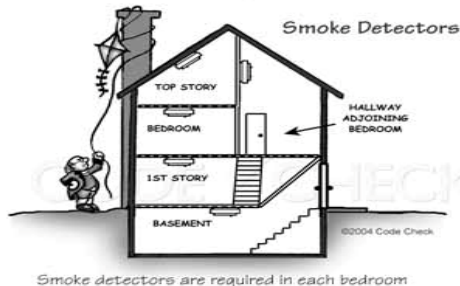
- It is recommended to test detectors monthly, change batteries annually, and to replace each detector at least once every ten years.
- Modern requirements dictate that smoke detector(s) should be hardwired to the electrical system with battery backup; this can be expensive on homes that do not have wiring in place for this purpose (generally older homes). Alarm(s) were not disassembled to determine if they were/were not hard wired. Consult an electrician if concerned.

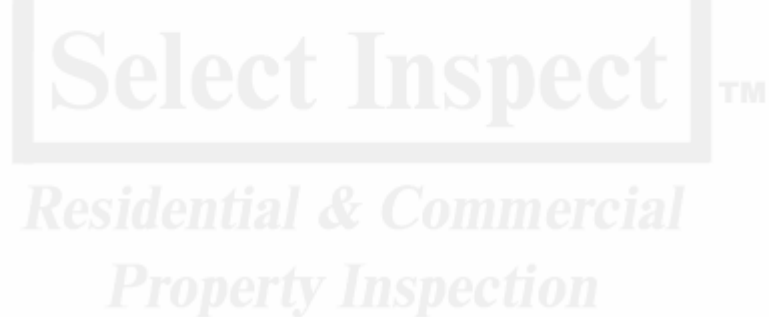
- It is beyond the scope of this inspection to operate laundry plumbing connections and laundry appliances. These fixtures are visually inspected only when accessible. Some conditions remain undetermined. If present, laundry equipment is not moved or inspected.

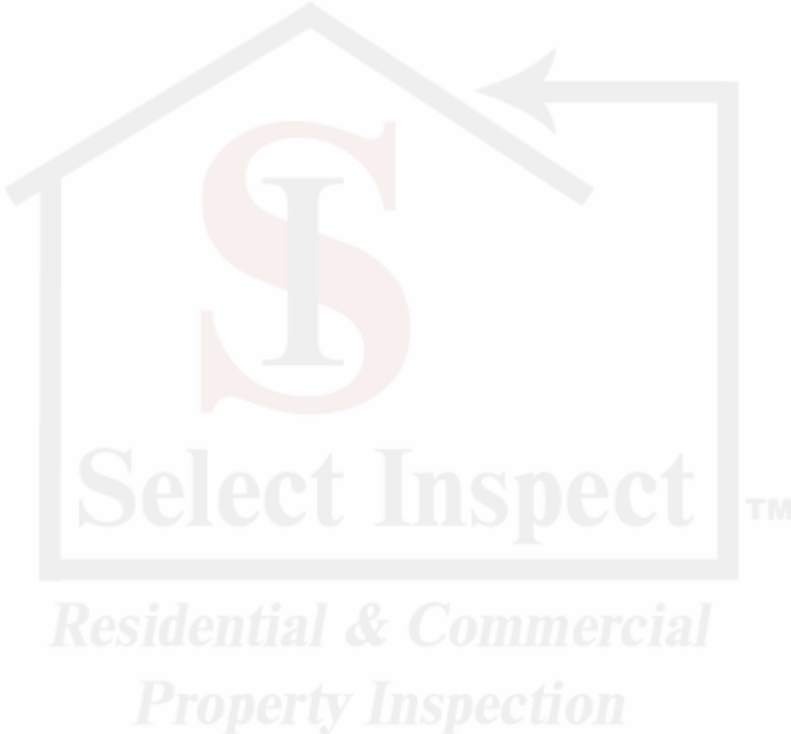
LIMITATIONS, EXPLANATIONS, & DEFINITIONS

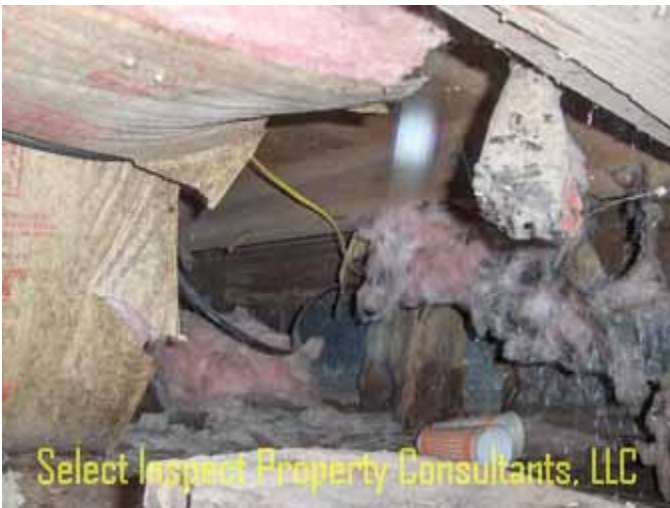
↑ low clearance & crawl space debris; under living room

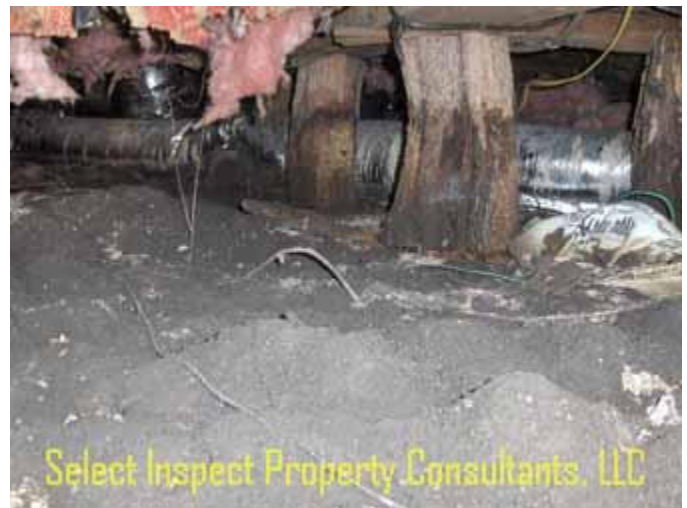
↑ deficient insulation & ducting; crawl space

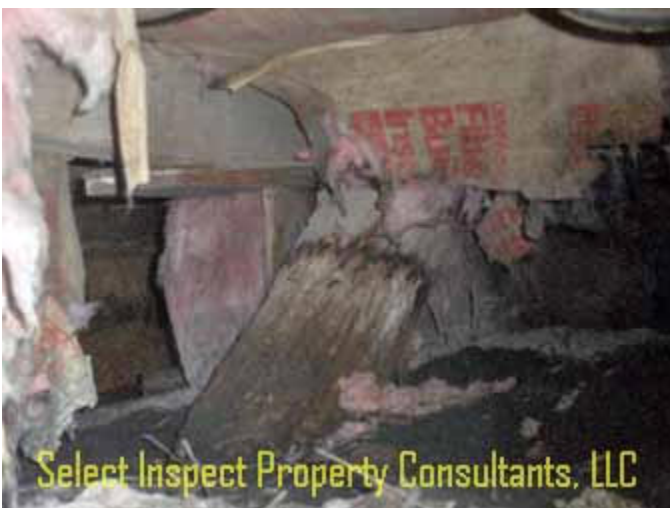
↑ deficient insulation in crawl space

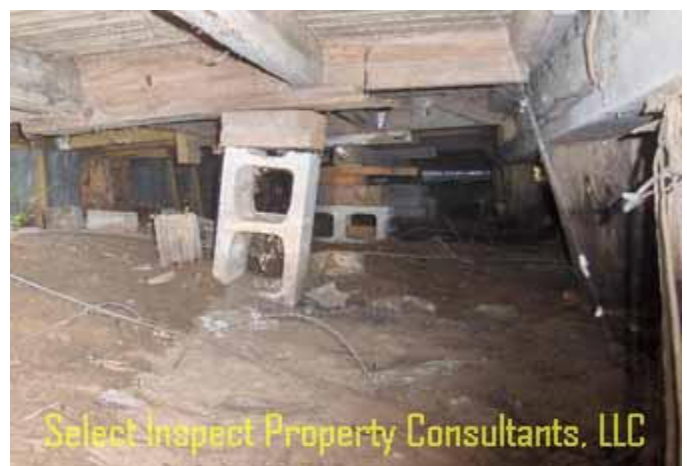
↑ leaning cinder block, should have holes vertical

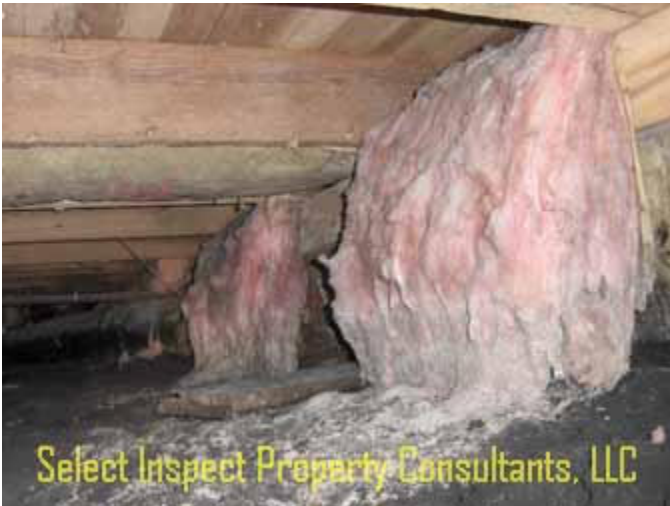
↑ deficient insulation; crawl space

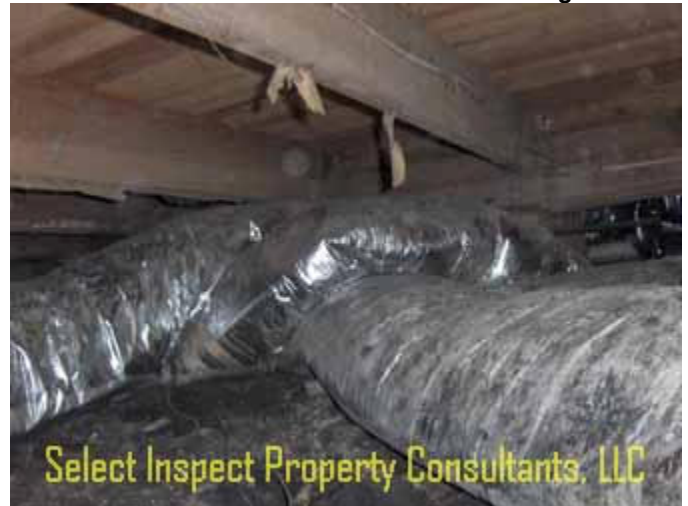
↑ crimped ducting on soil; crawl space

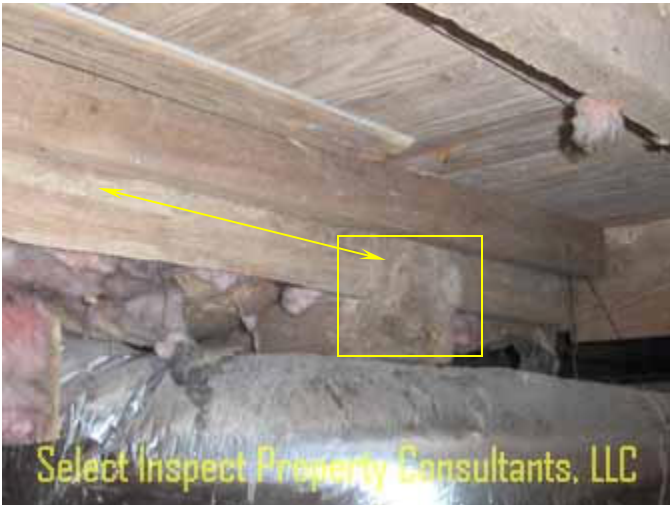
↑ insect damage; crawl space central

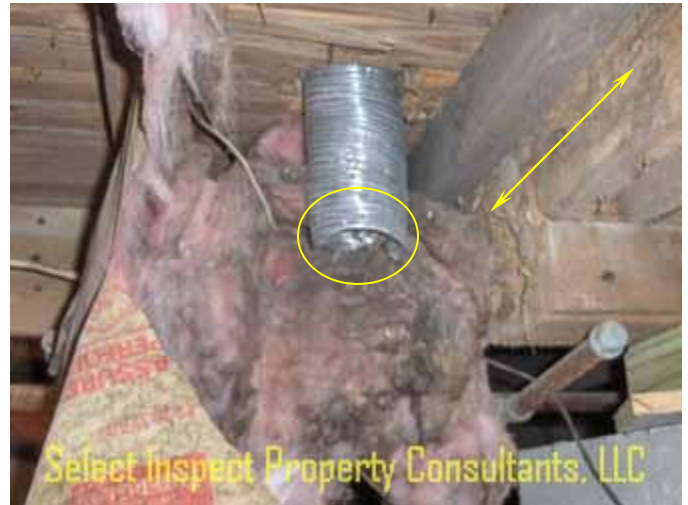
↑ insect damage, deficient insulation, & improper exhaust fan (suspected) termination; crawl space central

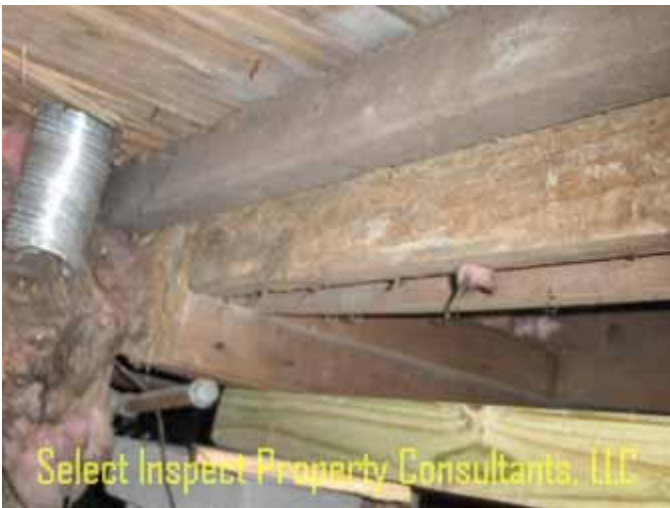
↑ insect damage, newer treated (small 2x4) bracing on wood shims

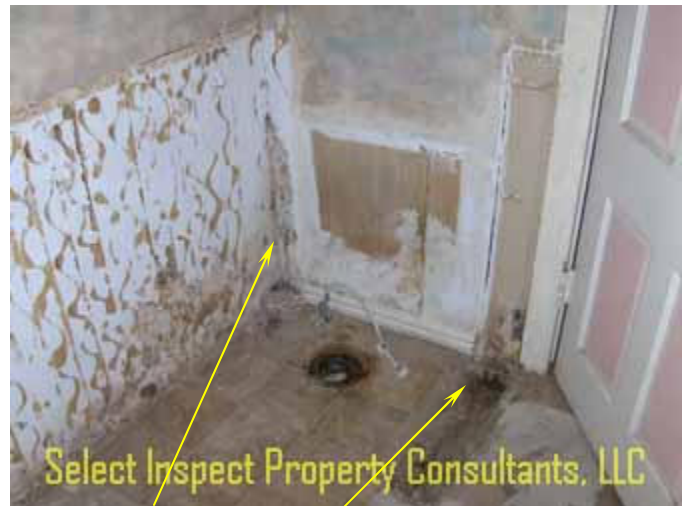
↑ insect damage & moisture damage & fungus downstairs bathroom

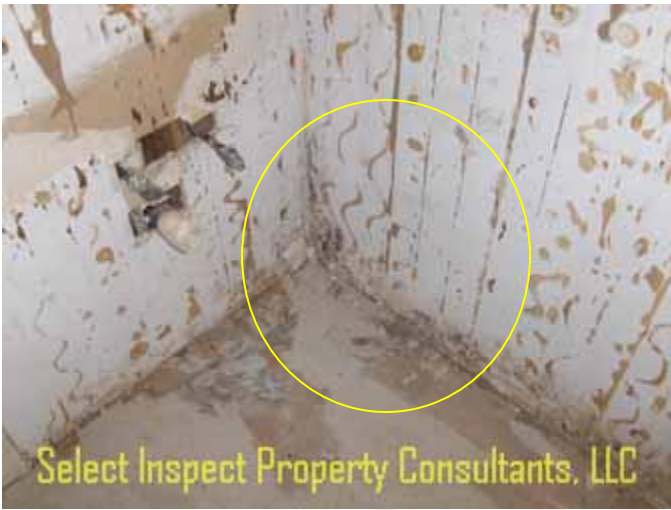
↑ moisture damage & fungus; downstairs bathroom

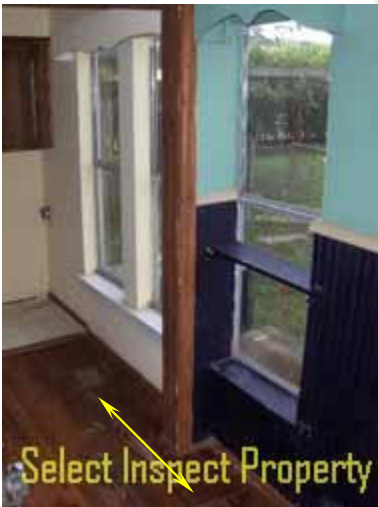
↑ insect damage; laundry room & kitchen hall

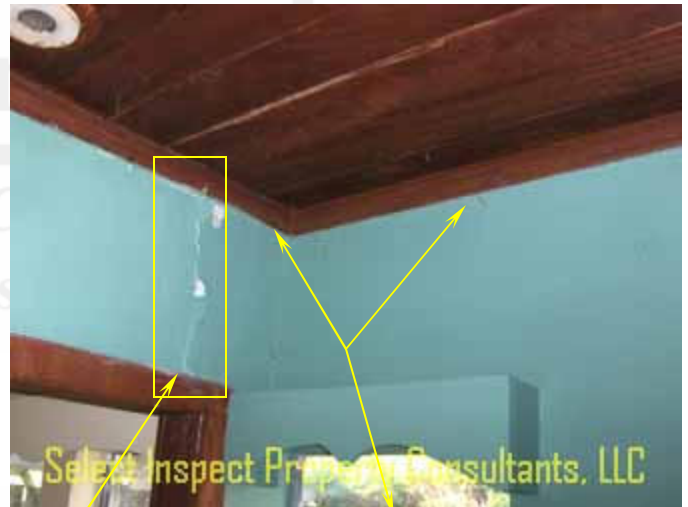
↑ stress cracks/compression, insect damage; laundry room & kitchen hall

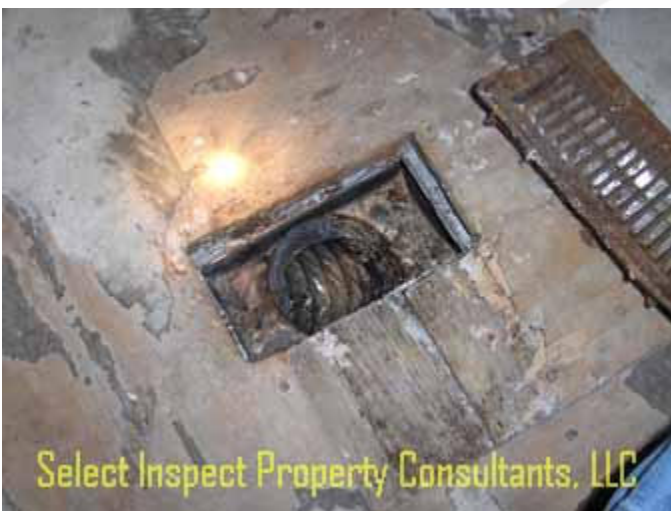
↑ corrosion, unsanitary ducting, damage, inadequately secured floor; example at downstairs bathroom

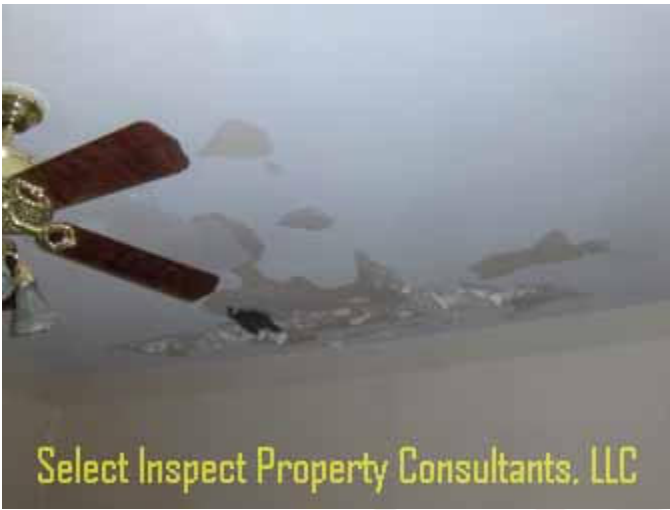
↑ moisture damage at downstairs bedroom

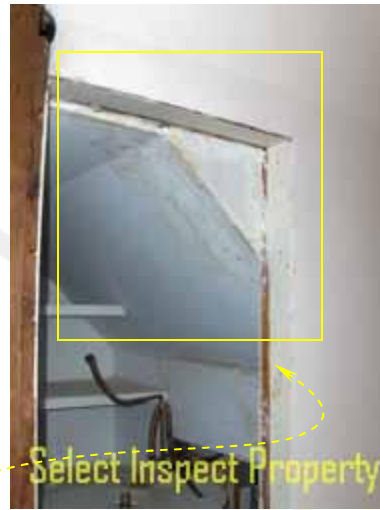
↑ moisture damage upstairs south adjacent the dormer

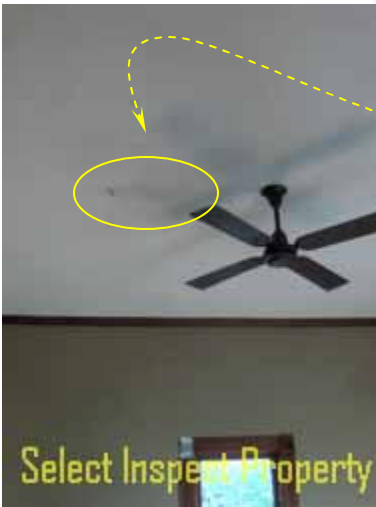
↑ moisture damage at family room; in proximity below upstairs water heater & roof leakage location; may be related

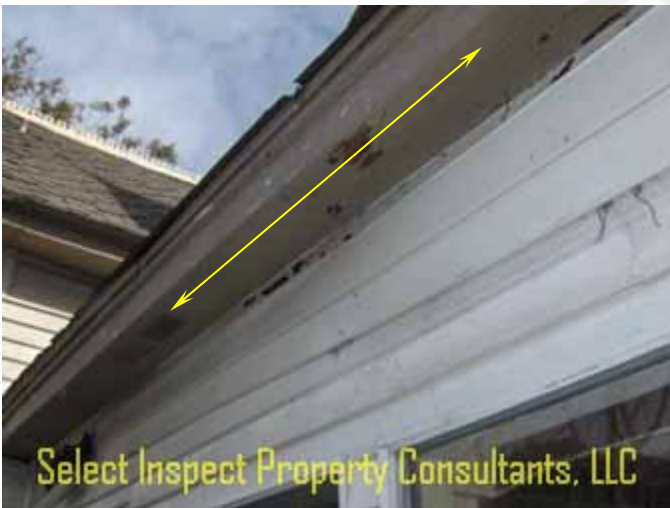
↑ deficient siding & moisture damage at eave; rear

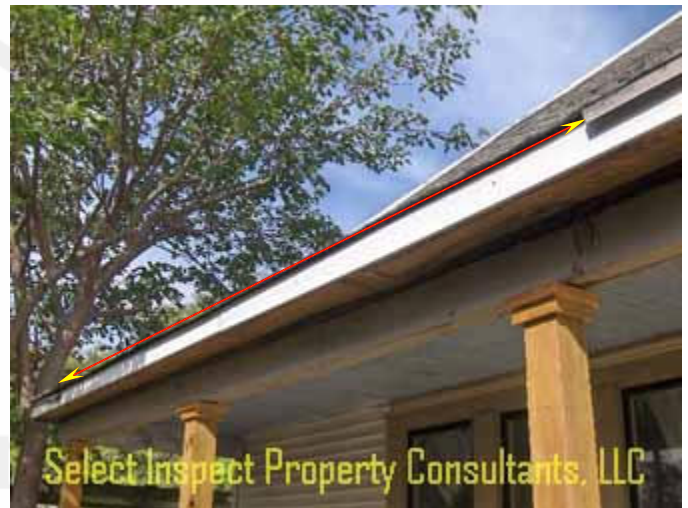
↑ incomplete drip edge flashing; side porch

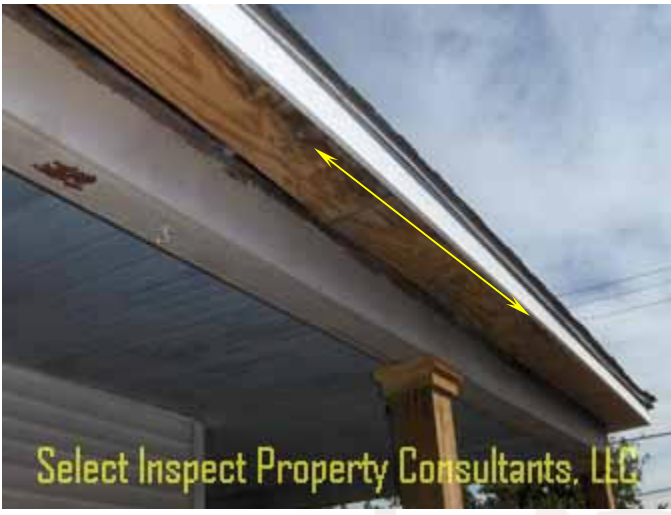
↑ moisture damage at side porch eave

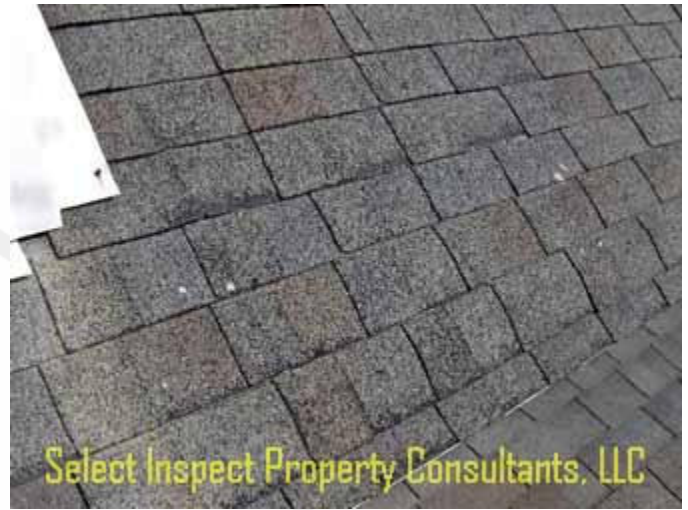
↑ example worn shingles

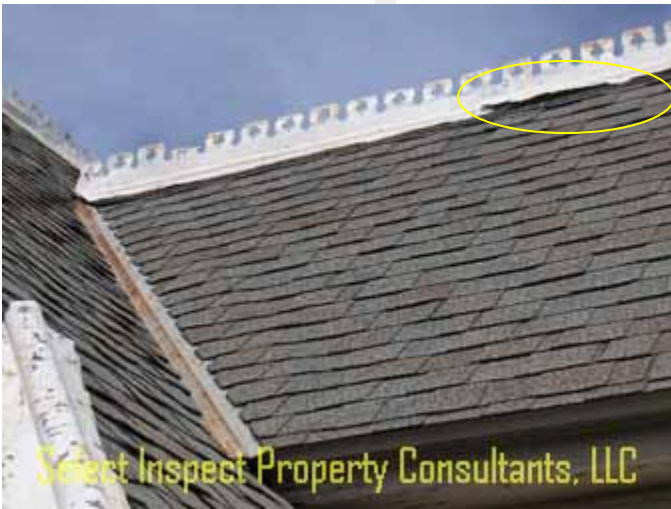
↑ amiss ridge cap; example

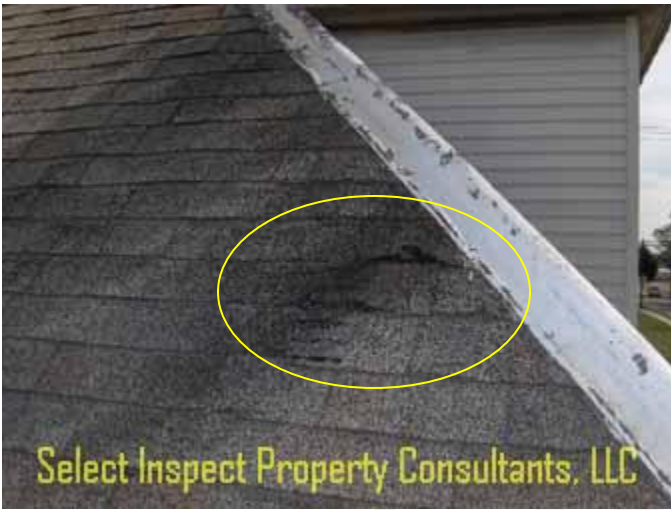
Report Identification 1887 Old Street; McKinney, TX

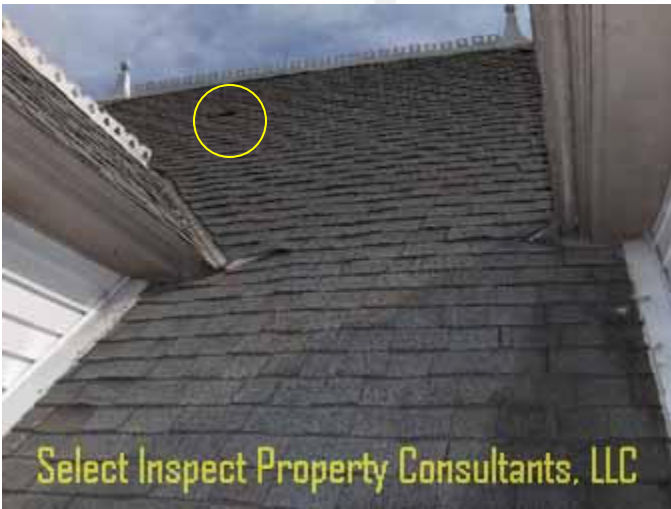
↑ popped nails, & worn shingles; example

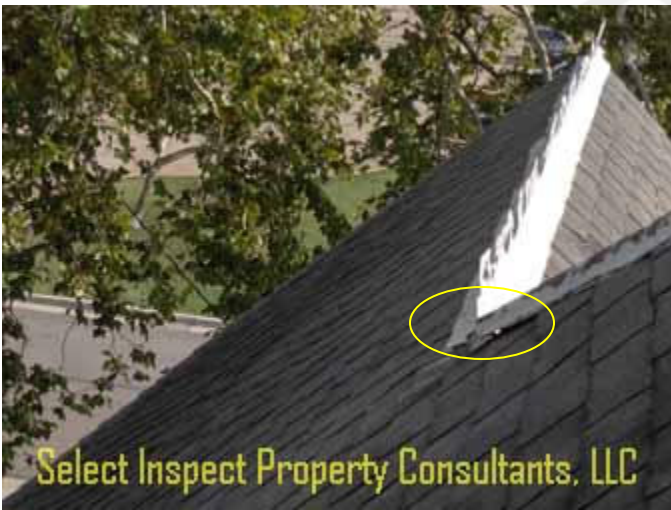
↑ deficient ridge cap north-northeast

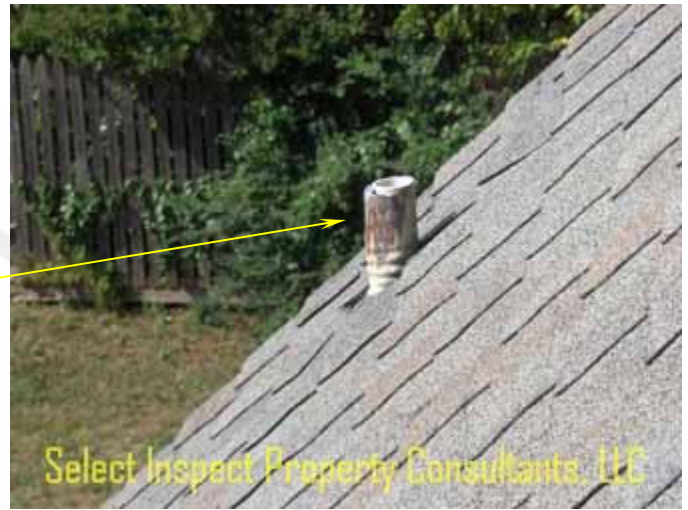
↑ close view of image at left; should be minimum 6" above roof, & lead wrap damaged (rodent)

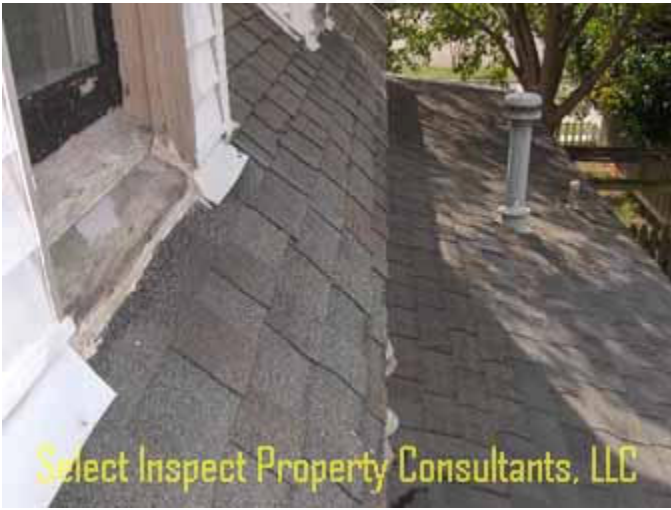
↑ deficient flashing at rear upstairs windows; undetermined flue; variant shingles imply patch/repair history

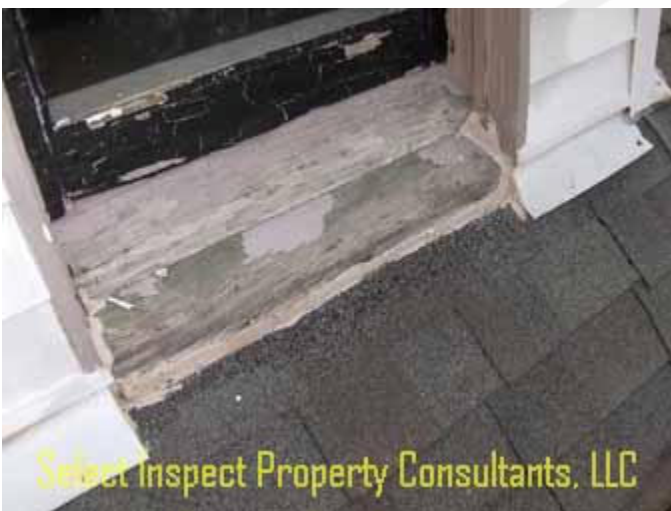
↑ close view of image above; missing flashing at window below sill; heavy sealant implies repair attempts.

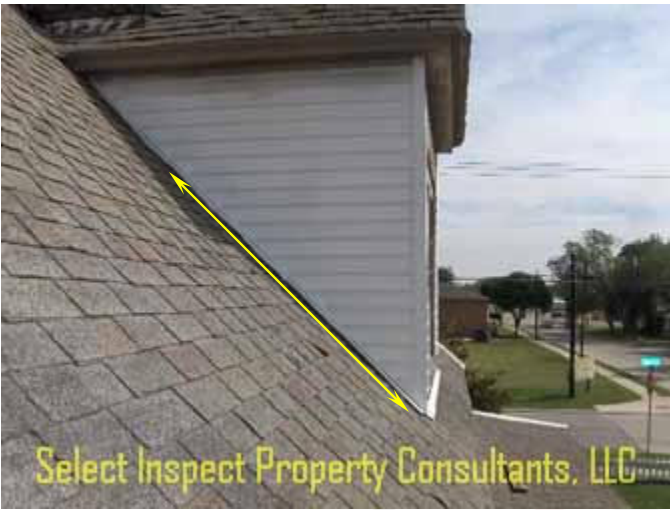
↑ raised flashing; example at south dormer

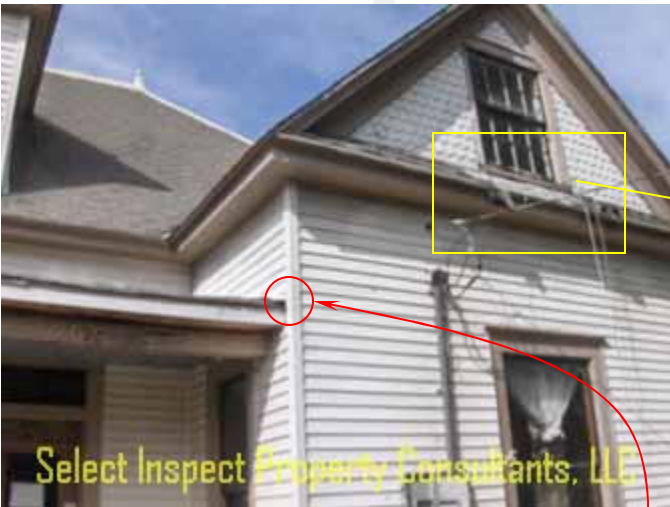
↑ deficient roof, deficient window, deficient flashing

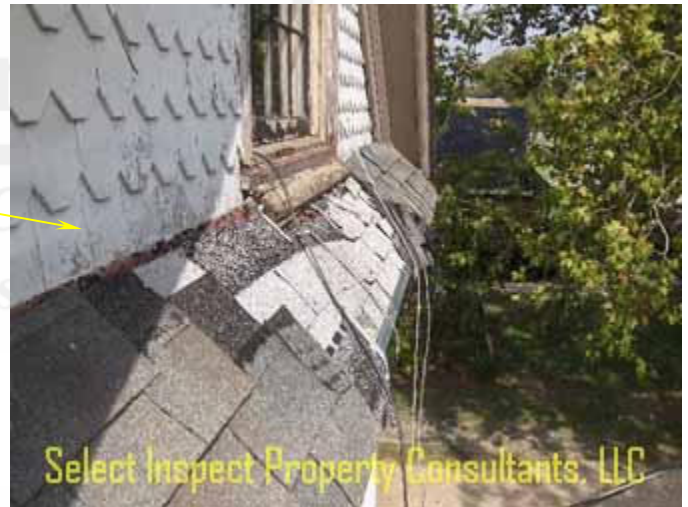
↑ 3 layers of composition/asphalt-type shingles seen here; extremely unworkmanlike cable work

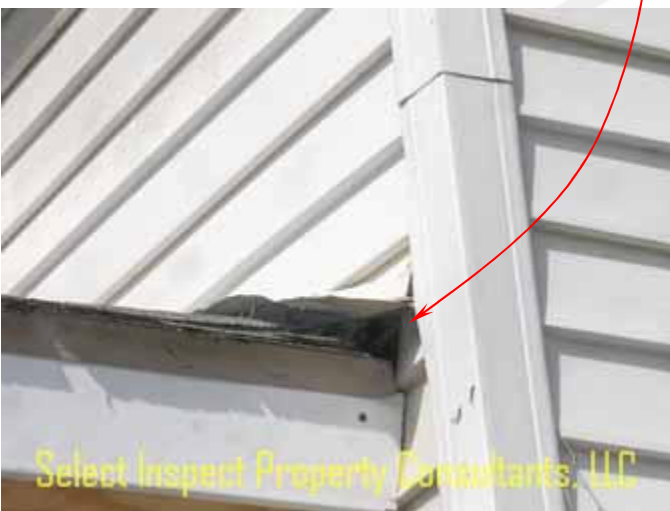
↑ opening may allow moisture intrusion in driving rains; daylight seen from attic

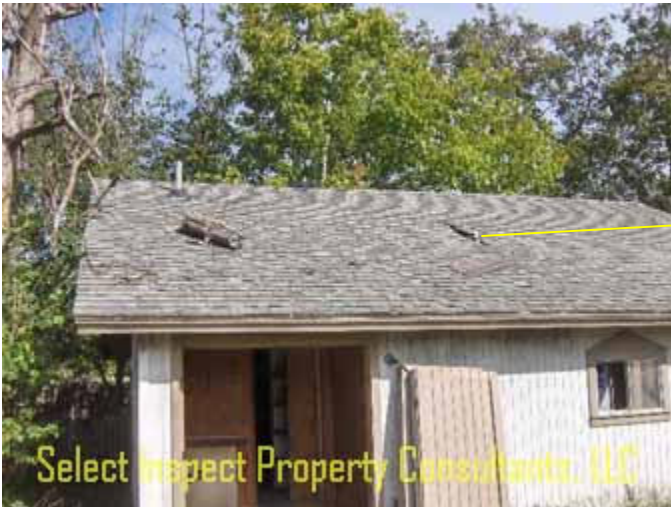
↑ tree damage at detached garage

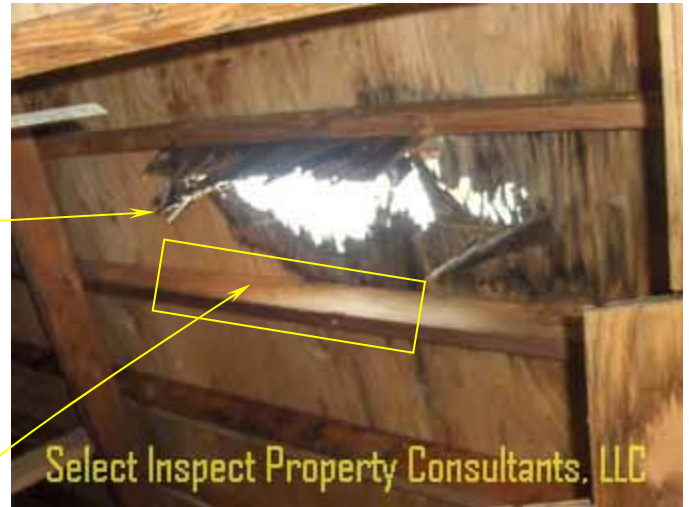
↑ attic of detached garage

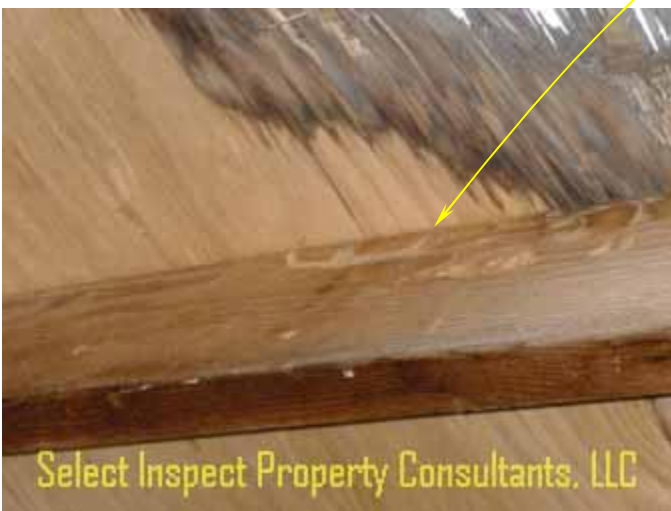
↑ damage from an undetermined wood-boring-insect

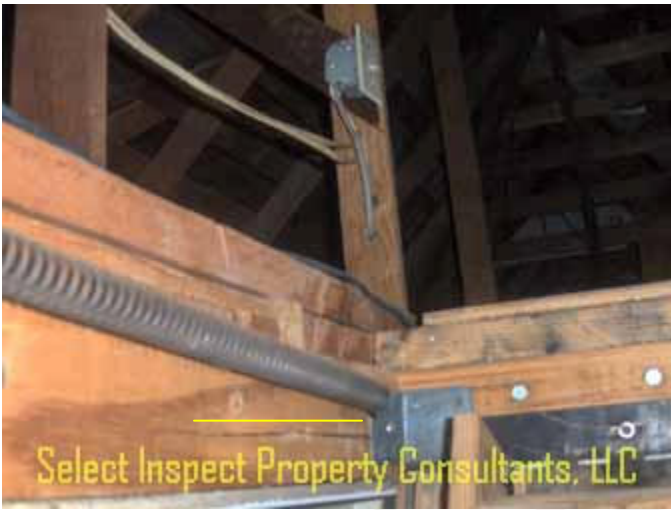
↑ cracked frame of attic stair at home

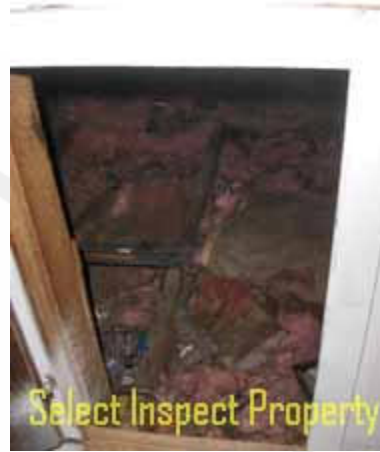
↑ attic access too small; southwest

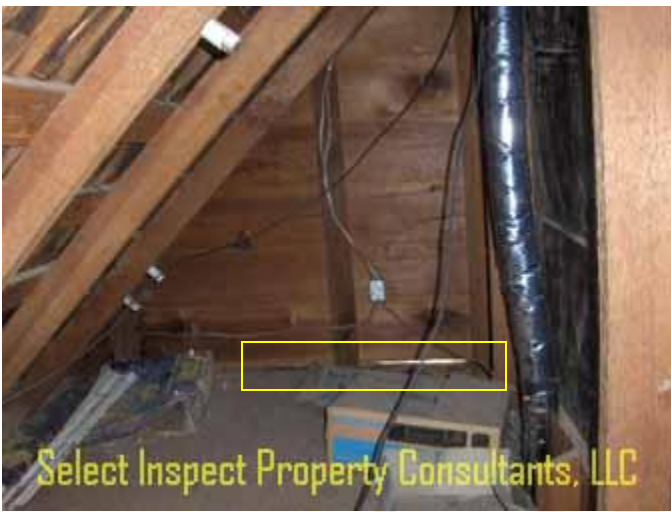
↑ inadequate seal from attic to south bedroom

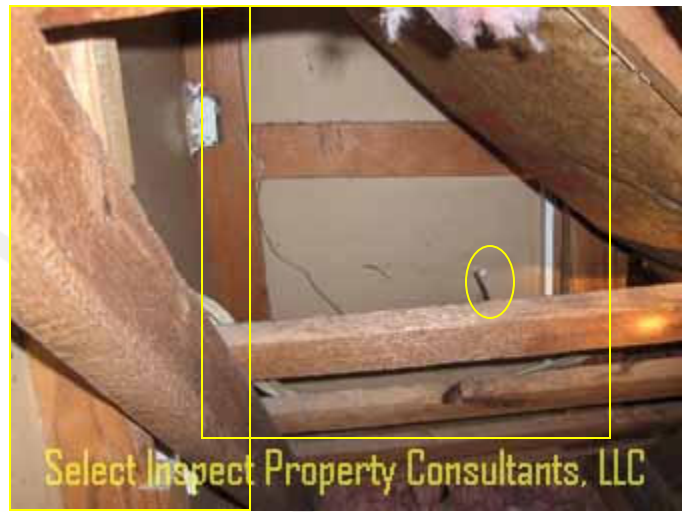
↑ inadequate seal attic to northeast bedroom & deficient insulation

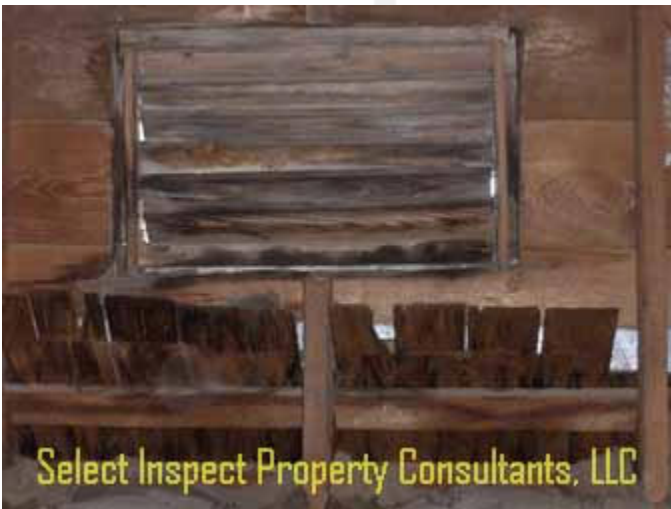
↑ moisture intrusion evidence at dormer/gable vents; example south east

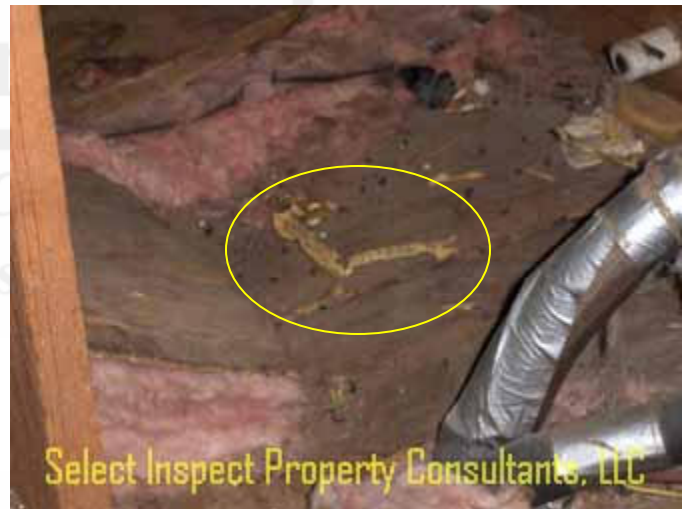
↑ rodent evidence & reversed insulation; upper attic

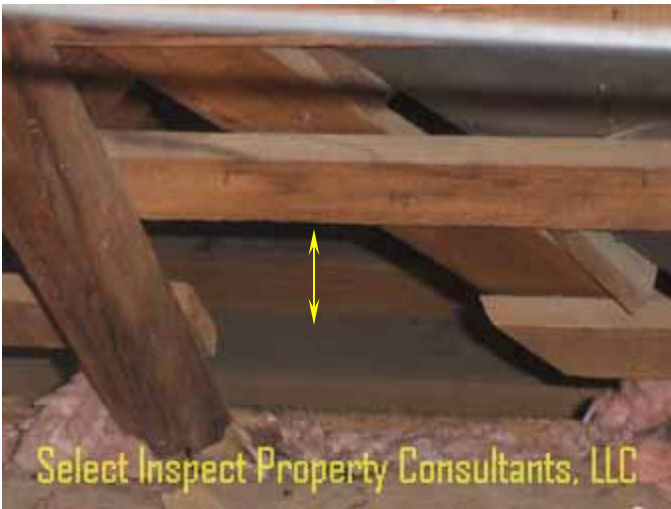
↑ missing insulation above upstairs west-southwest bathroom

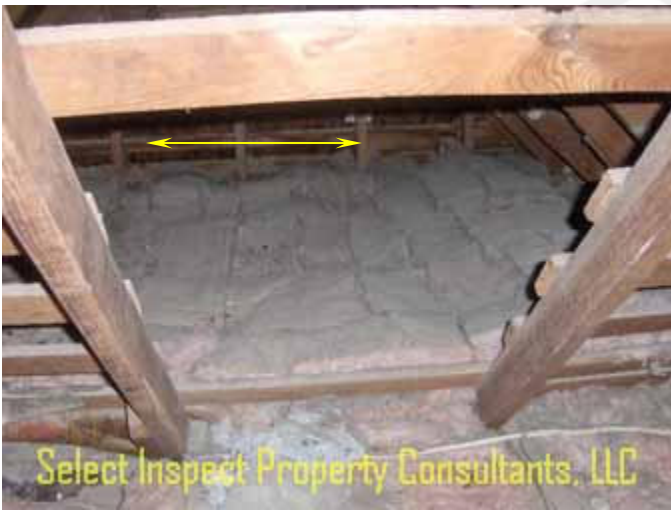
↑ insulation appeared reversed (unless backing is both-sides); & moisture staining at gable

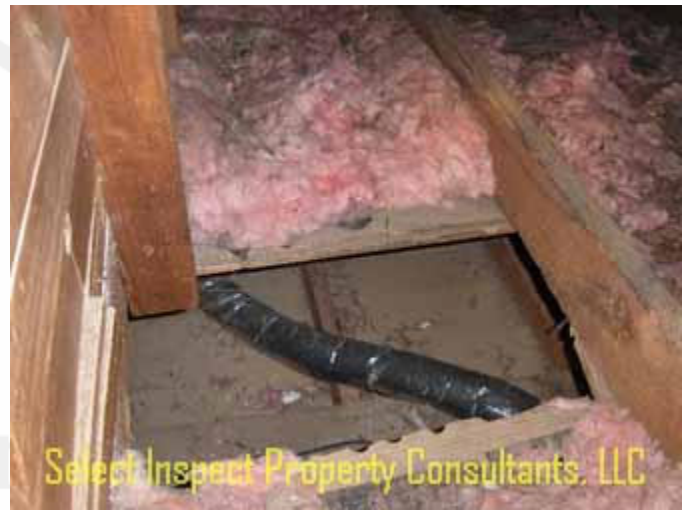
↑ missing insulation; rodent damaged refrigerant pipe insulation; southwest attic

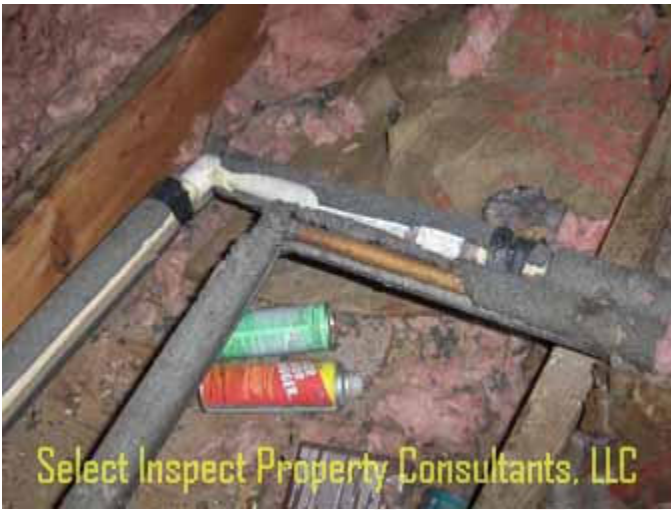
↑ rodent damaged plumbing pipe insulation; southwest attic

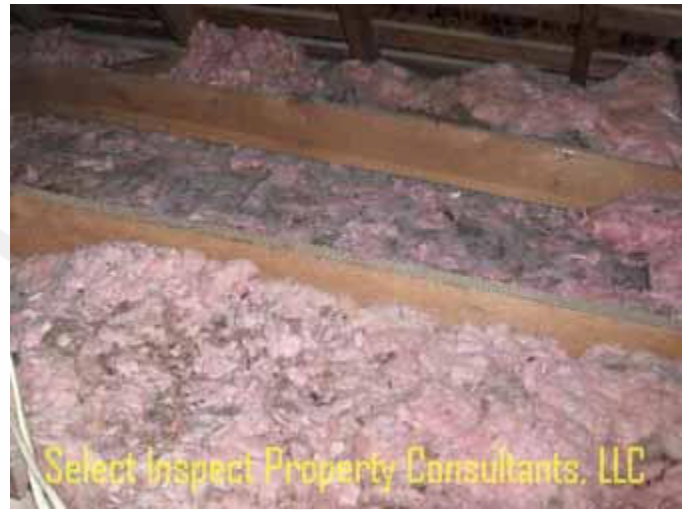
↑ rodent evidence & inadequate insulation; southwest attic

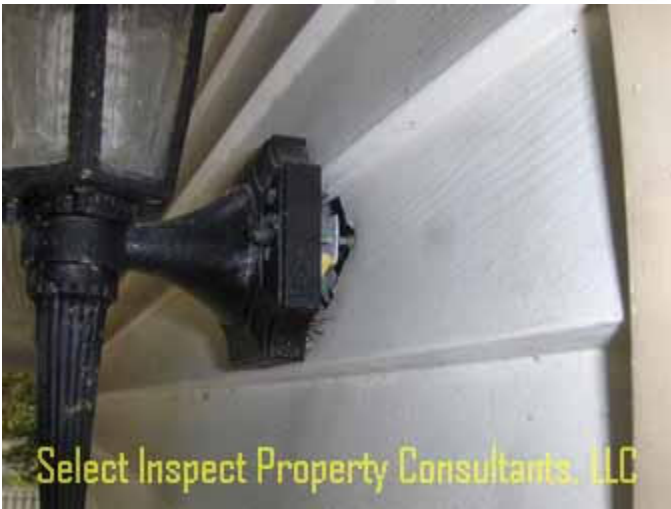
↑ caulking/sealant needed atop exterior lights; example; & Deficient excess reveal

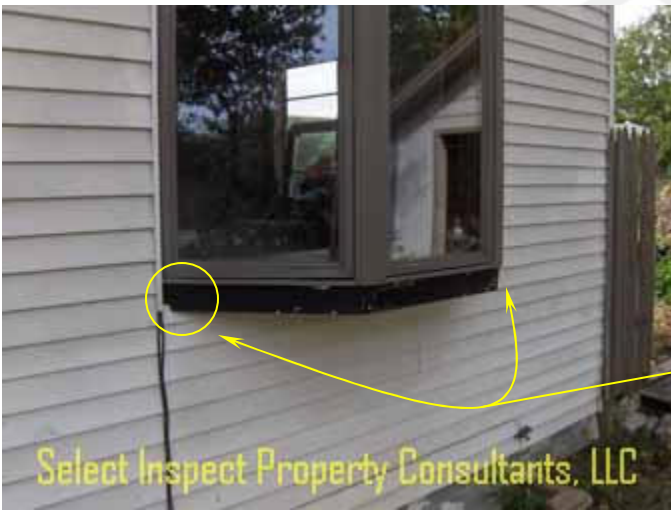
↑ unworkmanlike details at vinyl; example

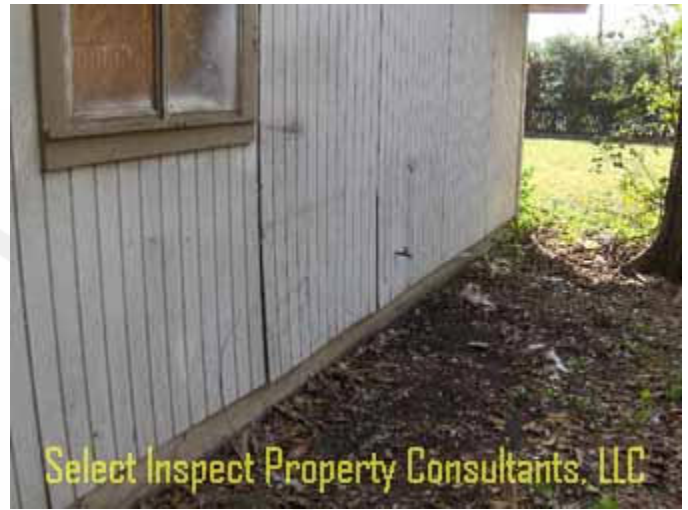
↑ detached garage siding; inadequately secured

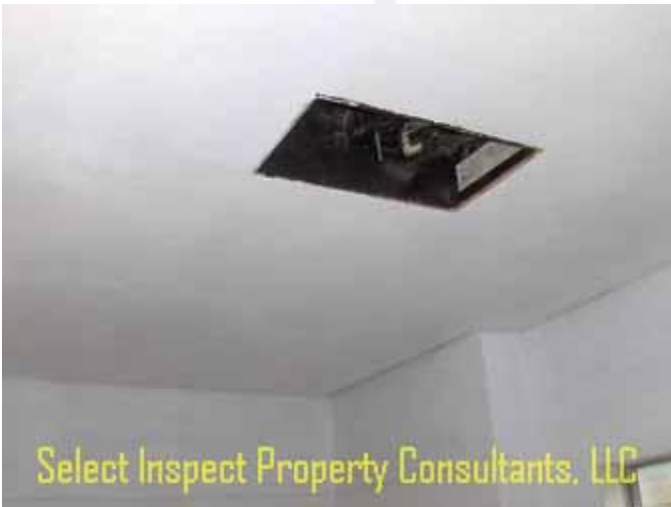
↑ undetermined ceiling tile; possibly asbestos-based

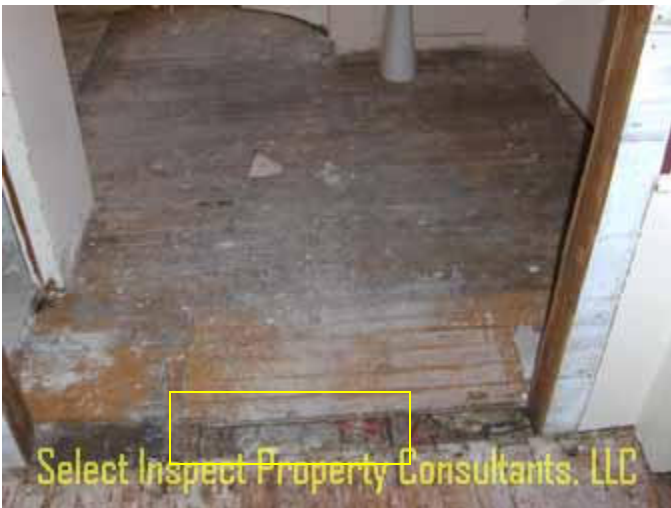
↑ example unstable floor; openings; trip hazards; debris & rodent feces discovered within

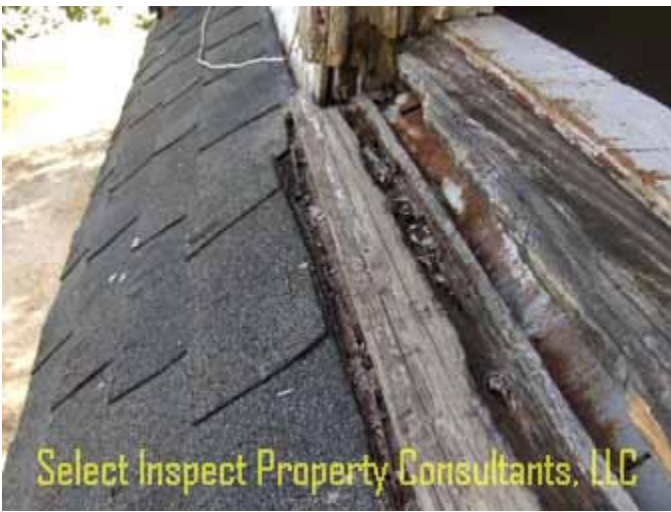
↑ moisture damage & amiss flashing; upstairs north

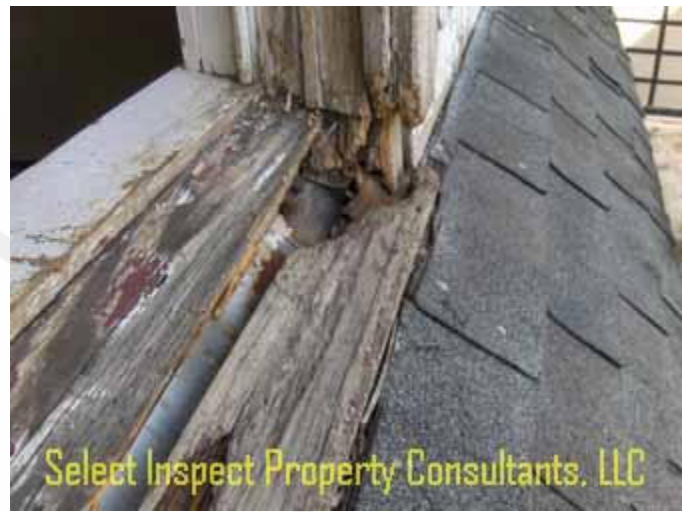
↑ moisture damage & amiss flashing; upstairs north

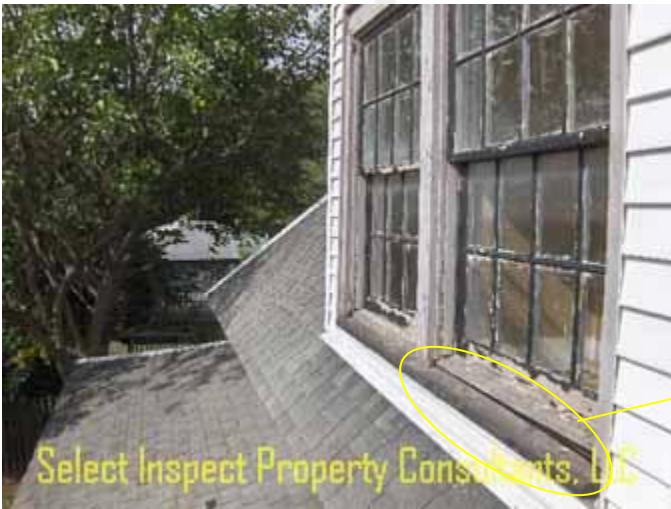
↑ moisture damage & openings; upstairs south

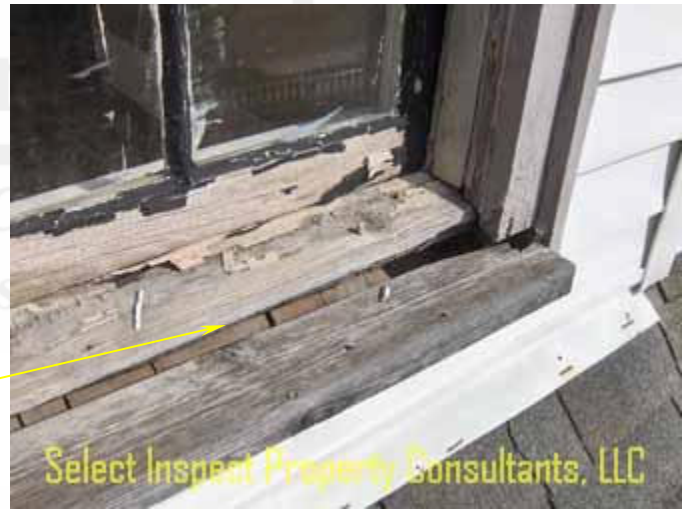
↑ close view of image at left

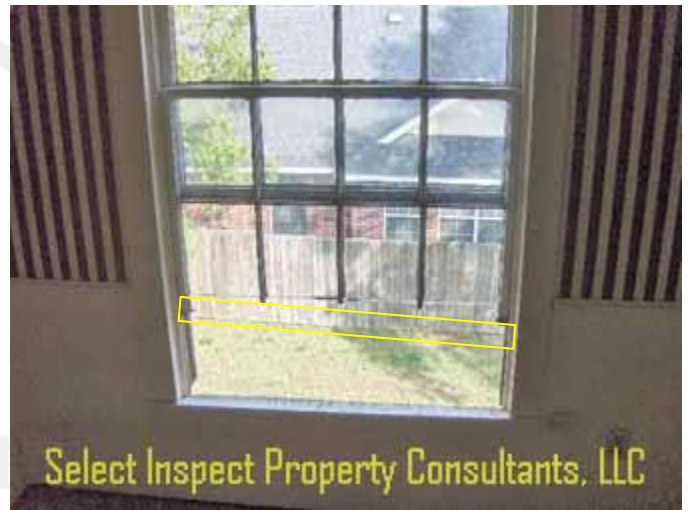
↑ missing window component(s); upstairs north

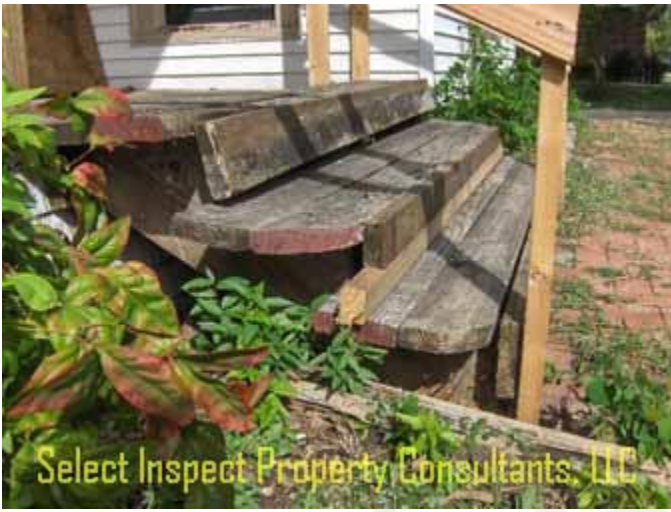
↑ unworkmanlike steps; trip/injury hazard

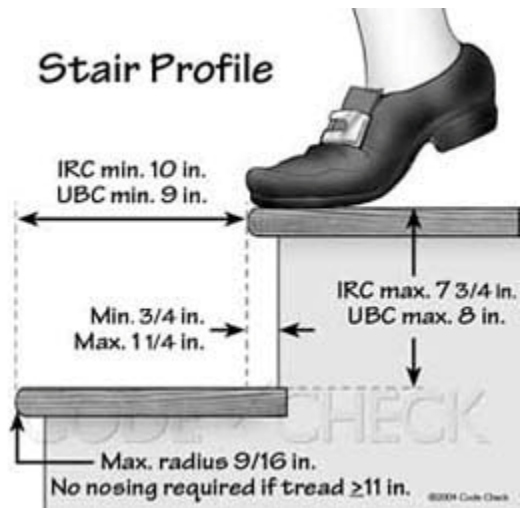
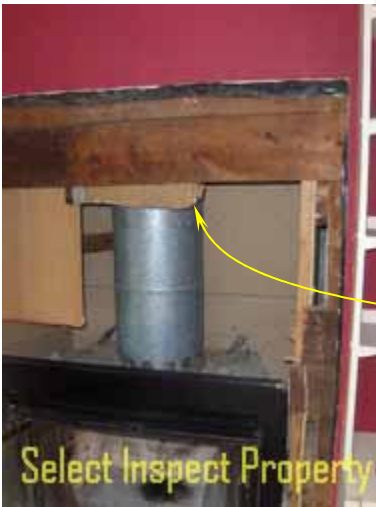
↑ family room fireplace

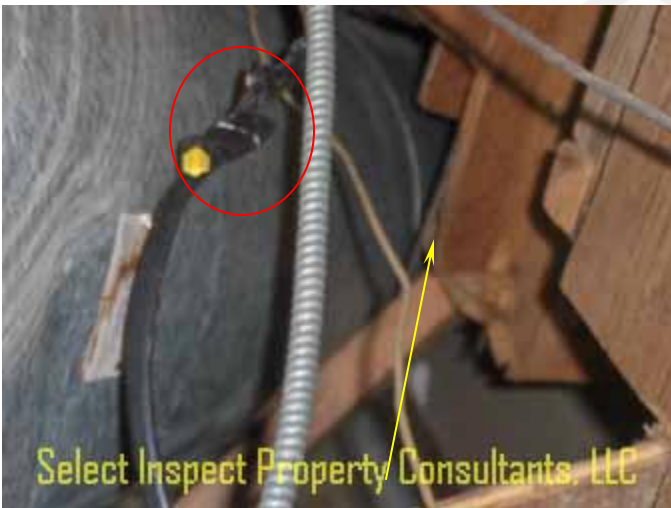
↑ fireplace flue did not meet clearance requirements to combustibles & unworkmanlike unsafe electrical

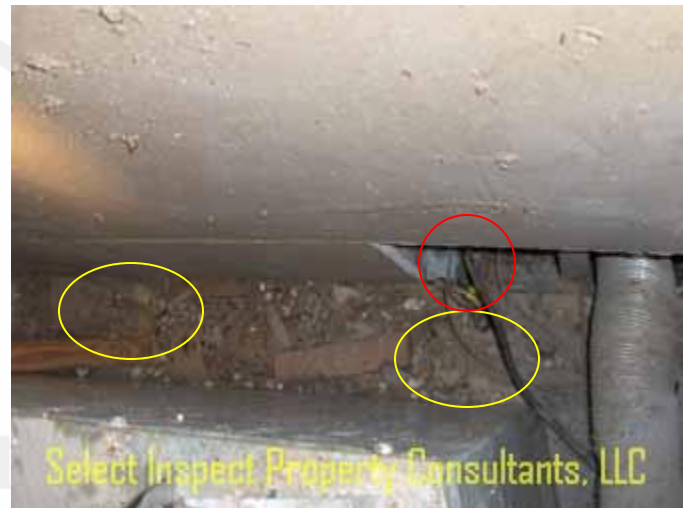
↑ incapacitated rodents & unworkmanlike electrical behind fireplace

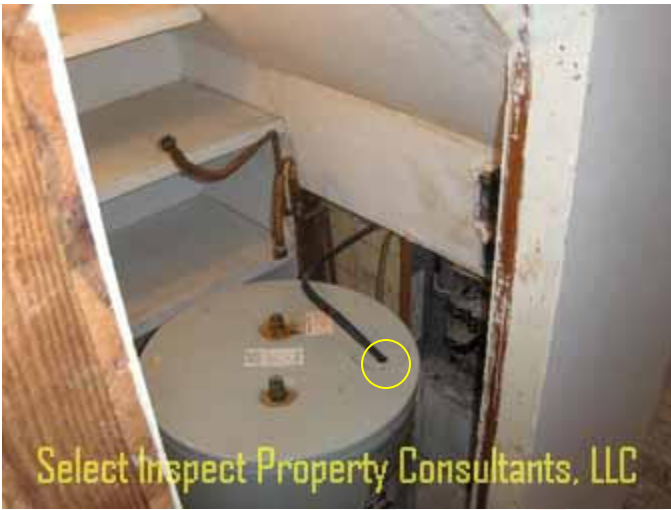
↑ upstairs electrical panel(s) did not have appropriate service clearance, & missing clamp at disconnected h2oh

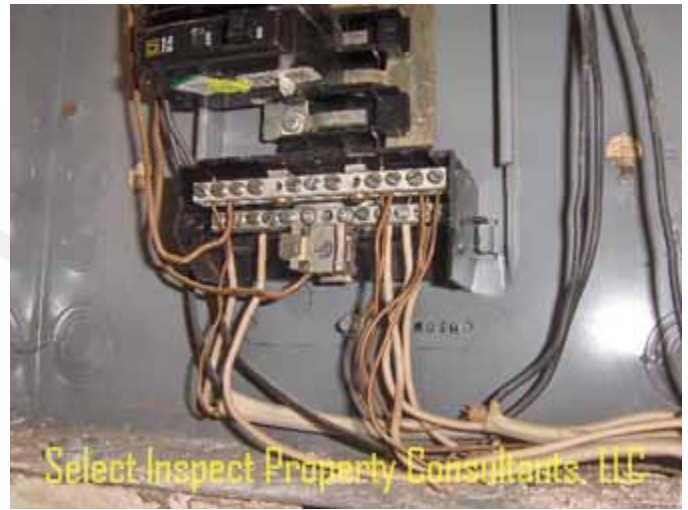
↑ small ground conductor for upstairs panel
