Select Inspect

Property Consultants, LLC

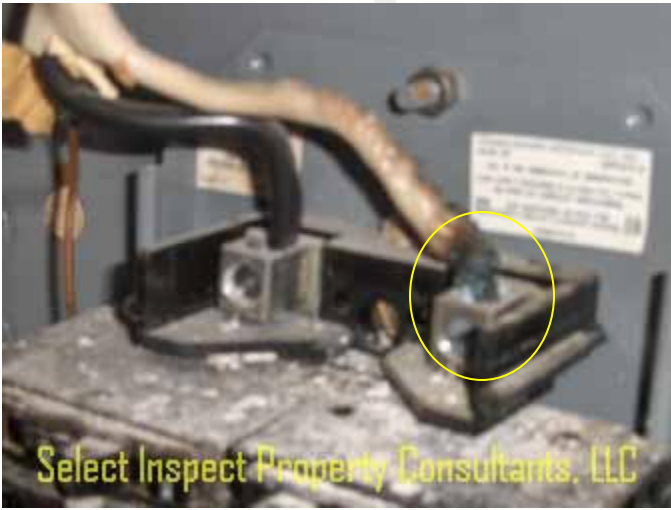
↑ overheating evidence; unsafe; upstairs panel

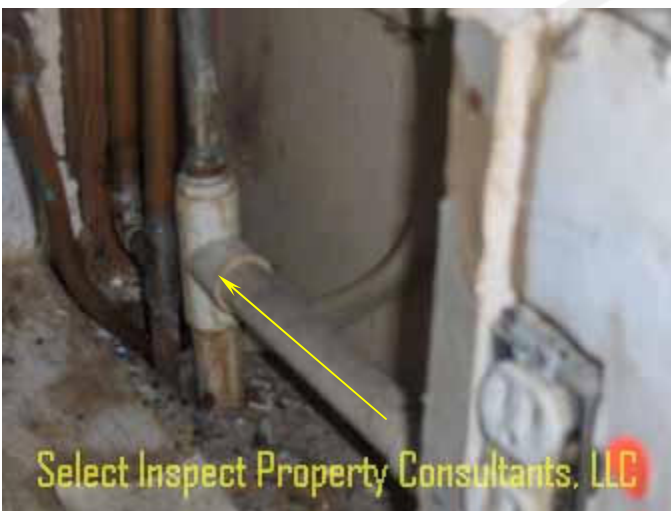
↑ Possible air conditioning primary condensate drain termination? These pipes were too small if they are drains, though may be supply piping (unusual copper / pvc mix); upstairs bathroom south

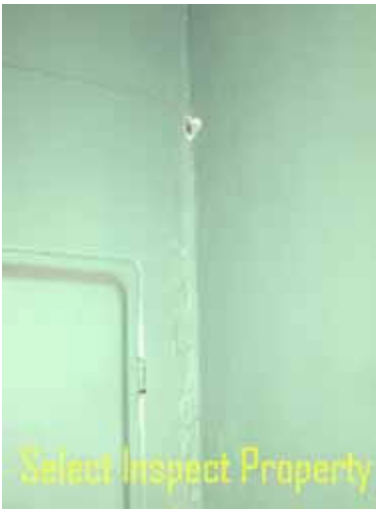
↑ **downstairs** electrical panel(s) did not have appropriate service clearance; painted panel cover;

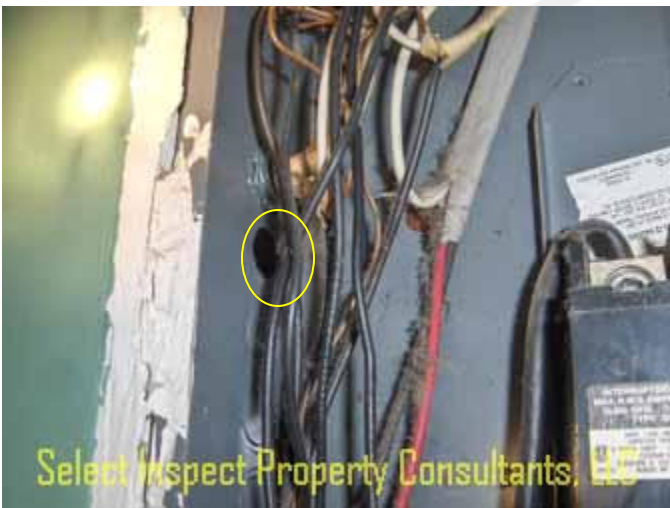
↑ missing knock-out plug

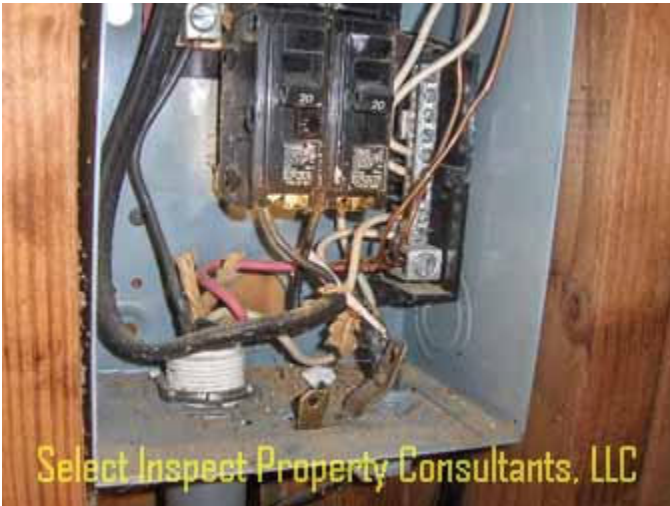
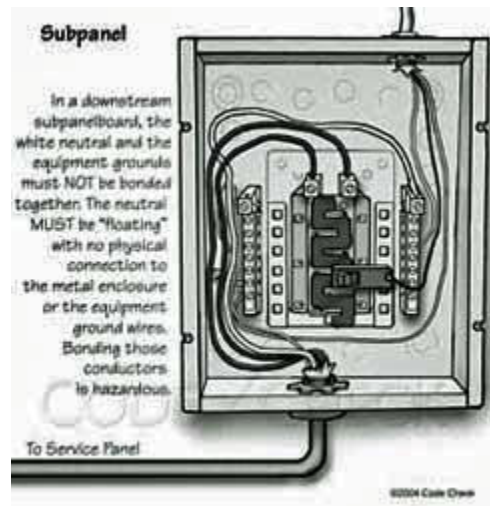
↑ **garage panel**; neutral conductors must be isolated from equipment grounds in a subpanel; unworkmanlike wiring

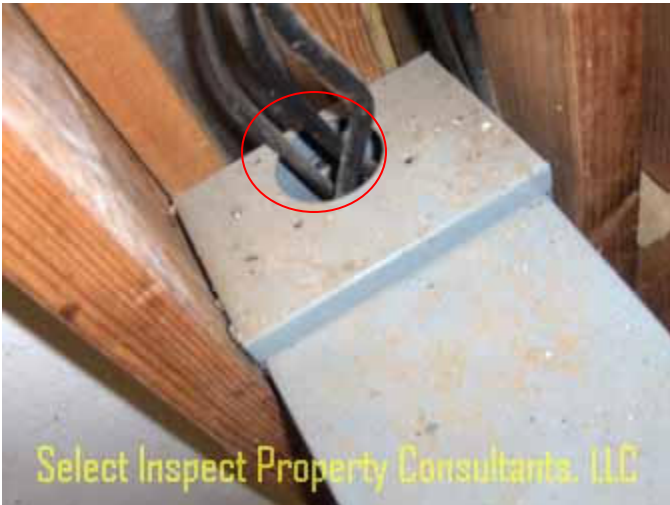
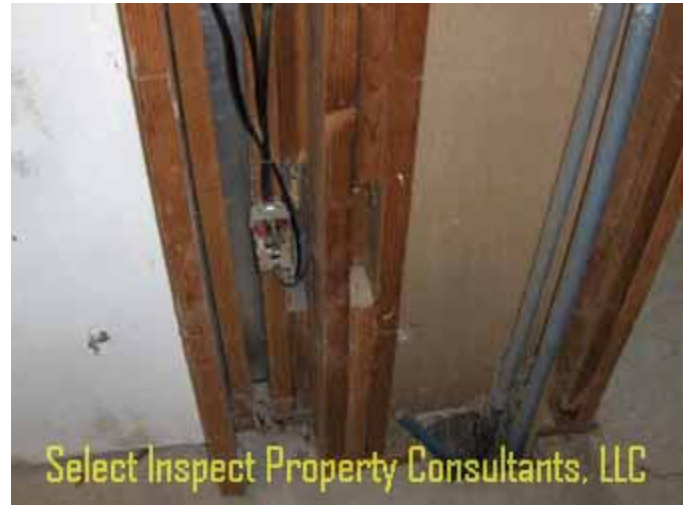
↑ missing knock-out grommet at top

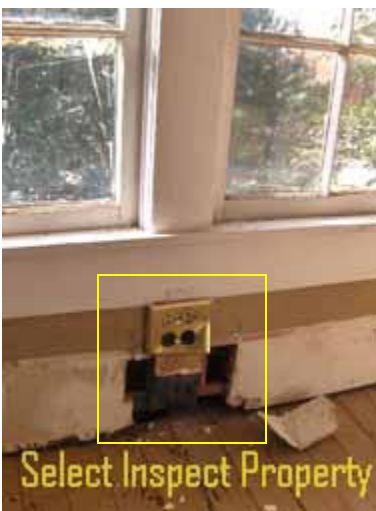
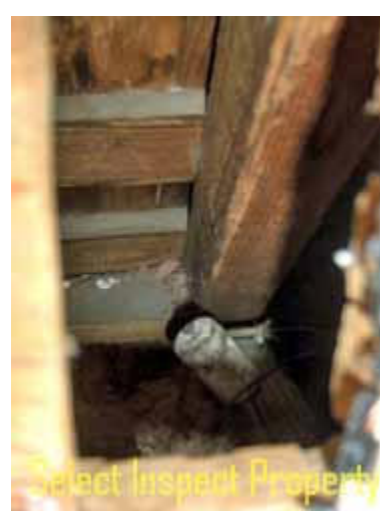
↑ unworkmanlike electrical; upstairs south

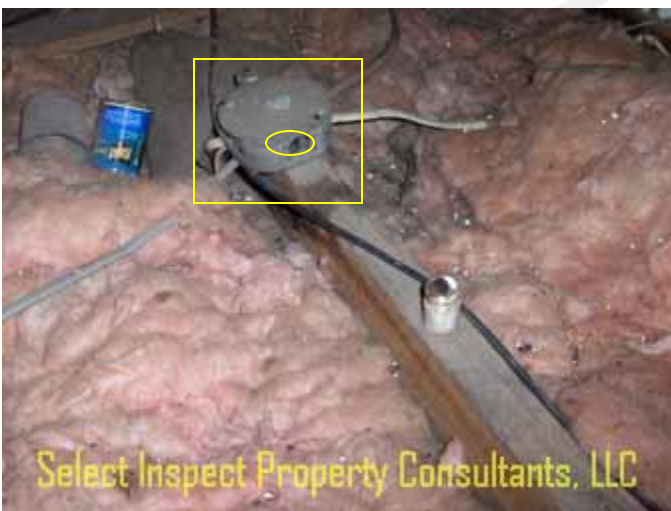
↑ deficient clamping; upper attic electrical

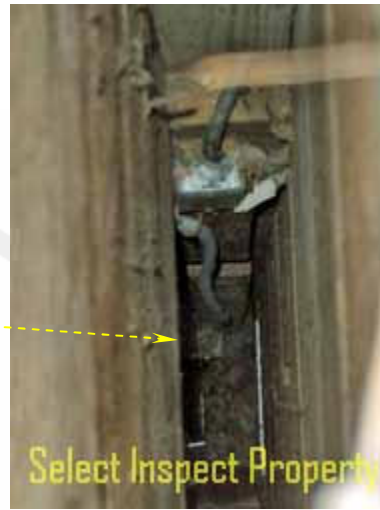
↑ looking down through chase; electrical here & missing continuous flue would make this unacceptable for venting

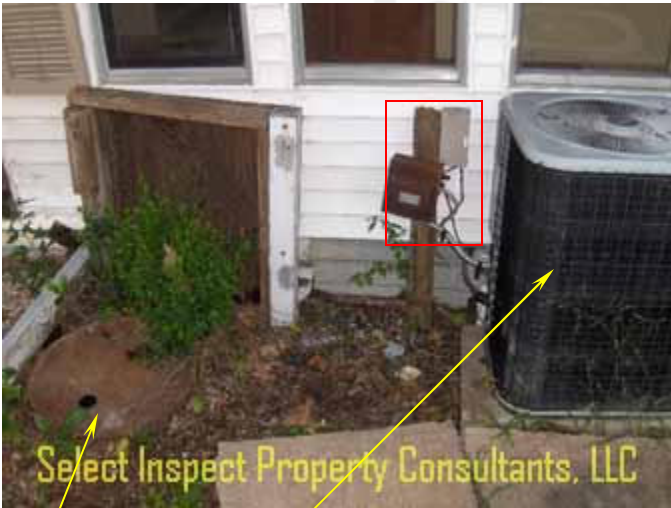
↑ well? Hail damage at air conditioning coils; inadequately secured disconnects

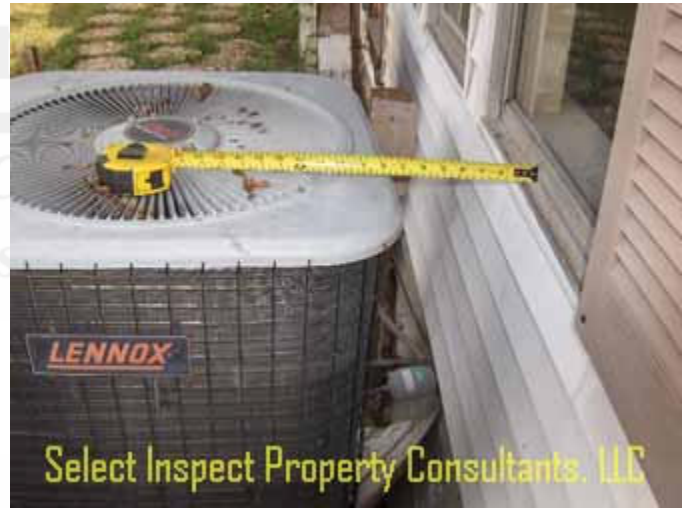
↑ air conditioning condenser(s) did not have adequate clearance; minimum 12" all sides

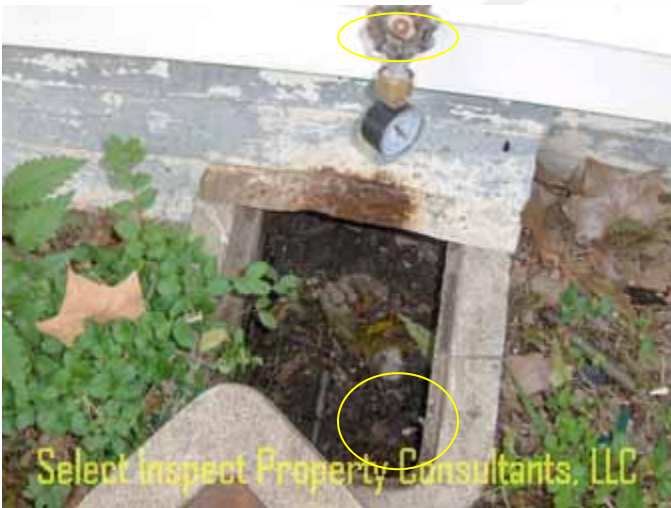
↑ deficient water shut-off-valve

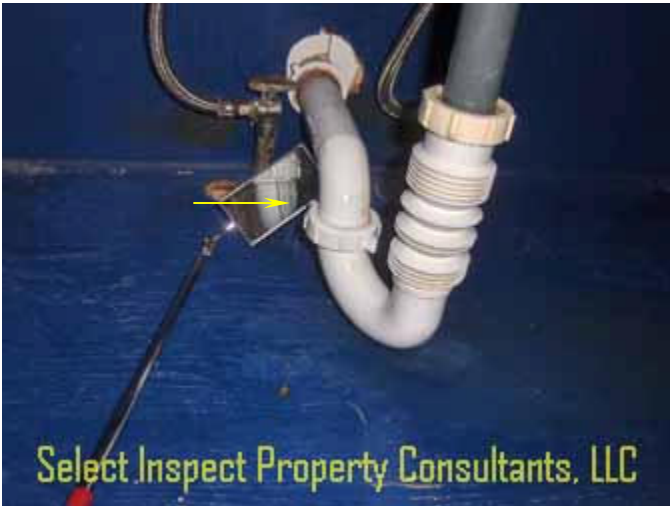
↑ leak at sink drain; flex drain tubing is not recommended; prone to congestion

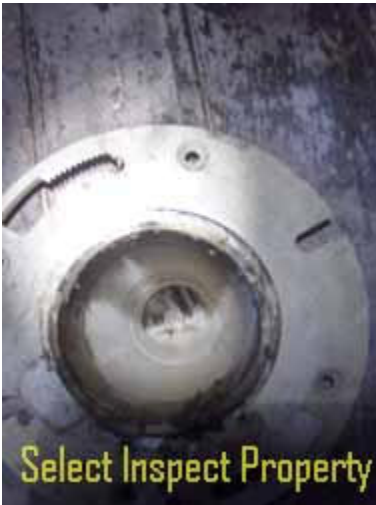
↑ debris present in various plumbing traps; example at toilet trap downstairs
