Select Inspect

Property Consultants, LLC

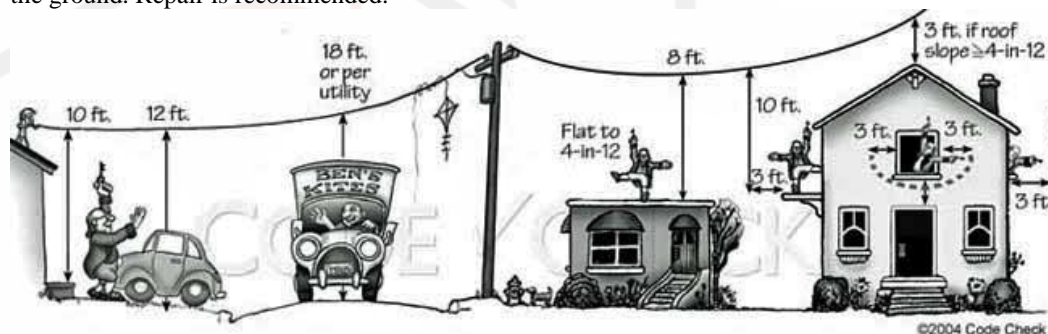
Service Drop Clearances

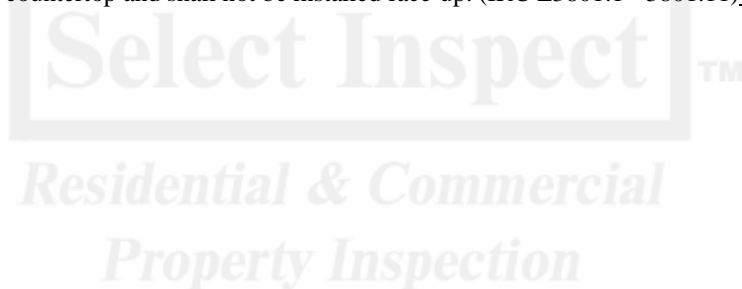
- ✦ did not have enough or properly located electrical receptacle(s). “Receptacles shall be installed so that no point along the floor line in any wall space is more than 6 feet horizontally from an outlet in that space.” Each wall/counter space 12 inches or wider shall have a receptacle; and no point along those walls shall exceed 24 inches horizontally without a receptacle. Island and peninsular countertops ≥24” x ≥12” require at least one receptacle(s). Receptacle(s) shall be no more than 20” above the countertop and shall not be installed face-up. (IRC E3801.1 - 3801.11) related image on next page

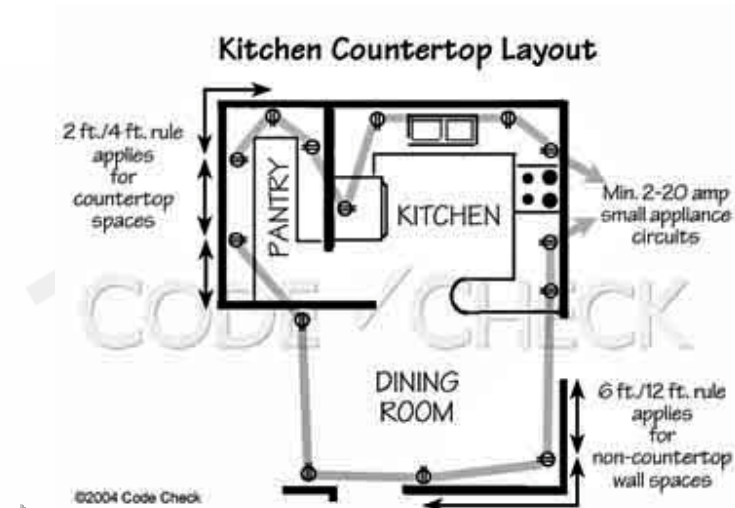
- Some older 2-prong outlets in this home have been updated with 3-prong outlets. It is possible that one or more of the 3-prong outlets has a “fake” ground. This occurs when a ground wire is legged to the neutral (grounding through the neutral). This gives the false reading of a ground with many testing devices, and can be unsafe and a false sense of security. The inspector does not generally remove outlet covers, and this condition may exist. It would be prudent to have your electrician examine this potential condition, when other electrical items are serviced.

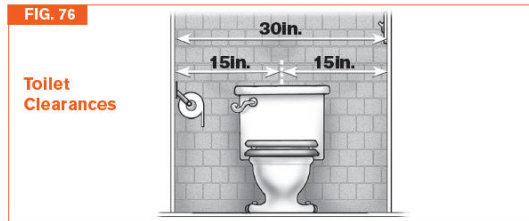
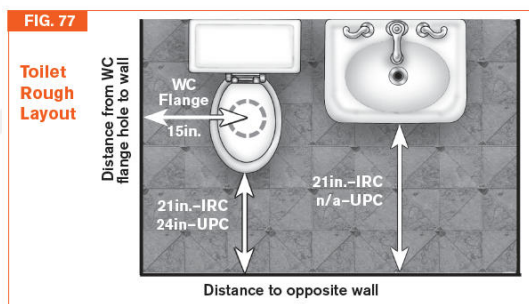
- East toilet(s) was inadequately secured at the floor. Correction / improvement would be prudent.
- Spacing & clearances around the southeast toilet were amiss / deficient

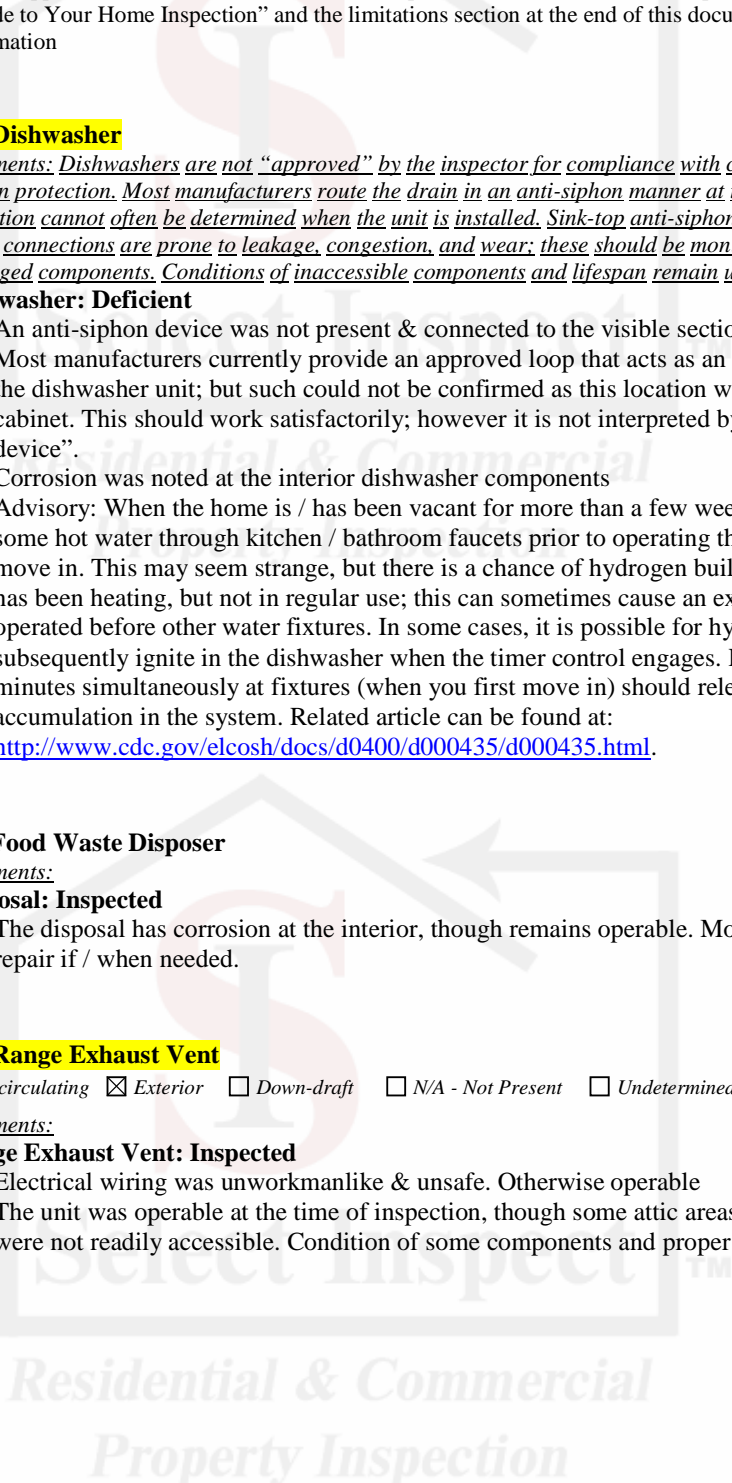
- Electrical wiring was unworkmanlike & unsafe. Otherwise operable
- The unit was operable at the time of inspection, though some attic areas above and including this vent were not readily accessible. Condition of some components and proper termination is undetermined.

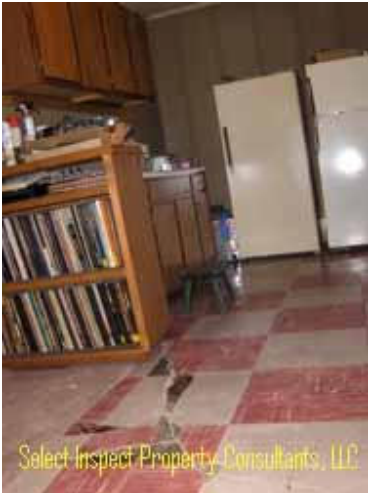
↑ upheaval cracks & other stress at garage conversion

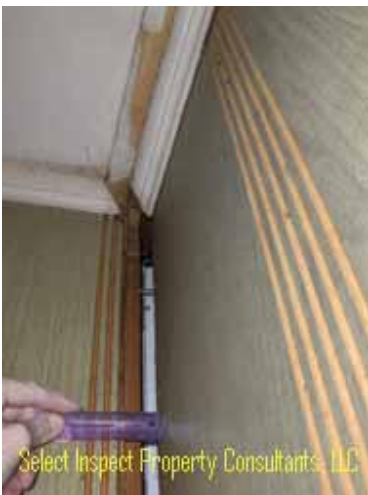
↑ wall stress greater than 1" garage conversion- southwest & western ceiling/wall

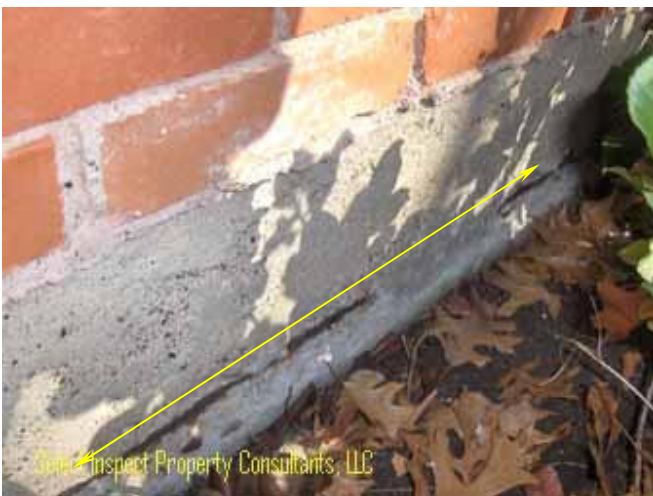
↑ spalling concrete & exposed reinforcement steel at south

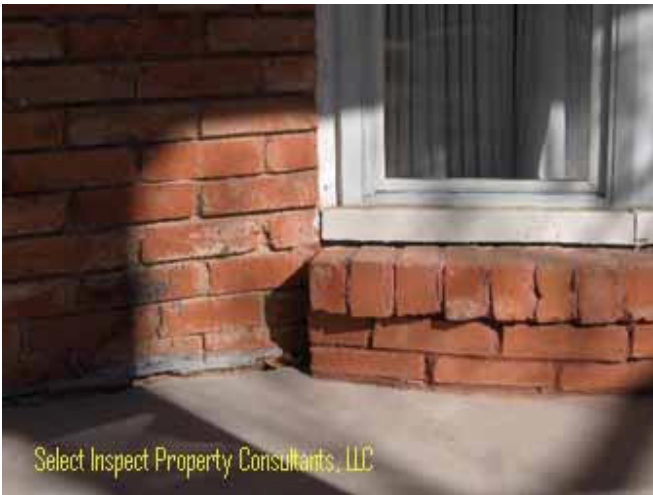
↑ uneven dining room bay window; openings exist

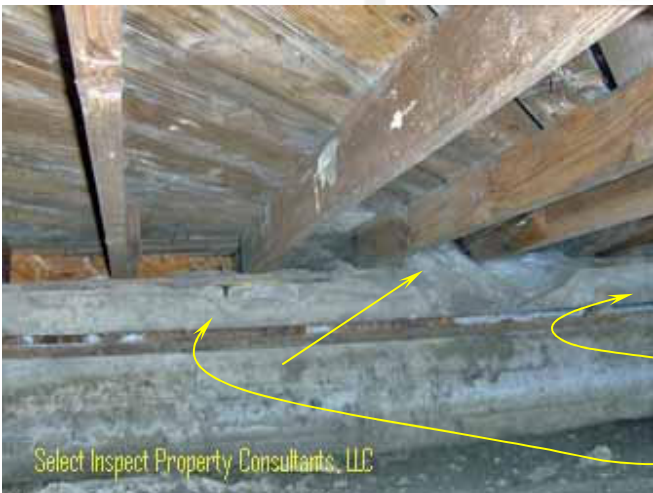
↑ plastic & moisture intrusion evidence below dining room window

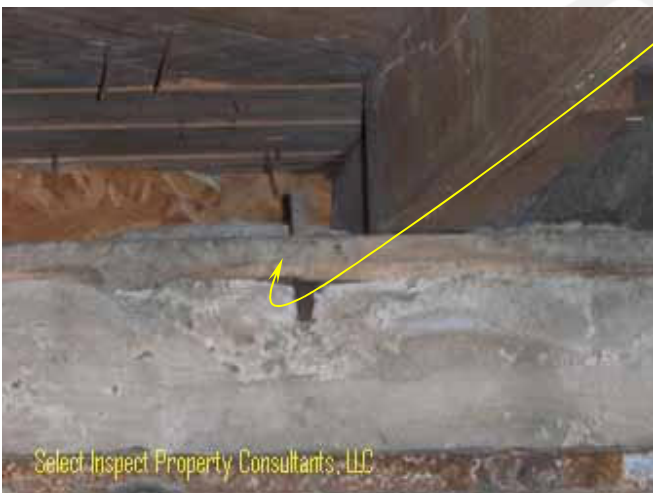
↑ spalling & unsecured anchor; crawl space southwest

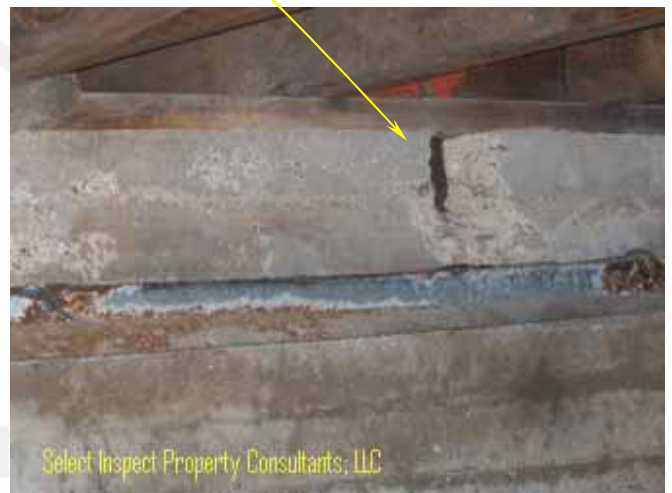
↑ spalling & unsecured anchor; crawl space southwest

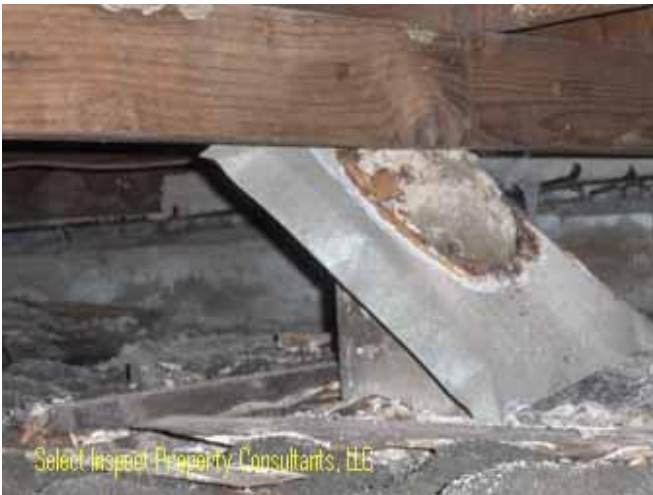
↑ corrosion & inadequate termite shield; example & worn pier; east crawl space

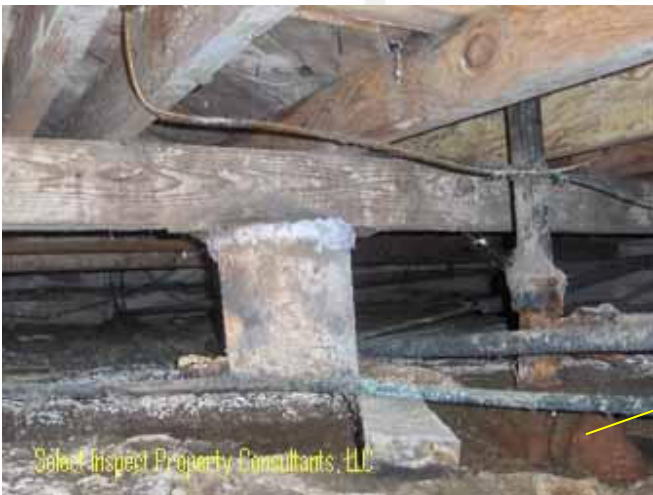
↑ leak below east bathroom & consistent moisture history (salt deposits at pier & muddy soils)

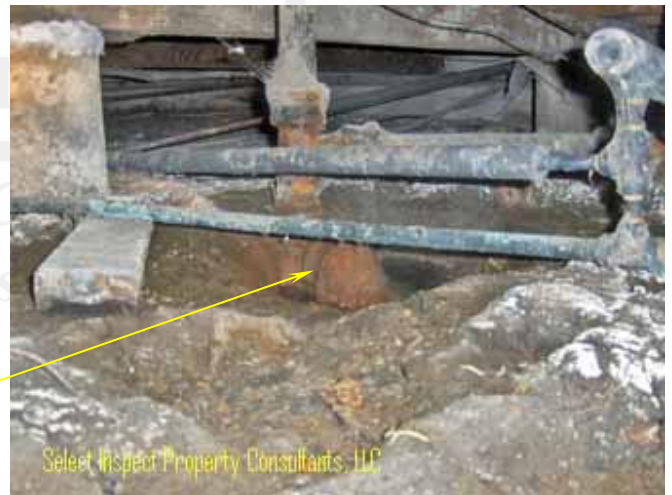
↑ close view of image at left; pooling water

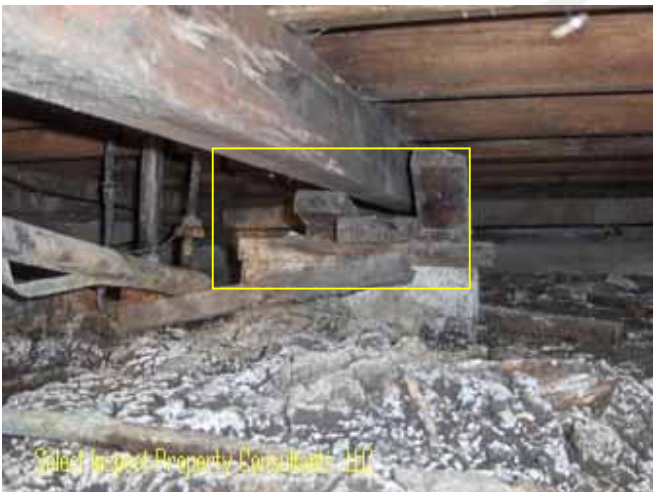
↑ inadequate wood shimming & calcium-like deposits on soil

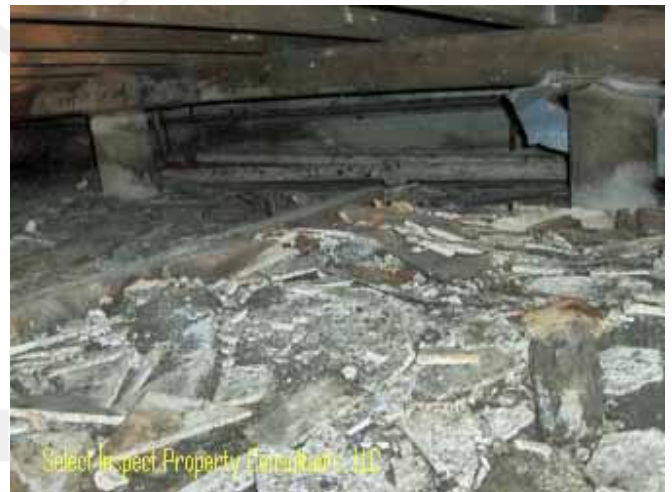
↑ wood debris; example at west side of fireplace foundation; conducive to wood destroying insects

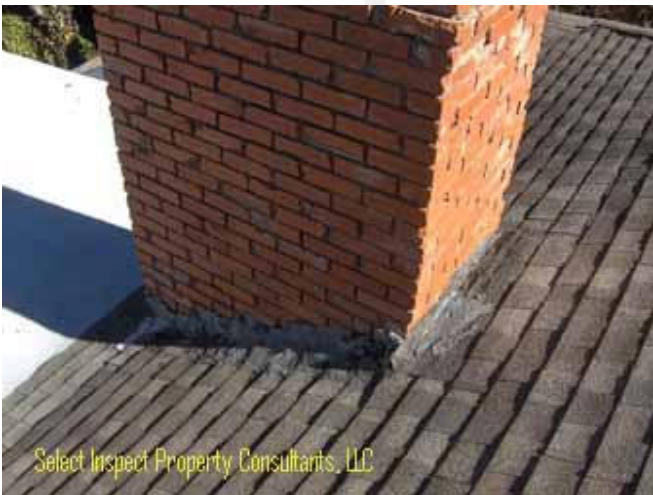
↑ excess tar repair attempt example at chimney

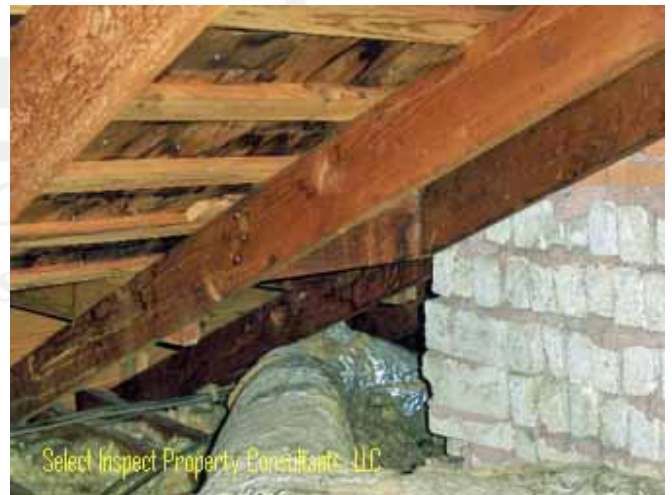
↑ moisture staining adjacent chimney in the attic

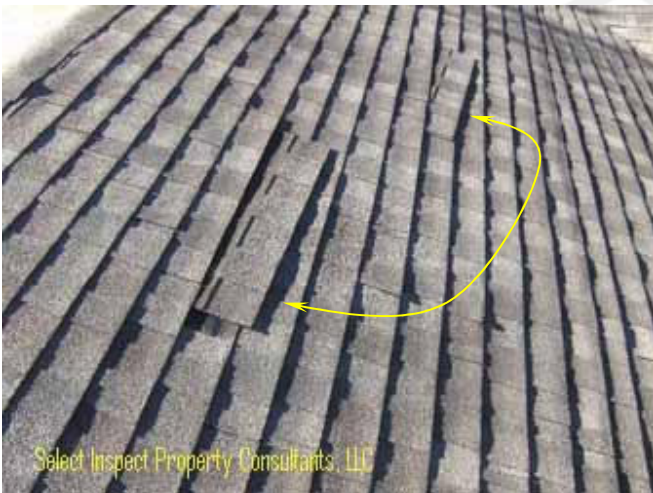
↑ slipped shingles; north exposure(s)

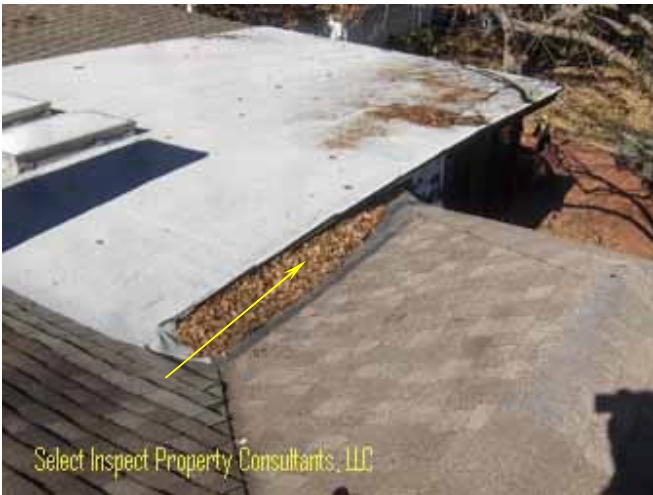
↑ converging valley; inadequate slope; excess tar & debris

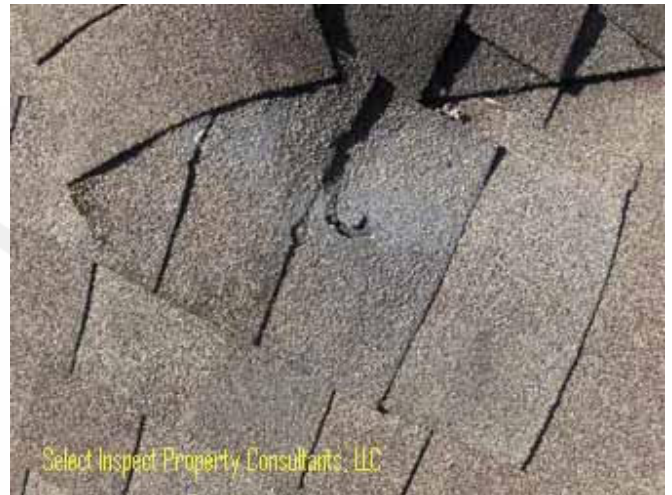
↑ example worn shingles & split hip

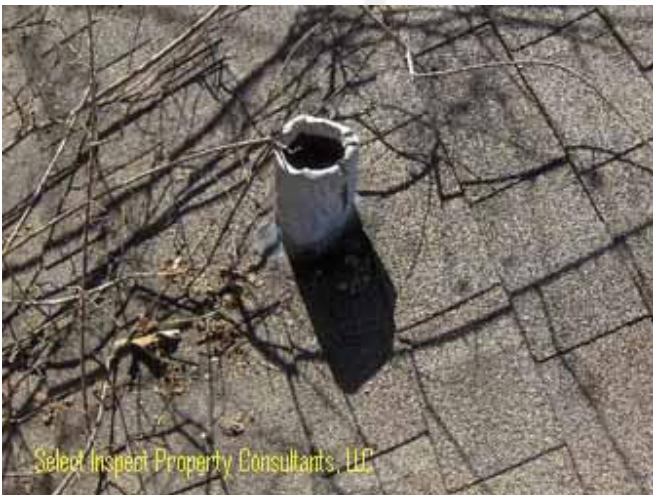
↑ unworkmanlike plumbing vent flashing below shingles; example

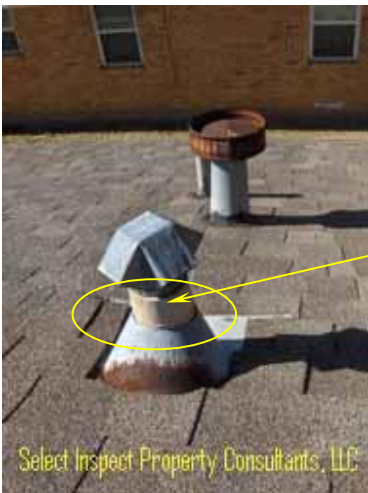
↑ missing rain shield at water heater flue

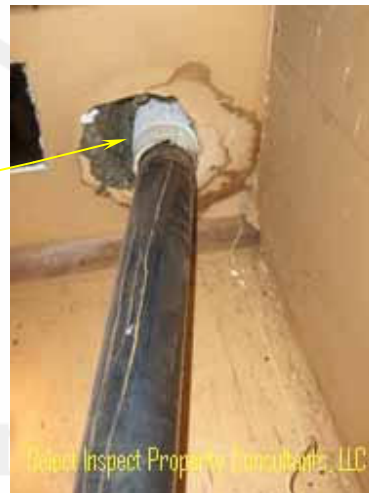
↑ moisture intrusion & corrosion evidence at water heater closet (white section is "transite" pipe)

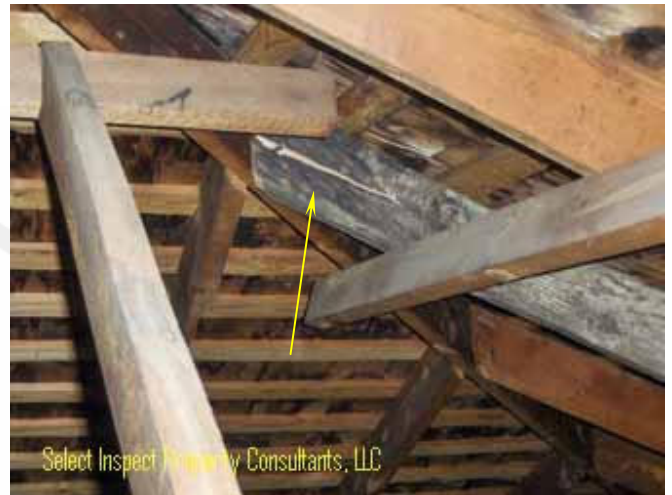
↑ example cracked framing in attic

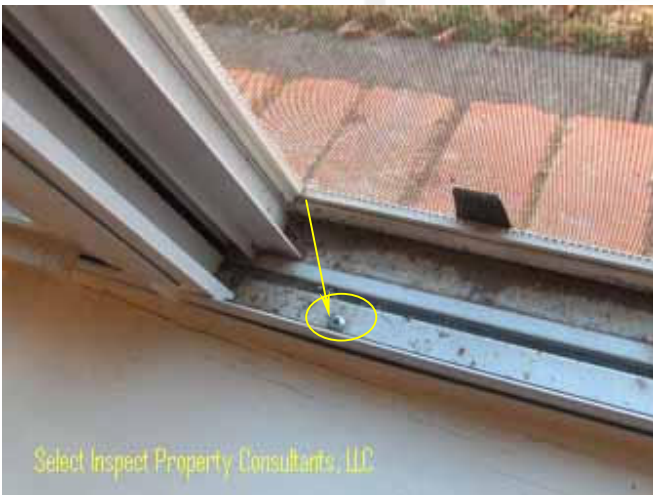
↑ screw at bottom of window is prone to moisture intrusion; unworkmanlike installation; example

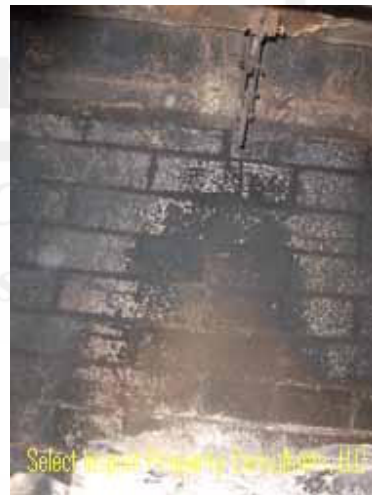
↑ moisture intrusion evidence & cracks at fireplace interior

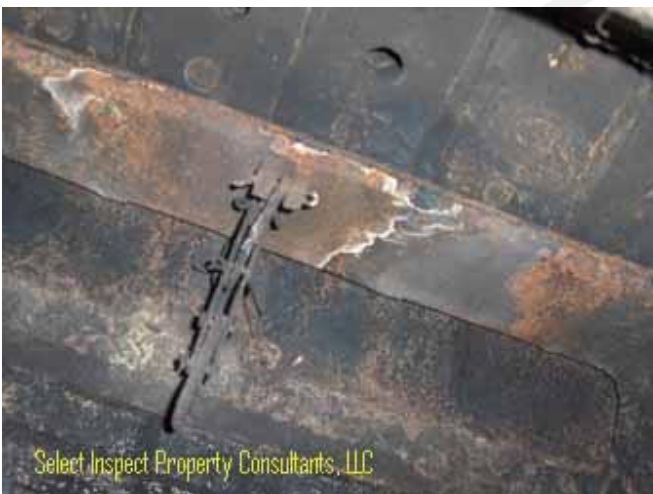
↑ corrosion at damper implies moisture intrusion history

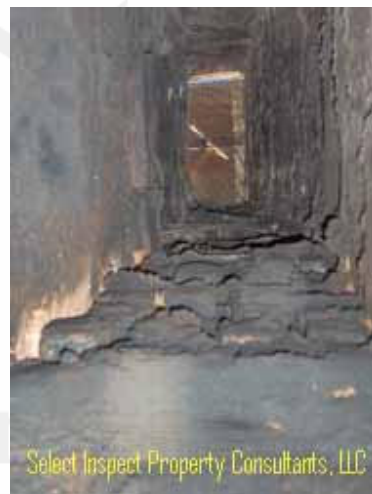
↑ fireplace flue needs professional cleaning & repair

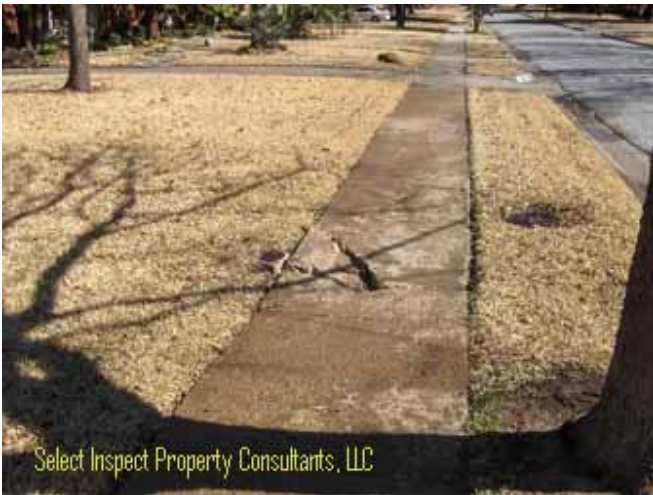
↑ trip hazard; sunken sidewalk

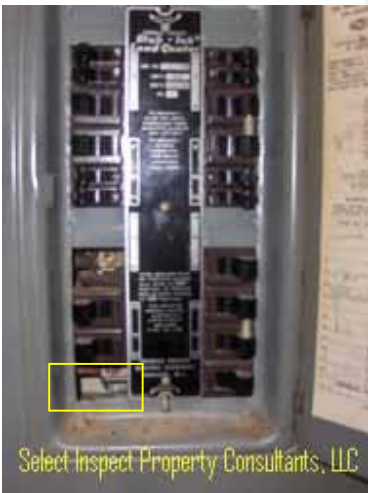
↑ missing knock-outs; example at closet panel

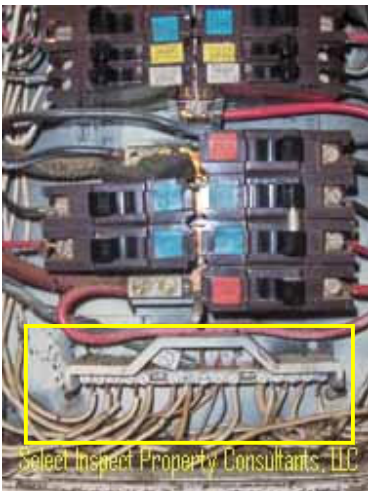
↑ neutral conductors must be isolated from equipment grounds in a subpanel; unworkmanlike wiring

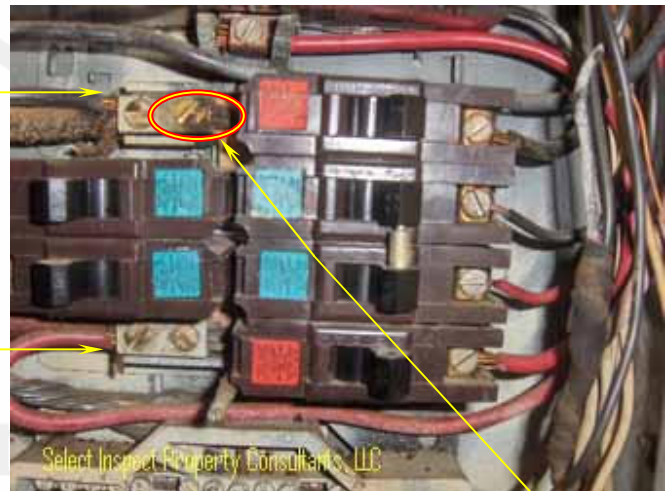
↑ double-tapped service terminals at sub panel; unworkmanlike; overheating evidence at black double tapped terminal; potential fire hazard

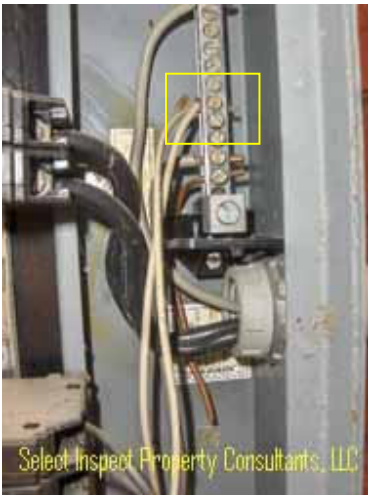
↑ conductors shall be terminated individually in lugs / breakers; main panel outside

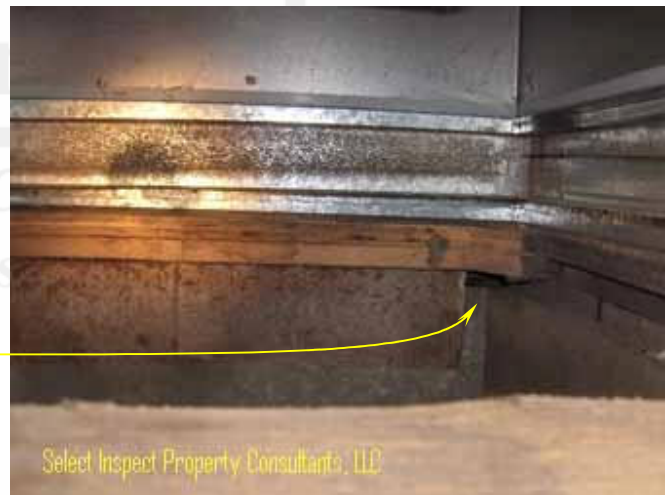
↑ inadequate seal of plenum below HVAC; pulls crawl space air

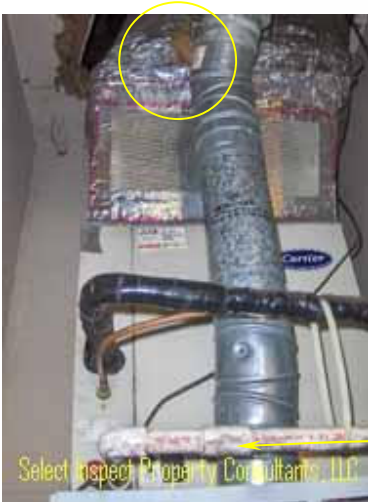
↑ inadequate seal at supply plenum above HVAC & fungus at primary condensate drain

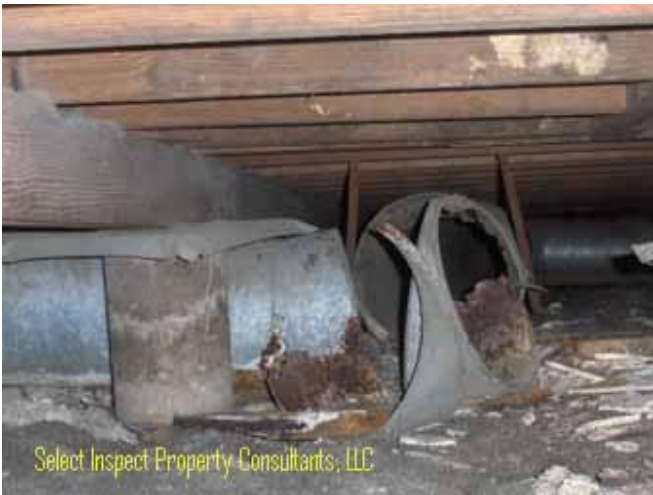
↑ unclean, corroded, disconnect return ducting in central crawl space; disrepair; very unhealthy

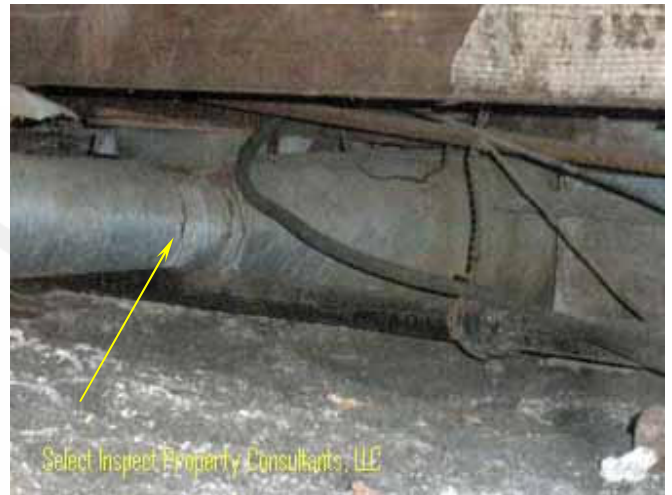
↑ crushed ducting in crawl space, near the HVAC

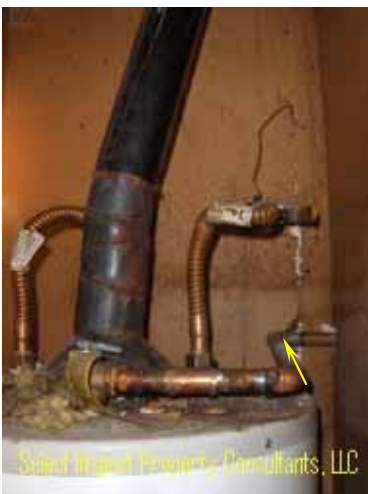
↑ temperature/pressure relief drain improperly routed uphill & moisture damage at flue; suspected moisture damage at interior of burn chamber as well

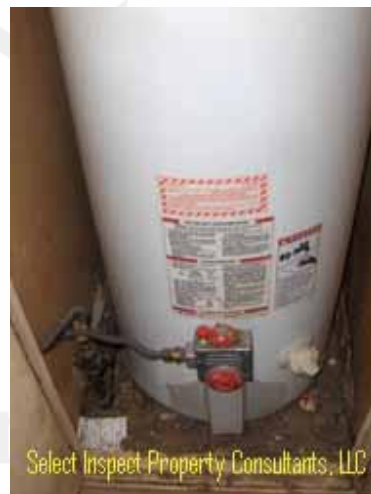
↑ moisture damage below water heater; auxiliary pan should have been installed with this device in 2000

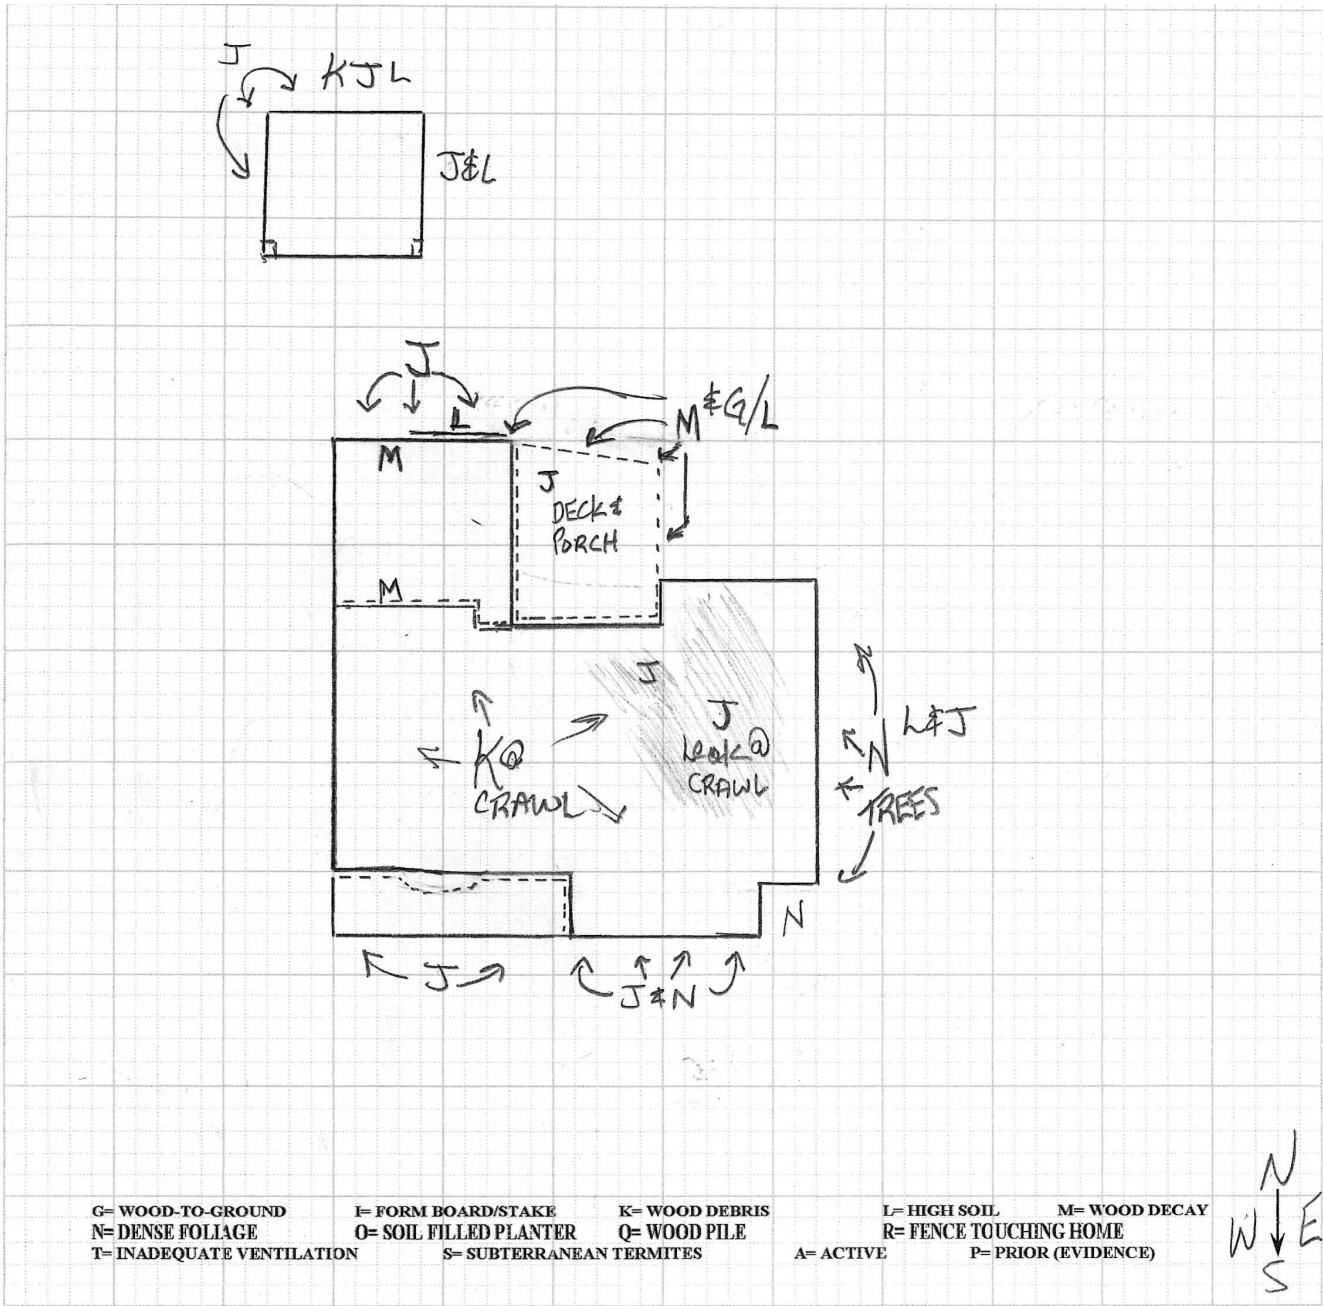
G= WOOD-TO-GROUND	I= FORM BOARD/STAKE	K= WOOD DEBRIS	L= HIGH SOIL	M= WOOD DECAY
N= DENSE FOLIAGE	O= SOIL FILLED PLANTER	Q= WOOD PILE	R= FENCE TOUCHING HOME	
T= INADEQUATE VENTILATION	S= SUBTERRANEAN TERMITES		A= ACTIVE	P= PRIOR (EVIDENCE)
